# Performance Evaluation of KYTC Bridge Deck Overlays Used for Maintenance Activities

Report Number: KTC-26-01

**September 2025**

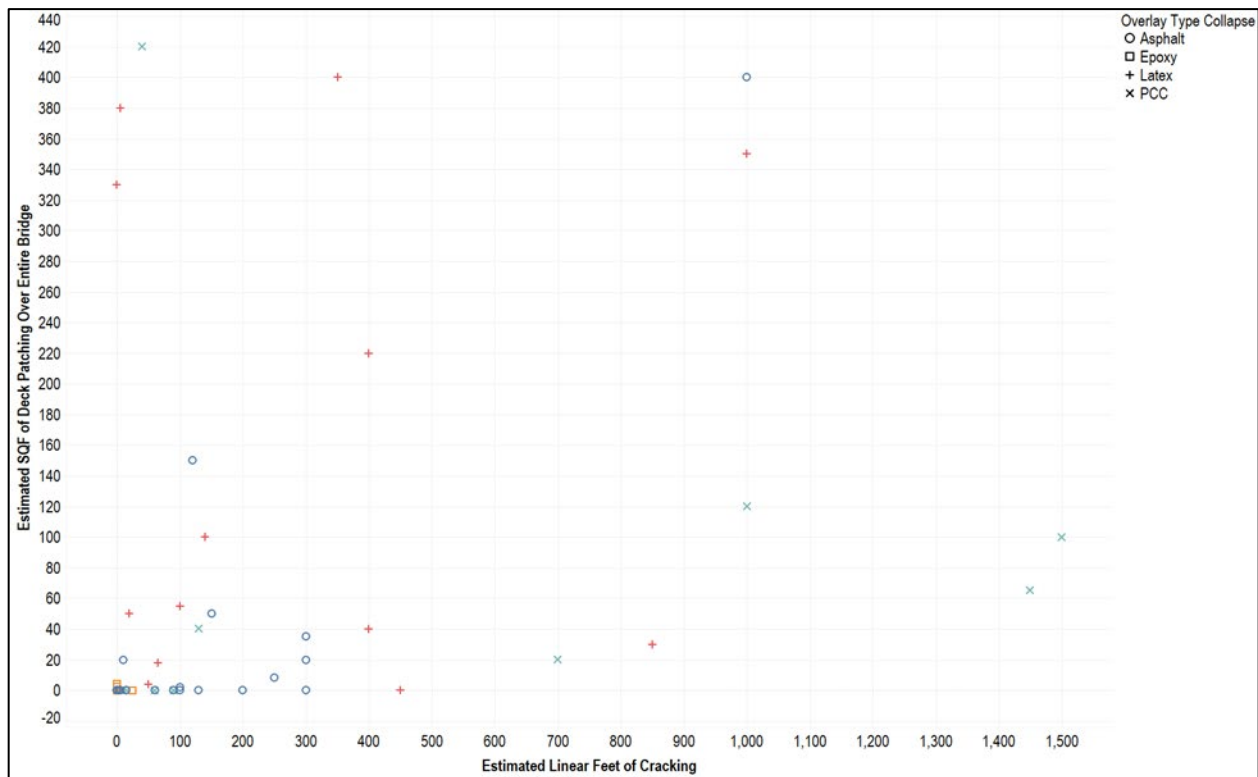
**Figure 3.12** Relationship Between Linear Feet of Cracking and Deck Patching

Correlations between deck patching and cracking on overlays (Figure 3.12), deck patching/cracking and ADT (Figure 3.13), and cracking and ADT (Figure 3.14) indicated no robust predictor of overlay performance.
