DOT/FAA/CT-93/78
DOT-VNTSC-FAA-93-10

Full-Scale Testing and Analysis of Curved Aircraft Fuselage Panels

December 1993

Final Report

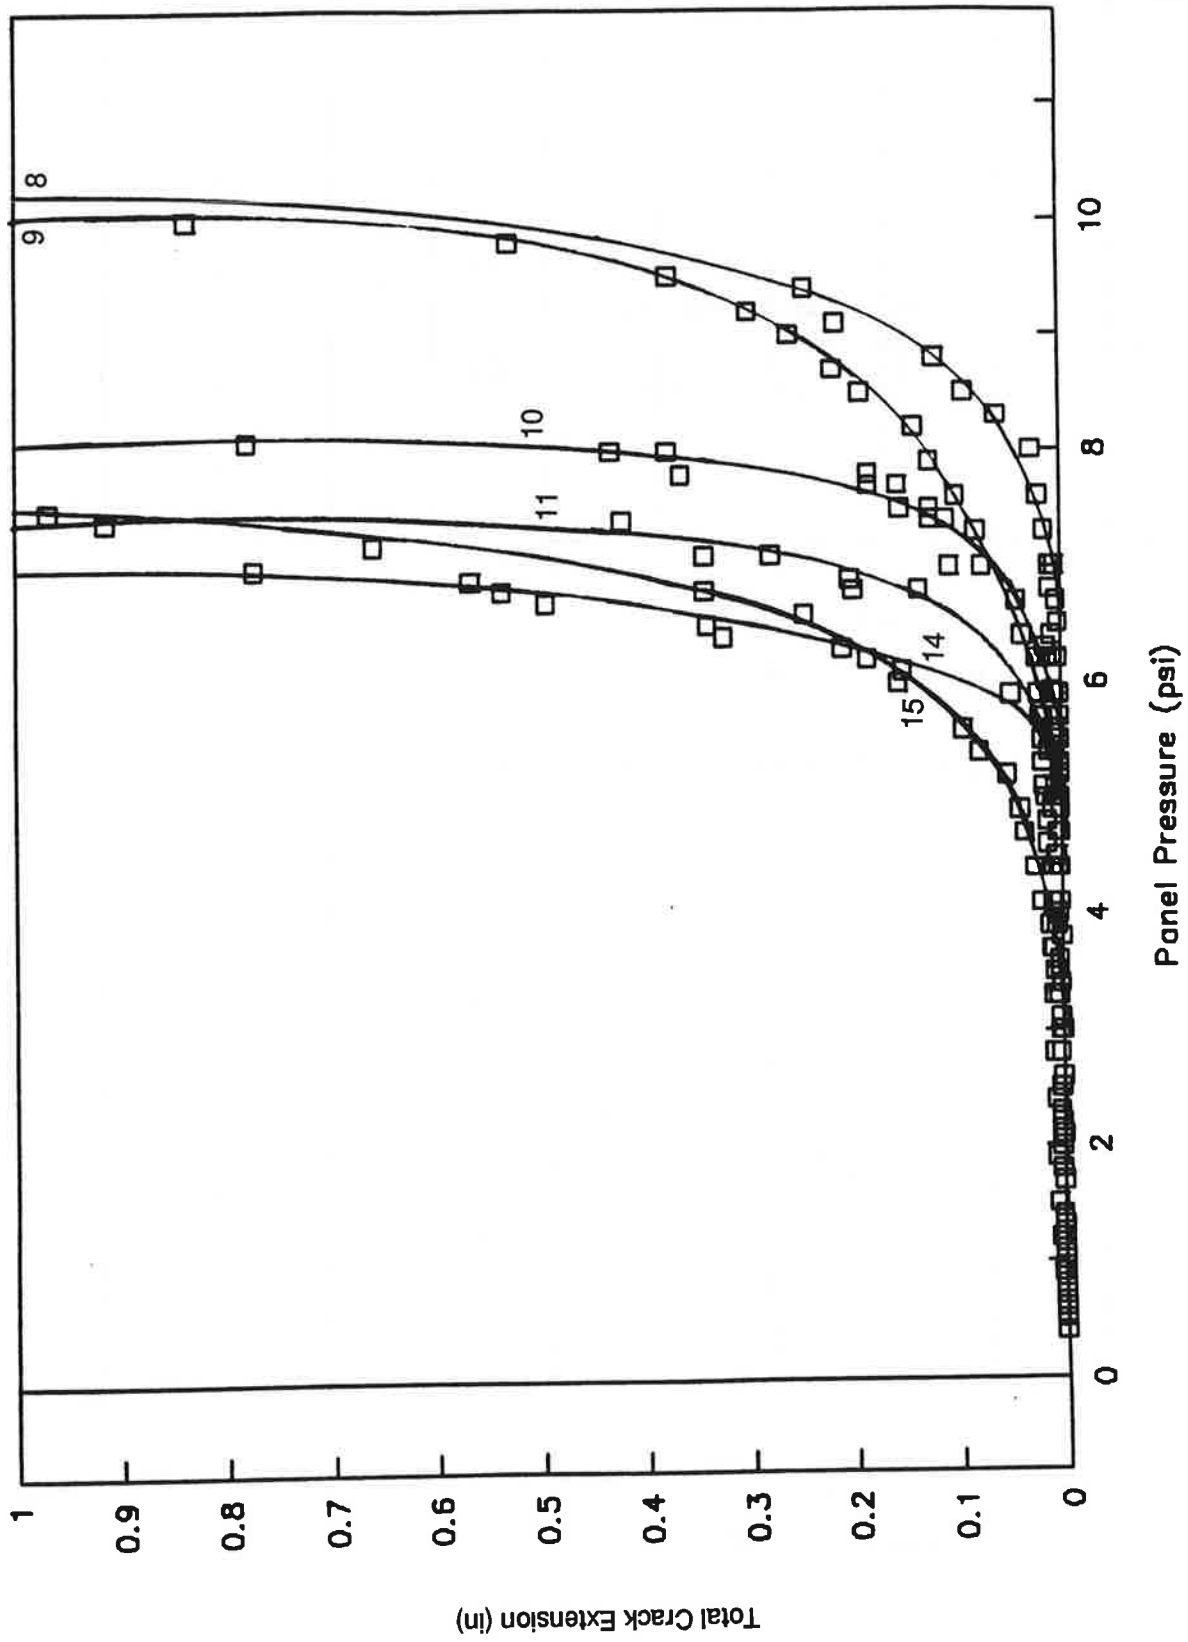
Figure 7. Crack Propagation in Residual Strength Tests

Test data and correlations with analytic predictions follow. The residual strength is expressed in terms of panel internal pressure at the onset of fast crack growth. Hoop and longitudinal stresses were measured with strain gauges. Crack propagations in the first ligaments beyond the lead crack tips were measured with an indirect DC potential drop system. The relationships between crack propagation and applied pressure are shown in Figure 7. The following subsections discuss the results of each test.

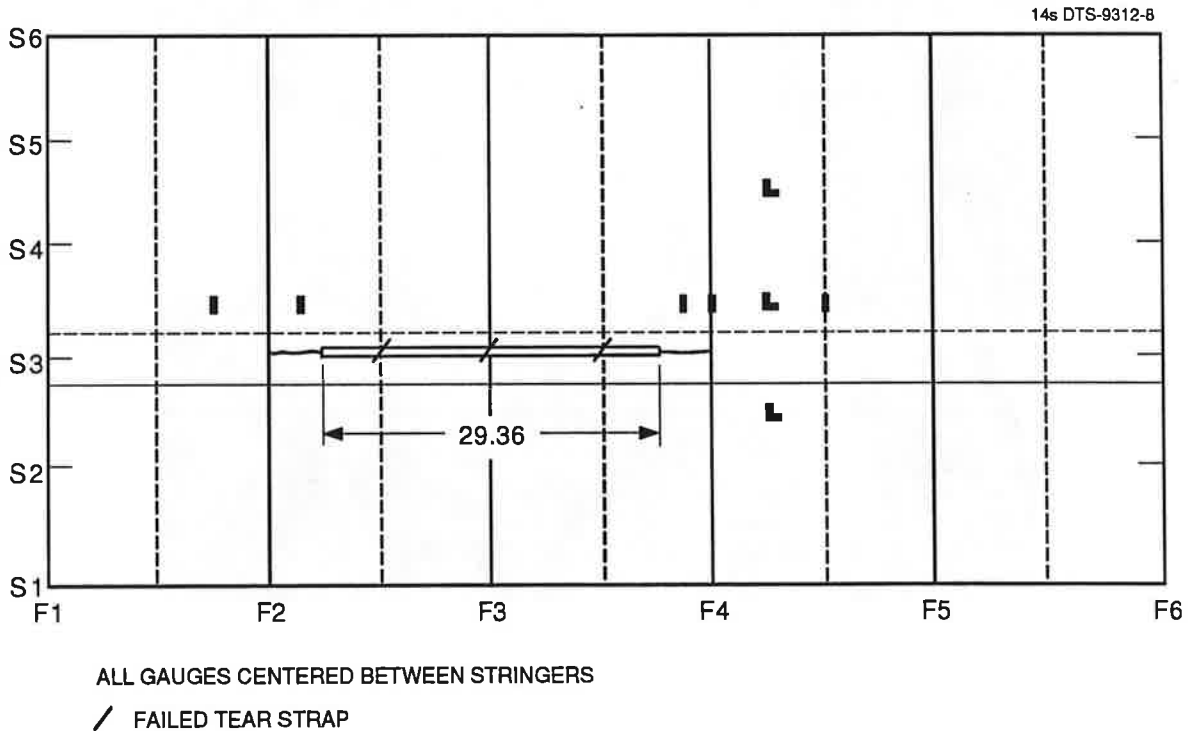
Figure 14. Panel 10 - After Fracture

Stable crack growth was observed in Panel No. 10 at approximately 6.2 psi. The total crack extension reached 0.1 in. at 6.9 psi. The three center tear straps failed at 8.1 psi. From the crack propagation gauges, it is evident that complete failure of the first ligaments also occurred at 8.1 psi. The crack propagated in both directions to the next frame. The final crack is shown in Figure 14. A photograph of the failed panel is shown in Figure 15.

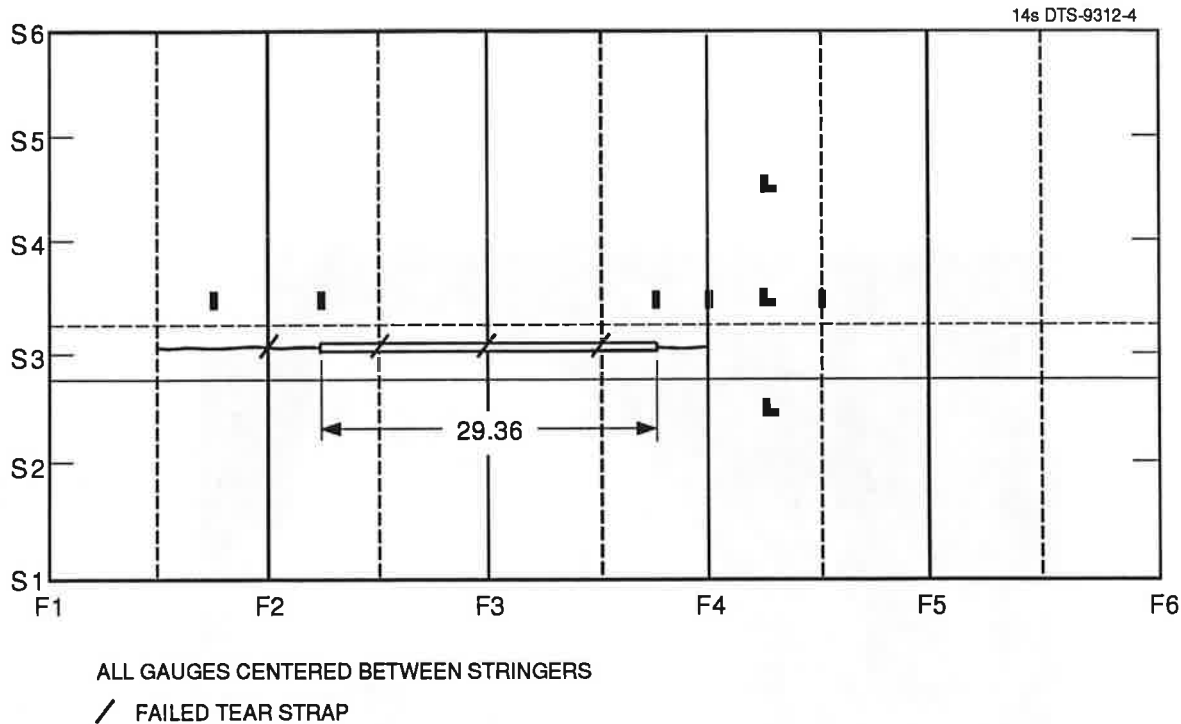
Figure 16. Panel 11 - After Fracture

grew to the tear strap between F1 and F2. The final crack is shown in Figure 16. A photograph of the failed panel is shown in Figure 17.

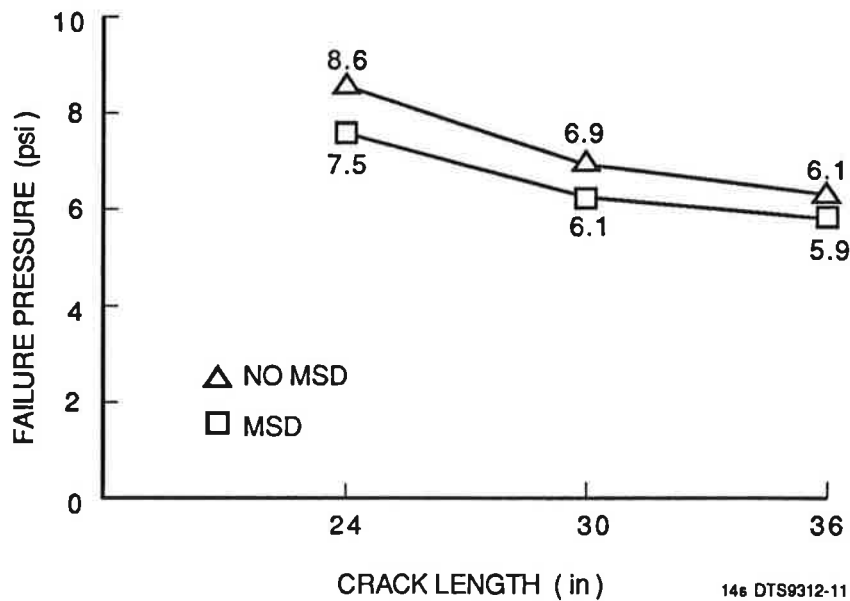
Figure 27. Panel Residual Strength

The residual strengths (failure pressures) for the test panels were shown in Table 5. The relationship between failure pressure and lead crack length is shown in Figure 27. The strength reduction due to MSD can be related, by an elementary analysis, to the area of the first

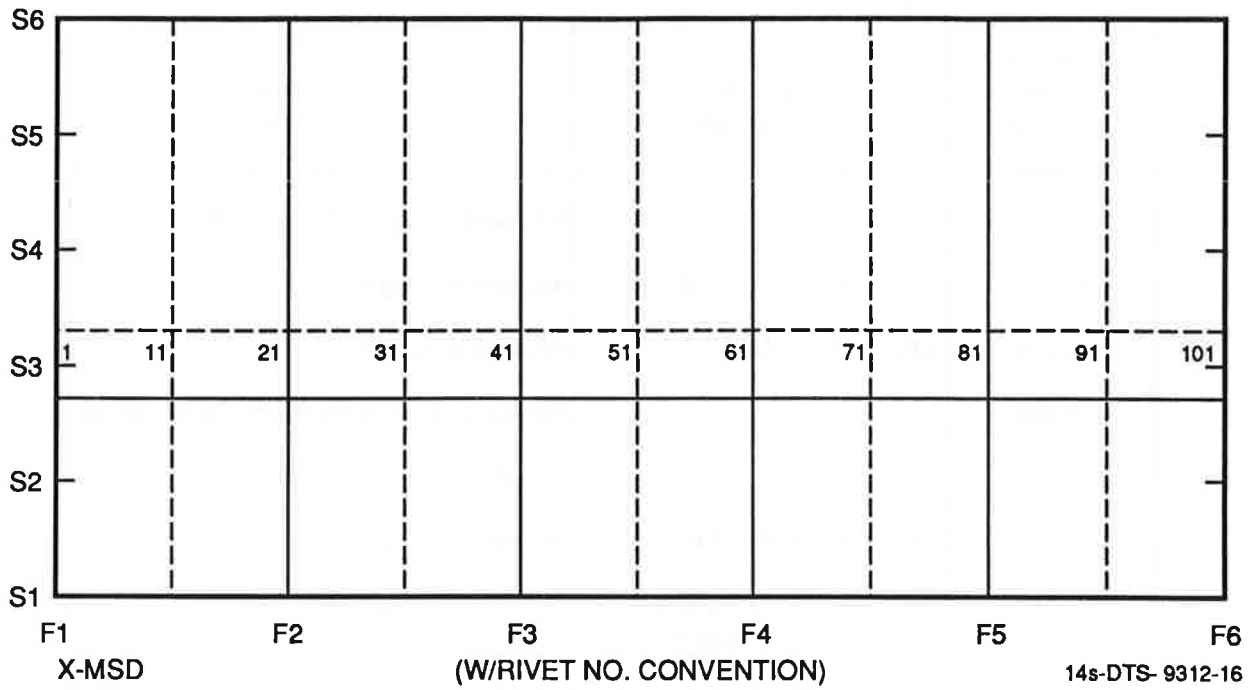
Figure 37. Test Panel No. 12 - Undamaged with Rivet Number Convention

The progression of test events is summarized in Table 6. For convenience in identifying damage locations, the rivet stations were consecutively numbered from F1 to F6 as shown in Figure 37. Damage to the numerically ascending and descending sides of the rivet are designated "+" and "-" respectively.

visible along the upper rivet row. At 114,571 cycles, lap joint leakage became pronounced. Upon inspection, link-up had occurred between rivets 35-37 on the lower rivet row. The panel fractured at 115,755 cycles. The failure occurred from rivets 22 through 51 on the lower rivet row, which ruptured the lower skin, as shown in Figures 38 through 40. No tear straps were broken.
