FRA-76-7-II
REPORT NO. FRA/ORD-76/303,II

TRAIN-TO-TRAIN REAR END
IMPACT TESTS
Volume II - Impact Test Summaries

MARCH 1977

FINAL REPORT

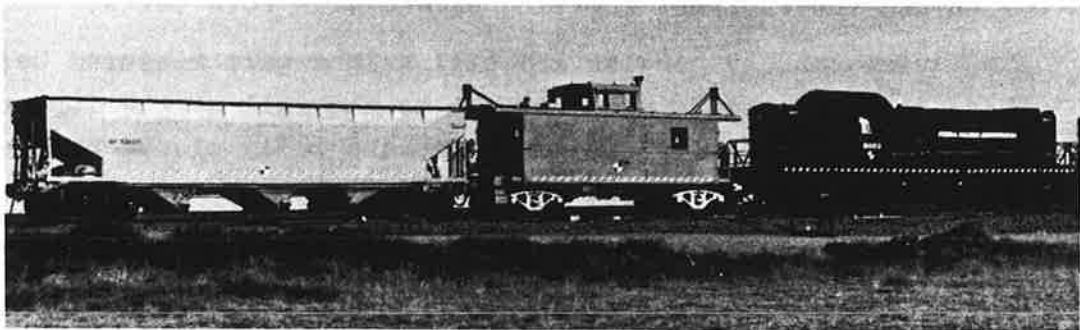
FIGURE 17. "SHORT TRAIN" USED FOR TESTS 1 THROUGH 4.

Figure 17 is a photograph of the "short train" used for Tests 1 through 4. The hopper car was loaded with ballast for Tests 3 and 4, and during impact, the ballast shifted toward the caboose. The most significant movement of ballast occurred during Test 4 (8.8 mph). Tests 5 through 7 showed little indication of additional ballast shift.

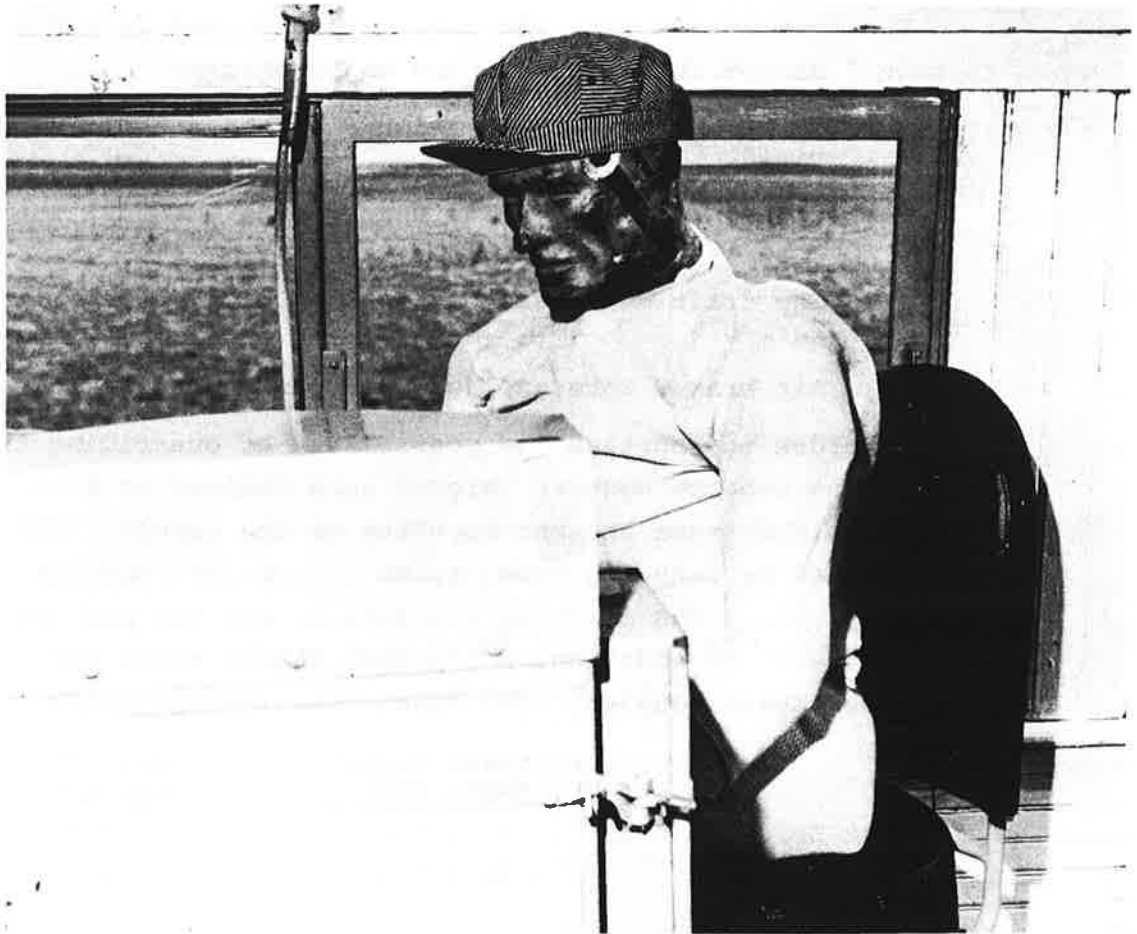
FIGURE 19. ANTHROPOMORPHIC 95TH PERCENTILE MALE DUMMY PLACED IN THE LOCOMOTIVE OPERATORS SEATING POSITION.

Ninety-fifth percentile (215-pound) anthropomorphic dummies were placed in the impacting locomotive to simulate a brakeman and an operating engineer (see Figure 19). In Test 4, the brakeman slid forward on the bench and hit a rear window, breaking the glass. Test 7 produced a similar occurrence with the brakeman and the engineer shifting slightly in both tests.

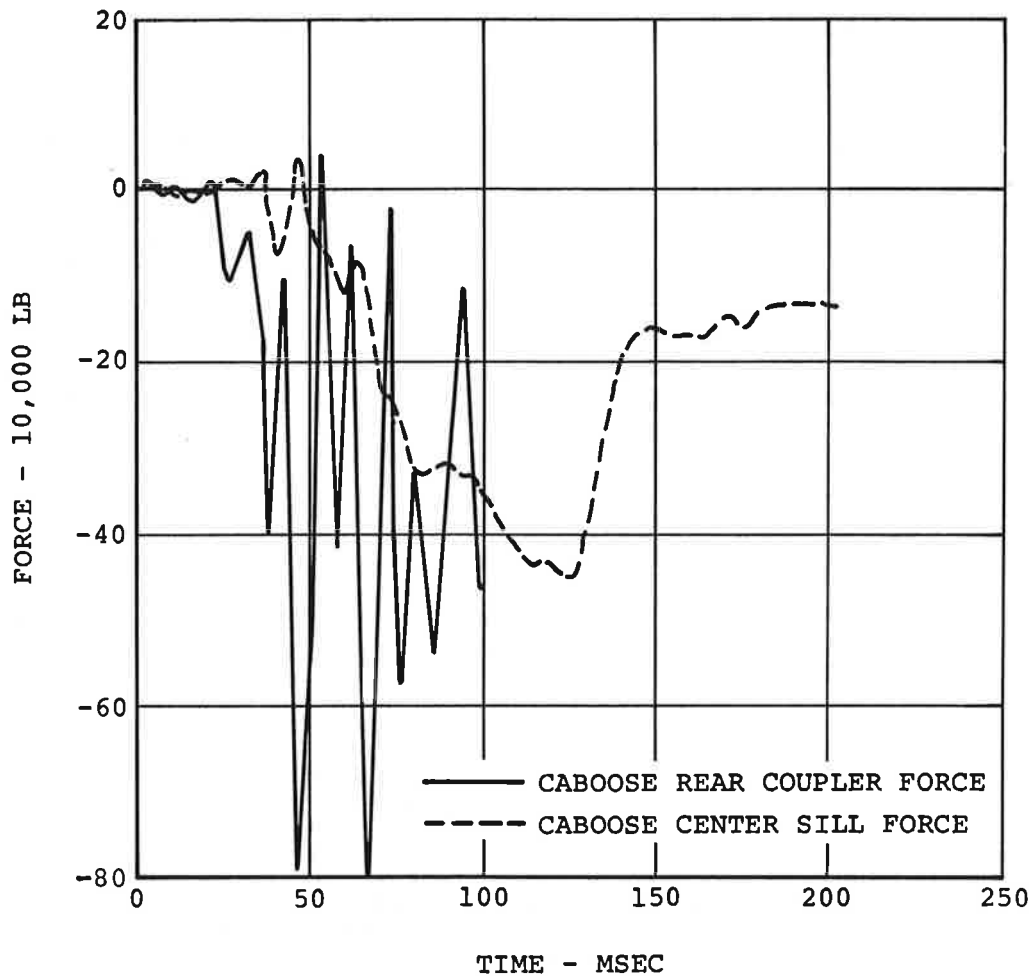
FIGURE 36. CABOOSE COUPLER FORCE AND CENTER SILL FORCE - TEST 8.

sill also was instrumented and calibrated to measure the force in the end section. Before the coupler bottomed out, the coupler applied the force to the center sill inside the strain gauge so that the sill did not register the compressive force until the coupler bottomed out. In fact, the end portion of the sill accelerated the structure of the end of the caboose and had a small tension force. Figure 36 is a superposition of the caboose coupler and center sill force. Note how the coupler force level was dropping as the center sill rose. This happened as the caboose began to move and rotate. The total force on the caboose at about 80 msec was approximately the sum of these two and was estimated to be approximately 600,000 pounds. One coupler between each car was instrumented with a strain gauge for measuring force. Figures 37 and 38 superpose the coupler force curves for the stationary and moving trains, respectively. These curves illustrate how the force propagated through the train. The front caboose coupler force was relatively low as the coupler between the caboose and hopper was decoupled by the rotation of the caboose before large forces could be realized.

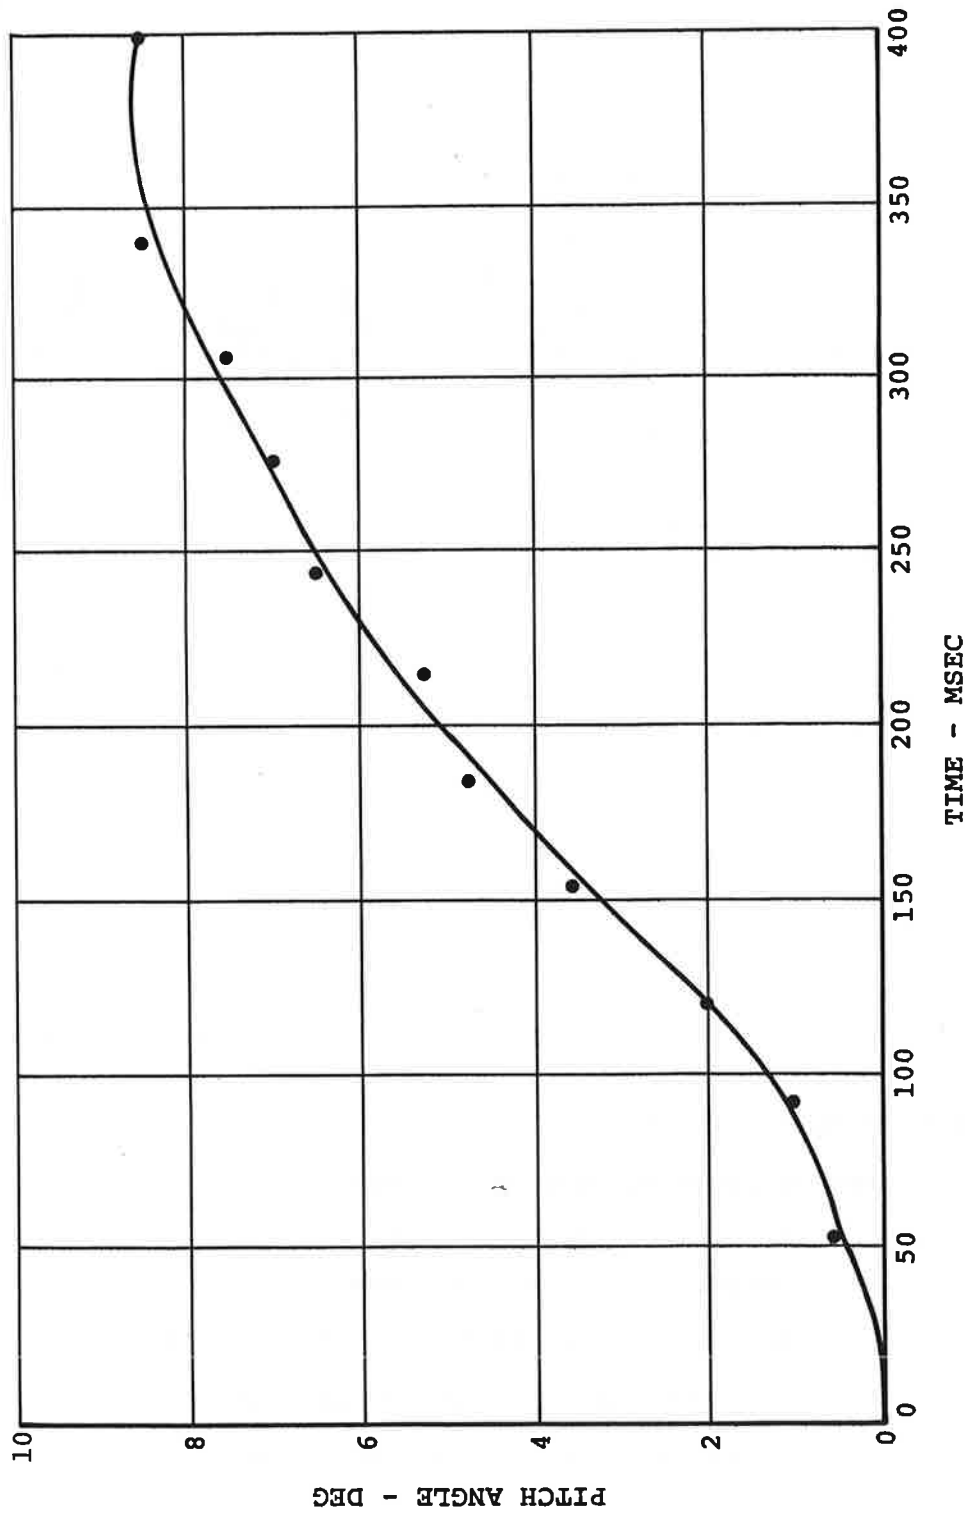
FIGURE 41. CABOOSE PITCH - TEST 8.

The caboose rotation as taken from an analysis of the film is shown in Figure 41. The angular velocity at about 100 msec was approximately 17 deg/sec. Between about 100 and 300 msec the caboose had an average angular acceleration, α , of 155 deg/sec². This is approximately 2.7 radians/sec². The caboose had a c.g. height, x , of 24 inches and a mass moment of inertia, I , of 754,643 in.-lb-sec². This means a force applied through the center of the coupler can be found from the relation.

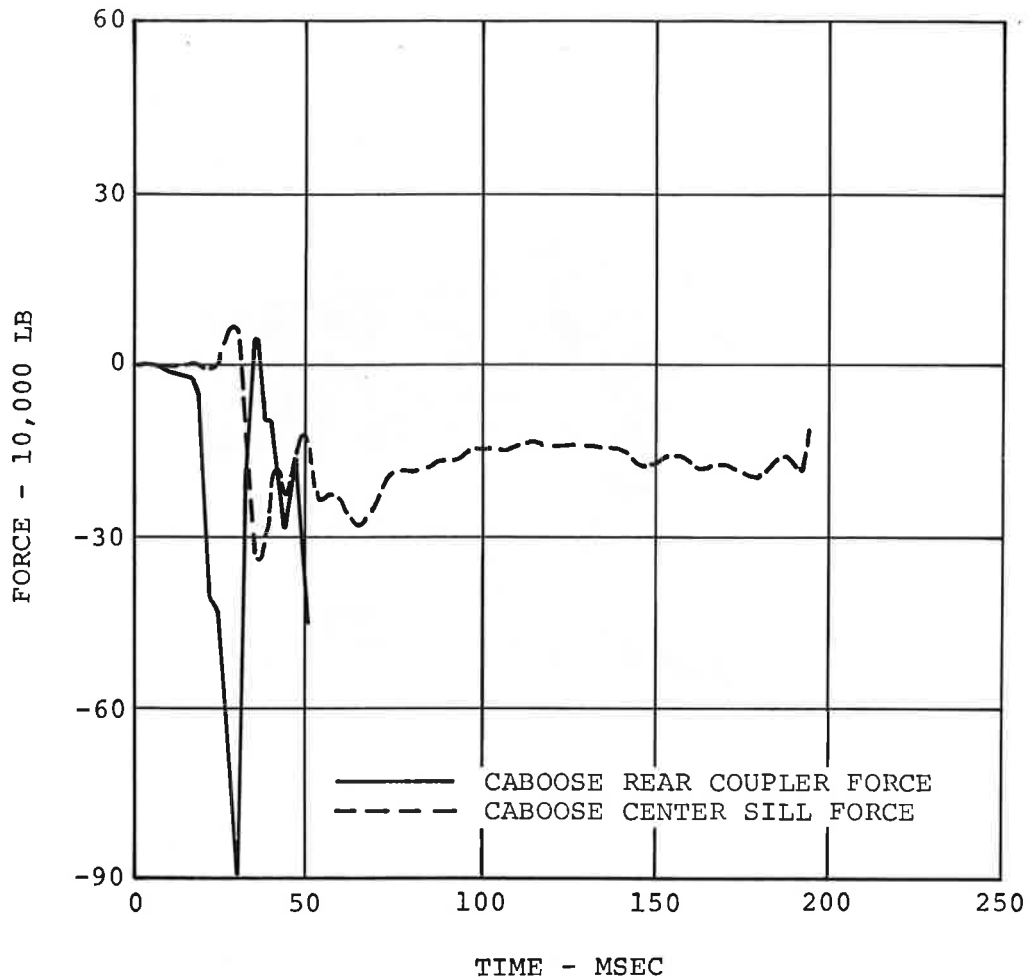
FIGURE 58. CABOOSE COUPLER FORCE AND CENTER SILL FORCE TESTING.

bottomed out. In fact, the end portion of the sill was actually in compression as the sill accelerated the structure of the end of the caboose and had a small tension force. Figure 58 is a superposition of the caboose rear coupler force and the force measured by the center sill strain gauges. Note how the sill force begins to rise as the coupler force lowers. This occurred in time shortly after the coupler was observed to contact the buffer casting and as the caboose began to move forward. The total force on the caboose at about 50 msec is estimated to be approximately 500,000 pounds.

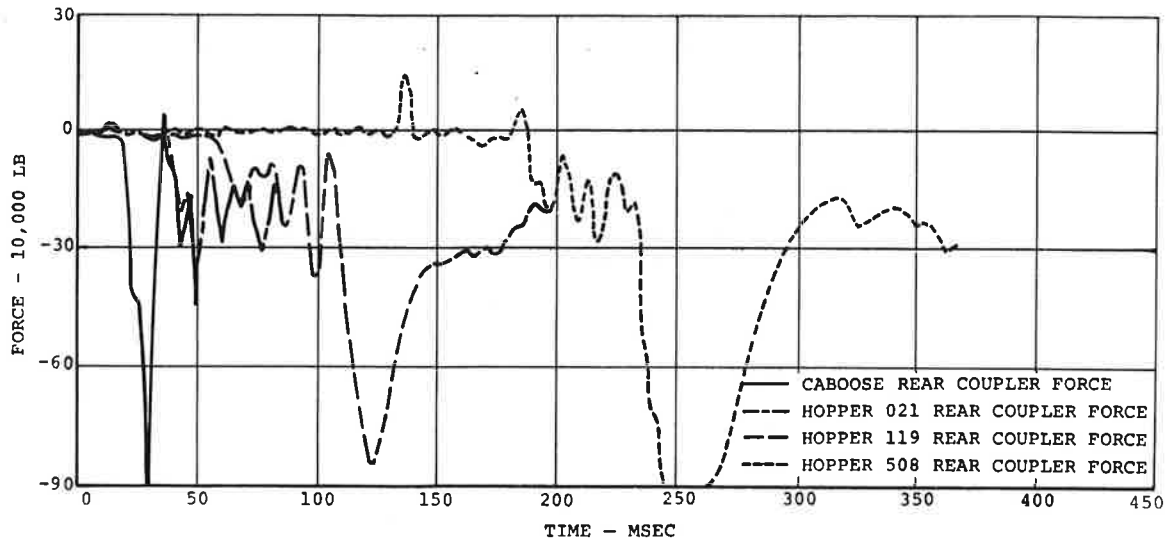
One of the couplers between each car was instrumented with a strain gauge. Figures 59 and 60 superpose the coupler forces as measured by these couplers for the stationary train and moving train, respectively. These curves illustrate how the force wave

traveled down each train. The time between the initial peak for each successive car increased as the distance the cars were from impact increased, particularly for the stationary train.

FIGURE 59. COUPLER FORCE PROPAGATION THROUGH STANDING TRAIN - TEST 9.

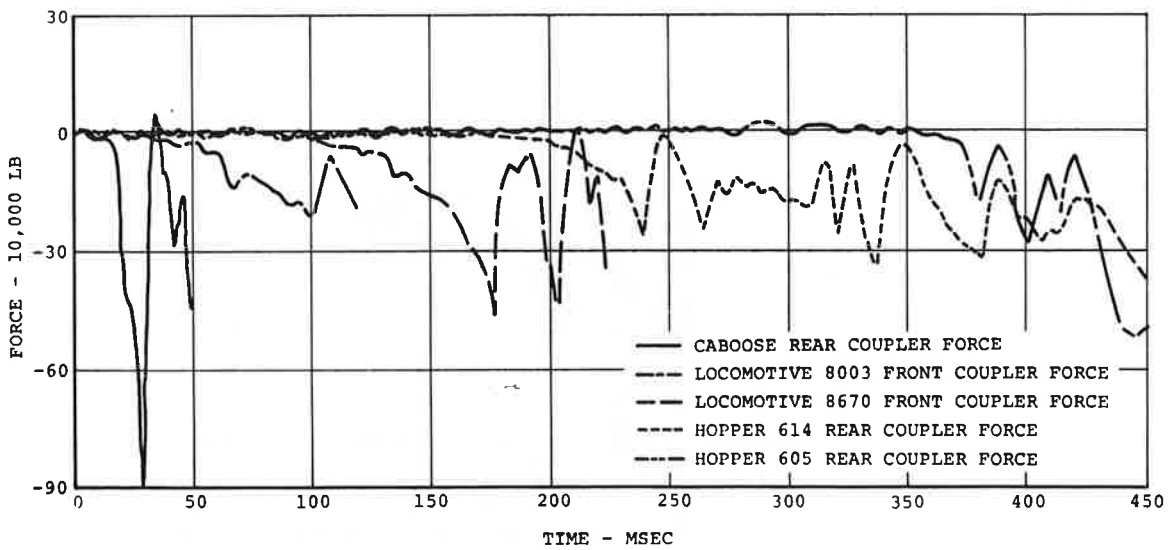
FIGURE 60. COUPLER FORCE PROPAGATION THROUGH MOVING TRAIN - TEST 9.

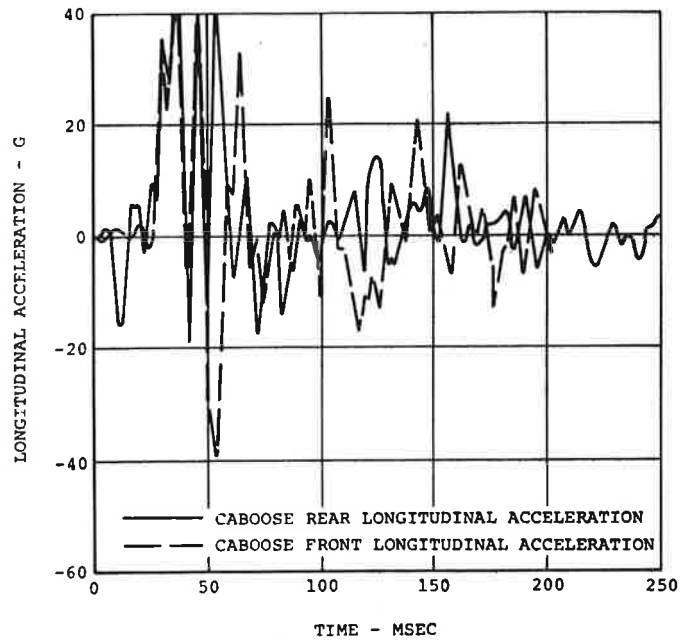
The accelerometers on the caboose for this impact exhibited a lot of high frequency vibrational "spikes". Figures 61 and 62 superpose the longitudinal and vertical accelerations from each end of the caboose.

FIGURE 61. CABOOSE LONGITUDINAL ACCELERATION - TEST 9.

If the caboose weight is taken as 30,000 pounds, and the average longitudinal force was 500,000 near 50 msec, then the average acceleration near 50 msec should be about 17G.

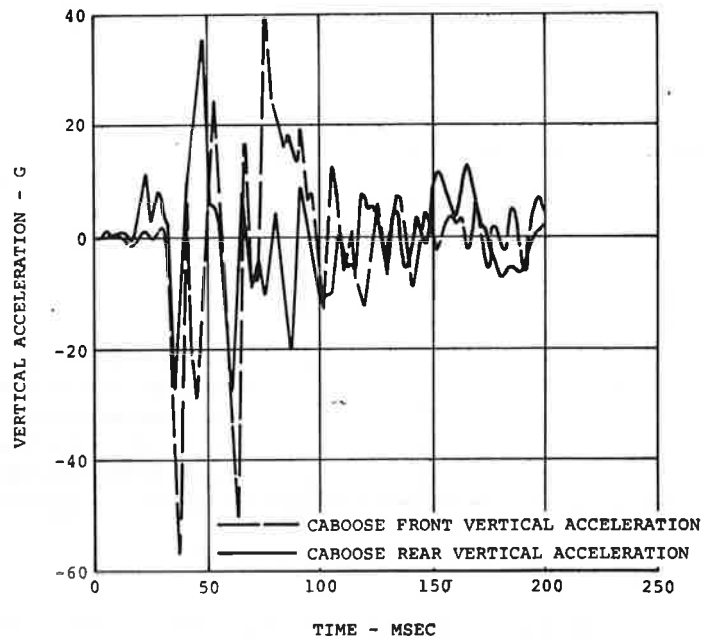
FIGURE 62. CABOOSE VERTICAL ACCELERATION - TEST 9.

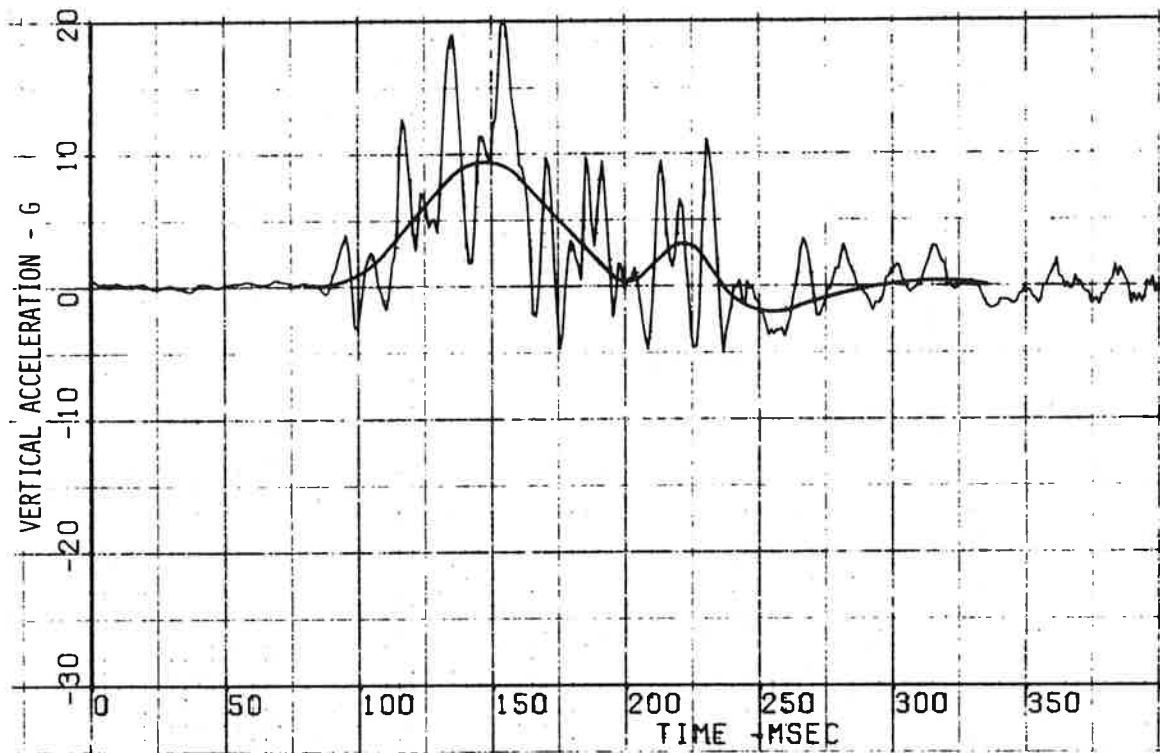
Data from the digital plots shown in the Appendix are tabulated here for the more important instruments in order to show relationships, trends, and unusual occurrences. The values shown in the tables were obtained from filtered or smoothed curves. The curves were smoothed as required to eliminate local vibrational effects. In many cases, the data displayed a high-frequency ringing noise superposed on the lower frequency data that represent rigid body-type motion of the train or train components. This high-frequency part of the data is in the form of spikes of short duration. The physical gross motion of the instrument is difficult to determine without smoothing. This is true, particularly of accelerometers and strain gauges. An example of this smoothing of an acceleration curve which shows high acceleration peaks is shown in Figure 63.

FIGURE 63. EXAMPLE OF CURVE SMOOTHING OF ACCELEROMETER DATA.

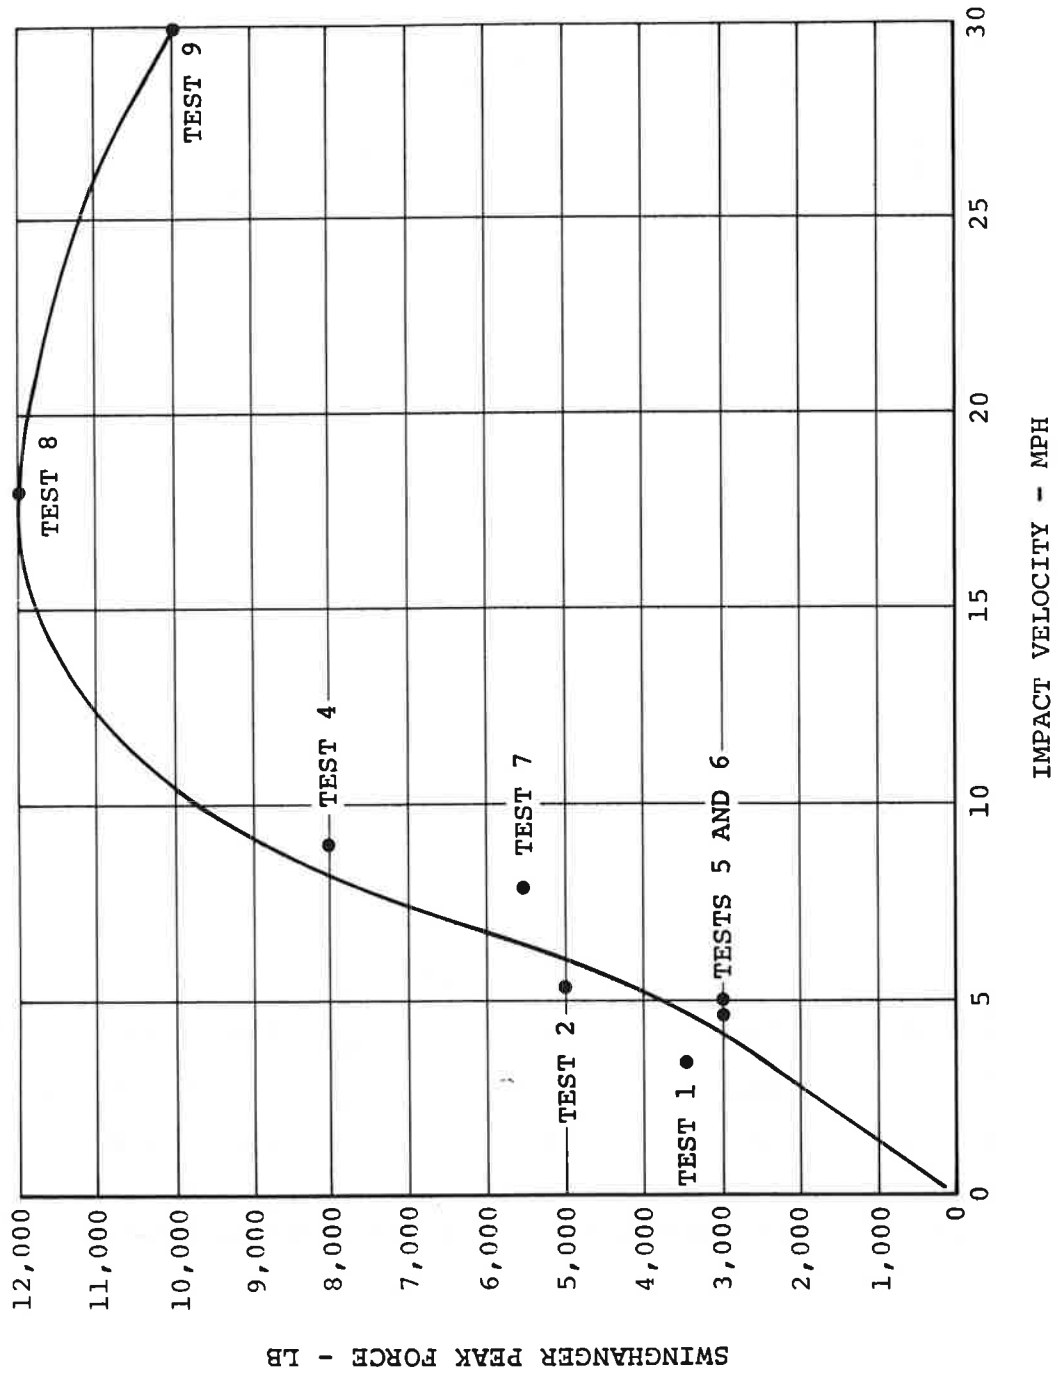
Table 14 summarizes the peak resultant swinghanger forces for both caboose trucks. A positive number is downward compressive force (more tension in the swinghangers) and a negative number is lifting of the caboose (less tension in the swinghangers). Again, the rear end of the caboose went down and then up while the front end only went up. The downward force increased with increased impact velocity (see Figure 64) up to 18 mph, but at 30 mph, the longitudinal motion was larger than the downward motion. For this test, the caboose center plate passed beyond the rim of the bolster before the end of the caboose reached its maximum downward motion.

FIGURE 64. CABOOSE REAR END DOWNWARD FORCE

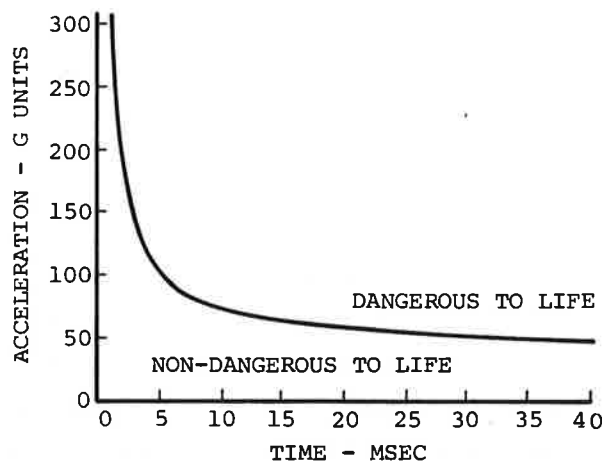
Experimental evidence suggests that human tolerance limits depend on the duration as well as the magnitude of deceleration (Figure 65).

FIGURE 65. HEAD ACCELERATION VERSUS TIME FOR HUMAN SURVIVAL.

Both Tests 8 and 9 had very low values (less than 20G) of maximum deceleration in the locomotive cab (Location MA2) and the caboose (Location SA1). It can be inferred, then, that the acceleration levels were not high enough to cause significant injury. This does not eliminate possibilities of injuries due to contacting sharp interior surfaces, intrusion, whiplash, etc.

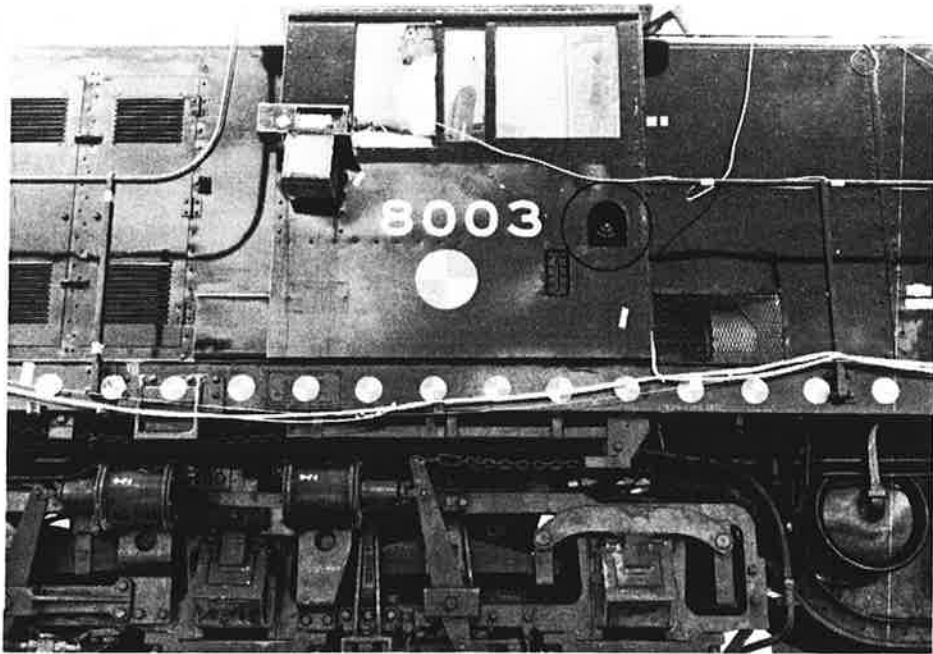
Filling is accomplished through filler connections located in the top tank near sight gauge glasses which permit observation of the fuel level during filling (see Figure 66). Fuel from the top tank is gravity fed to the lower tank through the equalizing pipe on the right side of the locomotive which is shown in Figure 67. The fuel feed and return lines, shown in Figure 68, exit the lower tank from the front left corner of the tank.

FIGURE 66. LOCOMOTIVE FUEL FILLER.

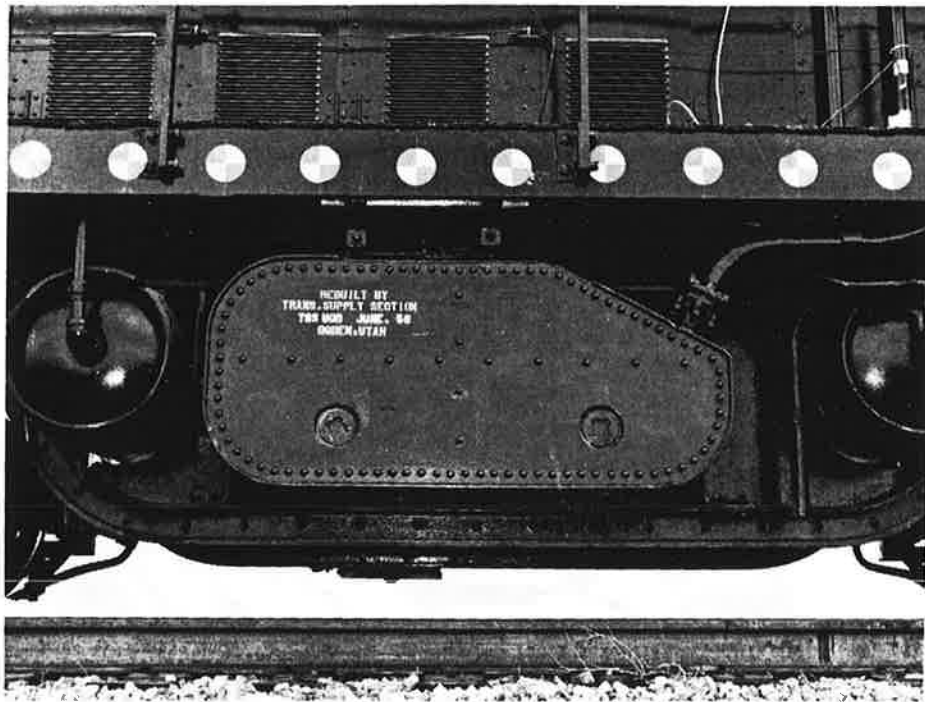
FIGURE 67. LOCOMOTIVE LOWER FUEL TANK.

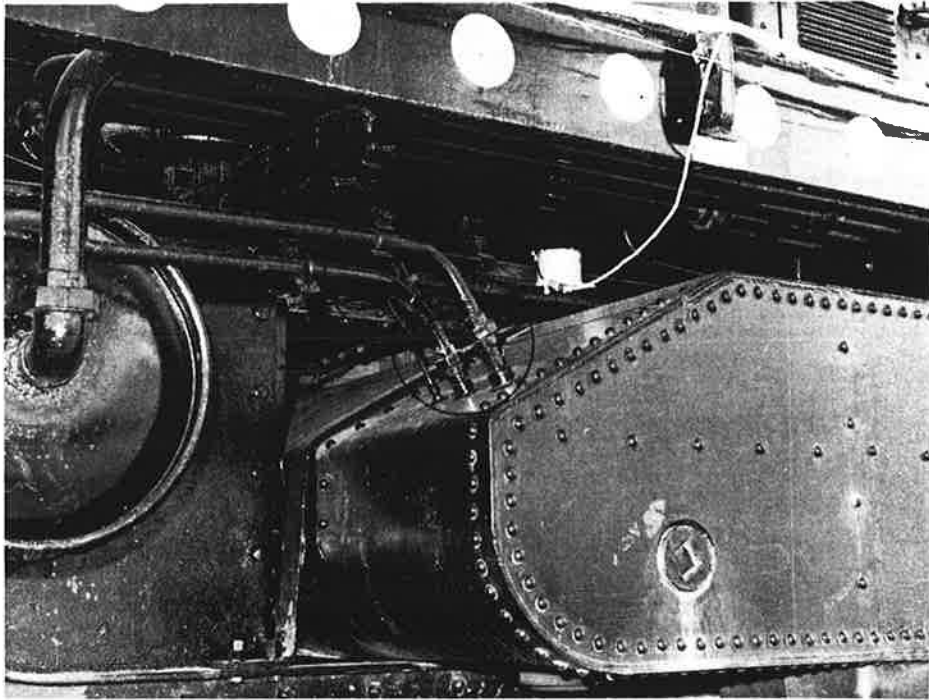
FIGURE 68. LOCOMOTIVE FUEL FEED AND RETURN LINES.
