Publication No. FHWA-RD-93-097
July 1994

Testing of Small and Large Sign Support Systems FOIL Test Numbers: 92F009 and 92F010

U.S. Department of Transportation
Federal Highway Administration

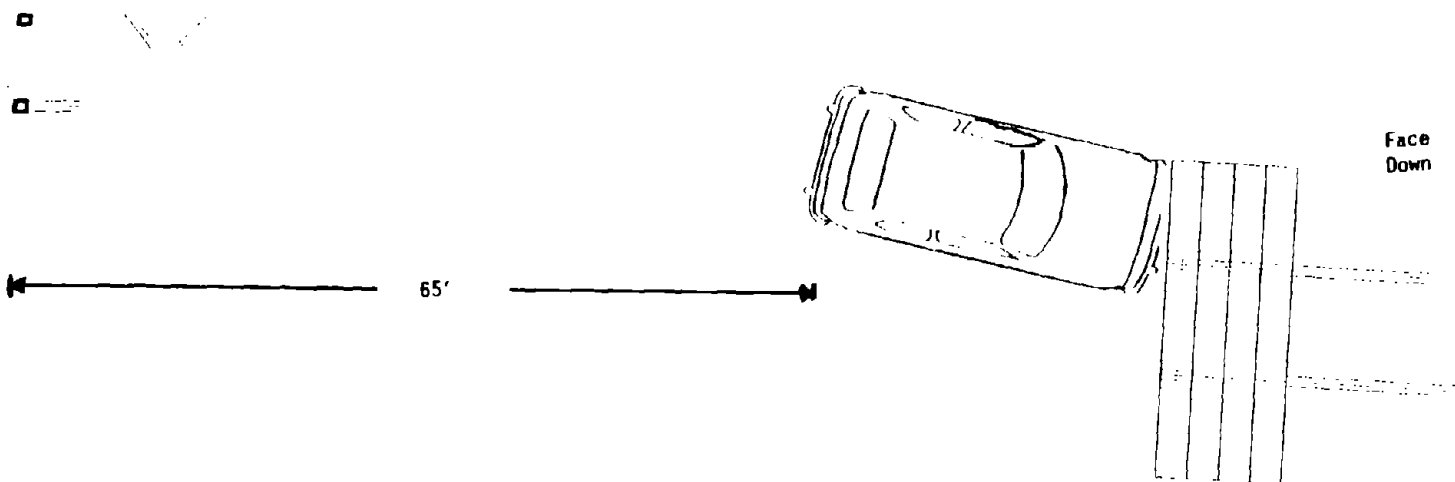
Figure 4. Summary of test 92F009.

The occupant impact velocity using the 2-ft (0.6-m) flail space model outlined NCHRP Report Number 230, was determined to be 8.6 ft/s (2.6 m/s). The occupant impact velocity was reached 0.286 s into the crash event. The ridedown acceleration was 3.4 g's. The ridedown acceleration was attributed to the secondary impact between vehicle and sign panel as the sign fell on top of the vehicle. The peak force (300 Hz data) for the impact event was 16.5 g's (30.7 kips (136 kN)). Because the sign remained in contact with vehicle the vehicle change in velocity was calculated to be 14.3 ft/s (4.4 m/s).

Vehicle analysis:	<u>Observed</u>	<u>Design/Limit</u>
Longitudinal:		
Occupant Delta V at 2 ft.....	8.6 ft/s	≤16 ft/s
Ridedown Acceleration.....	3.4 g's	15/20 g's
Lateral:		
Occupant Delta V at 1 ft.....	no contact	no spec
Ridedown Acceleration.....	no contact	no spec
Peak 50 msec acceleration		
Longitudinal.....		3.4 g's
Lateral.....		NA
Vehicle Damage (TAD).....		12-FC-1
(VDI).....		12FDAU1
Vehicle crush.....		no residual crush
Vehicle velocity change.....		14.3 ft/s
Exit angle.....		15 degrees

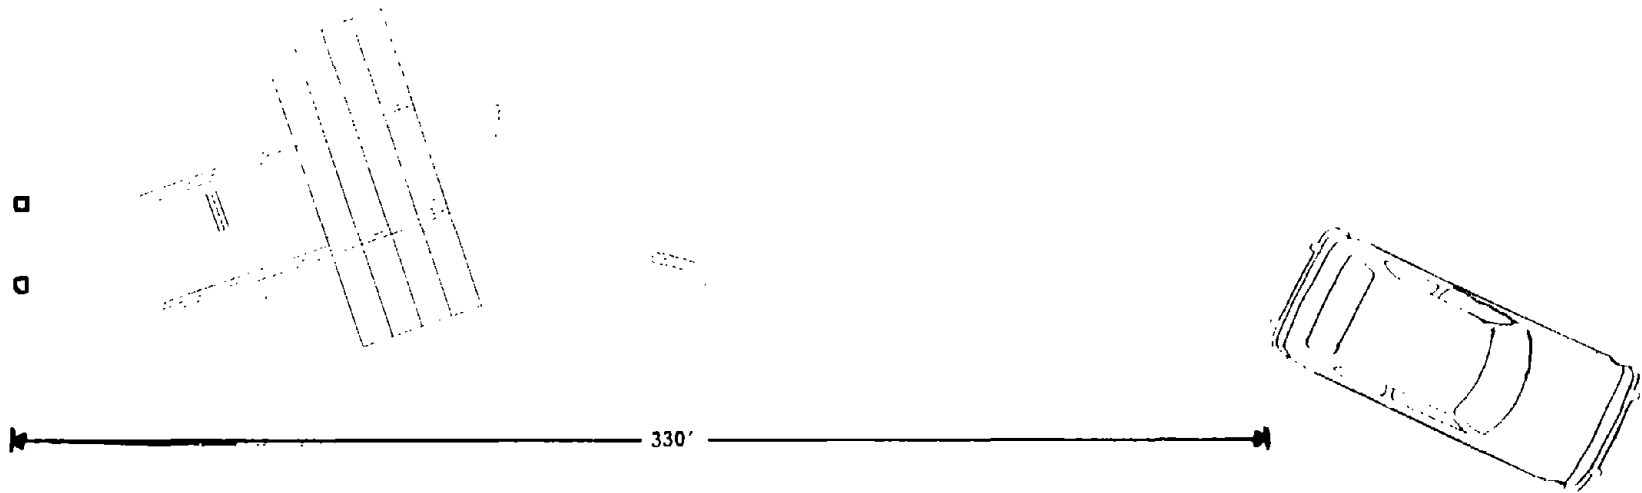
Figure 12. Summary of test 92F010.

Vehicle analysis:	<u>Observed</u>	<u>Design/Limit</u>
Longitudinal:		
Occupant Delta V at 2 ft.....	7.5 ft/s	≤16 ft/s
Ridedown Acceleration.....	0.5 g's	15/20 g's
Lateral:		
Occupant Delta V at 1 ft.....	no contact	no spec
Ridedown Acceleration.....	no contact	no spec
Peak 50 msec acceleration		
Longitudinal.....		3.1 g's
Lateral.....		NA
Vehicle Damage (TAD).....		12-FC-2
(VDI).....		12FOEN1
Vehicle crush.....		7.3 inches
Vehicle velocity change.....		7.5 ft/s
Exit angle.....		0 degrees
