Publication No. FHWA-RD-93-103

July 1994

# Testing of Small and Large Sign Support Systems FOIL Test Number: 92F015

7. Author(s) Christopher M. Brown		8. Performing Organization Report No.	
9. Performing Organization Name and Address Advanced Technology & Research Corp. 15210 Dino Drive Burtonsville, MD 20866		10. Work Unit No. (FRAIS) 3A5f3142	11. Contract or Grant No. DTFH61-91-Z-00002

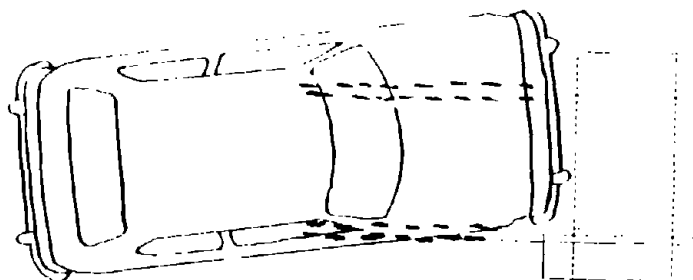
Figure 4. Summary of test 92F015.

The results indicate that the small sign support system does not meet all of the applicable criteria for the low-speed test in weak soil. There was no occupant compartment intrusion and no significant stub remaining after the test, however the occupant impact velocity was 17.4 ft/s (5.3 m/s) which is not less than or equal to the 16 ft/s (4.9 m/s) limit specified by the FHWA.

Test number.....	92F015	Vehicle analysis:	<u>Observed</u>	<u>Design/limit</u>
Date.....	June 17, 1992	Longitudinal:		
Test vehicle.....	1985 Honda Civic	Occupant Delta V at 2 ft.....	17.4 ft/s	≤16 ft/s
Vehicle weight.....	1860 lb (844 kg)	Ridedown Acceleration.....	2.3 g's	15/20 g's
Test article.....	Small Sign Support	Lateral:		
Material.....	4 inch by 4 inch wood 2-Leg, 2-Hit	Occupant Delta V at 1 ft.....	no contact	no spec
Embedment depth.....	2.5 feet	Ridedown Acceleration.....	no contact	no spec
Panel type.....	4 foot by 5 foot 8 inch alum. sheet	Peak 50 msec acceleration		
Height.....	11 feet	Longitudinal.....		5.8 g's
Foundation.....	18 inch dia. concrete footers in S-2 Weak Soil	Lateral.....		NA
Impact speed.....	31.7 ft/s (9.7 m/s)	Vehicle Damage (TAD).....		I2-FC-2
Impact angle.....	0 degrees	(VDI).....		I2FDEN2
Impact location.....	Head-on, centerline	Vehicle crush.....		10.5 inches
		Vehicle velocity change.....		29.0 ft/s

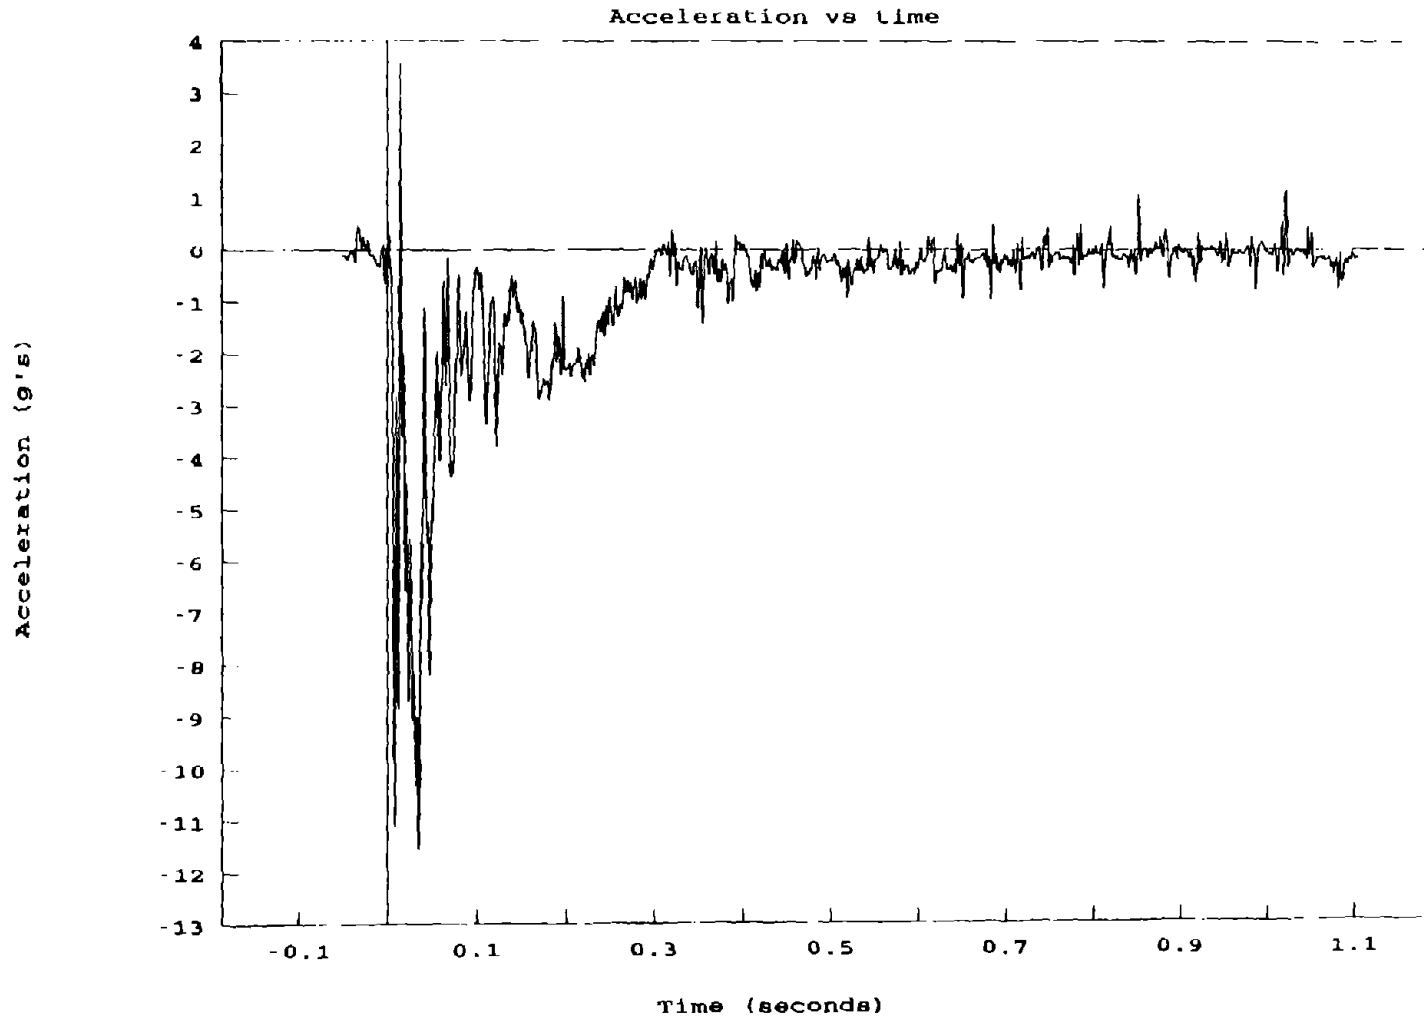
Figure 5. Acceleration versus time, X-axis, test 92F015.

The occupant impact velocity using the 2-ft (0.6-m) flail space model outlined in NCHRP Report Number 230, was determined to be 17.4 ft/s (5.3 m/s). The occupant impact velocity was reached 0.185 s into the crash event. The 10 ms ridedown acceleration was determined to be 2.3 g's. The peak force (300 Hz data) for the impact event was 11.6 g's (21.5 kips (95 kN)). Because the sign stopped the vehicle, the vehicle change in velocity was equal to the impact velocity. The actual vehicle change in velocity was calculated to be 29.0 ft/s (8.8 m/s). Photographs during the impact event are presented in figure 3. A summary of the impact conditions and the test results is presented in figure 4. Figures 5 through 8 are plots of data collected during the test. Pre and post-test photographs of the vehicle and sign support system are presented in figures 9 through 12. Figure 13 is sketch of the vehicle static crush recorded after the test.
