Publication No. FHWA-RD-93-107

July 1994

Testing of Small and Large Sign Support Systems FOIL Test Number: 92F019

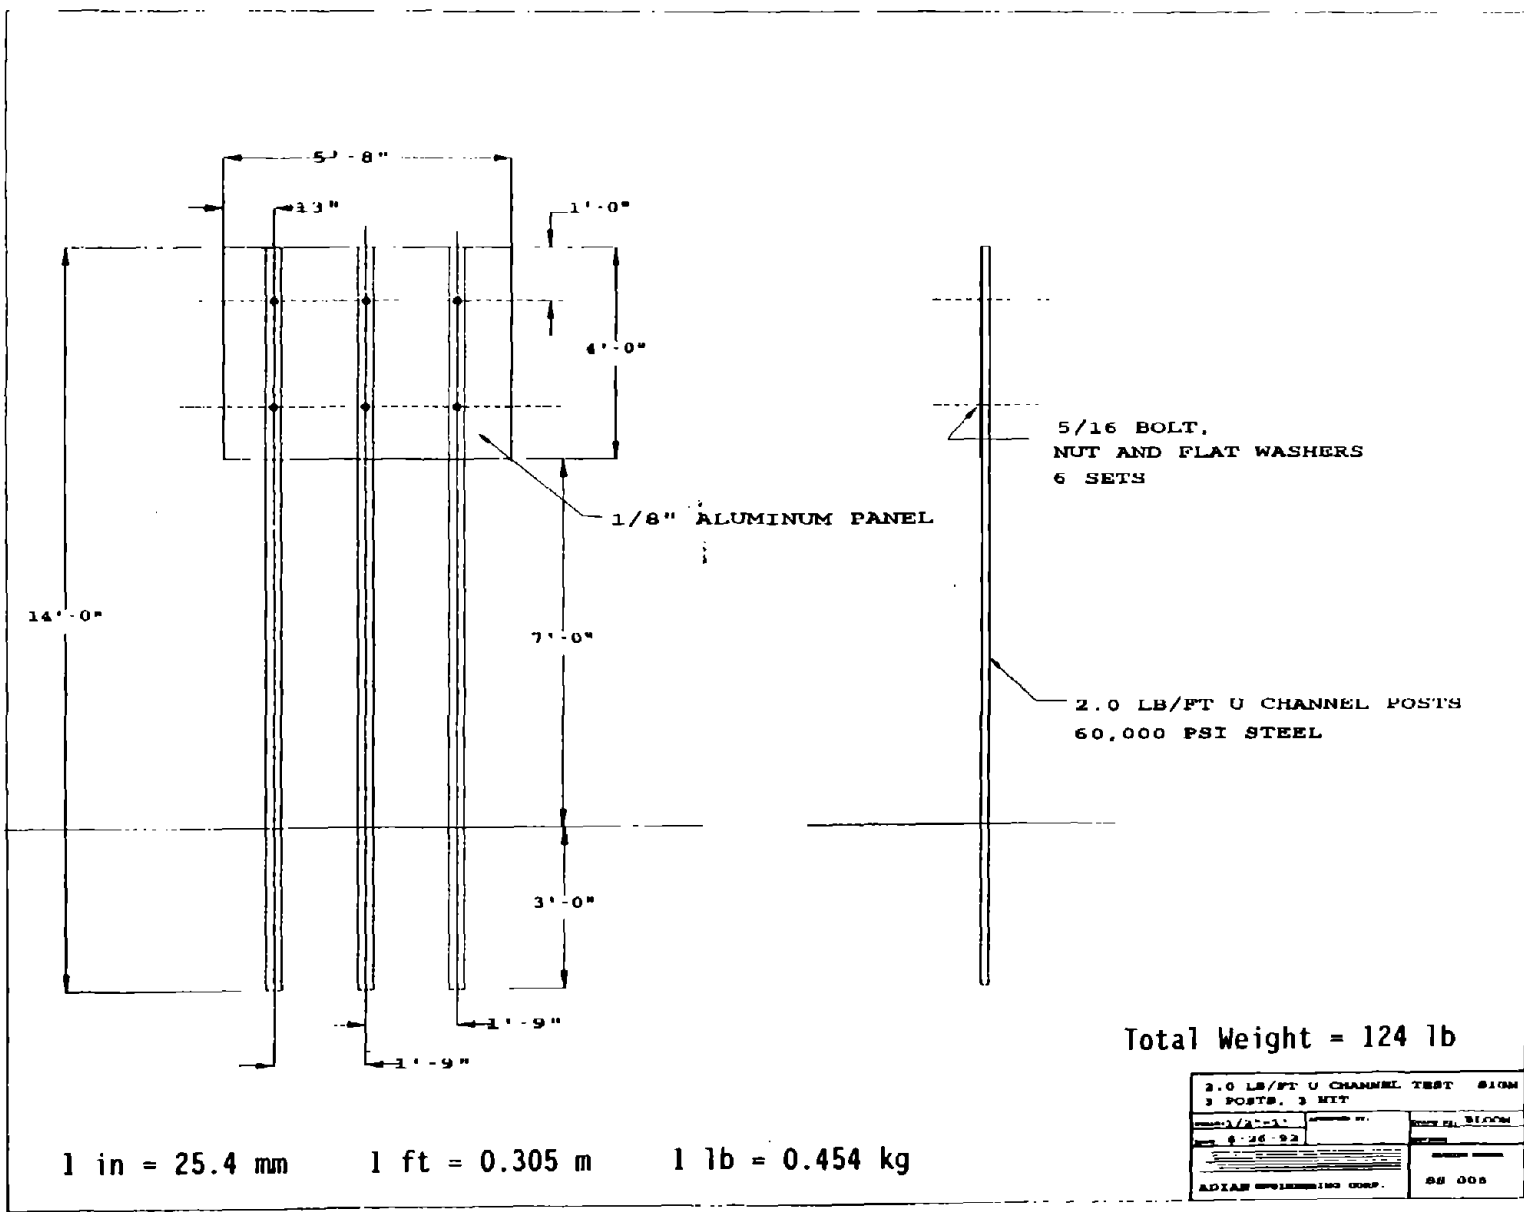
Figure 1. Sketch of small sign support.

The sign support system consisted of three 2 lb/ft (2.98 kg/m) steel u-channel legs 15 ft (4.6 m) long. Three ft (0.9 m) of each leg was buried in NCHRP Report 230 S-2 weak soil (sand). Attached to the 3 legs was a 4-ft high by 5-ft 8-in (1.2-m by 1.7-m) wide aluminum sign panel. The panel was a 0.125-in (3.2-mm) thick aluminum sheet and was installed 7 ft (2.1 m) above ground. The three legs were installed 1.7 ft (0.5 m) apart. The whole sign support system was assembled and inserted in a hole in the weak soil. The hole was backfilled in 6-in (152.4-mm) lifts and compacted until the final grade was reached. Figure 1 is a drawing of the sign support system.

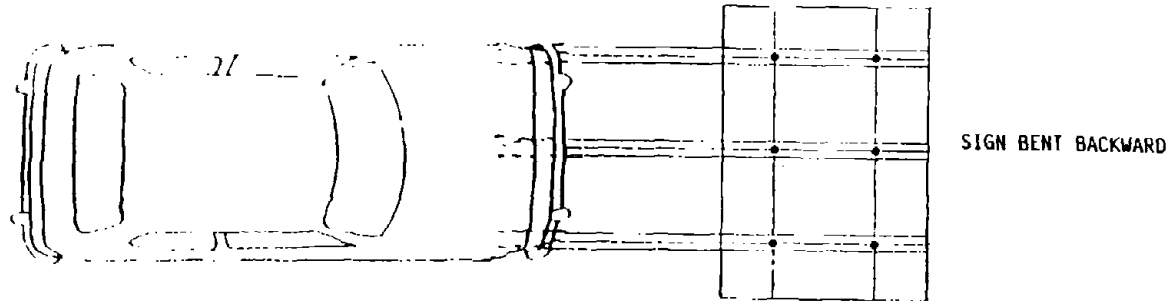
Figure 3. Summary of test 92F019.

The test results indicate that the small sign support system does not meet all of the applicable criteria for the low-speed test in weak soil. There was no occupant compartment intrusion and no significant stub remaining after the test, however the occupant impact velocity was 17.8 ft/s (5.4 m/s) which is not less than or equal to the 16 ft/s (4.9 m/s) limit specified by the FHWA.

VEHICLE ROLLED UP SIGN

Vehicle analysis:	<u>Observed</u>	<u>Design/Limit</u>
Longitudinal:		
Occupant Delta V at 2 ft.....	17.8 ft/s	≤16 ft/s
Ridedown Acceleration.....	1.4 g's	15/20 g's
Lateral:		
Occupant Delta V at 1 ft.....	no contact	no spec
Ridedown Acceleration.....	no contact	no spec
Peak 50 msec acceleration		
Longitudinal.....		3.7 g's
Lateral.....		NA
Vehicle Damage (TAD).....12-FC-1		
(VDI).....12FDEN1		
Vehicle crush......2 in		
Vehicle velocity change......20.0 ft/s		
Exit angle.....no exit
