INTERSTATE COMMERCE COMMISSION

REPORT OF THE CHIEF OF THE BUREAU OF SAFETY IN RE INVESTIGATION OF AN ACCIDENT WHICH OCCURRED ON THE MISSOURI PACIFIC RAILROAD AT SULPHUR SPRINGS, MO , ON AUGUST 5, 1922

OCTOBER 10, 1922

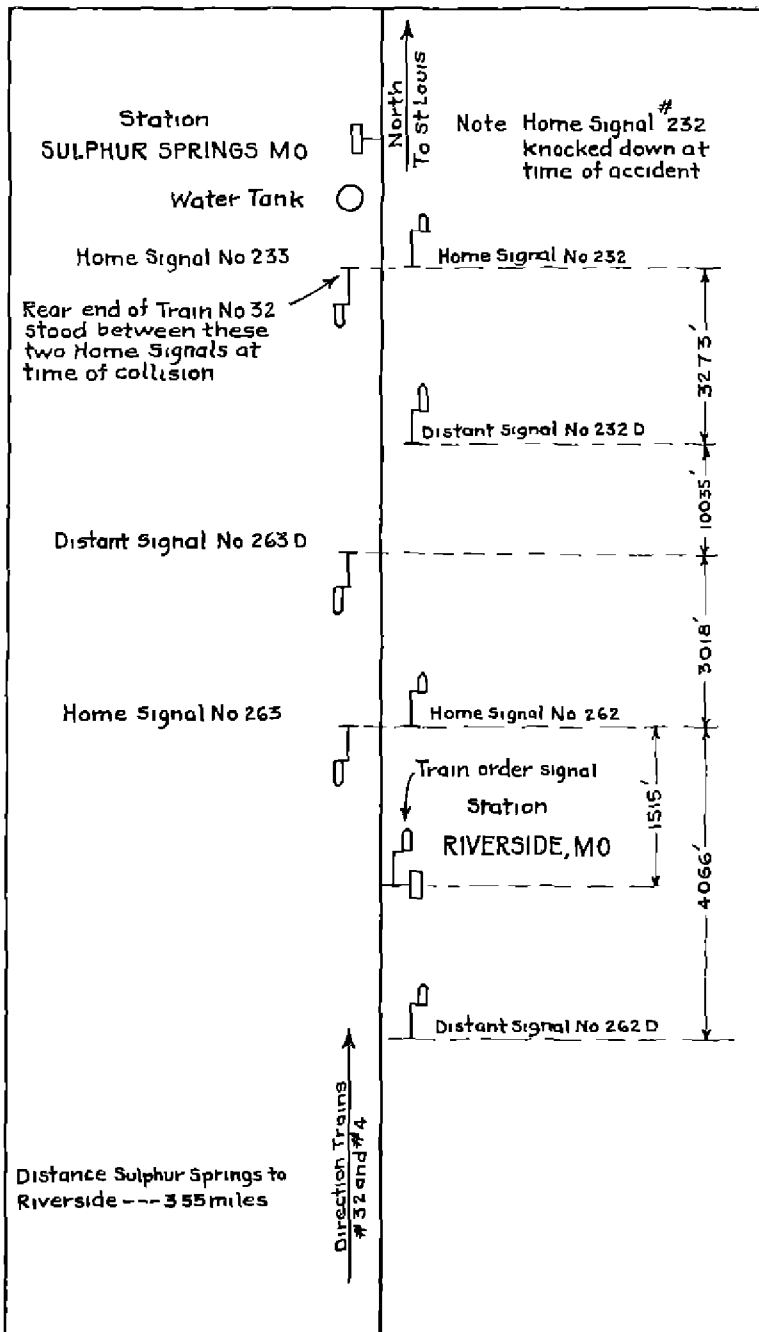
Signal locations and distances approaching point of accident

Beginning at a point about 4 miles south of the point of accident and proceeding northward, the following is the location of signals involved in this accident

Designation of signal	Distance from point of accident
	<i>Feet</i>
Automatic distant signal 262-D	20,392
Train order signal, Riverside	17,841
Automatic home signal 262	16,426
Automatic distant signal 232-D	3,273
Automatic home signal 232	(¹)
Automatic home signal 220 (north)	5,500

Signals 262-D and 232-D are so located that they can be observed from a considerable distance. Signal 262 is located on a curve and can be seen for a distance of approximately 900 feet. Signal 232 is also located on a curve and can be seen for a considerable distance.

This accident was caused by the failure of Engineman Glenn, of train No. 4, properly to observe and be governed by automatic block-signal indications, and by the failure of the crew of train No. 32 to protect the rear of their train against following trains, as required by rule, for which Flagman Boston, Conductor Long, and Engineman Gross are responsible.
