REPORT NO. DOT-TSC-OST-76-14, II

TRUCK NOISE X
NOISE REDUCTION OPTIONS FOR
DIESEL POWERED INTERNATIONAL HARVESTER TRUCKS
Volume II - Cost-Noise Analysis and Field Installation

S. T. Razzacki

International Harvester Company
Truck Engineering Center
P.O. Box 1109
Fort Wayne IN 46801

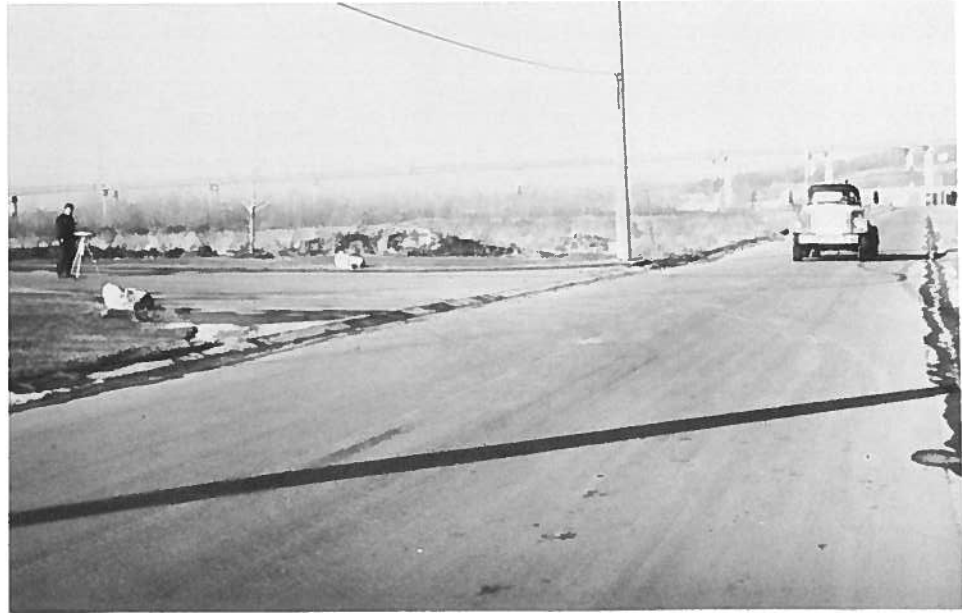
FIGURE 3.1 TYPICAL SITE FOR SAE J336B DRIVE BY TEST

Site requirements for SAE drive-by noise measurements are described in SAE J366b Standard Practice in Appendix D. These requirements were keenly observed in locating adequate site wherever the installation was scheduled. May it be a big city or small, finding a site was equally difficult because of traffic situation. Open area with paved surface with no reflecting surfaces within 100 foot (30.48M) radius of measurement zone as required could not be found. Parking lots were specifically checked, and those that met the requirements were extremely busy. As a substitute, T-intersection roadway segments were found that were not heavily travelled, and met other critical requirements. A typical site is shown in Figure 3.1. The sound level meter was located on a tripod in the middle of the road teeing in the straight road at 50 feet (15.24M) from the centerline of the left lane of the straight road. Another mark was located at 50 feet (15.24M) from the centerline of the right lane.

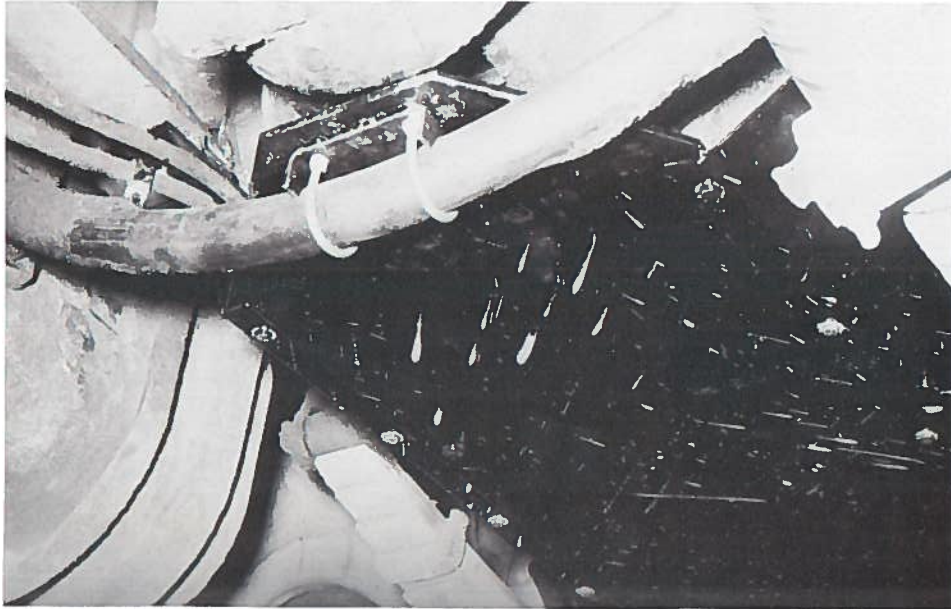
FIGURE 5.3 BELLYPAN REAR MOUNT.

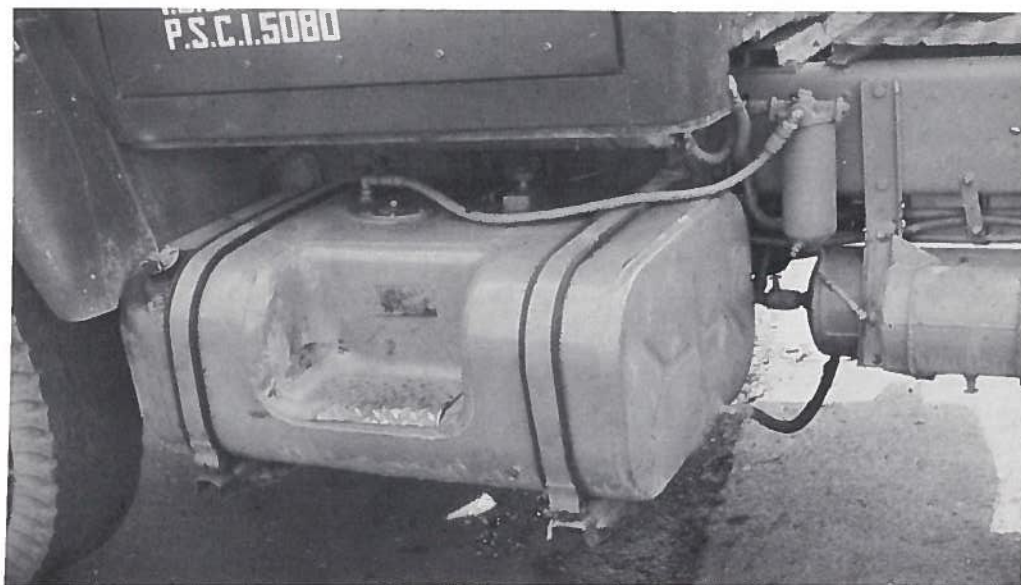
FIGURE 5.5 FUEL TANK ISOLATED.

The engine mounts in the 2000D model were isolated with high stiffness material. Consequently the structure-borne vibrations of the engine are transmitted to the frame, cab, etc. The fuel tanks are strap-mounted to the frame rails on both sides without isolation. Frame rail vibration is sufficient to excite the fuel tanks making them significant contributors to the overall truck exterior noise. Therefore, the mounting straps were isolated with rubber straps as shown in Figure 5.5 and noise measurements were taken with exhaust modified, bellypan installed, and fuel tanks isolated. Since exhaust modifications and bellypan installation had quieted the truck exterior noise to fairly low level of 84.5 dB(A), only .5 dB(A) reduction was realized with fuel tank isolation in the total truck environment.

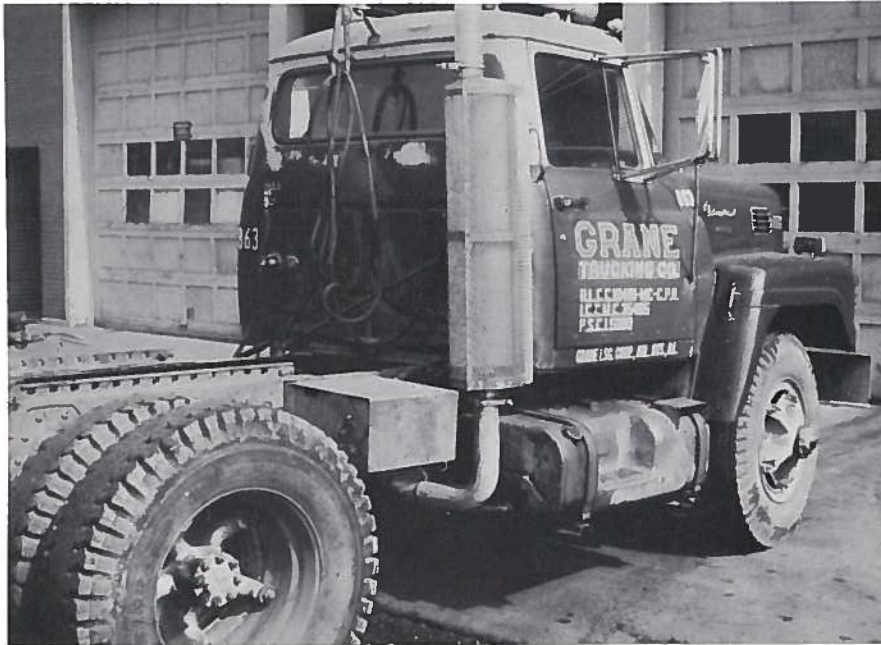
FIGURE 5.6 WTM10-0066 MUFFLER INSTALLED WITH WELDED MOUNT.

The field installation truck had the bolted-bracket muffler mount and was replaced with the pedestal type bracket for installation of improved muffler as shown in Figure 5.6. The exterior truck noise level per SAE J366b with improved muffler showed more than 1 dB(A) reduction in the baseline truck exterior noise level.

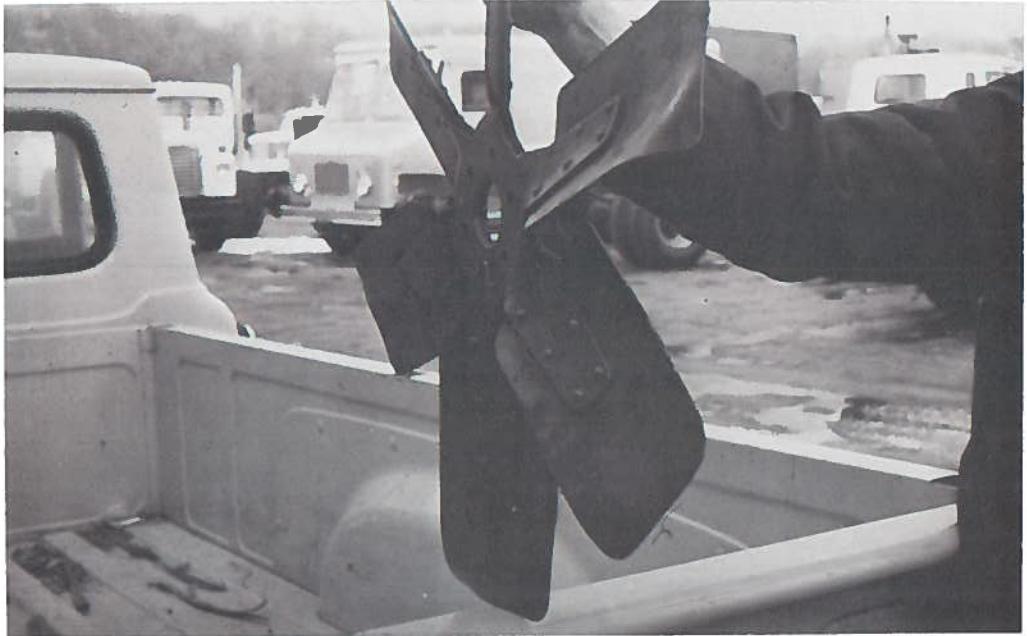
FIGURE 5.8 TWISTED BLADE FAN

(1.5" (38mm)), was evaluated, the results indicated a lower fan noise level but considerable reduction in the cooling ability. This may be true in the case of this particular fan.

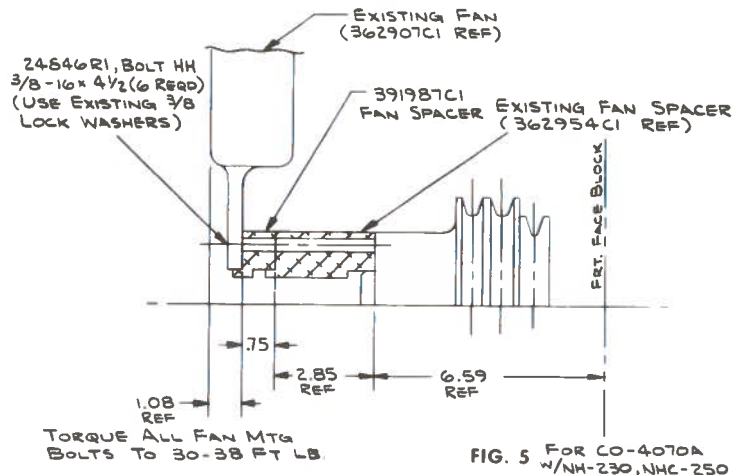
Cooling System Treatment on CO-4070A with Cummins NHC-250 and NH-230 Engines

1. Obtain fan spacer (391987-C1) and six bolts (24846-R1) for cooling noise level treatment.
2. Remove fan.
3. Position fan spacer (391987-C1) on end of existing spacer.
4. Reinstall existing fan using six 3/8 - 16 x 4 1/2" bolts as shown in Fig. 5.
5. Torque fan mounting bolts to 30-38 ft. lbs.
