U.S. Department of  
Transportation  
**Federal Railroad  
Administration**

# Rail Base Corrosion and Cracking Prevention

1. AGENCY USE ONLY (Leave blank)	2. REPORT DATE July 2014	3. REPORT TYPE AND DATES COVERED Final (September 2012 – June 2013)	
4. TITLE AND SUBTITLE Rail Base Corrosion and Cracking Prevention		5. FUNDING NUMBERS DTFR-12-C-0024

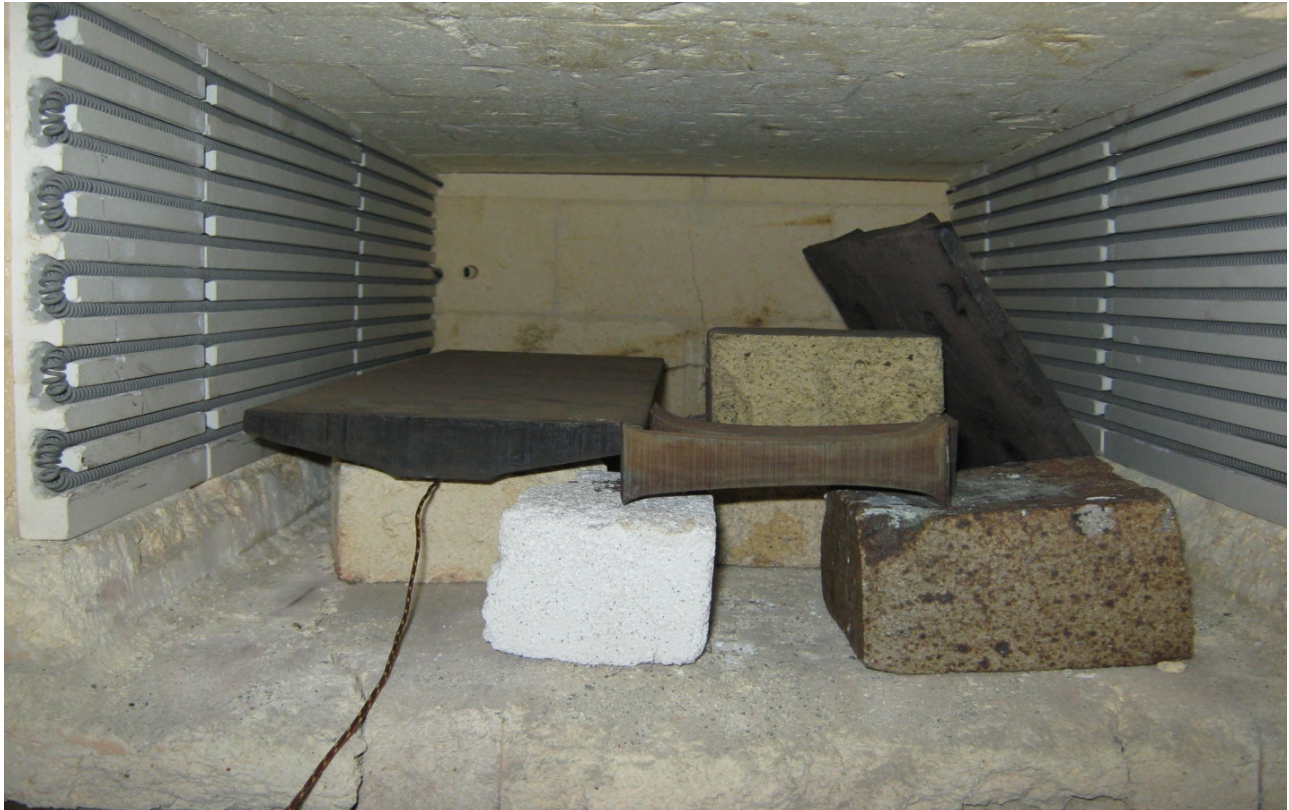
**Figure 3. (ALL) Specimens in Bake Furnace**

All the flange pieces and tie plates were grit-blasted to remove excess scale and rust. The appropriate treatments were then applied using the same approaches as those for Task 1. The ALL three-step samples were baked at 550°C for 3 hours to set the zirconium oxide sol-gel sealer. The samples, as placed into the bake furnace, are shown in Figure 3, and the thermocouple trace for the bake is shown in Figure 4.

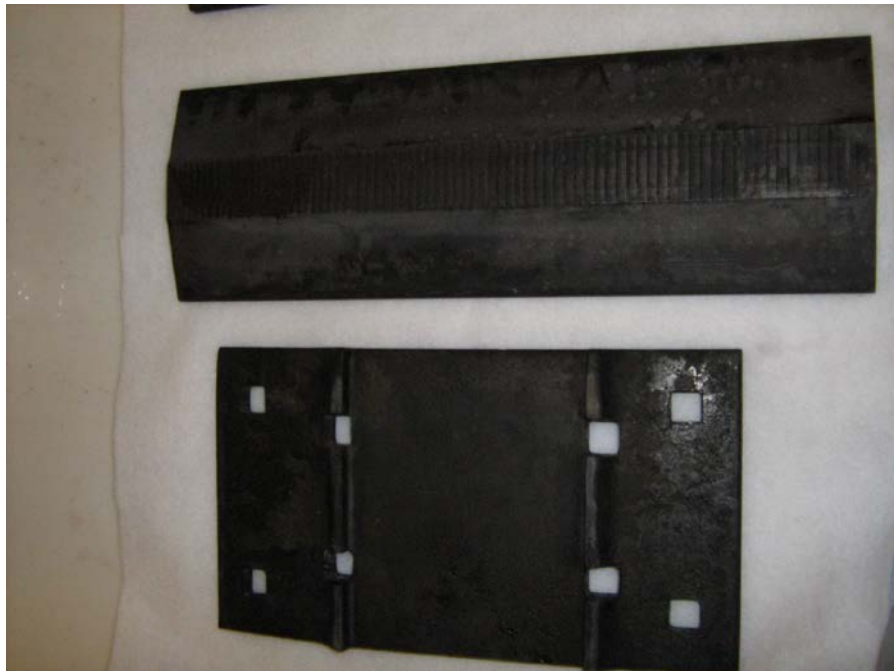
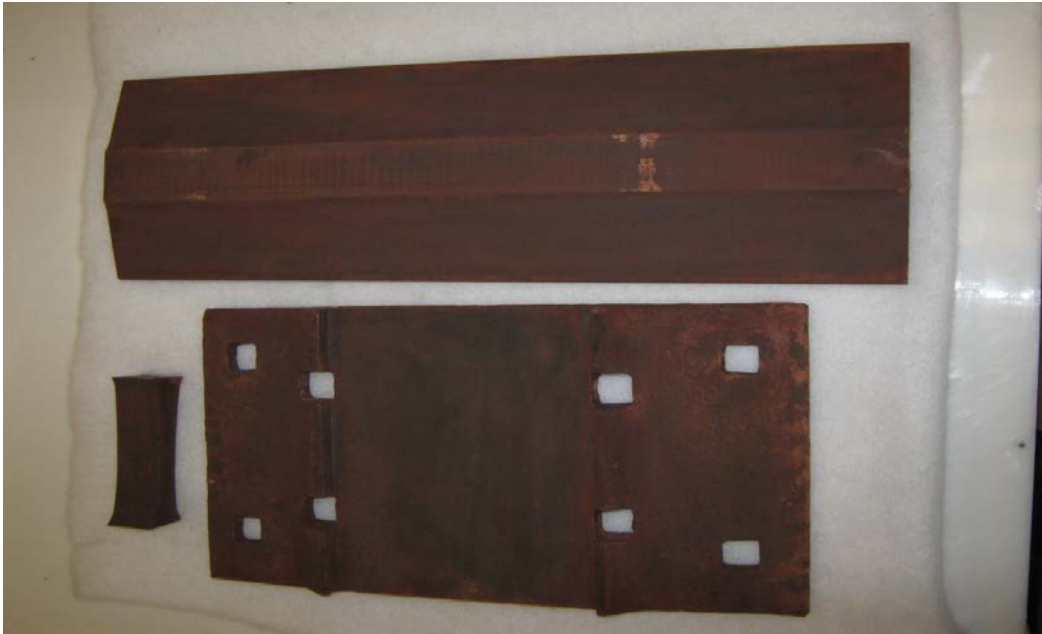
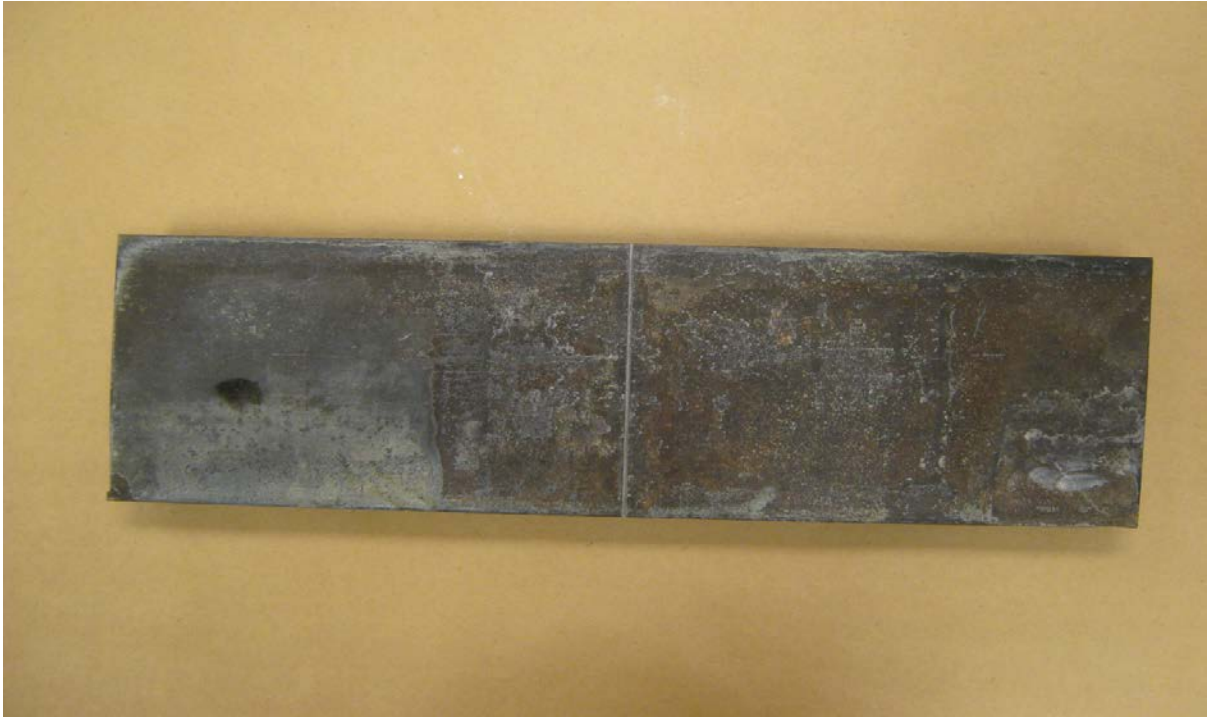
Figure 5 through Figure 8 show the specimens just prior to corrosion exposure.

**Figure 5. PD Two-Step Treated Sample Set**

**Figure 6. ALL Three-Step Treated Sample Set**

**Figure 7. EonCoat® Treated Sample Set**

**Figure 8. No Treatment Flange Base**

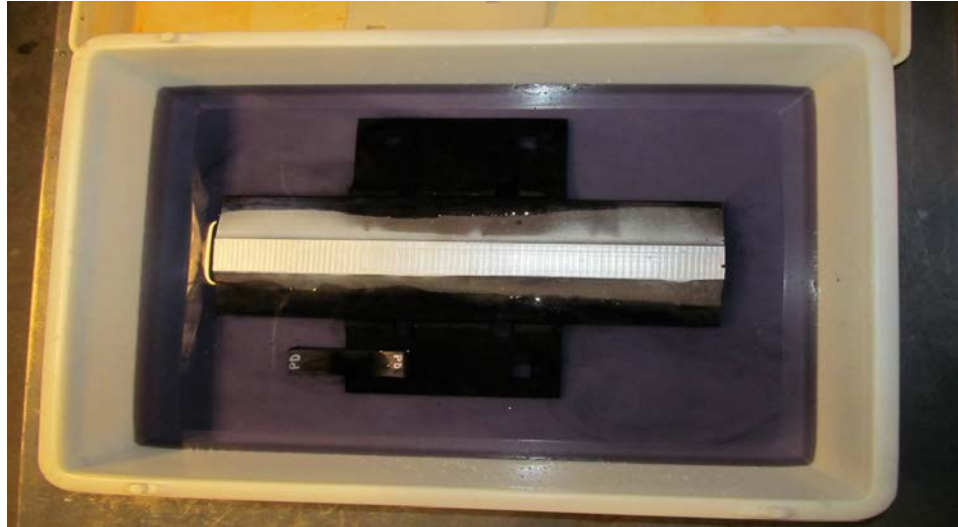
**Figure 9. PD Samples on First Exposure to Saltwater**

The saltwater solution was fixed at 5 percent by weight in a water solution of road deicing salt in tap water. Deicing salt contains magnesium chloride and calcium chloride in addition to the predominant sodium chloride. When the samples were first placed in saltwater, the PD system began to bleed blue-black color. (This also happened with the small-scale test bars in Task 1.) It was found later that this only happened when first immersed. In subsequent weeks of exposure, there was no additional bleeding (see Figure 9).

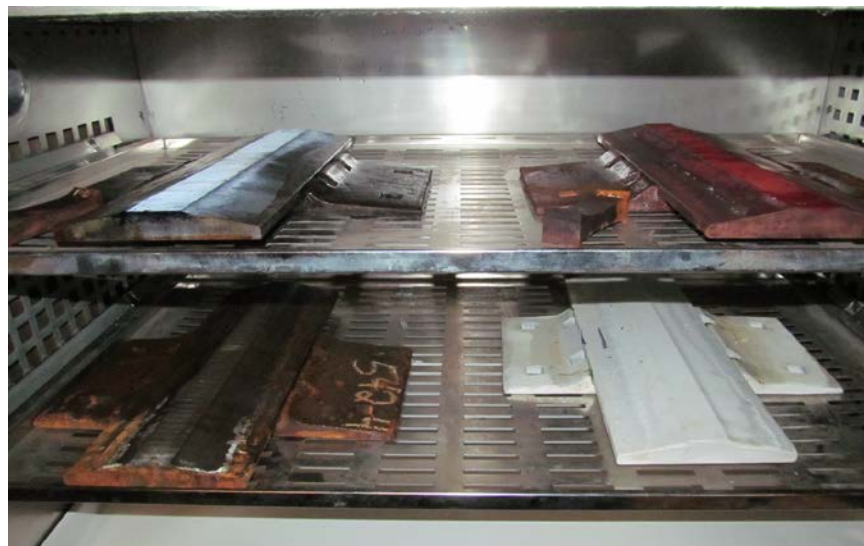
**Figure 10. Placement of Samples in Humidity Cabinet**

The hot-wet exposure took place in a large temperature and humidity controlled cabinet set at 50°C with saturated humidity. For the humidity exposures, the stacked specimens were placed into the controlled temperature-humidity cabinet, as shown in Figure 10. Notice it is possible for condensate from the upper samples to drip down onto the lower samples.

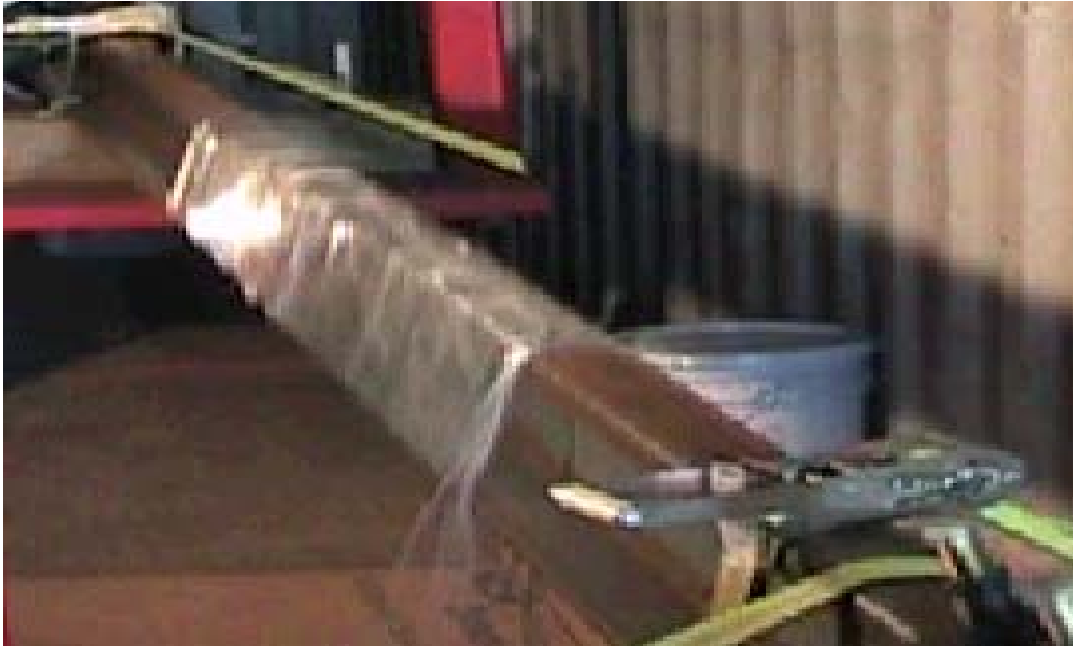
**Figure 12. Rail Suspended in Resonant Fatigue Apparatus**

As applied here, a 20-foot section of rail was suspended between, and strapped to, two support points (Figure 12). Counterweights of calculated size were then attached to the ends. The cyclic excitation at close to the resonant frequency, provided by an eccentric drive cam at one end, forces the rail into self-resonance around the center line, creating what amounts to a standing wave on the rail with maximum stress in bending at the center of the length. The rail becomes an oscillator element.

Strain gauges monitor the cyclic strains at several locations on the part, but especially near the center. At some point, a crack will grow to sufficient size by fatigue to cause the rail to fracture. This is the failure point at which the machine stops and the cycles to failure are noted. In this case, the rail went into self-resonance at approximately 21 Hz. The applied stress level was determined by the difference between the resonant and excitation frequencies. The excitation and self-resonance induced a stress on the rail head of 28–40 ksi and a stress on the rail base of 25–26 ksi, for notched rail, not accounting for the additional stress concentration at the notch.

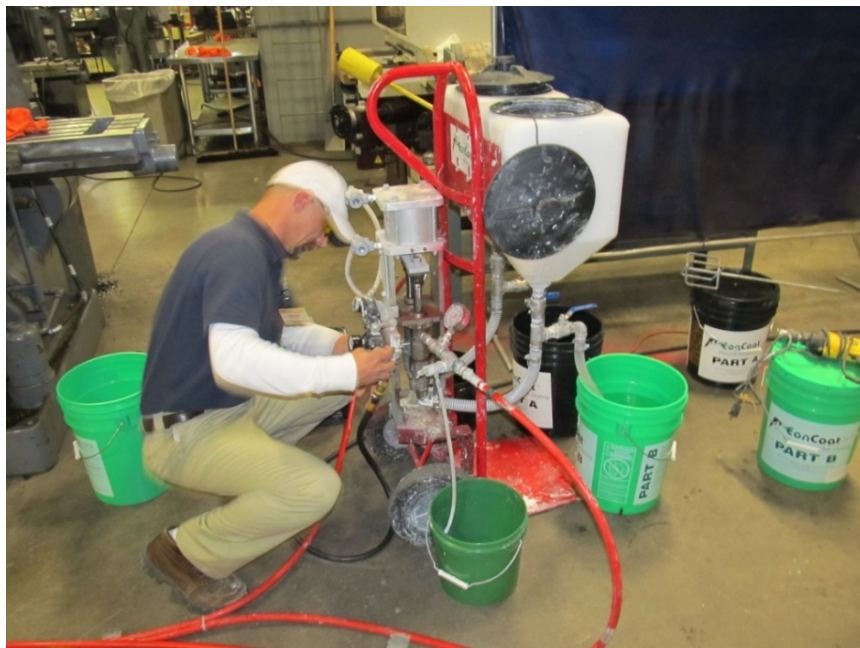
**Figure 14. Technician Readies EonCoat® Applicator System**

The vendor applied EonCoat® to the rail segment at EWI. Standard two-component spray equipment was used with a mixer-head nozzle (Figure 14). It dried within minutes of application. A second coat was then applied after approximately 10–15 minutes. That rail segment is shown in Figure 15. There was evidence of some debonding of the spray at the edges (circled in the figure). These locations were outside the prepared regions.

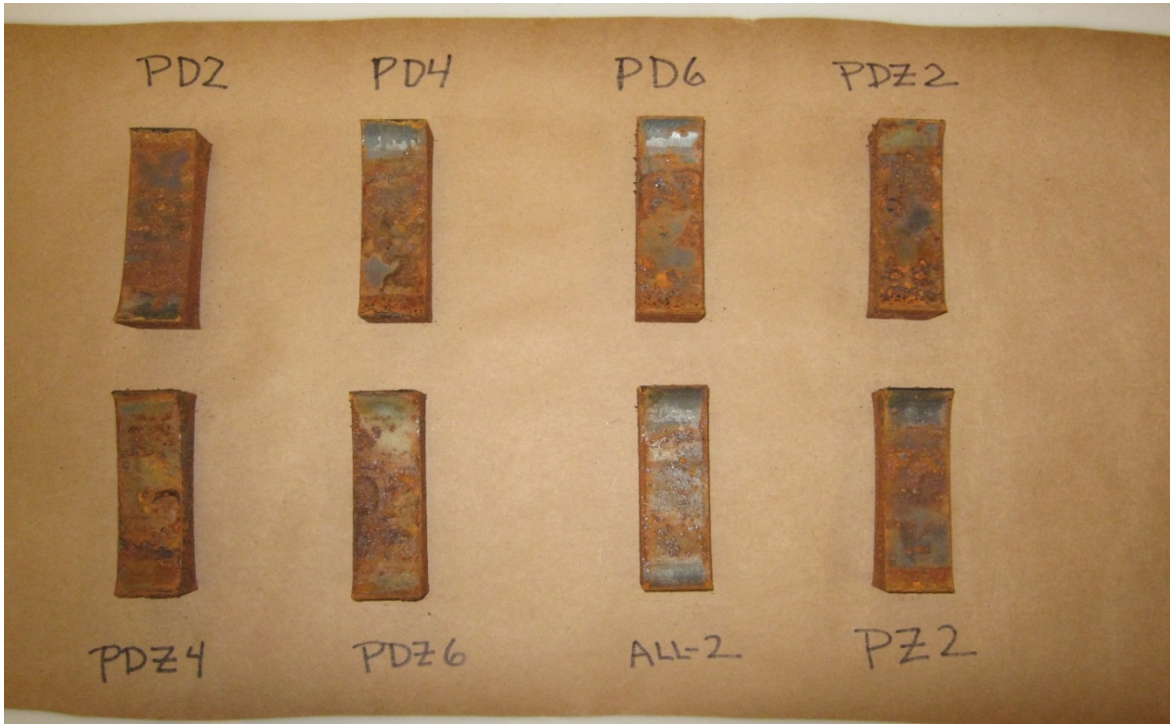
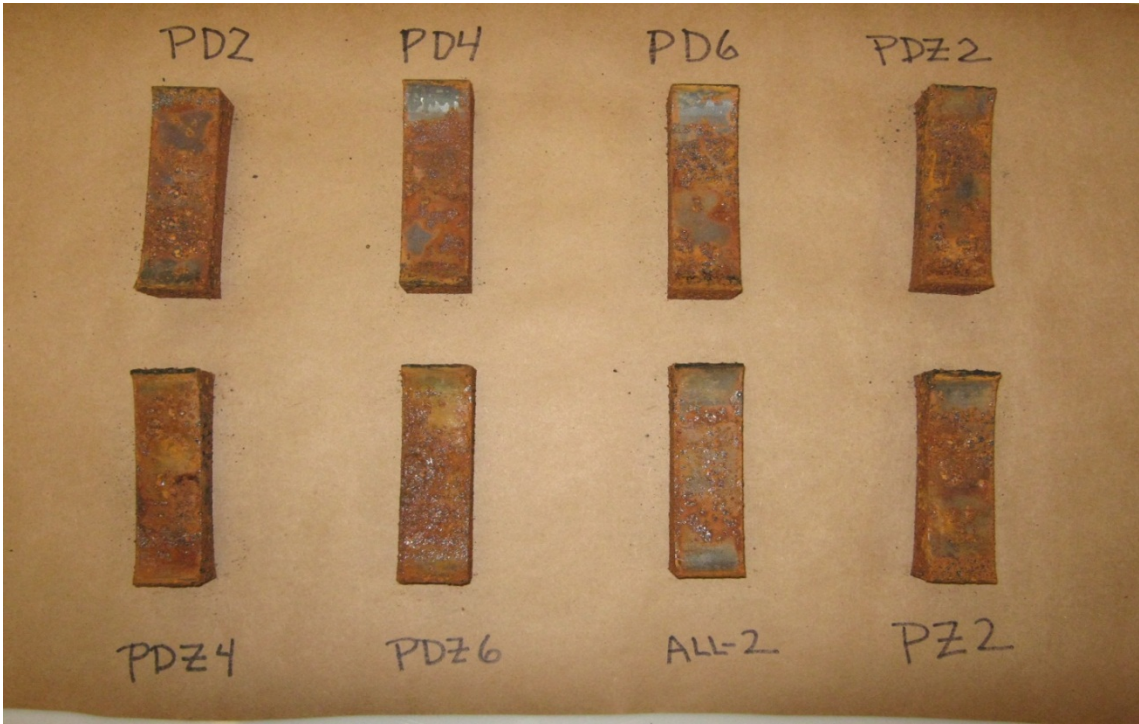
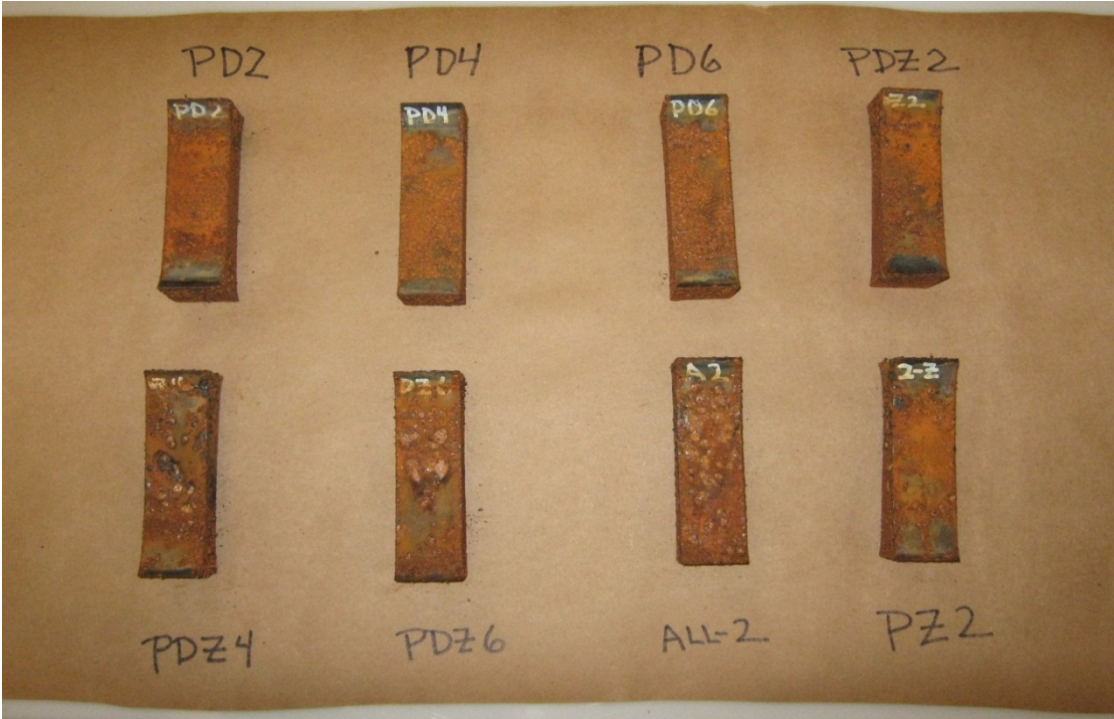
Particular attention was paid to the condition of the bottom surface of the samples. This would be the area of most concern in a rail tunnel since it would not easily dry. Figure 16 and Figure 17 show the views of the bottoms of the samples after 2-week and 3-week exposure, respectively. Figure 18 and Figure 19 show the same samples, but for the top surfaces.

One of the more striking observations was the degree of overall corrosion attack after 3 weeks compared with 2 weeks. The corrosion became quite aggressive during the third week. The results show that the ALL variant, which had the three-step application system with final bake, performed best in protecting the bottoms. However, the best performance for protecting the tops was the PD variant, which is a two-step process with no bake.

Figure 16. Bottoms of Samples after 2-Week Corrosion Cycle

Figure 17. Bottoms of Samples after 3-Week Corrosion Cycle

Figure 18. Tops of Samples after 2-Week Corrosion Cycles

Figure 19. Tops of Samples after 3-Week Corrosion Cycle

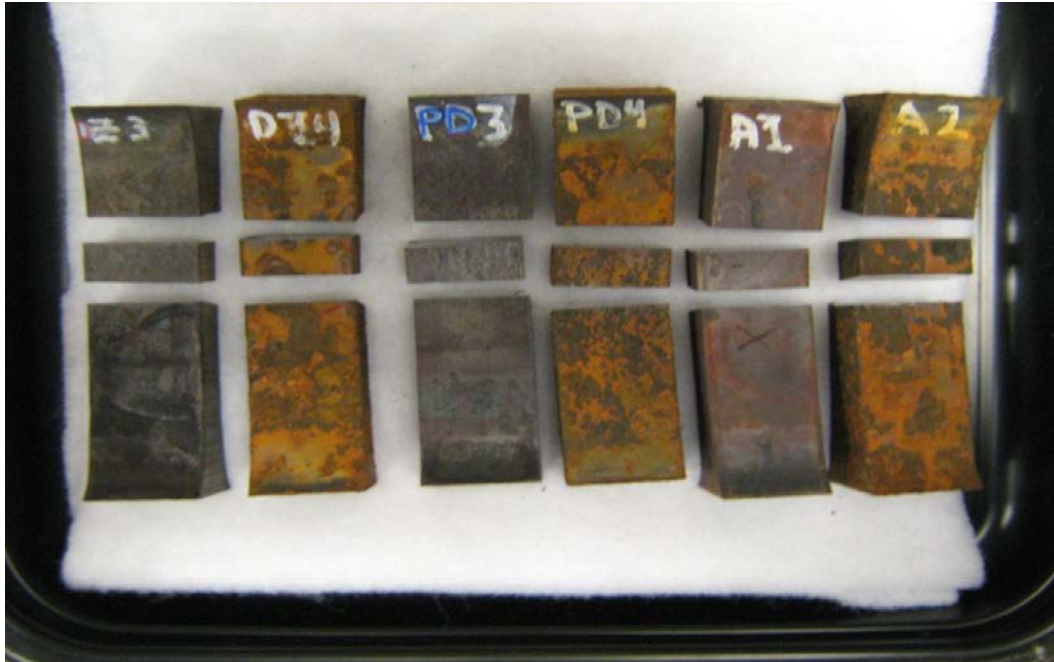
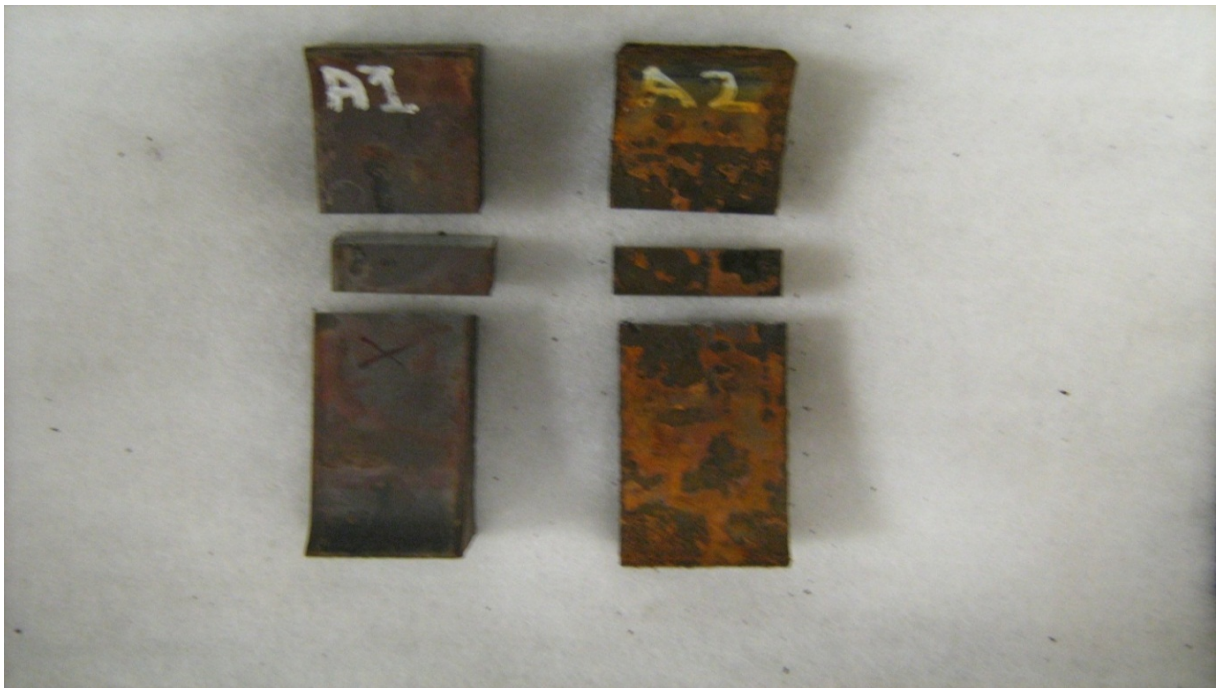
Samples were cut to provide test articles for scanning electron microscopy (SEM) and elemental x-ray dispersive (EDS) analyses. These were pieces taken from the center portions, as shown below (Figure 20 through Figure 23). The top sides were marked for orientation in the SEM instrument. The samples were analyzed using SEM to examine morphology. Integrated EDS capability was used to examine the coatings for chemical composition. The samples were examined both as cross cuts through the coatings (“sideways”) and also on the tops themselves.

**Figure 20. Photograph Summary of Samples for SEM/EDS Examination**

**Figure 21. Close-Up of PD3/4 Series**

**Figure 22. Close-Up of PDZ3/4 Series**

**Figure 23. Close-Up of ALL1/ALL2 Series**

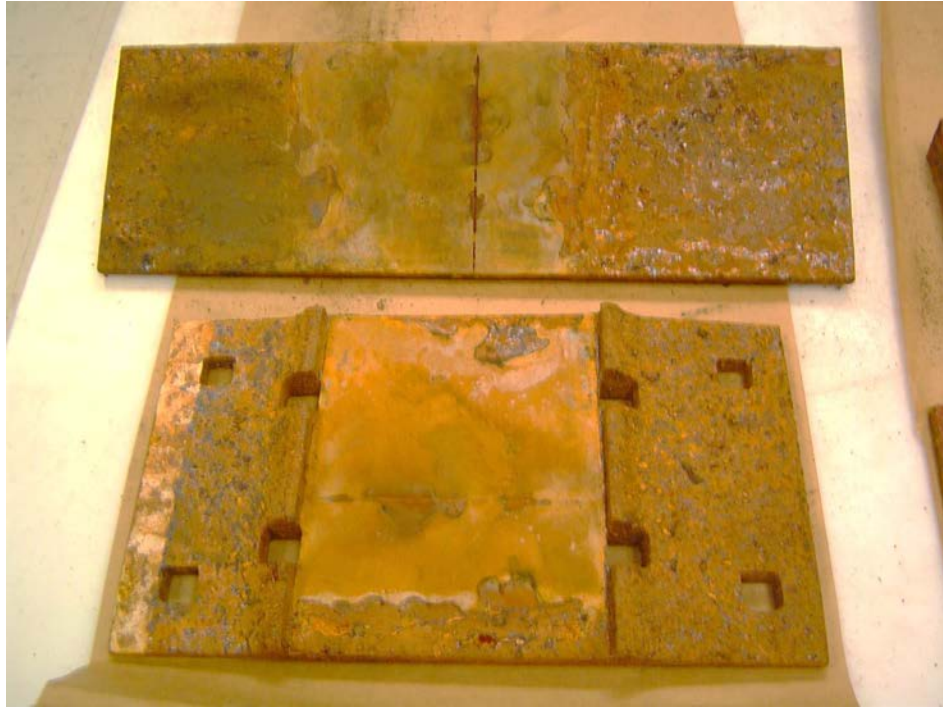
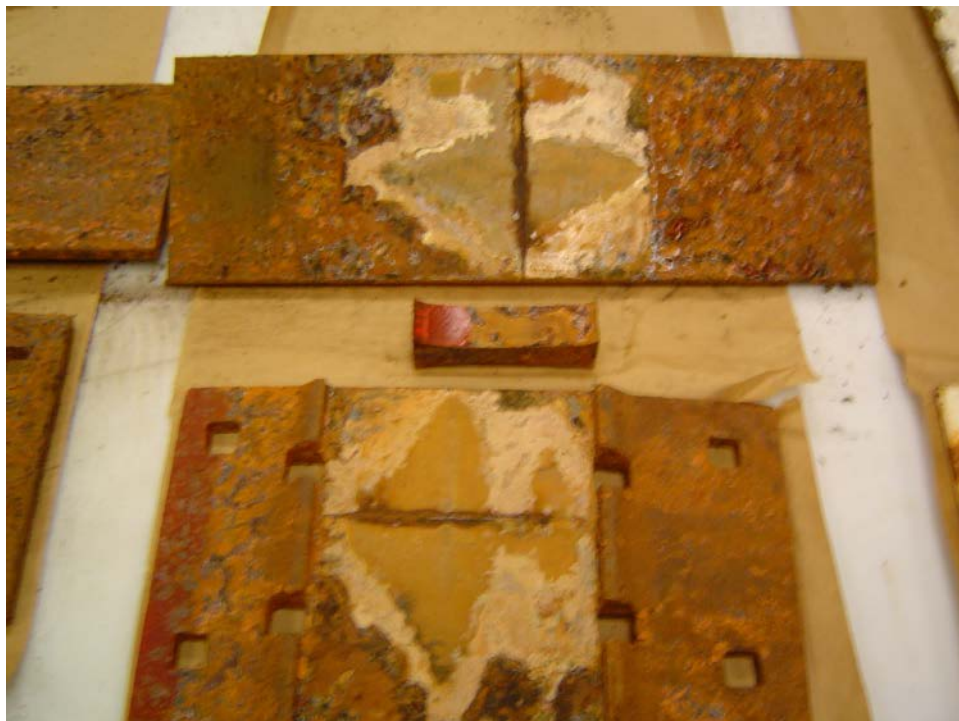
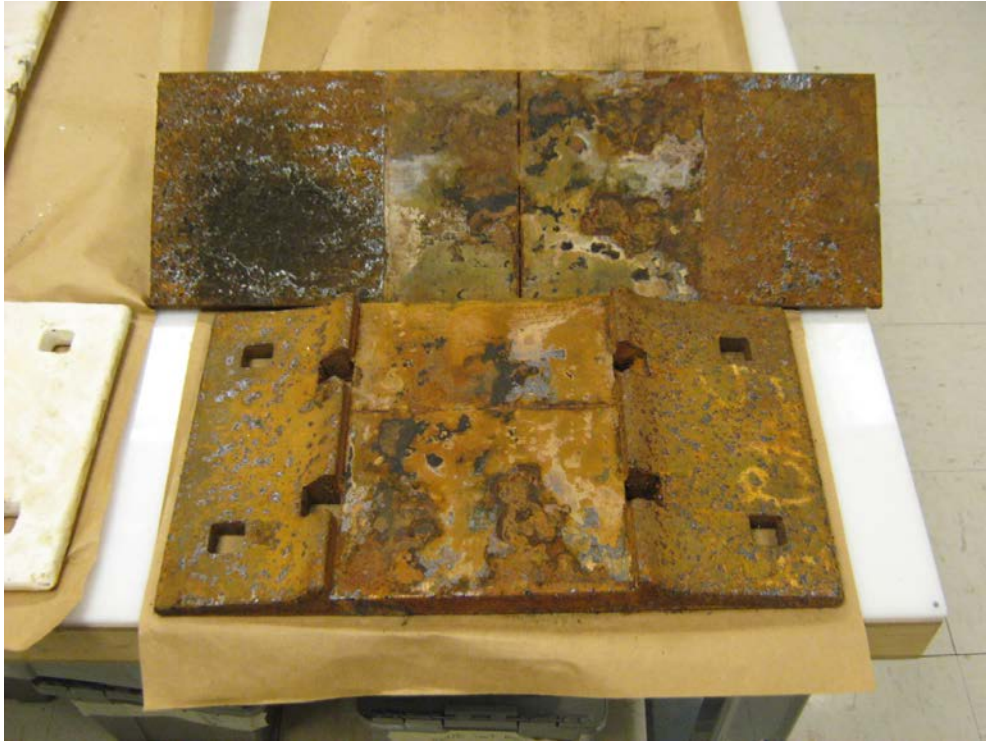
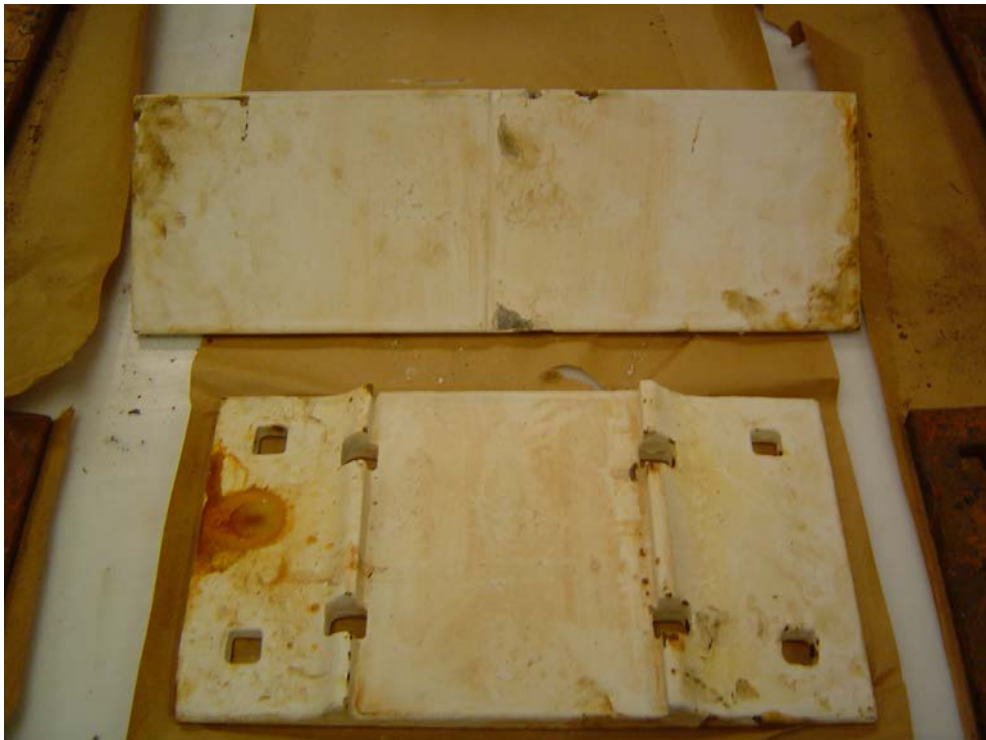
The sequential progress of corrosion is shown pictorially in Appendix A. A synopsis follows. At the end of the 3-week corrosion exposure, the PD, ALL, and untreated samples were corroded in varying degrees while the EonCoat® system showed virtually no corrosion (Figure 30 through Figure 33). The bottoms of the flanges and the tops of the tie plates are shown.

**Figure 30. PD Treated Samples after 3-Week Exposure (Tie Plate and Flange Bottom)**

**Figure 31. ALL Samples after 3-Week Exposure**

**Figure 32. Untreated Samples after 3-Week Exposure**

**Figure 33. EonCoat® Samples after 3-Week Exposure**

Based on visual examination, the EonCoat®-treated sample showed considerable resistance to the combined corrosion cycles. The rust spots on the EonCoat® surface were caused by condensate from the specimen on the shelf above it in the humidity cabinet. A beneficial observation was that areas of the EonCoat® that had been chipped or physically damaged in handling still did *not* succumb to corrosion attack.

In general, the time spent in humidity was very aggressive and most likely to produce the most sequential damage. Of interest concerning the samples treated with the ALL conversion system was the considerable protection between the flange bottom and the tie plate nested surface even in the presence of aggressive corrosion attack (Figure 31). The outer exposed portions of the samples were severely corroded.

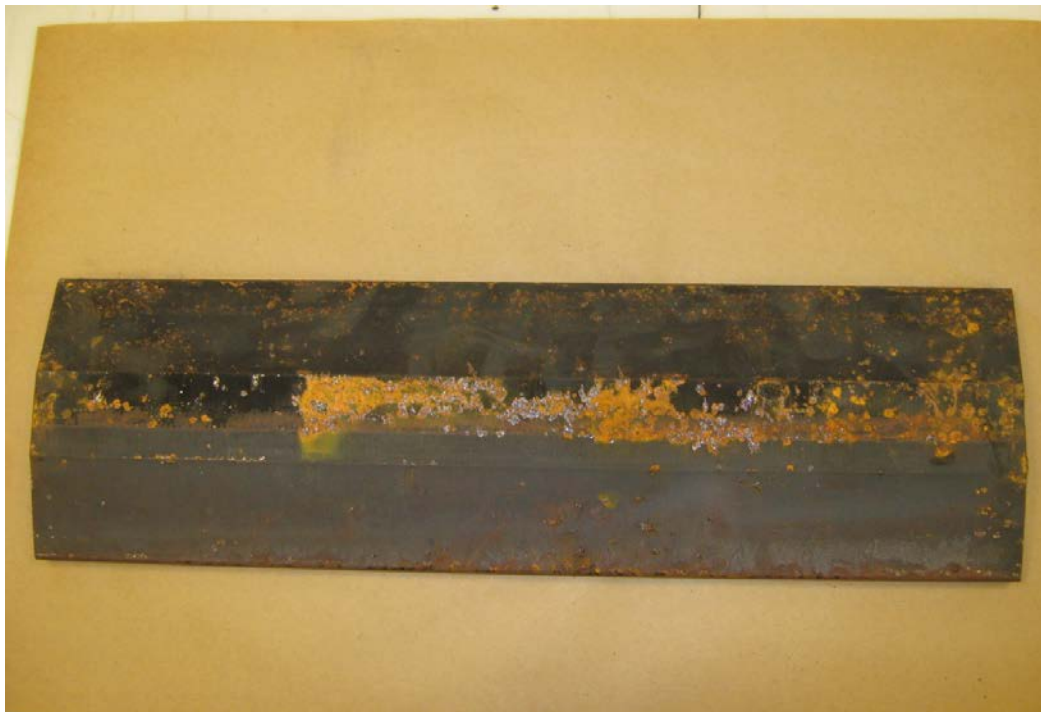
**Figure 34. Drip Zone Top Surface after 3 Weeks**

The results after 3 weeks for the top and bottom of the drip zone sample are shown in Figure 34 and Figure 35, respectively. In both cases, the protected portions were on the bottom half of the photographs. The protection on the bottom half of the top surface was fairly good. The protection for the trapped portion on the flange bottom was fair, but noticeable. There was possibly some benefit from the ALL treatment, and it might prolong rail life in actual service, but the protection was not dramatic.

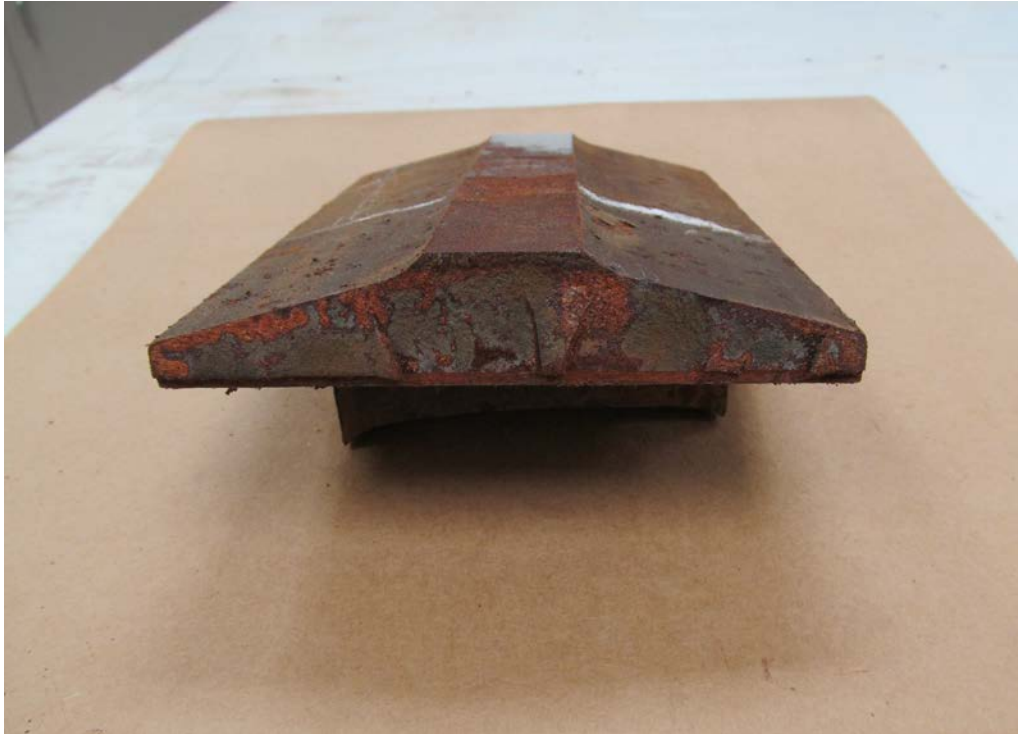
**Figure 36. Fracture Surface of Corroded Sample with No Protection**

The fracture surfaces for Sample #2 (NONE) and Sample #4 (ALL) are shown in Figure 36 and Figure 37, respectively. Notice the advance of corrosion in the damage zone is greater for the sample with no protection than for the sample with corrosion protection.

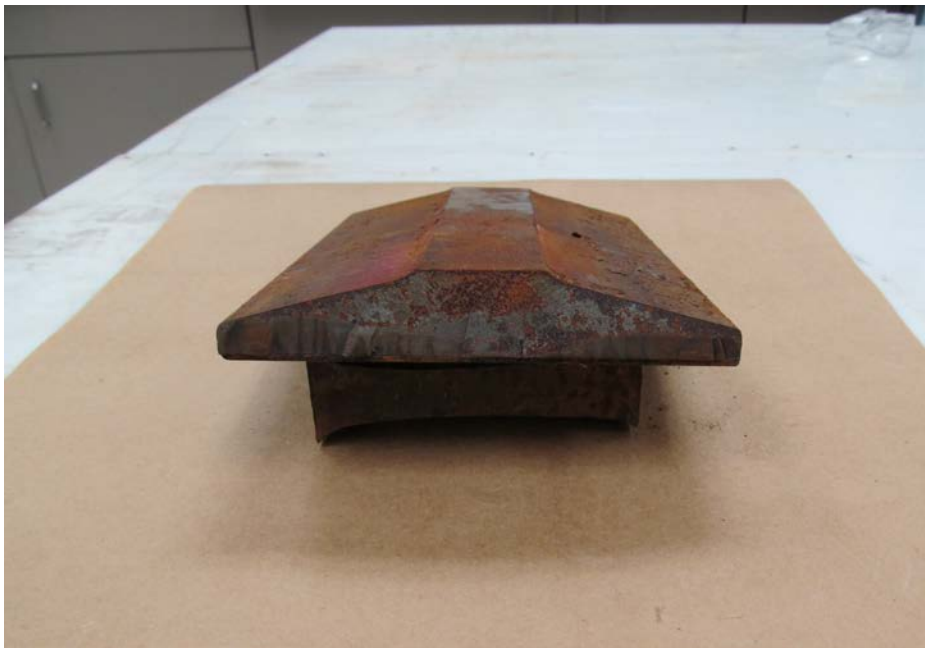
**Figure 37. Fracture Surface of Corroded Sample with ALL Treatment**

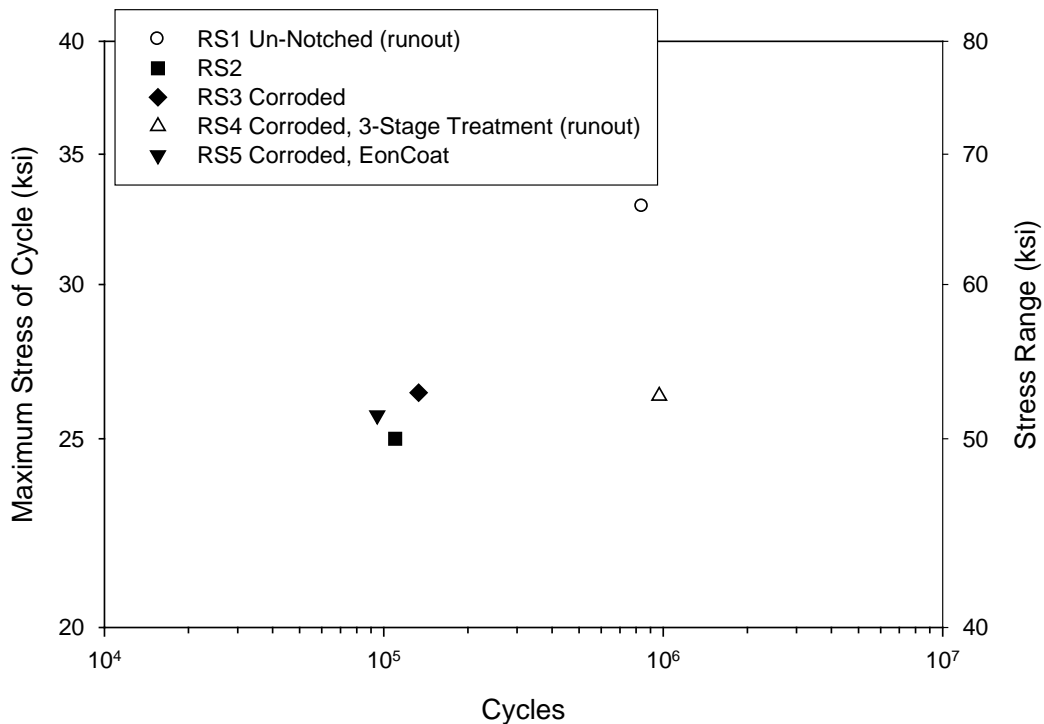
**Figure 38. Resonant Fatigue Test Lifetime Results**

The results of the resonant fatigue testing are summarized in Table 10 and Figure 38.

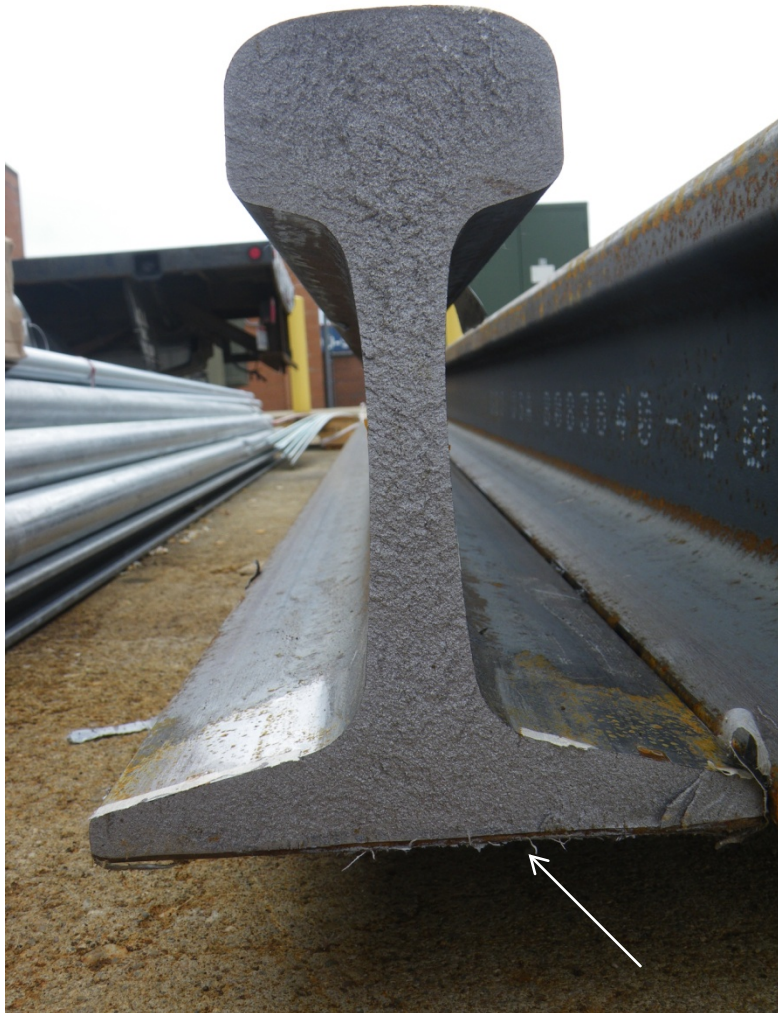
**Figure 39. Resonant Fatigue Fracture Surface of Unprotected, Corroded Rail (Sample RS3)  
Arrow Shows Crack Zone**

Fatigue results are judged partly based on the range of stress loading. Since the cycles provide reversed loading, the stress ranges will be twice the values given in Table 10, or roughly 60–80 ksi. Sample RS1 was tested without a notch and at a higher stress range than the notched rails. Failure of that sample was not induced in the testing. Samples RS2–RS5 were pre-notched before treatments, corrosion cycles, or testing. RS2 was not protected from corrosion, but it also did not see purposeful corrosion cycles. Sample RS3 was unprotected, but *did* undergo corrosion cycling and had a saltwater solution “diaper” applied during resonant fatigue. It could represent older rail in service that had somehow been damaged and suffered corrosion attack. It failed in the crack zone, but showed slightly higher fatigue life despite the corrosion and lack of protection. Rust formation is clearly evident in the failure zone of RS3 (Figure 39).

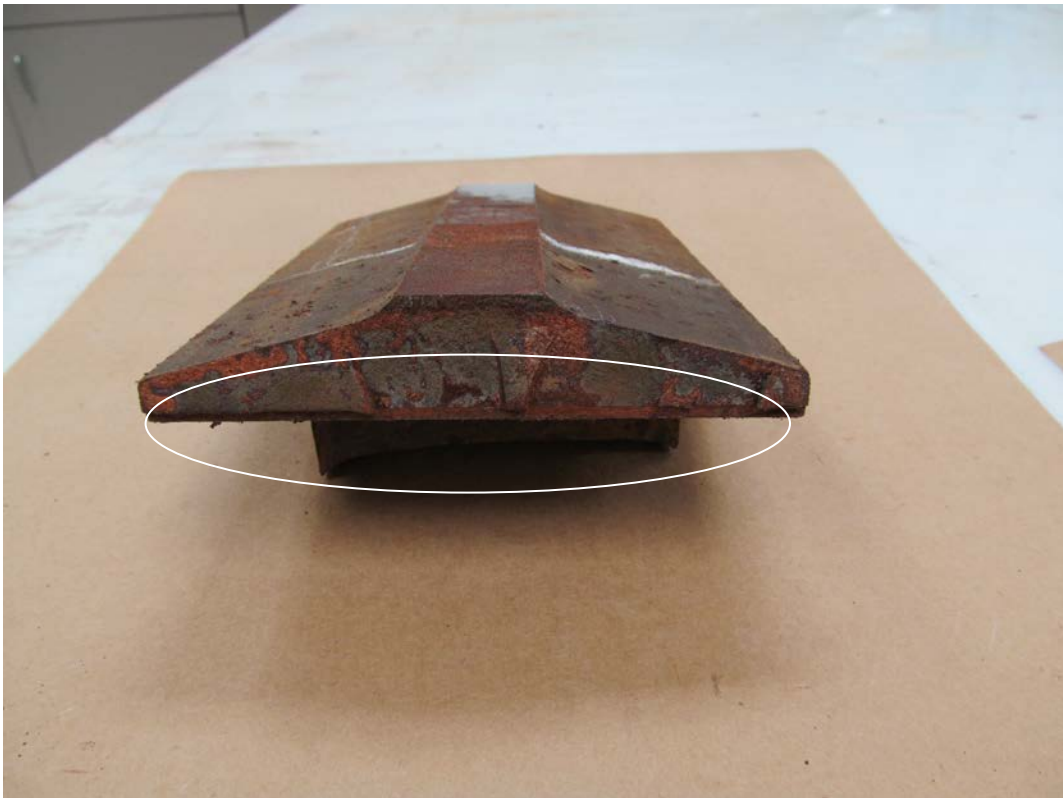
**Figure 40. Fracture Surface of Corroded Sample with No Protection (Crack – corrosion area is circled)**

In comparing the character of the fracture surfaces with those for the medium-scale samples, the resonant fatigue samples showed much smaller regions of fatigue cracking than those visible on the medium-scale samples (Figure 40 and Figure 41, tested in Task 3). This difference is attributed to the larger cross-section of the full rail inducing a higher stress intensity factor in the rail at the fatigue crack tip, allowing brittle fracture to take over from fatigue at a smaller crack size.

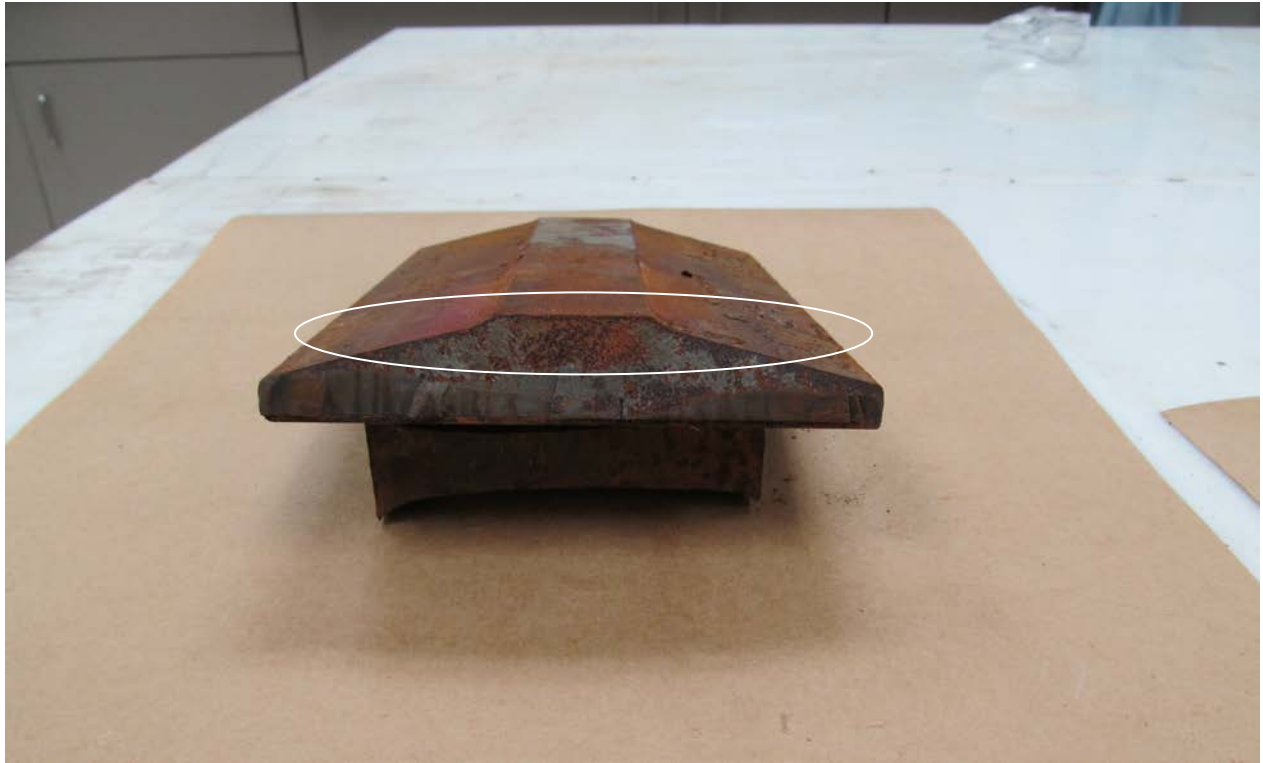
**Figure 41. Fracture Surface of Corroded Sample with ALL Treatment**

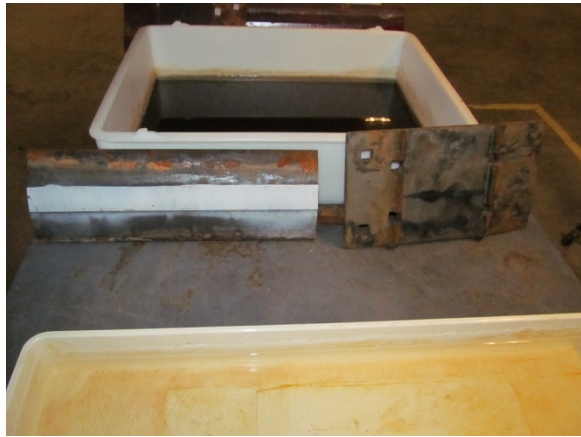
**Fig. A-1. Week 1 – PD after Salt Water**

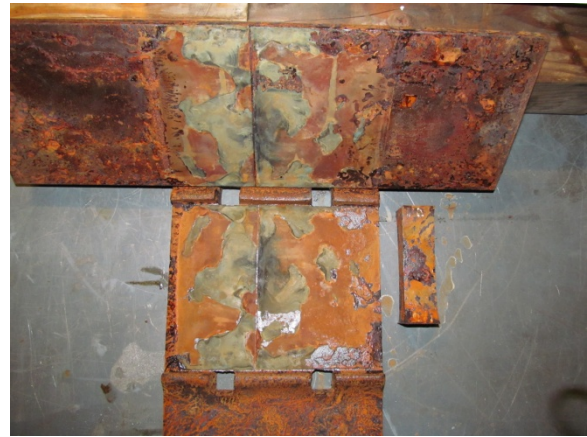
**Fig. A-2. Week 1 – PD after Humidity**

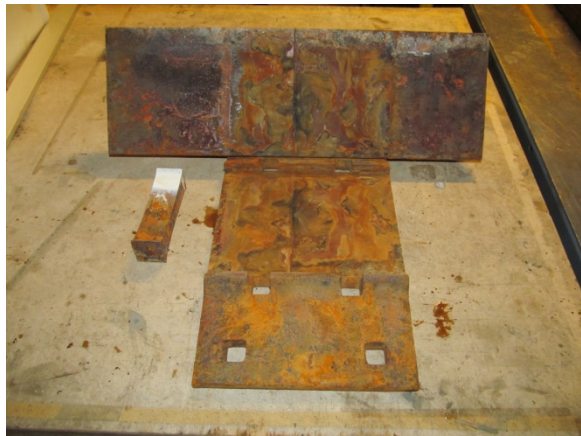
**Fig. A-3. Week 2 – PD after Salt Water**

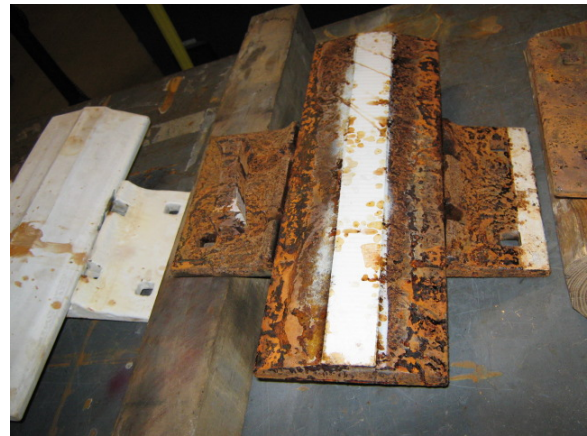
**Fig. A-4. Week 2 – PD after Humidity**

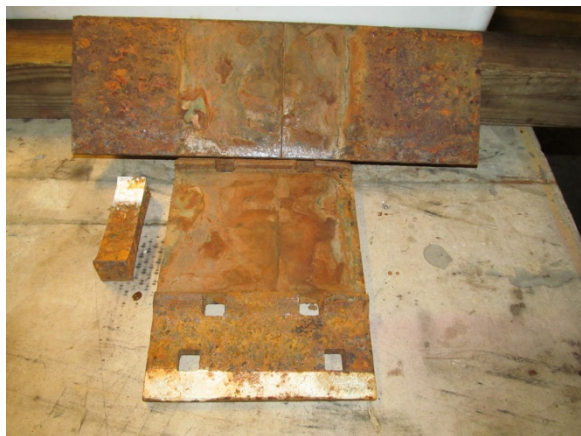
**Fig. A-5. Week 3 – PD after Salt Water**

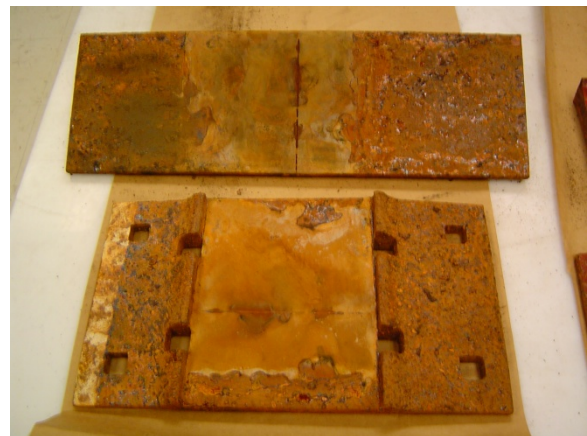
**Fig. A-6. Week 3 – PD after Humidity**

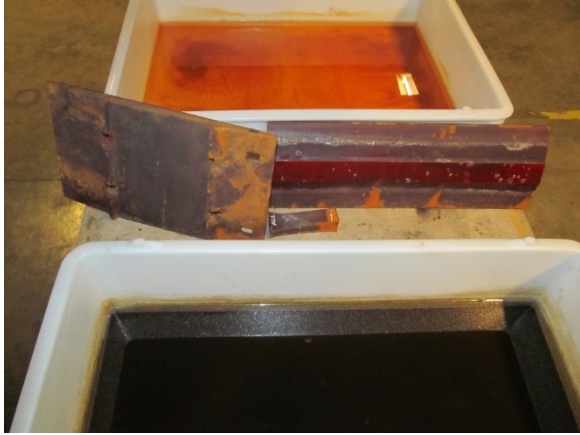
**Fig. A-7. Week 1 – ALL after Salt Water**

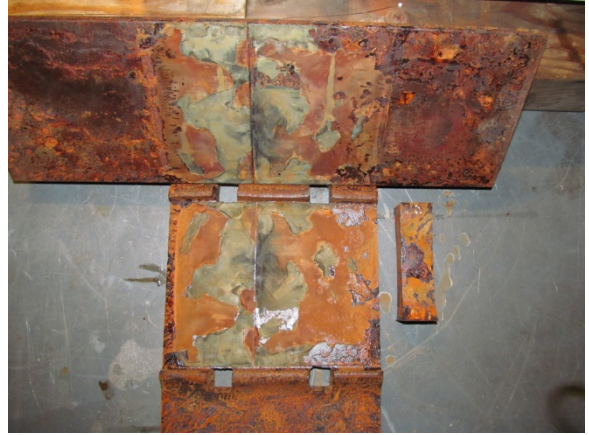
**Fig. A-8. Week 1 – ALL after Humidity**

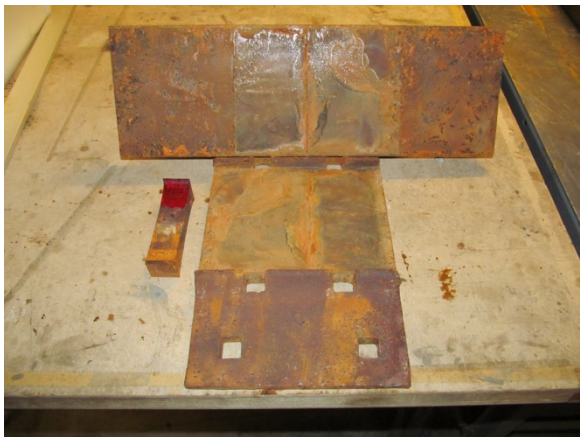
**Fig. A-9. Week 2 – ALL after Salt Water**

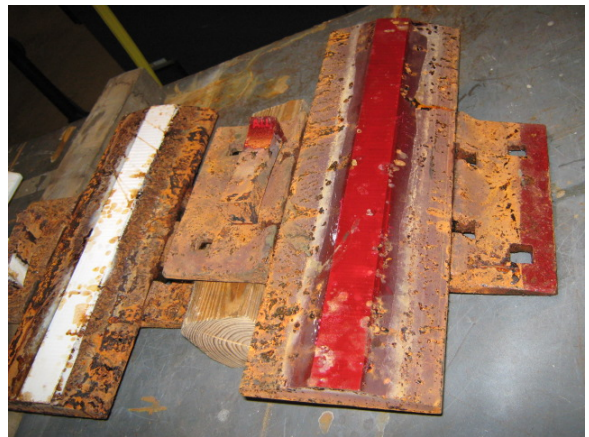
**Fig. A-10. Week 2 – ALL after Humidity**
