U.S. Department of  
Transportation  
**Federal Railroad  
Administration**

# Rail Base Corrosion and Cracking Prevention

1. AGENCY USE ONLY (Leave blank)	2. REPORT DATE July 2014	3. REPORT TYPE AND DATES COVERED Final (September 2012 – June 2013)	
4. TITLE AND SUBTITLE Rail Base Corrosion and Cracking Prevention		5. FUNDING NUMBERS DTFR-12-C-0024

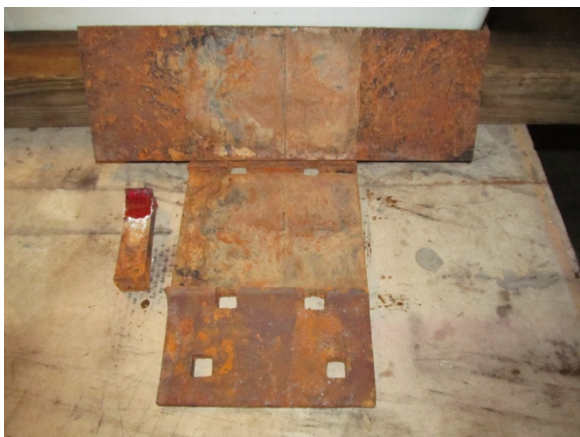
**Fig. A-11. Week 3 – ALL after Salt Water**

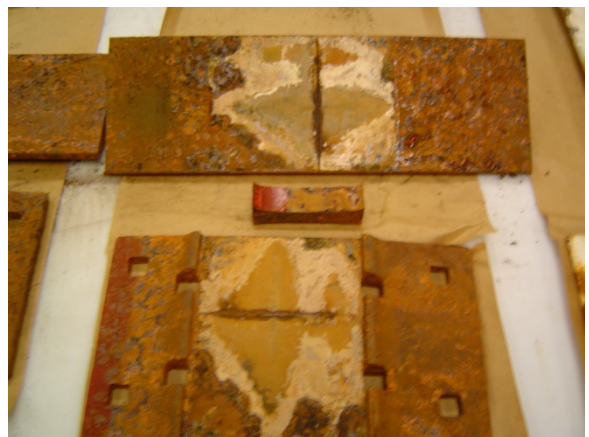
**Fig. A-12. Week 3 – ALL after Humidity**

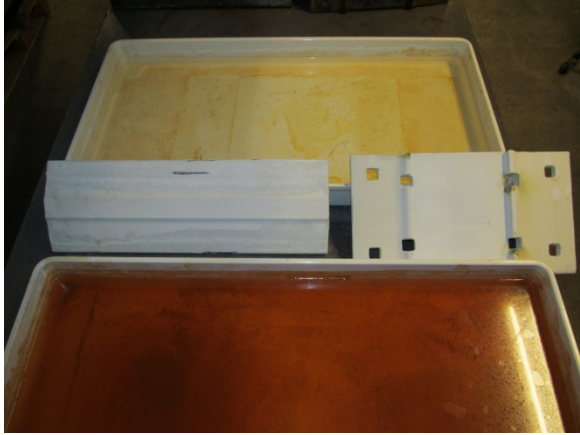
**Fig. A-13. Week 1 – EC after Salt Water**

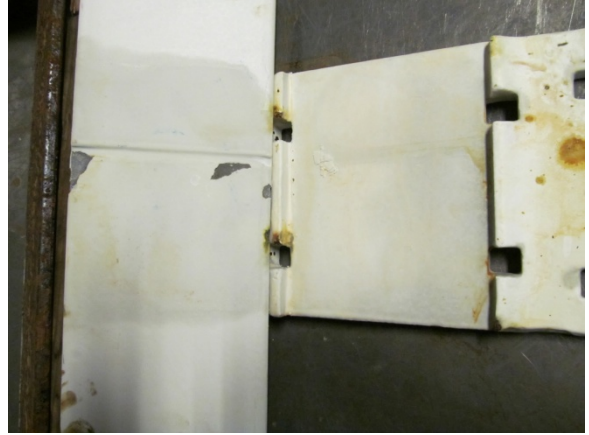
**Fig. A-14. Week 1 – EC after Humidity**

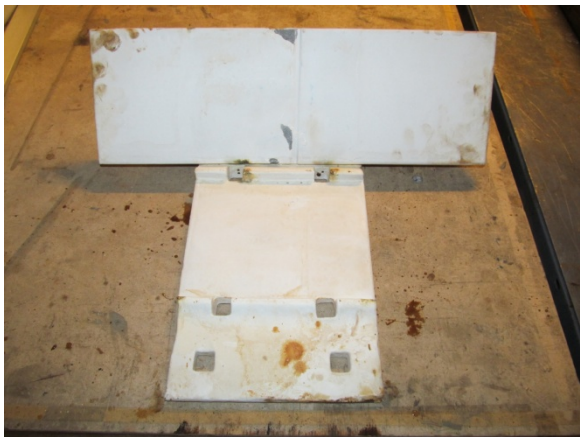
**Fig. A-15. Week 2 – EC after Salt Water**

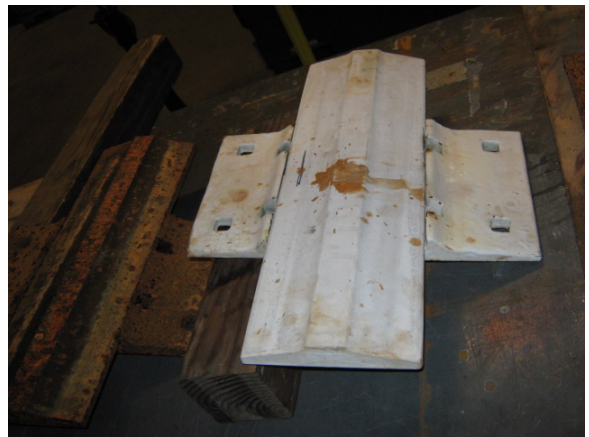
**Fig. A-16. Week 2 – EC after Humidity**

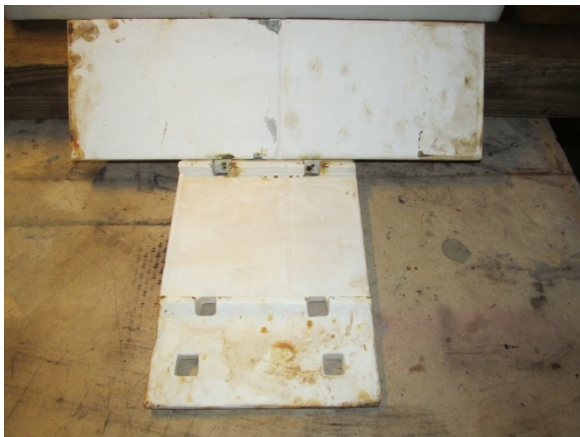
**Fig. A-17. Week 3 – EC after Salt Water**

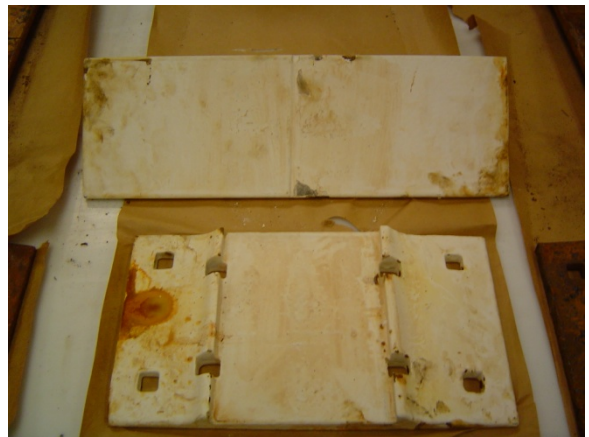
**Fig. A-18. Week 3 – EC after Humidity**

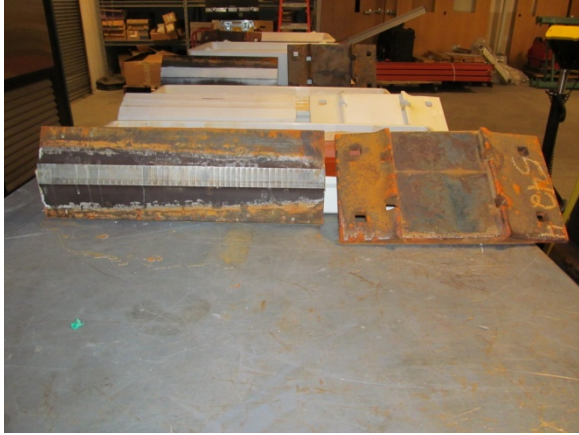
**Fig. A-19 Week 1 – No Treat, Salt Water**

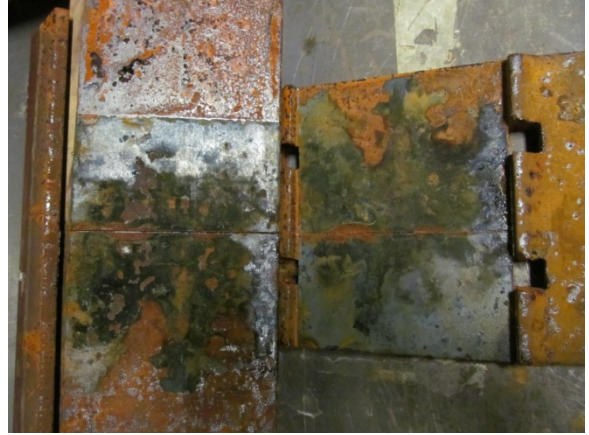
**Fig. A-20. Week 1 – No Treat, Humidity**

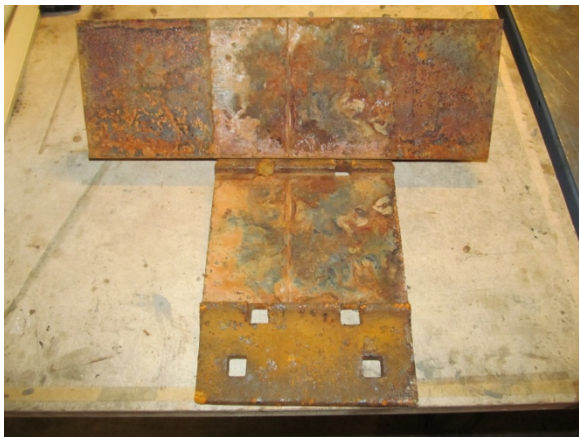
**Fig. A-21 Week 2 – No Treat, Salt Water**

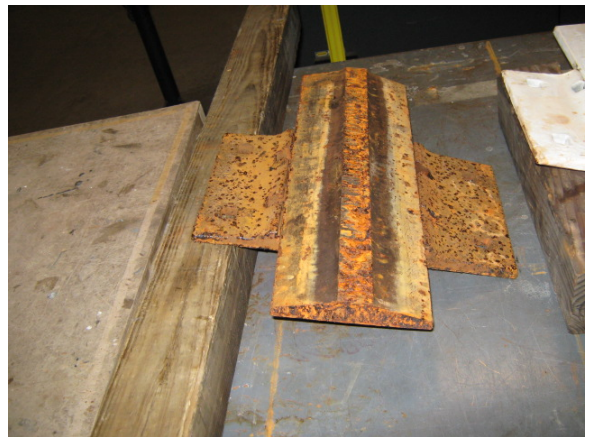
**Fig. A-22. Week 2 – No Treat, Humidity**

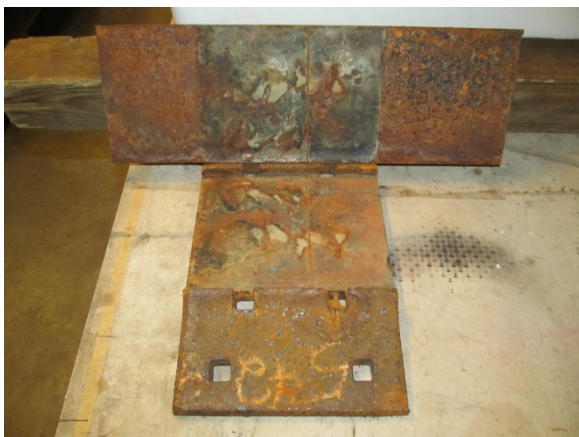
**Fig. A-23. Week 3 – No Treat, Salt Water**

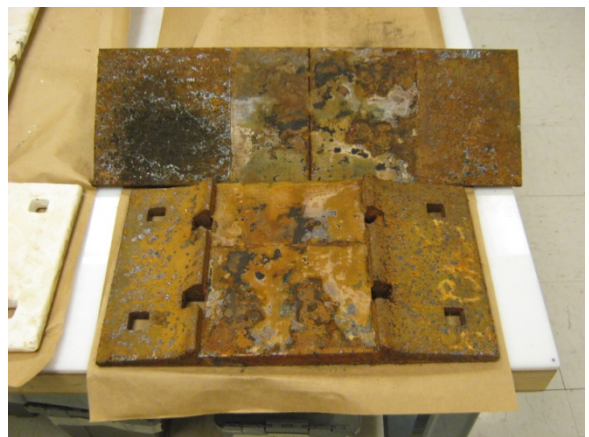
**Fig. A-24. Week 3 – No Treat, Humidity**

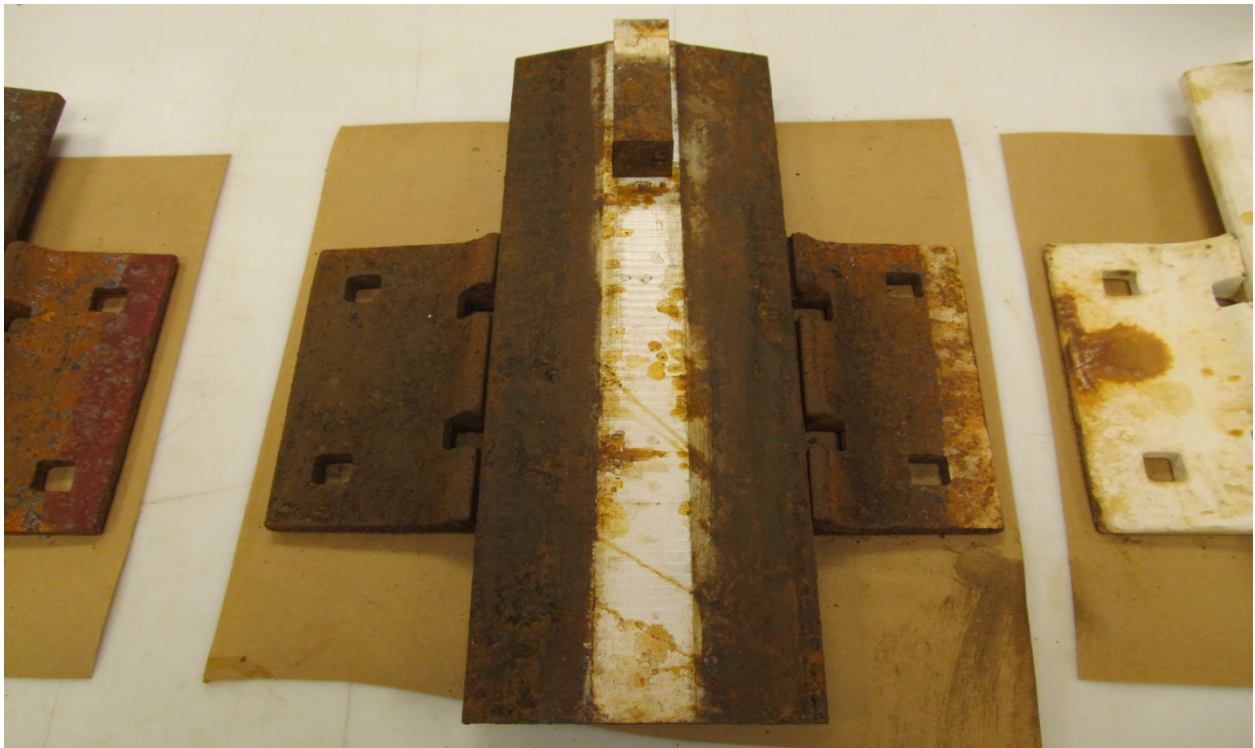
**Figure A-26. PD after Cleaning**

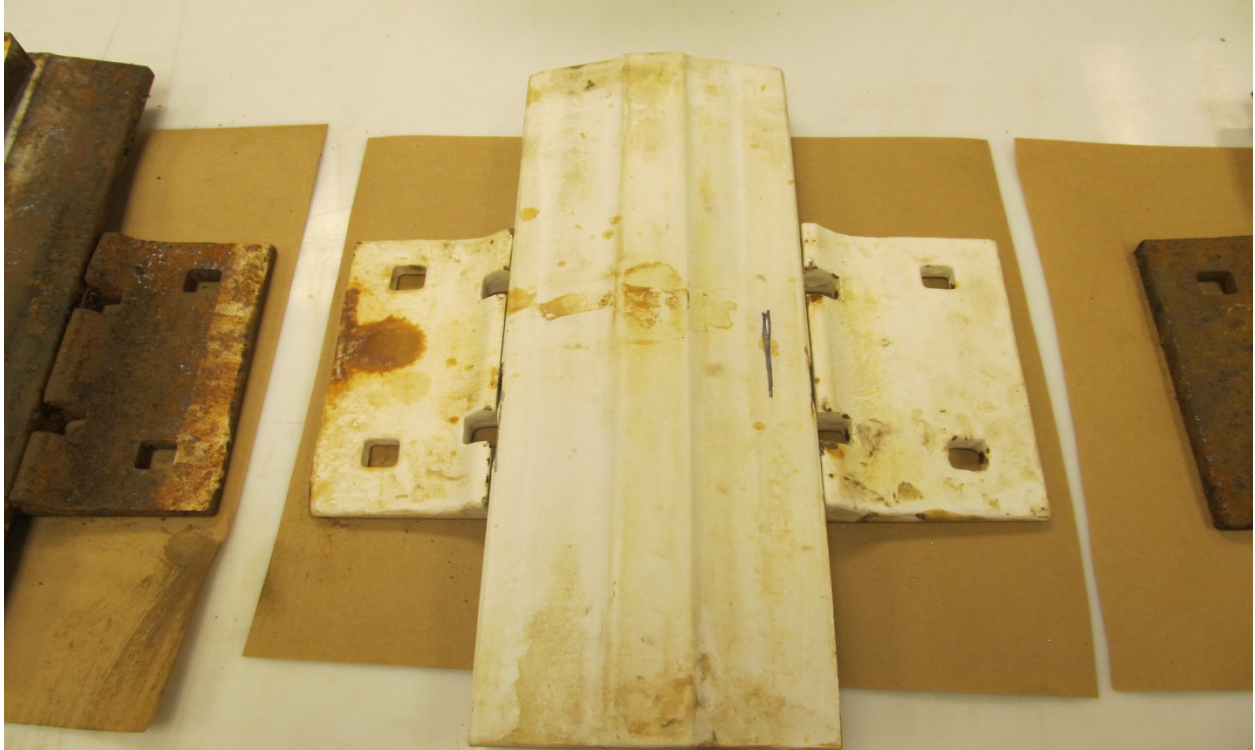
**Figure A-27. EonCoat® after Cleaning**

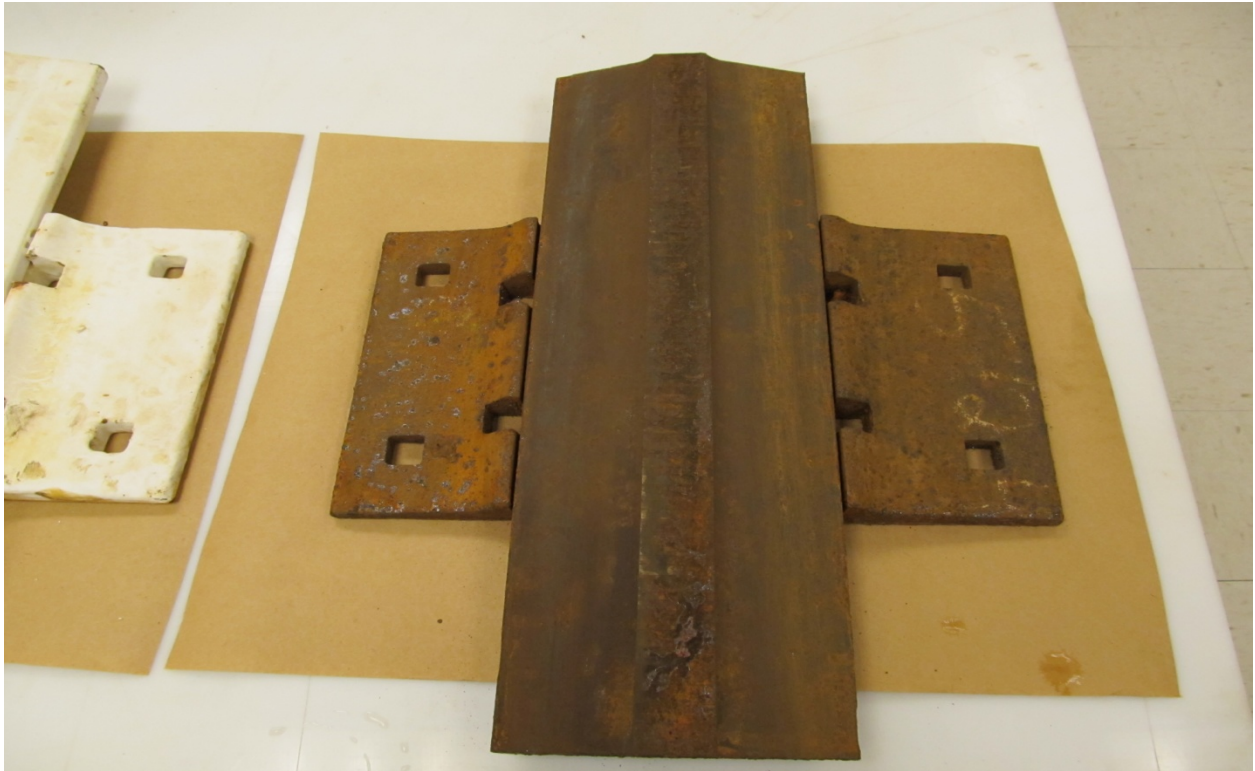
**Figure A-28. No Treatment, after Cleaning**

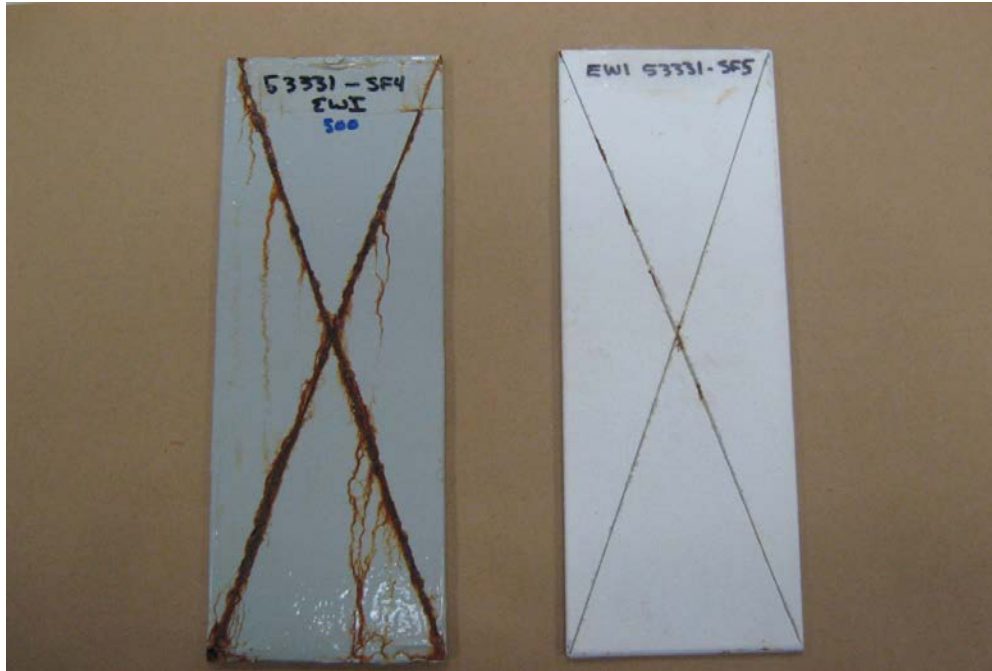
**Figure B-1. EWI (left) and EonCoat® (right) after 500 Hours, Scribed to Metal.**

After 500 hours, the EWI sample showed attack on the scribed side (Figure B-1), while the EonCoat® system showed very little attack. After 5,000-hour exposure (Figure B-2) the EWI system sustained significant damage with undercutting and blistering, whereas the EonCoat® system was still holding up very well and offering good protection.

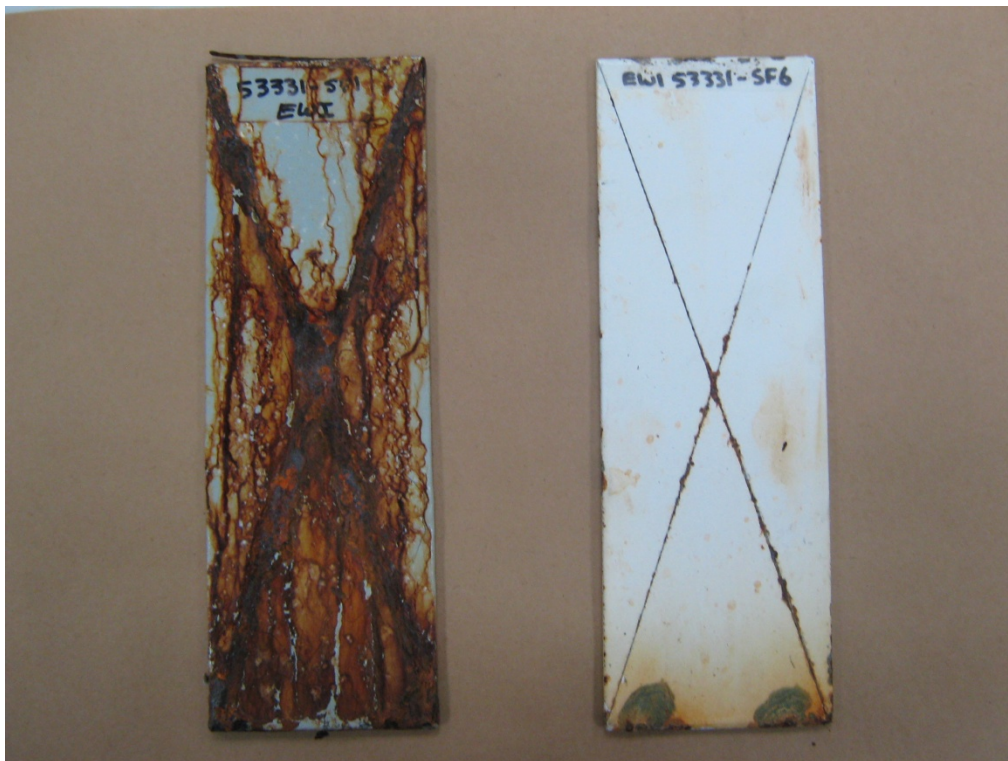
**Figure B-2. EWI (left) and EonCoat® (right) after 5000 Hours, Scribed to Metal**

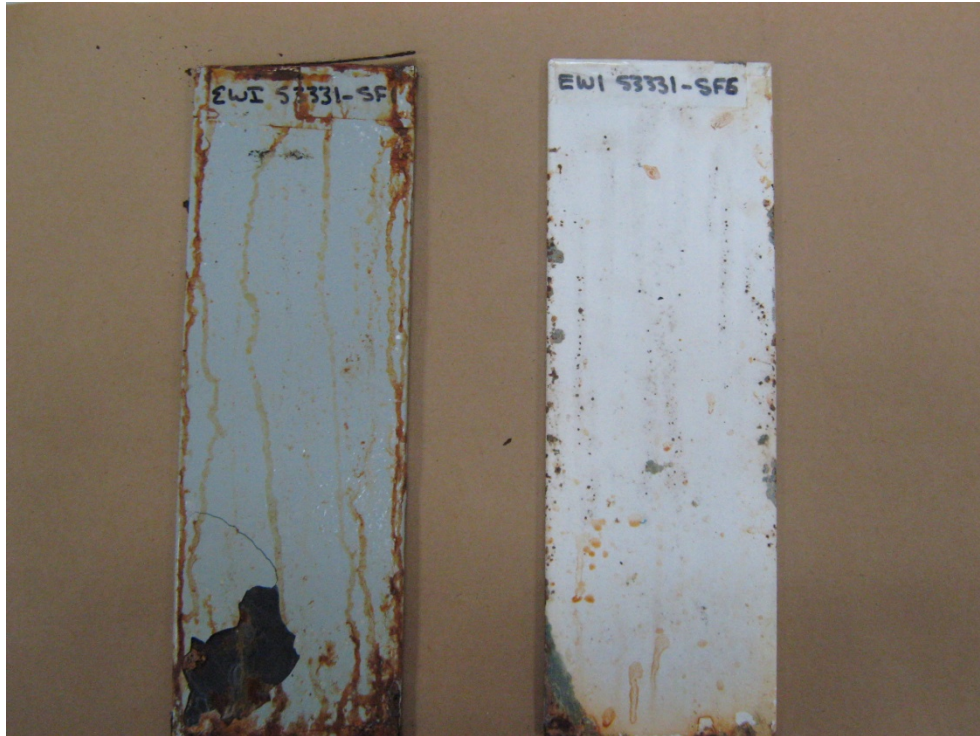
**Figure B-3. EWI (left) and EonCoat® (right) after 5,000 Hours, Back Side**

After 5,000 hours, the back sides (Figures B-3) were showing delamination for the EWI system, but there was still residual protection on the exposed metal. This suggests the EWI system as a primer can continue to provide protection even if the top coat is dislodged, as long as the primer is intact (not scribed or damaged).
