PROJECT SUMMARY REPORT 1788-S

EVALUATION OF THE CAPE SEAL PROCESS
AS A PAVEMENT REHABILITATION
ALTERNATIVE

Mansour Solaimanian and Thomas W. Kennedy

OCTOBER 1998

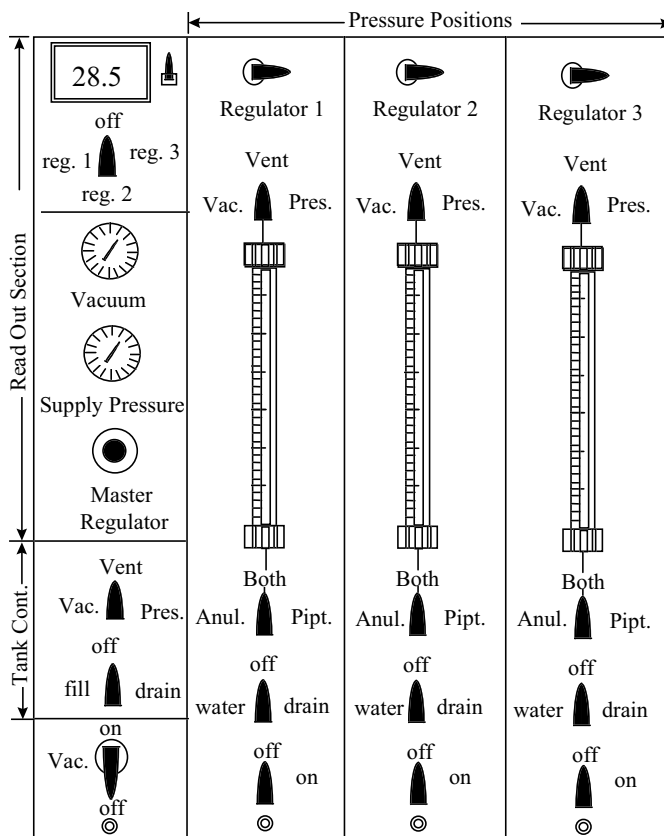
The permeability tests were performed using a permeameter cell and a water flow control panel. The equipment, very efficient for running permeability tests, includes several vacuum and pressure gauges capable of accurate application of pressure and measure of flow (Figure 3.2).

Figure 3.2. Pressure-drainage-vacuum control panel used for permeability study

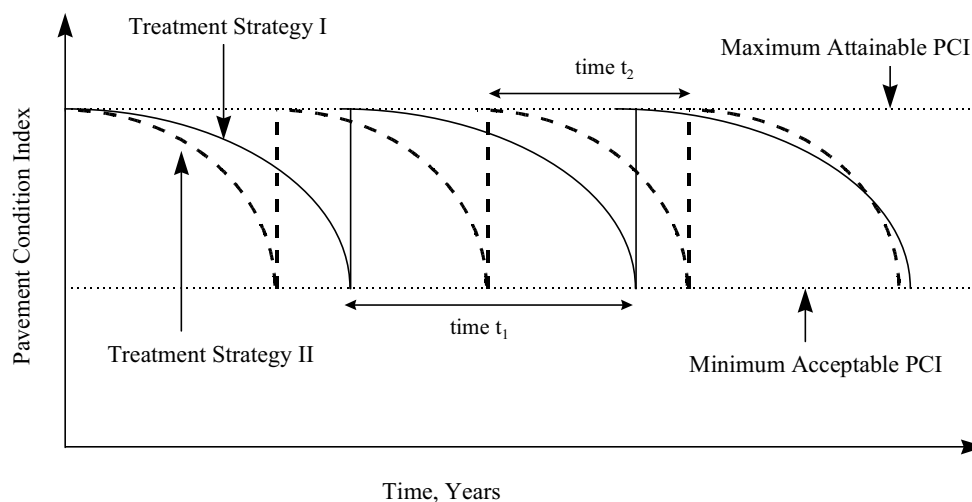
The expected pavement performance curve shown in Figure 4.2 provides the basis for conducting the cost comparison. The ordinate on the graph is a performance index, which can be determined using one of several existing approaches. One common approach is the pavement condition index (PCI), which ranges from 0 to 100, with 100 representing a new pavement in excellent condition and 0 representing a completely deteriorated pavement. Another approach is the pavement serviceability index (PSI), which ranges from 0 to 5, with 5 being the highest level of serviceability.

Figure 4.2. Generalized pavement performance curve for cost comparisons between two strategies

In comparing the cost of rehabilitation using Cape seal with microsurfacing or HMAC, it is assumed that the condition level achieved after rehabilitation is almost the same regardless of the strategy selected. This is not necessarily true if the condition is quantified in the form of PCI or PSI. As shown in Figure 4.2, it is assumed that the rate of deterioration (i.e., reduction in PCI) varies between different strategies. The difference in performance requires that the pavement be treated at different points in time (Figure 4.2). These different points in time are bounded by (1) the present time, and (2) the time of maximum tolerable “poor” condition. It is also assumed that the user costs during treatment are the same whether

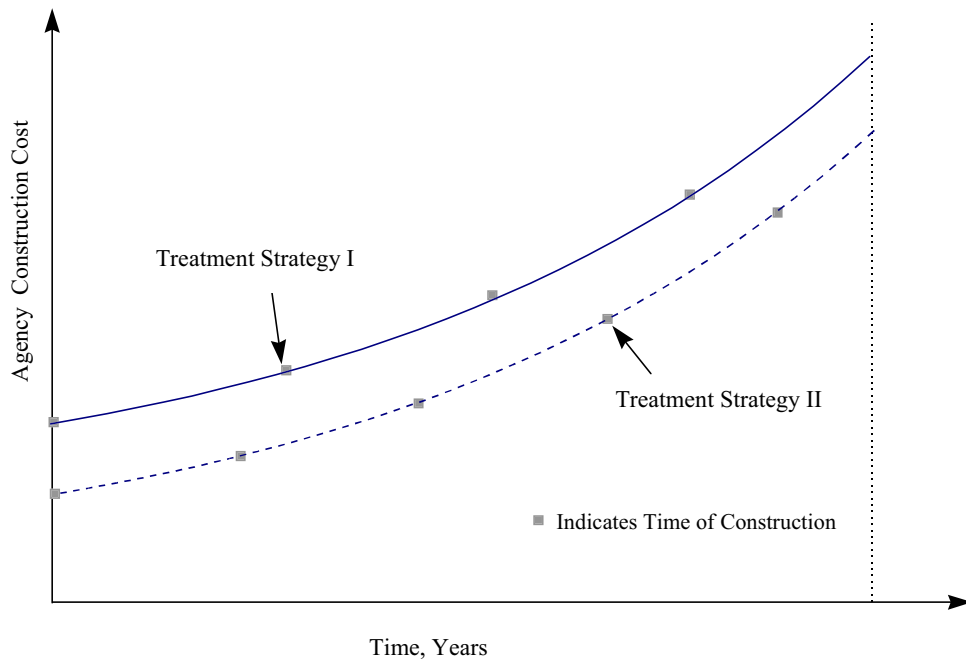
Figure 4.3. The change in construction cost with time for two different strategies assuming a fixed inflation rate and assuming equivalent user cost and annual typical maintenance cost for both strategies (note Strategy II with more construction frequency because of shorter life)

The performance of HMAC on high-volume roads has been considerably varied, given that such performance can be affected by construction/structural/materials parameters, conditions of the existing pavement, climatic conditions, and traffic level. An average life of 7 to 8 years can be considered typical for 50-mm HMAC mixes. A good Cape seal is assumed to last about the same time. The oldest Cape seal application visited during this research project is 6 years old. The project is in good shape as of today (October 1998). However, if we assume a shorter life span for Cape seal (i.e., Strategy I representing Cape seal in Figure 4.2, and Strategy II representing HMAC), then use of this treatment is required at a higher frequency. During a certain time frame (for example, a 30-year period), with a fixed inflation rate, the construction cost for these two strategies will follow the pattern shown in Figure 4.3.
