Guidelines for Routine Maintenance of Concrete Pavements

Project Title: Develop Guidelines for
Routine Maintenance of Concrete Pavement

Performed in cooperation with the Texas Department of
Transportation and the Federal Highway Administration
April 2008

TEXAS TRANSPORTATION INSTITUTE

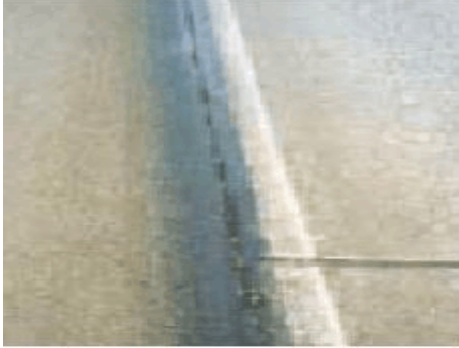
Description: Edge/shoulder drop-offs are normally associated with the use of a flexible shoulder on pavements where the main lanes are concrete. Large differences in elevation of the main lanes versus the shoulder can be safety problems and should be addressed by maintenance forces. Frequently, the edge/shoulder joint has deteriorated and is now open. Water will enter this joint and cause erosion of the layers supporting the concrete. This can lead to rapid failure of the concrete slab. This problem has been largely eliminated in Texas in new pavements because of the use of tied concrete shoulders. The edge/shoulder problem is particularly severe with old, narrow jointed concrete pavements, which may have been only 18 or 20 feet wide.

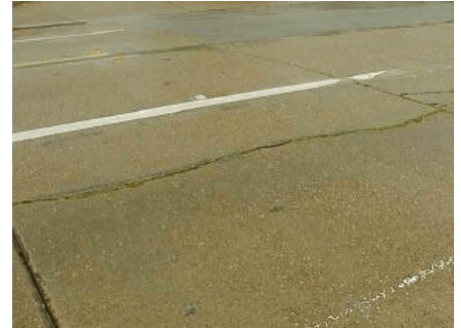
Description: Longitudinal cracks are cracks that are approximately parallel to the centerline of the roadway. Such cracks are generally straight, but in some instances they may be curved. In severe cases, the pavements may also be faulted on one side of the crack.

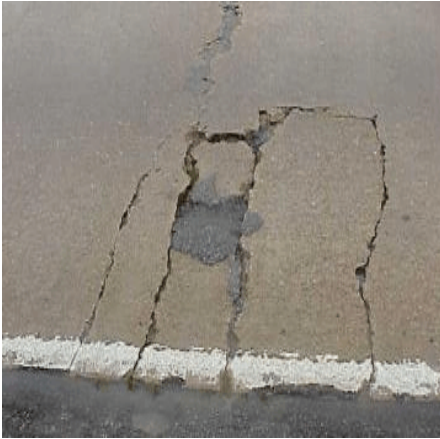
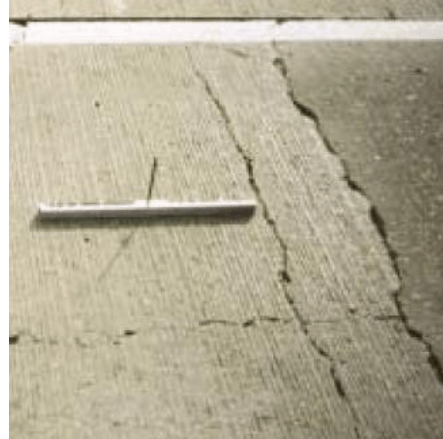
Description: A punchout is a full-depth block of pavement, formed at the edge, when a longitudinal crack forms between two existing transverse cracks. The existing cracks are closely spaced, usually less than 4 feet apart. The punchout is often rectangular, but some may appear in other shapes. Punchouts are most common in continuously reinforced concrete pavements.

The interconnecting cracks will not create any riding or safety problems. The cracks will allow additional moisture to come into contact with the base materials, resulting in accelerated erosion and pumping.

The punchout will develop spalled edges, settlement, and rupturing reinforcement under heavy loads. Once spalling and settlement have occurred, safety and riding quality problems will follow. Also, the punchout will expand to nearby cracks if it is not immediately repaired.
