10	echnical Report Documentation Pag
1. Report No.	2. Government Acce	ession No.	3. Recipient's Catalo	g No.
FHWA/TX-09/0-4588-2 4. Title and Subtitle				
EFFECT OF VOIDS IN GROUTE	D DOST TENSIO	NED	5. Report Date February 2009)
CONCRETE BRIDGE CONSTRU				
			Published: No 6. Performing Organ	
REPAIR MANUAL FOR EXTERN		N	0. Ferforning Organ	
SEGMENTAL, POST-TENSIONE	D BRIDGES

Administration. Project Title: Effect of Voids in Gro <u>URL: http://tti.tamu.edu/documents</u> ^{16. Abstract} Segmental, post-tensioned (PT) brid designed and constructed because th	/0-4588-2.pdf lges are major struney are economica	actures that carry	y significant traff ong distances. In	ic. These bridges are Texas, there are several
Administration. Project Title: Effect of Voids in Gro URL: <u>http://tti.tamu.edu/documents</u> ^{16. Abstract} Segmental, post-tensioned (PT) brid designed and constructed because th	/0-4588-2.pdf lges are major struney are economica	actures that carry	y significant traff ong distances. In	ic. These bridges are Texas, there are several
Administration. Project Title: Effect of Voids in Gro URL: <u>http://tti.tamu.edu/documents</u> ^{16. Abstract} Segmental, post-tensioned (PT)

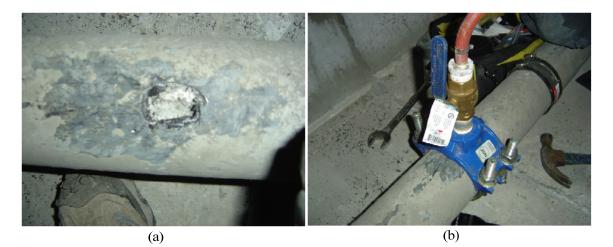
Figure A-3. (a) Air Outlet Hole for PVG Method, and (b) Pipe Saddle Tap and Ball Valve for Connecting Vacuum Safety Device and Vacuum Pump.

- Apply the vacuum pump to reduce pressure by 80 percent of atmospheric pressure (23.9 inHg).
 - Open the grout inlet at the top anchorage and inject repair grout using a hand grout pump.

- Close the valve of the vacuum safety device until the hand grout pump cannot pump more grout. If the repair grout flows out of the air outlet, close the ball valve at the pipe saddle tap and apply the hand grout pump until it cannot pump more grout.
- Turn off the vacuum pump.
- Close the valve of the grout inlet.
- **R-7:** Disconnect the vacuum safety device and pipe saddle tap, and seal the air outlet.
- **R-8 to R-11**: Evaluate the repair grouting.
 - On the following day after repair grouting, perform sounding tests on the repaired tendons to identify voids, if remaining. Record the observed void conditions in the repaired tendon on the repair grouting report form.
 - Submit the report to the repair program manager.

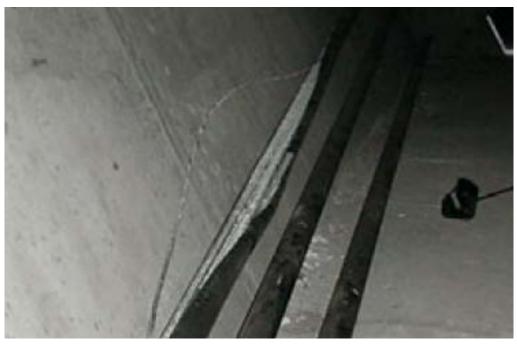
Figure A. Broken strands and broken ducts.

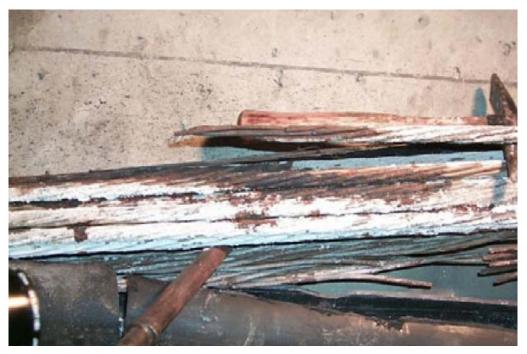
Figure B. Corroded and broken strands and broken ducts.

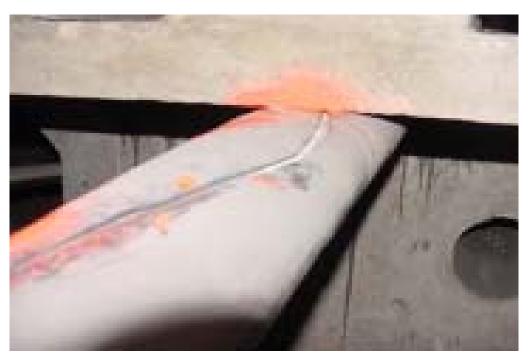
Figure D. Cracked ducts.

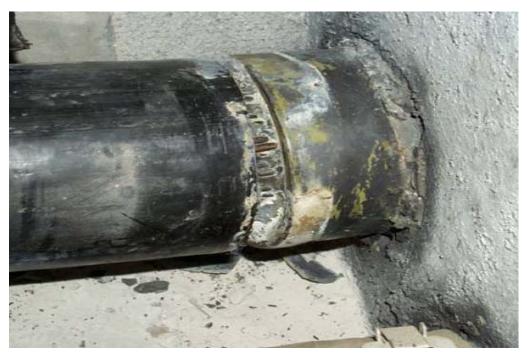
Figure E. Broken ducts and exposed strands.

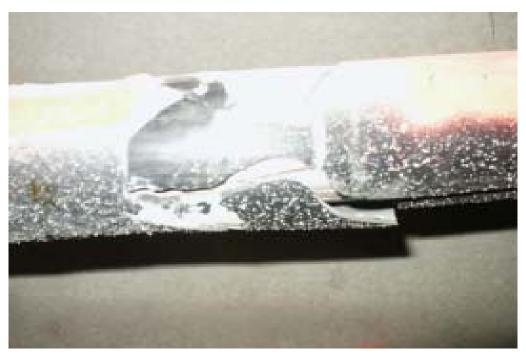
Figure F. Broken ducts and exposed strands.

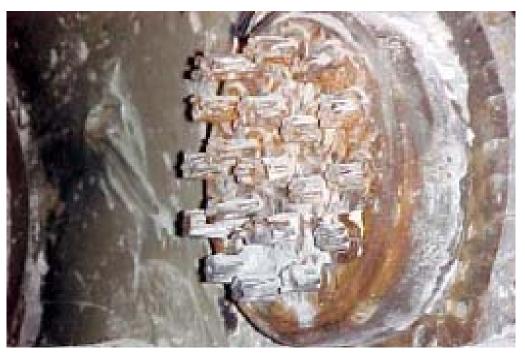
Figure I. Missing anchorage cap, exposed anchor head, and corroded strands.

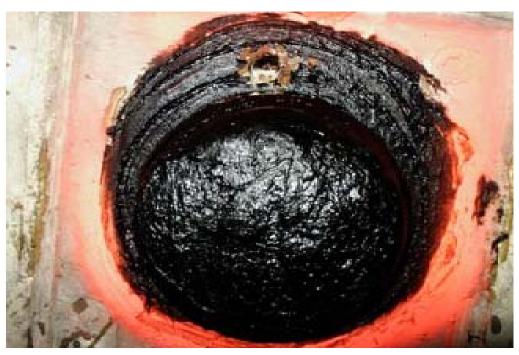
Figure K. Opened grout port.

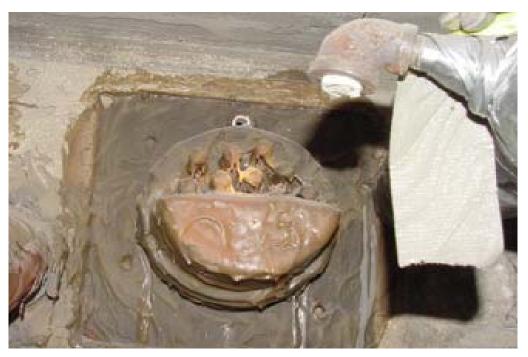
Figure L. Opened grout port, broken anchorage cap, and exposed anchorage zone.

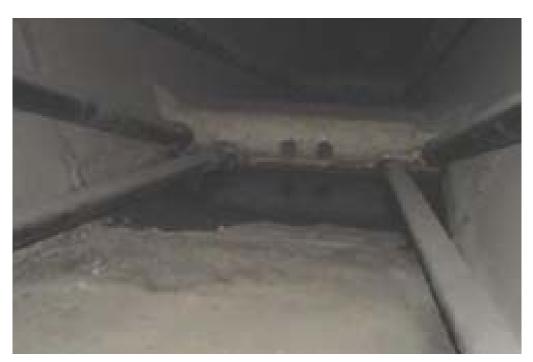
Figure N. Standing water in the concrete box girder.

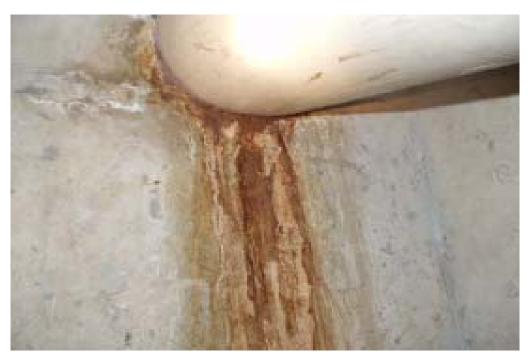
Figure O. Sign of past moisture infiltration in the concrete girder, broken drainage pipe.
