# Evaluation of Barriers for Very High Speed Roadways

## Research/Test Report 0-6071-2

**TEXAS TRANSPORTATION INSTITUTE  
THE TEXAS A&M UNIVERSITY SYSTEM  
COLLEGE STATION, TEXAS**

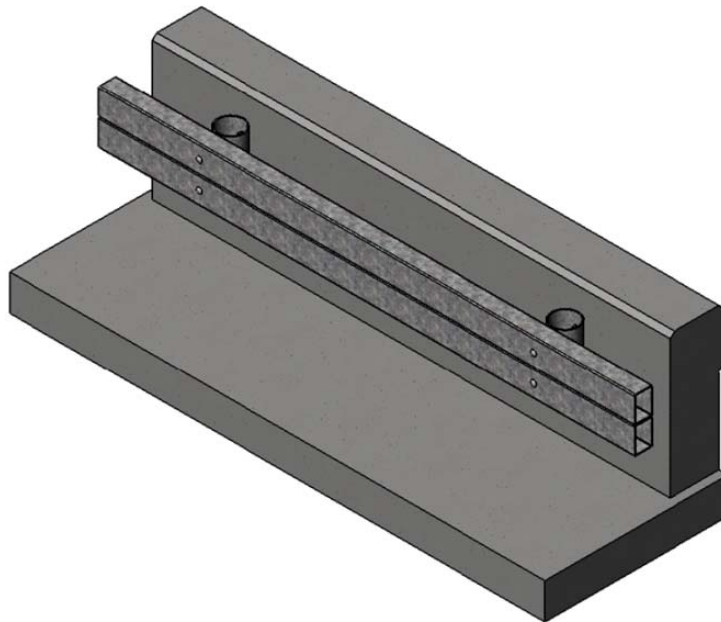
Therefore, the basic concept of the energy absorbing bridge rail shown in Figure 2.1 was conceived. This concept involves using a vertical concrete wall to support two tubular steel rails. Pipe spacers are incorporated into the system to offset the tubular rails from the rigid concrete parapet and to function as an energy-absorbing mechanism. The spacers are intended to deform upon vehicle impact and, thereby, absorb some of the vehicle's kinetic energy to lessen the impact severity below that of impacting a rigid concrete wall.

**Figure 2.1. Conceptual Drawing of the Energy Absorbing Bridge Rail.**

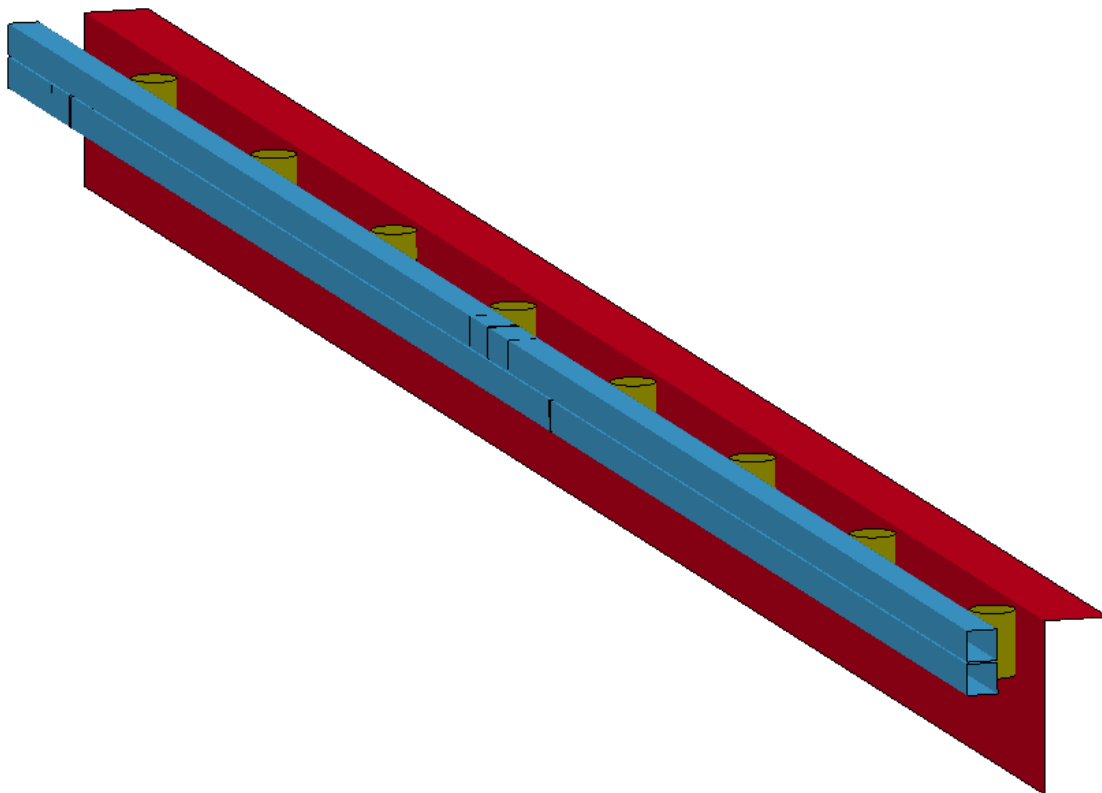
The finite element model of the rail is depicted in Figure 2.2. The 32-inch tall vertical concrete wall was modeled using a rigid material representation. The 12-inch tall, 8-inch diameter Schedule 40 pipe spacers were modeled using an elastic-plastic material representation with the properties of ASTM A53 steel. In the conceptual design, the pipes spacers were connected to the wall using bolts that pass through the concrete wall. A second bolt or stud is used to attach the two 6-inch  $\times$  4-inch  $\times$   $\frac{1}{4}$ -inch tubular steel rails to the traffic side of the pipe spacer. The two tubular steel rail sections were additionally connected to each other mid-span between pipe spacers using a through-bolt that passed from the top surface of the top rail to the bottom surface of the bottom rail.

Since no significant damage of these bolts was anticipated, they were modeled using nodal-rigid-body constraints in LS-DYNA. The use of nodal rigid body constraints in lieu of an explicit bolt model reduces the complexity of the model by eliminating edge contacts between the bolt shaft and hole that are generally difficult to numerically enforce. It also reduces computational time by eliminating the need for further mesh refinement.

**Figure 2.2. Finite Element Model of the Energy Absorbing Bridge Rail.**

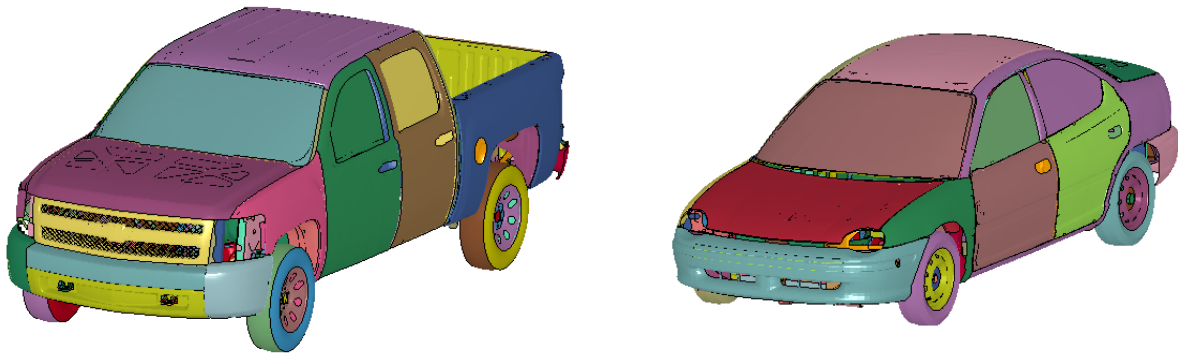
To evaluate the performance of the bridge rail under *MASH* criteria, impact simulations were performed with models of a pickup truck and small passenger car. The pickup truck model used was a ½-ton, 4-door Chevrolet Silverado with a weight of 5000 lb (see Figure 2.3). This model was developed by the National Crash Analysis Center under sponsorship from Federal Highway Administration and the National Highway Traffic Safety Administration.

The *MASH* test matrix for longitudinal barriers also includes a test with a 2425-lb passenger car. Since a public domain finite element model of this design vehicle was not available at the time of this research, the researchers chose to use a 2900-lb Dodge Neon model to evaluate the impact performance of the bridge rail for test designation 3-10 (see Figure 2.3). This model was considered to be a reasonable alternative for the 2425-lb design passenger car vehicle in a previous phase of this research study (4). In all of the simulations performed, the vehicle impacted the rail at a speed of 85 mi/h and an angle of 25 degrees.

**Figure 2.3. Finite Element Models Used in the Simulation Analysis.**

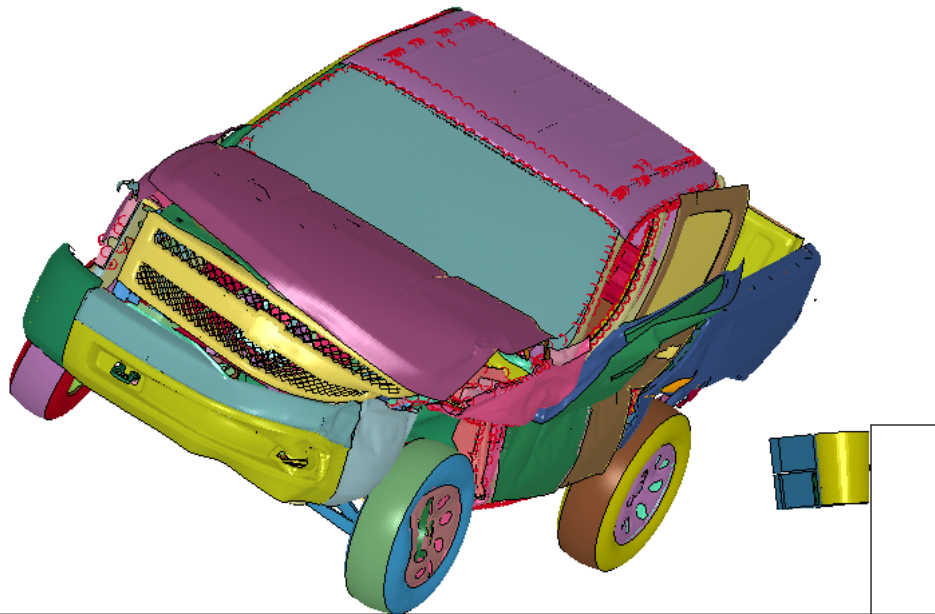
The initial height of the tubular steel rails evaluated through simulation was 27 inches. The results of the simulation showed the pickup truck rolling over as it was redirected by the barrier. In a subsequent design iteration, the height of the rail was raised to 31 inches. Even though significant roll was observed (see Figure 2.4), the pickup truck did not rollover.

**Figure 2.4. Pickup Truck Redirects but has a High Roll after Impact with the Rail at 31-Inch Rail Height.**

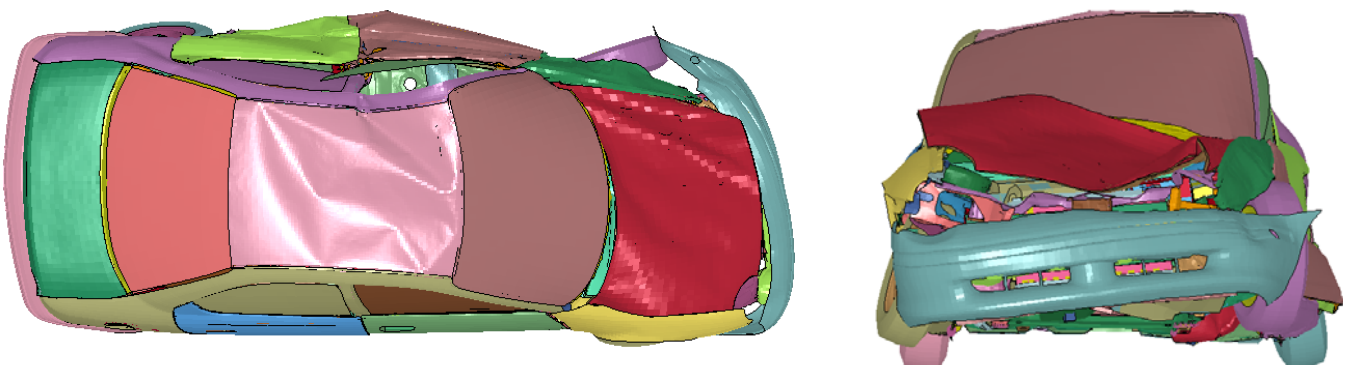
A simulation with the 2900-lb passenger car model was performed with the tubular rails set at a height of 31 inches to the top of the stacked rails. The car was redirected in a stable manner. However, the high impact severity resulted in an occupant impact velocity (OIV) that was at the allowable threshold of 12 m/s and significant damage to the vehicle's occupant compartment as shown in Figure 2.5. The occupant compartment deformation was aggravated by the proximity of the tubular steel rails to the vehicles A-pillar. It was hypothesized that if the height of the steel rails could be reduced, or if the two rail tubes were separated such that the bottom rail could engage the small car at a lower height, it might prevent the vehicle from trying to under-ride the rails, thus lowering the occupant compartment deformation.

**Figure 2.5. Deformation of the Small Car after Impact with the Rail at 36-Inch Rail Height.**

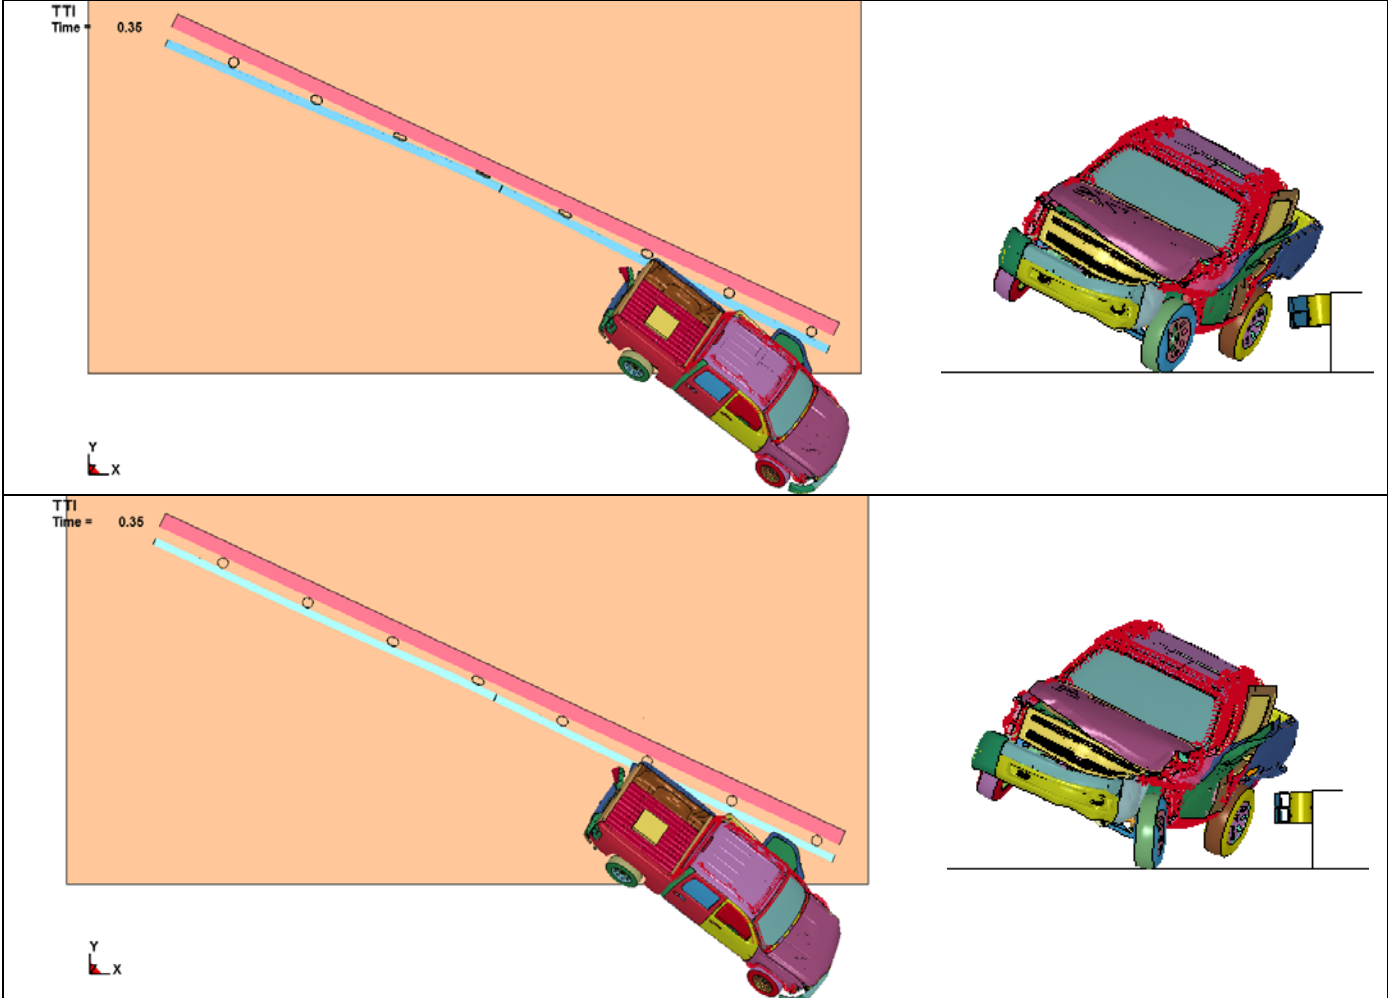
Results of the simulation analysis indicated that some of the Schedule 40 pipe spacers collapsed quickly during the pickup truck impact prior to any substantial redirection of the vehicle. Once the pipes collapse in the region of impact, the stiffness of the rail increases significantly and the energy management becomes less controlled. It was theorized that if the rate of collapse of the pipe spacers could be reduced through the use of stiffer pipe sections, the impulse on the pickup truck would be reduced and vehicle stability could be improved. To investigate this theory, a pickup truck impact simulation was performed with thicker Schedule 80 pipe spacers substituted for the Schedule 40 pipe spacers. The results were not significantly different from those for the system with Schedule 40 pipes (see Figure 2.6). Furthermore, none of the Schedule 80 pipes spacers were fully collapsed and this raised concern that the added stiffness could further increase the severity of the small car impact. Therefore, Schedule 40 pipes spacers were used in the final design.

Figure 2.6. Performance of Schedule 40 (Top) and Schedule 80 (Bottom) Pipe Spacers.

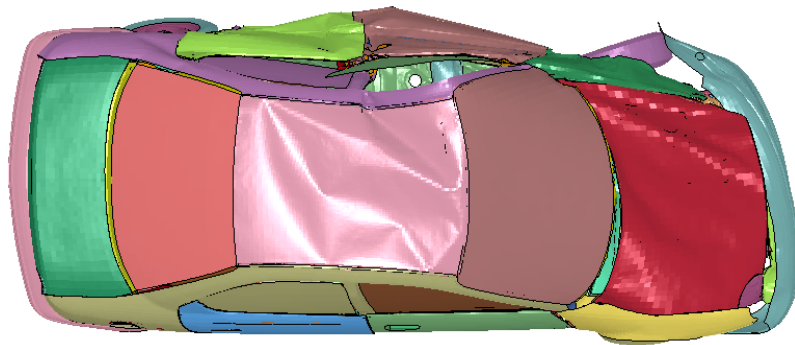
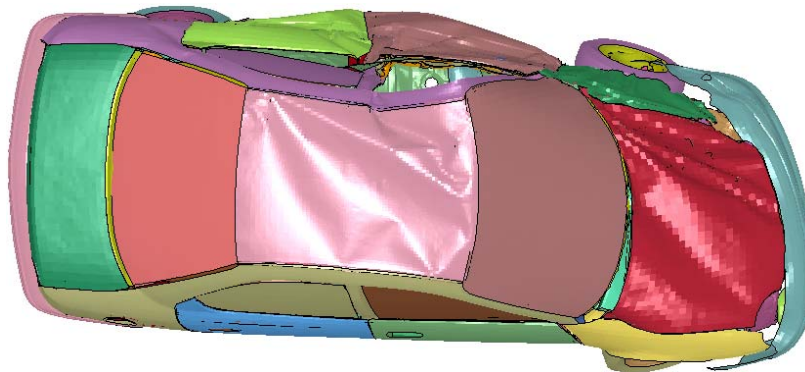
The researchers also evaluated the affect of pipe spacing on the overall performance of the rail. It was expected the by placing the pipes closer, the collapse of the pipes will occur at a slower rate, which may reduce the occupant compartment deformation in the small passenger vehicle and/or improve stability of the pickup. A small passenger car impact simulation was performed with the Schedule 40 pipes spacing on 4-ft centers along the length of the rail. The results were compared to those for the rail with 6.25-ft pipe spacing. The results are shown in Figure 2.7. While the pipes collapsed at a slower rate when placed closer together, no significant differences were observed in the occupant compartment deformation. Thus the larger pipe spacing of 6.25-ft was selected for the final design.

**Figure 2.7. Affect of Pipe Spacing.**

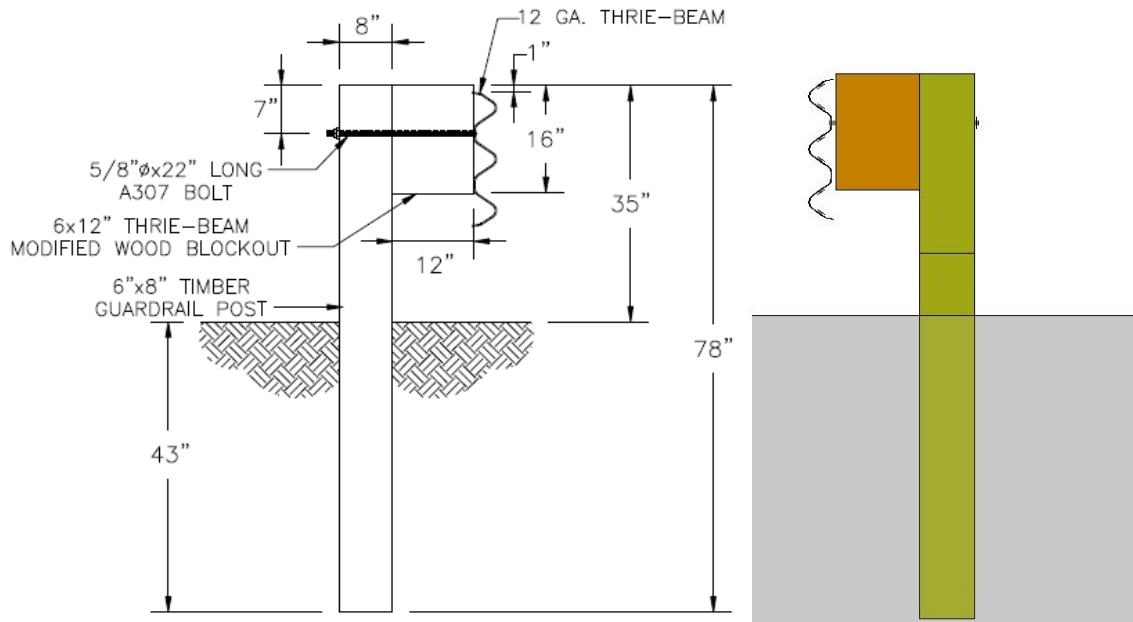
The modified wood post thrie-beam guardrail that was modeled is shown in Figure 3.1. The thrie beam rail is mounted on 6-inch × 8 inch wood posts at a height of 34 inches. The rail is offset from the post using partial depth 6-inch × 12-inch wood spacer blocks. The bottom

corrugation of the thrie beam rail is left unsupported. The rail and the blockout are attached to the post using a 5/8-inch diameter × 22-inch long bolt.

**Figure 3.1. Cross Section of the Modified Wood Post Thrie-Beam System from Drawings and Model.**

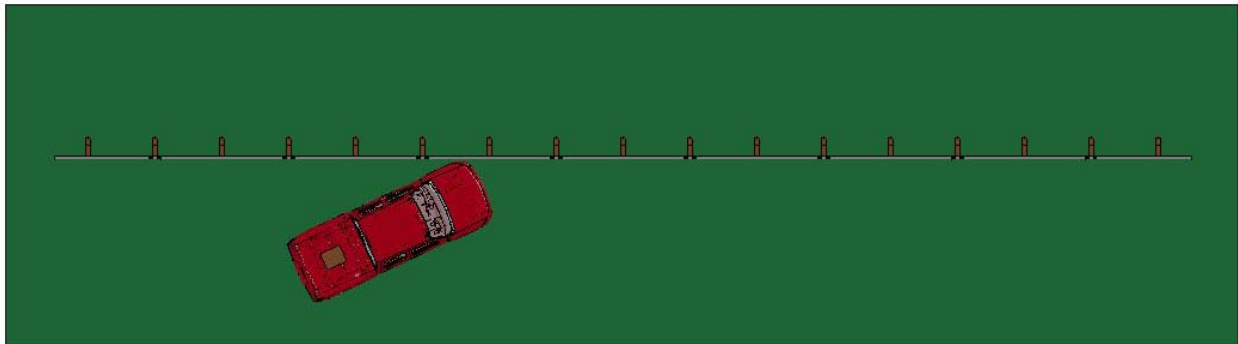
The length of the system modeled was 106 ft-3 inches and had 17 wood posts spaced 6 ft-3 inches center to center as shown in Figure 3.2. The ends of the thrie-beam rail were attached to springs that were assigned properties representative of the stiffness of a 37.5-ft long, *NCHRP Report 350* TL-3 compliant terminal system.

**Figure 3.2. System Layout with Vehicle Impact Location.**

The vehicle model used in the impact simulation was a ½-ton, 4-door, Chevrolet Silverado that is representative of the 2270P design vehicle in *MASH*. This vehicle model was developed by the National Crash Analysis Center under the sponsorship of the Federal Highway Administration. The vehicle was assigned an initial velocity of 85 mi/h and had a 25 degree impact angle with the barrier as shown in Figures 3.2 and 3.3. The vehicle impact location was just before the 7<sup>th</sup> post from the upstream end of the barrier as shown in Figure 3.2.

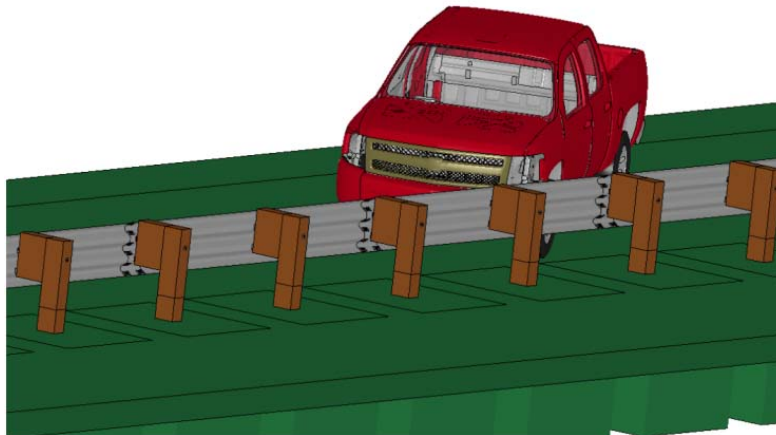
**Figure 3.3. Iso-Parametric View of the 2270 kg Vehicle Set Up with the Modified Thrie-Beam Rail.**

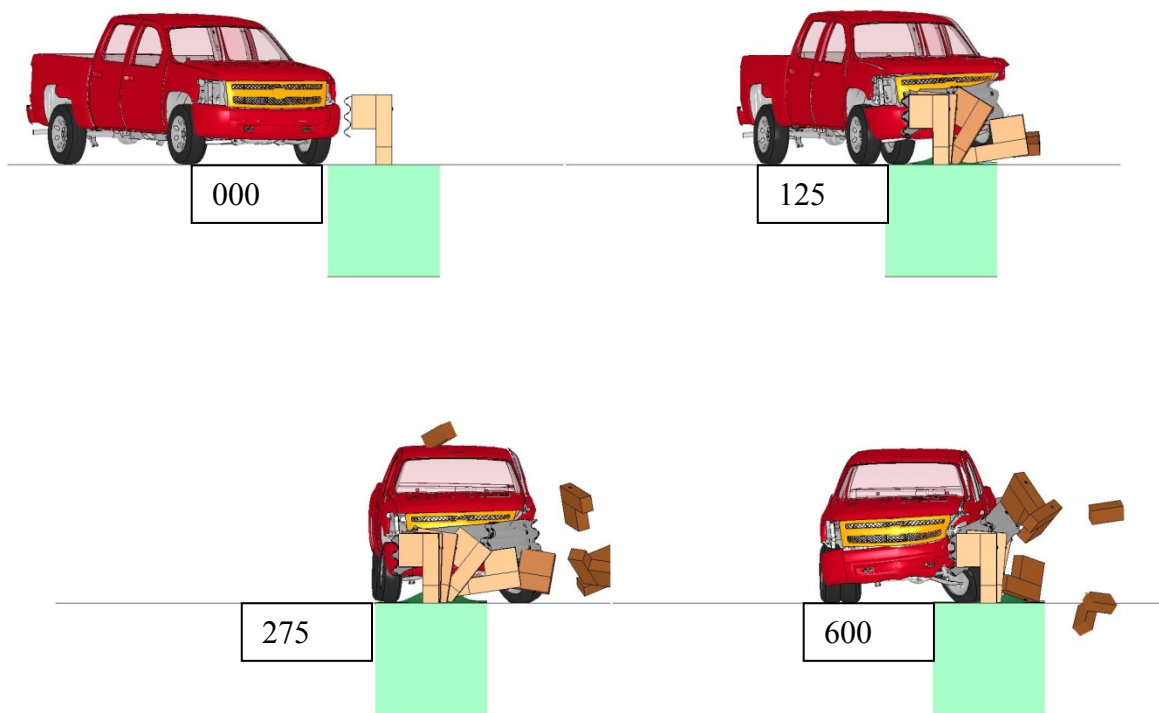
The modified wood post thrie beam guardrail system was able to contain and redirect the vehicle. Sequential images of the impact event are shown in Figure 3.4. A total of 11 posts were predicted to fracture during the impact, but there were no obvious signs of pocketing or rail rupture. The maximum rail deflection was 74 inches (see Figure 3.5).

**Figure 3.4. Sequential Images of 2270P Impact with Modified Wood Post Thrie Beam Guardrail.**

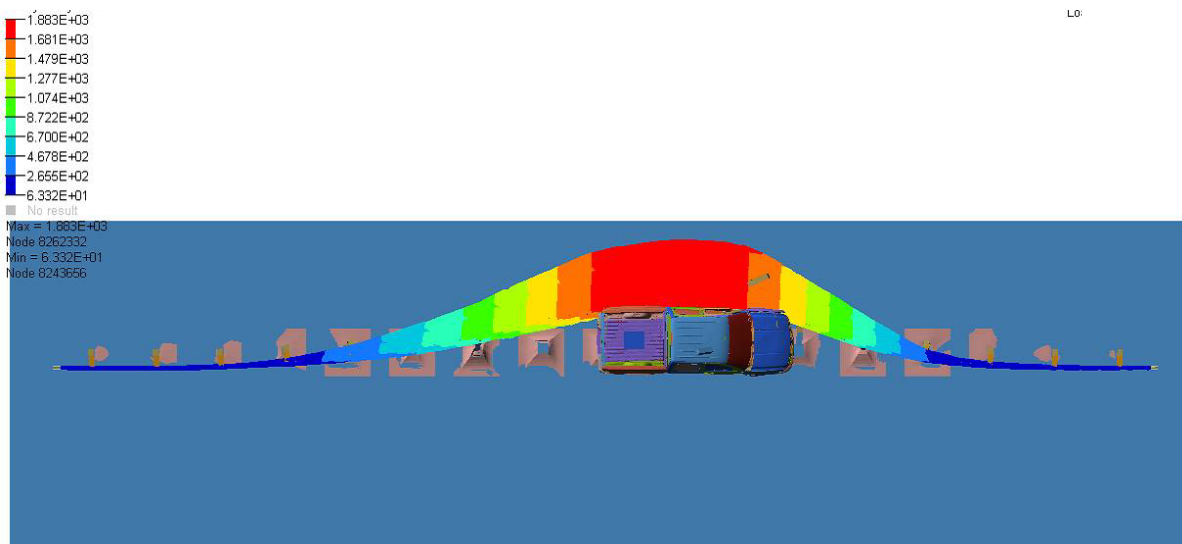
**Figure 3.5. Impact at Time of Maximum Rail Deflection.**

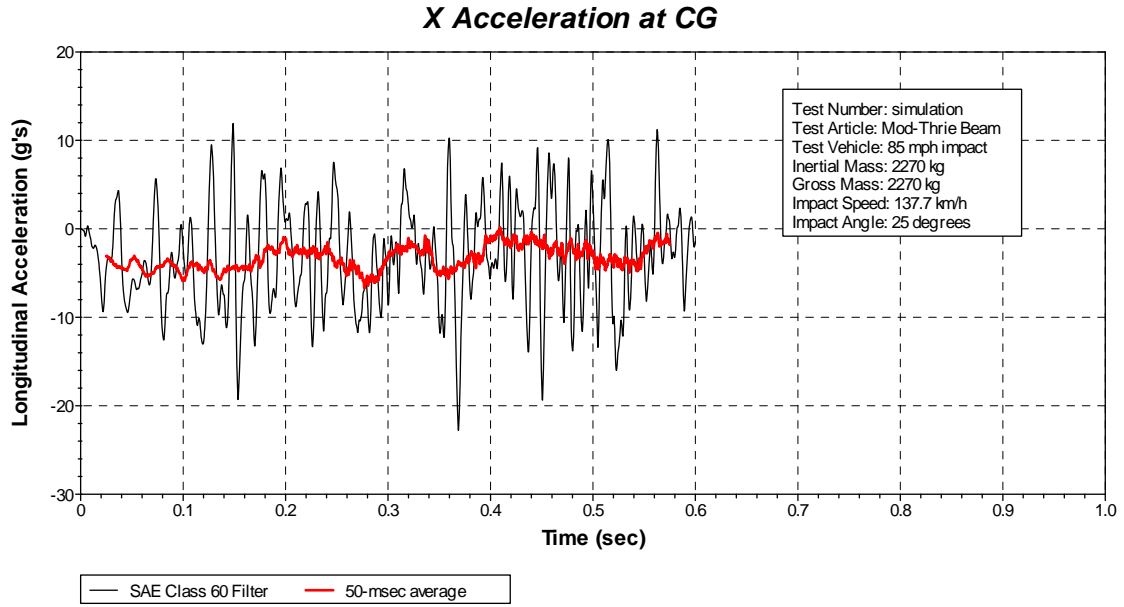
The longitudinal acceleration time history for the impact is shown in Figure 3.6. All occupant risk indices were predicted to be acceptable and overall damage to the vehicle was moderate (see Figure 3.7).

**Figure 3.6. Longitudinal Acceleration History for CG of the 2270 kg Vehicle.**

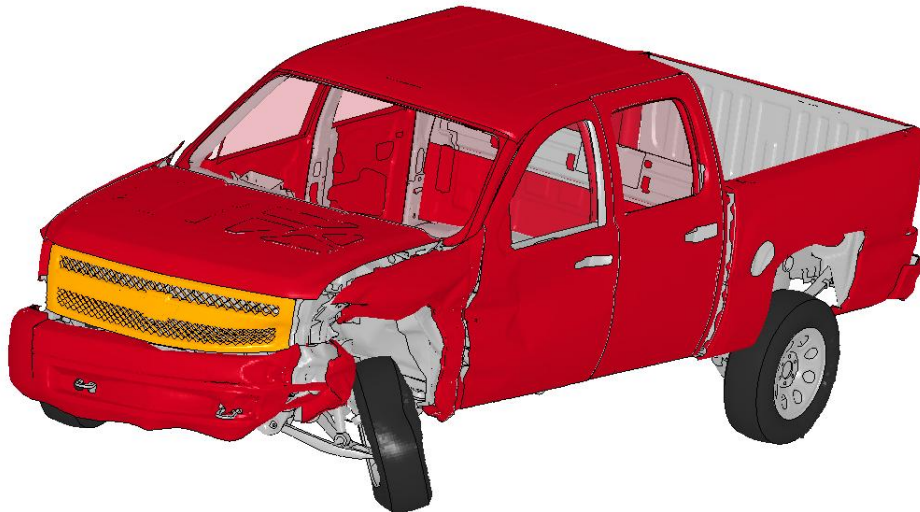
**Figure 3.7. Damage to the Vehicle in the 85 mi/h Simulation.**

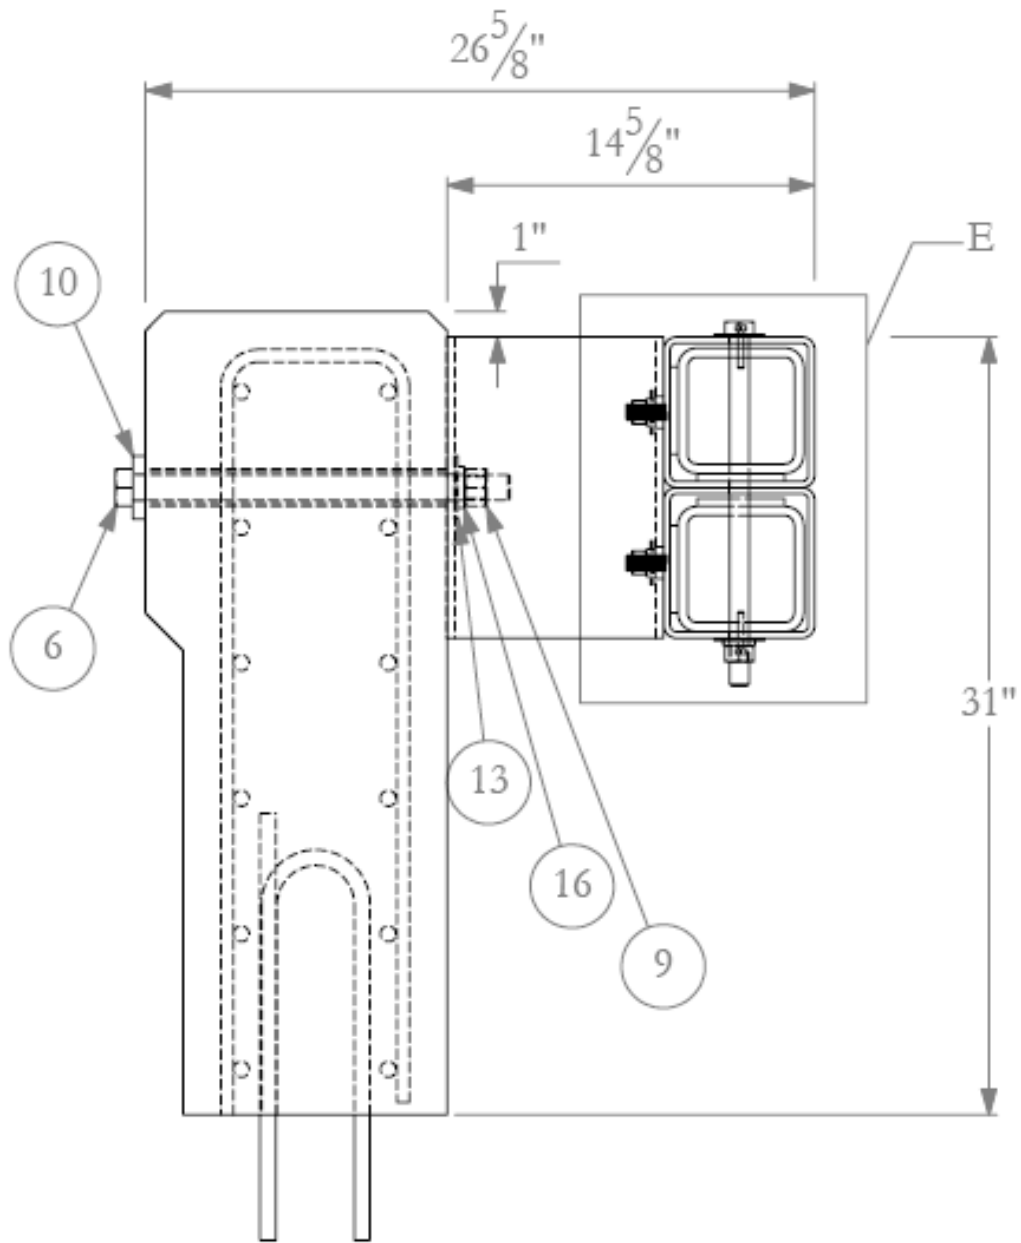
A cross section of the high-speed energy absorbing bridge rail is shown in Figure 5.1. Photographs of the completed test installation are shown in Figure 5.2. Detailed drawings of the bridge rail are presented in Appendix B.

The concrete for the parapet was specified to have a 28-day compressive strength of 3600 psi. The concrete strength on the day of the test was 4424 psi. All reinforcing steel was grade 60. The tubular rail sections and tubular splice sleeves were ASTM A500 steel. The pipe spacers were ASTM A53 steel, and the connection bolts used to attach the rails to one another and the pipe spacers to the concrete parapet were ASTM A325. The studs used to connect the pipe spacers to the tubular rail members were ASTM A307.

**Figure 5.1. Details of the High-Speed Energy-Absorbing Bridge Rail.**

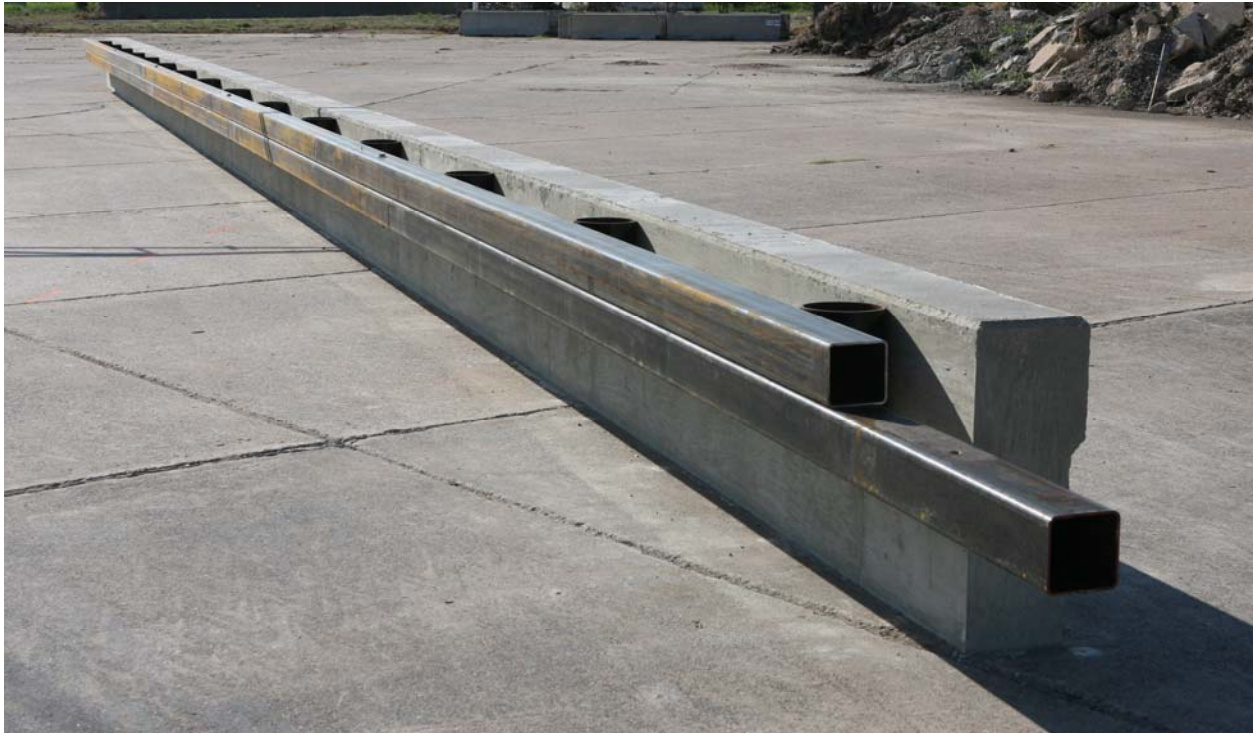
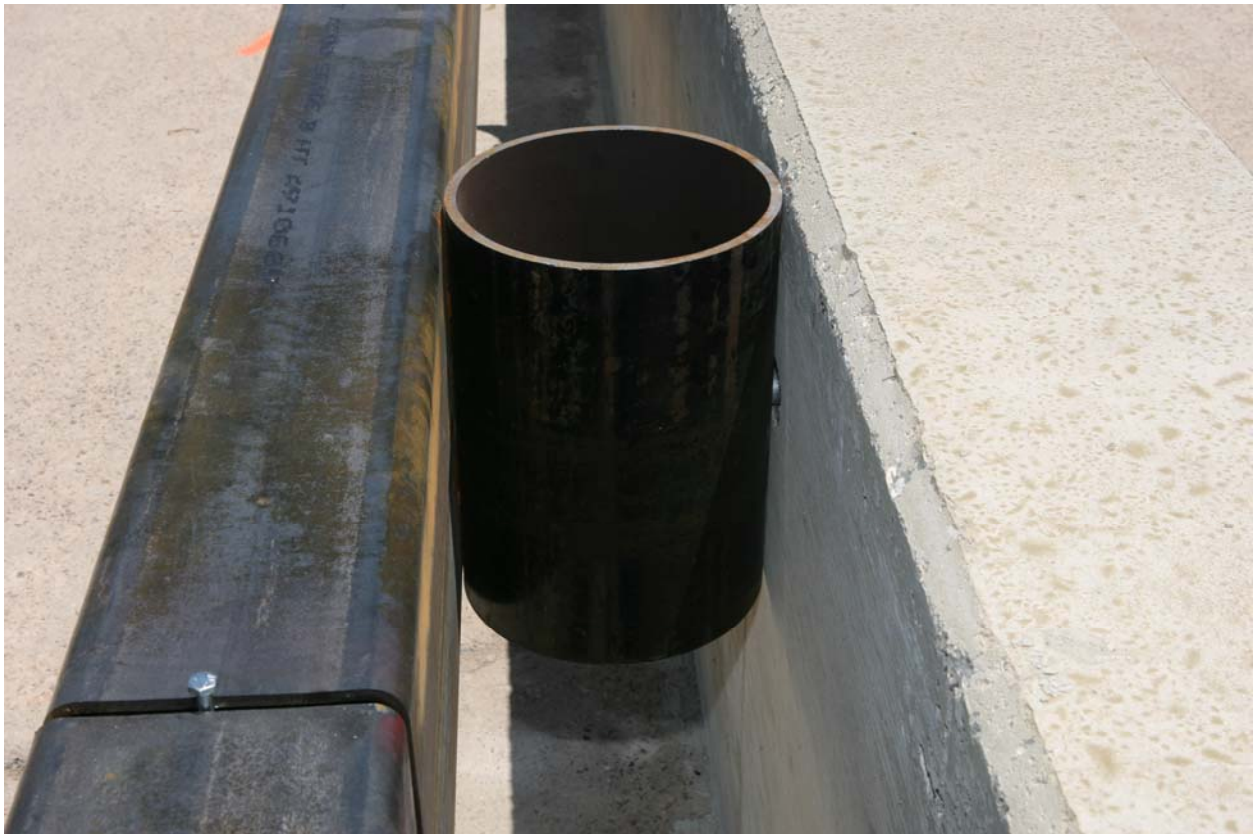
**Figure 5.2. Energy-Absorbing Bridge Rail Installation before Test Nos. 470619-1 and 2.**

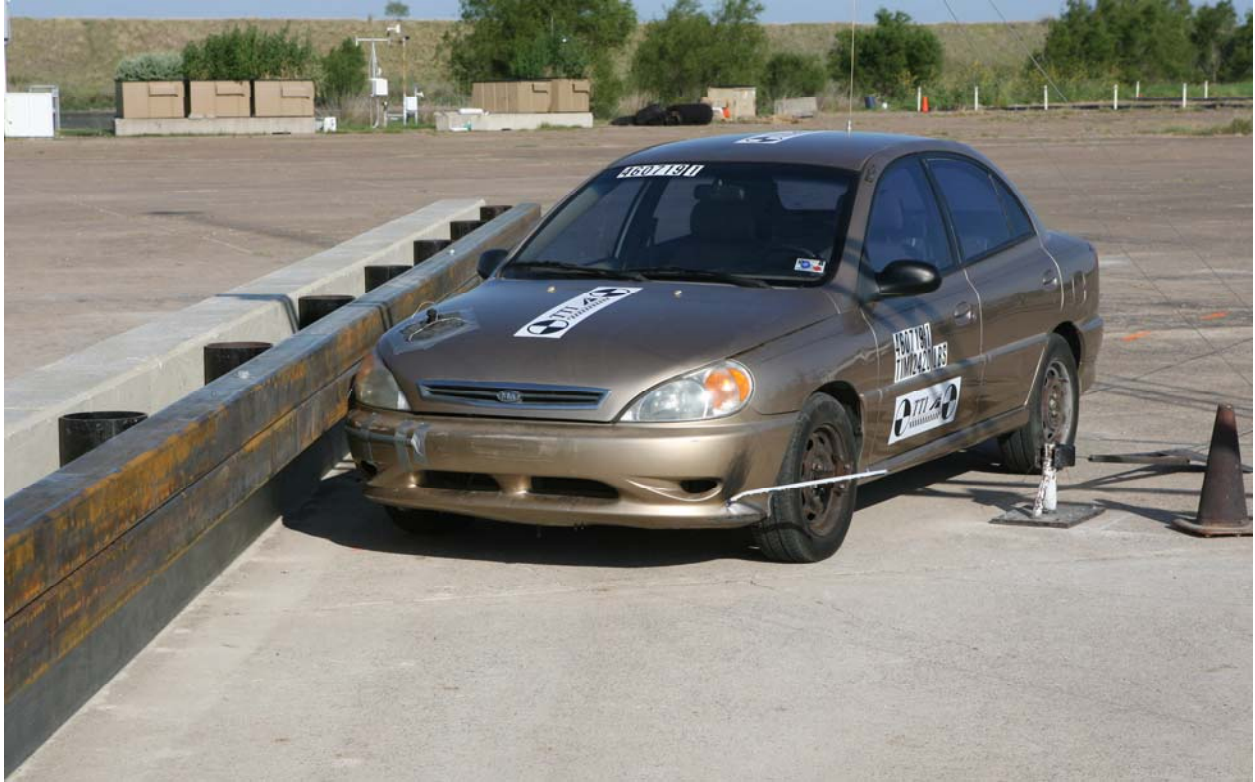
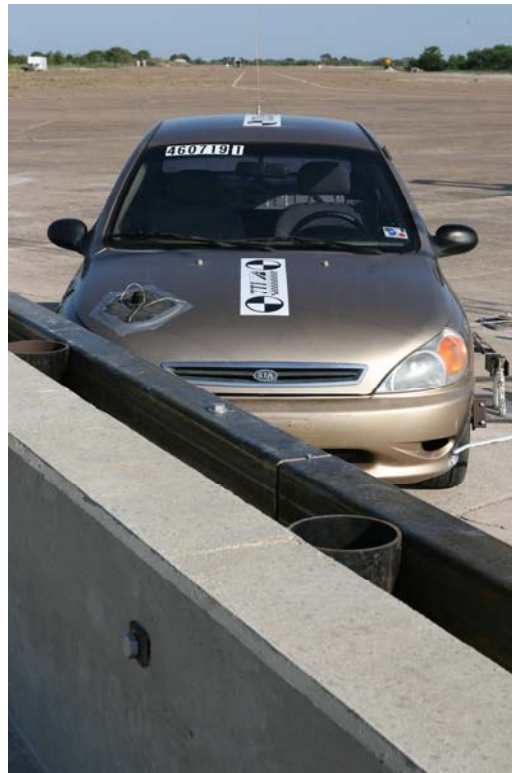
**Figure 5.3. Vehicle/Installation Geometrics for Test No. 460719-1.**

A 2002 Kia Rio, shown in Figures 5.3 and 5.4, was used for the crash test. Test inertia weight of the vehicle was 2438 lb, and its gross static weight was 2606 lb. The height to the lower edge of the vehicle bumper was 8.50 inches, and the height to the upper edge of the bumper was 22.75 inches. Figure C1 in Appendix C gives additional dimensions and information on the vehicle. The vehicle was directed into the installation using the cable reverse tow and guidance system and was released to be free-wheeling and unrestrained just prior to impact.

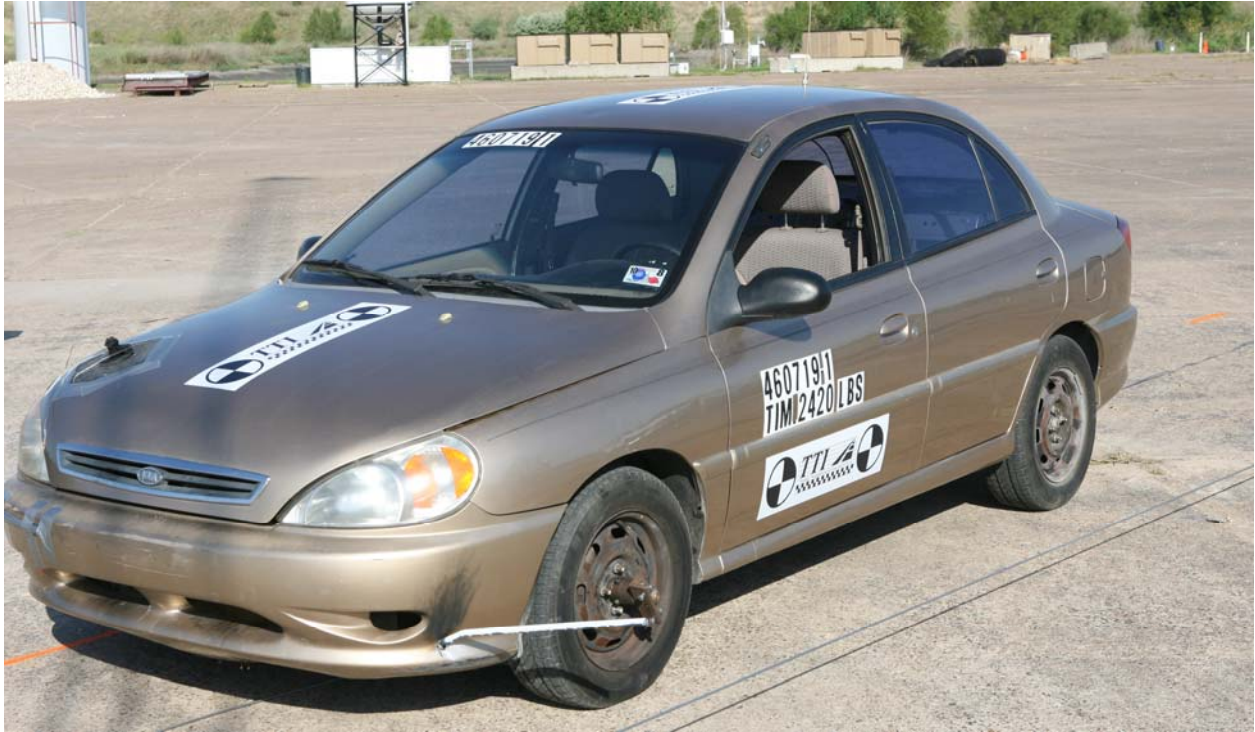
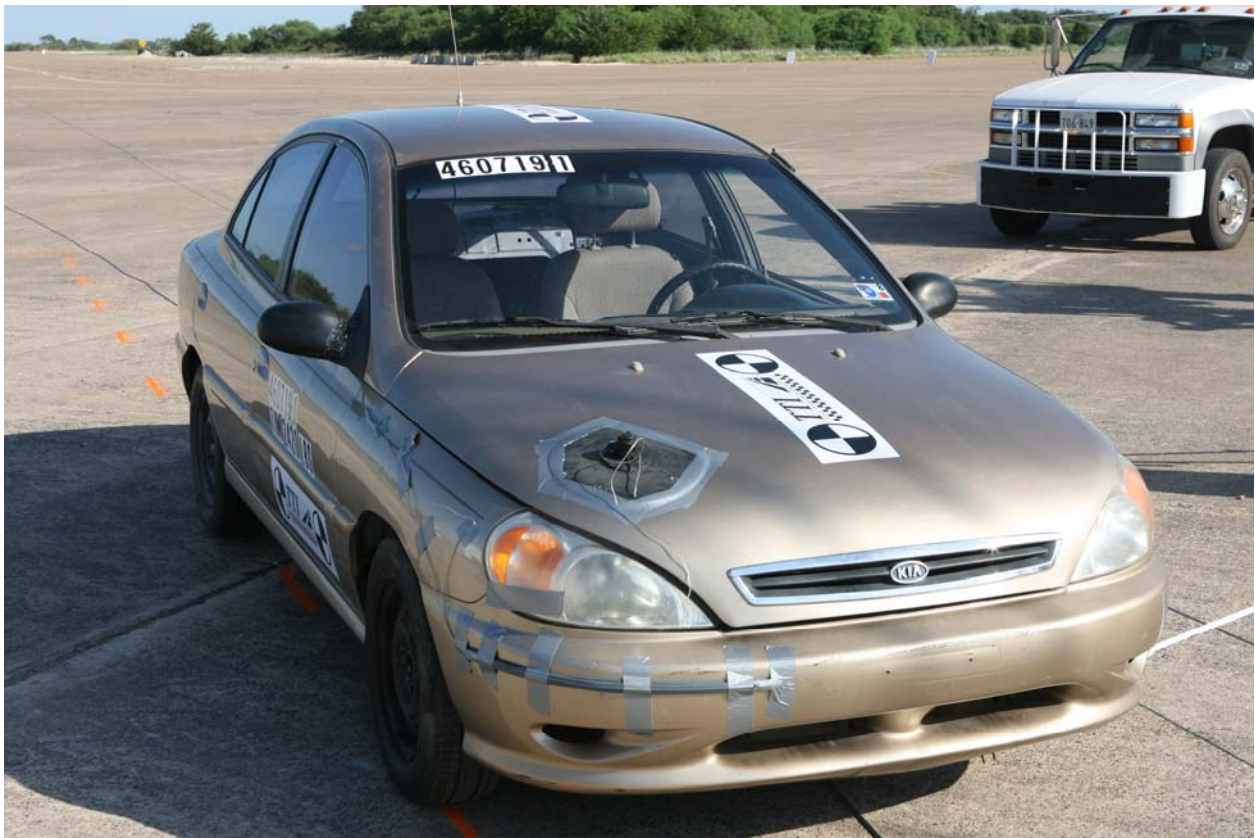
**Figure 5.4. Vehicle before Test No. 460719-1.**

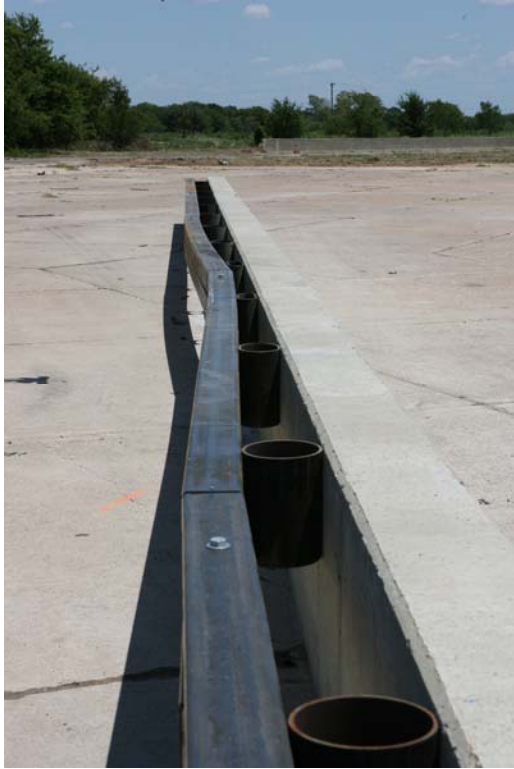
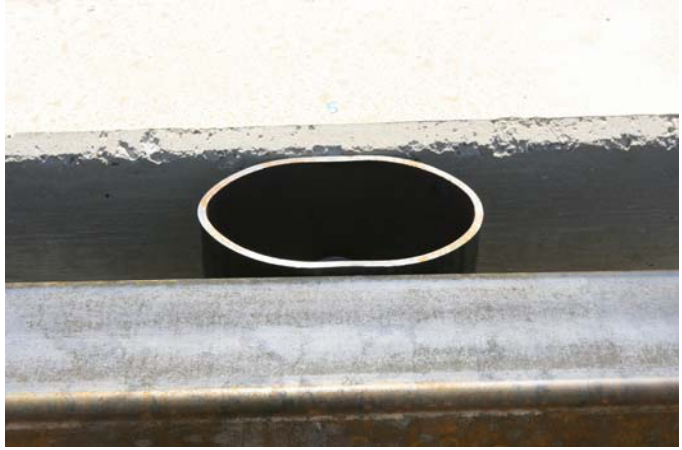
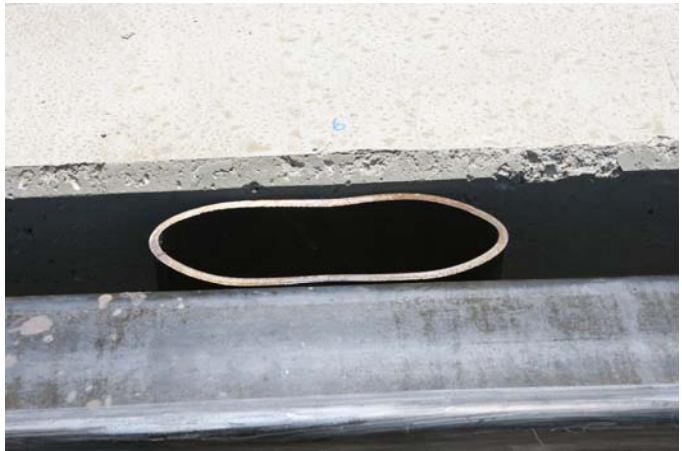
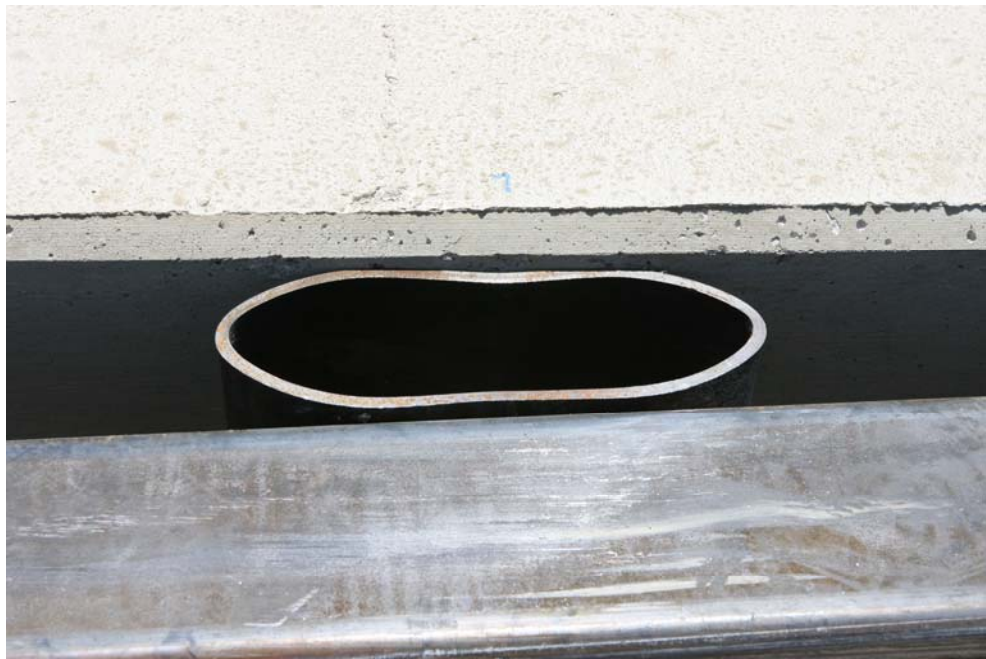
The vehicle contacted the energy-absorbing bridge rail 32 ft-5 inches downstream from the end of the bridge rail and remained in contact with the metal rail element for a distance of 13 ft. The maximum rail deflection was 5.25 inches at joint 2-3. No damage to the concrete wall was evident. Figure 5.5 shows damage to the installation.

**Figure 5.5. Installation after Test No. 460719-1.**

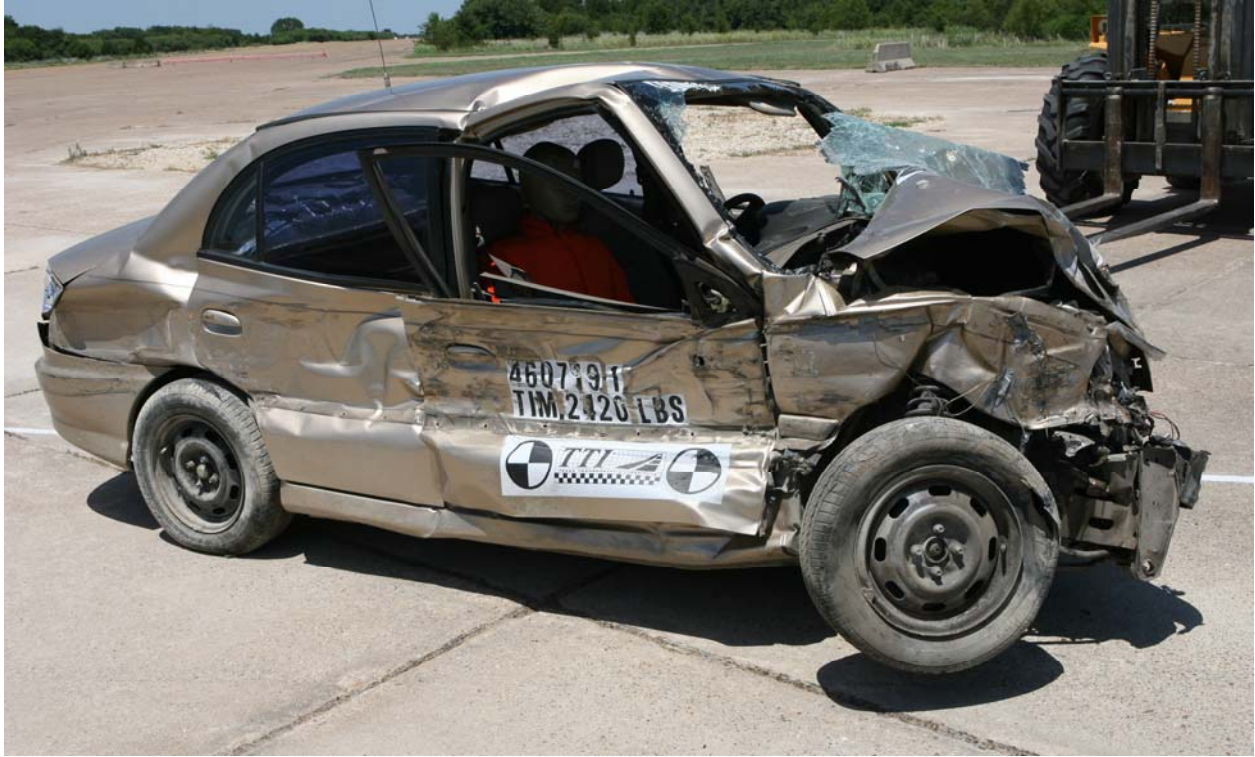
**Figure 5.6. Vehicle after Test No. 460719-1.**

A secondary frontal impact of the redirected vehicle with the end of another rigid concrete barrier complicated the damage assessment of the vehicle. The secondary impact occurred on the left side of the vehicle and, therefore, the following damage on the right side of the vehicle was attributed to the initial impact with the bridge rail. The front bumper, hood, right front fender, right front tire and wheel rim, roof over the passenger side, right B-post, right door and door glass, right rear quarter panel, rear bumper, right side floor pan, right side firewall, and right side kickpanel were damaged due to impact with the energy-absorbing bridge rail. Maximum exterior crush to the right side of the vehicle was 16 inches in the side plane at the right front corner at bumper height. Maximum occupant compartment deformation (OCD) on the right side was 9.0 inches in the firewall area. It is believed that the secondary impact likely contributed to the damage in this area, but the OCD measurement was not adjusted for this. Photographs of the vehicle after the test are shown in Figures 5.6 and 5.7. Exterior crush and occupant compartment measurements are documented in Appendix C, Tables C1 and C2.
