# Evaluation of Barriers for Very High Speed Roadways

## Research/Test Report 0-6071-2

**TEXAS TRANSPORTATION INSTITUTE  
THE TEXAS A&M UNIVERSITY SYSTEM  
COLLEGE STATION, TEXAS**

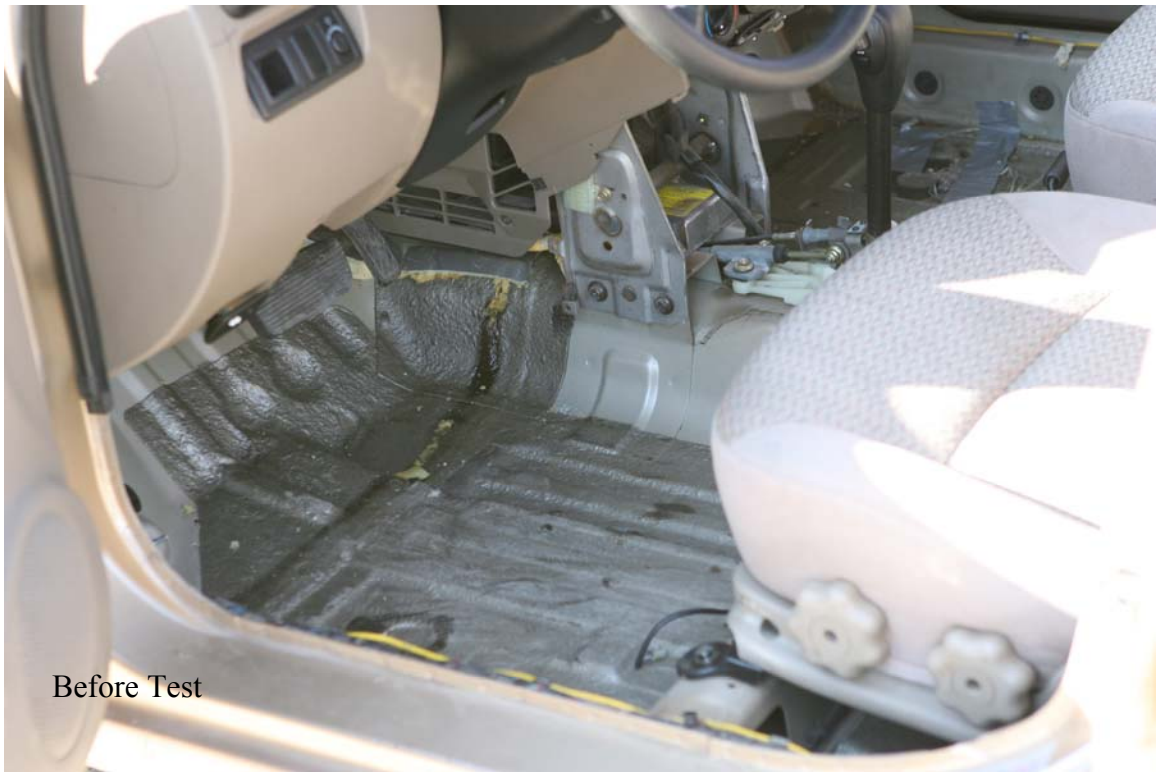
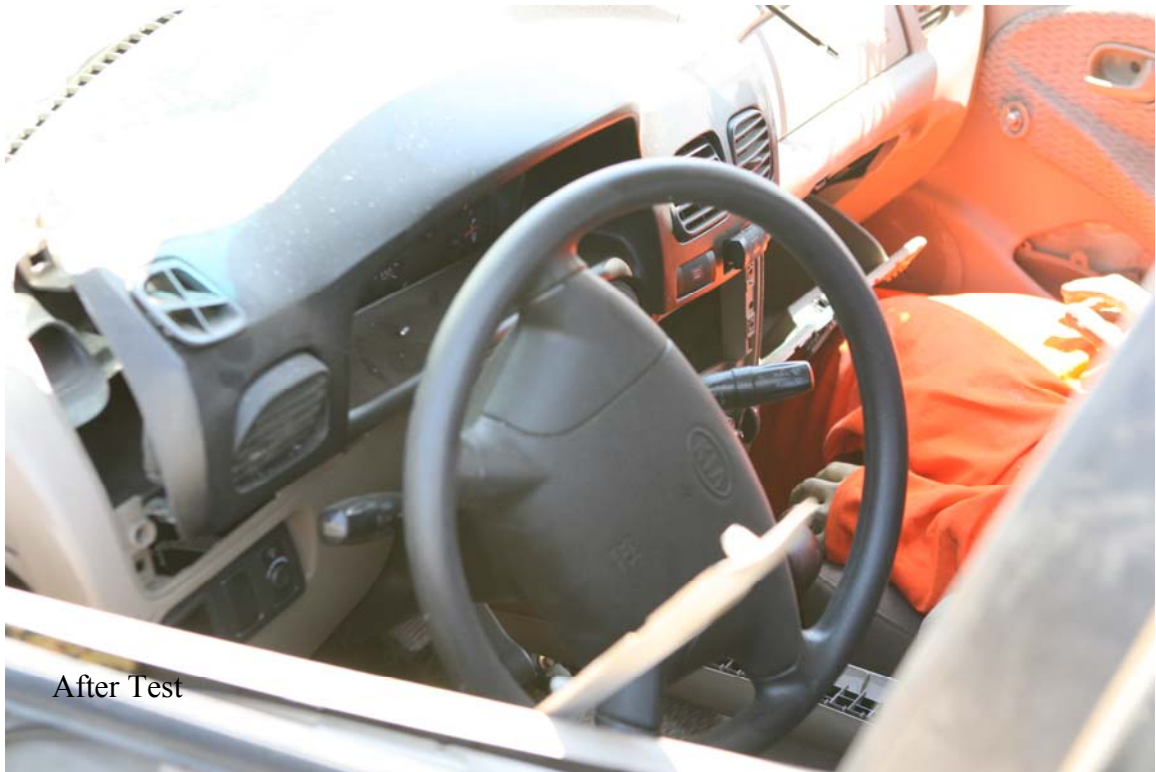
**Figure 5.7. Interior of Vehicle for Test No. 460719-1.**

A secondary frontal impact of the redirected vehicle with the end of another rigid concrete barrier complicated the damage assessment of the vehicle. The secondary impact occurred on the left side of the vehicle and, therefore, the following damage on the right side of the vehicle was attributed to the initial impact with the bridge rail. The front bumper, hood, right front fender, right front tire and wheel rim, roof over the passenger side, right B-post, right door and door glass, right rear quarter panel, rear bumper, right side floor pan, right side firewall, and right side kickpanel were damaged due to impact with the energy-absorbing bridge rail. Maximum exterior crush to the right side of the vehicle was 16 inches in the side plane at the right front corner at bumper height. Maximum occupant compartment deformation (OCD) on the right side was 9.0 inches in the firewall area. It is believed that the secondary impact likely contributed to the damage in this area, but the OCD measurement was not adjusted for this. Photographs of the vehicle after the test are shown in Figures 5.6 and 5.7. Exterior crush and occupant compartment measurements are documented in Appendix C, Tables C1 and C2.

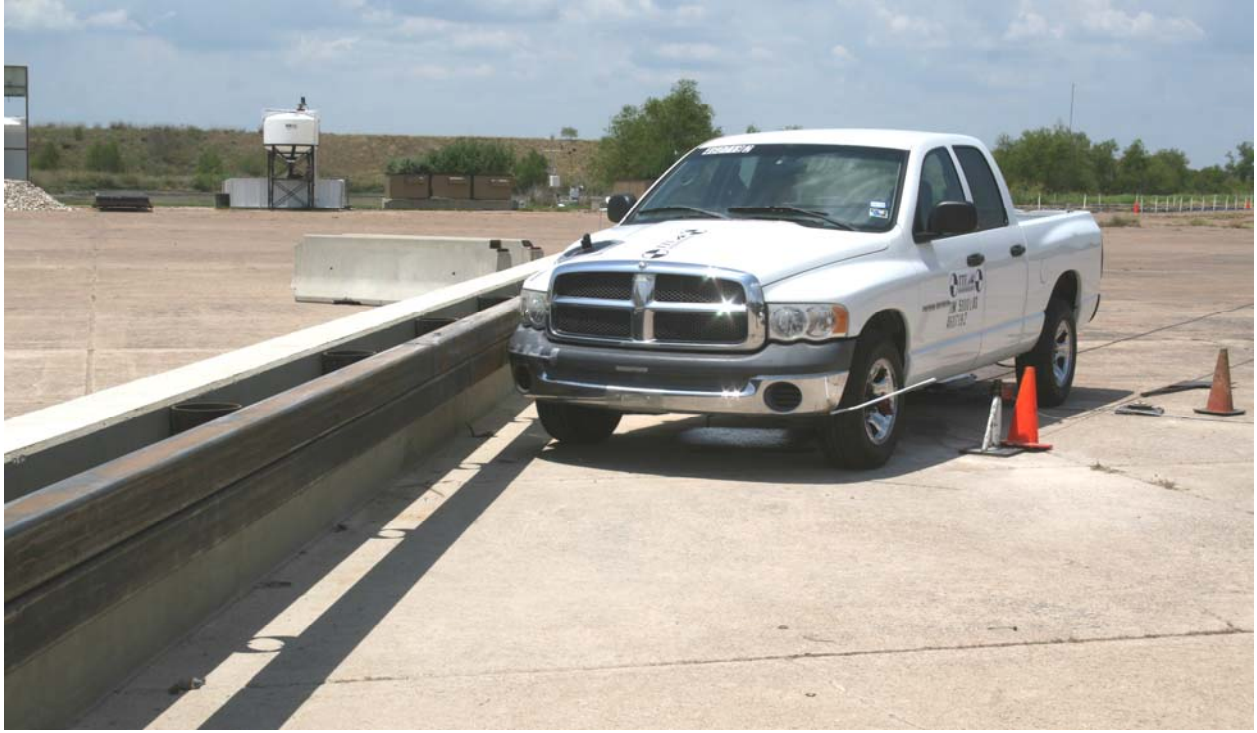
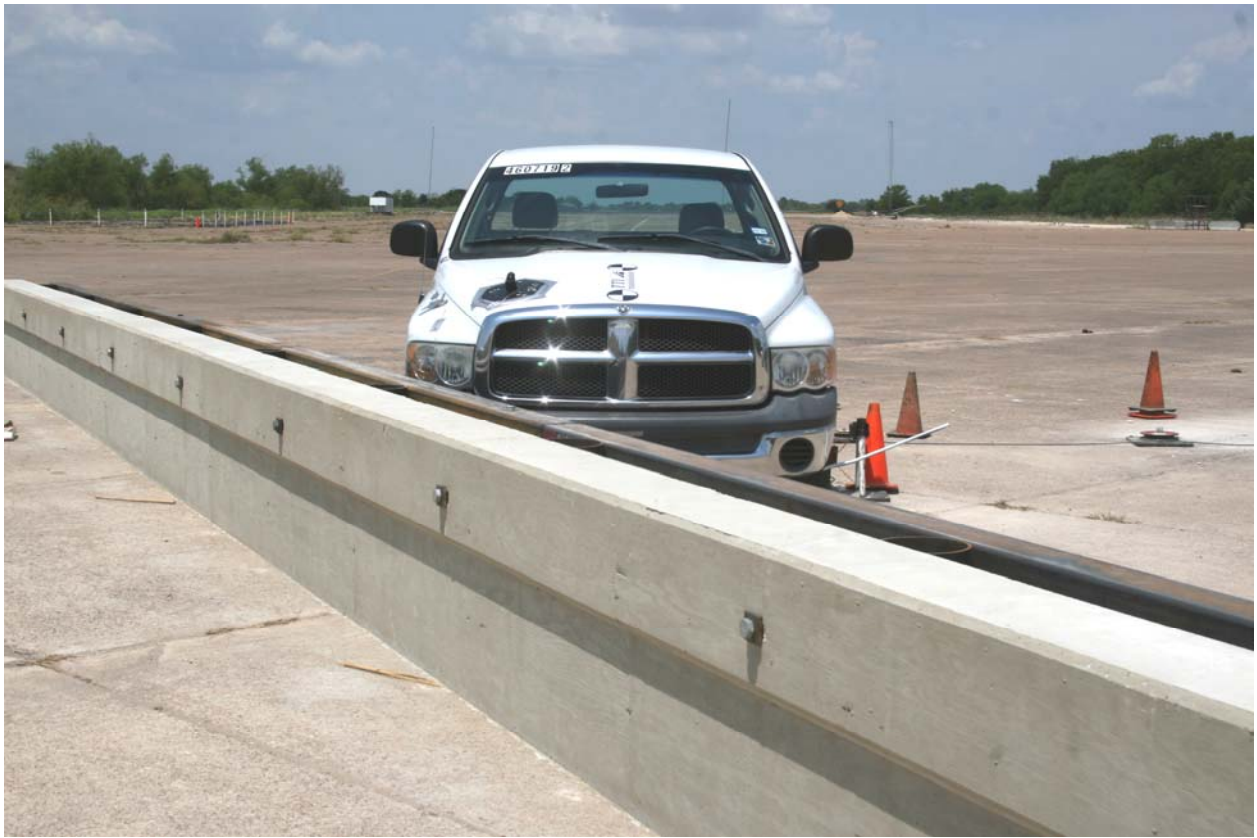
**Figure 5.9. Vehicle/Installation Geometrics for Test No. 460719-2.**

A 2002 Dodge Ram 1500 Quad-Cab pickup, shown in Figures 5.9 and 5.10, was used for the crash test. Test inertia weight of the vehicle was 5006 lb, and its gross static weight was 5006 lb. The height to the lower edge of the pickup bumper was 13.5 inches, and height to the upper edge of the bumper was 26.0 inches. Height to the center of gravity of the pickup was 28.06 inches. Figure C2 in Appendix C gives additional dimensions and information on the vehicle. The vehicle was directed into the installation using the cable reverse tow and guidance system, and was released to be free-wheeling and unrestrained just prior to impact.

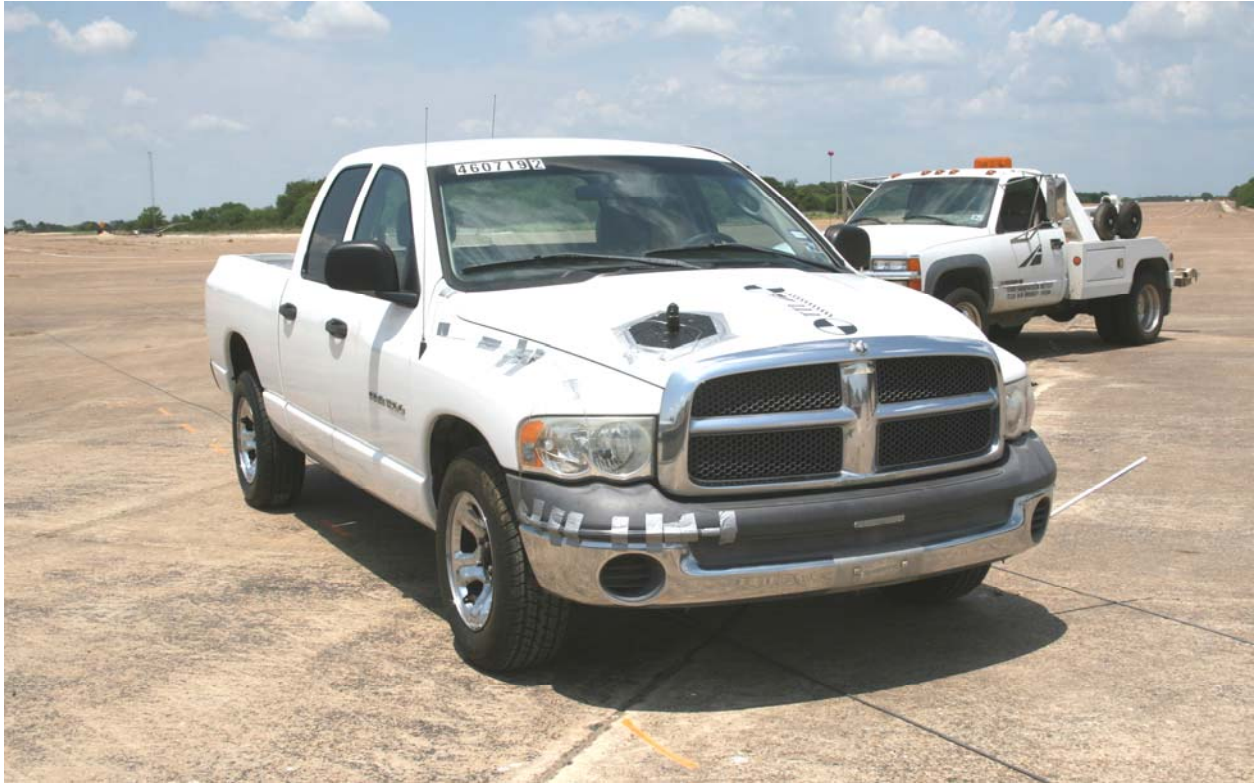
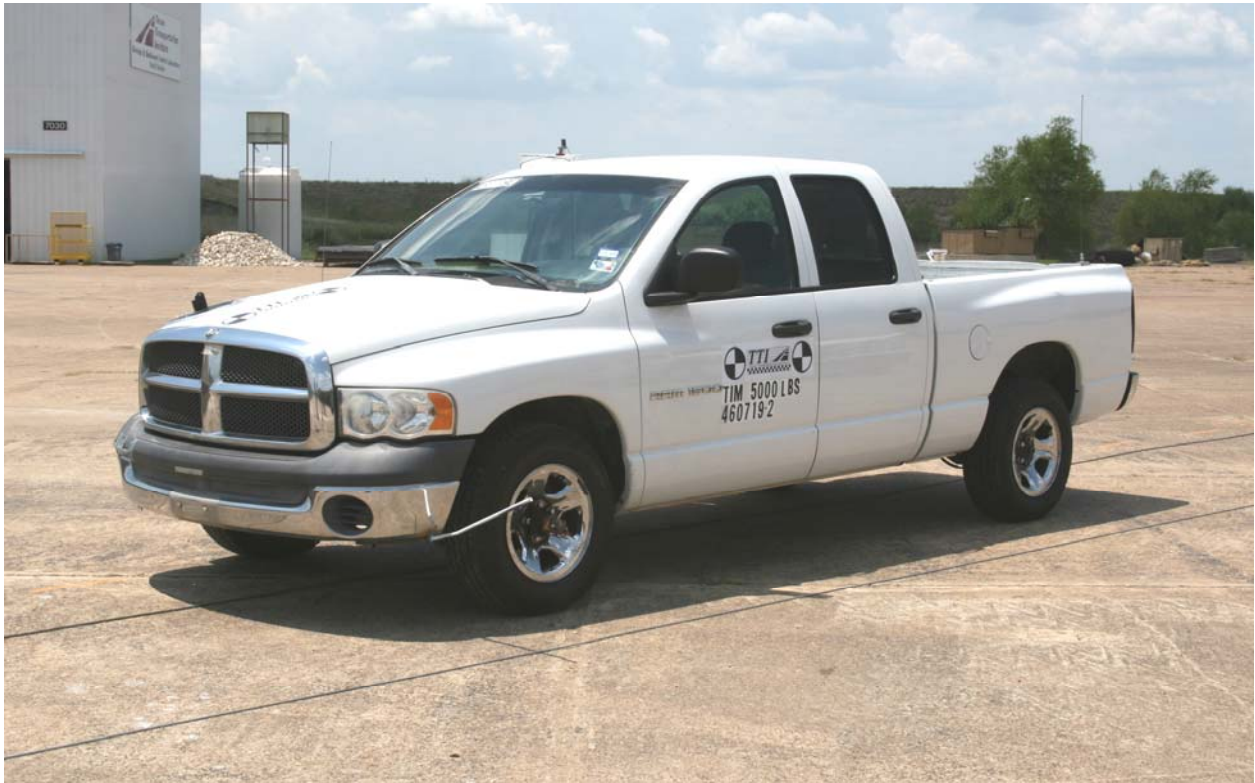
**Figure 5.10. Vehicle before Test No. 460719-2.**

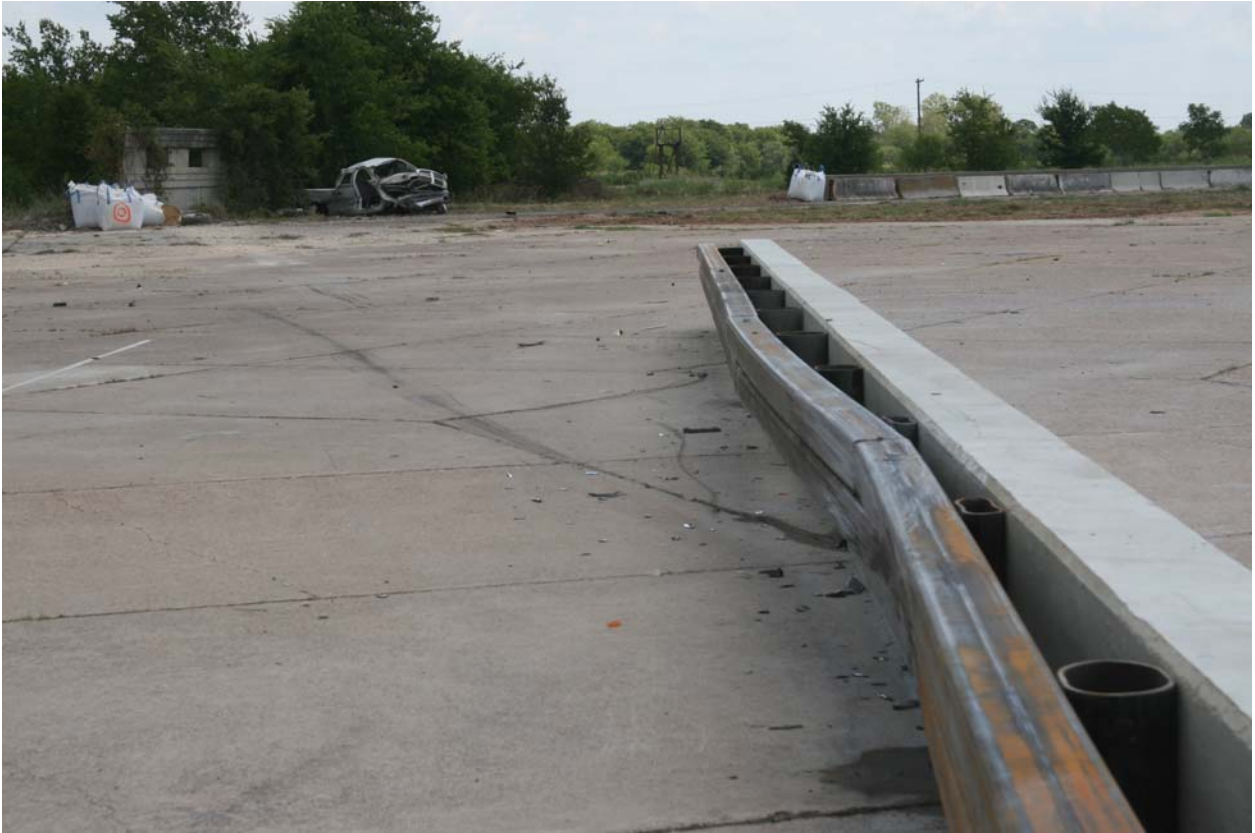
Damage to the bridge rail is shown in Figures 5.11 and 5.12. The fifth through eighth pipe spacers between the concrete parapet and the metal rail were deformed. The rail had a maximum permanent deflection of 6.5 inches between the sixth and seventh pipe spacer. Working width was 2.38 ft.

**Figure 5.11. After Impact Trajectory Path for Test No. 460719-2.**

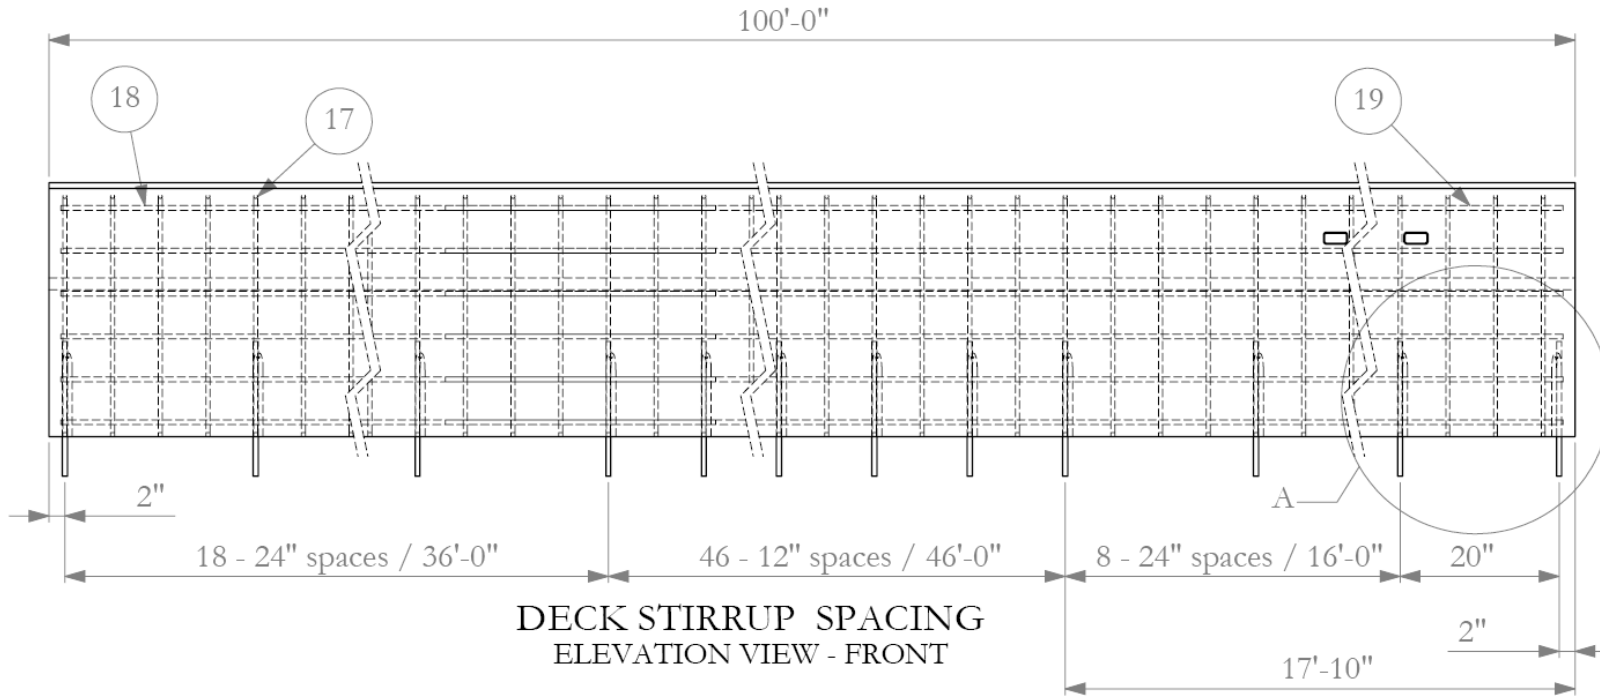
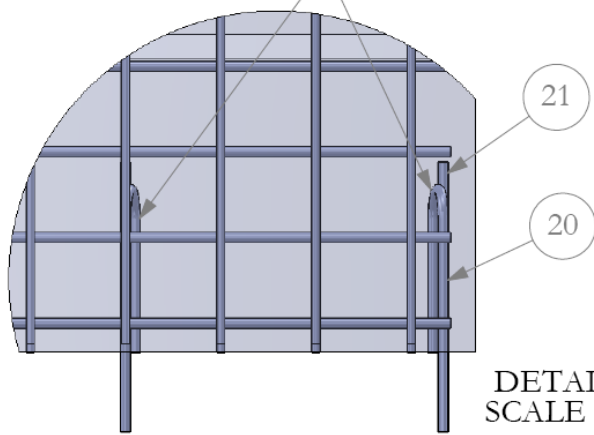
DECK STIRRUPS (20) TURNED TO AVOID 17" #5 REBAR (21)

DECK STIRRUPS AND 17" #5 BARS IN 3/4" x 5" HOLES DRILLED IN CONCRETE, ANCHORED WITH HILTI RE500 EPOXY.

The Texas A&M University System							
Revisions:				Texas Transportation Institute College Station, Texas, 77843			
No.	Date	By	Chk	Date	Drawn By	Scale	Sheet No.
1.				2009-07-02	GES	1:20	3 of 10
2.				Project No. 460719-1		Deck Stirrup Spacing and Rebar Parts	
3.				High Speed Bridge Rail			
4.							
5.

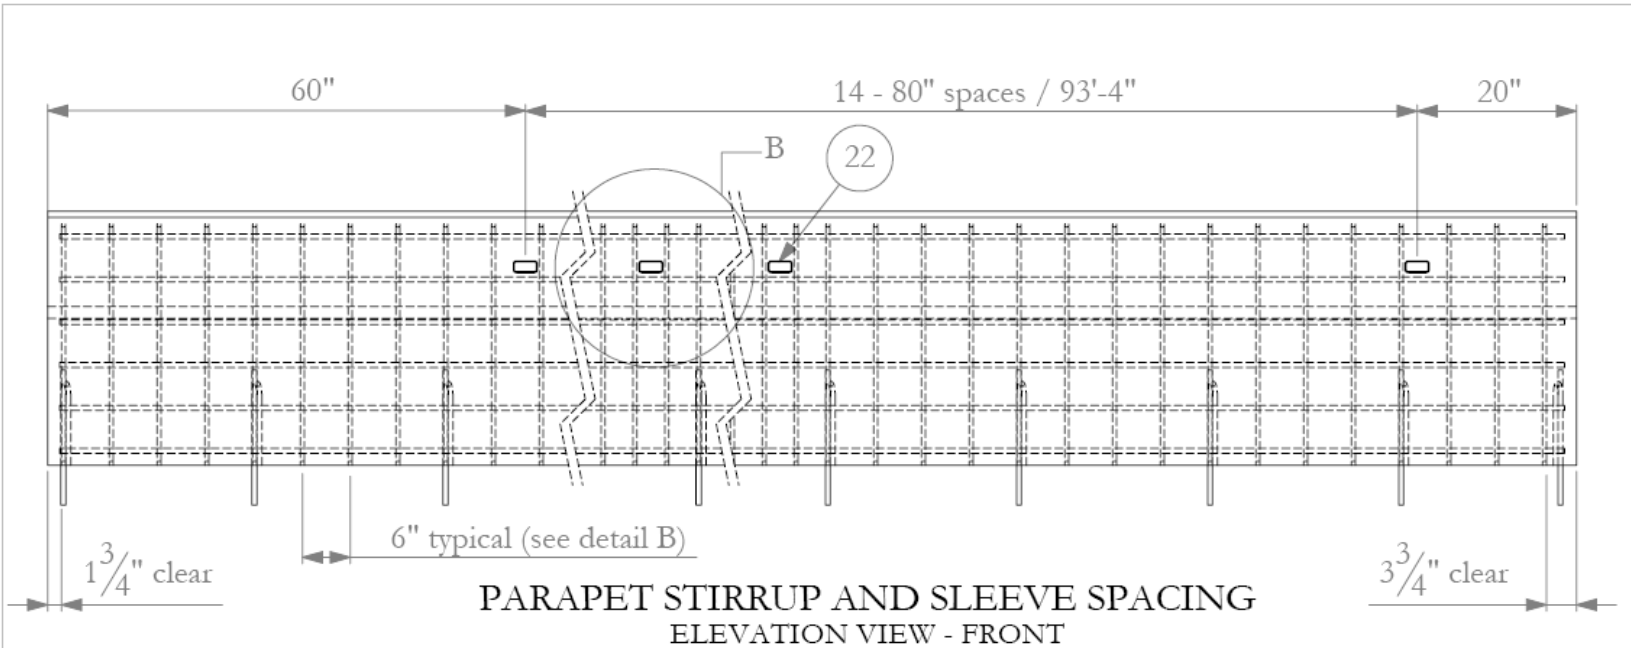
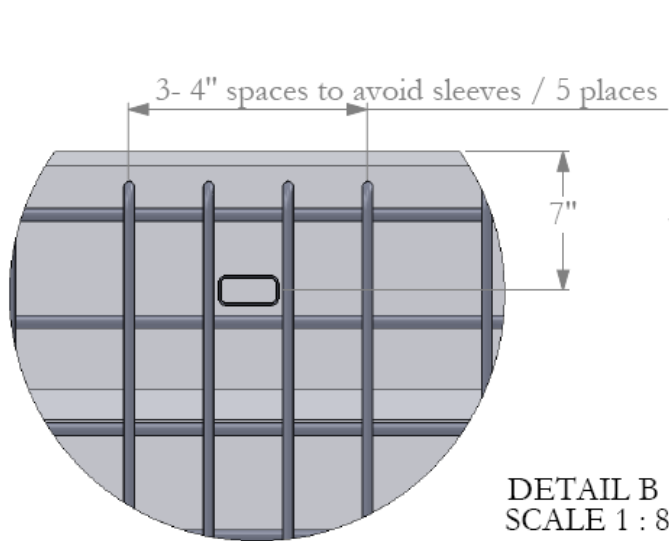
**22** SLEEVE  
11 GAUGE - A36 - SCALE 1:3.5

The Texas A&M University System							
Revisions:				Texas Transportation Institute College Station, Texas, 77843			
No.	Date	By	Chk	Date	Drawn By	Scale	Sheet No.
1.				2009-07-02	GES	1:20	4 of 10
2.				Project No. 460719-1		Parapet Stirrup and Sleeve Spacing	
3.				High Speed Bridge Rail			
4.							
5.

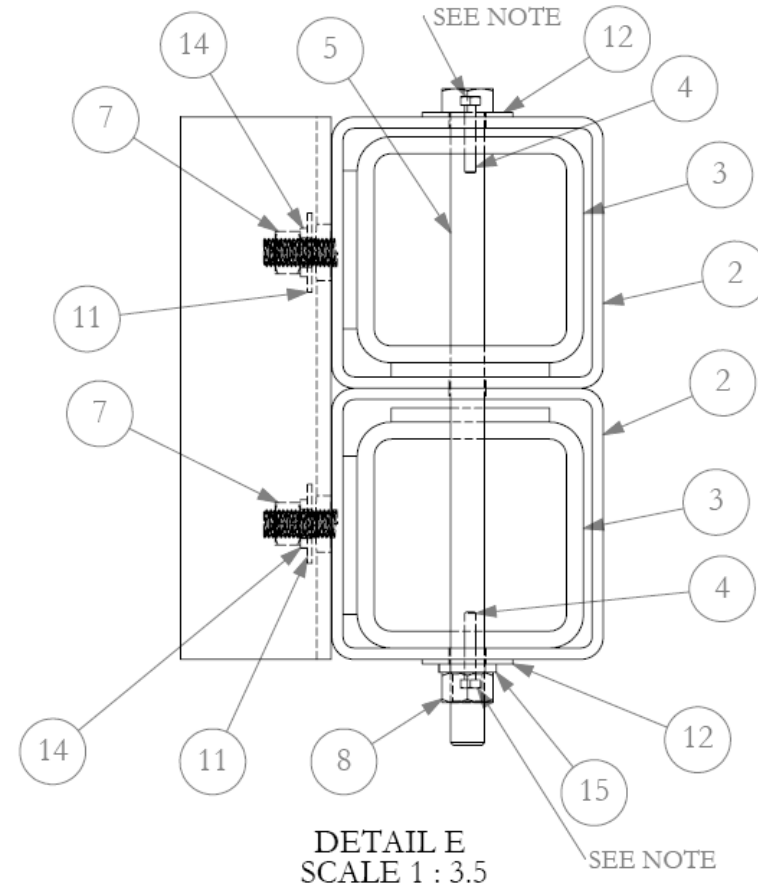
**PARAPET WITH RAIL**  
ELEVATION VIEW - END

\*HEAD OF BOLT (4) SHOULD PROTRUDE PAST RAIL APPROXIMATELY 1/4".

**DETAIL E**  
SCALE 1 : 3.5

Revisions:				Texas Transportation Institute College Station, Texas, 77843			
No.	Date	By	Chk	Date	Drawn By	Scale	Sheet No.
1.				2009-07-02	GES	1:8	7 of 10
2.							
3.				Project No.		End View	
4.				460719-1			
5.				High Speed Bridge Rail

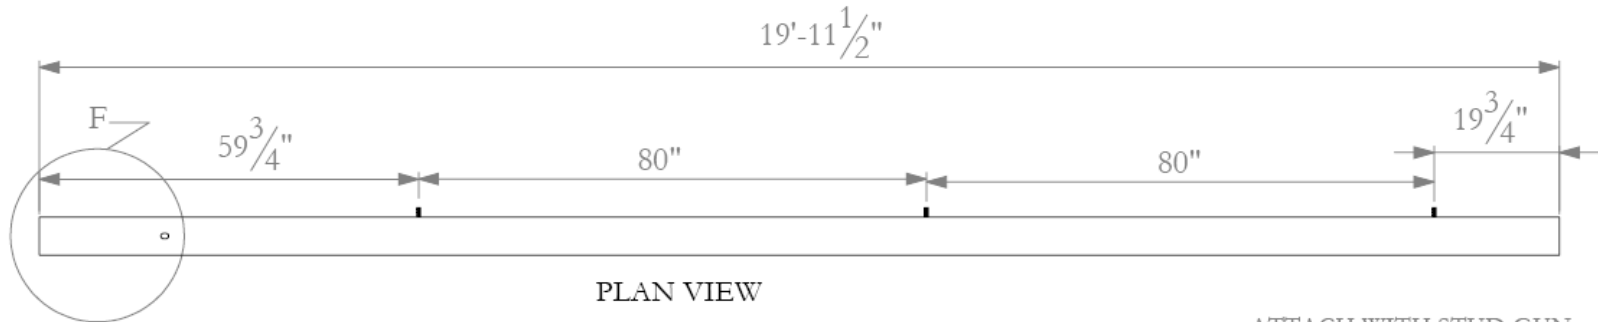
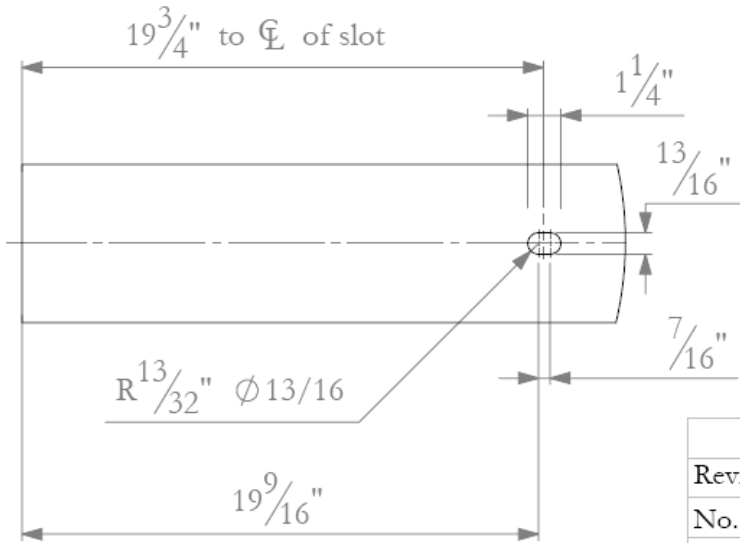
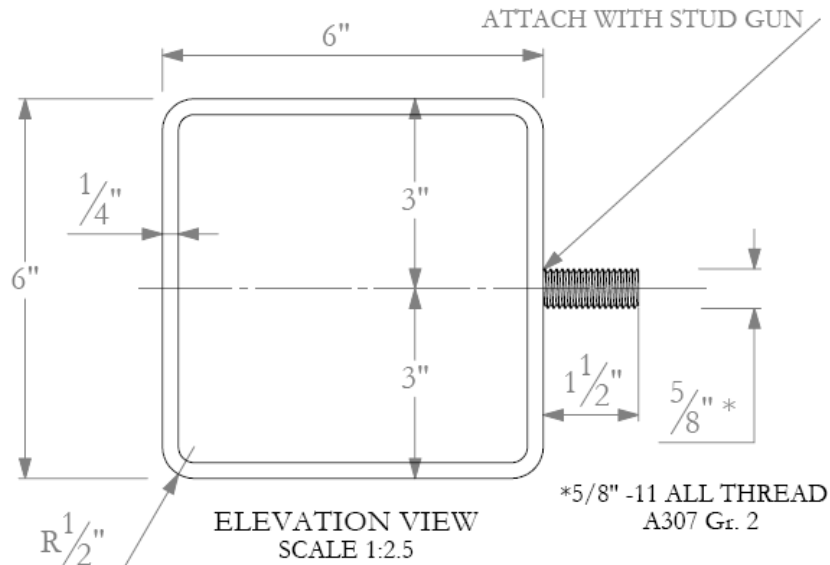
2 RAIL TUBE  
A500 STEEL

DETAIL F  
SCALE 1 : 6

ELEVATION VIEW  
SCALE 1:2.5

The Texas A&M University System							
Revisions:				Texas Transportation Institute College Station, Texas, 77843			
No.	Date	By	Chk	Date	Drawn By	Scale	Sheet No.
1.				2009-07-02	GES	1:25	9 of 10
2.				Project No.		Rail	
3.				460719-1			
4.				High Speed Bridge Rail			
5.

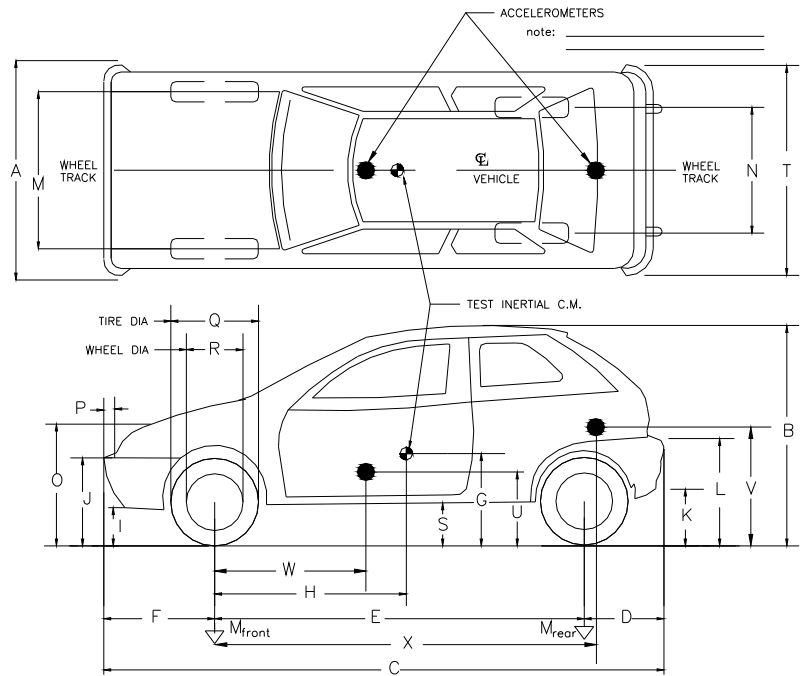
**Geometry:** inches

A	<u>62.50</u>	F	<u>32.00</u>	K	<u>12.00</u>	P	<u>3.25</u>	U	<u>15.50</u>
B	<u>56.12</u>	G	<u>          </u>	L	<u>24.25</u>	Q	<u>22.50</u>	V	<u>21.50</u>
C	<u>164.25</u>	H	<u>36.17</u>	M	<u>56.50</u>	R	<u>15.50</u>	W	<u>39.50</u>
D	<u>37.00</u>	I	<u>8.50</u>	N	<u>57.00</u>	S	<u>8.62</u>	X	<u>110.50</u>
E	<u>95.25</u>	J	<u>22.75</u>	O	<u>28.00</u>	T	<u>63.00</u>

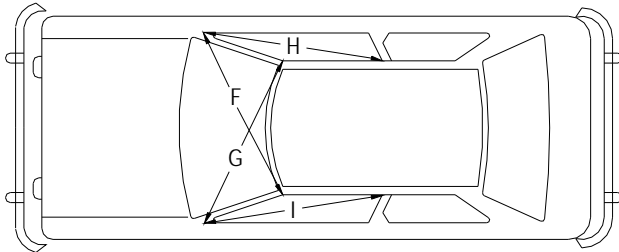
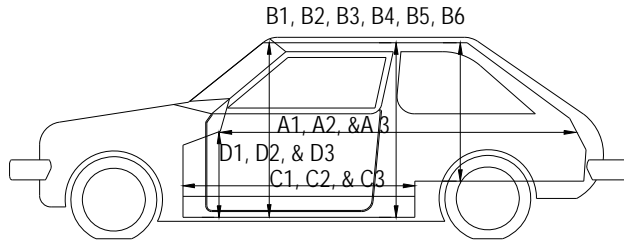
**OCCUPANT COMPARTMENT DEFORMATION MEASUREMENT**

**Table C2. Occupant Compartment Measurements for Test No. 460719-1.**

<b>Before</b> ( inches )	<b>After</b> ( inches )
A1	67.25	57.00
A2	64.50	55.75
A3	67.50	61.00
B1	39.50	44.00
B2	35.50	39.50
B3	39.12	44.75
B4	34.88	36.75
B5	35.12	36.75
B6	34.88	35.50
C1	26.62	13.00
C2	-----	-----
C3	26.25	17.25
D1	10.25	13.75
D2	-----	-----
D3	9.12	8.75
E1	49.44	49.00
E2	51.00	49.00
F	49.00	45.00
G	49.00	53.00
H	37.00	30.50
I	37.00	32.00
J*	50.25	44.25

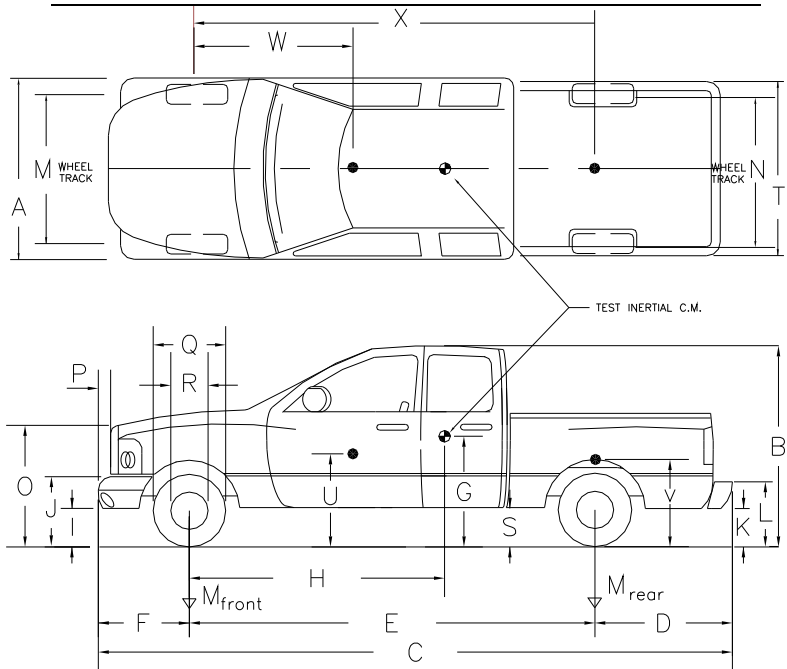
**Geometry:** inches

A	<u>77.00</u>	F	<u>39.00</u>	K	<u>20.50</u>	P	<u>3.00</u>	U	<u>27.50</u>
B	<u>73.25</u>	G	<u>28.06</u>	L	<u>28.75</u>	Q	<u>29.50</u>	V	<u>33.00</u>
C	<u>227.00</u>	H	<u>62.36</u>	M	<u>68.25</u>	R	<u>18.50</u>	W	<u>59.50</u>
D	<u>47.50</u>	I	<u>13.50</u>	N	<u>67.25</u>	S	<u>14.25</u>	X	<u>140.50</u>
E	<u>140.50</u>	J	<u>26.00</u>	O	<u>44.75</u>	T	<u>75.50</u>

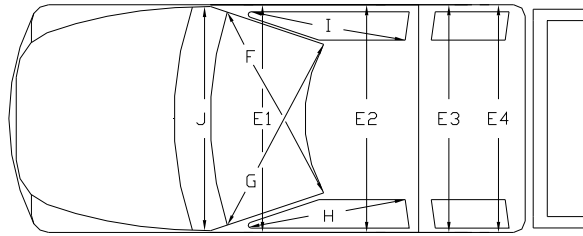
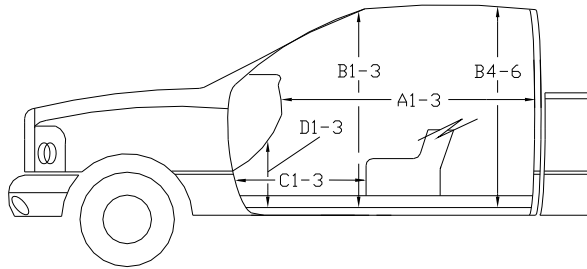
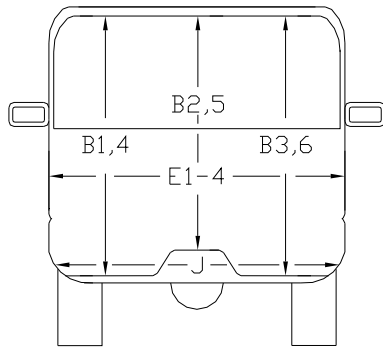
**OCCUPANT COMPARTMENT DEFORMATION MEASUREMENT**

Date: 2009-08-14 Test No.: 460719-2 VIN No.: 3D7HA18N22G161086  
 Year: 2002 Make: Dodge Model: Ram 1500

<b>Before</b> ( inches )	<b>After</b> ( inches )
A1	64.50	64.25
A2	64.25	63.50
A3	65.25	63.25
B1	44.50	48.75
B2	39.38	71.69
B3	45.25	47.25
B4	42.18	43.31
B5	42.50	43.44
B6	42.19	38.50
C1	29.50	-----
C2	-----	-----
C3	27.25	26.00
D1	12.75	-----
D2	2.62	N/A
D3	11.62	14.75
E1	62.50	N/A
E2	64.75	N/A
E3	64.50	N/A
E4	64.12	62.38
F	60.00	59.00
G	60.00	57.00
H	39.75	N/A
I	39.75	37.25
J*	24.56	16.25

\*Lateral area across the cab from driver's side kickpanel to passenger's side kickpanel.

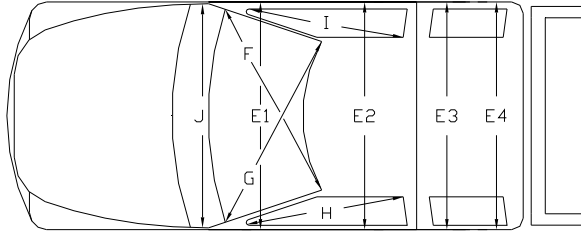
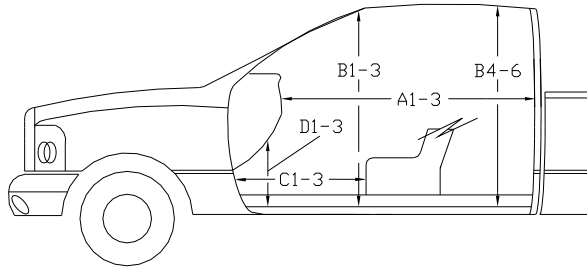
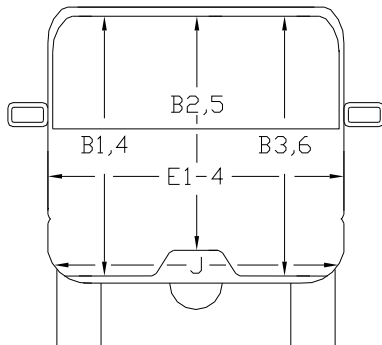
**OCCUPANT COMPARTMENT  
DEFORMATION MEASUREMENT**

Year: 2003 Make: Dodge Model: Ram 1500 Quad-Cab

<b>Before ( inches )</b>	<b>After ( inches )</b>
A1	64.44	64.44
A2	64.50	64.50
A3	65.12	65.12
B1	45.25	45.25
B2	39.25	39.25
B3	45.50	45.50
B4	52.25	52.25
B5	42.75	42.75
B6	42.75	42.75
C1	29.75	29.75
C2	-----	-----
C3	27.75	27.75
D1	12.75	12.75
D2	2.50	2.50
D3	11.62	11.62
E1	62.50	62.50
E2	64.50	64.50
E3	64.31	64.31
E4	64.00	64.00
F	59.50	59.50
G	59.50	59.50
H	39.00	39.00
I	39.00	39.00
J*	62.12	62.12

\*Lateral area across the cab from driver's side kickpanel to passenger's side kickpanel.

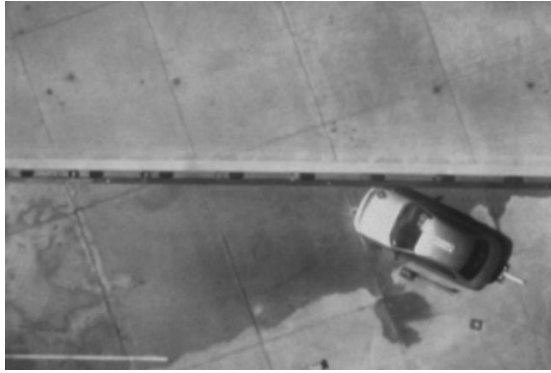
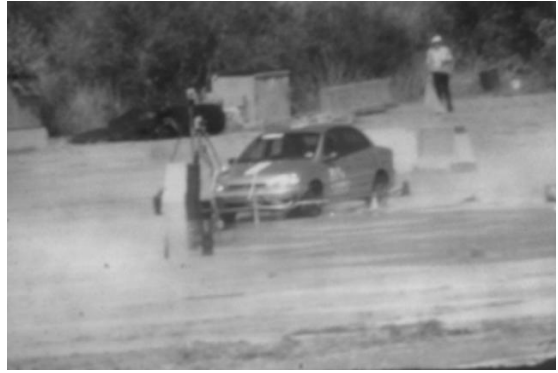
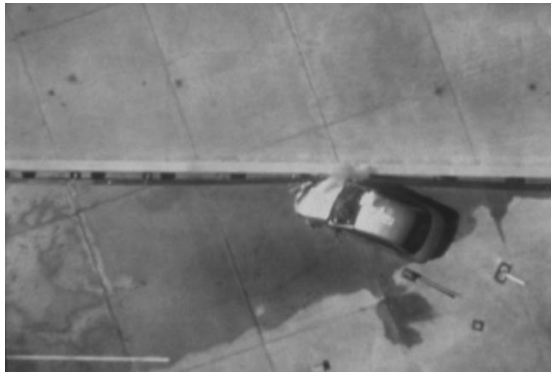
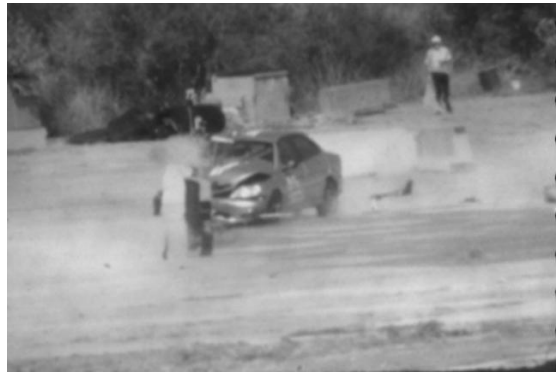
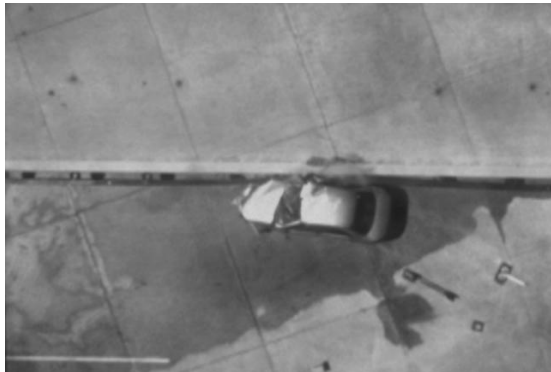
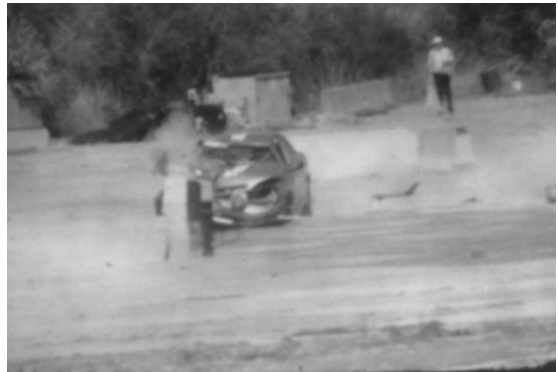
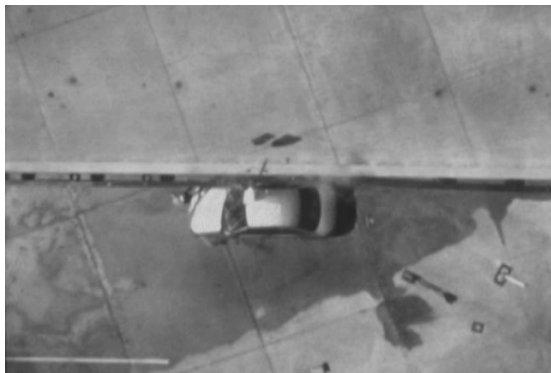
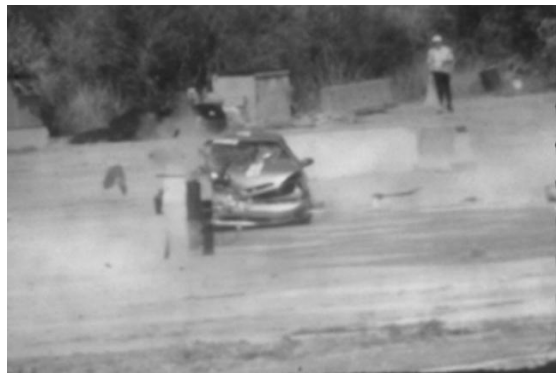
**Figure D1. Sequential Photographs for Test No. 460719-1 (Overhead and Frontal Views).**

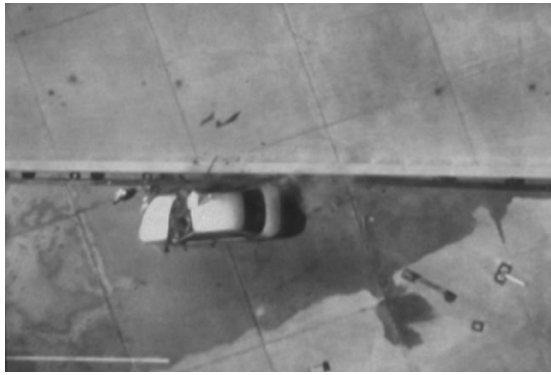
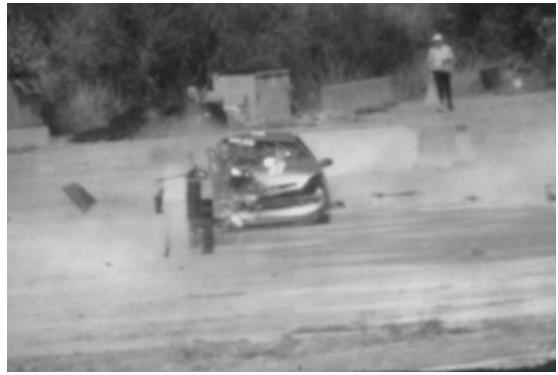
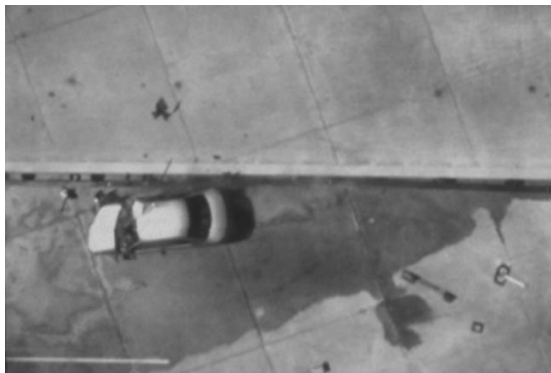
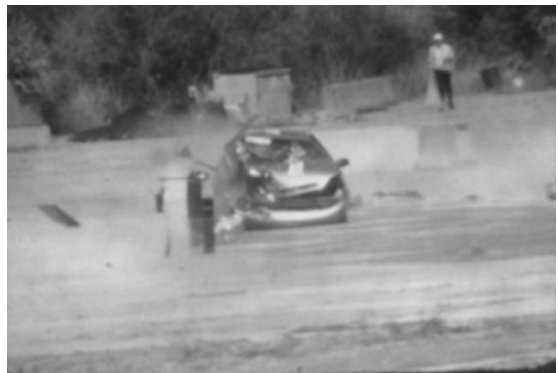
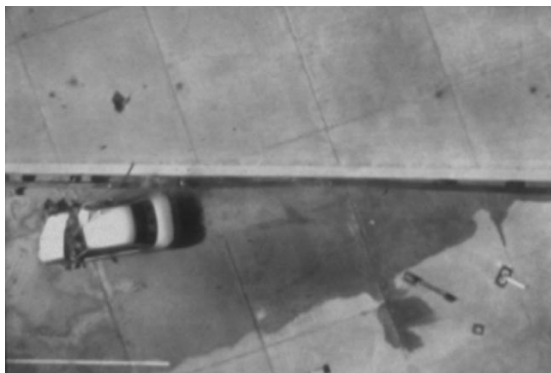
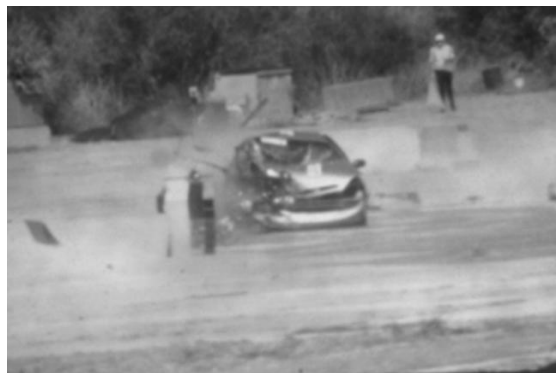
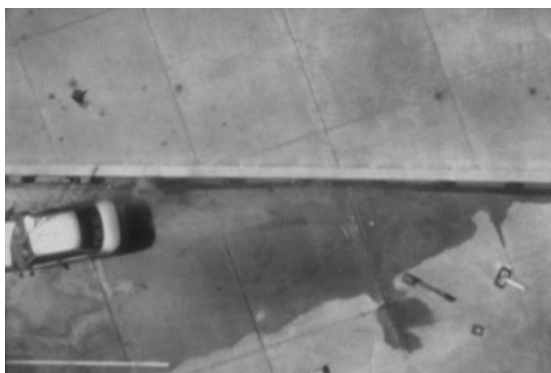
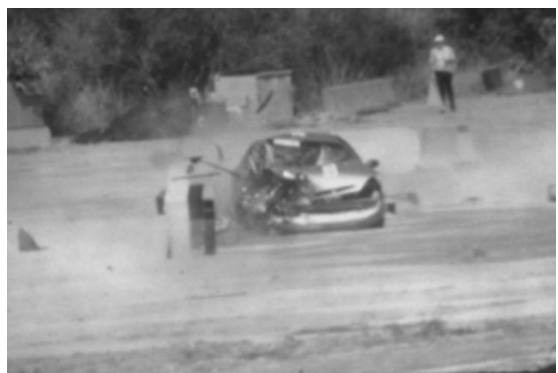
**Figure D1. Sequential Photographs for Test No. 460719-1  
(Overhead and Frontal Views) (Continued).**

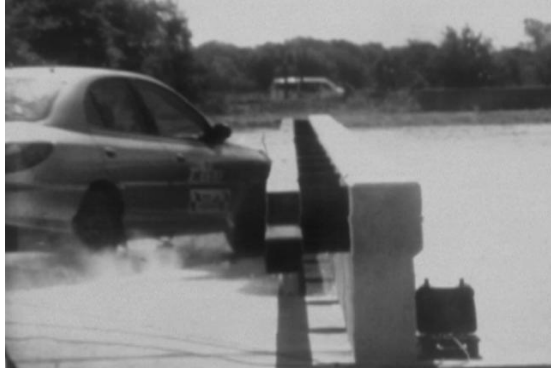
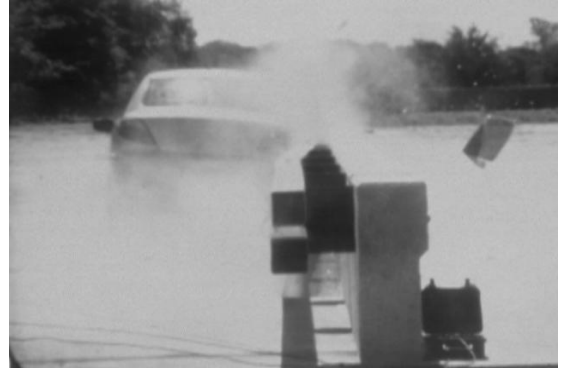
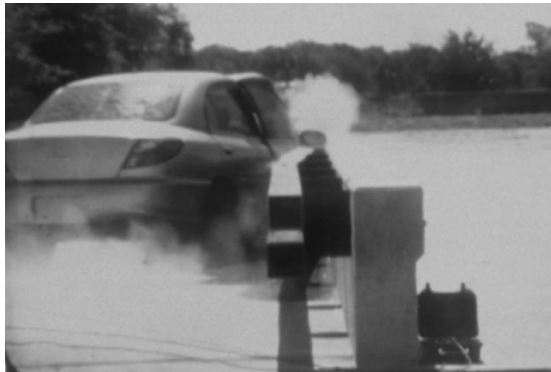
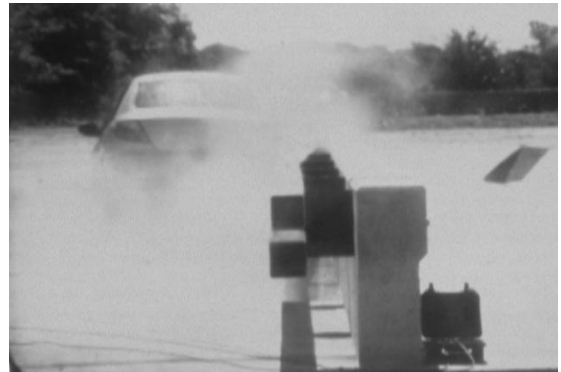
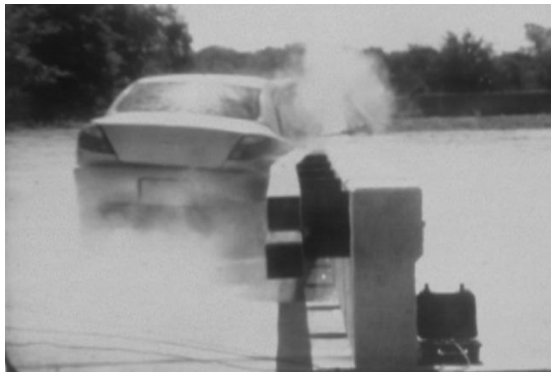
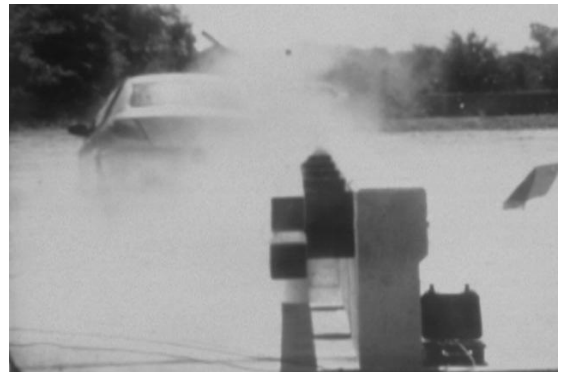
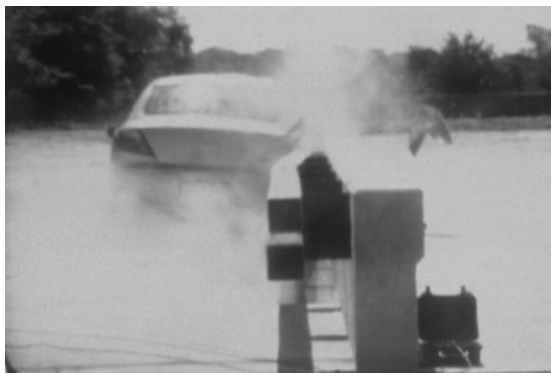
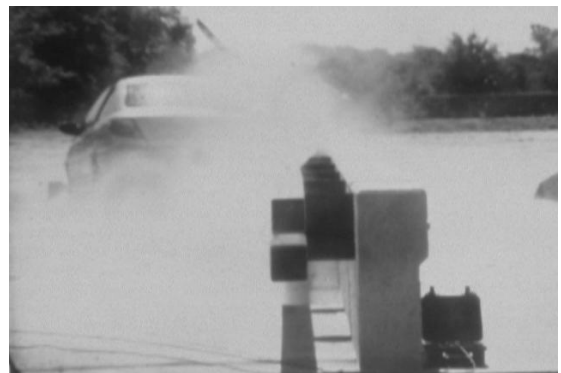
**Figure D2. Sequential Photographs for Test No. 460719-1 (Rear View).**

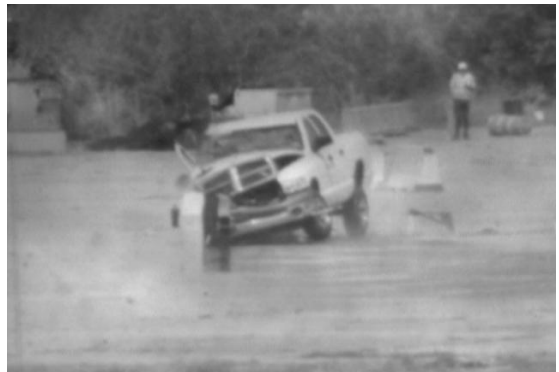
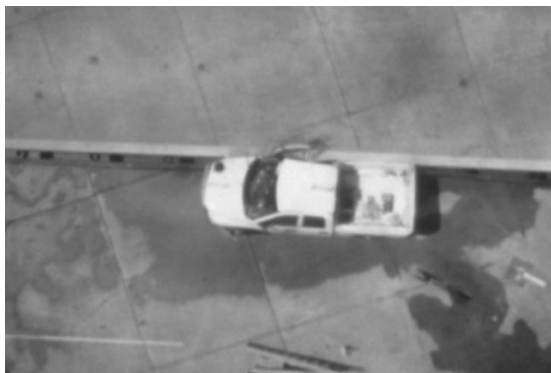
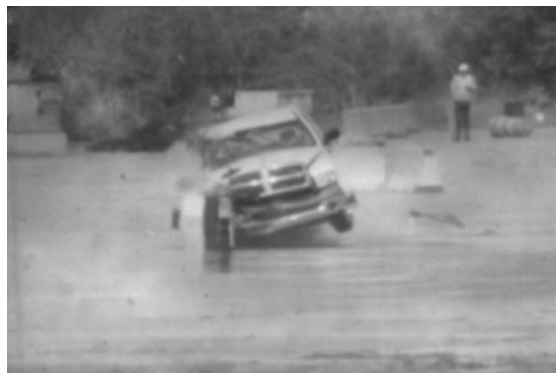
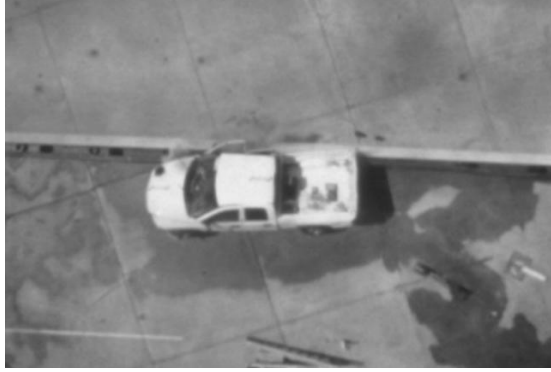
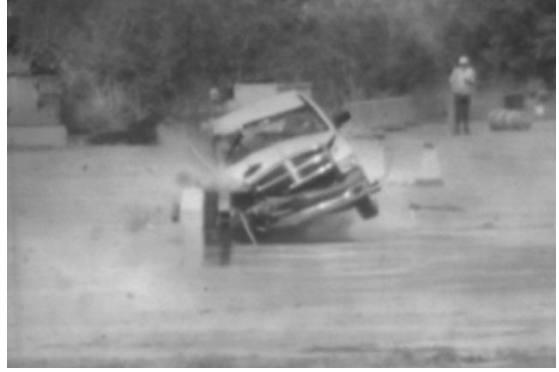
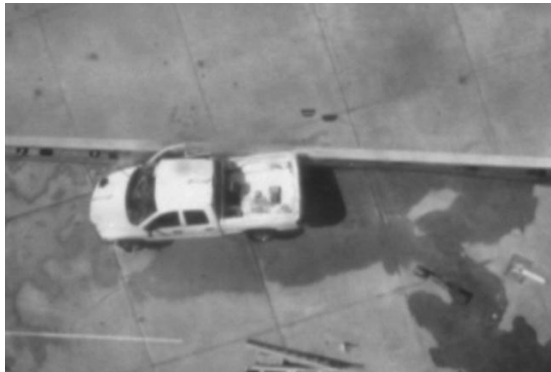
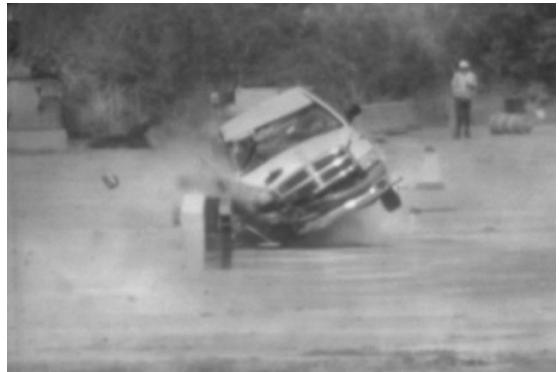
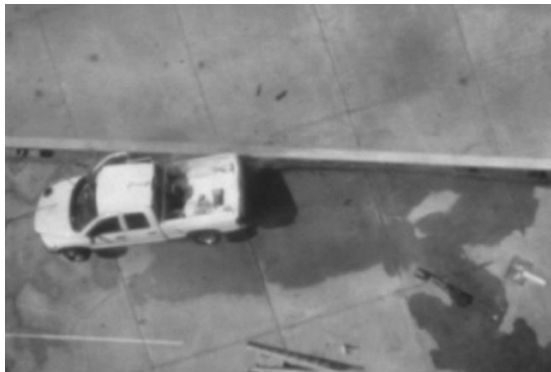
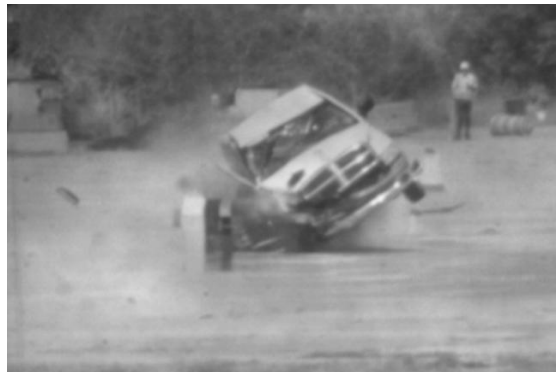
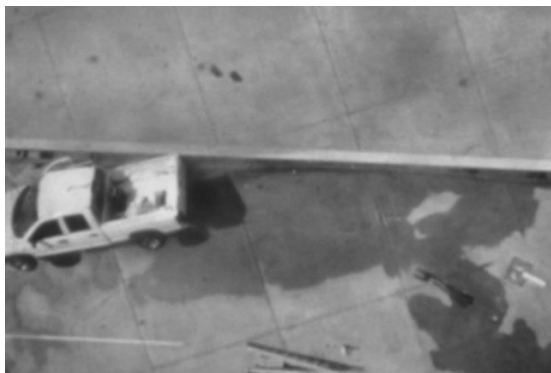
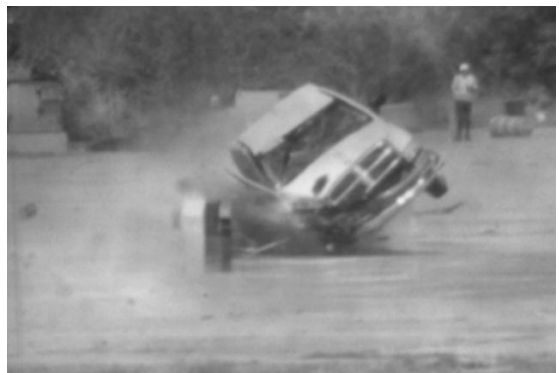
**Figure D3. Sequential Photographs for Test 460719-2 (Overhead and Frontal Views).**

**Figure D3. Sequential Photographs for Test 460719-2  
(Overhead and Frontal Views) (Continued).**
