# Evaluation of Barriers for Very High Speed Roadways

## Research/Test Report 0-6071-2

**TEXAS TRANSPORTATION INSTITUTE  
THE TEXAS A&M UNIVERSITY SYSTEM  
COLLEGE STATION, TEXAS**

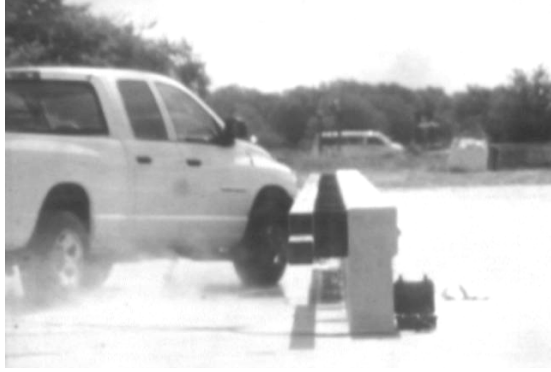
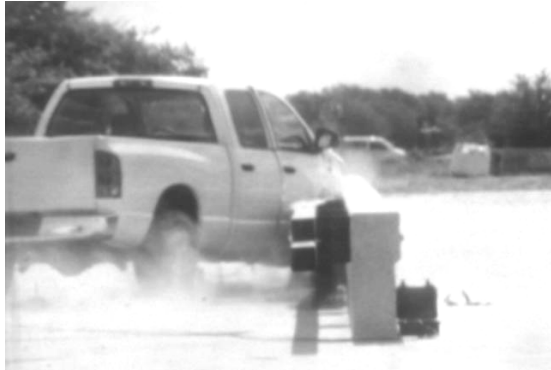
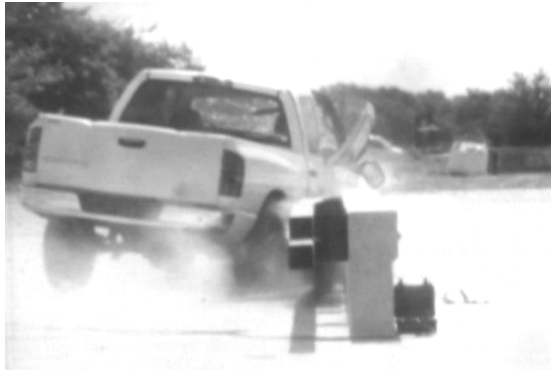
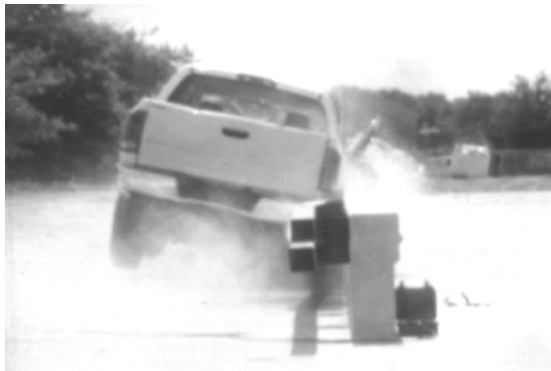
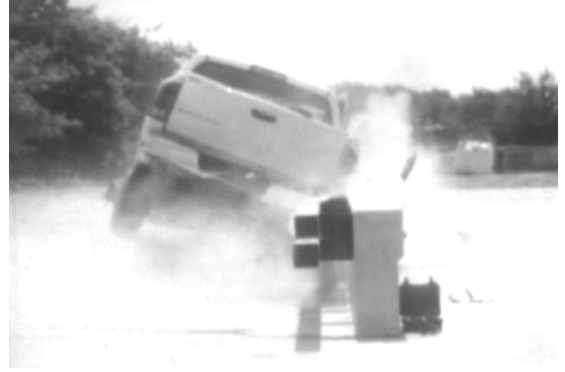
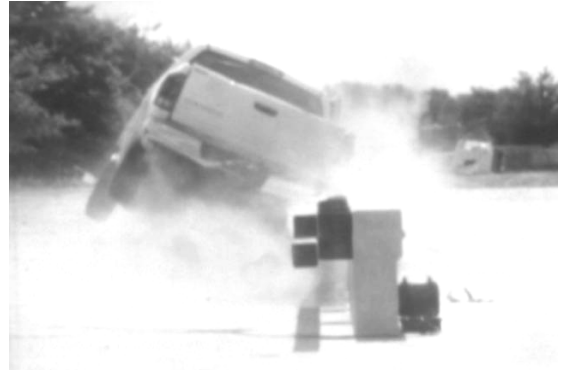
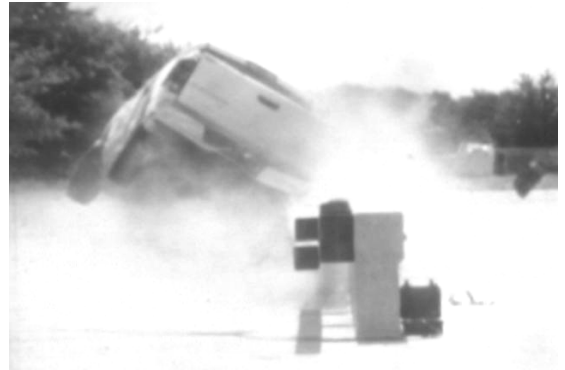
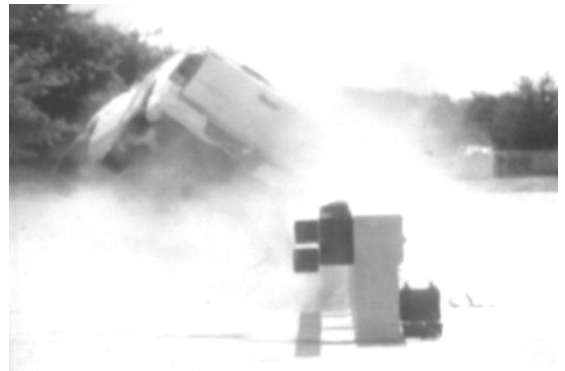
**Figure D4. Sequential Photographs for Test 460719-2  
(Rear View).**

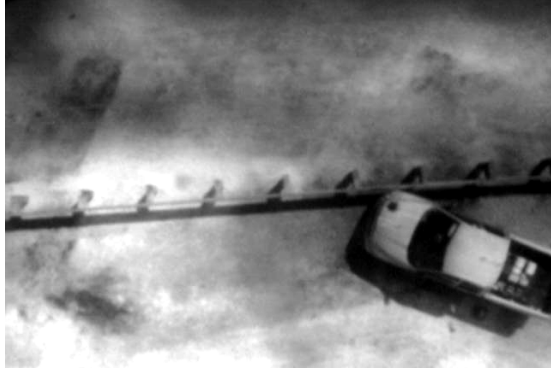
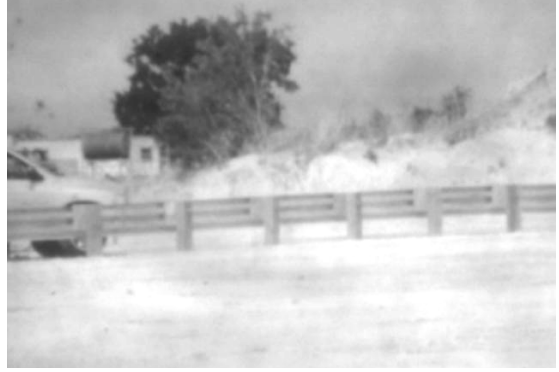
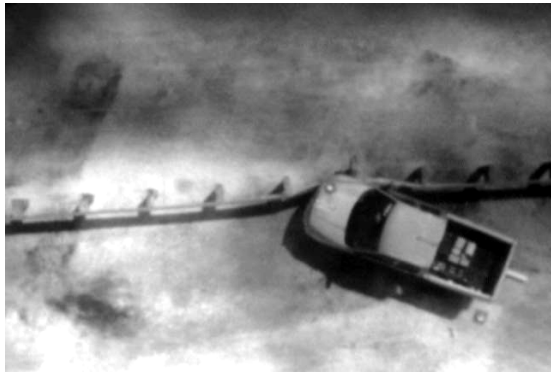
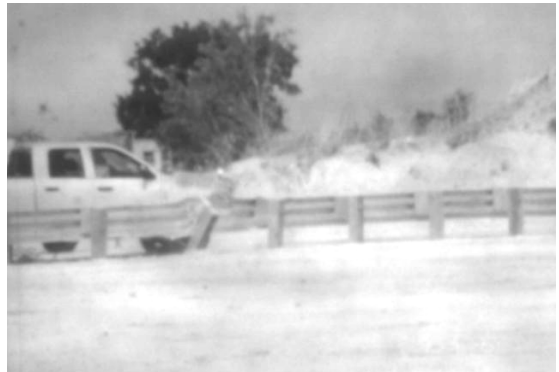
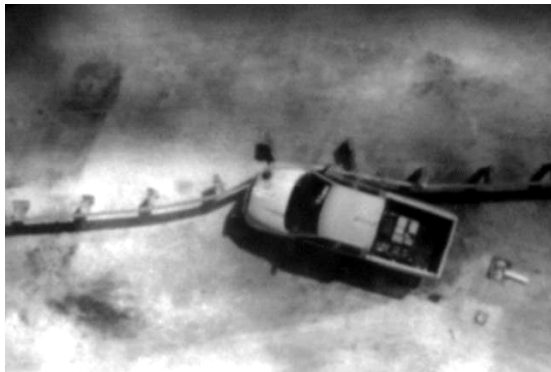
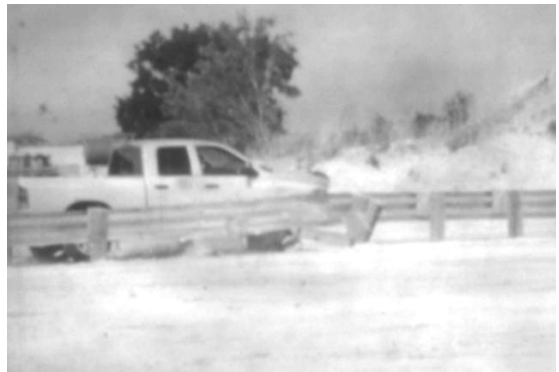
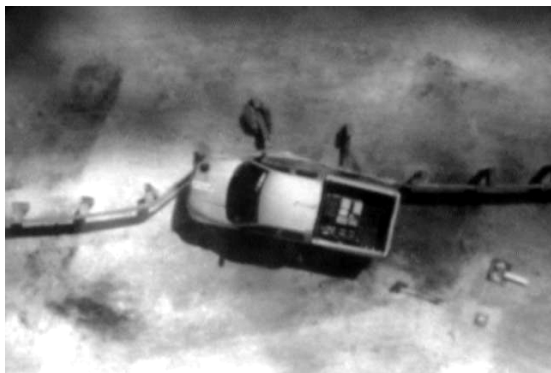
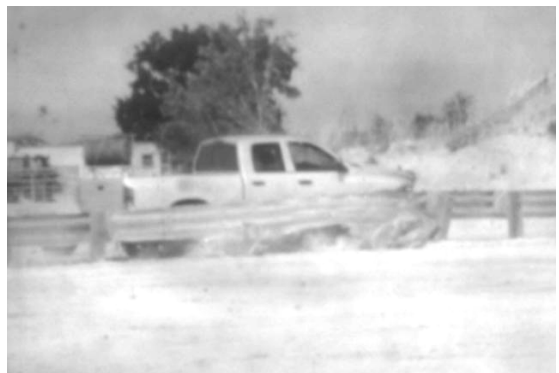
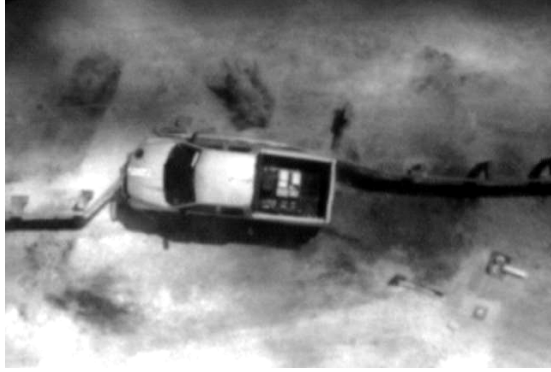
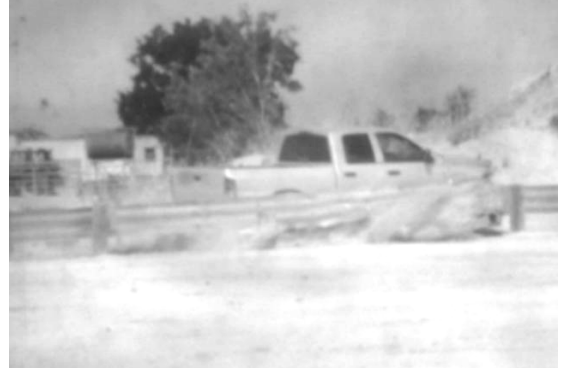
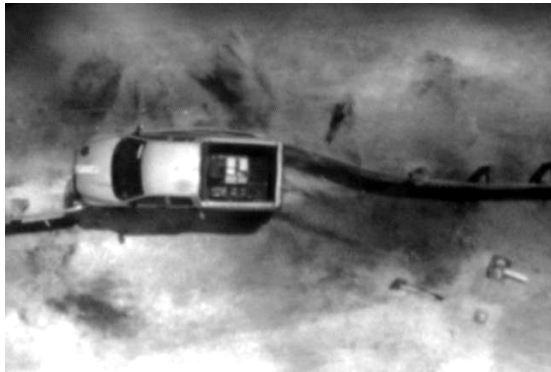
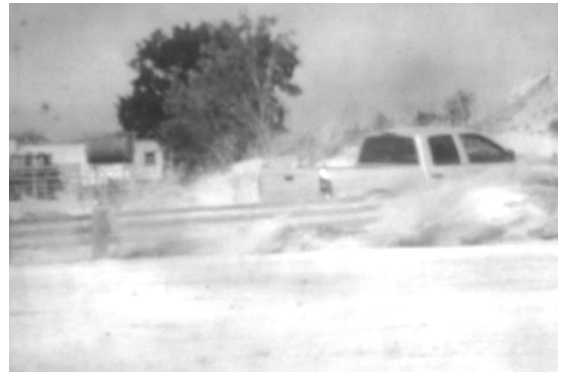
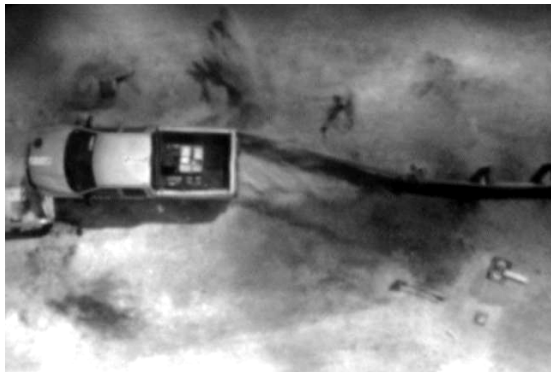
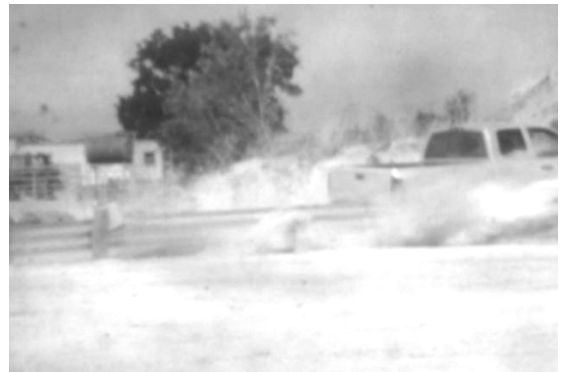
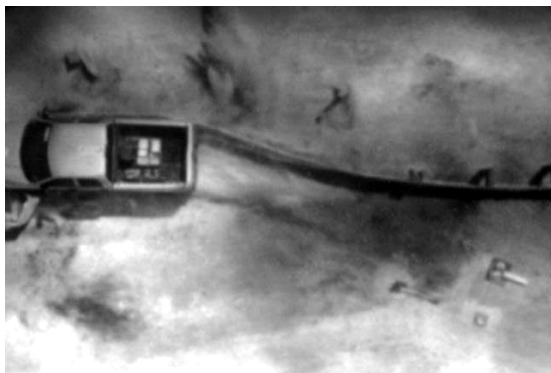
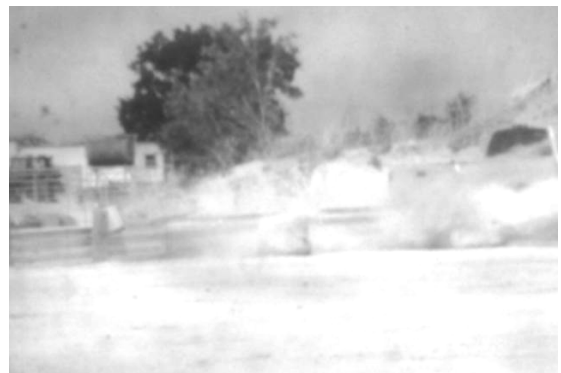
**Figure D5. Sequential Photographs for Test No. 460719-3  
(Overhead and Frontal Views).**

**Figure D5. Sequential Photographs for Test No. 460719-3  
(Overhead and Frontal Views) (Continued).**

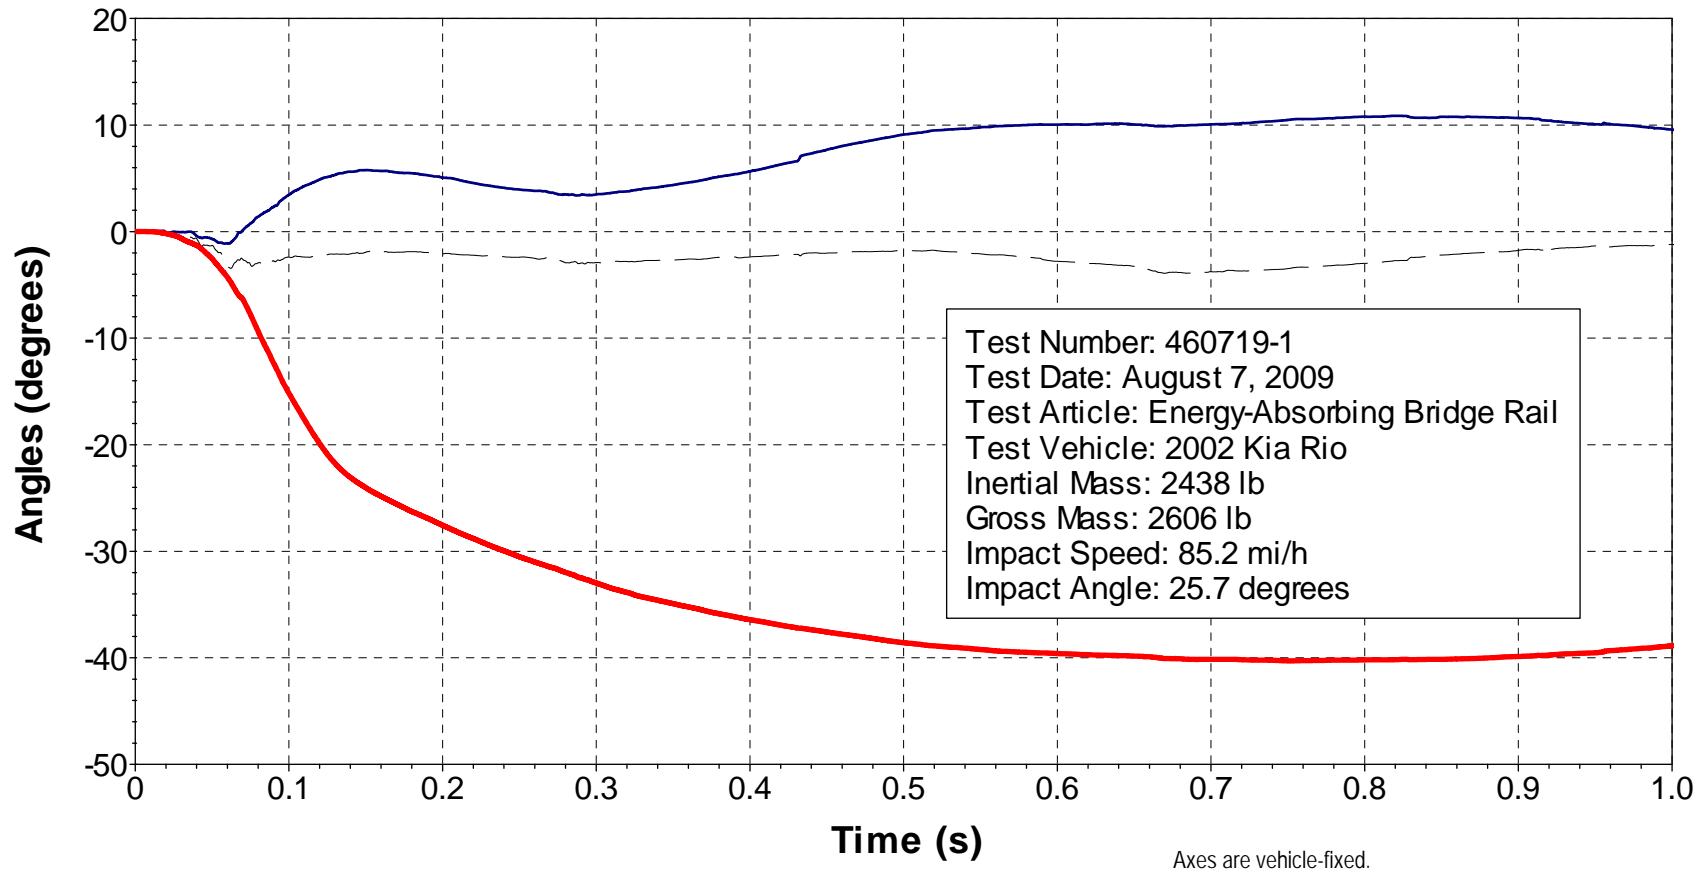
Figure E1. Vehicle Angular Displacements for Test No. 460719-1.

Test Number: 460719-1  
 Test Date: August 7, 2009  
 Test Article: Energy-Absorbing Bridge Rail  
 Test Vehicle: 2002 Kia Rio  
 Inertial Mass: 2438 lb  
 Gross Mass: 2606 lb  
 Impact Speed: 85.2 mi/h  
 Impact Angle: 25.7 degrees

The energy-absorbing bridge rail contained and redirected the 1100C vehicle. The 1100C vehicle remained upright during and after the collision event. Maximum roll angle was 13 degrees at 1.7 s, and maximum pitch angle was 10 degrees at 2.00 s. Maximum occupant compartment deformation was 9.0 inches in the right side floor pan/toe pan area, which is the allowable limit for this area recommended in *MASH*. Longitudinal occupant impact velocity was 24.6 ft/s, and lateral occupant impact velocity was 40.7 ft/s. The maximum limit according to *MASH* is 40 ft/s, which was slightly exceeded in the lateral direction. It is noted that under NCHRP Report 350, a value of 41 ft/s (12.49 m/s) was considered acceptable by FHWA. Longitudinal and lateral ridedown accelerations were -16.3 G and -10.0 G, respectively, both of which are below the recommended threshold of 20 G. As summarized in Table 7.1, the performance of the energy absorbing bridge rail was considered marginal.

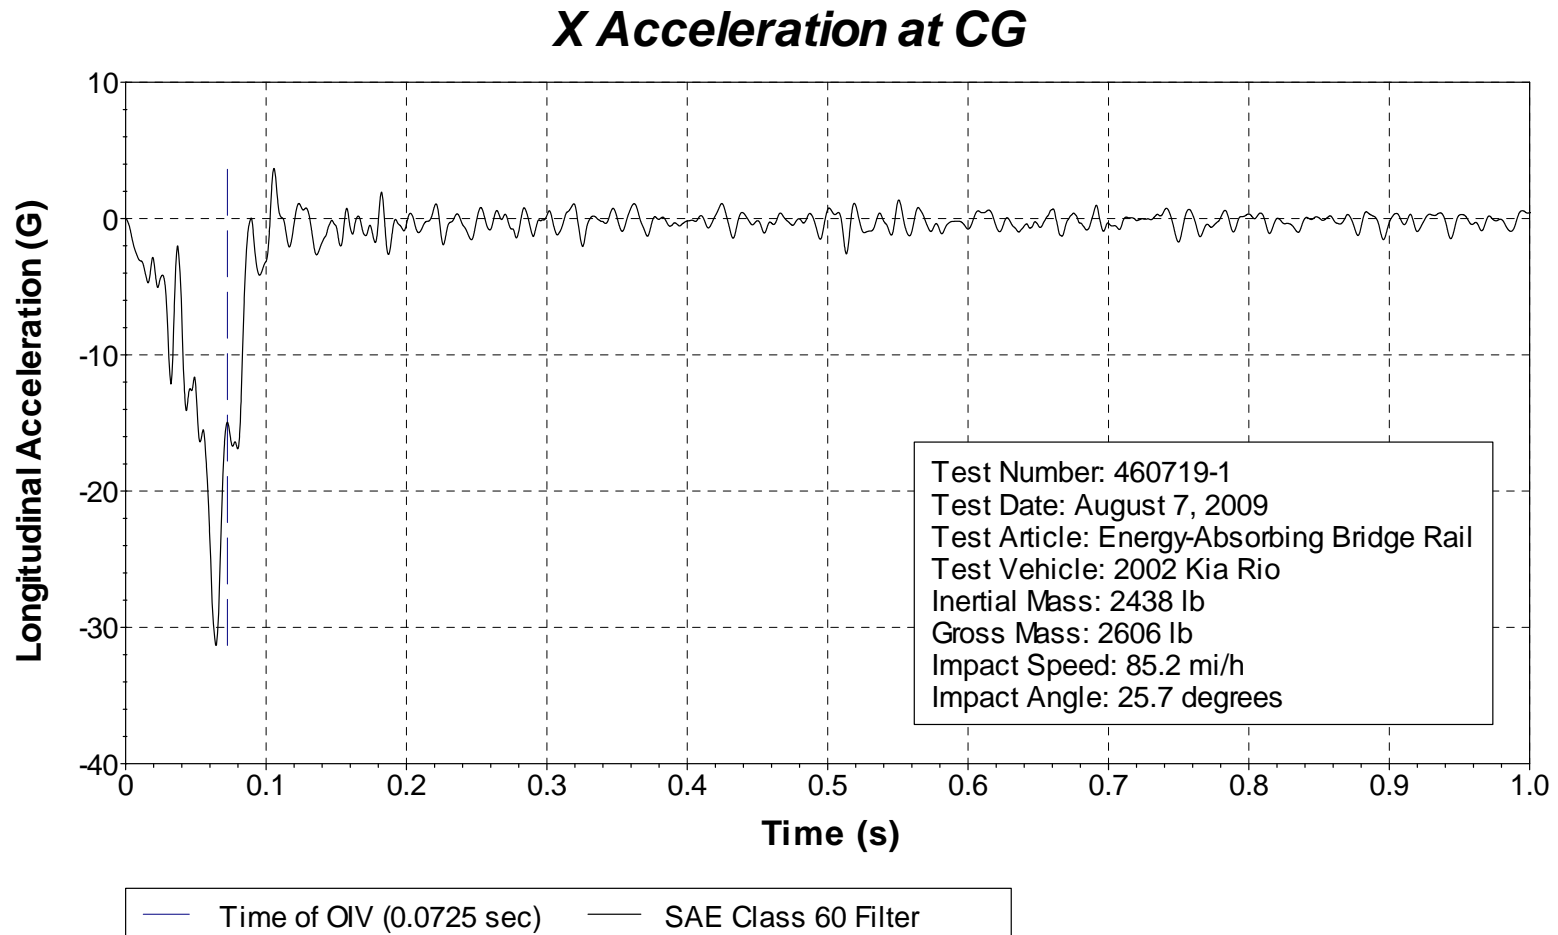
**Figure E2. Vehicle Longitudinal Accelerometer Trace for Test No. 460719-1  
(Accelerometer Located at Center of Gravity).**

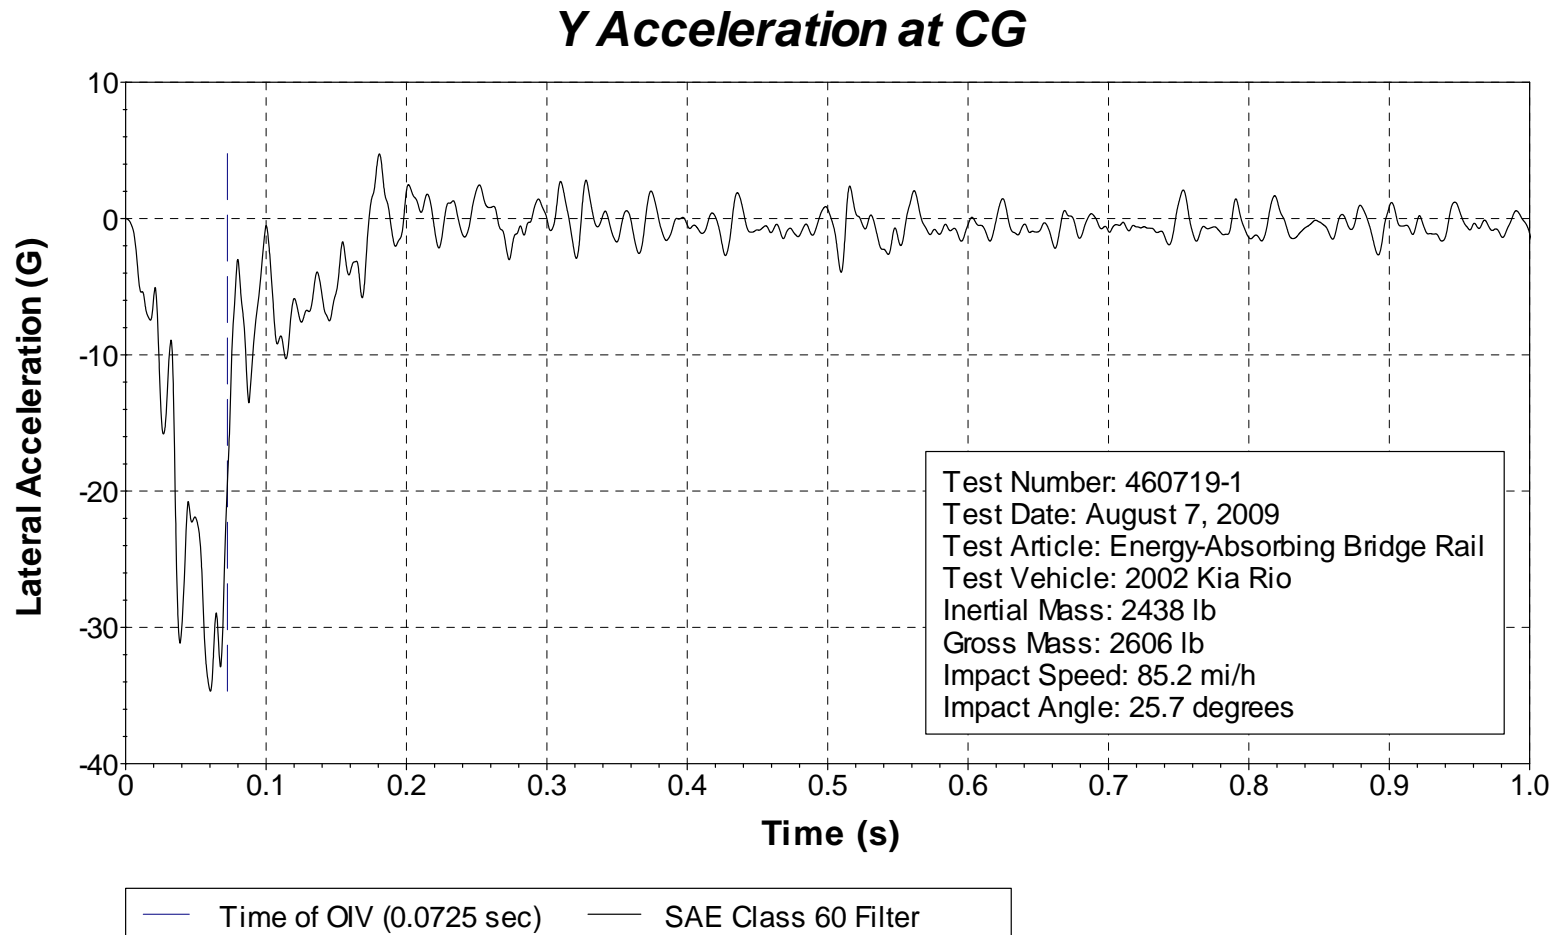
**Figure E3. Vehicle Lateral Accelerometer Trace for Test No. 460719-1  
(Accelerometer Located at Center of Gravity).**

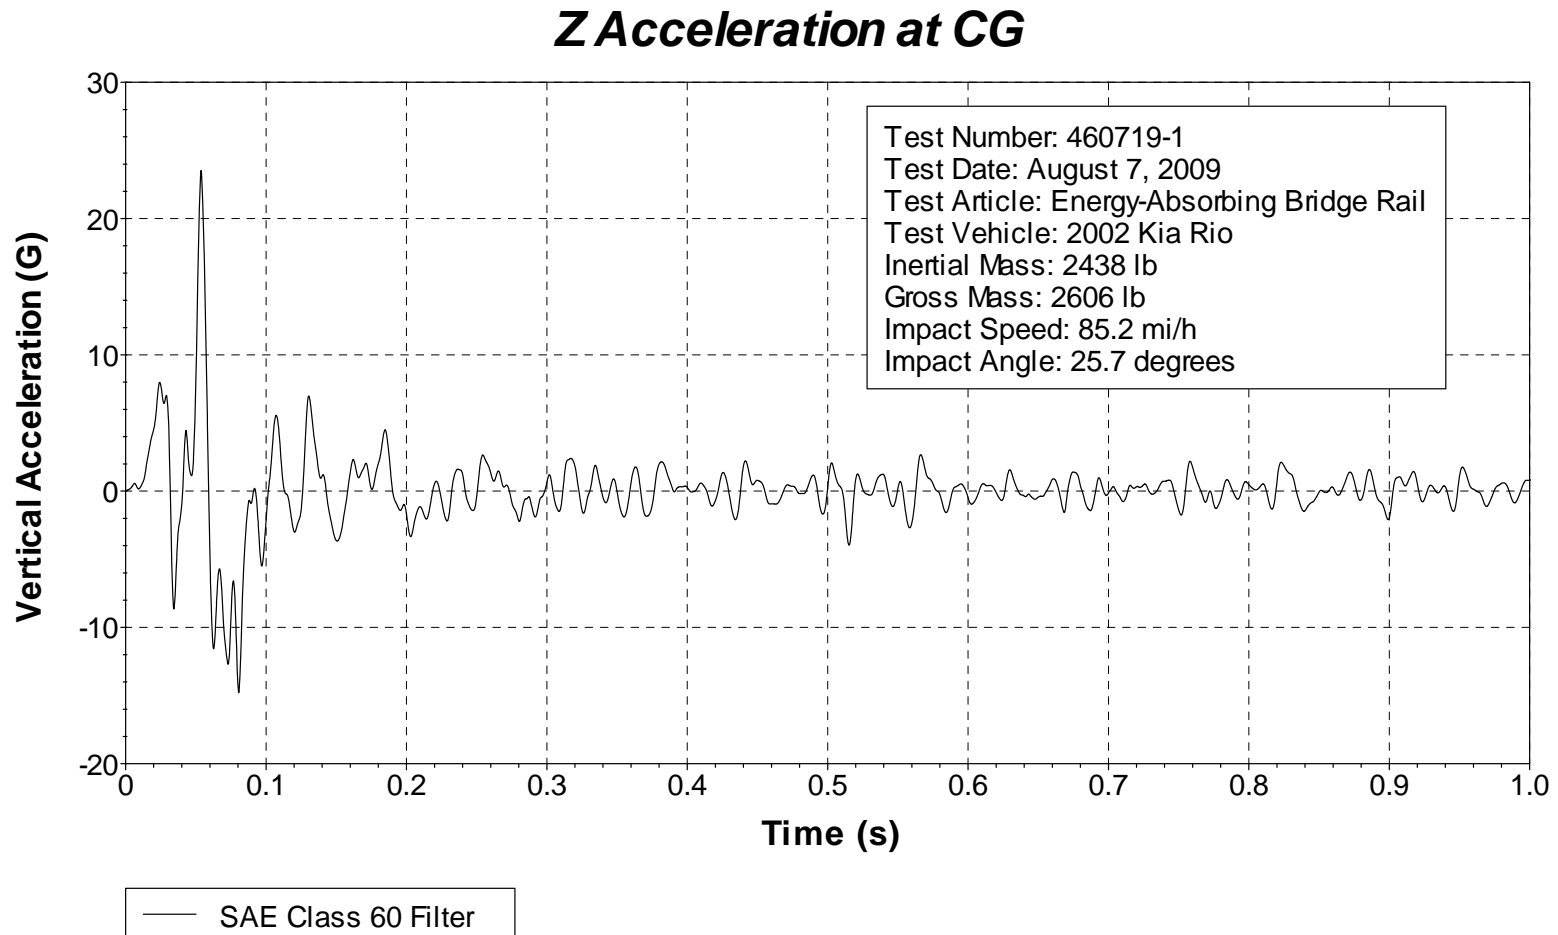
**Figure E4. Vehicle Vertical Accelerometer Trace for Test No. 460719-1  
(Accelerometer Located at Center of Gravity).**

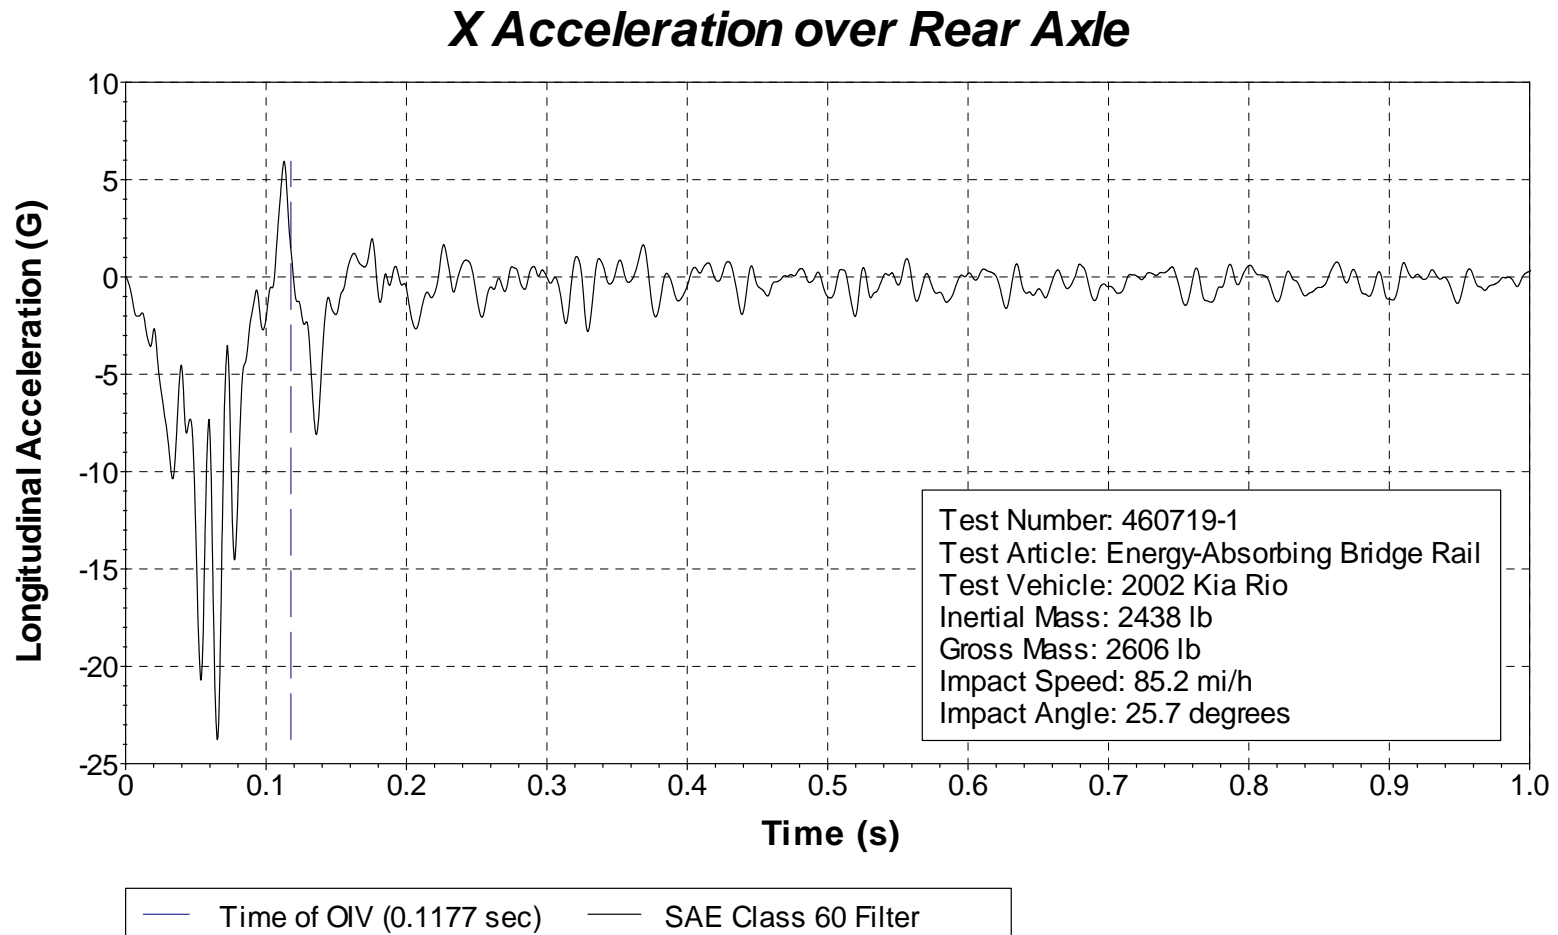
**Figure E5. Vehicle Longitudinal Accelerometer Trace for Test No. 460719-1  
(Accelerometer Located over Rear Axle).**

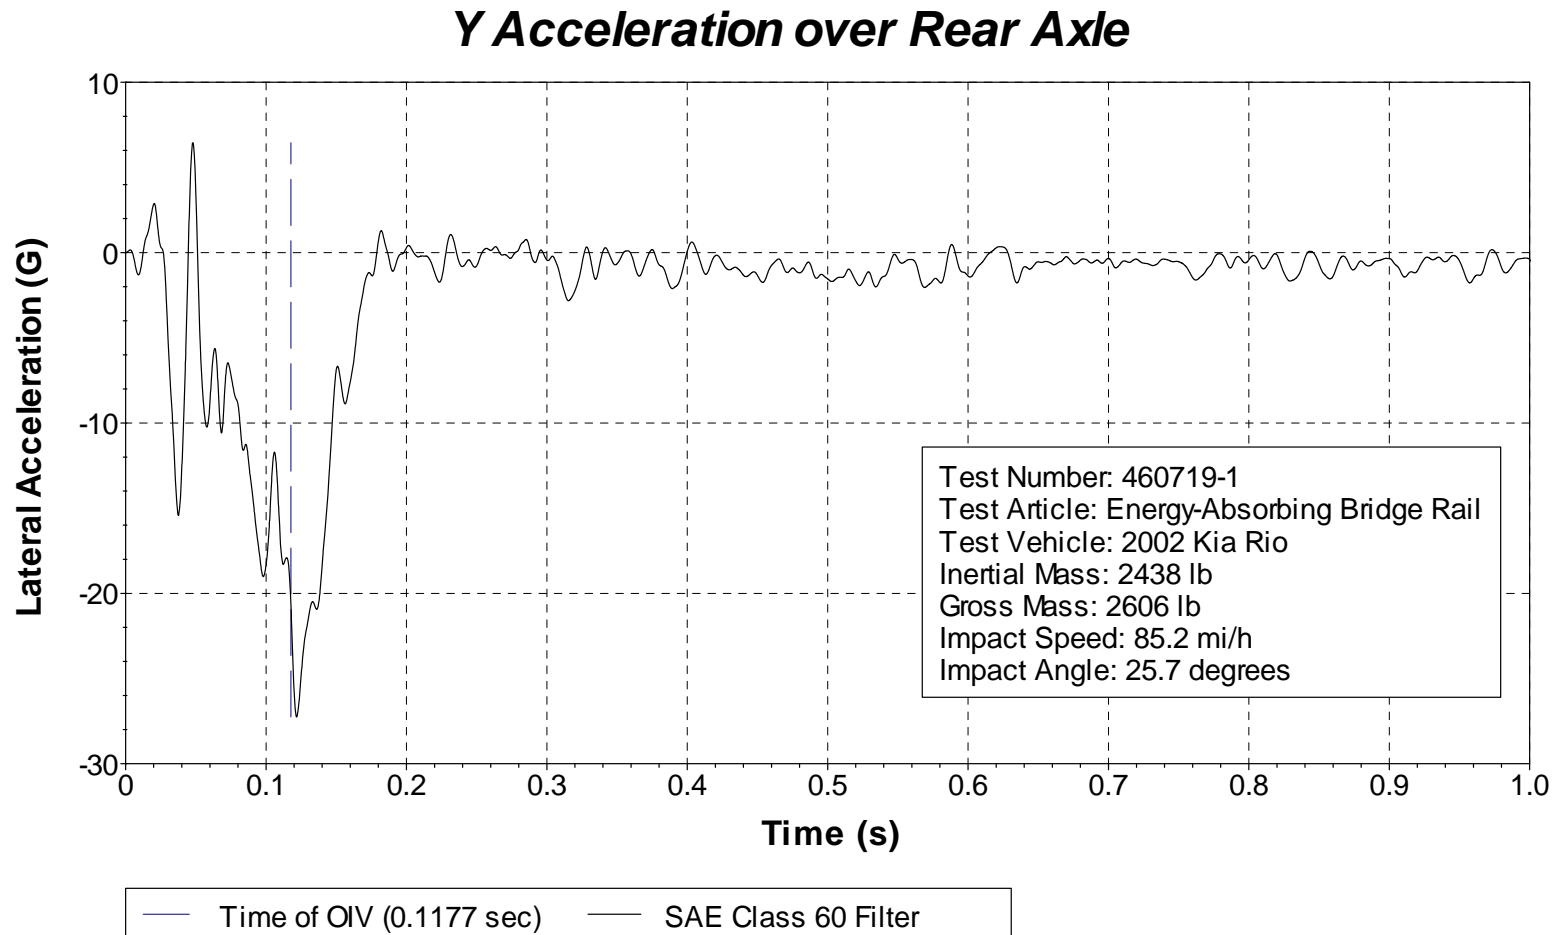
**Figure E6. Vehicle Lateral Accelerometer Trace for Test No. 460719-1  
(Accelerometer Located over Rear Axle).**

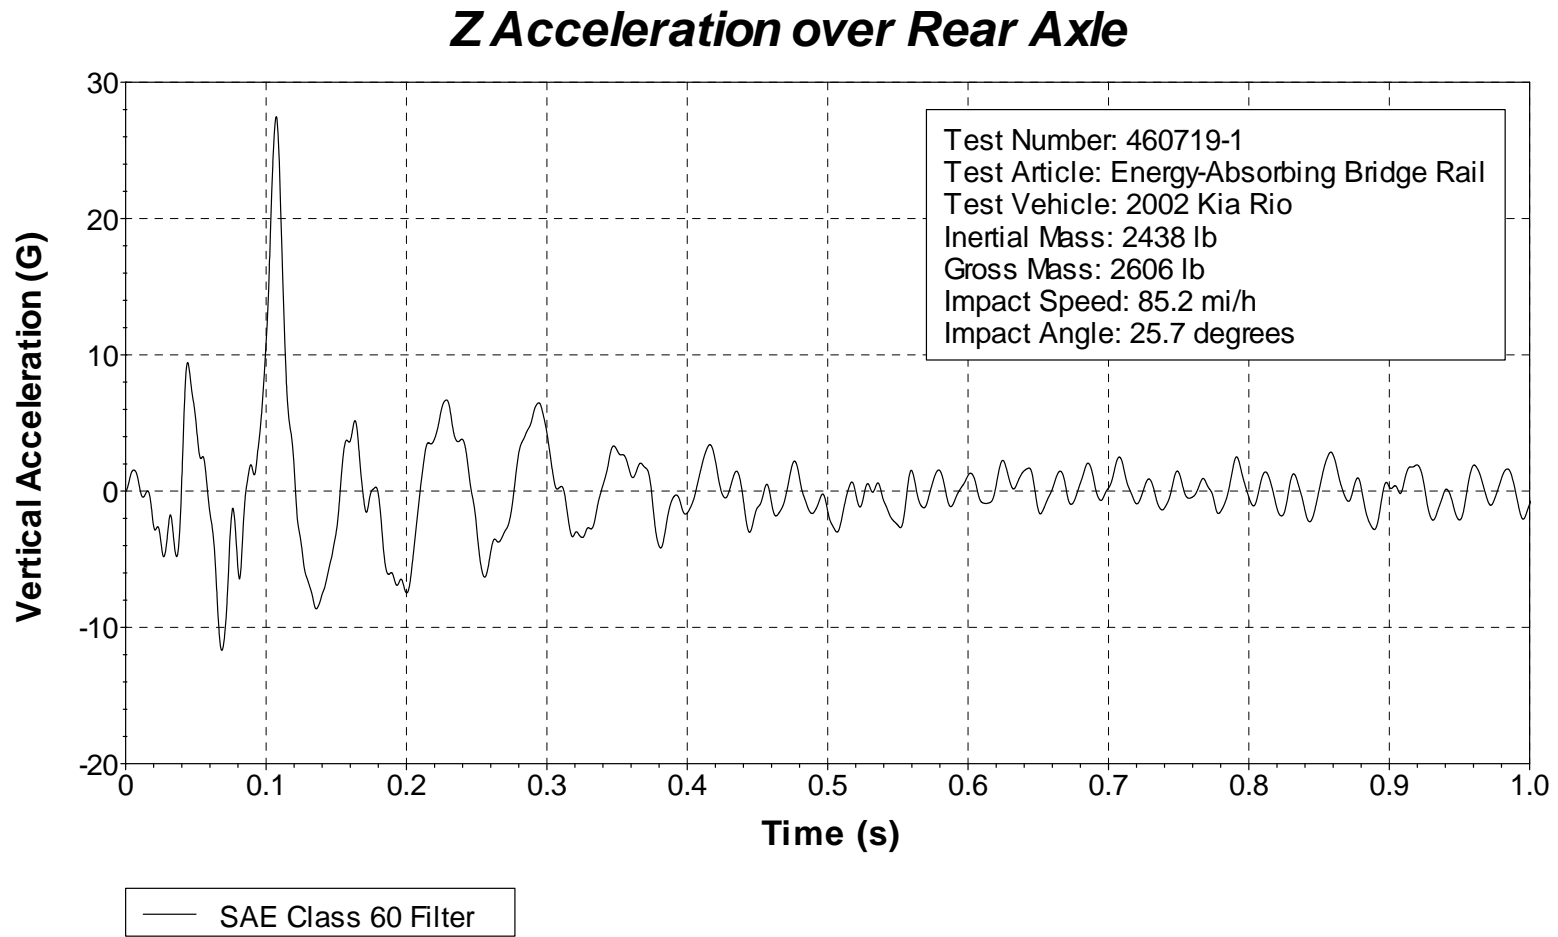
**Figure E7. Vehicle Vertical Accelerometer Trace for Test No. 460719-1  
(Accelerometer Located over Rear Axle).**

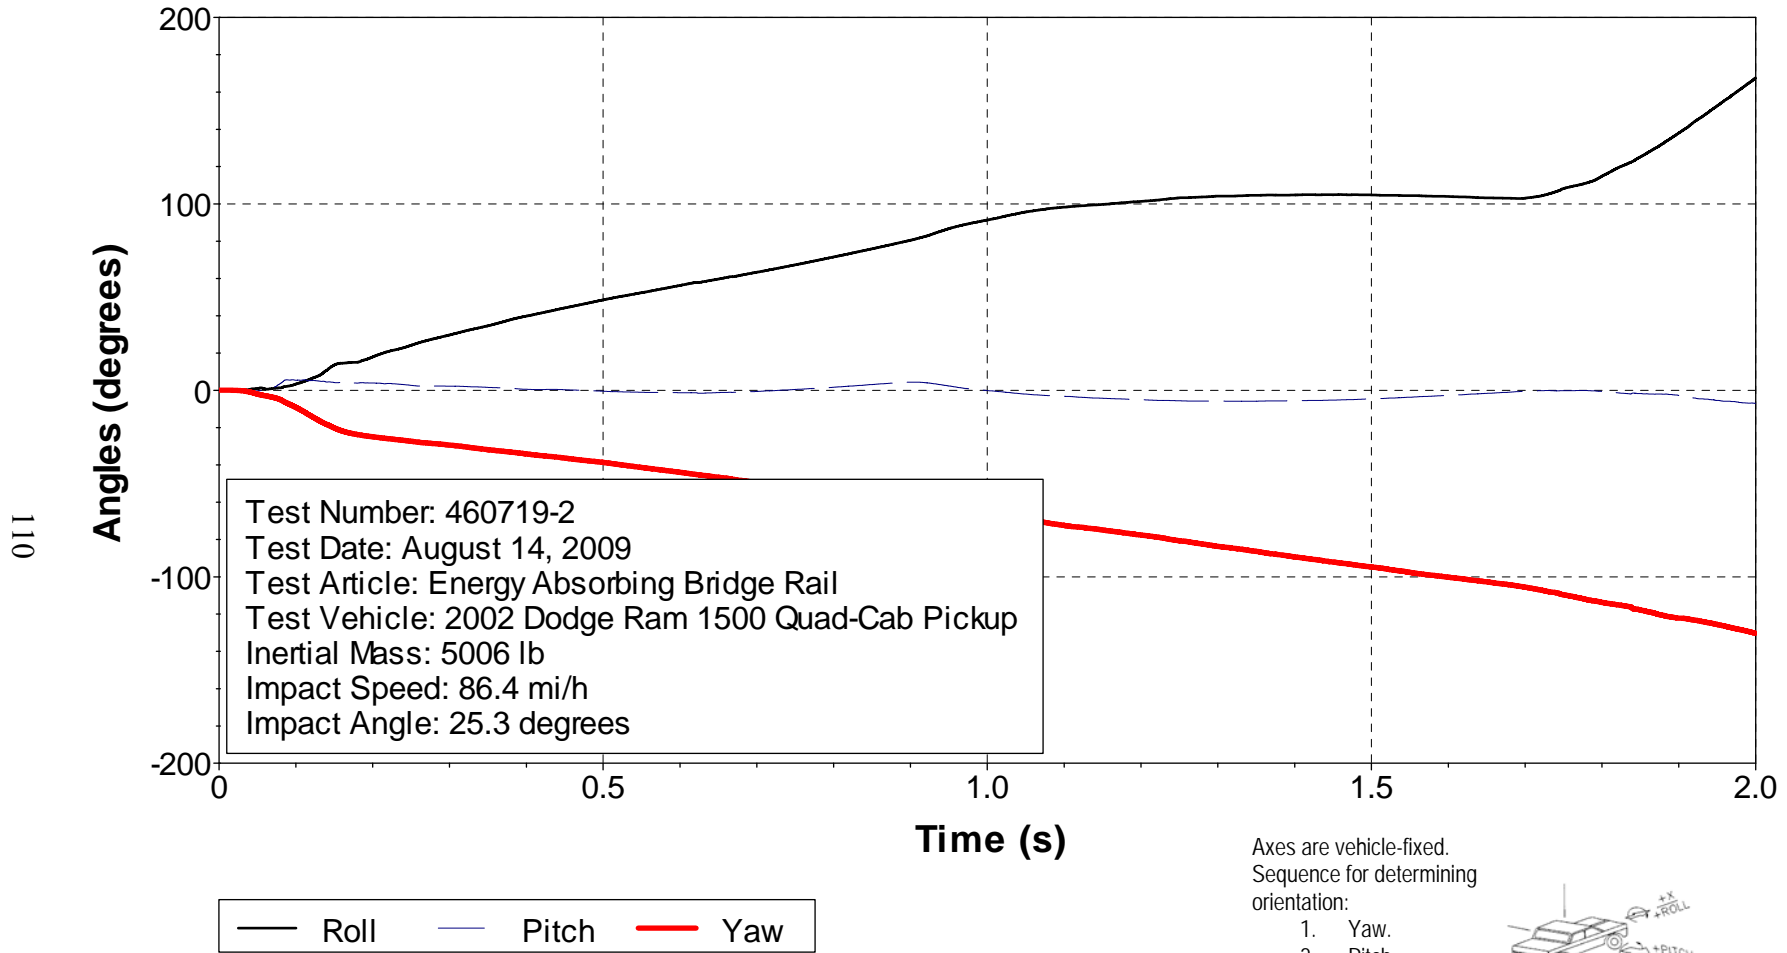
**Figure E8. Vehicle Angular Displacements for Test No. 460719-2.**

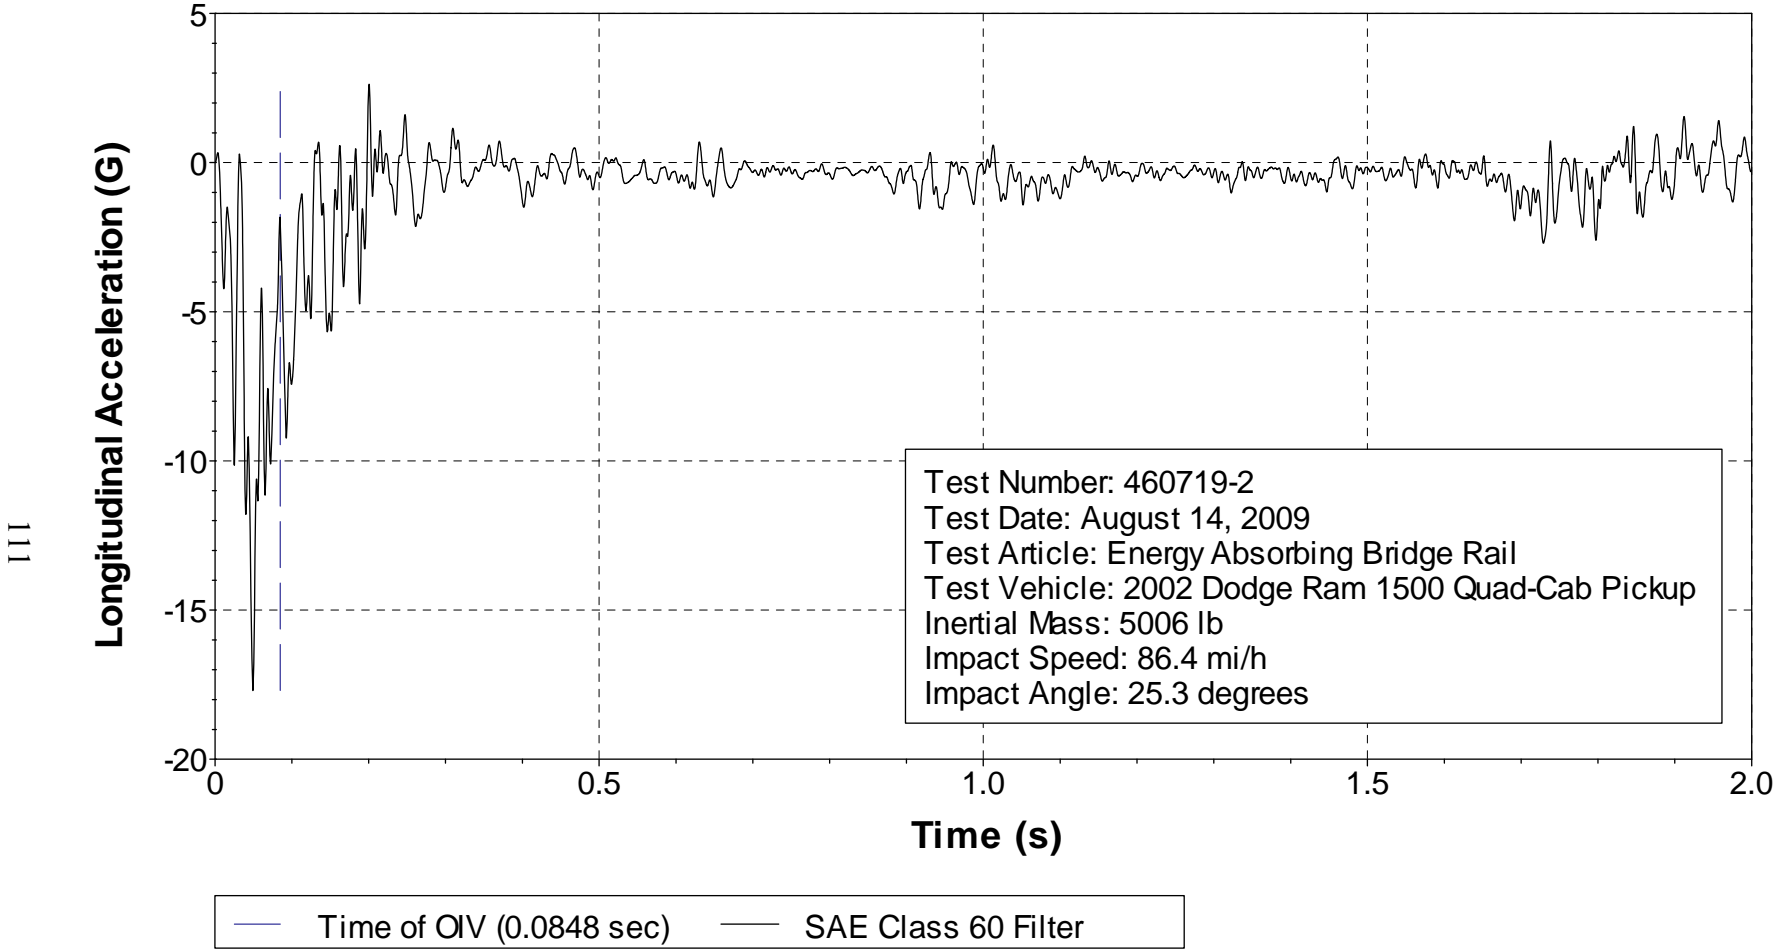
**Figure E9. Vehicle Longitudinal Accelerometer Trace for Test No. 460719-2 (Accelerometer Located at Center of Gravity).**

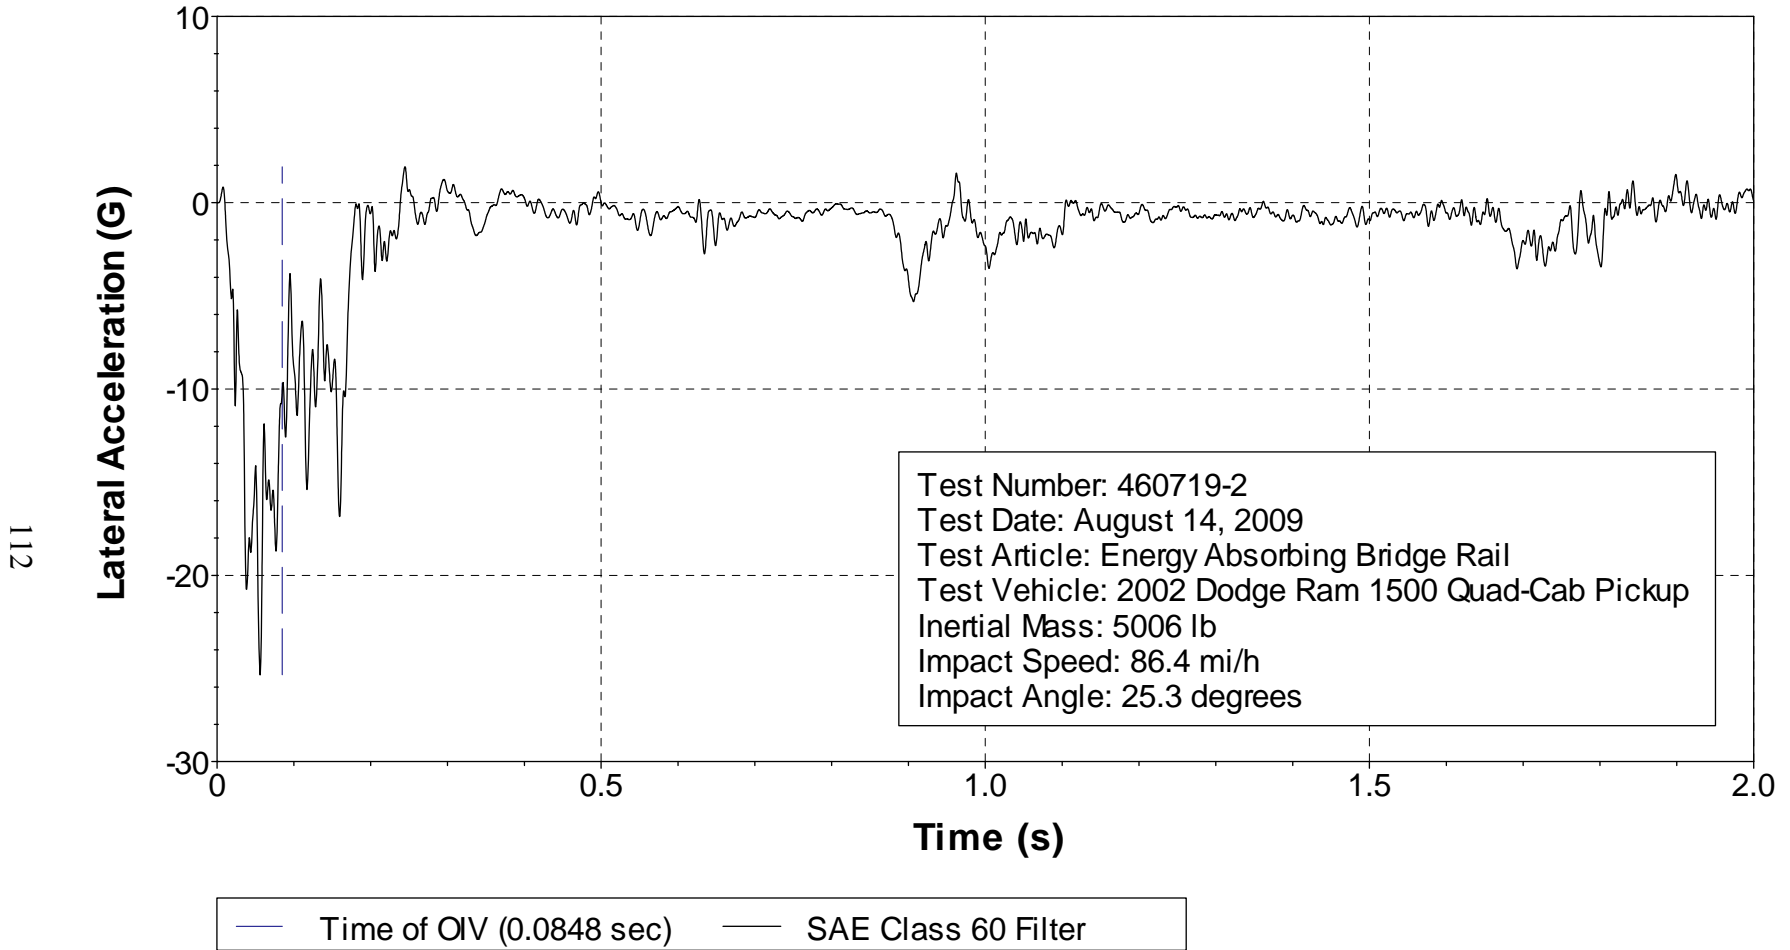
**Figure E10. Vehicle Lateral Accelerometer Trace for Test No. 460719-2 (Accelerometer Located at Center of Gravity).**

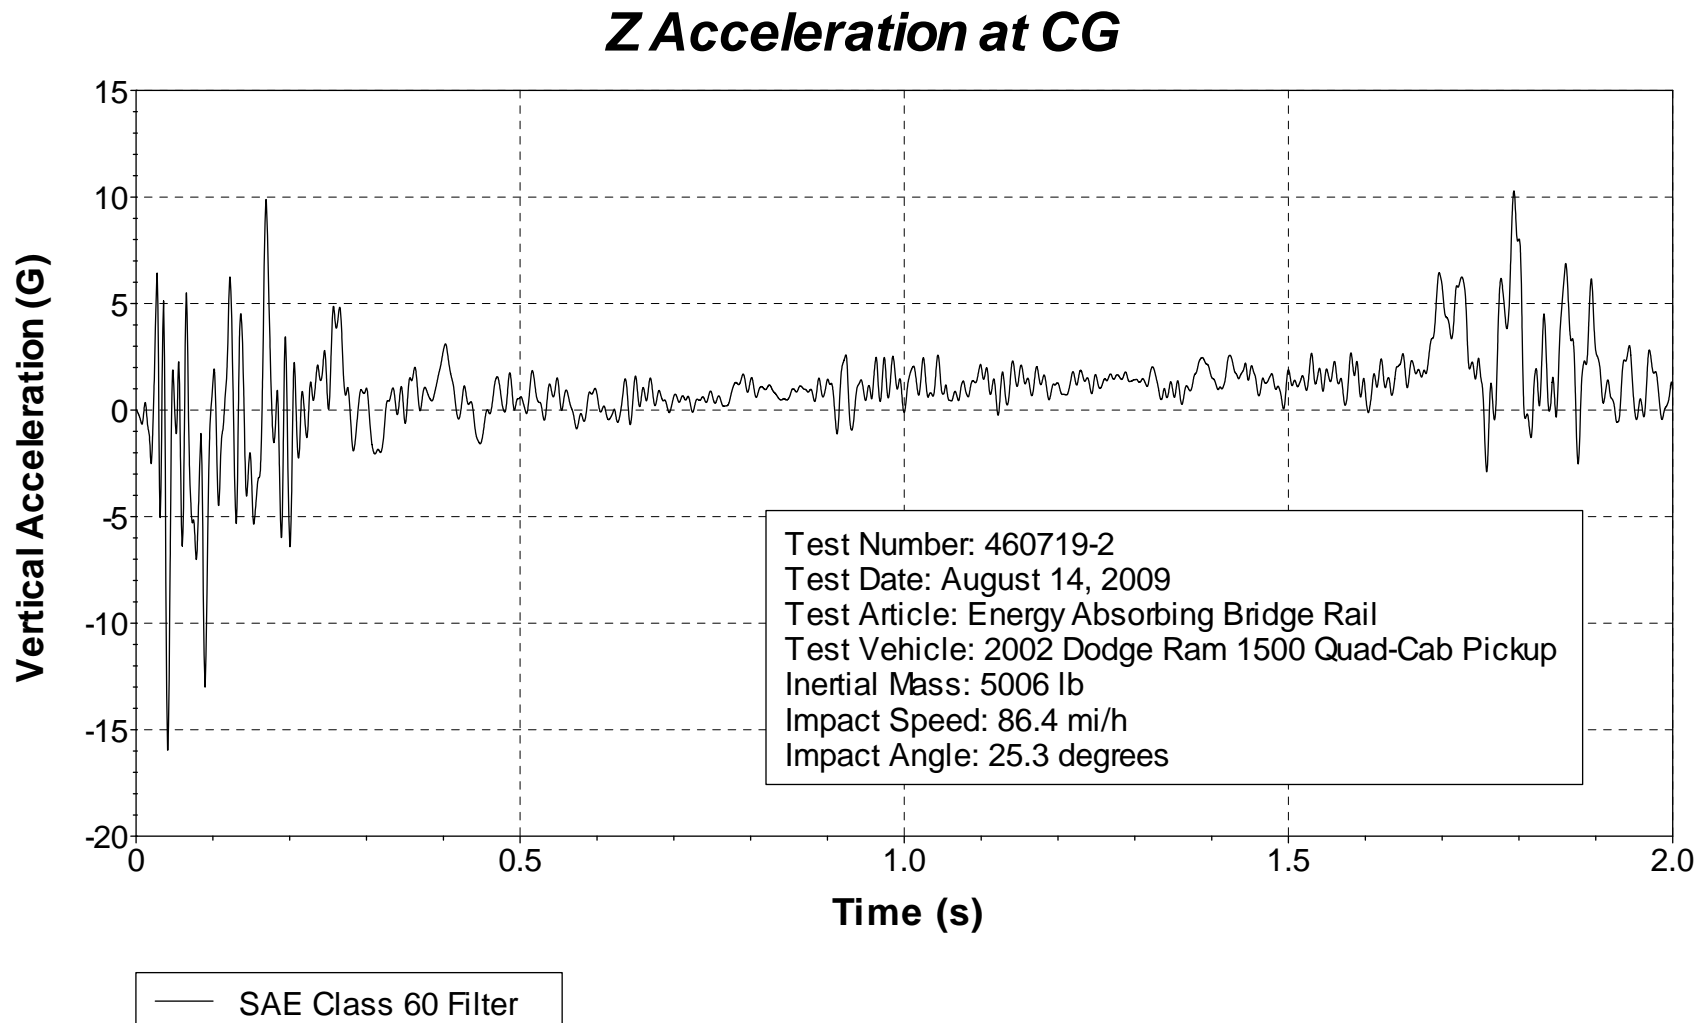
**Figure E11. Vehicle Vertical Accelerometer Trace for Test No. 460719-2  
(Accelerometer Located at Center of Gravity).**
