# Evaluation of Barriers for Very High Speed Roadways

## Research/Test Report 0-6071-2

**TEXAS TRANSPORTATION INSTITUTE  
THE TEXAS A&M UNIVERSITY SYSTEM  
COLLEGE STATION, TEXAS**

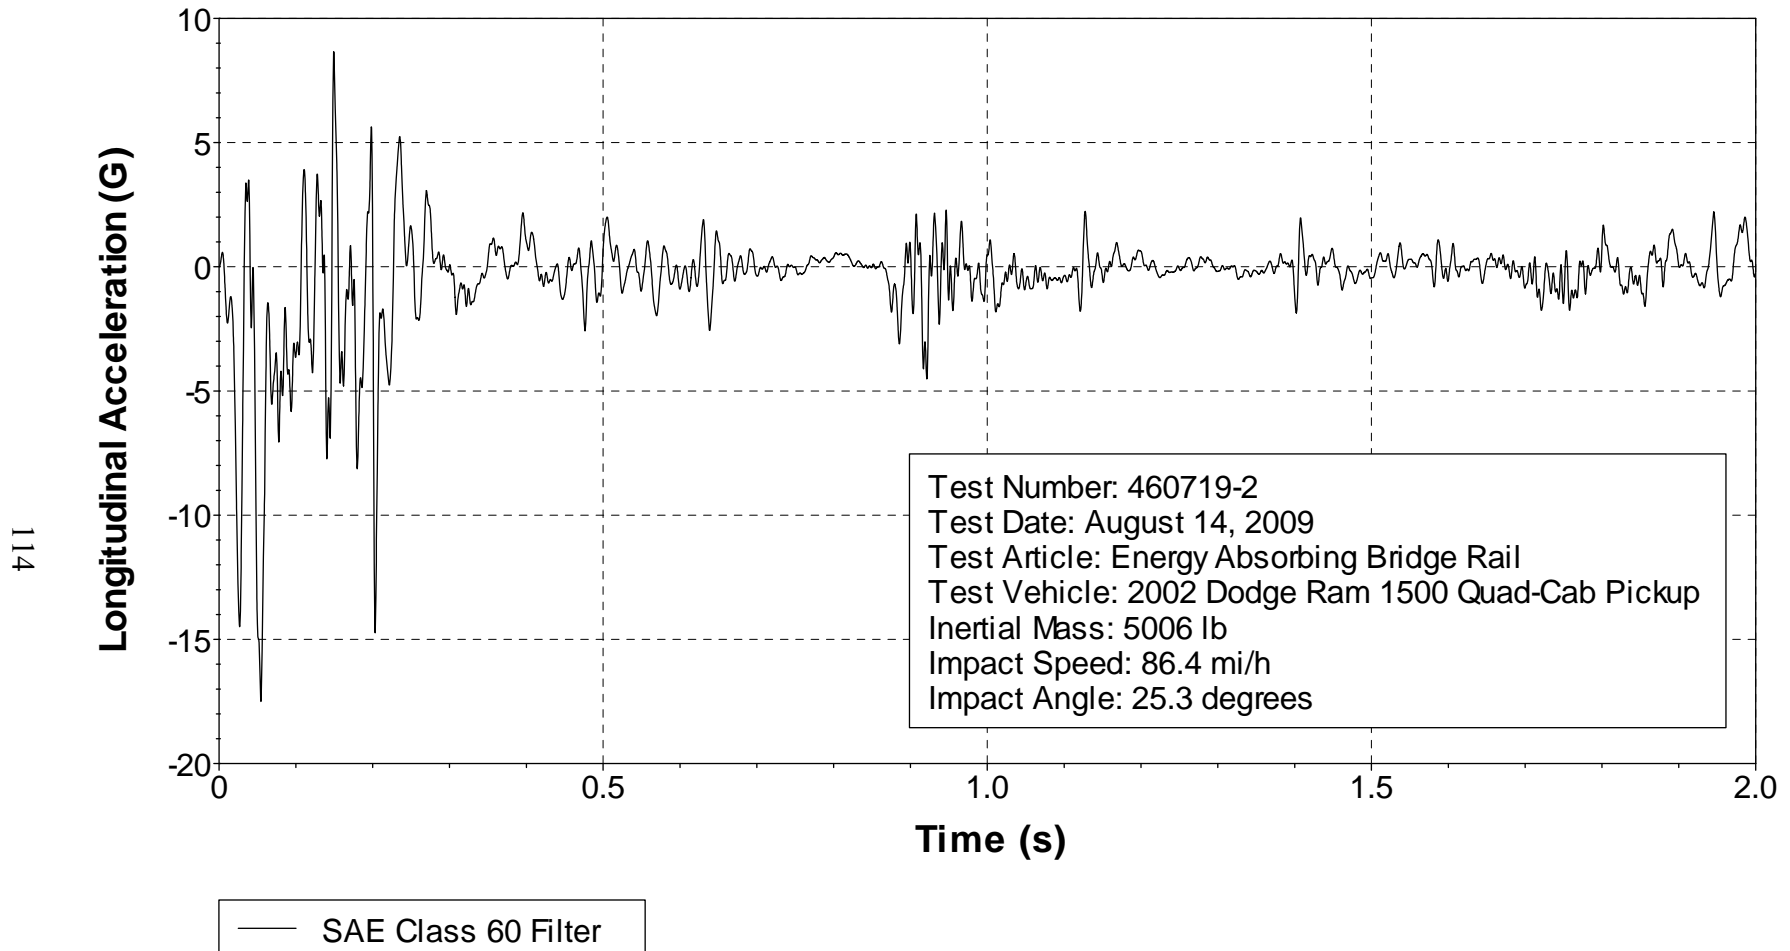
**Figure E12. Vehicle Longitudinal Accelerometer Trace for Test No. 460719-2  
(Accelerometer Located over Rear Axle).**

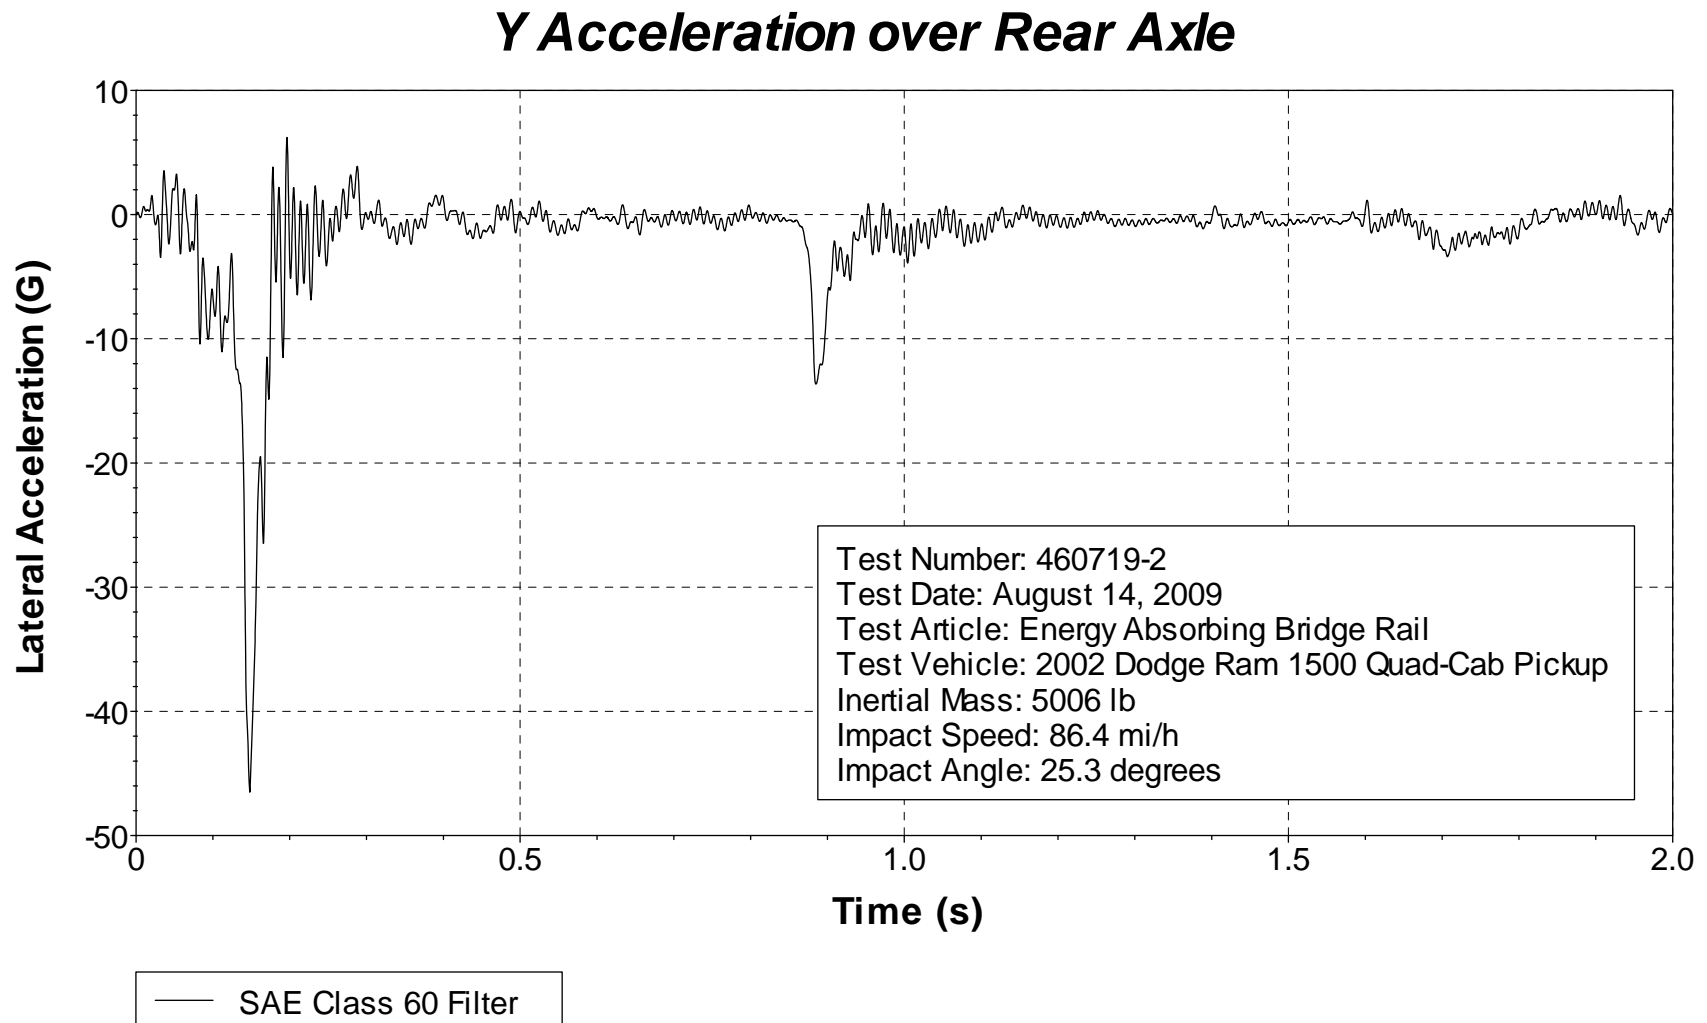
**Figure E13. Vehicle Lateral Accelerometer Trace for Test No. 460719-2  
(Accelerometer Located over Rear Axle).**

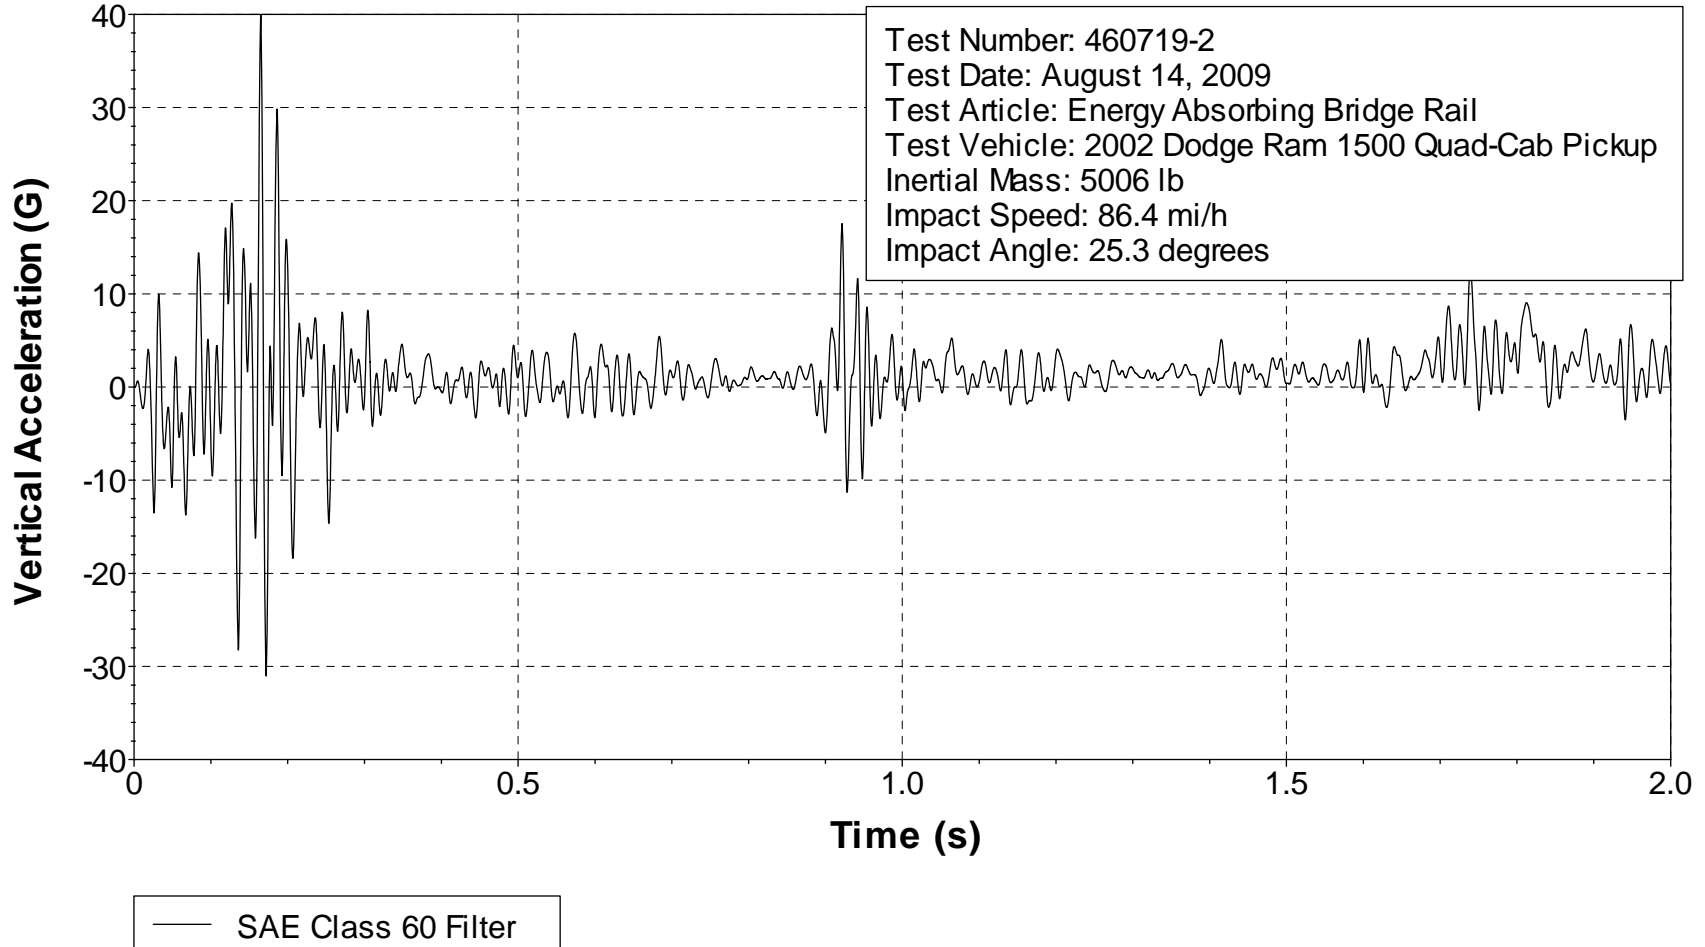
**Figure E14. Vehicle Vertical Accelerometer Trace for Test No. 460719-2  
(Accelerometer Located over Rear Axle).**

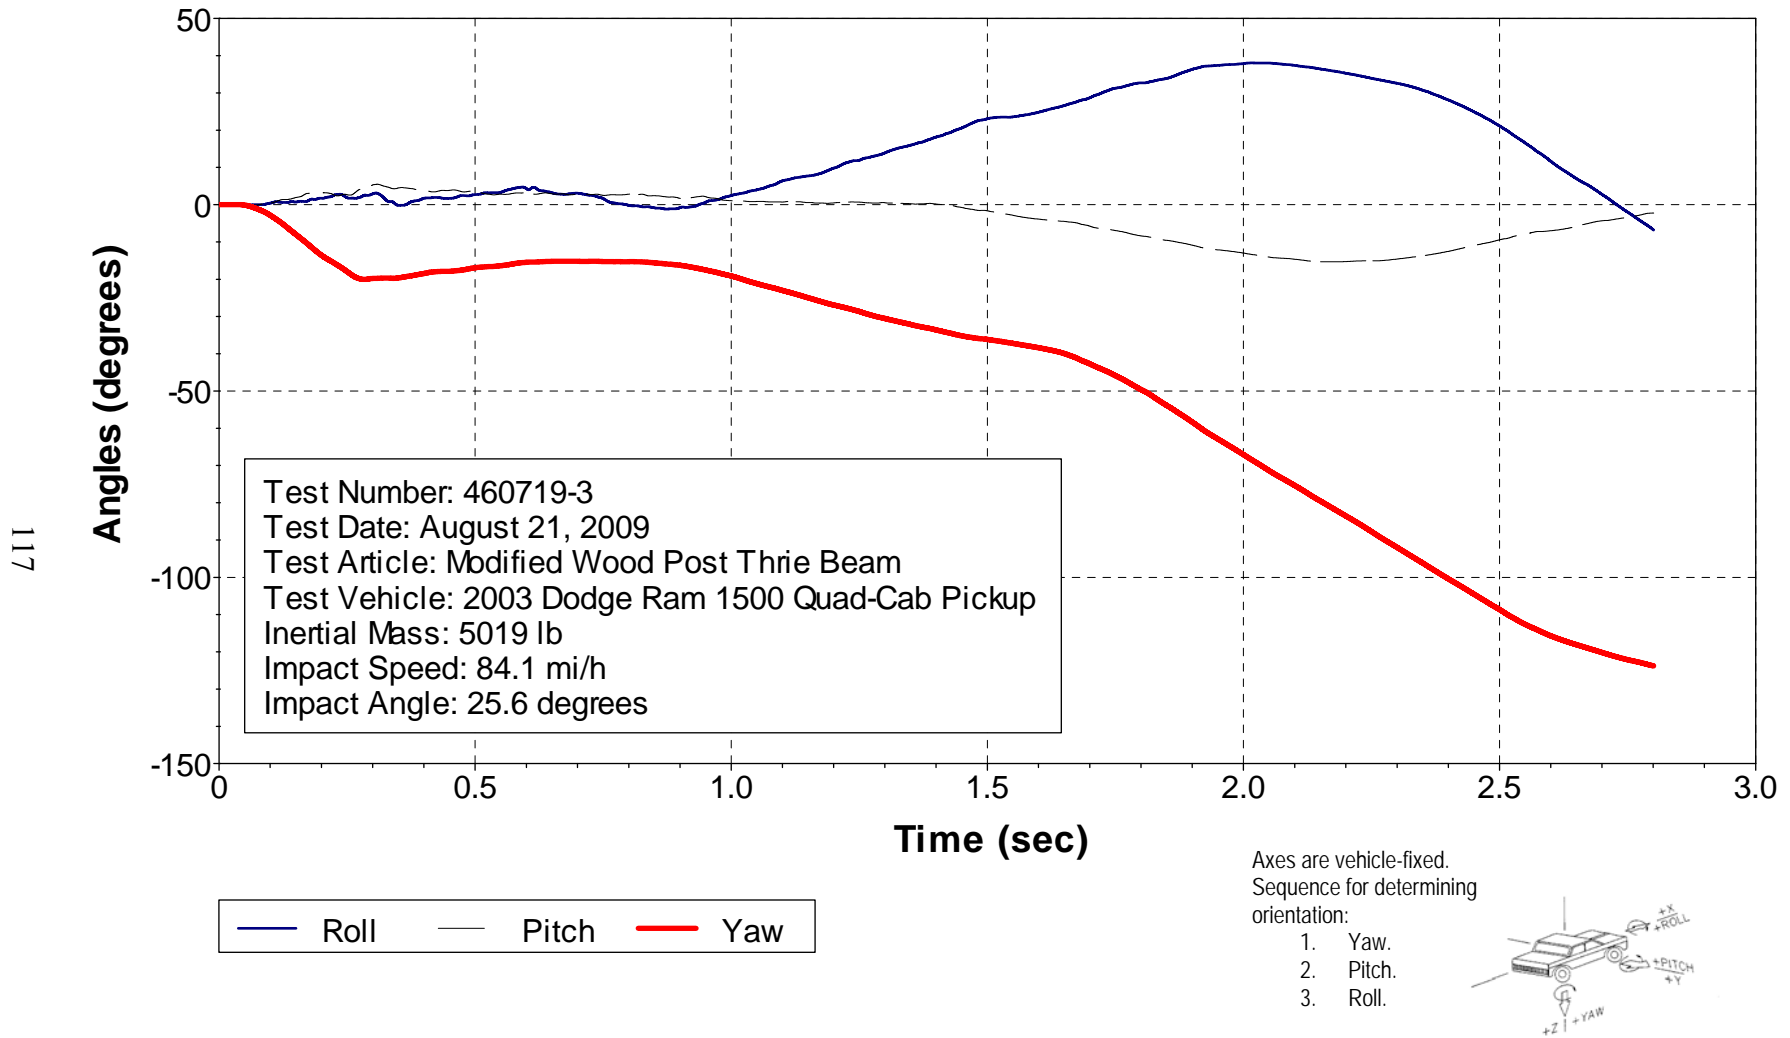
**Figure E15. Vehicle Angular Displacements for Test No. 460719-3.**

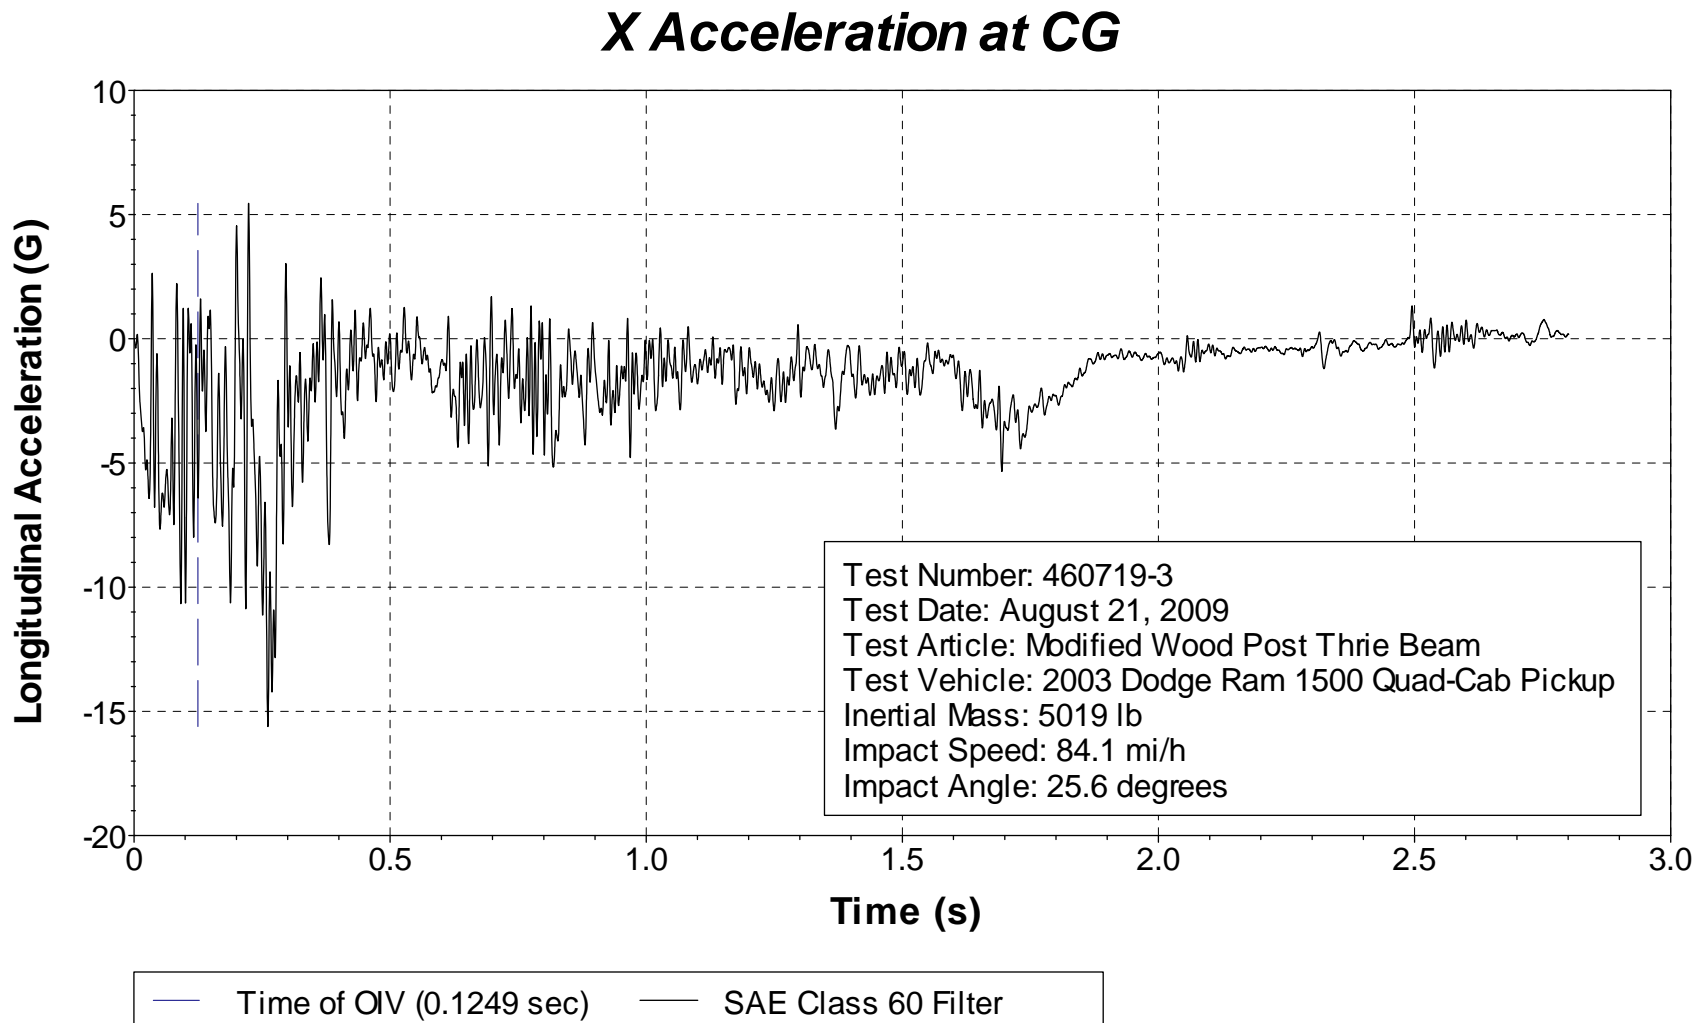
**Figure E16. Vehicle Longitudinal Accelerometer Trace for Test No. 460719-3  
(Accelerometer Located at Center of Gravity).**

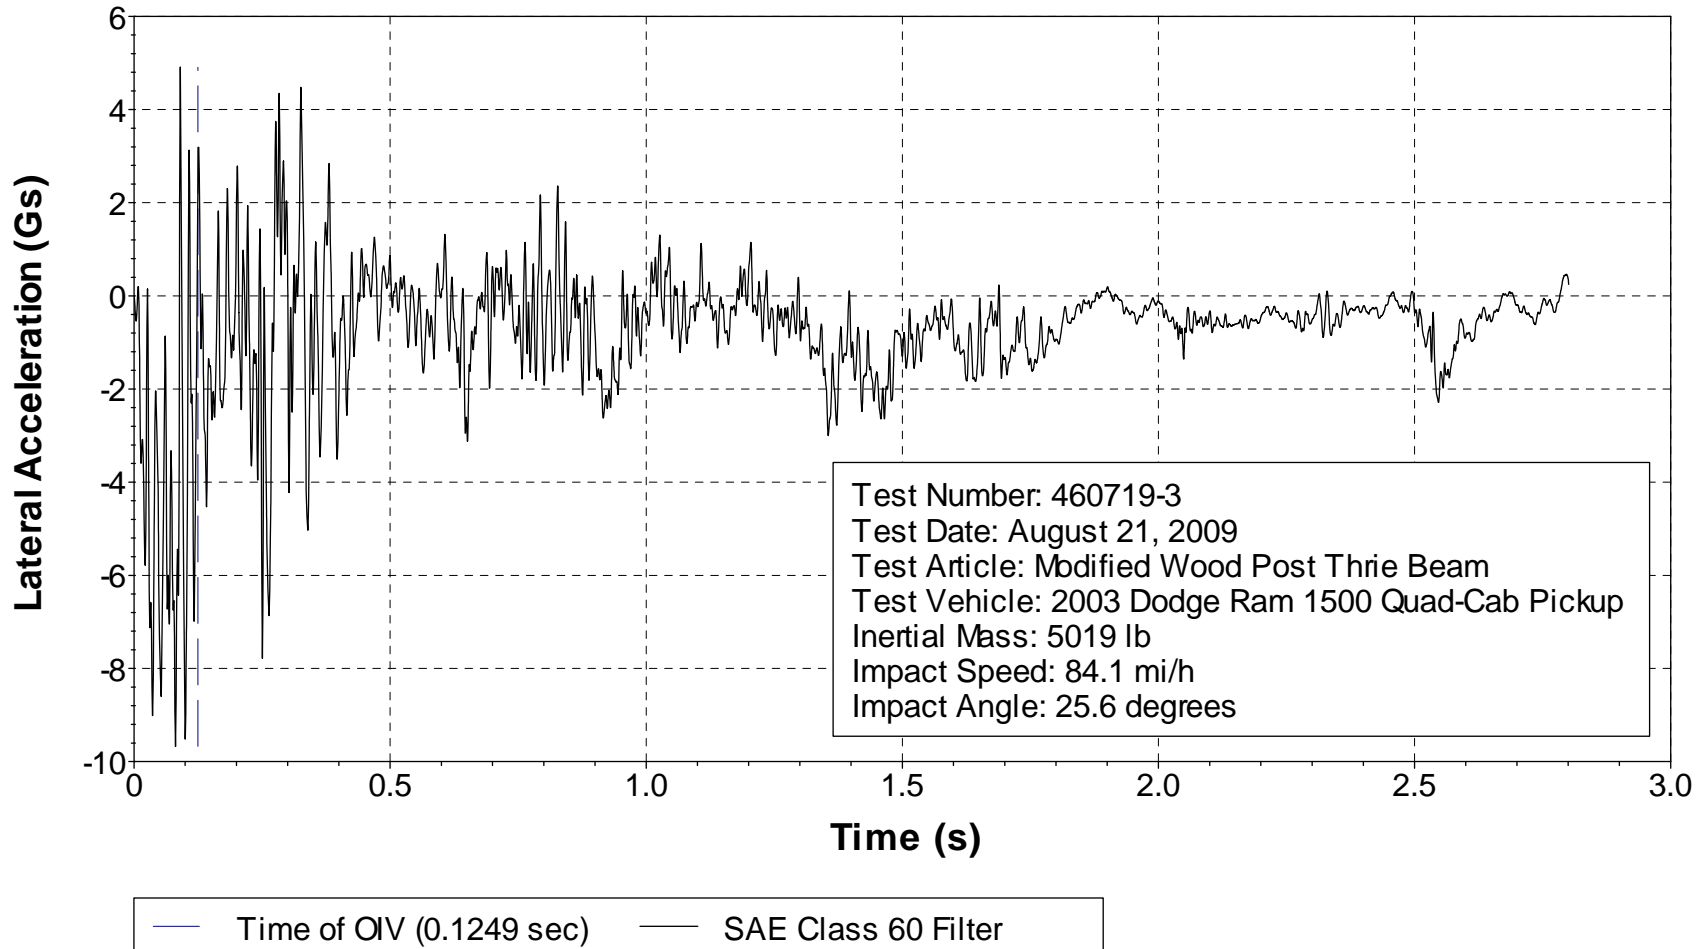
**Figure E17. Vehicle Lateral Accelerometer Trace for Test No. 460719-3  
(Accelerometer Located at Center of Gravity).**

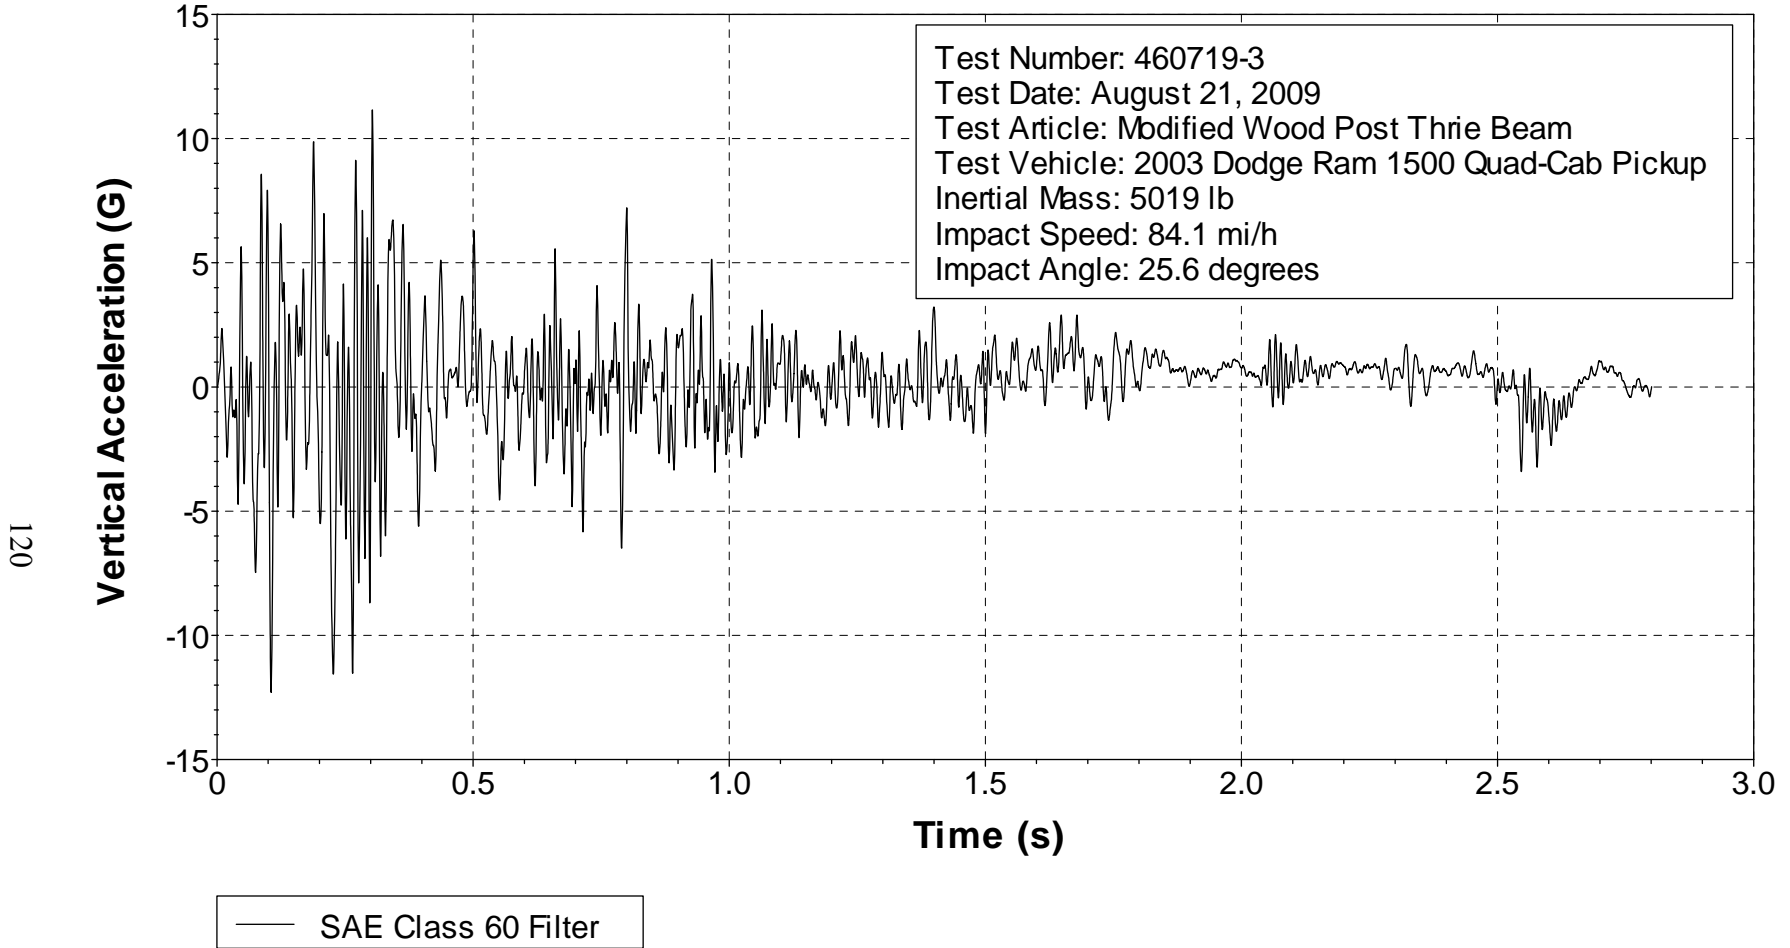
**Figure E18. Vehicle Vertical Accelerometer Trace for Test No. 460719-3 (Accelerometer Located at Center of Gravity).**

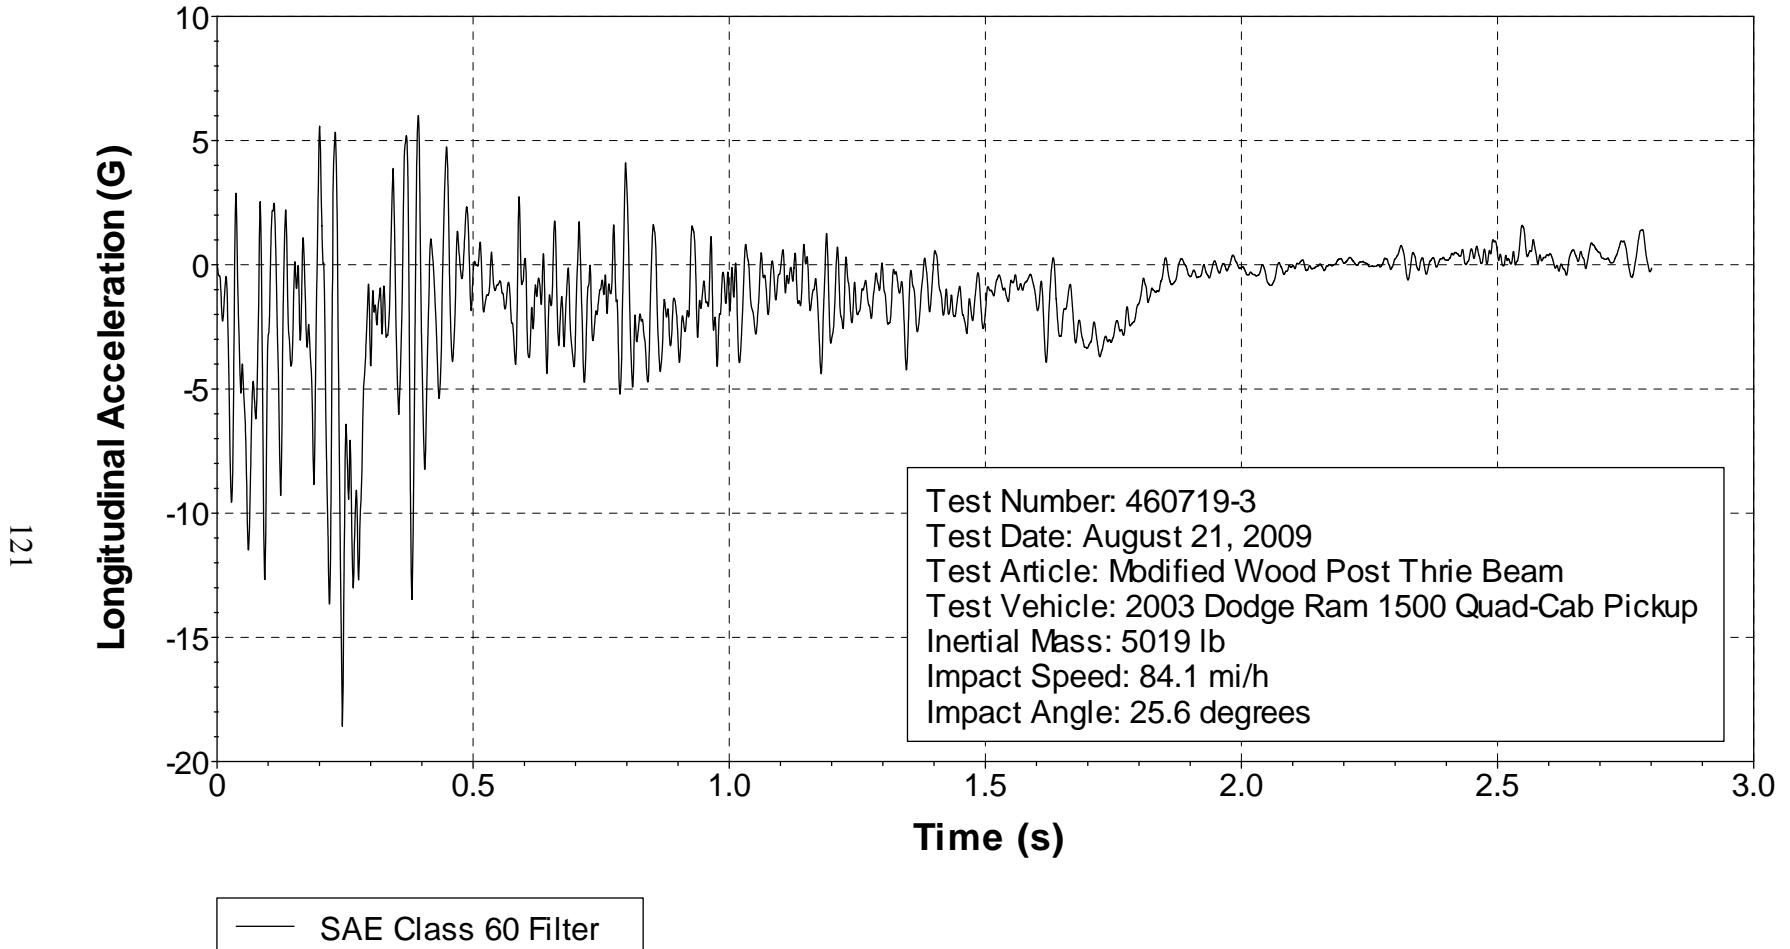
**Figure E19. Vehicle Longitudinal Accelerometer Trace for Test No. 460719-3  
(Accelerometer Located over Rear Axle).**

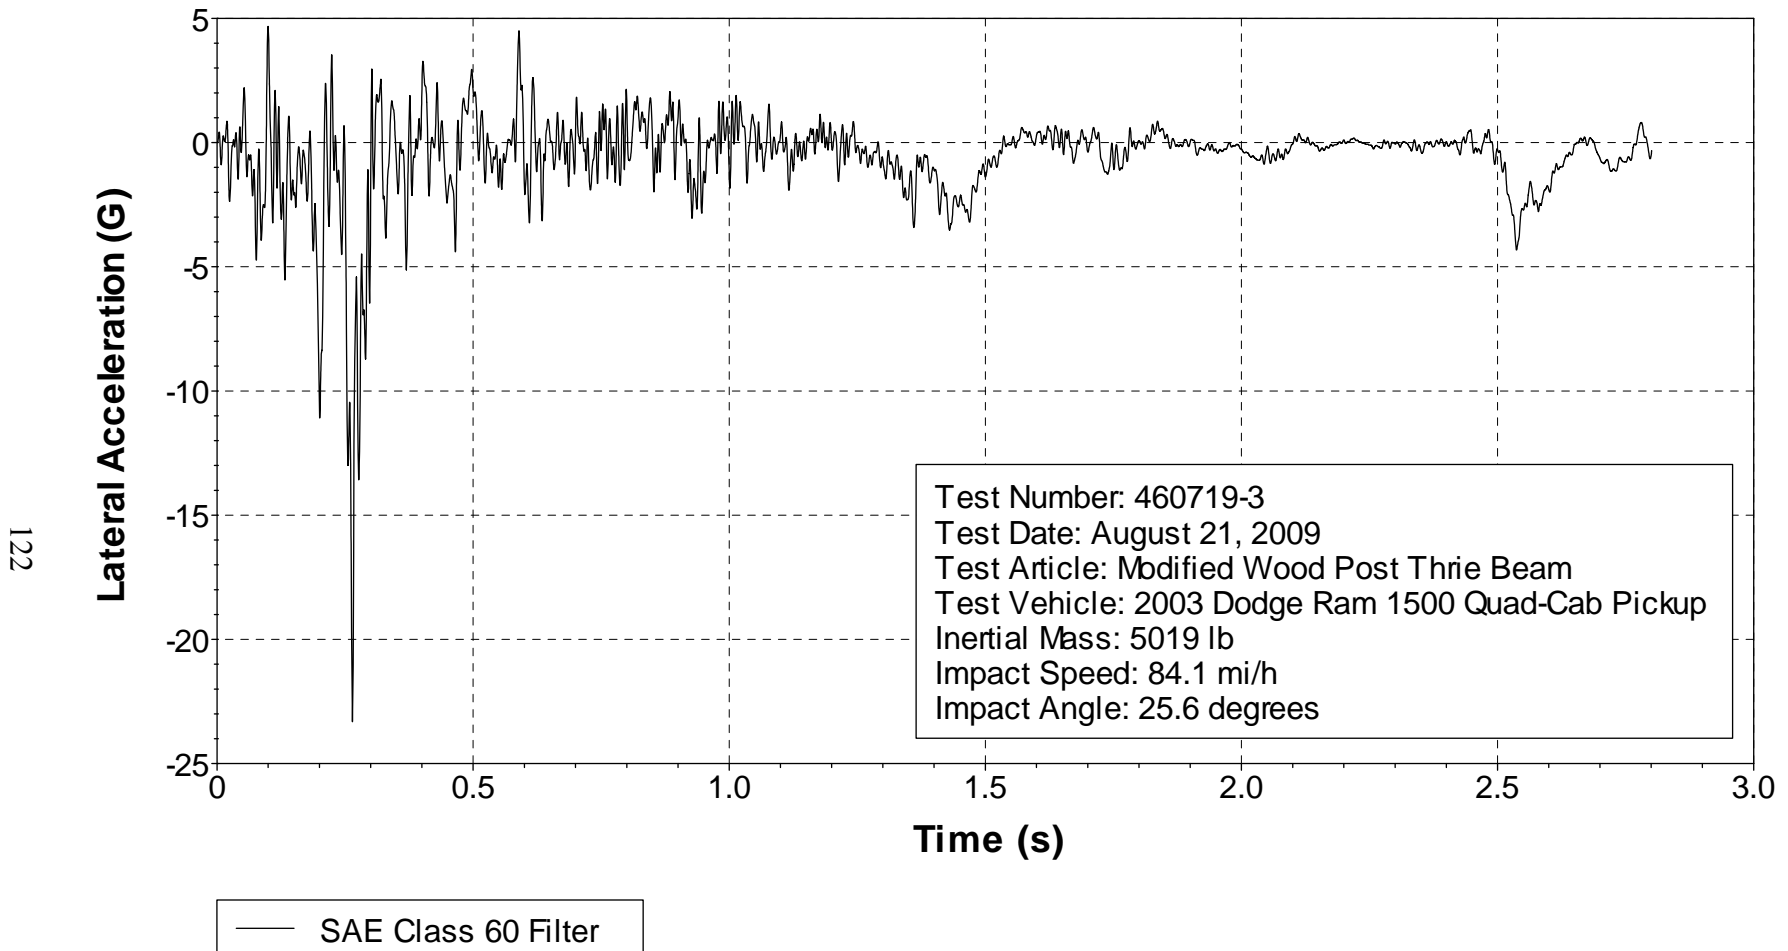
**Figure E20. Vehicle Lateral Accelerometer Trace for Test No. 460719-3  
(Accelerometer Located over Rear Axle).**

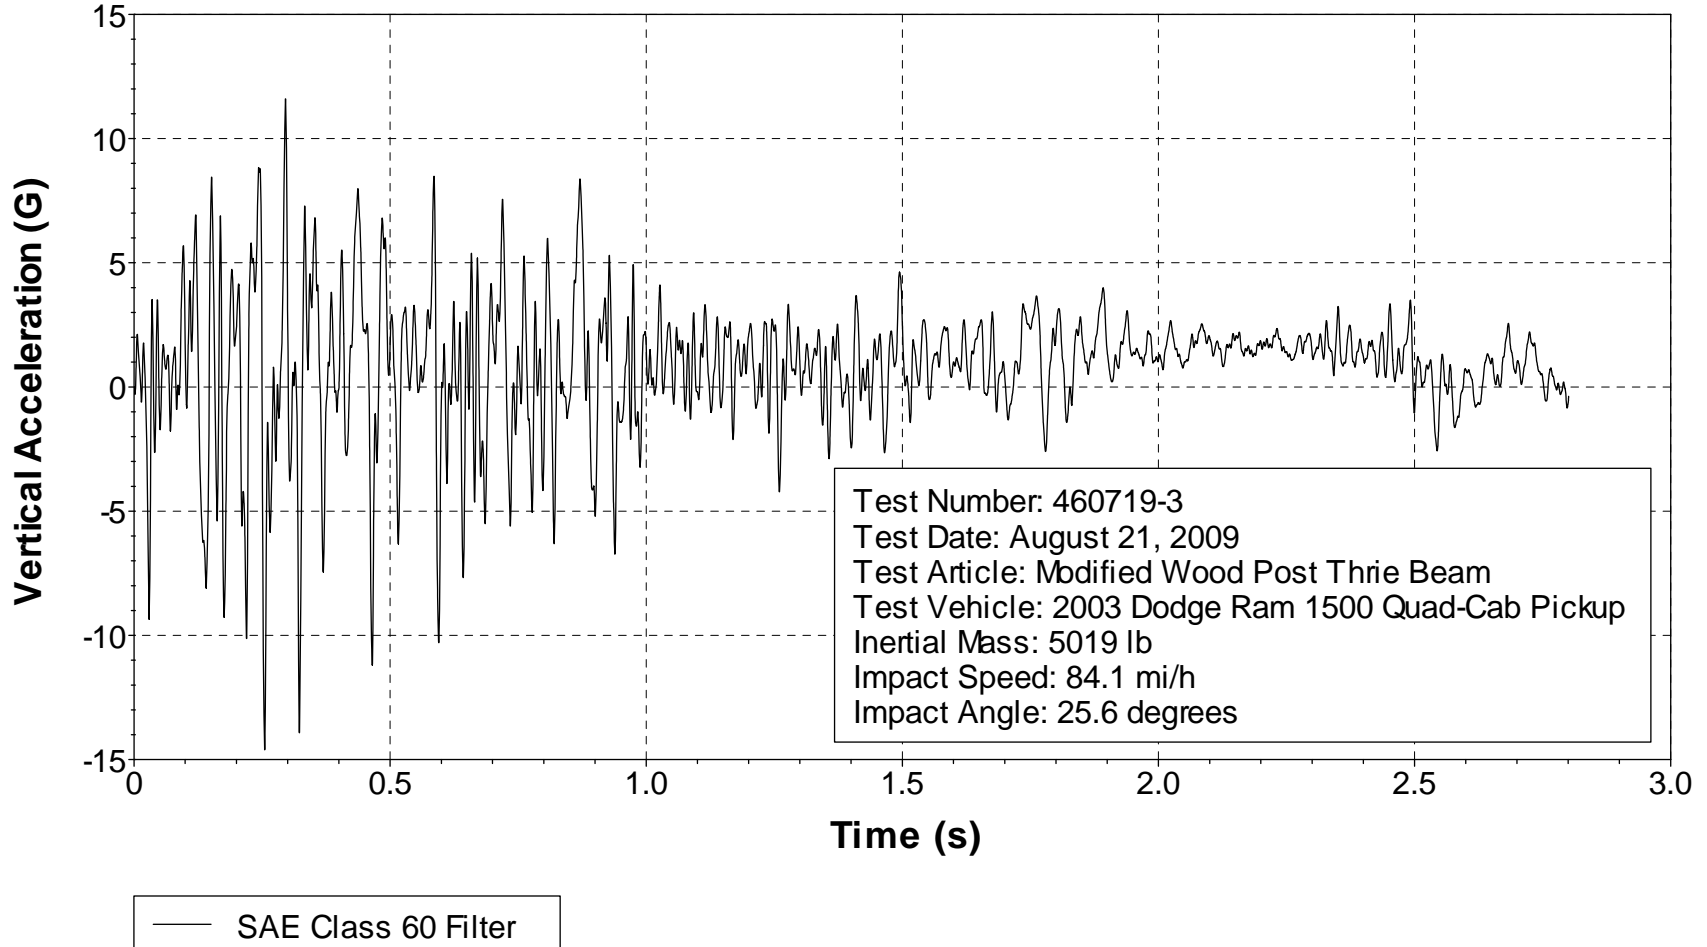
**Figure E21. Vehicle Vertical Accelerometer Trace for Test No. 460719-3  
(Accelerometer Located over Rear Axle).**

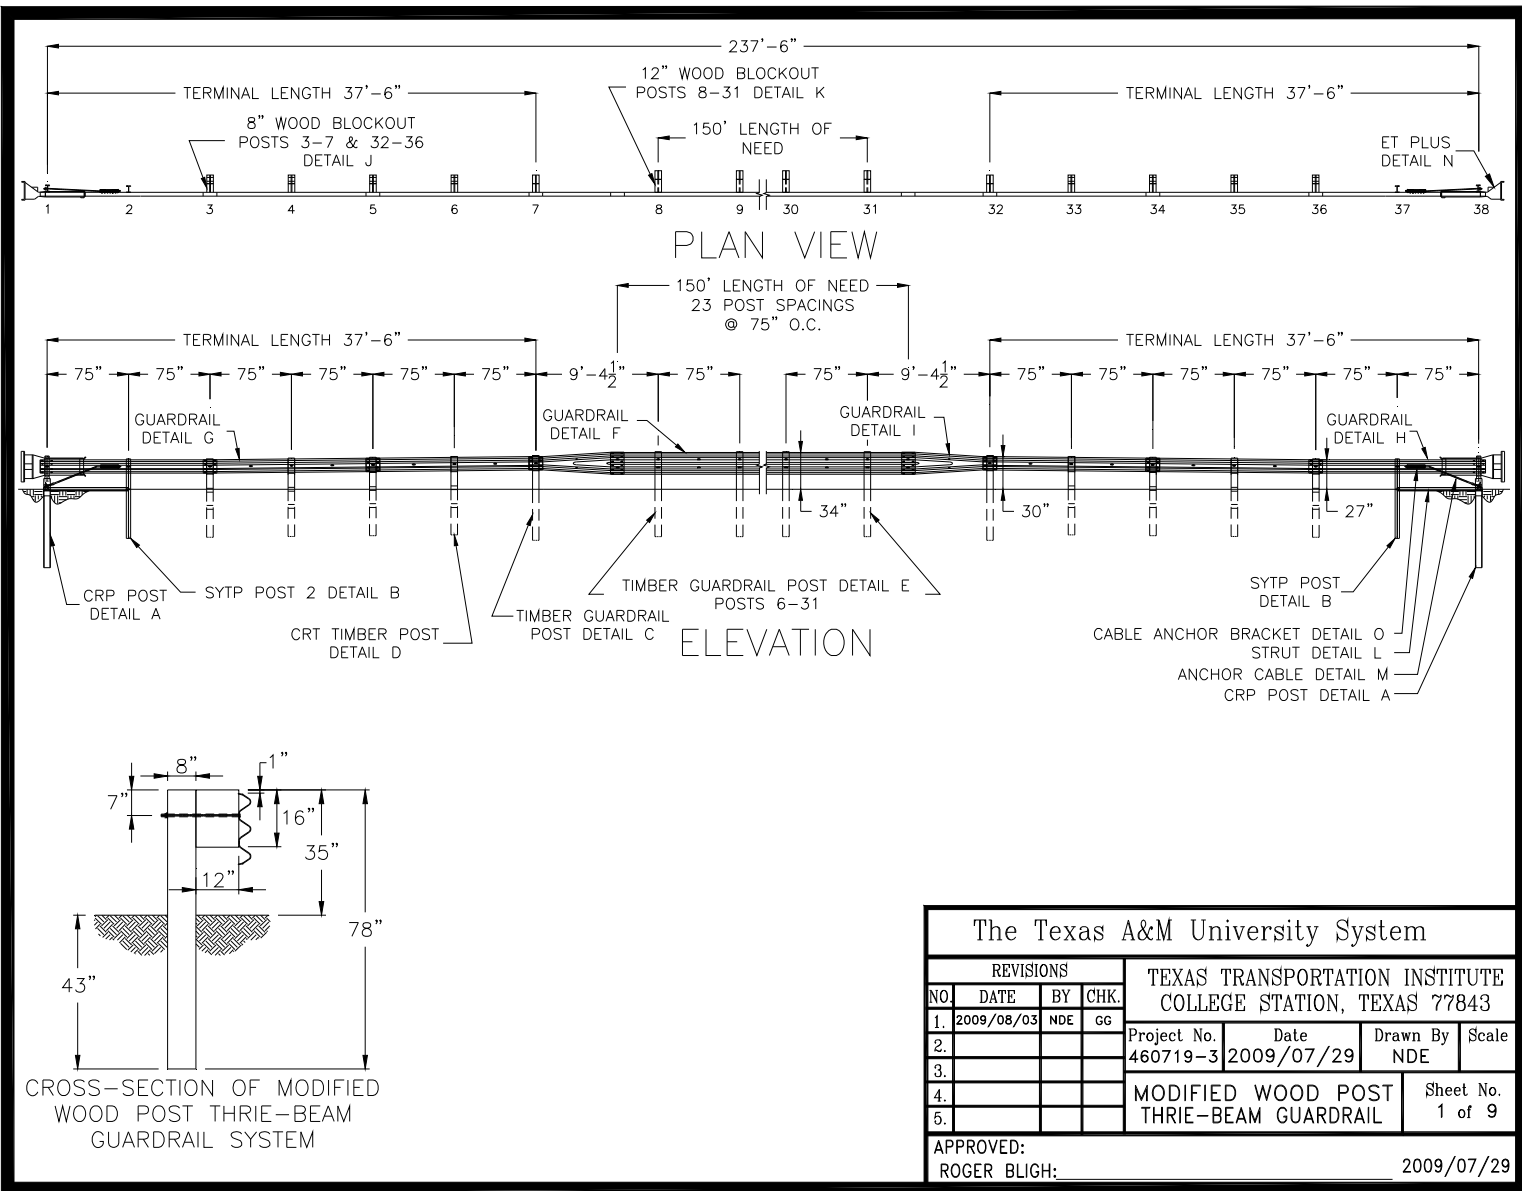
APPENDIX F. DETAILS OF THE HIGH-SPEED  
THRIE BEAM GUARDRAIL

The researchers proposed some modifications to mitigate this behavior. It was recommended that the steel posts and the blockouts be replaced with wood posts and wood blockouts. The objective was to eliminate vehicle climb by preventing collapse of the blockouts and changing the failure mode of the posts. The impact simulation of this modified wood post three beam guardrail predicted stable containment and redirection of the pickup truck.

During the full-scale crash test, the upstream end anchorage failed and released the rail. This allowed the pickup truck to penetrate behind the guardrail system. The terminal system was not explicitly modeled in the simulation. The length of the guardrail installation was believed to be sufficient to limit the forces reaching the anchor assembly.

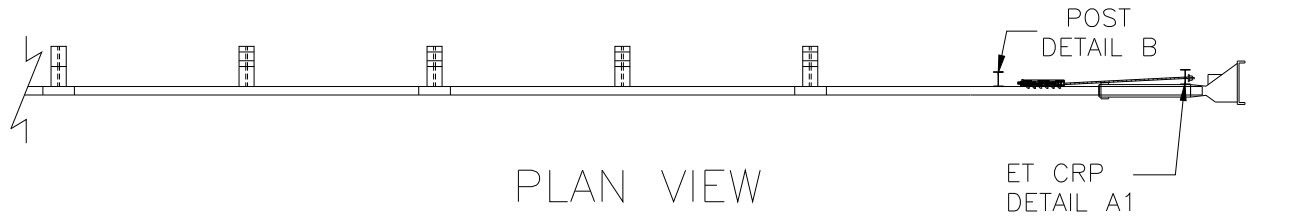
PLAN VIEW

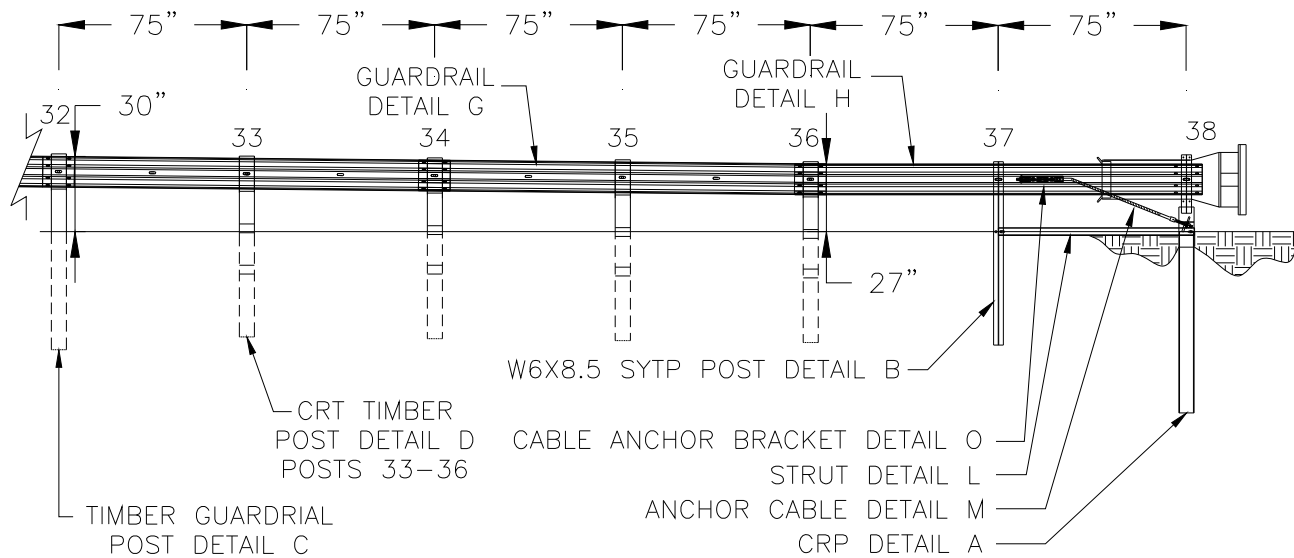
ELEVATION VIEW

NOTE:  
 -TAPER GUARDRAIL HEIGHT FROM  
 30" TO 27" OVER 25 FT.

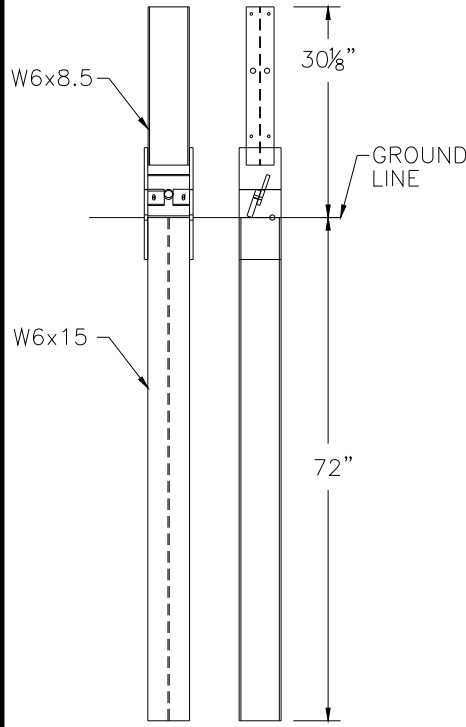
STANDARD CRP  
WITH 20° OFFSET  
DETAIL A

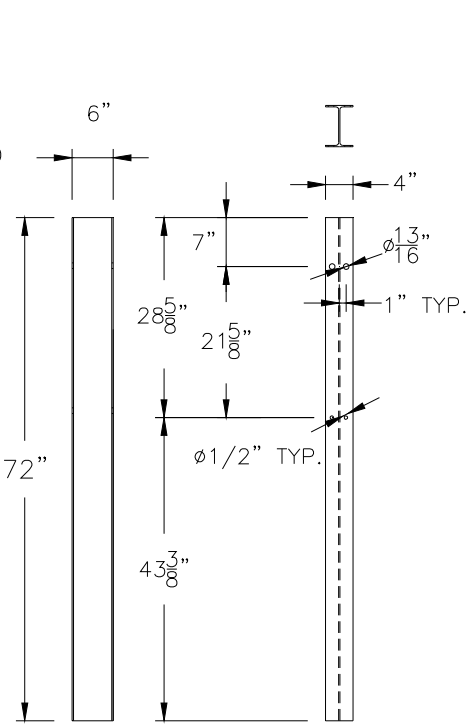
SYTP-W6X8.5  
DETAIL B

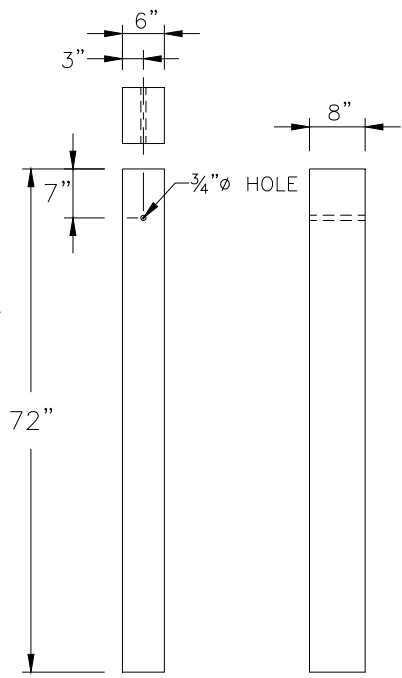
TIMBER GUARDRAIL POST  
DETAIL C (AASHTO-AGC-  
ARTBA #PDE02)

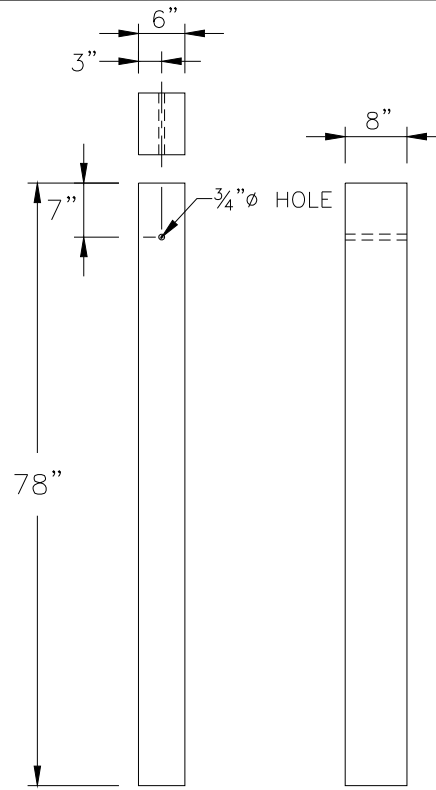
TIMBER GUARDRAIL POST  
DETAIL E  
(AASHTO-AGC-ARTBA #PDE03)

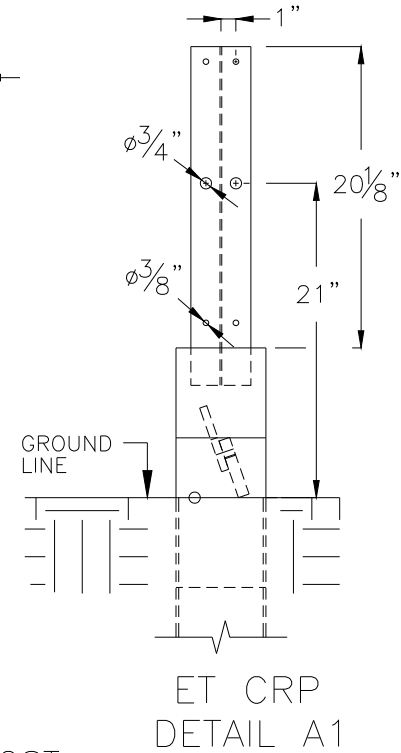
ET CRP  
DETAIL A1

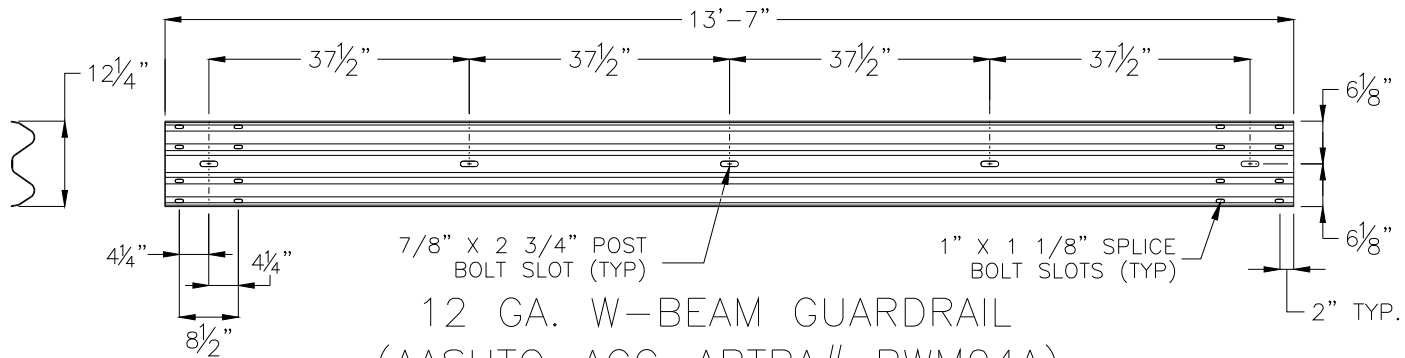
12 GA. W-BEAM GUARDRAIL  
(AASHTO-AGC-ARTBA# RWM04A)  
DETAIL G

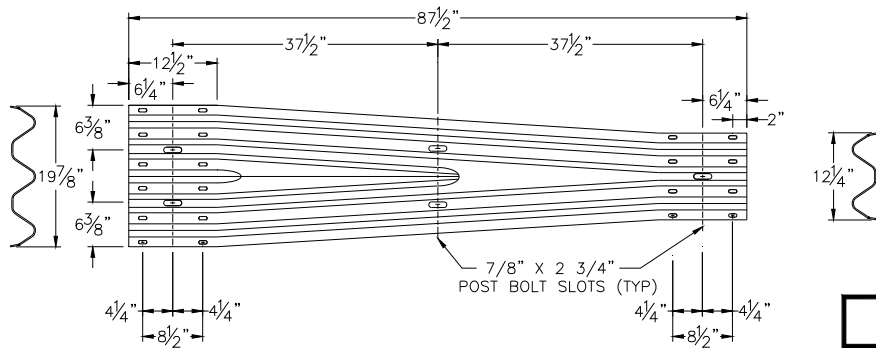
12 GA. THRIE-BEAM TRANSITION  
(AASHTO-AGC-ARTBA# RWT01A)  
DETAIL I

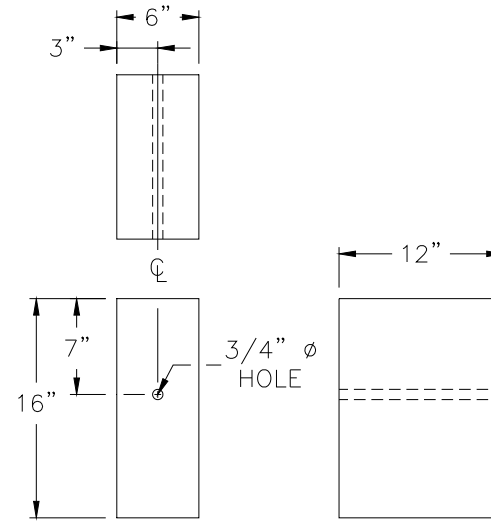
12" THRIE-BEAM  
WOOD BLOCKOUT  
DETAIL K
