Evaluation of Concrete Inlay for Continuously Reinforced Concrete Pavement Rehabilitation

Evaluation of Concrete Inlay for
Continuously Reinforced Concrete Pavement Rehabilitation
Research Study # FEP-96-01

Report # FEP-04-10

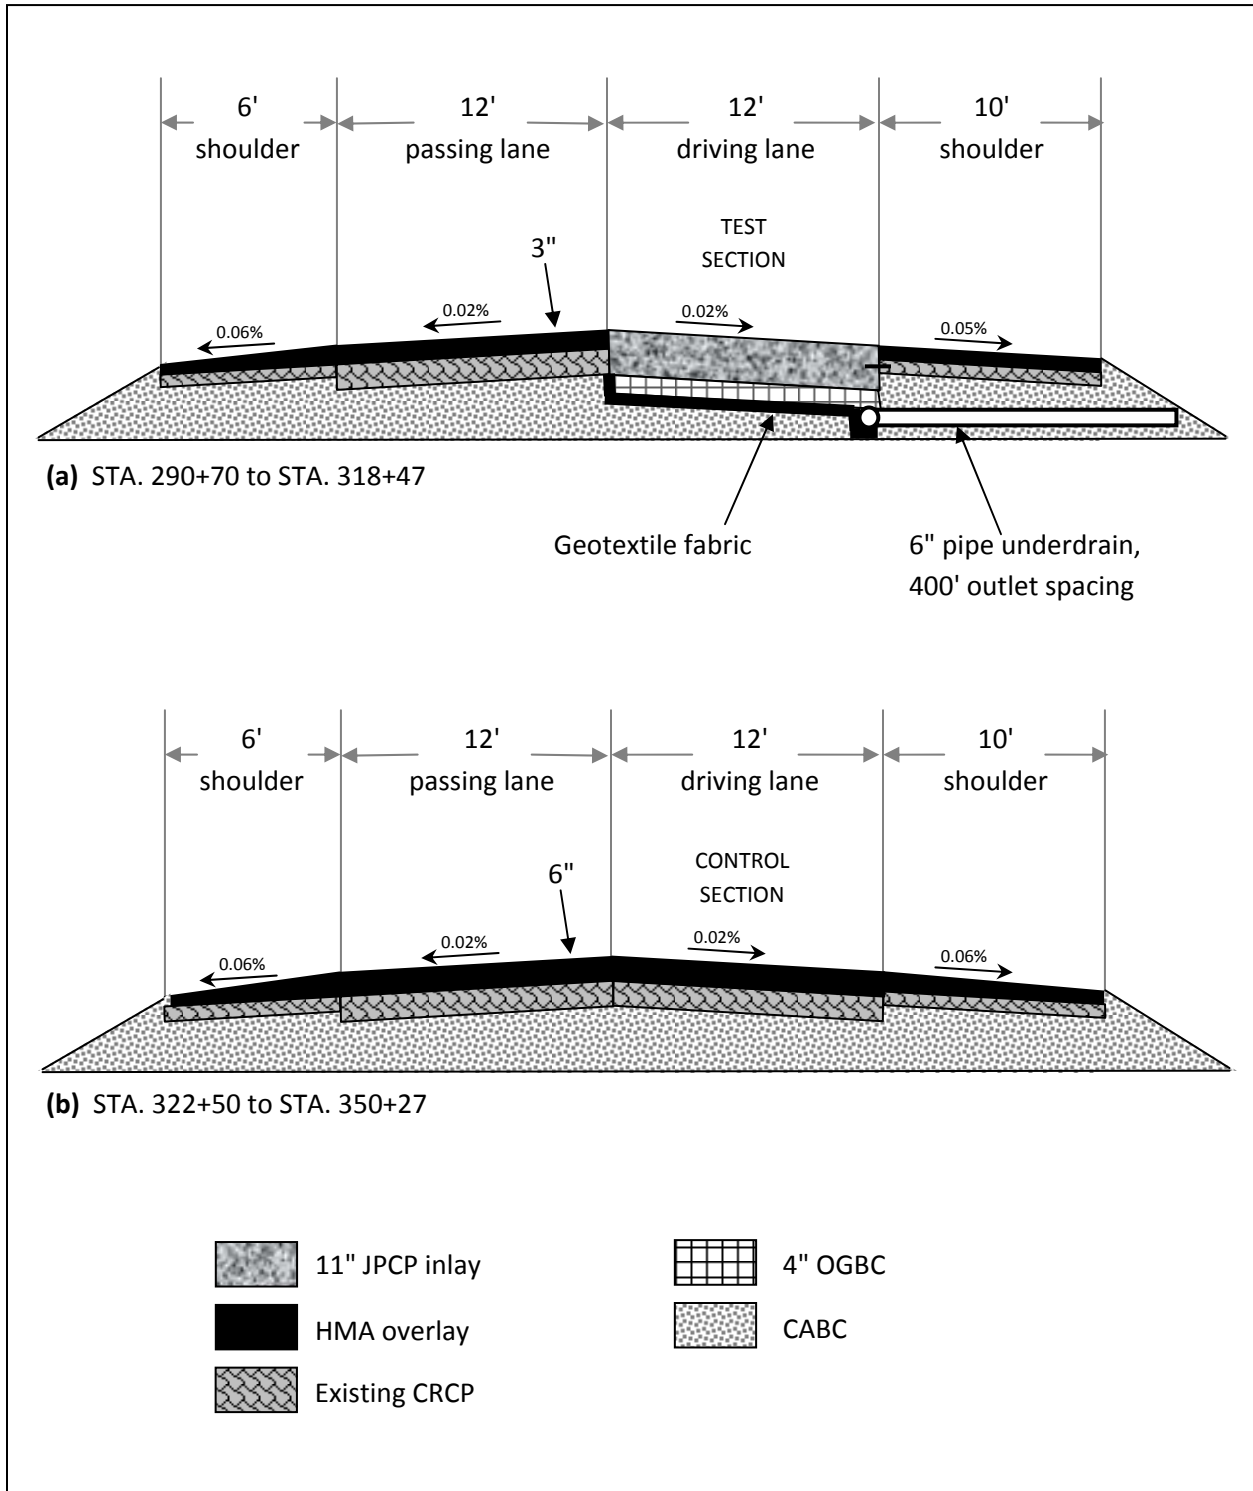
Figure 3. Pavement cross sections: (a) test section; and (b) control section.

The test section for this study was designed for 2777 feet in the northbound driving lane on the I-43 rehabilitation project. The existing 8-inch CRCP was removed full-depth, along with a portion of the existing crushed aggregate base course (CABC). The CABC was replaced with 4 inches of open graded base course (OGBC) along with a geotextile fabric layer and a 6-inch pipe underdrain system to provide drainage. Eleven inches of new JPCP was paved and tied to the existing driving lane shoulder. The shoulder was overlaid with 3 inches of HMA (see Figure 3). Joints in the inlay test section were doweled, skewed, unsealed and spaced at approximately 20 feet.

The control section was constructed in the northbound driving lane, just north of the test section. The control section began at a point where the HMA overlay thickness transitioned from 3 to 6 inches; the control section HMA overlay thickness was 6 inches. In the control section, and for the remainder of the I-43 rehabilitation project, doweled concrete patches were used to repair distressed areas. The entire

lane was then overlaid with HMA (6 inches in the control section and 3 to 6 inches elsewhere). The existing passing lane shoulder was also overlaid with HMA (see Figure 3).
