Seismic Retrofit of Cruciform-Shaped Columns in the Aurora Avenue Bridge Using FRP Wrapping

WA-RD 753.1

WSDOT Research Report

**SEISMIC RETROFIT OF CRUCIFORM-SHAPED COLUMNS
IN THE AURORA AVENUE BRIDGE USING FRP WRAPPING**

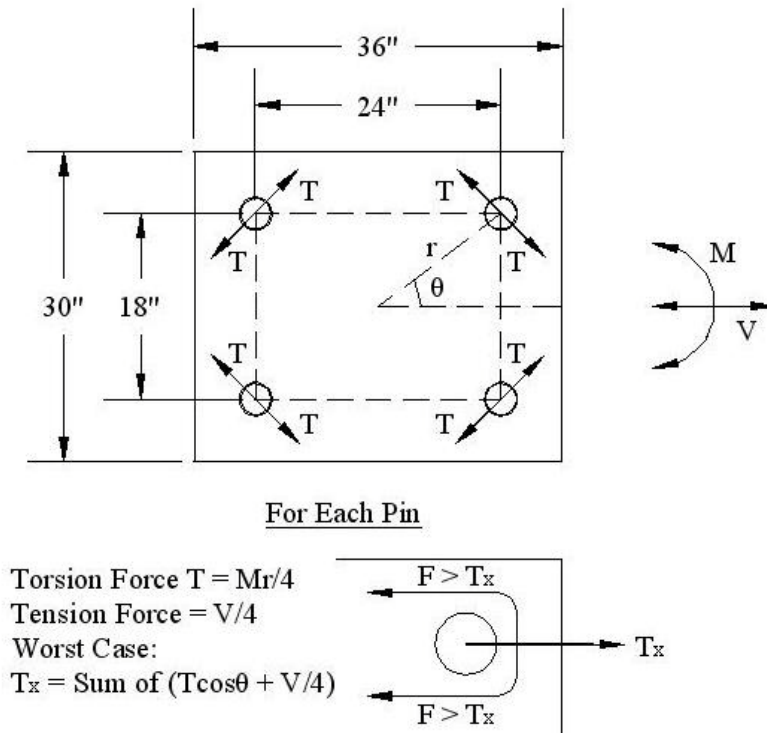
Figure 9 – Torsion Design in Top Loading Stub (1 in. = 25.4 mm)

A heavily-reinforced loading stub was constructed at the top of the solid columns. The loading stub contained (30) No. 5 Grade 60 straight bars with 90° hooks running in the horizontal direction and (8) No. 5 Grade 60 hoops and (16) No. 5 Grade 60 crossies in the vertical direction. (4) 3-in. (76 mm) diameter standard steel pipes were cast into the load stub to connect the load stub to the load frame. (3) No. 6 Grade 60 hairpins were provided between each of the four steel pipes to resist the design shear and the torsion force developed at the four steel pipe locations due to the column top moment and applied shear forces, as shown in Figure 9. These hairpins were provided in both the horizontal and vertical directions for a total of (12) hairpins, which provided a lateral tension capacity of 158 kips (703 kN) at each bend. This was considered to be adequate to resist the worst possible loading case shown in Figure 9, associate with a shear force of 120 kips (534 kN) and an equivalent moment of 427 k-ft (579 kN-m) at the center of the load stub, producing a tension force, T , of 98 kips (436 kN) at each bend.

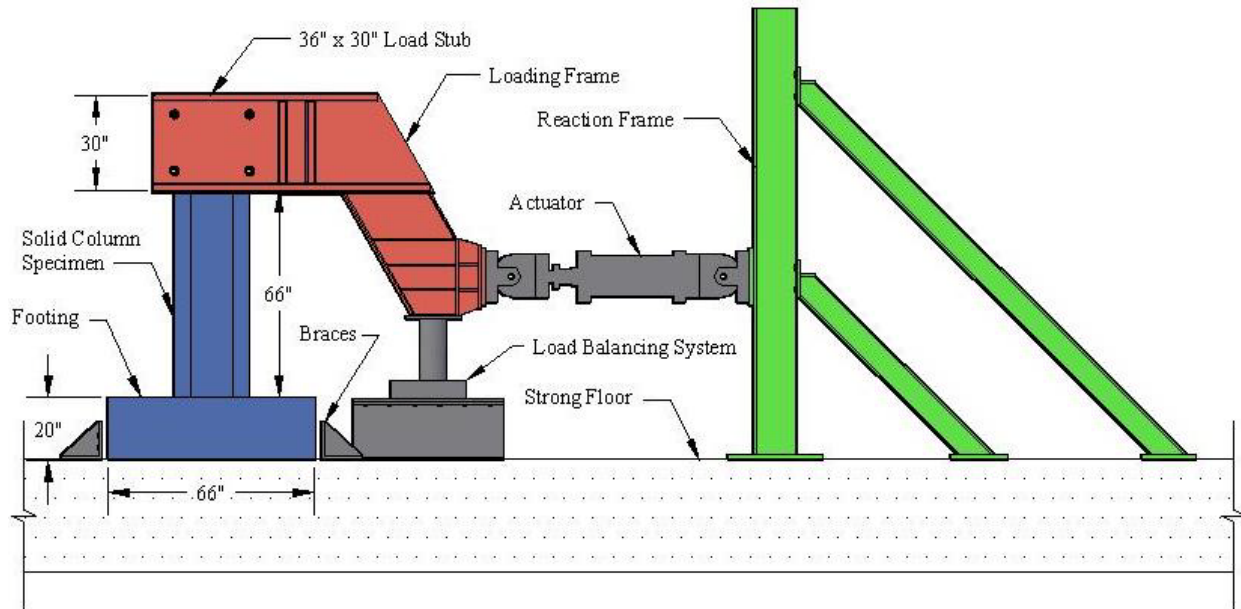
Figure 14 – Test Setup for the Solid Columns (1 in. = 25.4 mm)

The test setup for the solid column specimens was adapted from testing performed at the University of California at San Diego (Verma et al, 1993). Figure 14 shows the overall test setup for the solid columns. A stiff loading frame connected the column loading stub to a horizontal double-acting actuator aligned at the point of zero moment, inducing double bending in the column specimen. Moment was introduced into the top of the specimen through large bolts that passed through tubes cast into the loading stub. The footing was bolted to the strong floor to prevent overturning of the specimen. Sliding of the footing base was prevented by two stiff brackets bolted to the floor. Loading frame eccentricity was compensated for using a load-balancing system consisting of a load-follower jack which counteracted the extra bending

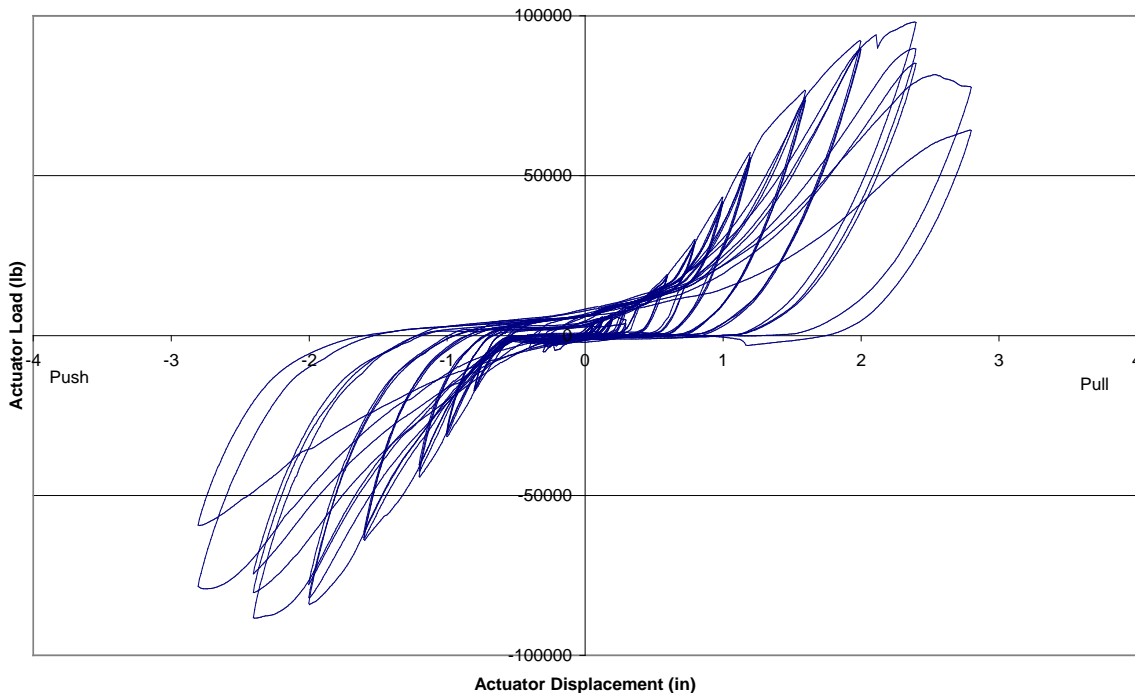
**Figure 16 – Column 1 Lateral Load vs. Displacement Hysteresis Curves
(1 kip = 4.45 kN, 1 in. = 25.4 mm)**

Figure 16 shows the overall hysteretic performance of Column 1 in terms of the lateral force vs. actuator displacement. The displacements shown in the figure include unintentional displacements due to gaps between the steel pipes cast into the load stub and the steel loading rods

used to connect the loading frame. These gaps were intended to provide construction tolerances for placing the loading rods, but also resulted in flat spots in the hysteresis curves. i.e., displacements under zero lateral force. These unintended displacements were later removed from the data for the purpose of comparing results with other tests. Shims between the steel pipes in the load stub and the loading pins were also installed in later tests to minimize these unintended displacements.

Column 1 exhibited moderate energy dissipation capacity but little ductility. The stiffness of the column showed minor degradation up to a displacement level of 1.2 in. (30 mm), with a loss in stiffness at later displacement levels up to the peak load. The peak lateral load achieved was 98 kips and occurred at a lateral displacement of 2.4 in. (61 mm). The column exhibited a significant decrease in lateral stiffness and strength at a displacement level of 2.8 in. (71 mm), and the applied

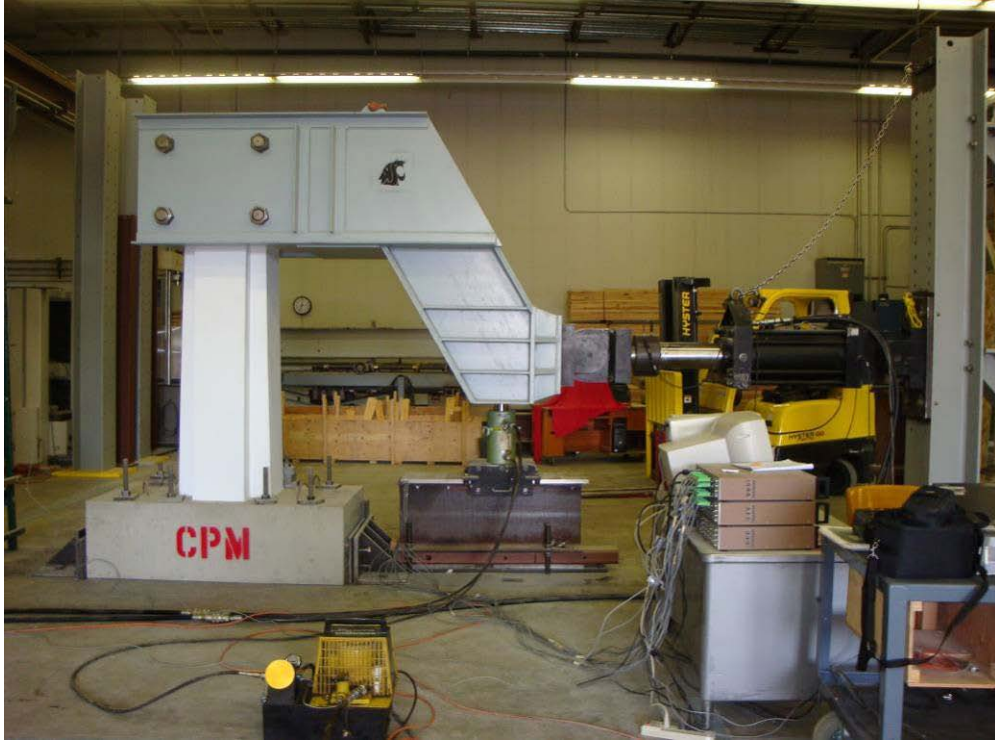
Figure 17 – Column 1 Test Setup

Figure 17 shows Column 1 at the beginning of the test. Yielding of the longitudinal bars first occurred at lateral force level of 27 kips (120 kN) followed by flexural cracking at the top and bottom of the column. Early shear cracks formed at a lateral force level of about 65 kips (290 kN). Yielding of the transverse reinforcement first occurred at a lateral force level of 88 kips (390 kN) followed by the opening of large shear cracks near the end of the test. The final failure mode for the column was a shear failure. Figure 18 shows the large shear cracks present near the end of testing.

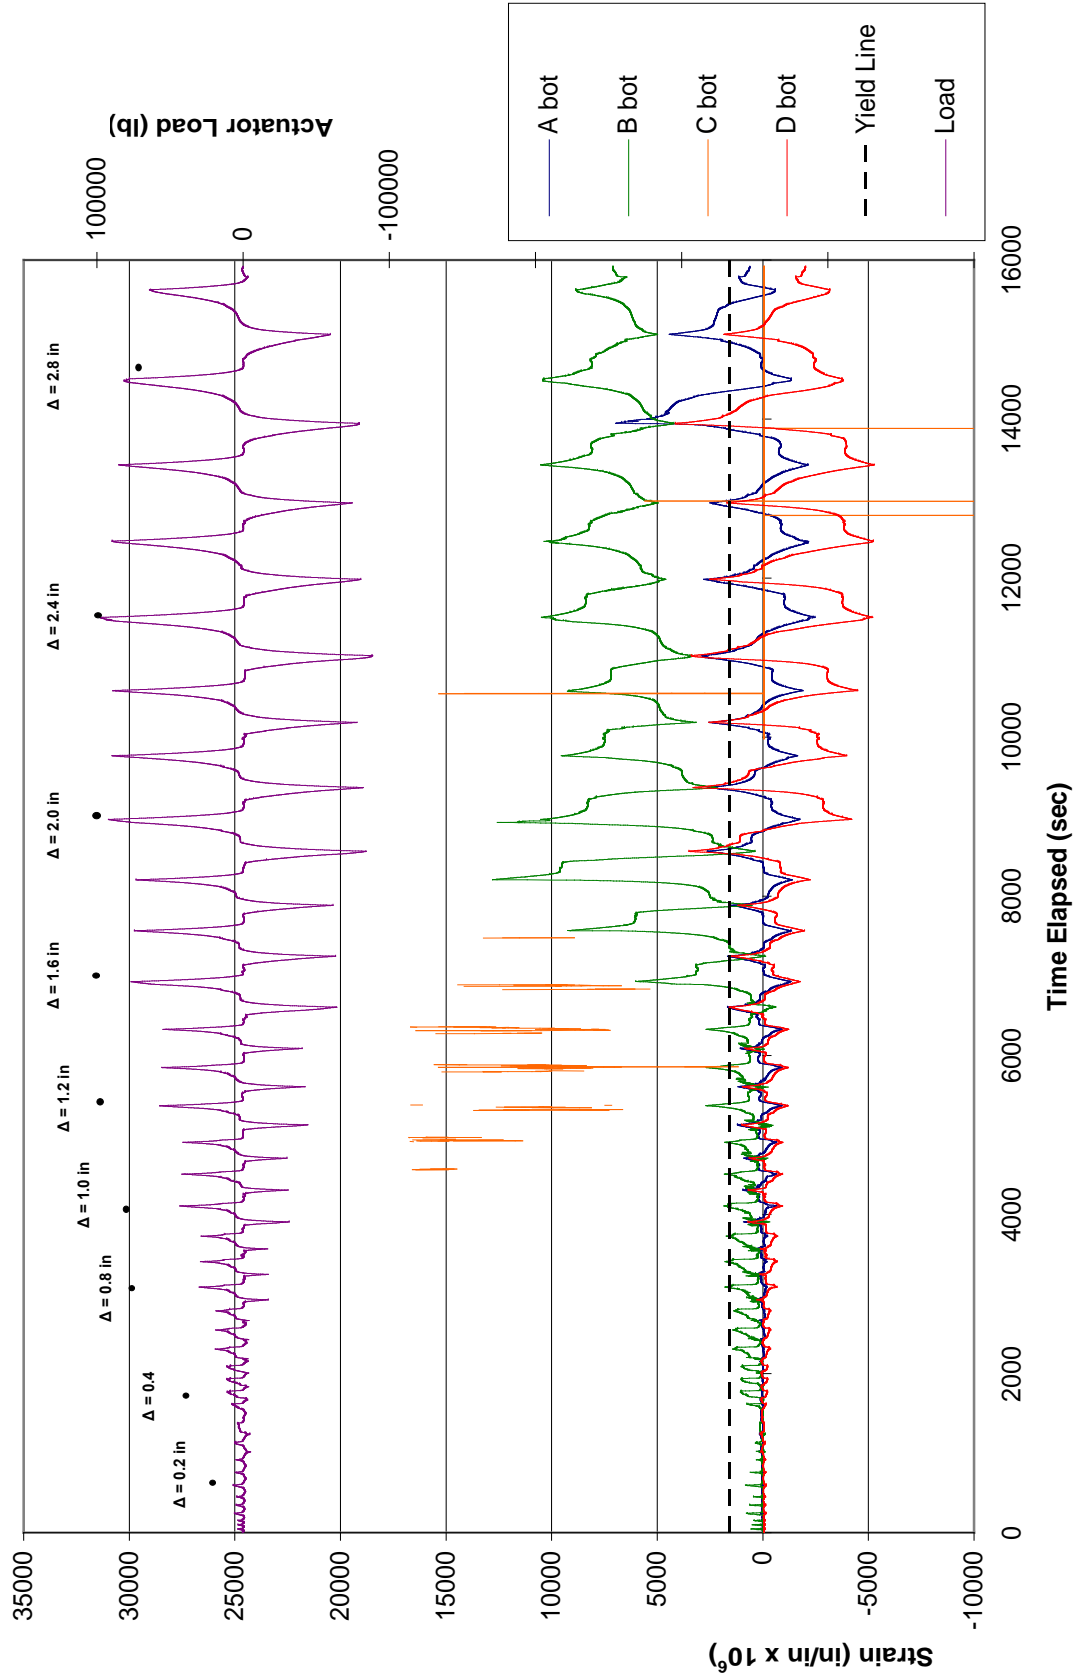
Figures 20 and 21 show the strains in the longitudinal bars at the top and bottom of the column, respectively. Approximately a linear strain profile was observed in the top strain gages up to the first yield at a displacement level of 1.6 in. (41 mm). Very large strains in excess of 15,000 $\mu\epsilon$ were observed during cycling at a displacement level of 2.4 in. (61 mm). Strains in the bottom strain gages reached first yield at a displacement level of about 0.8 in. (20 mm). Strains stayed nearly constant up to a displacement level of 1.6 in. (41 mm) and then increased rapidly to strains in excess of 5,000 $\mu\epsilon$ for the remainder of the test.

Figure 20 – Column 1 Longitudinal Bar Strain Gage Data at the Top of the Column (1 kip = 4.45 kN, 1 in. = 25.4 mm)

Figure 21 – Column 1 Longitudinal Bar Strain Gage Data at the Bottom of the Column (1 kip = 4.45 kN, 1 in. = 25.4 mm)

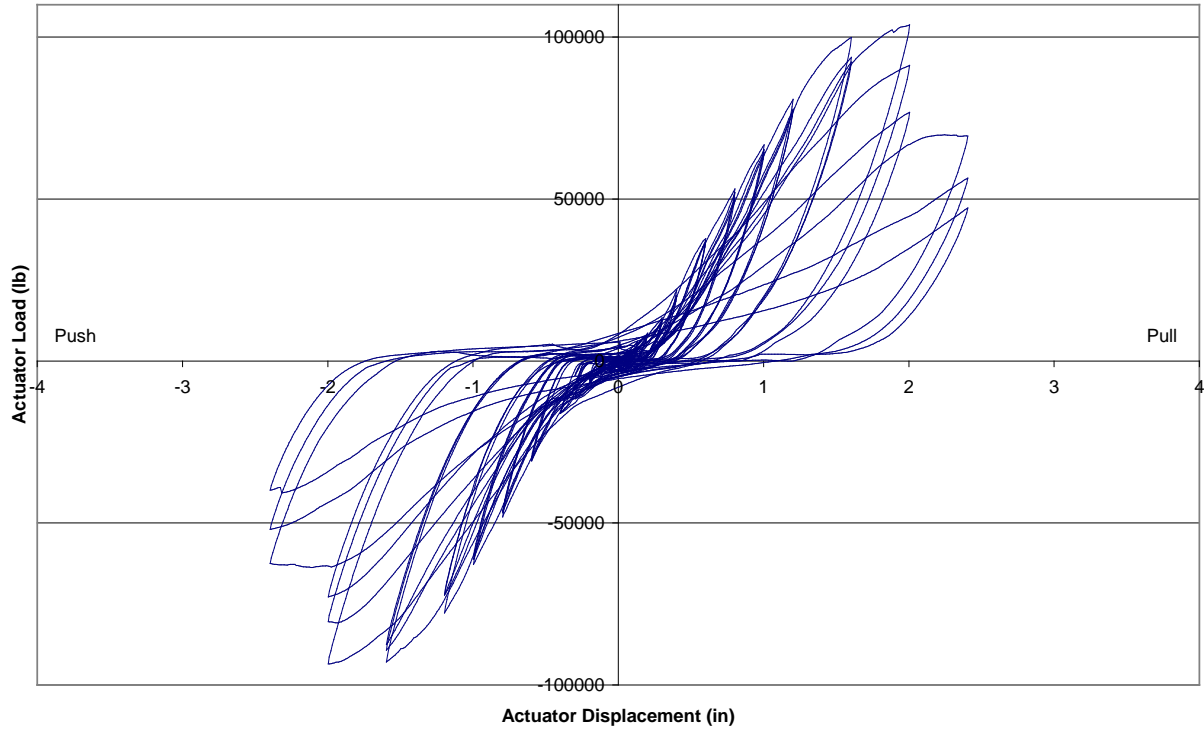
**Figure 22 – Column 5 Lateral Load vs. Displacement Hysteresis Curves
(1 kip = 4.45 kN, 1 in. = 25.4 mm)**

Figure 22 shows the overall hysteretic performance of Column 5 in terms of the lateral force vs. actuator displacement. The column exhibited moderate energy dissipation capacity but little ductility. The stiffness of the column showed minor degradation up to a displacement level of 1.2 in. (30 mm), followed by a loss in stiffness at later displacement levels up to the peak load. The peak lateral load achieved was 102 kips (453 kN) and occurred at a lateral displacement of 2.0 in. (51 mm). The column exhibited a significant decrease in lateral stiffness and strength at a displacement level of 2.0 in. (51 mm), and the applied load dropped below 80% of the peak load during the third cycle at this displacement. The test was stopped after the third cycle at a displacement level of 2.4 in. (61 mm).

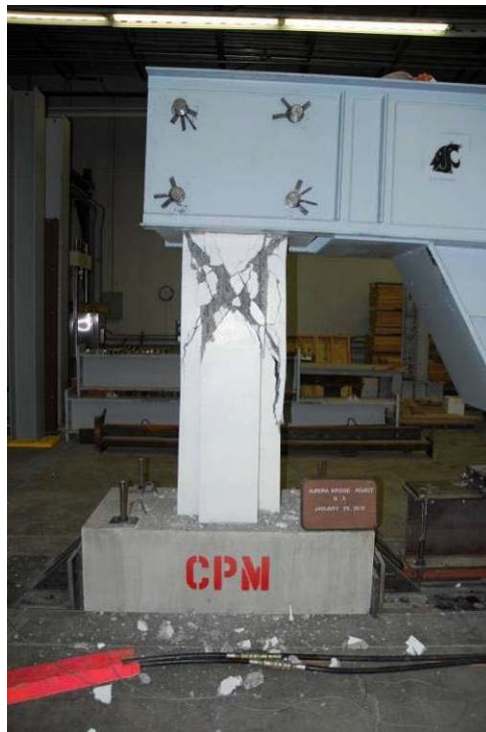
Figure 23 – Column 5 Shear Cracking Near the End of Testing

Yielding of the longitudinal bars in Column 5 first occurred at a lateral force level of 49 kips (218 kN) followed by flexural cracking at the top and bottom of the column. Early shear cracks formed at a lateral force level of about 73 kips (325 kN). Yielding of the transverse reinforcement first occurred at a lateral force level of 93 kips (414 kN) followed by the opening of large shear cracks near the end of the test. The final failure mode for the column was a shear failure. Figure 23 shows the large shear cracks present near the end of testing.

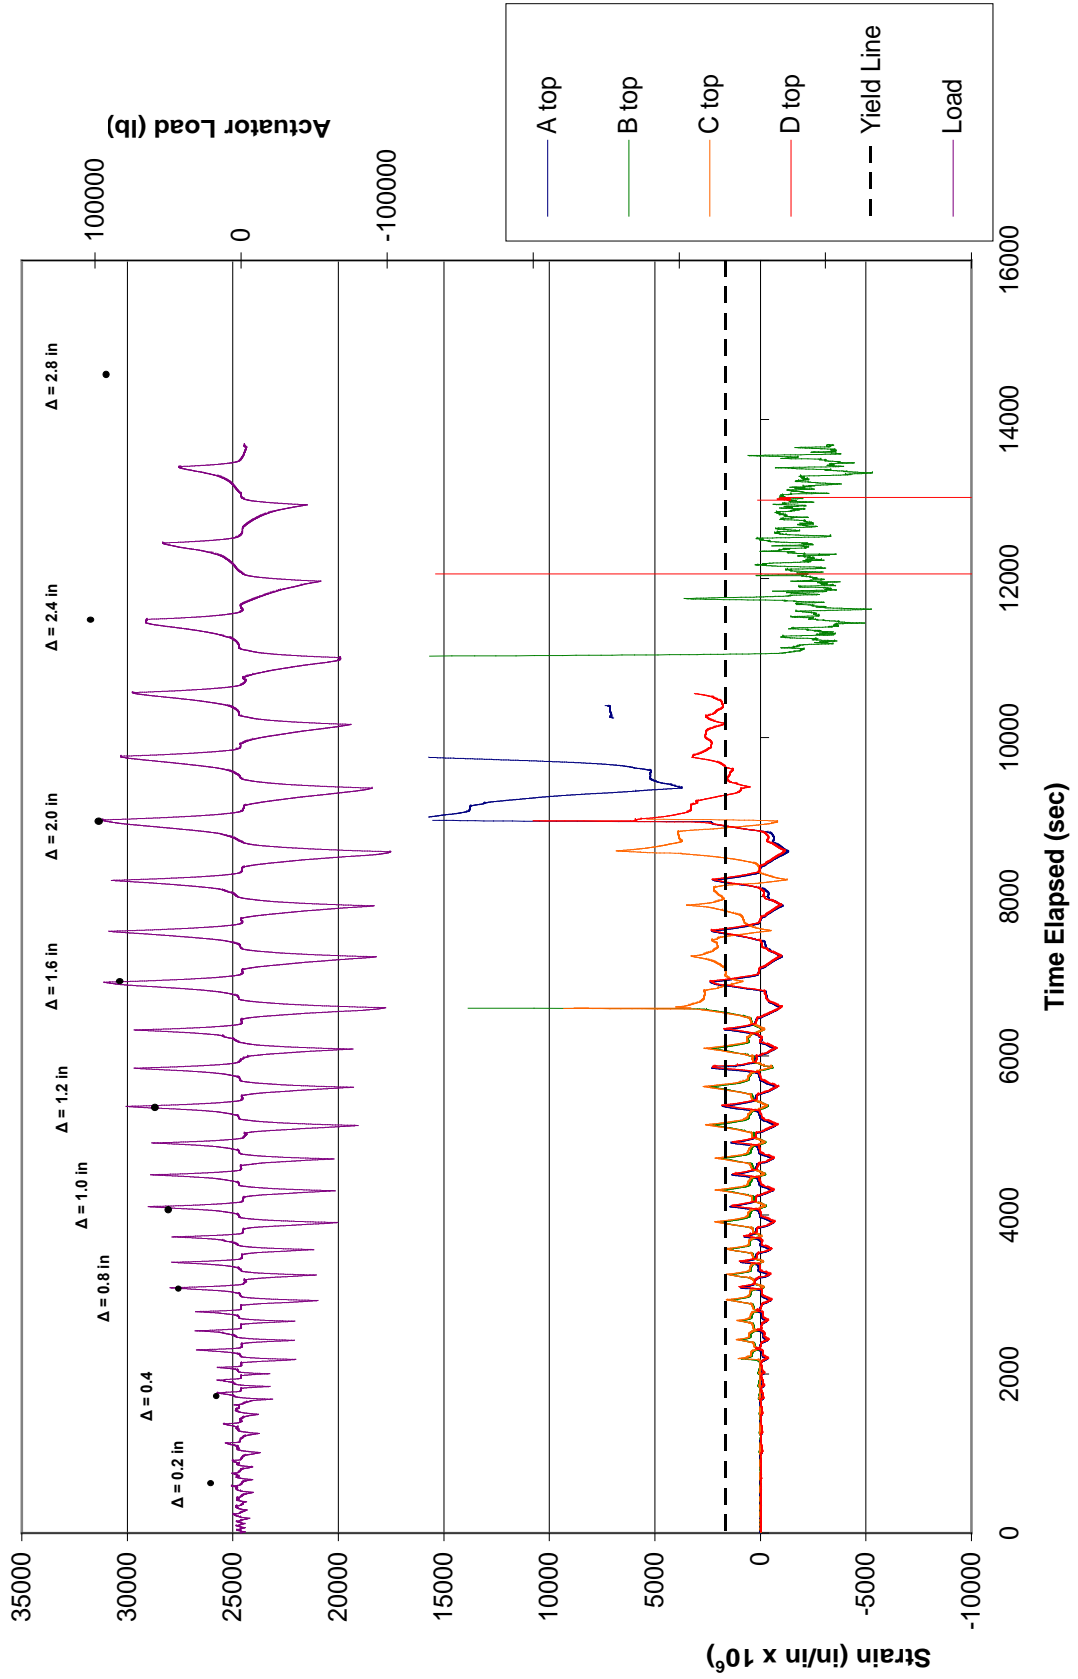
Figures 25 and 26 show the strains in the longitudinal bars at the top and bottom of the column, respectively. A linear strain profile was observed in the top strain gages up to the first yield at a displacement level of 1.0 in. (25 mm). Strains stayed nearly constant until the first cycle at a displacement level of 1.6 in. (41 mm), after which very large strains in excess of 15,000 $\mu\epsilon$ were observed. Strains in the bottom strain gages reached first yield at a displacement level of about 0.8 in. (20 mm). Strains stayed nearly constant up to a displacement level of 1.2 in. (30 mm) and then increased rapidly to strains in excess of 10,000 $\mu\epsilon$ for the remainder of the test.

Figure 25 – Column 5 Longitudinal Bar Strain Gage Data at the Top of the Column (1 kip = 4.45 kN, 1 in. = 25.4 mm)

Figure 26 – Column 5 Longitudinal Bar Strain Gage Data at the Bottom of the Column (1 kip = 4.45 kN, 1 in. = 25.4 mm)

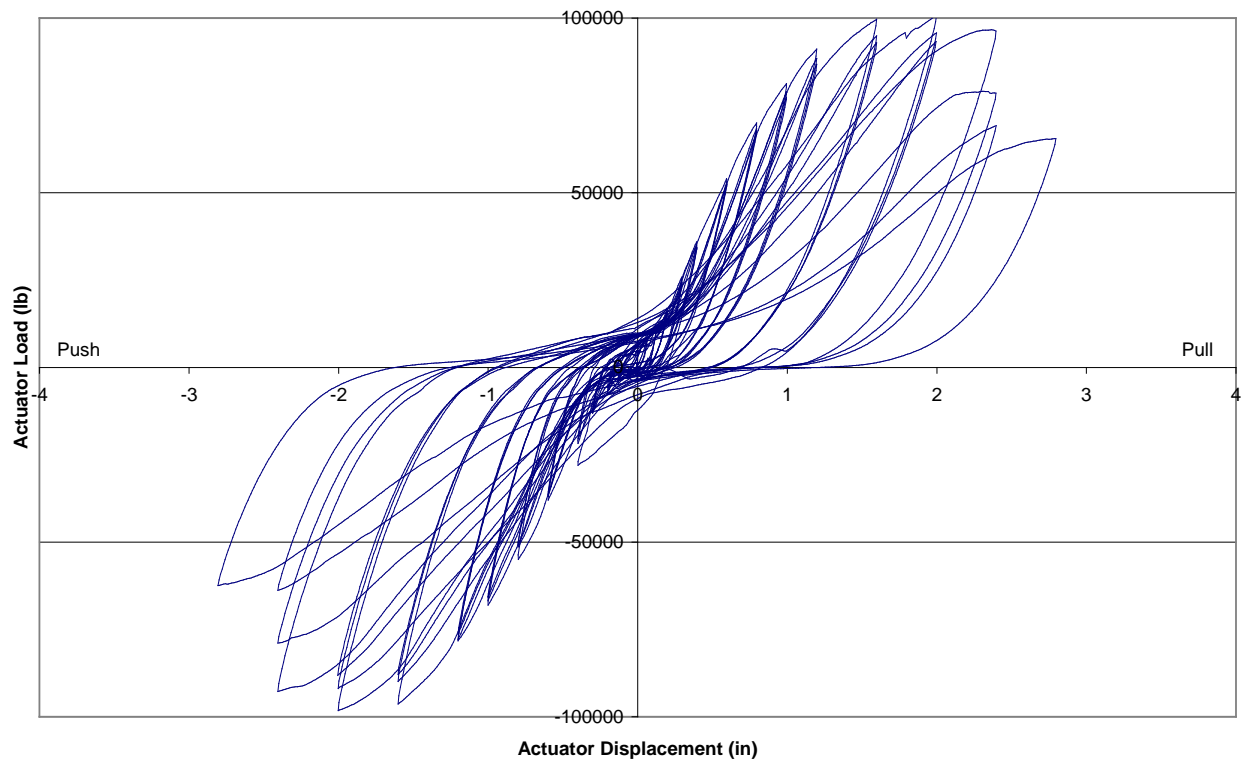
**Figure 27 – Column 2 Lateral Load vs. Displacement Hysteresis Curves
(1 kip = 4.45 kN, 1 in. = 25.4 mm)**

Yielding of the longitudinal bars in Column 2 first occurred at a lateral force level of 48 kips (214 kN) followed by flexural cracking at the top and bottom of the column. No shear distress was observed in the column up to the peak lateral load of 101 kips (450 kN). After cycling several times near 100 kips (450 kN), the FRP jacket began to pull away from the

reentrant corners at the top and bottom of the column, most noticeably at the top. With continued cycling, the pullout of the FRP began to extend down the column, resulting in a significant decrease in the peak lateral load. Figure 28 shows the pullout of the FRP jacket from the reentrant corners. Yielding of the transverse reinforcement first occurred at a lateral force level of 88 kips (390 kN) during the second cycle at a displacement level of 2.0 in. (51 mm). After removing the FRP jacket at the end of testing, it was evident that the final failure mode for the column was a shear failure. Inspection of the specimen after testing showed that the pullout of FRP from the reentrant corners was likely due to spalling of the cover concrete from flexural hinging rather than debonding of the FRP jacket from the concrete.

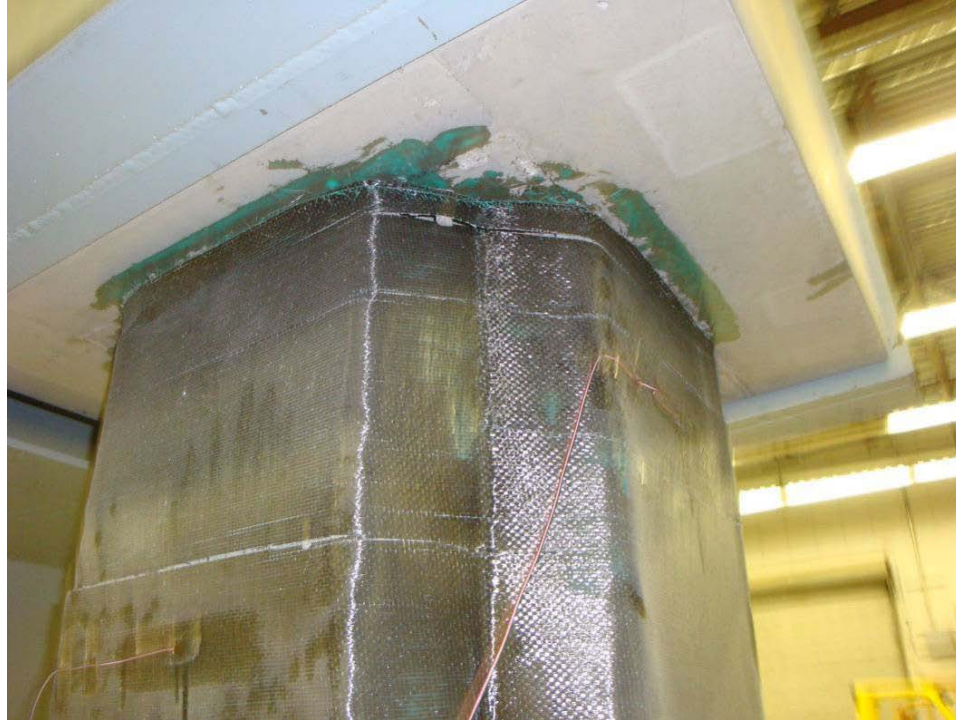
Figure 28 – Column 2 Pullout of FRP Jacket from Reentrant Corners

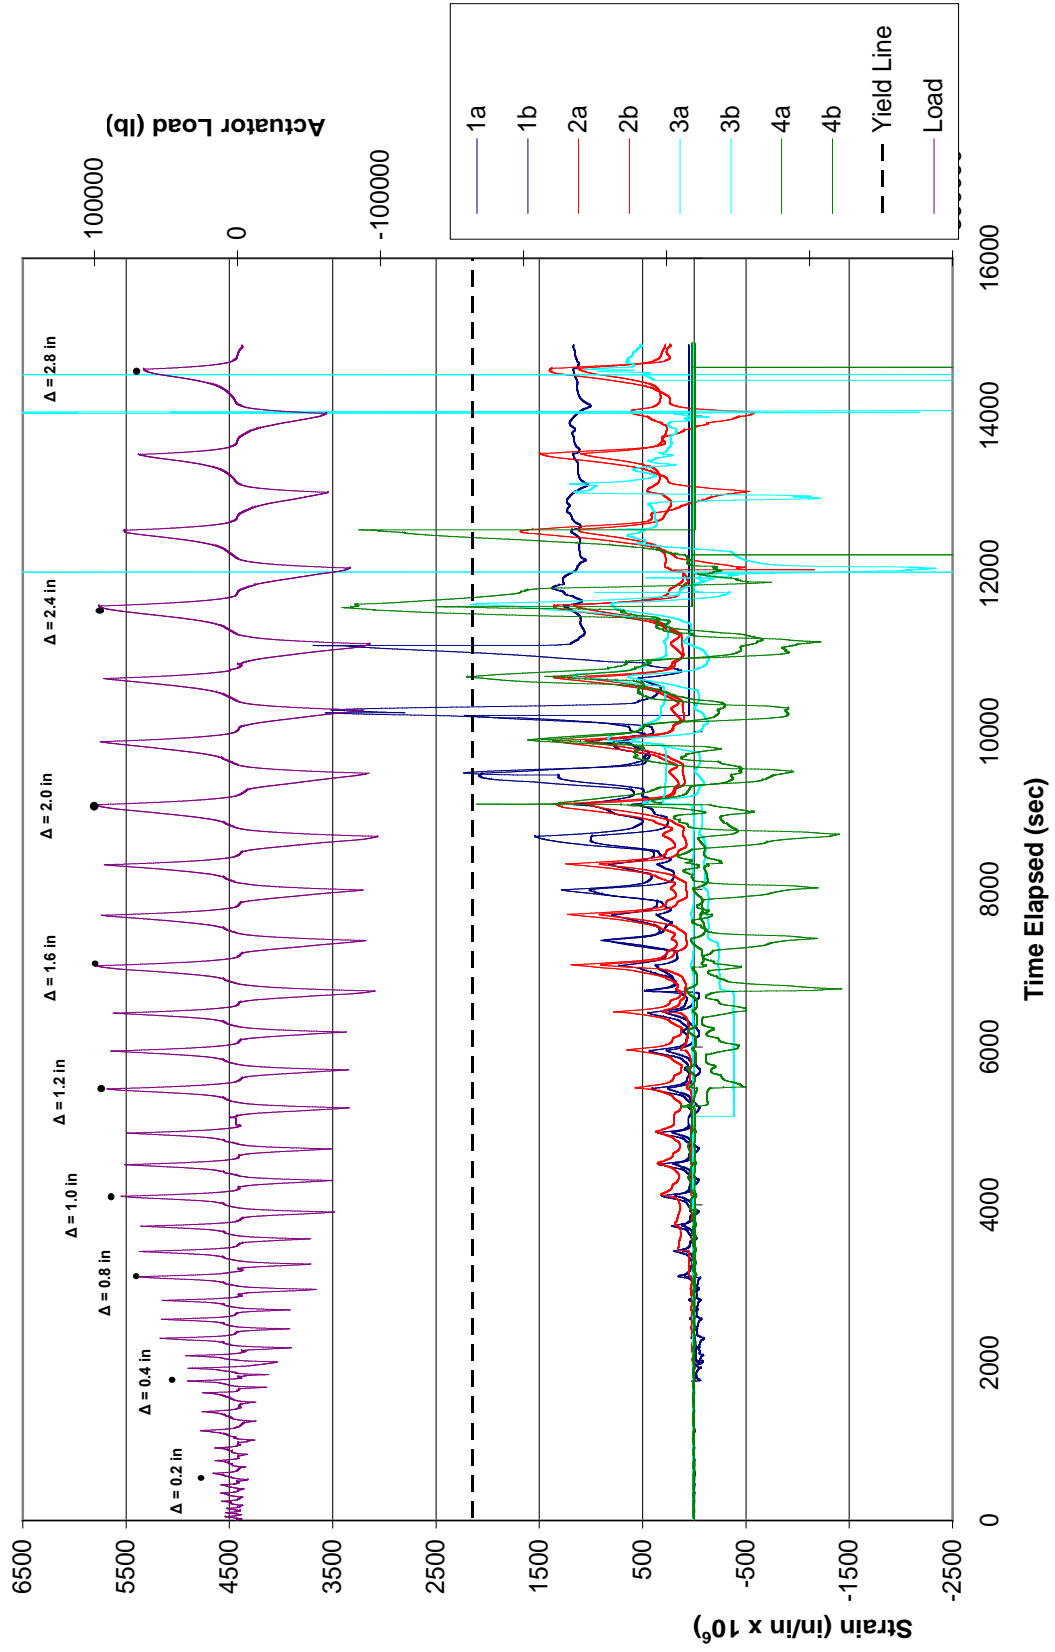
Figure 29 – Column 2 Transverse Strain Gage Data (1 kip = 4.45 kN, 1 in. = 25.4 mm)

Figure 29 shows a plot of the transverse tie strains with time. Almost negligible tie strains were observed up to a displacement level of 0.8 in. (20 mm). A linear strain profile was then observed up to the first yield of the transverse reinforcement during the second cycle at a displacement level of 2.0 in. (51 mm). Very large tie strains were observed during further testing as the FRP jacket pulled away from the reentrant corners.

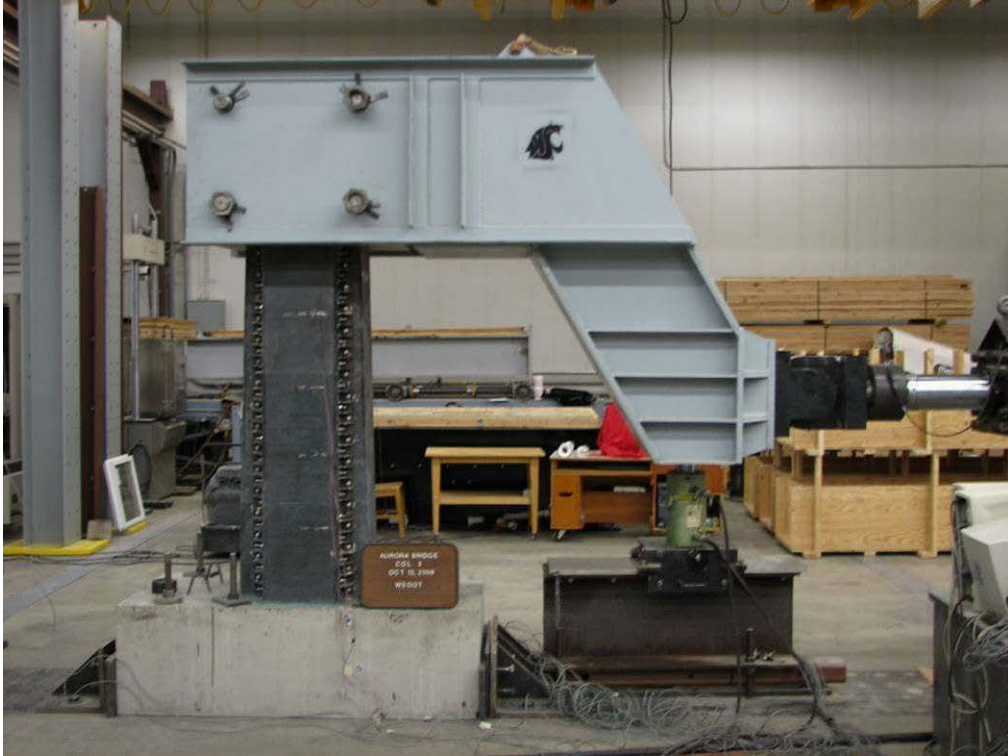
Figure 35 – Column 3 Test Setup

Figure 35 shows Column 3 at the beginning of the test. The response of the column was nearly identical to that of Column 2 through the early part of testing, with yielding of the longitudinal bars first occurring at a lateral force level of 50 kips (220 kN) followed by flexural cracking at the top and bottom of the column. Yielding of the transverse reinforcement first occurred at a lateral force level of 100 kips (445 kN) during the first cycle at a displacement level of 2.0 in. (51 mm). While cycling at a displacement level of 2.8 in. (71 mm), bulging began in the plastic hinge regions at the top and bottom of the column, although more pronounced at the top. With continued cycling, the bulging increased, resulting in a decrease in the peak lateral

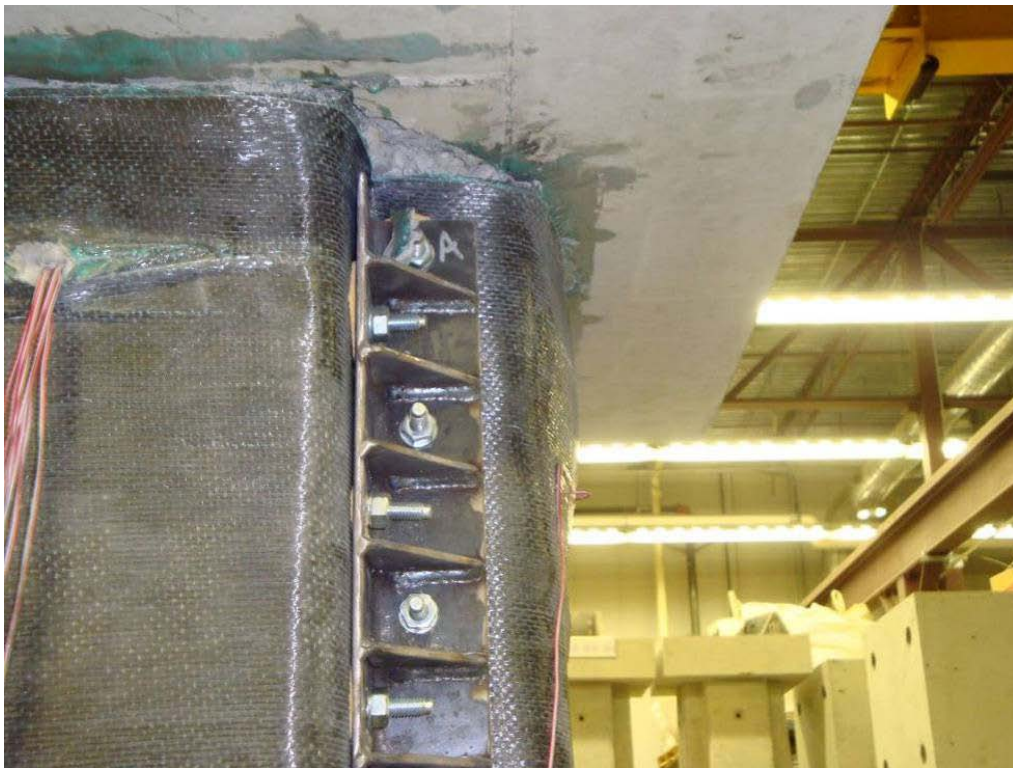
Figure 36 – Column 3 Bulging of FRP Jacket at the Top of the Column

loads. Figure 36 shows the bulging of the FRP jacket at the top of the column. During the first cycle at a displacement level of 3.2 in. (81 mm), the epoxy anchors at the top of the column failed and the load displacement curve peaked before reaching a lateral displacement of 3.2 in. (81 mm), producing failure in the column. No shear distress was observed in the column throughout the test, and the final failure mechanism was development of plastic hinges at the top and bottom of the column. The failure of the epoxy anchors at the top of the column near the end of testing was likely due to crushing and degradation of the concrete under the FRP jacket in the plastic hinge region.

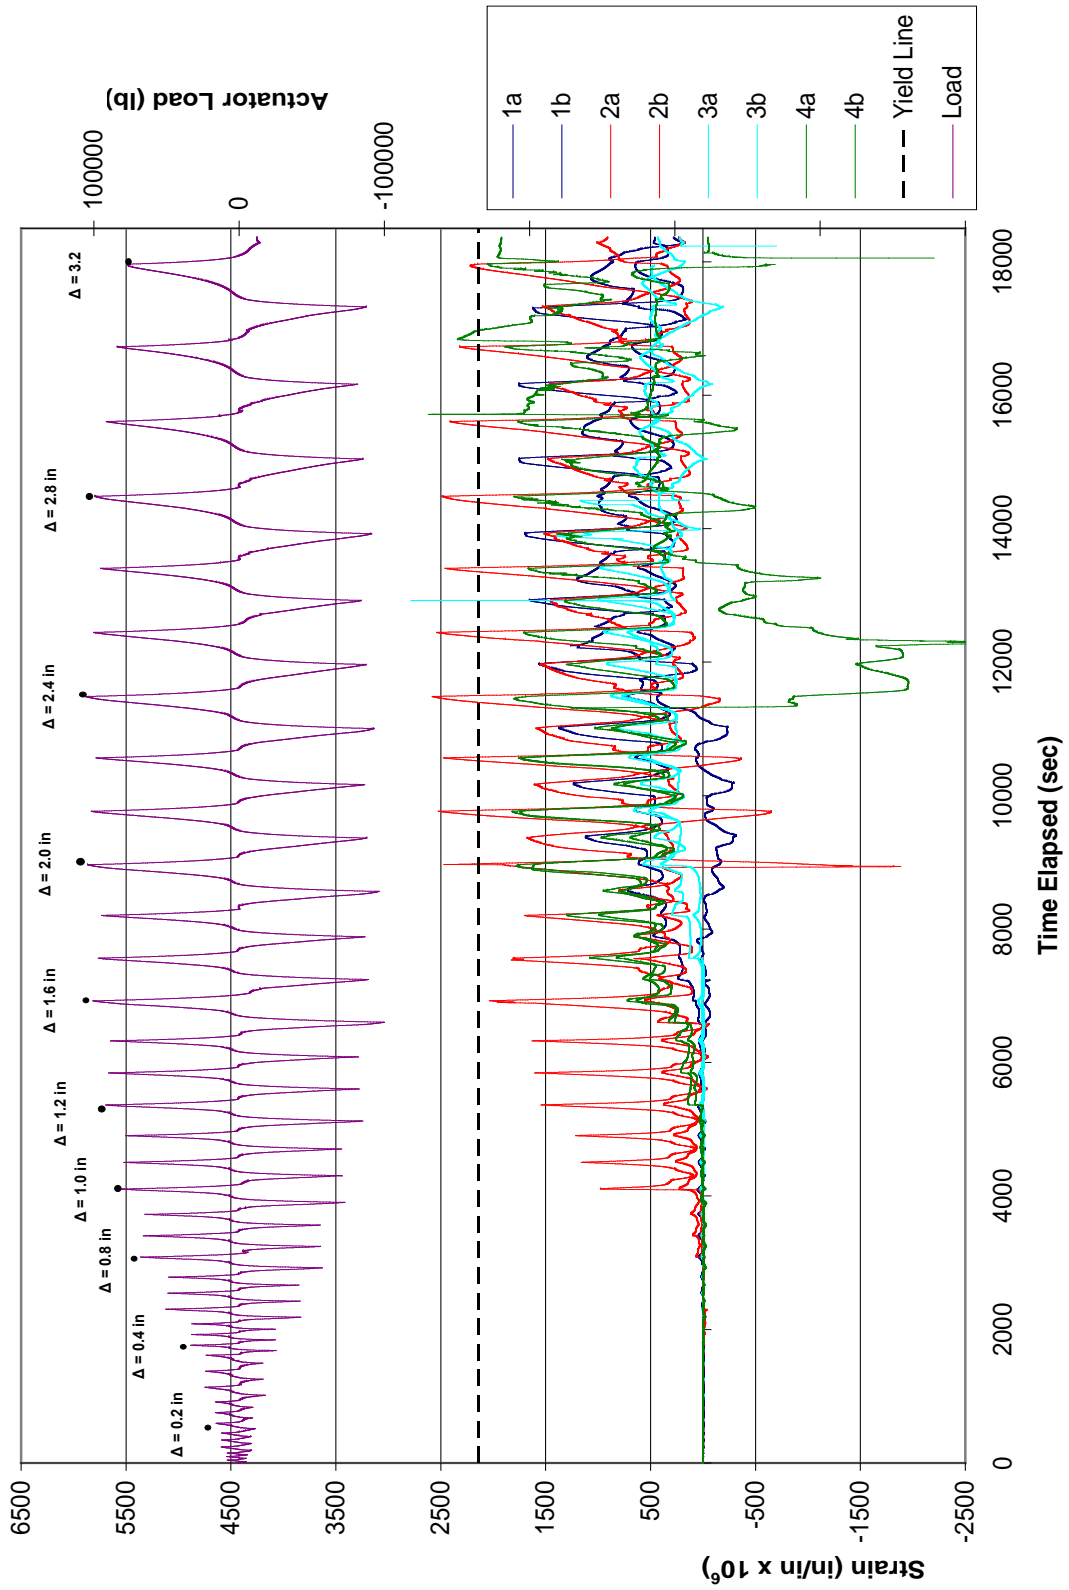
Figure 37– Column 3 Transverse Strain Gage Data (1 kip = 4.45 kN, 1 in. = 25.4 mm)

Figure 37 shows a plot of the transverse tie strains with time. Almost negligible tie strains were observed up to a displacement level of 1.0 in. (25 mm). First yield of the transverse reinforcement occurred during the first cycle at a displacement level of 2.0 in. (51 mm). The observed tie strains were nearly constant for the remainder of the test.

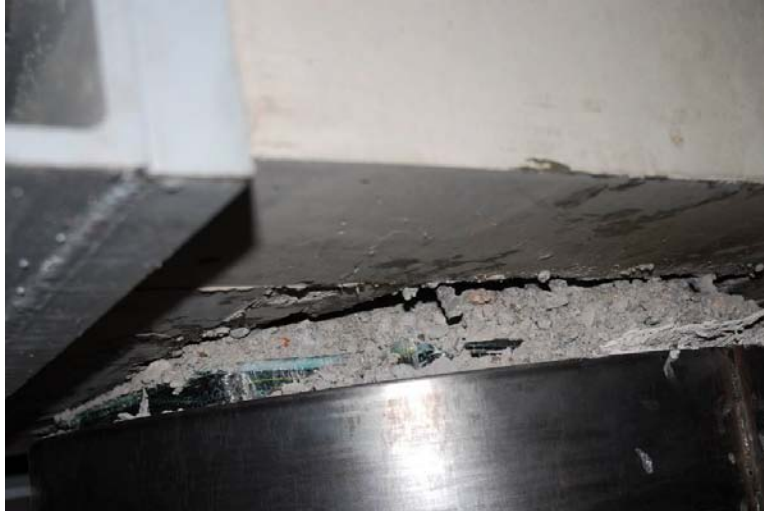
Figure 43 – Column 4 Longitudinal Rebar Fracture

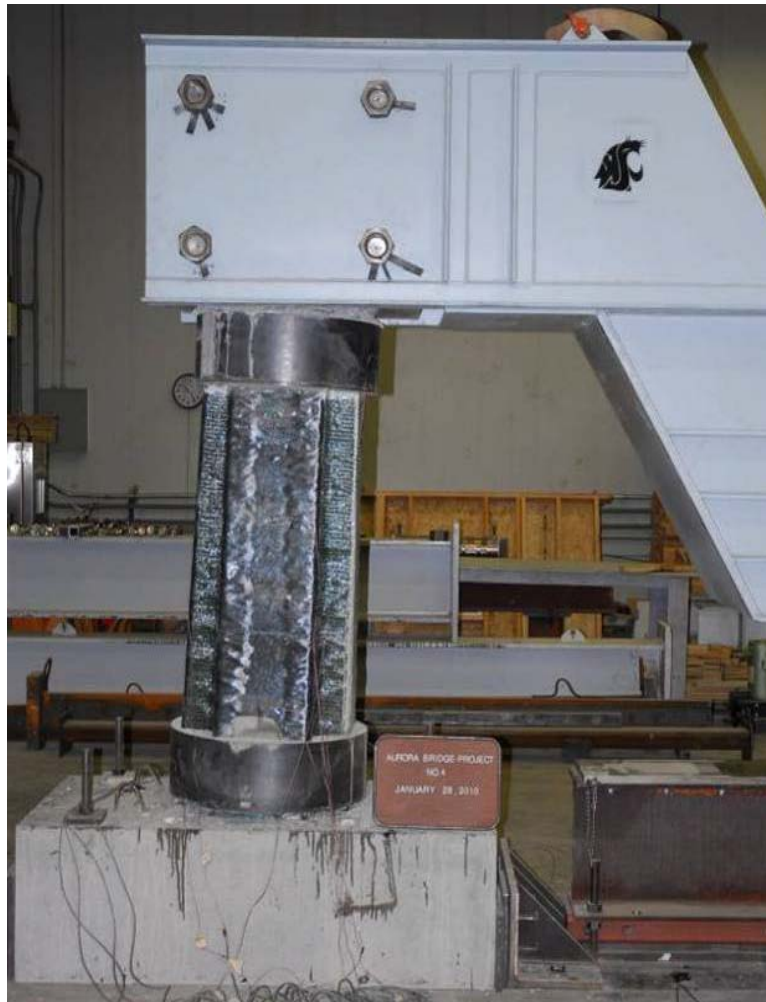
Figure 44 – Column 4 Near the End of Testing

strain. FRP jacket strains were slightly lower than those for Column 3 parallel to the applied load, and strains on the steel collar were almost negligible throughout the test. The applied lateral load remained nearly constant even after development of plastic hinges at the top and bottom of the column up to a displacement level of 3.6 in. (91 mm). While cycling at a displacement level of 3.6 in. (91 mm), several of the vertical reinforcing bars fractured, resulting in significant decrease in the lateral stiffness and strength. Figure 43 shows the fractured longitudinal steel which was caused by low-cycle fatigue due to the stress reversals in the plastic hinge region. The final failure mode for the column was flexural hinging leading to fracture of the longitudinal rebar with no distress observed in the FRP jacket and steel collar at the end of testing. Figure 44 shows the column at the end of testing and illustrates the significant rotation of the plastic hinge regions.

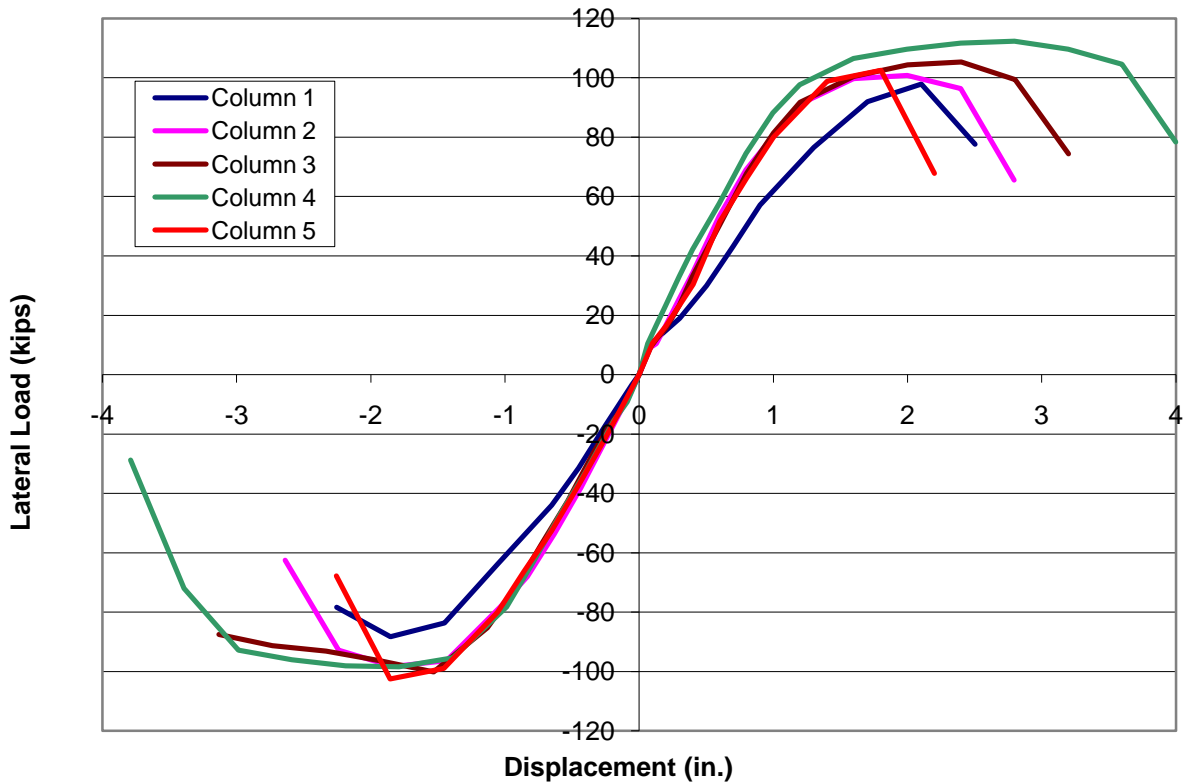
**Figure 50 – Envelope Lateral Load vs. Displacement Hysteresis Curves for Solid Columns
(1 kip = 4.45 kN, 1 in. = 25.4 mm)**

A summary of various characteristics for the solid column specimens is presented in Table 2. Listed characteristics include the effective secant stiffness and shear force corresponding to the first yield of the longitudinal reinforcement, the maximum observed column shear strength, the maximum displacement ductility and drift ratio attained at the maximum response, and the total amount of energy dissipated throughout the test. Figure 50 shows the envelope lateral load vs. actuator displacement curves for Columns 1-5. Values in Table 2 and Figure 50 for Column 1 were adjusted by removing estimated displacements associated with play between the loading rods and tubes in the loading stub. However, it is likely that this play

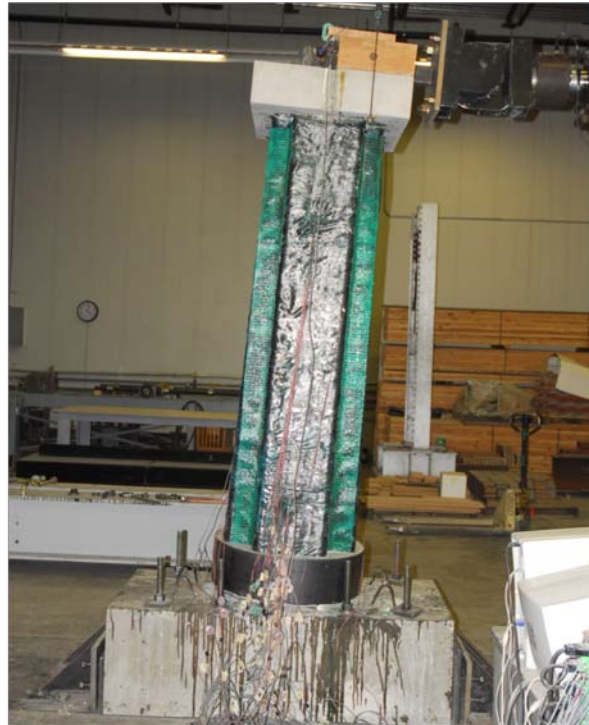
Figure 52 – Column 6 Near the End of Testing

Flexural hinging developed at the bottom of Column 6 during testing. There was no evidence of any distress in the FRP jacket or in the retrofit collar through cycling to a displacement level of 6 in. (150 mm). The FRP jacket remained fully connected in the reentrant corners and to the flat surfaces of the column. No displacements occurred between the two split sections (both visually, and through measurements at the split location). Final failure of the column was due to fracture of several of the longitudinal column bars from low-cycle fatigue. This is the same failure mechanism that occurred in Column 4. Figure 52 shows the column at the end of testing and illustrates the significant rotation of the plastic hinge regions.

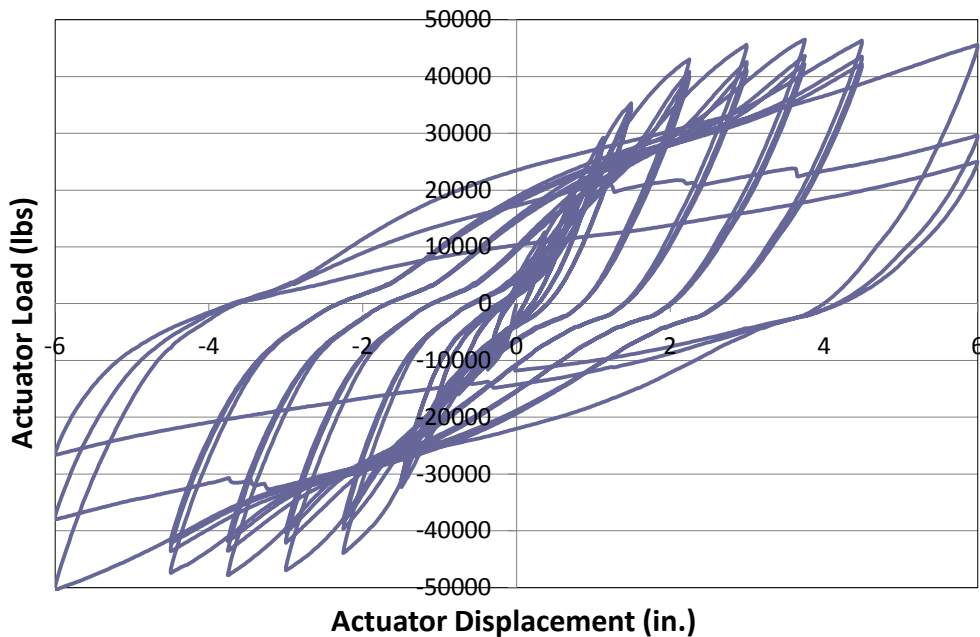
**Figure 54 – Column 7 Lateral Load vs. Displacement Hysteresis Curves
(1 kip = 4.45 kN, 1 in. = 25.4 mm)**

Figure 54 shows the overall hysteretic performance of Column 7 in terms of the lateral force vs. actuator displacement. The peak lateral load achieved was 49 kips (209 kN) and occurred at a lateral displacement of 6.0 in. (150 mm). The peak load dropped rapidly during the second cycle at a displacement level of 6.0 in. (120 mm), and the test was stopped after completing the third cycle at this displacement level.

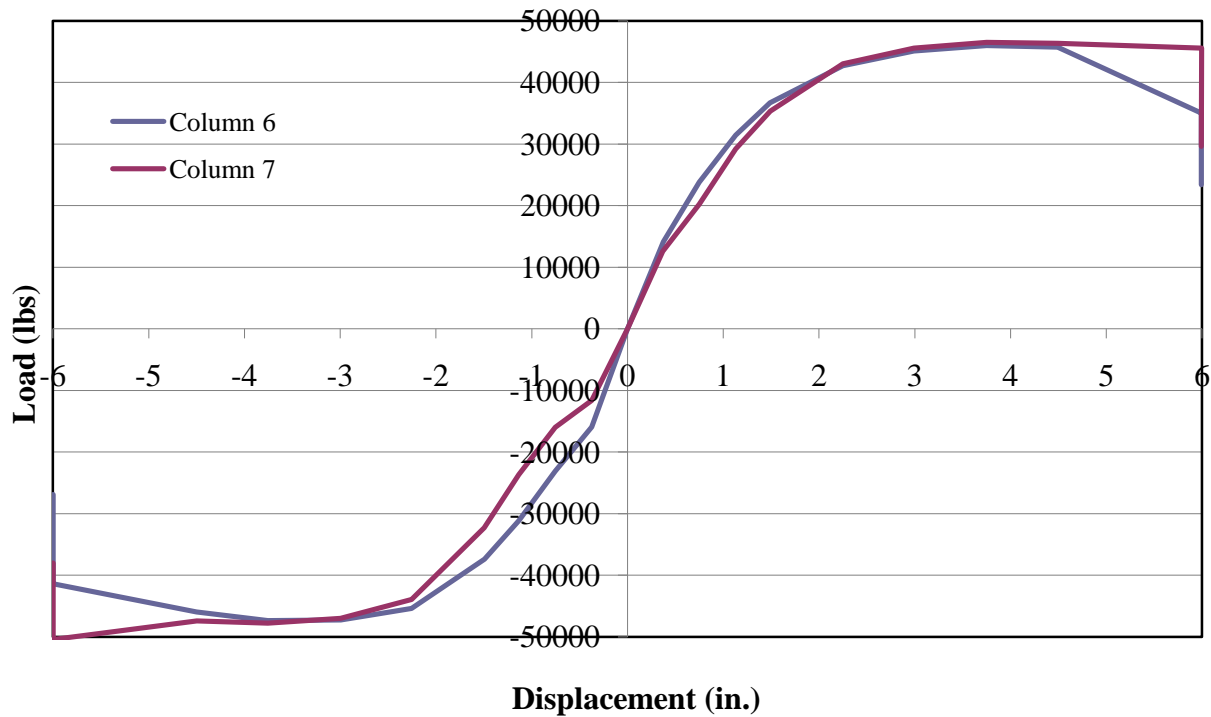
Figure 55 – Envelope Lateral Load vs. Displacement Hysteresis Curves for Split Columns (1 kip = 4.45 kN, 1 in. = 25.4 mm)

A summary of various characteristics for the split column specimens is presented in Table 3. Listed characteristics include the effective secant stiffness and shear force corresponding to the first yield of the longitudinal reinforcement, the maximum observed column shear strength, the maximum displacement ductility and drift ratio attained at the maximum response, and the total amount of energy dissipated throughout the test. Figure 55 shows the envelope of the lateral load vs. actuator displacement curves for Columns 6 and 7. The characteristics and responses from both columns are very similar.
