IMPLEMENTATION REPORT

INSTALLATION OF RAISED PAVEMENT MARKERS FOR REDUCING
INCIDENCES OF WRONG-WAY DRIVING

Virginia Highway & Transportation Research Council
(A Cooperative Organization Sponsored Jointly by the Virginia Department
of Highways and Transportation and the University of Virginia)

June 1977
VHTRC 77-R58

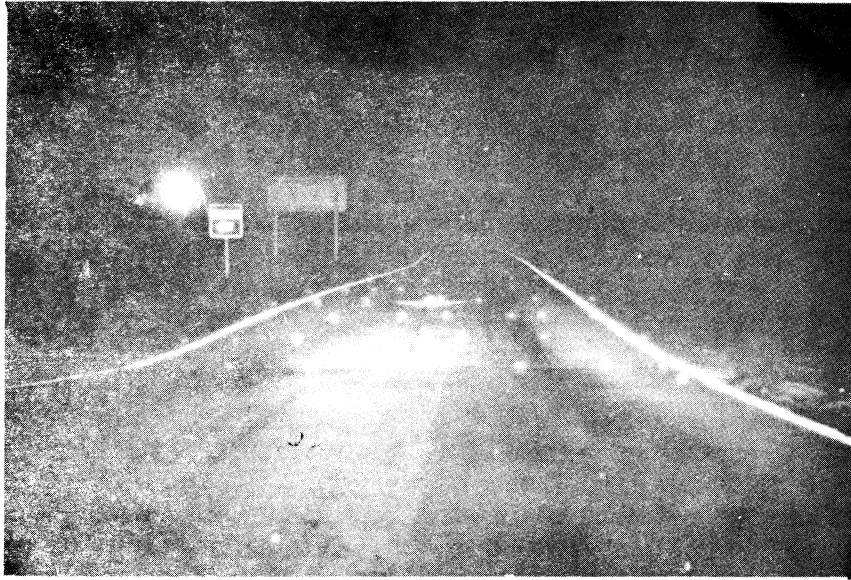
Figure 9. Lynnhaven site from wrong-way approach.

The length, width, and position of the marked area are dependent on the particular roadway geometrics and alignment; therefore, it is difficult to establish a criterion for placement, nonetheless, the markers were placed longitudinally to give the motorist a chance to turn completely into the ramp area before crossing the marked section. Also, it was felt that the termination of the marked section in the vicinity of the wrong-way sign would help call attention to the sign. Figures 9 and 10 show the Lynnhaven and 21st Street sites, respectively, as they would appear to the wrong-way driver at night with vehicle lights on high beam.
