EVALUATION OF TREATED WOODEN SIGN POSTS

Virginia Highway & Transportation Research Council
(A Cooperative Organization Sponsored Jointly by the Virginia
Department of Highways & Transportation and
the University of Virginia)

July 1979

VHTRC 80-R7

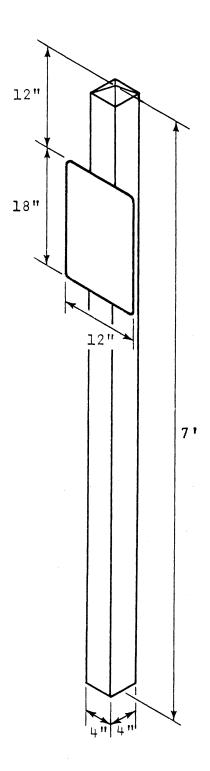
1 foot = .3048 meter
1 inch = 2.54 centimeters

Figure 1. Sign panel and post dimensions for the evaluation — of the sign facing material.

One test sign was constructed using a seven-foot (2.13 m) treated wooden sign post and a sign panel 12 inches (30.48 cm) wide by 18 inches (45.72 cm) high mounted one foot (30.48 cm) from the top of the post as shown in Figure 1. The sign panel was fabricated from green, enclosed lens, reflective sheeting. The test sign was placed in the lot of the Charlottesville Residency Office for exposure to weathering on December 29, 1975. The sign panel was installed facing south and was mounted on a test stand in the standard vertical position.

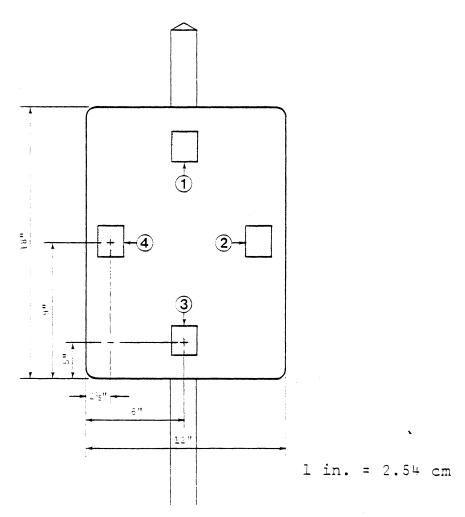
Figure 2. Retroreflective reading locations.

Bimonthly retroreflective readings were taken at four locations on the test sample (see Figure 2). A template was used to ensure that all bimonthly readings were taken at the same locations on the sign panel. A modified Gardner portable reflectometer was used to take the readings.
