SIGN POST PAINT EVALUATION

Steve R. Blackwell  
Traffic Technician

May 1977  
VHTRC 77-R51

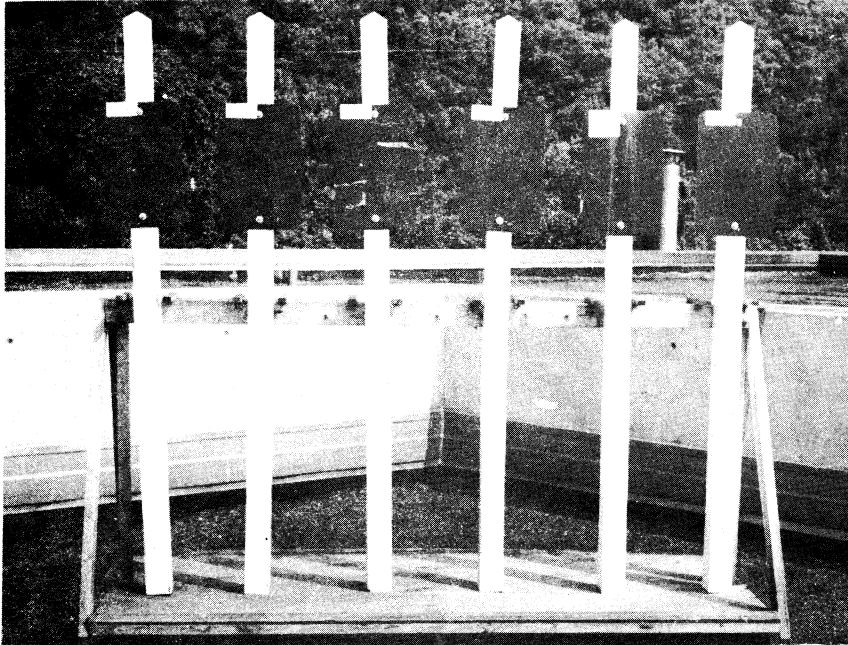
Figure 2. Test stand with six posts and panels.

The painted sign posts with panels were placed on the roof of the Research Council building for exposure to weathering on February 28, 1974. In November 1975, the sign posts and panels were moved to a field test site at the Charlottesville Residency. The sign panels are facing south and are mounted in the standard vertical position as shown in Figure 2.
