t Documentation Page
1. Repart No.	2 Government Acce		3. Recipient's Catalog	g No.
"AA-AM-81-	AD-A103	3191	17.	
1. Title and Subtitle	114 115-2	<u> </u>	5. Report Date	
MERGENCY CABIN LIGHTI	NG INSTALLATIONS.	AN ANALYSTS	Feb. 1981	. )
OF CEILING- VS. LOWER			6. Performing Organiz	
EVACUATION TRIALS			or comming organiza	U. (U.)

The Protection and Survival Laboratory of the Civil Aeromedical Institute (CAMI) initiated a program to study cabin lighting in response to a request from the Federal Aviation Administration's Systems Research and Development Service, Washington, D.C. (2). The purpose of the study was to evaluate the relative effectiveness of emergency cabin lighting under conditions of stratified or layered smoke in an aircraft cabin with respect to passenger evacuation rates. Two lighting systems, one a conventional ceiling-mounted system and the other an aisle-mounted system were compared during evacuation trials in the CAMI evacuation simulator. The program, which began in 1976, evaluated the effectiveness of present lighting requirements in dense cabin smoke typical of a post-crash fire environment. A CAMI memorandum report was published in 1977 as an interim report (3

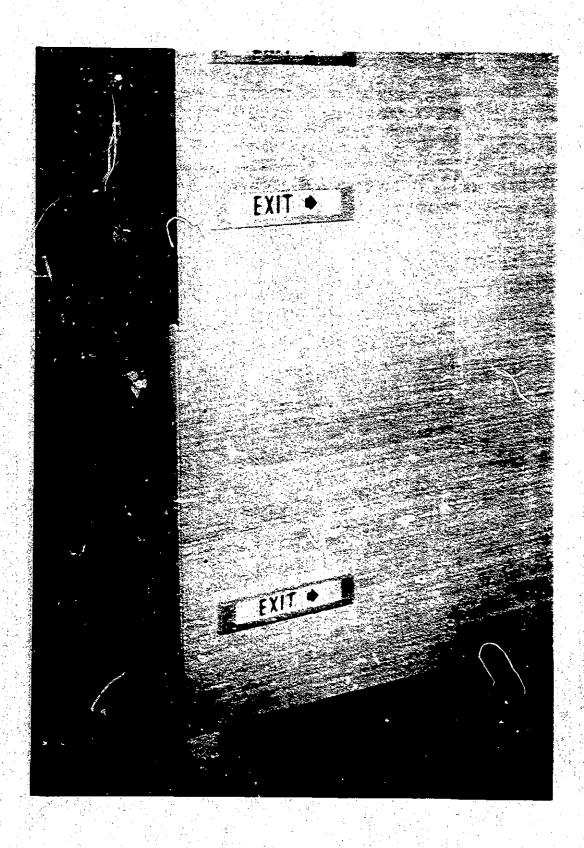
Figure 4. Two 8-watt fluorescent exit locator signs mounted on the cross-aisle bulkhead at and below the midpoint of the cabin.

Two 8-watt fluorescent exit locator signs (directional arrows) were mounted on the cross-aisle bulkhead (Figure 4), at and below the midpoint of the cabin floor-to-ceiling distance. The upper sign shown at midpoint of the cabin was located 122cm (approximately 48 in) above the cross aisle. The lower sign was located 42cm (approximately 16.5 in) above the aisle, and provided floor level illumination as well as exit location information to the subjects.

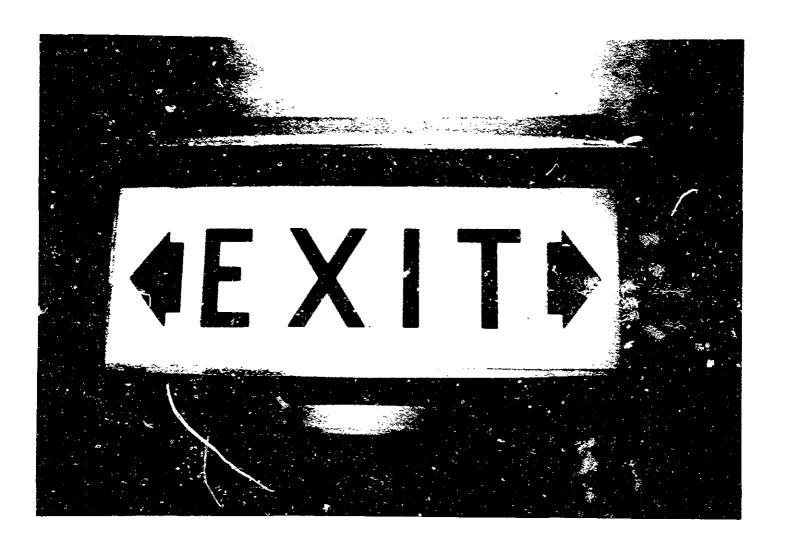
Figure 5. Cross-aisle exit locator sign mounted above the intersection of main and cross aisle at ceiling height.

The lighting system used for comparison was composed of ceiling-mounted fixtures with incandescent bulbs providing general aisle illumination of 1.2 lux (0.11 foot candle) at seat armrest height without smoke in the cabin. This value is more than twice the minimum value required by FAR 25.812(c)(9). A single incandescent cross-aisle exit locator sign and two exit identification signs were also used as part of the conventionally mounted emergency lighting system. The cross-aisle sign (Figure 5) was a Luminator (TM)\* unit located 245cm (96.5 in) above the floor and provided 0.32 lux (0.03 foot candle) on the cross aisle which is also above the minimum specified by FAR 25.812(d). One of the two exit identifier signs was a cabin sidewall—mounted Luminator (TM)\*\* unit located 137cm (54 in) above the floor. The other exit identifier was a Grimes\*\*\* unit mounted 198cm (78 in) above floor level and above the Type A exit (Figure 6).
