**IDENTIFICATION OF PAVEMENT
DISTRESS IN KENTUCKY**

Research Report
KTC-05-29/SPR-267-02-1F

Tim C. Scully Jr,
Transportation Research Investigator

Kentucky Transportation Center
College of Engineering
University of Kentucky
Lexington, Kentucky

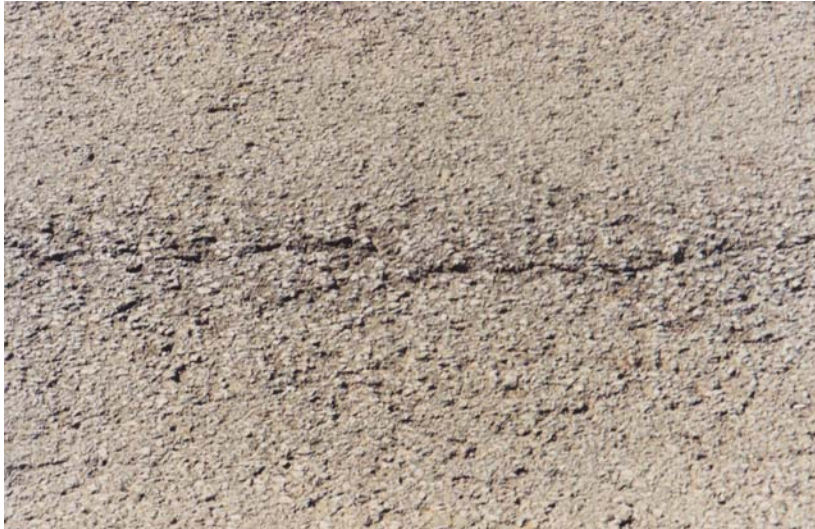
Very small cracks often undefined in width and length. It is usually harder to determine how long cracks travel, do to their undefined nature.

Figure 1a. Longitudinal Cracking (Slight)

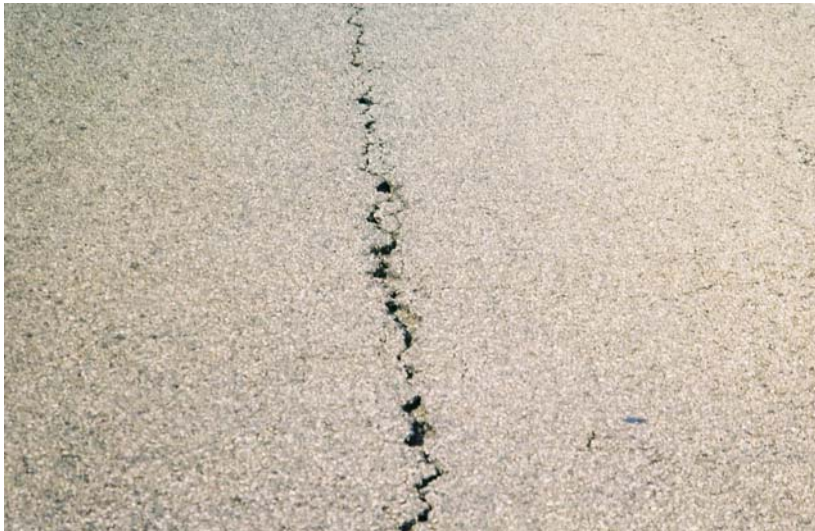
More pronounced cracking traveling for longer distances and penetrating deeper into the pavement.

Figure 1b. Longitudinal Cracking (Moderate)

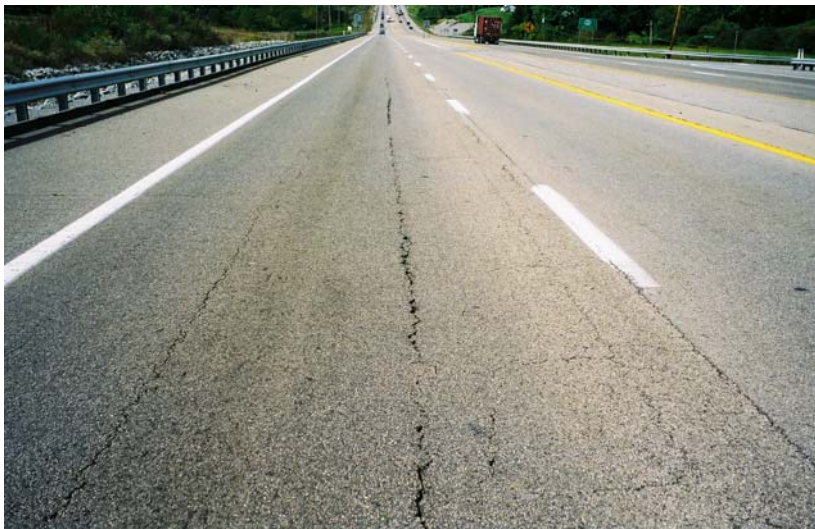
Bold, wide cracking that travel long distances, and penetrate deep into the pavement.

Gap > 1/4 inch or depression > 1 inch

Figure 1c. Longitudinal Cracking (Severe)

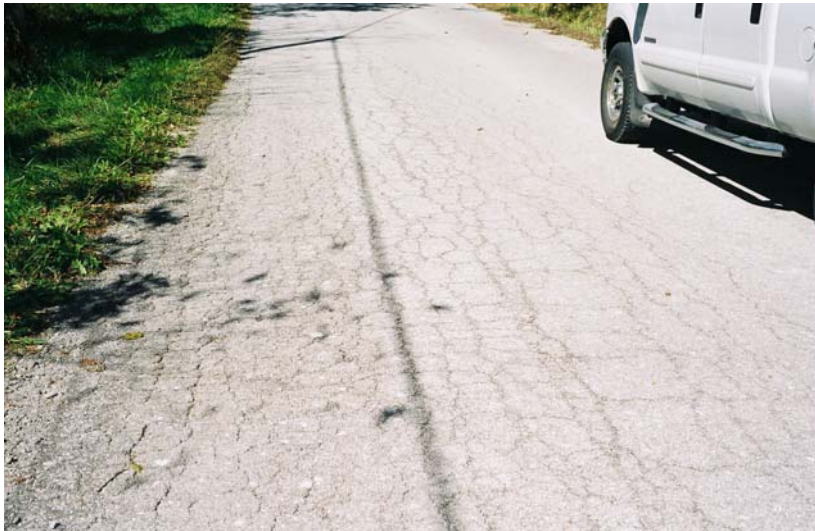
There is light cracking with an alligator pattern usually forming in the wheel paths.

Figure 2a. Alligator Cracking (Slight)

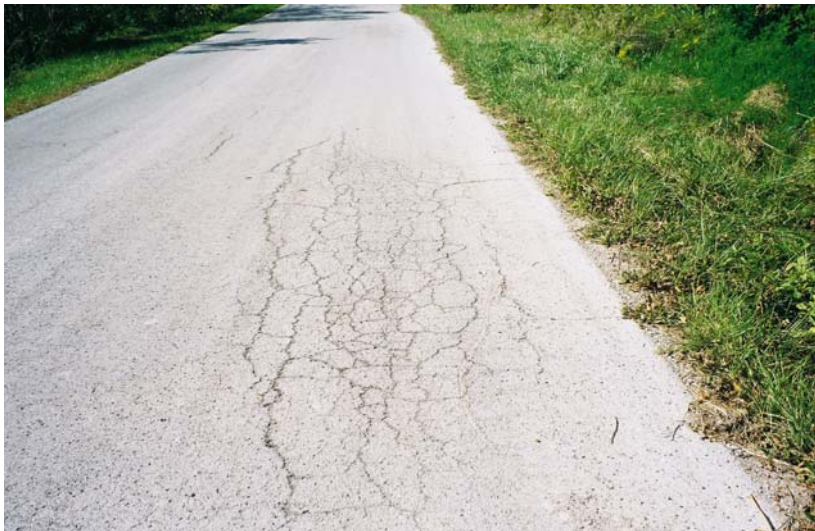
A more severe alligator-shaped cracking with some mild spalling.

Figure 2b. Alligator Cracking (Moderate)

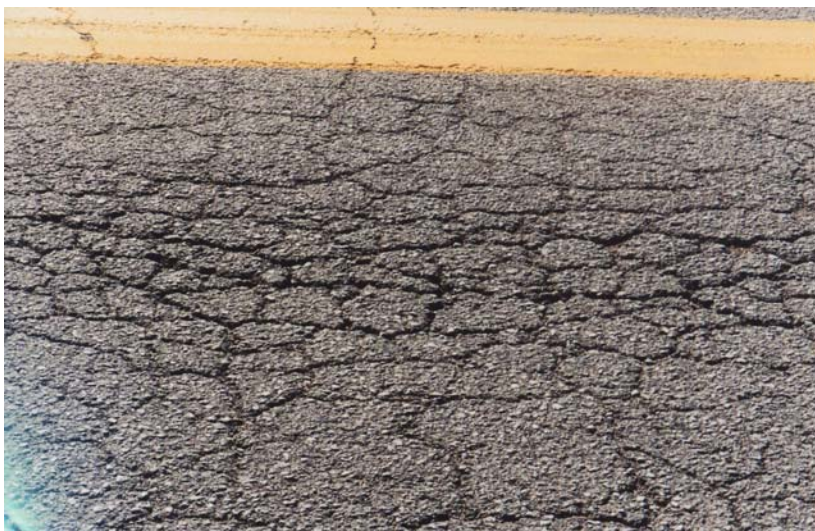
Heavy cracking with some pieces faulting and others popping out. Many times there will be areas of potholes forming.

Gap > 1/4 inch or depression > 1 inch

Figure 2c. Alligator Cracking (Severe)

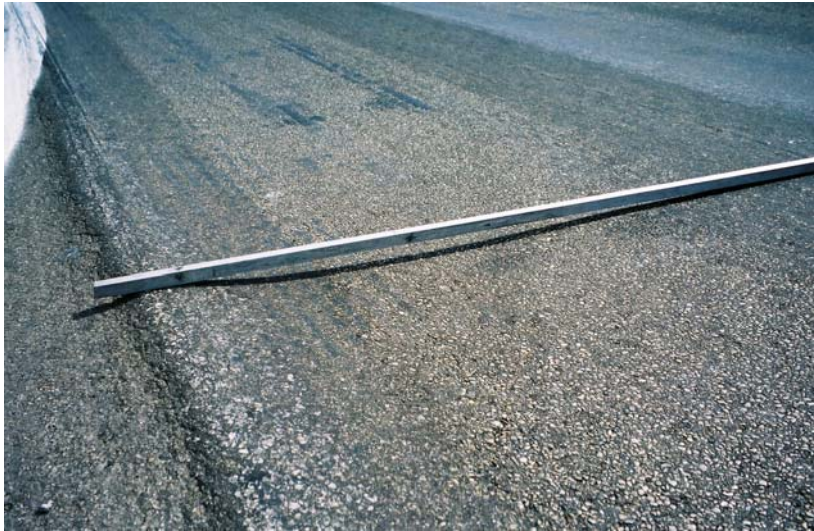
The depressions are forming deeper into wheel paths. Some longitudinal cracking may also be present. Refer to the chart below to categorizing the rutting.

Figure 3b. Rutting (Moderate)

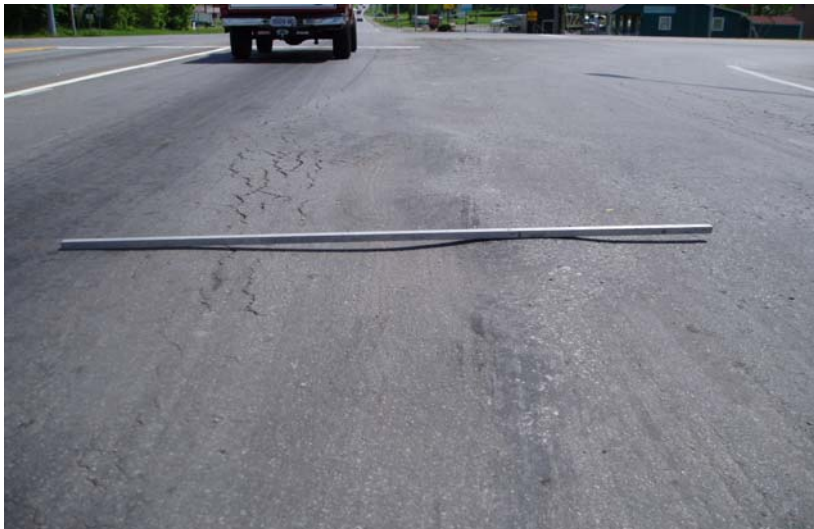
When there are deep depressions formed in the wheel paths. There will often be longitudinal cracks present. Refer to the chart below to categorizing the rutting.

Ruts measuring 11/16 and greater

Figure 3c. Rutting (Moderate)

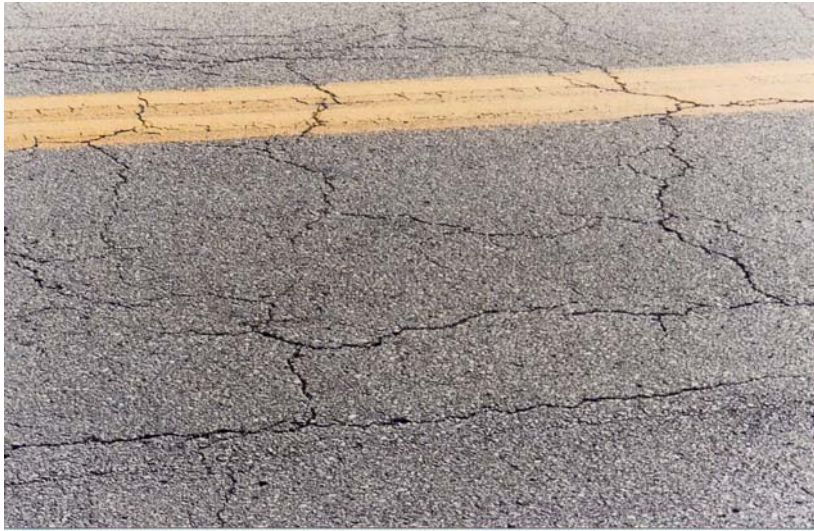
Very small cracks, uniform in shape, but not very distinct having widths that are difficult to determine.

Figure 4a. Block Cracking (Slight)

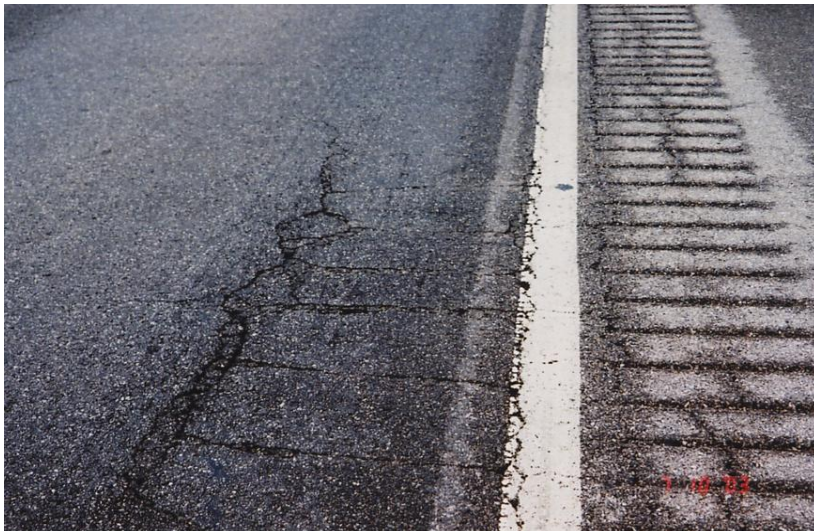
These are larger cracks with a more distinct pattern. The crack widths are more visible and defined.

Figure 4b. Block Cracking (Moderate)

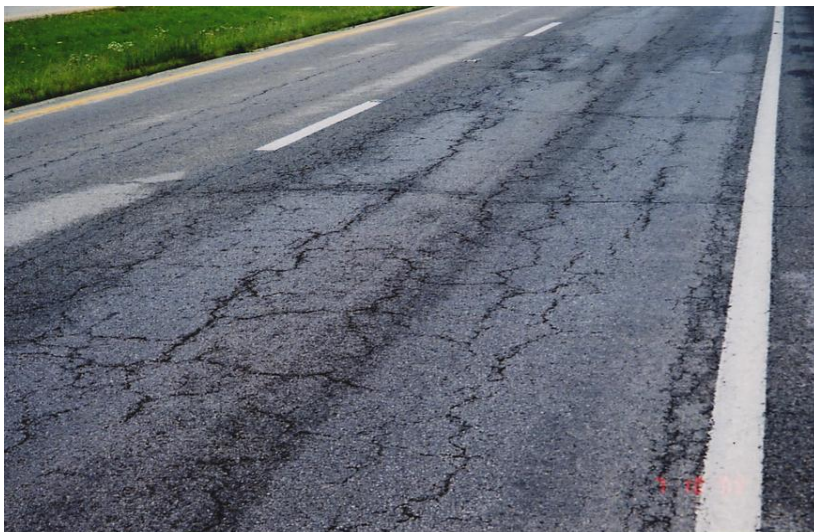
Severe block cracking that shows heavy cracks in bold square shapes that are very wide.

Gap > 1/4 inch

Figure 4c. Block Cracking (Severe)

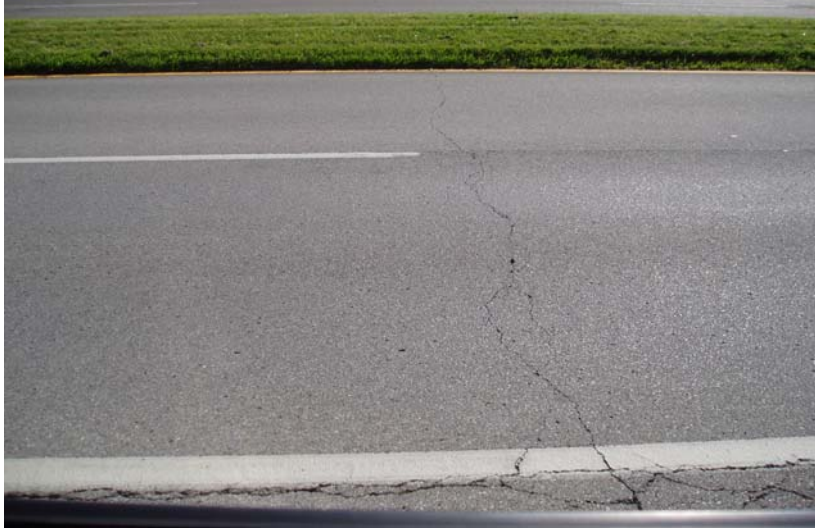
Light transverse cracking reflecting upward from existing pavement.

Figure 5a. Reflective Cracking (Slight).

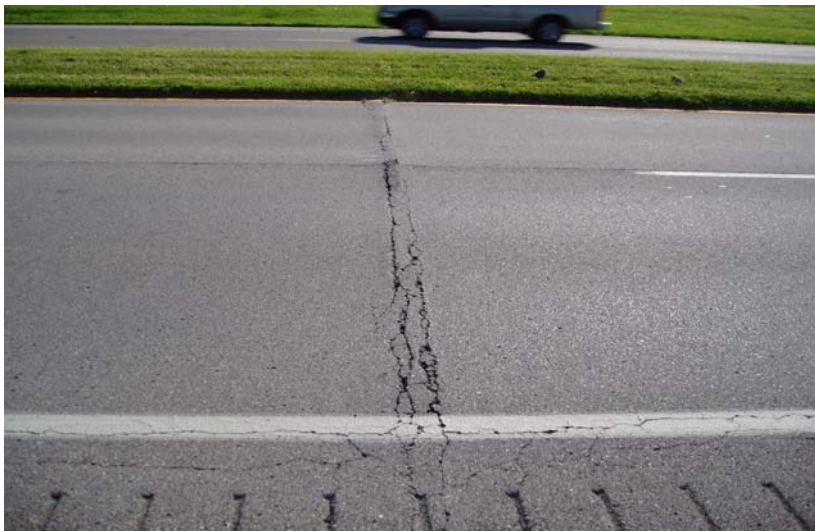
A larger transverse crack with a more pronounced hump or blow up at the joint.

Figure 5b. Reflective Cracking (Moderate).

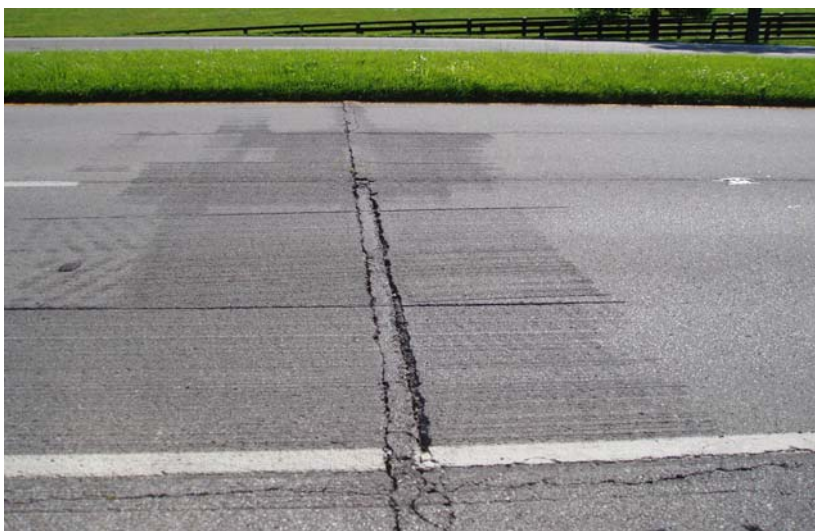
A severe hump has formed in the pavement where the transverse crack is located. This usually is indicative of a larger problem below with the original pavement.

Gap > 1/4

Figure 5c. Reflective Cracking (Severe).

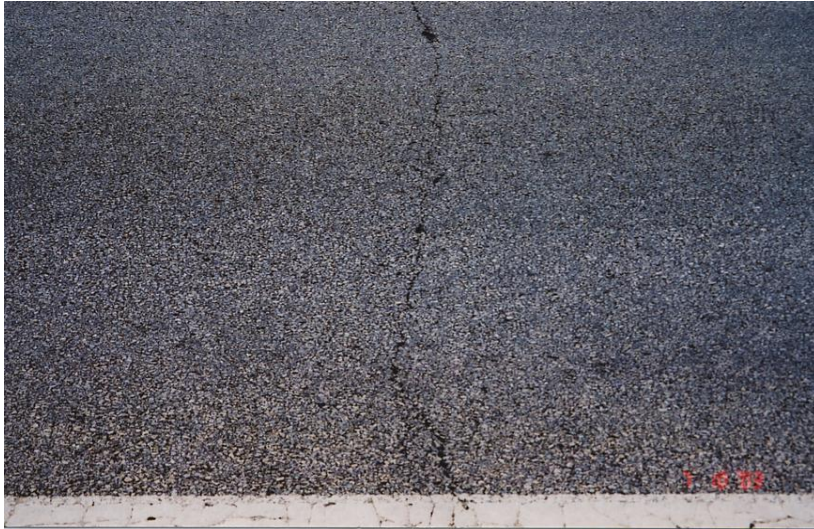
In the early stages of transverse cracking the crack is very faint with little or no pavement separation.

Figure 6a. Transverse Cracking (Slight).

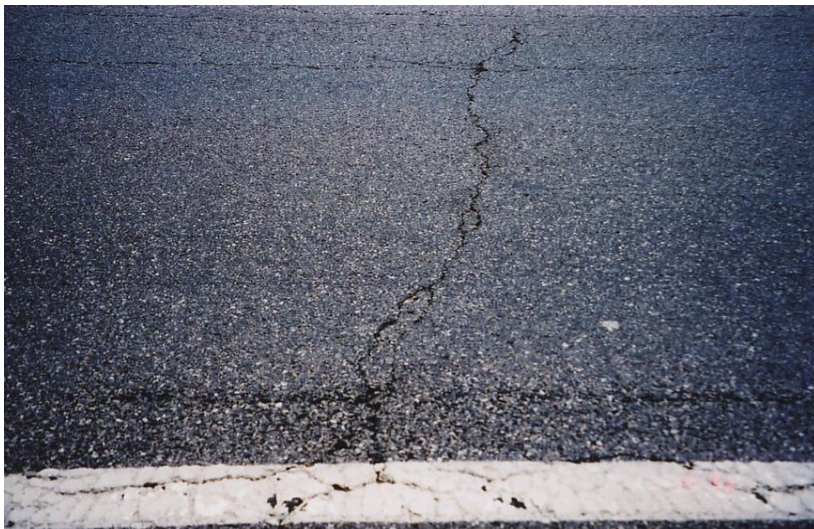
More pronounced transverse cracking is visible. There is more separation, and the cracks appear to travel deeper into the pavement.

Figure 6b. Transverse Cracking (Moderate).

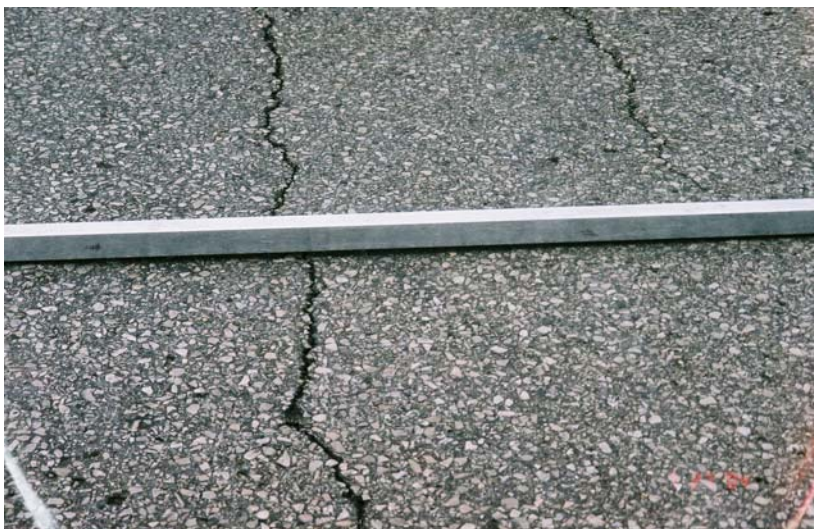
Transverse cracks that are wide and deep. The crack may propagate across an entire lane.

Gap > 1/4 inch

Figure 6c. Transverse Cracking (Severe).

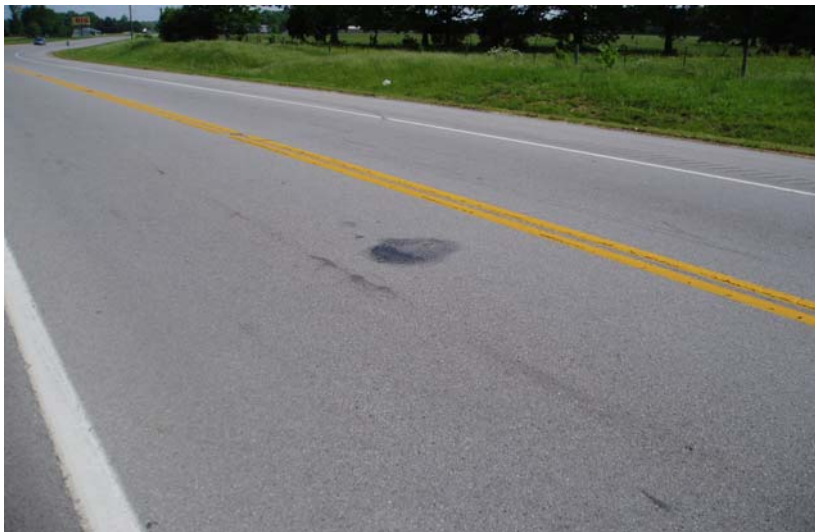
Figure 7a. Bleeding (Slight)

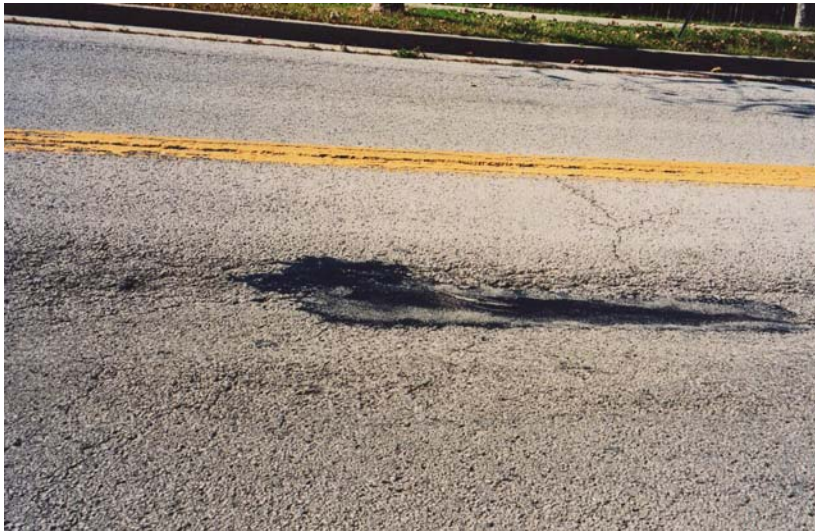
There is a more distinct change in pavement color in wheel paths caused from migrating binder. Often the pavements voids will be filled with the residue.

Figure 7b. Bleeding (Moderate)

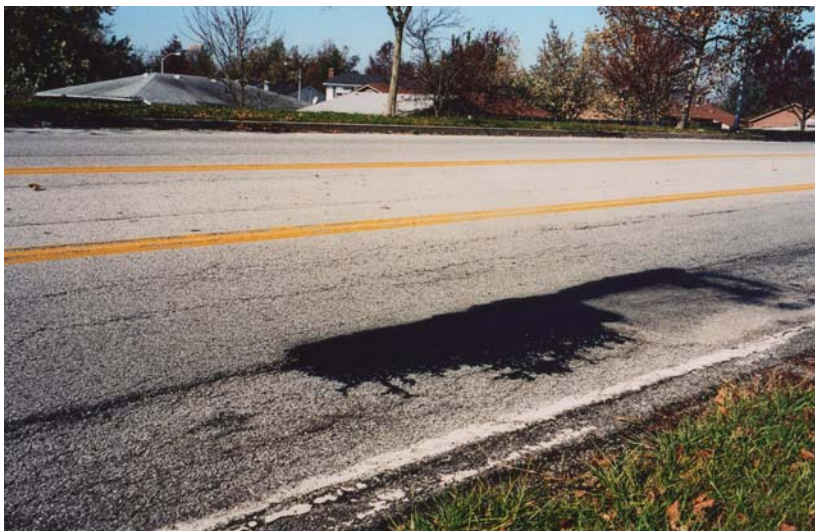
Areas of heavy black residue shining through in the pavement wheel paths.

Figure 7c. Bleeding (Severe)

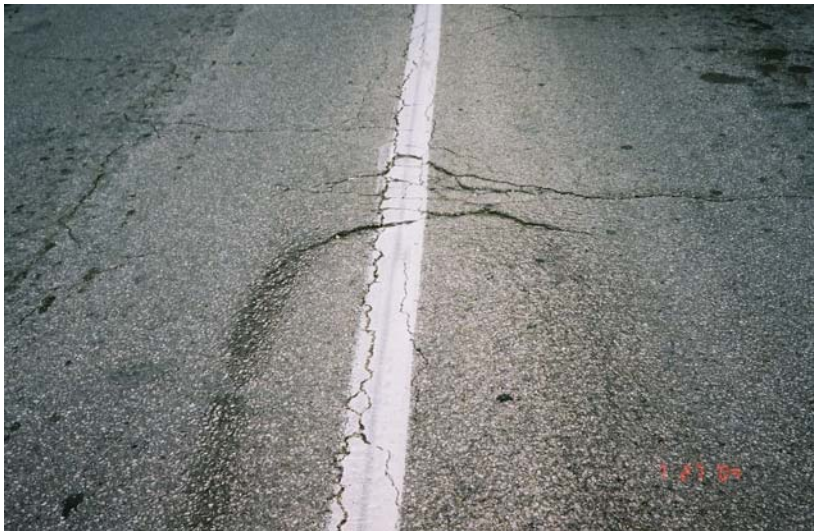
Figure 7a. Shoving (Slight)

Shoving occurs when the pavement is pushed longitudinally. This is usually caused by repetitive braking in particular areas such as hills and intersections. The continuous braking in these areas forces the pavement forward causing a rippling, or humping effect.

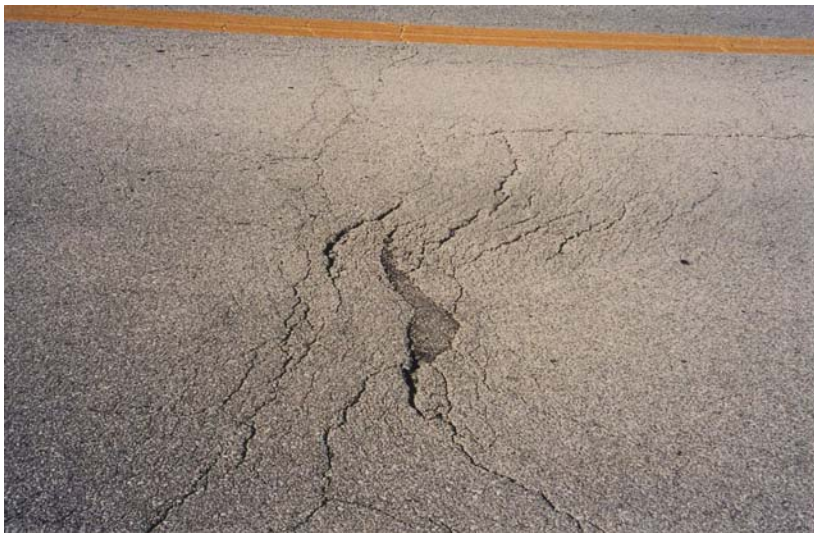
Figure 7b. Shoving (Moderate)

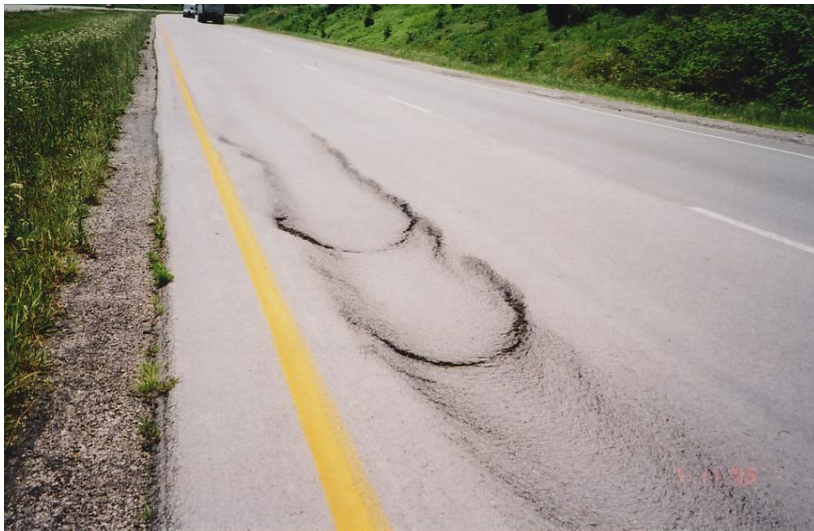
Larger humps are visible causing an uncomfortable ride to passengers passing over these areas.

Figure 7c. Shoving (Severe)

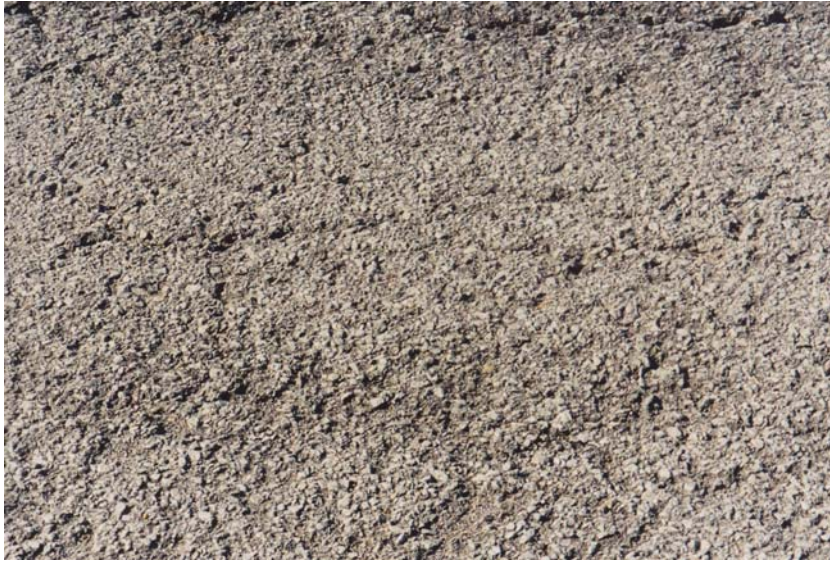
Figure 8a. Raveling (Slight)

The erosion of a pavement caused by the loss of fine and coarse aggregate. This is usually most common in the wheel paths, but may occur over an entire lane.

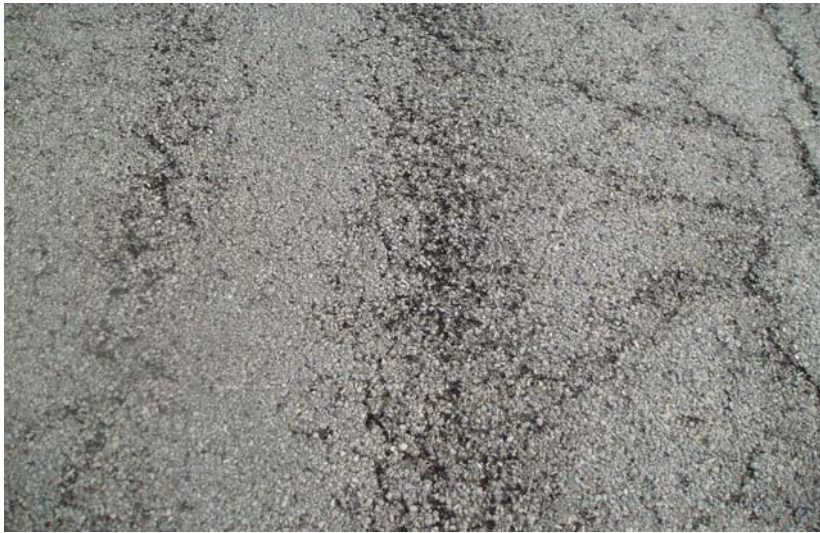
The lack of small aggregate particles is more visible. The pavement has a pitted, or worn appearance. Small loose pieces of aggregate are often present.

Figure 8b. Raveling (Moderate)

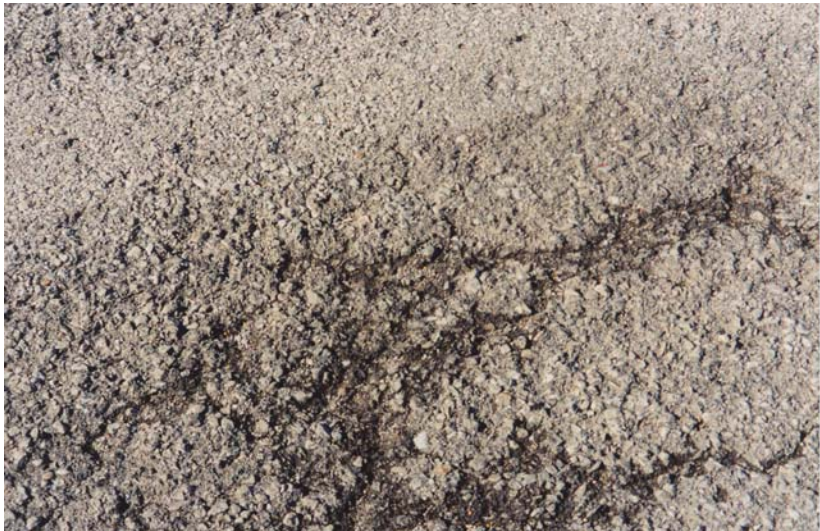
There is an extensive loss of aggregate. The pavement is very rough with an open textured appearance.

Figure 8c. Raveling (Severe)

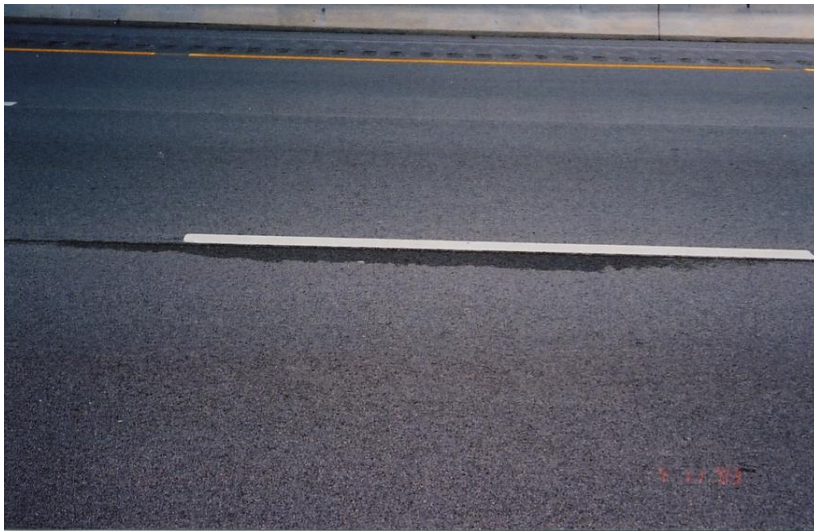
Small areas of water or staining are visible at the surface.

Figure 9a. Water Pumping (Slight)

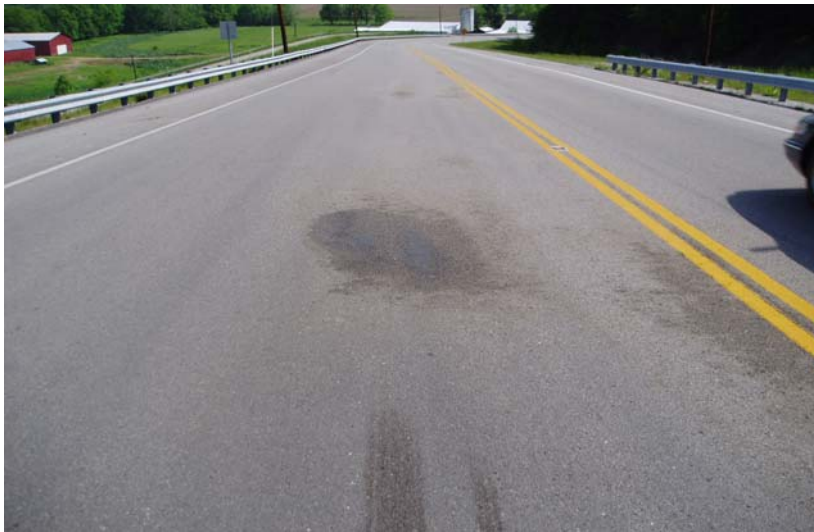
Medium sized areas of water or staining are present along with an increased amount of fine materials

Figure 9b. Water Pumping (Moderate)

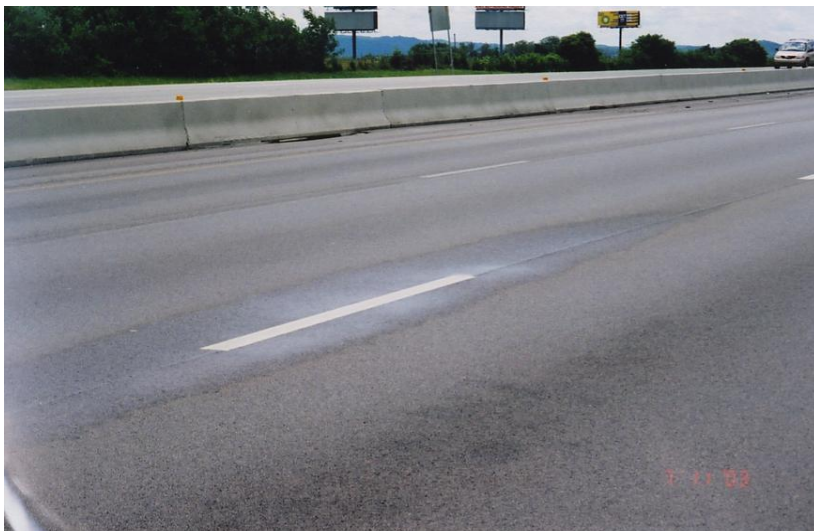
In severe cases of pumping, water may be standing. When water is not present there will be large areas of heavy staining.

Figure 9c. Water Pumping (Severe)

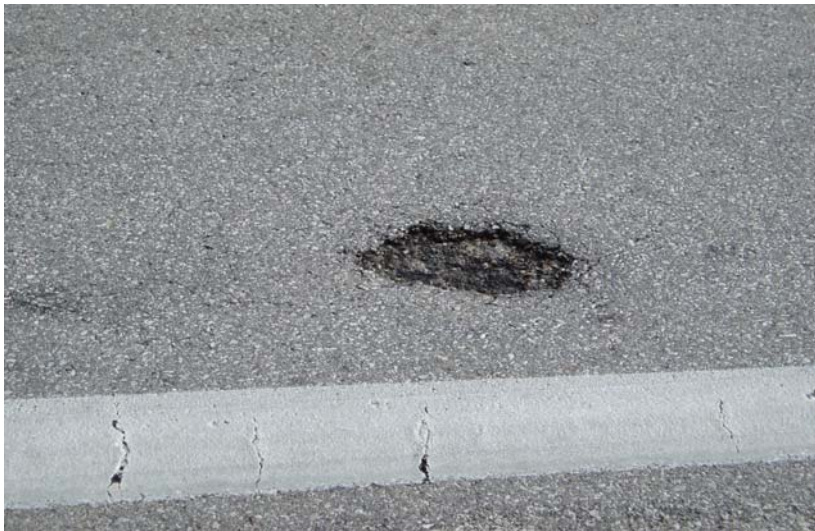
Figure 10a. Pothole (Slight)

Round holes forming in the pavement often associated with freezing and thawing conditions. Once potholes have started they will grow rapidly if not repaired.

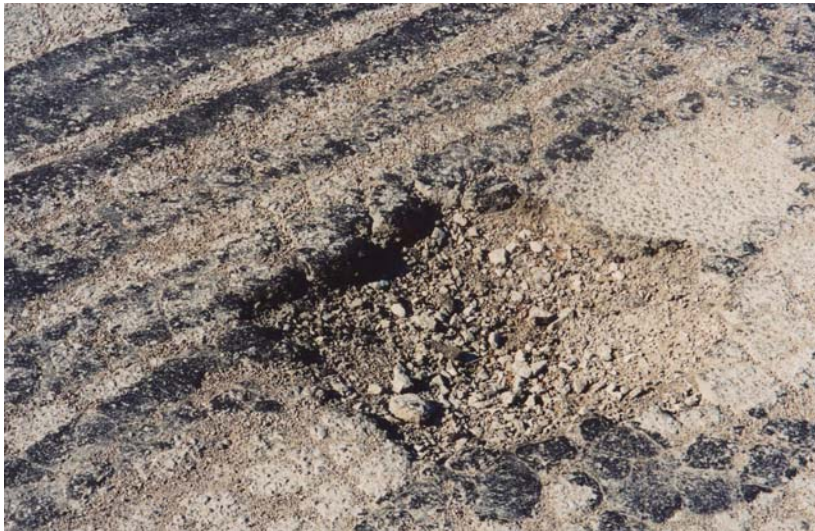
Figure 10b. Pothole (Moderate)

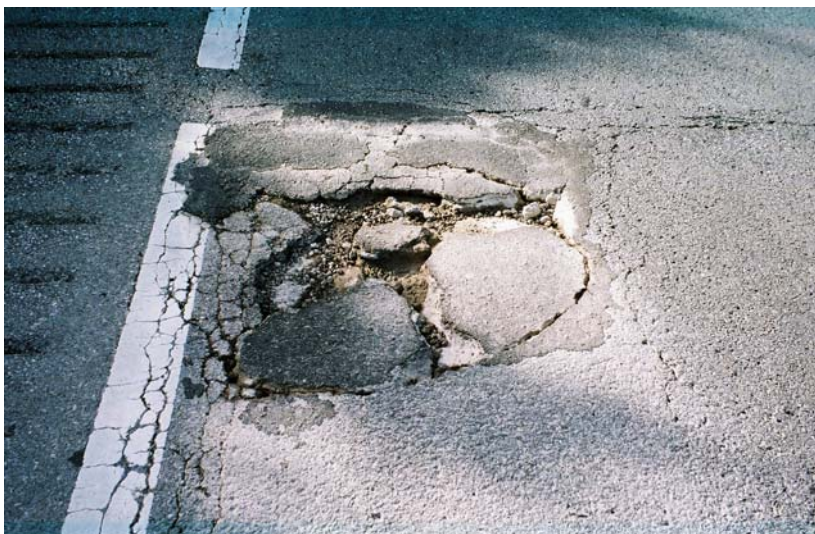
Large holes in pavement which are very deep. Refer to chart below to aid in classifying severity.

Figure 10c. Pothole (Severe)

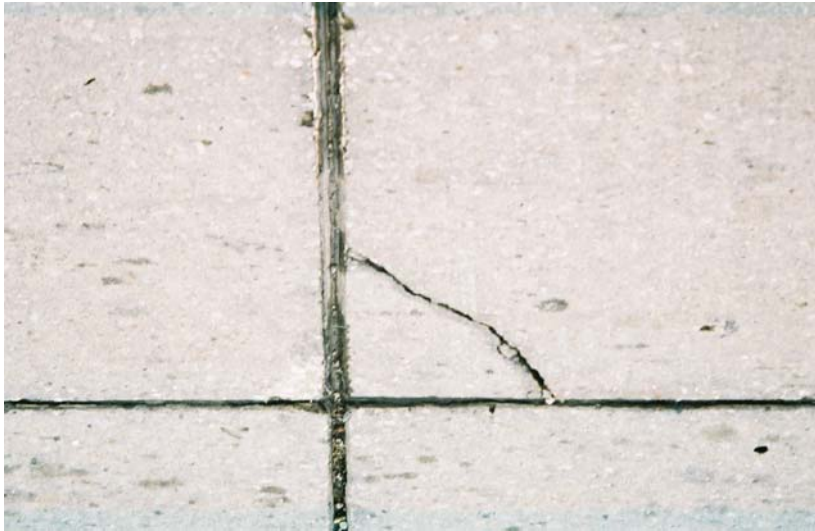
The corner crack shows no signs of spalling or faulting, and there are no broken pieces.

Figure 11a. Corner Cracking (Slight)

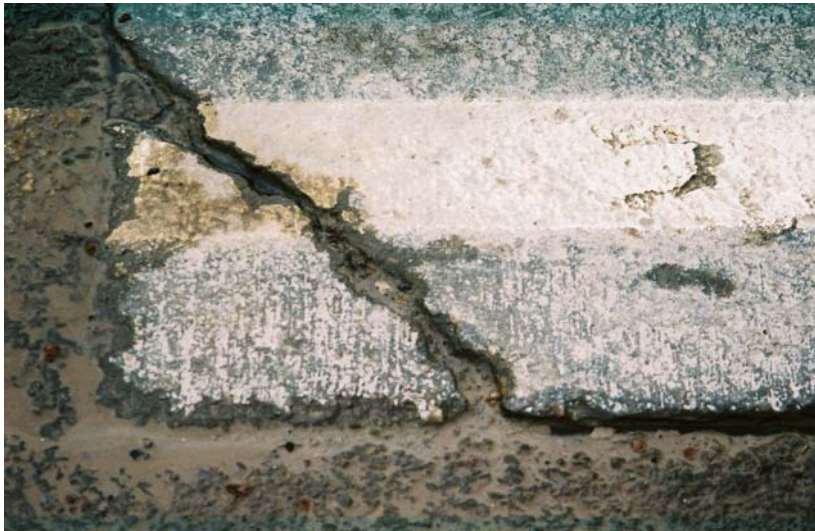
The corner crack displays minimal spalling and faulting, and there are no broken pieces.

Figure 11b. Corner Cracking (Moderate)

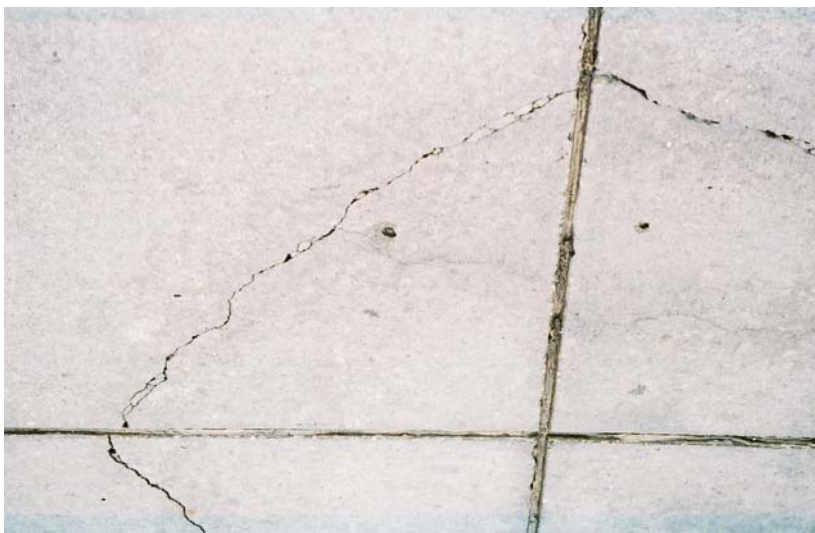
The corner crack shows sign of moderate to severe spalling and faulting, and there may be broken pieces.

Gap > 3/16 inch

Figure 11c. Corner Crack (Severe)

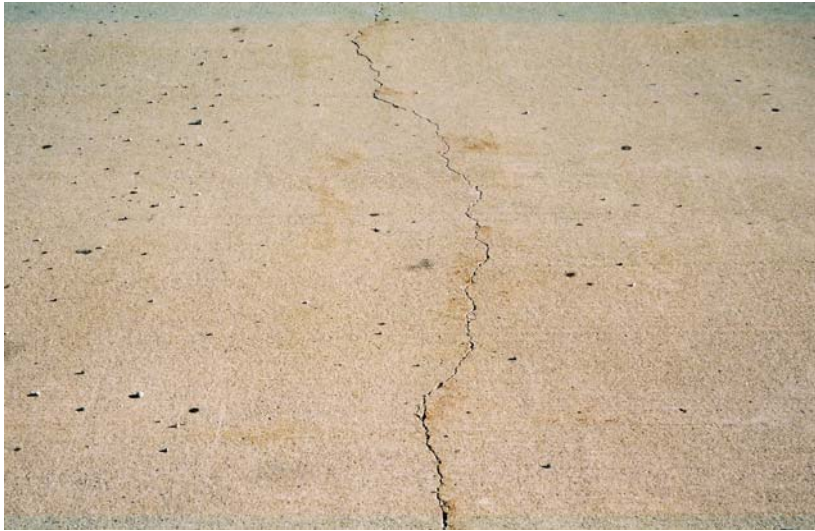
In the early stages of transverse cracking the crack is very faint with little or no pavement separation.

Figure 12a. Transverse Crack (Slight)

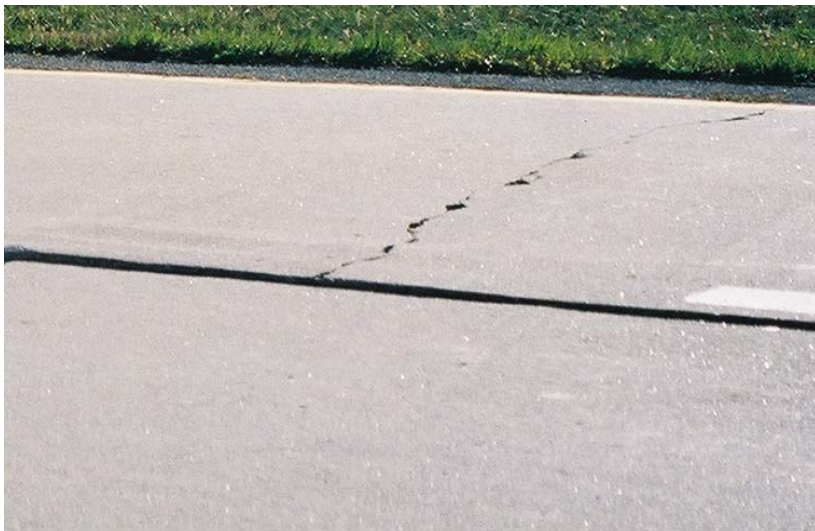
More pronounced transverse cracking is visible. There is more separation and cracks appear to travel deeper into the pavement.

Figure 12b. Transverse Crack (Moderate)

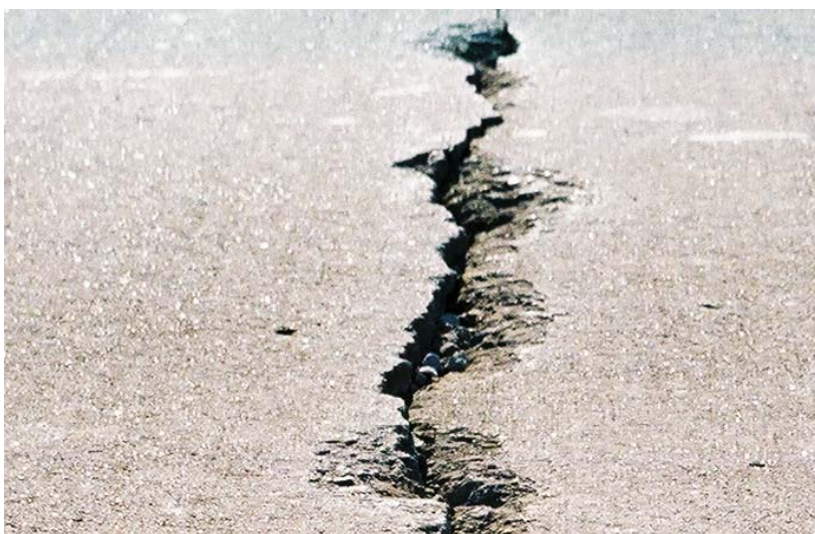
Transverse cracks that are wide and deep. The crack may travel across an entire lane, and usually has areas of spalling or potholing around the crack.

Gap > 3/16 inch

Figure 12c. Transverse Crack (Severe)

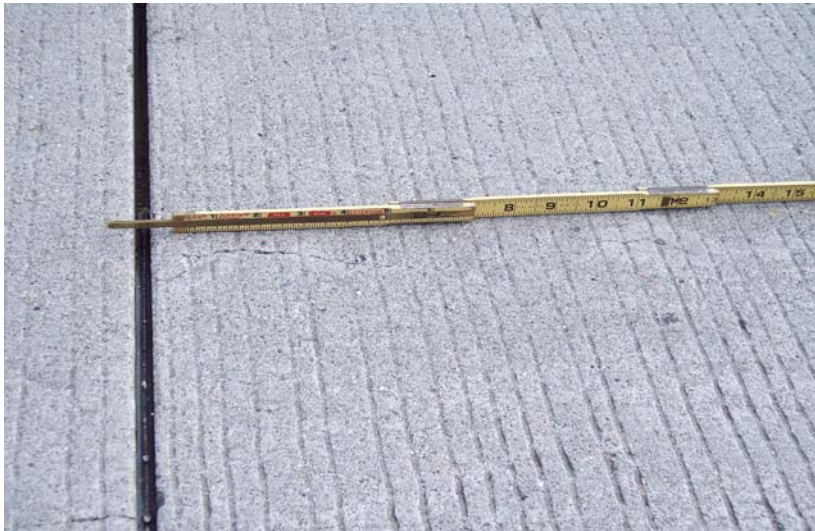
In the early stages of transverse cracking the crack is very faint with little or no pavement separation.

Figure 13a. Longitudinal Crack (Slight)

Cracks traveling parallel with the pavement, usually located near the wheel paths, between wheel paths, or in the centerline of the pavement.

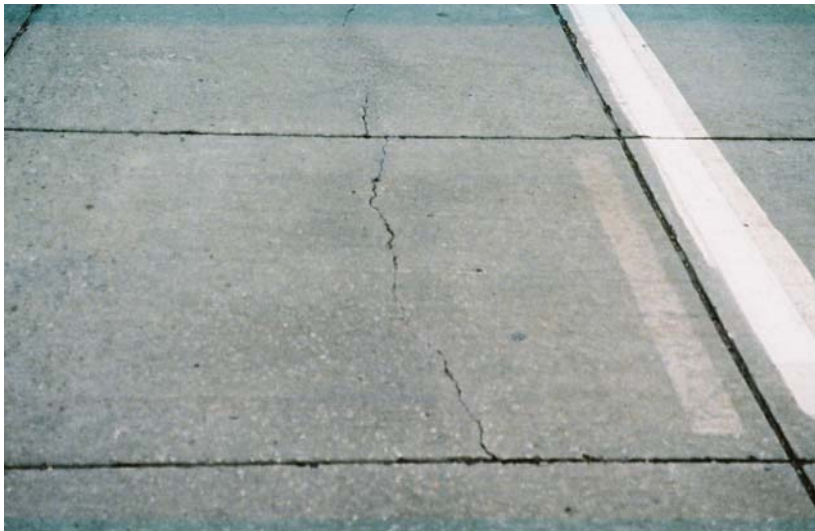
Figure 13a. Longitudinal Crack (Moderate)

More pronounced transverse cracking is visible. There is more separation, and the cracks appear to travel deeper into the pavement.

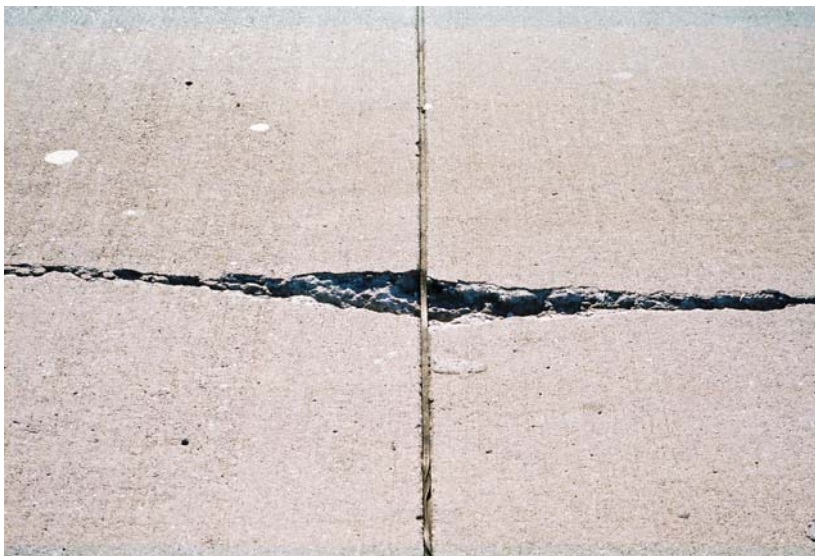
Figure 13a. Longitudinal Crack (Severe)

Transverse cracks that are wide and deep. The crack may travel across an entire lane, and usually has areas of spalling or potholing around the crack.

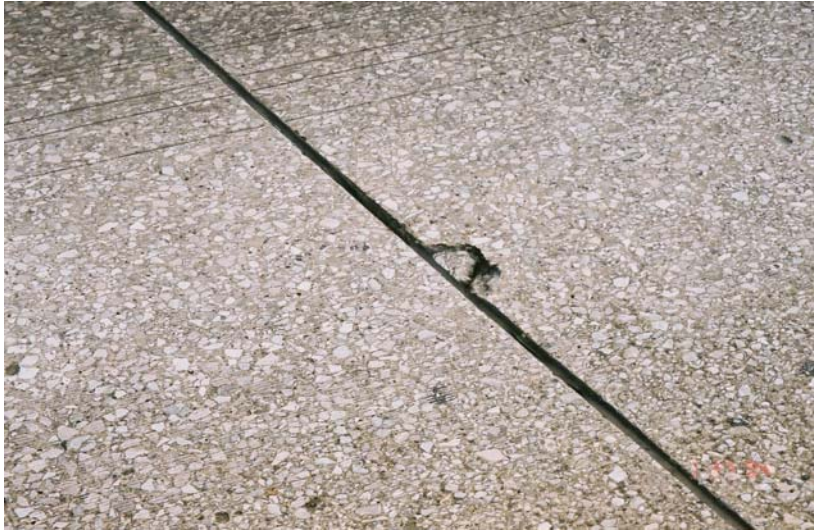
Figure 14a. D Cracking (Slight)

Half moon or D shaped cracks that form along the edge of longitudinal and transverse joints. This is how many of the spalls you see begin. The D shape forms, and over time the D shaped piece pops out leaving a spall.

The D crack is tight, with no spalling present. They are often hard to detect.

D Cracks < 1/32 inch and no spalling

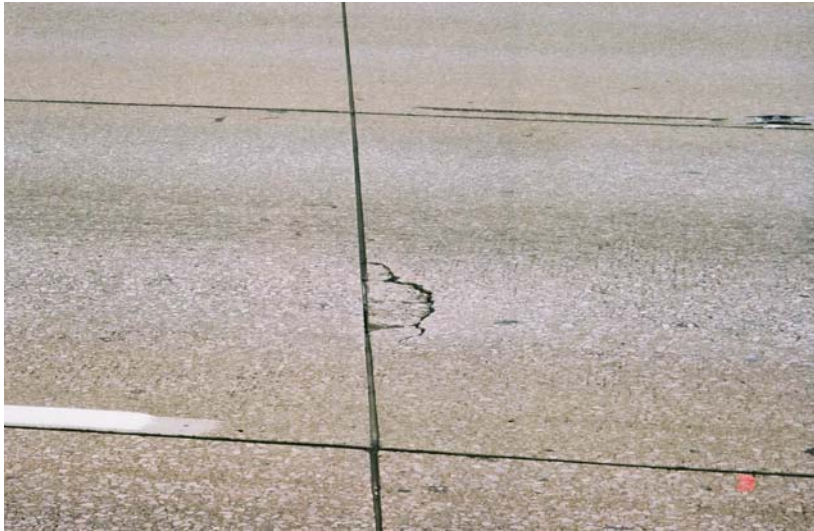
Figure 14b. D Cracking (Moderate)

D cracks > 1/16 inch or spalled width < 3 inch

The D crack will be opened a bit more possibly displaying signs of spalling or faulting. Patching may be present.

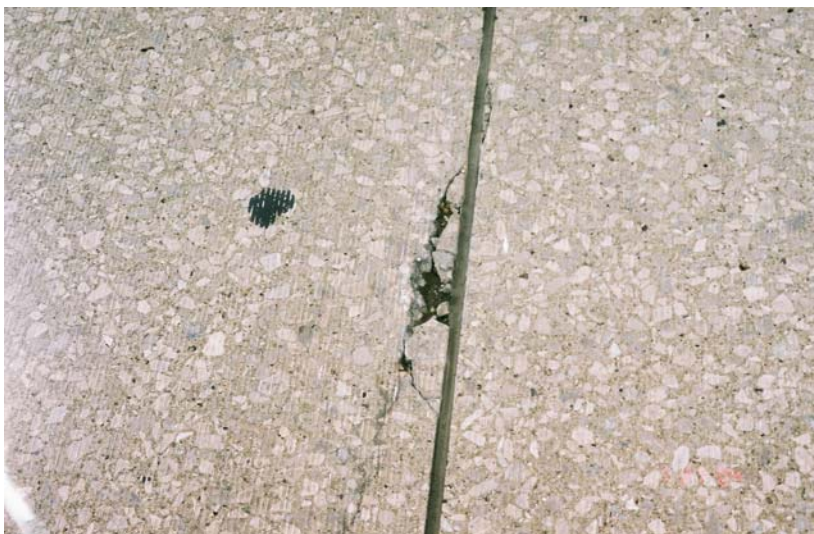
Figure 14c. D Cracking (Severe)

There is heavy cracking with spalling and possibly faulting present. These typically are patched or need to be patched.

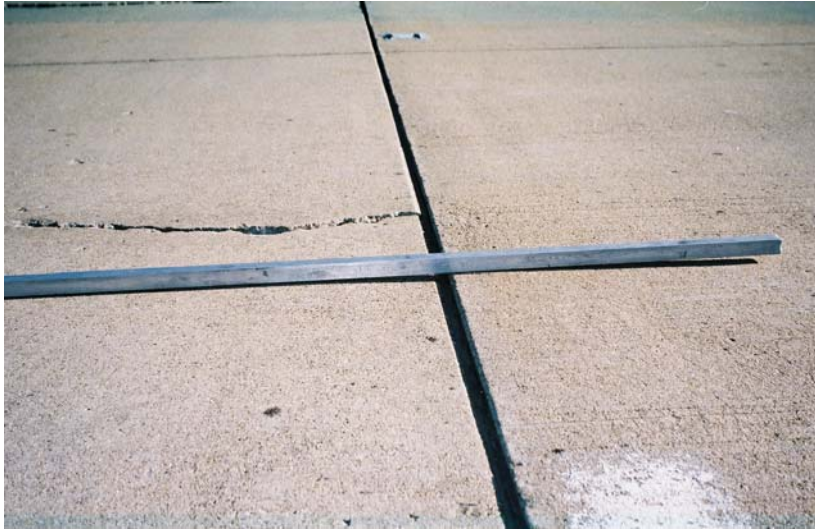
Figure 15a. Longitudinal Faulting (Slight)

One side of a joint or crack will be lower than the other. This offset will cause a disturbance to motorist when changing lanes.

A small drop in elevation across a crack or joint is present.

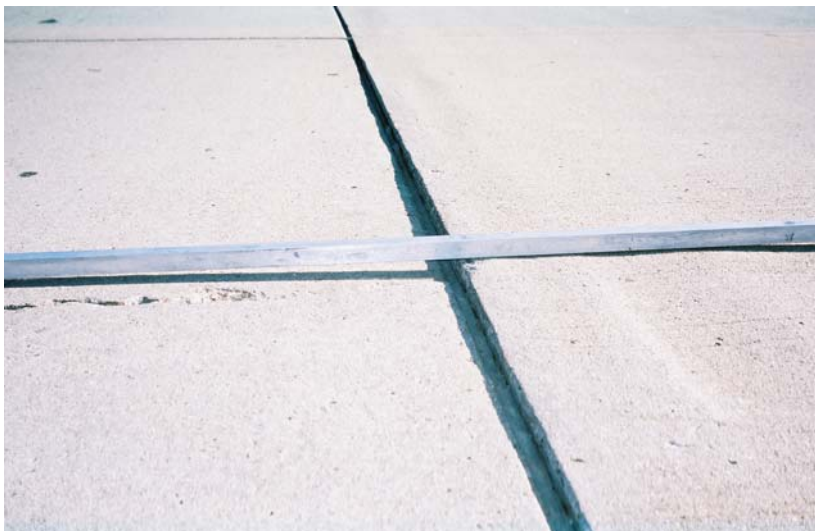
Figure 15b. Longitudinal Faulting (Moderate)

A more noticeable drop in elevation across a crack or joint is visible.

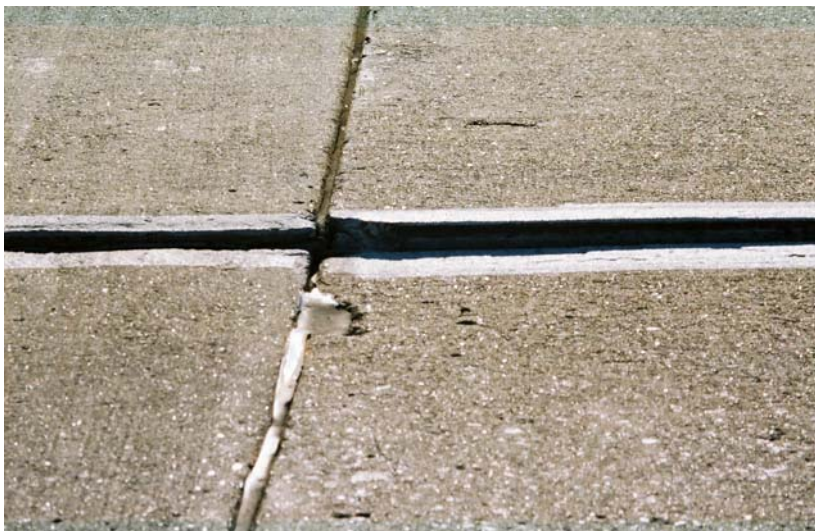
Figure 15c. Longitudinal Faulting (Severe)

A considerable drop in elevation across a crack or joint is seen and felt by the motorist.

> 1/2

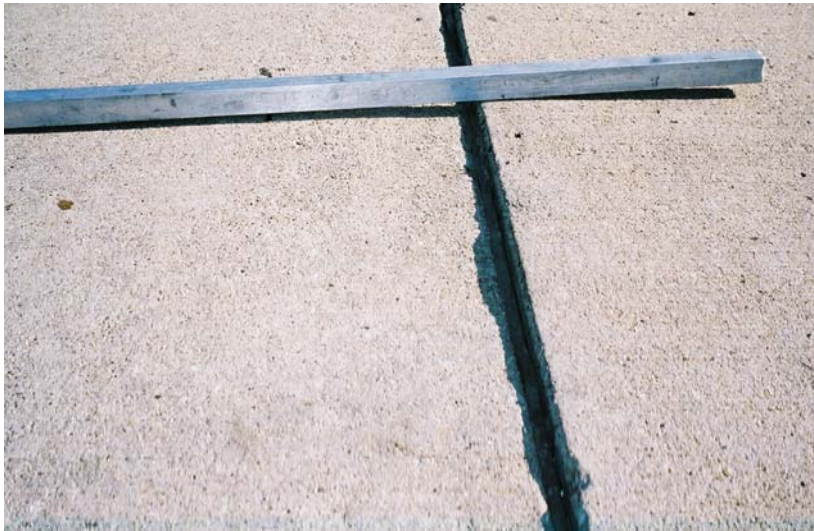
Figure 16a. Transverse Faulting (Slight)

One side of a joint or crack will be lower than the other. This offset will cause a disturbance to motorist when traveling across faulted pavements.

A small drop in elevation across a crack or joint is present.
