**IDENTIFICATION OF PAVEMENT
DISTRESS IN KENTUCKY**

Research Report
KTC-05-29/SPR-267-02-1F

Tim C. Scully Jr,
Transportation Research Investigator

Kentucky Transportation Center
College of Engineering
University of Kentucky
Lexington, Kentucky

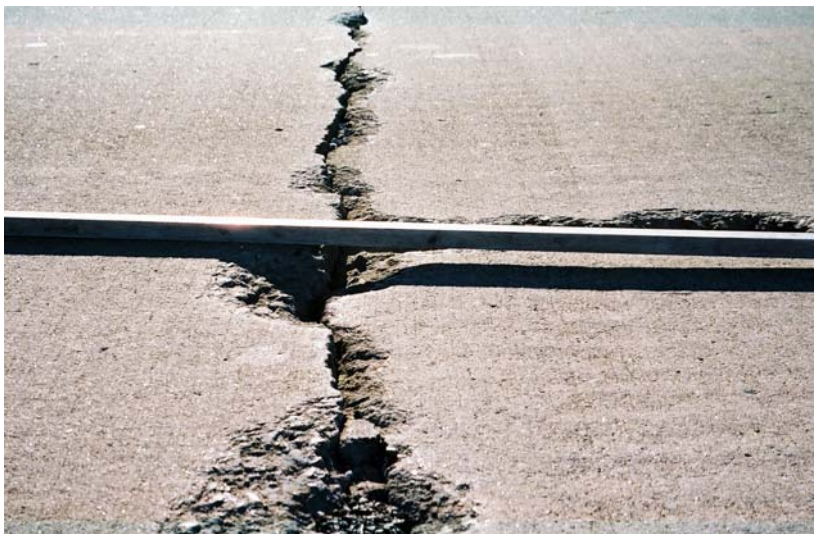
Figure 16b. Transverse Faulting (Moderate)

A more noticeable drop in elevation across a crack or joint is visible.

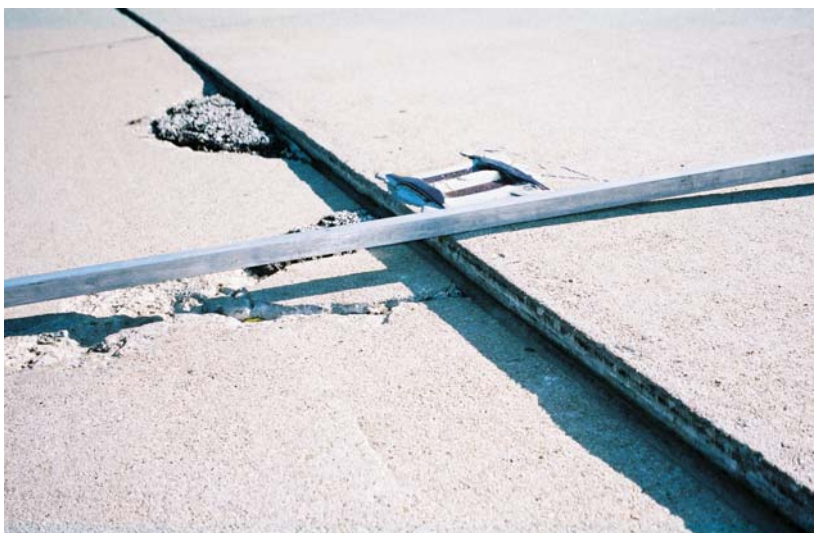
Figure 16c. Transverse Faulting (Severe)

A considerable drop in elevation across a crack or joint is seen and felt by the motorist.

> 1/2

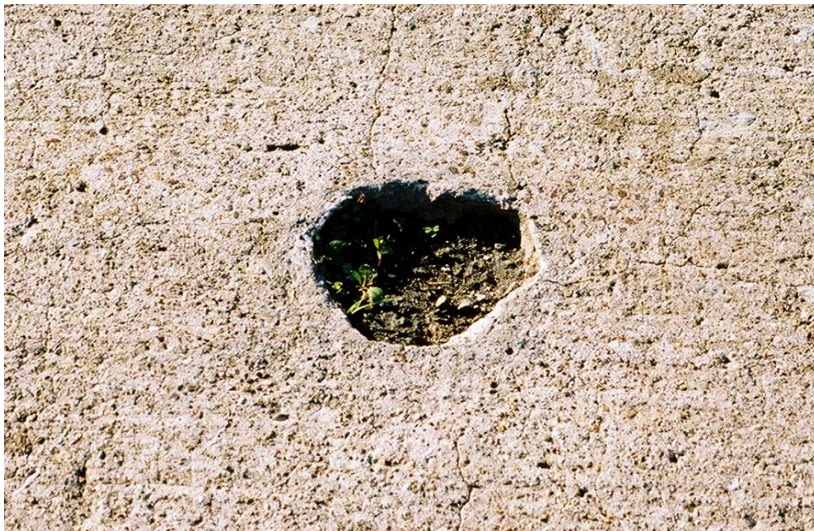
Figure 17c. Pop Out (Severe)

When the hole in the pavement has become rather large and could become a bigger problem.

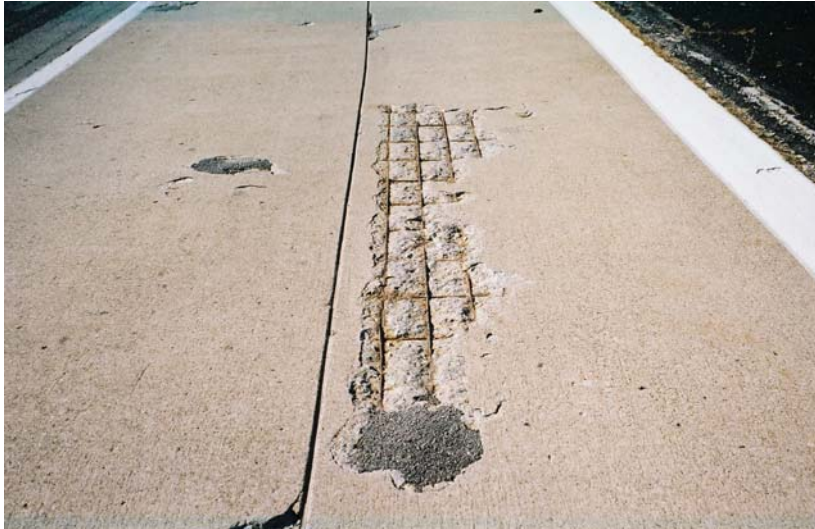
Figure 18a. Spall (Slight)

Spalls usually occur around the joints of concrete pavements, and often begin as D cracks. Once the D crack has developed, the broken aggregate will spall out away from the joint. Spalls can worsen just like the pop out. As a spall fills with debris, and goes through freezing and thawing, the area will deteriorate.

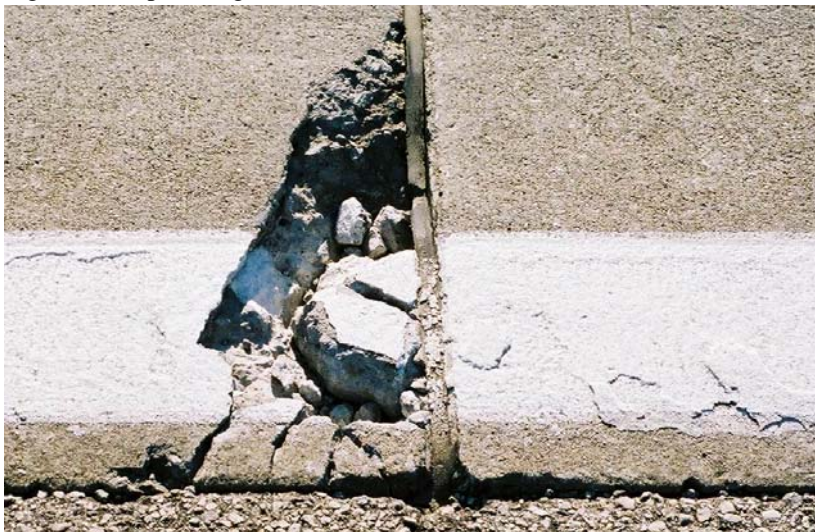
Figure 18b. Spall (Moderate)

Small to medium size pieces of pavement are spalling out, causing bigger voids to appear.

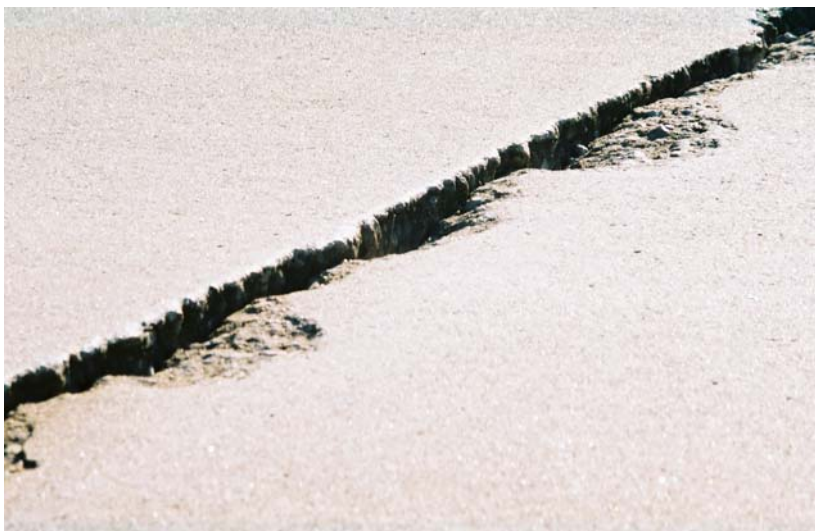
Figure 18c. Spall (Severe)

Large pieces of aggregate are missing, and at this time it is usually time for repairs.

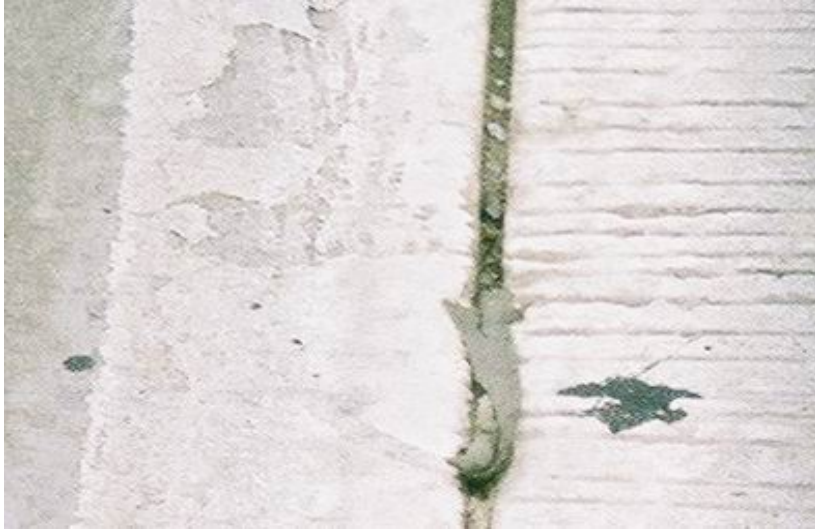
Figure 18 a. Joint Seal Failure (Slight)

Joint seal failure occurs when the seal is displaced. This usually occurs because the joints were not sawed deep enough or can occur when the slabs move back and forth. Either way, this is a serious problem. Once the seal is out of the joint, the joint will fill with debris and begin to spall.

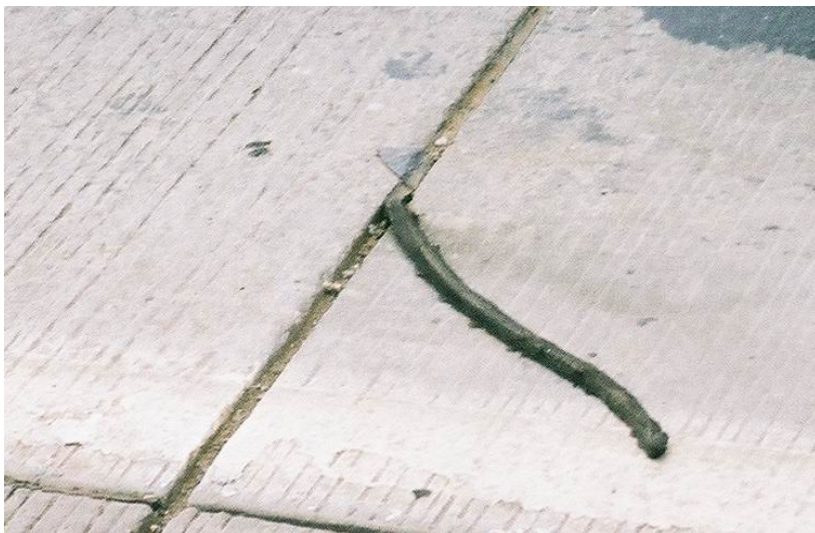
Figure 18c. Joint Seal Failure (Severe)

The seal may be gone completely and the joint will be full of debris.
