### POST EARTHQUAKE INVESTIGATION FIELD MANUAL FOR THE STATE OF KENTUCKY

Research Report  
KTC-06-30/SPR234-01-1F

# POST EARTHQUAKE INVESTIGATION FIELD MANUAL FOR THE STATE OF KENTUCKY

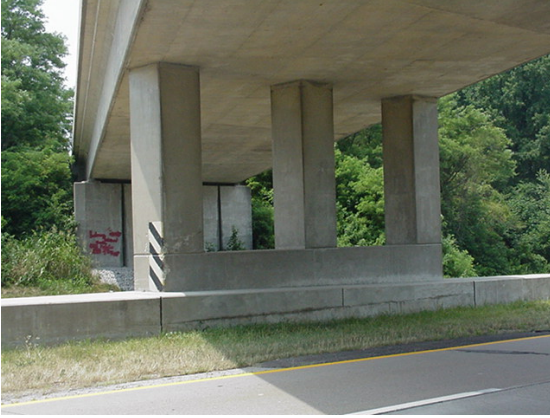
Figure 7  
Cast-in-Place Box Girder Bridge (25)

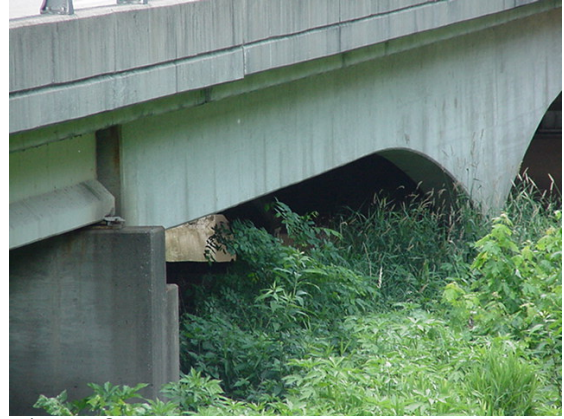
Figure 8  
"Haunched" Concrete Girder Bridge (25)

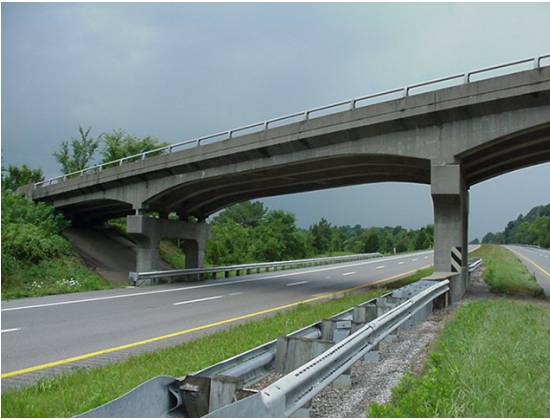
Figure 9  
"Haunched" Concrete Girder Bridge (25)

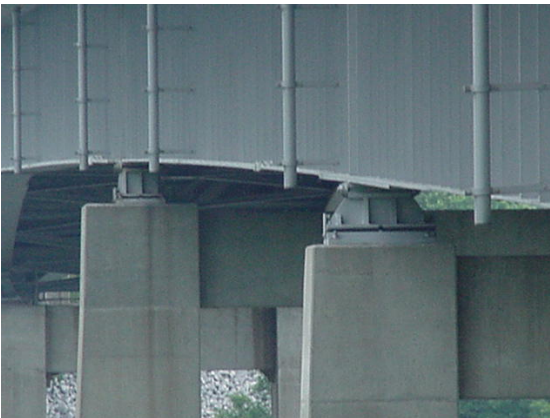
Figure 11  
Continuous Welded Plate Girder Bridge (25)

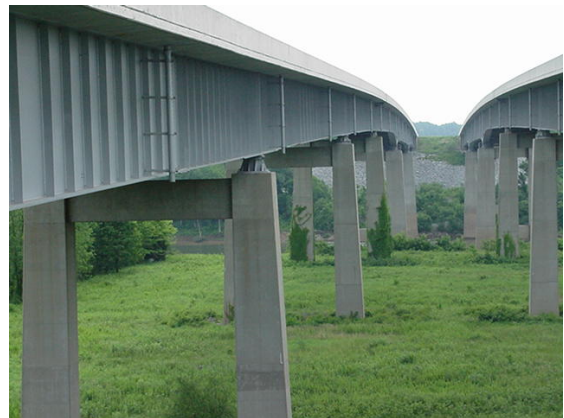
Figure 12  
Continuous Welded Plate Girder Bridge (25)

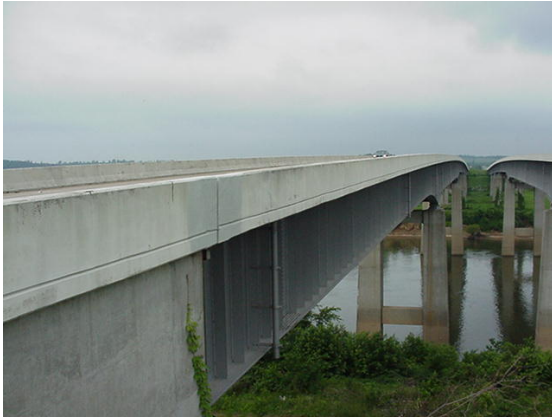
Figure 13  
Welded Plate Girder Bridge (25)

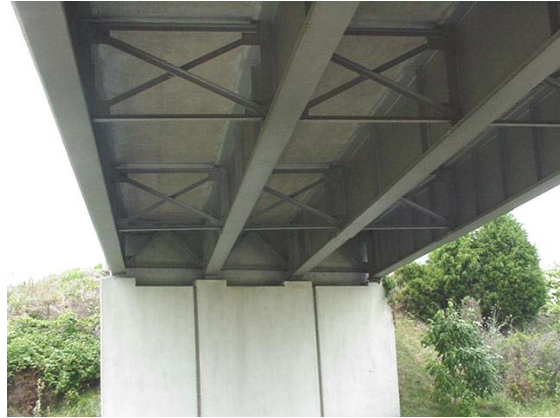
Figure 14  
Welded Plate Girder Bridge (25)

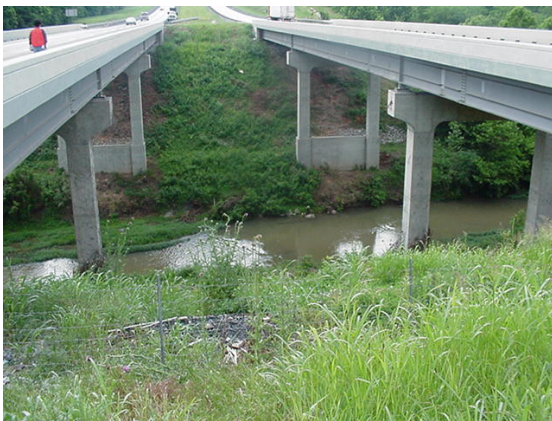
Figure 15  
Welded Plate Girder Bridge (25)

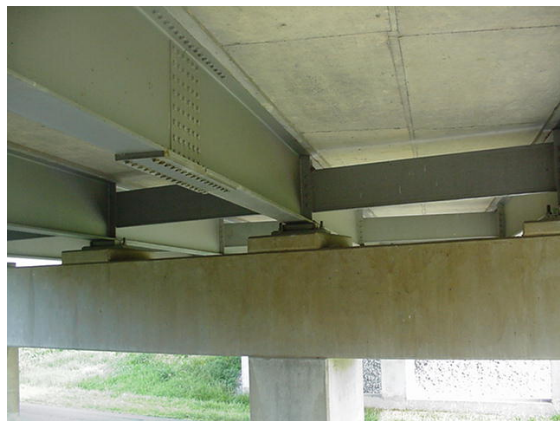
Figure 16  
Welded Plate Girder Bridge (25)

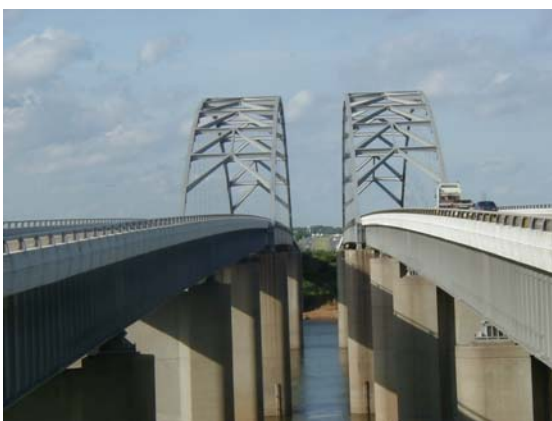
Figure 17  
Plate Girder Bridge with Steel Arch (25)

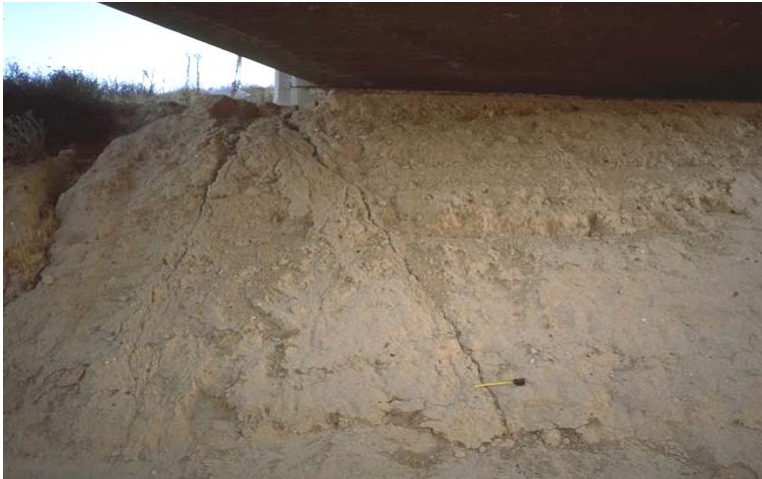
Figure 18 **Minor damage.** Ground crack extending diagonally down slope under the abutment. (1)

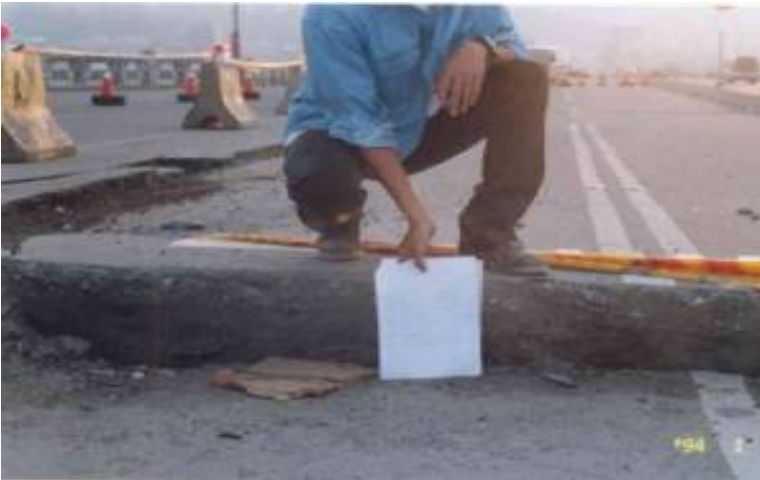
Figure 21 **Moderate Damage.** Approach settlement at the abutment. (2)

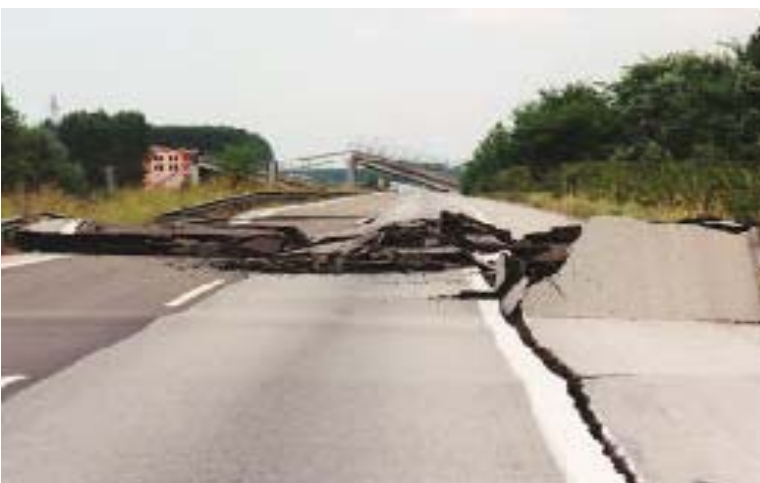
Figure 22 **Severe Damage.** Damage to the roadway due to fault rupture. (3)

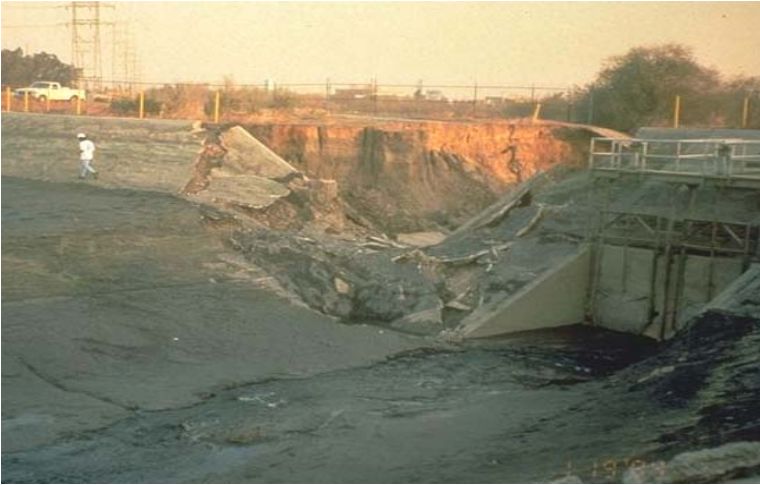
Figure 23 **Total Failure.** Embankment settlement. (1)

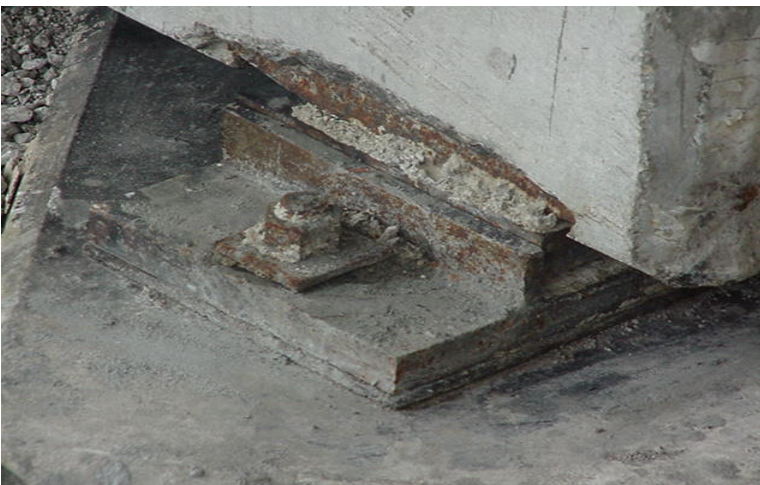
Figure 24 An already corroded “slider” type bearing assembly is susceptible to transverse shearing forces induced by seismic demands and may pose a threat of collapse if the displacements become excessive once sheared. (25)

Concrete spans should be inspected for flexural cracks, shear cracks and spalling at the bearings. Excessive deflection should also be noted, as this would indicate yielded reinforcement or prestressing strands that may not be capable of supporting necessary live loads. In concrete structures it is possible to tap on the section with a hammer and determine its integrity. A resulting high pitch sound indicates that the concrete section is solid, whereas, and a low pitch “thud” indicates the section is cracked. The bearing assemblies should be examined for cracking or spalling concrete. The girders should be inspected for any shifting or misalignment. Typically, precast, prestressed concrete girders are supported on neoprene pads in a formed key or slider type bearings, as shown in Figure 24.

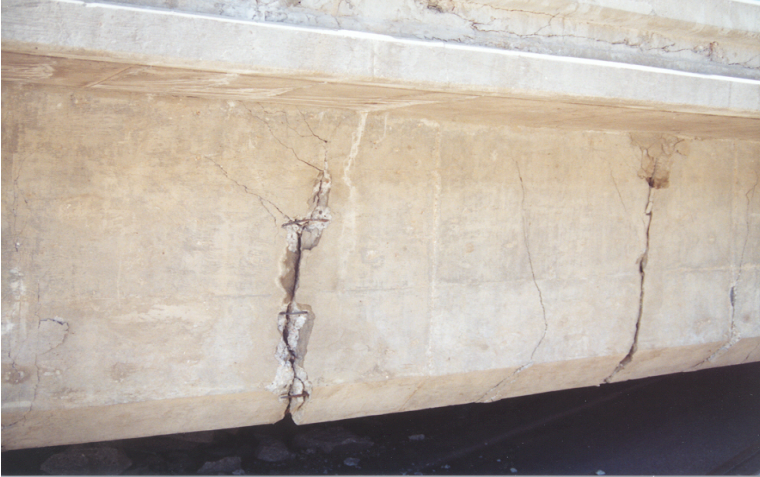
Figure 27 **Moderate Damage.** Flexural cracks in a concrete box girder bridge. (5)

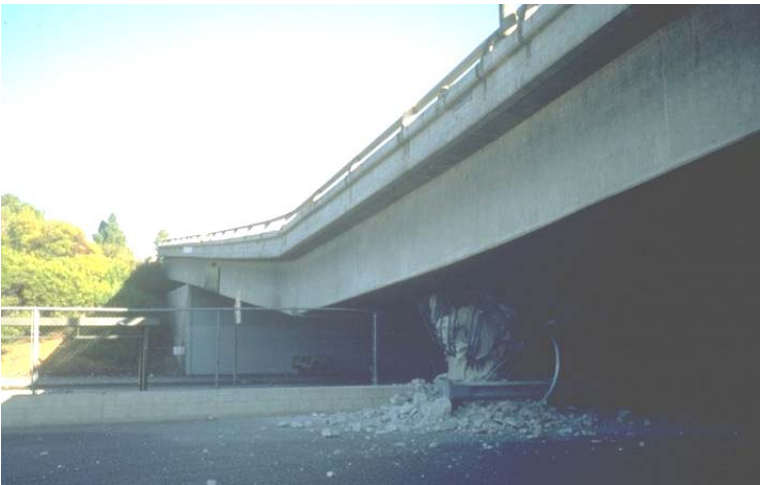
Figure 28 **Severe Damage.** Excessive damage to the superstructure and the substructure has caused partial collapse to the bridge, rendering it unsafe for traffic. (1)

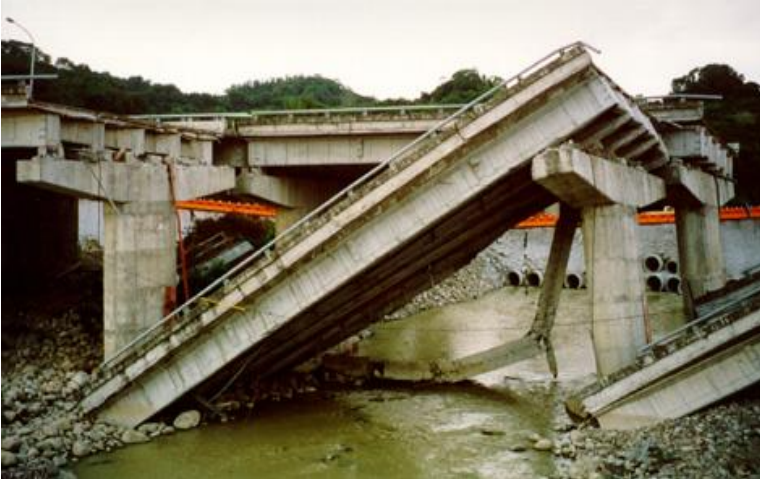
Figure 29 **Total Failure.** Collapse of simply supported precast, prestressed concrete girders. (4)

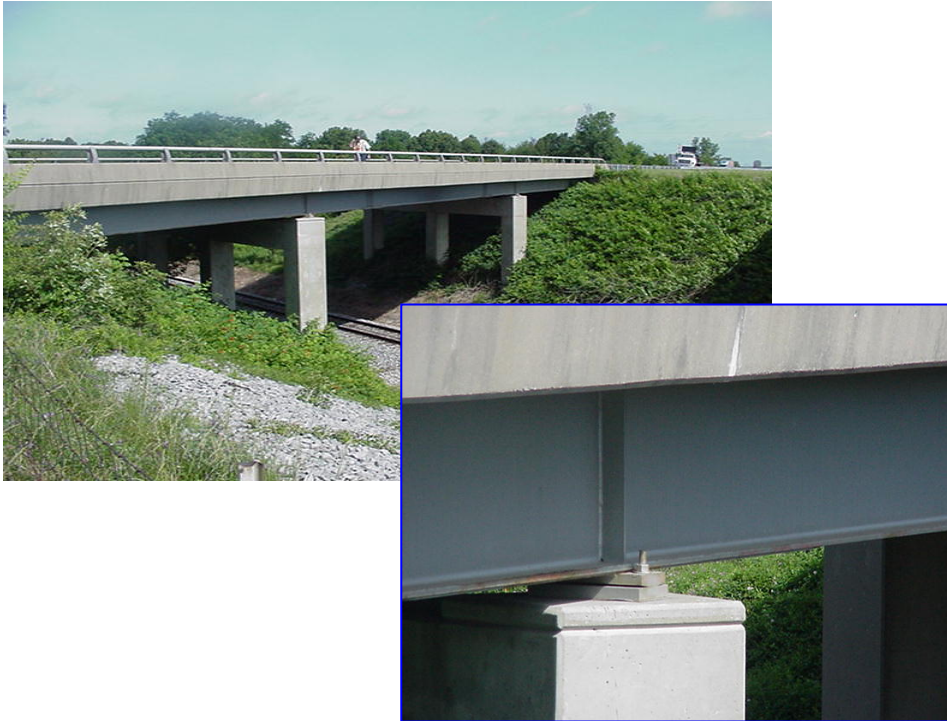
Figure 31 Continuous steel plate girder bridge. (25)

A majority of the steel plate girder bridges in Western Kentucky along Interstate I-24 are multi-span with continuity provided over the supports, as shown in Figure 31, which do not employ the use of “hanger pins”. Because of this continuity, these types of structures provide an added redundancy against seismic attack due to the lack of expansion joints and the possibility of becoming unseated, as would be the case in a simply supported span.

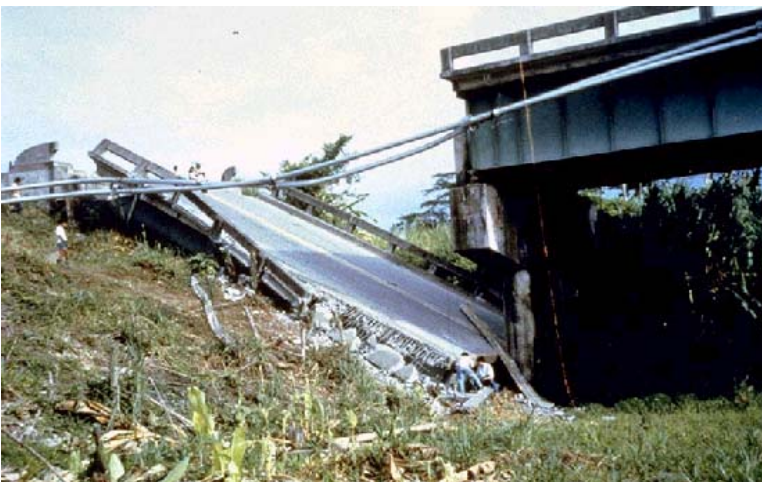
Figure 36 **Total Failure.** Collapse of the simply supported span due to anchor bolt failure and spalling of the concrete cover. (11)

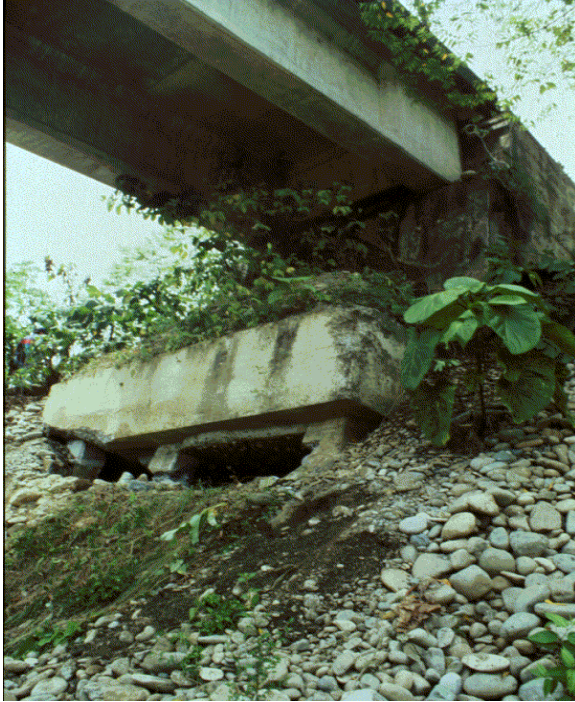
Figure 48 **Severe Damage.** Foundation movement. Longitudinal displacement and rotation of the abutment footing. Notice the flexure and shear failure of the exposed piles. (10)

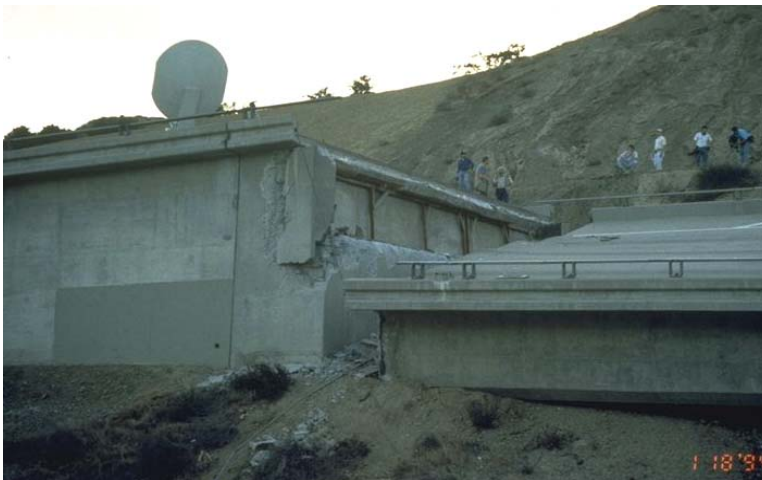
Figure 49 **Total Failure.** The shear key failed and the span unseated at the abutment. (1)

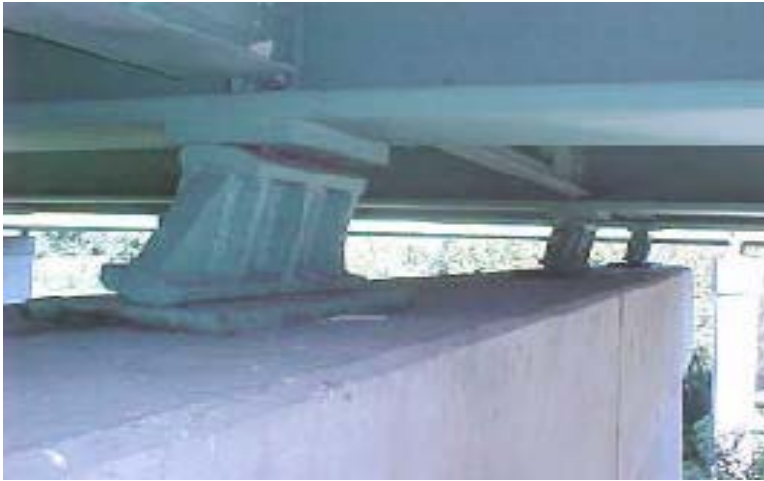
Figure 50 **No Damage.** Movement of the rocker bearing due to thermal loads. (13)

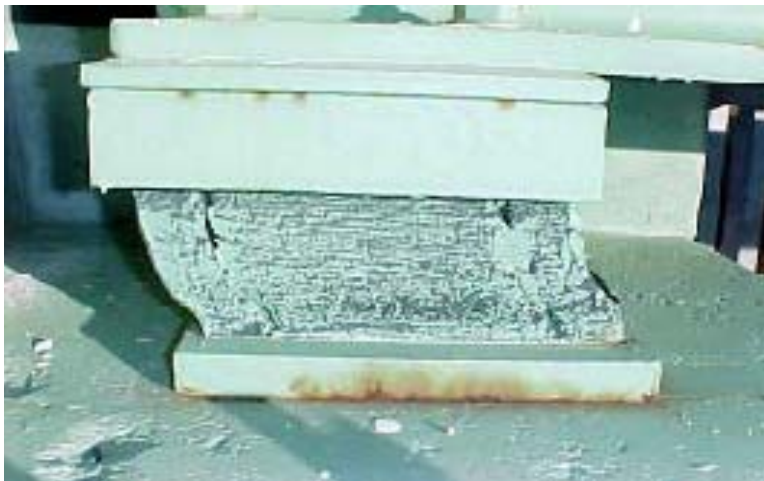
Figure 51 **No Damage.** Movement of the elastomeric bearing under thermal loads. (13)

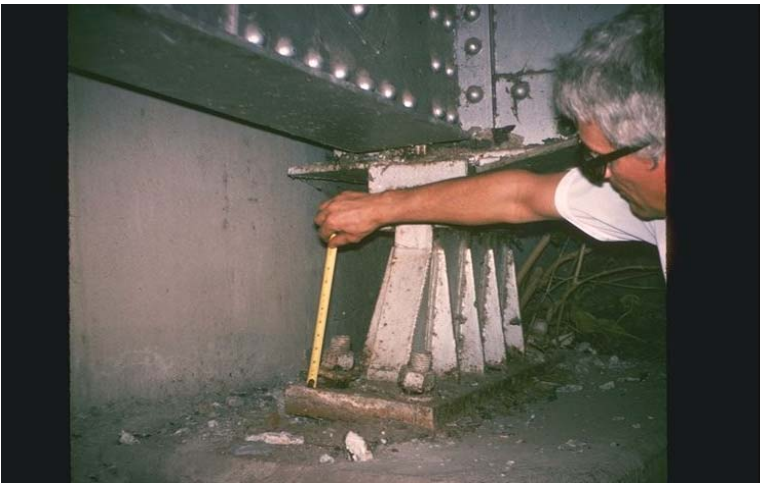
Figure 55 **Moderate Damage.** Crushed bearing assembly. Also note the slightly elongated bolts. (1)

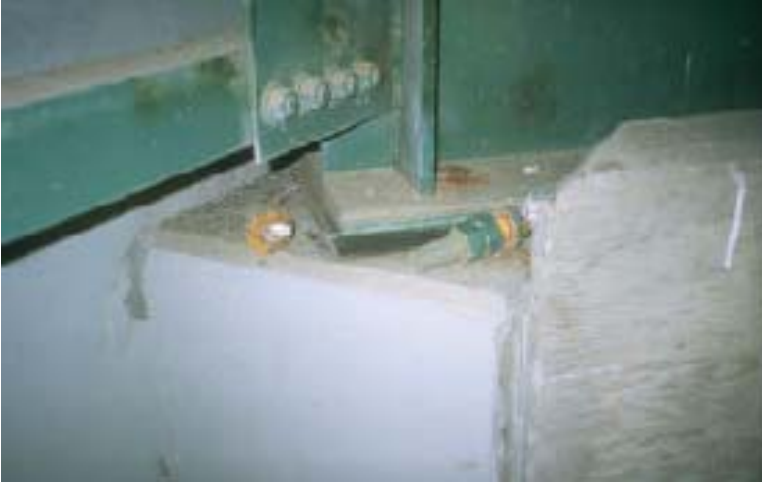
Figure 56 **Moderate Damage.** Sheared anchor bolts. (1)

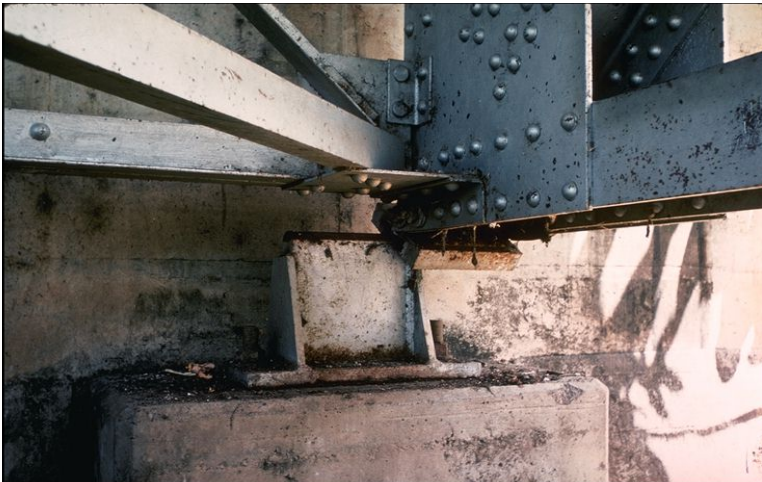
Figure 57 **Severe Damage.** Displacement of the steel girder off the bearing support. (1)

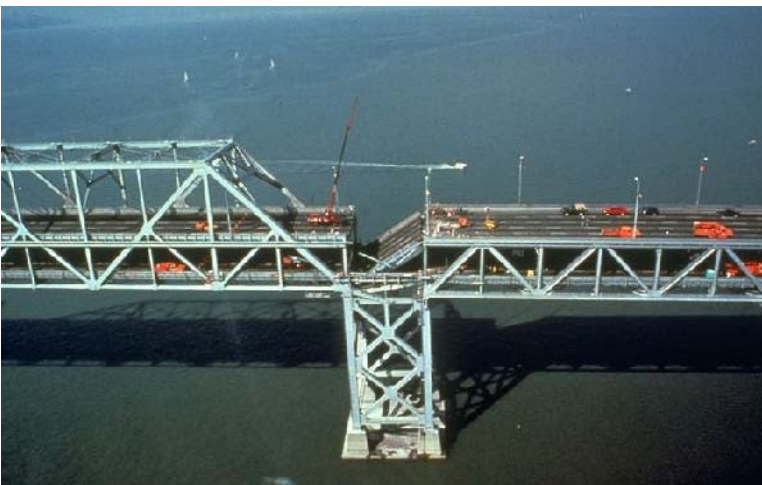
Figure 58 **Total Failure.** Unseating at the expansion joint. (1)

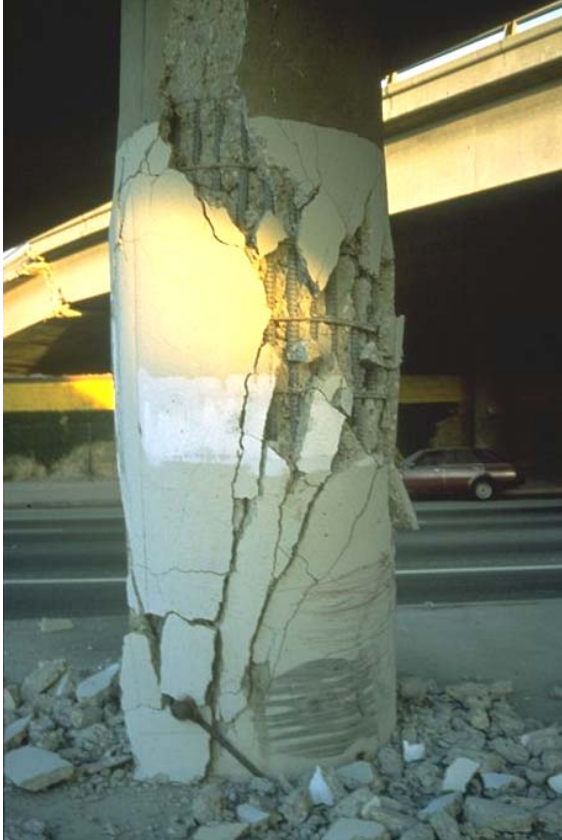
Figure 66 **Severe Damage.** Shear failure in column. (1)
