1. Report No. FHWA/LA-88/210		2. Government Accession No.		3. Recipient's Catalog No.	
4. Title and Subtitle Development of Design Criteria for the Prevention of Slope Failures		5. Report Date March 1990

DEVELOPMENT OF DESIGN  
CRITERIA FOR PREVENTION  
OF SLOPE FAILURES

# DESIGN CRITERIA FOR PREVENTION OF SLOPE FAILURES

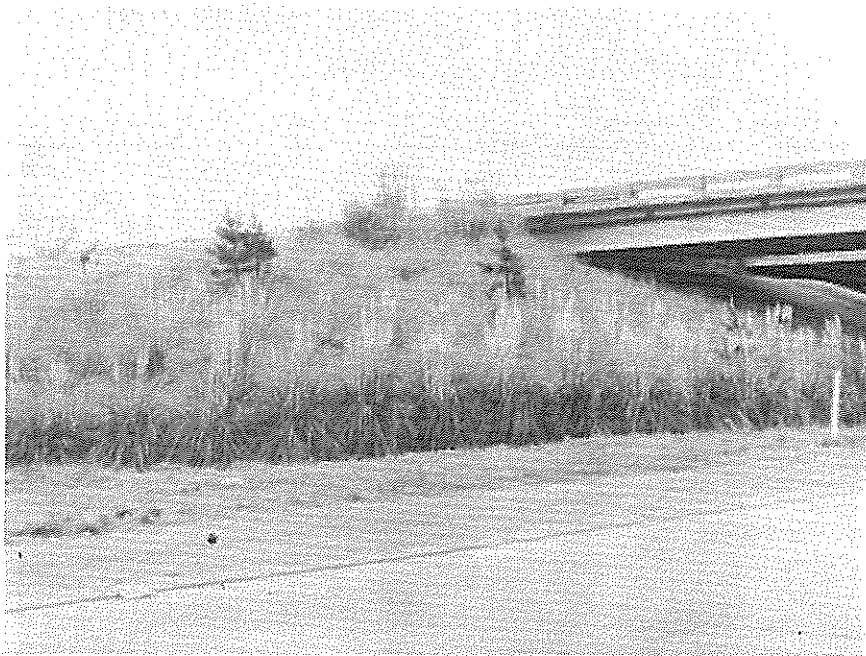
Figure 10. Slope stabilization with exotic vegetation. At this locality S1 in Calcasieu Parish in the I-10 study area, pampas grass has been successfully used to stabilize a repaired slope.

- 1) Do not use pilings to repair slopes that are constructed of high- or intermediate-risk soils. They merely become conduits for moisture to enter the slope and actually increase the chances of slope instability.
- 2) Extend the revetment of overpasses around the sides of the embankment (Figure 9).
- 3) Provide ample drainage to keep water off of the slope.
- 4) Vegetate the slope not with grass, but with pampas grass (Cortaderia selloana) if it is available (Figure 10). Unlike grass, pampas grass will not require mowing and thus will further stabilize the slope.
