EVALUATION OF  
IMS - SWEDISH LASER ROAD TESTER

Final Report

OREGON STATE HIGHWAY DIVISION  
Materials and Research Section  
Salem, Oregon 97301

September 1990

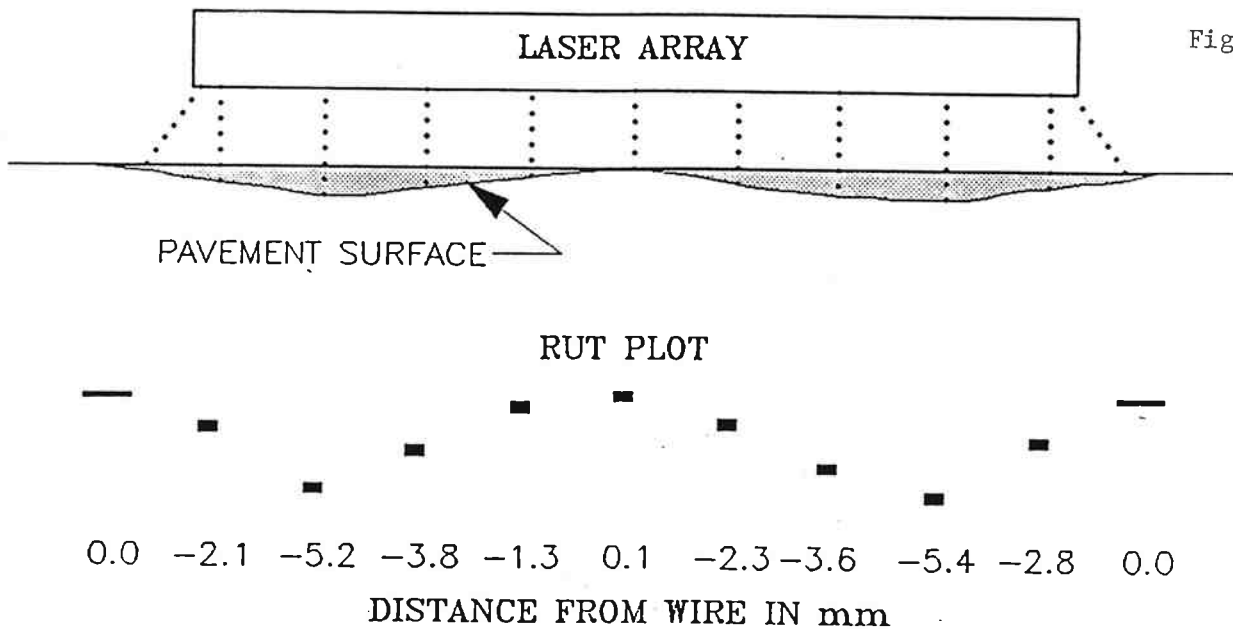
### SAMPLE TRANSVERSE LASER ARRAY AND RUT PLOT

At the end of the test section, an average rut depth is reported and a percentage of distance where the rutting was greater than two operator selected limits (normally 1/2" and 1") is reported. The data is reported in real time. Rut depth is measured by the wire method (see figure 2).
