ICE DETECTION SYSTEMS

Experimental Feature  
Final Report

OREGON STATE HIGHWAY DIVISION  
Research Section  
Salem, Oregon 97310

January 1986

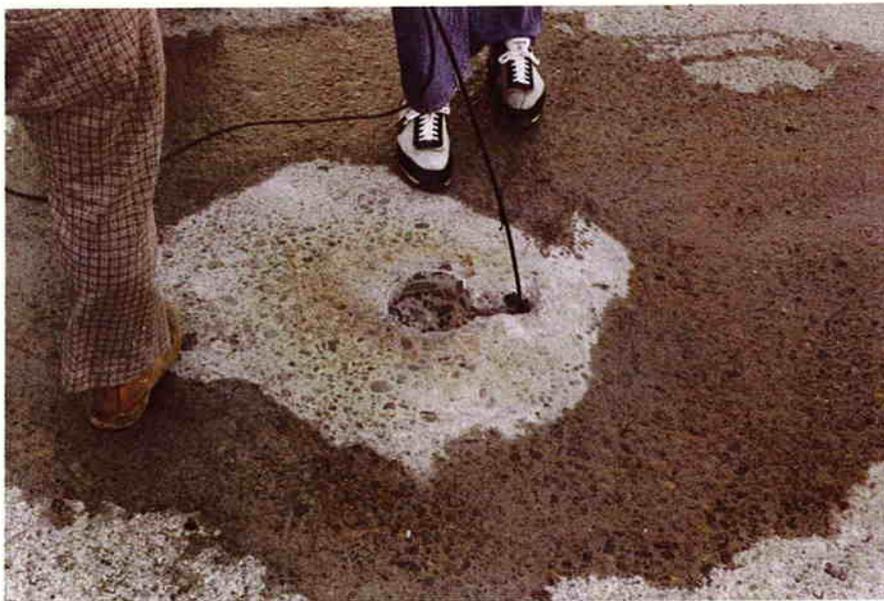
FIGURE 4

Sensor cable, along with ground wire, is passed through deck.

For installation of each sensor, Sensor Setting Compound was rolled into three balls, then stuck to the bottom of the sensor in a tripod pattern. A ground wire was wrapped around the sensor head and passed through the bridge deck with the sensor cable (See Figures 3 and 4) and the sensor placed into a 6" circular cavity, with the head slightly above the surrounding pavement. Using a straight-edged board, the sensor head was then pressed flush with the pavement surface (Figures 5 and 6).

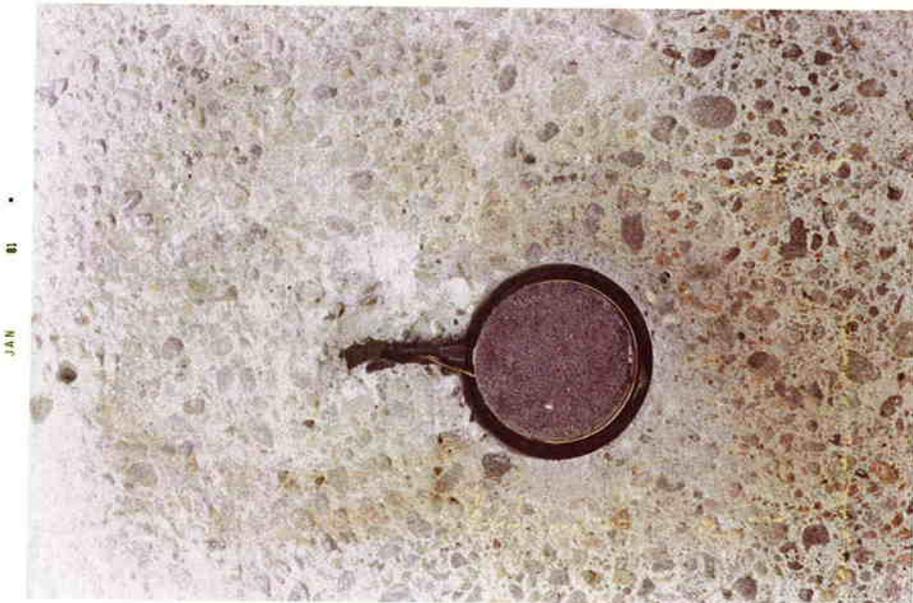
FIGURE 6  
Sensor flush with pavement surface. Note ground wire wrapped around sensor head.

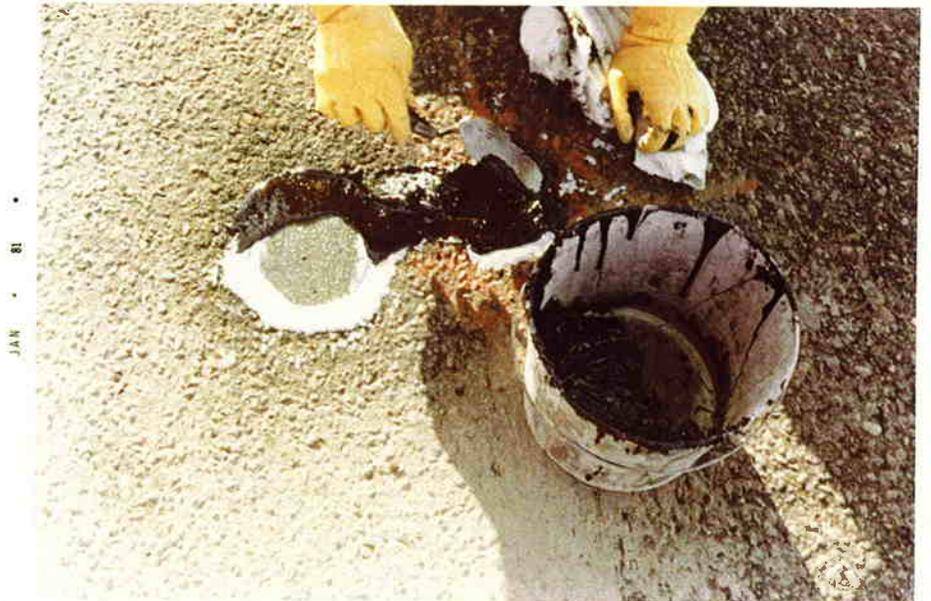
FIGURE 10

...and allowed to set slightly...

Encapsulating epoxy was injected into the sensor cavity so that it flowed under and around the sensor, filling the cavity to within 1/8" of the surface (Figures 7 and 8). After it set up (approximately 15 to 45 minutes) leveling epoxy was troweled around each sensor (Figures 9 and 10) and allowed to set slightly before a thin layer of sand was applied (Figure 11). This sand was allowed to "cure" into the epoxy.

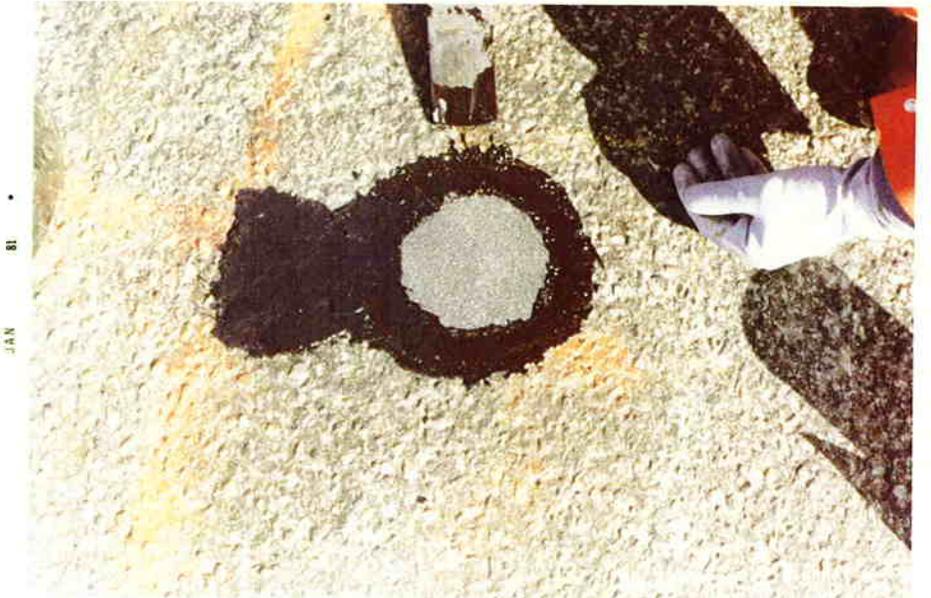
FIGURE 11

...before a thin layer of sand was applied. This sand was allowed to "cure" into the epoxy.
