Florida Department of Transportation Research

Damage Detection and Repair Methods for GFRP Bridge Decks

BDK75 977-17

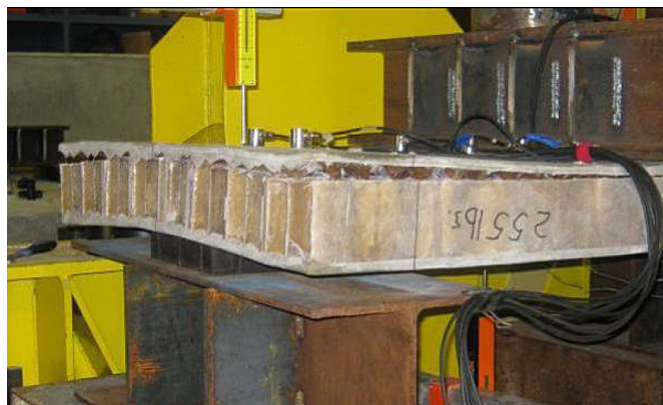
A section of GFRP deck is loaded to failure in a laboratory setup.

Three commercial GFRP bridge decks were tested in both positive and negative bending in a three-point loading setup. Each specimen was subjected to sequential load tests consisting of service, ultimate, then service. Load steps were separated by a brief load reduction to allow observation of Kaiser and felicity effects during reloading. Two AE analysis methods, intensity analysis and relative ratio analysis, were used to evaluate the data. Intensity analysis did not provide sufficient discrimination between damaged and undamaged states, but relative ratio analysis provided sufficient discrimination to allow development of criteria for laboratory testing. A modified form of relative ratio analysis was also used to analyze selected AE data from a bridge load test.
