DEVELOPMENT GUIDANCE FOR SIGN DESIGN STANDARDS

Test Report 0-6363-1

Project Title: Improvements to Large and Small Roadside Sign Hardware and Design

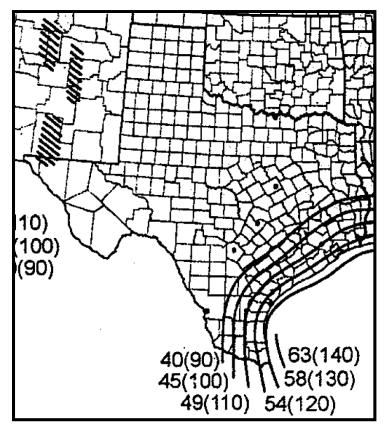
Figure 2.1. Texas Isotachs Wind Load Chart.

The design wind pressure is based on the basic wind speed and the anticipated design life of the structure. The basic wind speed is associated with the annual probability of 0.02 (or a 50 year mean recurrence interval), and is prescribed by isotachs contained in the AASHTO *Standard Specifications for Structural Supports for Highway Signs, Luminaires and Traffic Signals*. Figure 2.1 shows that the basic wind speed varies with geographical location across Texas and ranges from 90 mph to 130 mph near the coast. The current basic wind speed is modified by an importance factor based on the recommended minimum design life of a structure. The recommended minimum design life for roadside sign structures is 10 years.

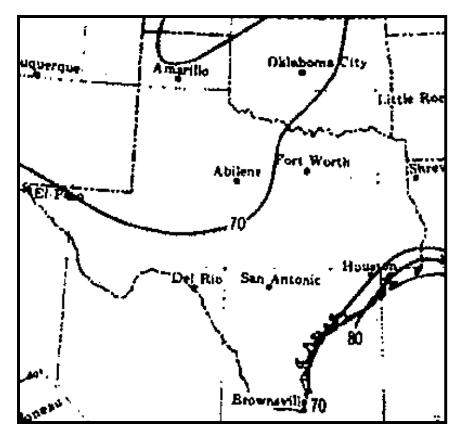
Figure 2.2. Appendix C: 10-Year Recurrence Interval Wind Load Chart.

The design wind pressure is based on the 10 year recurrence (based on design life) interval wind speed. The 10-year recurrence wind speed is prescribed by isotachs contained in Appendix C of the AASHTO *Standard Specifications for Structural Supports for Highway Signs, Luminaires and Traffic Signals*. Figure 2.2 shows the basic wind speed varies with geographical location across Texas and ranges from 60 mph to 80 mph near the coast. Again, the recommended minimum design life for roadside sign structures is 10 years.

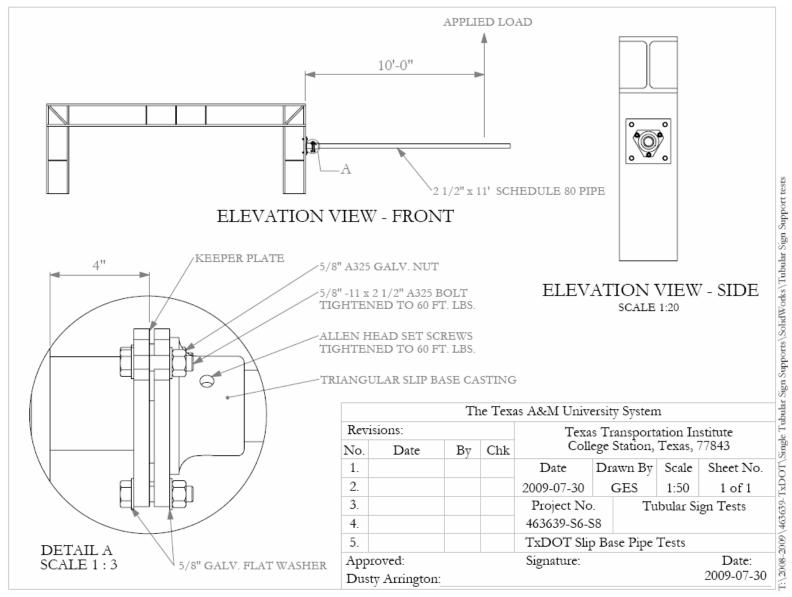
Figure 3.1. Schedule 80 Support Static Testing Setup.

To determine the maximum allowable force, three static tests (S6-S8 as described in Appendix A) on schedule 80 support posts were preformed utilizing standard slipbase connections. Each static test consisted of a cantilevered slipbase connection attached to a rigid load frame. An 11-ft, 2.5-inch schedule 80 sign support was then inserted into each slipbase, which was installed with standard hardware. Each test article was then loaded perpendicular to the support post at an effective height of 10 ft. Deflection was also recorded at the point of load application. Each test sample was then loaded until the article failed or the load reached a maximum and then began trending downwards. Figure 3.1 shows the test setup of this series of testing.

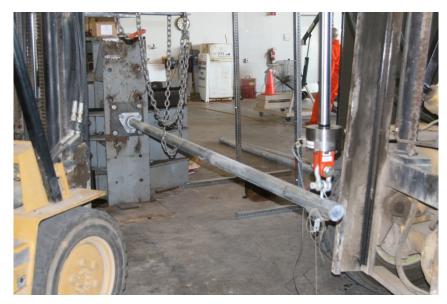
Figure 3.2. Schedule 80 Support Static Testing Setup before Load Application.

Figure 3.2 shows the test setup before load application, and Figure 3.3 shows the test setup at the point of maximum loading. Table 3.1 presents a summary of recorded loads. The testing resulted in an average failure load of 1022 lb. All three tests yielded the post support plastically at the slipbase interface. Notice that all the recorded failure loads are within 10 percent of the average failure load meeting the AASHTO requirement of a maximum allowable 681-lb wind load.

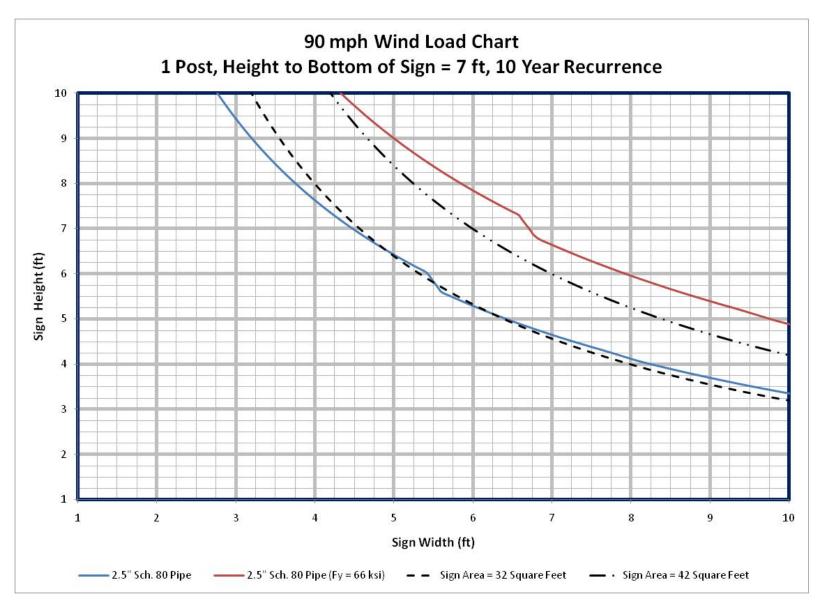
Figure 3.4. Updated Schedule 80 Wind Load Chart (Current Pressure Method).

Figure 3.4 is a wind load generated using two basic yield stresses. This wind load chart was generated using the current method of calculating wind pressures, not the legacy method described in Appendix C of the current AASHTO *Standard*. All calculations represented in this chart assume a 7 ft mounting height of the sign. The calculations also assume a 10-year recurrence interval (standard practices for roadside sign supports). The blue line represents the capacity of a 2.5-inch schedule 80 support post assuming a yield stress equal to 46 ksi (TxDOT's minimum requirement). The red line represents the 2.5-inch schedule 80 support post assuming a yield stress equal to 66 ksi (actual test sample values).

Using the maximum allowable design wind load force (681 lb) from the static testing above and an assumed sign area of 42 ft², the support can sustain a wind pressure of 16.2 lb/ft². A 90 mph wind speed, assuming again a 6 ft tall sign mounted at 7 ft height, results in a wind pressure of 16.4 lb/ft² (total wind force of 689 lb). This again leads to the conclusion that the test samples would be capable of sustaining a 42 ft² sign.

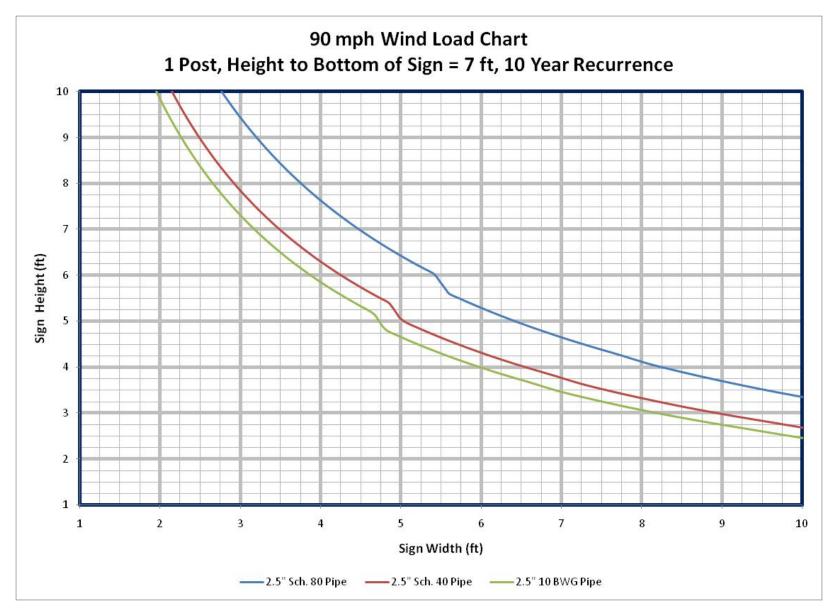
Figure 4.1. 2.5-Inch Pipe Support Wind Load Chart Comparison (Current Pressure Method).

Using the section properties detailed in Table 4.1 and the current wind pressure method described in AASHTO, the research team generated wind load charts (see Figure 4.1) for all three 2.5-inch pipe sections (10 BWG, schedule 40, and schedule 80) to demonstrate their relative capacities. Furthermore, Figure 4.1 shows that the schedule 40 pipe support does fall between the 10 BWG and the schedule 80 sections. However, the capacity is fairly close to that of the 10 BWG, showing that there will be only a few instances where a schedule 40 could be used instead of a schedule 80 support.

Cost per foot values were collected for each of the three sections for a cost comparison. The schedule 80, schedule 40, and 10 BWG cost \$9/ft, \$5/ft, and \$3/ft, respectively. Therefore, a schedule 40 support costs 67 percent more than a BWG 10 and is only 8 percent stronger. The minor increase in strength is due to the wide variance in minimum yield stress values between the two materials used to fabricate the supports. Schedule 40 sections have a minimum yield stress value of 42 ksi, whereas a 10 BWG has a minimum stress value of 55 ksi. Again, if TxDOT required the minimum yield stress values for the schedule 40 sections to exceed 55 ksi, the gap between the wind load chart lines would increase substantially, making the option of inventorying the schedule 40 section more palatable to local districts.

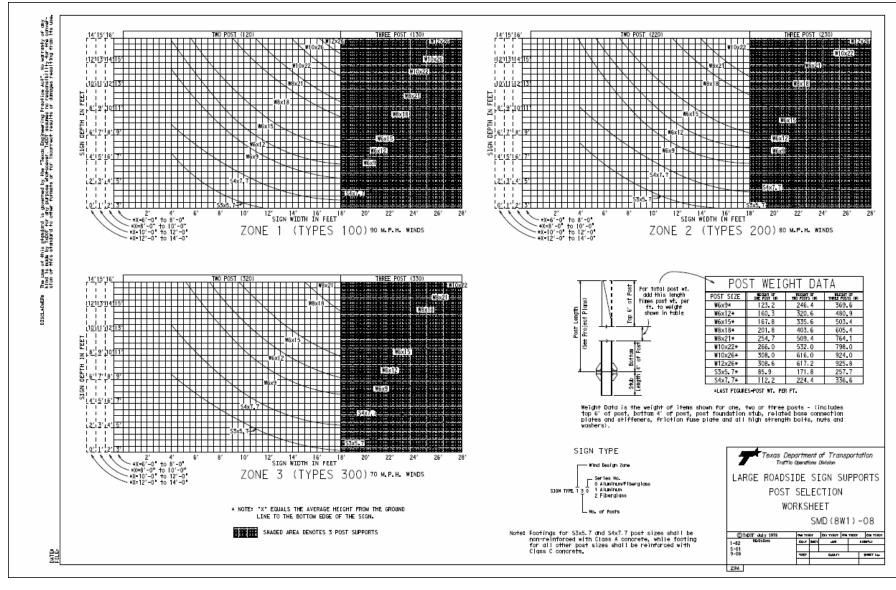
Figure 5.1. Current TxDOT Large Guide Sign Wind Load Charts.

Current large guide sign support selection charts were obtained from TxDOT's standards website for review. Figure 5.1 is an image of the current standard obtained. Figure 5.2 is an enlarged image of Zone 1 of the current selection chart. This chart was developed many years ago, and there is no record of who developed it or how it was developed. Therefore, to evaluate this chart's accuracy, new wind load charts were generated using the current support specifications according to the legacy wind pressure method detailed in Appendix C of AASHTO *Standard*. Figure 5.3 shows the resulting chart, which assumes the same conditions defined by Zone 1 (90 mph wind speed) of the TxDOT support selection chart. Also, Figure 5.3 assumes a 7-ft mounting height and that the sign is mounted on two support posts.

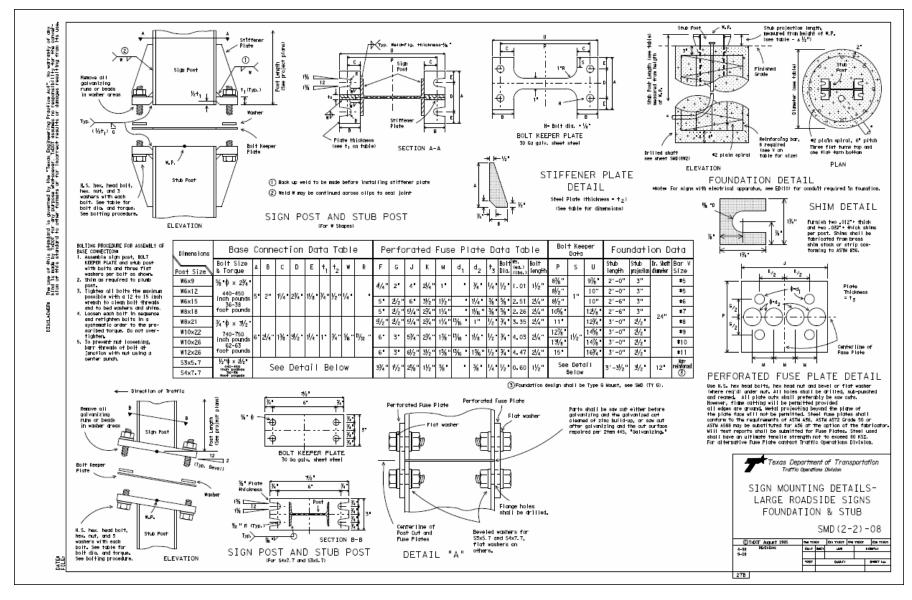
Figure 5.4. Current TxDOT Large Guide Sign Supports Slipbase and Fuse Plate Details.

The answer lies in the fuse plate capacity. Figure 5.4 is an image of the current TxDOT standard detailing the slipbase and fuse plate connections. Table 5.1 is an enlarged image of the design table detailing the sizes of each of the components corresponding to each support section's size. Also, Figure 5.4 is the current generic fabrication diagram for all fuse plate designs; the sections that have equivalent wind load capacities share the same fuse plate details. Researchers conducted further investigation into the cause of the phenomena.

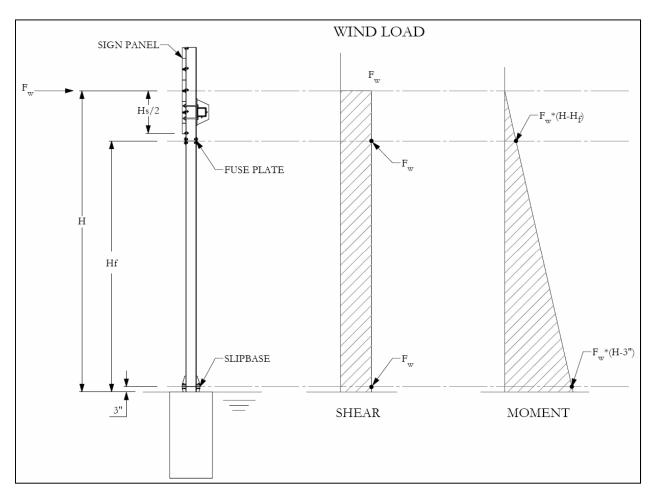
Figure 5.6. Large Guide Sign Support Force Diagram for Wind Load Condition.

Figure 5.6 is a diagram showing the forces resisted by the support section under a wind loading event. The shear force is constant across the length of the support. However, the moment increases linearly until it reaches a maximum value at ground level. This diagram details the forces that must be resisted to support the sign during the wind load event. Three important locations that need to be investigated are the height of the fuse plate, the height of the slipbase, and, finally, the forces at ground level. The first location equates to the minimum moment capacity of the fuse plate connection to support. The second corresponds to the minimum capacity of the slipbase connection. Finally, the final location corresponds to the minimum capacity of the support post. If any of the calculated capacities exceed those of the support components, then the support system will not be able to support that sign configuration.

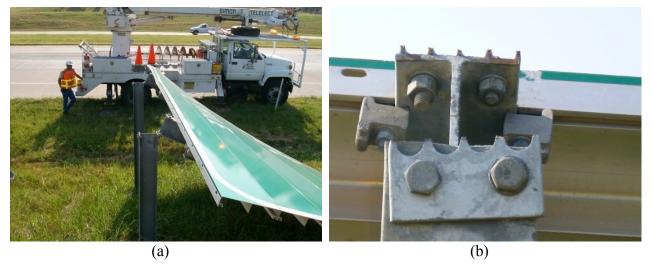
Figure 5.7. Typical Fuse Plate Failure Mode Reported by Districts.

Many districts, including Atlanta, Lubbock, and Waco Districts, have reported similar failures, (see Figures 5.7 (a) and (b)). The Atlanta district was contacted specifically because of the abnormally high number of instances of fuse plate failure in recent history. The district representatives conveyed the following field maintenance problems during the conversation with TTI.

- Localized high wind events causing fuse plate failure (high winds typically not in excess of design wind load conditions)
- Fuse plate connecting bolts were becoming loose over time (varied between a few days to a few months)
- Some sign locations were failing between two and three times a year.
- Dual fuse plate and single fuse plate designs were equally represented in failures.
- After further investigation, the W8×18 sign supports made up an abnormally large percentage of the sign installations failing under high wind loading events.

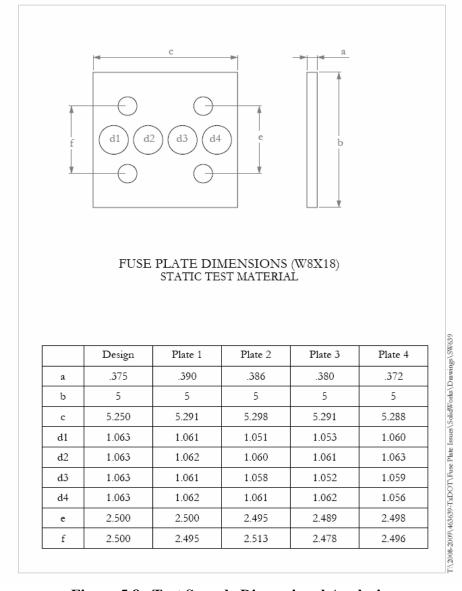
Figure 5.8. Test Sample Dimensional Analysis.

Fuse plate tensile testing was performed to verify the calculated capacity of the machined fuse plate; a local supplier sent four test samples. TTI requested that the supplier send ungalvanized samples to allow for verification of primary dimensions. Figure 5.8 details the measured dimensions of each of the test samples, and lists the intended design measurements.

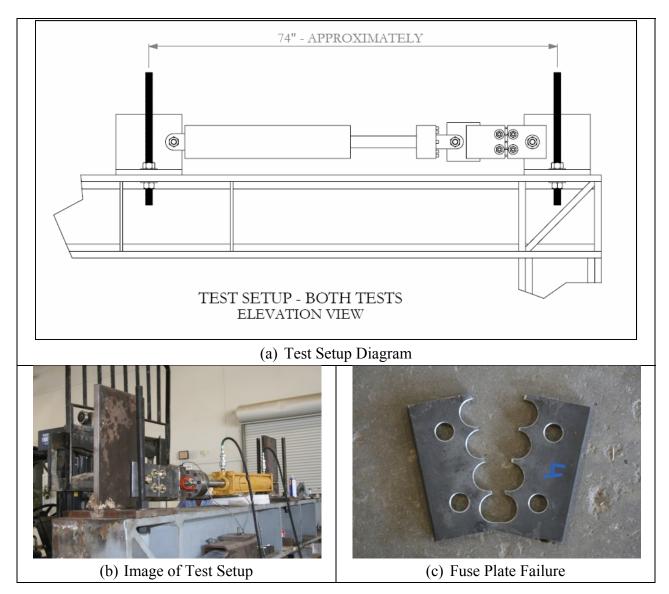
Figure 5.9. Fuse Plate Tensile Test (S12–S14).

Three of the samples were then chosen at random for testing (S12–S14). Loading was applied using a hydraulic cylinder. Care was taken to ensure bending stresses were not induced into the fuse plate during loading. This ensures that failure loads are not artificially reduced by combined stresses due to bending. Appendix B gives a recorded force-time history of the load event. Figure 5.9 (a-c) details the test setup and typical failure witnessed during the testing.

A total net area of cross sections through the fuse plate along the axis of perforations was calculated to be equal to 0.375 inches². A36 steel has a minimum ultimate stress of 58 ksi. This equates to a predicted failure load of 21.8 kips. The three static tests resulted in the following failure forces: 34.3 kips (S12), 33.3 kips (S13), and 32.0 kips (S14). Each test failure capacity was significantly higher than the calculated capacity. S12 was 57 percent above the minimum, S13 was 53 percent above the minimum, and S14 was 47 percent above the minimum. This testing has ensured that fuse plates are being fabricated according to TxDOT requirements and

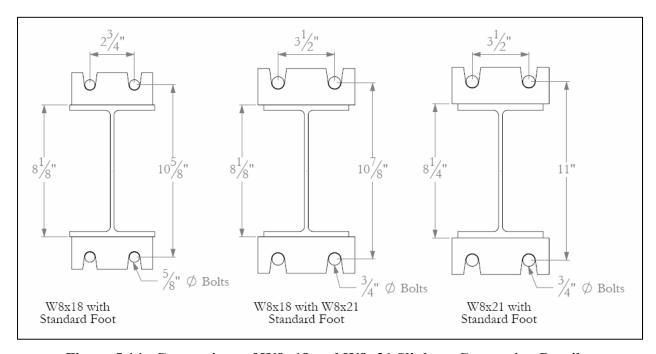
Figure 5.14. Comparison of W8×18 and W8×21 Slipbase Connection Details.

One option to make the connection more consistent across these two sections is to utilize the stronger W8×21 slipbase connection details on the weaker W8×18 post section. As this connection detail will be stronger than the original configuration, it will not affect the structural capacity of the system. Figure 5.14 shows diagrams of each of the configurations. The addition

of the W8×21 feet on the W8×18 section may allow for the attachment of a W8×18 post on a W8×21 base, and vice versa. The sections appear to be compatible; however, it is not recommended to mix sections like this due to possible maintenance and structural capacity issues. TTI recommends that fuse plate details for these sections should be left as is due to unknown effects on impact performance.

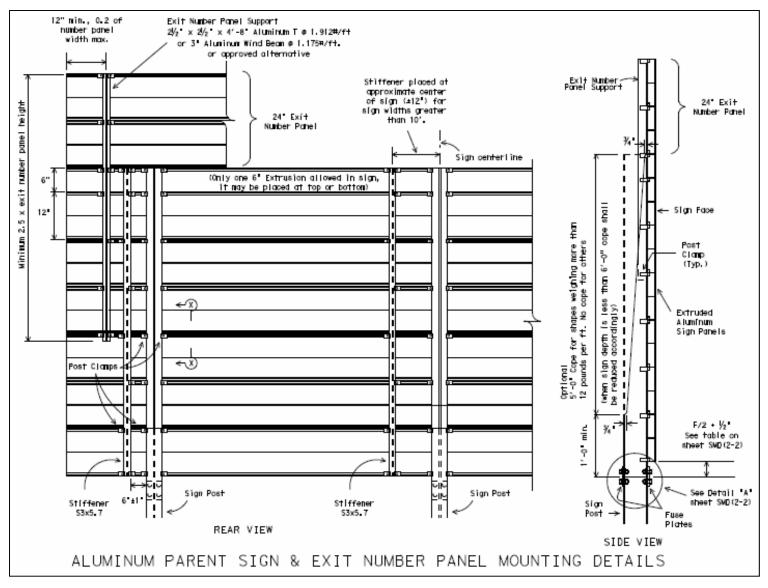
Figure 6.1. Current TxDOT Vertical Stiffener Detail Sheet.

As the true design intent of the vertical stiffeners is unknown, TTI researchers have theorized the intent is to increase the torsional stiffness of the sign panel. This facilitates the activation of the fuse plate connections in the event of an errant vehicle striking the panel. To verify this assumption and to develop torsional stiffness relationships, static tests were performed with two main objectives. The first was to determine the torsional capacity relationship for sign panels without vertical stiffeners. The second objective was to determine how much additional torsional stiffness is gained by adding the standard vertical stiffeners. Figure 6.1 shows an image of current TxDOT vertical stiffener details for large guide signs.

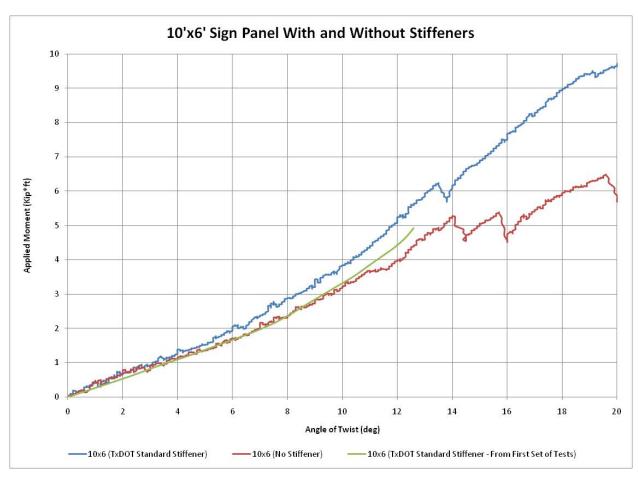
Figure 6.2. 10 ft × 6 ft Sign Panel Torsional Stiffness Relationship Comparison.

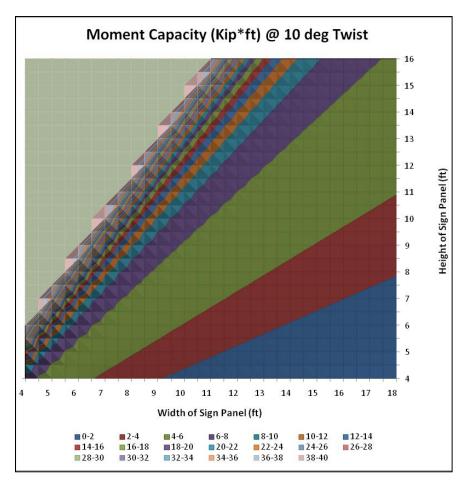
All experimental data were analyzed and used to extrapolate the torsional capacity for all sign panel configurations. From testing, it was determined that sign clips have an increased chance of failing if sign panel twist exceeds 10 degrees. Figure 6.3 shows a graphical representation of the stiffness extrapolation of all sign panel configurations at a 10-degree twist angle. This would equate to the predicted maximum static torsional capacity of each sign configuration.

Figure 6.3. Predicted Maximum Sign Panel Assembly Torsional Capacity.

This analysis has resulted in the conclusion that the vertical stiffeners provide little to no increased torsional capacity to the extruded aluminum sign panels. For this reason, it has been concluded that the stiffeners are not required for impact loading conditions; however, some stiffeners may still need to be installed to take advantage of the abovementioned benefits. The researchers suggest that if stiffeners are installed, they should be moved to within 6 inches of each end of the sign panel. This will help prevent damage to the sign panel corners when the sign strikes the ground after an errant vehicle hits the support system.

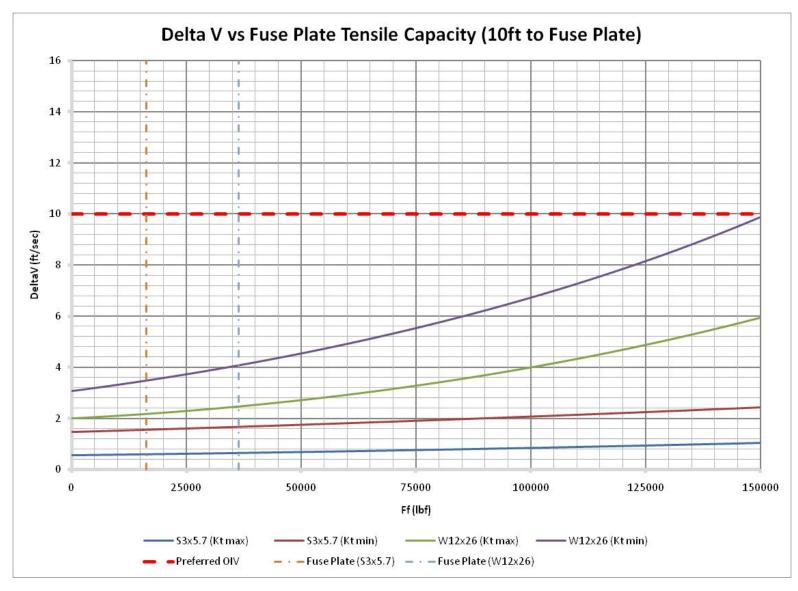
To address the condition of increasing the stiffness beyond OIV limits, simulation was performed according to the method described in NCHRP Synthesis 318 (4). This analysis allows the prediction of OIV values when impacting a dual support system with fuse plate connections. The method predicts the OIV values given certain system properties, such as weight per foot of the beam and rupture strength of the fuse plate connection. A simulation was then performed for each post assembly configuration. Each simulation was then utilized to predict the maximum allowable rupture fuse plate force which predicts a OIV value less than or equal to 10 ft/sec (maximum value set by *MASH*). The analysis predicts the activation force of the slipbase given the tensile force in each bolt. This force can be determined from the applied torque given a specified conversion factor (K). This factor varies with bolt construction; however, upper and lower limits on K are described in the conversion method. Instead of determining the K value for each bolt experimentally, the analysis was performed with both the maximum and minimum values, giving a range of solutions. Figure 7.1 is a plot of the results of the simulation. As seen in Figure 7.1, the fuse plate tensile force have to be increased beyond realistic values to cause OIV values to exceed mandated limits.

Figure 7.1. Predicted OIV Analysis.

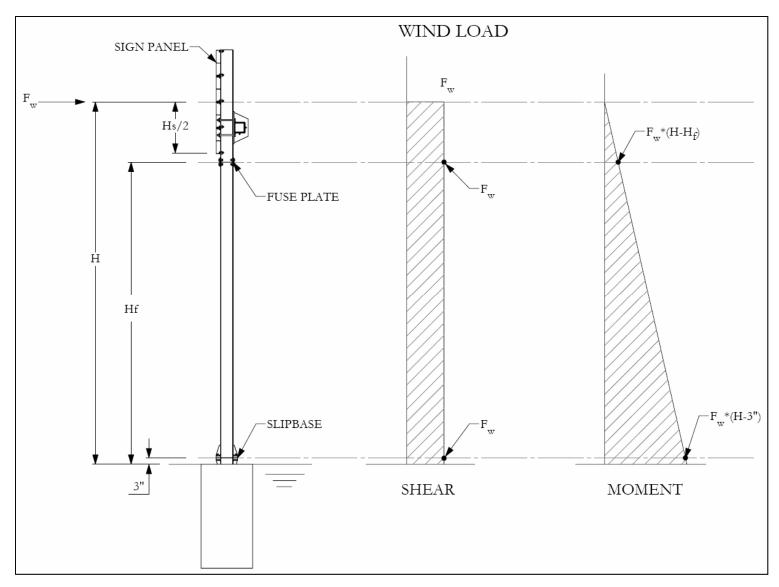
Figure 7.2. Wind Load Condition.

event. Diagrams of wind loading (Figure 7.2) and impact loading (Figure 7.3) can be found below. This is not always possible; however, to ensure impact performance, the impact loading condition should be the overriding controlling factor. If both conditions can be achieved, the minimum fuse plate connection strength should be used.

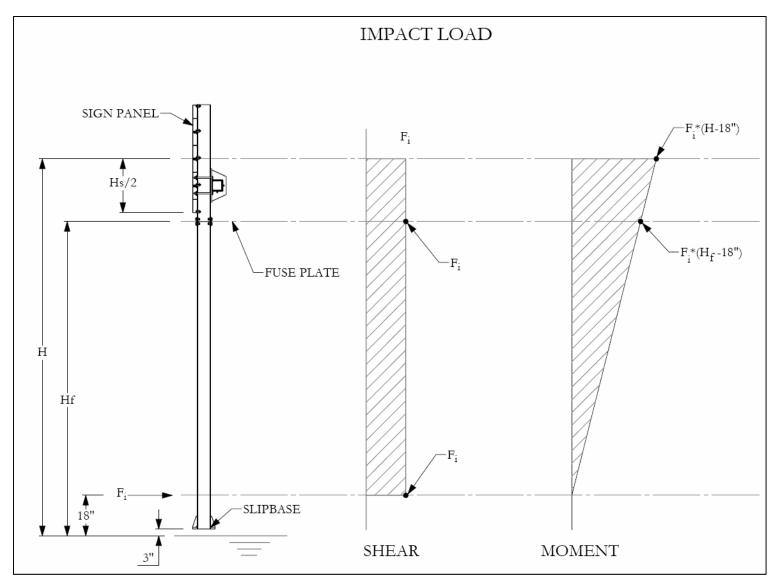
Figure 7.3. Impact Load Condition.

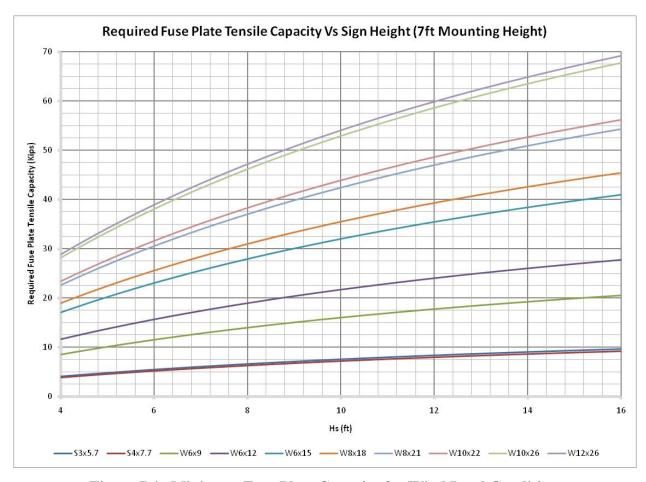
To facilitate this analysis, a chart of minimum fuse plate capacities for wind loading is plotted in Figure 7.4 for a minimum mounting height of 7 ft for each post section. If the fuse plate capacity falls below the plotted line in Figure 7.4, the fuse plate will control the maximum sign area instead of the post section, leading to inefficiencies in the system design. Table 7.1 is a list of maximum fuse plate tensile capacities that will ensure that the fuse plate connection will fail before the post will yield or buckle. Notice all maximum tensile capacities are in excess of the minimum required in Figure 7.4, except for the W6×9 support condition. Figure 7.4 shows that a minimum capacity of approximately 22 kips is required to ensure that the post will control in a wind load condition. However, the maximum tensile capacity for impact loading is only 17 kips. For this reason, it is not possible to ensure that the fuse plate will not control in all wind load conditions. This special situation is primarily due to the fact that a W6×9 is a "non-compact section." This means that the bending capacity of this section will drop off more rapidly than a "compact section" allowing this condition to occur.

Figure 7.4. Minimum Fuse Plate Capacity for Wind Load Condition.

Again, Figure 7.4 is a graphical representation of the extrapolated torsional capacity of varying sign configurations at a rotation of 10 degrees. When comparing the values in Table 7.2 to the chart in Figure 7.5, it is quickly evident that for a majority of the sign configurations, the static capacity of the sign panels are far less than the static capacities of the fuse plate

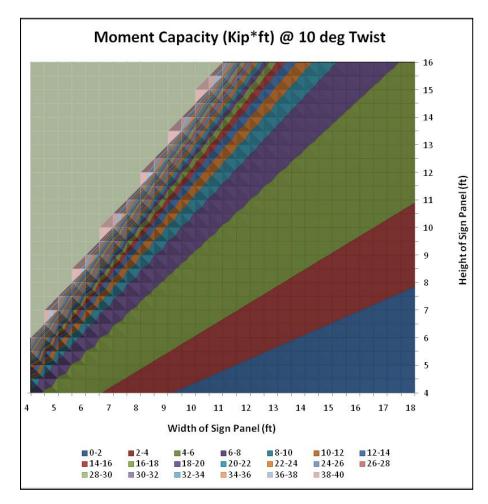
Figure 7.5. Predicted Maximum Sign Panel Assembly Torsional Capacity.

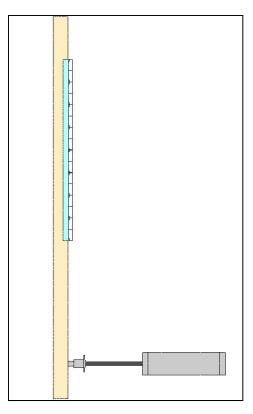
To verify, the research team performed a simplified series of LS-DYNA simulations. This simulation was constructed to represent a 10 ft × 8 ft sign panel mounted on a W8×18 post continuous post section with a 7-ft sign mounting height; the slipbase and fuse plate connections were not incorporated into this model. The model was then impacted using a simulated 1800 kg vehicle surrogate modeled after TTI's pendulum impact vehicle. Due to the simplifications of this model, validation against static testing was not performed. Since the researchers were looking for a capacity amplification factor, the validation of the model was not required. Figure 7.6 is an image of the simplified simulation setup.

Figure 7.6. Simplified LSDYNA Impact Simulation Setup.

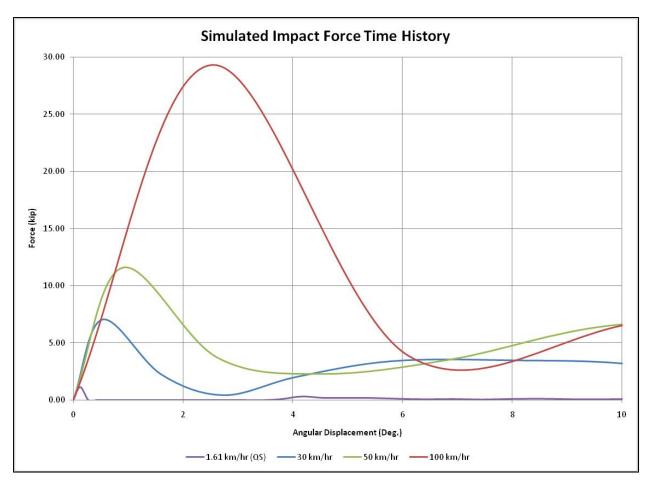
The impact force-time history induced by the impacting surrogate vehicle was recorded for four different loading rates: quasi-static (QS), 18.6 mph, 31.1 mph, and 62.1 mph. Figure 7.7 shows all four force-time histories plotted on a single chart. The resultant maximum forces were then recorded: QS = 1.1 kips, 18.6 mph = 7.0 kips, 31.1 mph = 11.6 kips, and 62.1 mph = 29.3 kips. These forces resulted in the following amplification factors: 18.6 mph = 6, 31.1 mph = 10, and 62.1 mph = 25.

Figure 7.7. Simulated Force Times Histories.

As MASH TL-3 specification requires testing at 18.6 mph and 62.1 mph, the worst case need to be applied when designing the system to verify that the system will provide the capacity to fail the fuse plate connection. Past research has shown that lower impact velocities induce the highest force on the vehicle for activation of the slipbase connection. Therefore, future design calculations will assume a multiplication factor of 6, corresponding to a impact velocity of 18.6 mph.

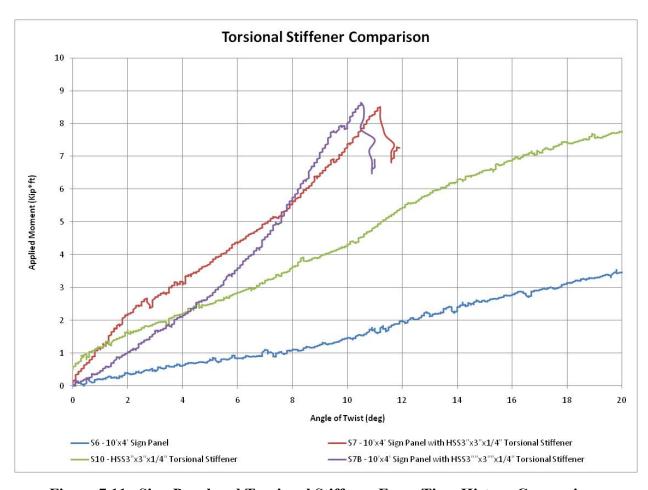
Figure 7.11. Sign Panel and Torsional Stiffener Force Time History Comparison.

Figure 7.10 and 7.11 have the test results. Figure 7.10 compares the capacities of various torsional stiffeners, while Figure 7.11 compares those of torsional stiffeners with and without sign panels. Figures 7.10 and 7.11 show that the attachment method makes a significant difference in the stiffness of the torsional stiffener. The $HSS3\times3\times1/8$ -inch stiffener actually yielded after the maximum load was reached when installed using the sleeve bracket. Figure 7.11 shows that the summation of the individual stiffness approximates the combined stiffness.

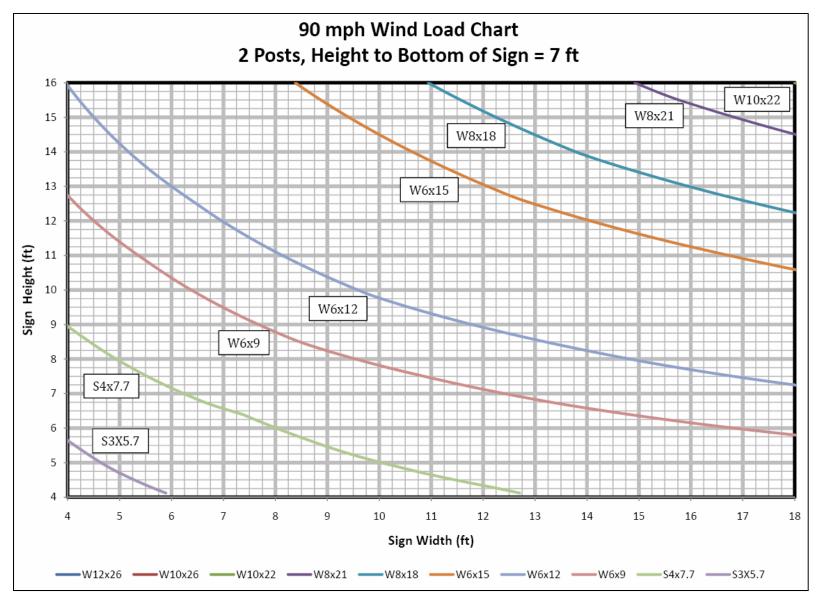
Figure 7.12. 90 mph Selection Chart for Optimized Fuse Plate Hbs = 7 ft (Current Method).

Two impact conditions were selected for high-speed testing. The first was selected to provide the highest stiffness for a 10-ft wide sign panel. Figure 7.12 is the updated wind load chart (according to current method) for a 90 mph wind zone and a mounting height of 7 ft. A 10 ft × 16 ft sign panel was selected which has a predicted static torsional capacity of 81.1 kip*ft. This is well in excess of the capacity required to fail the W8×18 fuse plate connection selected from Figure 7.12. Therefore, no torsional stiffeners will be installed. This installation will verify that the sign panel without stiffeners will provide sufficient capacity to fail the optimized W8×18 fuse plate connection without failing the OIV requirements.

To visualize the benefit of the optimized fuse plate connections when compared to the current fuse plate design, one must compare the support selection charts. Figures 7.12 and 7.14 both represent charts generated for 90 mph wind zones according to the current method of calculating wind pressures. Both charts assume dual supports and a sign mounting height of 7 ft. Figure 7.14 was generated for the optimized fuse plate design, and Figure 7.12 was generated for the current fuse plate design. Note the substantial increase in almost all the support assemblies' wind load capacity.

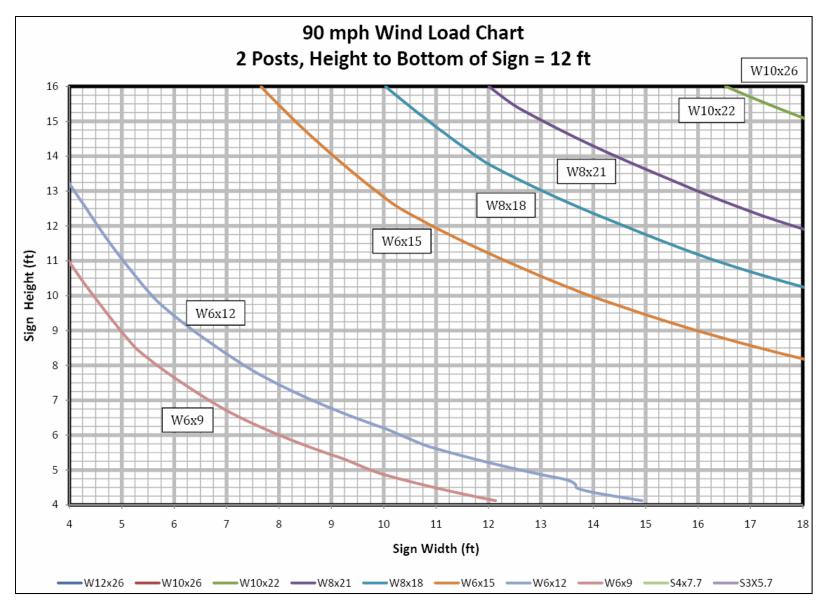
Figure 7.13. 90 mph Selection Chart for Optimized Fuse Plate Hbs = 12 ft (Current Method).

The second test was formulated to provide the weakest system to verify that the fuse plate would fail before the weakened post would yield/buckle when struck by an impacting vehicle. Again, a 10-ft wide sign panel was selected for testing. Figure 7.13 is a plot of updated wind load charts using current method of determining wind pressures. A 10 ft \times 4 ft sign was selected to be mounted on a W6×9 post assembly. A 10 ft \times 4 ft sign assembly has a capacity of 1.6 kip*ft.

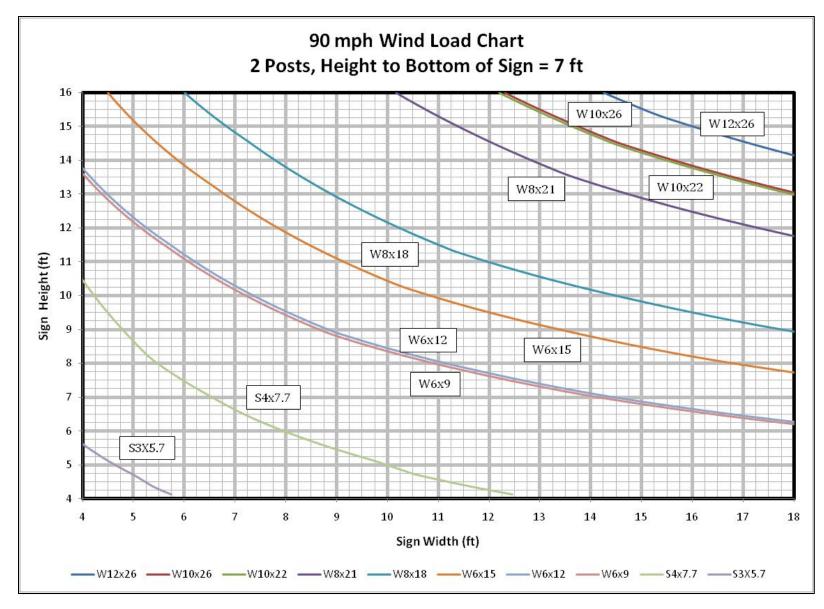
Figure 7.14. 90 mph Selection Chart for Current Fuse Plate Hbs = 7 ft (Current Method).

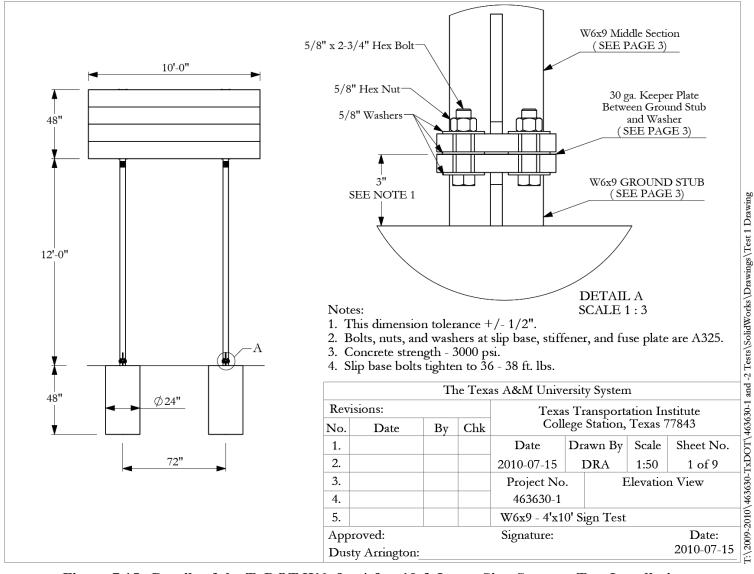
Figure 7.15. Details of the TxDOT W6×9 – 4-ft \times 10-ft Large Sign Support Test Installation.

Figure 7.15 is a diagram of the test installation as tested, and Figure 7.16 presents photographs of the installation as tested. Appendix E, Figure E1 features further fabrication details and specifications.

All hot rolled W-sections conform to A992 material specifications. Every tube section conforms to A500 grade B specification. All bolts and nuts meet A325 material specifications. The State of Texas Prison System supplied all extruded sign panels and post clamps, which meet AASHTO and TxDOT material specifications. All other steel sections and plate meet A36 specifications. The concrete used in the foundation has a compression strength in excess of 3000 psi.

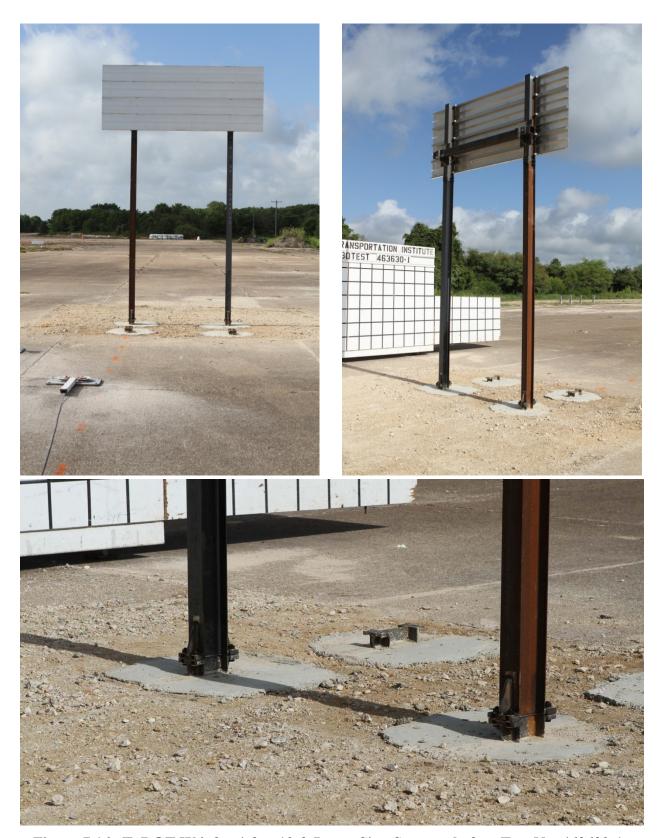
Figure 7.16. TxDOT W6×9 – 4-ft × 10-ft Large Sign Support before Test No. 463630-1.

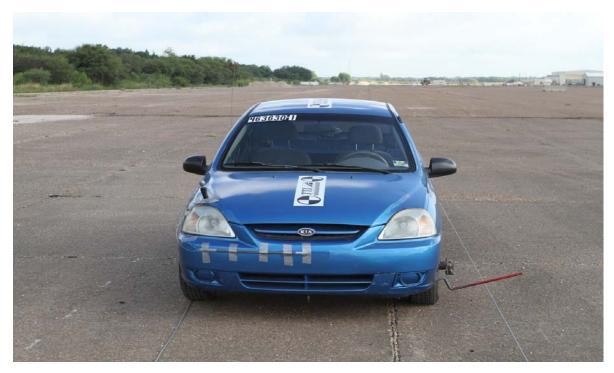
Figure 7.18. Vehicle before Test No. 463630-1.

Figures 7.17 and 7.18 show the 2004 Kia Rio used for the crash test. Test inertia weight of the vehicle was 2414 lb, and its gross static weight was 2575 lb. The height to the lower edge of the vehicle bumper was 8.50 inches, and it was 22.75 inches to the upper edge of the bumper. Table E1 in Appendix E gives additional dimensions and information on the vehicle. The vehicle was directed into the installation using the cable reverse tow and guidance system, and was released to be free-wheeling and unrestrained just prior to impact.

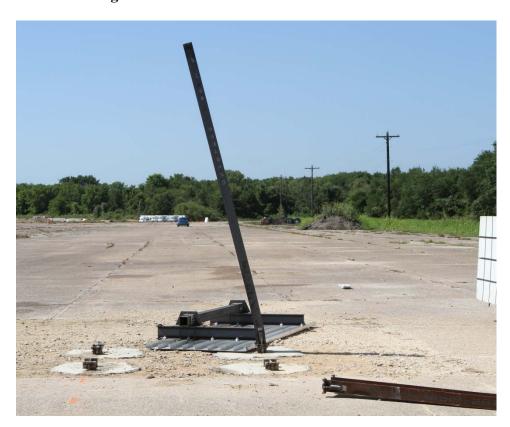
Figure 7.19. Installation/Vehicle Positions after Test No. 463630-1.

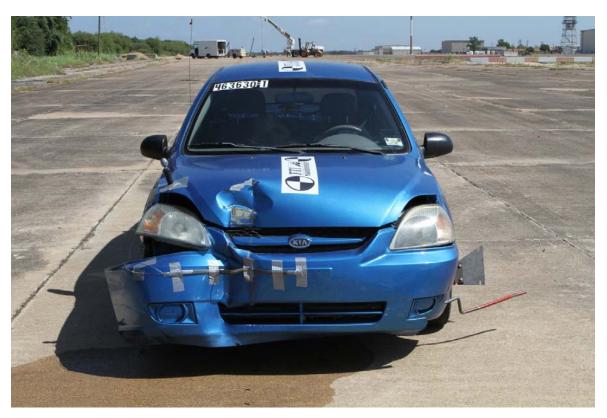
Figure 7.21. Vehicle after Test No. 463630-1.

Figure 7.21 shows that the 1100C vehicle sustained minimal damage. The front bumper, hood, radiator, and radiator support were deformed, and the right headlight was broken. Maximum external crush to the vehicle at the right front quarter point at bumper height was 3.5 inches. No occupant compartment deformation occurred. Figure 7.22 shows photographs of the interior of the vehicle. Tables E2 and E3 in Appendix E, provide the exterior crush and occupant compartment measurements.

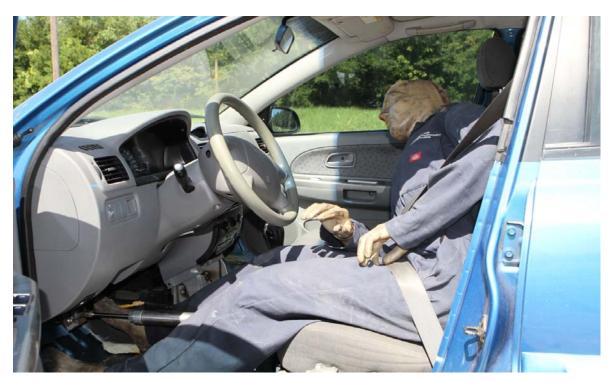
Figure 7.22. Interior of Vehicle for Test No. 463630-1.

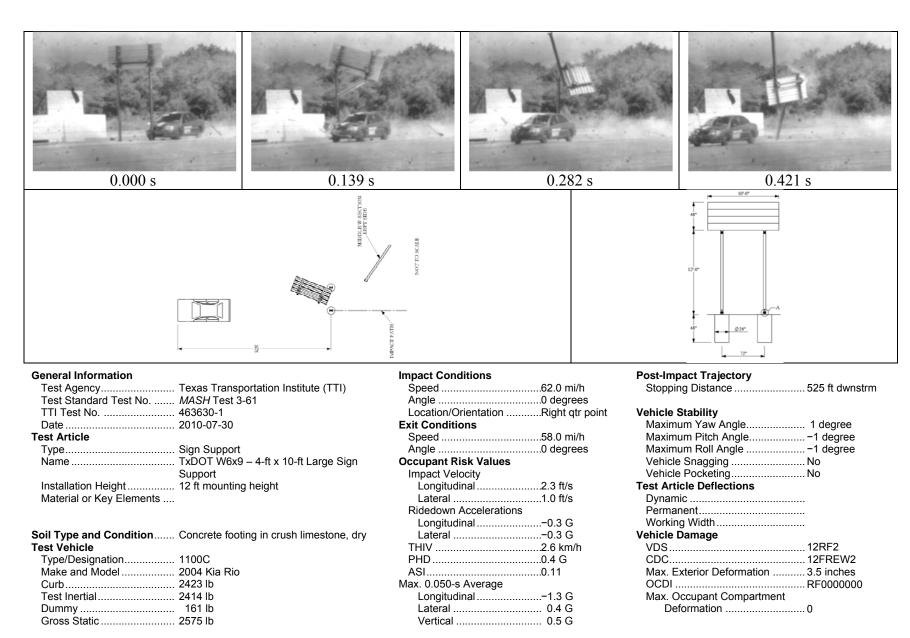
Figure 7.23. Summary of Results for MASH Test 3-61 on the TxDOT Large Sign Support (W6×9 – 4-ft × 10-ft).

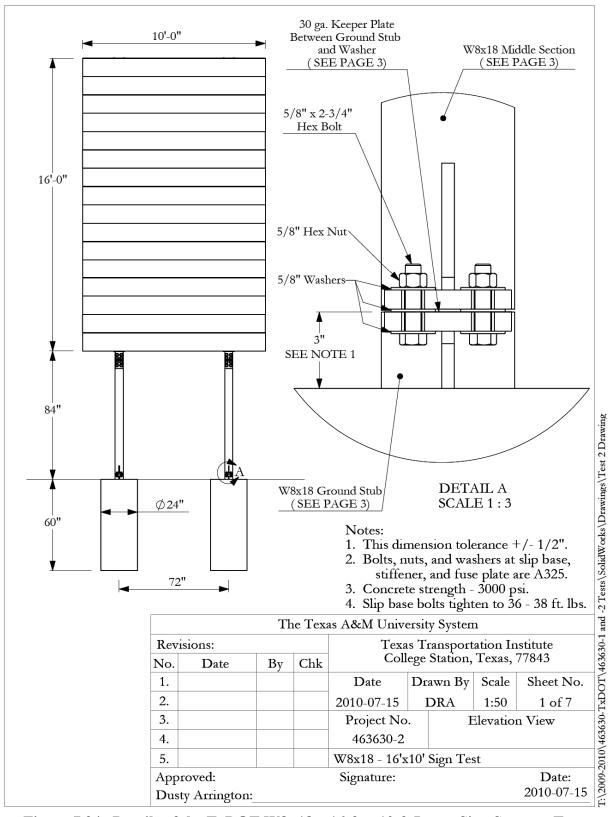
Figure 7.24. Details of the TxDOT W8×18 – 16-ft × 10-ft Large Sign Support Test Installation.

Torsional stiffeners were not used in this installation. Figure 7.24 is a diagram of the test installation as tested, and Figure 7.25 presents photographs of the installation as tested. Further fabrication details and specifications can be found in Appendix F, Figure F1.

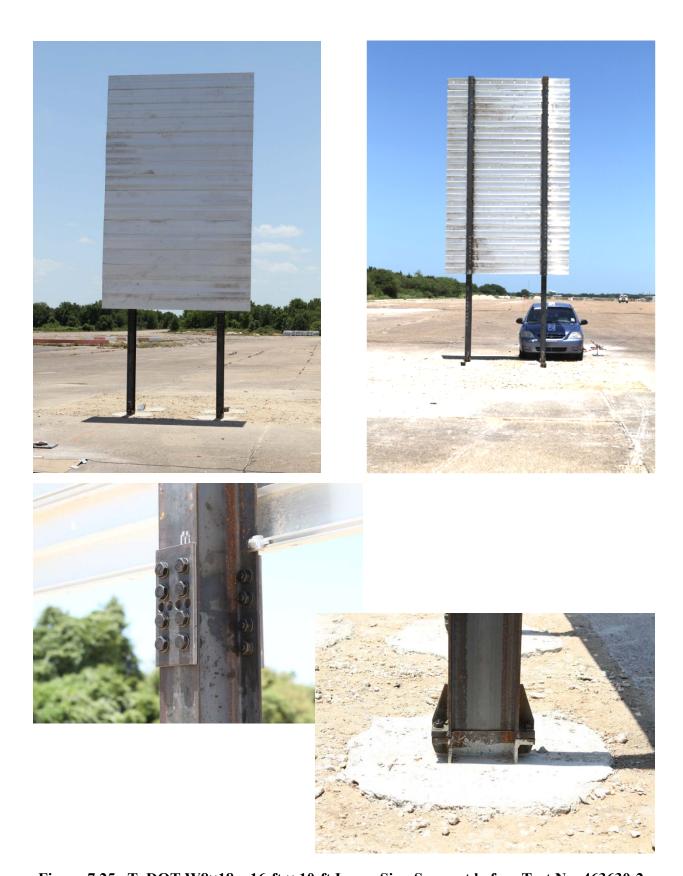
Figure 7.25. TxDOT W8×18 – 16-ft × 10-ft Large Sign Support before Test No. 463630-2.

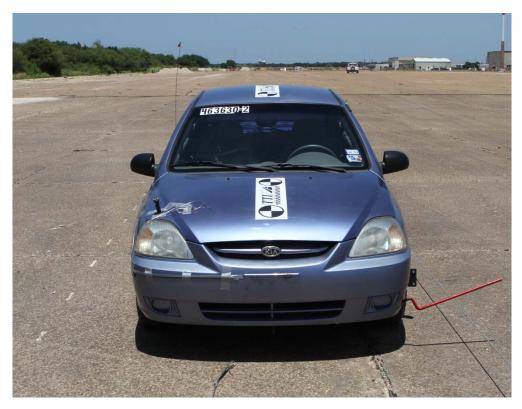
Figure 7.27. Vehicle before Test No. 463630-2.

Figures 7.26 and 7.27 show the 2005 Kia Rio used for the crash test. Test inertia weight of the vehicle was 2431 lb, and its gross static weight was 2606 lb. The height to the lower edge of the vehicle bumper was 8.50 inches, and it was 22.75 inches to the upper edge of the bumper. Tables F1 and F2 in Appendix F give additional dimensions and information on the vehicle. The vehicle was directed into the installation using the cable reverse tow and guidance system, and was released to be free-wheeling and unrestrained just prior to impact.

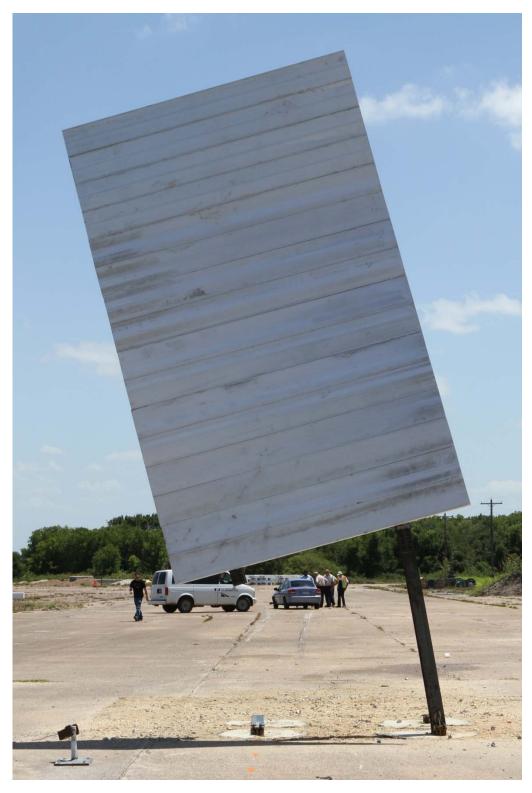
Figure 7.28. Installation/Vehicle Positions after Test No. 463630-2.

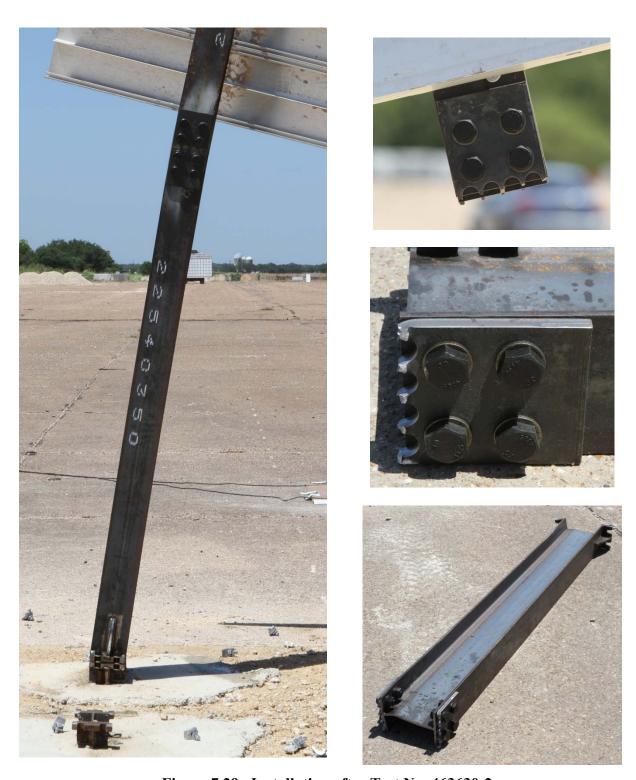
Figure 7.29. Installation after Test No. 463630-2.

Figures 7.28 and 7.29 show damage to the sign support. The slipbase and fuse plates (hinge connections) activated as designed. The right support leg remained standing but was leaning 10 degrees in the direction of where the left support leg originally was installed before the test. The left support leg was resting on the ground surface 15 ft toward the field side and 22.5 ft to the right of centerline of the vehicle path. The sign panel remained attached to the

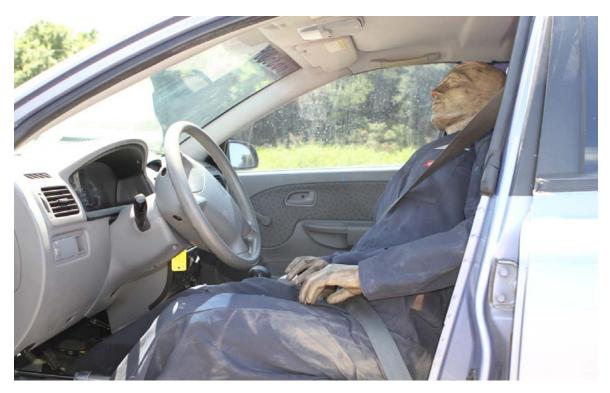
Figure 7.31. Interior of Vehicle for Test No. 463630-2.

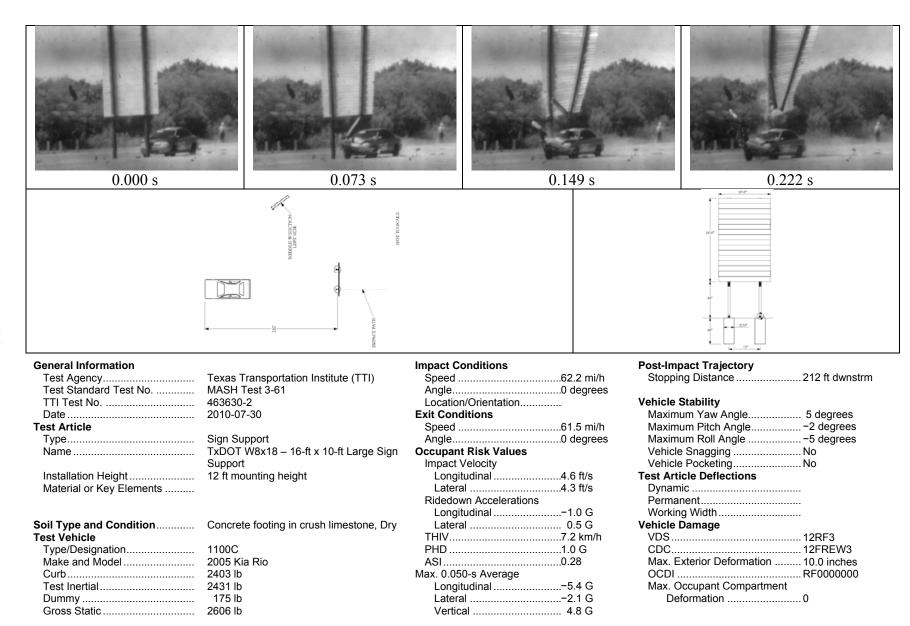
Figure 7.32. Summary of Results for MASH Test 3-61 on the TxDOT W8×18 – 16-ft × 10-ft Large Sign Support.
