DEVELOPMENT GUIDANCE FOR SIGN DESIGN STANDARDS

Test Report 0-6363-1

Project Title: Improvements to Large and Small Roadside Sign Hardware and Design

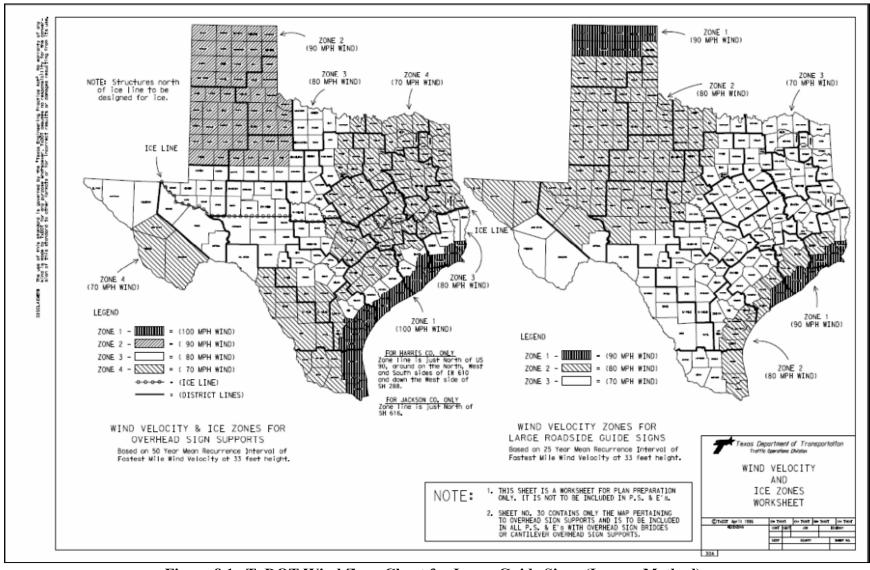
TxDOT has decided to proceed with generating the wind load charts according to the legacy method of calculating wind pressures. This is to remain consistent with other wind load dependent structures in TxDOT's inventory. If the charts were generated according to the current wind pressure method, this task would require the addition of a second Texas wind load chart, which would only be used for large guide signs. Figure 8.1 shows all other designs would require the use of the legacy wind chart. This would lead to confusion in the design process and may lead to either over- or under-designed structures. The chart breaks Texas into three basic wind zones: Zone 1 (90 mph), Zone 2 (80 mph), and Zone 3 (70 mph).

Figure 8.1. TxDOT Wind Zone Chart for Large Guide Signs (Legacy Method).

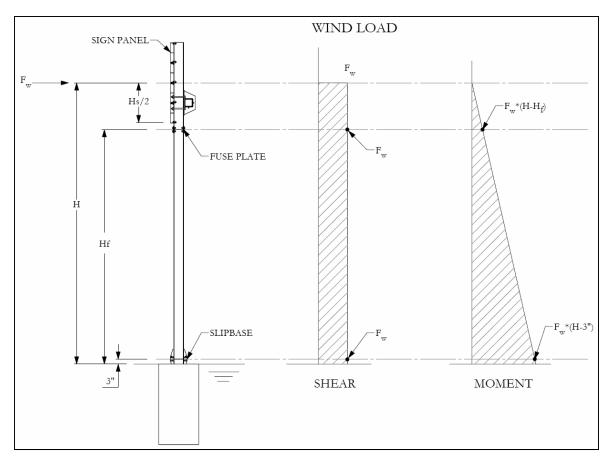
Again, Figure 8.1 describes the loading in a wind load condition. The process of determining the maximum sign area for each sign support was automated to give results for all support configurations and mounting heights. The results of this process provide for efficient use of each section; however, this process requires the use of 30 selection charts; one chart for each post section, and a chart for each post section for each wind load condition. Currently, TxDOT utilizes three charts to cover all of the sections and all three wind zones.

Figure 8.2. Wind Load Condition.

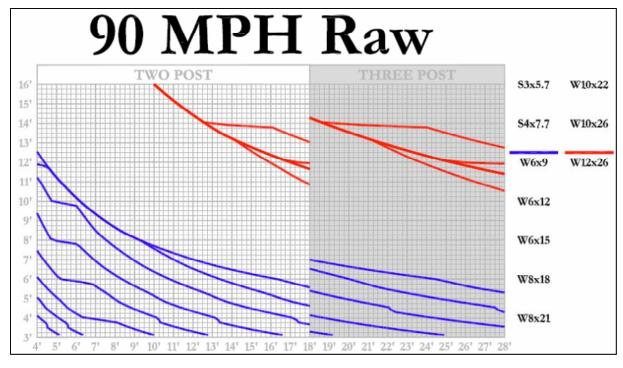
Figure 8.2 includes the raw results of the wind load analysis for $W6\times9$ and $W12\times26$ support assemblies. Each of the lines represents a different mounting height of the sign panel. Generally, as the mounting height of the sign panel increases, the capacity of the support structure decreases. There is one exception to this rule. If the fuse plate is controlling the capacity of the support assembly, the change in mounting height would not affect the capacity. These two sections were chosen because they represent the two extremes of the effects of changing the mounting heights of the signs. With the $W6\times9$, the fuse capacity generally is greater than the capacity of the post; therefore, the capacity decreases with each increase in mounting height. The $W12\times26$ represents the other extreme, where the fuse plate controls the capacity of the support assembly in almost all situations. For this reason, the support capacity of the $W12\times26$ is generally unaffected by an increase in sign mounting height.

Figure 8.3. 90 mph Raw Support Selection Chart.

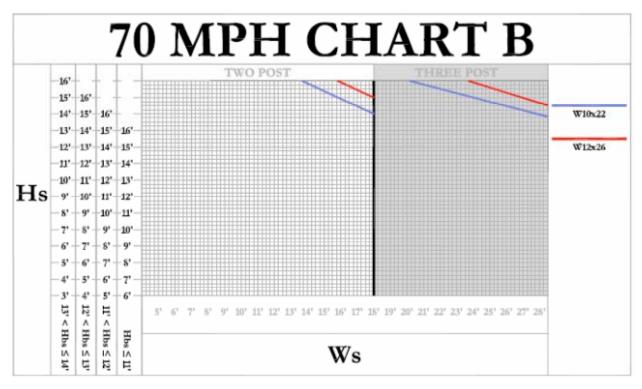
Figure 8.5. Updated Zone 3 Chart B Support Selection Chart (Current Method).

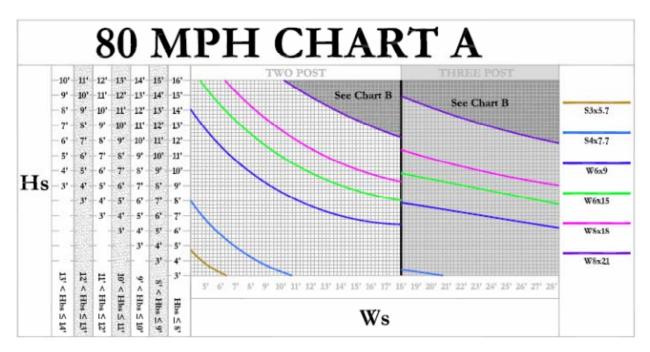
Figure 8.6. Updated Zone 2 Chart A Support Selection Chart (Current Method).

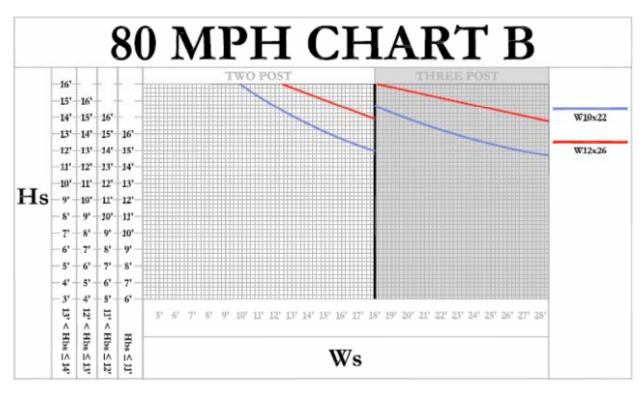
Figure 8.7. Updated Zone 2 Chart B Support Selection Chart (Current Method).

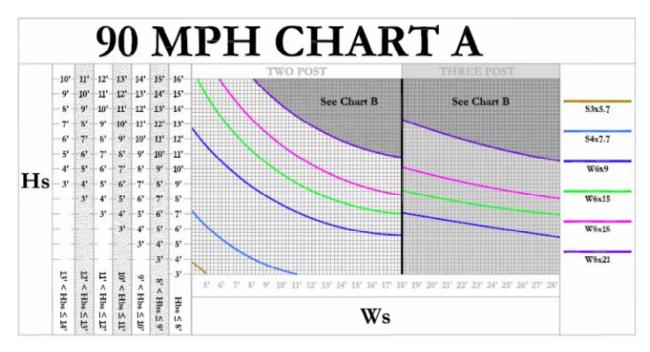
Figure 8.8. Updated Zone 1 Chart A Support Selection Chart (Current Method).

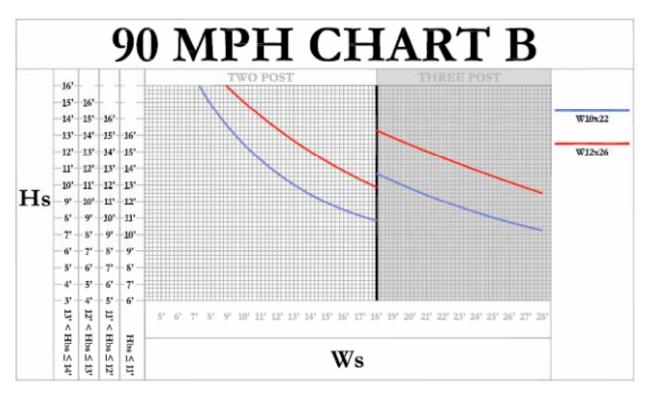
Figure 8.9. Updated Zone 1 Chart B Support Selection Chart (Current Method).

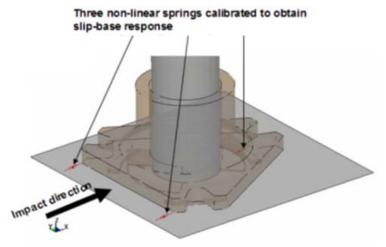
Figure 9.1 shows the upper triangular slipbase casting was explicitly modeled to properly account for the inertial properties of the sign support system. The casting was modeled using solid elements and a rigid material representation. Since the bottom triangular slip-plate remains fixed to the foundation without any significant movement, it was not explicitly modeled. The bolts of the triangular slipbase were also not modeled explicitly. Instead, three nonlinear springs were modeled (see Figure 9.1). One end of each spring was attached to the top slipbase casting, and the other end was attached to the rigid bottom plate. The force-deflection properties of the springs were calibrated using crash test results. The complexity of the slipbase model was greatly reduced using the abovementioned modeling techniques without significant loss of accuracy of results. This technique enabled multiple impact simulations to be conducted within the resources of the project.

Figure 9.1. Finite Element Model of Slipbase Sign Support System.

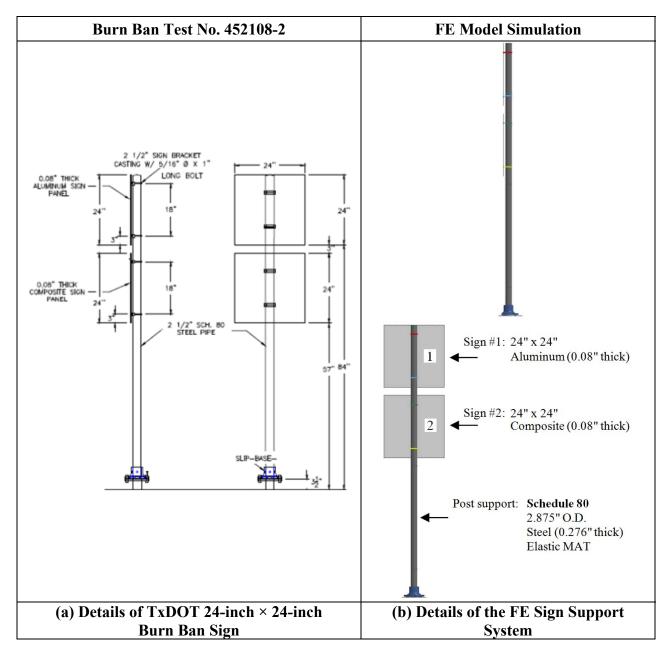
Figure 9.3 shows the finite element model of the sign support for the FE computer simulation aimed at replicating burn ban test no. 452108-2. The support post was a 2.875-inch O.D., 0.276-inch schedule 80 steel pipe, which was modeled using elastic material properties. A 24-inch \times 24-inch \times 0.080-inch thick aluminum sign panel was constrained to the schedule 80 support using nodal rigid body constraints at the location of connecting bolts. The mounting height to the bottom of the confirmation sign was 7 ft. A second 24-inch \times 24-inch \times 0.080-inch thick composite sign was constrained to the schedule 80 support in the same manner as the first sign.

Figure 9.3. Comparison between Burn Ban Test No. 452108-2 and FE Model Sign Support Slipbase System Configurations.

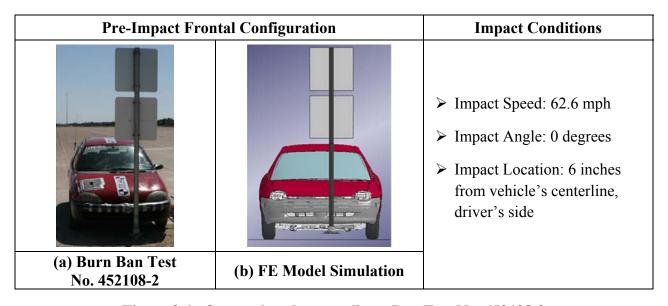
Figure 9.4 shows the Dodge Neon vehicle model impacted the single sign support slipbase model at 62.6 mph and 0 degrees to match the actual crash test conditions. The impact location was 6 inches from the vehicle's centerline, on the driver's side. The properties of the slipbase were calibrated to match the pipe support kinematics after slipbase release and roof sign impact location.

Figure 9.4. Comparison between Burn Ban Test No. 452108-2 and FE Model Impact Conditions.

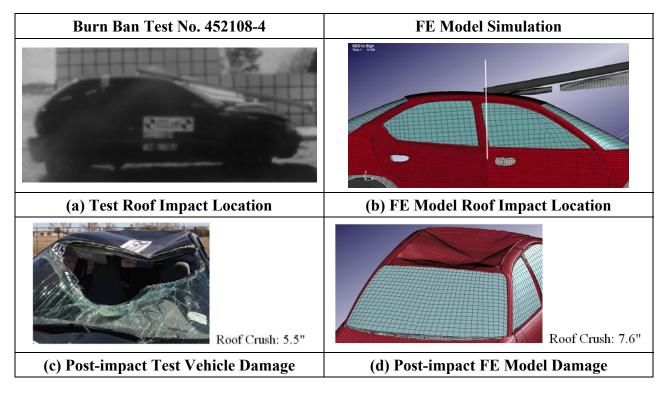
Figure 9.11 compares the results of the roof impact location and roof deformation to those of the crash test. A reasonable correlation was achieved between simulation and test results. FE simulation predicted the roof crush to be 7.6 inches, while the maximum roof deformation recorded in the test was 5.5 inches (windshield damage of the Geo Metro was not due to the impact event in the test, but occurred while the vehicle was transported from the test site).

Figure 9.11. Comparison between Burn Ban Test No. 452108-4 and FE Model Results.

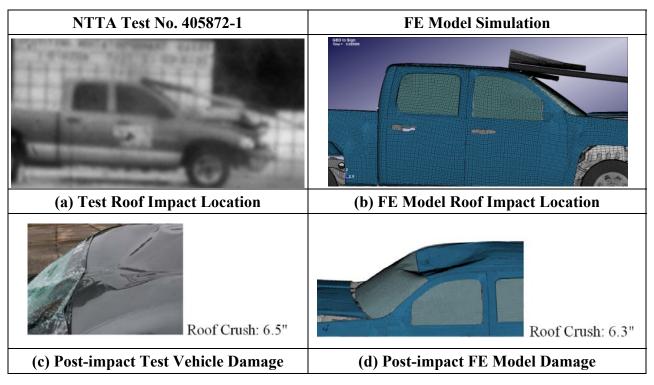
Figure 9.14 compares the results of the roof impact location and roof deformation to those of the crash test. A reasonable correlation was achieved between simulation and test results. The FE simulation predicted the roof crush predicted at 6.3 inches, while the maximum roof deformation recorded in the test was 6.5 inches.

Figure 9.14. Comparison between NTTA Test No. 405870-1 and FE Model Impact Results.

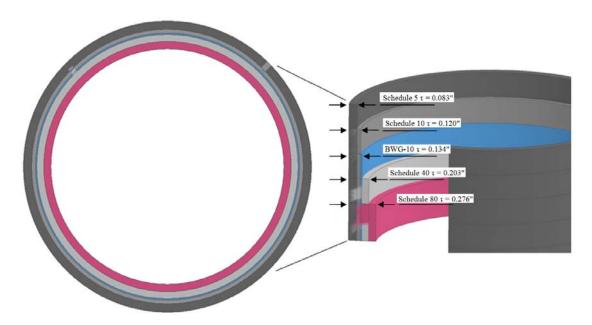
Pipe supports were modeled with elastic material properties. Three different types of 2.875-inch outside diameter steel pipe support generally employed for use on slipbase systems were considered for simulations (see Figure 9.18). Having all the same outside diameter, these pipe supports differ only in the inside diameter:

- BWG 10 with a wall thickness of 0.134 inches.
- Schedule 40 with a wall thickness of 0.203 inches.
- Schedule 80 with a wall thickness of 0.276 inches.

Figure 9.18. Thickness Comparison of Size 2.5-Inch Pipe Supports for Use on Slipbase Systems.

Figure 9.18. Thickness Comparison of Size 2.5-Inch Pipe Supports for Use on Slipbase Systems (Continued).

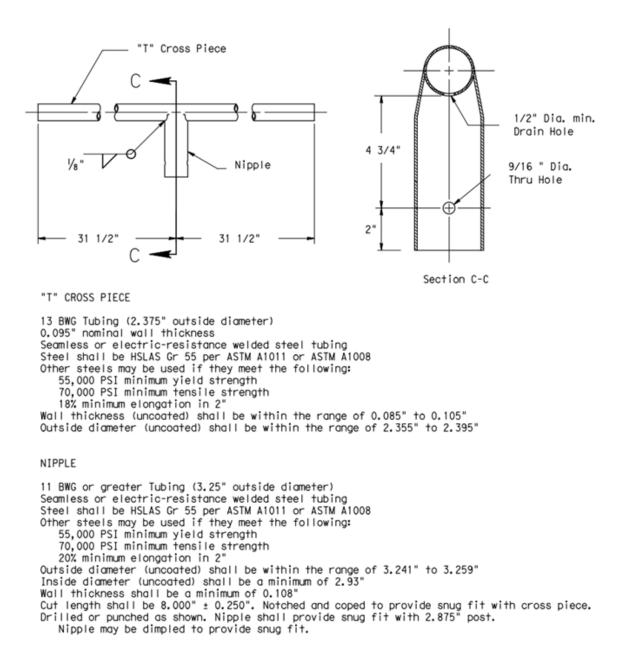
Geometry and material modeling of the T-bracket components was performed to comply with TxDOT standard specifications for the prefabricated T-bracket–Texas universal triangular slipbase system, reported in Figure 9.20 (10). The T-cross piece was modeled as 13 BWG tubing, with a 2.375-inch O.D. and a wall thickness of 0.095 inches. The nipple was modeled as 11 BWG tubing, with a 3.25-inch O.D. and a wall thickness of 0.108 inches. Both T-cross and nipple pieces were modeled with elastic material properties.

Figure 9.20. Prefabricated "T" Bracket-Texas Universal Triangular Slipbase System (9).

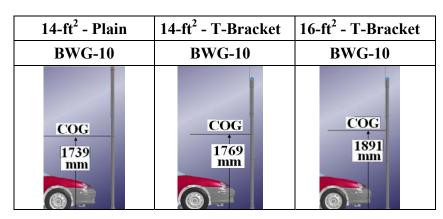
The sign support system vertical position of the C.G. depends mainly on the type of pipe support and sign area considered. Increment of sign size and/or choice of T-bracket pipe support with respect to plain support cause the C.G. to have a higher position in the system. A higher C.G. means also a higher position of the center of rotation (CR) of the system, causing all sign supports to rotate slowly after being impacted by the vehicle and the slipbase was released. One of the scopes of this study was to evaluate how sign support systems CR heights affect occupant risk after vehicle impact. Figure 9.21 compares C.G. position for sign support systems with the different configurations evaluated.

12-ft² - Plain		12-ft ² - T-Bracket					
12-11	- Flain	Config. #1	Config. #2	Config. #2	Config. #2		
BWG-10	Schedule-80	BWG-10	BWG-10	Schedule-80	Schedule-40		
COG 1642 mm	COG 1645 mm	COG 1701 mm	COG 1749 mm	COG 1682 mm	COG 1707 mm

Figure 9.21. Center of Gravity for Pole System with Varying Sign Areas.

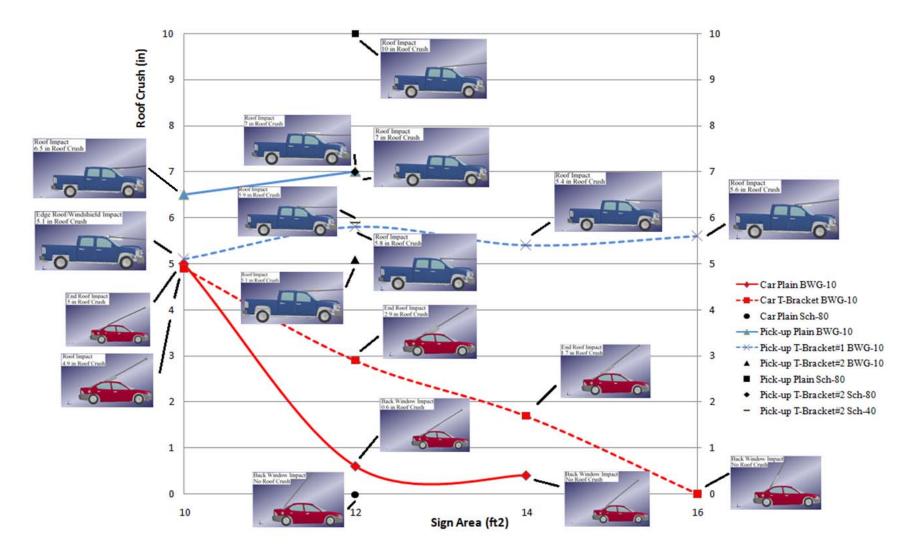
Simulations were run with the vehicle impacting head-on into the single sign support at 62 mph. The first impact was located 6 inches from the vehicle's centerline, on the driver's side. Figures 9.22 and 9.23 summarize the configurations and the results of the FE simulations in terms of roof crush. Figures 9.24 through 9.26 report vehicle roof deformation sensitivity with respect to the size of sign area mounted on the pipe support.

Figure 9.24. Roof Crush Results with Varying Sign Areas and Pole Systems for Both 1100C and 2270P Vehicles.

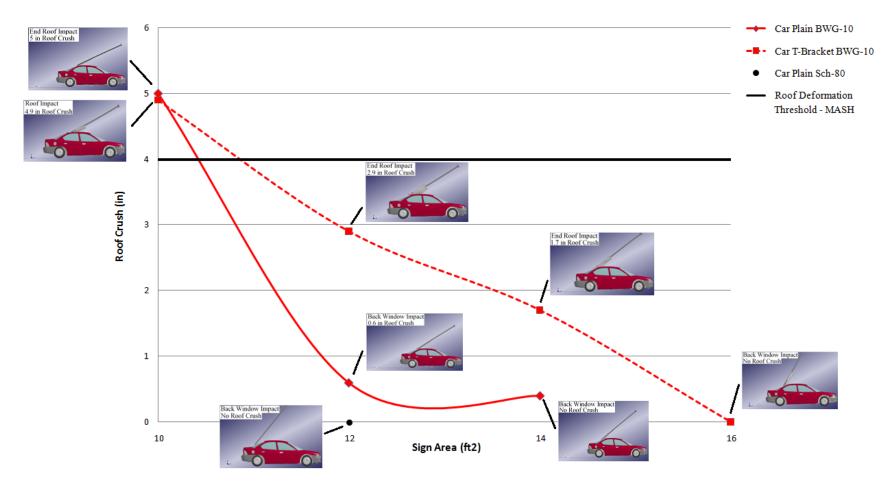
Figure 9.25. Roof Crush Results with Varying Sign Areas and Pole Systems for 1100C Vehicle.

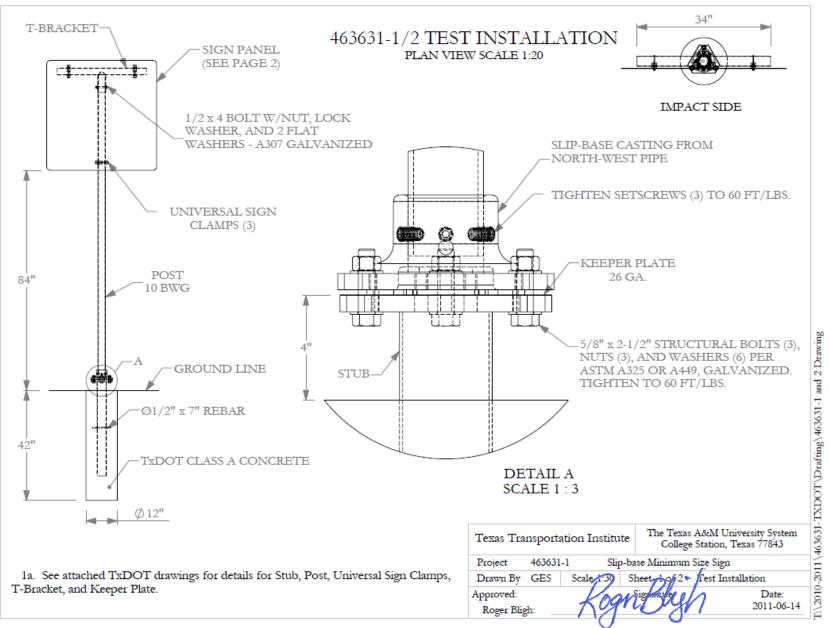
Figures 9.27 through 9.29 show a schematic of the triangular slipbase sign support installation, with further details in Appendix H, Figure H1. Figure 9.30 presents photographs of the completed test installation.

Figure 9.27. Details of the Sign Support System Used for Test Nos. 463631-1 and 463631-2.

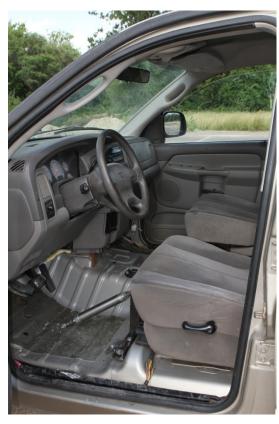
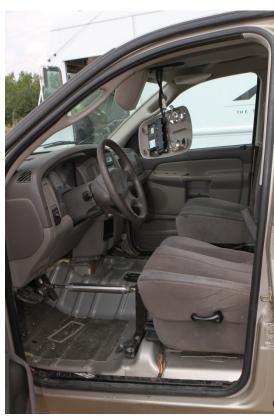
Figure 9.35. Interior of Vehicle for Test No. 463631-1.

Before Test

After Test

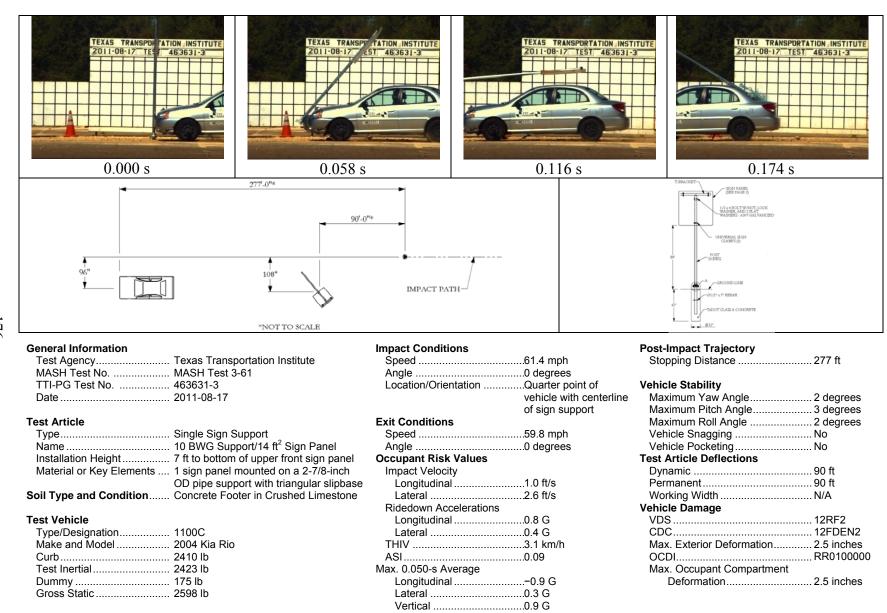
Figure 9.60. Summary of Results for *MASH* Test 3-61 on the 10 BWG Steel Pipe Slipbase Support with 14 ft² Sign Panel (Test No. 463631-3).

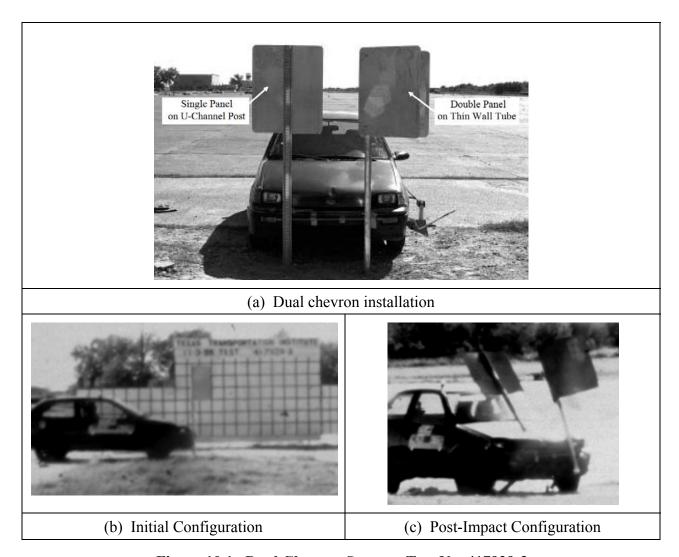
Figure 10.1. Dual Chevron Support Test No. 417929-3.

TxDOT funded a project entitled "Impact Performance Evaluation of Work Zone Traffic Control Devices" aimed at providing traffic control devices for use in work zones (in accordance with *NCHRP Report 350* guidelines) that would perform acceptably when impacted by errant vehicles. One test performed under this research project was a high-speed passenger car impact against a dual chevron installation with panels at a 4-ft mounting height on flat, level ground. Figure 10.1(a) shows that the installation had a single panel through-bolted to a U channel post, and the other installation had two panels attached to a 13 BWG pole using the standard mounting brackets. Of particular interest for the scope of this research study is the outcome of the vehicle impact with the two-panel chevron. The two-panel sign was 24 inches wide and 30 inches high. A Geo Metro passenger car impacted the sign supports head-on at a speed of 62.0 mi/h (see Figure 10.1[b]).

The U-channel chevron support failed to meet the requirements of *NCHRP Report 350*, since it contacted the windshield and cut the roof just behind the windshield frame, thereby showing potential for penetrating the occupant compartment. The thin wall chevron support performed acceptably according to the guidelines of *NCHRP Report 350*. The pole yielded at the bumper impact location and pulled out the socket system. The impacting vehicle then pushed it away, so it never had a second impact with any part of the passenger car (see Figure 10.1[c]). The sign was able to slide through the pole and leave the support impacting the windshield, but did not cause any deformation or intrusion in the occupant compartment.

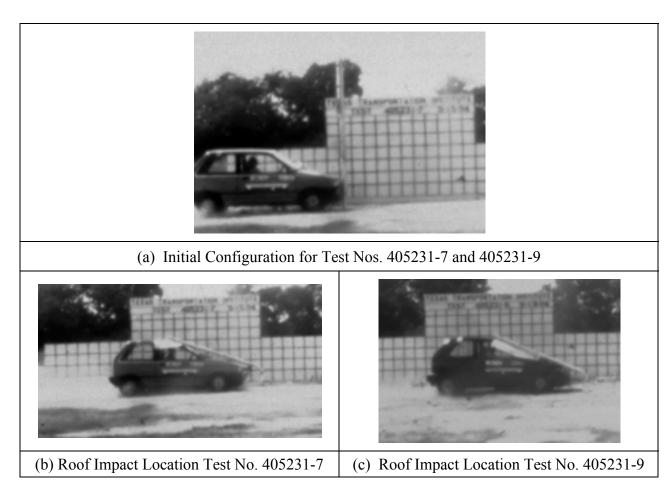
Figure 10.2. Thin-Walled Aluminum Sign Support Tests Nos. 405231-7 and 405231-9.

In 1995, the New Hampshire Department of Transportation initiated a crash-test program in cooperation with the Vermont Agency of Transportation with the scope of evaluating the safety performance of small sign supports used in their states (16). The study was performed at the Texas Transportation Institute. During this study, the performance of a 12ft^2 aluminum sign panel (36 inches \times 48 inches), mounted on a 4-inch diameter Schedule 10 support at a 7-ft mounting height on flat, level ground, was evaluated (see Figure 10.2[a]).

In Test no. 405231-7, the test article was installed in strong soil and impacted by a passenger car at 62.3 mi/h. The support was bent, pocketed around the bumper, fractured, and impacted the roof of the vehicle (see Figure 10.2[b]). Maximum roof crush was 2.4 inches. In

Test no. 405231-9, the test article was installed in weak soil and impacted by a passenger car at 63.0 mi/h. The support was bent, collapsed around the bumper, fractured and impacted the roof of the vehicle (Figure 10.2[c]). Maximum roof crush was 4.3 inches. Tests results were evaluated according to the criteria of *NCHRP Report 350*, which allows a maximum occupant compartment deformation of 5.9 inches.

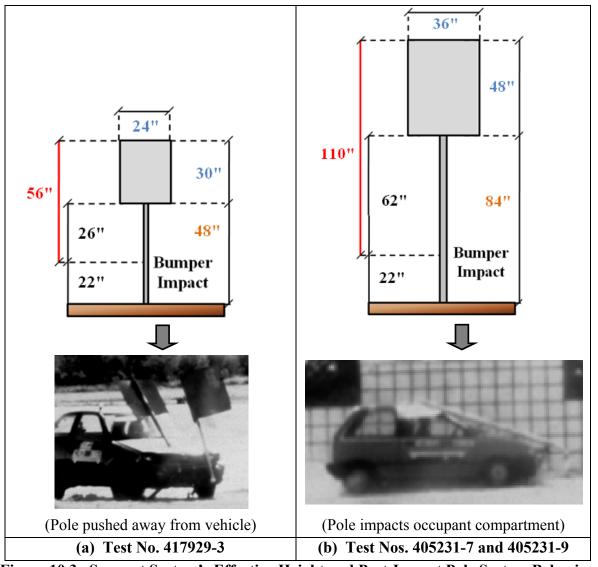
Figure 10.3. Support System's Effective Height and Post-Impact Pole System Behavior.

These research projects highlighted two very distinct pole system behaviors once impacted by the vehicle. Test No. 417929-3 showed that the pole yielded at bumper level, pulled out from the socket, and was carried away by the vehicle. No contact between the pole and the vehicle's occupant compartment occurred. However, in both Test nos. 405231-7 and 405231-9, the pole had a secondary impact with the roof of the passenger car, after being yielded at bumper level and pulled out from the socket system. These two different post-impact behaviors are related to the different total mass of the systems, the brittleness of the support post, and the effective height of the pole, which is the height of the pole measured from the vehicle's bumper impact location.

Test no. 417929-3, with a mounting height of 4 ft and a sign height of 30 inches, had a total height of 78 inches. Considering a bumper impact location at approximately 22 inches from ground level, the effective pole height is approximately 56 inches (see Figure 10.3[a]). As for Test nos. 405231-7 and 405231-9, the mounting height was 7 ft, and the sign height was 48 inches. Figure 10.3(b) shows that the effective pole height was approximately 110 inches (The taller pole also resulted in a higher pole system mass and inertia, so that the impacting vehicle cannot be easily pushed away).

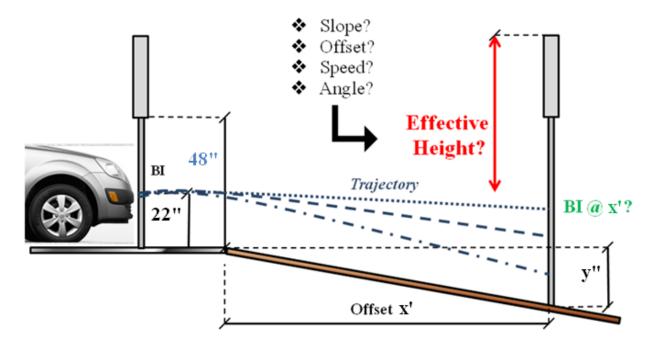
Figure 10.4. Effective Pole Height Variation for Chevron Installation in a Ditch.

A common TxDOT practice is to install chevron sign systems in ditches. For this type of installation, TxDOT standards specify that the sign mounting height has to be considered from the pavement surface. Once a sign support system is installed on a slope, the mounting height of the sign (calculated from ground level at the location of installation) will be greater than the same mounting height evaluated for a sign installed on flat level ground. For an installation of a sign support system on a slope at a general "x" distance offset from the pavement surface, the depth "y" of the ditch itself at the particular installation location contributes to an increase in the total height of the pole and the sign mounting height (see Figure 10.4).

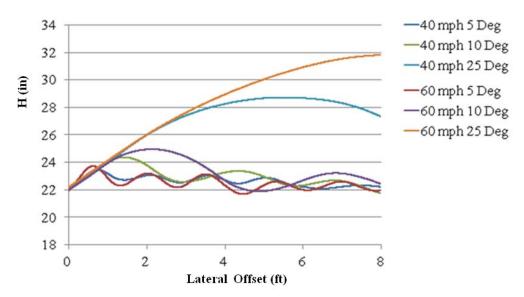
Figure 10.5. Relative Bumper Impact Height for Chevron Installation in a 6H:1V Ditch.

Figure 10.5 shows the relative bumper impact height for the pole support, calculated for different vehicle speed, angles and for a range of lateral offset distances of chevron installation. Analyses show that when the vehicle enters the ditch with an angle smaller than 25 degrees, it is most likely the tires will stay in contact with the ground throughout the whole ditch, no matter what the vehicle's entering speed. The bumper's distance from ground, also referred to as the relative bumper impact height, oscillates around a constant value (22 inches) due to the vehicle's suspension dynamic. On the other hand, if the vehicle enters the ditch at a 25-degree angle, it becomes airborne. The distance of the bumper from ground level can increase from the initial

22 inch value (bumper impact location on pole when on flat level ground) up to 32 inches when the vehicle has a speed of 60 mph.

Trajectory analyses were evaluated for a passenger car entering a 6H:1V slope ditch at different speeds (40 and 60 mph) and angles (5, 10, and 25 degrees). A 6H:1V slope ditch was chosen since it appears to be a reasonable upper limit of maximum common ditch slope in Texas. Also, lateral offset between 2 ft and 8 ft from the pavement surface was considered, since TxDOT standards allow chevron signs installation between 2-ft and 8-ft lateral distance from the road. Trajectory analyses were evaluated using a computer program called CarSim® (18). Figures 10.5 and 10.6 report the results from the trajectory analysis.

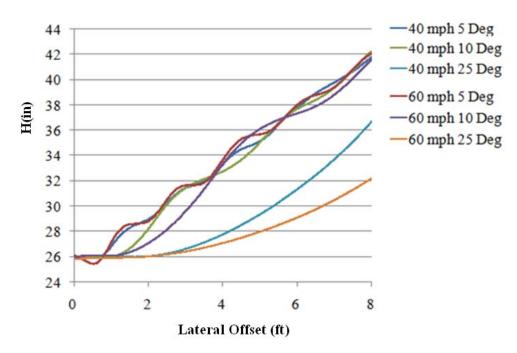
Figure 10.6. Relative Distance between Bumper Impact Location and Bottom Edge of Chevron in a 6H:1V Ditch.

Considering the scope of this study, the worst scenario to be considered for crashworthiness evaluation of chevron signs in ditches is one whereby a vehicle enters the ditch at high speed (60 mph), at an angle of 10 degrees. In this case, the pole length between the bumper impact location and the sign bottom edge is maximized for a given lateral offset of system installation (see Figure 10.5). Also, Figure 10.6 shows that the maximum pole length between bumper impact location and sign bottom edge is reached when the chevron sign system is installed at 8-ft lateral offset from the pavement surface.

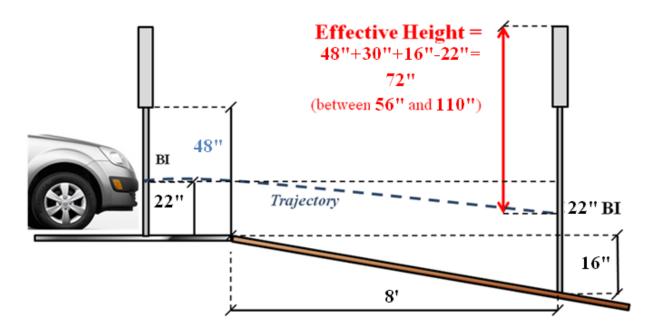
Figure 10.7. Effective Pole Height for a 30-Inch-High Chevron Sign Installation on 4-Ft Mounting Height, at 8-Ft Lateral Offset in a 6H:1V Ditch.

In a 6H:1V slope ditch at 8-ft lateral offset, the depth of the ditch is 16 inches. When a 30-inch tall chevron sign is mounted at 8-ft lateral offset on a 4-ft mounting height from the pavement surface, the total height of the pole is 92 inches. Considering an errant vehicle entering the ditch at 60 mph and 10 degrees and impacting the chevron sign system at 8-ft lateral offset, the bumper impacts the pole at approximately 22 inches above the ditch surface (see Figure 10.7).

As a result, the effective height of the chevron pole system is 72 inches. The previous section had stated that the crashworthiness behavior of an impacted pole system with an effective height between 56–110 inches is not currently known. For this reason, the researchers suggest investigating this configuration to determine its crashworthiness. Should the evaluation determine the installation as not crashworthy; the simple solution is to increase the mounting height to 7 ft above the roadway surface. Previous crash testing of 7-ft mounting heights with

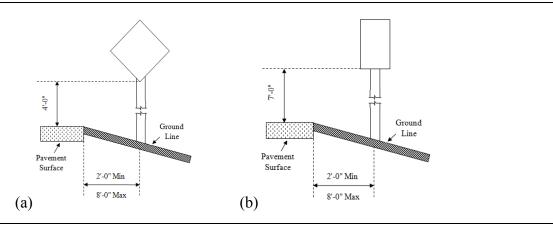
(c) Distinction between 4' and 7' mounting height options for Chevrons

All current sizes of Chevron signs can be mounted at 7'-0" mounting height from the pavement surface. Only certain sizes, however, can be mounted at 4'-0" mounting height. Also, the mounting height is no longer reported as a "Min" height.

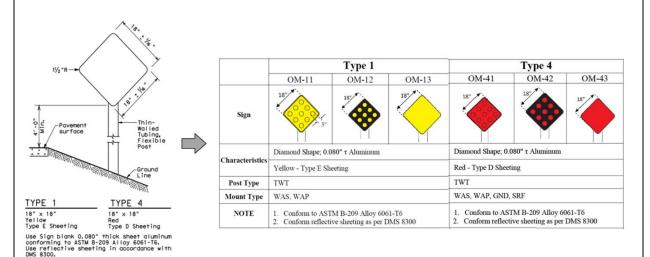
(d) Inclusion of Type 1 and 4 Object Markers signs with use of reflectors

In the current TxDOT standard sheet, there is no illustration of the Object Marker (Type 1 and 4) design with use of reflectors and Object Markers type 1, 2 and 4 are not recalled with their descriptive name OM-XX. A new layout for showing all allowable Object Marker Type 1 and 4 signs is proposed. Post types are now recalled with their code.

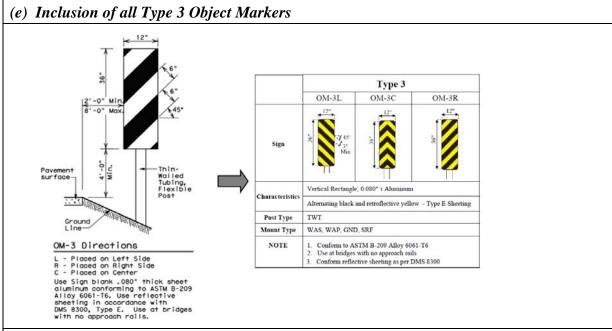
In the current TxDOT standard sheet, only Object Marker Type 3R is illustrated. In the proposed layout, all Object Markers Type 3 are illustrated.

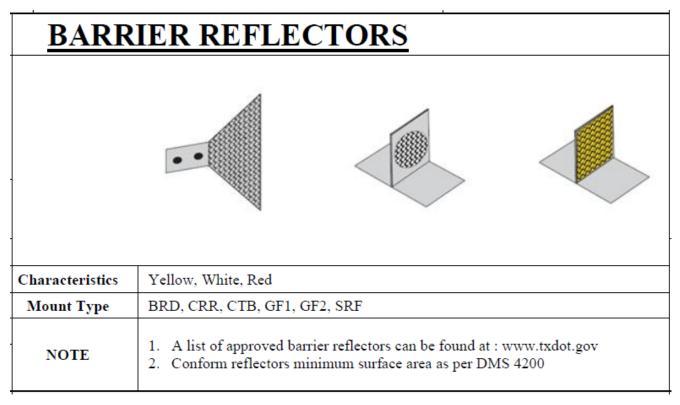
Figure 10.10. "Barrier Reflectors" Section in the Proposed New Layout TxDOT D&OM(1)-11, Option #1.

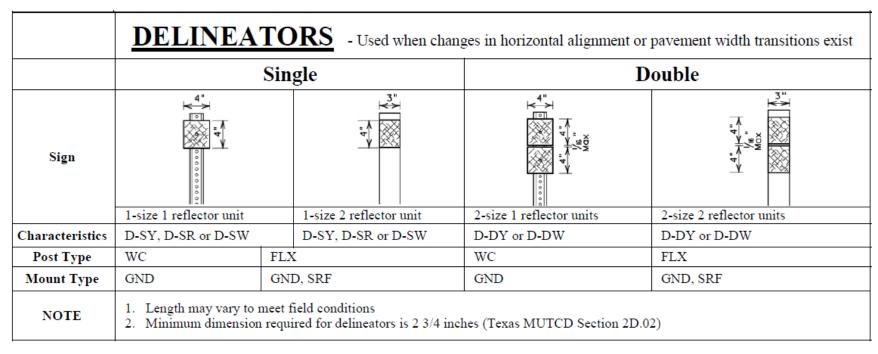
Figure 10.11. "Delineators" Section in the Proposed New Layout TxDOT D&OM(1)-11, Option #1.

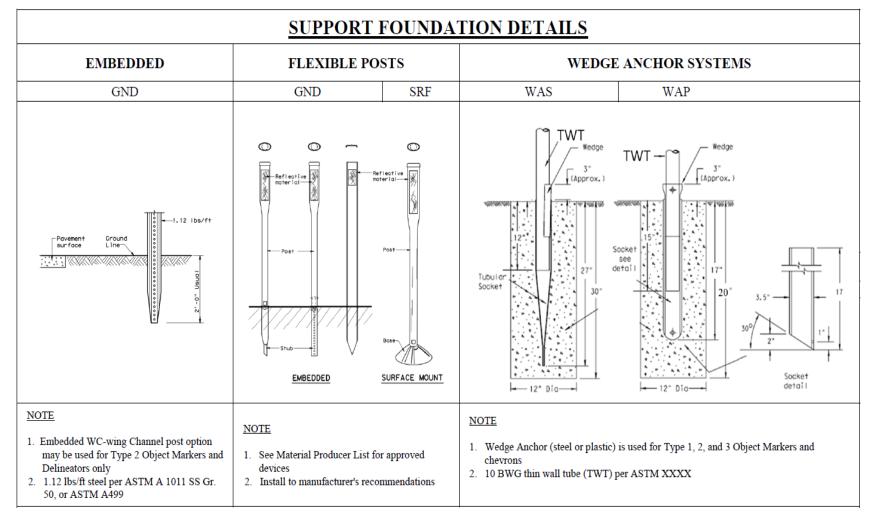
Figure 10.13. "Support Foundation Details" Section in the Proposed New Layout TxDOT D&OM(1)-11, Options #1 and #2.

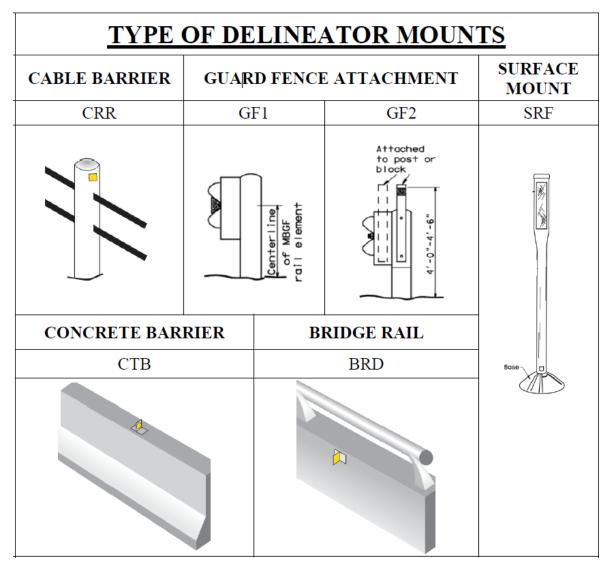
Figure 10.14. "Type of Delineator Mounts" Section in the Proposed New Layout TxDOT D&OM(1)-11, Options #1 and #2.

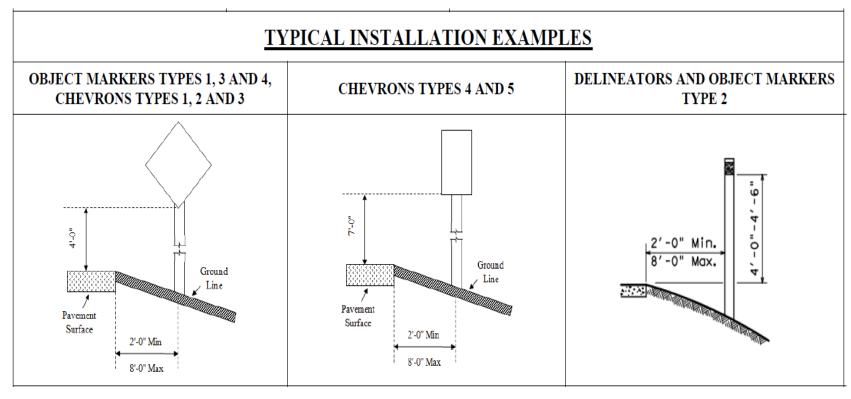
Figure 10.15. "Typical Installation Examples" Section in the Proposed New Layout TxDOT D&OM(1)-11, Options #1 and #2.

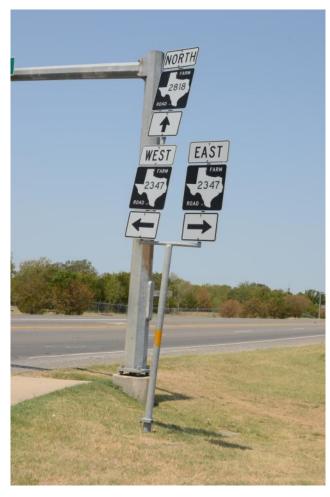
Figure 11.1. Example of U-Bracket Failure.

District maintenance personnel have reported multiple instances of "U-bracket" failures. Figures 11.1 through 11.3 show one failure mode reported, which is located in the Bryan district at the northeast corner of the intersection of FM2818 and FM2347. These images show that the sign is still visible to motorists; however, the left upright of the U-bracket is rotated in the direction of travel. After further inspection, researchers have determined that this installation was an older design that has subsequently been discontinued and is no longer being installed.

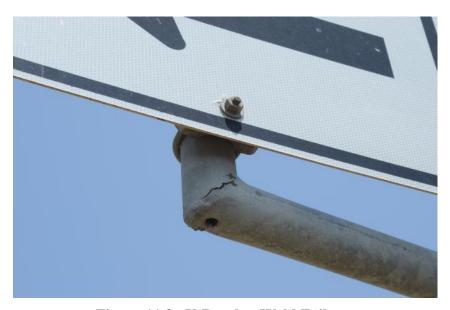
Figure 11.2. U-Bracket Weld Failure.

The current design bends the U-pipe to form the "U" and is fabricated from a 23/8-inch 10BWG pipe. This discontinued design utilizes a smaller diameter U-pipe and miters the U-pipe instead of bending it to form the "U." When inspecting the failed support the cause of the failure was determined to be the weld in the left miter joint. Figure 11.2 shows the large crack that is evident of this mode of failure. A list of possible causes for this weld failure includes: wind overloading event (winds in excess of design speeds), improper fabrication (poor weld quality), cyclic fatigue, or possible corrosion. As the system is still in-service, a further inspection to determine exactly what caused the weld failure was not possible.

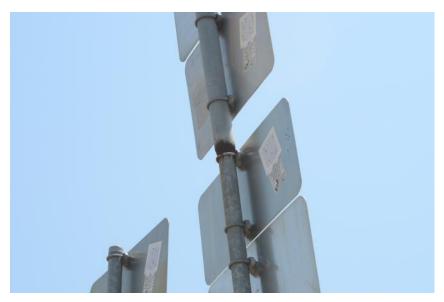
Figure 11.3. Improper Installation of U-Bracket Extension Tube.

Another item to note is that the extension tube at the top of the tube was fabricated to fit the current U-bracket design. As this extension tube is much larger in diameter than the discontinued U-bracket, the extension tube was field modified to make it fit into the smaller U-pipe. However, this damaged much of the protective galvanization, leading to corrosion (see Figure 11.3).

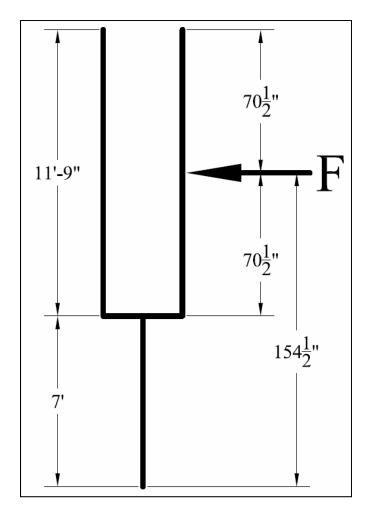
Figure 11.4. U-Bracket Installation Configuration for Engineering Analysis.

After reviewing TxDOT sign standards, the research team applied two constraints to this problem. First, from TxDOT standard sheets, a U-bracket may not be configured to have a height greater than 11 ft-9 inches. From TxDOT sign support standards, a sign may not be mounted less than 7 ft above the roadway surface. These constraints lead to the configuration shown in Figure 11.4. As this configuration is the worst case, if the calculated wind load capacity (F) for the U-bracket is in excess of the calculated capacity (F) of the tubular support, then it should always be in excess of the support no matter the configuration (as long as the configuration does not violate these constraints). An efficient design will balance the calculated capacities (F) of these components for this configuration.

The engineering analysis discussed previously in this report only looked at the bending, shear, and torsion in the U-pipe itself. This form of methodology did not allow for the analysis of the U-pipe to sleeve connection due to its complex geometry. Therefore, to analyze this connection, a Finite Element (FE) simulation of a static loading due to wind load needed to be performed. All simulated conditions were based on the configuration presented in Figure 11.4. In these simulations, a displacement, "D," was applied at the mid height of the U-bracket supports

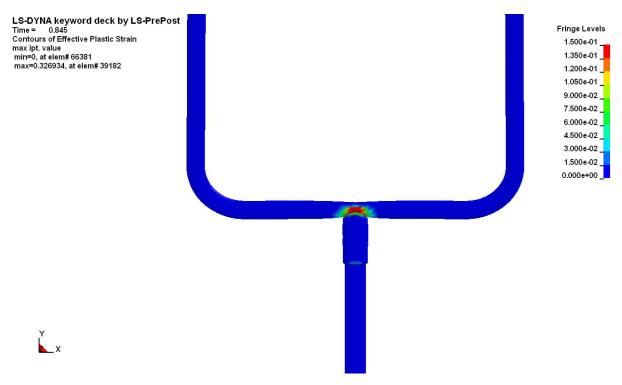
The first simulation was generated to represent the current U-bracket and support configurations. The U-pipe was simulated as a 2.375-inch 10 BWG pipe (55 ksi yield) section that had a 39-inch center to center vertical support spacing. The height of the U-bracket vertical supports was simulated to be 11 ft-9 inches The U-bracket nipple was simulated as a 3.25-inch 11 BWG pipe (55 ksi yield) support that was necked down to accept the U-pipe at one end. The geometry was a best-fit interpretation of the actual geometry since exact dimension drawings were not available. Finally, a 2.875-inch schedule 80 pipe support was simulated to support the U-bracket. A constant rate displacement was applied perpendicular to the U-bracket at 154.5 inches above the rigid fixed end support. The displacement was increased until a large yield region developed in the U-pipe near at the nipple attachment location (see Figure 11.5). This simulation predicts that the U-pipe will yield at the weld location before the schedule 80 support will yield.

Figure 11.5. Simulation of Current TxDOT Design.

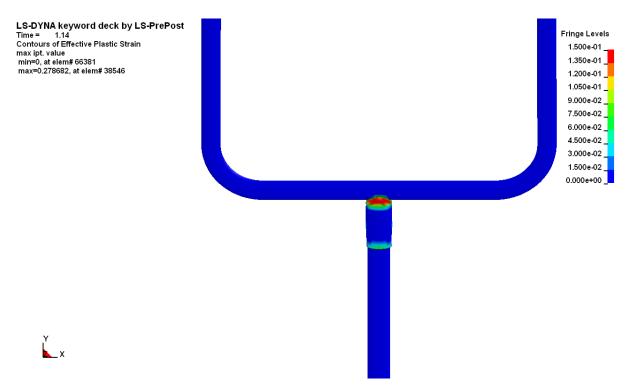
Figure 11.6. Simulation of Schedule 80 U-Pipe.

In an attempt to increase the capacity of the system, the thickness of the U-pipe section was increased to schedule 80 from BWG10. The change did prevent the yielding zone in the U-pipe, however, the nipple then became the limiting factor, evident in the large yield region shown in Figure 11.6. This simulation predicts that the nipple will yield before yielding the schedule 80 support.

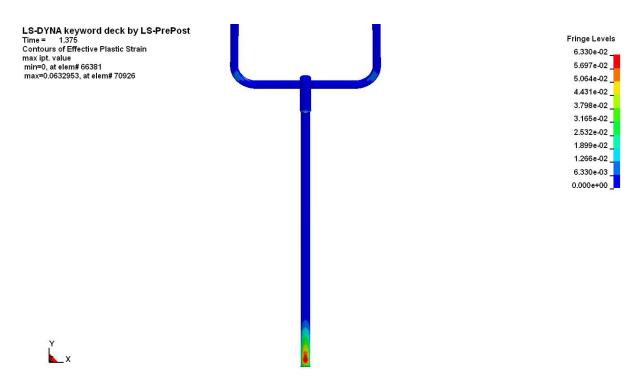
Figure 11.7. Simulation of Modified Nipple Design.

In an attempt to strengthen the connection between the nipple and the U-pipe, a new design was proposed where the nipple no longer necked down to attach to the U-pipe. Instead, the nipple was extended and a hole was drilled through it. The nipple was then threaded through the hole, and the entire assembly was welded up, giving a much larger connection area between the U-pipe and the modified nipple. This larger area helped to strengthen the connection and resulted in the schedule 80 support post yielding at the rigid fixed end condition (see Figure 11.7). Figure 11.8 shows a full detailed drawing comparing the new proposed U-bracket design to the current TxDOT design. This simulation predicted that the modified design would have a higher capacity than that of the schedule 80 pipe support.

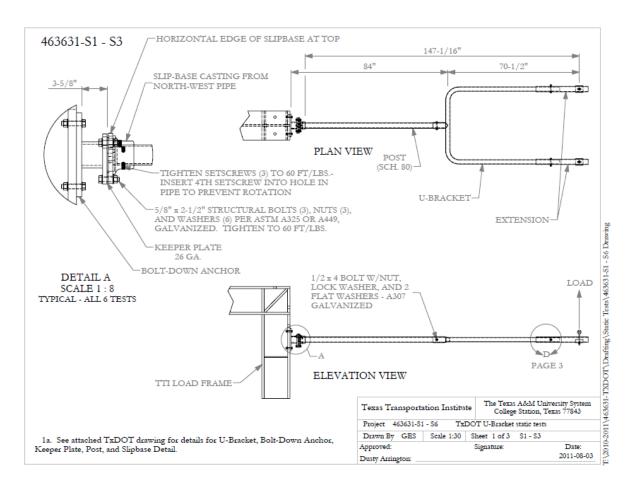
Figure 11.9. U-Bracket Installation Static Test Setup Drawings.

Tests S1-S3 were developed to measure the maximum wind load force that the U-bracket assembly could withstand at a height of 154.5 inches as previously described in the engineering analysis section of this report. The installation was rigidly cantilevered out horizontally from a load rigid load frame (see Figure 11.9). Figure 11.10 shows the test setup before load application. For this test, the load needed to be spread equally among the two vertical U-bracket supports and will help prevent the U-bracket assembly from twisting in the slip base due to unbalanced applied loads. This was accomplished through the use of a spreader bar shown in Figure 11.11, which ensures both load and deflection are applied to each of the U-brackets vertical supports uniformly while utilizing only a single hydraulic cylinder.

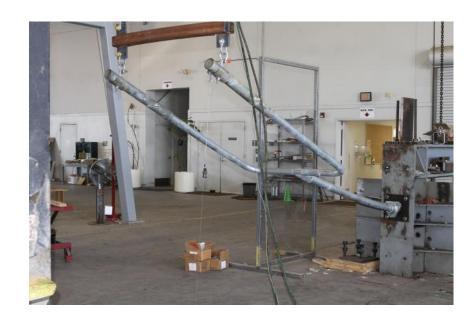
Figure 11.12(a). Image of U-Bracket Installation Static Test Setup at Maximum Load.

During the test, a load cell was used to measure the applied load, and a string pot, attached at the load application site, was used to measure deflection. Load application was only halted upon reaching the maximum deflection that the hydraulic cylinder allowed (48 inches). The data was then digitally recorded and plotted for comparison (see Figure 11.12). As seen from the load versus deflection plots, there was very little variance in measured capacity of the supports. Notice that the measured capacity meets/exceeds that of the calculated capacity of the support using the actual material yield strength of 57 ksi. Two dashed lines are plotted on Figure 11.12; one is the calculated capacity of the schedule 80 support, and the other is the adjusted calculated capacity of the support, including the weight of the post. Both were calculated using the actual yield stress defined in the provided mill certificates that came with the samples.

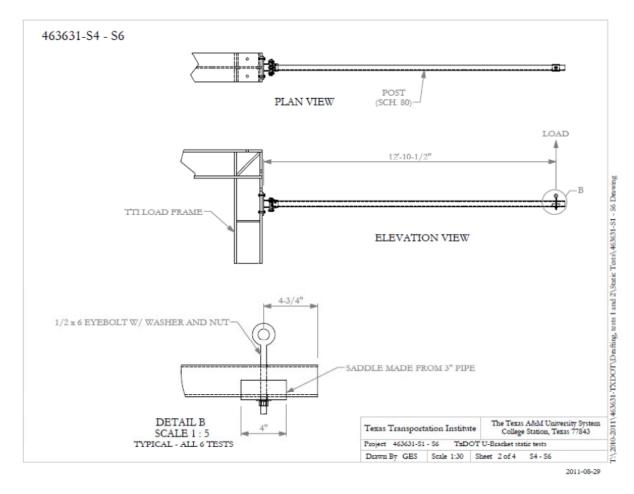
Figure 11.13. Schedule 80 Pipe Support Static Test Setup Drawings.

Tests S4 through S6 were performed on single schedule 80 pipe supports. The test was set up to reproduce the loading conditions found in tests S1 through S3. Again, in this case, the load was applied at a height of 154.5 inches, as described in the engineering analysis section of this report. Figure 11.13 is a detailed diagram of the test setup. Figures 11.14 and 11.15 are images of the test setup before load application and at maximum load application. Figure 11.16 is an image of the deformed support end of the schedule 80 pipe support.

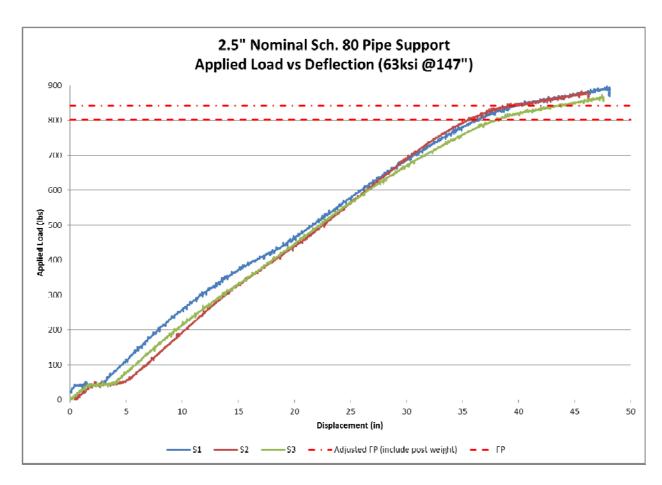
Figure 11.17. Load versus Deflection Curves for Tests S4-S6.

The load was continuously increased until a maximum deflection of approximately 48 inches was reached. The measured load and deflection was then digitally recorded and plotted. Figure 11.17 plots all three load versus deflection curves. Notice that the measured values meet/exceeded the calculated force using the actual yield stress of 63 ksi. Once more, the two dashed lines represent the calculated capacity of the support and the adjusted calculated capacity of the support to include the weight of the support.

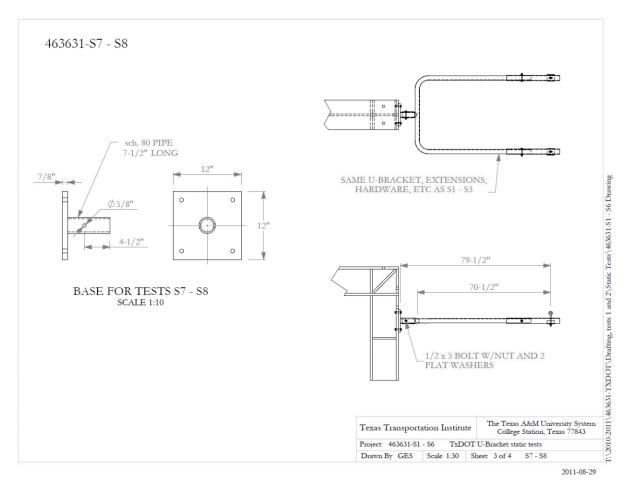
Figure 11.18. U-Bracket Support Static Test Setup Drawings.

Tests S7 through S8 were performed on single U-bracket supports. The test was set up to directly relate applied load values to those found in Tests S1 through S6. In this case, the load was applied at a height of 70.5 inches, which would directly correspond to the applied loading height (154.5 inches) in Tests S1-S6. Figure 11.13 shows a detailed diagram of the test setup. Figures 11.14 and 11.15 show the test setup before load application and at maximum load application. Figure 11.16 presents the failed support end of the U-bracket support. In this case, the U-pipe failed at the tension side nipple to U-pipe weld location.

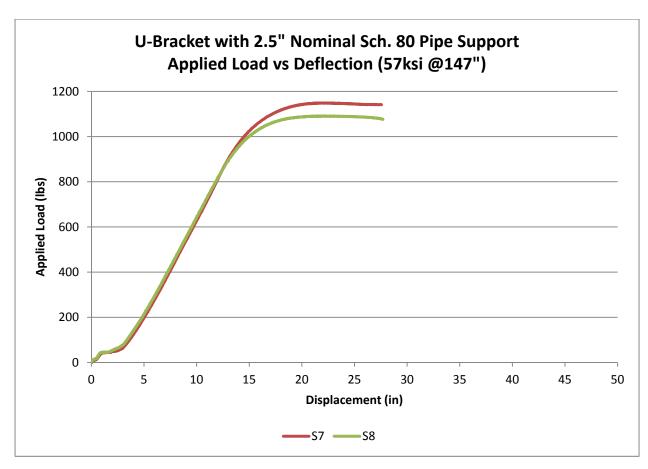
Figure 11.22. Load versus Deflection Curves for Tests S7-S8.

Again, the load was continuously increased until a maximum deflection of approximately 48 inches was reached. The measured load and deflection was then digitally recorded and plotted. Figure 11.22 is a plot of all two load versus deflection curves. Notice the measured values meet/exceeded the measured loads recorded in S1-S6.

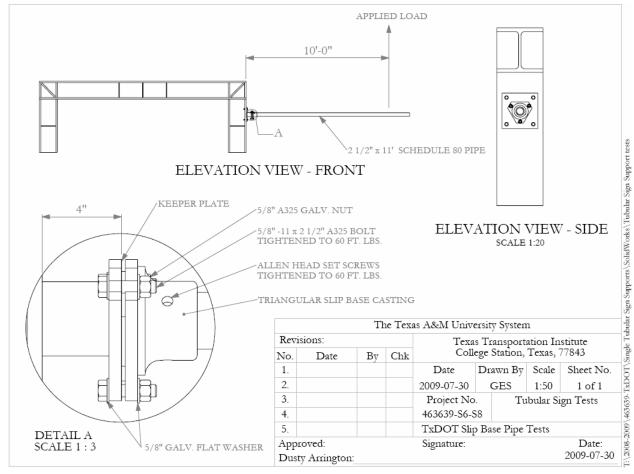
Figure A1. Test Setup for S6–S8.

Three tests were conducted to quantify the flexural capacity of a schedule 80 pipe sign support. The tests were conducted on a cantilevered schedule 80 pipe attached to a standard TxDOT triangular slip base. This connection utilized three \(^5\gamma_\)-inch diameter A325 bolts. The three bolts are installed in the slip base slots and torque to 60 ft-lb. A bolt keeper plate was used between the upper and lower slip plates to help retain the bolts within the slots. The upper slip plate was integral to a ductile iron casting. The schedule 80 pipe support was inserted into a sleeve on top of the casting and secured with a set screw. Figure A1 shows a diagram of the test setup and test article.
