DEVELOPMENT GUIDANCE FOR SIGN DESIGN STANDARDS

Test Report 0-6363-1

Project Title: Improvements to Large and Small Roadside Sign Hardware and Design

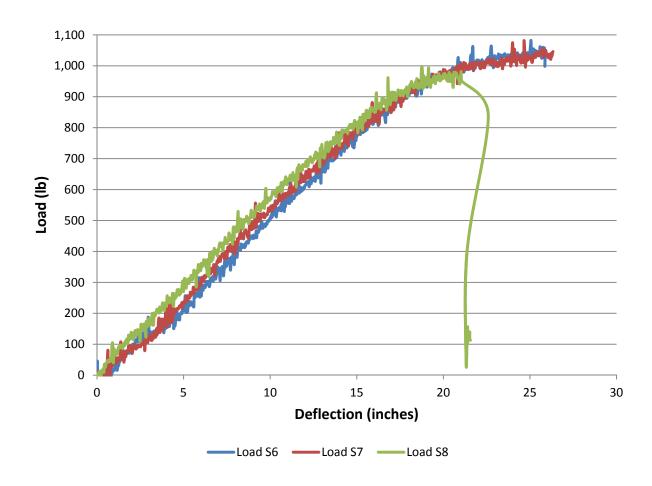
Figure A2. Load for Tests on the Schedule 80 Cantilever Support.

Tests S6 through S8 were performed on the schedule 80 cantilever support. Table A1 notes the maximum loads and displacements from these tests are noted. Figure A2 shows graphs of the load data. In test S8, the bottom bolt released. Figure A3 shows that the other two tests were halted after the post yielded plastically at the slipbase.

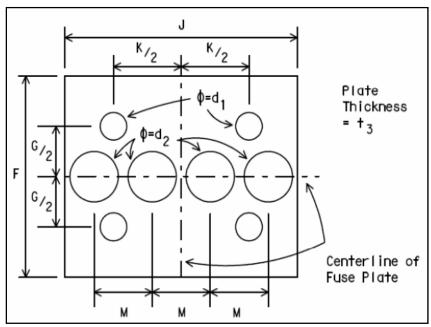
Figure B1. TxDOT Standard Fuse Plate Detail.

The standard fuse plate is made from steel bar or steel plate. The plates used in the testing were fabricated from A36 bar stock having an ultimate tensile capacity less than 80 ksi. The plates are $\frac{3}{8}$ -inch thick and $\frac{5}{4}$ inches wide. To reduce the rupture strength, four $\frac{1-1}{16}$ -inch diameter holes are drilled along the centerline of the plate effectively reducing the cross-sectional area (see Figure B1). A plate was bolted to both the compression or tension flanges of the W8×18 post sections using $\frac{5}{8}$ -inch diameter ASTM A325 bolts. The bolts were torqued to $\frac{36-38}{16}$ ft-lb. Figure B2 is the TxDOT standard detail sheet for mounting of large guide signs, and Figure B1 details the generic TxDOT fuse plate design.

Figures B1 and B2 also show details of the fuse plate TxDOT used on W8×21 support posts. The plates used in the tensile tests were fabricated from A36 bar stock having an ultimate tensile capacity less than 80 ksi. The plates were ½-inch thick and 5 ¼ inches wide. To control the rupture mode and strength, four 1-inch diameter holes are drilled along the centerline of the plate effectively reducing the cross-sectional area, (see Figure B2).

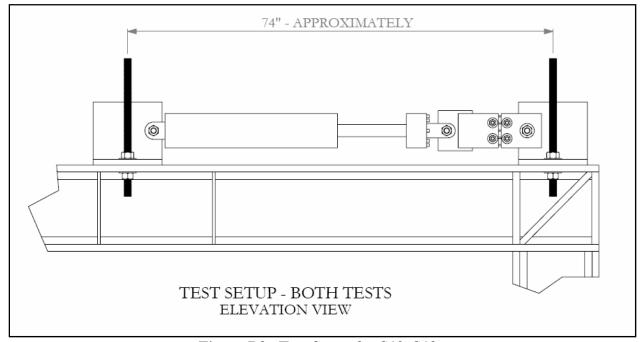
Figure B3. Test Setup for S12–S19.

Two supports fabricated from 1-inch thick steel plate were mounted to the top of a load frame. A 24-inch stroke hydraulic cylinder was used to apply the load. This cylinder has a maximum tensile capacity of 50 kips. A load cell was installed in line with the hydraulic cylinder to measure tensile load as a function of time. Connecting plates were bolted to the hydraulic cylinder on one end and the support bracket on the other end. These pinned connections enabled the specimens to be loaded in uniaxial tension without bending the vertical plane. Combined stresses arising from bending would effectively reduce the tensile capacity of the fuse plates. Figure B3 shows a diagram of the test setup.

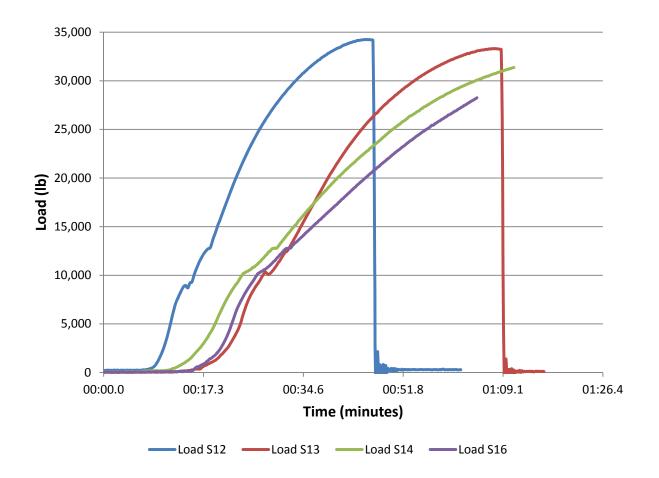
Figure B4. Load for Tests on Fuse Plates.

Table B1 notes the maximum load for Tests S12-S14 and Test S16,, and Figure B4 show graphs of the load data for these tests. In Tests S12-S14 the plates failed in tension (see Figure B5). The larger fuse plate used with W8×21 support posts exceeded the force capacity of the hydraulic cylinder. The loading was halted at a force of 50 kips without failing the fuse plate.

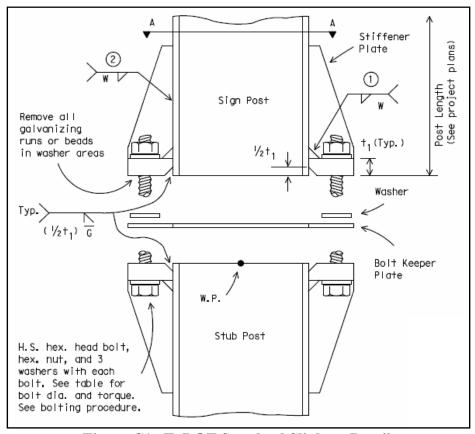
Figure C1. TxDOT Standard Slipbase Detail.

The standard TxDOT slip base connection consists of slotted plates welded to opposing flanges of the W8×18 post section and a lower foundation plate with similar geometry. A 5/8-inch diameter ASTM A325 connecting bolt is placed in each set of slots and tightened to a prescribed torque of xx ft-lb to clamp the W8×18 post section to the foundation and provide the required moment resistance for wind loads. A 30-gauge keeper plate is placed between the foundation plate an upper slip plates to help retain the bolts in the slots. The bolts were torqued to 36-38 ft-lb. When impacted by a vehicle, the upper slip plates displace relative to the foundation plate. The keeper plate is ruptured as the slip bolts are kicked out of the slots. Figure C1 is an exploded view of a standard TxDOT slip base connection for large signs.

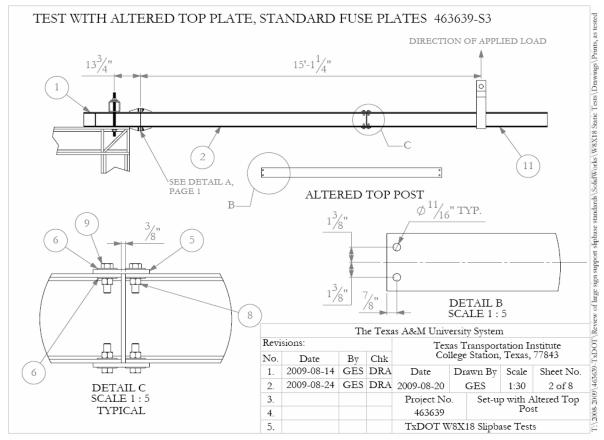
Figure C2. Test Setup for S3.

TxDOT standard fuse plates and slipbase connections were utilized to erect the W8×18 support post section (see Figure C2). The post assembly was then clamped to a load frame 13.75 inches below the slipbase connection. A vertical force was applied to the W8×18 post section in the strong axis direction 16 ft-3 inches above the clamped location. The force was measured by an in-line load cell, and deflection of the support post was measured at the point of load application using a string pot.

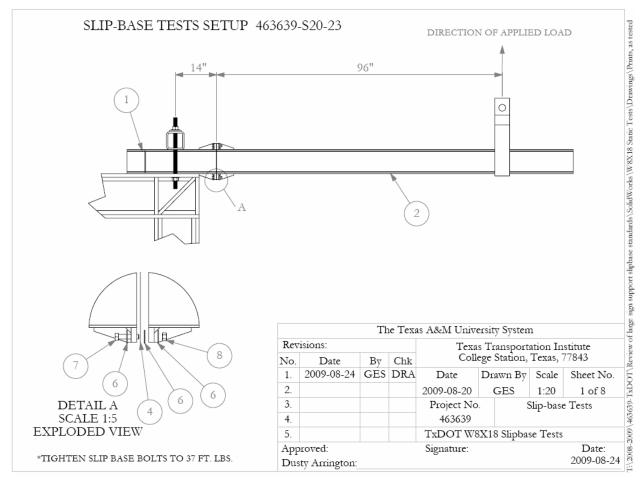
Figure C3. Test Setup for S20-23.

These tests evaluated the capacity of the standard TxDOT slipbase connection for large signs. Two W8×18 post sections were spliced together using a standard TxDOT slipbase connection (see Figure C3). The post assembly was clamped to the load frame 14 inches below the slipbase connection. A vertical load was applied in the strong axis direction of the W8×18 post section 9 -2 inches above the clamped location. An in-line load cell measured the force, and deflection of the support post was measured at the point of load application using a string pot.

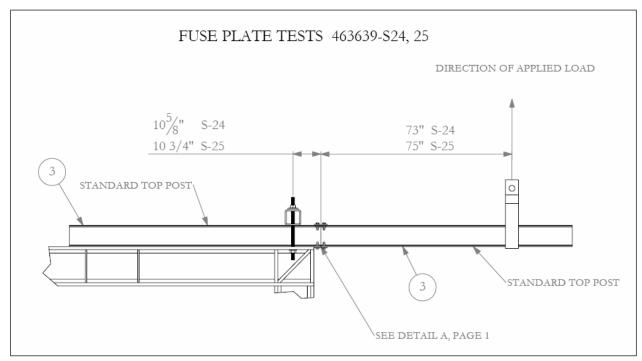
Figure C4. Test Setup for S24 and 25.

These tests evaluated the capacity of a standard splice connection. Two W8×18 post sections were spliced together using a standard TxDOT fuse plate connection (see Figure C4). The test samples were fabricated such that the gap between the spliced post sections was less than ½ inch. The post assembly was clamped to the load frame approximately 10.75 inches below the slipbase connection. A vertical load was applied in the strong axis direction of the W8×18 post section approximately 7 ft above the clamped location. Figure C4 has the actual distances for each test. An in-line load cell measured the force, and deflection of the support post was measured at the point of load application using a string pot.

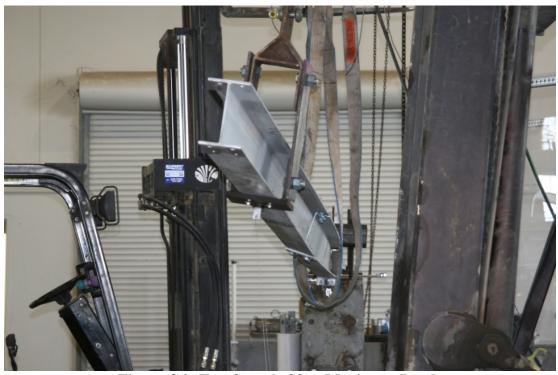
Figure C6. Test Sample S3 at Maximum Load.

In Test S3, the W8×18 support experienced significant twisting due to lateral torsional buckling (LTB), but there was no failure of the splice connection (see Figure C6). Figures C7 and C8 show that in Tests S20, S21, and S23, the nuts stripped off the threads of the slip bolts on the tension side of the slip base assembly. In Test S22, one of the bolts on the tension side of the slip base assembly ruptures and the threads stripped off the other bolt.

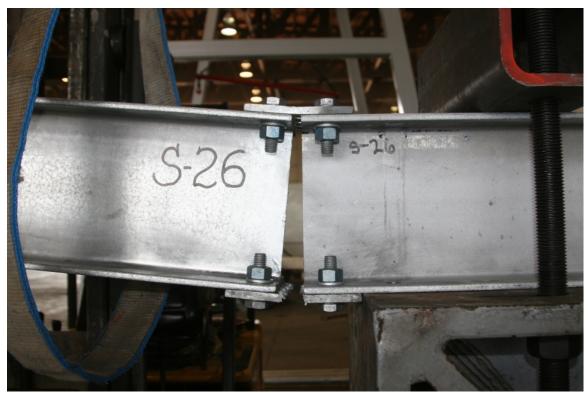
Figure C9. Test Sample S26 after Fuse Plate Rupture.

In Tests S24 and 25, the fuse plate on the tension side of the splice connection ruptured. Figure C9 shows that a similar fuse plate failure was observed in tests S26 and S27 on the separated splice connection.

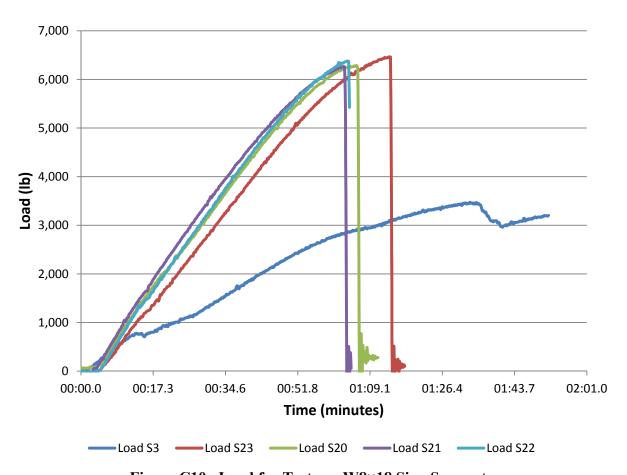
Figure C10. Load for Tests on W8×18 Sign Support.

Table C1 lists the maximum load and displacements from the static load tests. Figure C10 shows the graphs of the load data.

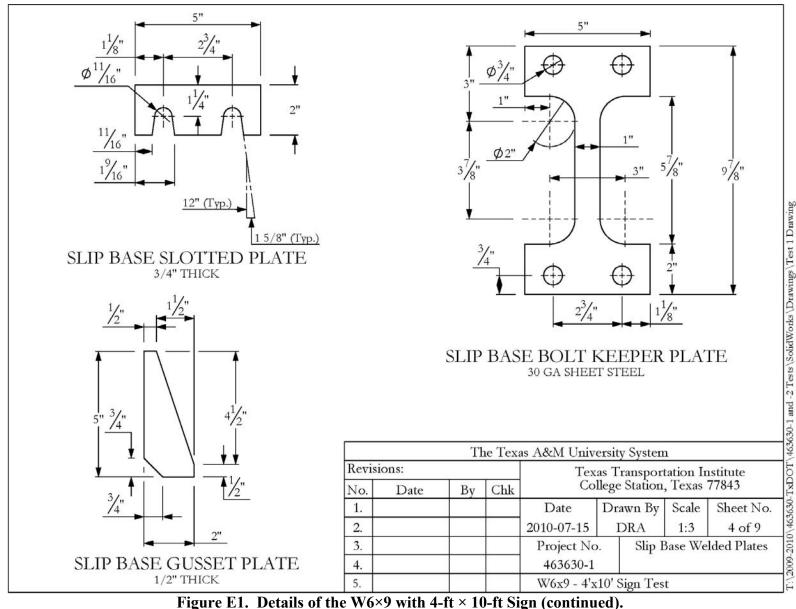
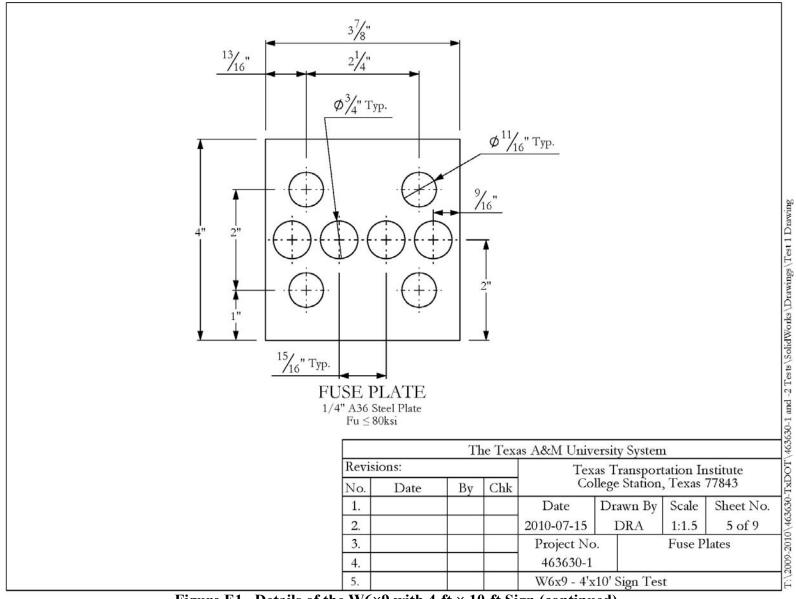
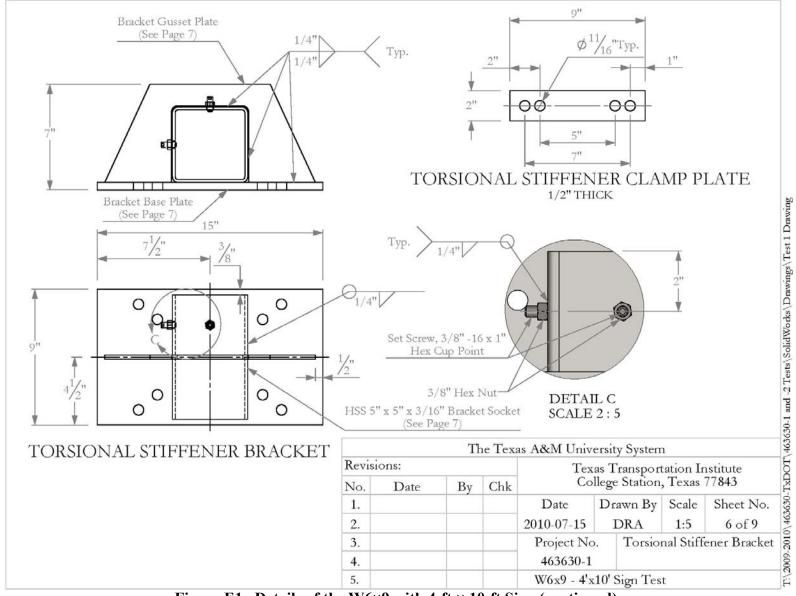
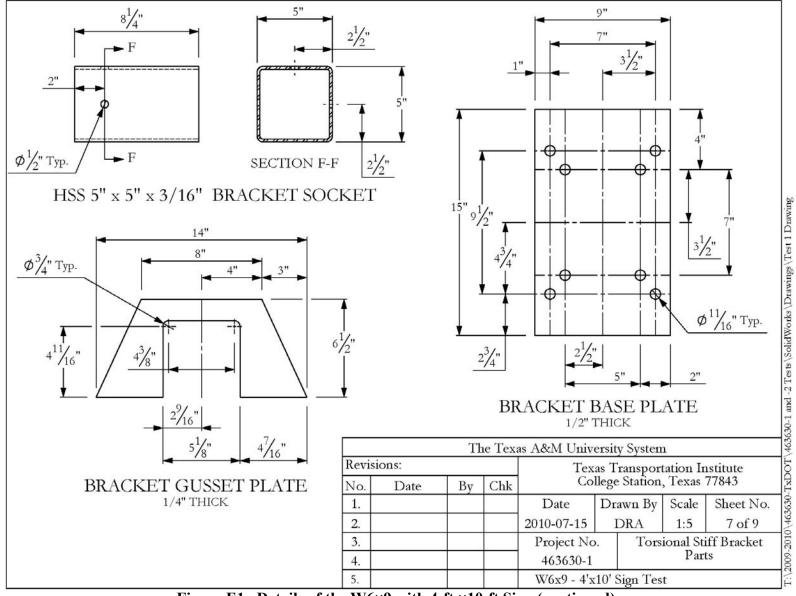
Figure E1. Details of the W6×9 with 4-ft \times 10-ft Sign (continued).

Figure E1. Details of the W6×9 with 4-ft ×10-ft Sign (continued).

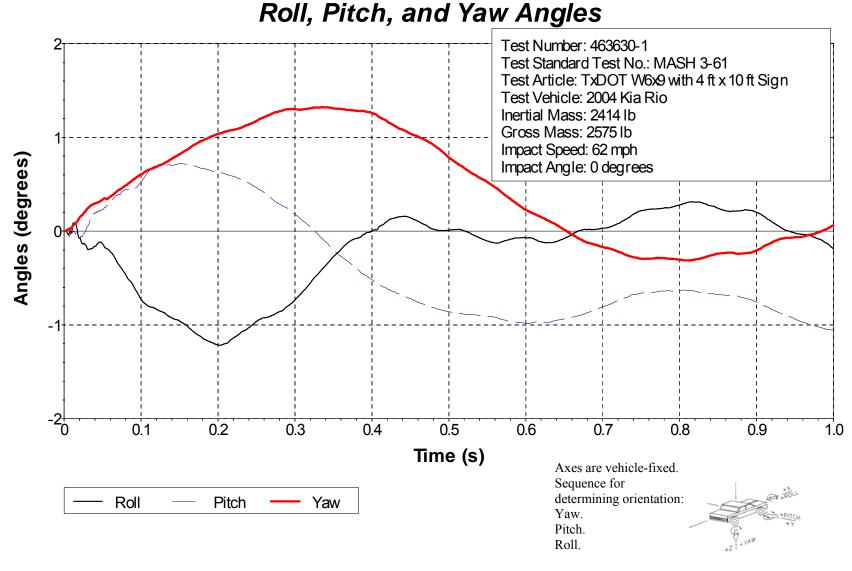
Figure E3. Vehicle Angular Displacements for Test No. 463630-1.

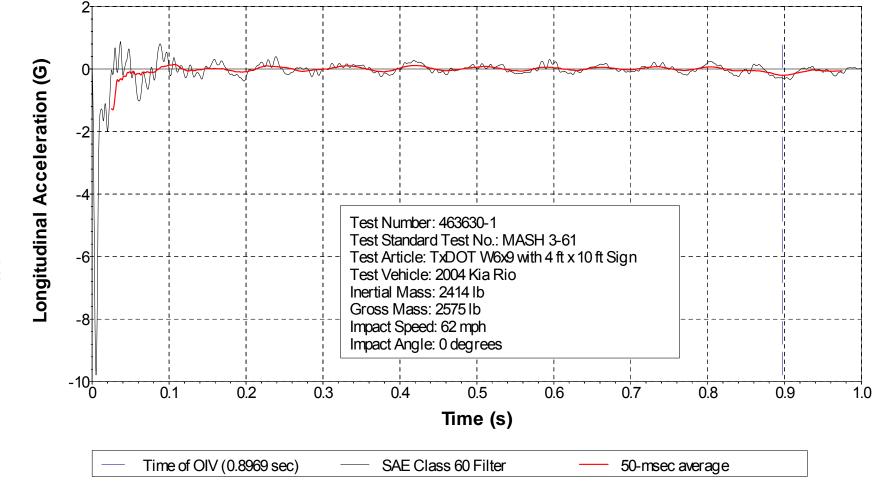
Figure E4. Vehicle Longitudinal Accelerometer Trace for Test No. 463630-1 (Accelerometer Located at Center of Gravity).

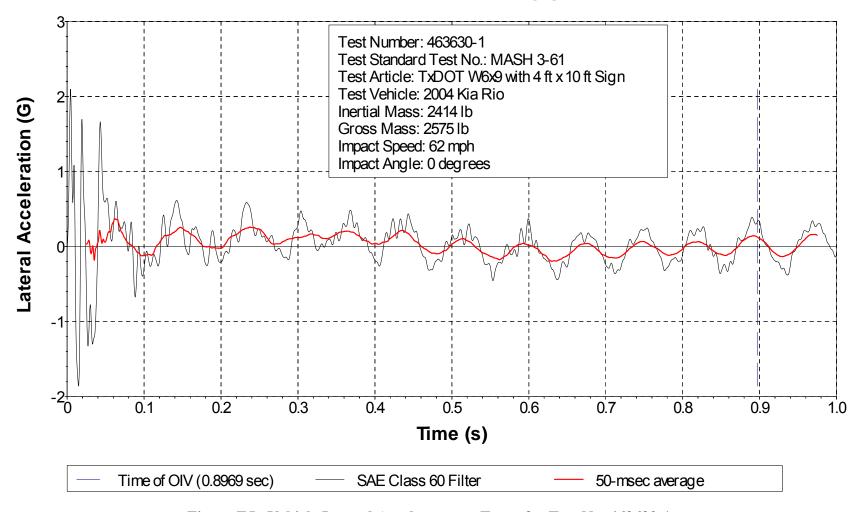
Figure E5. Vehicle Lateral Accelerometer Trace for Test No. 463630-1 (Accelerometer Located at Center of Gravity).

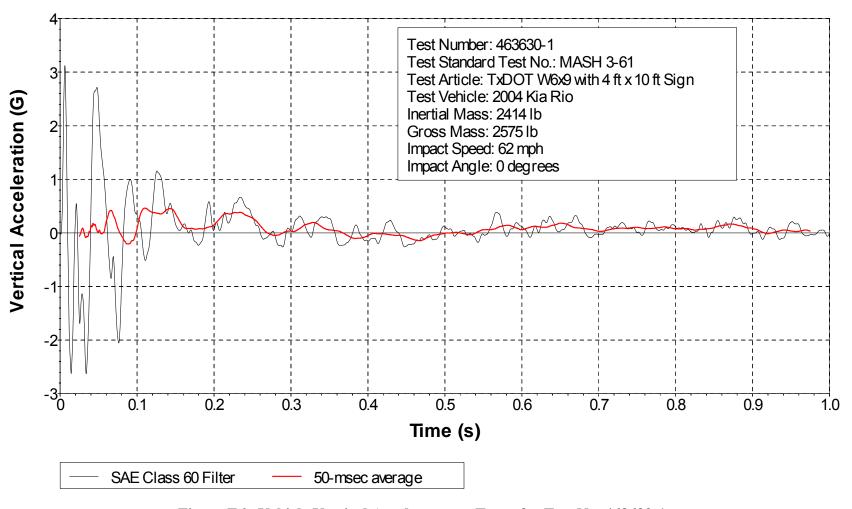
Figure E6. Vehicle Vertical Accelerometer Trace for Test No. 463630-1 (Accelerometer Located at Center of Gravity).

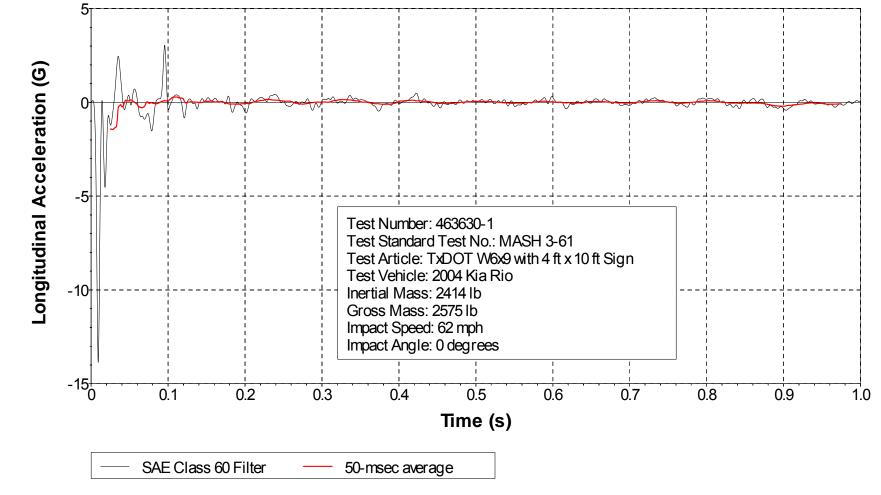
Figure E7. Vehicle Longitudinal Accelerometer Trace for Test No. 463630-1 (Accelerometer Located over Rear Axle).

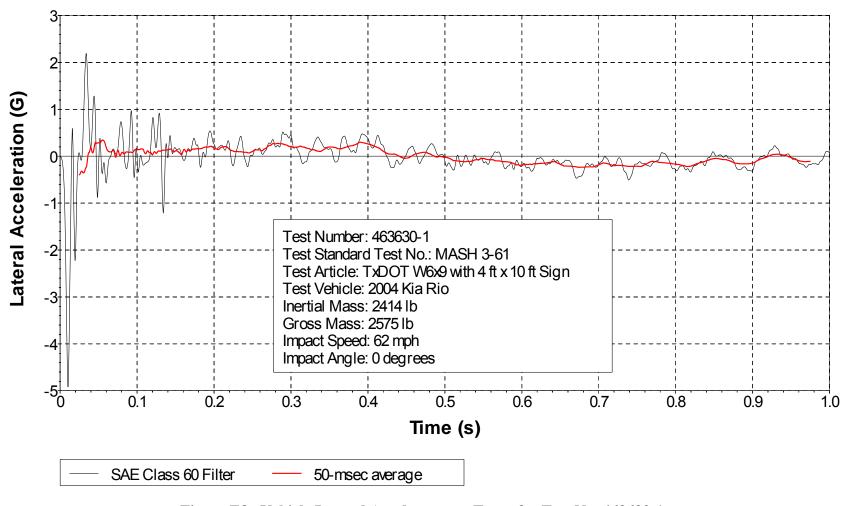
Figure E8. Vehicle Lateral Accelerometer Trace for Test No. 463630-1 (Accelerometer Located over Rear Axle).

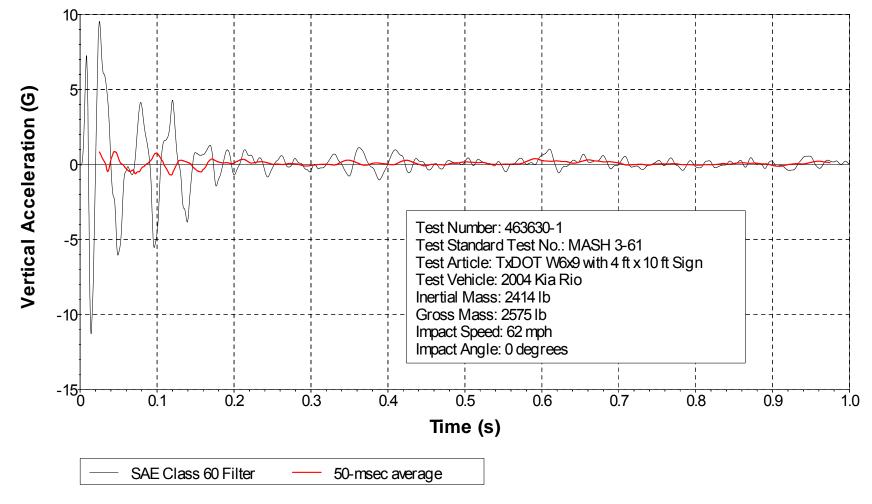
Figure E9. Vehicle Vertical Accelerometer Trace for Test No. 463630-1 (Accelerometer Located over Rear Axle).

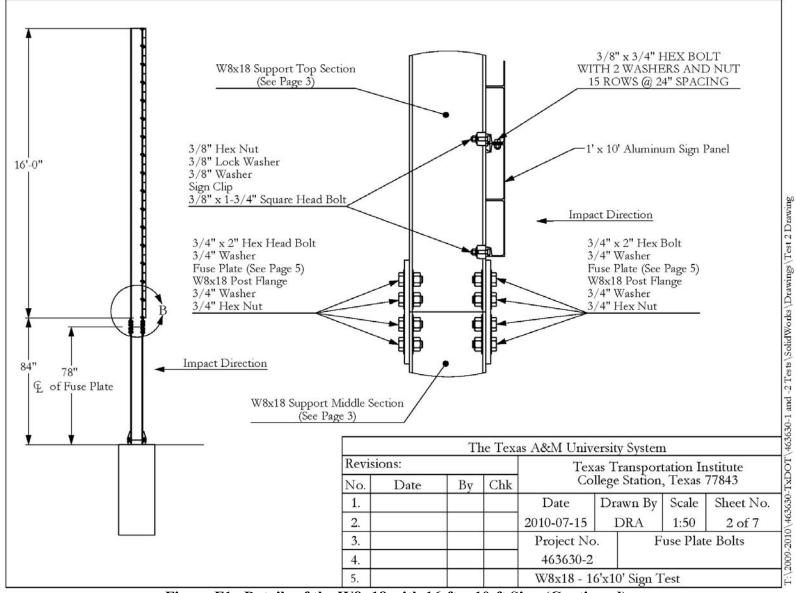
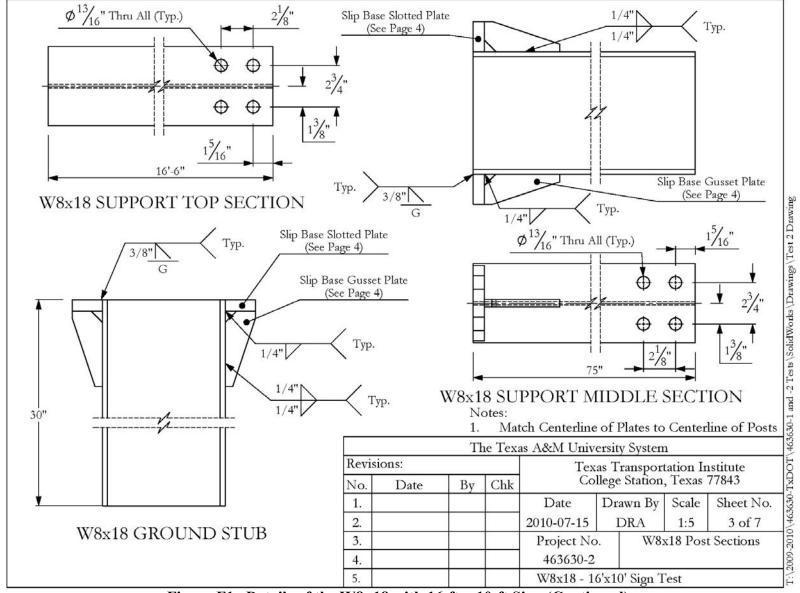
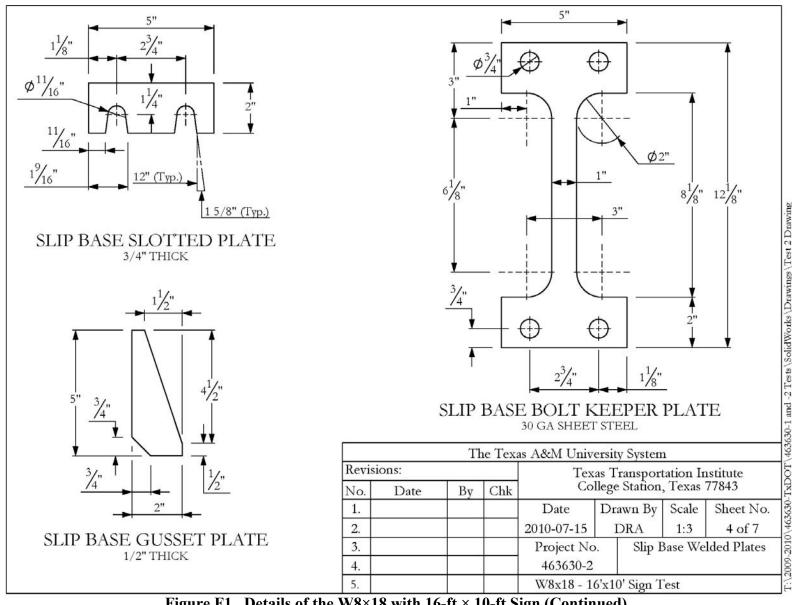
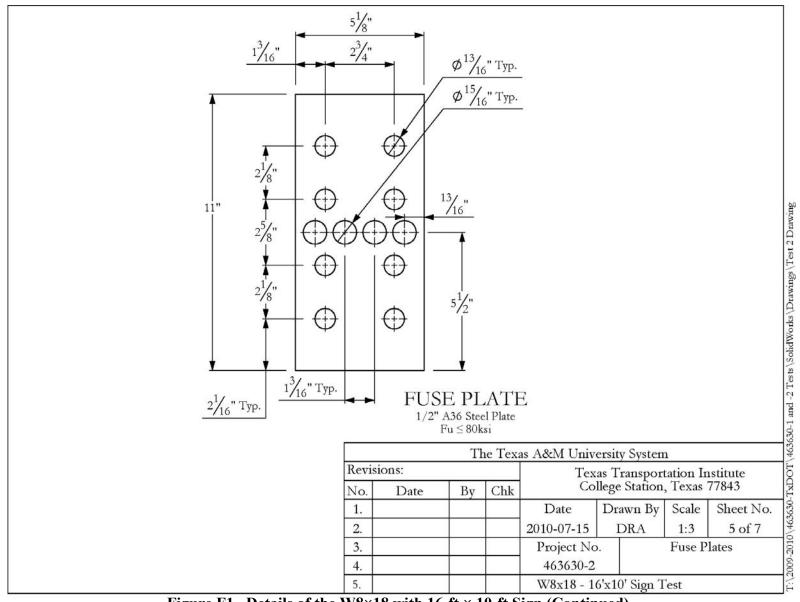
Figure F1. Details of the W8×18 with 16-ft × 10-ft Sign.

Figure F1. Details of the W8×18 with 16-ft × 10-ft Sign (Continued).

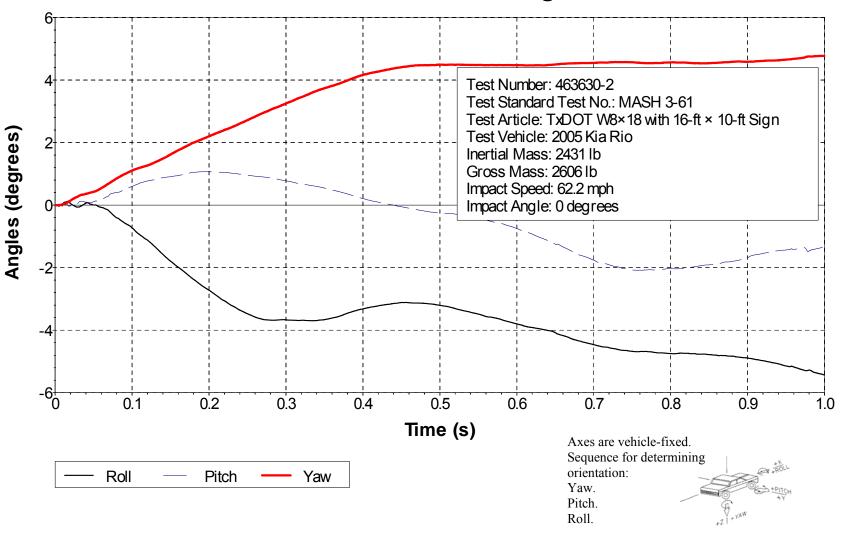
Figure F3. Vehicle Angular Displacements for Test No. 463630-2.

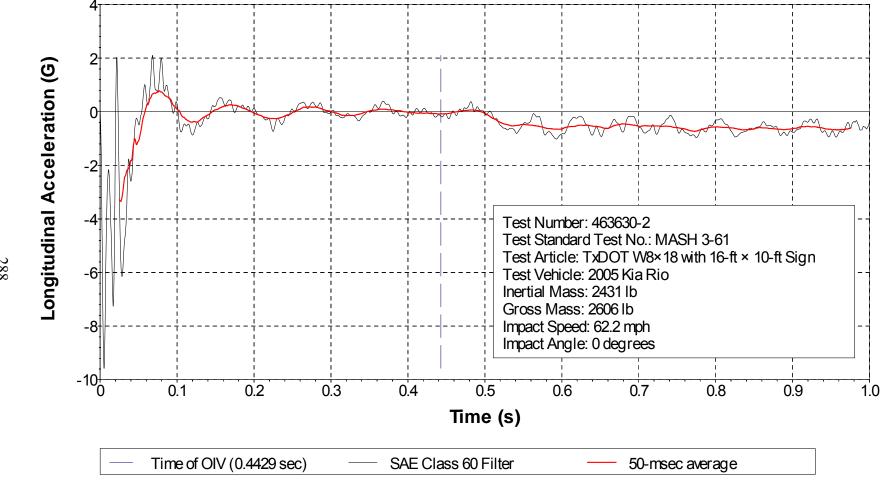
Figure F4. Vehicle Longitudinal Accelerometer Trace for Test No. 463630-2 (Accelerometer Located at Center of Gravity).

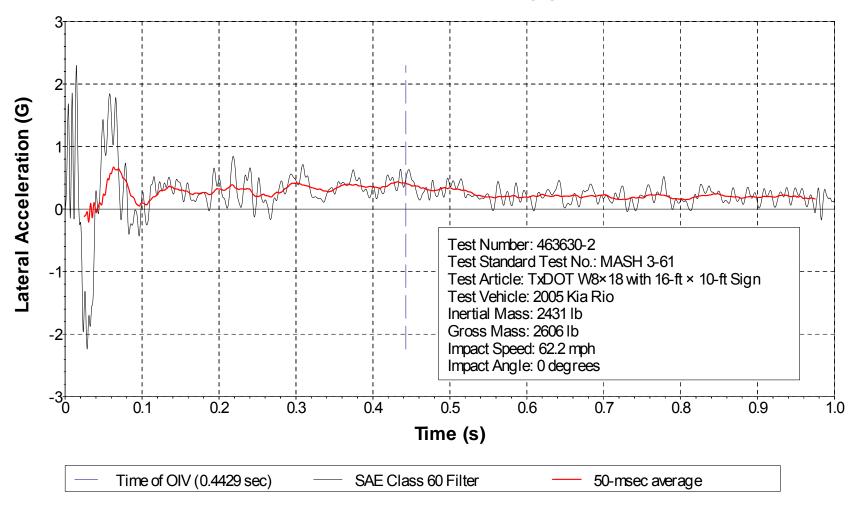
Figure F5. Vehicle Lateral Accelerometer Trace for Test No. 463630-2 (Accelerometer Located at Center of Gravity).

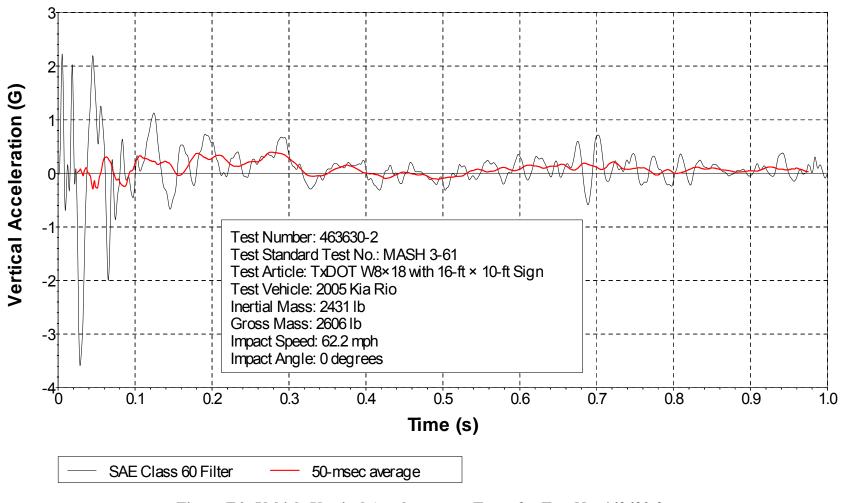
Figure F6. Vehicle Vertical Accelerometer Trace for Test No. 463630-2 (Accelerometer Located at Center of Gravity).

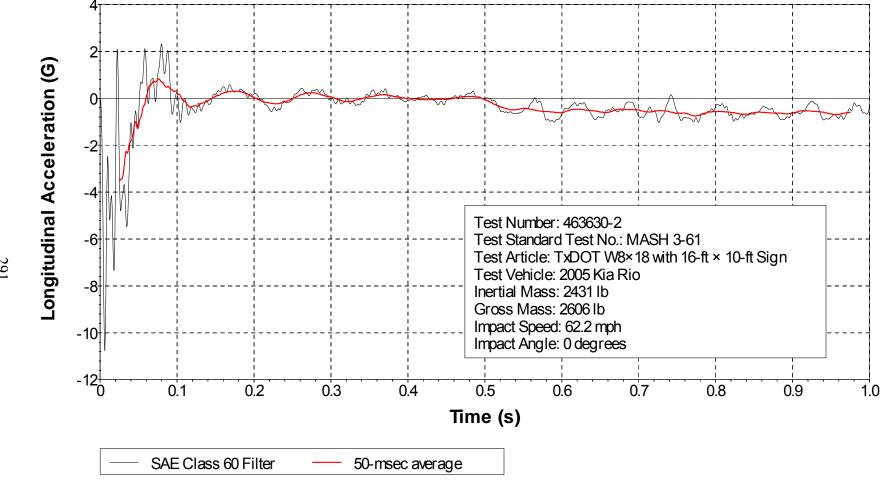
Figure F7. Vehicle Longitudinal Accelerometer Trace for Test No. 463630-2 (Accelerometer Located over Rear Axle).

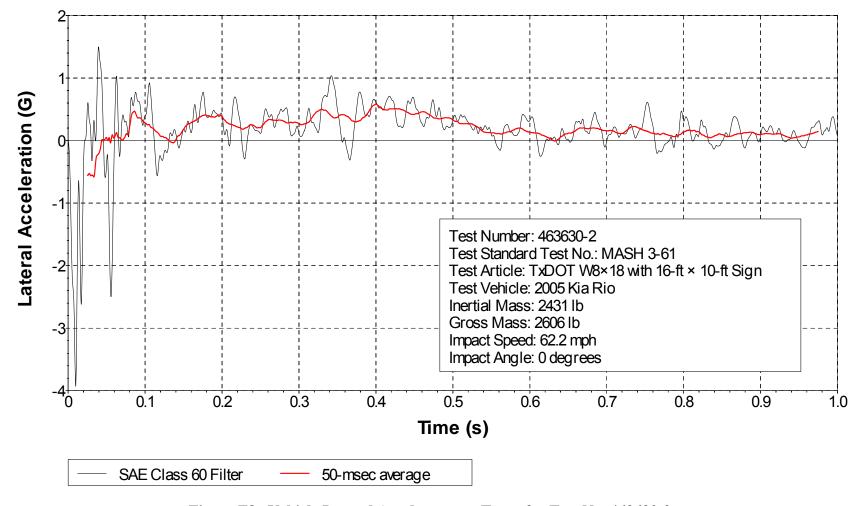
Figure F8. Vehicle Lateral Accelerometer Trace for Test No. 463630-2 (Accelerometer Located over Rear Axle).

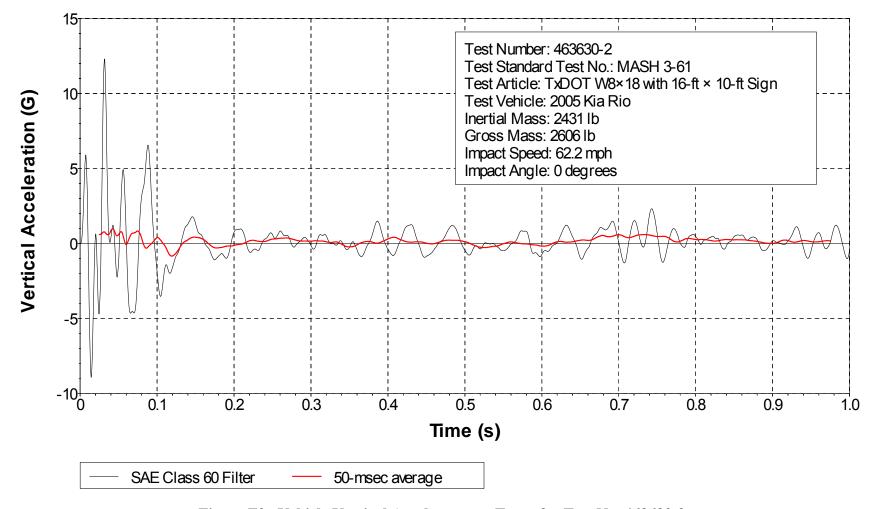
Figure F9. Vehicle Vertical Accelerometer Trace for Test No. 463630-2 (Accelerometer Located over Rear Axle).

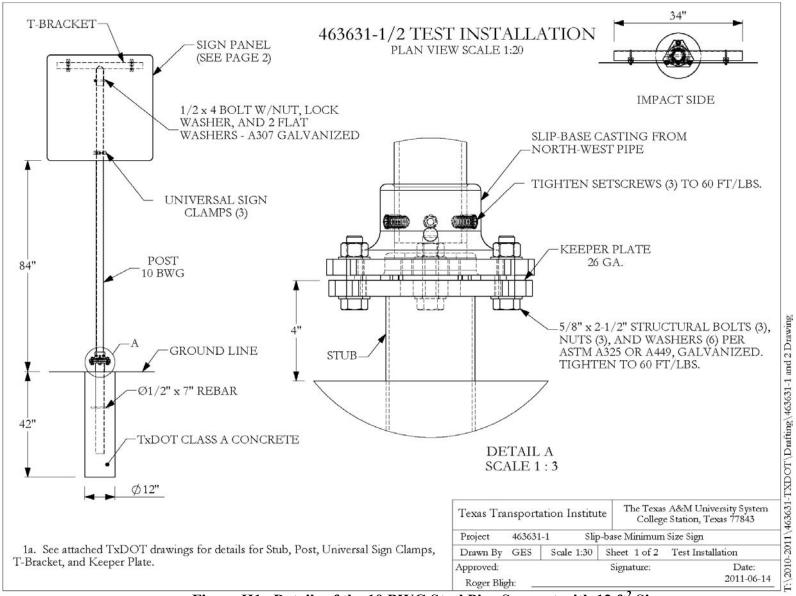
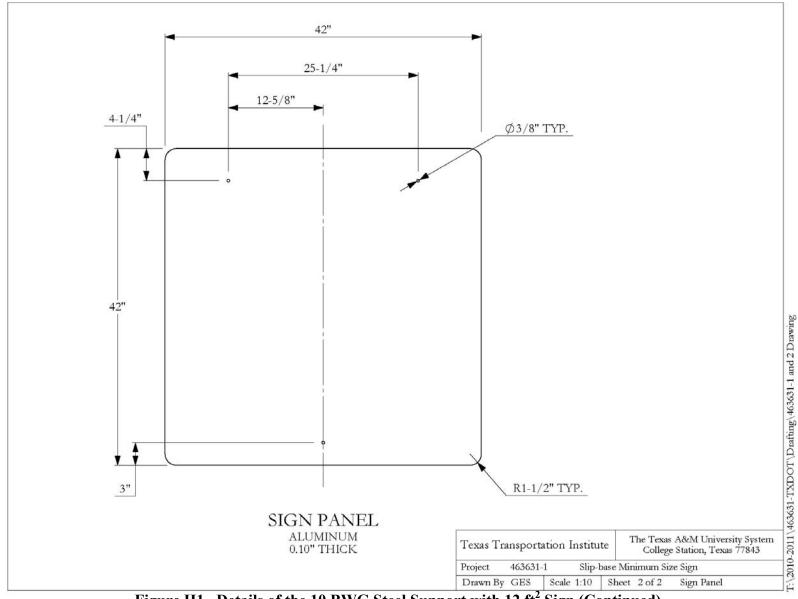
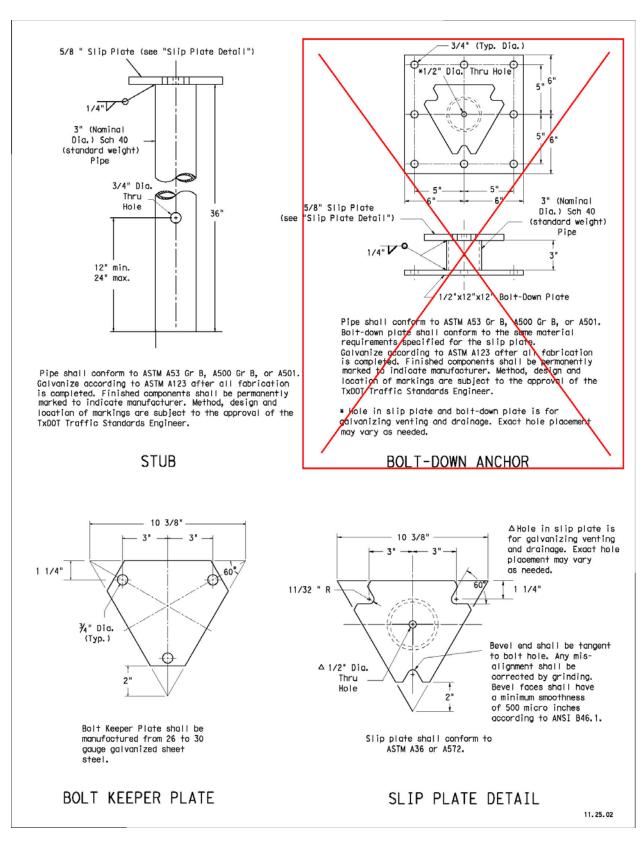
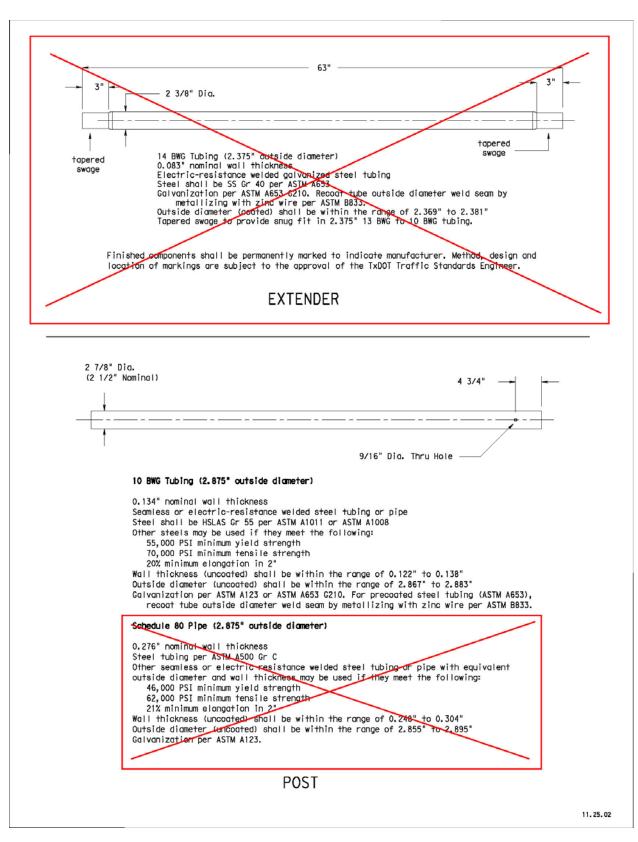
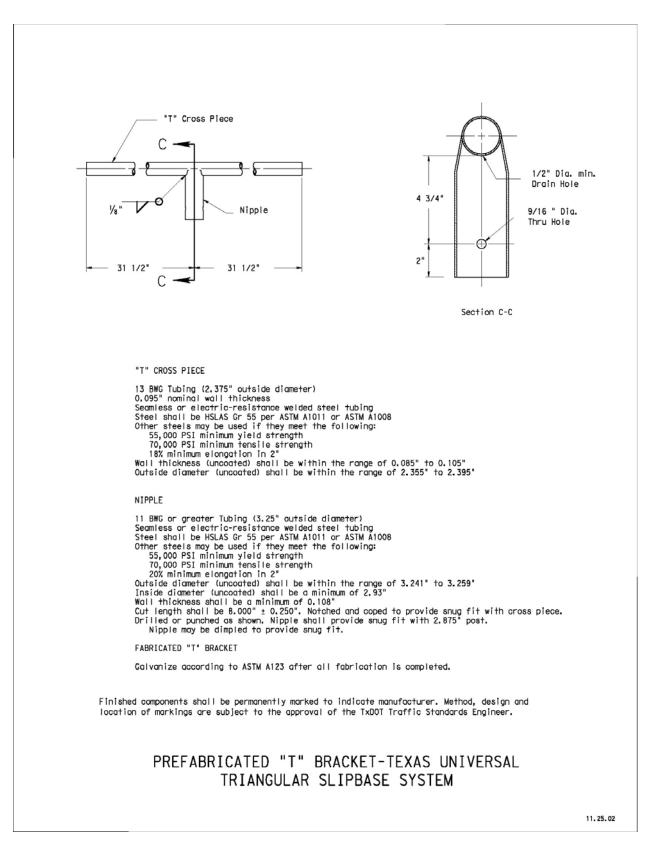
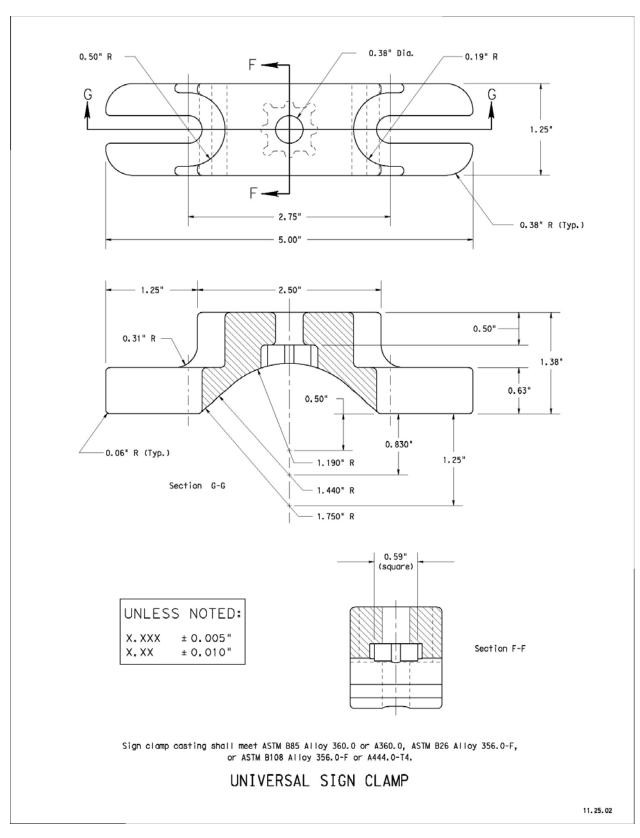
Figure H1. Details of the 10 BWG Steel Pipe Support with 12 ft² Sign.

Figure H1. Details of the 10 BWG Steel Support with 12 ft² Sign (Continued).

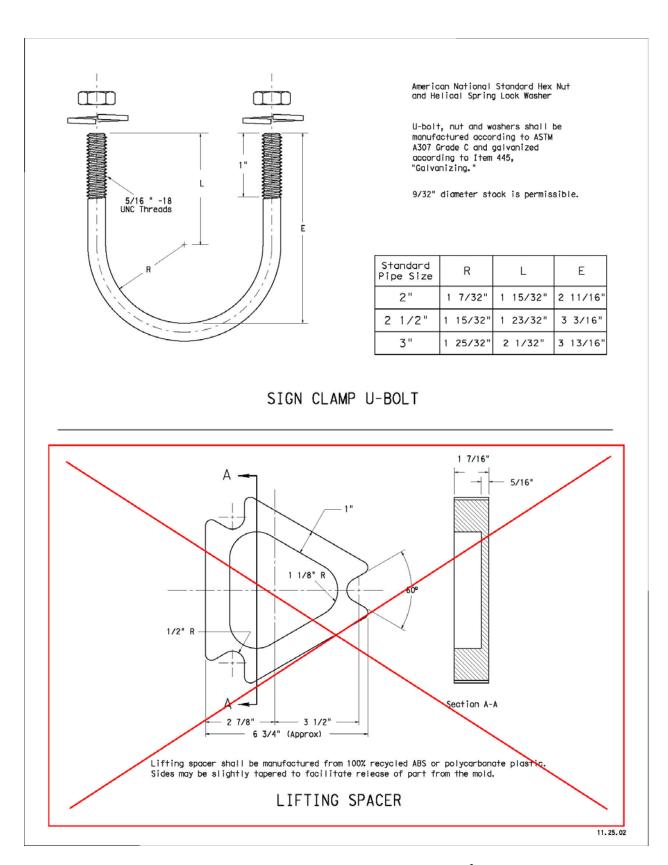
Figure H1. Details of the 10 BWG Steel Support with 12 ft² Sign (Continued).

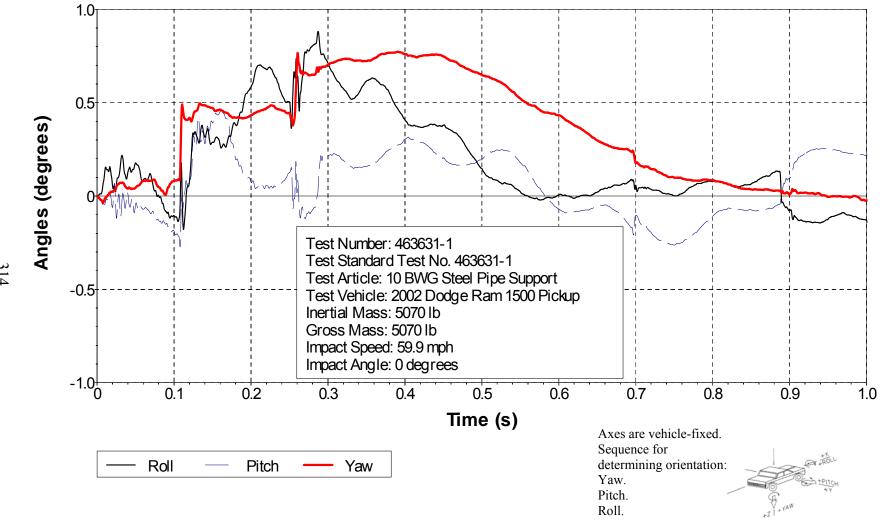
Figure H3. Vehicle Angular Displacements for Test No. 463631-1.

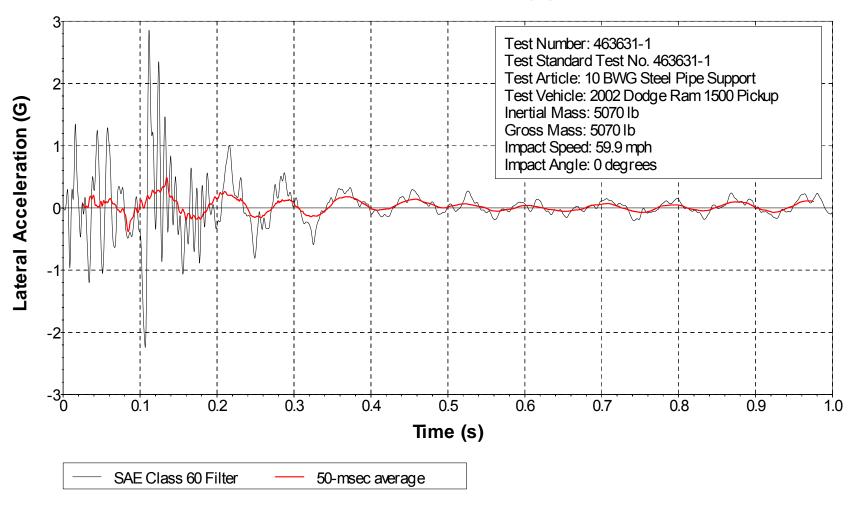
Figure H5. Vehicle Lateral Accelerometer Trace for Test No. 463631-1 (Accelerometer Located at Center of Gravity).

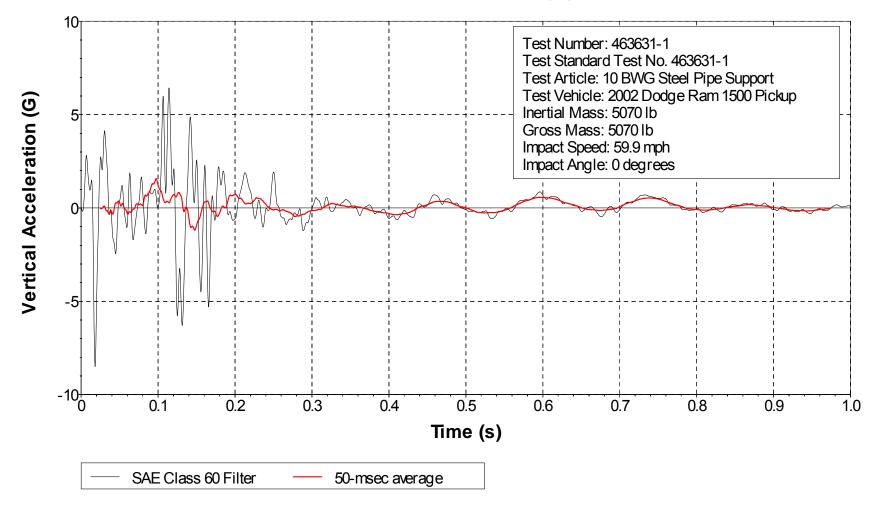
Figure H6. Vehicle Vertical Accelerometer Trace for Test No. 463631-1 (Accelerometer Located at Center of Gravity).

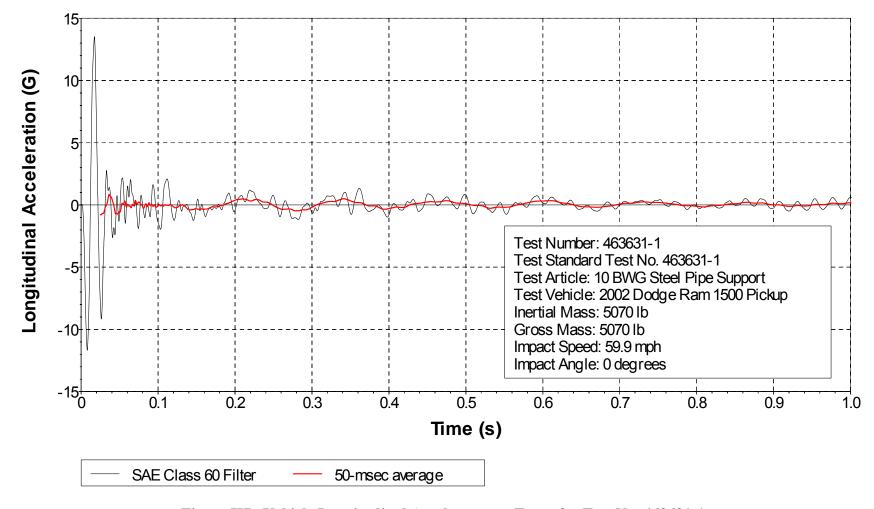
Figure H7. Vehicle Longitudinal Accelerometer Trace for Test No. 463631-1 (Accelerometer Located over Rear Axle).

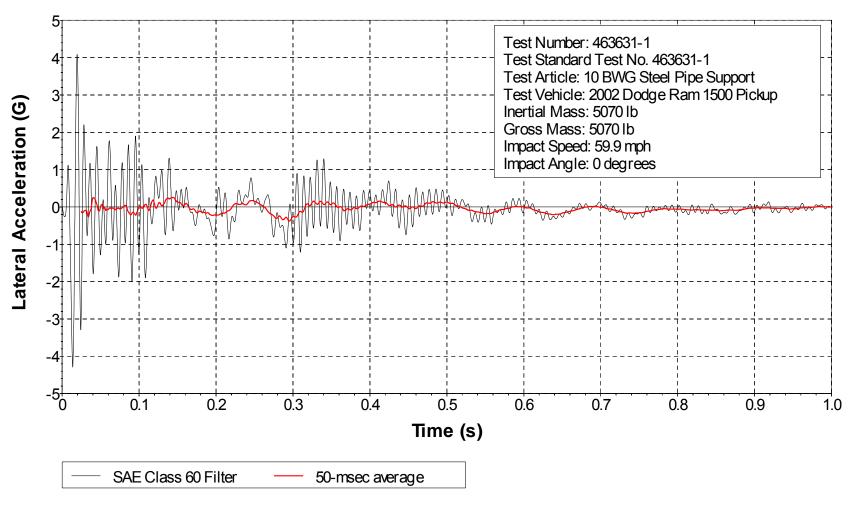
Figure H8. Vehicle Lateral Accelerometer Trace for Test No. 463631-1 (Accelerometer Located over Rear Axle).

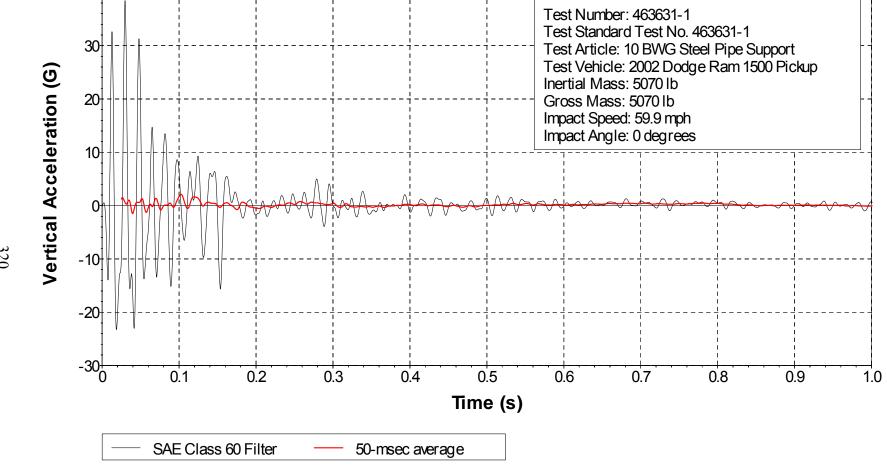
Figure H9. Vehicle Vertical Accelerometer Trace for Test No. 463631-1 (Accelerometer Located over Rear Axle).

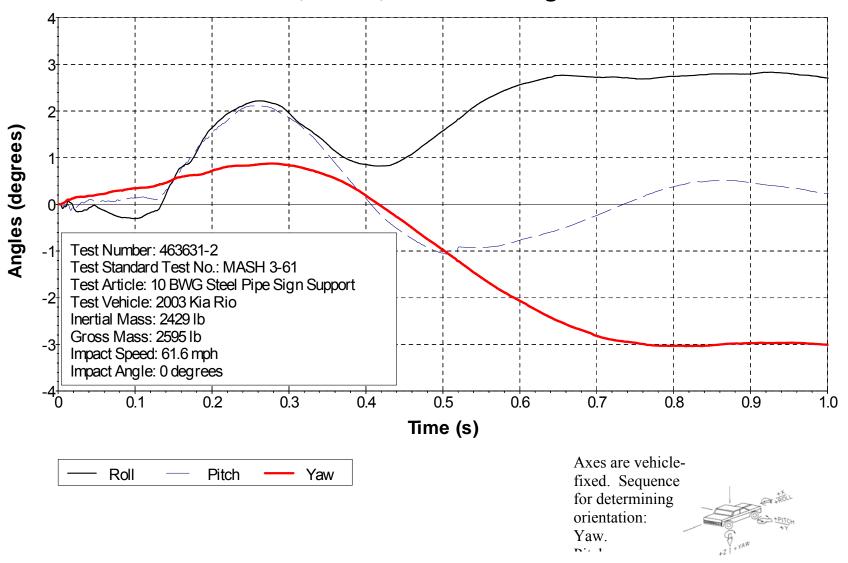
Figure I2. Vehicle Angular Displacements for Test No. 463631-2.

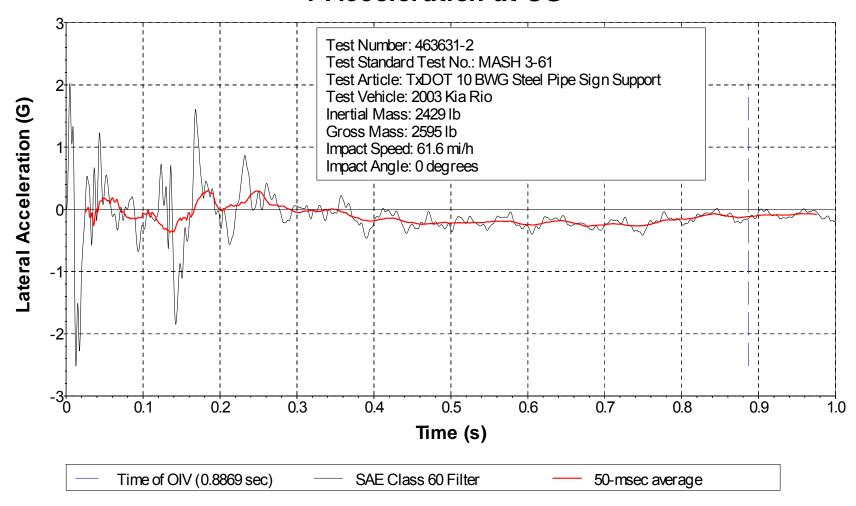
Figure I4. Vehicle Lateral Accelerometer Trace for Test No. 463631-2 (Accelerometer Located at Center of Gravity).

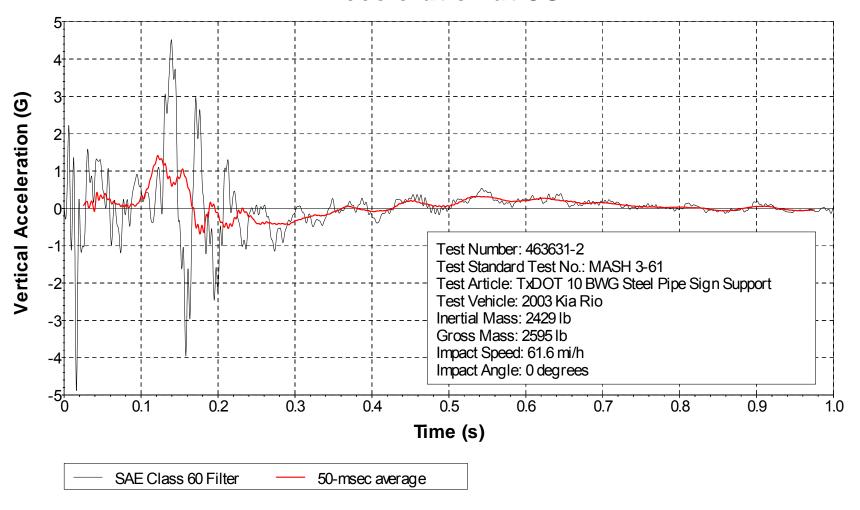
Figure I5. Vehicle Vertical Accelerometer Trace for Test No. 463631-2 (Accelerometer Located at Center of Gravity).
