DEVELOPMENT GUIDANCE FOR SIGN DESIGN STANDARDS

Test Report 0-6363-1

Project Title: Improvements to Large and Small Roadside Sign Hardware and Design

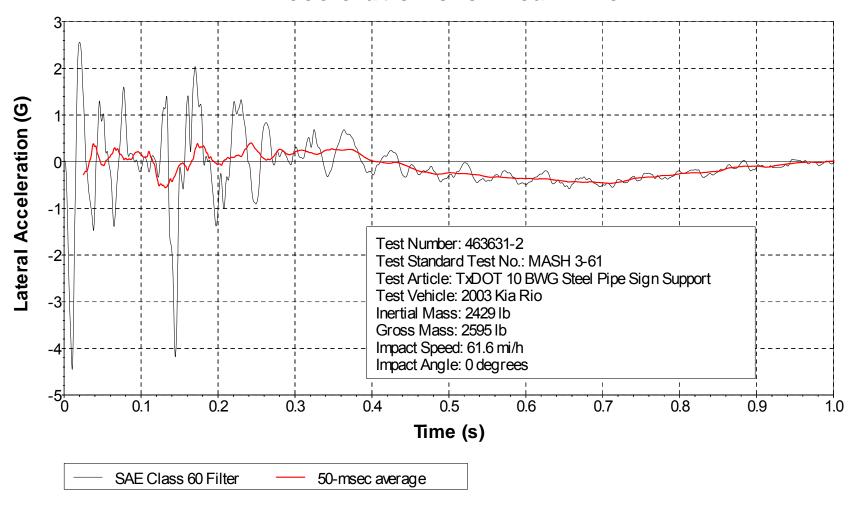
Figure I7. Vehicle Lateral Accelerometer Trace for Test No. 463631-2 (Accelerometer Located over Rear Axle).

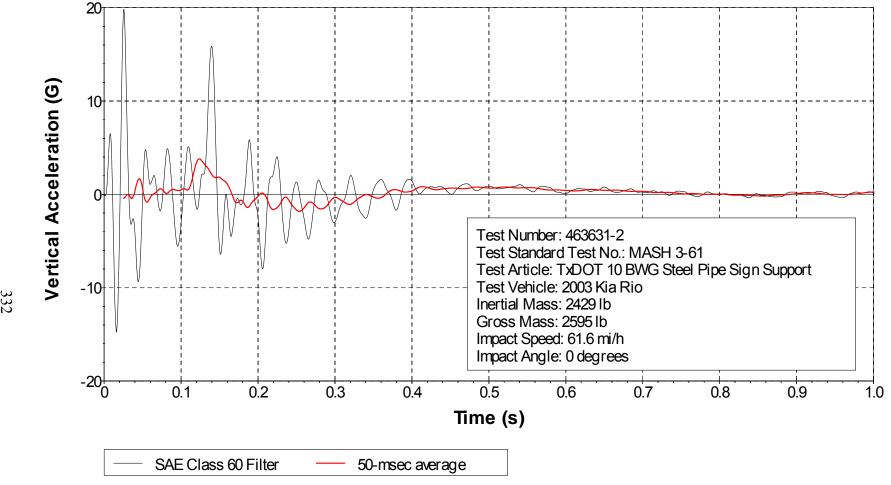
Figure I8. Vehicle Vertical Accelerometer Trace for Test No. 463631-2 (Accelerometer Located over Rear Axle).

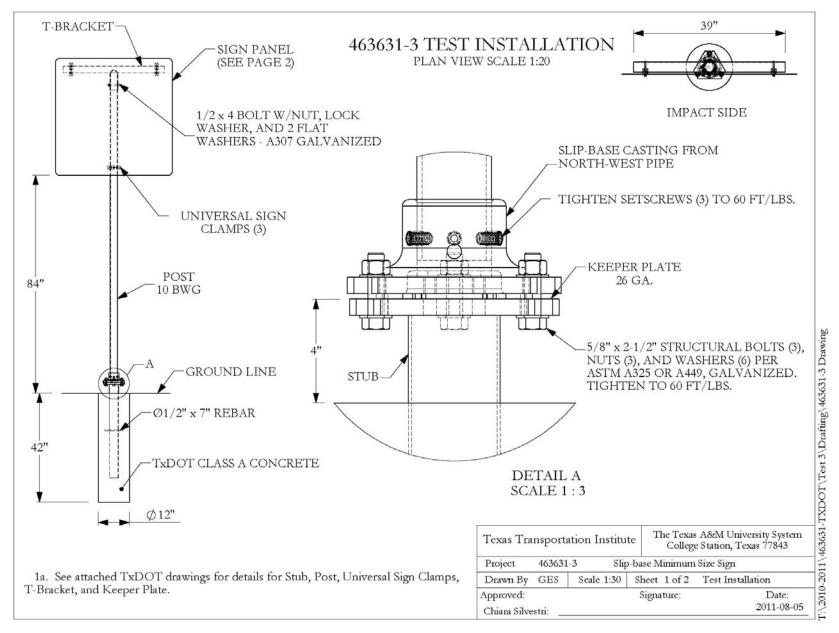
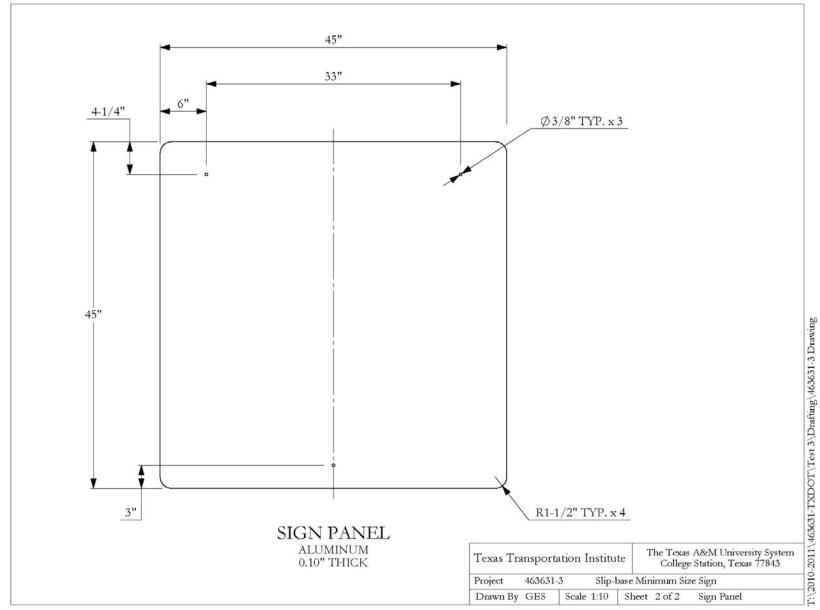
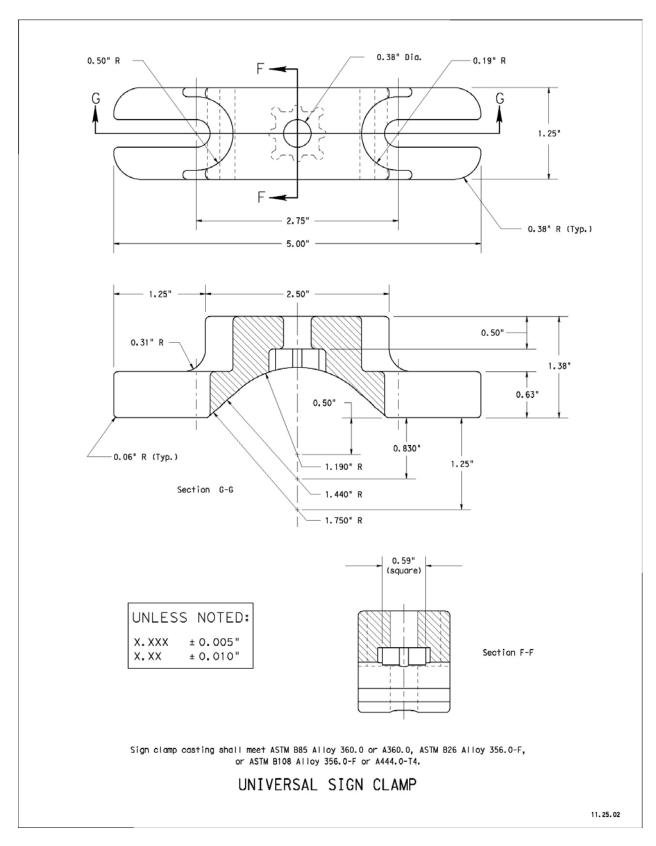
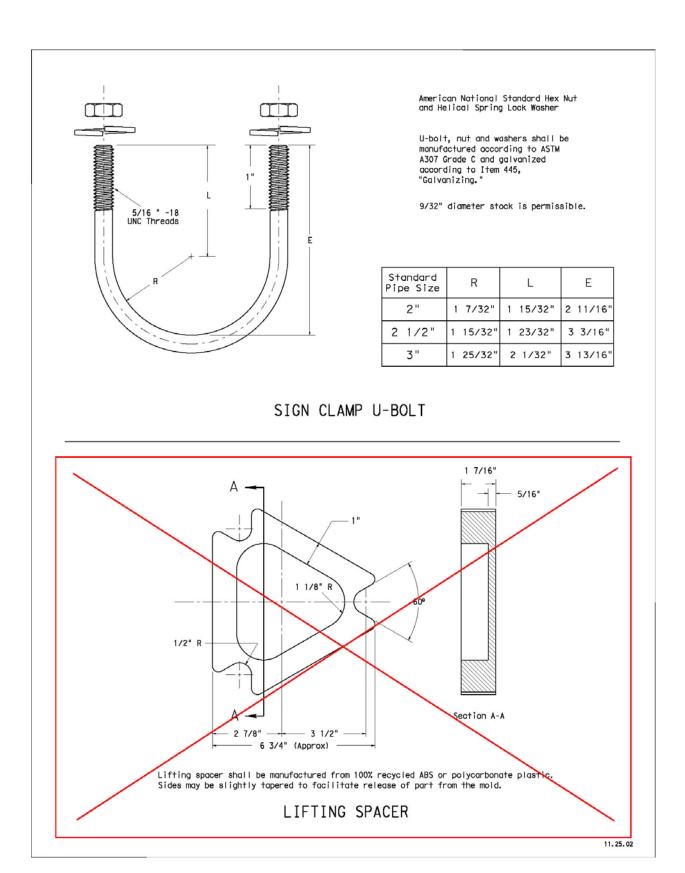
Figure J1. Details of the 10 BWG Steel Support with 14 ft² Sign.

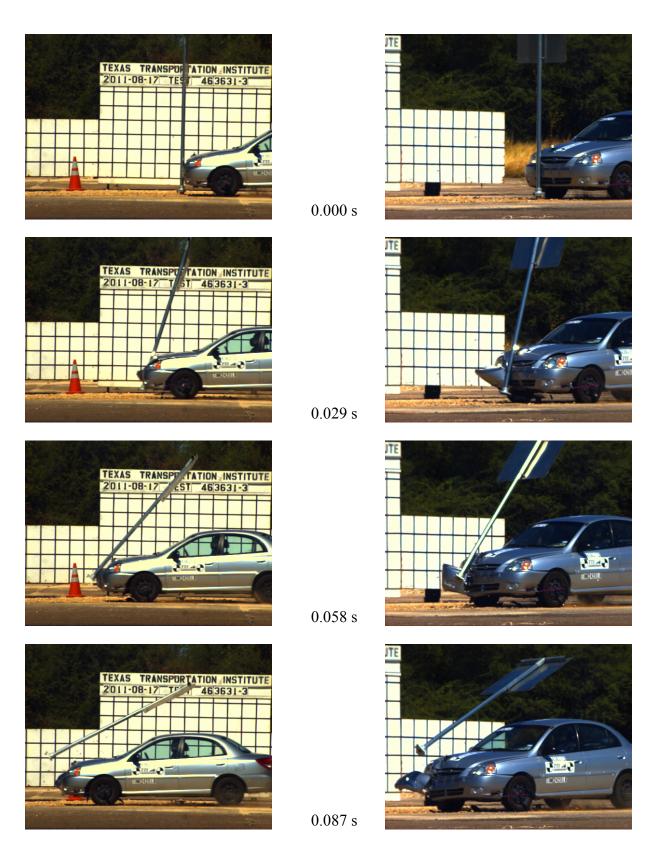
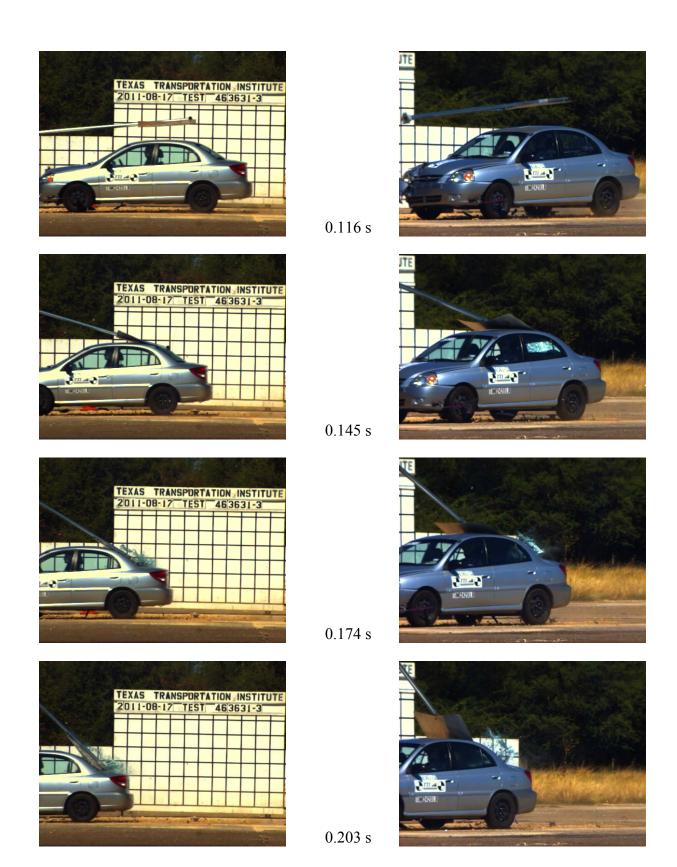
Figure J2. Sequential Photographs for Test No. 463631-3 (Perpendicular and Oblique Views).

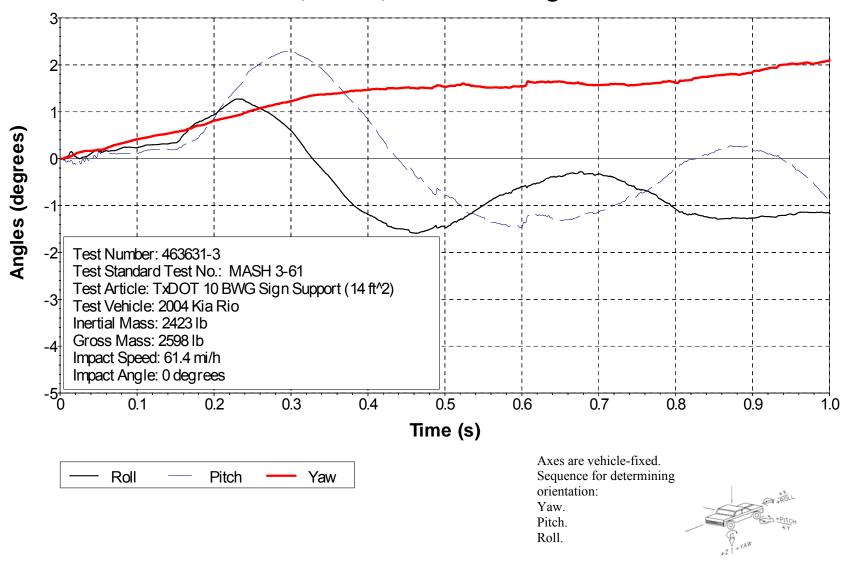
Figure J3. Vehicle Angular Displacements for Test No. 463631-3.

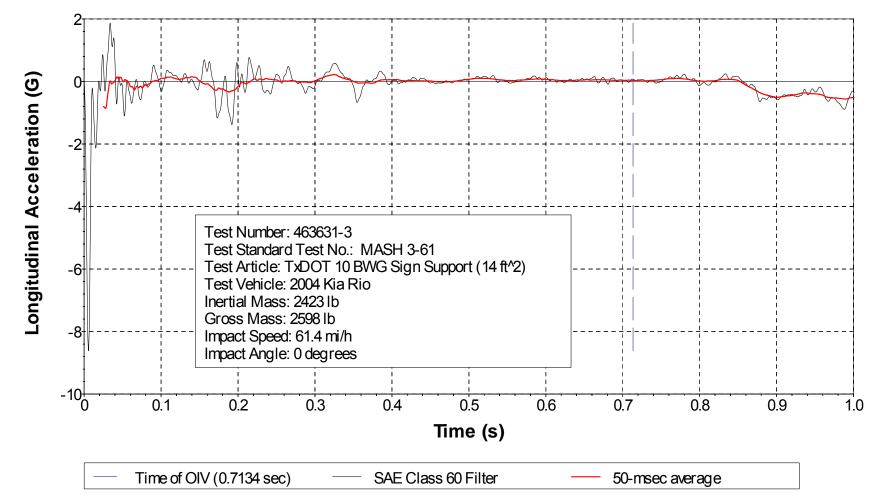
Figure J4. Vehicle Longitudinal Accelerometer Trace for Test No. 463631-3 (Accelerometer Located at Center of Gravity).

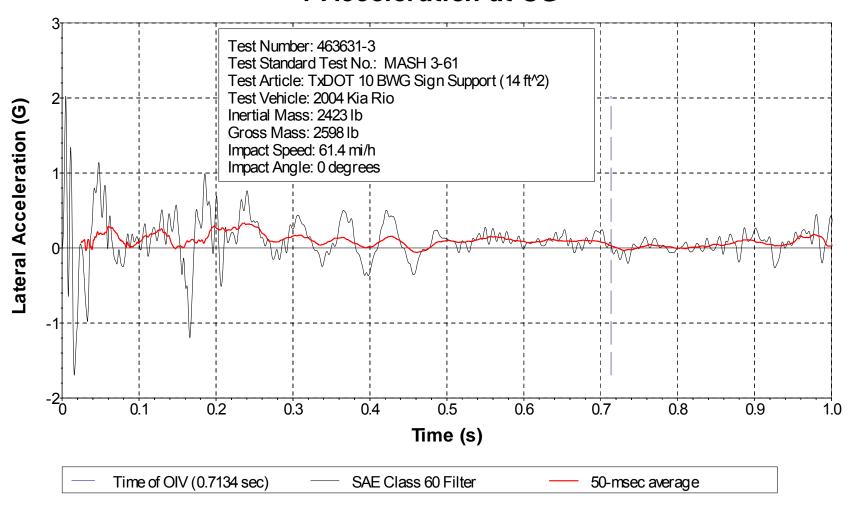
Figure J5. Vehicle Lateral Accelerometer Trace for Test No. 463631-3 (Accelerometer Located at Center of Gravity).

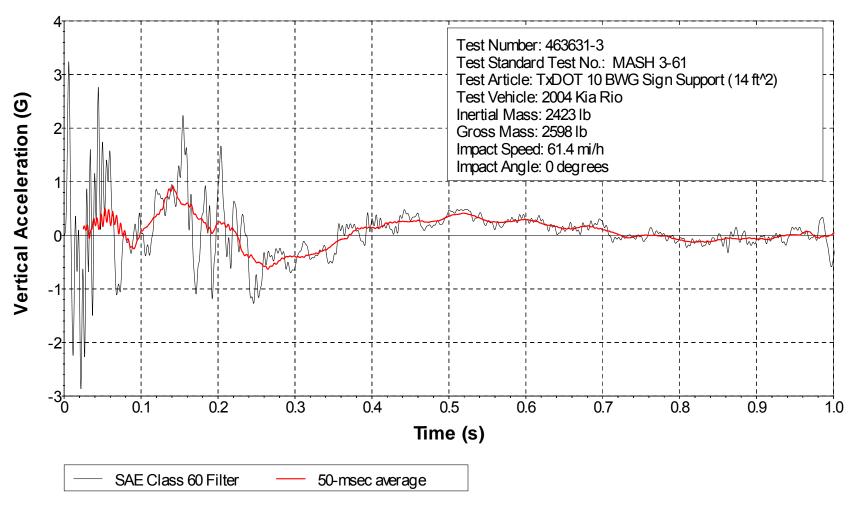
Figure J6. Vehicle Vertical Accelerometer Trace for Test No. 463631-3 (Accelerometer Located at Center of Gravity).

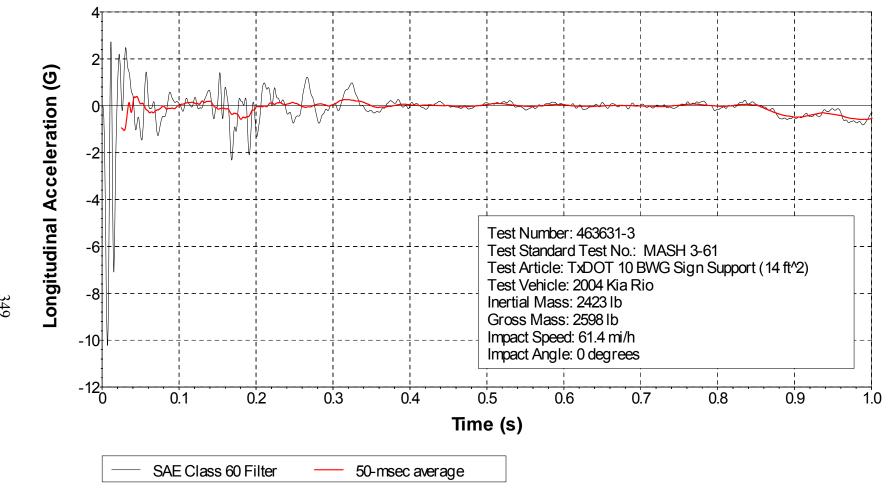
Figure J7. Vehicle Longitudinal Accelerometer Trace for Test No. 463631-3 (Accelerometer Located over Rear Axle).

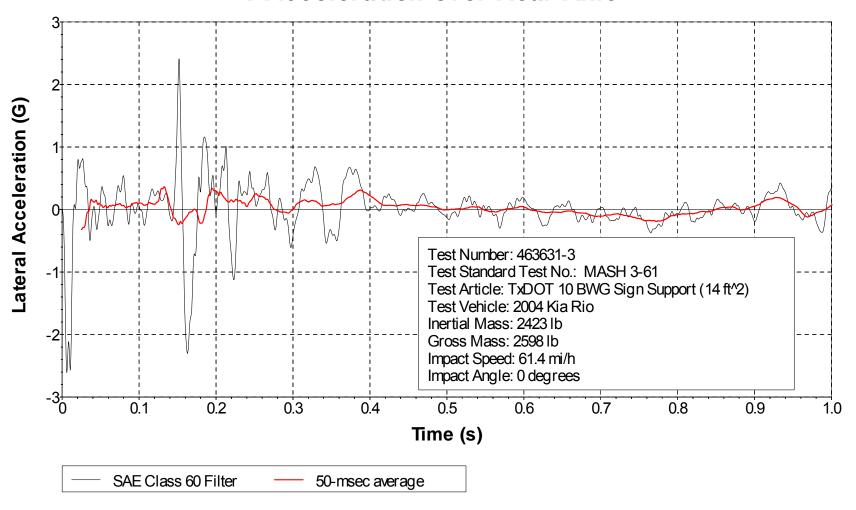
Figure J8. Vehicle Lateral Accelerometer Trace for Test No. 463631-3 (Accelerometer Located over Rear Axle).

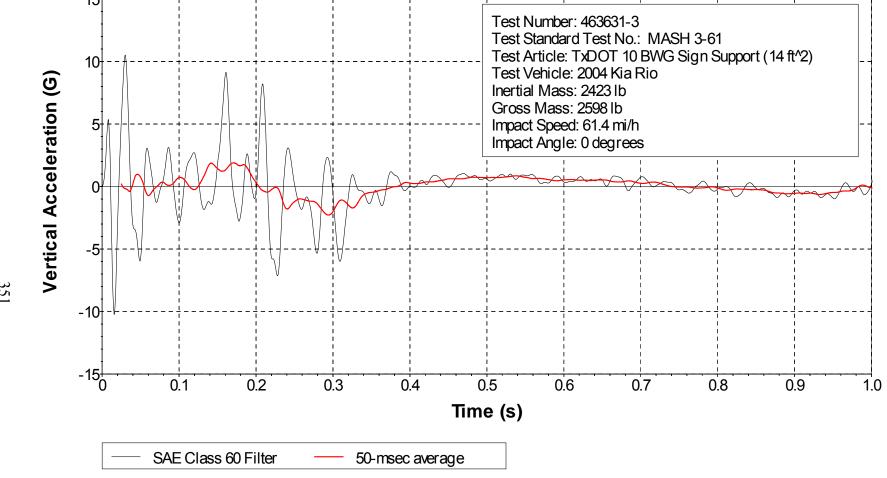
Figure J9. Vehicle Vertical Accelerometer Trace for Test No. 463631-3 (Accelerometer Located over Rear Axle).

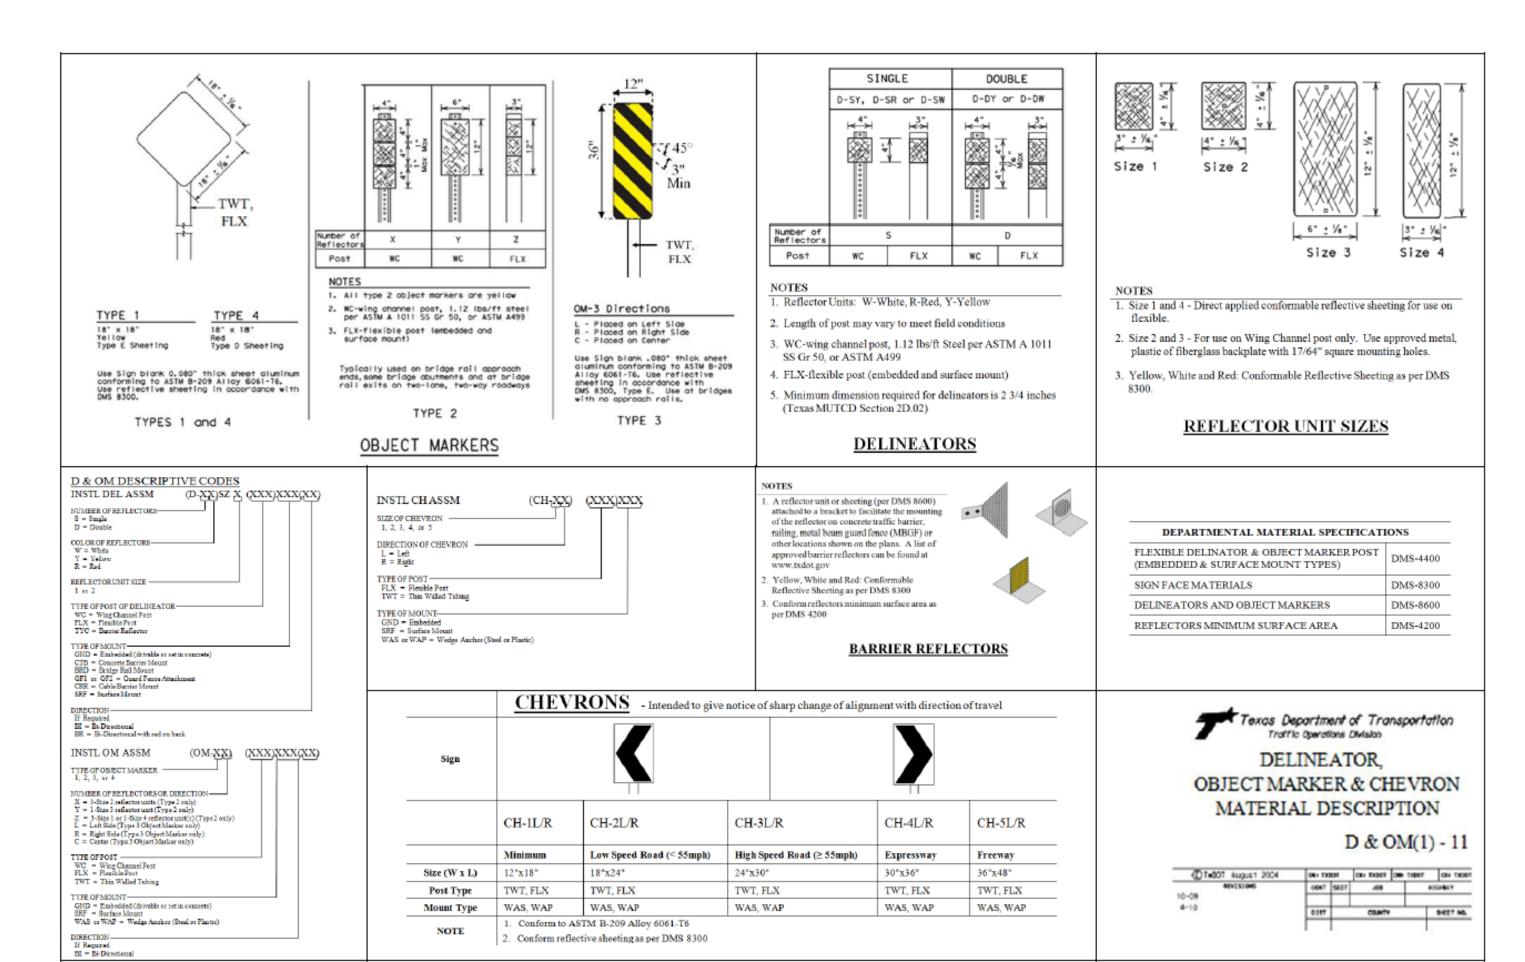
Figure K2. Proposed TxDOT D&OM(1)-11, Option #2.

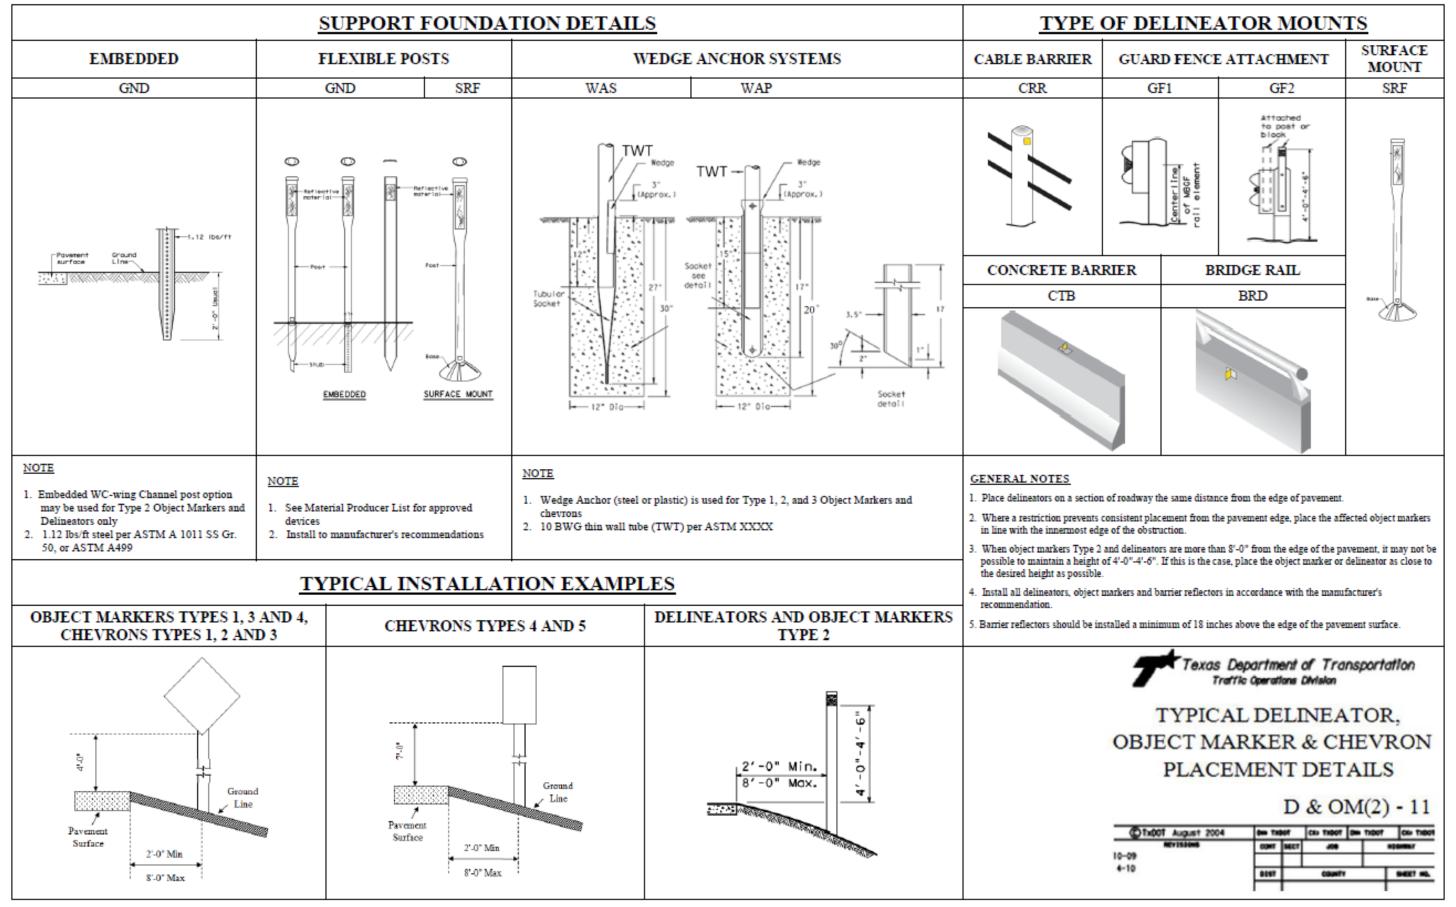
Figure K3. Proposed TxDOT D&OM(2)-11.

Figure K3. Proposed TxDOT D&OM(2)-11 "Typical Delineator, Object Marker & Chevron Placement Details D&OM(2) – 11"

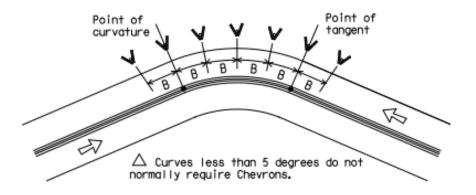
The Chevron may be used to provide additional emphasis and guidance for a change in horizontal alignment. A Chevron may be used as a supplement to delineation.
