# Evaluation of the Buena Vista IBRD Bridge: A Furthering of Accelerated Bridge Construction in Iowa

**Final Report**  
**February 2012**

**Sponsored by**  
Iowa Highway Research Board  
(IHRB Project TR-605)  
Iowa Department of Transportation  
(InTrans Project 08-342)

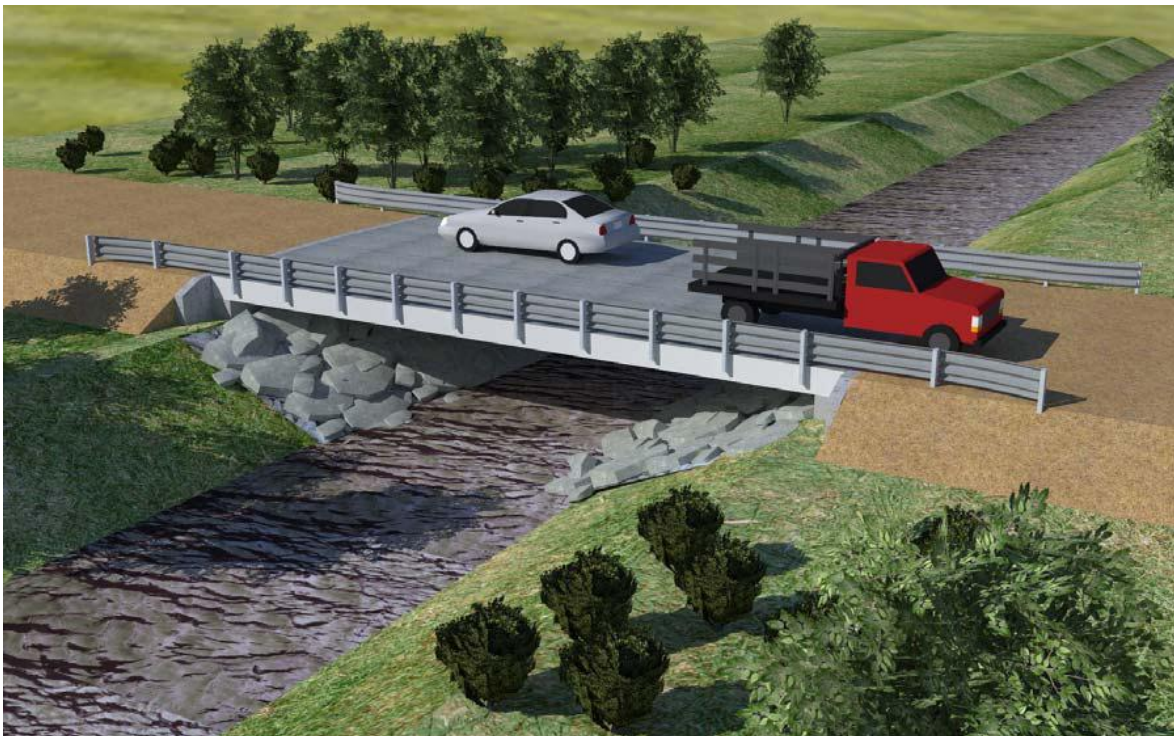
The BVC Bridge is a nominal 50 ft long and 28 ft wide. (A complete set of plans for this bridge is included in Appendix A.) Several three-dimensional (3D) images were also created by Nielsen to assist the contractor in visualizing the accelerated bridge construction process. An overall view of the concept model of the bridge is shown in Figure 1.1.

**Figure 1.1. Concept model showing final bridge**

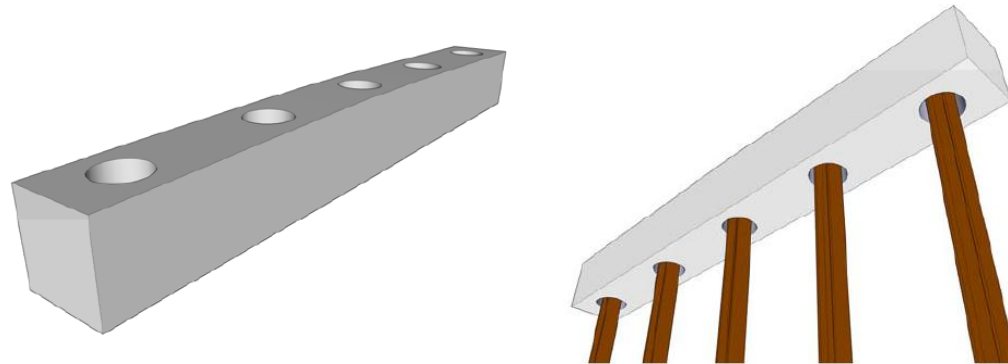
Abutments were a combination of piling driven in the field (5 for each abutment) and precast abutment caps (3 ft x 3 ft x 28 ft), which were cast with five voids (21 in. in diameter to accommodate the piling (Figure 1.2a). The combination of the piling and precast abutment cap is shown in Figure 1.2b.

a.) Precast abutment

b.) Precast abutment on piles

**Figure 1.2. Schematic of precast abutment cap**

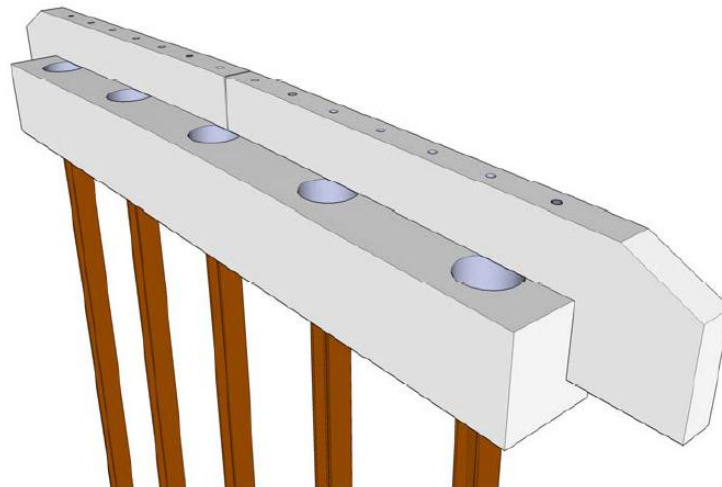
Precast abutment caps were used on two previous accelerated bridge construction projects—one in Madison County (Phares et al. 2009) and one in Boone County (Klaiber et al. 2009). As a result of these successful applications, they were used on this bridge. This is, however, the first accelerated bridge project in which precast backwalls were used (Figure 1.3).

**Figure 1.3. Precast backwall and abutment**

As shown in Figure 1.3, the precast backwall units were attached to the abutment caps with dowels. The backwalls were actually placed after the seven precast box beams (Figure 1.4) were set.

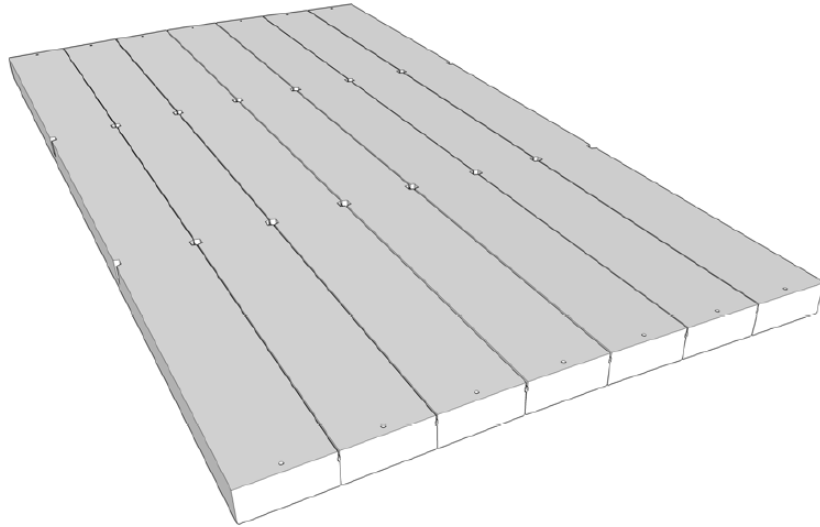
**Figure 1.4. Voided slab precast deck beams**

The box beam units (4 ft x 1 ft 9 in x 50 ft 10 in) were connected to the precast abutments with 1.5 in diameter dowels; they were connected transversely at the third points with 1 in. diameter thread rods.

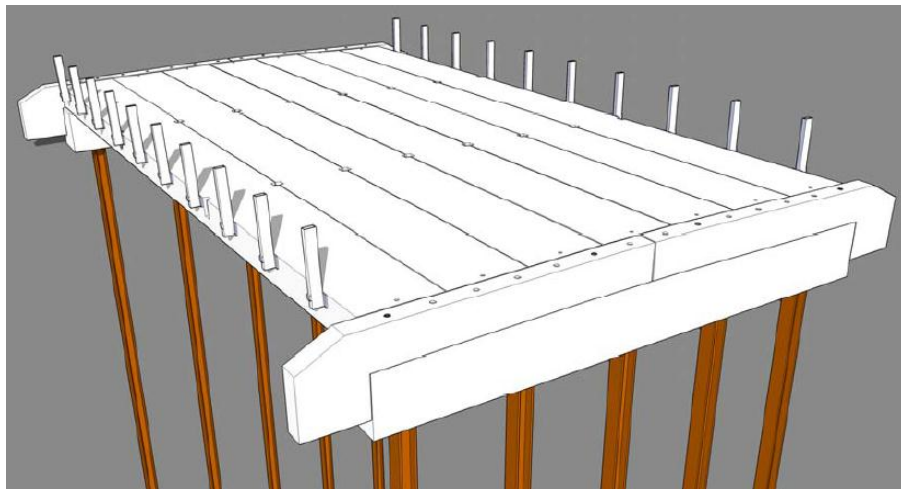
A schematic of the various precast elements assembled and the guardrail posts and piling are shown in Figure 1.5.

**Figure 1.5. Guardrail posts**

The guardrail posts were attached to the exterior box beams using anchor bolts that had been cast in these units. In this report, the terms box beam, deck beam, and simple beam have been used to describe the flexural elements.

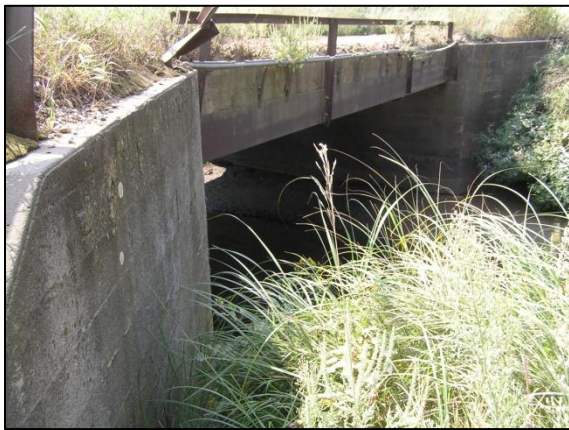
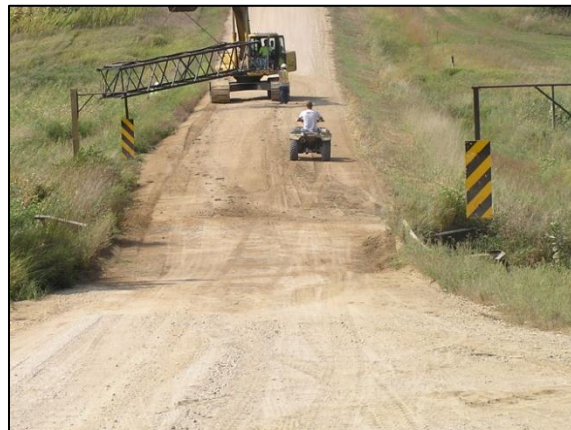
The new bridge replaced a posted timber bridge (26 ft 8 in. long by ~ 18 ft wide) that was constructed in 1936. The original bridge is shown in Figure 2.2.

a. Elevation

b. End view

**Figure 2.2. Original bridge at demonstration site**

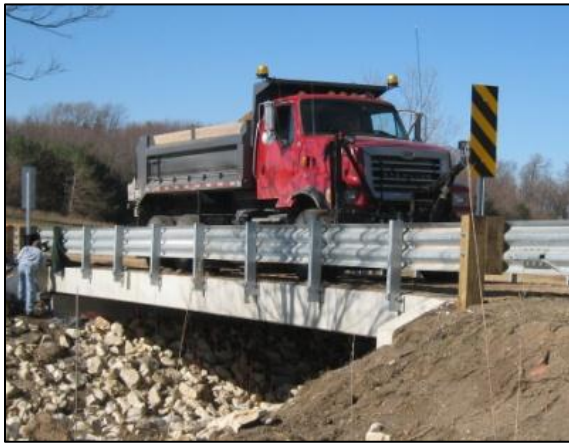
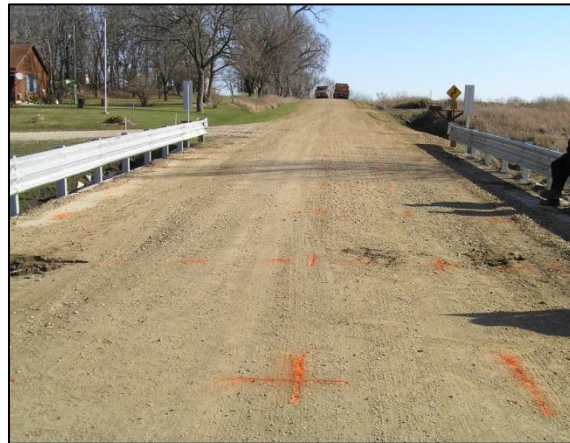
The new bridge, shown in Figure 2.3, has precast abutment caps, backwalls, and box beams; and, this single-span bridge has a span length of 50 ft center to center of supports.

a. Elevation

b. End view

**Figure 2.3. New Buena Vista County box beam bridge**

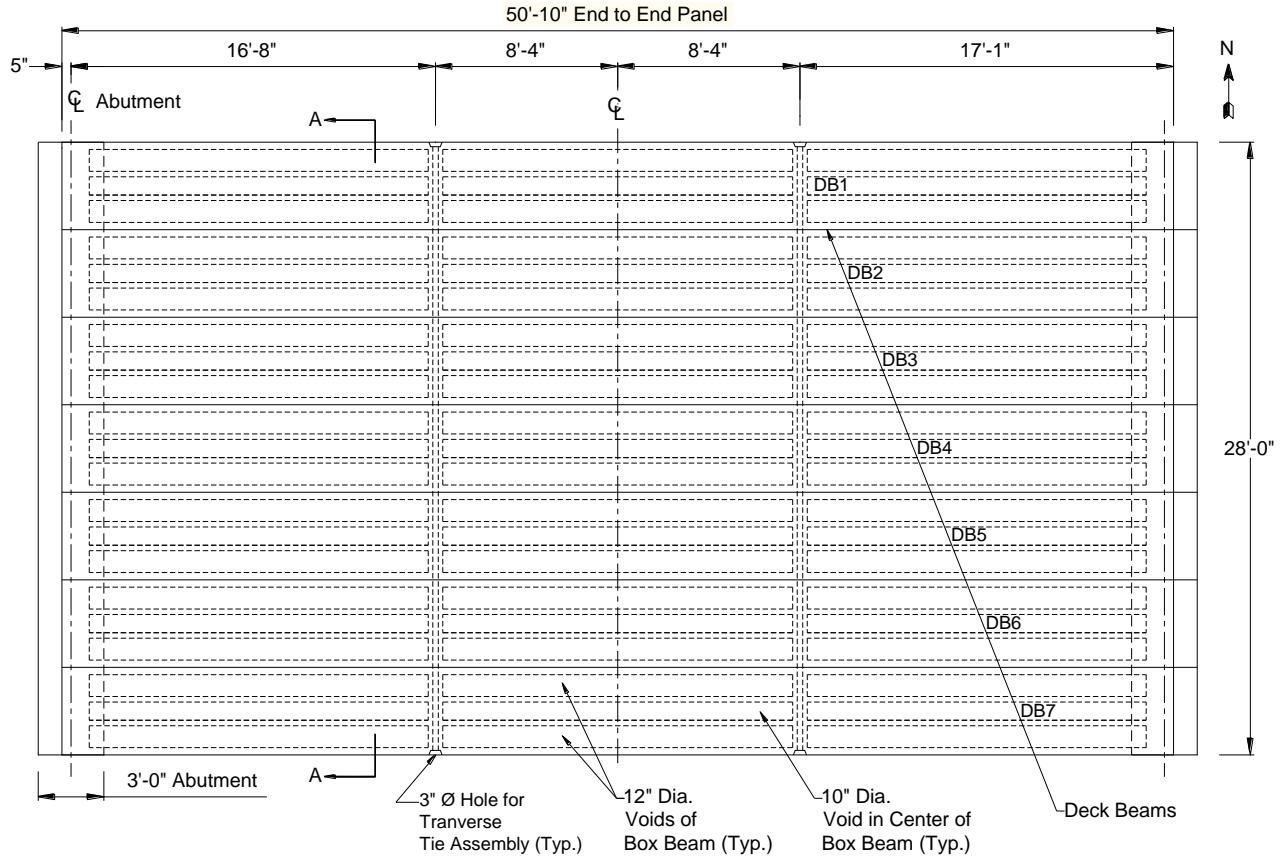
Overall dimensions of the bridge (shown in Figure 2.4) are out-to-out deck width of 28 ft and out-to-out length of 50 ft 10 in.

a. Plan view

b. Section A-A

**Figure 2.4. Plan and section of bridge**

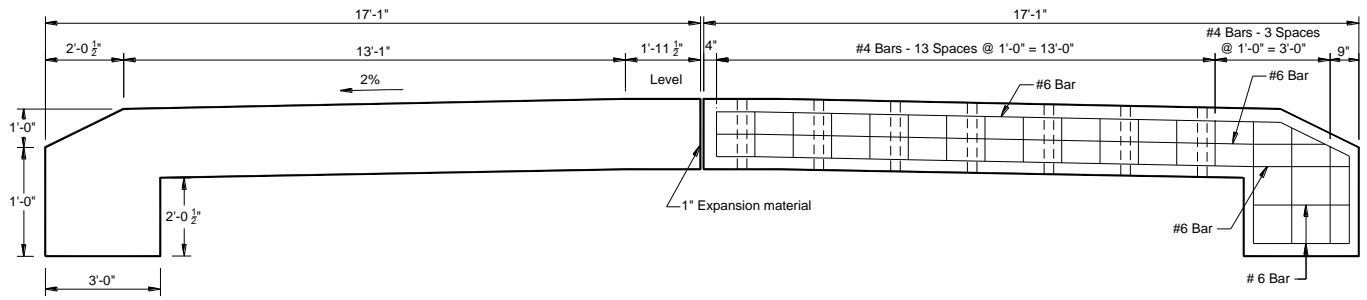
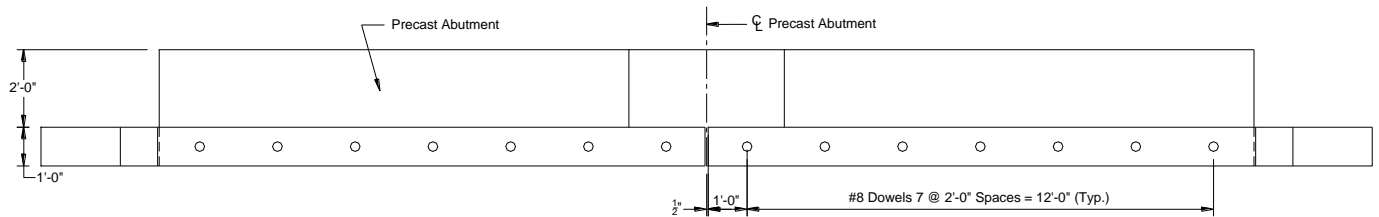
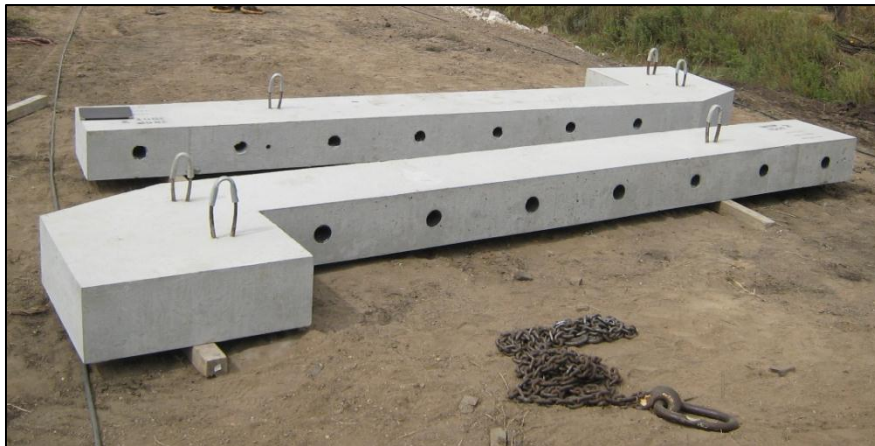
As previously mentioned, this bridge had several precast elements: two abutment caps, four backwall segments, and seven precast, prestressed box beams. Details of the abutment backwalls are shown in Figure 2.5. Each backwall was comprised of two precast segments.

a. Elevation view

b. Plan view

c. Wing wall segments

**Figure 2.5. Abutment backwall details**

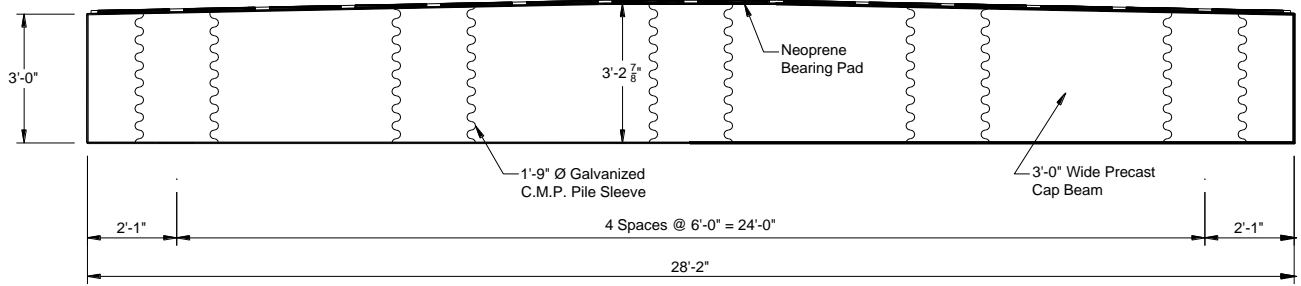
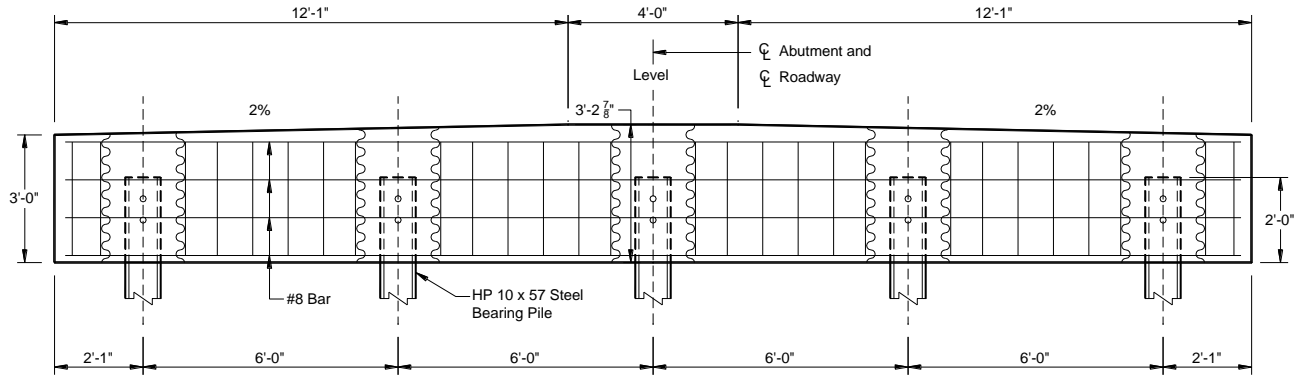
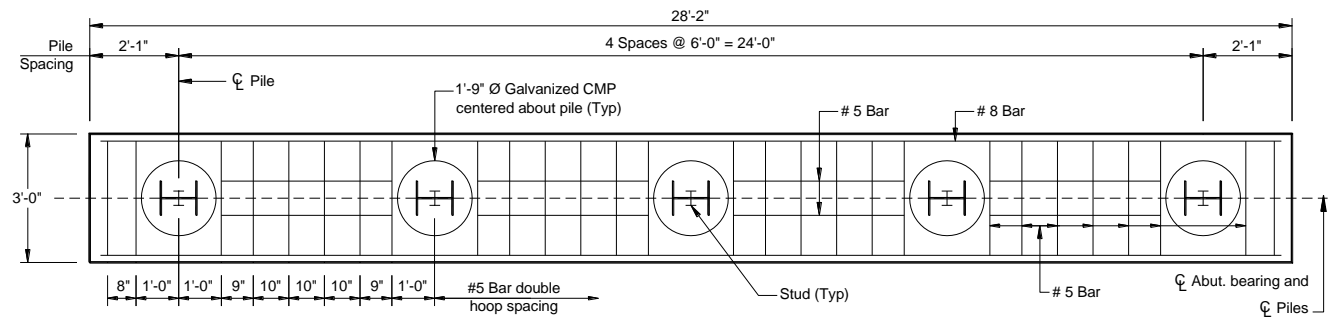
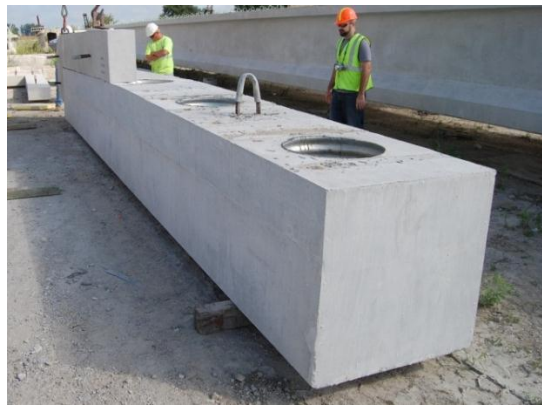
Abutment caps details are shown in Figure 2.6. As shown in Figure 2.6a, the precast abutment cap is 26 ft 2 in long, 3 ft wide, and varies in depth from 3 ft at the ends to 3 ft 2 7/8 in. deep at the centerline. Voids in the caps, created by 21 in. diameter corrugated metal pipe (CMP), are to accommodate the piling.

Abutment cap reinforcement details are shown in Figures 2.6b and 2.6c and one of the caps is shown in Figure 2.6d. As Figure 2.6b shows, the primarily longitudinal reinforcement is eight #8 bars, and #5 bars are used for the shear reinforcement.

a. Overall dimensions

b. Reinforcement details – side view

c. Reinforcement details – top view

d. Abutment cap

**Figure 2.6. Abutment cap details**

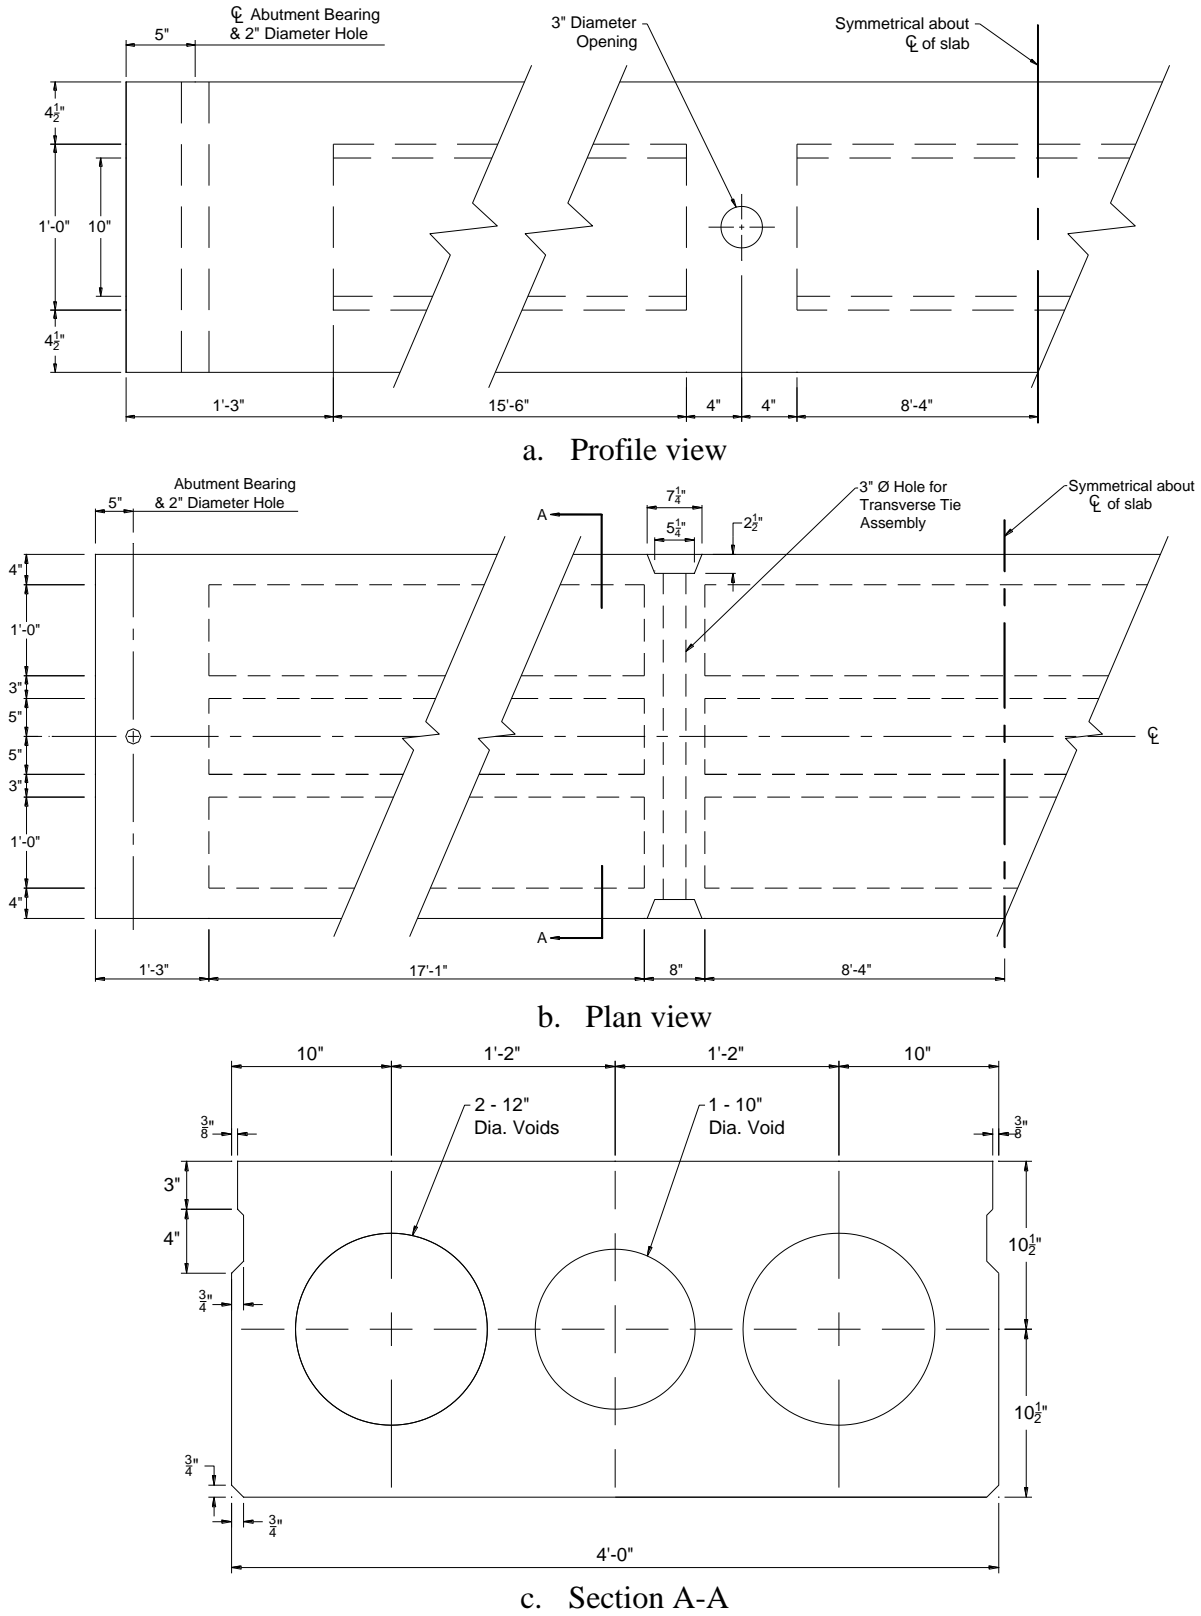
Details on the seven box beams in the bridge are shown in Figures 2.7 and 2.8. Overall dimensions of the box beams, as shown in Figure 2.7, are 50 ft 10 in. long, 4 ft wide, and 21 in. deep. Each unit has three circular voids—two 12 in. in diameter and one 10 in. in diameter.

As shown in Figure 2.7a, the box beams were solid concrete 1 ft 3 in. from each end and for 8 in. around the two transverse tie regions. The 12 in. and 10 in. diameter voids created top and bottom slab thicknesses varying between 4 1/2 and 5 1/2 in., and a total nominal web thickness of 14 in., which is divided among the four webs that vary in thickness due to the circular voids.

Shear keys (4 in. x 3/4 in.) in the vertical faces of the box girders are shown in Figure 2.7c. As the purpose of the shear keys is to transfer a portion of the load between adjustment units, only interior beam units have shear keys in both vertical faces. The two exterior beams only have shear keys on their interior faces. However, exterior units do have inserts in the exterior face for attachment of the guardrails.

**Figure 2.7. Box beam dimensions**

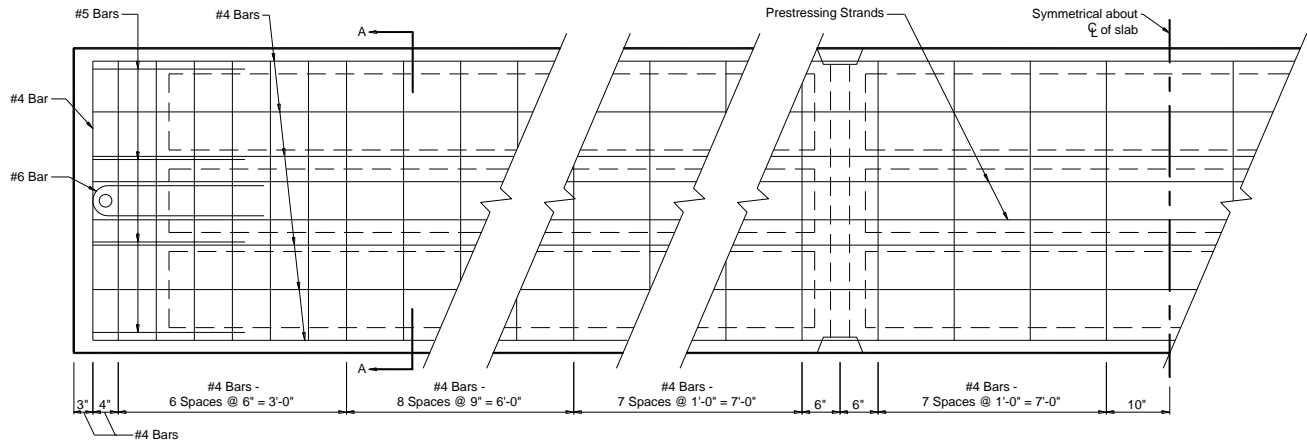
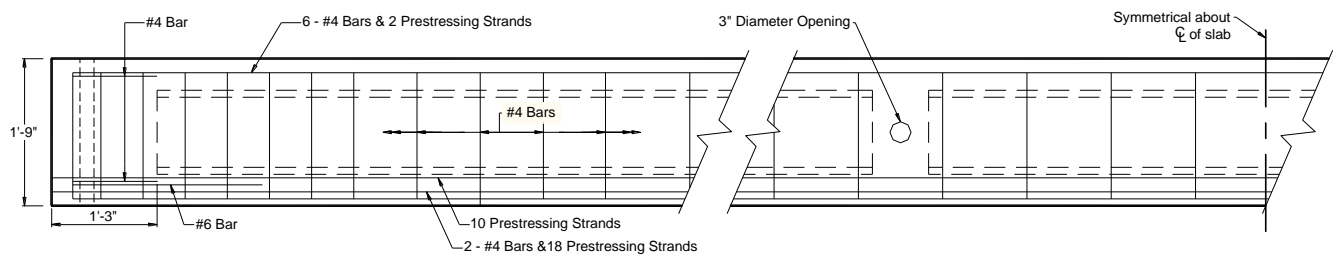
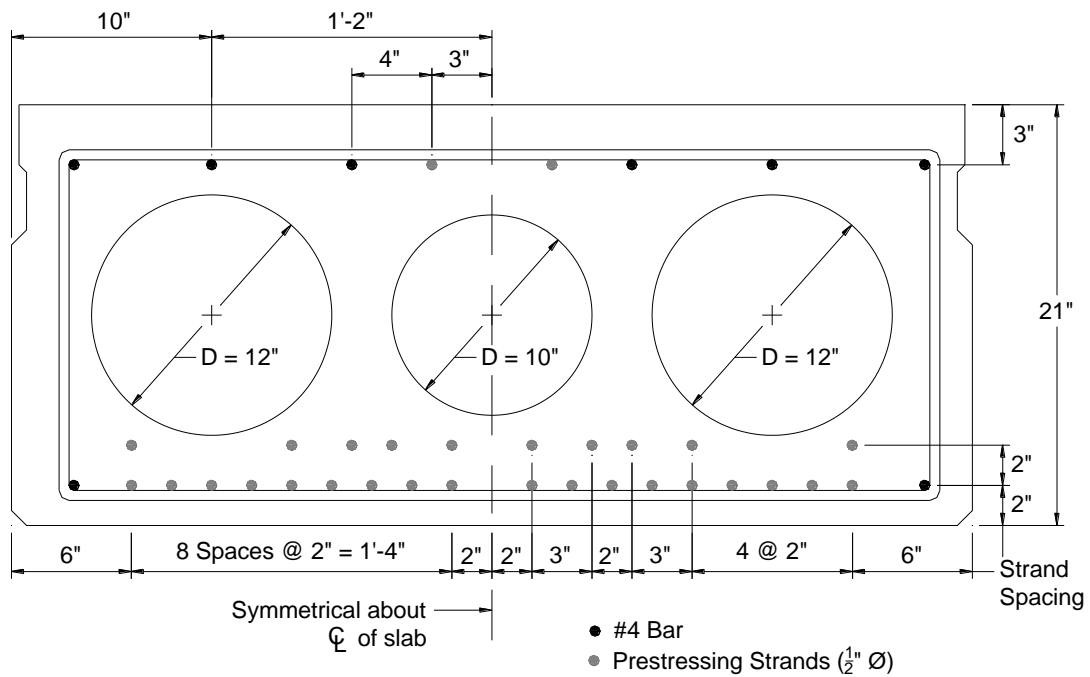
Reinforcement details for the box girders are shown in Figure 2.8. One-half inch diameter, seven-wire, uncoated, low-relaxation, prestressing strand plus mild #4 (Grade 60) reinforcing bars were used for the flexural reinforcement. Twenty-eight strands were in the bottom of the slab and two strands were in the top of the slab; and, a total initial prestress of 900.5 kips was applied to the straight strands.

Shear reinforcement consisted of overlapping #4 U-shaped bars. These stirrups were on 6 in. centers in the region 3 ft from the beam ends, then on 9 in. centers for the next 6 ft, and then on 12 in. centers in the remaining portion of the beams, except in the vicinity of the transverse tie where the spacing was reduced to 6 in. (see Figures 2.8a and 2.8b).

a. Top slab reinforcement

b. Profile view of reinforcing layout

c. Section A-A

Figure 2.8. Box beam details

As illustrated, the corner #4 bars, as well as the corner #4 bars in the bottom layer, were replaced with 1/2 in. diameter prestressing strand tensioned to 3,000 lbs. The reason for replacing the four #4 bars (shown in Figure 2.8c) was to create more rigidity at the corners to simplify tying the shear reinforcement. Thus, reinforcement in the top layer was four prestressing strands (two fully-stressed and two stressed to 3,000 lbs) and four #4 bars.

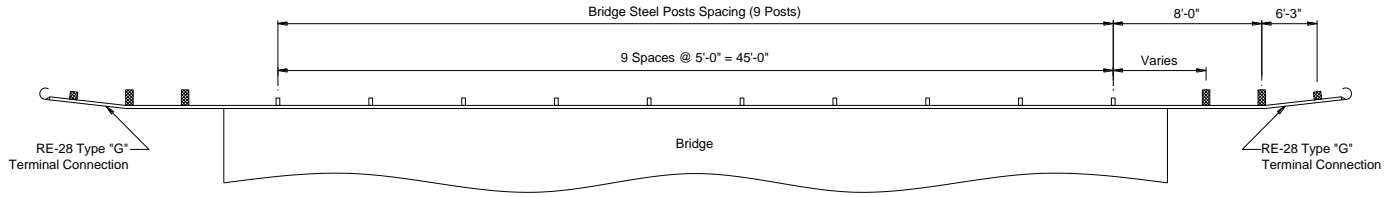
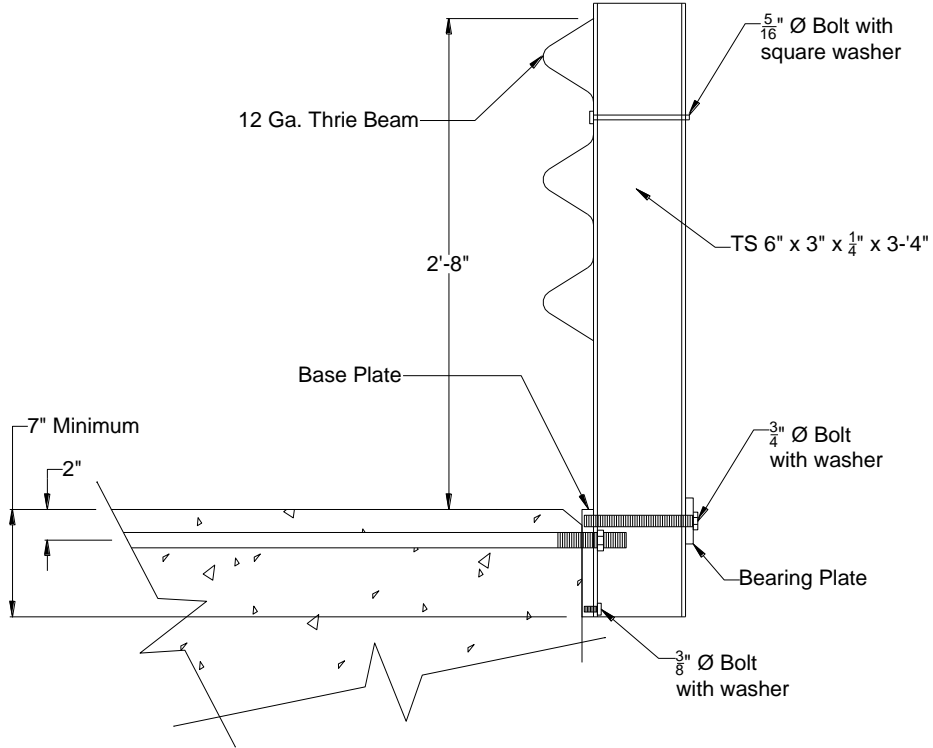
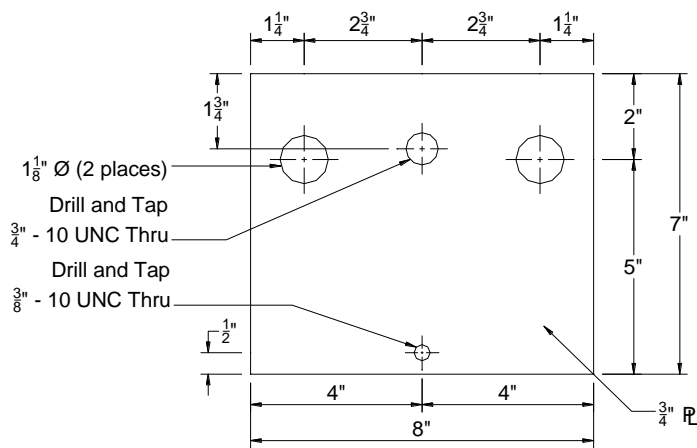
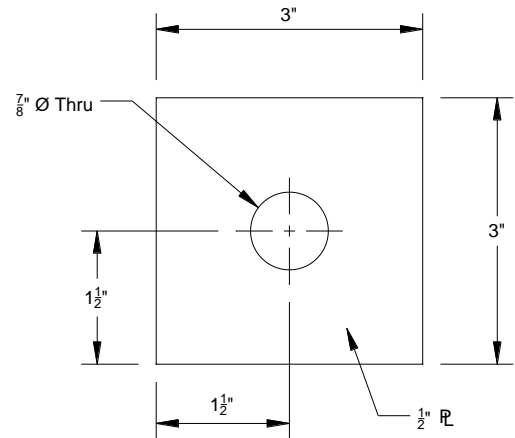
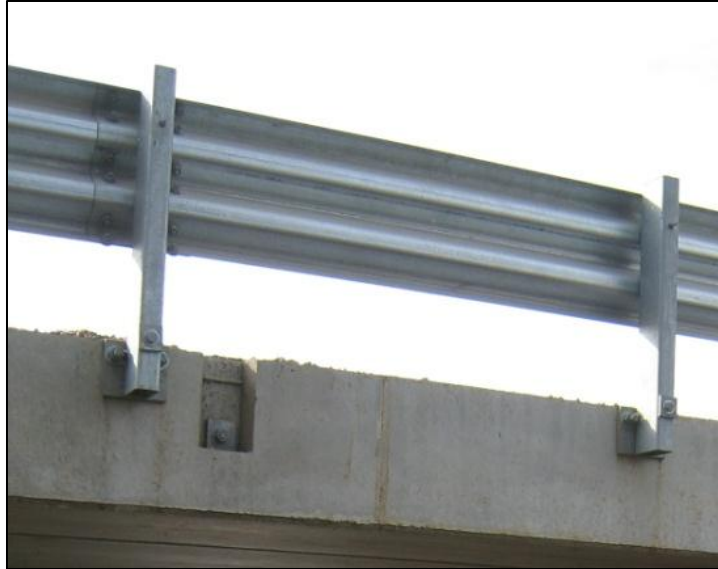
The two exterior box beams were fabricated with 1 in. diameter anchor bolts on their exterior sides for connecting the eight guardrail posts. The posts were spaced uniformly on 6 ft 3 in. centers as shown in Figure 2.9.

Two anchor bolts (spaced 2 3/4 in. off the post centerline) were required for attaching each post. Guardrail posts (3 ft 4 in. long) were fabricated from TS 6 x 3 x 1/4 in. sections; a 12 gauge thrie beam was used for the guardrail. Each post is connected to a 3/4 in. thick steel base plate (8 in. x 7 in.) with a 3/4 in. diameter A325 bolt and a 3/8 in. diameter bolt. This assembly was connected to the bridge using the two 1 in. diameter anchor bolts described previously.

a. Plan view of guardrail post spacing

b. Profile view of guardrail and connection

c. Base plate

d. Bearing plate

Figure 2.9. Box beam guardrail system

e. Guardrail system

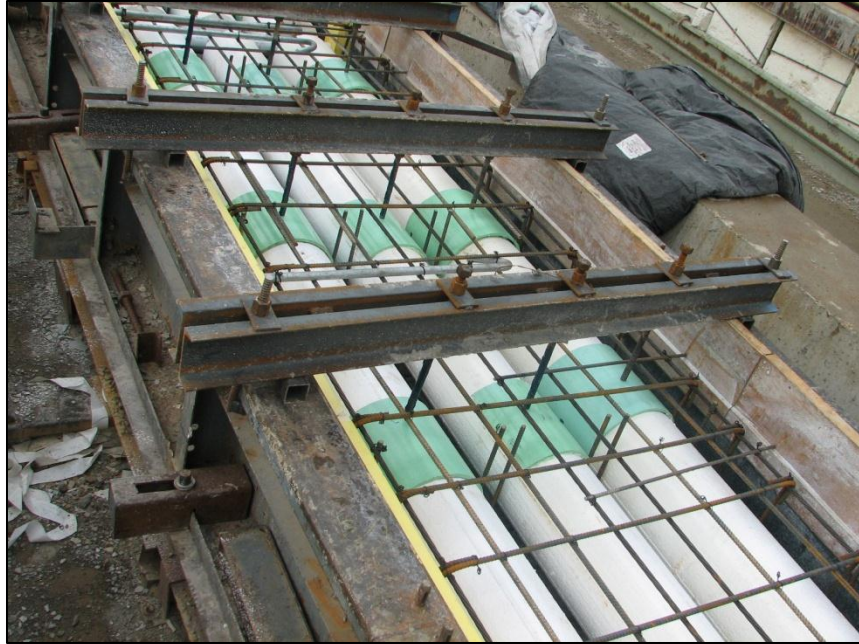
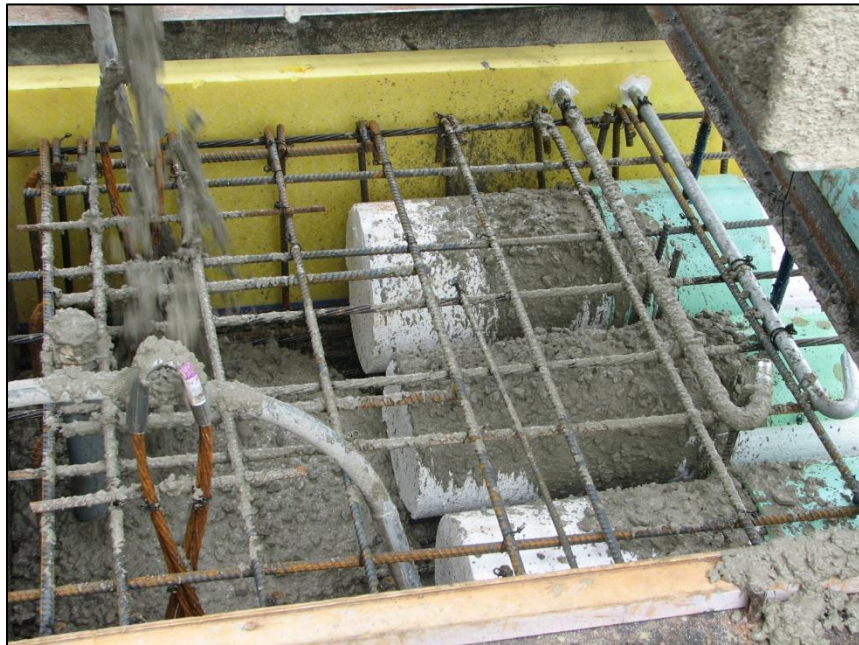
As may be observed, concrete strengths in all elements exceeded the design target values. For convenience, box girders were cast two at a time in one prestressing bed with bulkheads separating the two girders. Because seven box girders were required for the project, only one girder was cast in one of the pours. Figure 2.10 shows the top reinforcement in the box beams.

a. Overall view

b. Placement of concrete in box beam forms

**Figure 2.10. Box beam fabrication**

Also shown in this figure are the Styrofoam cylinders used to create the voids in the box girders. Hold-downs to keep the Styrofoam from floating are shown in Figure 2.10a. As shown in Figure 2.10b, the Styrofoam cylinders were terminated 1 ft 3 in. from the beam ends to create the solid beam ends. Two other items, which can be seen in Figure 2.10b, are the guardrail post anchor rods and the cable-lifting loops, which are cut off after the box beams are placed in the field.

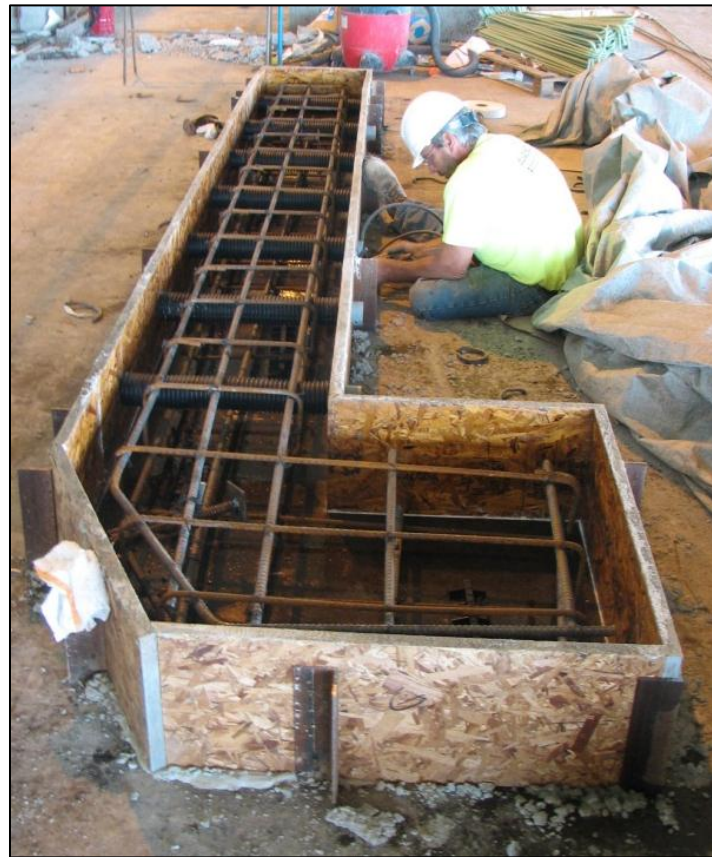
Backwall elements were cast one at a time; formwork, as well as the reinforcement for these elements, are shown in Figure 2.11. For installation, each of the backwall panels had three cable lifting loops and two screw inserts for additional lifting points.

**Figure 2.11. Backwall formwork**

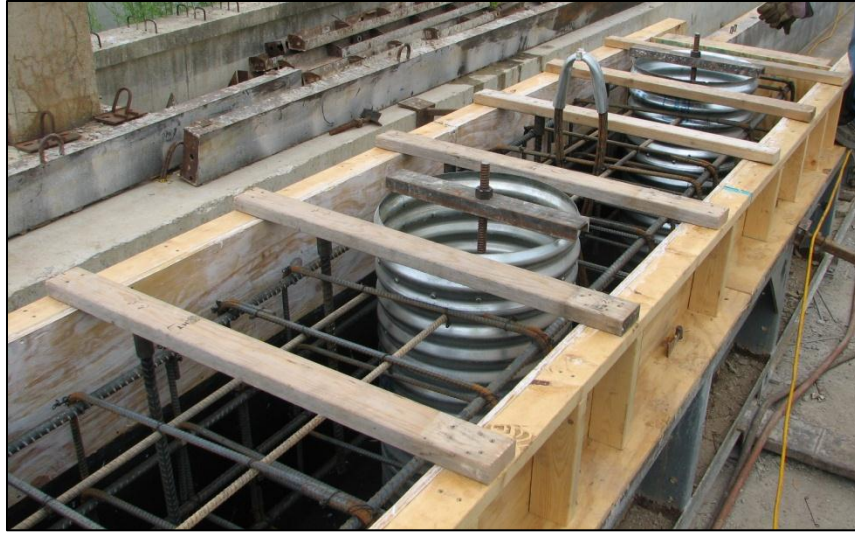
The two abutment caps were also cast one at a time. Figure 2.12 shows the abutment cap formwork, one of the two required cable lifting loops, reinforcement, and two of the five pieces of CMP, required to create voids for the piling.

**Figure 2.12. Abutment cap forms**

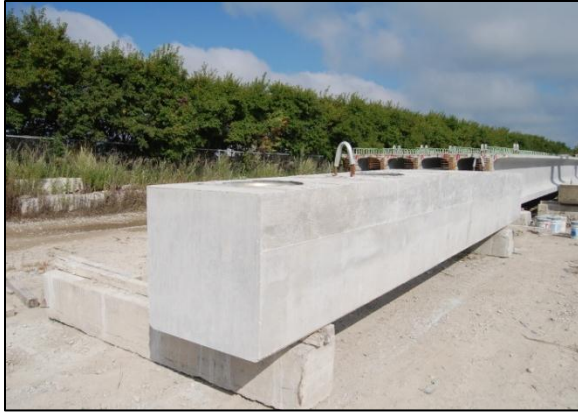
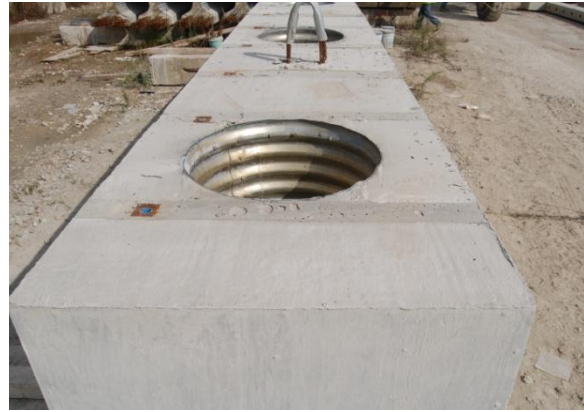
Prior to being shipped to the bridge site, the individual precast elements were inspected and partially assembled in the precast yard to ensure the elements fit together properly. This step also gave the contractor, who was new to this type of construction, a chance to review the various elements and ask questions about the construction sequence. Images of the precast abutments in the precast yard are shown in Figure 2.13.

a. Overall view of precast abutment

b.) Precast abutment pile connection openings

**Figure 2.13. Prefabricated abutments in precast yard**

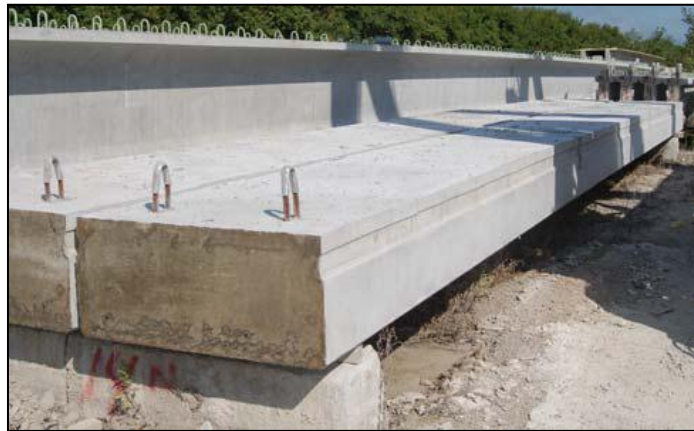
The fit between two adjacent box beams is shown in Figure 2.14. In this setup, the trueness of the elements, as well as the alignment of the transverse tie assembly, could be checked.

**Figure 2.14. Voided precast beams**

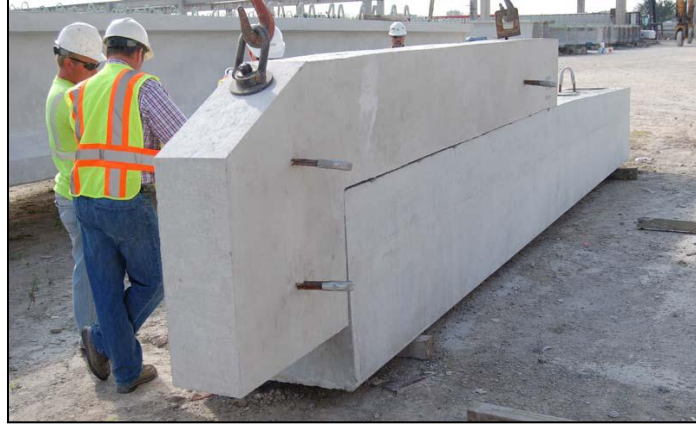
Figure 2.15 shows one of the backwall segments positioned on the precast abutment cap. The four backwall segments were cast “flat” and lifted out of the forms using the three lift cables shown in this figure.

To lift the backwall segments into place, lifting hooks were attached with bolts screwed into inserts in the top of the backwall elements (Figure 2.15). After the 13 elements were inspected and partial assembly was completed, these were stored at the precast yard until needed at the bridge site.

**Figure 2.15. Precast backwall and abutment**

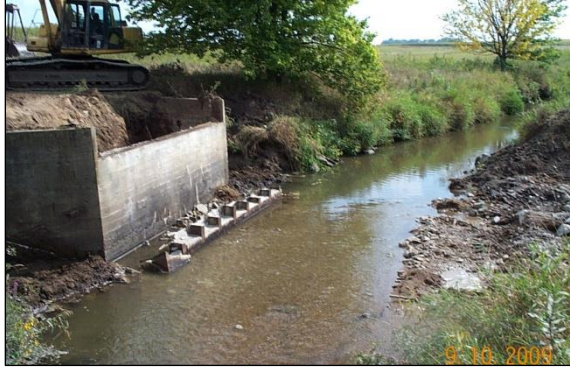
It took essentially one day to remove the existing bridge at the site. As shown in Figure 2.16a, the superstructure has been removed and all that remains at the east end of the bridge is the abutment and piling from the previous bridge at the site.

a. Existing east abutment

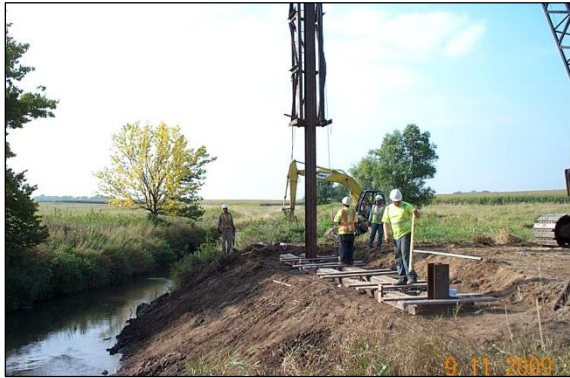
Figure 2.16c shows the driving of the second pile in the west abutment, while Figure 2.16d shows all west abutment piling is in place and cut to the desired length. Driving of the final pile in the east abutment is shown in Figure 2.16e; also shown in this figure is the installed filter fabric.

c. Pile driving in west abutment

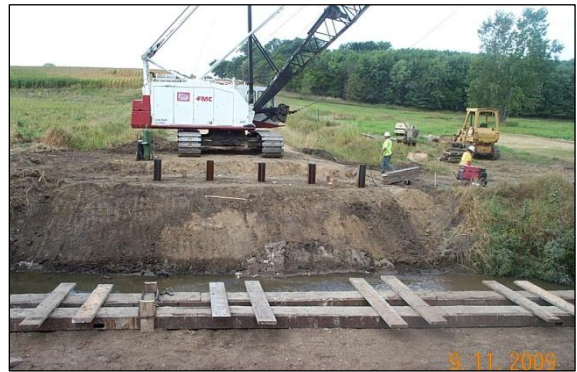
d. Piling completed in west abutment

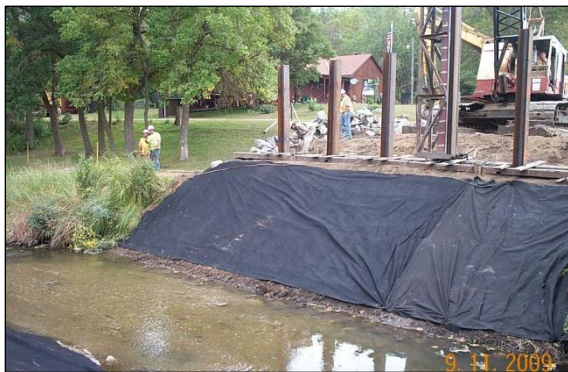
e. Driving piling in east abutment

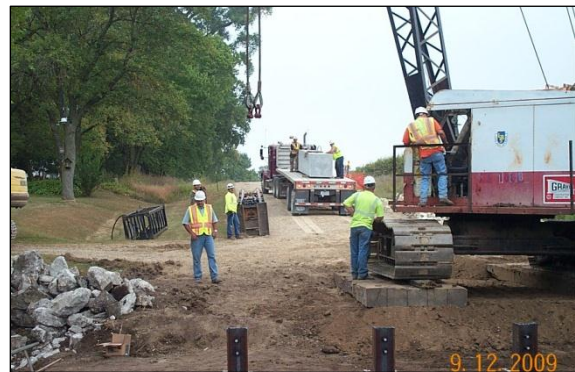
It took only one day (September 11, 2009) to drive all 10 piles required for the bridge substructure. Arrival of the east pile cap is shown in Figure 2.16f; the installed abutment cap is shown in Figure 2.16g.

f. East abutment cap arriving at site

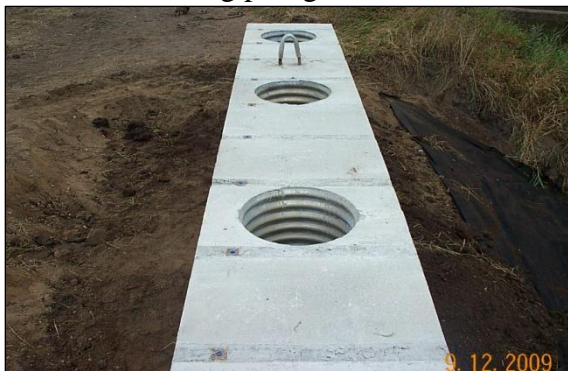
g. East abutment cap in place

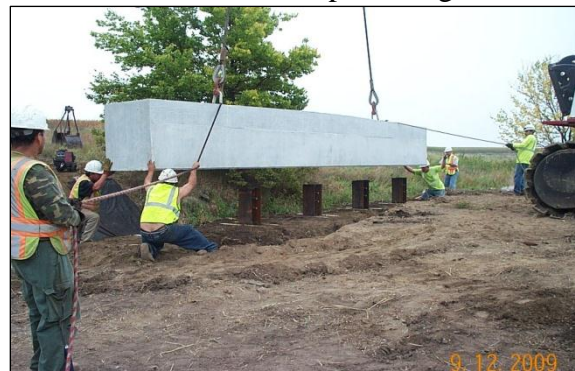
h. Installing west abutment cap

The same process was repeated for installation of the west abutment cap, which is shown being positioned in Figure 2.16h. After installation of the two abutment caps, concrete was placed in the abutment voids on September 12, 2009 and allowed to cure over the weekend.

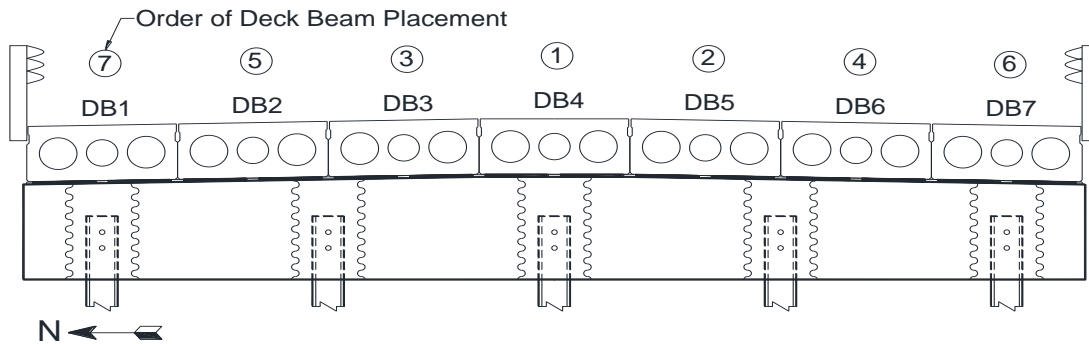
The superstructure and guardrail installations (except for approach guardrails) were completed in one day (September 14, 2009). The order of the precast beam placement is shown in Figure 2.17; as can be seen in the middle box beam (Bm #4) was placed first and the two exterior beams (Bms #1 and #7) were placed last.

**Figure 2.17. Order of box beam placement**

Erection times for the various beams are presented in Table 2.3. Total time required for lifting beams from the seven trucks and placing them on the abutments was slightly less than an hour.

Total time (from when the first truck arrived until the last beam was placed) was slightly less than four hours. The additional time was due to a problem with the depth of Bm #5 that delayed placement of Bm #3 and Truck #7 getting lost between the precast yard and the project site.
