# Evaluation of the Buena Vista IBRD Bridge: A Furthering of Accelerated Bridge Construction in Iowa

**Final Report**  
**February 2012**

**Sponsored by**  
Iowa Highway Research Board  
(IHRB Project TR-605)  
Iowa Department of Transportation  
(InTrans Project 08-342)

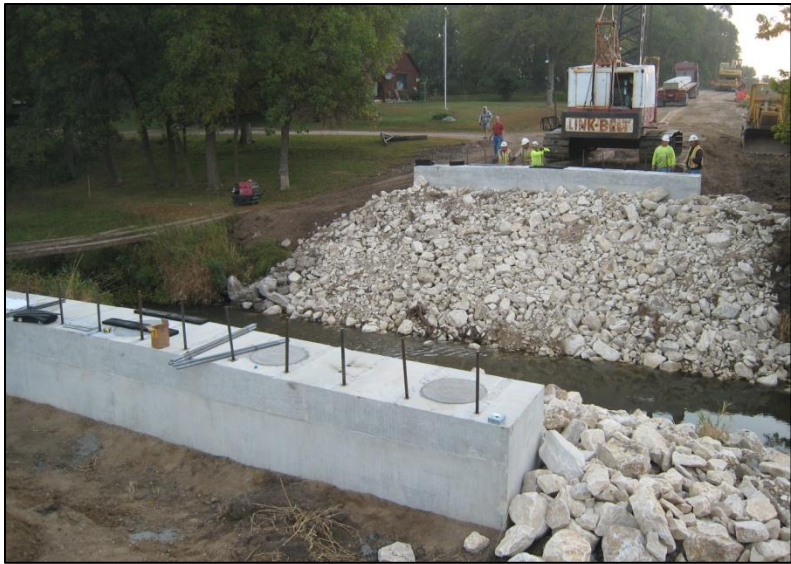
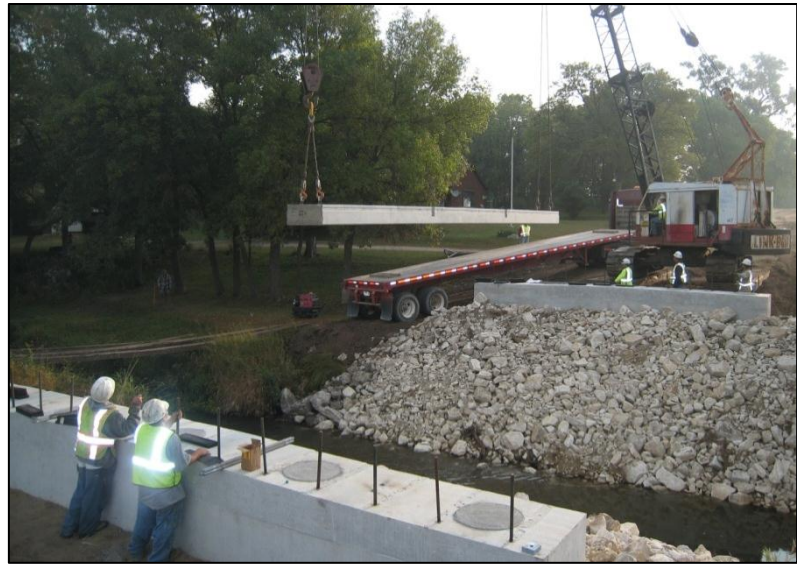
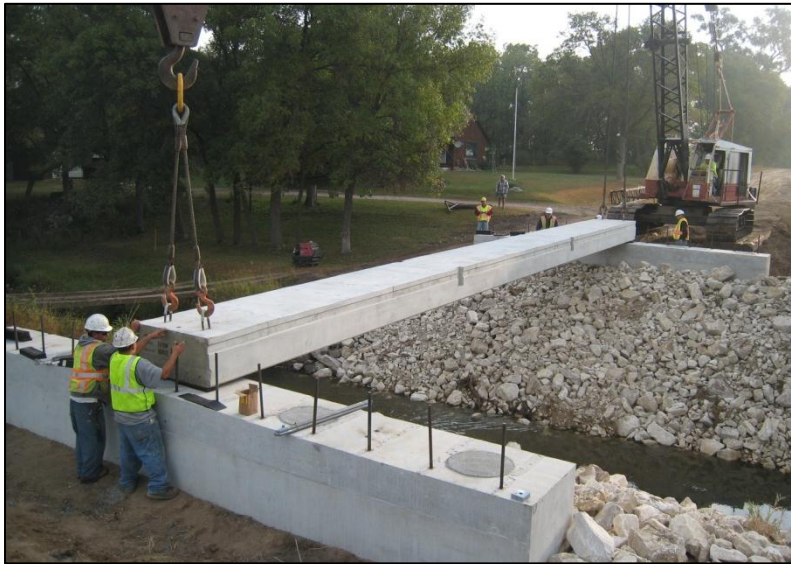
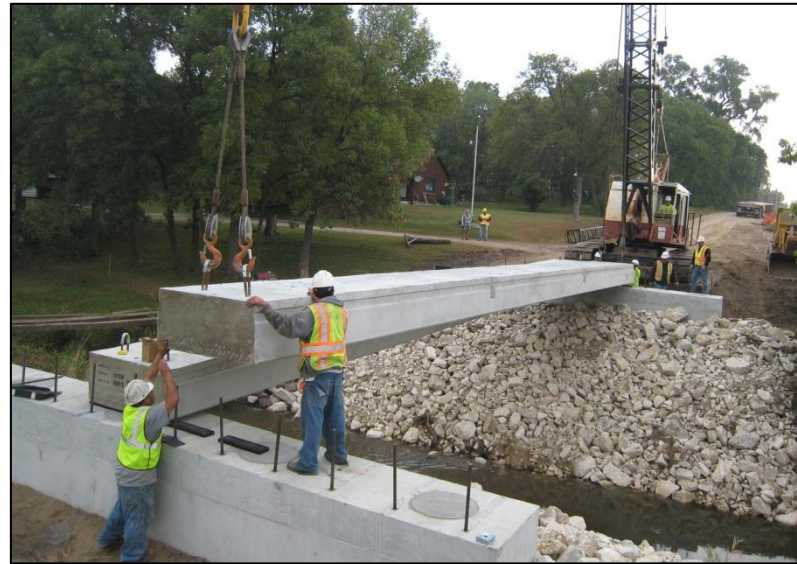
Two backwall sections were transported on Truck #4 and two on Truck #5. Upon arrival at the project site, they were unloaded and placed on dunnage until installation. Images of the various steps completed during the construction of the superstructure are shown in Figure 2.18. Details of the steps are described briefly in Table 2.4.

a. Both abutments in place

b. Unloading of Beam #4

c. Positioning of Beam #4

d. Setting of Beam #5

**Figure 2.18. Construction of the superstructure**

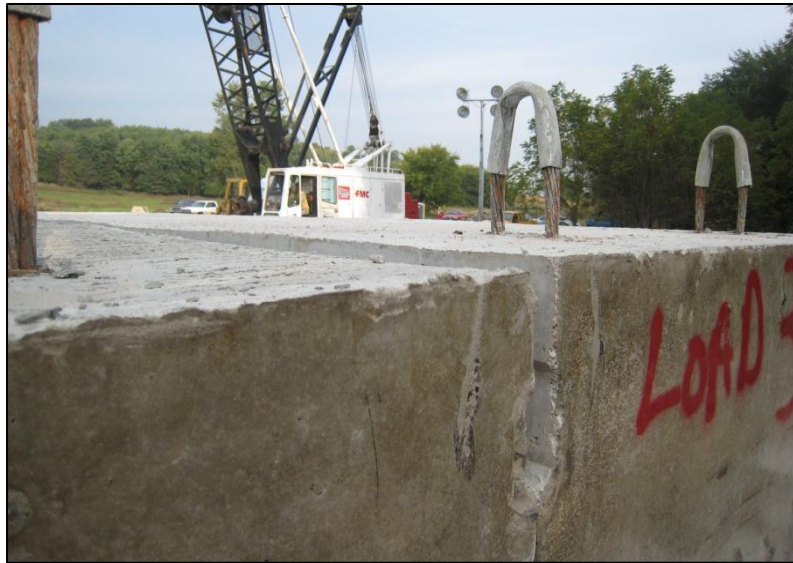
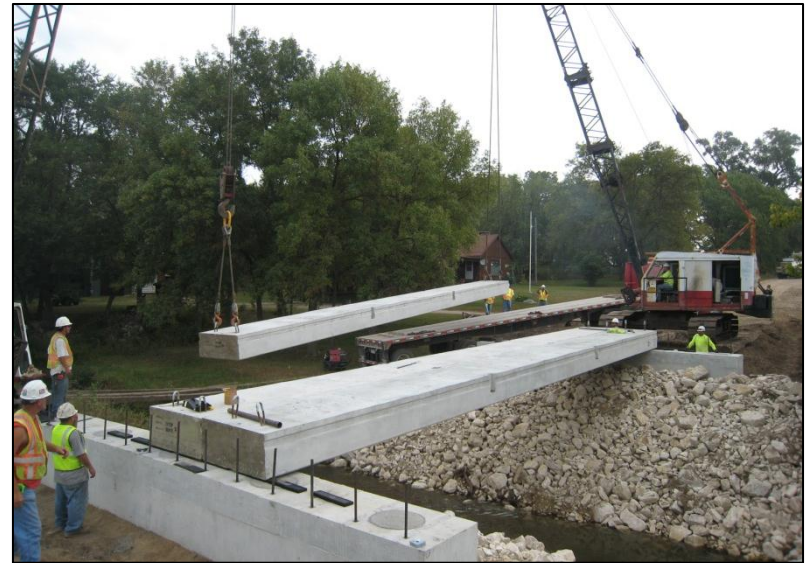
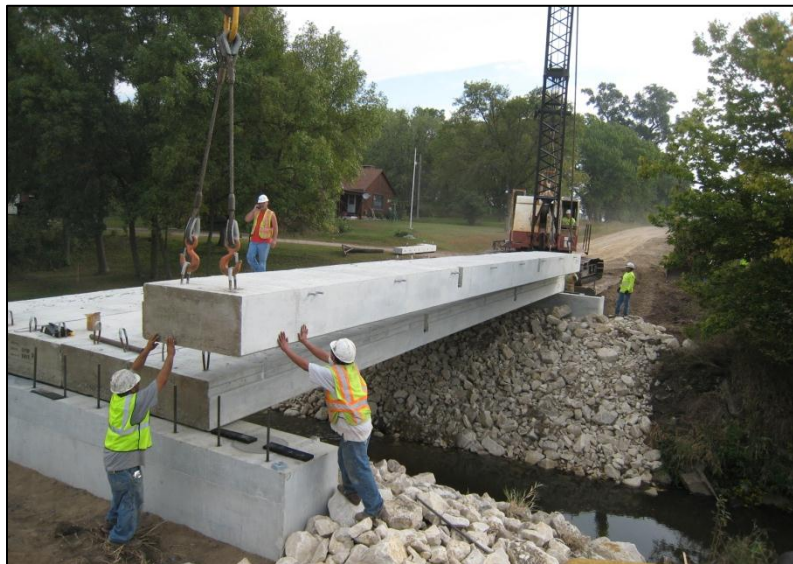
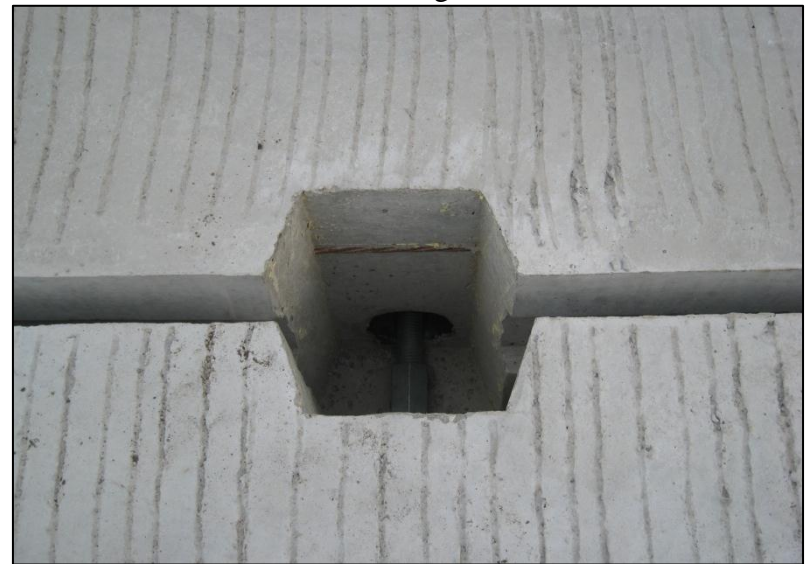
e. Difference in beam thickness

f. Positioning of Beam #3

g. Positioning of exterior Beam #7

h. Tie rod block out

f	Bm #3 has been lifted and is being positioned to place next to Bm #5.
g	Setting of the south exterior Bm #7 showing the extension of the anchor rods for attachment of the guardrail posts.
h	Voids in adjacent box beams (17 ft 1 in. from each end) created space so the coupling nuts required for the transverse tie assembly could be tightened. The exterior top prestressing tendon that is exposed will be covered when the grout between the adjacent units is placed and this void is filled.
i	Tightening of the transverse tie rods through the voids previously described in Figure 2.18h.
j	Workers using an impact rotary drill to create a 1 1/2 in. diameter hole 12 in. into the abutment cap. After the transverse tie assembly has been tightened, 1 1/2 in. smooth dowels (2 ft 3 in. long) will be epoxied in these holes.
k	Prior to grouting the various joints and voids in the bridge, the lifting loops were cut off slightly below the surface of the concrete deck. These regions were then filled with grout. Images of the several steps required for installing the backwalls and guardrails are shown in Figure 2.19 with a brief description of the construction in Table 2.5.

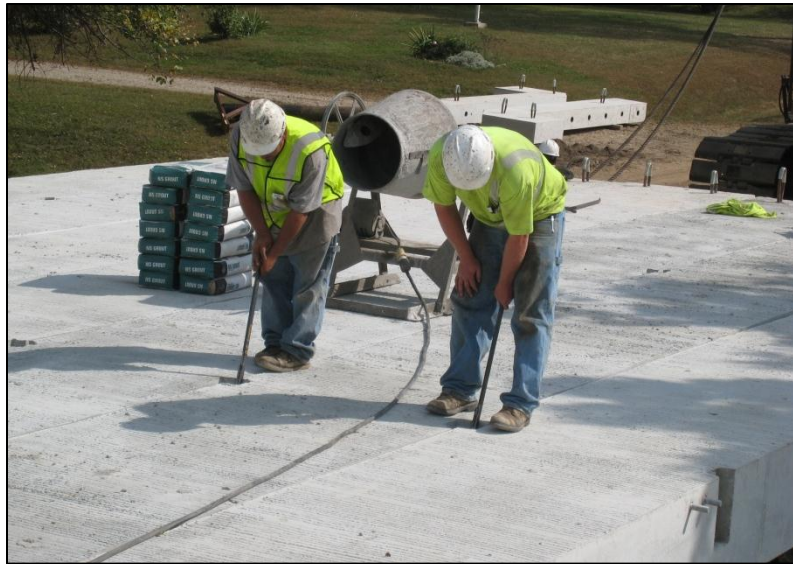
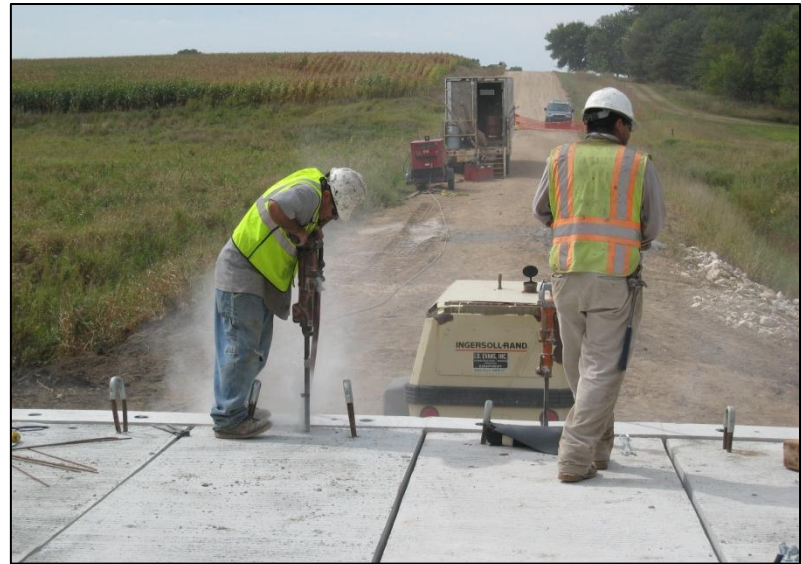
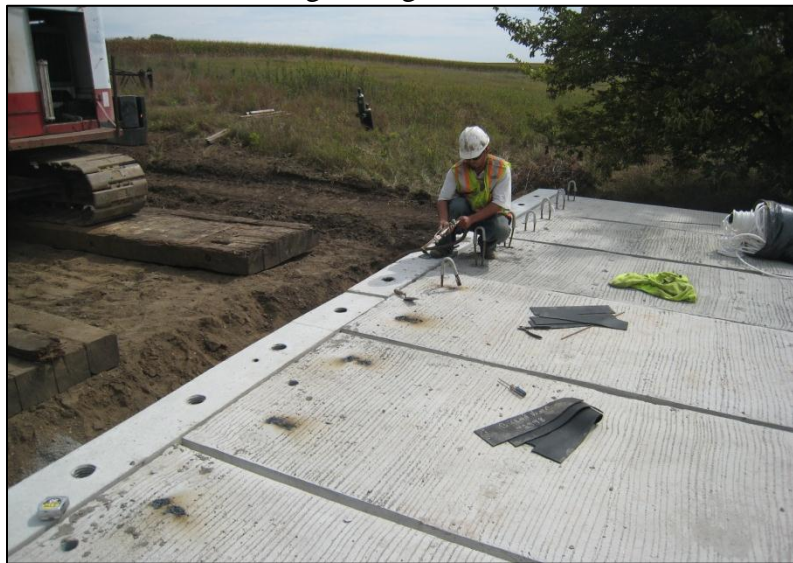
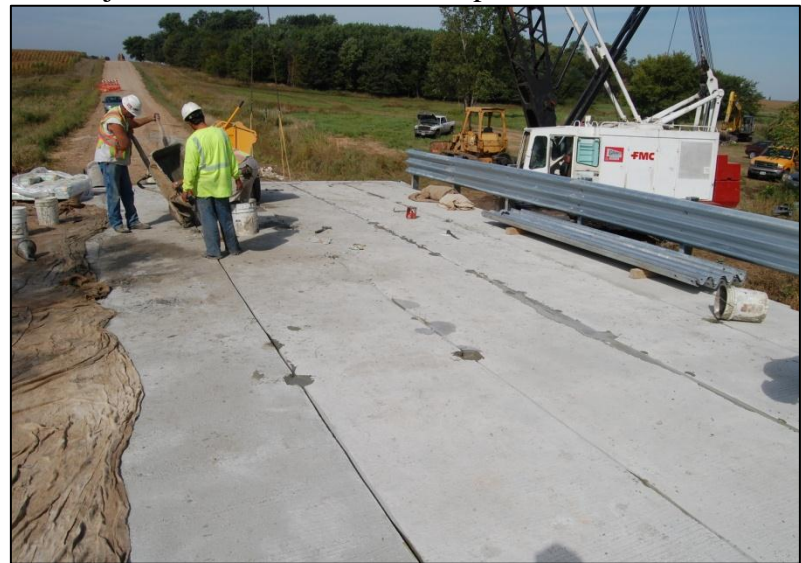
i. Tightening interior tie rods

j. Drill hole in abutment cap for new anchor rods

k. Cutting off beam lift cables

l. Placement of non-shrink grout

l	Workers shown placing non-shrink, non-metallic grout (NS Grout manufactured by The Euclid Chemical Company) in the joints between the adjacent beams and the pockets required for tightening the transverse tie assembly. Prior to placement of the grout, polystyrene backer rod was placed in the joint where required. Note the joint between Beams 6 and 7 has been completed and has been covered with wet burlap for curing.

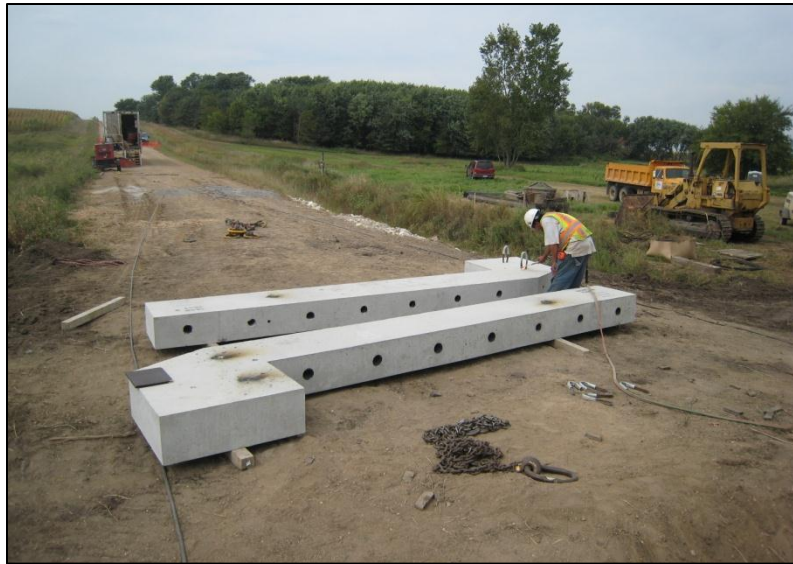
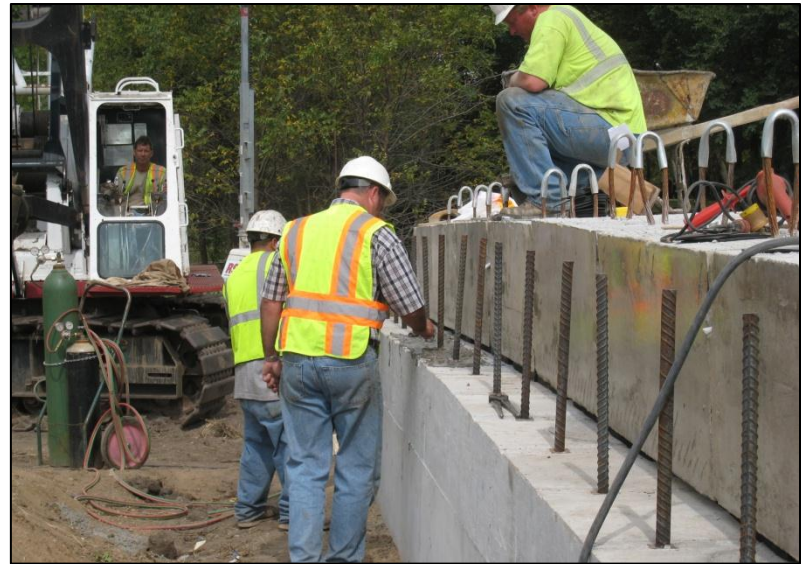
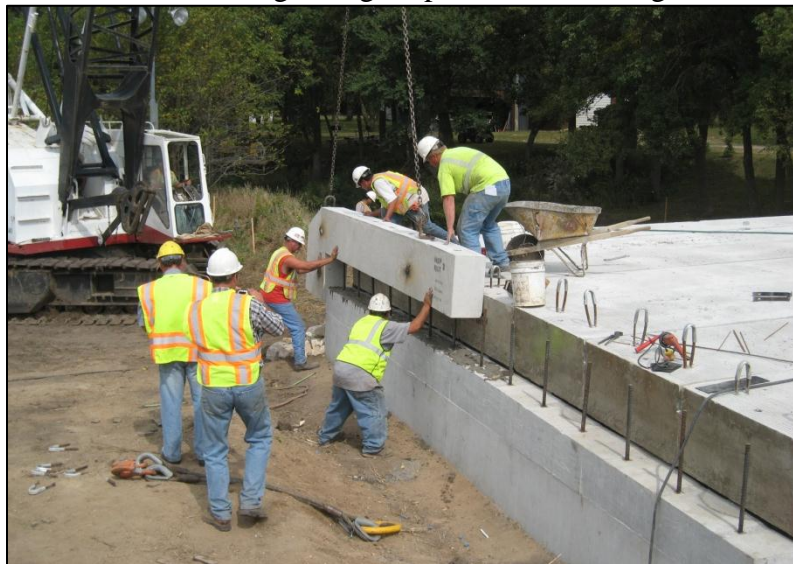
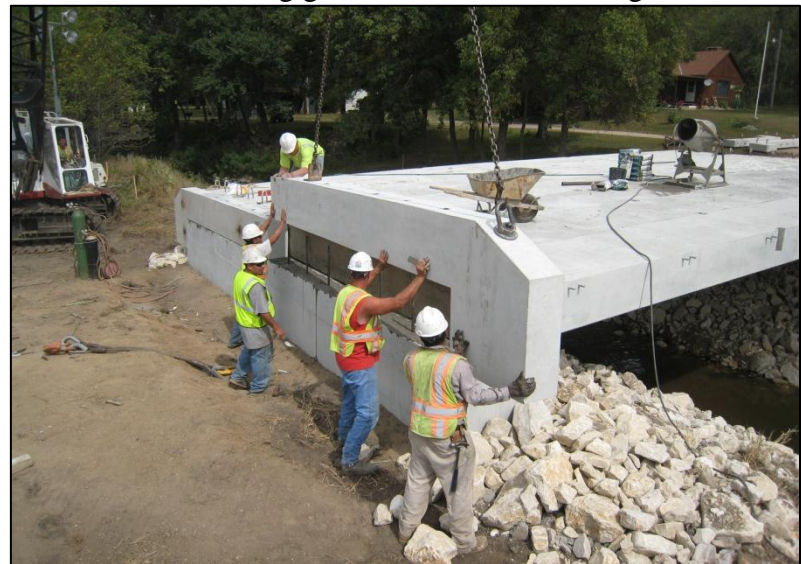
Details on the installation of the backwalls and guardrails are presented in Figure 2.19 and Table 2.5.

a. Removing lifting loops on backwall segments

b. Placing grout bed for backwall segment

c. Placement of a backwall segment

d. Placement of second backwall segment at west end

**Figure 2.19. Installation of precast backwalls and guardrail system**

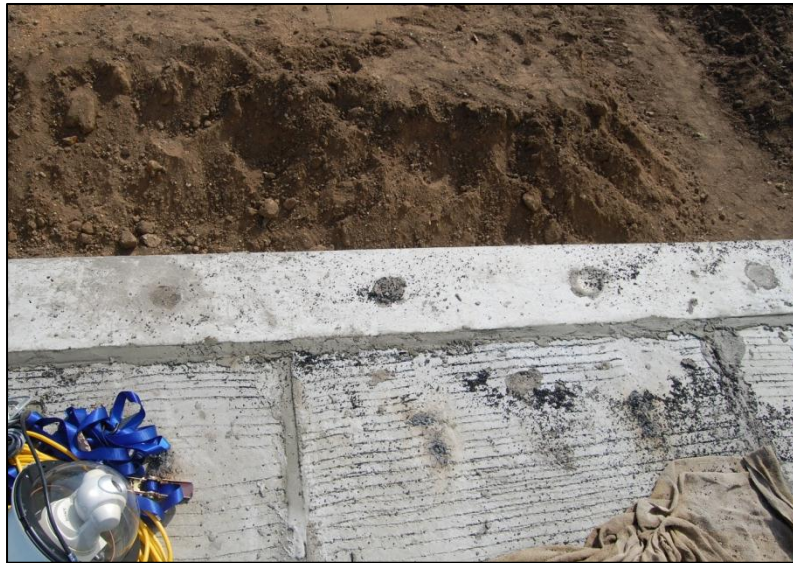
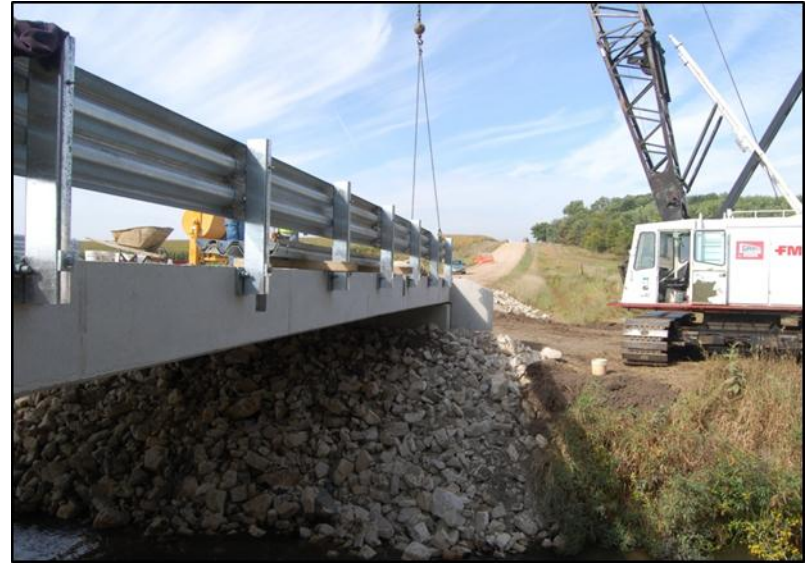
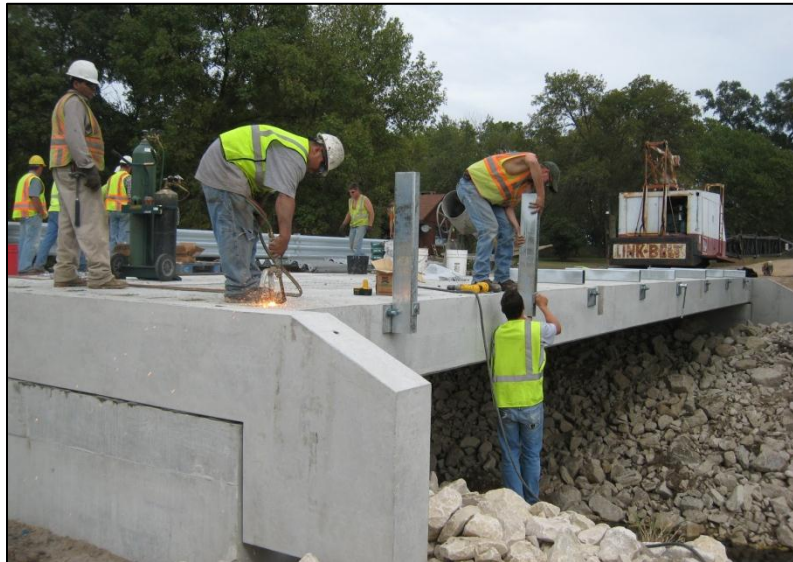
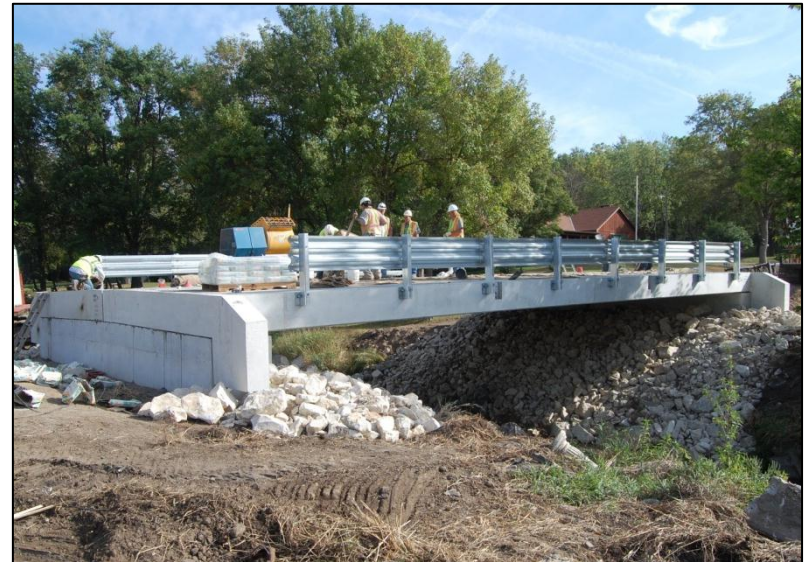
e. Grouting of various voids and joints

f. Completing north guardrail

g. Installation of guardrail post on south side of bridge

h. "Completed" bridge

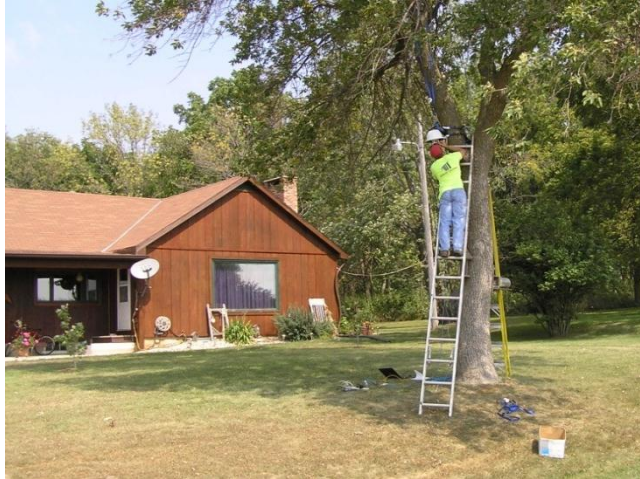
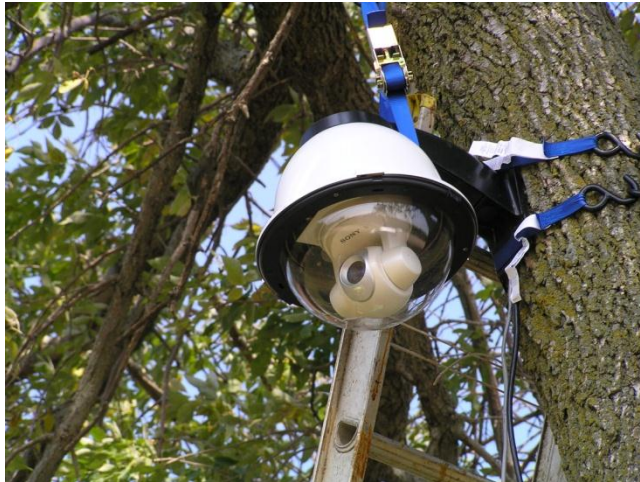
A Sony internet-based web-camera was installed relatively close to the northeast corner of the bridge site as shown in Figure 2.20a. A close-up of the camera is shown in Figure 2.20b.

This camera was installed on September 8, 2009 and recorded an image of the construction site every 5 minutes until September 15, 2009 when the camera was removed.

a. Camera installation

b. Time-lapse camera

**Figure 2.20. Time-lapse camera at bridge site during bridge construction**

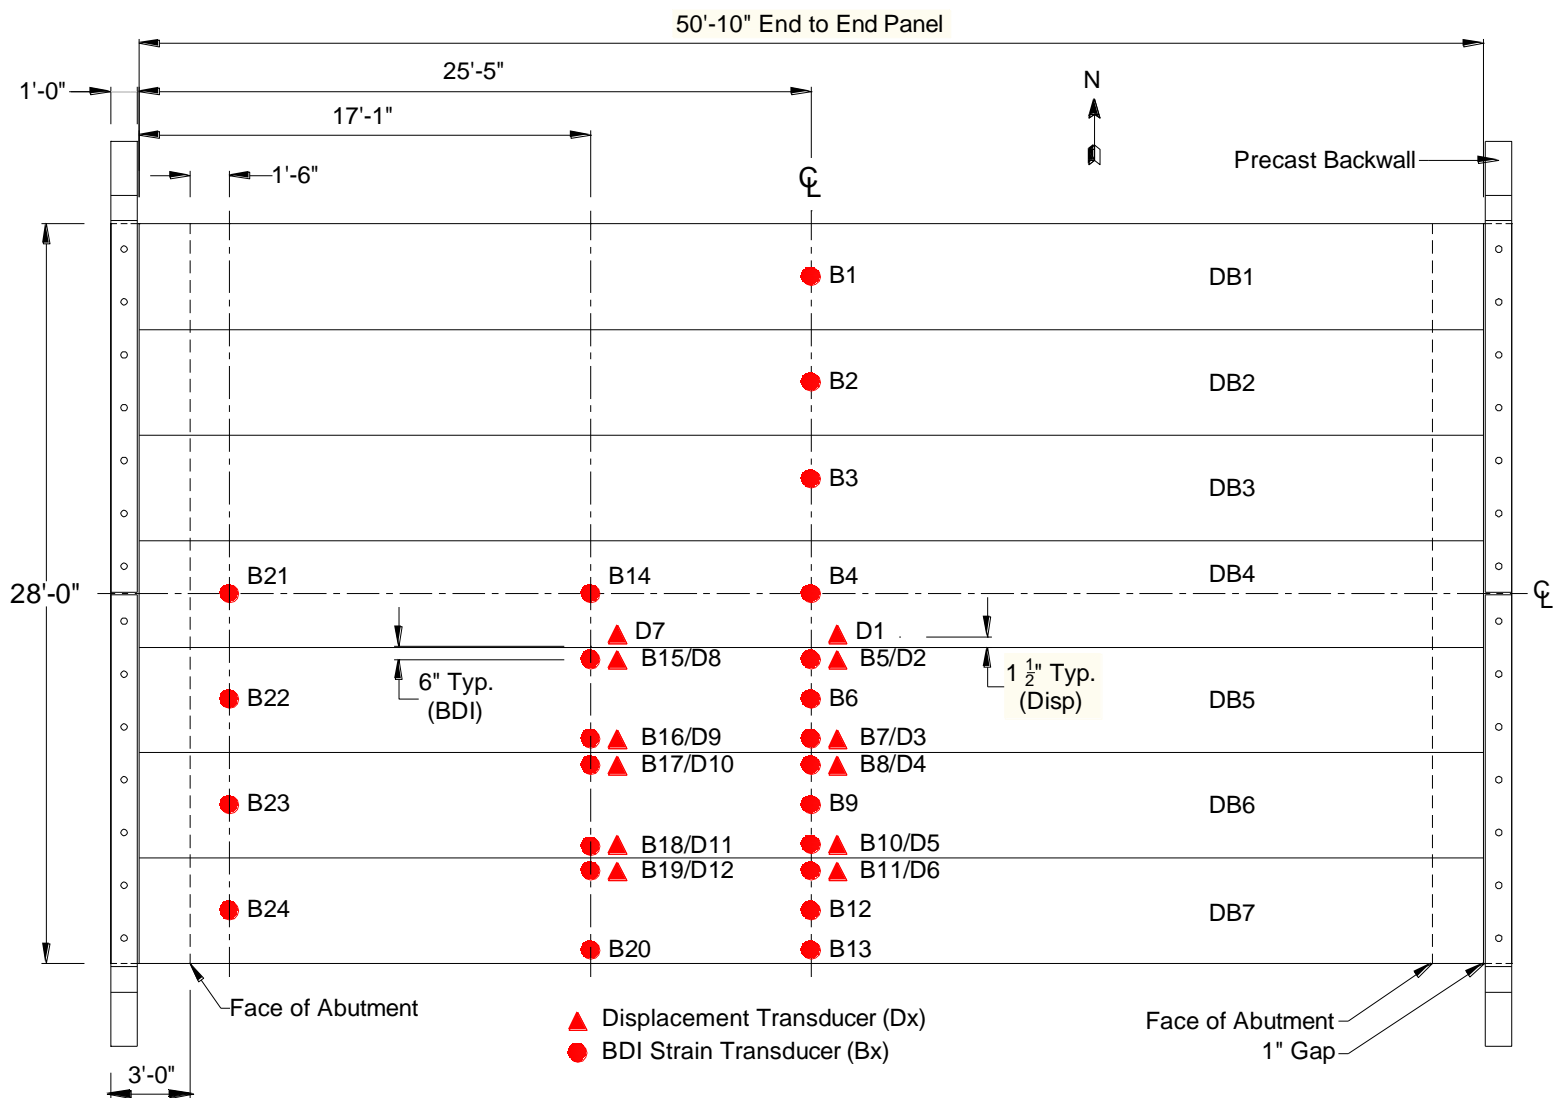
The BEC in conjunction with BVC and the Iowa DOT developed the monitoring and evaluation plan for the bridge. The plan entailed investigating the behavior of the bridge after its completion and its behavior approximately one year later. Instrumentation was placed at important locations to measure overall deflections, relative deflections between adjacent box beams, and strains. The location of the instrumentation used for the two tests is shown in Figure 3.1 (2009 instrumentation in Figure 3.1a and 2010 instrumentation in Figure 3.1b).

Based on results from the 2009 tests, slightly less instrumentation was used in the 2010 tests. In the 2009 tests, 24 Bridge Diagnostics Inc. BDI transducers were used for measuring strains at desired locations and 12 displacement transducers were used for measuring deflections at desired locations. The arrangement of deflection transducers made it possible to measure global displacements of the bridge as well as relative displacements between adjacent box beams. In 2010, relative displacement transducers (shown in Figure 3.2) were used, given it was desired to determine the relative displacement between adjacent box beams rather than global displacements.

a. 2009 Instrumentation

**Figure 3.1. Instrumentation layout**

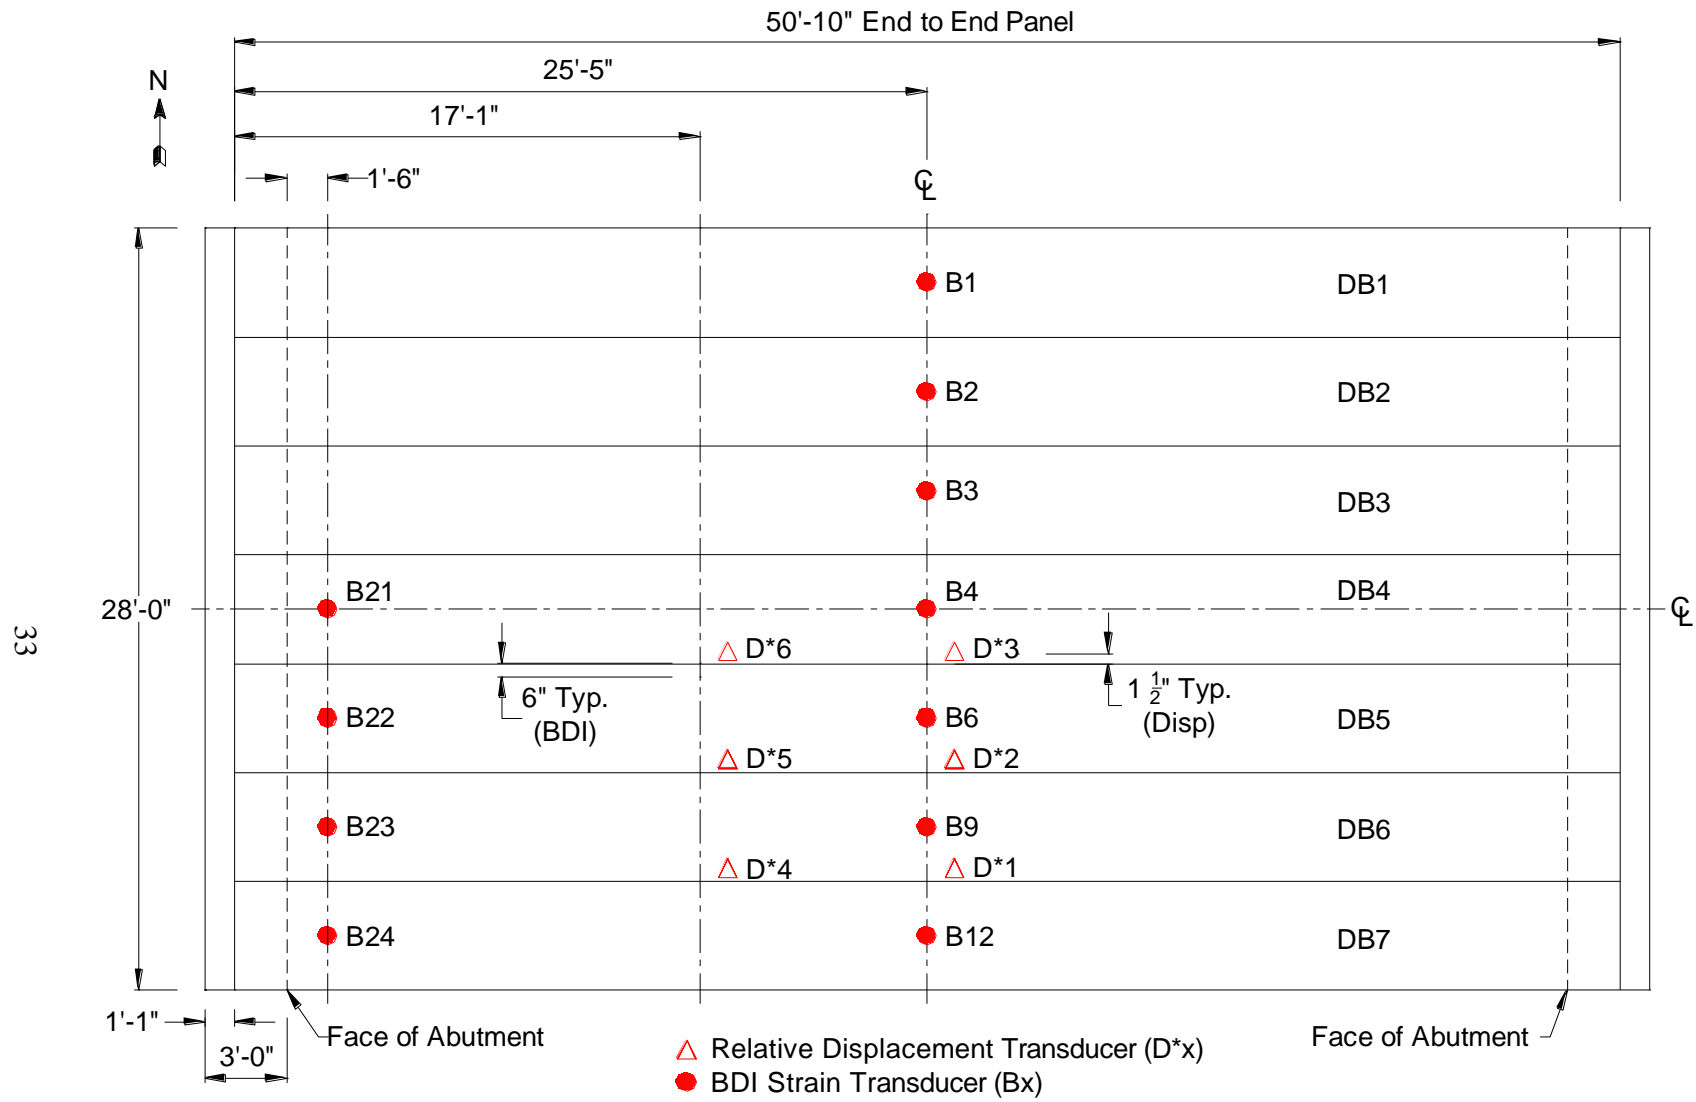
b. 2010 Instrumentation

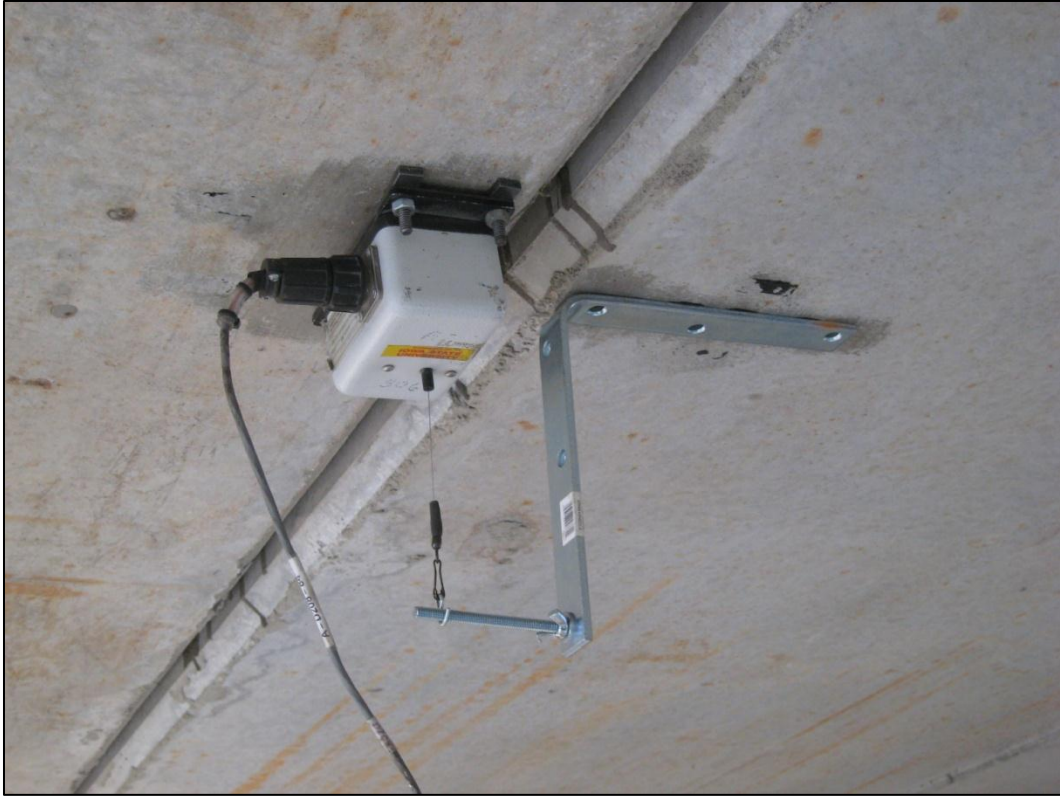
**Figure 3.2. Relative displacement transducer between DBs 5 and 6**

In 2010, the transducer (shown in Figure 3.2), which measures differential displacements between adjacent units, was used to determine differential displacements directly. When reviewing the data in Figure 4.3, note that two different vertical scales were used.

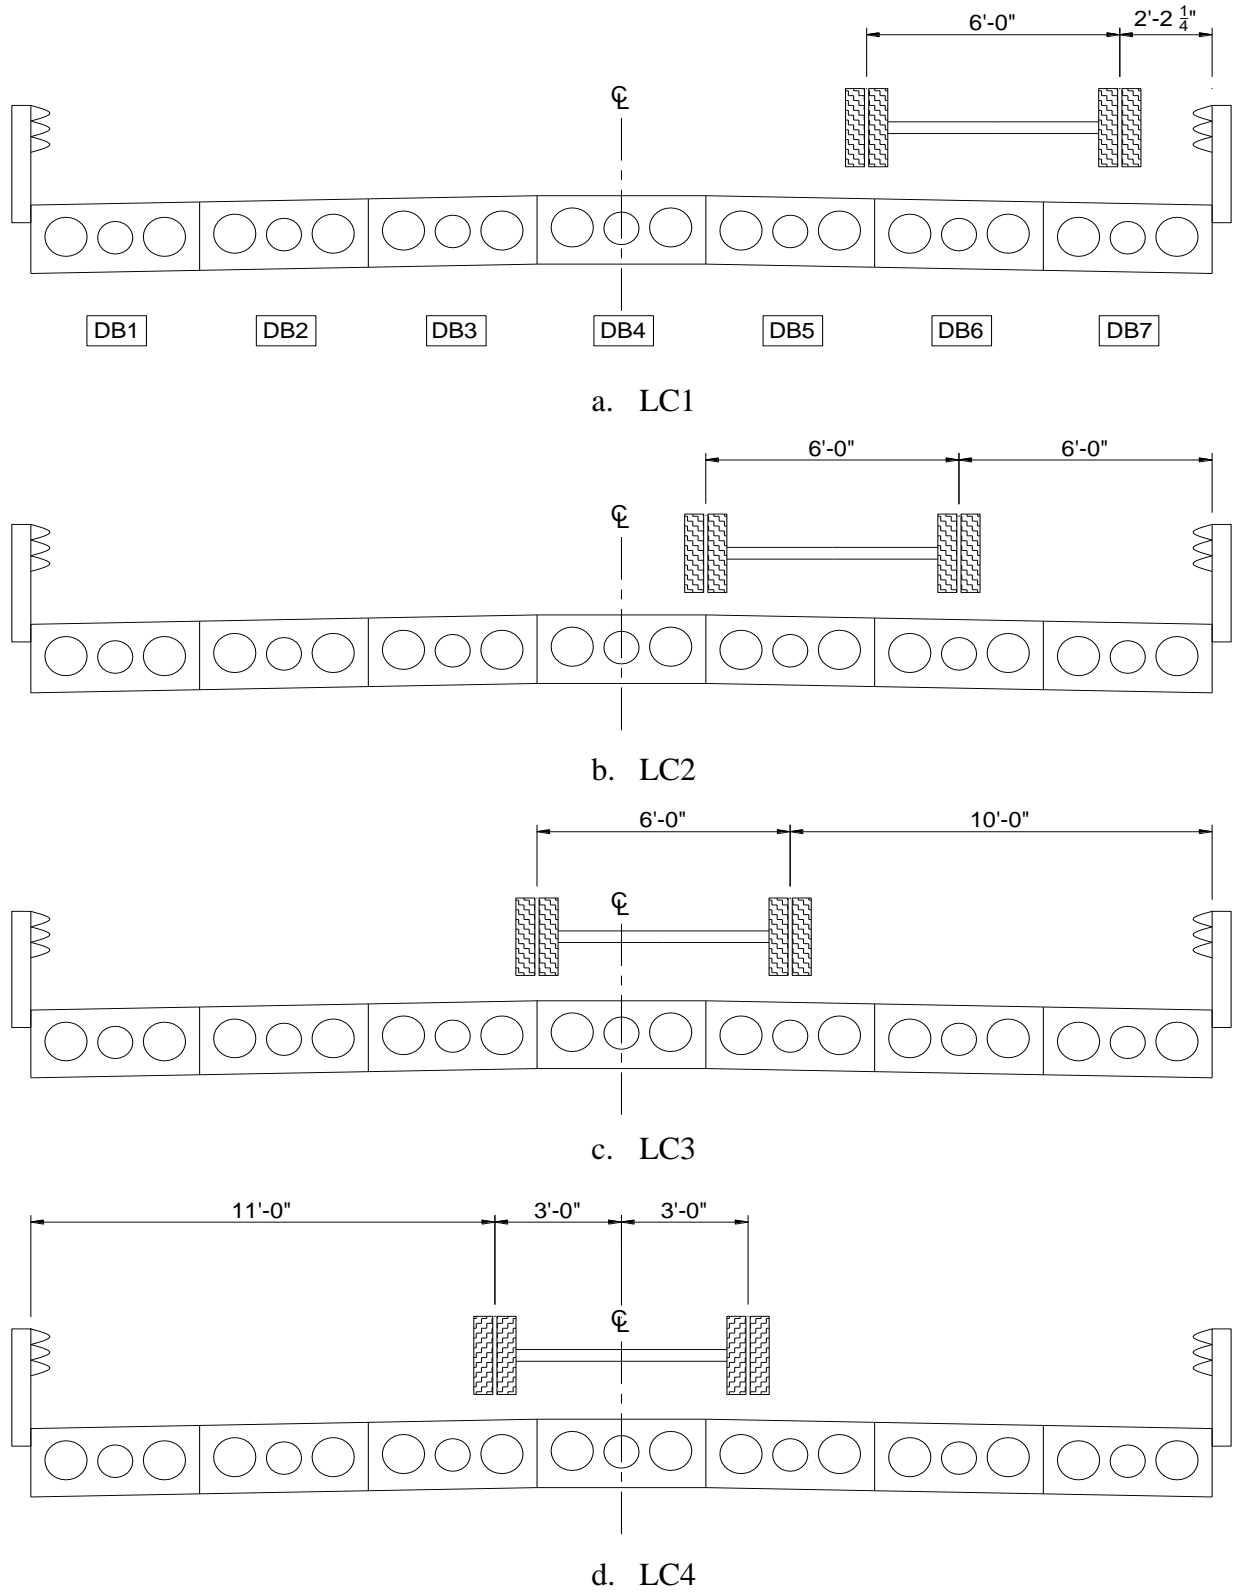
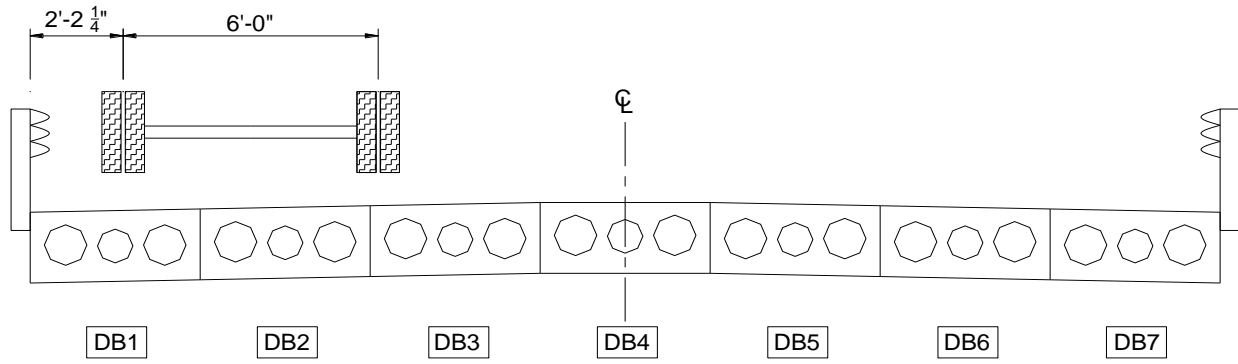
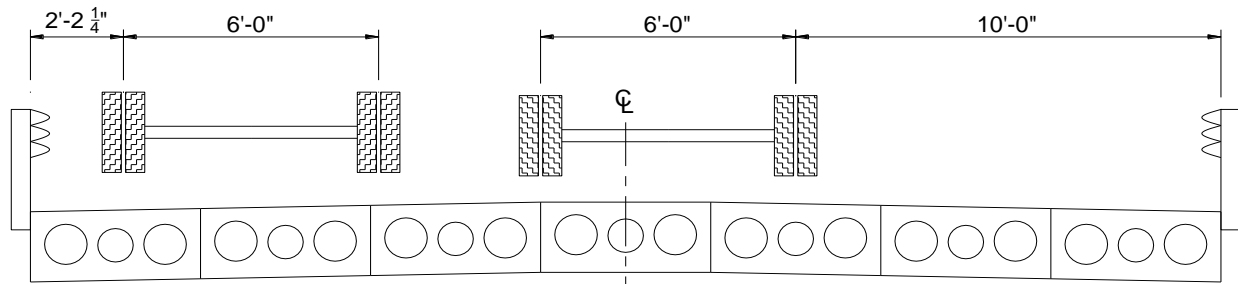
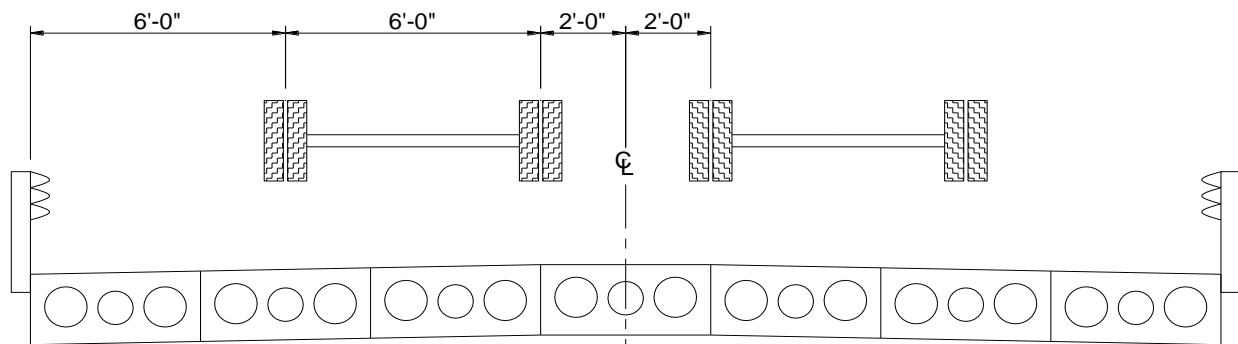
A total of seven load cases, shown in Figure 3.3 (LC1 through LC7), in which the transverse position of the truck(s) was varied, were used in 2009. Note that in LC6 and LC7, there were two trucks on the bridge. In the 2010 tests, the same load cases (shown in Figure 3.3) were used, except that LC6 was omitted.

**Figure 3.3. Transverse load positions: vehicle traveled east (into page)**

e. LC5

f. LC6 [summation of LC3 + LC5]

g. LC7

As noted previously, only static tests were performed (slow moving truck when one truck was on the bridge and stationary trucks when two trucks were on the bridge) each year on the bridge. In Figure 3.3, eight load cases are shown: five cases with one truck on the bridge and three cases with two trucks on the bridge. In 2010, LC6 was not ran and results for this load case were obtained by adding the results from 2010 LC3 and LC5.

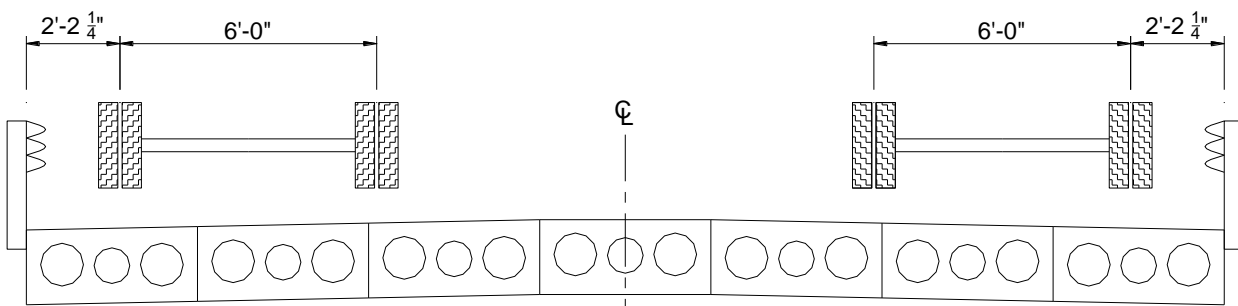
h. LC8 (2009, 2010: [summation of LC1 + LC5])

**Figure 3.3. Continued**

To obtain an approximation of lane load distribution, data from two trucks on the bridge were used. In 2009, this involved LC6 and LC7. Data for LC8 (shown in Figure 3.3) was obtained by adding the results from LC1 and LC5. In 2010, only LC7 was actually completed in the field. Results for LC6 and LC8 were obtained by adding the results for having one truck on the bridge ( $LC6 = LC3 + LC5$ ;  $LC8 = LC1 + LC5$ ). Load fraction for these three combination load cases are shown in Figure 4.11.

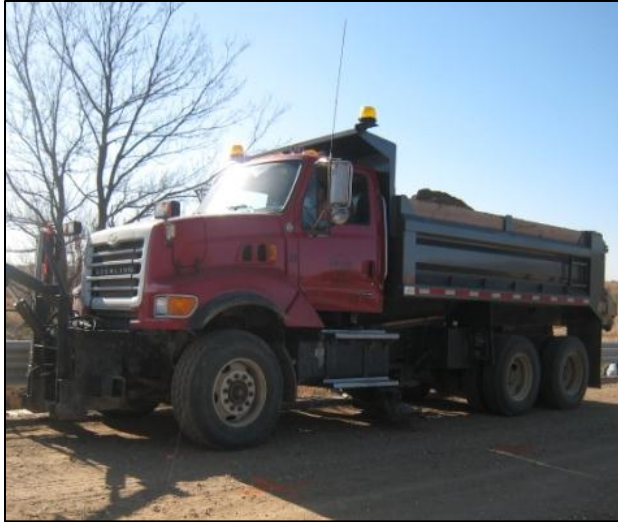
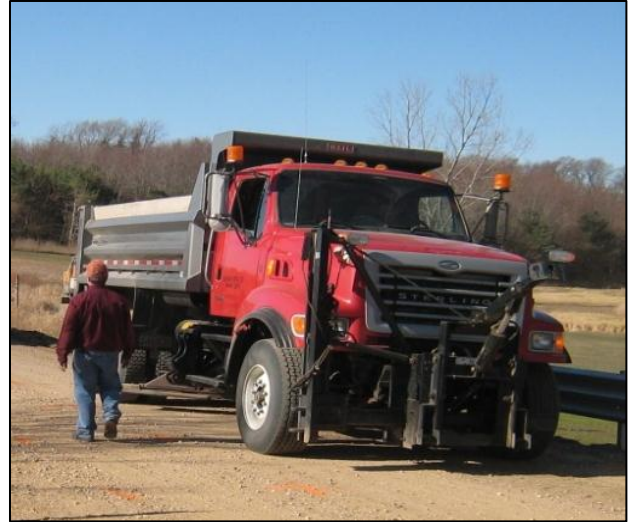
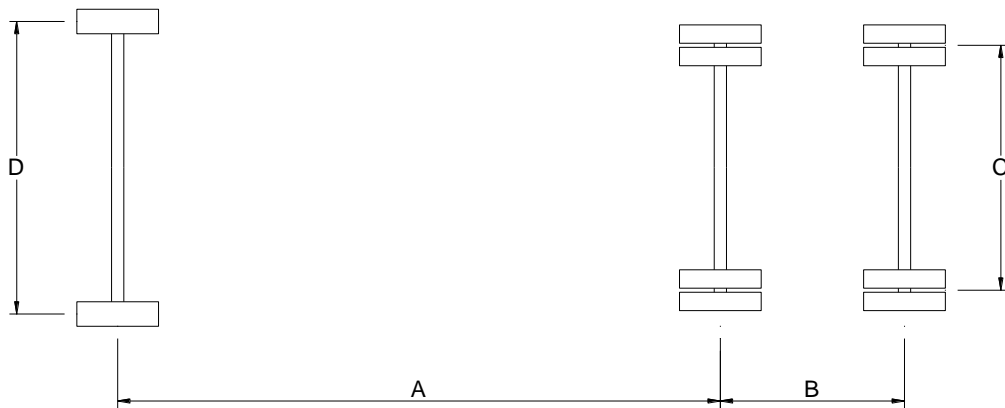
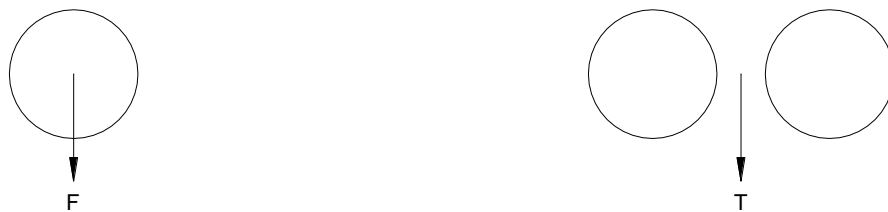
a. Truck 28

b. Truck 13 (same as Truck 12)

c. Top view

d. Side view

Year	Truck	Dimensions				Load (lbs)		
		A	B	C	D	F	T	Gross
2009	28	14'-9"	4'-6"	6'-0"	7'-2"	18,800	38,140	56,940
	13	15'-2"	4'-5"	6'-0"	7'-2"	17,600	37,820	55,420
2010	28	14'-9"	4'-6"	6'-0"	7'-2"	17,000	39,340	56,380
	12	15'-2"	4'-5"	6'-0"	7'-2"	17,540	41,000	58,540

Figure 3.4. Dimensions and weights of test trucks used in 2009 and 2010 bridge field tests

The dimensions and weights of the test trucks used each year are presented in Figure 3.4. Truck 28 was used both years and was the truck used in the single truck load cases (LC1-LC5). Based on total weight, the weight of the truck was approximately the same each year; however, there was some difference in the axle weight distribution.

In 2009, Truck 13 was the second truck on the bridge in LC6 and LC7, while, in 2010, Truck 12 was used with Truck 28 in the two truck load tests (LC7). As Figure 3.4 shows, Truck 12's weight (used in the 2010 test) was about 3,000 lbs greater than Truck 13 (used in the 2009 test); however, the axle spacing in the two trucks is the same. An image of the two trucks on the bridge during LC7 in 2010 is shown in Figure 3.5.

Considering the slight difference in the truck weights between 2009 and 2010 (Figure 3.4) and the variation in the transverse distribution of the gravel in the trucks used in the 16 different tests (eight in 2009 and eight in 2010), there is very good agreement in the magnitudes of strains measured each year, as well as their distribution in the seven box beams.

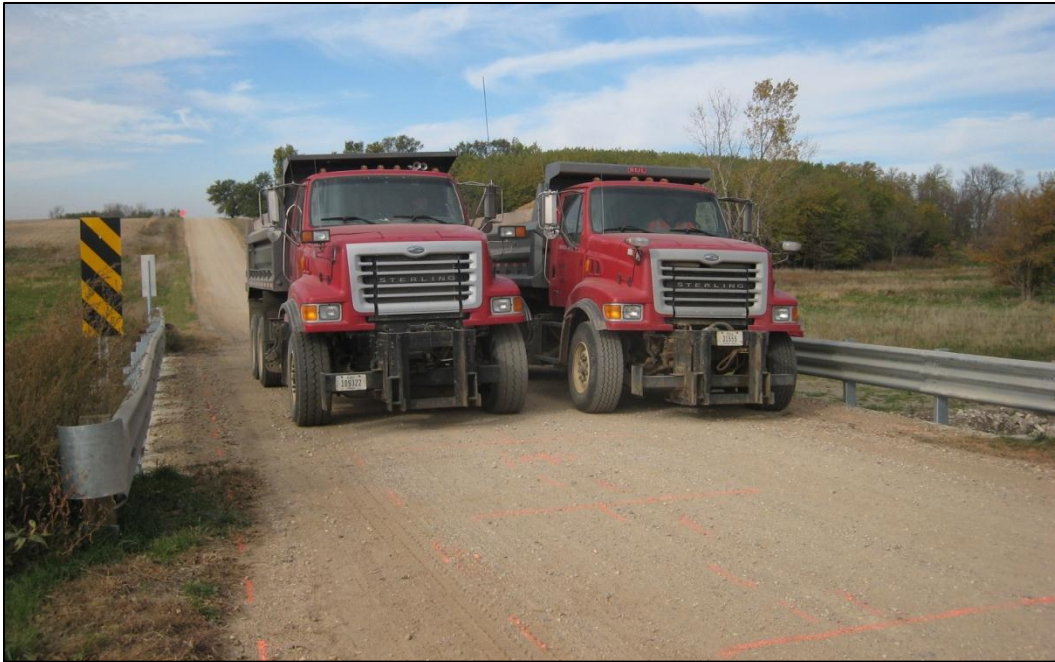
**Figure 3.5. Trucks on bridge during 2010 LC7 test**
