# Evaluation of the Buena Vista IBRD Bridge: A Furthering of Accelerated Bridge Construction in Iowa

**Final Report**  
**February 2012**

**Sponsored by**  
Iowa Highway Research Board  
(IHRB Project TR-605)  
Iowa Department of Transportation  
(InTrans Project 08-342)

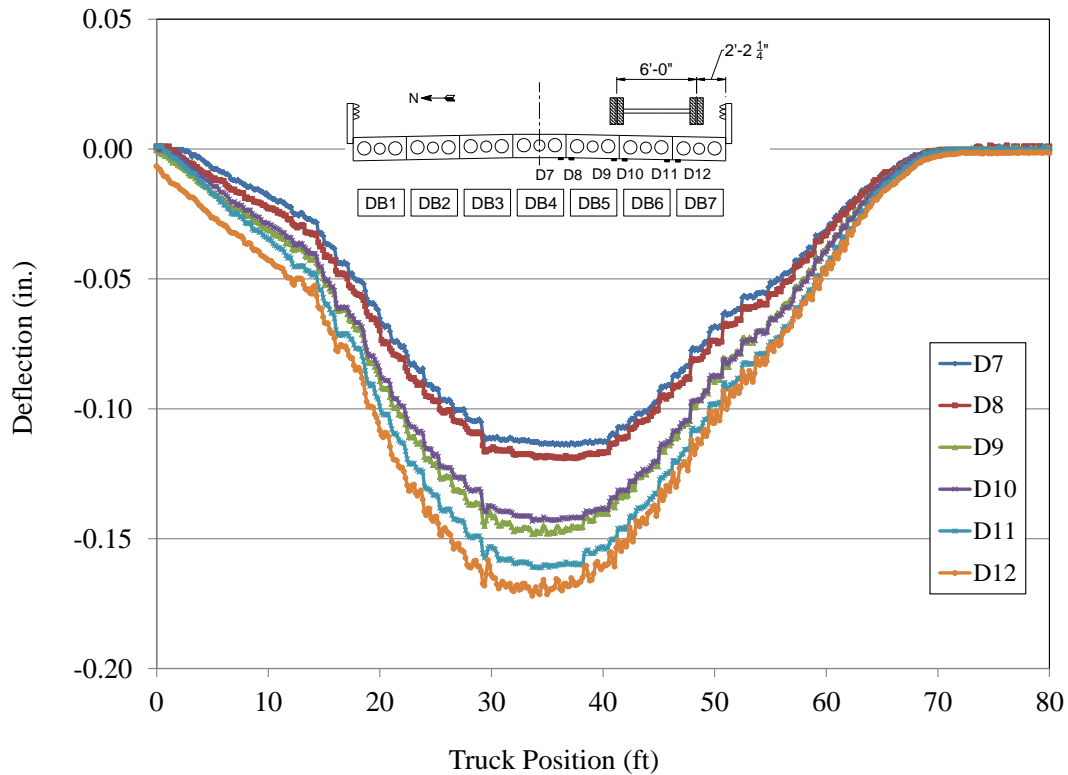
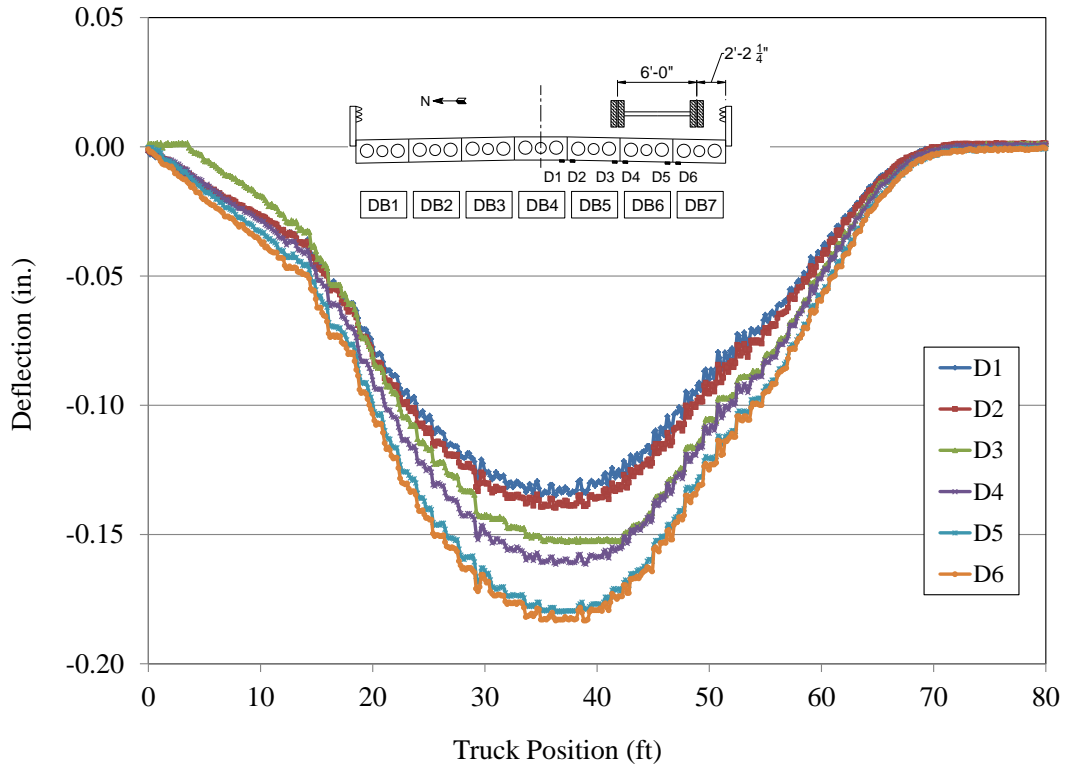
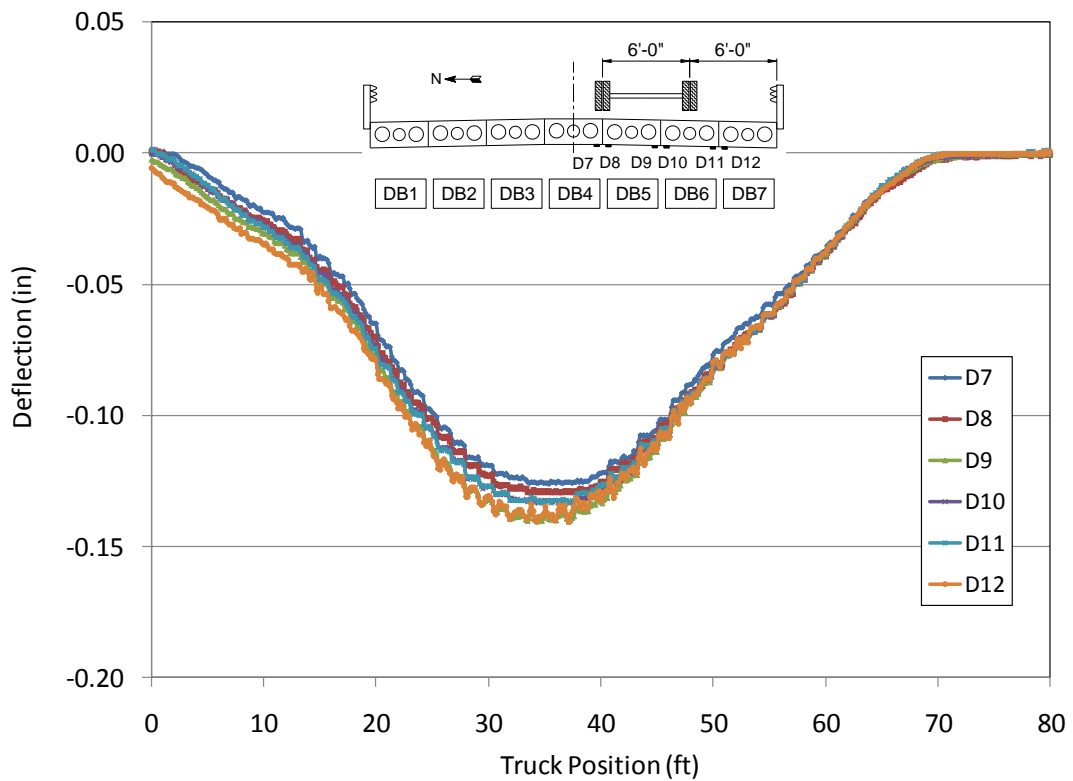
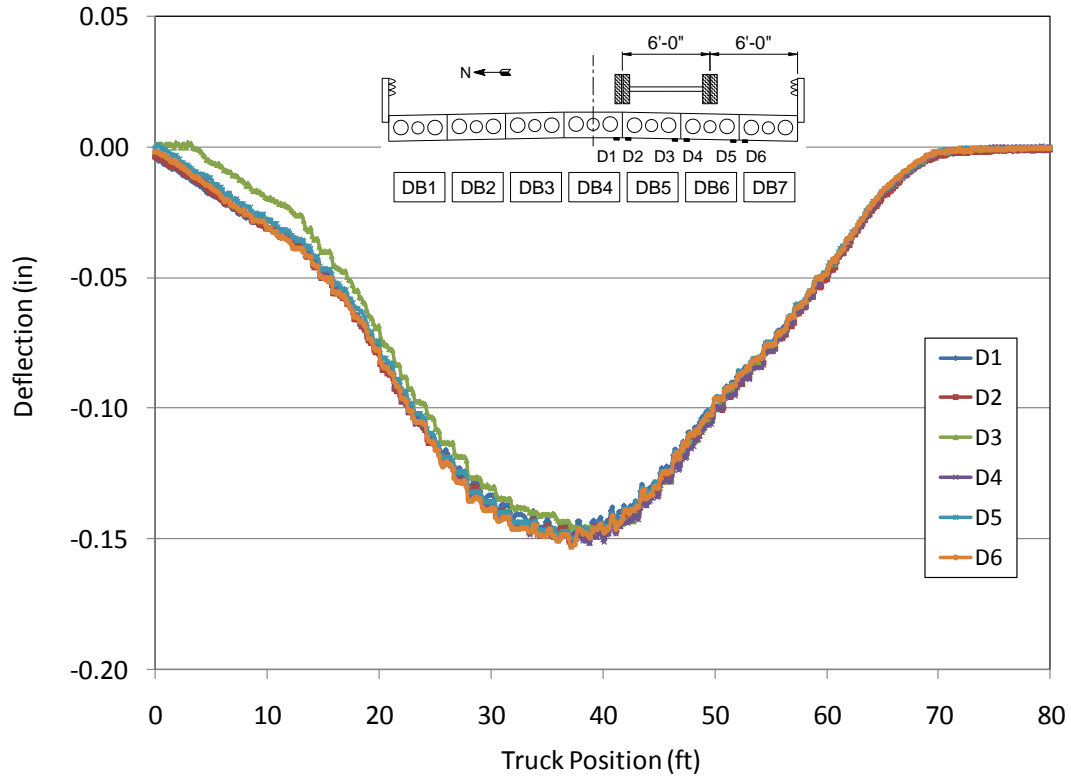
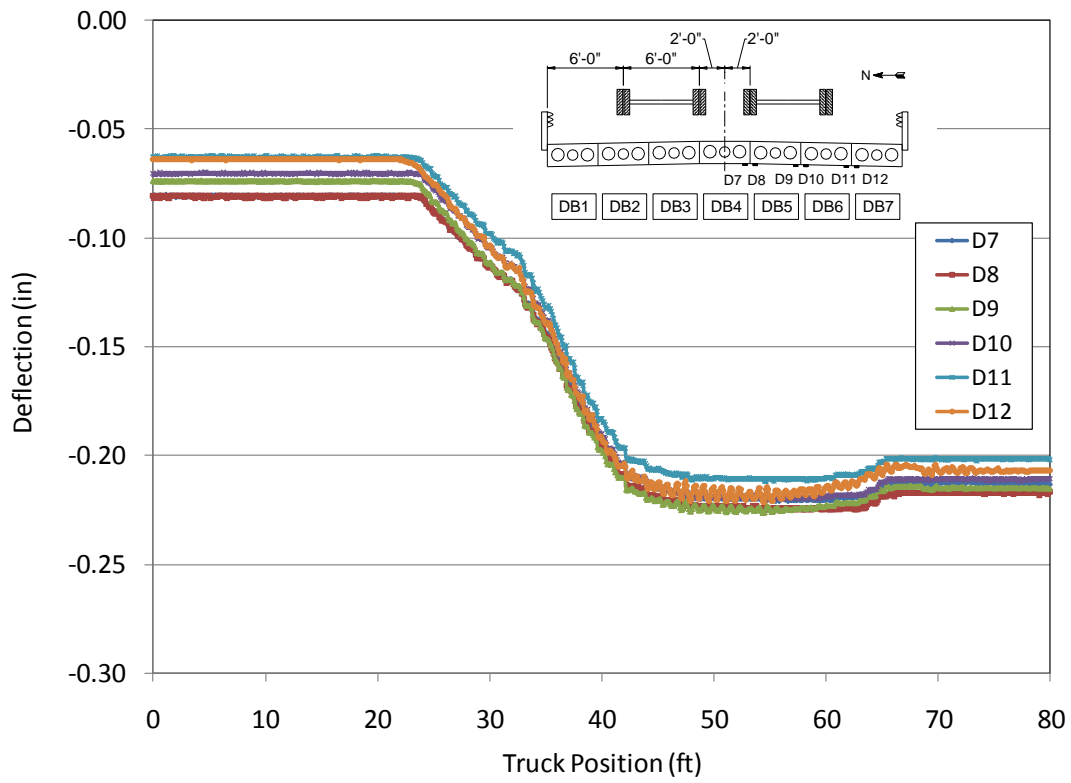
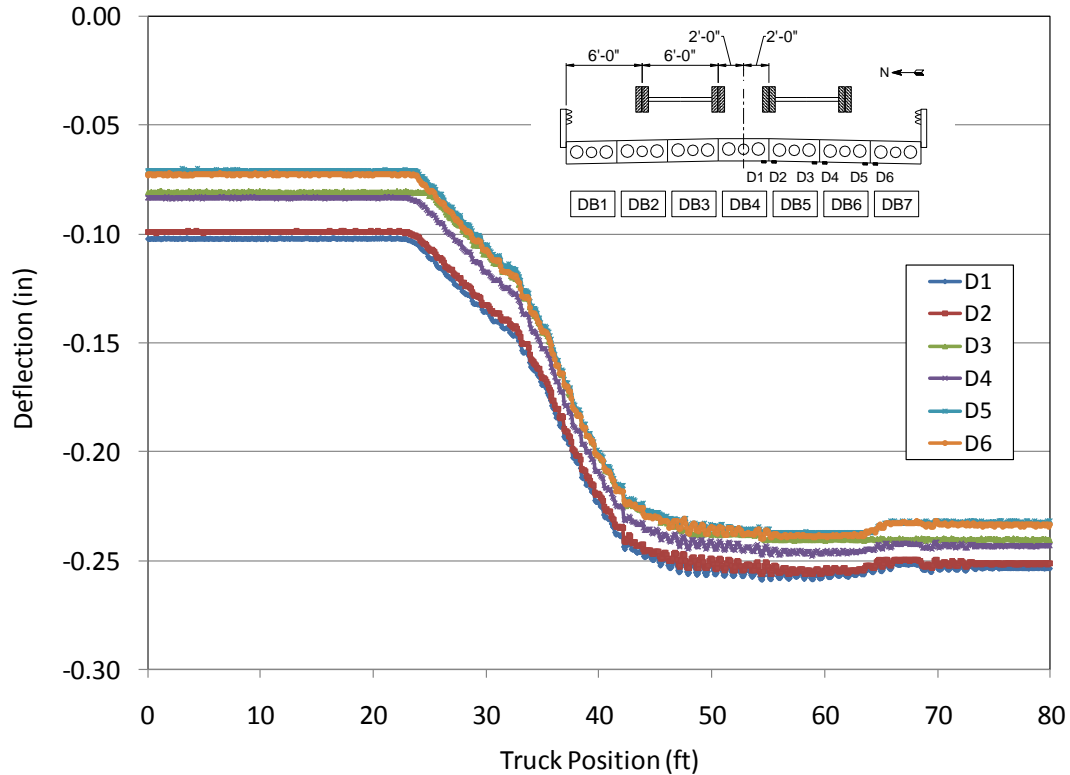
The various time history plots show deflections at midspan and quarter span at the edges of deck beams DB4, DB5, DB6, and DB7. With these data, the differential deflection between the four deck beams can be determined. A review of this deflection data indicates the differential movement between the adjacent deck beams for LC2 and LC7 is very small. In general, the deck beams that had the largest deflections were located closest to the applied load.

a. LC 1 – Quarterspan

**Figure 4.1. Representative time history – 2009 deflections**

f. LC 7 – Midspan  
**Figure 4.1. Continued**

Representative time-history deflections for 2009 LC1, LC2, and LC7 are presented in Figure 4.1.

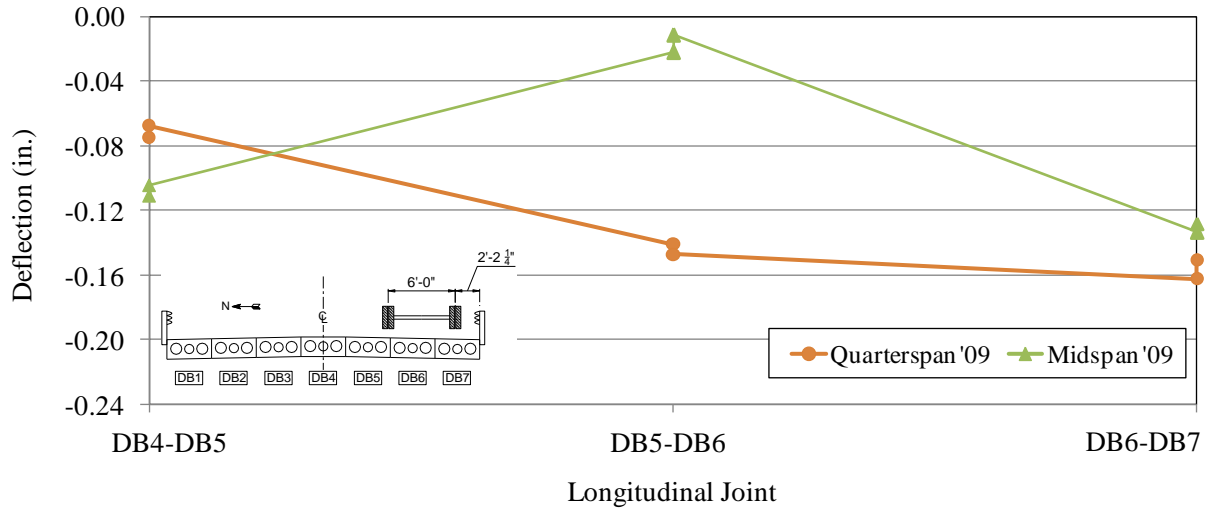
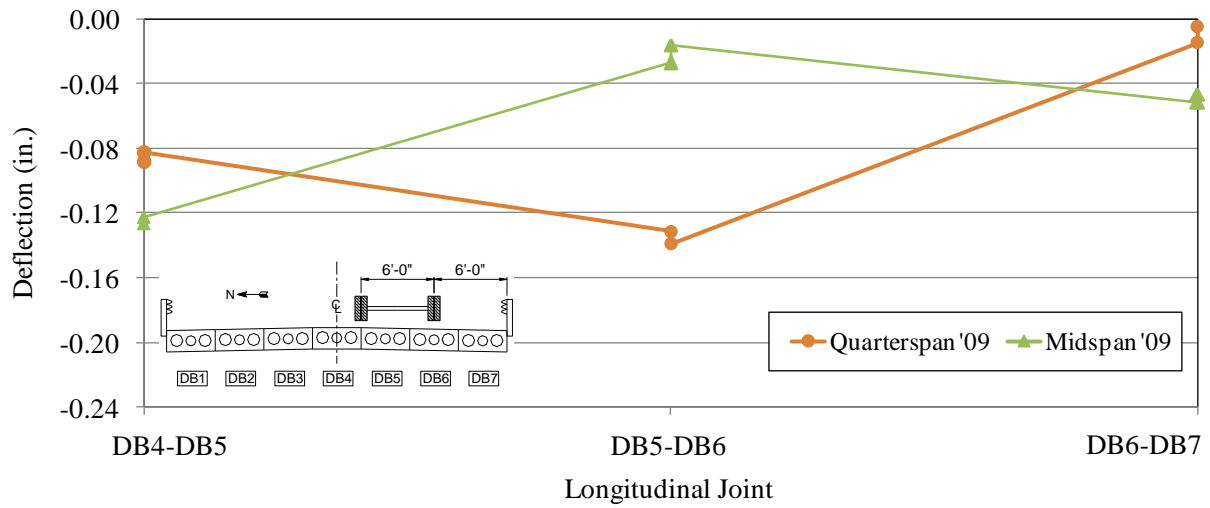
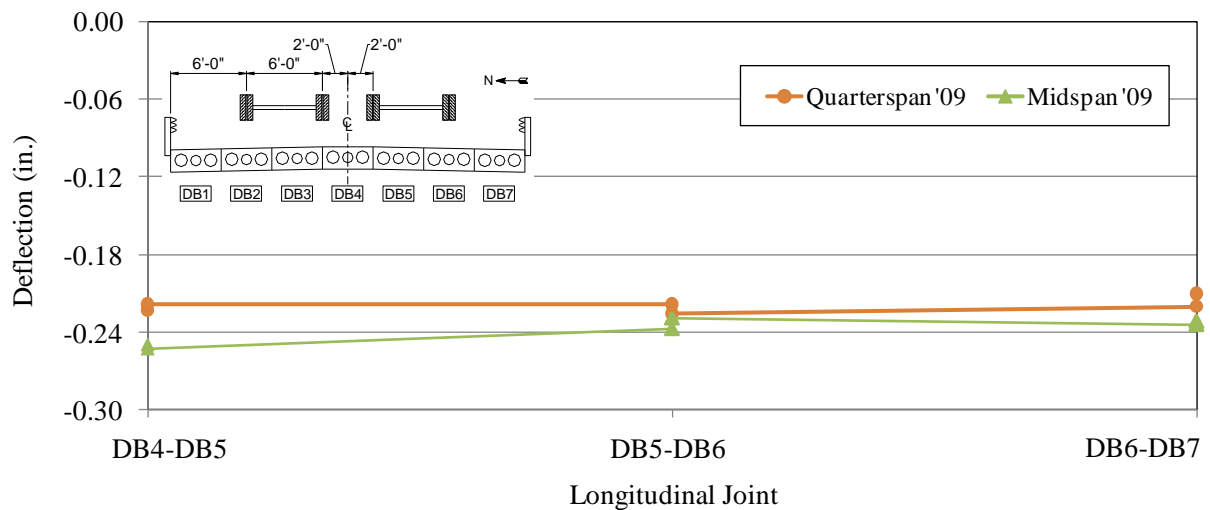
As noted previously, LC1 and LC7 produced the maximum deflections for one and two trucks, respectively. Transverse load distribution is evident as shown in this figure, as the deck beams adjacent to directly-loaded deck beams also deflect, creating a continuous deflected shape. Although not the actual behavior, for illustration, the various deflection points have been connected with straight lines.

a. LC1

b. LC2

c. LC7

Figure 4.2. 2009 Transverse deflected shape at midspan and quarterspan

Partial (since displacements were only measured on one-half of the bridge) transverse deflections for the same three load cases (LC1, LC2, and LC7) are presented in Figure 4.2.

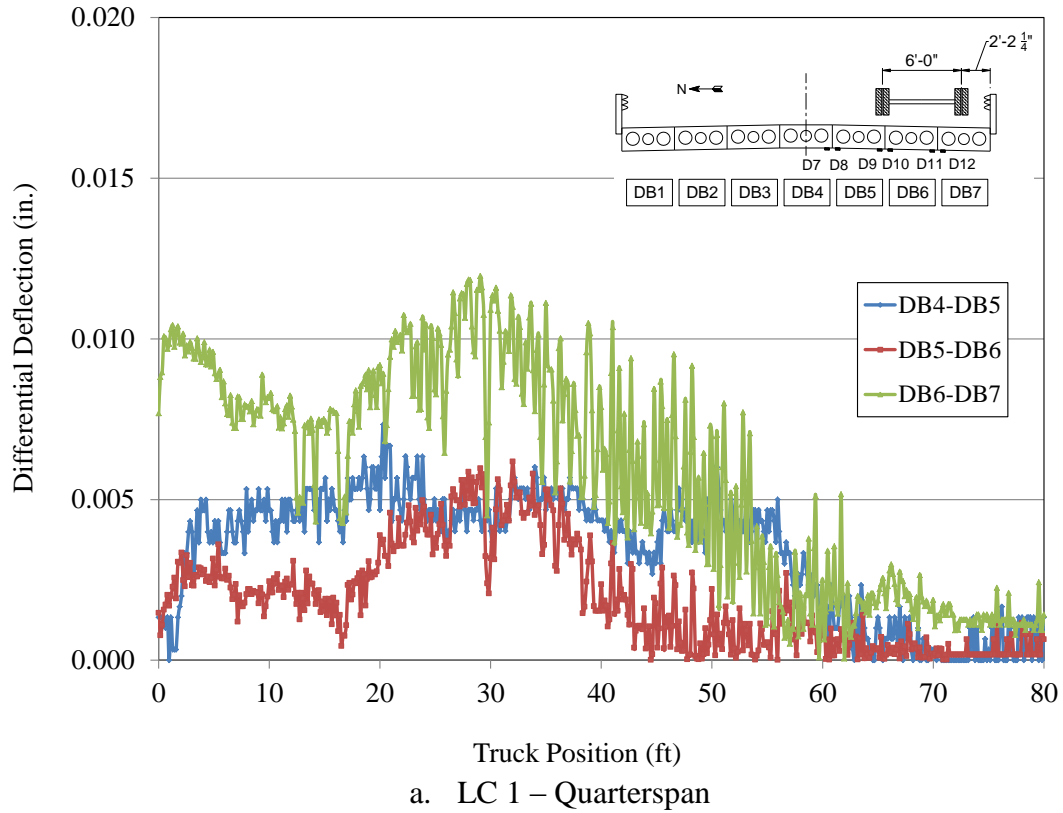
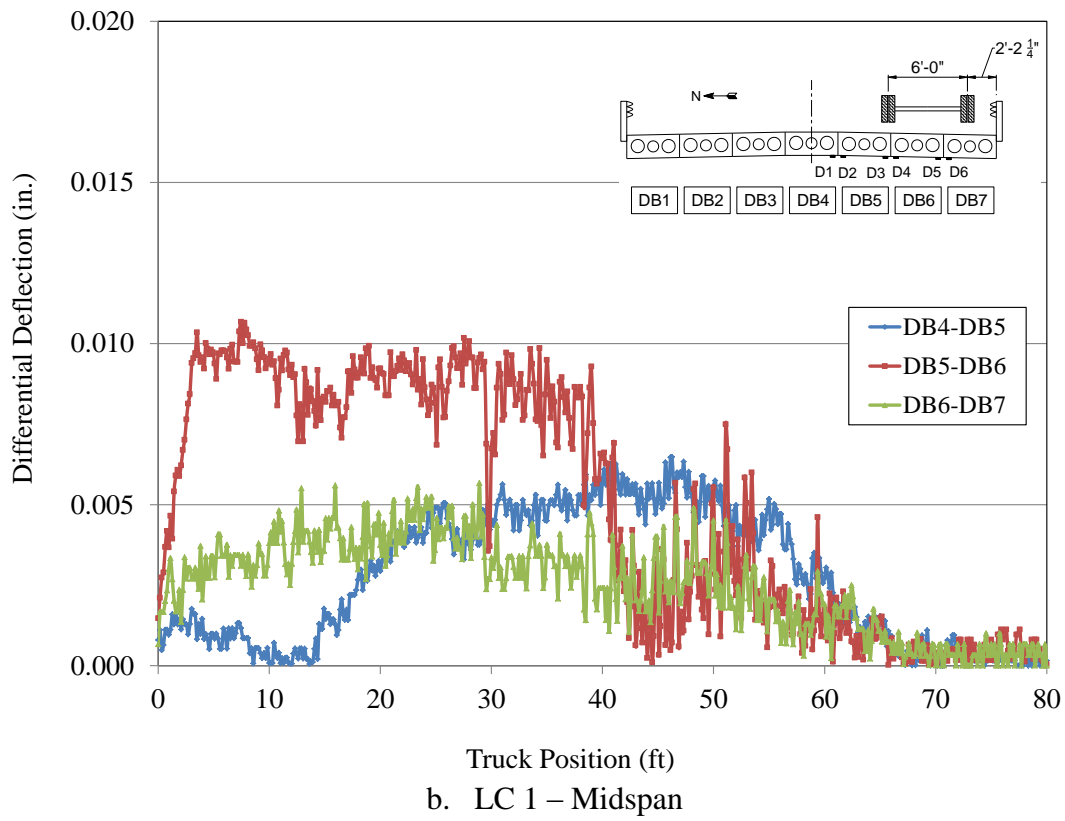
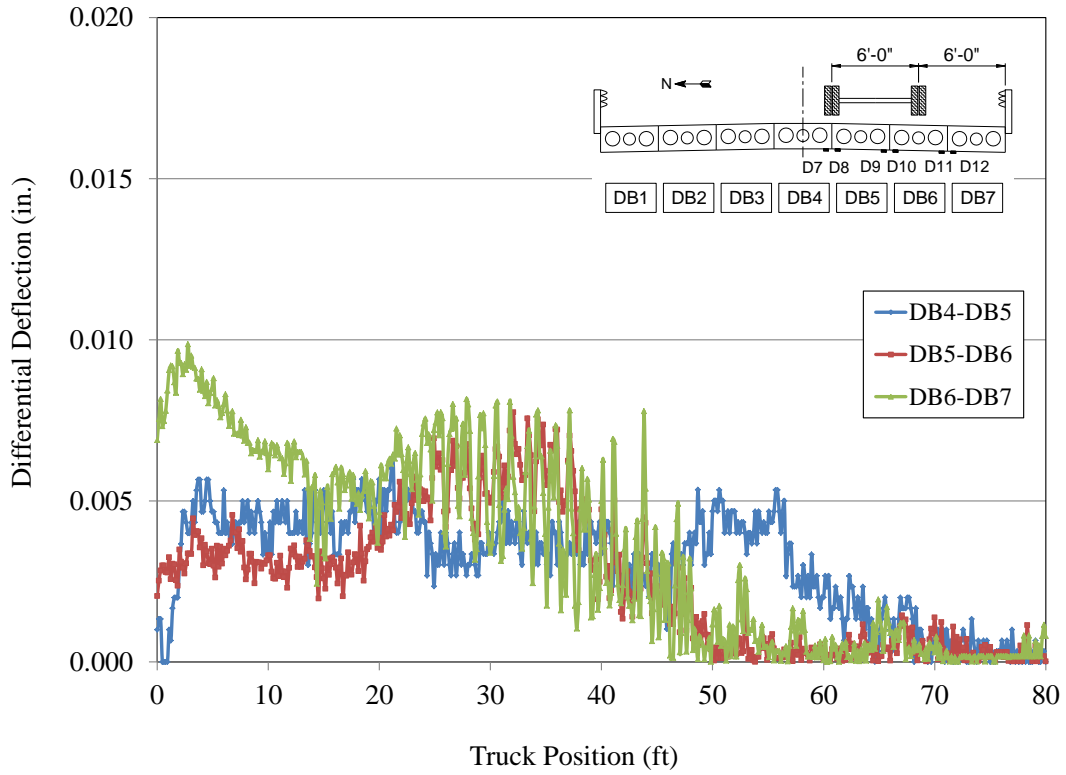
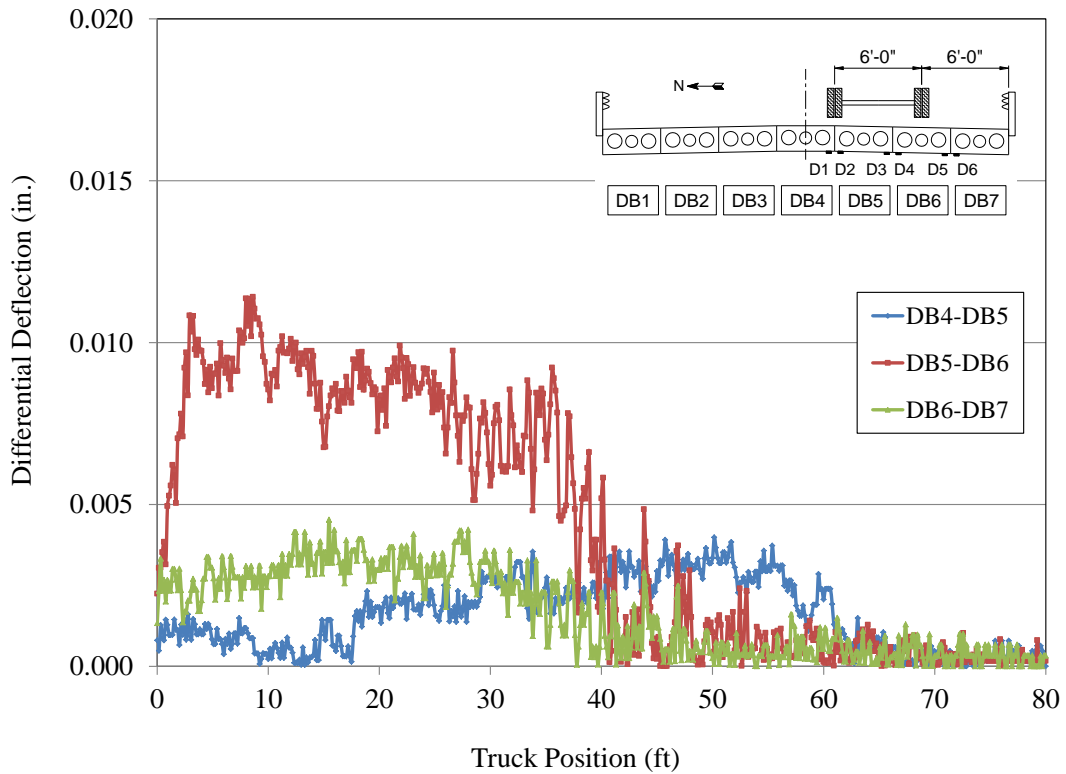
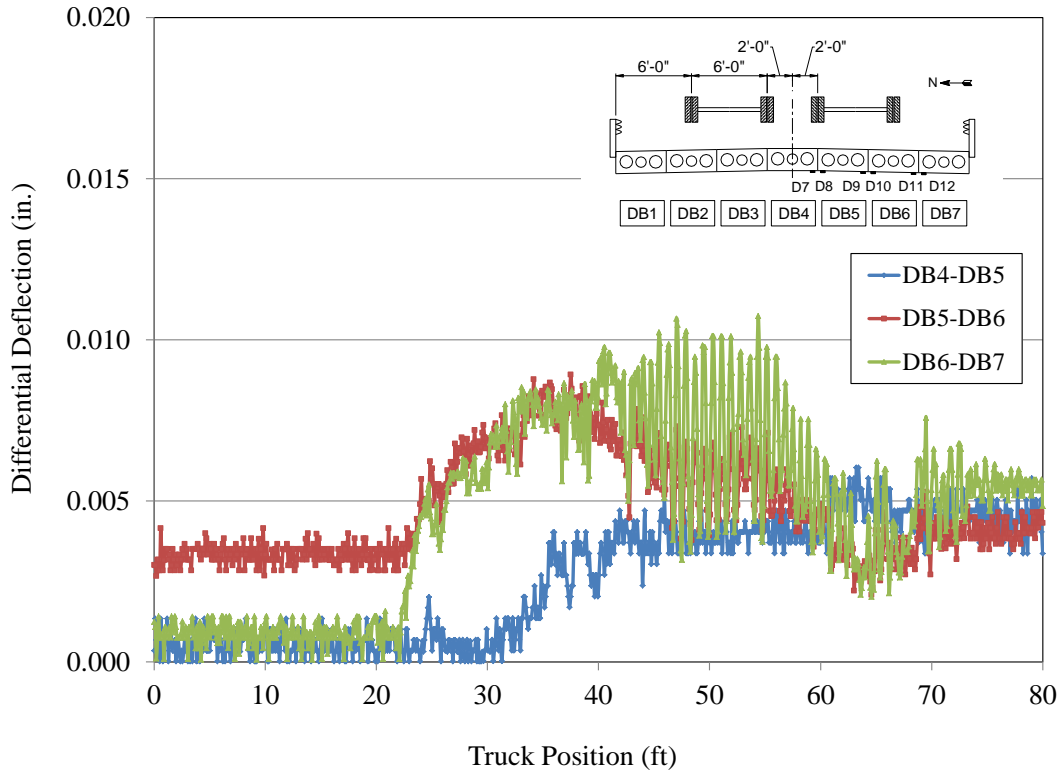
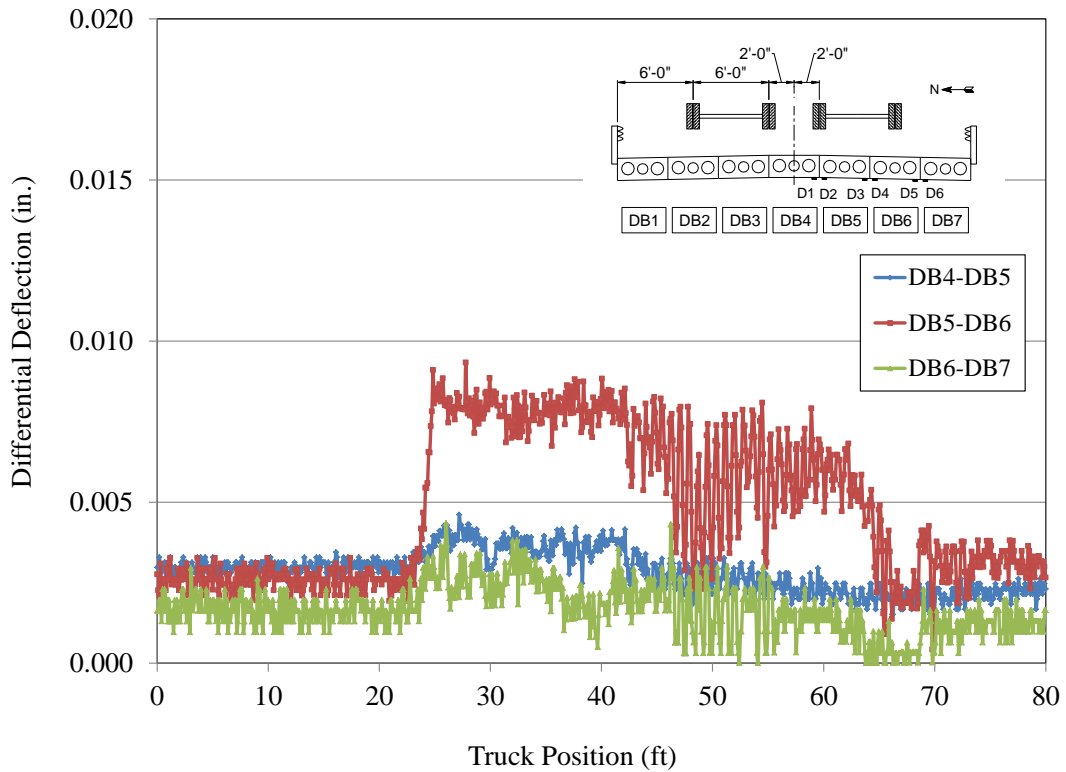
Differential movements that occurred during the 2009 load tests for LC1, LC2, and LC7 (representative load cases), at the quarterspan and the midspan are presented in Figure 4.3. Maximum values shown in these figures are presented in Table 4.2.

**Figure 4.3. Representative time history differentials**

c. LC 2 – Quarterspan

d. LC 2 – Midspan

e. LC7 – Quarterspan

f. LC7 – Midspan

Figures 4.3 and 4.4 are included to show how the differential movement between DB4 and DB5, DB5 and DB6, and DB6 and DB7 varied as the test vehicle crossed the bridge.

In 2010, the transducer (shown in Figure 3.2), which measures differential displacements between adjacent units, was used to determine differential displacements directly. When reviewing the data in Figure 4.3, note that two different vertical scales were used.

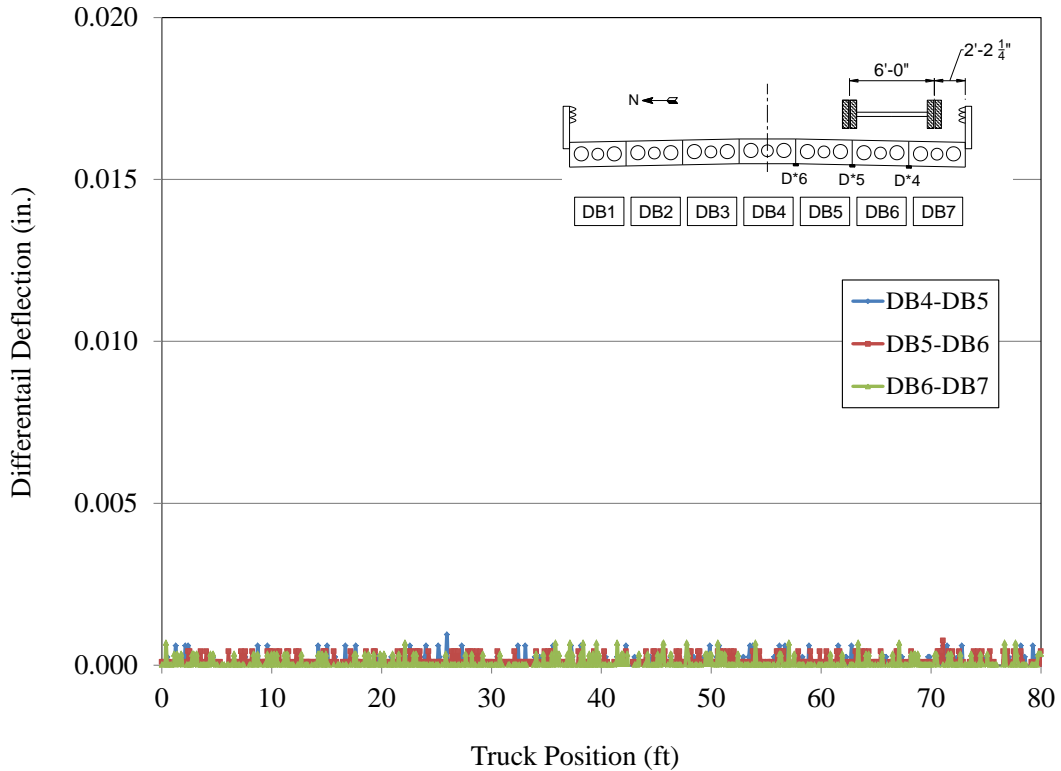
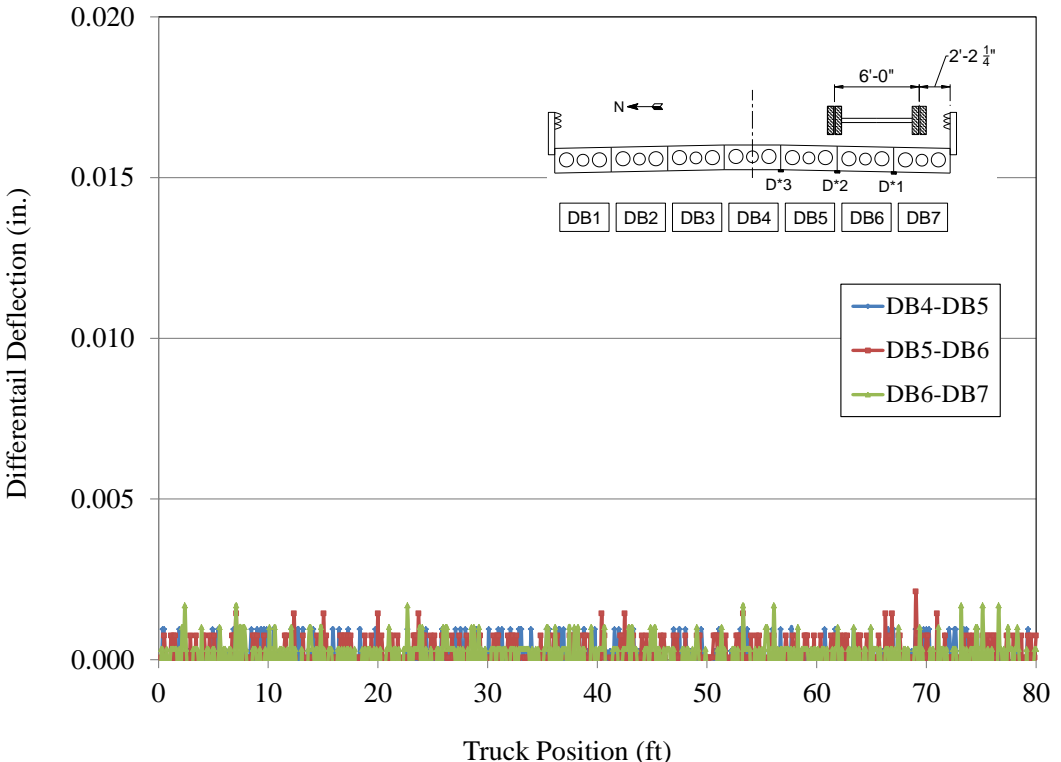
As was noted previously, the differential movements measured during the bridge test in 2010 were very small (approximately 1/10 the values measured during the 2009 tests. For this reason, only the 2010 differential movements measured during one load case, LC1, are presented in this report (see Figure 4.4).

a. LC 1 – Quarterspan

b. LC 1 – Midspan

**Figure 4.4. Representative time history – 2010 differentials**

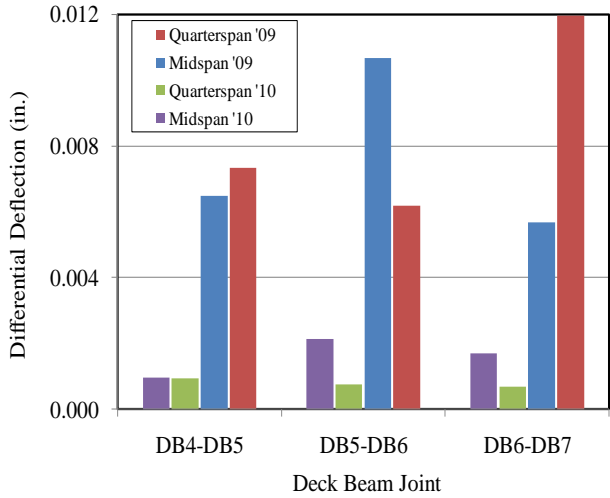
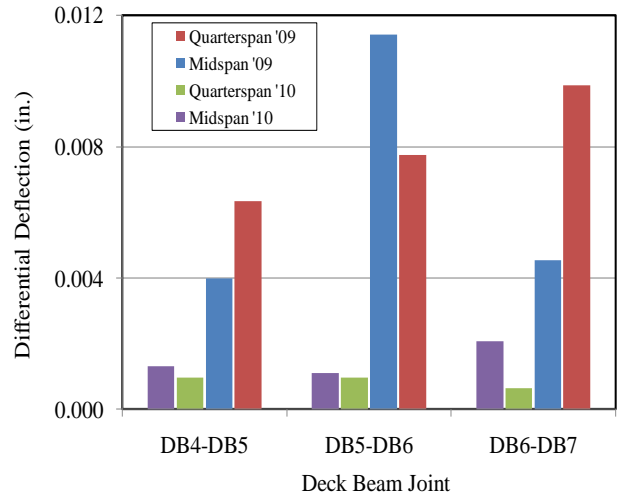
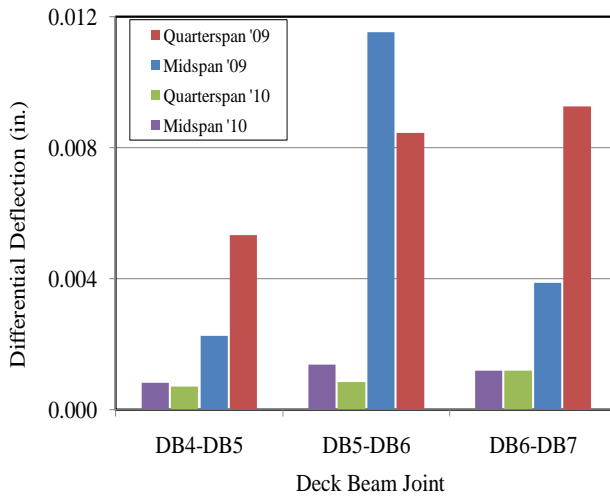
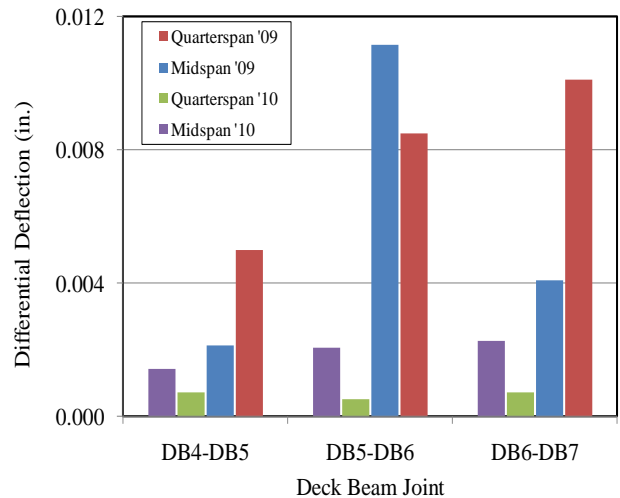
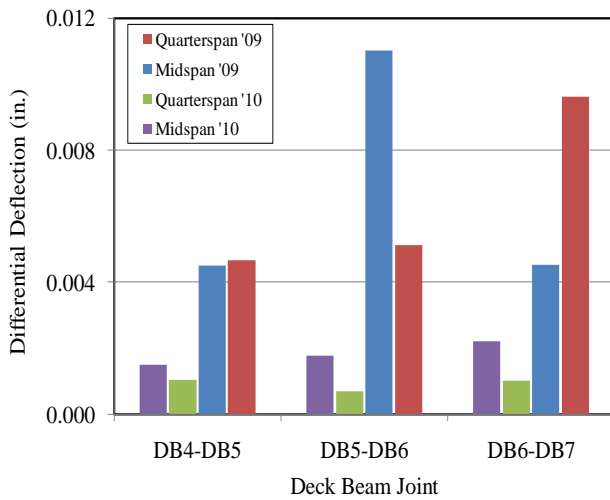
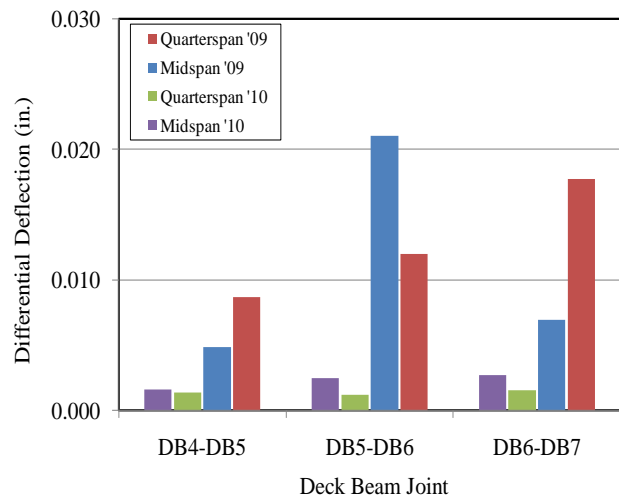
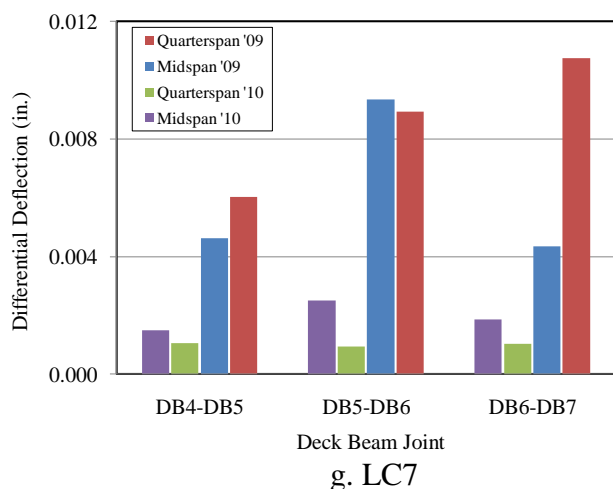
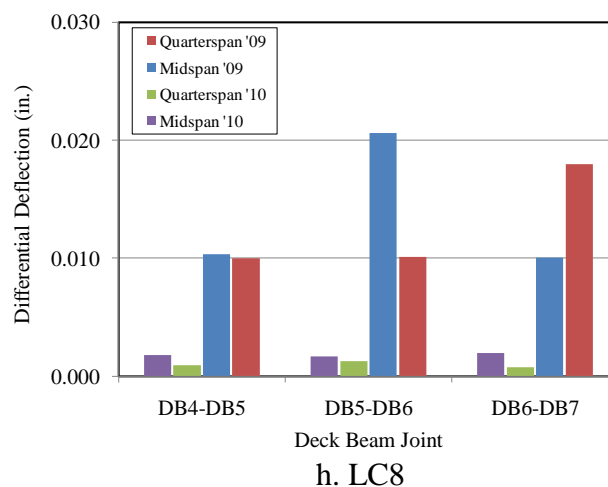
Figure 4.5 presents the absolute maximum differential deflections at midspan and quarterspan for each of the 2009 and 2010 load cases. Given the differential deflections were so small and the variation in truck weights from year to year were also small, direct comparison of differential displacements were made without normalizing for the truck weight differences.

Figure 4.5. 2009 and 2010 Differential deflections

In 2009 global bridge displacements were measured on each side of the joints between DB4 and 5, DB5 and 6, and DB6 and 7; these values were then used to determine the differential values.

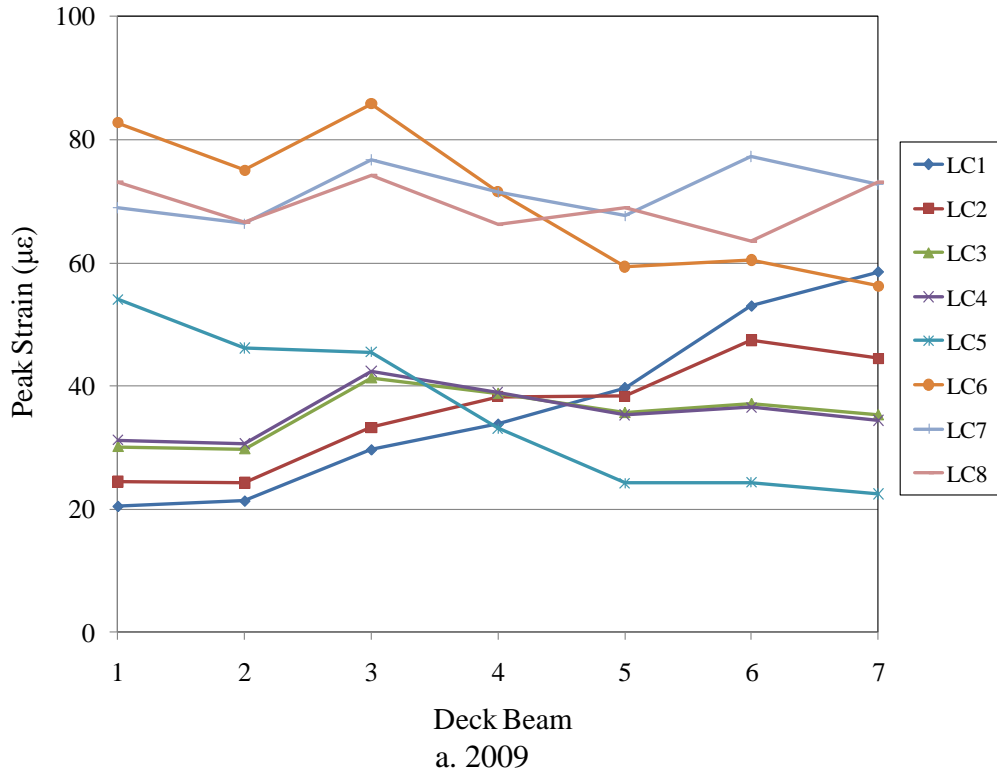
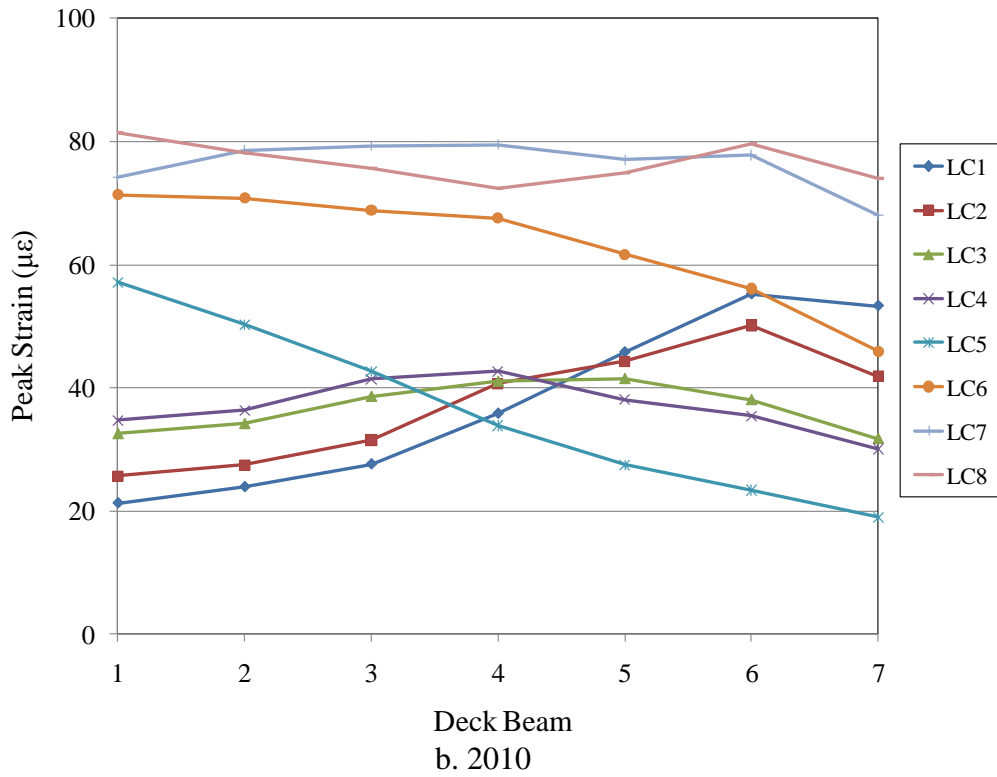
Distributions of midspan box beam strains measured in the seven box beams for each of the eight load cases completed in 2009 and 2010 are shown in Figure 4.6.

**Figure 4.6. Midspan strains for various load cases**

Considering the slight difference in the truck weights between 2009 and 2010 (Figure 3.4) and the variation in the transverse distribution of the gravel in the trucks used in the 16 different tests (eight in 2009 and eight in 2010), there is very good agreement in the magnitudes of strains measured each year, as well as their distribution in the seven box beams.

A review of the strains measured in 2009 indicates that, more than likely, there was a problem with the BDI or its installation on DB3 and DB5. Maximum values observed in this figure were tabulated and shown previously in Tables 4.4 and 4.5 (2009 and 2010 test data, respectively).

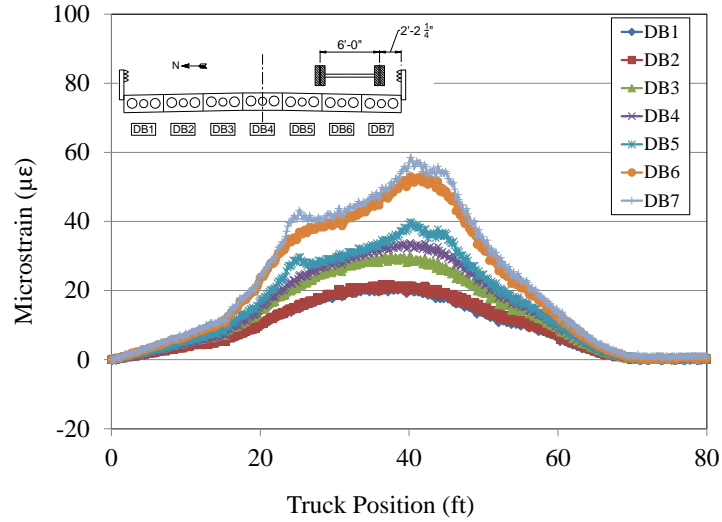
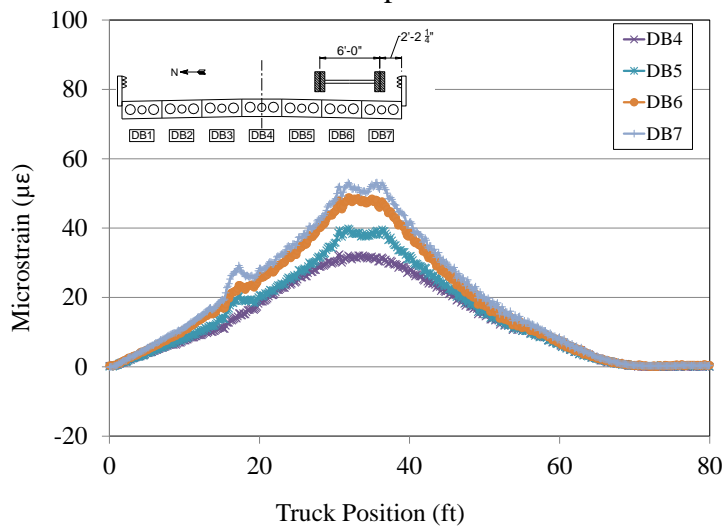
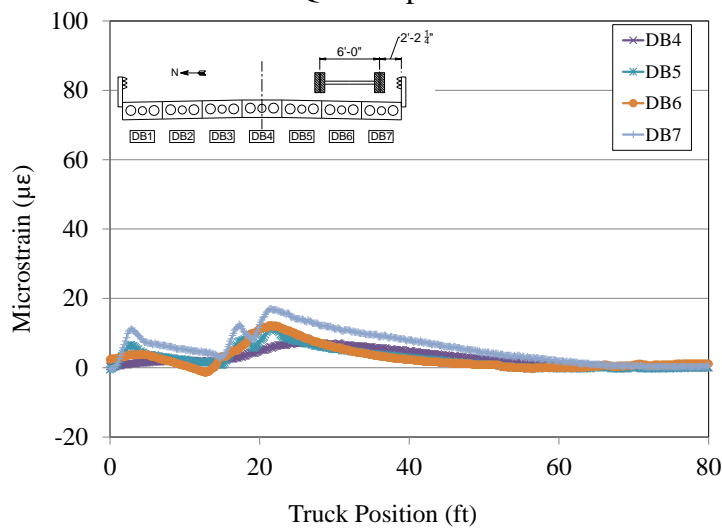
Distribution of box beam strains for a representative load case, LC1, as the test vehicle crosses the bridge are presented in Figures 4.7 and 4.8 for the 2009 and 2010 tests, respectively. In 2009, three sections were instrumented: midspan (Figure 4.7a), quarterspan (Figure 4.7b), and near the bridge end (1 ft 6 in. from the face of the abutment in Figure 4.7c).

**Figure 4.7. 2009 Experimental strains for LC1**

A review of the strains in the box beams instrumented (DB4, DB5, DB6, and DB7) – small tensile strains – indicated minimal end restraint. It is interesting to note that the magnitude of strains measured each year were essentially the same although maximum values in 2010 occurred when the truck's front axle was approximately 10 ft farther from the end of the bridge.

Similar results were seen at midspan (Figures 4.7a and 4.8a), with essentially the same magnitude of strain occurring in 2009 and 2010; however, the maximum strain in 2010 occurred when the truck was approximately 10 ft farther from the end of the bridge. The only possible explanation the researchers have for this behavior is there may have been an error in determining the location of the truck on the bridge in 2009 or 2010.

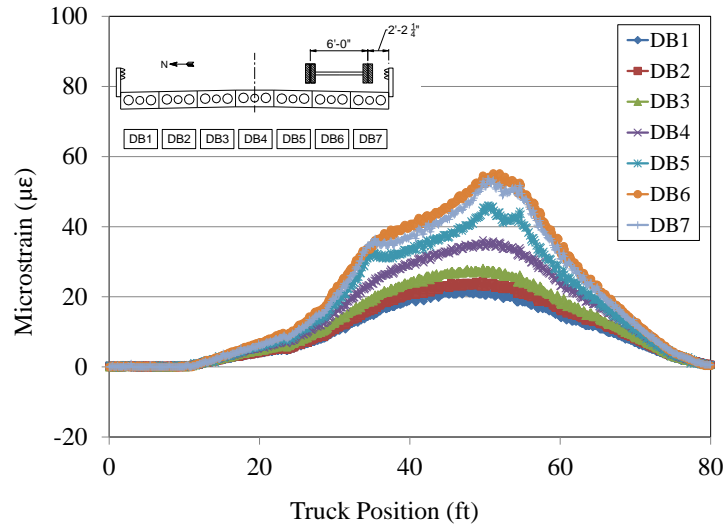
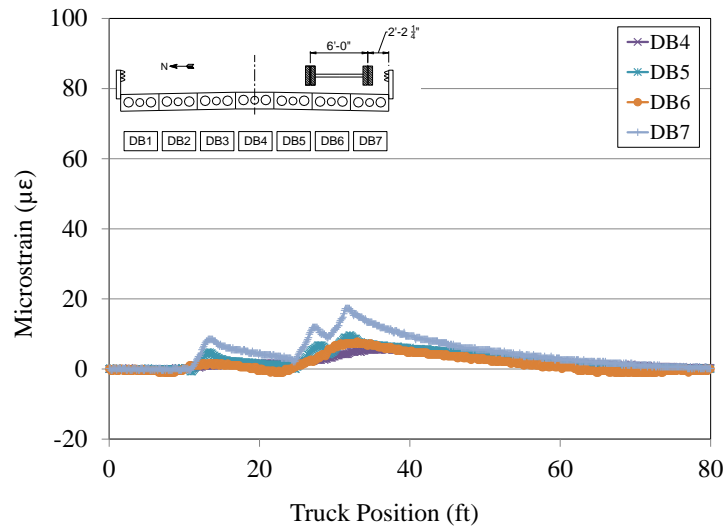
In 2010, two sections were instrumented: midspan (Figure 4.8a) and near the end (as in 2009, 1 ft 6 in. from the face of the abutment in Figure 4.8b). The end span sections were instrumented to determine if there was significant end restraint due to construction details.

a. Midspan strain

b. Strain 1 ft 6 in. from face of abutment

**Figure 4.8. 2010 Experimental strains for LC1**

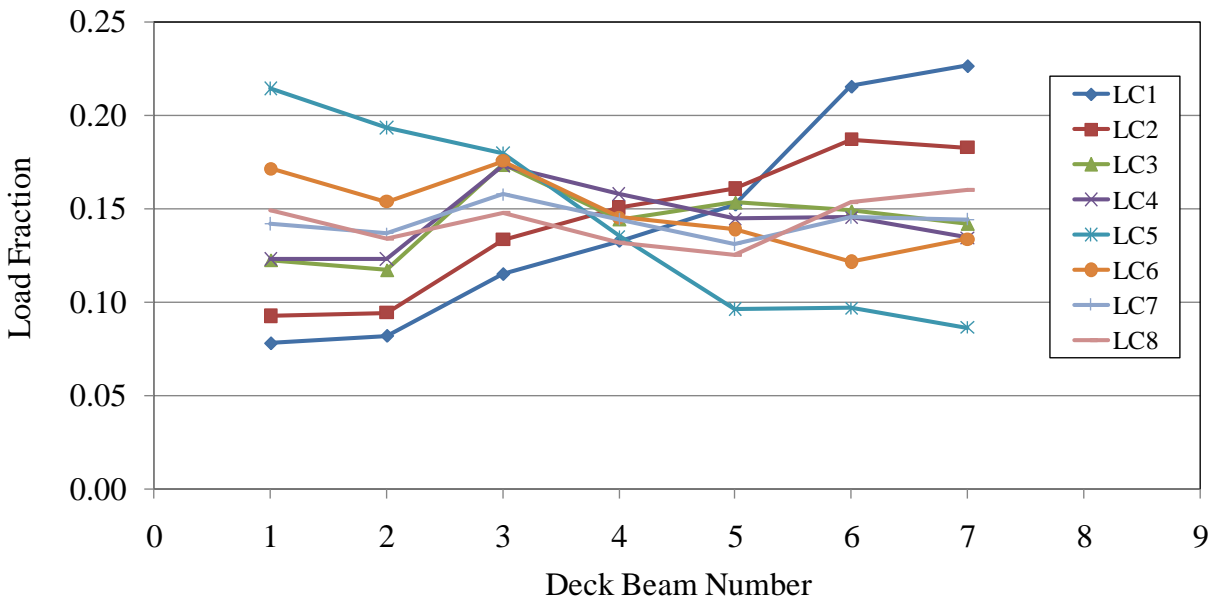
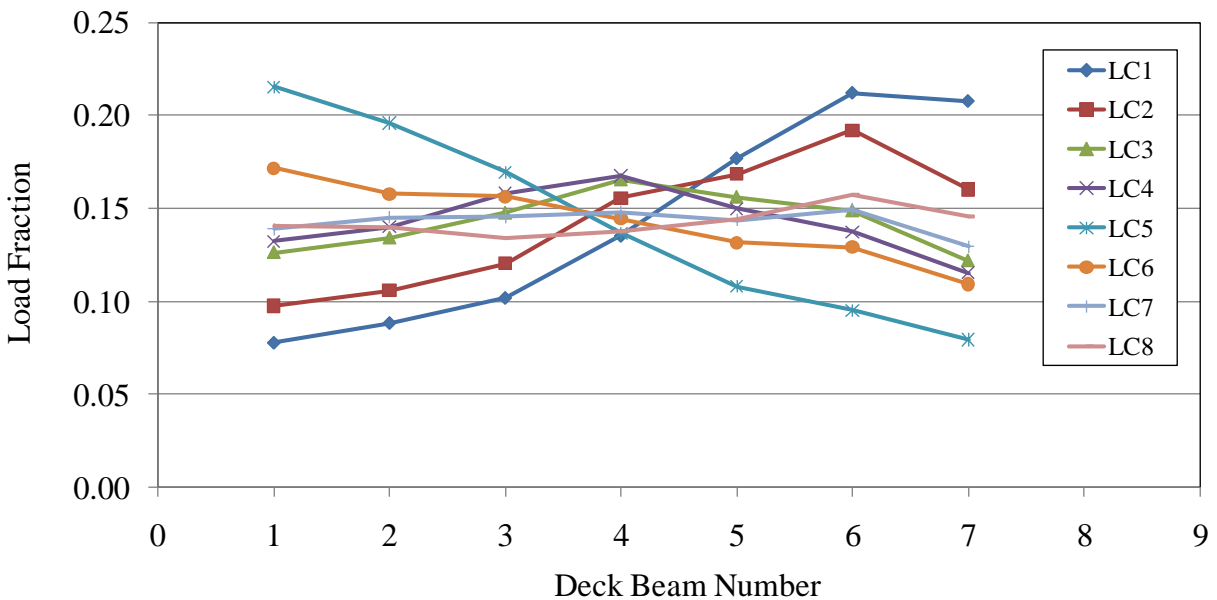
The load fractions determined for the 2009 and 2010 tests are shown in Figure 4.9.

a. 2009 Midspan load fraction for eight load cases

b. 2010 Midspan load fraction for eight load cases

**Figure 4.9. Experimentally-determined load fractions**
