# Evaluation of the Buena Vista IBRD Bridge: A Furthering of Accelerated Bridge Construction in Iowa

**Final Report**  
**February 2012**

**Sponsored by**  
Iowa Highway Research Board  
(IHRB Project TR-605)  
Iowa Department of Transportation  
(InTrans Project 08-342)

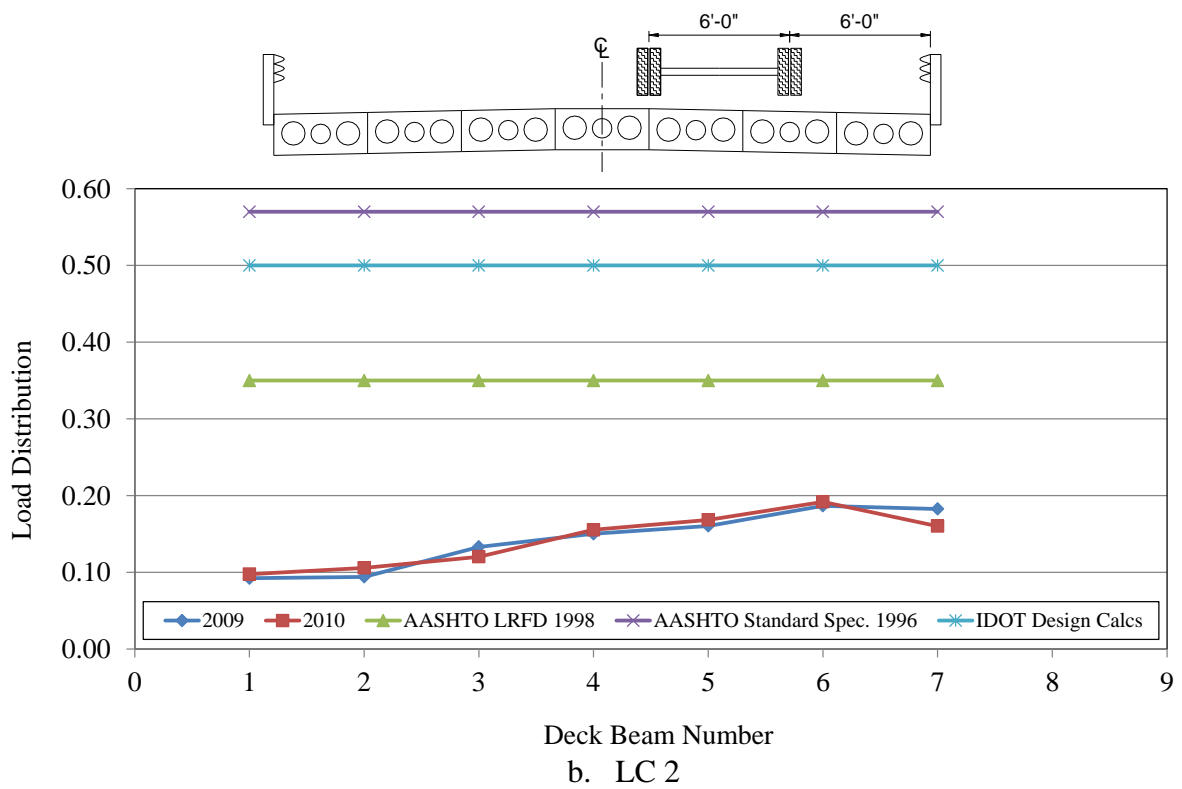
Figure 4.10. Experimental and codified load distributions for one truck on bridge

Representative load fraction determined for one truck on the bridge for LC1, LC2, and LC5 are compared to code values, and the values used by the Iowa DOT in their design calculations in Figure 4.10. As shown, the values determined using experimental data are significantly smaller than the code and design calculation values.

As shown in Figure 4.10, there is excellent agreement between the distribution results obtained in 2009 and 2010 for the three load cases in the figure. Although the results for the other load cases have not been included in this report, there was excellent agreement between values from the two years.

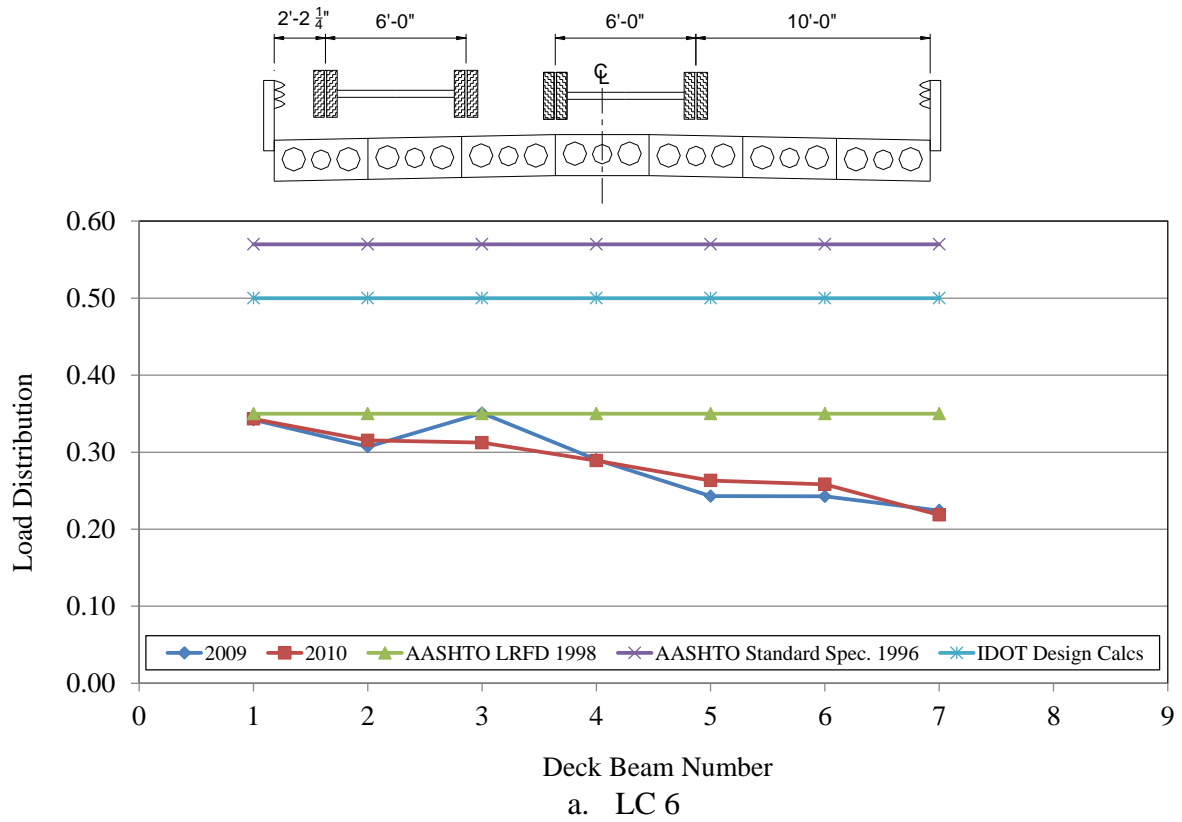
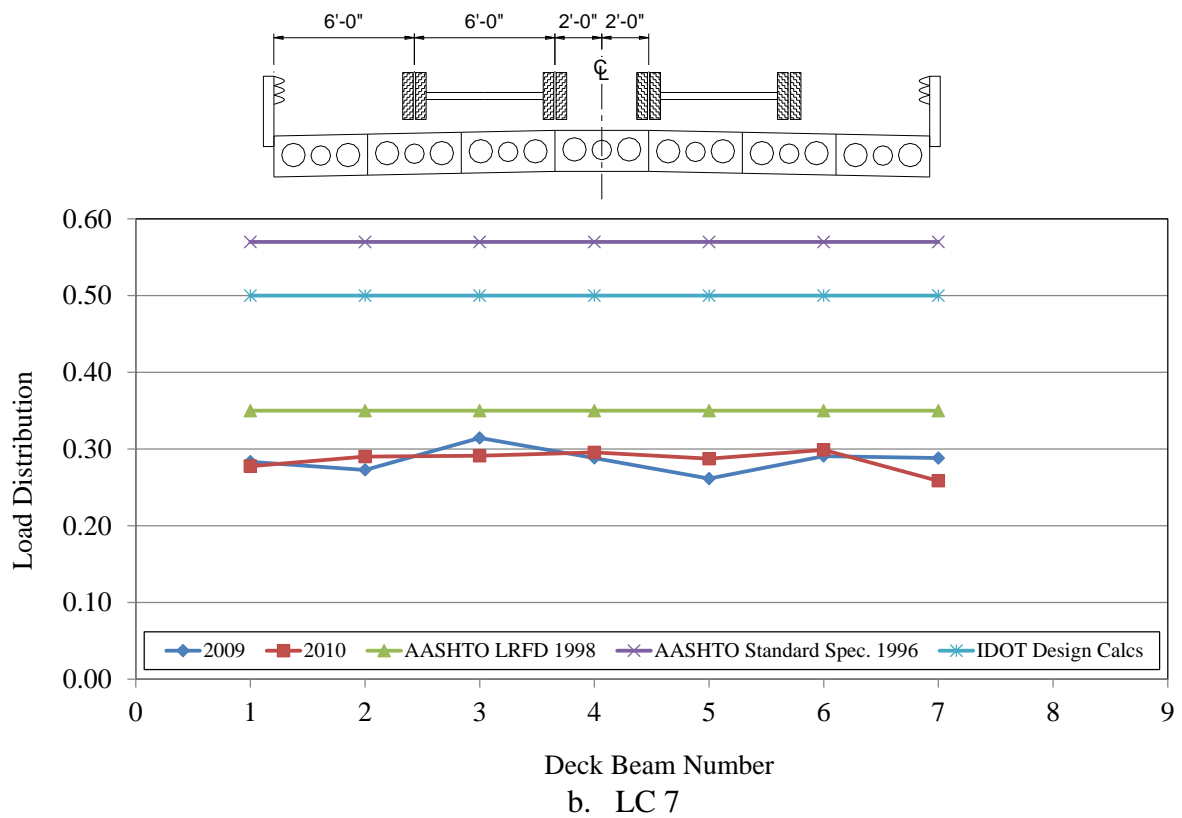
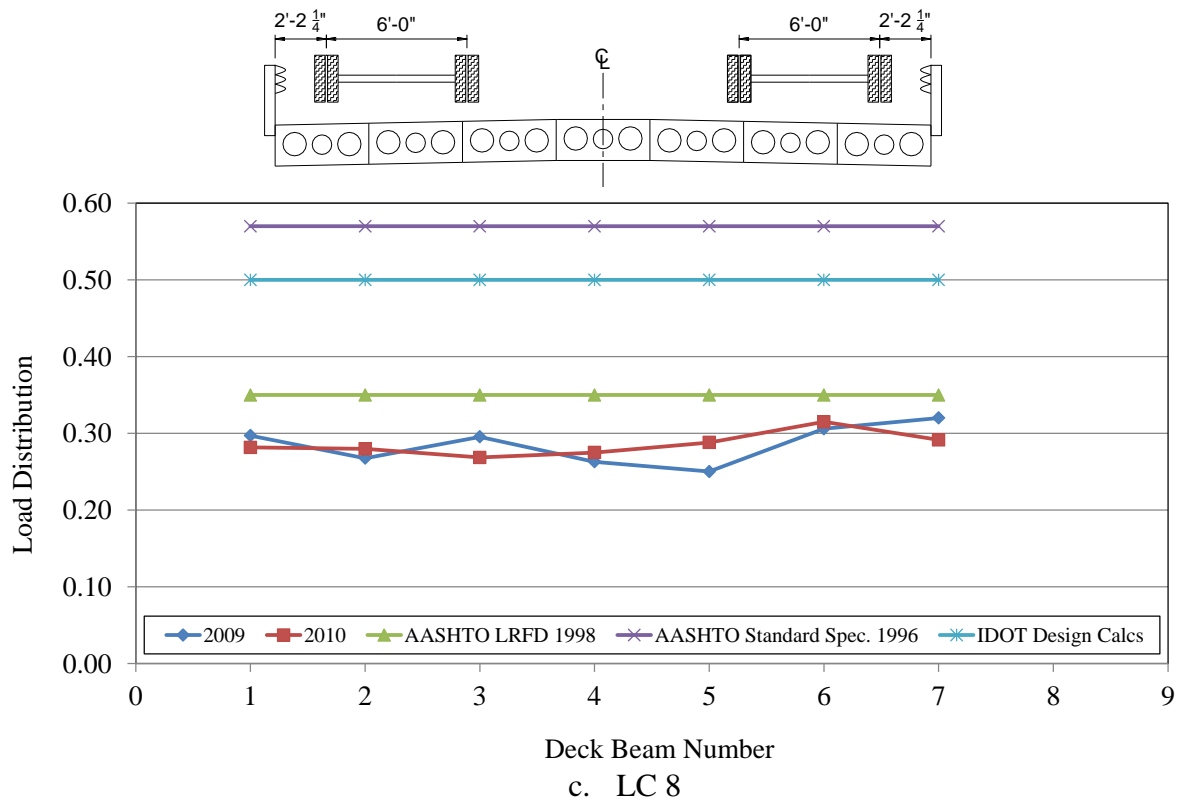
Figure 4.11. Experimental and codified load distribution for lane loading

To obtain an approximation of lane load distribution, data from two trucks on the bridge were used. In 2009, this involved LC6 and LC7. Data for LC8 (shown in Figure 3.3) was obtained by adding the results from LC1 and LC5. In 2010, only LC7 was actually completed in the field. Results for LC6 and LC8 were obtained by adding the results for having one truck on the bridge ( $LC6 = LC3 + LC5$ ;  $LC8 = LC1 + LC5$ ). Load fraction for these three combination load cases are shown in Figure 4.11.

In this figure, as was the case in Figure 4.10, the experimental values obtained in 2009 and 2010, which are essentially the same, are compared to the design values used by the Iowa DOT, code distribution factors from the 1998 AASHTO LRFD, and code distribution factors from the 1996 AASHTO standard specifications.

A review of the three graphs in this figure (i.e., comparing the experimental values, AASHTO values, and the Iowa DOT values) show the bridge's performance is conservative.

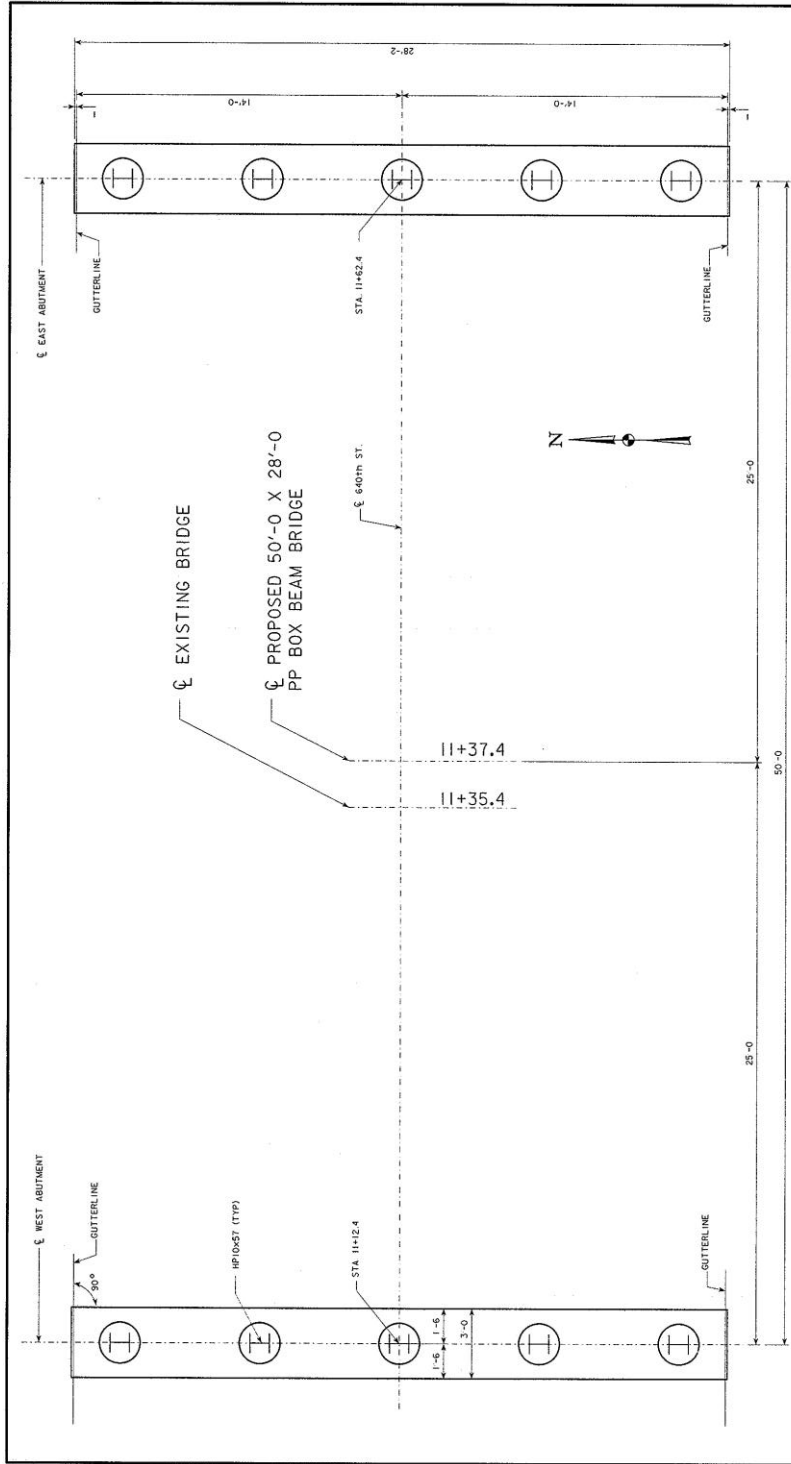
DESIGN FOR 0° SKEW  
**50'-0 X 28' PRECAST PRETENSIONED  
 BOX BEAM BRIDGE**  
 50'-0 SPAN  
**STAKING DIAGRAM**  
 STA. 11+35.4  
 BUENA VISTA COUNTY  
 IOWA DEPARTMENT OF TRANSPORTATION - HIGHWAY DIVISION  
 DESIGN SHEET NO. 3 OF 12 FILE NO. 20385 DESIGN NO. 103

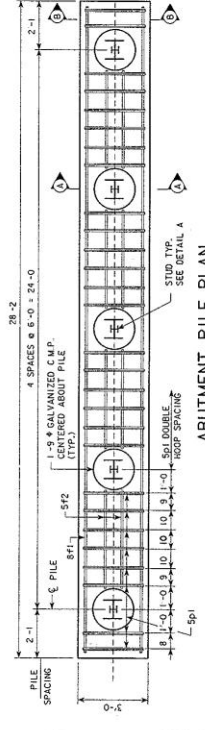
**ABUTMENT PILE PLAN**

NOTE: 4 STUDS PER PILE.

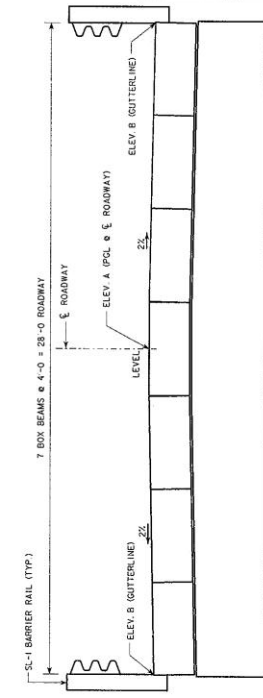
**REAR ELEVATION AT ABUTMENT**

(ORIGINAL NOT SHOWN FOR CLARITY)

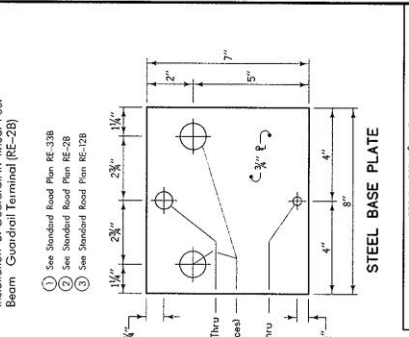
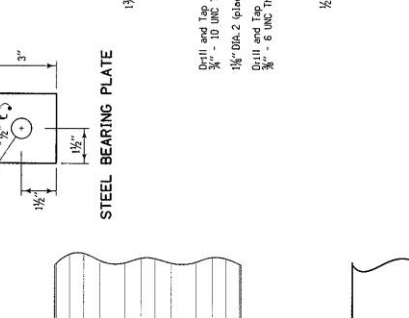
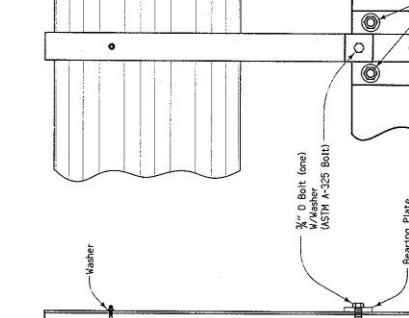
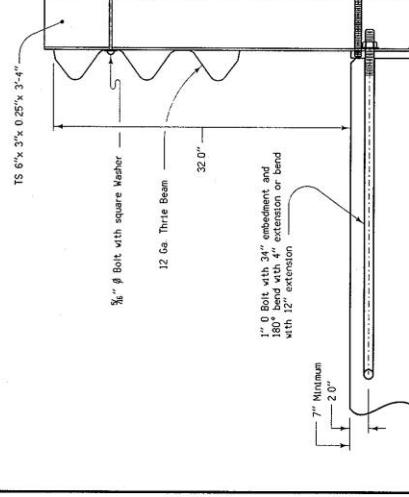
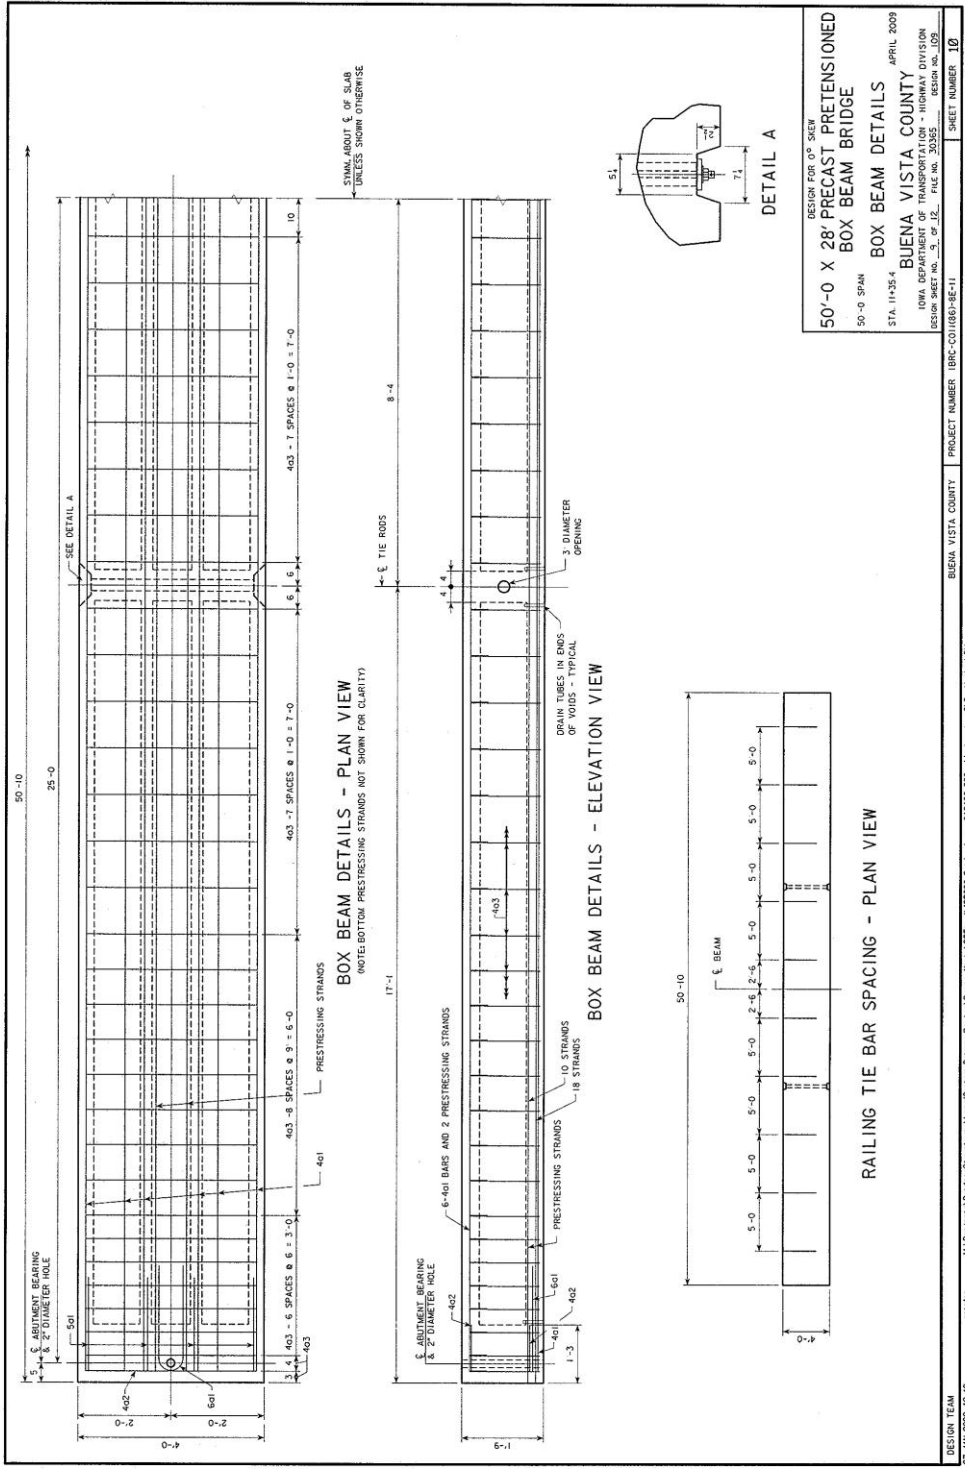
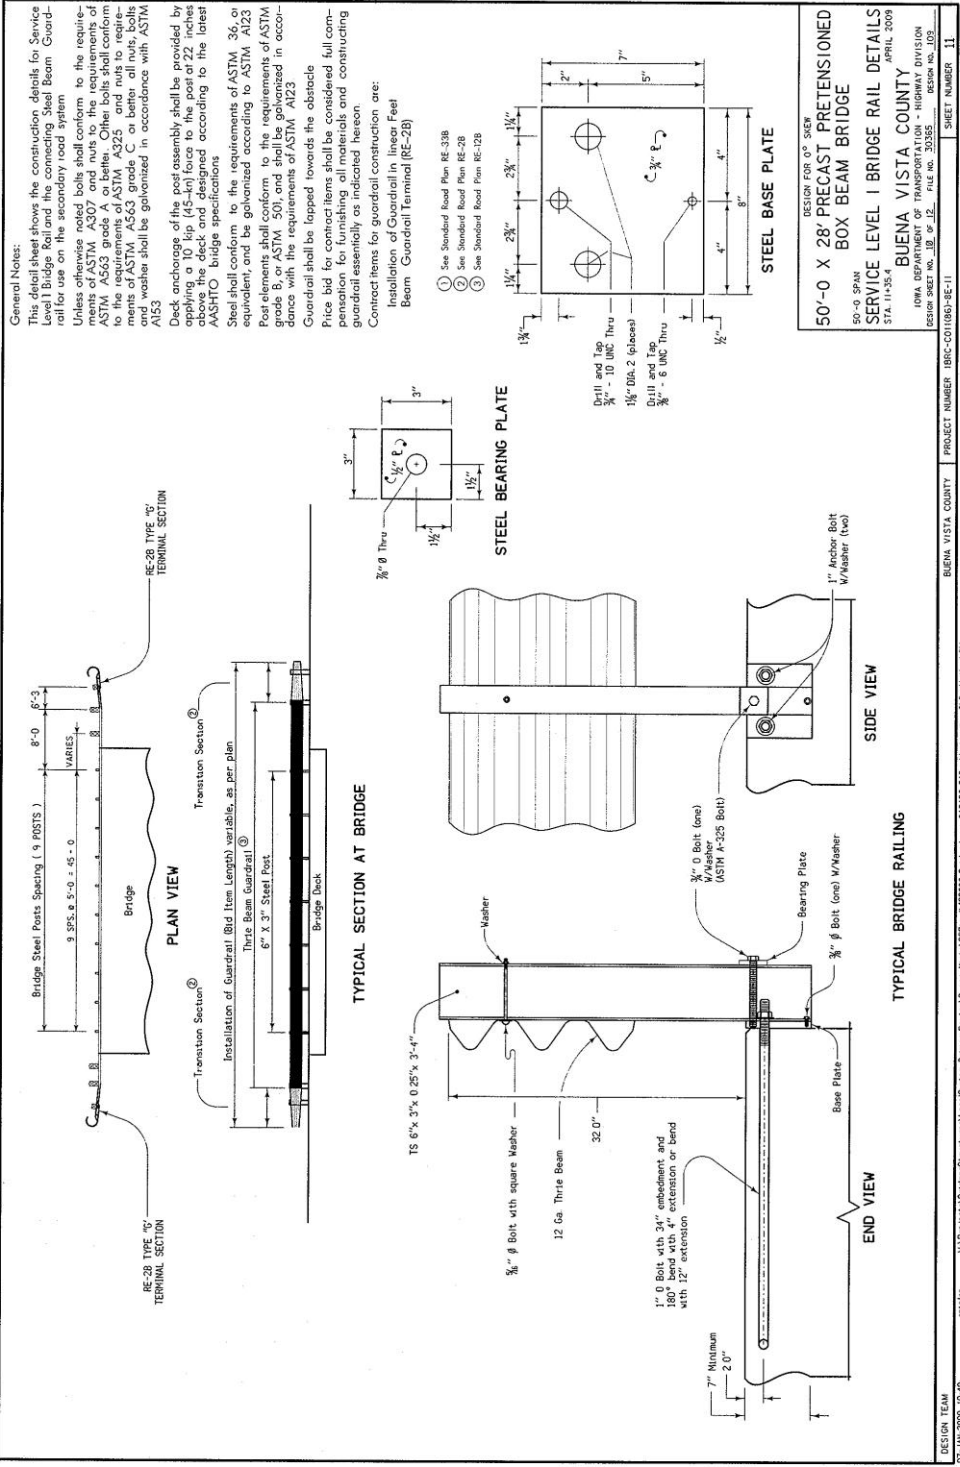
**DESIGN FOR 0<sup>th</sup> SKEW**  
**50'-0" X 28' PRECAST PRETENSIONED BOX BEAM BRIDGE**  
**SERVICE LEVEL I BRIDGE RAIL DETAILS**  
 APRIL 2009  
 BUENA VISTA COUNTY  
 IOWA DEPARTMENT OF TRANSPORTATION - HIGHWAY DIVISION  
 DESIGN SHEET NO. 103  
 FILE NO. 30355

**General Notes:**  
 This detail sheet shows the construction details for Service Level I Bridge and the connecting Steel Beam Guardrail for the bridge span.  
 Unless otherwise noted, bolts shall conform to the requirements of ASTM A307 and nuts to the requirements of ASTM A563 grade A or better. Other bolts shall conform to the requirements of ASTM A325 and nuts to the requirements of ASTM A563 grade C or better. All nuts, bolts and washers shall be galvanized in accordance with ASTM A153.  
 Deck anchors of this post assembly shall be provided by applicable local jurisdiction and shall be designed according to the latest AASHTO bridge specifications.  
 Steel shall conform to the requirements of ASTM 36, or equivalent, and be galvanized according to ASTM A123.  
 Post elements shall conform to the requirements of ASTM grade B, or ASTM 501, and shall be galvanized in accordance with the requirements of ASTM A123.

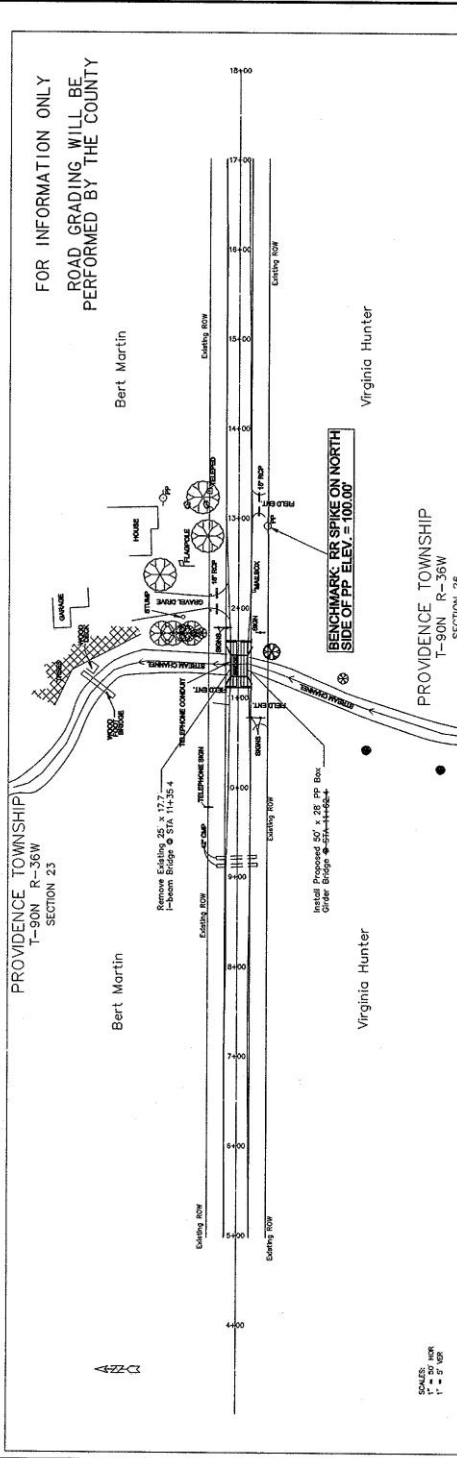
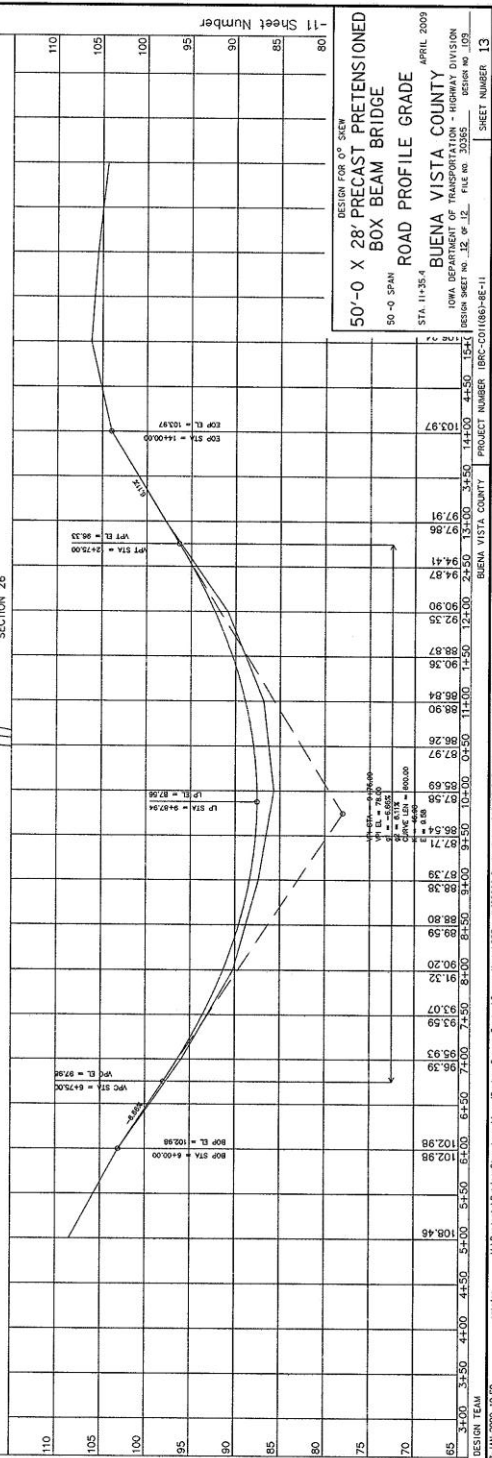
DESIGN FOR 0° SKEW  
50'-0" SPAN  
50'-0" ROAD PROFILE GRADE  
50'-0" PRECAST PRETENSIONED  
BOX BEAM BRIDGE

FOR INFORMATION ONLY  
ROAD GRADING WILL BE  
PERFORMED BY THE COUNTY
