U.S. Department
of Transportation

**Federal Railroad
Administration**

On-Line High-Speed Rail Defect Detection, Part II

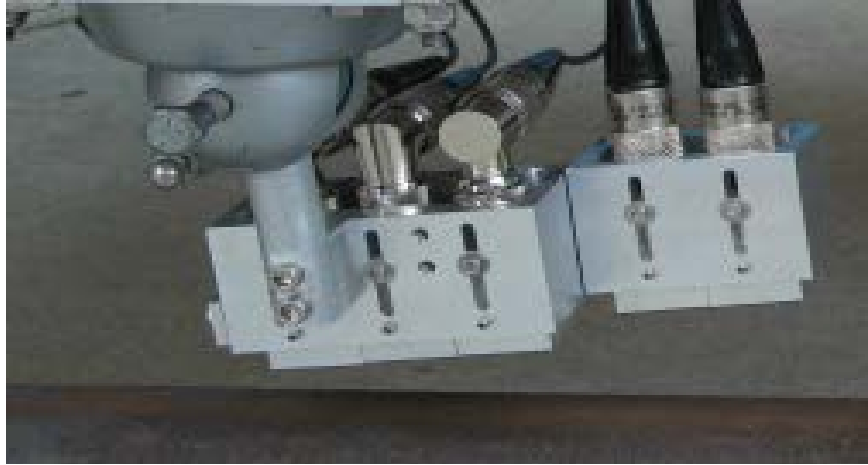
Figure 6.2. Piezocomposite Sensors Arranged in an Array Configuration

- (b) use of sensor arrays based on the new piezocomposite devices (Figure 6.2), which cover different frequency bands;
- (c) improved compactness of the system, including electromagnetically shielded and water-tight boxes containing all sensor electronics (amplifiers, filters, etc.) and data acquisition unit (Figure 6.3-left); simplified covers for laser and sensors (Figure 6.3-right). The new covers also provided complete enclosure of the laser beam via an aluminum tube, which improved safety of standby personnel and minimized the need for wearing laser-protection glasses in close proximity to the system.

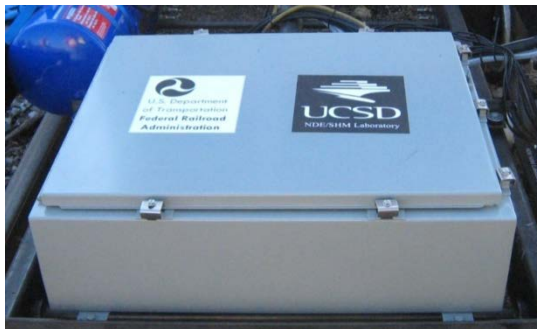
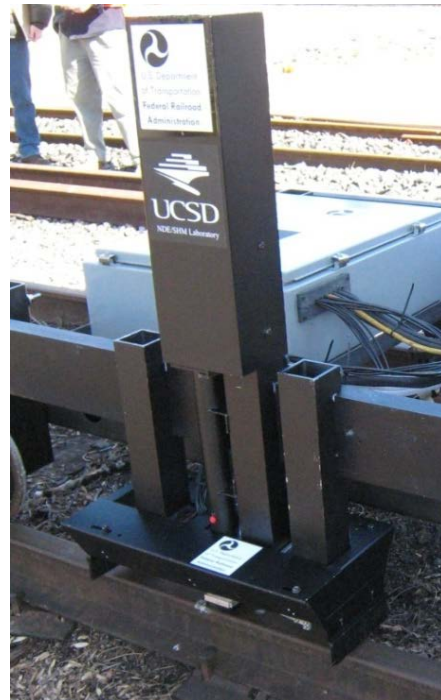
Figure 6.3. (left) Water-Tight Steel Case Containing All Electronic Components Attached to the Sensing Lines; (right) Improved Covers for Laser and Sensors

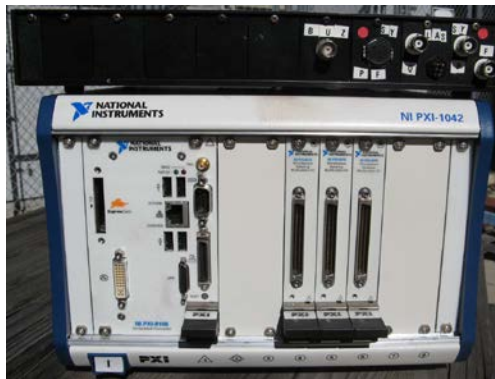
Figure 7.1. Breakout Box and PXI Unit; the Box Is Connecting the Sensor Lines to the PXI Data Acquisition Unit

The electronic components were housed in a metal box positioned on the outdoor deck of R-4. The system included a breakout box, which connected the shielded multichannel cable coming from the metal box to the acquisition unit located inside the Hy-Railer. The breakout box is depicted in Figure 7.1, along with the PXI unit, which hosted the software for the real-time acquisition and processing of the ultrasonic signals.

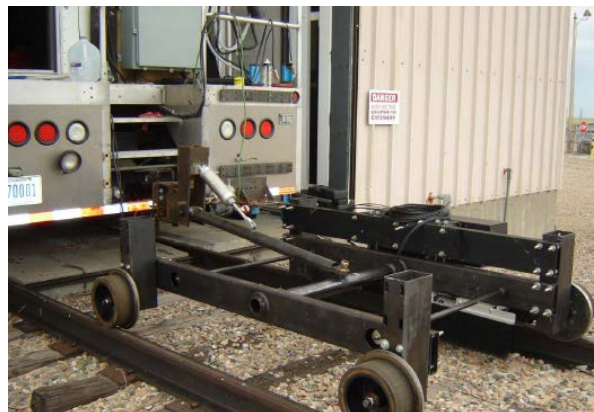
Figure 9.2. The Cart with the Prototype Installed before Cabling

The installation of the cart on R-4 was smooth; the prototype was mounted on the cart beam (Figure 9.2) and the laser sensor, used for tracking the position of the cart relative to the rail, was mounted off-center on the cart beam to allow for a closer installation of the ultrasonic transducers (Figure 9.3).

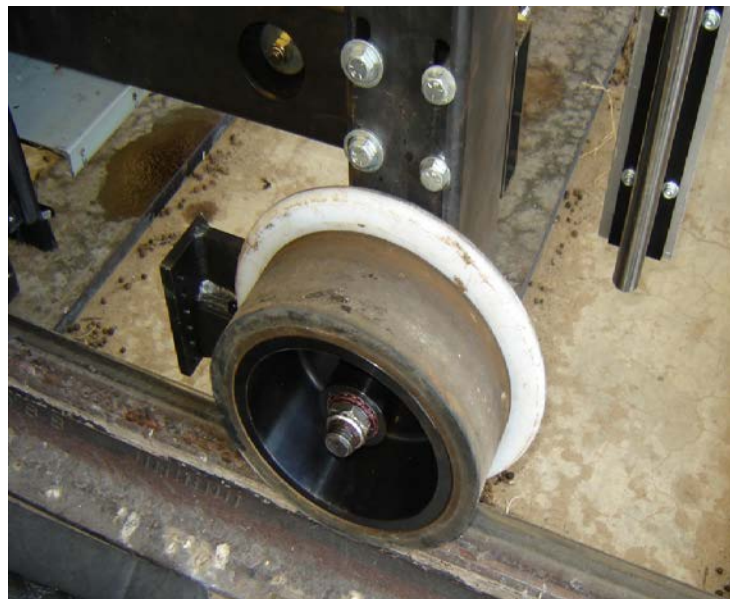
Figure 9.4. Detail of the New Nylon Wheel Flanges Required for Noise Reduction

Figure 9.4 shows a detail of the cart new nylon wheel flanges, required to eliminate any noise eventually generated by the friction between the wheel and the rail during an inspection.

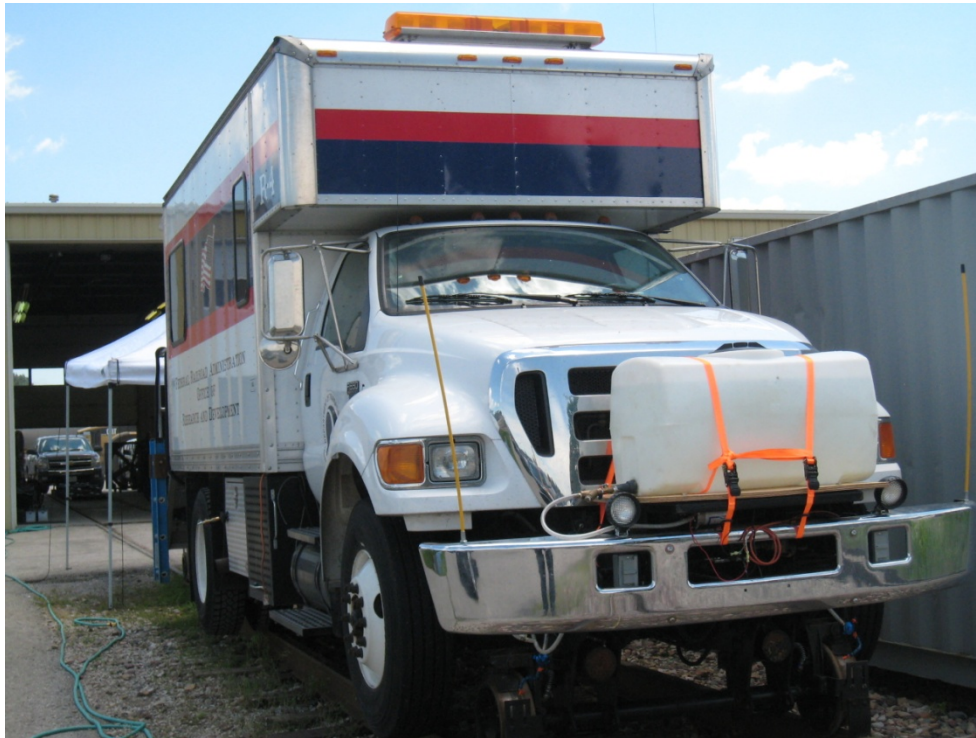
Figure 10.1. Water Reservoir for the Supply of the Water Spray System Installed to Reduce the Noise Created at the Wheel-Rail Interface

Day #1 and part of day #2 were spent by UCSD and ENSCO teams setting up the prototype on R-4 in Herzog Services' main building. R-4 was equipped with a new system of nozzles spraying water at the four R-4 wheel locations, aiming at reducing the noise occurring at the wheel-rail interface. The water reservoir was installed in the front of R-4 (Figure 10.1).

The system performance at Herzog Services rail defect farm was very promising. The improved water-spraying system worked successfully for the reduction of the noise generated by R-4 at the wheel-rail interface.

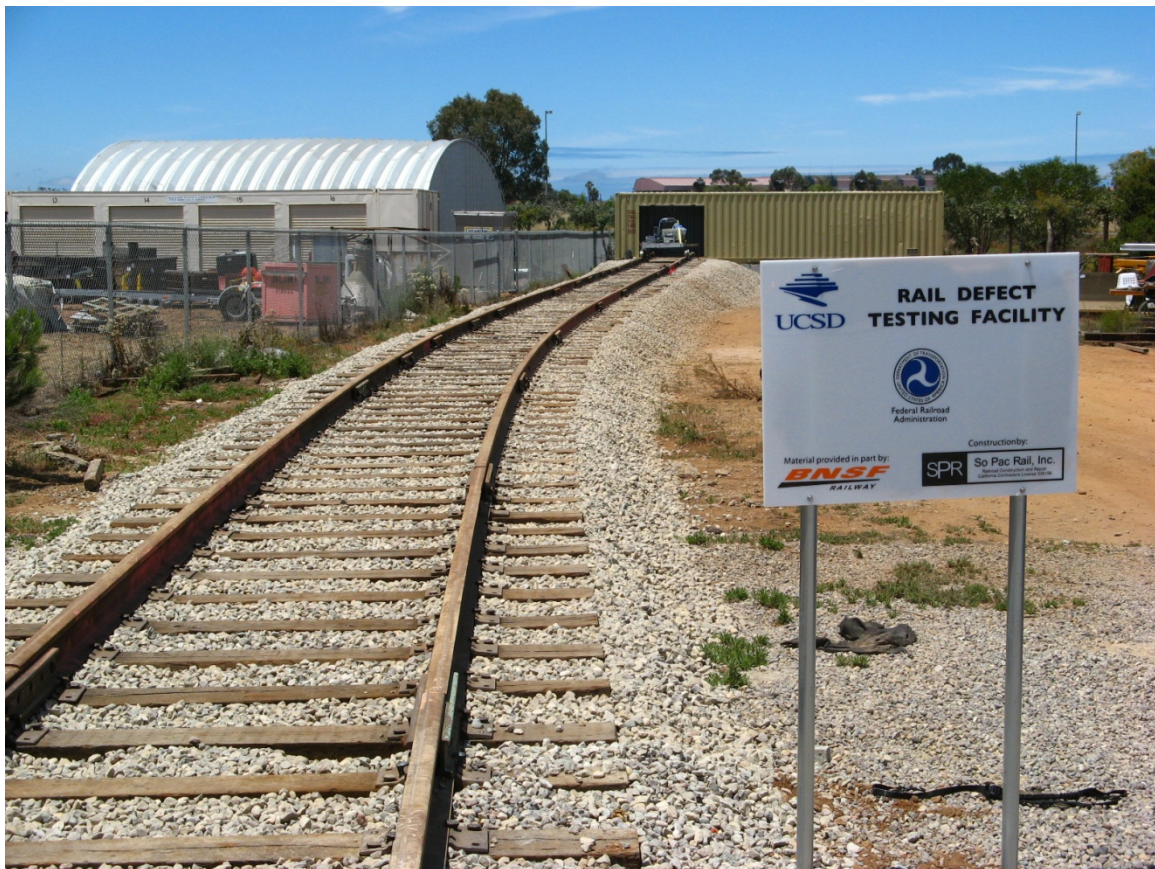
Figure 11.1. The New Rail Defect Farm at UCSD for Development of Rail Inspection Technologies

The new UCSD/FRA Rail Defect Farm (Figure 11.1) is a 250-foot-long track with a tangent portion and an 8° curved portion. BNSF donated the rails and most of the ties and ballast. Sopac Rail, Inc., performed the construction. The track features approximately 15 natural rail defects, including TDs under shelling, and some artificial rail defects. This facility will be used primarily for the technology development of the FRA/UCSD rail inspection prototype. It is also expected that the facility will be available to other developers of rail inspection technologies.
