STATEWIDE CORROSIVITY STUDY ON
CORRUGATED STEEL CULVERT PIPE

FHWA/MT-01-001/8148

Final Report

November 2001

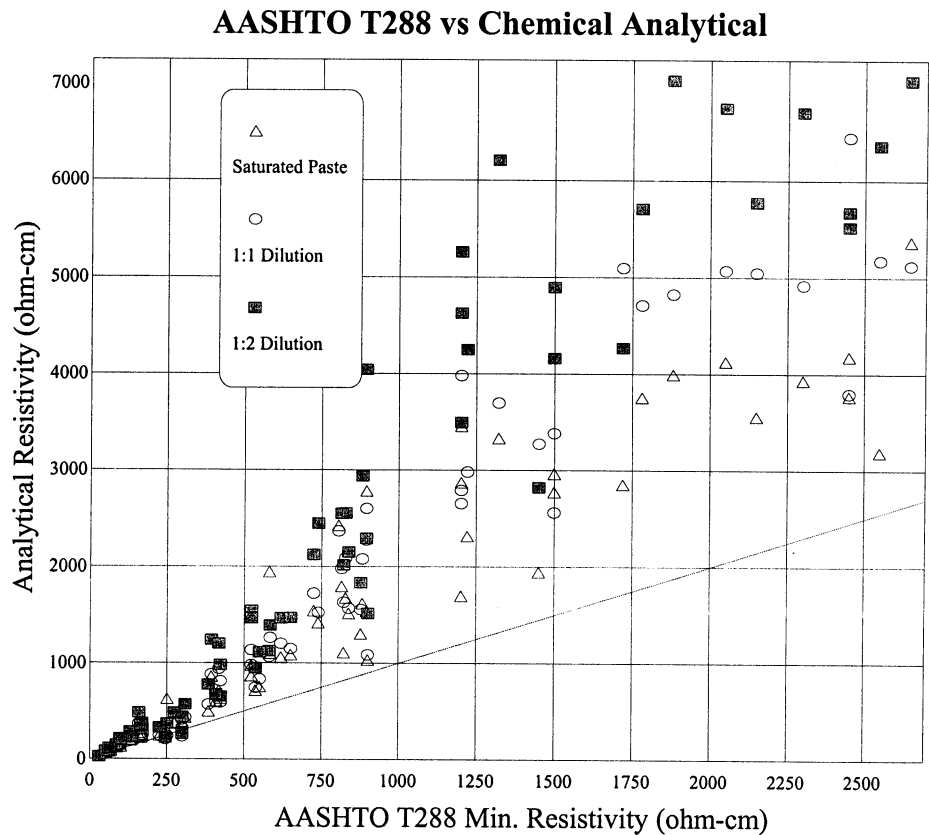
Figure 4 Comparison of Resistivity Test Data for AASHTO T288 Resistivity Values Less than 2,750 ohm·cm

To further illustrate the variability of test results for relatively low resistivity soil samples tested by the MDT procedures and AASHTO T288, Figure 3 has been reproduced below (Figure 4) and re-scaled to show only samples with minimum soil resistivity (as determined by AASHTO T288) of 2,750 ohm·cm or less. Each shaded, square marker on this graph corresponds to a single sample whose AASHTO T288 minimum resistivity is obtained from the vertical projection to the x-axis and whose MDT 1:2 resistivity is obtained from a horizontal projection to the y-axis.

For example, two of the samples had AASHTO T288 minimum resistivity values of approximately 1,500 ohm·cm and the same samples had MDT 1:2 resistivity values of approximately 4,000 and 5,000 ohm·cm. In view of the obvious variability in resistivity values that are obtained for the same sample using the different methods, it is understandable why there exists difficulty in relating resistivity to corrosivity using the same analysis method.
