# Evaluation of Effects of Fire on the I-465 Mainline Bridges—Volume II

## EVALUATION OF EFFECTS OF FIRE ON THE I-465 MAINLINE BRIDGES—VOLUME II

Report Number: FHWA/IN/JTRP-2012/13

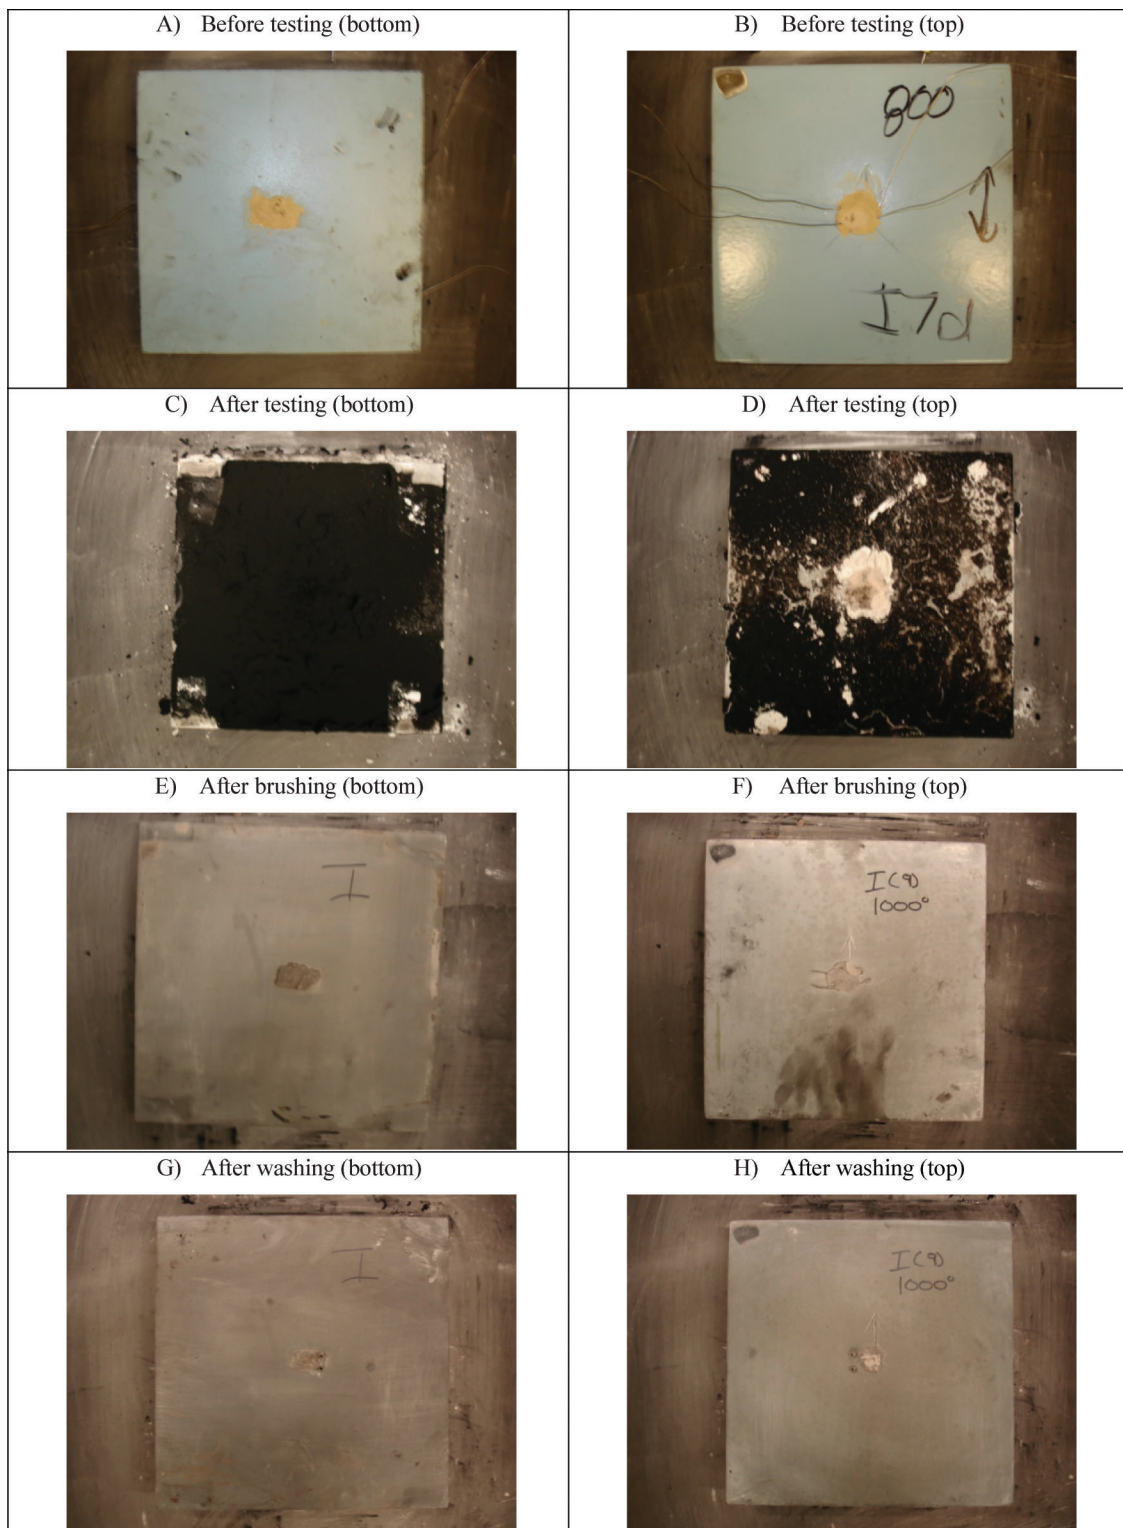
**Figure 5.29** Post-fire evaluation of Carbothane I (9) 1000°F.

Figures 5.29 to 5.34 show photographs of the post-fire evaluation of the plate specimens (Part 4) identified in Table 4.1 and again in Table 5.7. These
