# Development and *MASH* Full-Scale Crash Testing of a High-Mounting-Height Temporary Single Sign Support with Aluminum Sign

**Test Report No. 9-1002-12-5**

TEXAS A&M TRANSPORTATION INSTITUTE  
THE TEXAS A&M UNIVERSITY SYSTEM  
COLLEGE STATION, TEXAS

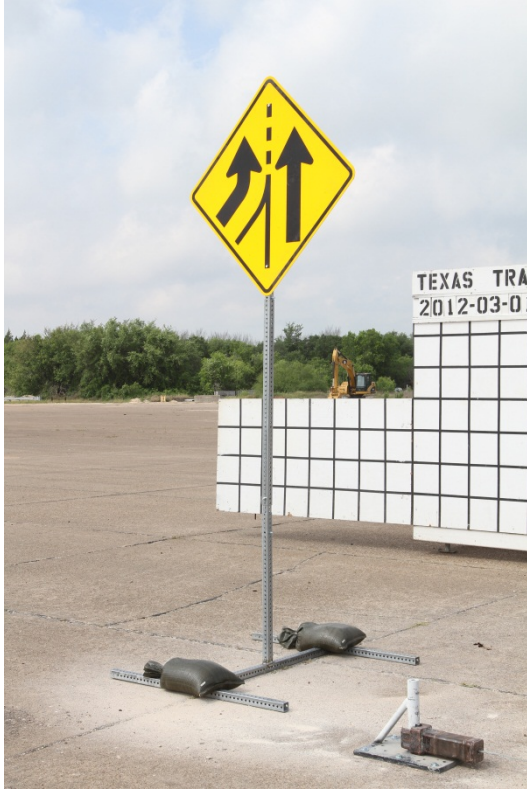
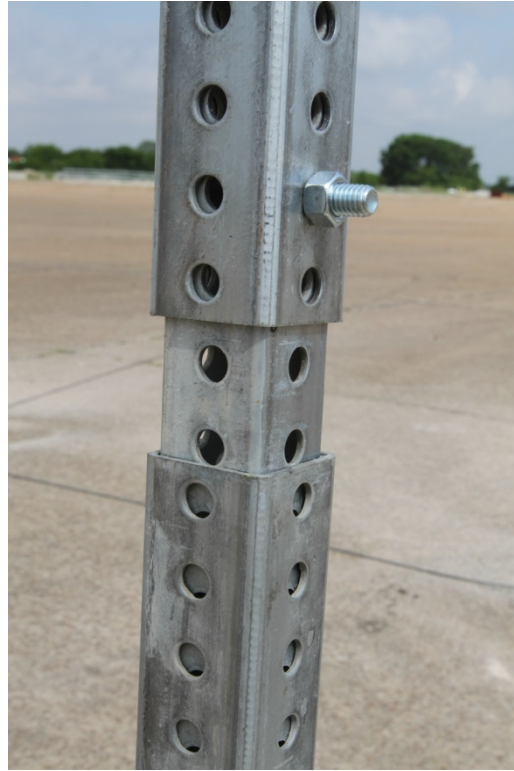
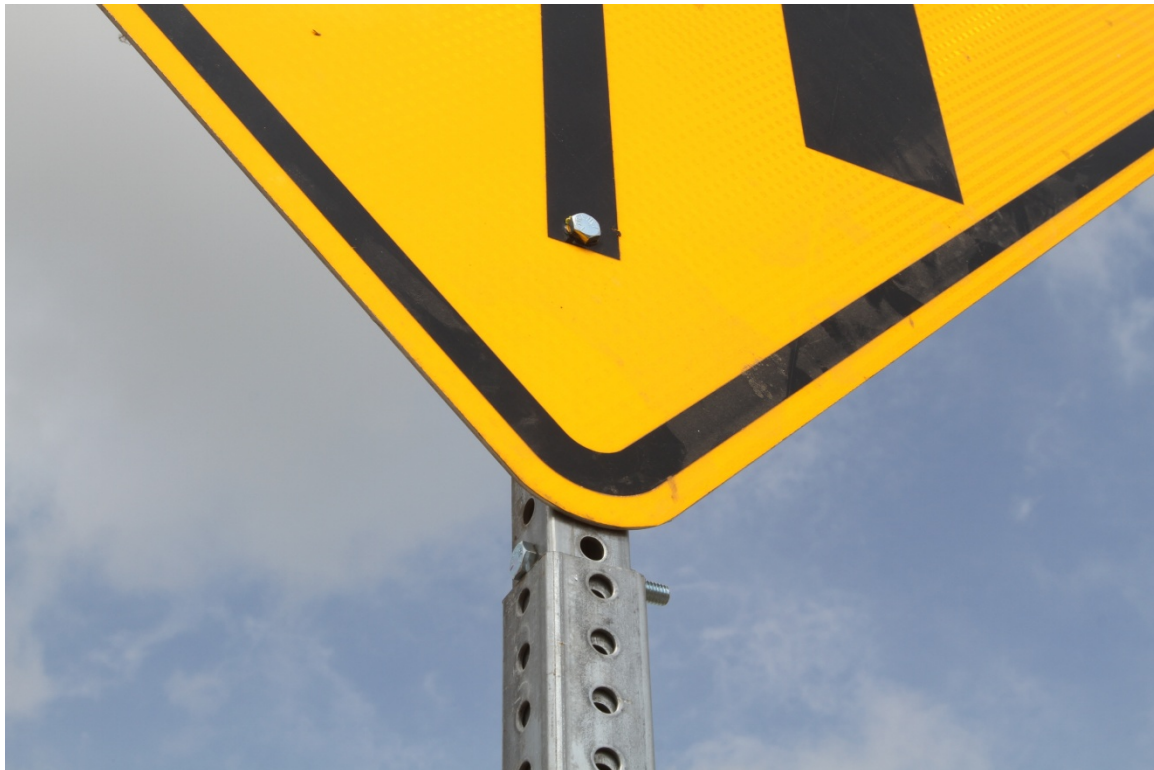
**Figure 4.5. Temporary Sign Support System prior to Test No. 490022-7-1.**

A 40-lb sand bag was laid on each side of the base assembly. All perforated square steel tubing was 12 gauge. All bolts were ASTM A307, but any grade bolt was considered acceptable. Figure 4.5 presents photographs of the completed test installation.

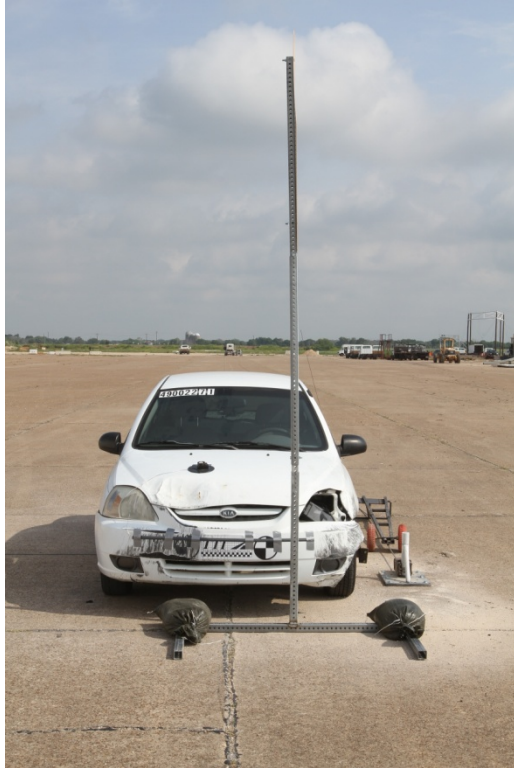
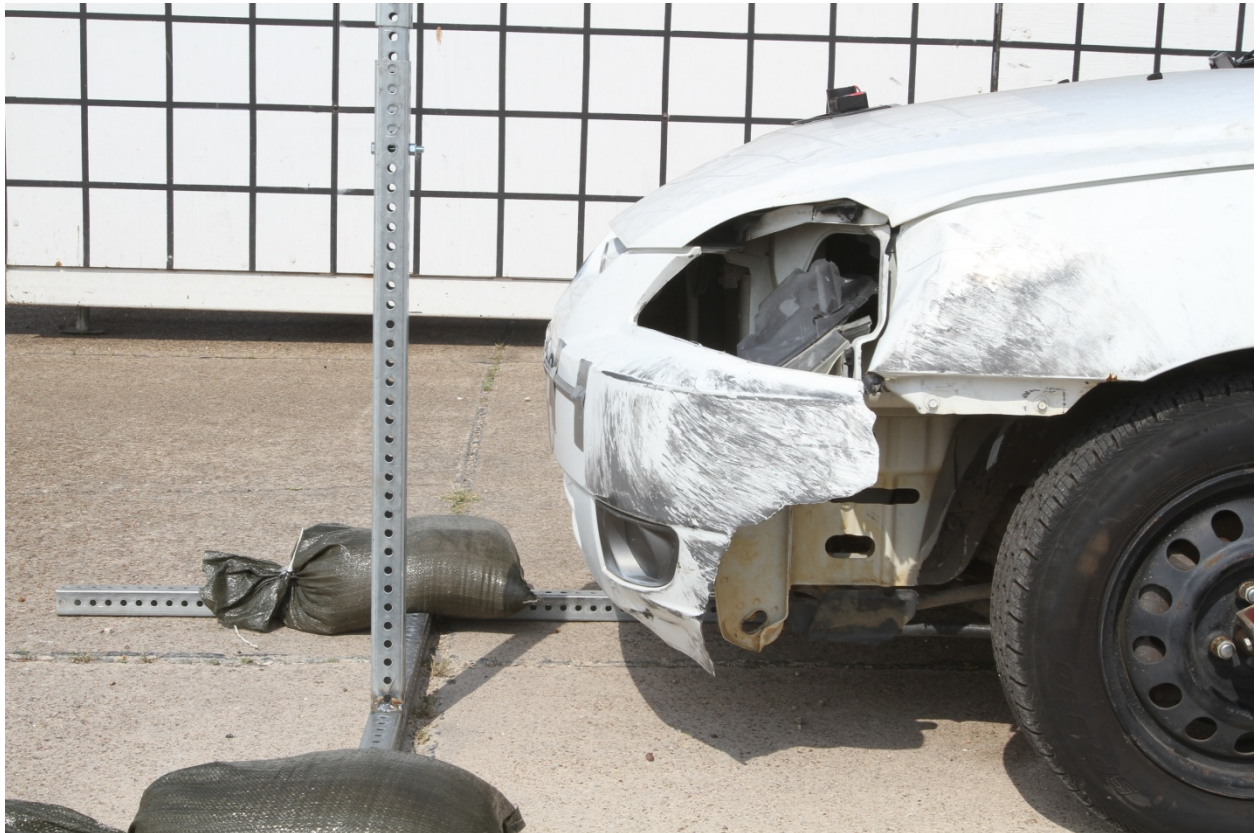
**Figure 4.6. Vehicle/Installation Geometrics for Test No. 490022-7-1.**

A 2003 Kia Rio passenger car (shown in Figures 4.6 and 4.7) was used for the crash test. This test vehicle was previously used in testing of flexible delineators and had some minor damage (e.g., broken head light, dented hood). However, it was concluded that this minor damage would not influence the impact performance or trajectory of the light weight, skid-mounted temporary sign support. Test inertia weight of the vehicle was 2425 lb, and gross static weight was 2425 lb. The height to the lower edge of the vehicle front bumper was 8.5 inches, and the height to the upper edge of the front bumper was 22.75 inches. Table C1 of Appendix C gives additional dimensions and information on the vehicle. The passenger car was directed into the installation using the cable reverse tow and guidance system, and was released to be free-wheeling prior to impact.

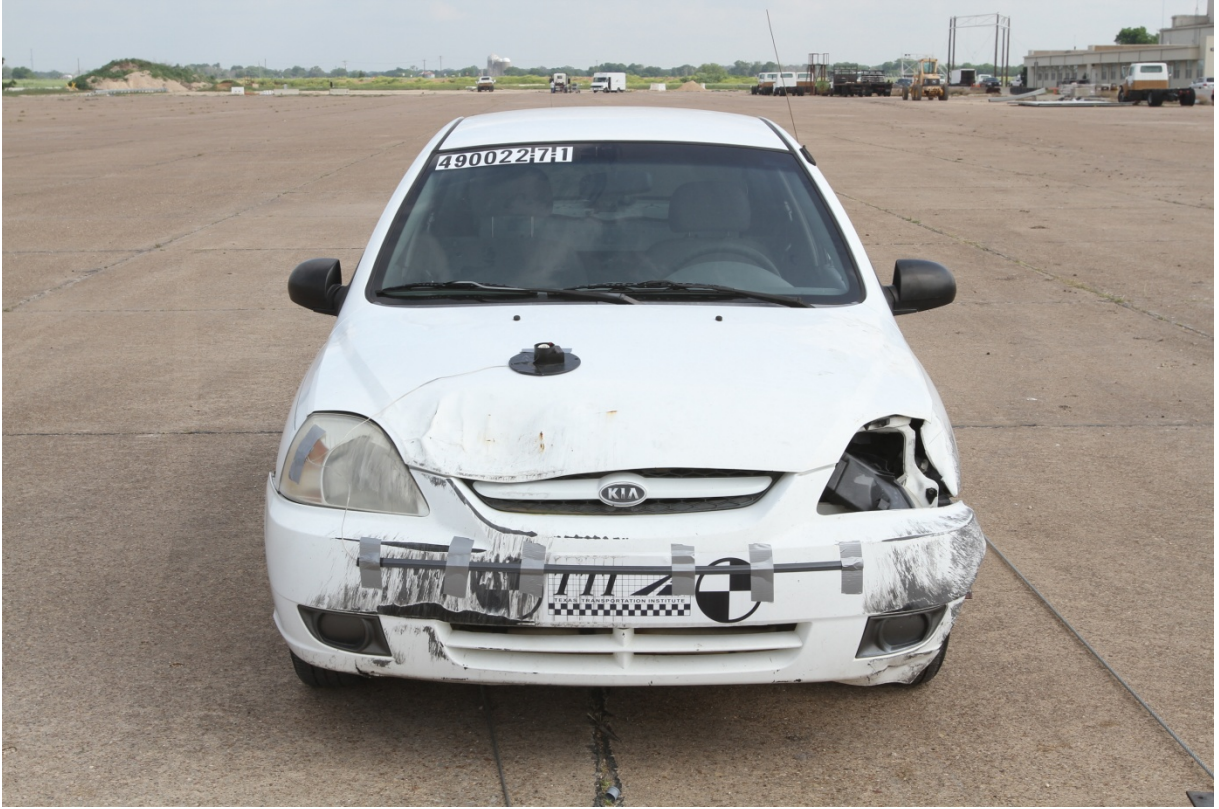
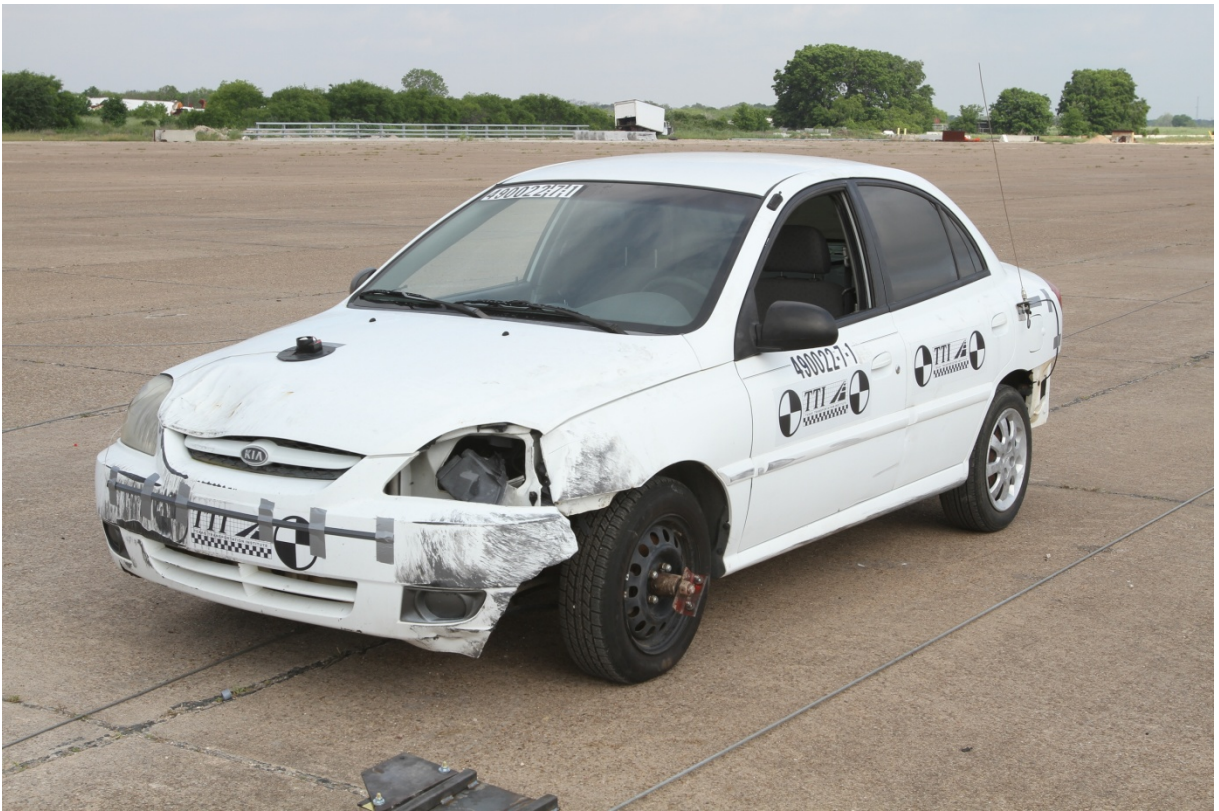
**Figure 4.7. Vehicle before Test No. 490022-7-1.**

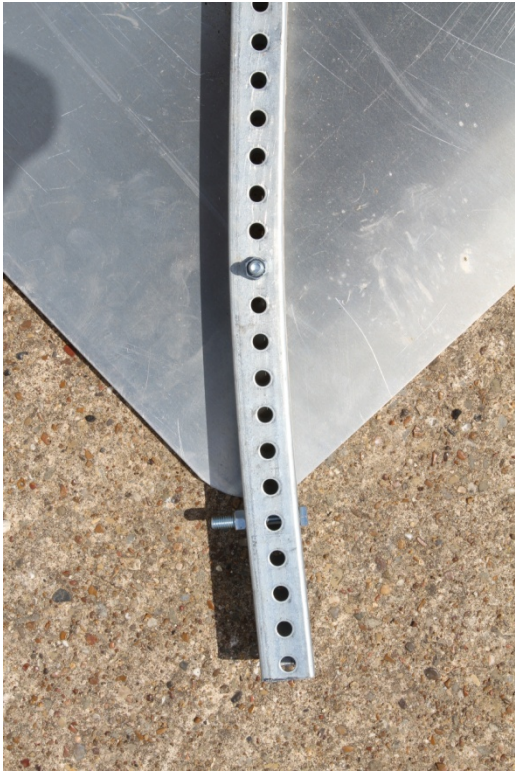
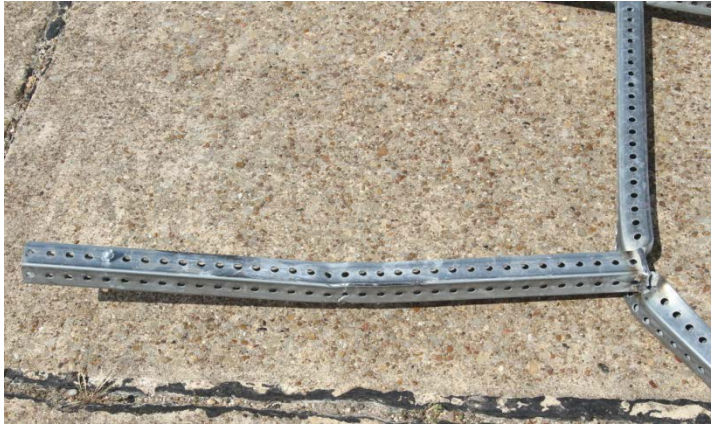
**Figure 4.8. Installation after Test No. 490022-7-1.**

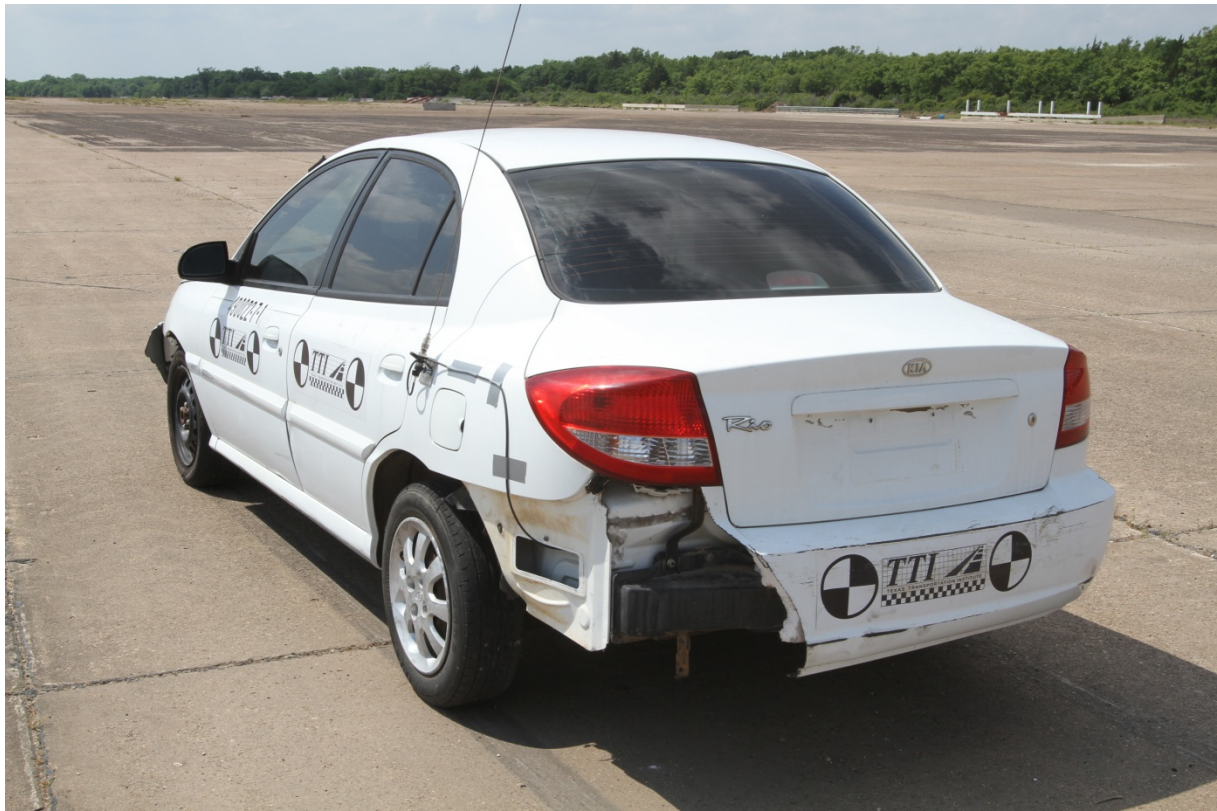
**Figure 4.9. Vehicle after Test No. 490022-7-1.**

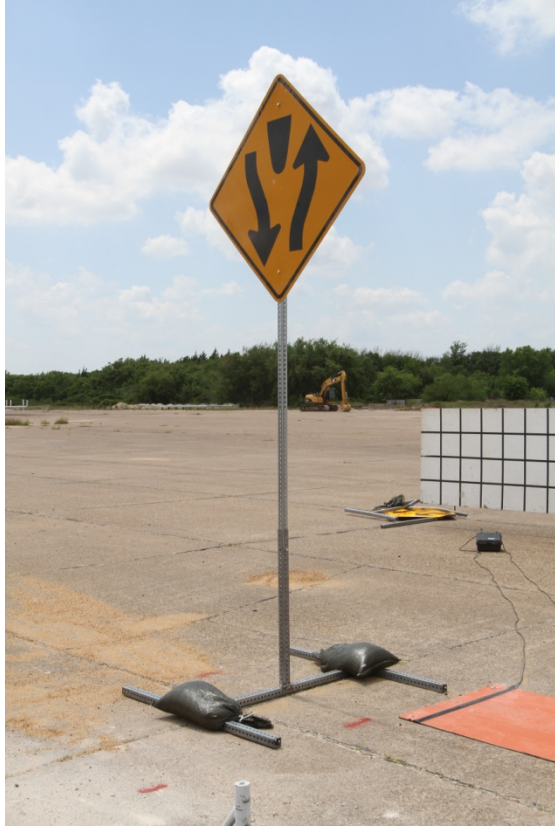
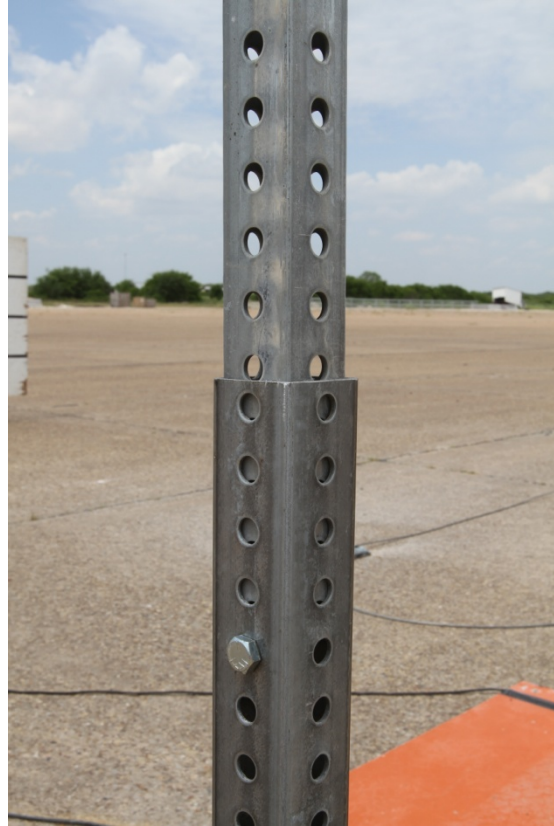
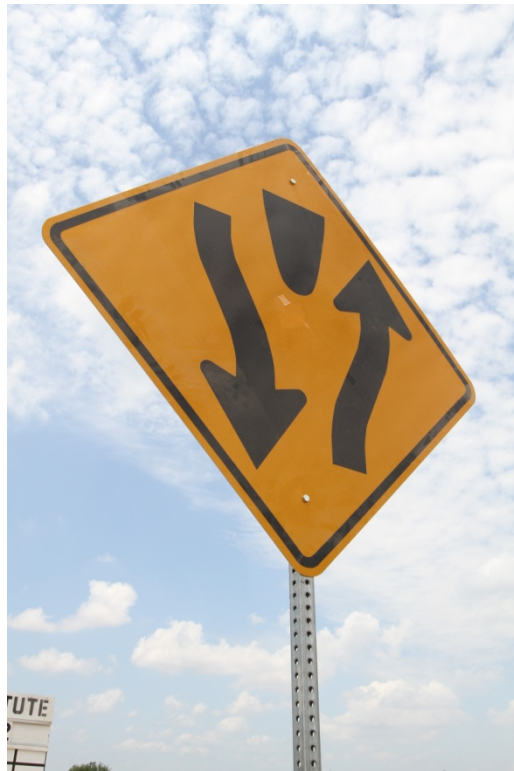
**Figure 4.14. Temporary Sign Support System prior to Test No. 490022-7-2.**

A 40-lb sand bag was laid on each side of the base assembly. All perforated square steel tubing was 12 gauge. All bolts were ASTM A307, but any grade bolt was considered acceptable. The test installation was placed on a concrete surface. Figure 4.14 presents photographs of the completed test installation.

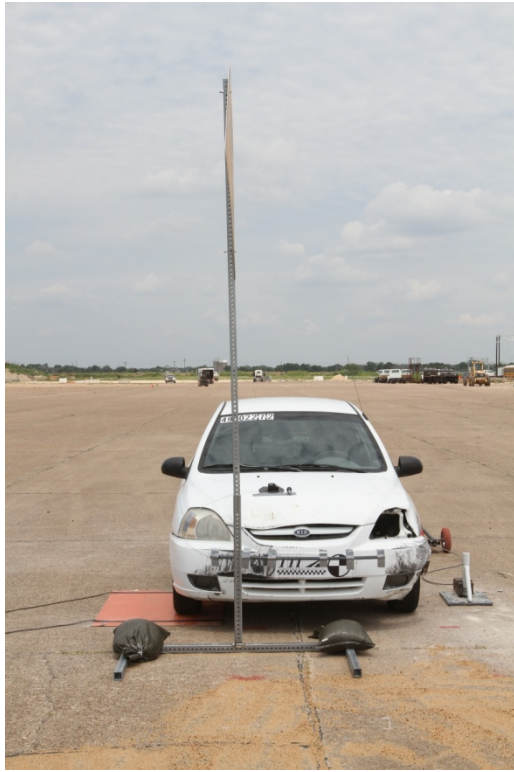
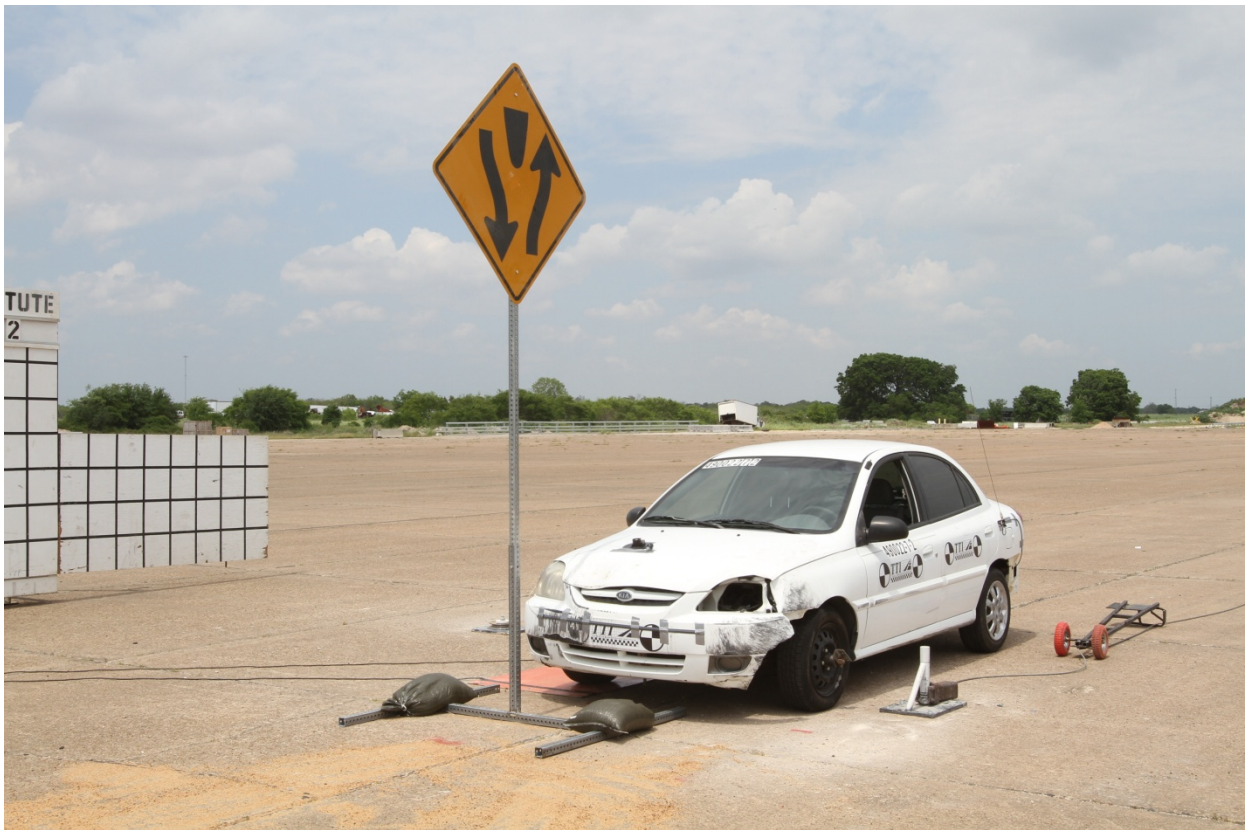
**Figure 4.15. Vehicle/Installation Geometrics for Test No. 490022-7-2.**

A 2003 Kia Rio passenger car (shown in Figures 4.15 and 4.16) was used for the crash test. Test inertia weight of the vehicle was 2425 lb, and gross static weight was 2425 lb. The height to the lower edge of the vehicle front bumper was 8.5 inches, and the height to the upper edge of the front bumper was 22.75 inches. Table D1 of Appendix D gives additional dimensions and information on the vehicle. The passenger car was directed into the installation using the cable reverse tow and guidance system, and was released to be free-wheeling and unrestrained just prior to impact.

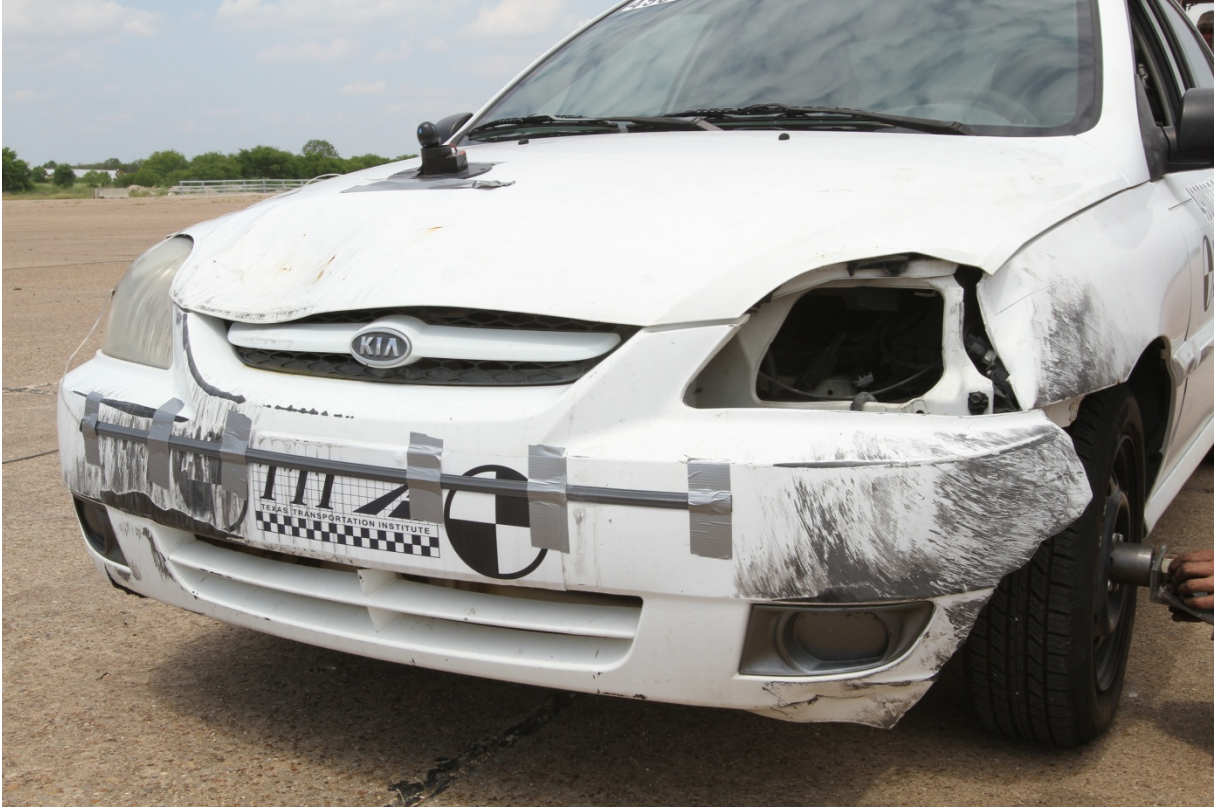
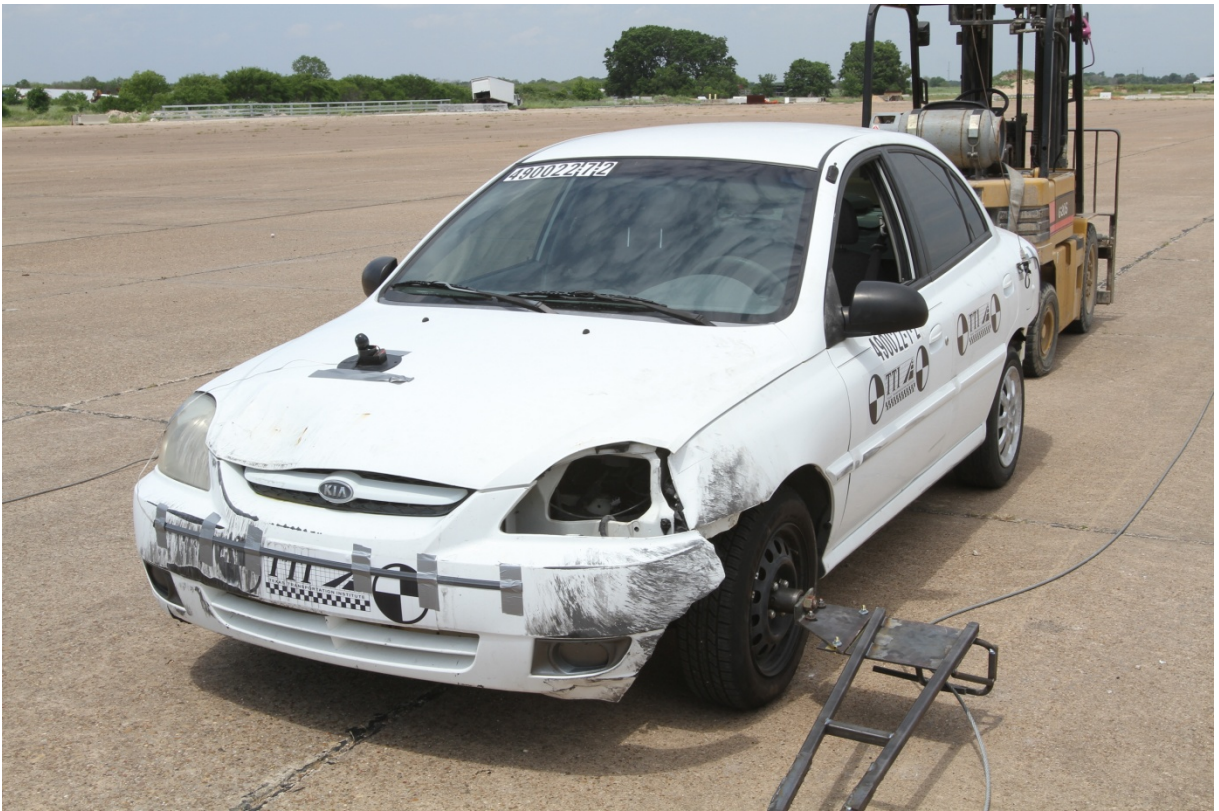
**Figure 4.16. Vehicle before Test No. 490022-7-2.**

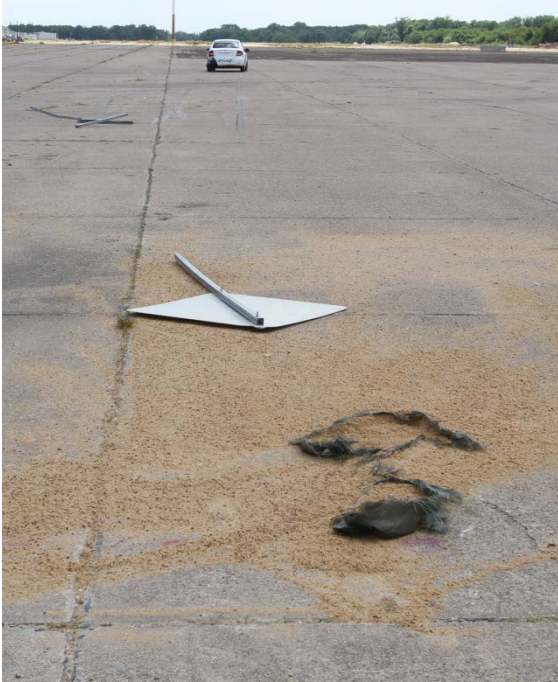
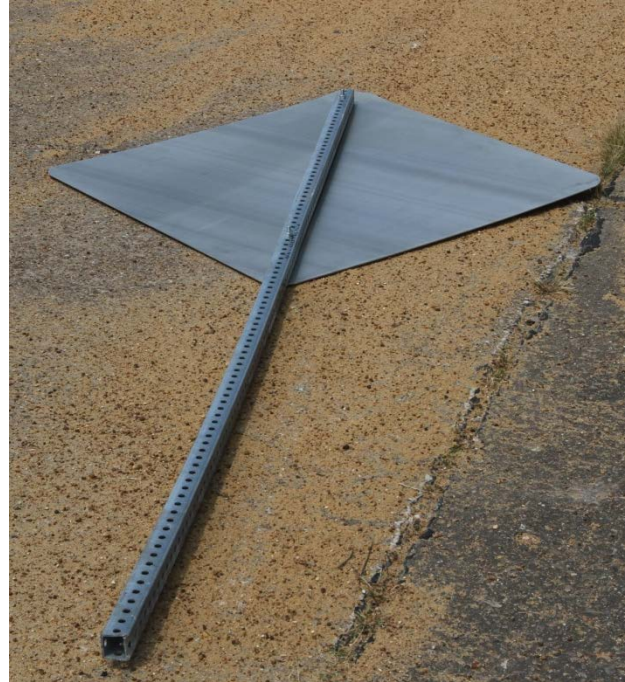
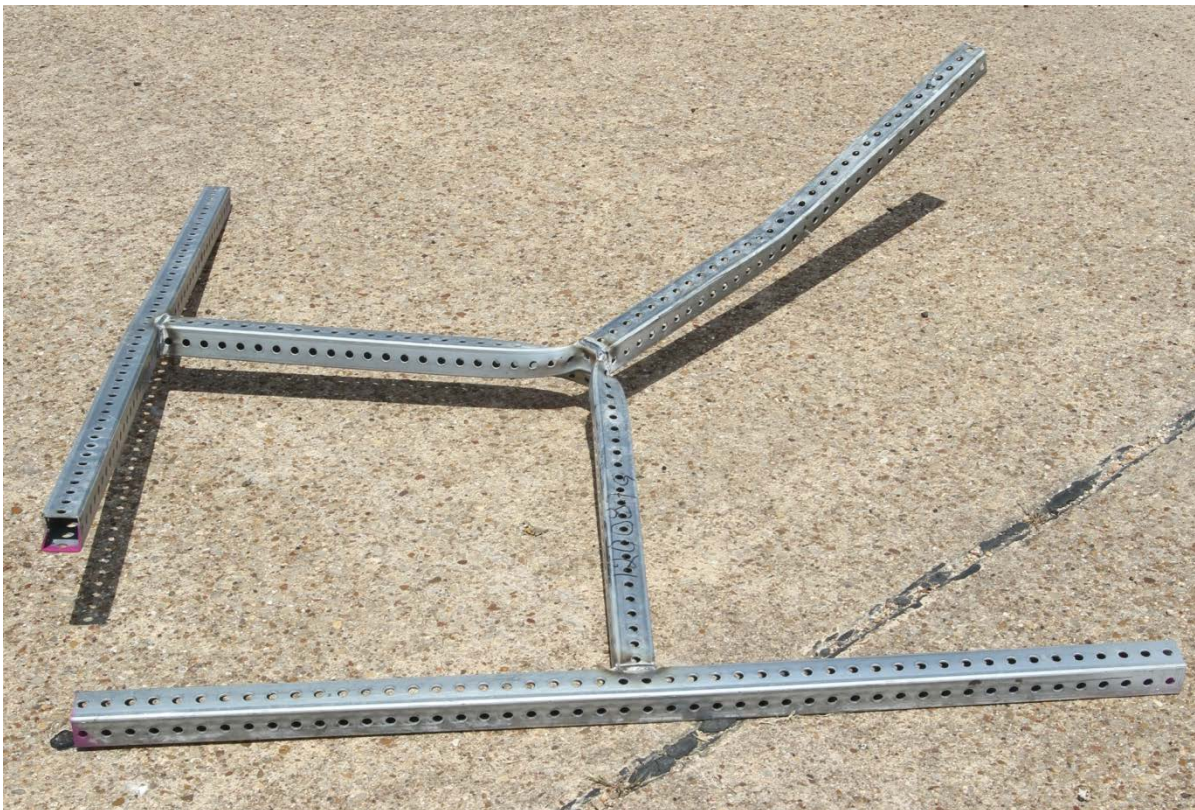
Figure 4.17 shows damage to the sign support system. The telescopic slip connection activated as designed and released the vertical support and sign panel from the base. The vertical sleeve and middle brace in the H-base to which it was attached were both deformed. The support post and sign panel came to rest 17.5 ft downstream of the impact point. The base assembly came to rest 82.5 ft downstream of the impact point.

**Figure 4.17. Installation after Test No. 490022-7-2.**

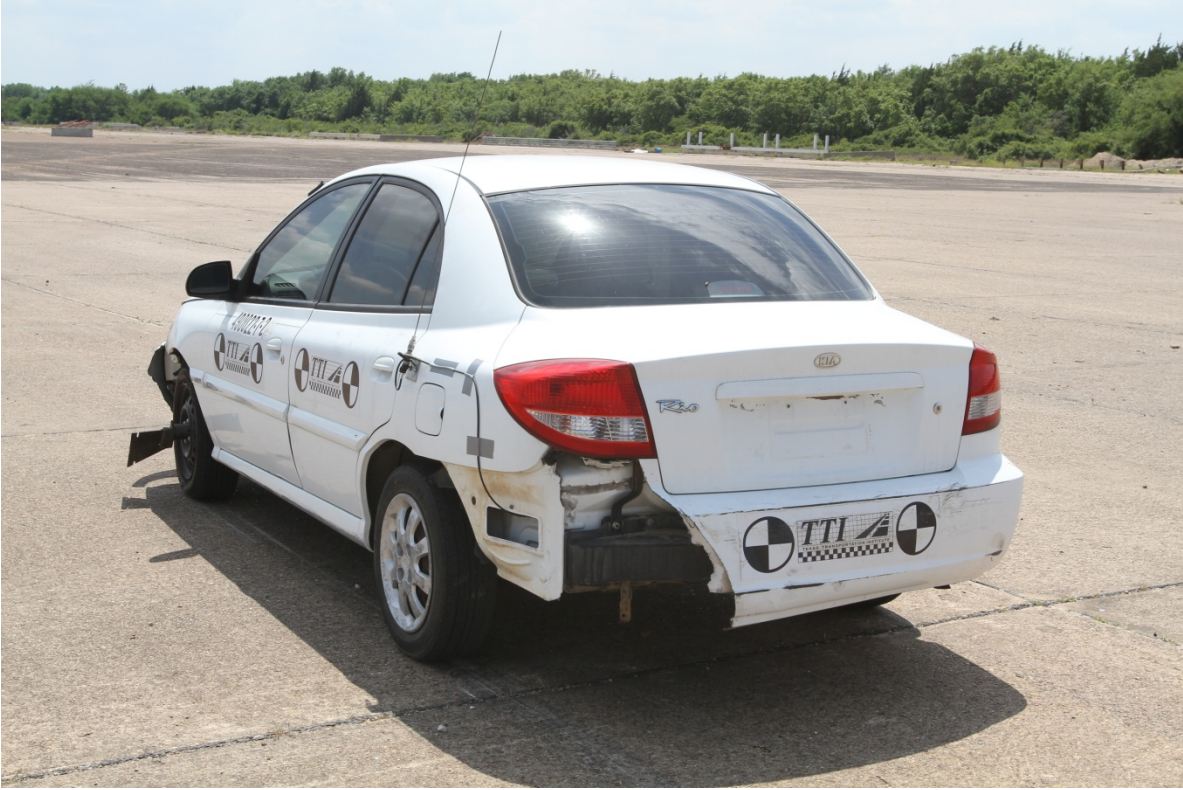
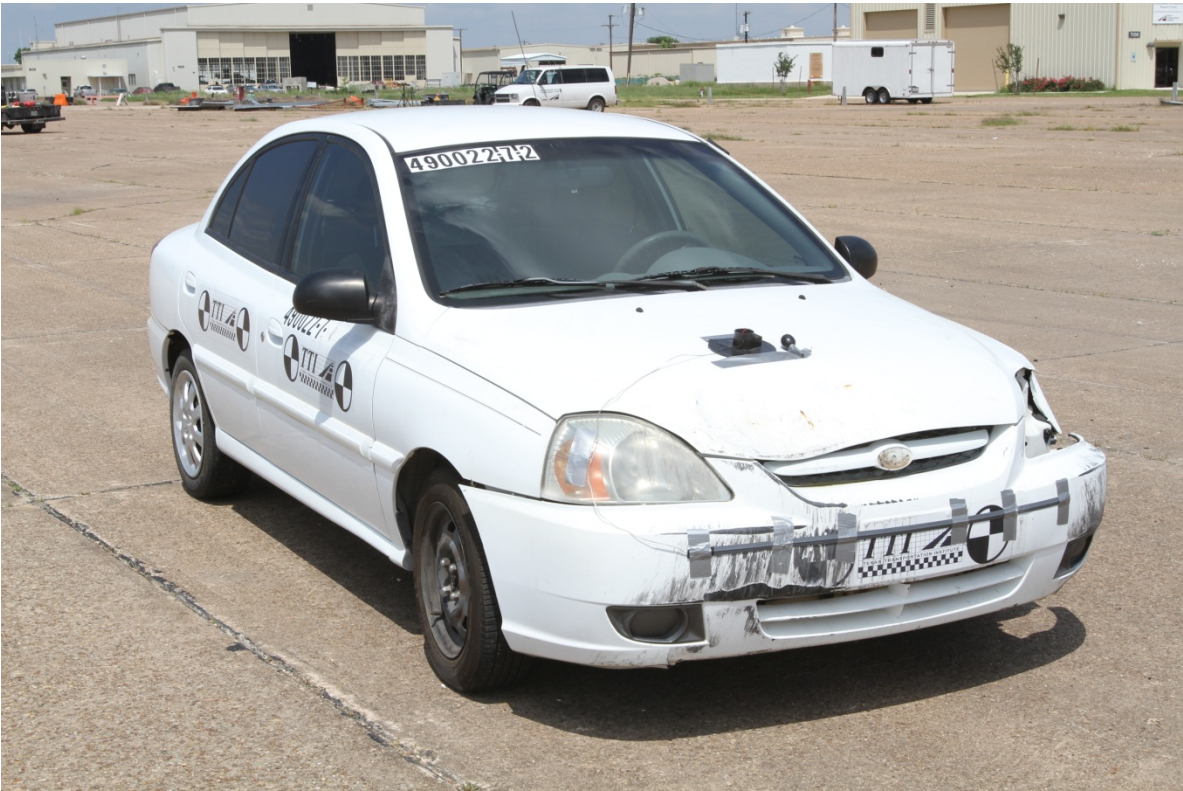
**Figure 4.18. Vehicle after Test No. 490022-7-2.**

The 1100C vehicle did not sustain any additional damage during the impact with the temporary single sign support. Figure 4.18 shows photographs of the exterior of the vehicle.

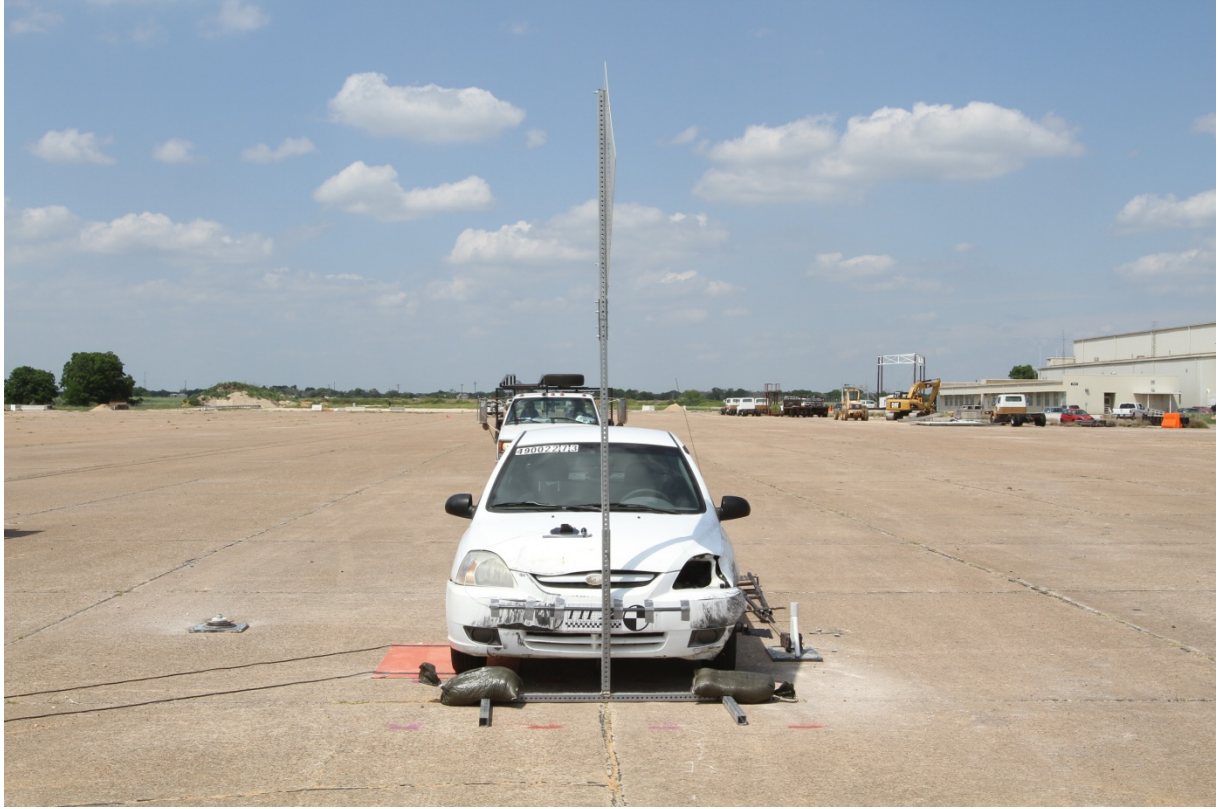
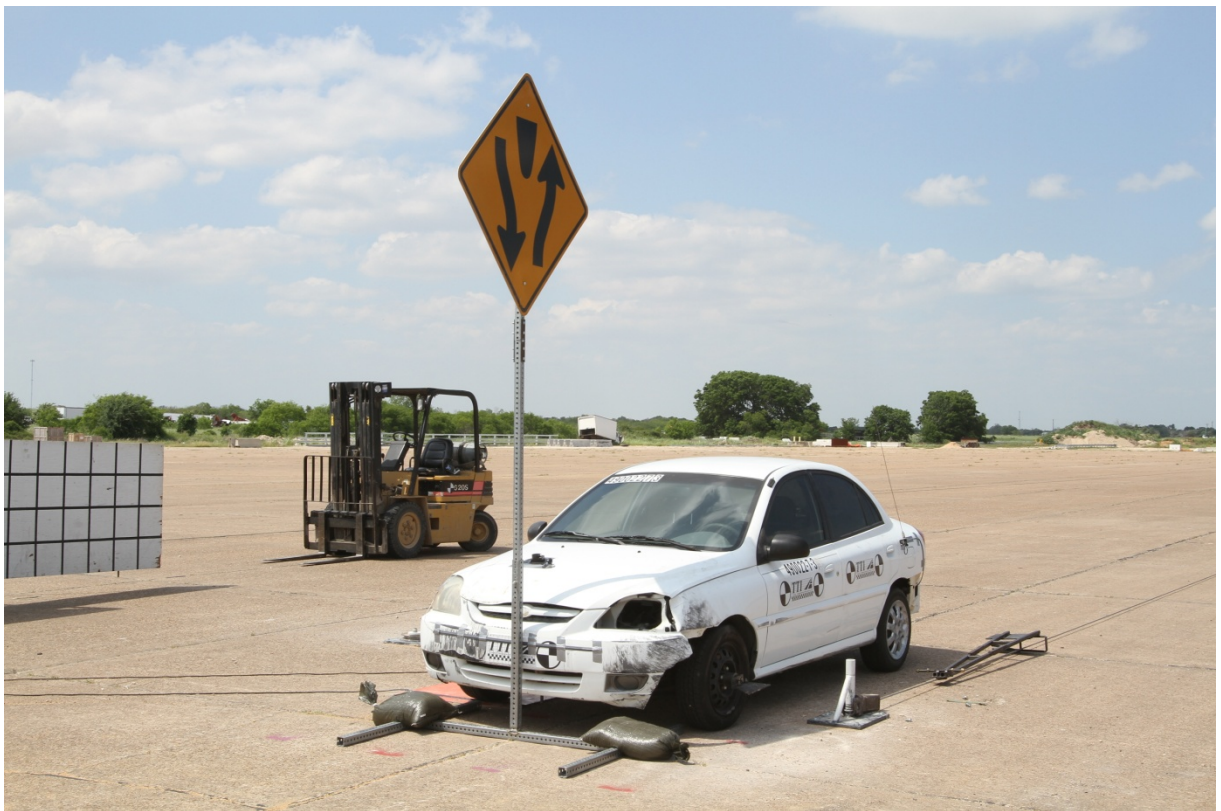
**Figure 4.24. Vehicle/Installation Geometrics for Test No. 490022-7-3.**

A 2003 Kia Rio passenger car (shown in Figures 4.24 and 4.25) was used for the crash test. Test inertia weight of the vehicle was 2425 lb, and gross static weight was 2425 lb. The height to the lower edge of the vehicle front bumper was 8.5 inches, and the height to the upper edge of the front bumper was 22.75 inches. Table E1 of Appendix E give additional dimensions and information on the vehicle. The passenger car was directed into the installation using the cable reverse tow and guidance system, and was released to be free-wheeling and unrestrained just prior to impact.

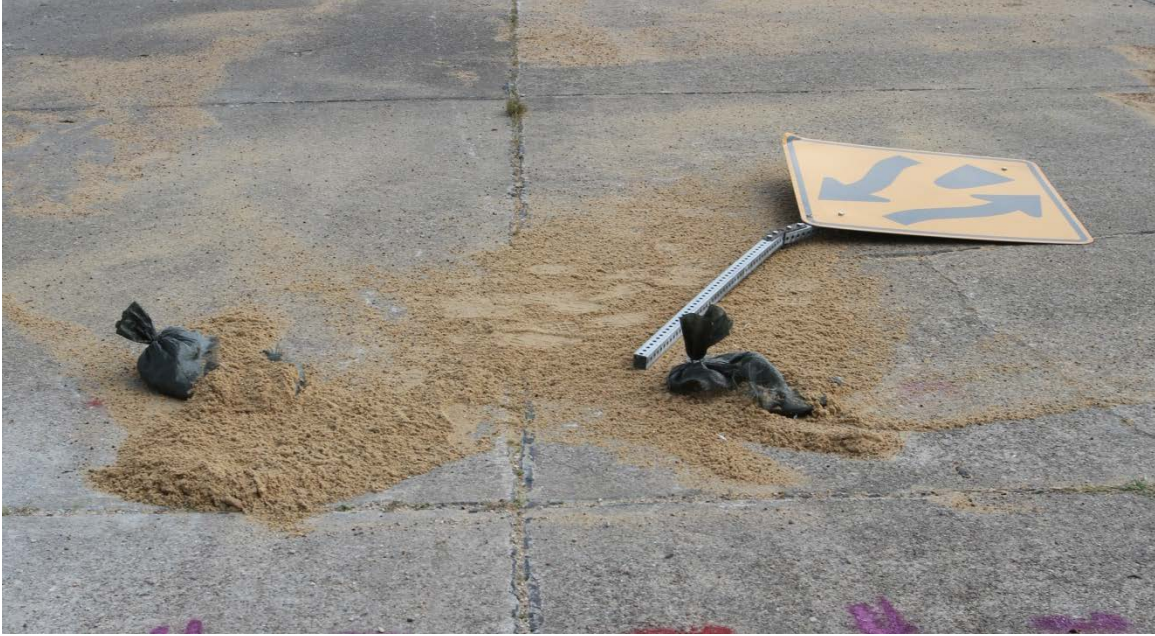
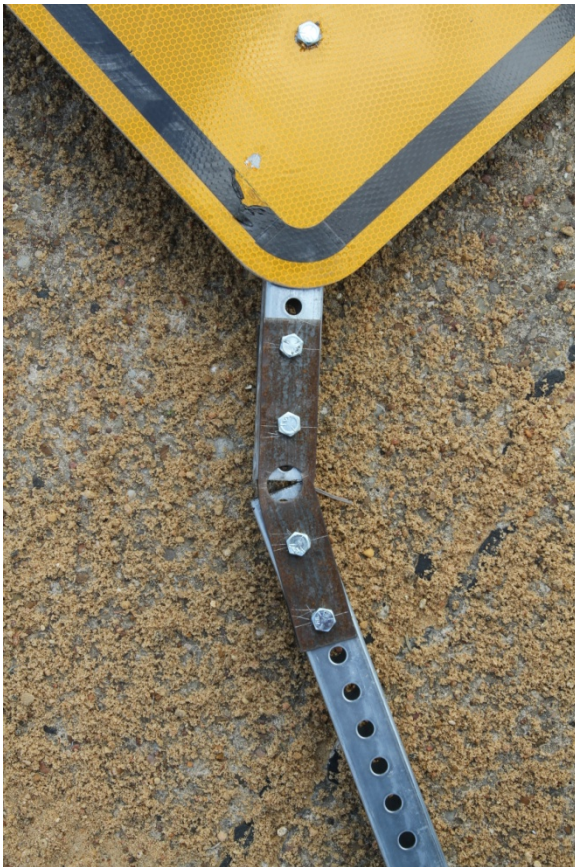
**Figure 4.26. Installation after Test No. 490022-7-3.**

Figure 4.26 shows damage to the sign support system. The lower telescopic slip connection and fuse plates activated as designed. The support post and sign assembly came to rest only a few inches downstream of the impact point. The base assembly was resting 225 ft downstream of the impact point, underneath the vehicle body.

Results: The temporary sign support activated readily by yielding to the vehicle and through activation of the slip connection. The fuse plates fractured on their tensile sides as designed. (PASS)

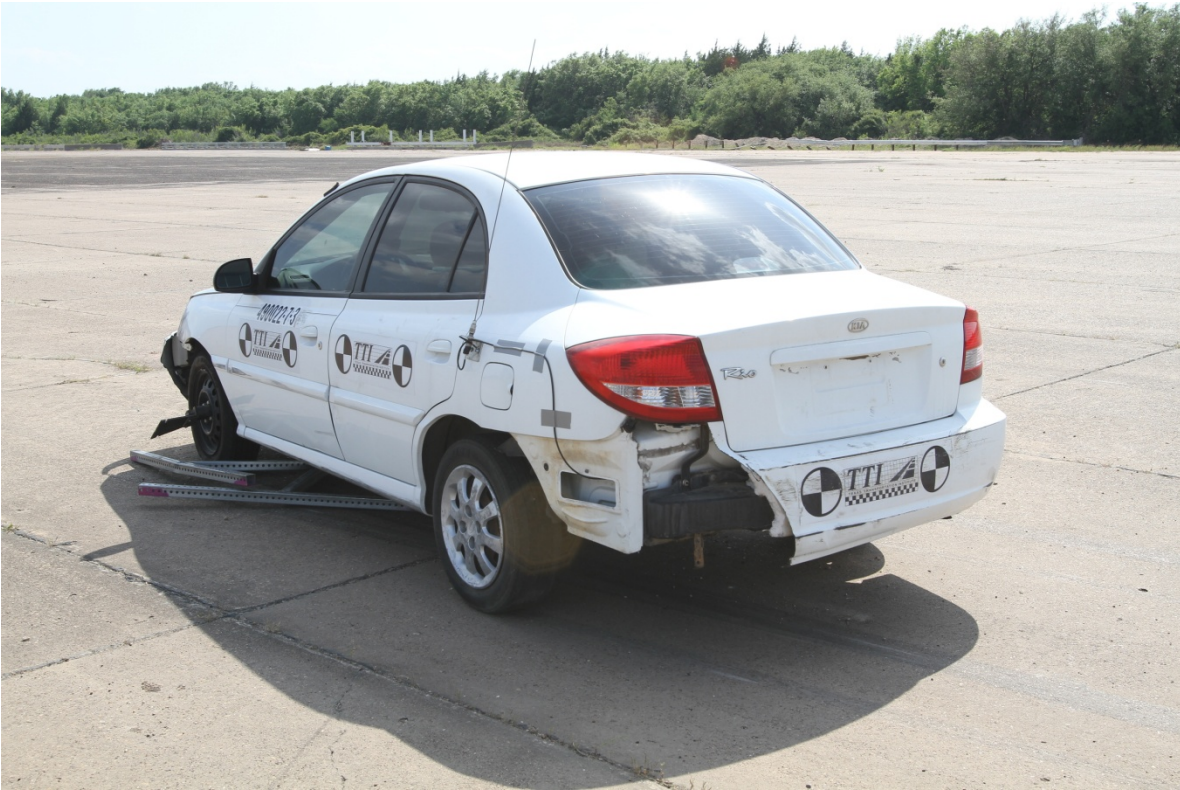
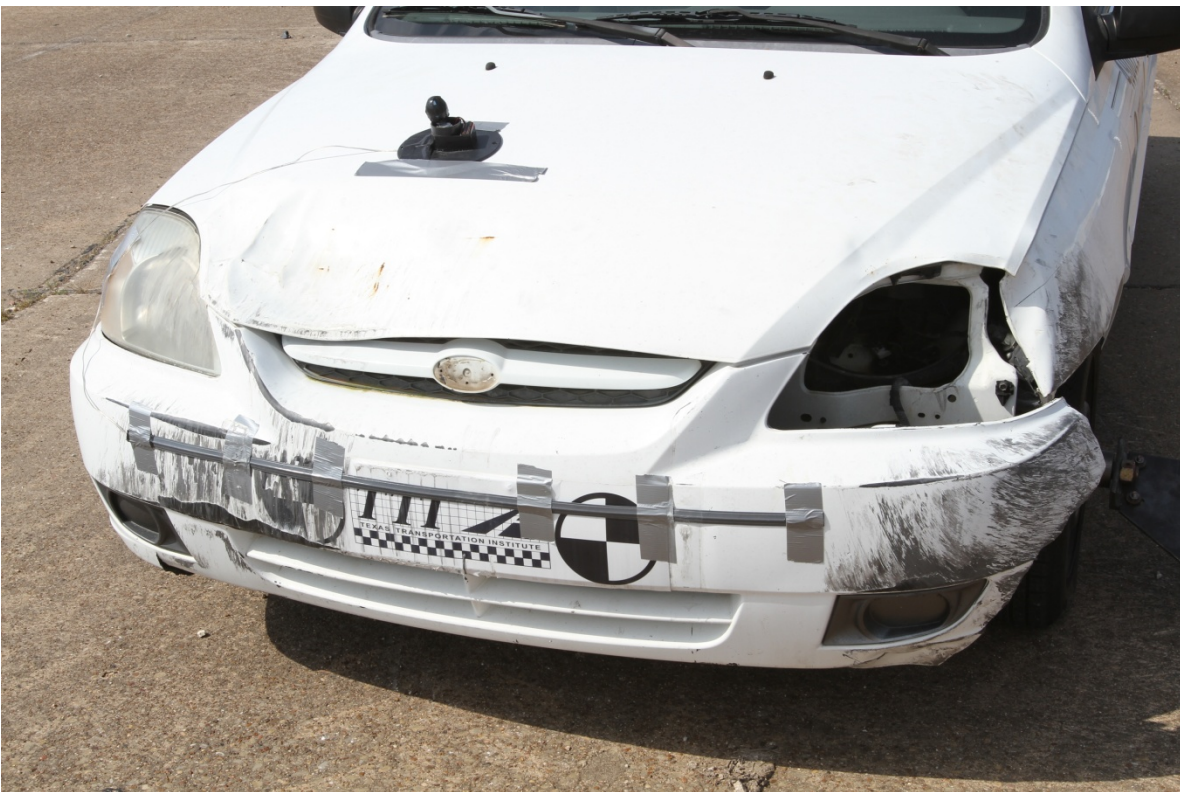
**Figure 4.27. Vehicle after Test No. 490022-7-3.**

The 1100C vehicle did not sustain any additional damage during the impact with the temporary single sign support. Figure 4.27 shows photographs of the exterior of the vehicle.

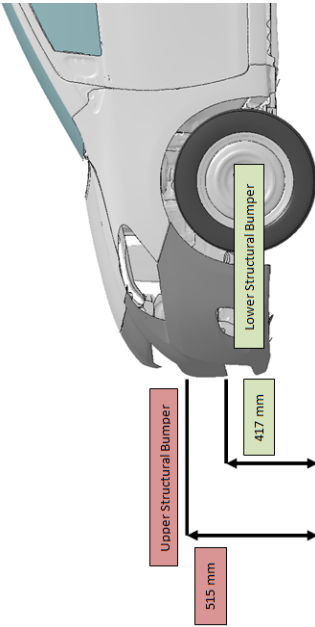
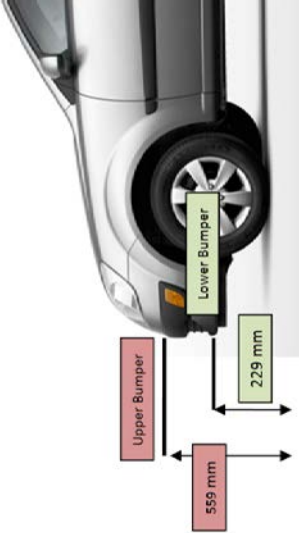
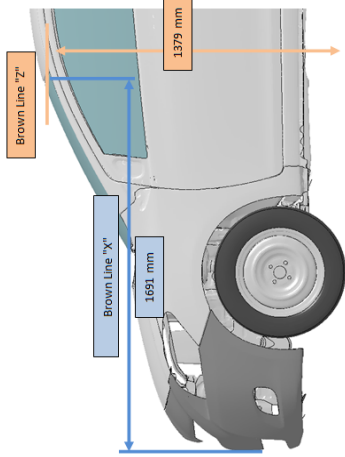
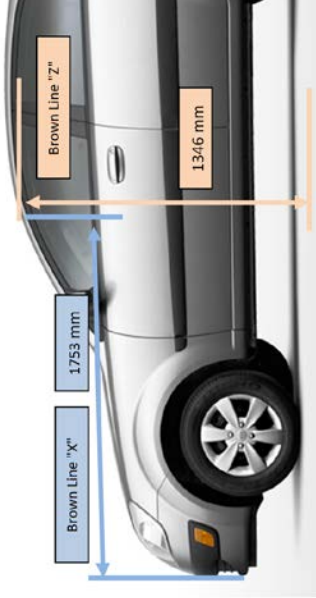
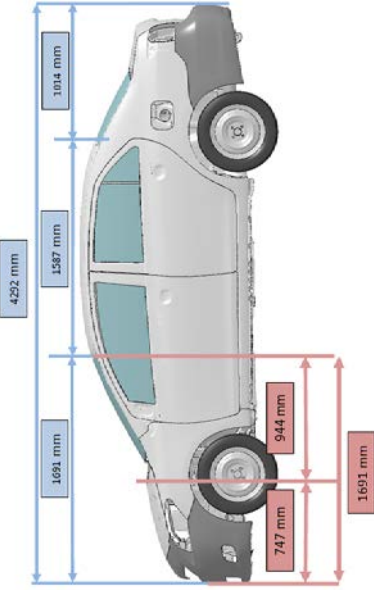
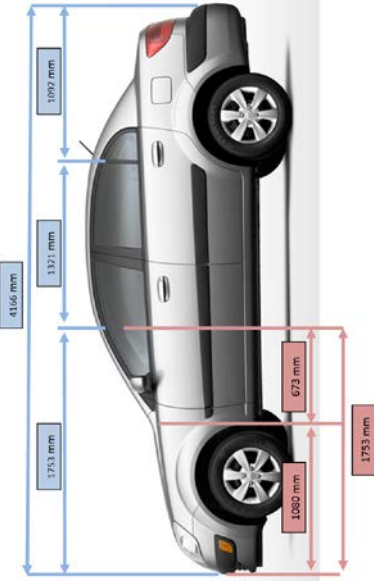
Figure 5.1. Dimensions Comparison between Toyota Yaris FE Model and Kia Rio Test Vehicle.

| Vehicle | Toyota Yaris | Kia Rio |
|---|--|---|
| <p><b>Bumper Dimensions</b></p> | <p>Upper Structural Bumper: 515 mm<br/>Lower Structural Bumper: 417 mm</p> | <p>Upper Bumper: 559 mm<br/>Lower Bumper: 229 mm</p> |
| <p><b>Brow Line Dimensions</b></p> | <p>Brown Line "X": 1691 mm<br/>Brown Line "Y": 1379 mm</p> | <p>Brown Line "X": 1753 mm<br/>Brown Line "Z": 1346 mm</p> |
| <p><b>General Dimensions</b></p> | <p>1691 mm, 4292 mm, 1587 mm, 1014 mm, 747 mm, 944 mm, 1691 mm</p> | <p>1753 mm, 1080 mm, 673 mm, 1753 mm, 1753 mm, 1321 mm, 1092 mm, 6166 mm</p> |

Figures 5.1 and 5.2 illustrate the finite element models of the small passenger car (Toyota Yaris) and the pickup truck (Chevrolet Silverado) used in the computer simulations performed during this project, and compares them to the actual vehicles used in the full-scale crash tests (i.e., Kia Rio and Dodge Ram 1500 pickup, respectively). The analyses were performed using the nonlinear finite element software LS-DYNA (9).
