# Development and *MASH* Full-Scale Crash Testing of a High-Mounting-Height Temporary Single Sign Support with Aluminum Sign

**Test Report No. 9-1002-12-5**

TEXAS A&M TRANSPORTATION INSTITUTE  
THE TEXAS A&M UNIVERSITY SYSTEM  
COLLEGE STATION, TEXAS

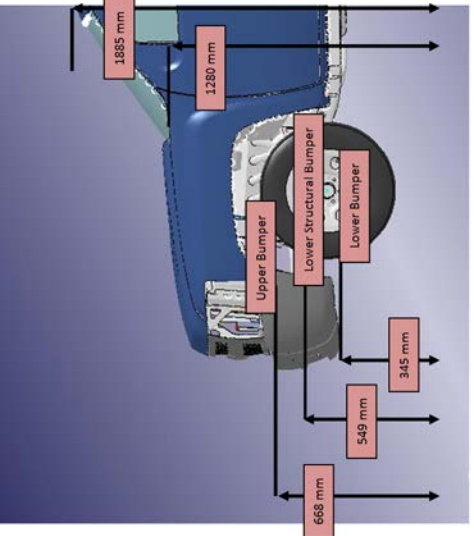
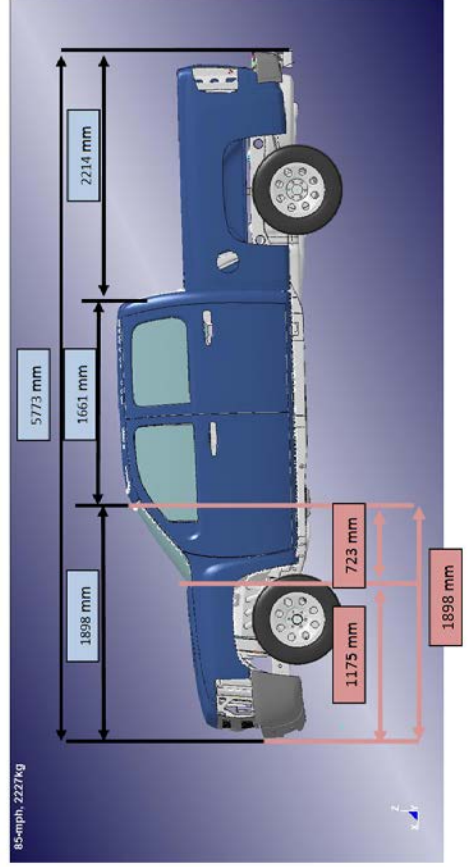
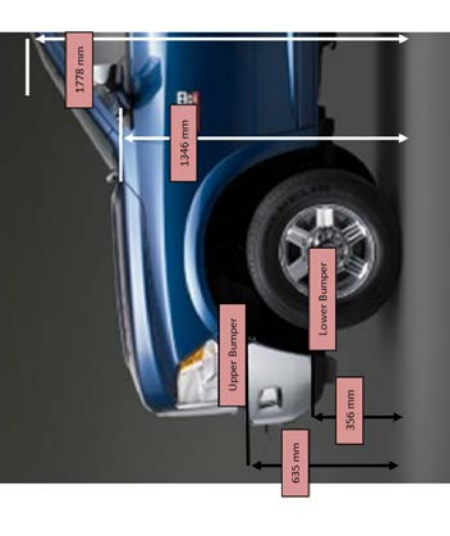
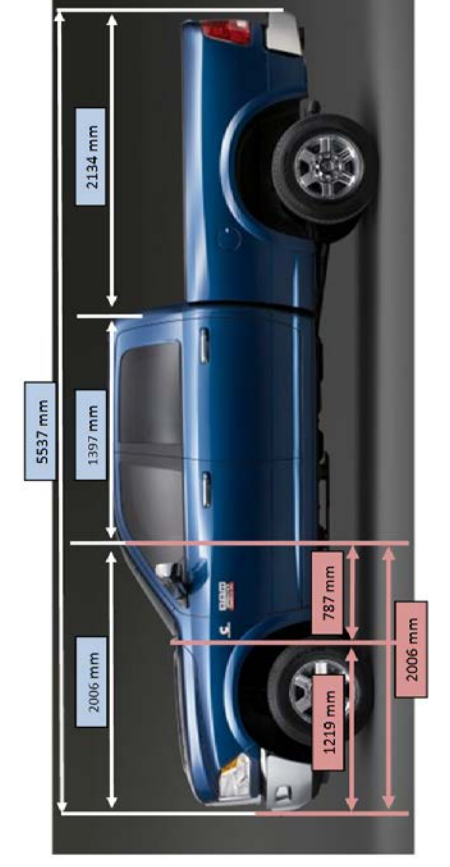
Figure 5.2. Dimensional Comparison between the Chevrolet Silverado FE Model and the Dodge Ram Test Vehicle.

| Vehicle | Bumper Dimensions | General Dimensions |
|---|---|---|
| Chevrolet Silverado | <p>Diagram showing bumper dimensions for the Chevrolet Silverado. The upper bumper is 1885 mm high. The lower bumper is 668 mm high. The lower structural bumper is 549 mm high. The lower bumper is 345 mm high. The wheel well height is 1280 mm.</p> | <p>Diagram showing general dimensions for the Chevrolet Silverado. The wheelbase is 1898 mm. The front overhang is 1175 mm. The rear overhang is 723 mm. The total length is 5773 mm. The wheel track is 1661 mm. The wheel offset is 2214 mm. The vehicle weight is 2227 kg and it is rated for 85 mph.</p> |
| Dodge Ram | <p>Diagram showing bumper dimensions for the Dodge Ram. The upper bumper is 1778 mm high. The lower bumper is 635 mm high. The wheel well height is 1246 mm. The lower bumper is 356 mm high.</p> | <p>Diagram showing general dimensions for the Dodge Ram. The wheelbase is 2006 mm. The front overhang is 1219 mm. The rear overhang is 787 mm. The total length is 5537 mm. The wheel track is 1397 mm. The wheel offset is 2134 mm.</p> |

Figures 5.1 and 5.2 illustrate the finite element models of the small passenger car (Toyota Yaris) and the pickup truck (Chevrolet Silverado) used in the computer simulations performed during this project, and compares them to the actual vehicles used in the full-scale crash tests (i.e., Kia Rio and Dodge Ram 1500 pickup, respectively). The analyses were performed using the nonlinear finite element software LS-DYNA (9).

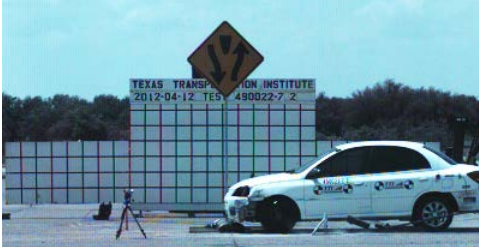
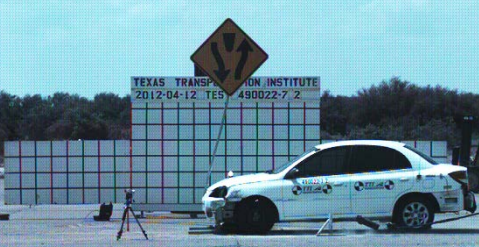
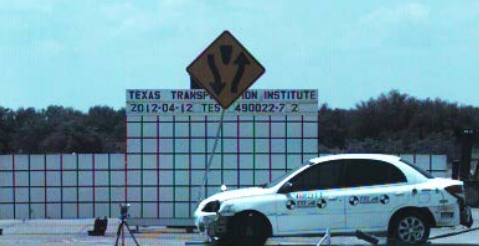
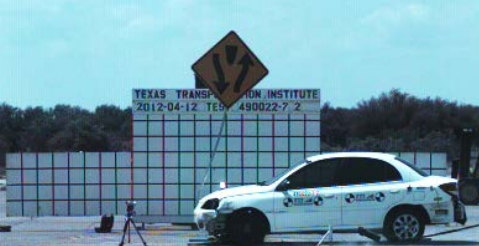
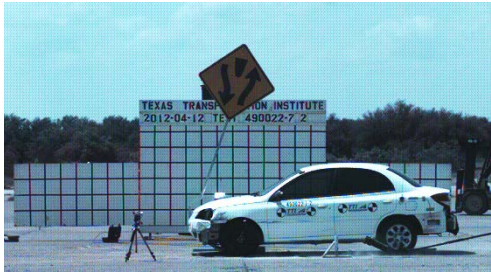
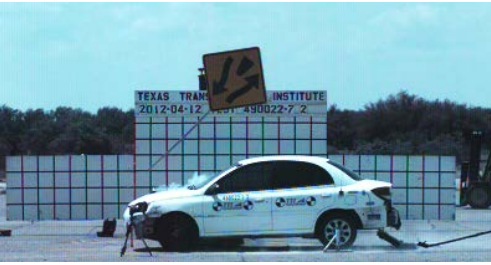
**Table 5.1. Comparison of 490022-7-2 Crash Test and FE Impact Simulation with Passenger Car (Yaris).**

| Time (sec) | 490022-7-2 Crash Test | FE Simulation |
|--|---|--|
| Middle Post Leaves Lower Telescopic Connection (0.019 sec) | | (0.018 sec) |

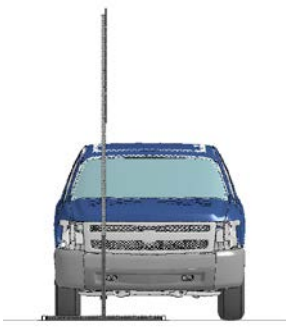
| Impact Configurations | | Initial Impact Conditions |
|---|--|---|
| | | <ul style="list-style-type: none"> <li>➤ Impact Speed: 62.4 mph</li> <li>➤ Impact Angle: 90 degrees</li> <li>➤ Impact Location: right quarter point from vehicle's centerline (passenger's side)</li> </ul> |

**Figure 5.6. Initial Configuration for Finite Element Impact Simulation with *MASH 2270P* Vehicle (Design #4).**

The impact performance of the selected temporary single sign support system (Design #4) with the 2270P pickup truck was evaluated using FE simulation. Figure 5.6 shows the initial simulation setup of the finite element model of the temporary single sign support and pickup truck. The impact speed was 62.4 mph, and the sign panel was oriented at 90 degrees. The initial impact location the right quarter point of the vehicle aligned with the centerline of the sign support. Figure 5.7 shows the interaction between the sign support system and the pickup truck vehicle model during the simulation. The simulation predicts contact of the corner of the sign panel with the windshield of the pickup truck. This interaction is likely to result in unacceptable occupant compartment deformation.

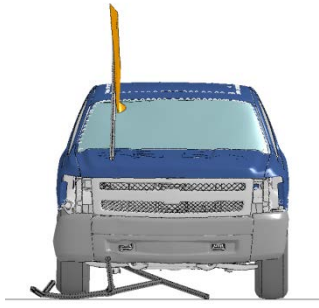
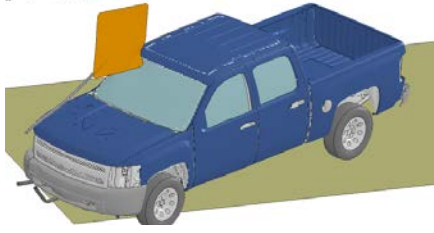
**Figure 5.7. Predicted Windshield Impact in Finite Element Simulation with *MASH 2270P* Vehicle (Design #4).**

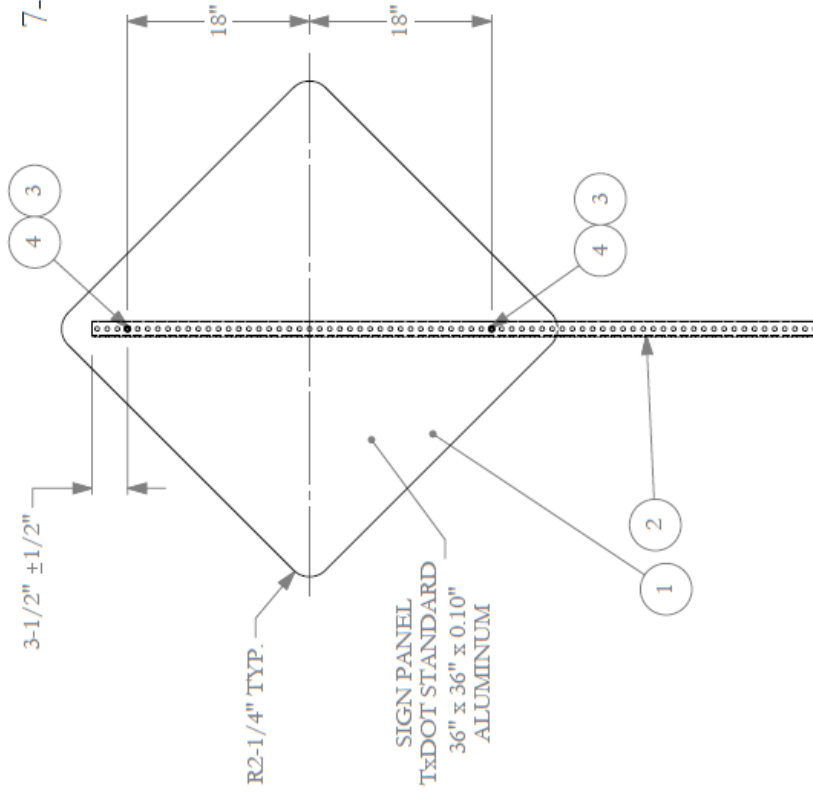
7-2 SIGN ASSEMBLY

Figure 5.10. Details of Design Modification #1 to Temporary Single Sign Support System – Sign Assembly.

The purpose of raising the height of the slip connection was to release the sign panel at a greater height and, thereby, avoid impacting the windshield. Figures 5.9 to 5.11 show details of the modified design.

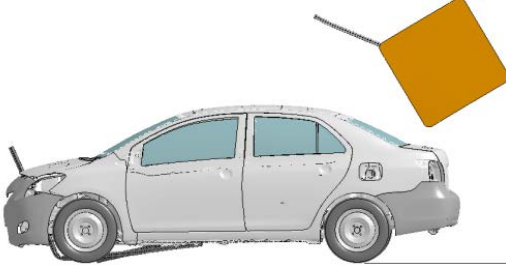
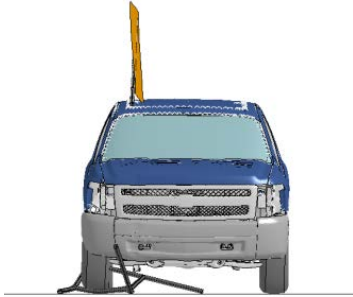
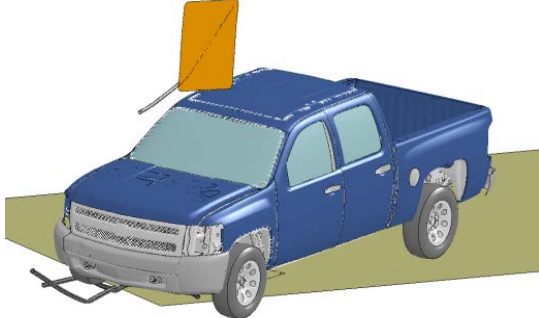
**Figure 5.14. Predicted Outcomes of Finite Element Simulations with (a and b) *MASH* 1100C and (c and d) *MASH* 2270P Vehicles (Design Modification #1).**

The FE simulation did not predict any second impact between the released sign support assembly and the 1100C vehicle (see Figure 5.14 (a and b)). However, although contact with the windshield was avoided, secondary contact between the sign support assembly and the roof was predicted in the simulation with the 2270P vehicle (see Figure 5.14 (c and d)). Figures 5.15 and 5.16 show the energy balance for the 1100C and 2270P simulations, respectively. Hourglass and sliding interface energy values remained under 5 percent for both simulations. Table 5.3 compares the sign support trajectory for the 1100C and 2270P vehicle simulations.

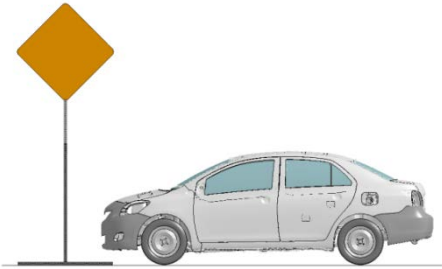
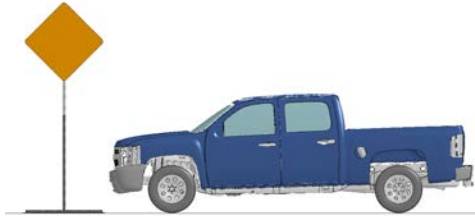
| Initial Configurations | | Initial Impact Conditions |
|---|--|---|
| | | <ul style="list-style-type: none"> <li>➤ Impact Speed: 62.0 mph</li> <li>➤ Impact Angle: 90 degrees</li> <li>➤ Impact Location: right quarter point from vehicle's centerline (passenger's side)</li> </ul> |

**Figure 5.21. Initial Configuration for the Finite Element Simulation with (a and b) *MASH* 1100C and (c and d) *MASH* 2270P Vehicles (Design Modification #2).**

Figure 5.20 shows the finite element model of Design Modification #2. Figure 5.21 shows the initial simulation setup for both the 1100C and 2270P vehicles impacting Design Modification #2 at 62.2 mph and 90 degrees. These impact conditions correspond to MASH tests 3-71 and 3-72, respectively. The initial impact location for each simulation was the right quarter point of the vehicle aligned with the centerline of the sign support system.

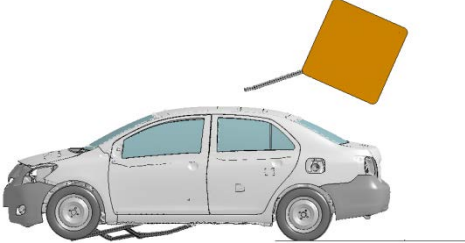
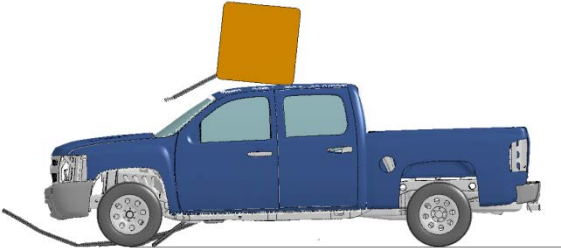
**Figure 5.22. Predicted Outcomes of Finite Element Simulations with (a and b) *MASH* 1100C and (c and d) *MASH* 2270P Vehicles (Design Modification #2).**

| <b>Final Configurations</b> | |
|---|--|
| <b>(a) Frontal View – 1100C Vehicle</b> | <b>(b) Lateral View – 1100C Vehicle</b> |
| <b>the Frontal View – 2270P Vehicle</b> | <b>(d) Perspective View – 2270P Vehicle</b> |

The FE simulation did not predict any second impact between the released sign support assembly and the 1100C vehicle (see Figure 5.22 (a and b)). However, although contact with the windshield was avoided, secondary contact between the sign support assembly and the roof was predicted in the simulation with the 2270P vehicle (see Figure 5.22 (c and d)). Figures 5.23 and 5.24 show the energy balance for the 1100C and 2270P simulations, respectively. Hourglass and sliding interface energy values remained under 5 percent for both simulations. Table 5.4 compares the sign support trajectory for the 1100C and 2270P vehicle simulations.

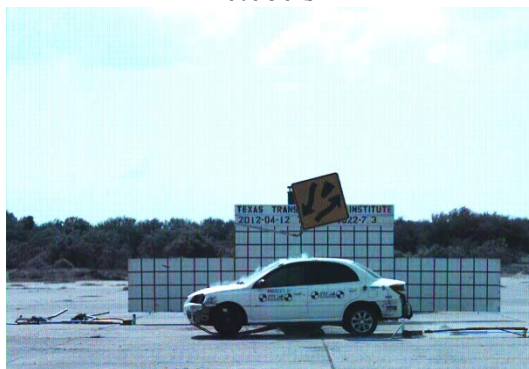
0.090 s

**Figure E1. Sequential Photographs for Test No. 490022-7-3  
(Perpendicular View).**

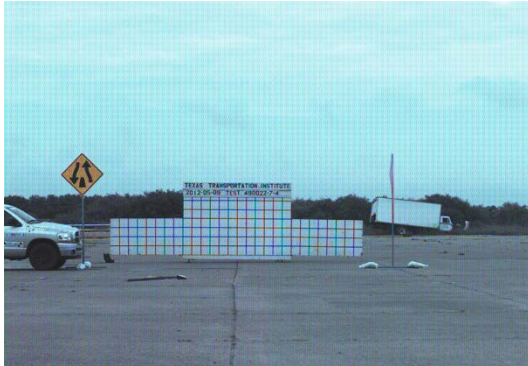
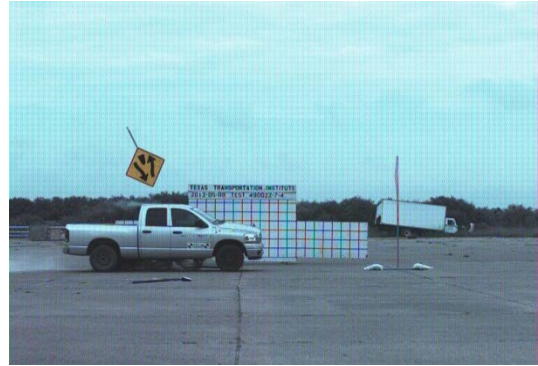
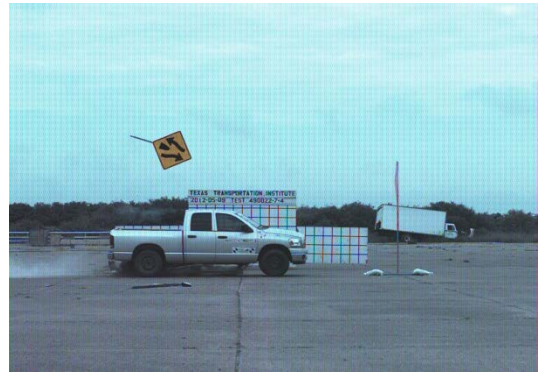
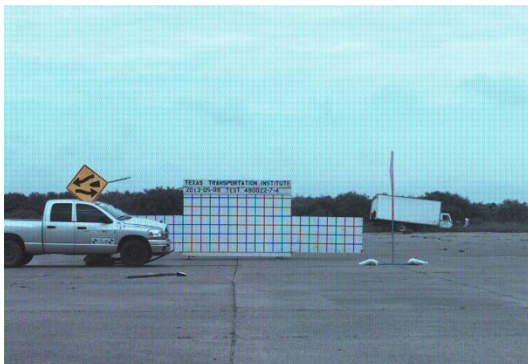
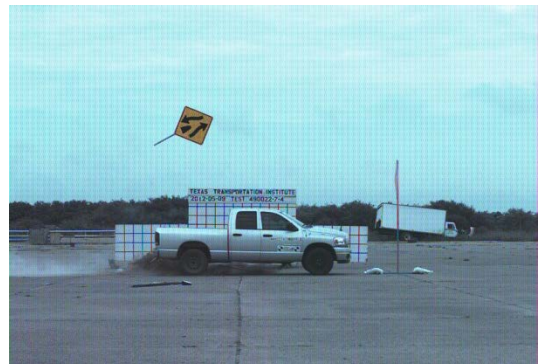
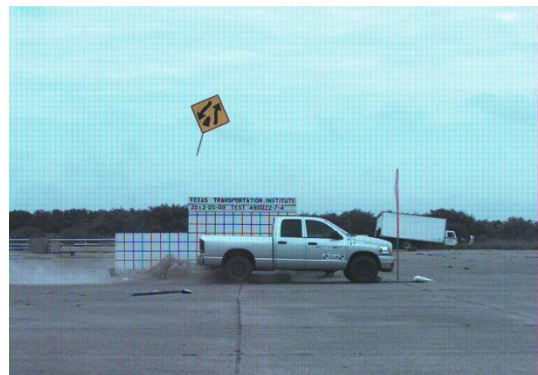
**Figure F1. Sequential Photographs for Test No. 490022-7-4/90-Degree Impact (Perpendicular View).**

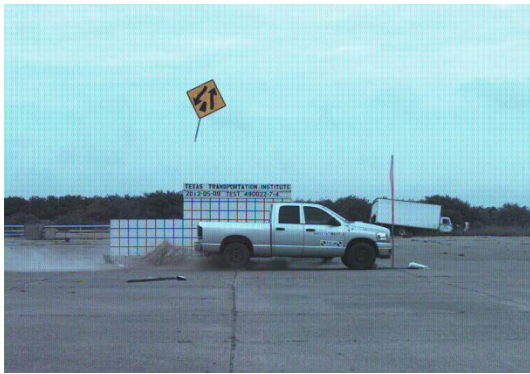
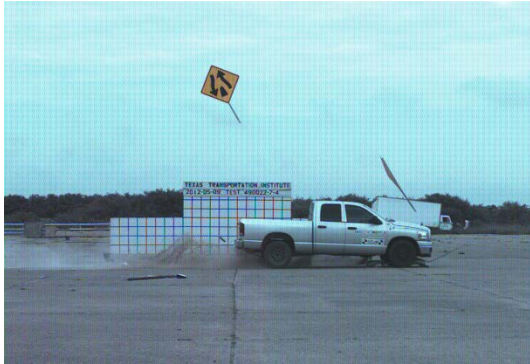
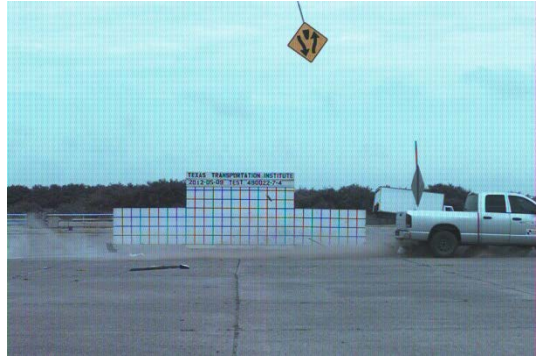
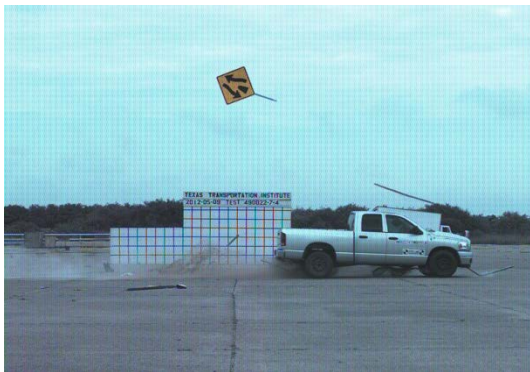
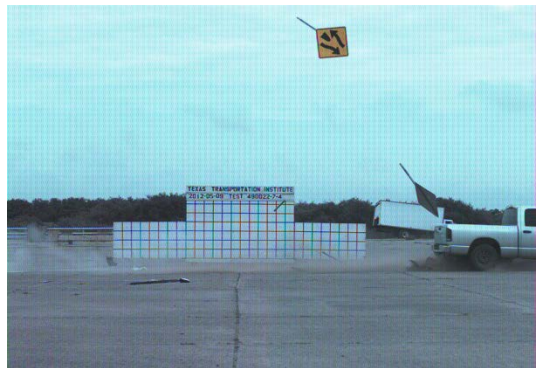
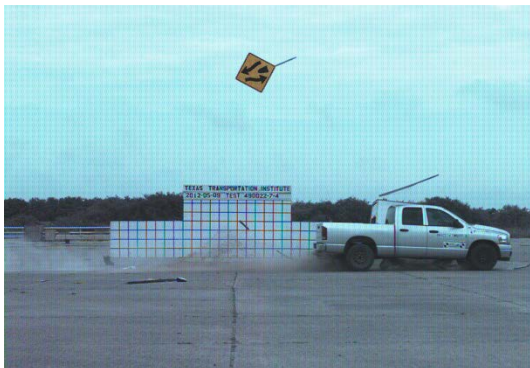
**Figure F2. Sequential Photographs for Test No. 490022-7-4/0-Degree Impact (Perpendicular View).**
