**FINAL REPORT**

**BEST PRACTICES FOR QUALITY MANAGEMENT OF STORMWATER PIPE  
CONSTRUCTION**

FDOT Contract Number BDK75-977-56

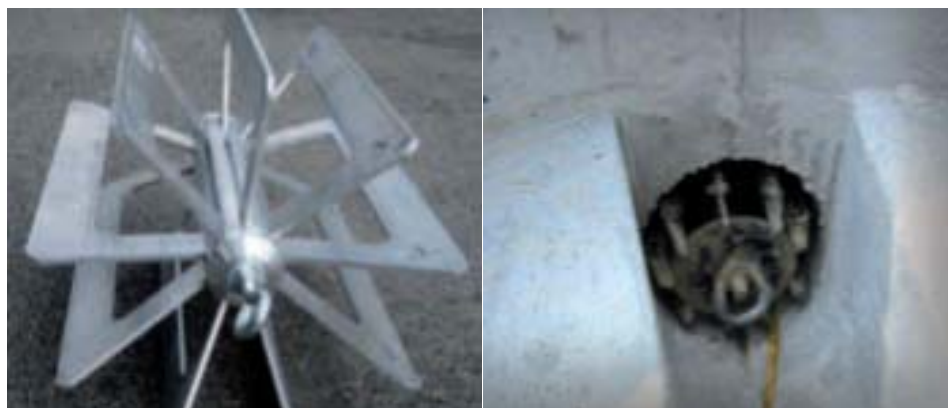
As a precursor to laser profiling, mandrels provided a much more primitive method for verifying ovality and locating deflections along a pipeline. A mandrel is a round apparatus that is driven through the interior of a pipe in order to verify that the pipe meets the minimum size requirements and contains no major obstructions to flow (RedZone 2011). The mandrel is slightly smaller than the required internal diameter of the pipe, and this difference in size corresponds to a proportional percent variance that is acceptable in the pipe size. If a mandrel does not successfully pass through the inner workings of a pipeline, the inspection is unsuccessful. A picture of a mandrel by itself, and in operation, is shown in Figure 2-3.

**Figure 2-2: Image of Pipe Mandrel by Itself and within a Pipeline**  
*(from the Ontario Concrete Pipe Association)*

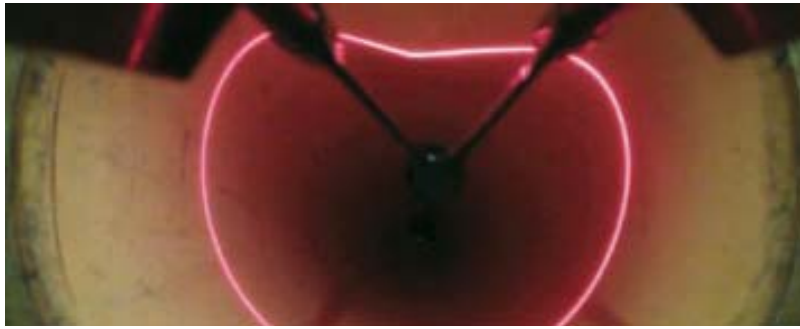
With respect to the laser profiling systems, the process can be performed in one of two ways: by laser ring or by point cloud. As the name implies, the laser ring method entails projecting a laser ring along the interior of the pipe culvert, just ahead of the CCTV camera. As the mechanism travels along the pipe invert, a laser ring is projected perpendicular to the longitudinal axis and any defects in the overall shape of the pipe are recorded both visually and digitally. A picture of a laser ring projected onto the interior wall of a pipe is shown in Figure 2-5 – note the inverted curve of the ring at the top of the pipe.

**Figure 2-4: Laser Ring Profiler**  
(from *Maverick Inspection Ltd.*)

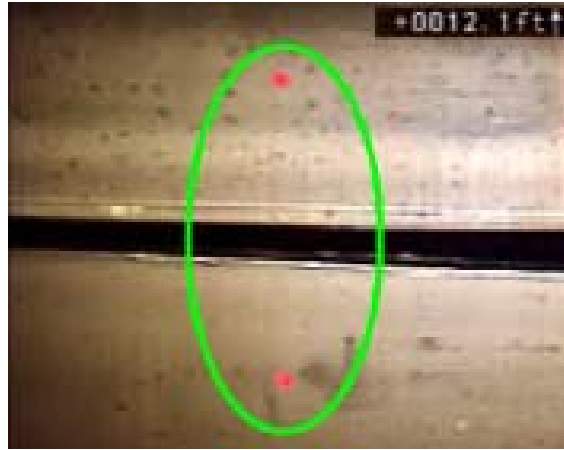
A video micrometer, typically attached or built into a laser profiling setup, consists of two parallel lasers. These lasers are spaced apart at a known distance, and they function as a reference point when measuring the required defect. Proper measurement of a pipe defect necessitates proper alignment of the CCTV mechanism. Using the image as a guide, an operator must maneuver the recording device so that the image and respective laser beams are perpendicular to the longitudinal axis of the pipe. When an image of the defect and the two laser points is properly captured on the screen, a ratio can be established between the screen image pixilation and the known reference distance between the two lasers. With this corresponding value, the profiling software can then calculate the corresponding defect measurement.

It is imperative that the two lasers form a  $90^\circ$  angle with the pipe to ensure there is no skewing of the laser lines. If the lasers are not exactly perpendicular to the defect surface, the corresponding defect measurement will be incorrect. Accounting for this likelihood of operator error, some video micrometer manufacturers offer an H-beam laser. As the name implies, the image produced by an H-beam laser resembles the letter H. The purpose of this particular shape is to verify on video if the laser is truly perpendicular to the defect – as a slight angle difference will cause an obvious visible distortion of the H-beam. Looking at Figures 2-9 and 2-10, one can compare the images of a two-point laser system with that of an H-beam laser system.

**Figure 2-8: Measurement of a Joint Gap with a Video-Micrometer – Using Two Laser Beams**  
*(from C-Tec Presentation)*

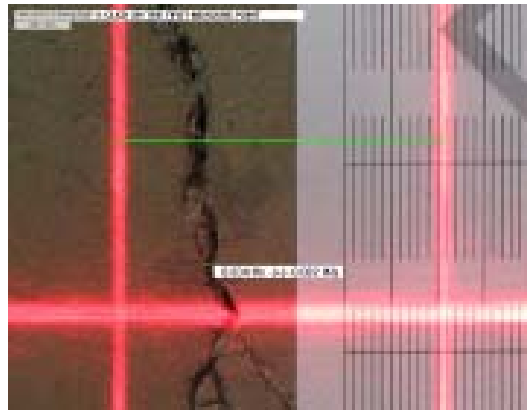
**Figure 2-9: Measurement of a Crack with a Video-Micrometer – Using an H-Laser Pattern**  
*(from C-Tec Presentation)*

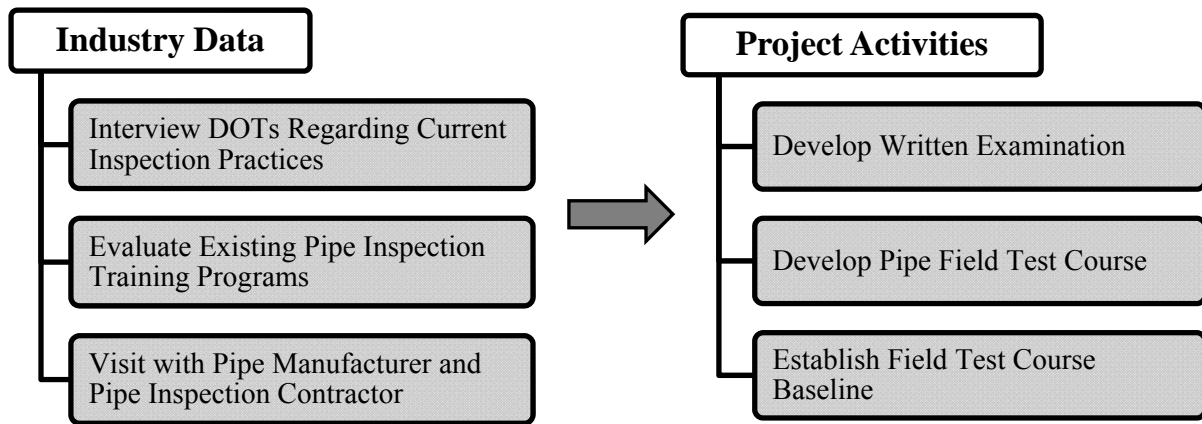
A synthesis of the industry was necessary to establish Florida’s standing in the use of laser profiling equipment for the inspection of post-installation pipe culverts. Moreover, an evaluation of the current practice in pipe culvert inspection was deemed essential in gauging the overall industry culture. As illustrated in Figure 3-1, input from all levels of the pipe inspection industry were essential in establishing key project activities. Regulating agencies, existing certifying organizations, pipe manufacturers and inspection contractors alike would provide the data in which to frame the basis for the written exam, field test course and baseline.

**Figure 3-1: Influence of Industry Data on Project Activities**

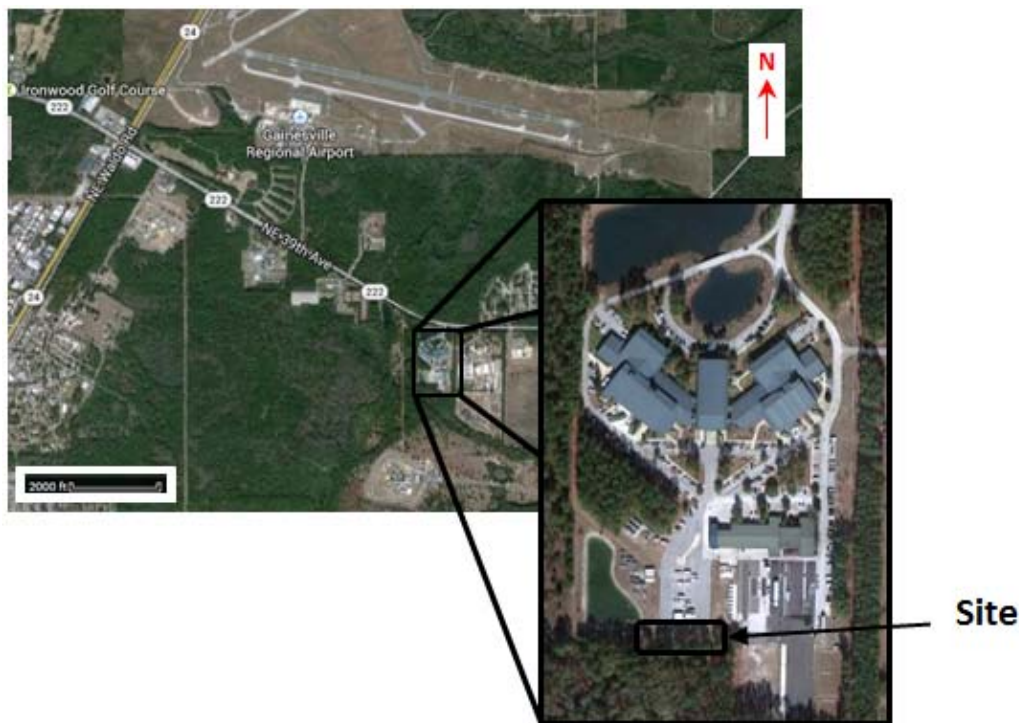
The research team met with key individuals from the FDOT State Materials Office (SMO) to establish an ideal location for the pipeline field test course. After discussing potential sites available to the research team, it was decided that setting up on the southernmost part of the SMO site was most convenient for accessibility. Figure 3-2 shows the designated area set aside by the SMO for the development of the field test course – located far enough away from existing testing facilities to prevent disturbance and still within access to the road for material delivery.

**Figure 3-2: SMO Site Map for Pipeline Field Test Course**

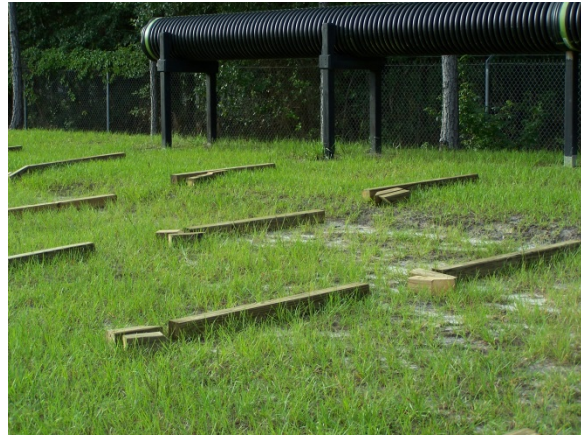
Once delivered onsite, pipe segments were positioned into place with the use of a 4-ton capacity forklift. Individual pipe segments rested on 4-foot pieces of 4"x4" lumber, with chocks to keep them in place. Figures 3-3 to 3-9 illustrate the positioning of pipe material.

**Figure 3-4: Lumber Supports and Chocks**

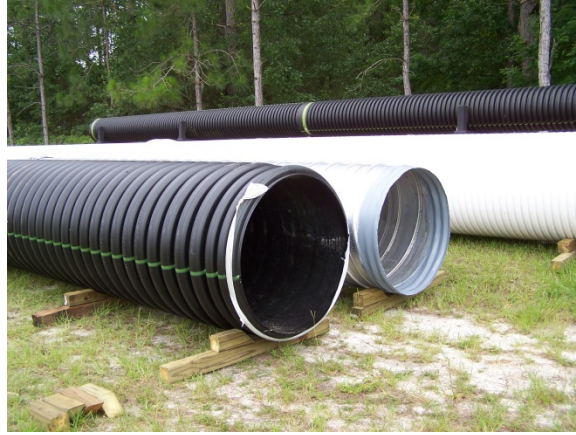
**Figure 3-9: Positioned PVC, CMP, and HDPE Pipes**

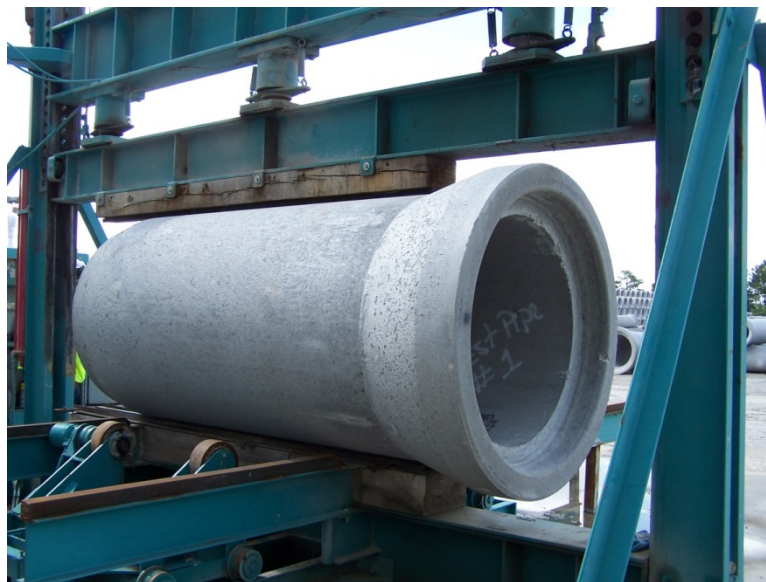
Prior to delivery of the RCP segments, suppliers introduced crack defects on four of the five segments by means of a three-edge bearing test device (Figure 3-10). The pipe segments were loaded until the development of hairline fractures was observed, and in some cases until failure occurred. This ensured a distribution of both “negligible” and “more substantial” cracks (Figures 3-11 and 3-12), illustrating situations that were both common-place and extreme for pipe culvert installation inspection.

**Figure 3-10: Introduction of Cracks on RCP by Means of Three-Edge Bearing Test Device**

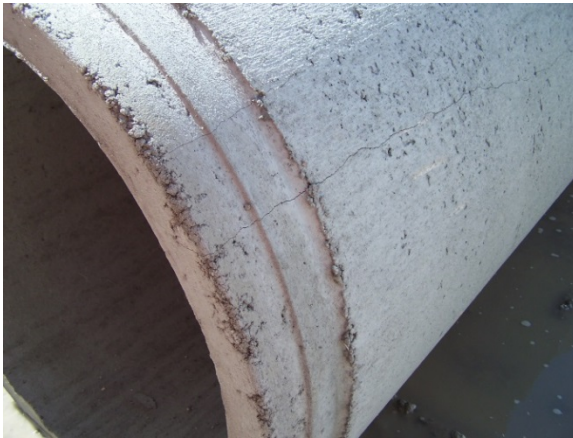
**Figure 3-11: Hairline Crack on RCP**

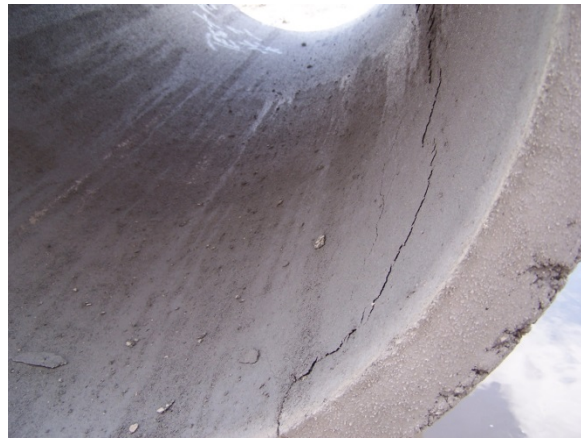
**Figure 3-12: Larger Crack on RCP**

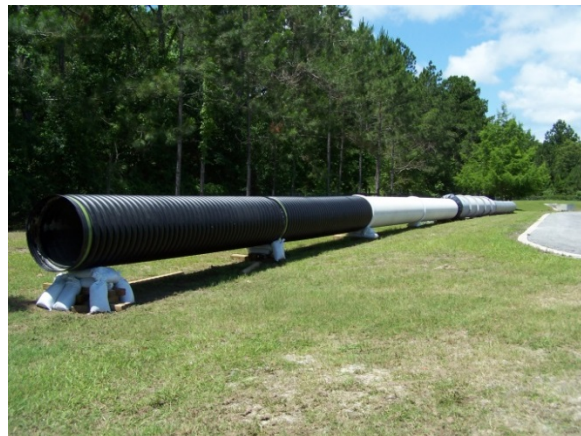
Because of this problem, the preliminary layout of four individual runs was changed a single 164-foot continuous run composed of varying pipe material. Relocation of the entire course, however, was now limited by the inability to move the installed concrete pipe run. Instead, the remaining three pipe runs (PVC, HDPE, and CMP) were relocated to either side of the RCP (Figure 3-13). In moving the pipe segments it was discovered that the terrain to the east of the RCP was at a lower elevation. Sandbags were used to raise individual pipe segments in order to provide a continuous line (Figure 3-14).

**Figure 3-14: Elevated Pipe Course Run**

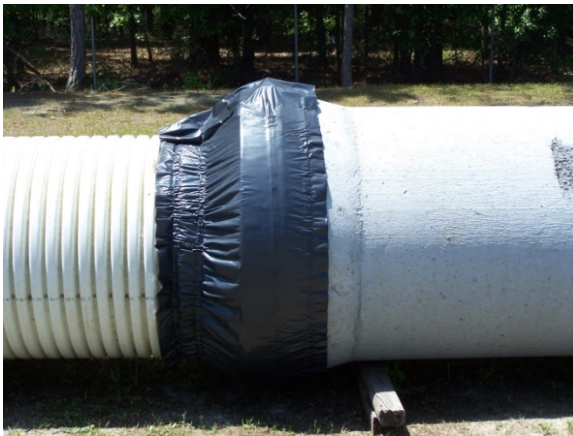
Figures 3-15 and 3-16 show the use of dissimilar pipe coupling material to seal the joints for the PVC-to-RCP and CMP-to-RCP runs. It should be noted that the use of these couplers for the specific dissimilar pipe junctions is not recommended by the coupling material supplier. Because of the extreme difference in outside pipe diameters, these couplers would probably not be used in proper pipe culvert installations.

**Figure 3-15: Dissimilar Pipe Coupler at PVC-to-RCP Junction**

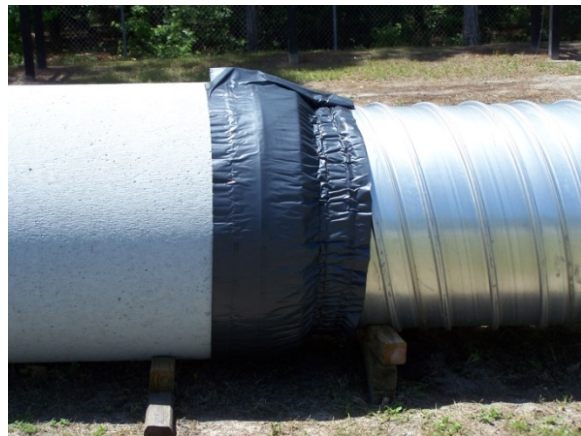
**Figure 3-16: Dissimilar Pipe Coupler at RCP-to-CMP Junction**

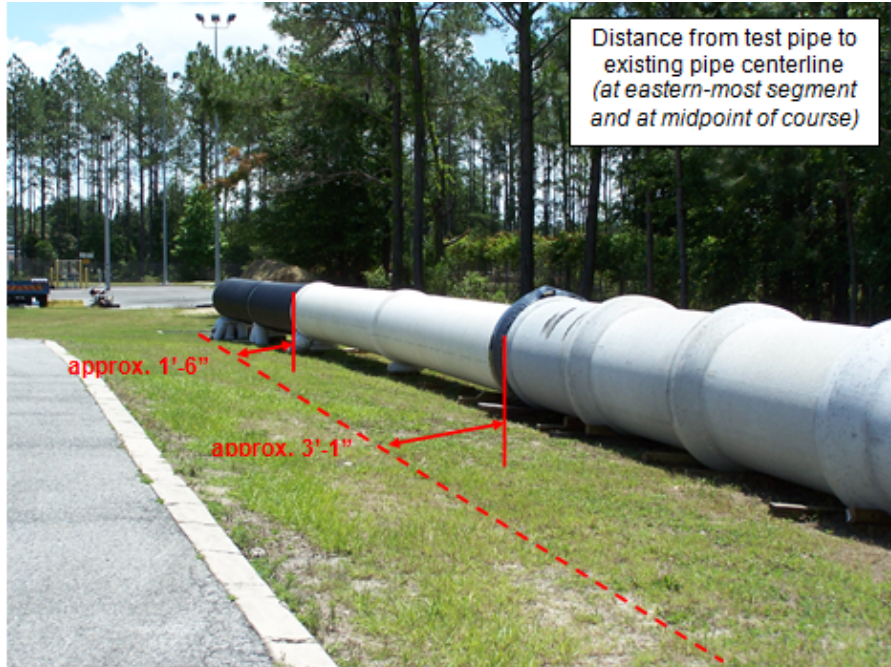
**Figure 3-21: Additional Distances to Existing Drainage Line**

Final dimensions for the tarp framing structure were approximately 6 feet wide by 170 feet long, with maximum and minimum heights of about 5 feet and 7 feet, respectively. Room was provided for easy access alongside the pipe.

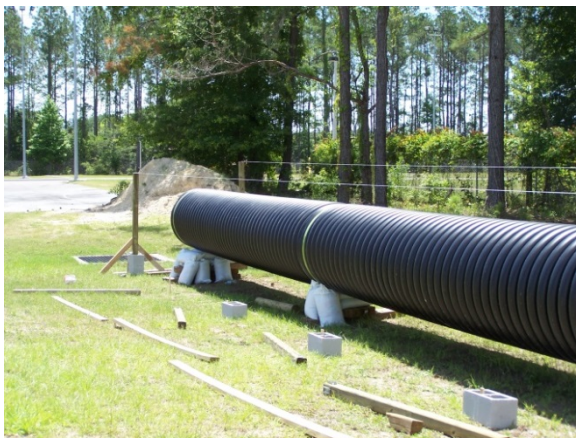
**Figure 3-22: Corner Posts (East End)**

The four corners of the framing structure were located; post locations were staked out; four corner and two mid-point posts were set up; and a line was strung up between the posts. The remainder of the post holes were dug, posts erected, and framing was set up.

Posts that were located directly above, or within close proximity to, the existing drainage pipe were not buried completely underground but instead were supported by cinder blocks filled with concrete. All other posts were buried at a maximum depth of 3 feet. Figures 3-22 to 3-31 illustrate the construction process of the framing structure.

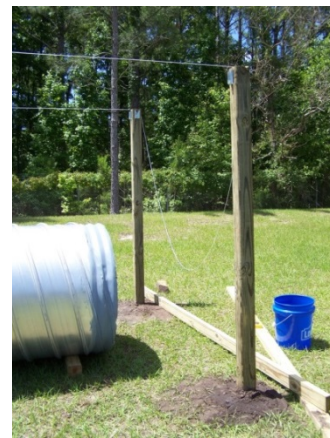
**Figure 3-23: Corner Posts (West End)**

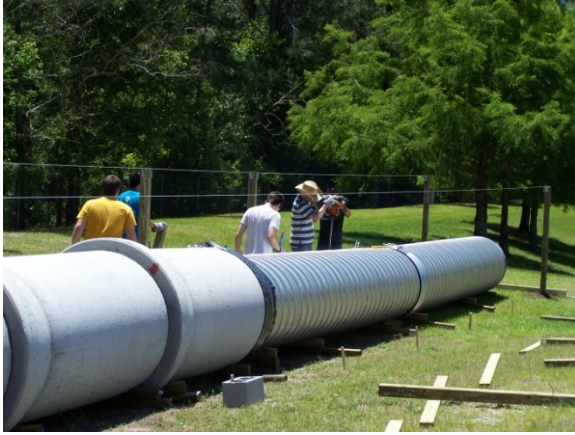
**Figure 3-24: Stringing Line**

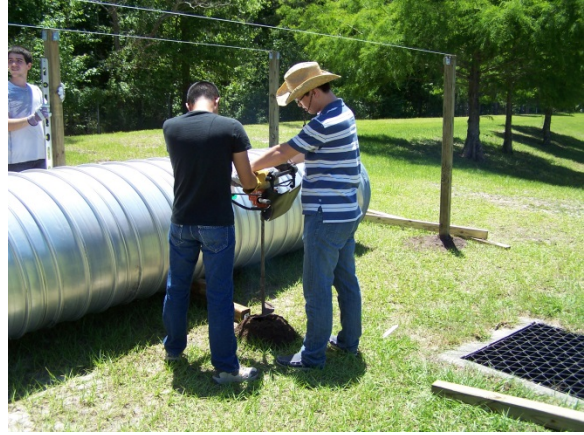
**Figure 3-25: Drilling Post Holes**

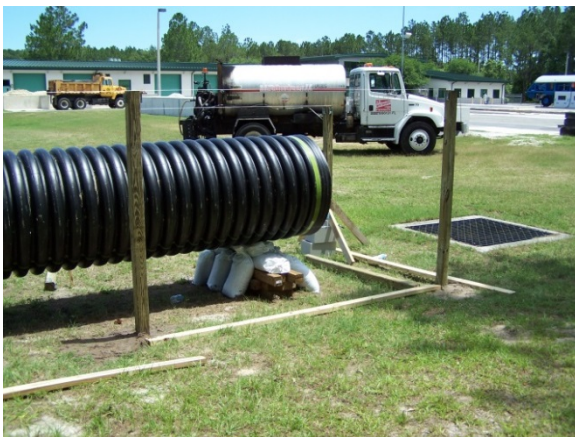
**Figure 3-26: Support Posts**

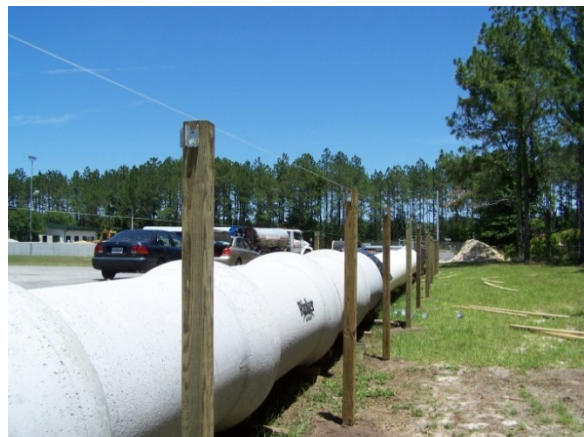
**Figure 3-27: Post Alignment**

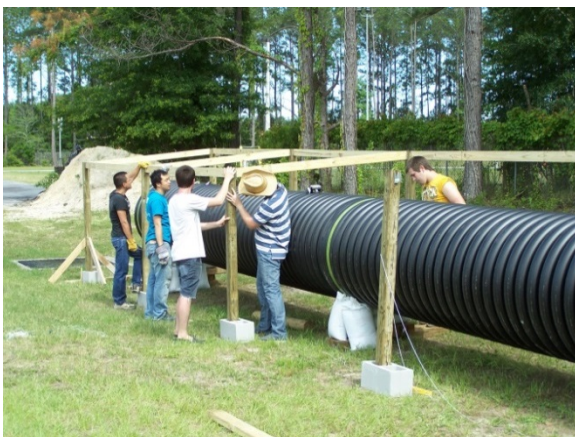
**Figure 3-28: Framing Installation**

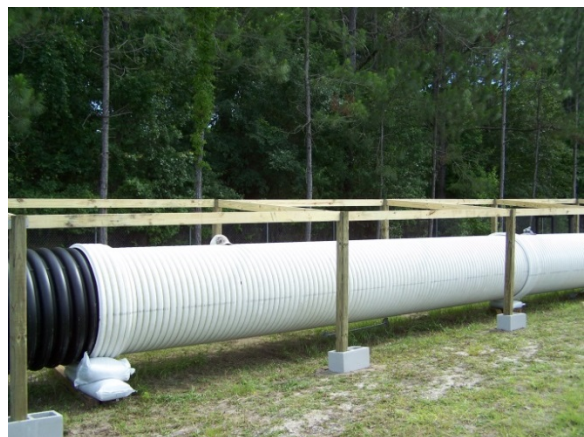
**Figure 3-29: Posts with Cinderblocks**

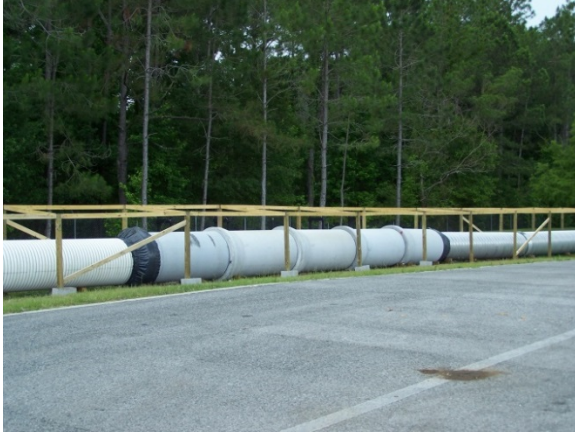
**Figure 3-30: Diagonal Cross-Bracing**

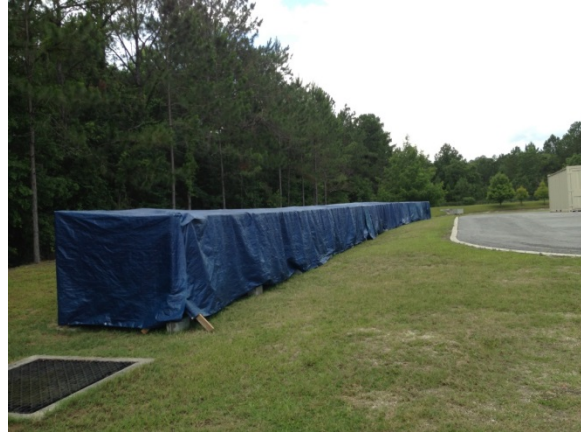
**Figure 3-31: Completed Structure with Tarp**

The course was covered by tarp for two reasons: (1) to prevent the influence of thermal expansion on pipe defects, potentially influencing operator crack measurements; and (2) to conceal the location of pipe defects, potentially influencing operator defect locations.

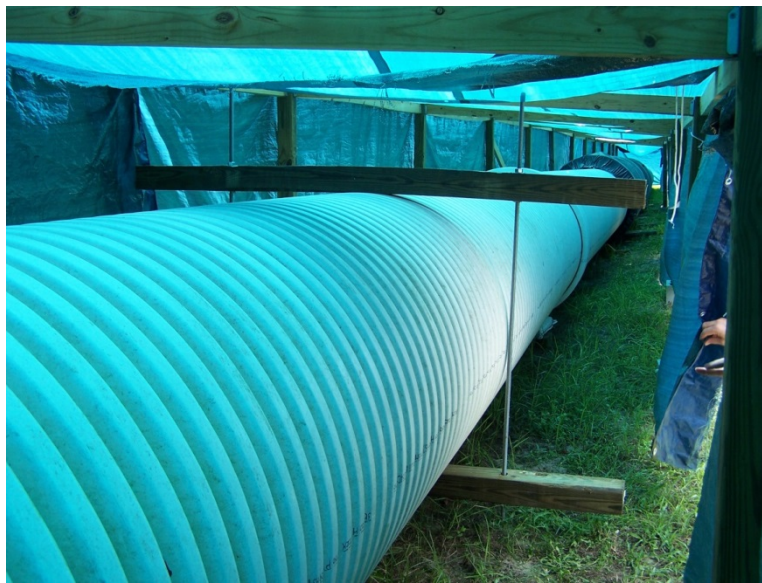
Besides the defects introduced during the assembly process, ovality issues were introduced once the entire course run and framing structure were completed. Deflection vices were created from 4x4 lumber pieces, threaded rods, galvanized hex nuts and washers as shown in Figure 3-32. The devices were tightened in order to produce observable defects within the interior of the pipe.

**Figure 3-32: Deflection Vice on PVC Pipe**

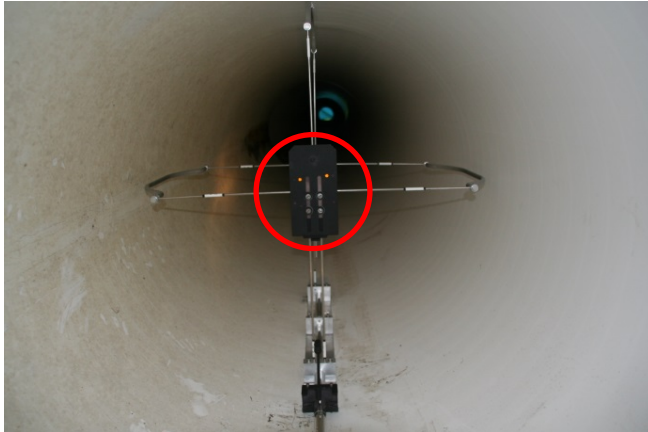
**Figure 3-33: Location before the Deflection Vice**

To ensure the device was “snug” within the confines of the pipe, the end arms were extended to fit a larger sized pipe, thus explaining the presence of two orange reflective dots (circled) at the onset of the test.

These two dots were regarded as a “baseline” and the intent was to observe changes in the number of reflective dots.

A pipe deflectometer was used to verify the presence and severity of pipe ovality as a result of the deflection vices. The deflectometer fits inside the pipe and is guided through with the use of attachable extension rods. The deflectometer can be adjusted to fit within different pipe sizes, and as such, spring-loaded mechanisms on the end arms of the device will rest flush with the inner walls of the pipe. As the deflectometer travels the length of the pipe, any variations in the inner diameter of the pipe (exclusively in either the X- or Y-direction) will be displayed by the presence of reflective dots on the faceplate, and the number of dots revealed correlates to the percentage of pipe ovality exceeding the 5% allowed per FDOT specifications – each reflective dot denotes a decrease in the pipe inner diameter by approximately  $\frac{1}{4}$  inch. Figures 3-33 to 3-35 illustrate the process by which the device was used to confirm deflection in the pipe.

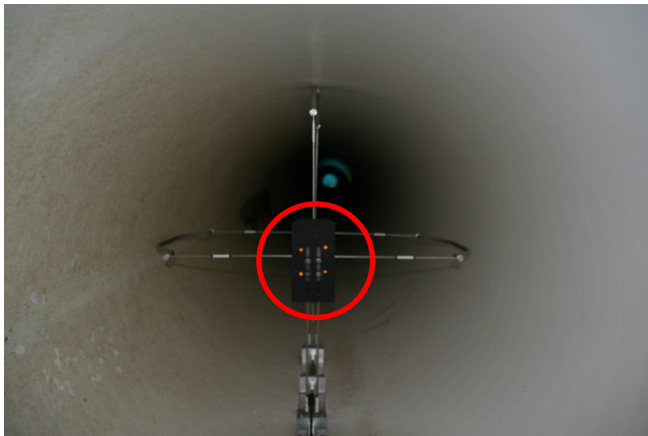
**Figure 3-34: Location at the Deflection Vice**

At the location of the deflection vice there is an observable increase in the number of reflective dots.

Two additional dots were seen for a total of four reflective dots (circled).

The net increase in reflective dots at the location of the deflection vice confirms a total deflection ranging between  $\frac{1}{4}$  to  $\frac{1}{2}$  inch, with each dot at the site of the defect representing approximately  $\frac{1}{4}$  inch change in inner pipe diameter.

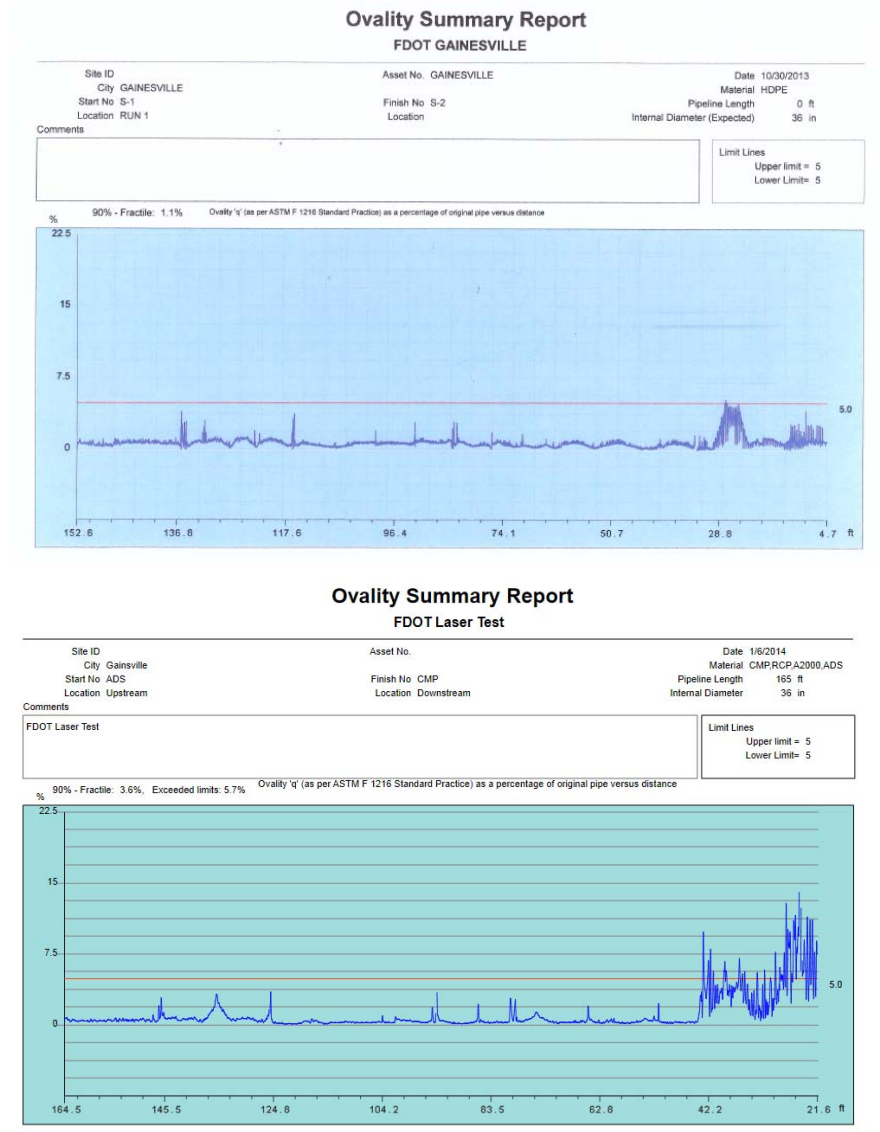
Comparing the content between reports was also revealing. Figure 4-12 shows ovality reports for both American In-Line and Granite Technologies and although the two graphs appear similar (and both use ring-based laser profiling systems) there are a few differences between the graphs. Both graphs appear to show the greatest variance in ovality for the last segment of pipe measured (HDPE). However, there is a notable difference in the magnitude of the values. American In-Line shows the data, on average, falling below the 5% line; however, Granite shows the data, on average, surpassing the 5% line. Since the two graphs present identical scales for the y-axis, there is a possibility that other settings have influenced the output. Profiler settings or software analysis

information could have potentially skewed the results, but without knowing what values were established prior to data processing for the two graphs, we cannot properly assess the reason for the disparity. Attempts to confirm the actual deflection by means of the SMO's pipe deflectometer device were unsuccessful. On two separate occasions, the deflectometer registered pipe deflections exceeding 10%, but when confirmed profiler measurements were taken, the readings came in at under 5%. Faulty design of the deflectometer was suggested but unconfirmed.

**Figure 4-12: Comparison of Ovality Reports between American In-Line (top) and Granite Technologies (bottom)**

Attempting to compare horizontal and vertical deviations Figure 4-13 to the ovality reports in Figure 4-12 illustrates the need for standardization between laser-based system output graphs. While the deviation values are not quite equivalent to pipe ovality,

general trends follow that the HDPE pipe for both reports (on the right for the ovality graphs and on the left for the deviations) show extreme fluctuations.

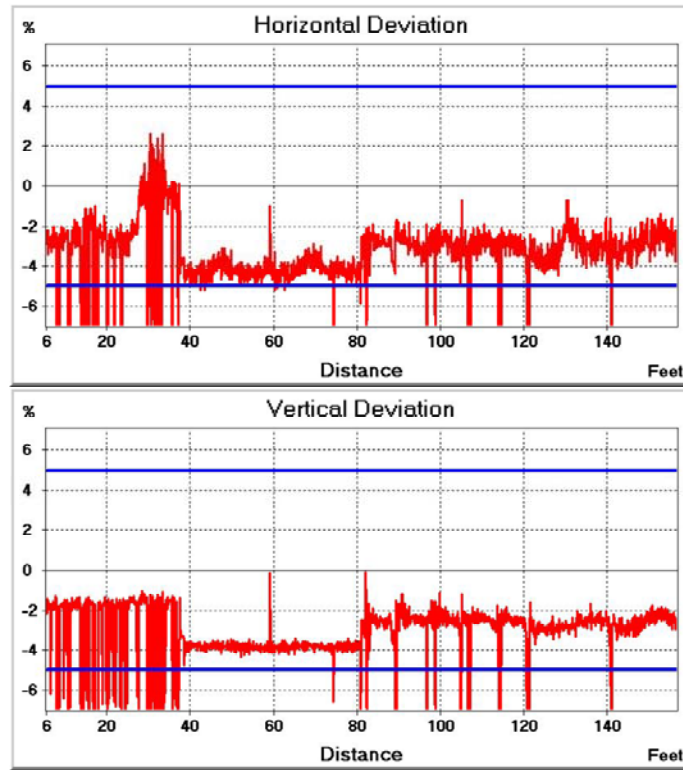
**Figure 4-13: Observation of Horizontal and Vertical Deviations by B&D Enterprises**
