TEMPORARY LARGE GUIDE SIGNS

Test Report 0-6782-1

**TEXAS A&M TRANSPORTATION INSTITUTE
COLLEGE STATION, TEXAS**

TEXAS DEPARTMENT OF TRANSPORTATION

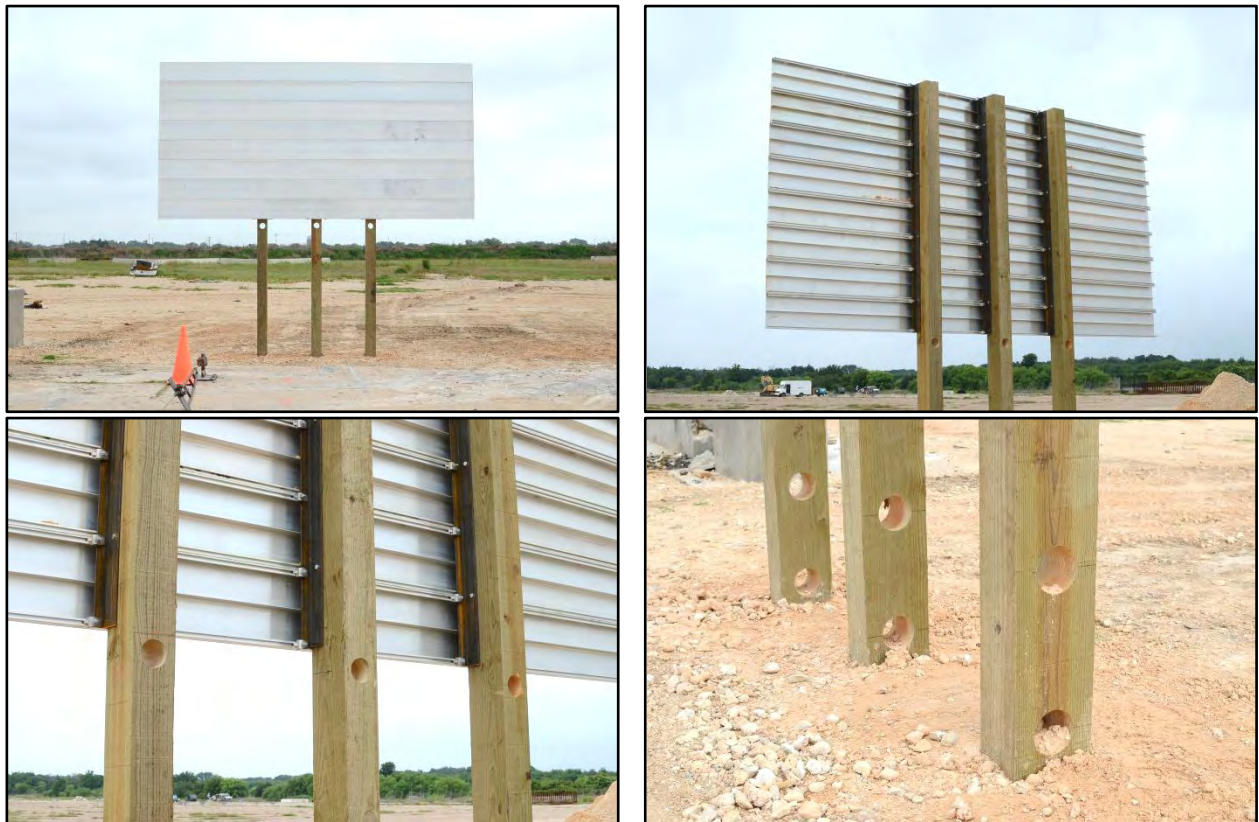
Figure 4.2. Direct Embedded Wood Support Temporary Guide Sign System before Test Nos. 467823-1 and 467823-2.

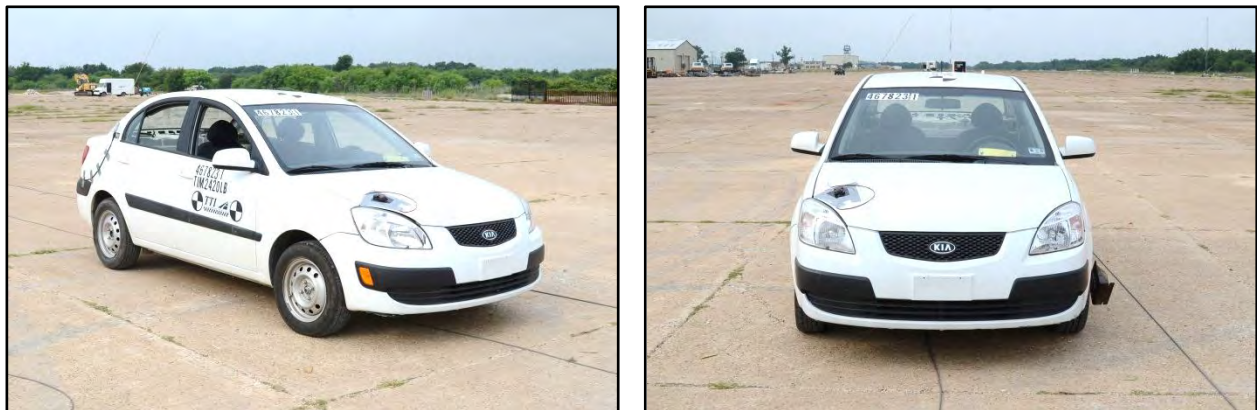
Figure 4.3. Vehicle before Test No. 467823-1.

A 2008 Kia Rio, shown in Figure 4.3, was used for the crash test. Test inertia weight of the vehicle was 2443 lb, and its gross static weight was 2612 lb. The height to the lower edge of the vehicle bumper was 7.12 inches, and it was 21.0 inches to the upper edge of the bumper. Table B1 in Appendix B gives additional dimensions and information on the vehicle. The vehicle was directed into the installation using the cable reverse tow and guidance system and was released to be free-wheeling and unrestrained just prior to impact.

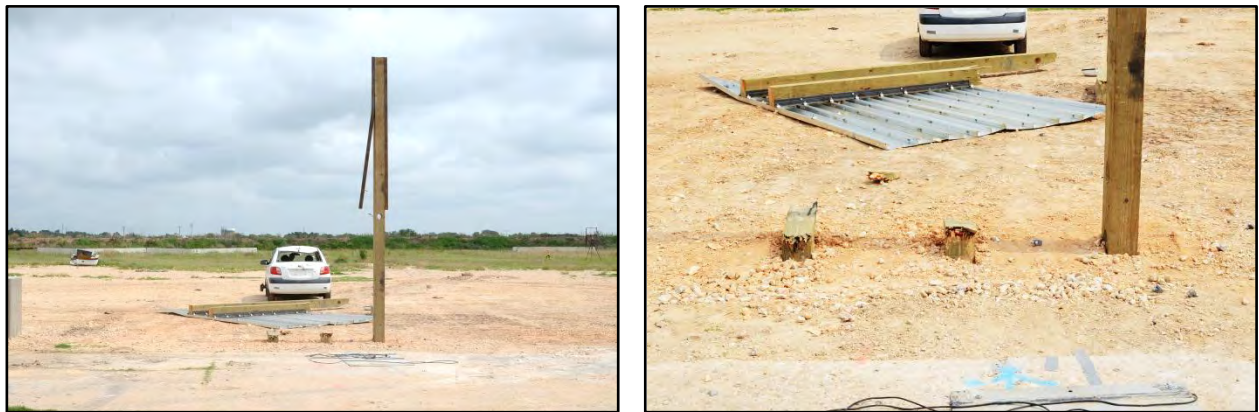
Figure 4.4. Direct Embedded Wood Support Temporary Guide Sign System after Test No. 467823-1.

Figure 4.4 shows damage to the wood post sign support system after the test. The left support leg fractured at the hole near ground level and remained connected to the sign panel. The middle support leg fractured at the hole the hole near ground level and below the sign panel. The upper portion of the middle support leg remained attached to the sign panel. The right support leg remained intact and the soil around the post was only disturbed. The sign panel separated from the right support leg and contacted the roof of the vehicle before coming to rest on the ground.

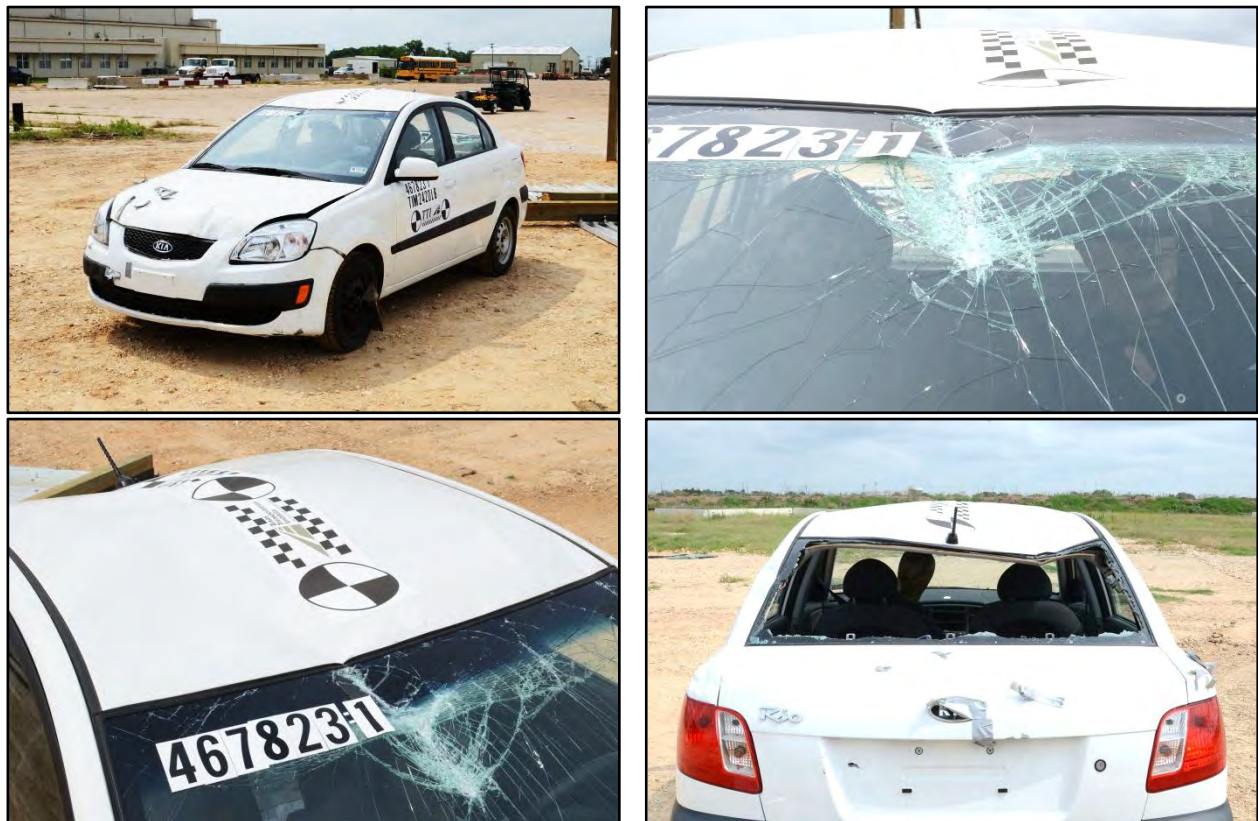
Figure 4.5. Vehicle after Test No. 467823-1.

Figure 4.5 shows the damage sustained by the vehicle during the test, which included the front bumper, hood, windshield, right A-post, roof, left C-post, top of trunk lid, and left rear quarter panel. The hood was deformed 2.0 inches in the front plane just left of centerline of the

vehicle. The windshield shattered over an area of 12 inches \times 16 inches near the top center, and just above this area the roof was pushed downward towards the occupant compartment 1.75 inches. Just right of centerline of the roof over the rear passenger compartment was an area measuring 23 inches \times 24 inches that was deformed downward towards the occupant compartment. Maximum occupant compartment deformation was 3.5 inches in the roof over the right rear occupant compartment. Exterior crush and occupant compartment measurements can be found in Tables B2 and B3 of Appendix B.

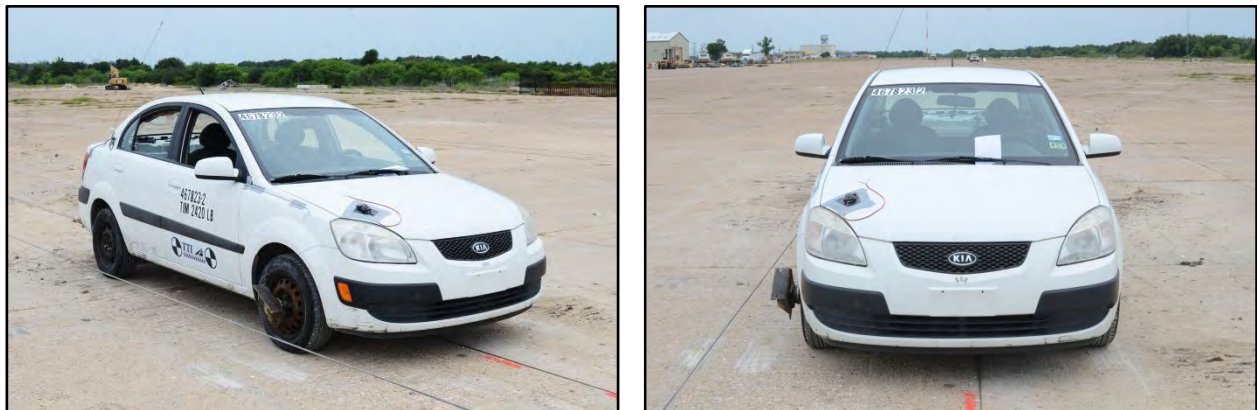
Figure 4.7. Vehicle before Test No. 467823-2.

A 2006 Kia Rio, shown in Figure 4.7, was used for the crash test. Test inertia weight of the vehicle was 2432 lb, and its gross static weight was 2611 lb. The height to the lower edge of the vehicle bumper was 7.12 inches, and the height to the upper edge of the bumper was 21.0 inches. Table C1 in Appendix C gives additional dimensions and information on the vehicle. The vehicle was directed into the installation using the cable reverse tow and guidance system and was released to be free-wheeling and unrestrained just prior to impact.

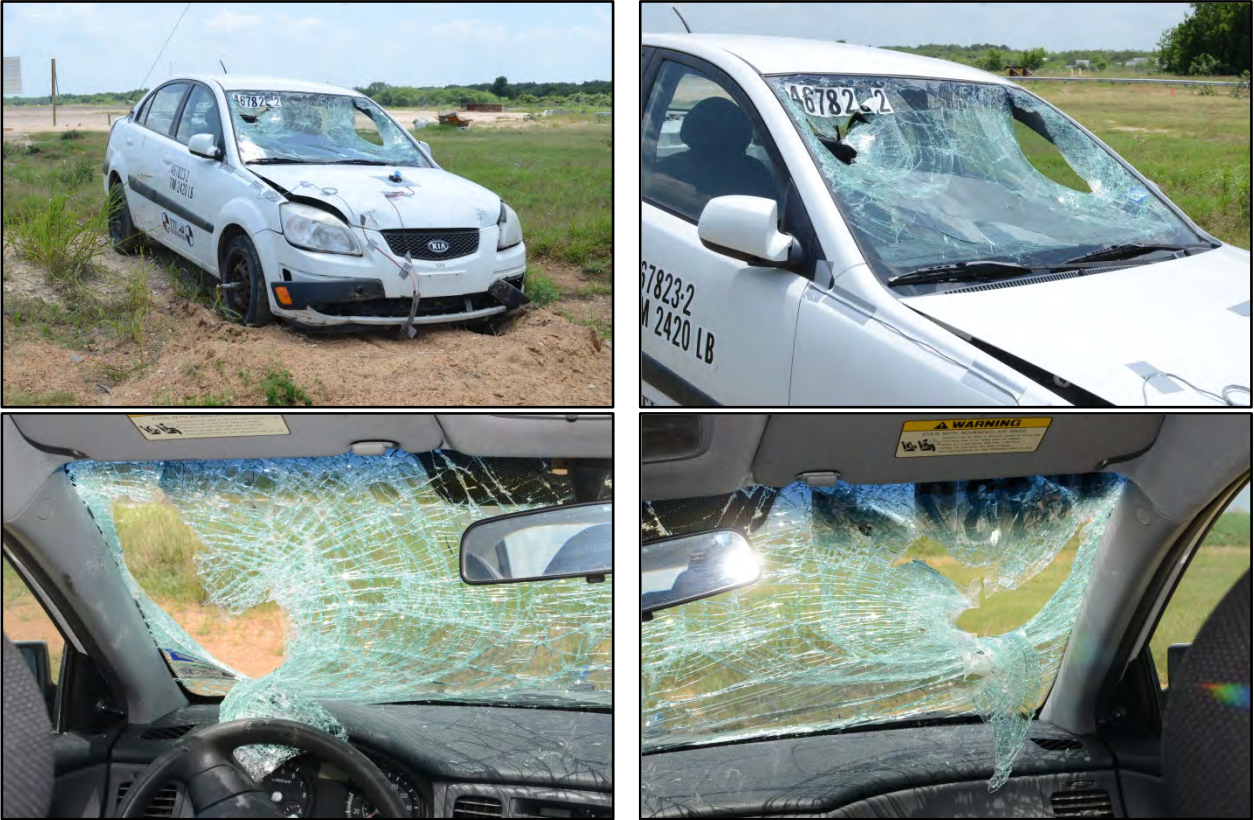
Figure 4.9. Vehicle after Test No. 467823-2.

Figure 4.9 shows the damage sustained by the vehicle during the test, which included the front bumper, hood, and windshield. The front bumper was deformed inward 1.0 inch right of centerline of the vehicle. Both supports penetrated through the windshield and into the occupant compartment. The windshield had two holes: one on the driver side measuring 7 inches × 14 inches and one on the passenger side measuring 7 inches × 8 inches. Exterior crush and occupant compartment measurements can be found in Tables C2 and C3 of Appendix C.

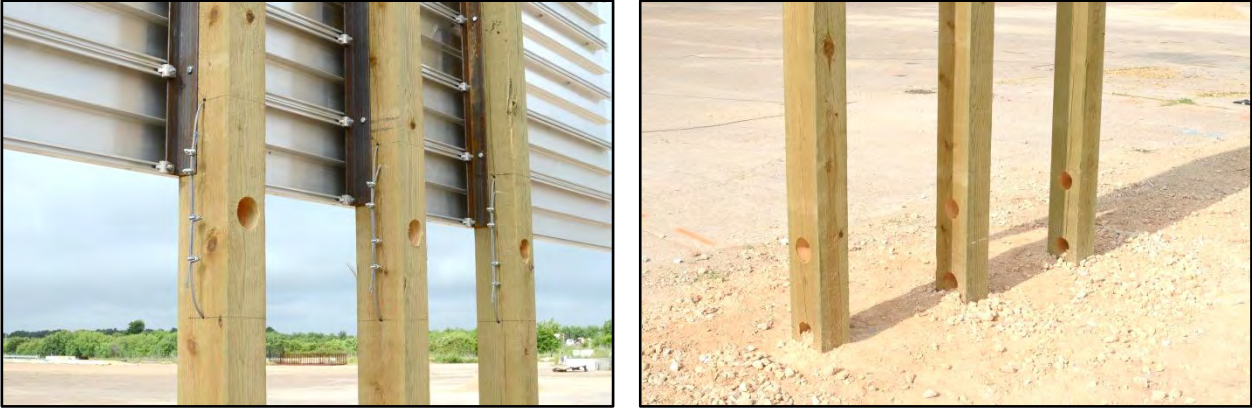
Figure 4.13. Modified Direct Embedded Wood Support Temporary Guide Sign System before Test Nos. 467823-2b and 467823-3.

sign system, and Appendix D includes further details. Figure 4.13 shows photographs of the installation prior to testing.

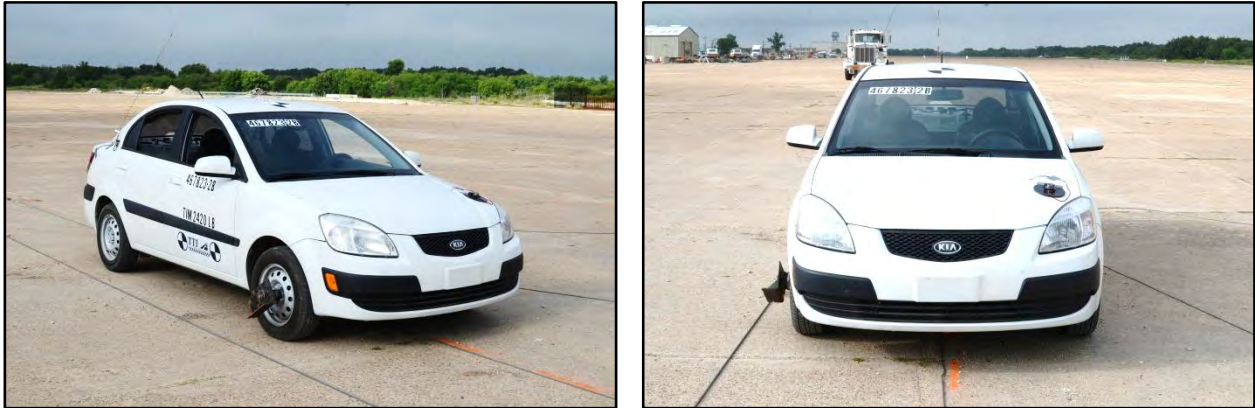
Figure 4.14. Vehicle before Test No. 467823-2b.

Figure 4.14 shows the 2006 Kia Rio used for the crash test. Test inertia weight of the vehicle was 2425 lb, and its gross static weight was 2604 lb. The height to the lower edge of the vehicle bumper was 7.12 inches, and the height to the upper edge of the bumper was 21.0 inches. Table E1 in Appendix E gives additional dimensions and information on the vehicle. The vehicle was directed into the installation using the cable reverse tow and guidance system and was released to be free-wheeling and unrestrained just prior to impact.

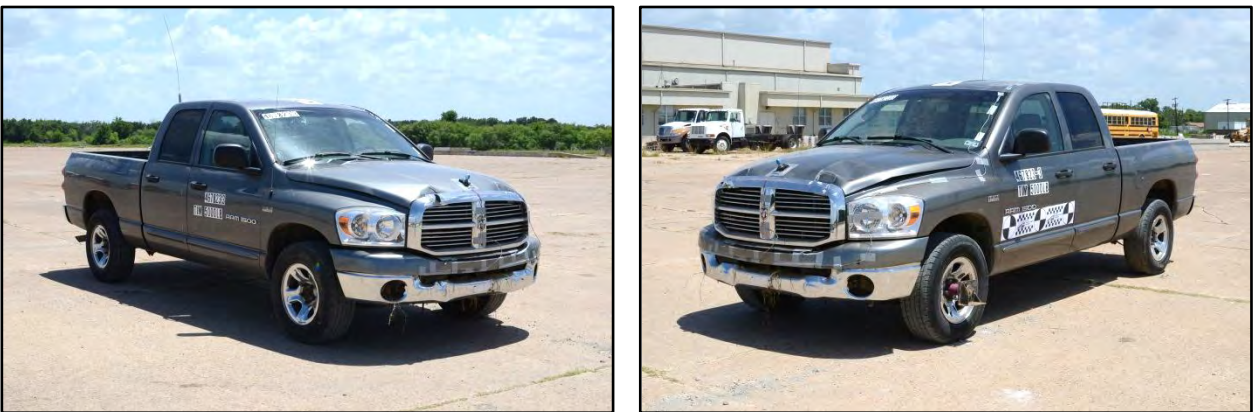
Figure 4.20. Vehicle after Test No. 467823-3.

Figure 4.20 shows the damage sustained by the vehicle during the test, which included the front bumper, hood, and roof. The front of the vehicle was deformed 1.0 inch both left and right of centerline of the vehicle at bumper height. There were two small dents in the roof, one measuring 1.5 inches wide \times 26 inches long \times 1.12 inches deep, and another 2.5 inches wide \times 25 inches long and 0.25 inch deep. No occupant compartment deformation or penetration occurred during the test. Exterior crush and occupant compartment measurements can be found in Tables F3 and F4 of Appendix F.

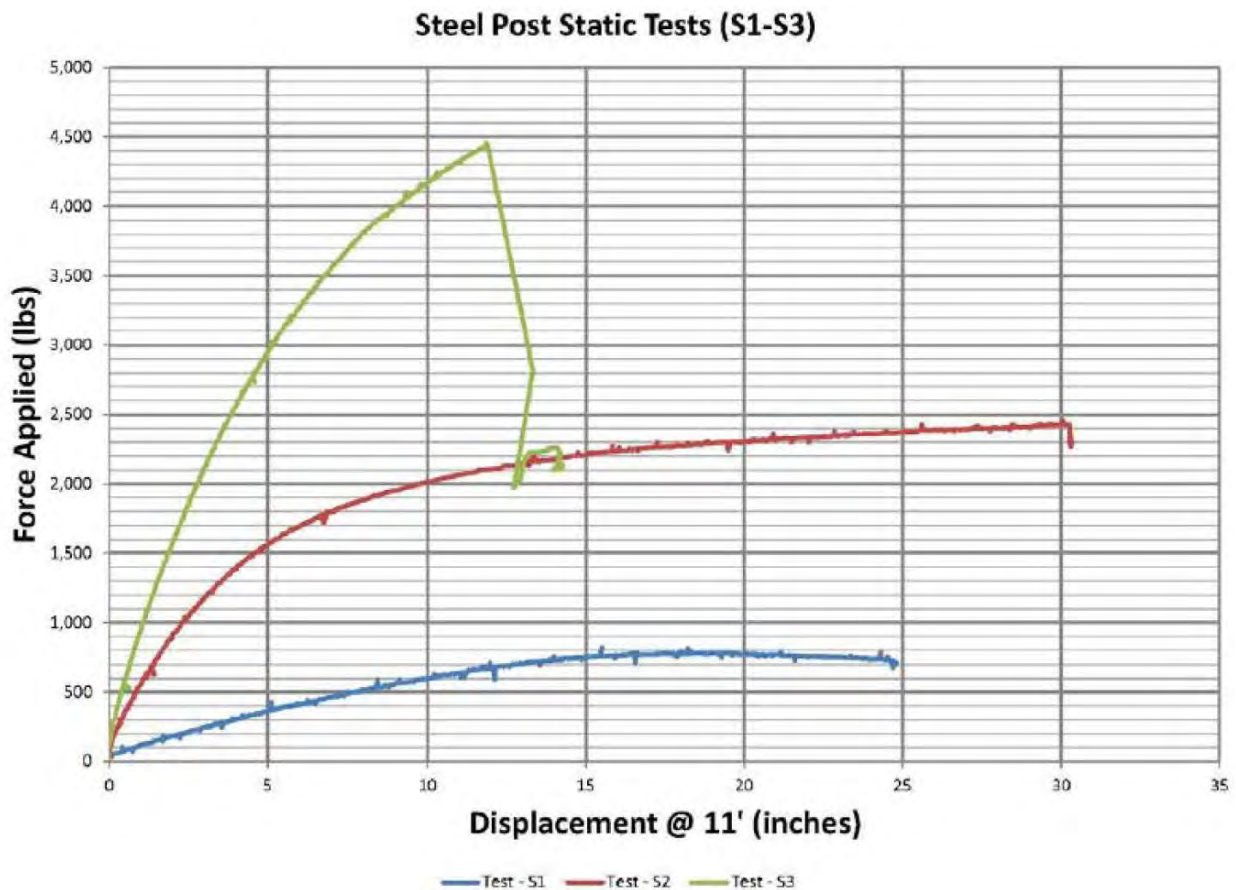
Figure 5.1. Static Test Results for S3x5.7 (Test S1), W6x9 (Test S2), and W8x18 (Test S3).

Figure 5.1 shows the force-deflection plots obtained from the static tests. In the test of the S3×5.7 foundation post, the post failed in lateral torsional buckling at a peak force of 0.82 kips. Given the force was applied at a height of 11 ft above grade, the resulting moment capacity is $0.82 \text{ kips} \times 11 \text{ ft} = 9.0 \text{ kip-ft}$. This value significantly exceeds the post capacity of 1.7 kip-ft.

In the test of the W6×9 post, the force-deflection curve was leveling off, and the test was halted due to significant deflection. The peak force at the time the test was halted was 2.46 kips. The corresponding moment capacity is 27.1 kip-ft, which is more than twice the post capacity of 11.8 kip-ft from Table 5.2.

In the test of the W8×18 foundation post, the test was halted when a weld on the slip base failed on the tension side of the post. The maximum force reached at time of failure was 4.45 kips. This corresponds to a moment capacity of 49.0 kip-ft, which exceeds the 36.4 kip-ft moment capacity of a W8×18 post section.

In summary, the measured static load capacity of all three foundation posts exceeded the calculated moment capacities of the corresponding steel support posts. This verifies the analytical procedure used to design the foundation posts and indicates the suitability of the foundation posts for the temporary installation of large guide signs.

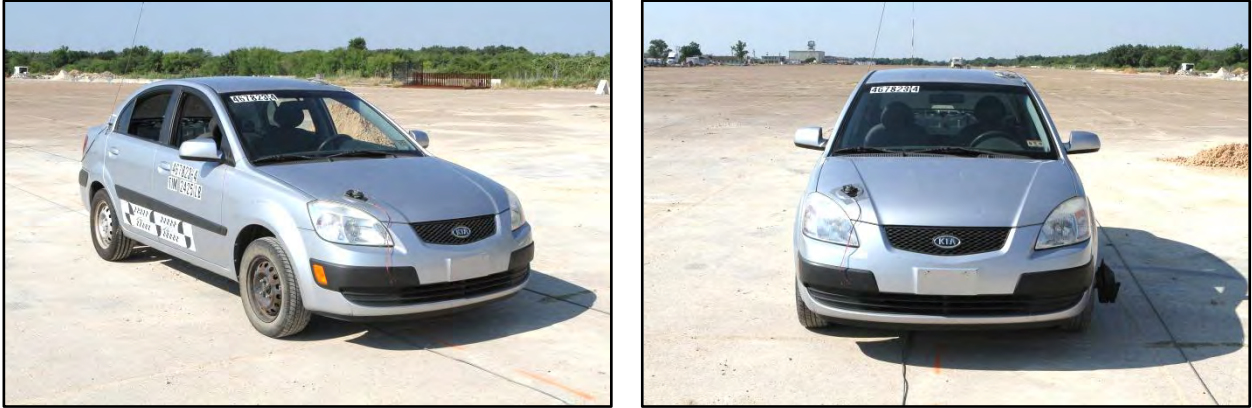
Figure 5.4. Vehicle before Test No. 467823-4.

Figure 5.4 shows the 2007 Kia Rio used for the crash test. Test inertia weight of the vehicle was 2425 lb, and its gross static weight was 2608 lb. The height to the lower edge of the vehicle bumper was 7.12 inches, and the height to the upper edge of the bumper was 21.0 inches. Table H1 in Appendix H gives additional dimensions and information on the vehicle. The vehicle was directed into the installation using the cable reverse tow and guidance system and was released to be free-wheeling and unrestrained just prior to impact.

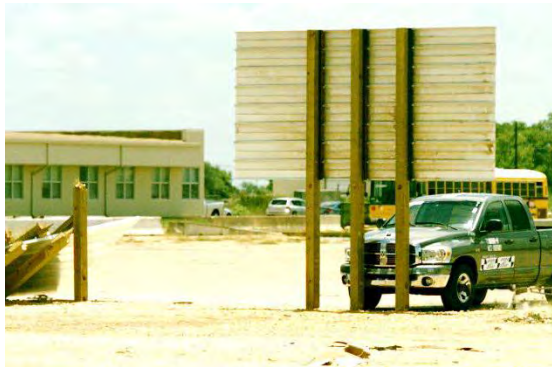
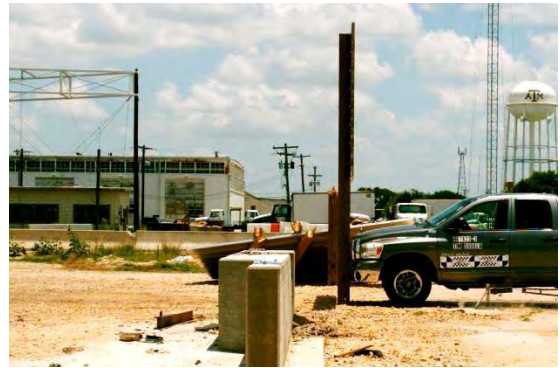
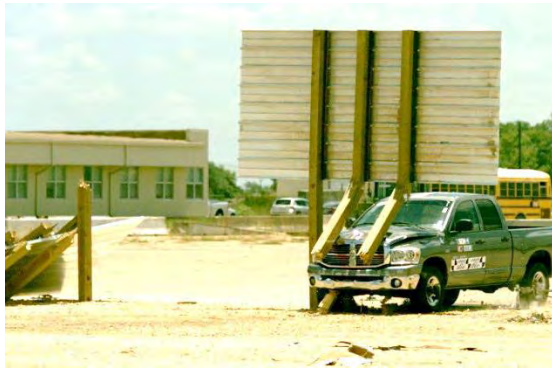
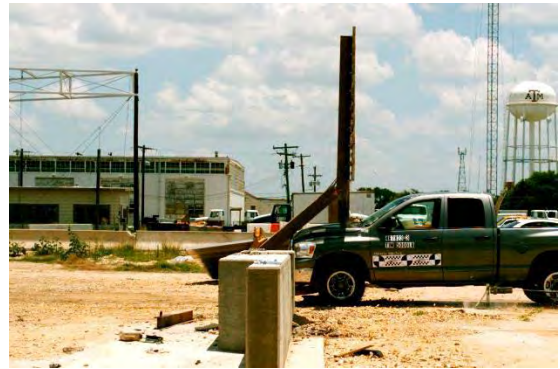
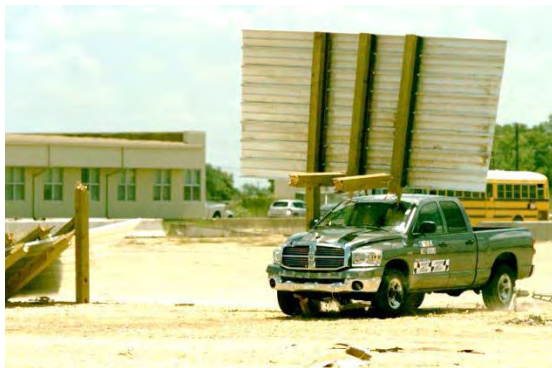
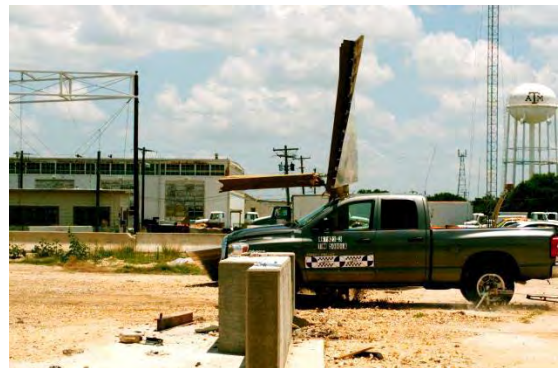
Figure F1. Sequential Photographs for Test No. 467823-3(Oblique and Perpendicular Views).

Test Agency: Texas A&M Transportation Institute		Test No.: 467823-3	Test Date: 2013-06-13
MASH Test 3-62 Evaluation Criteria		Test Results	Assessment
Structural Adequacy			
<i>C. Acceptable test article performance may be by redirection, controlled penetration, or controlled stopping of the vehicle.</i>		The modified direct embedded wood post support system for temporary guide signs performed acceptably by fracturing upon impact.	Pass
Occupant Risk			
<i>D. Detached elements, fragments, or other debris from the test article should not penetrate or show potential for penetrating the occupant compartment, or present an undue hazard to other traffic, pedestrians, or personnel in a work zone.</i>		The fractured sections of supports remained attached via the cables and did not penetrate or show potential for penetrating the occupant compartment, or to present hazard to others in the area.	Pass
<i>Deformations of, or intrusions into, the occupant compartment should not exceed limits set forth in Section 5.3 and Appendix E of MASH.</i>		No occupant penetration or deformation occurred.	Pass

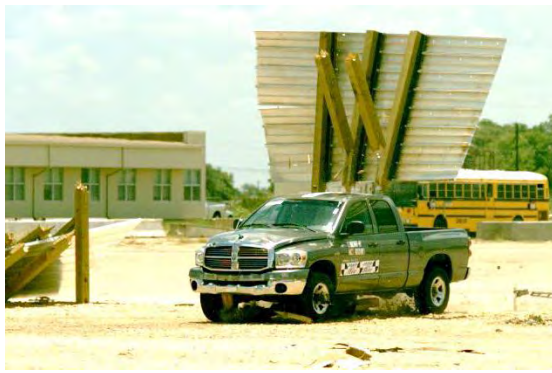
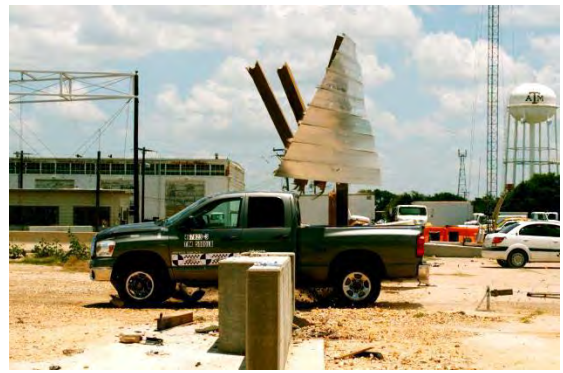
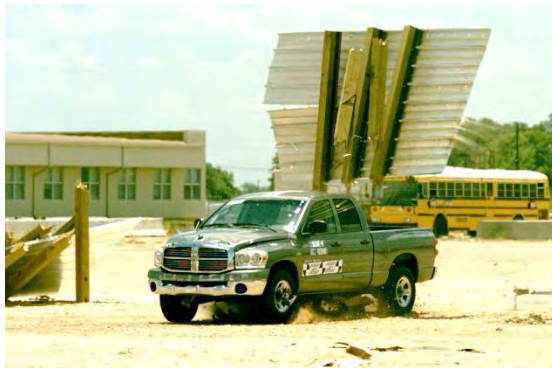
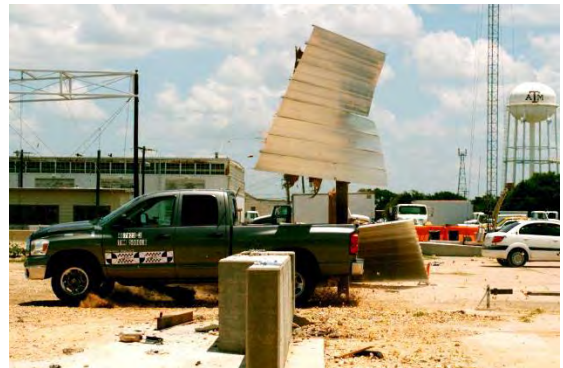
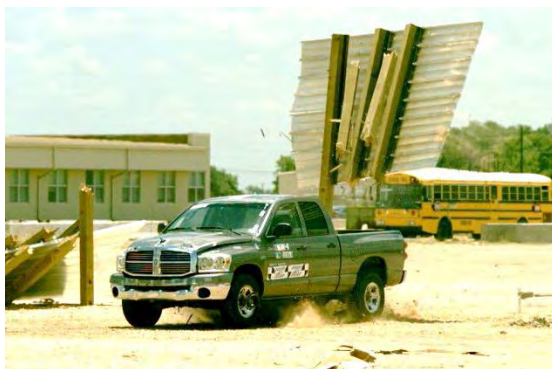
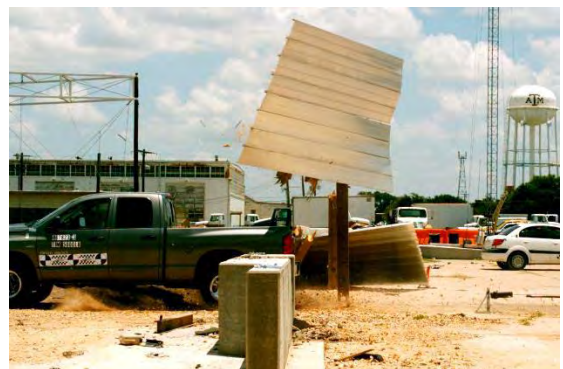
Figure F1. Sequential Photographs for Test No. 467823-3 (Oblique and Perpendicular Views) (Continued).

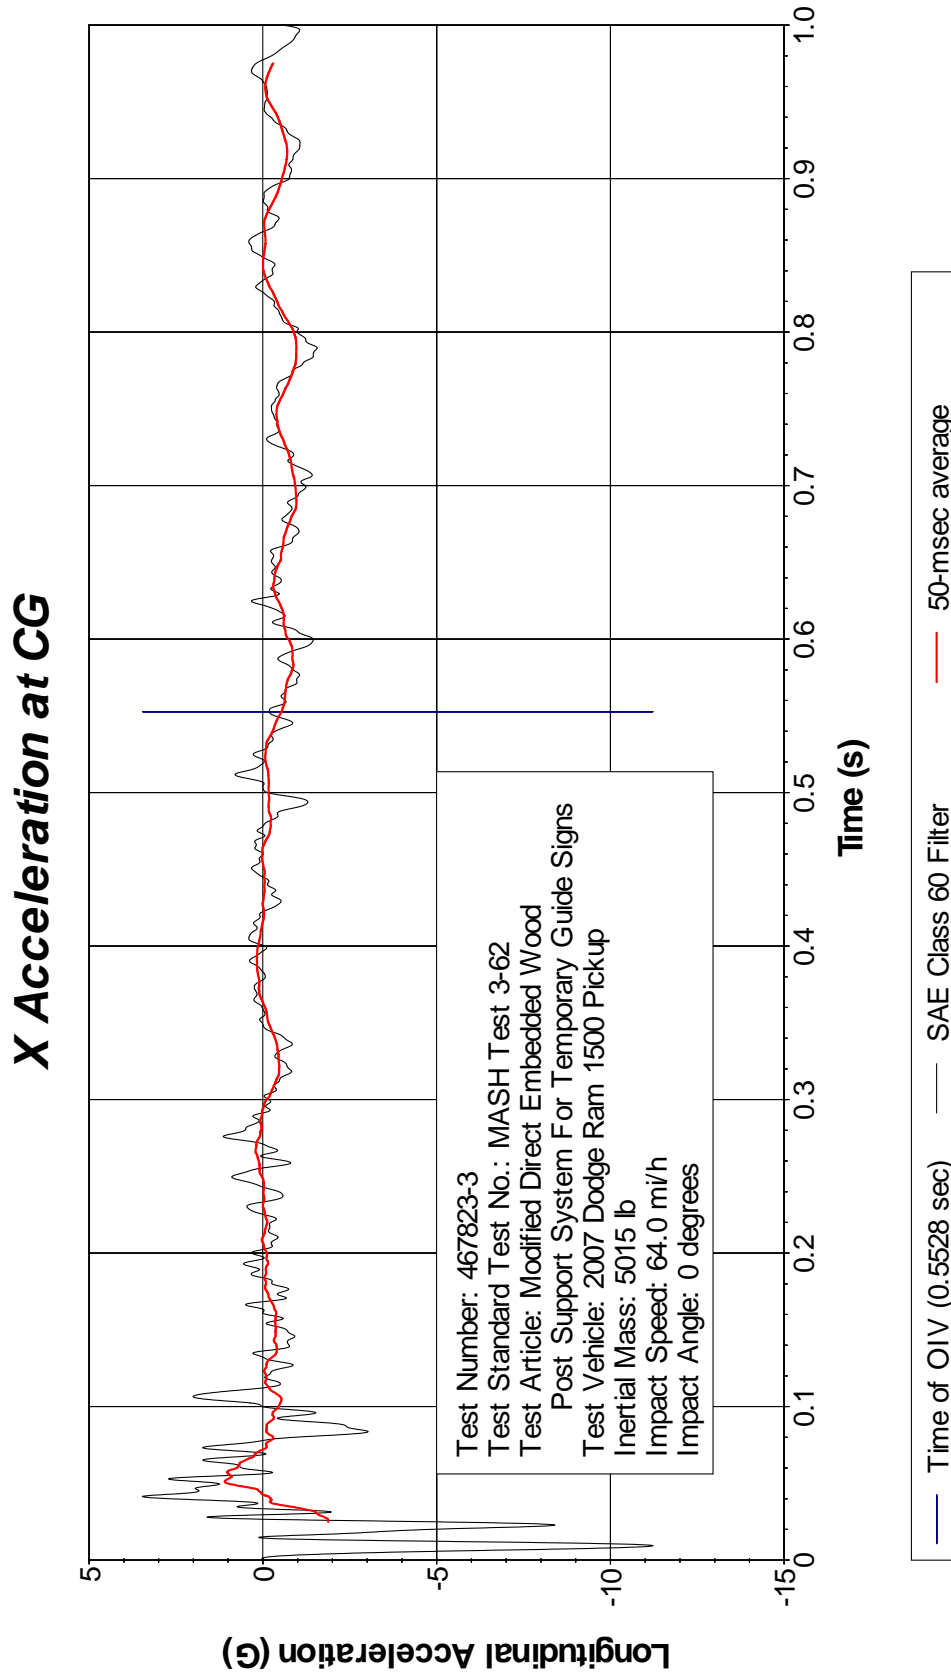
Figure F3. Vehicle Longitudinal Accelerometer Trace for Test No. 467823-3 (Accelerometer Located at Center of Gravity).

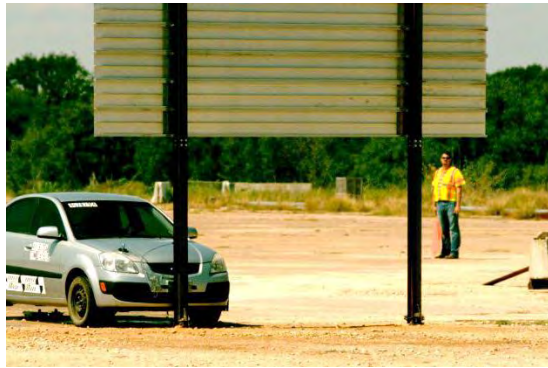
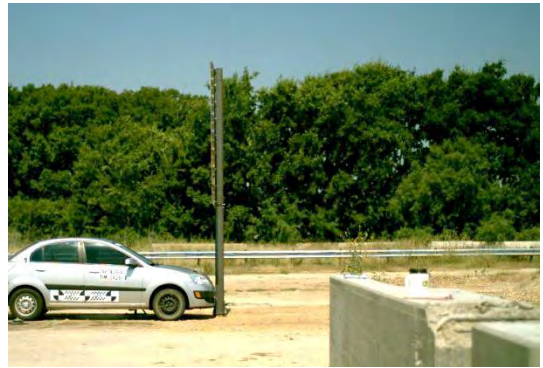
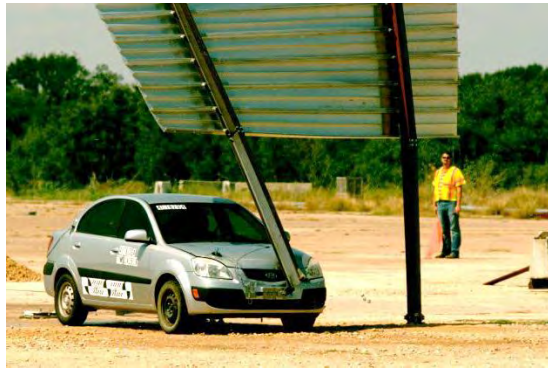
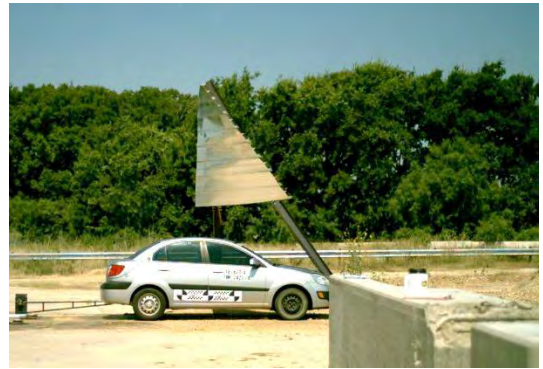
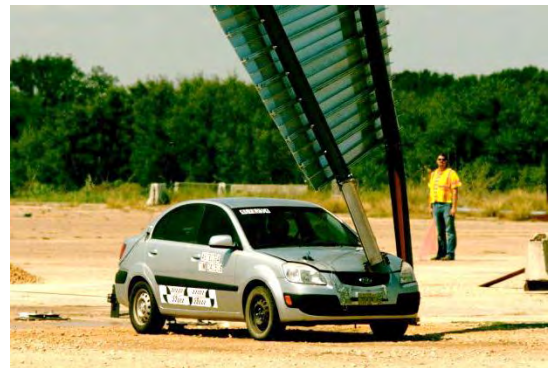
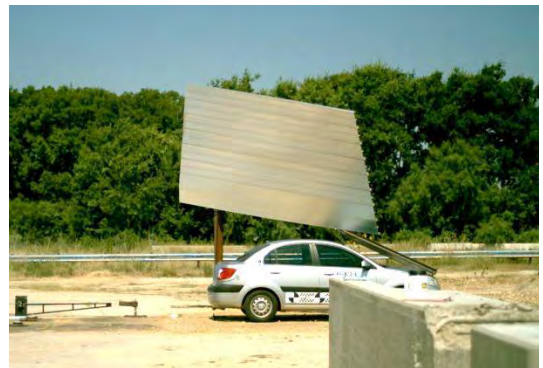
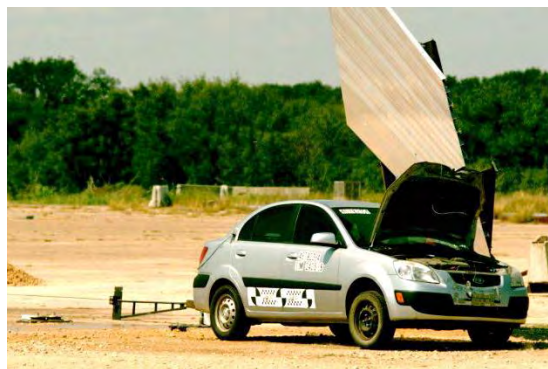
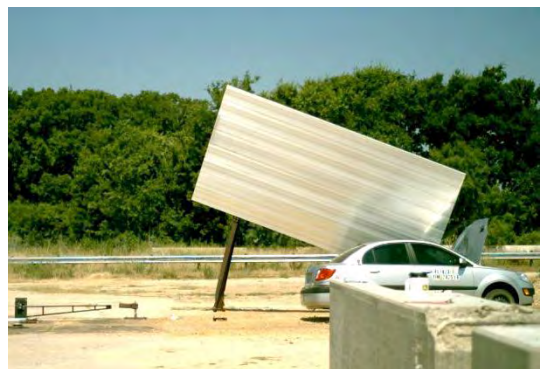
Figure H1. Sequential Photographs for Test No. 467823-4(Oblique and Perpendicular Views).

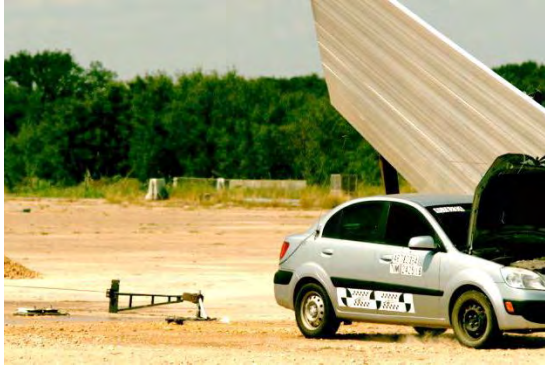
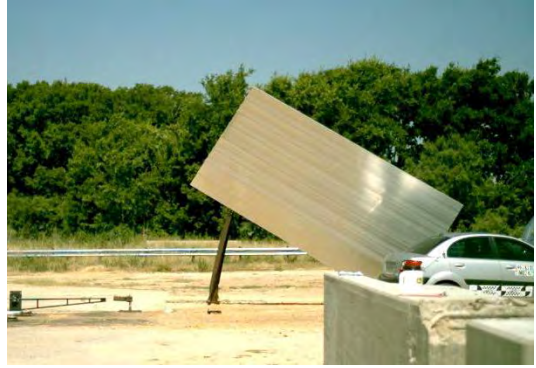
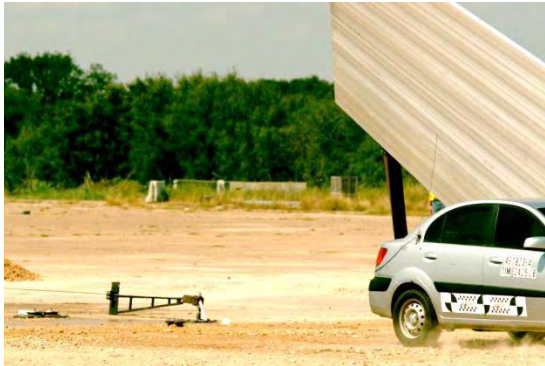
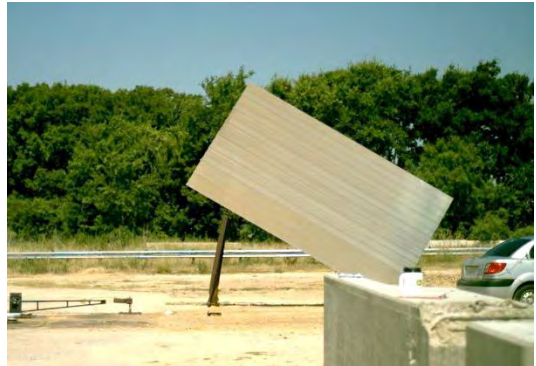
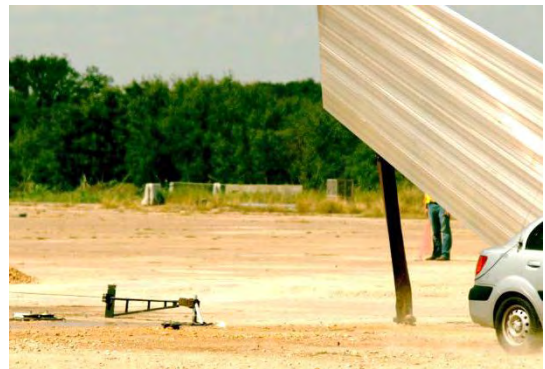
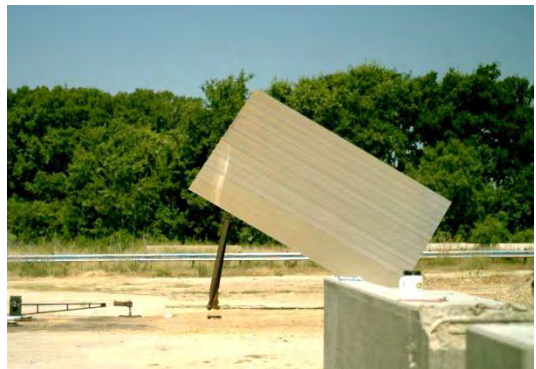
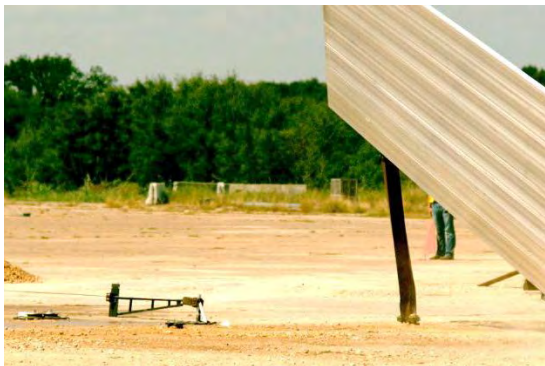
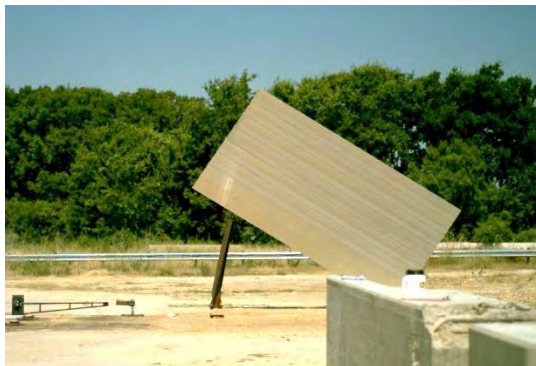
Figure H1. Sequential Photographs for Test No. 467823-4 (Oblique and Perpendicular Views) (Continued).
