**INTEGRATED REMOTE SENSING AND VISUALIZATION (IRSV)  
SYSTEM FOR TRANSPORTATION INFRASTRUCTURE  
OPERATIONS AND MANAGEMENT:  
PHASE TWO**

**VOLUME 5**

**AERIAL BRIDGE DECK IMAGING DATA COLLECTION AND  
SOFTWARE REVISION**

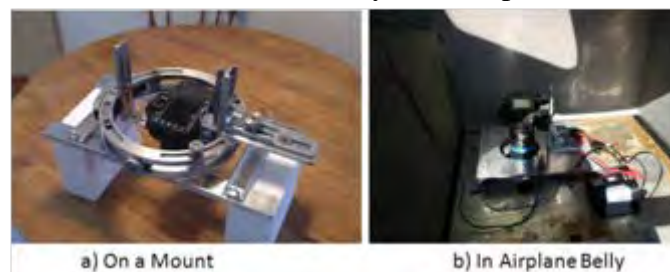
Figure 1: Camera for SI-SFAP

Conventional mapping-grade aerial photographs are taken at a high altitude of approximately 5000 feet and above, while SI-SFAP technique involves low flying (around 1000 feet altitude) at a controlled speed (typically around 100 mph). High resolution images in the sub-inch range can be captured because of low flying and onboard small-format DSLR (Digital Single Lens Reflex) camera with pre-calibrated shutter speeds. The orthogonal rectification of the imagery was not performed as the photos are taken from low altitudes. Rapid firing (4-5 frames per second) for maximum sensor utilization can be achieved using full frame camera (35 mm lenses) with high electrostatic recharge rates. The use of extremely high shutter speeds help avoid the need for Forward Motion Compensation (FMC). Figure 1 shows the camera set up including the camera in a) a mount and b) the belly of an airplane (Rice 2010).

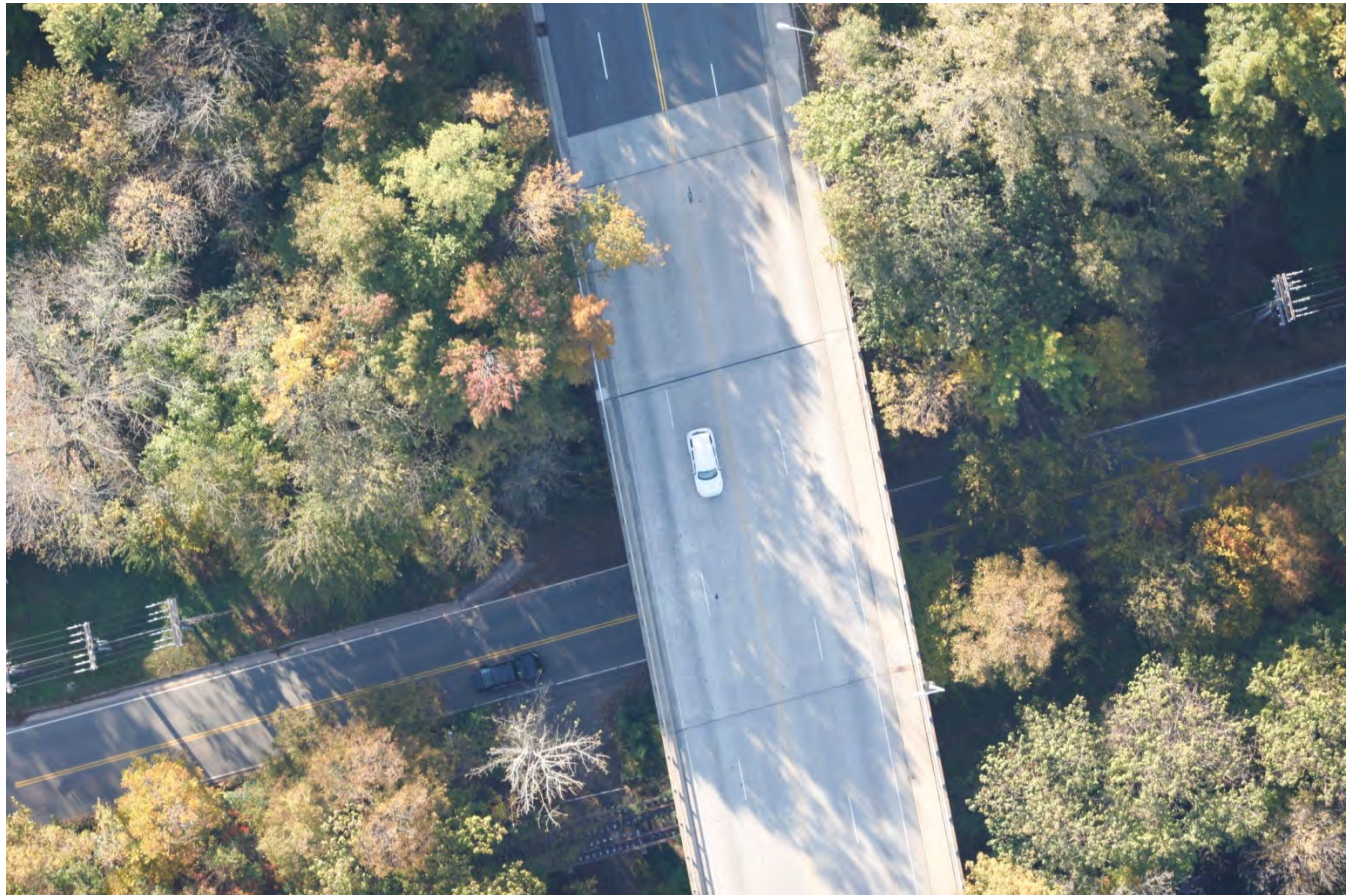
Figure 3: Heavily Shadowed Bridge Deck (SI-SFAP)

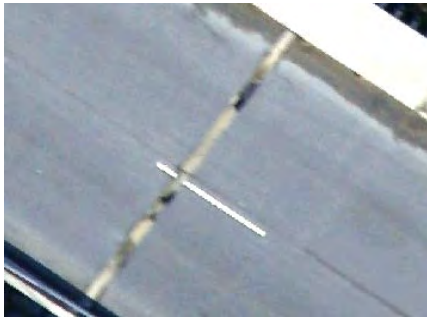
Figure 4: Joint damage progression

SI-SFAP provides ideal mapping of crack on bridge decks, hence, can provide reasonable BSCI values on a perfectly illuminated, obstruction-free deck surface. However, BSCI does not consider special damage scenarios including punching shear, corner cracking, spalling, potholes, expansion movement data, and other damages in the bridge. Another important feature of SI-SFAP method is the potential of quantifying bridge relative movements by measuring expansion joint openings. Current inspection reporting does not require exact joint movement measurements. Hence, no documentation of bridge superstructure movements has been included in the national bridge inventory database. However, using periodic, high-resolution aerial photography such as the SI-SFAP, it is possible to establish a temporal record of bridge joint movements. Figure 4 shows aerial image showing the transformation of a damaged joint over period and also the image taken at ground shot.

By detecting the expansion joint distances, an inspector can visually see bridge span horizontal movements at a specific period. With further analysis of temporal data, i.e. more aerial photos taken of one bridge across a period of months or even years, the actual movement of a particular bridge can be observed and actions can be proposed to address the situation at hand. It is noted that vertical movements were not studied due to suggestions that state that horizontal movements seem much more critical to structural damage than vertical movements (Moulton et al. 1985). Bridges experiencing noticeably larger horizontal movements, greater than 2 inches and 1.5 inches for abutments, should be flagged for possible immediate inspections.

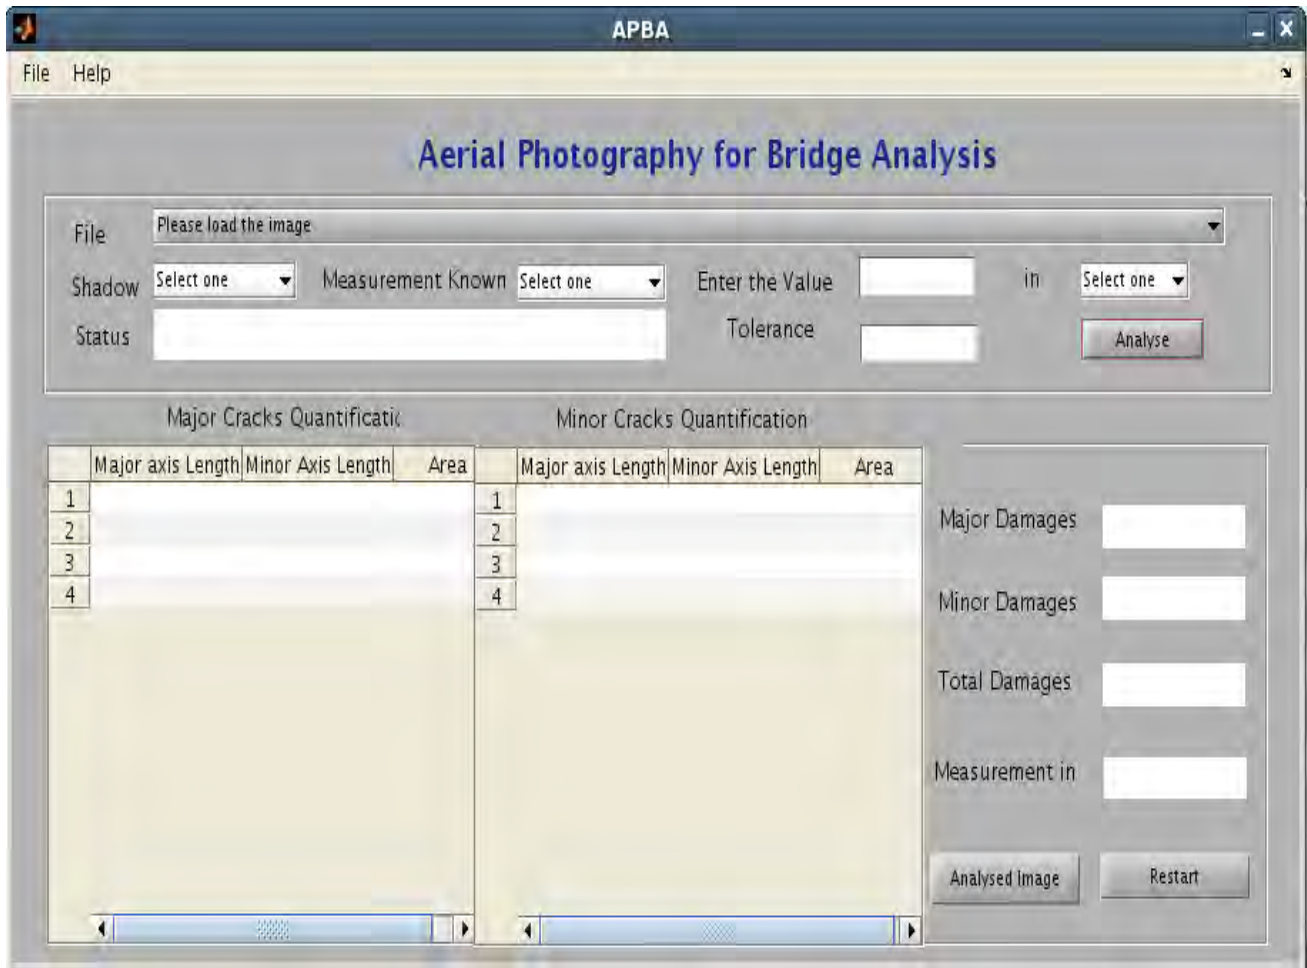
Figure 9: Graphical User Interface of APBA

The graphical user interface developed for APBA software is shown in Figure 9. The user interface is developed to help the user to analyze the images with ease. They are structured and simple interface developed in MATLAB using guide tool. The status of the data being given as input can be checked in the status space in user interface.

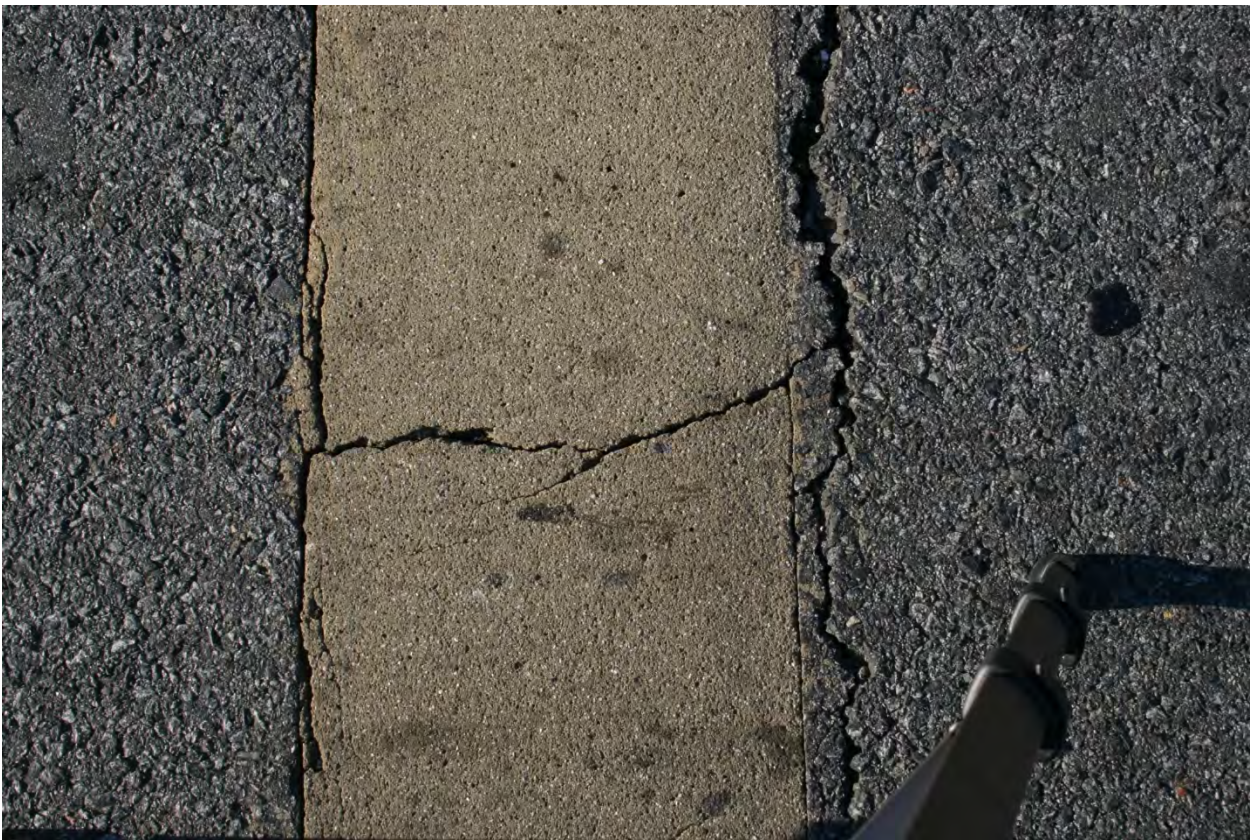
Figure 10: Ground image of Mallard creek church road bridge

The ground image (Figure 10) of Mallard Creek Church Road Bridge was taken on November 3<sup>rd</sup>, 2011. The images were taken at an elevation of 40 inches, 94 inches from the curb. The other measurements, such as distance from rod to focal length is 4 inches and also the distance from centre to focal length is 10 inches, were also documented. Figure 10. Shows the original ground image of Mallard Creek Church Road bridge taken during a field trip.

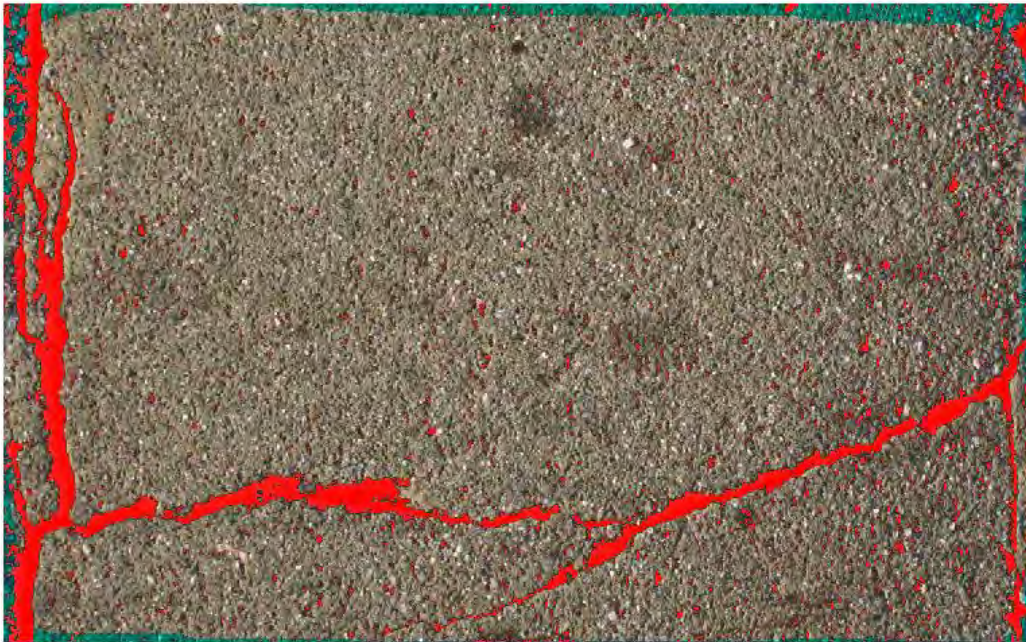
Figure 12: a.) Binary image of the area of interest with total crack regions; b.) Original image with total damages being marked up using APBA software as high value.

Pixel intensity normalization technique is used to analyze the area of interest for crack detection. Figure 12.a shows the binary image of the area of interest with total crack regions being marked as high; Figure 12.b shows the original image of the area of study being marked with total damages in red pixels. The crack detection is shown to be consistent with the original image Figure 12.c shows the binary image of the area of interest with major crack regions being identified using APBA; Figure 12.d shows the original image of the area of study being marked with only major cracks identified in red pixels. Figure 12.e shows the binary image of the area of interest with minor crack regions being identified using APBA; Figure 12.f shows the original image of the area of study being marked with only minor cracks identified in red pixels.

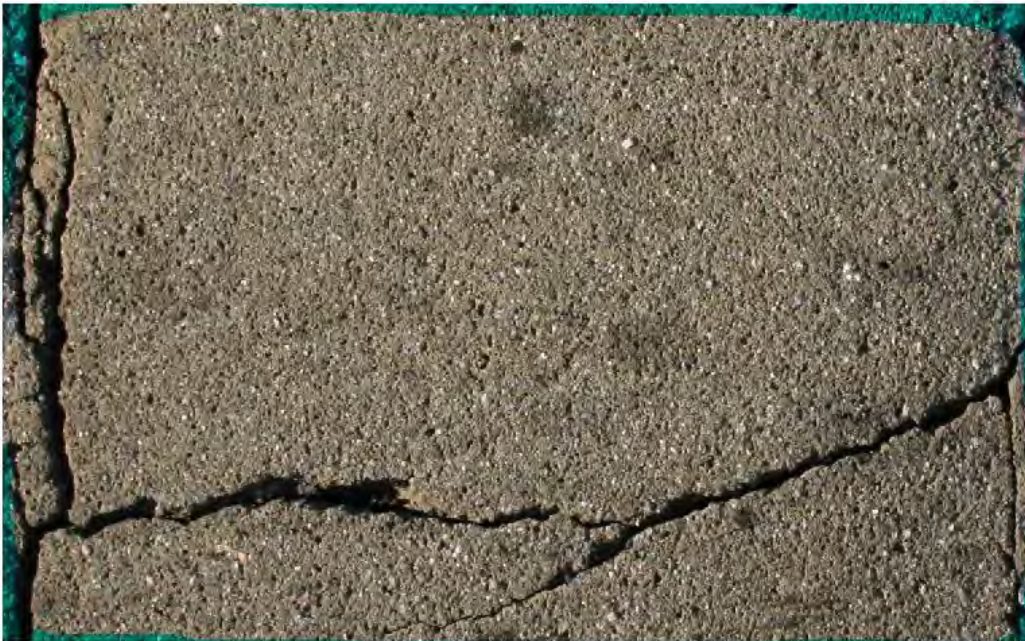
Figure 12: e.) Binary image of the area of interest with minor crack regions; f.) Original image with minor damages being marked up using APBA software as high value.

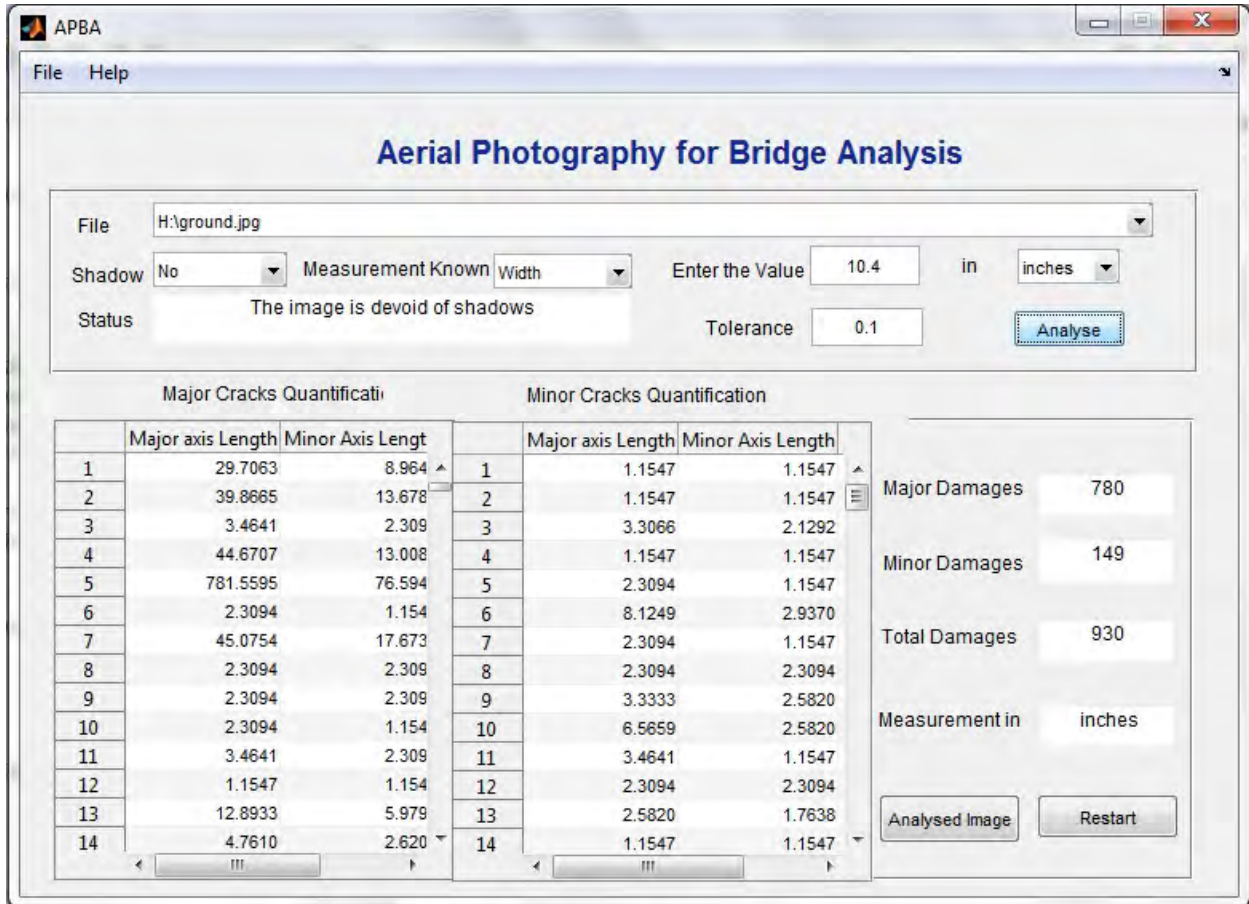
Figure 13: GUI with quantified results of major and minor crack region

Figure 13. shows the GUI with quantified results of major and minor crack regions using APBA software. Using the “save as” option in the GUI all the resultant images and the quantified results of total (930 pixels), major (780 pixels) and minor damages (149 pixels) can be saved in “.jpg” format and Ms-Excel (.xls) spreadsheet in a Windows OS (Appendix A- User Manual).

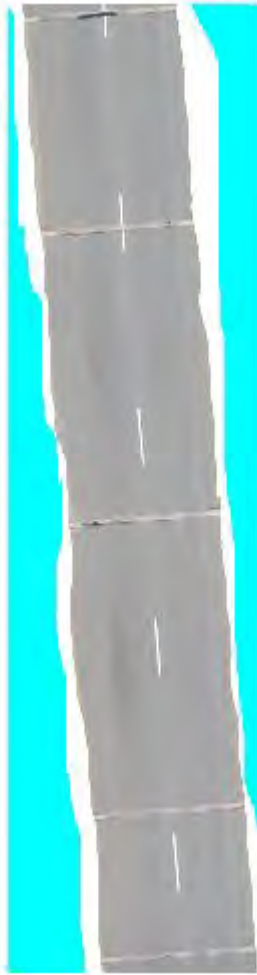
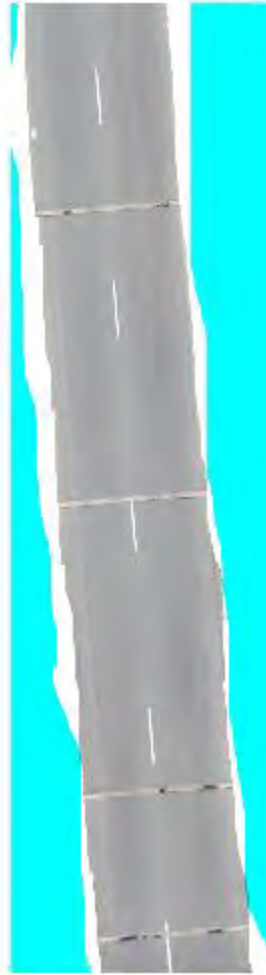
Figure 15: Cropped south bound and north bound sections of the Mallard Creek Church Road Bridge using APBA software.

Figure 15 shows the cropped sections of the Mallard Creek Church Road bridge using APBA software, showing the south bound and north bound bridge sections. The analysis is done individually for each parallel section. Figure 16.a shows the binary image of the area of interest with total crack regions being marked as high; Figure 16.b shows the original image (south bound) of the area of study being marked with total damages in red pixels. Figure 16.c shows the binary image of the south bound with only major crack regions being identified using APBA; Figure 16.d shows the original image of the south bound being marked with only major cracks in red pixels. Figure 16.e shows the binary image of the south bound with only minor crack regions being identified using APBA; Figure 16.f shows the original image of south bound being marked with only minor cracks in red pixels.

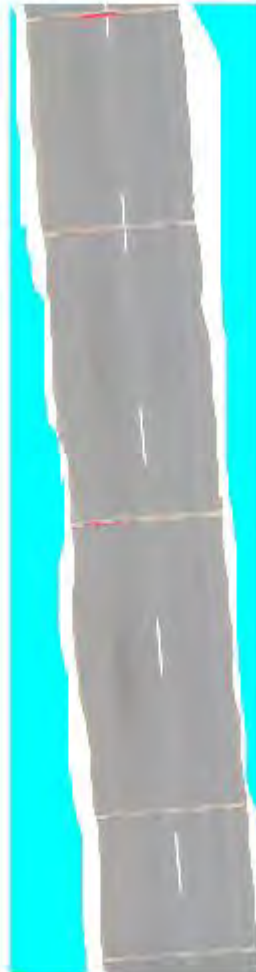
Figure 16: a.) Binary image of the area of interest with total crack regions being marked as high; b.)Original image of the area of study being marked with total damages in red pixels.

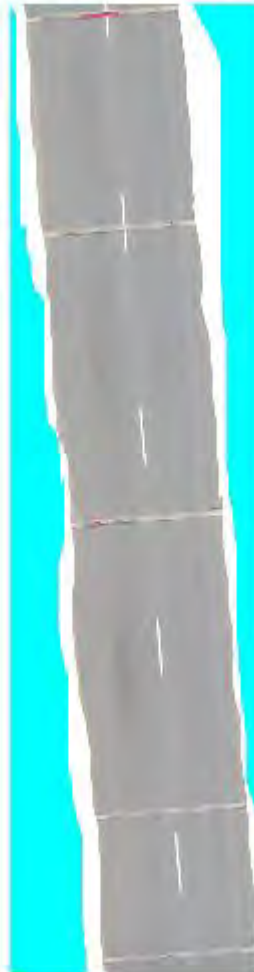
Figure 16: c.) Binary image of the area of interest with major crack regions being identified using APBA; d.) Original image of the area of study being marked with major cracks in red pixels.

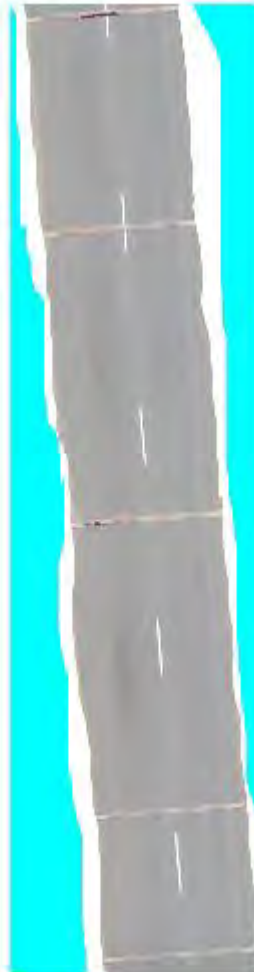
Figure 16: e.) Binary image of the area of interest with minor crack regions being identified using APBA; f.) Original image of the area of study being marked with minor cracks in red pixels

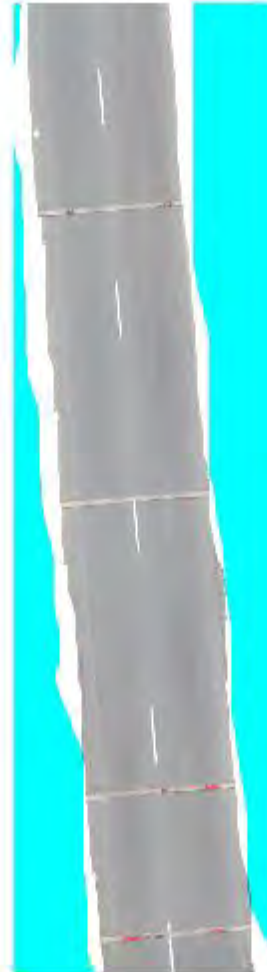
Figure 16: g.) Binary image of the area of interest with total crack regions being marked as high; h.) Original image of the area of study being marked with total damages in red pixels

The aerial images of the North Bound of the Mallard Creek Church Road bridge were taken for study. The damages are identified and marked up using red color. Figure 16.g shows the binary image of the North Bound with total crack regions being marked as high; Figure 16.h shows the original image of the North Bound being marked with total damages in red pixels. Figure 16.i shows the binary image of the North Bound with only major crack regions being identified using APBA; Figure 16.j shows the original image of the North Bound being marked with only major cracks in red pixels. Figure 16.k shows the binary image of the North Bound with only minor crack regions being identified using APBA; Figure 16.l shows the original image of North Bound being marked with only minor cracks in red pixels.

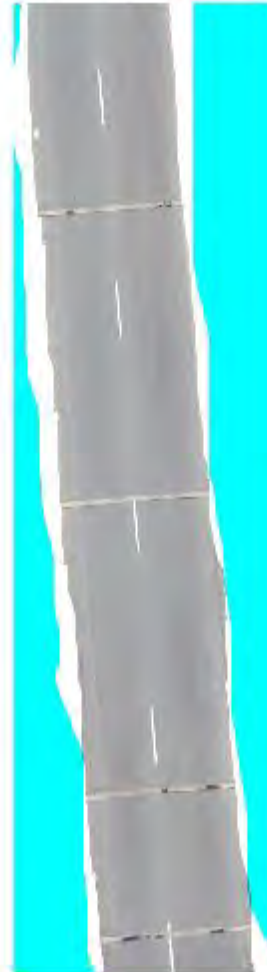
Figure 16: i.) Binary image of the area of interest with major crack regions being identified using APBA; j.) Original image of the area of study being marked with major cracks in red pixels.

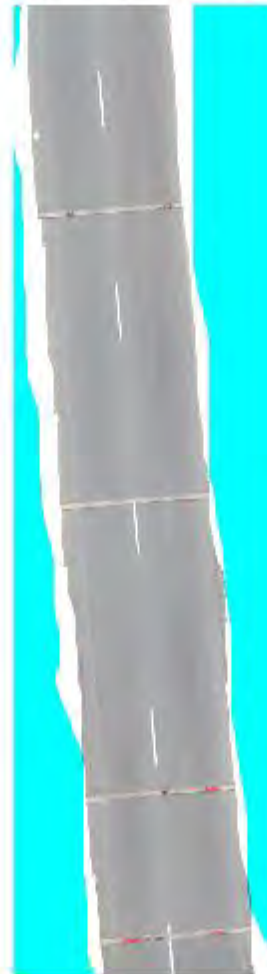
Figure 16: k.) Binary image of the area of interest with minor crack regions being identified using APBA; l.) Original image of the area of study being marked with minor cracks in red pixels

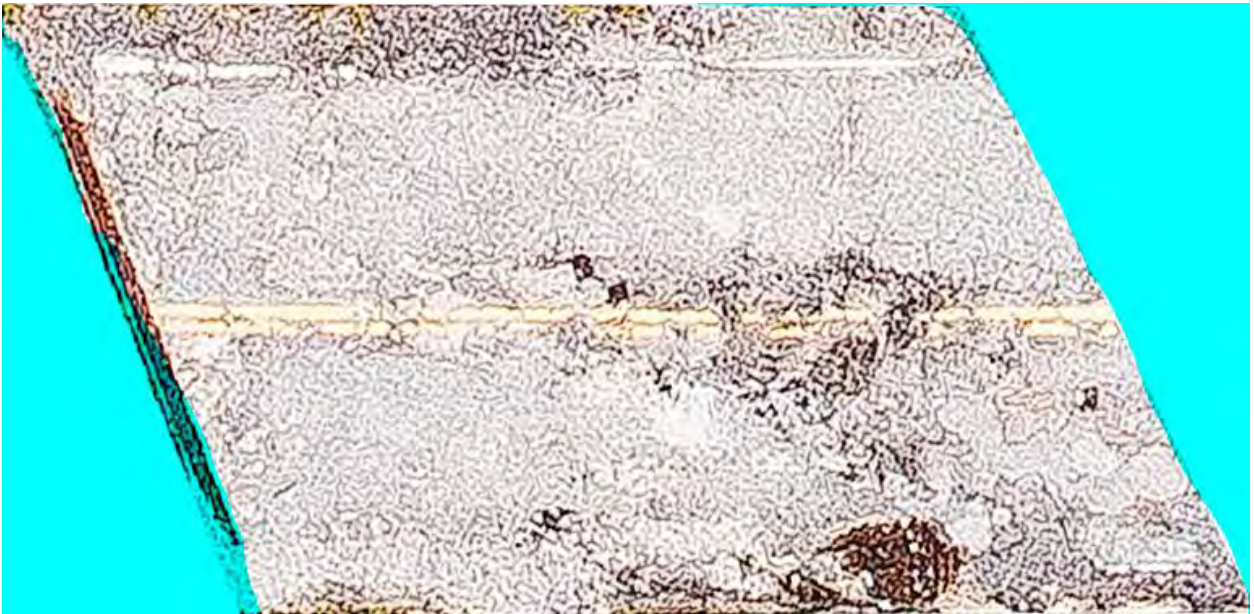
Figure 18: Cropped section (span A) of the bridge under study using APBA software

Aerial image of a heavily damaged bridge deck, taken for the bridge competition in 2010, is used for this study. Figure 18 shows the cropped sections (span A) of the bridge under study using APBA software. Figure 19.a shows the binary image of the area of interest with total crack regions being marked as high.

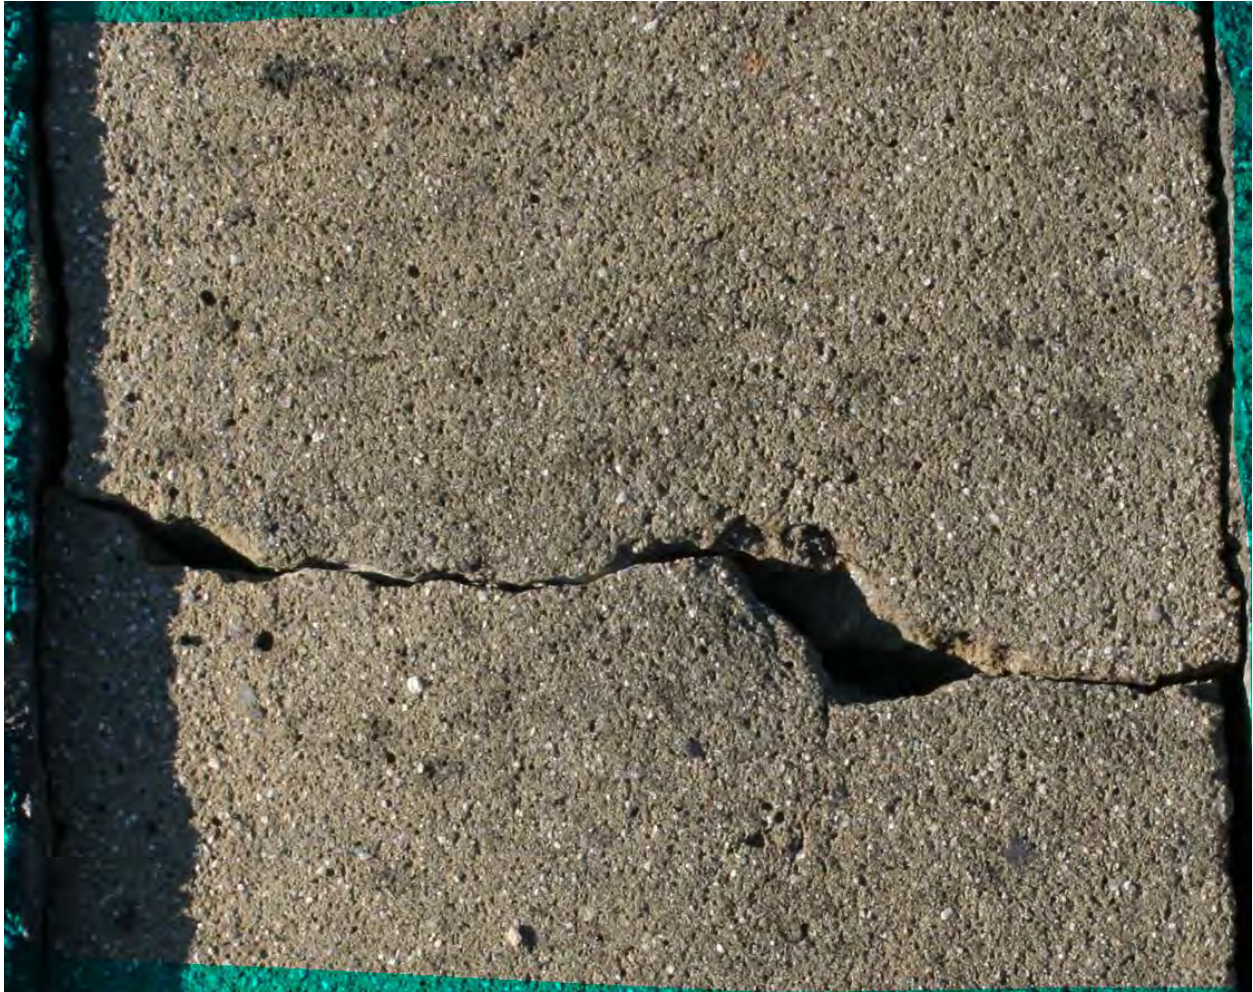
B.1.1: Cropped portion of the image under study

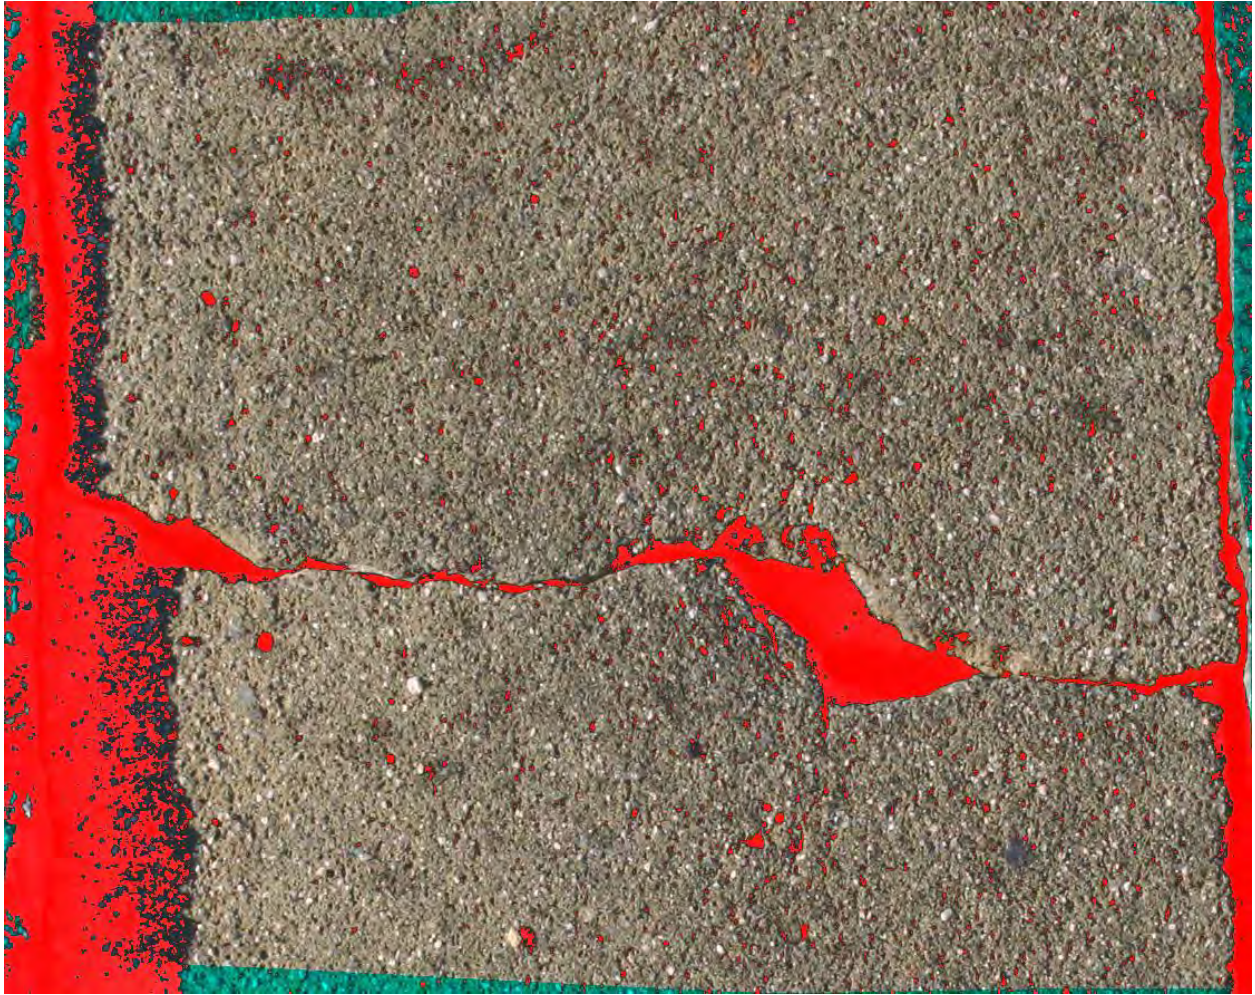
B.1.3: Original image of the area of study being marked with total damages in red pixels.

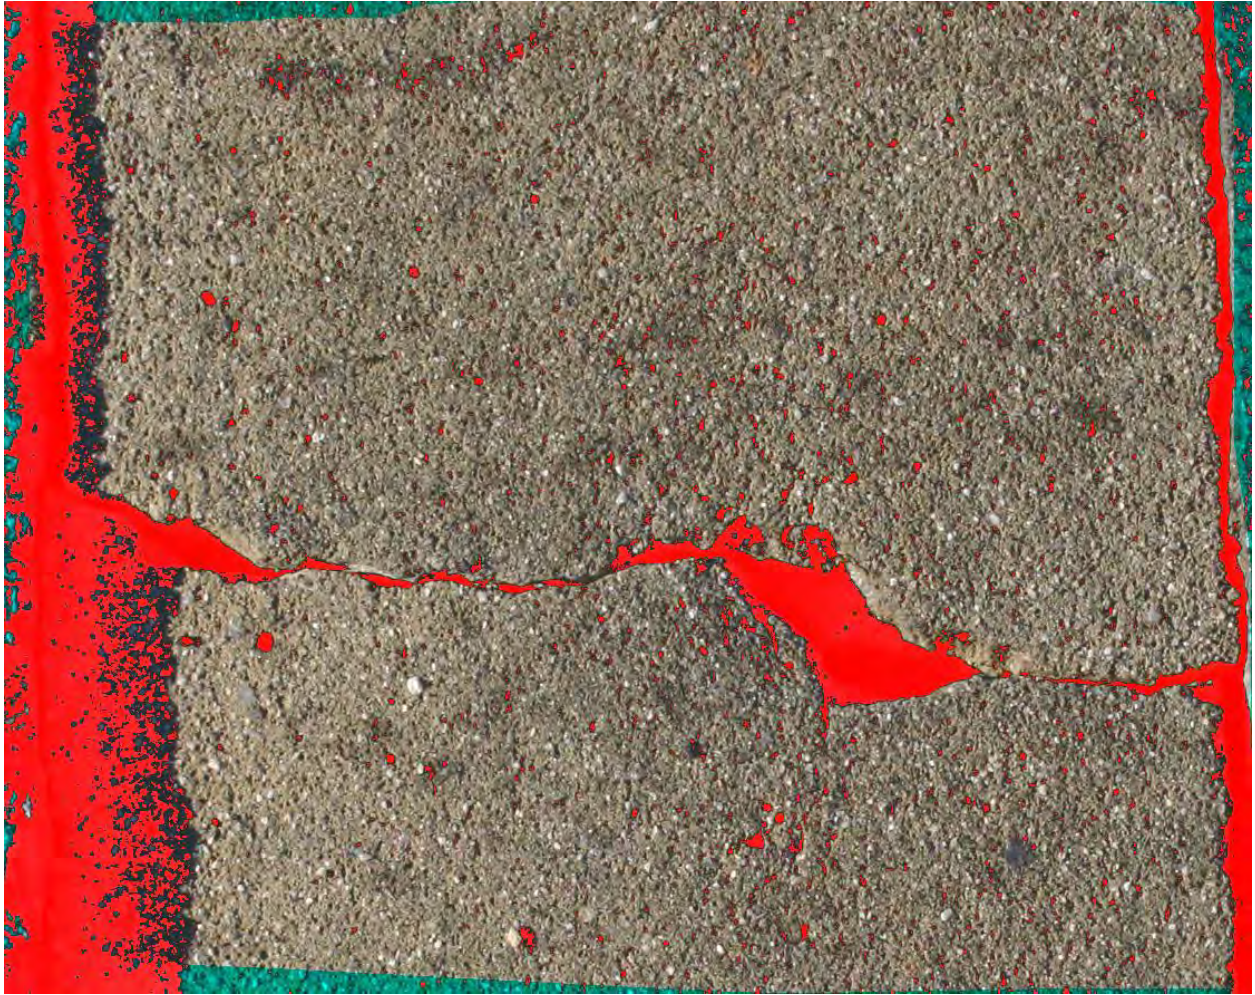
B.1.5: Original image of the area of study being marked with major cracks in red pixels

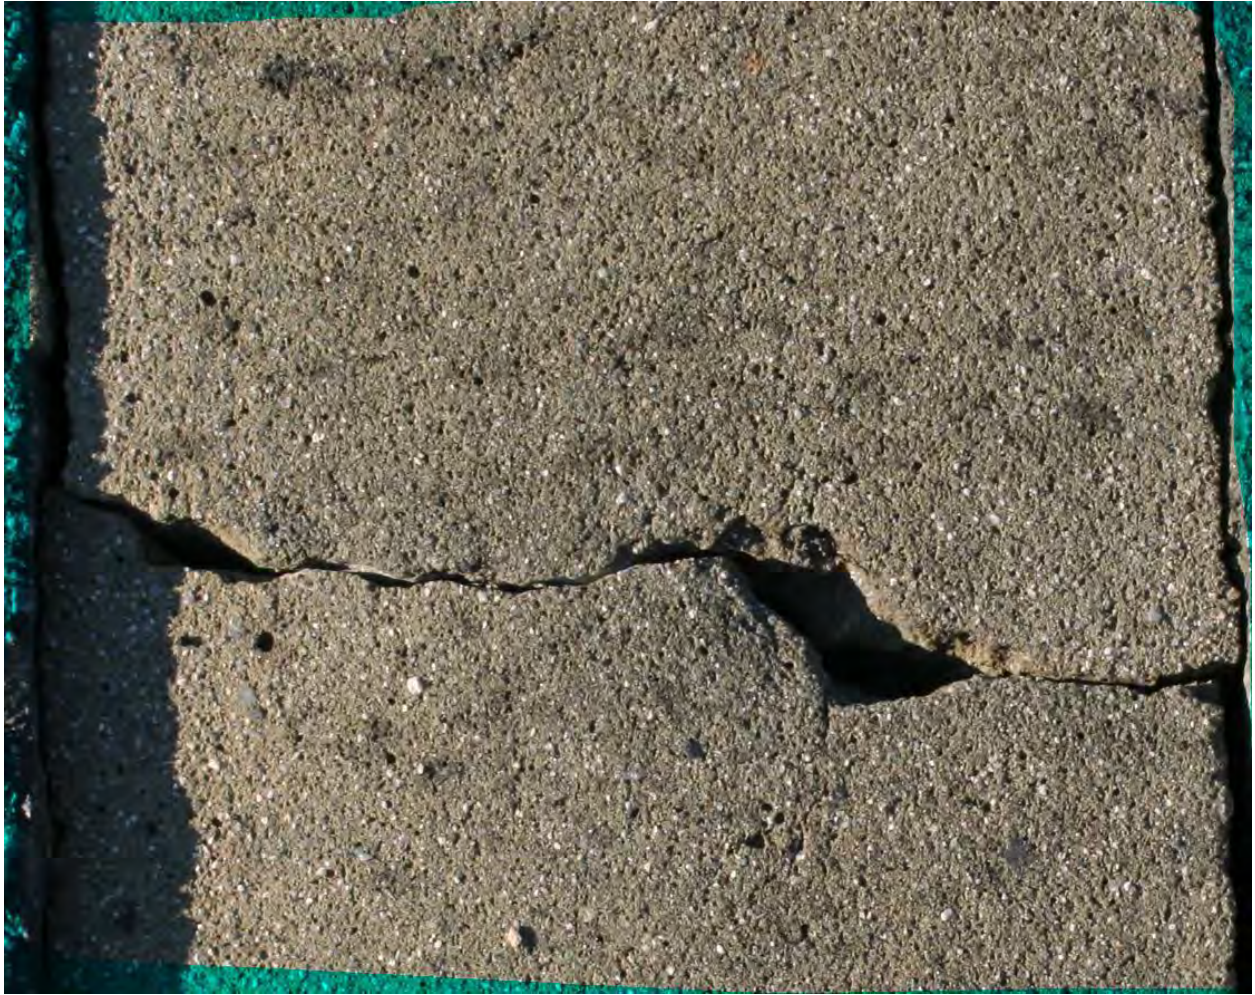
B.1.7: Original image of the area of study being marked with minor cracks in red pixels

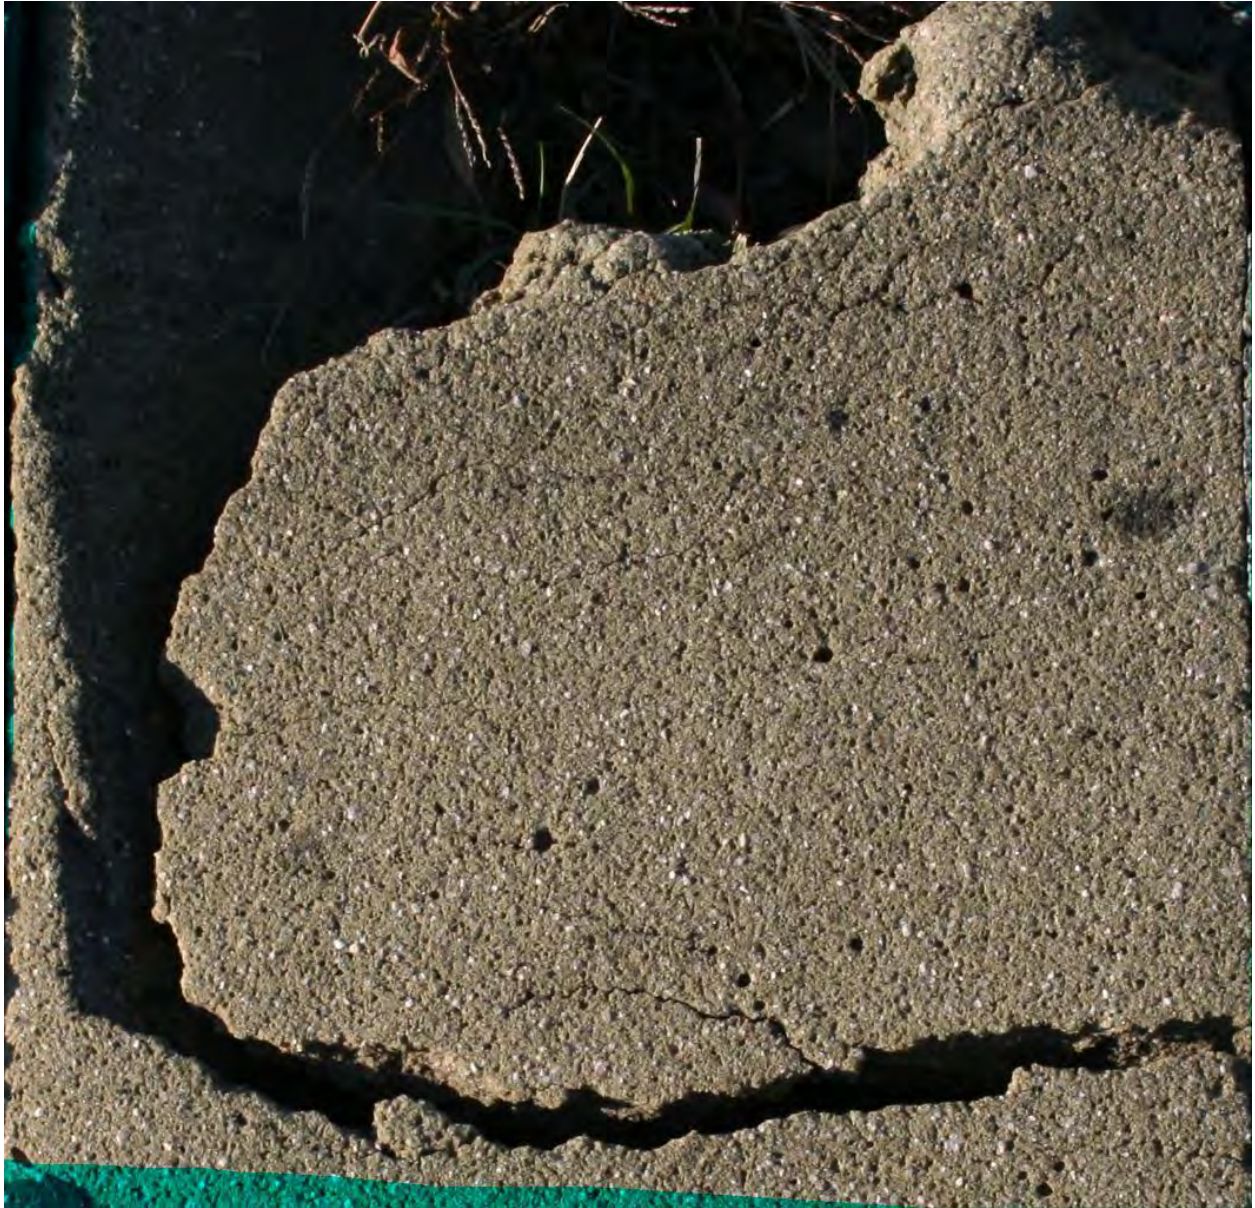
B.1.8: Cropped portion of the image under study

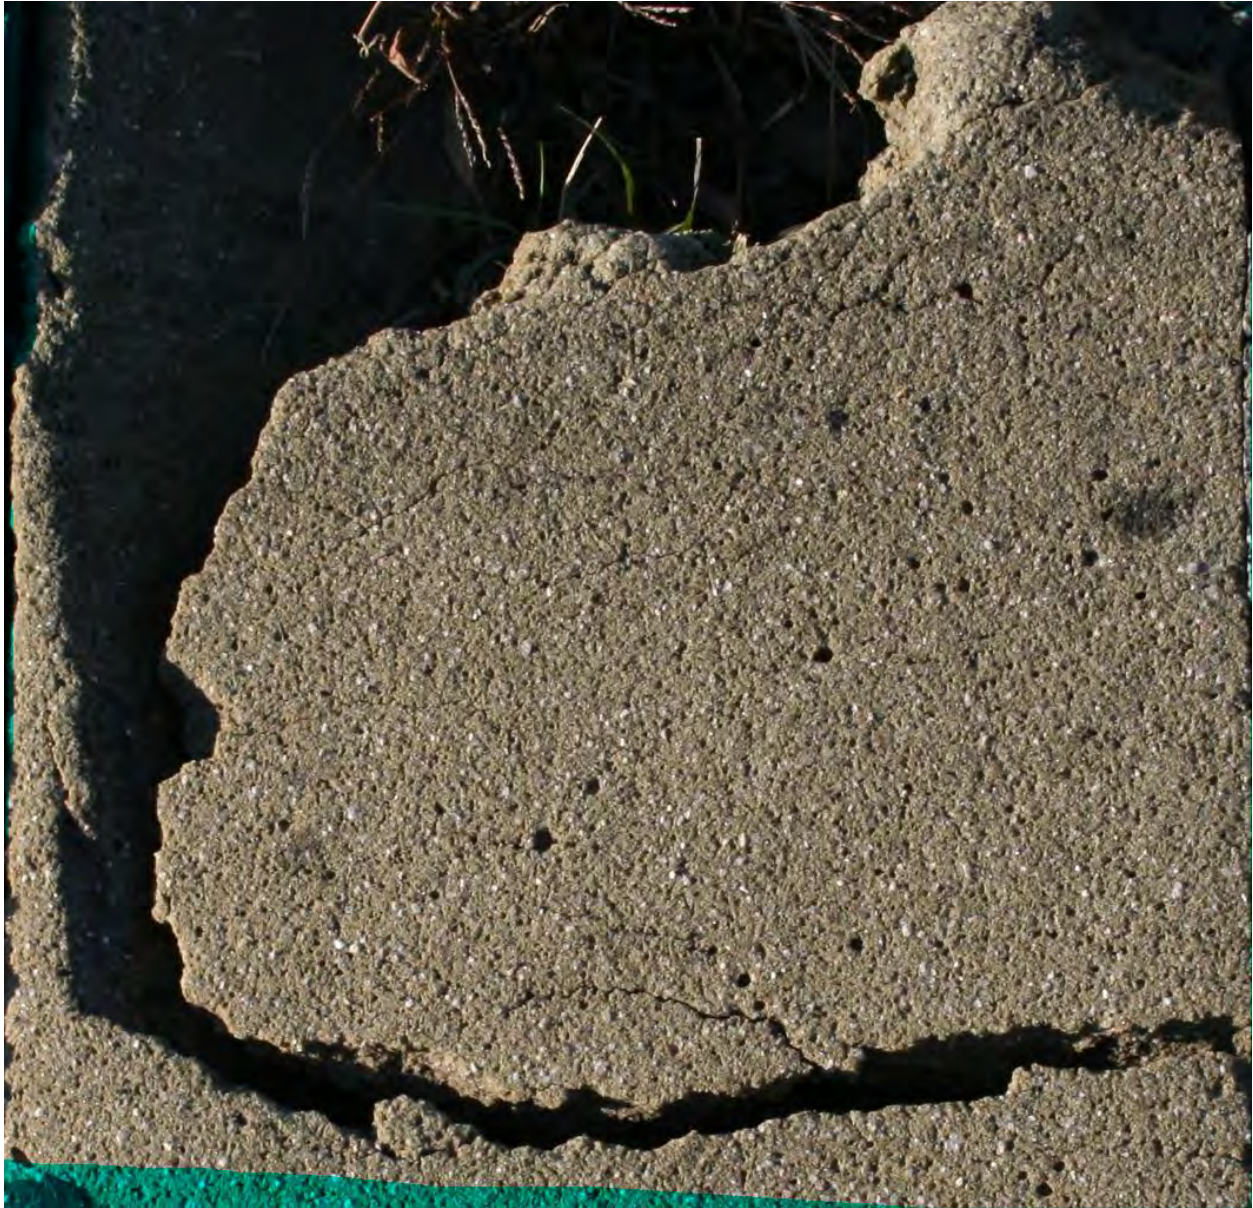
B.1.14: Original image of the area of study being marked with minor cracks in red pixels

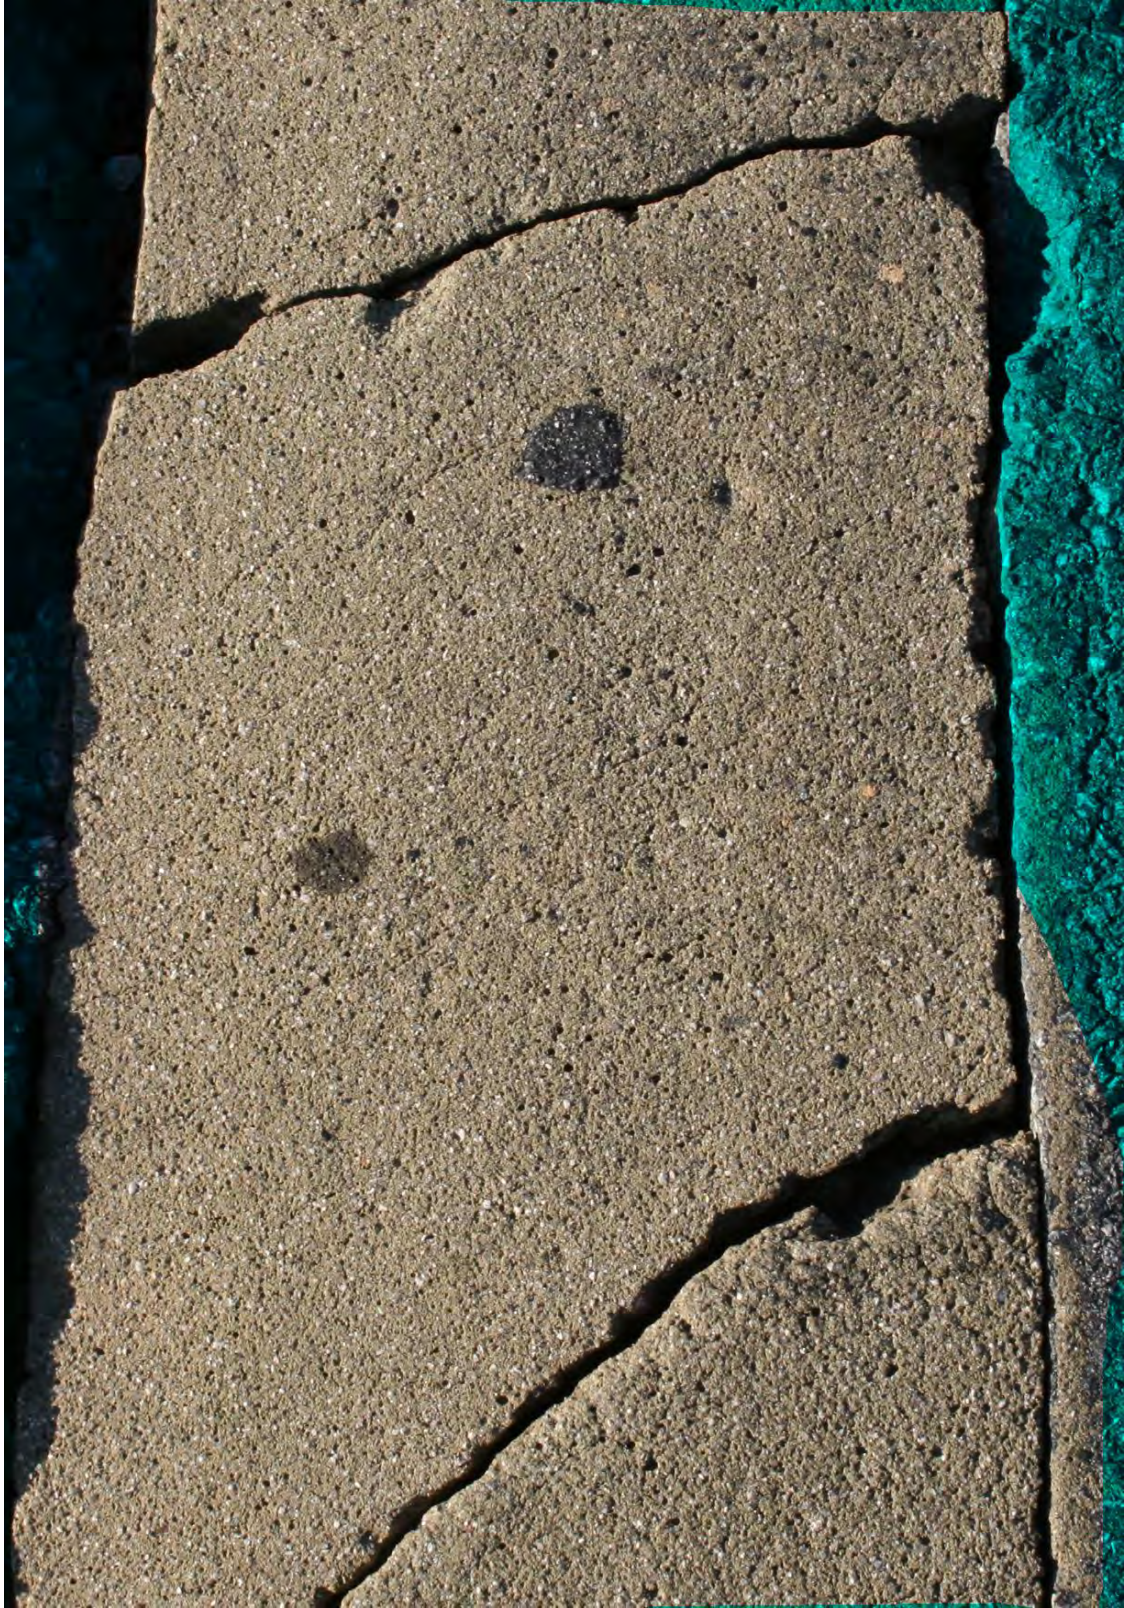
B.1.15: Cropped portion of the image under study

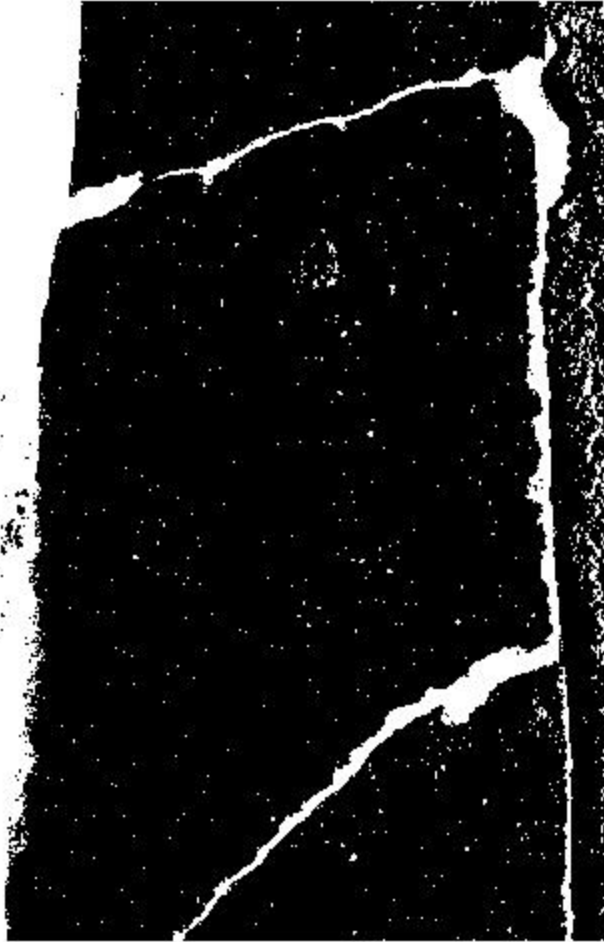
B.1.16: Binary image of the area of interest with total crack regions being marked as high

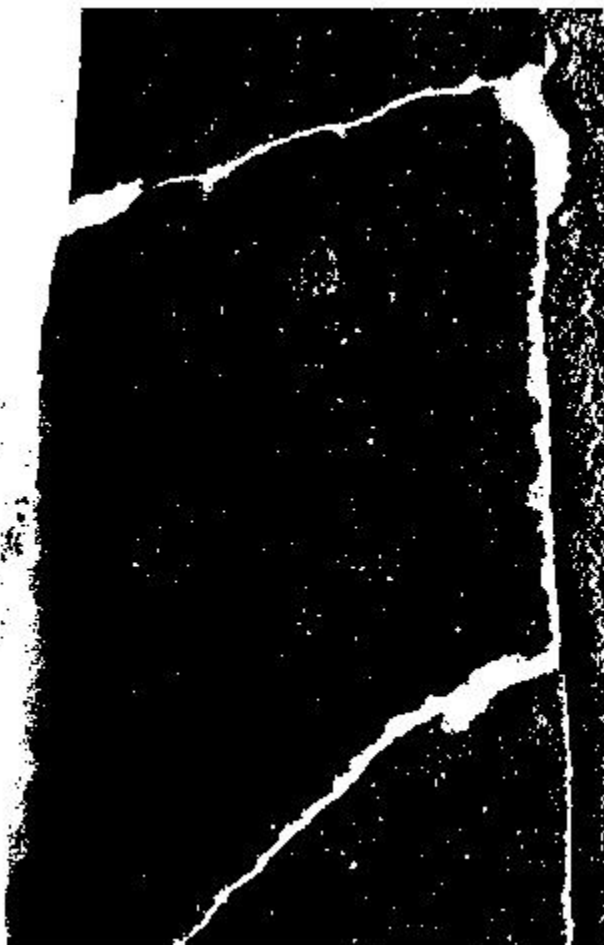
B.1.18: Binary image of the area of interest with major crack regions being identified using APBA
