**INTEGRATED REMOTE SENSING AND VISUALIZATION (IRSV)  
SYSTEM FOR TRANSPORTATION INFRASTRUCTURE  
OPERATIONS AND MANAGEMENT:  
PHASE TWO**

**VOLUME 5**

**AERIAL BRIDGE DECK IMAGING DATA COLLECTION AND  
SOFTWARE REVISION**

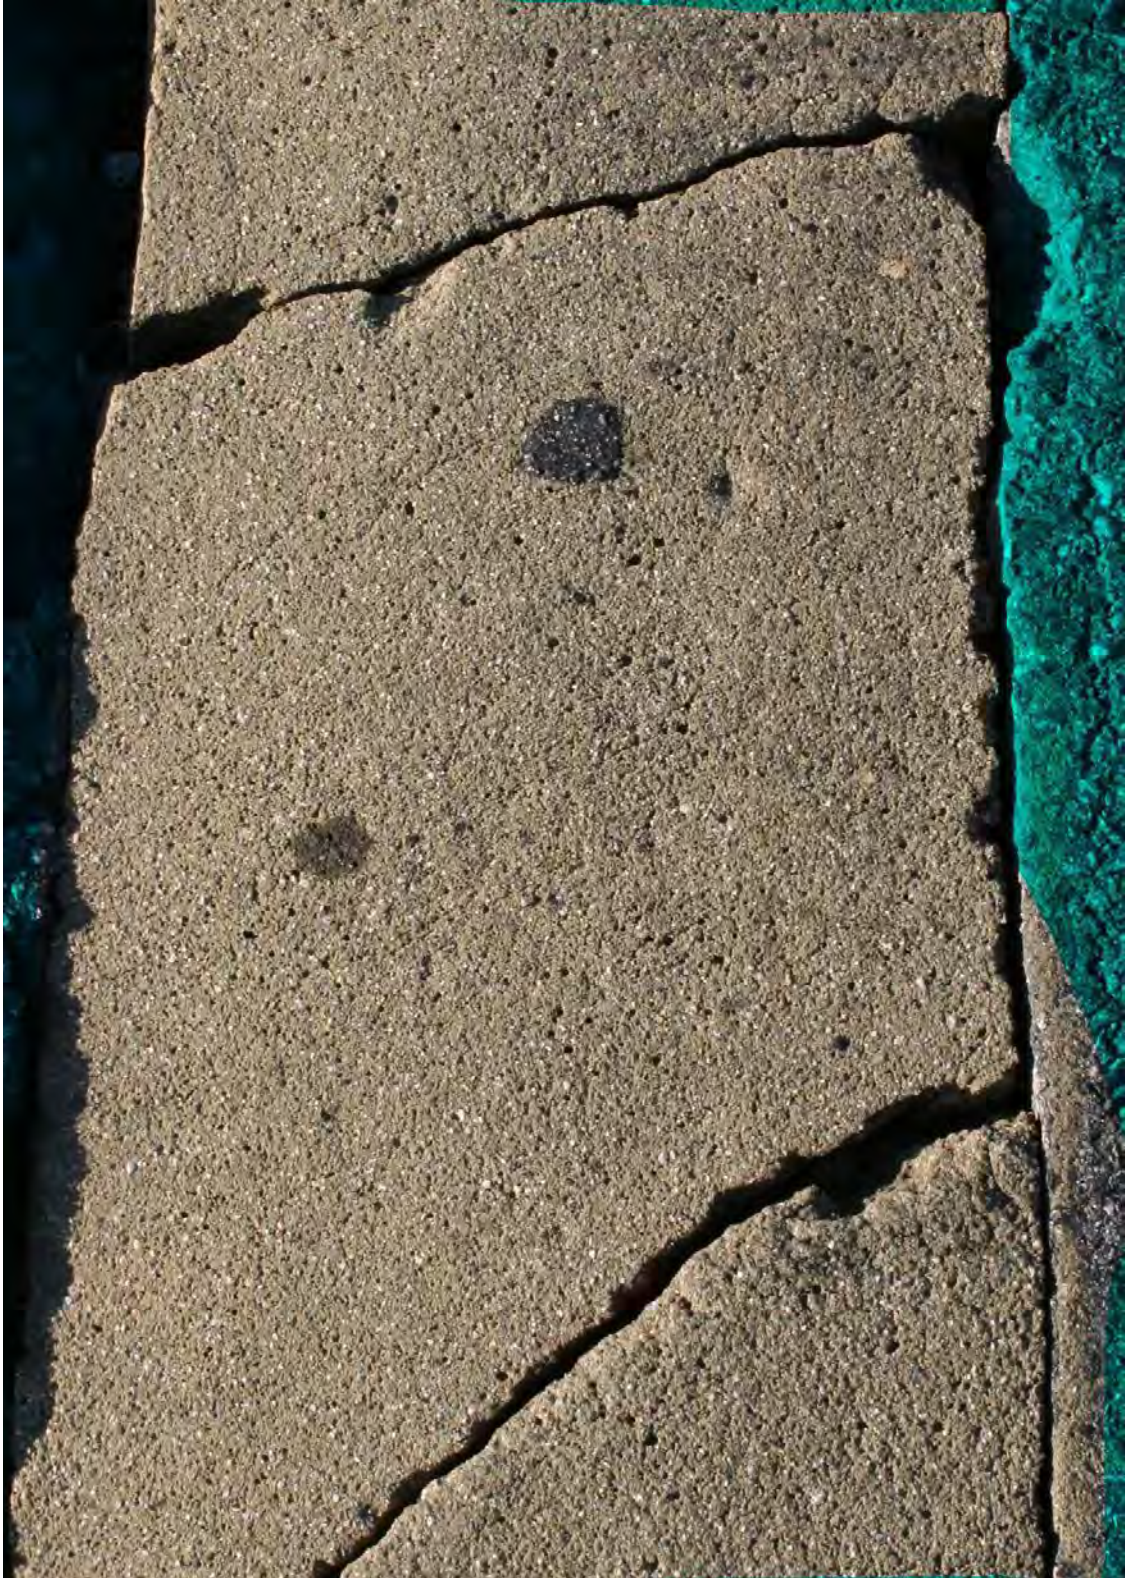
B.1.21: Original image of the area of study being marked with minor cracks in red pixels

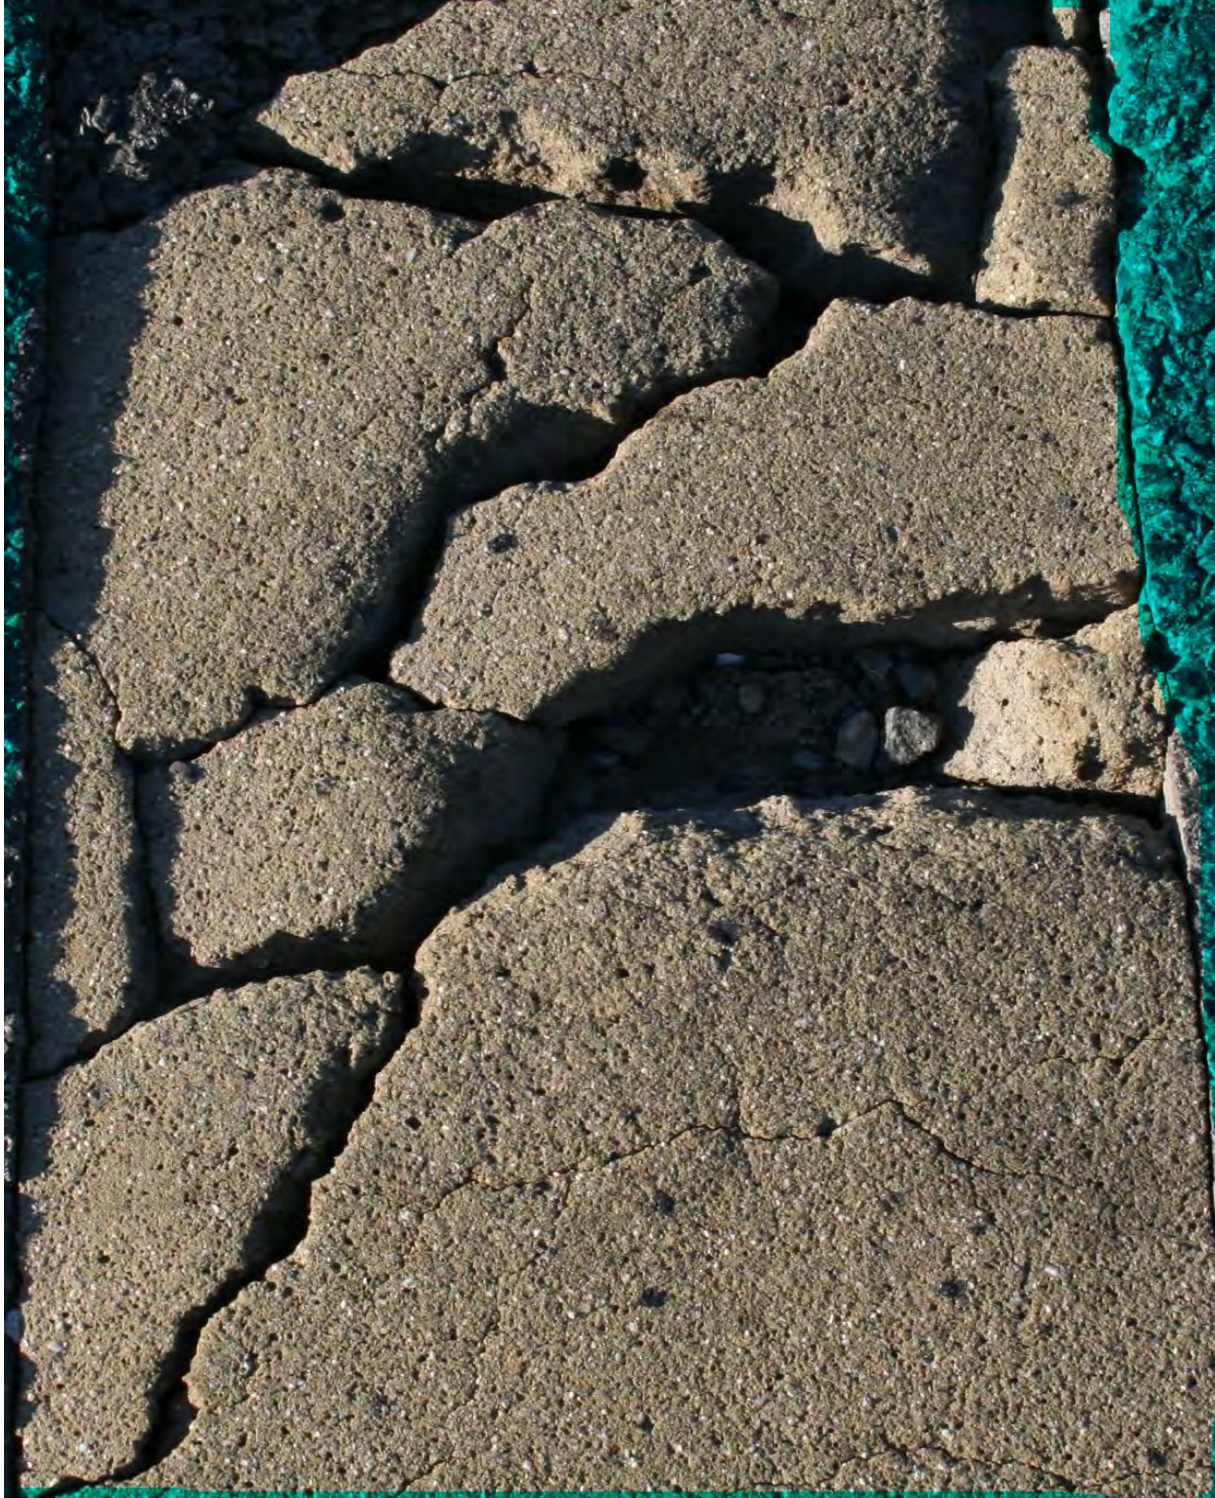
B.1.22: Cropped portion of the image under study

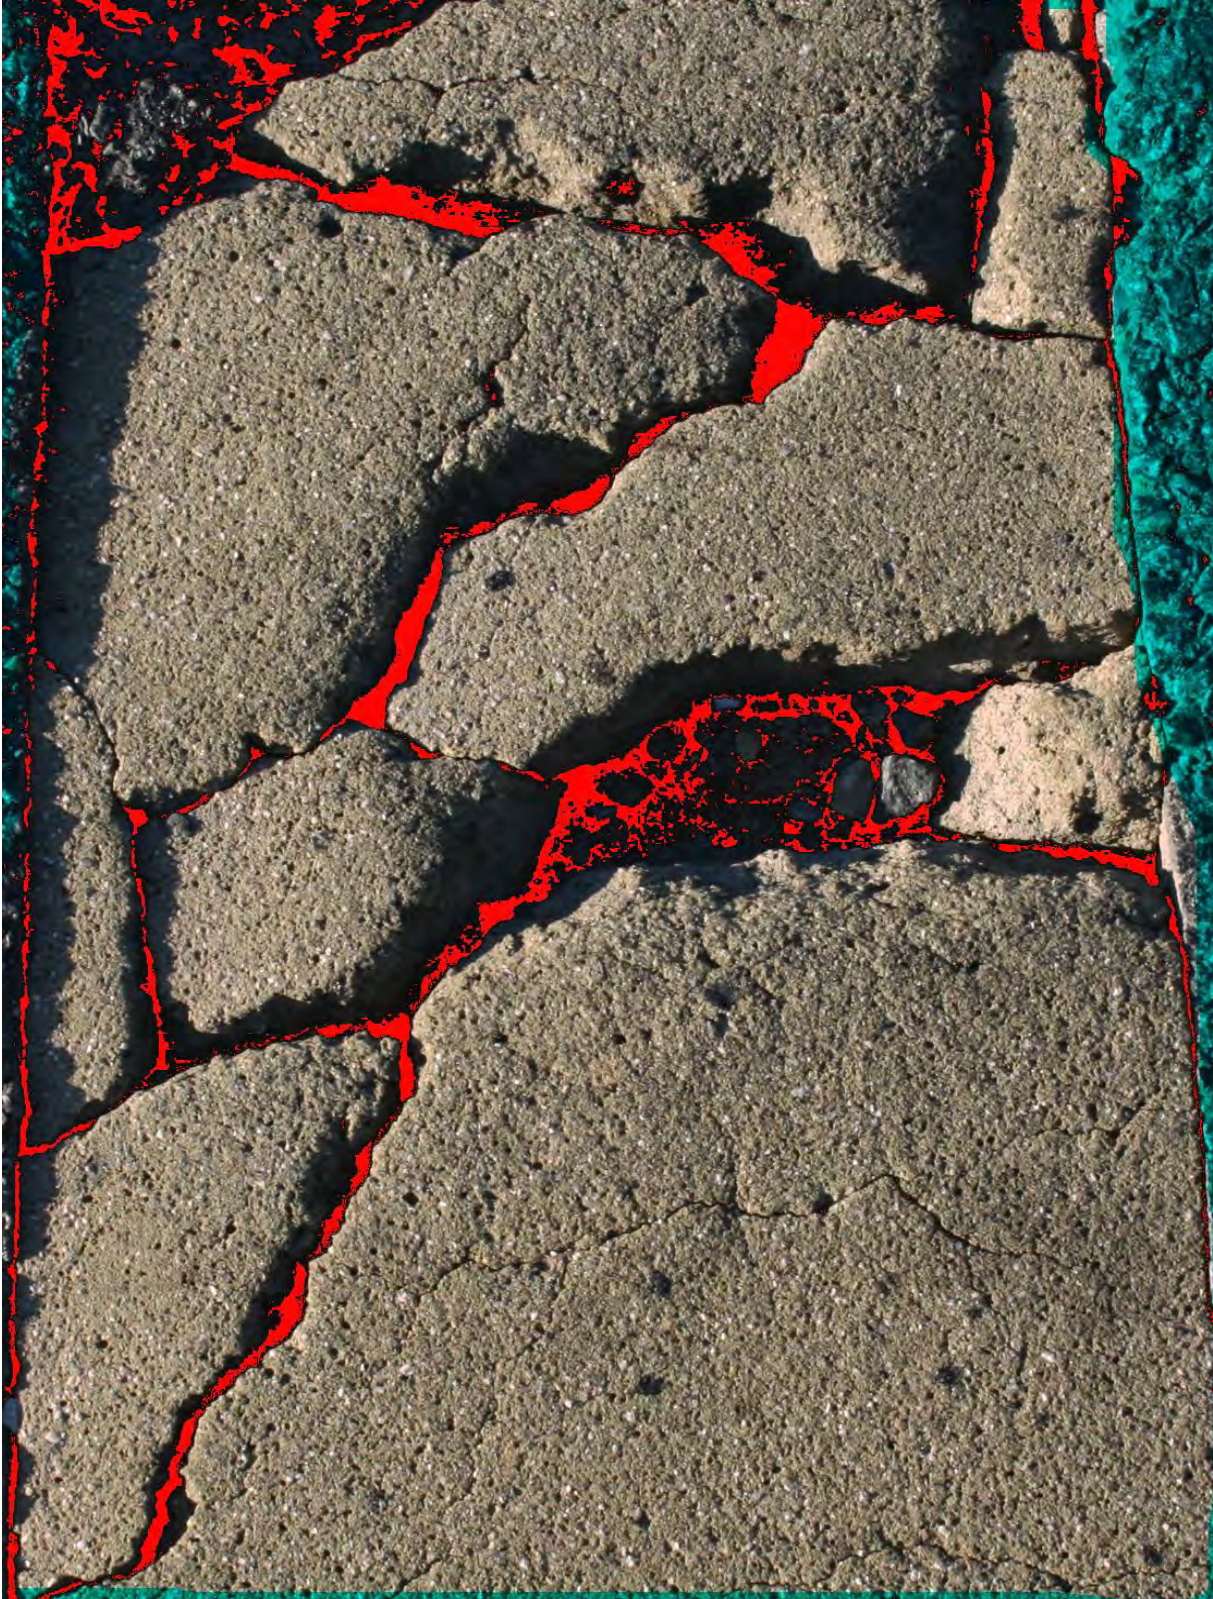
B.1.24: Original image of the area of study being marked with total damages in red pixels.

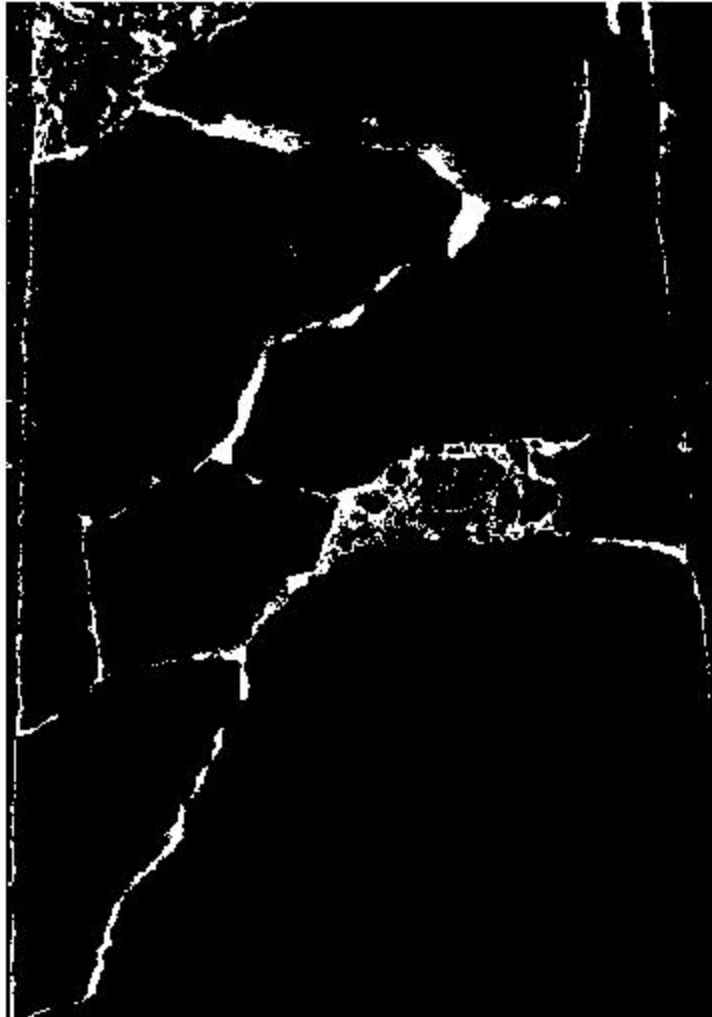
B.1.25: Binary image of the area of interest with major crack regions being identified using APBA

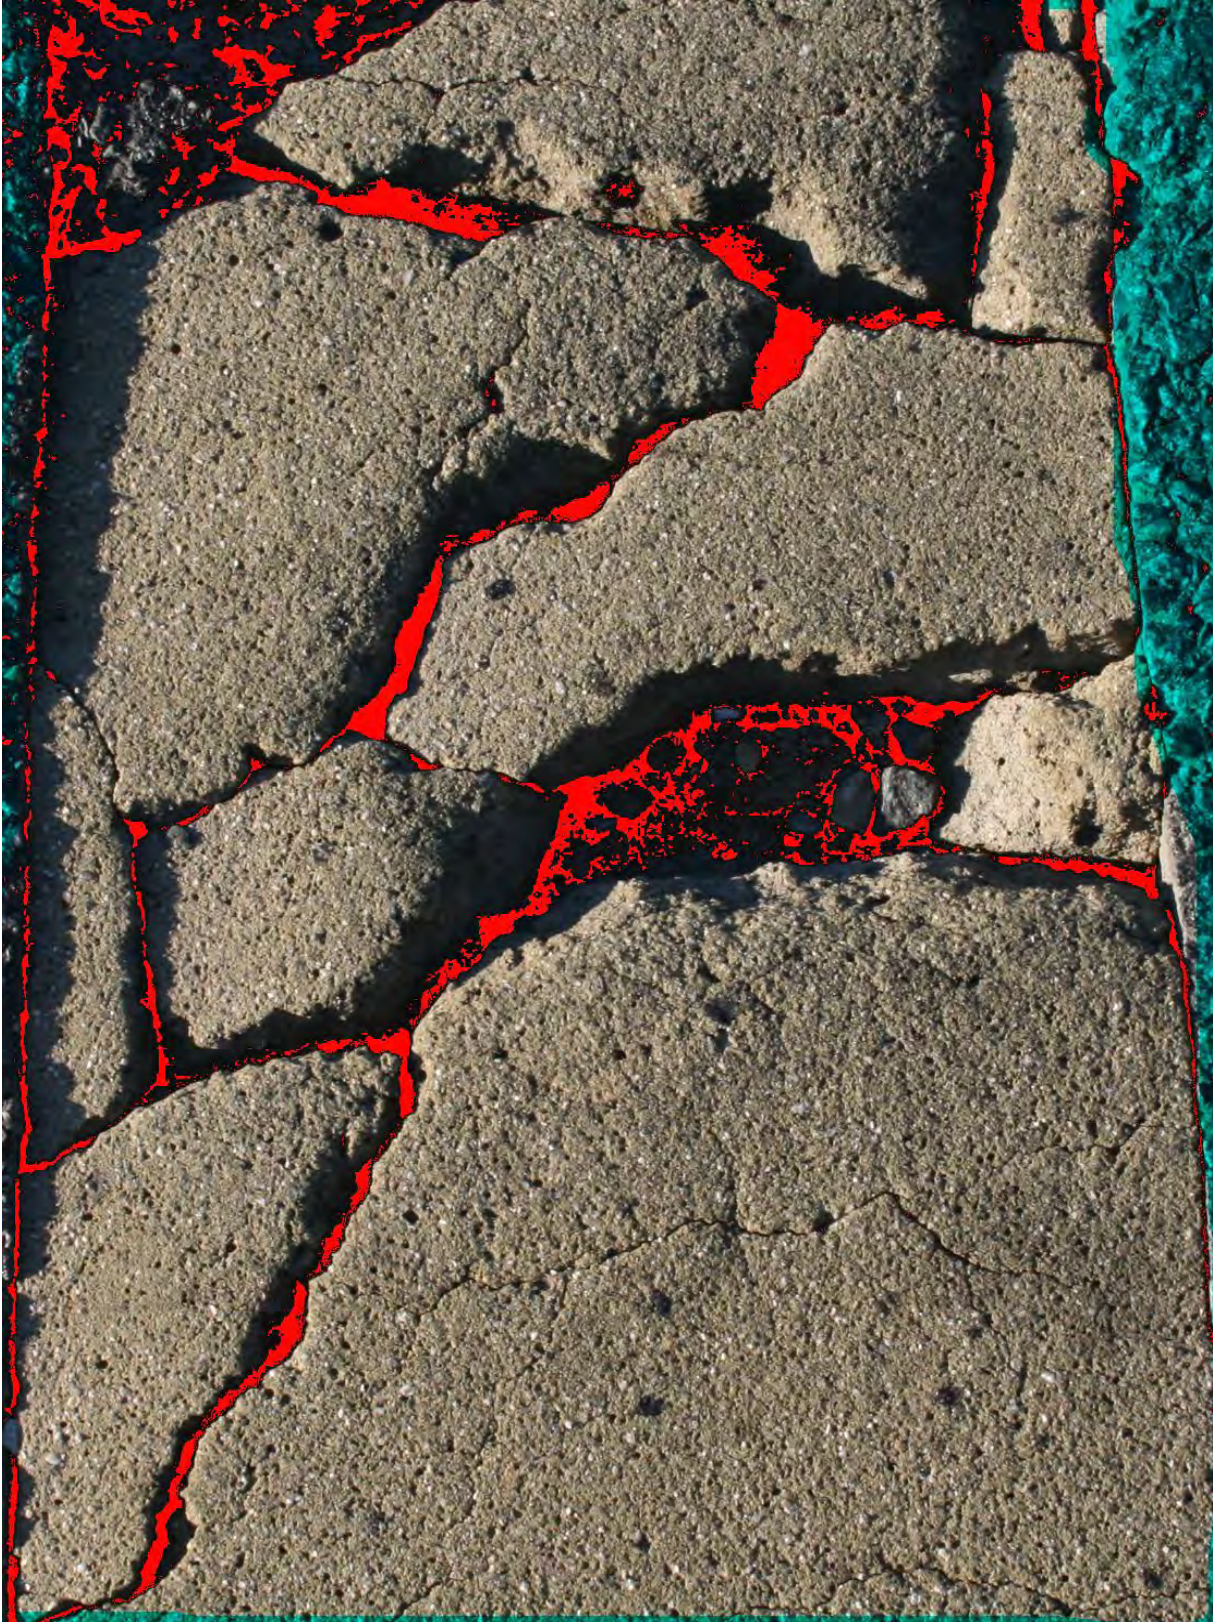
B.1.26: Original image of the area of study being marked with major cracks in red pixels

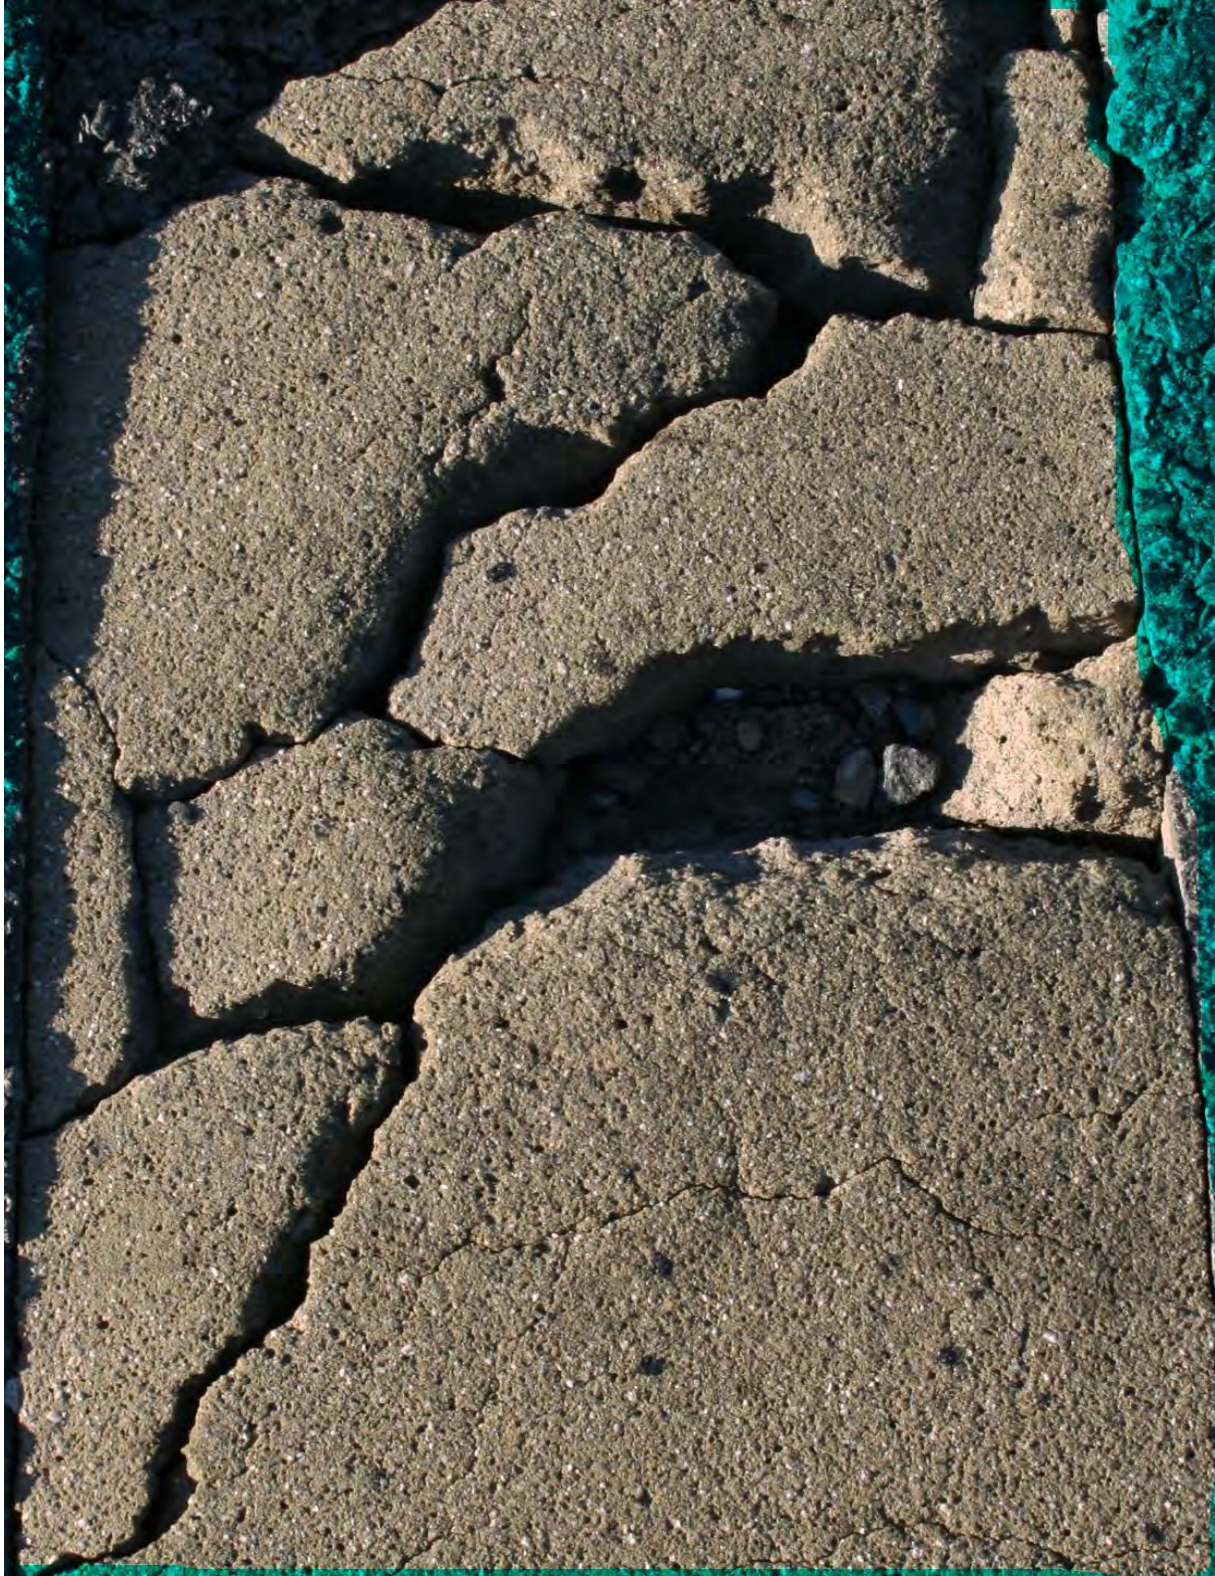
B.1.28: Original image of the area of study being marked with minor cracks in red pixels

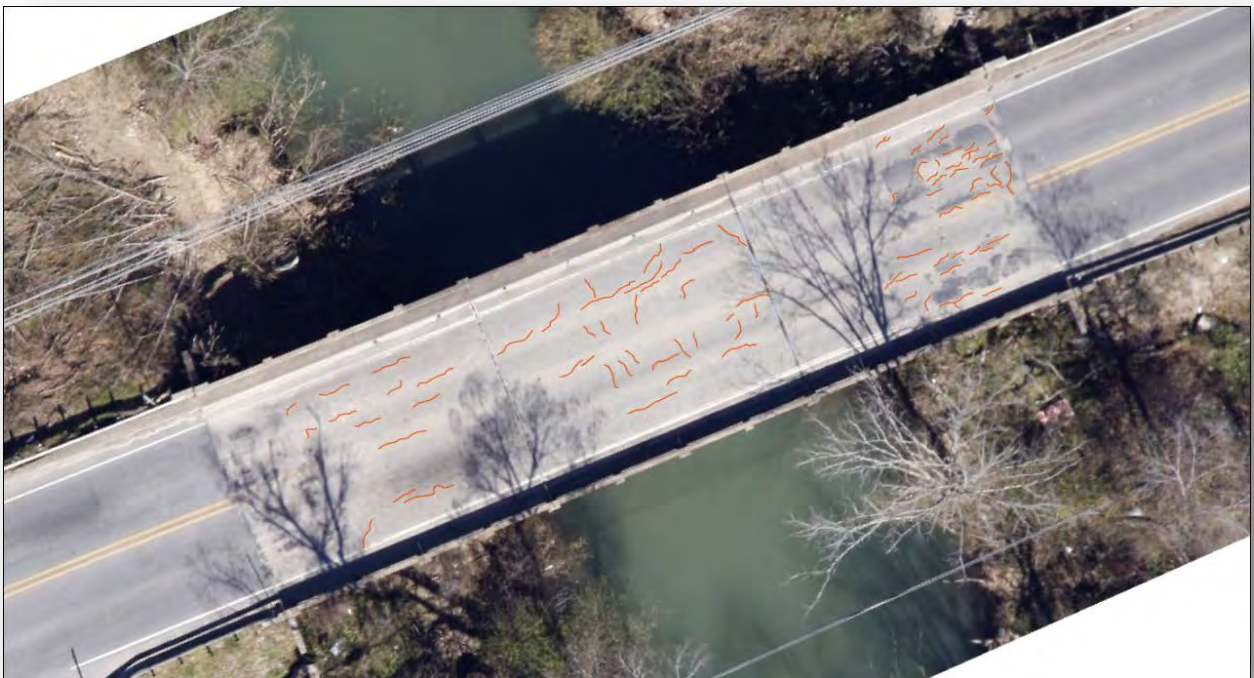
**Figure C.1.3: Bridge NO. 003267 Crack Image**

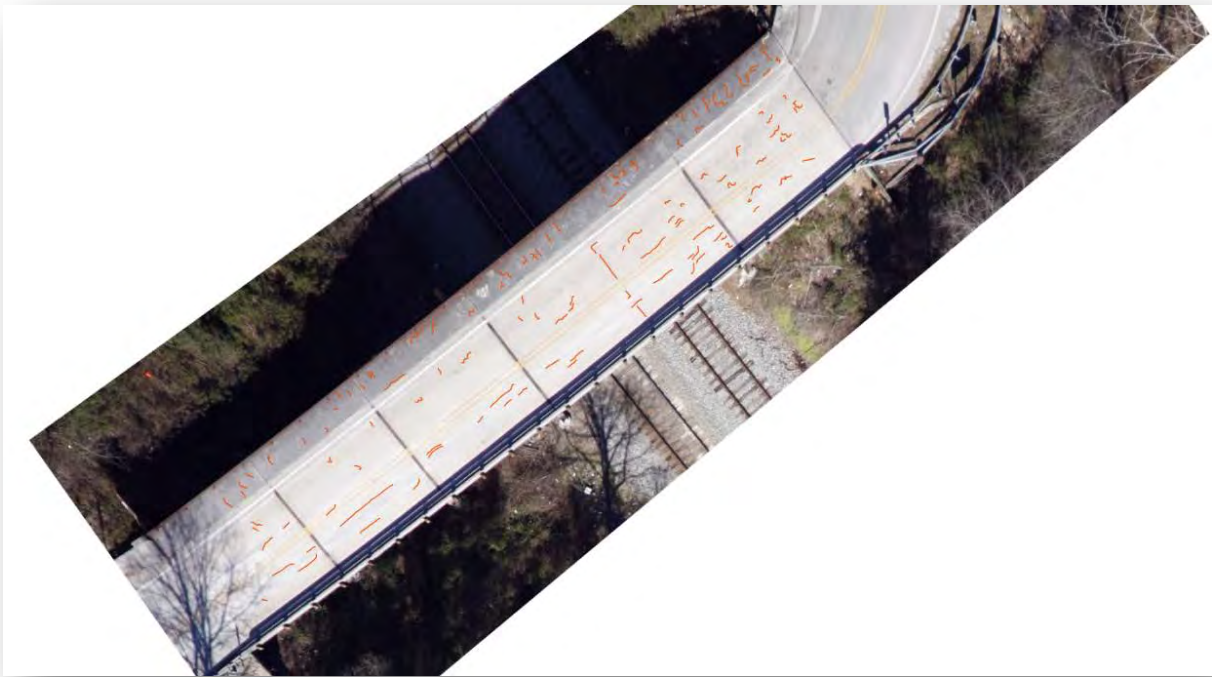
**Figure C.1.5: Bridge NO. 10357 Crack Image**

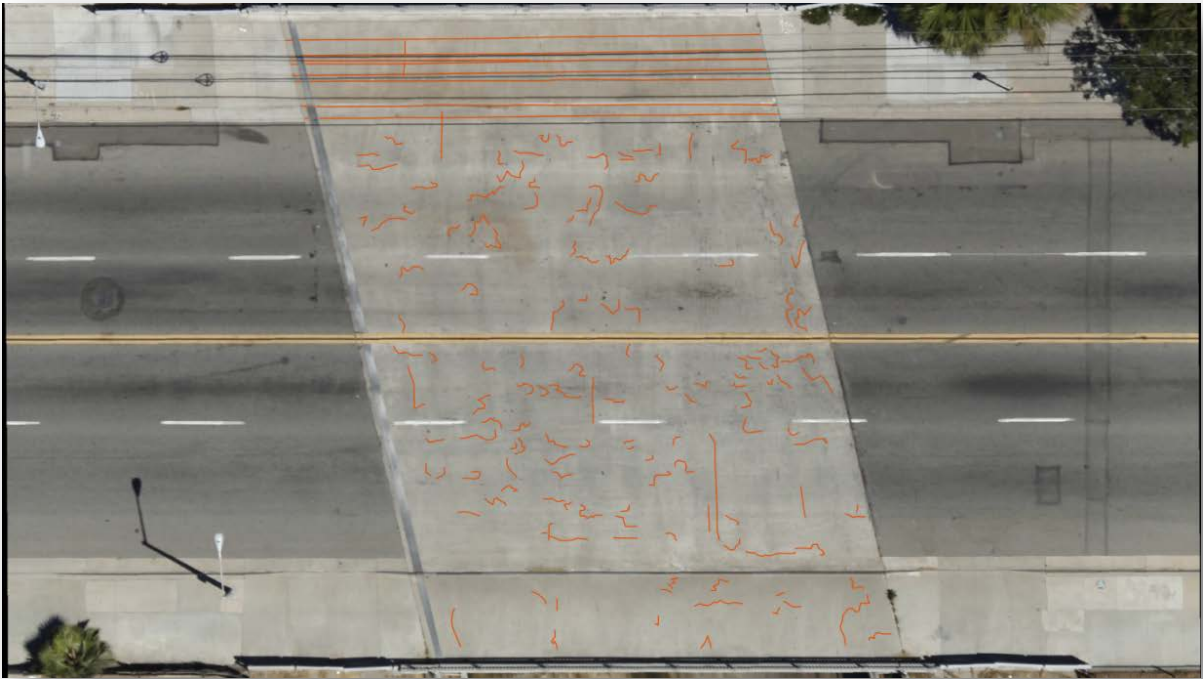
**Figure C.2.3: Bridge NO. 53C0625 Crack Image**

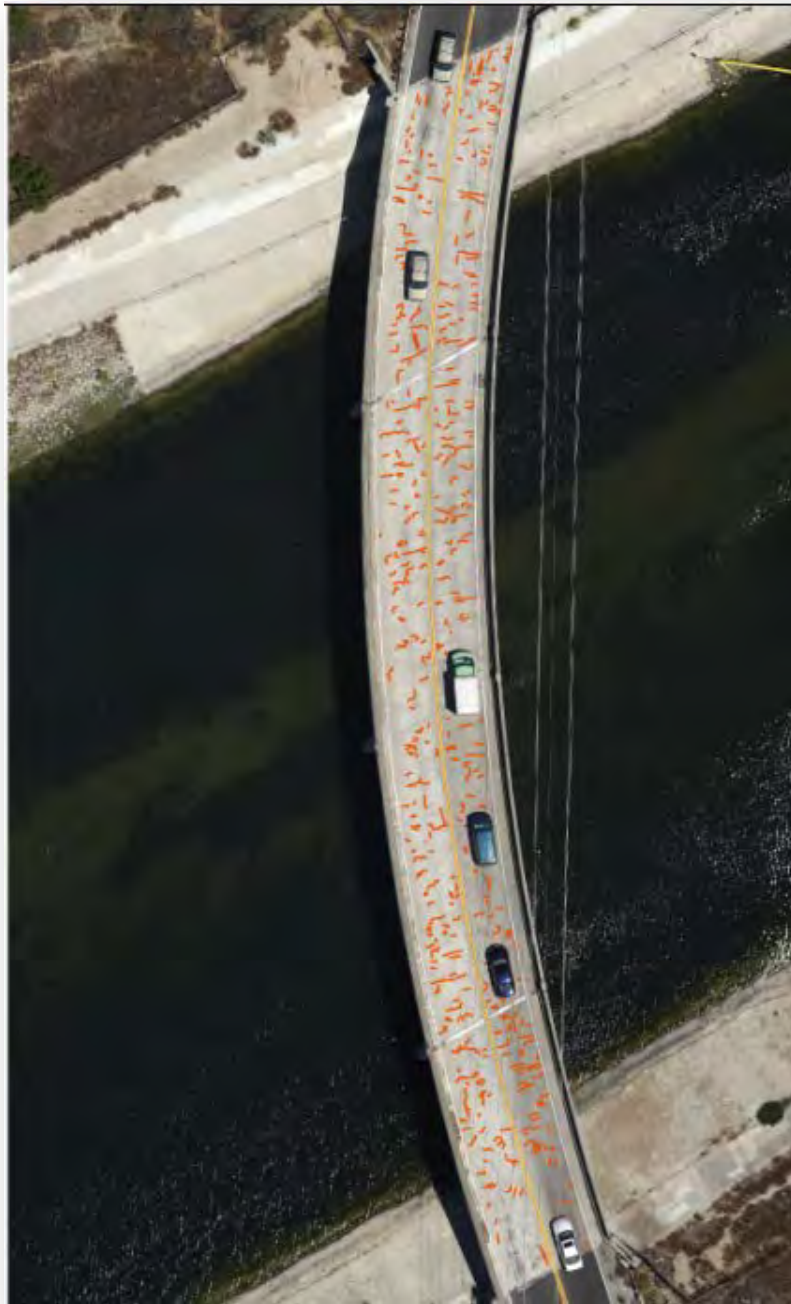
**Figure C.2.8: Bridge NO. 53C0602 Crack Image**

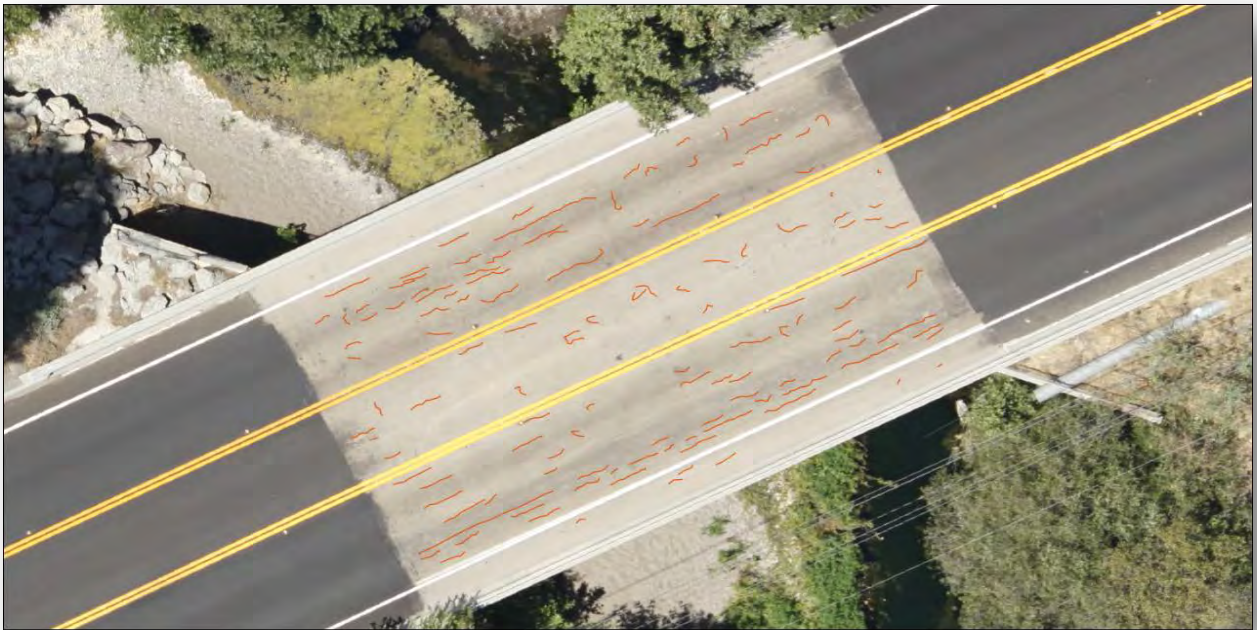
**Figure C.2.11: Bridge NO. 53C0775 Crack Image**

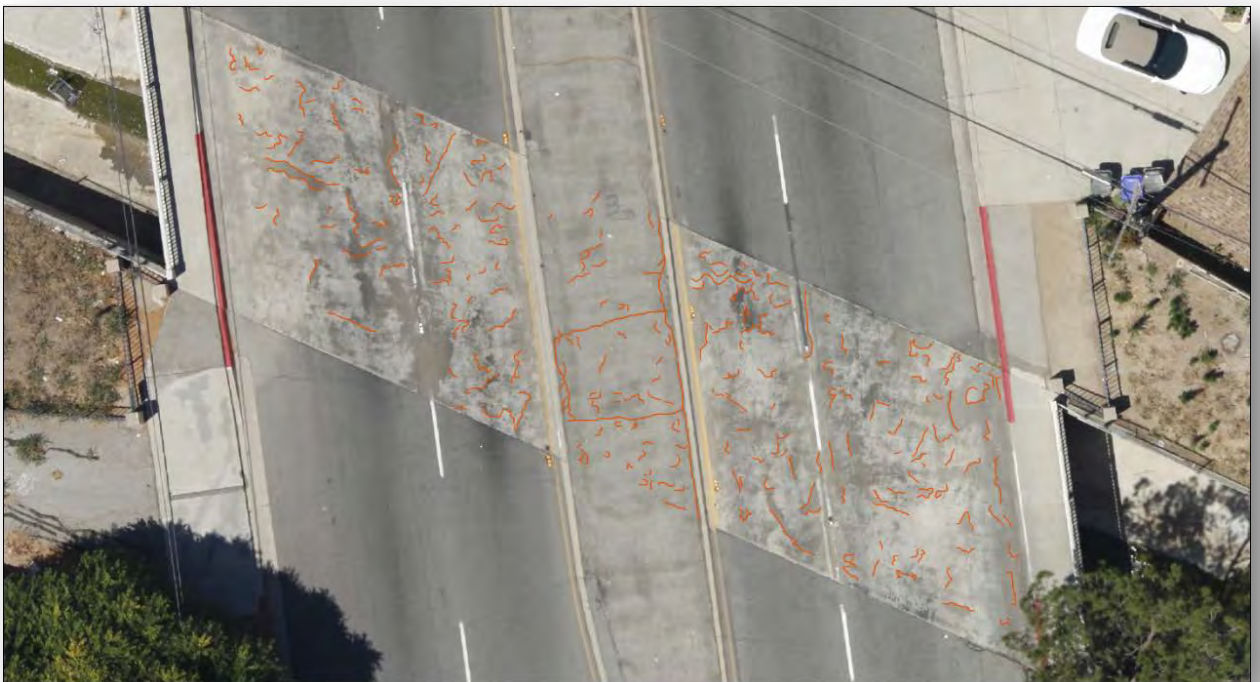
**Figure C.2.14: Bridge NO. 53C0470 Crack Image**

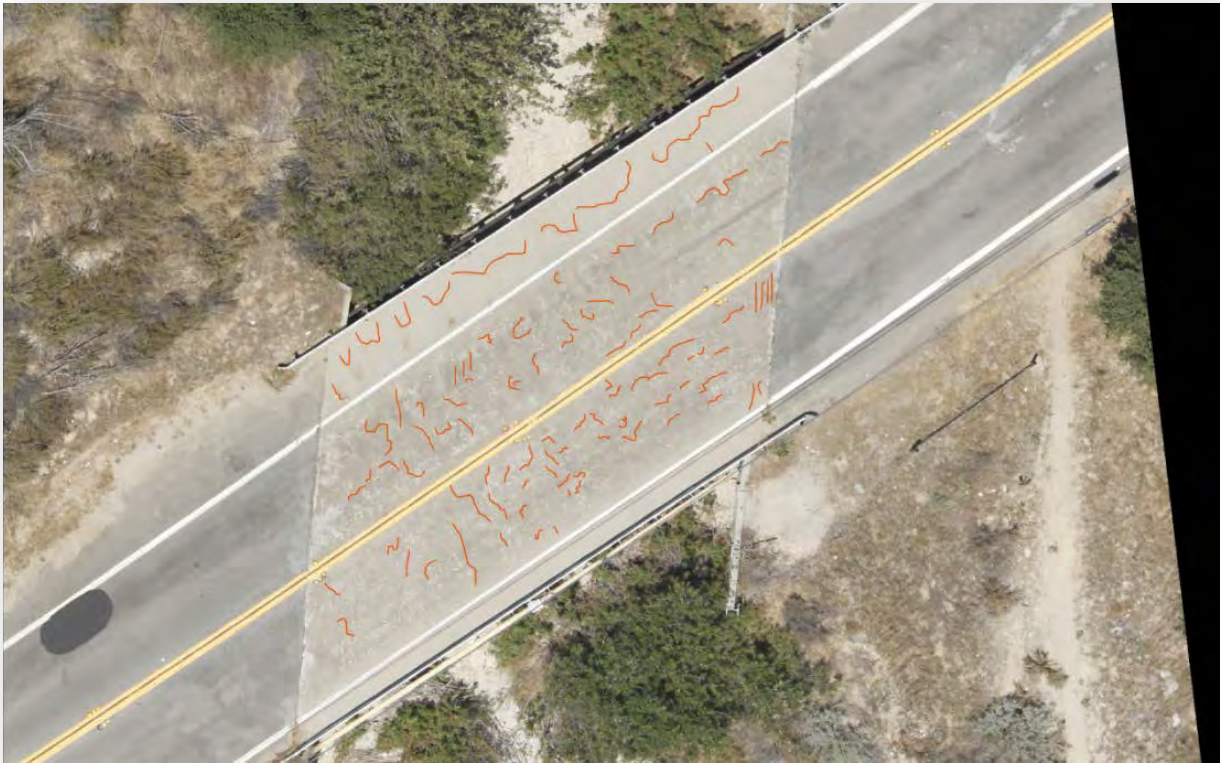
**Figure C.2.1612: Bridge NO. 53C1527 Crack Image**

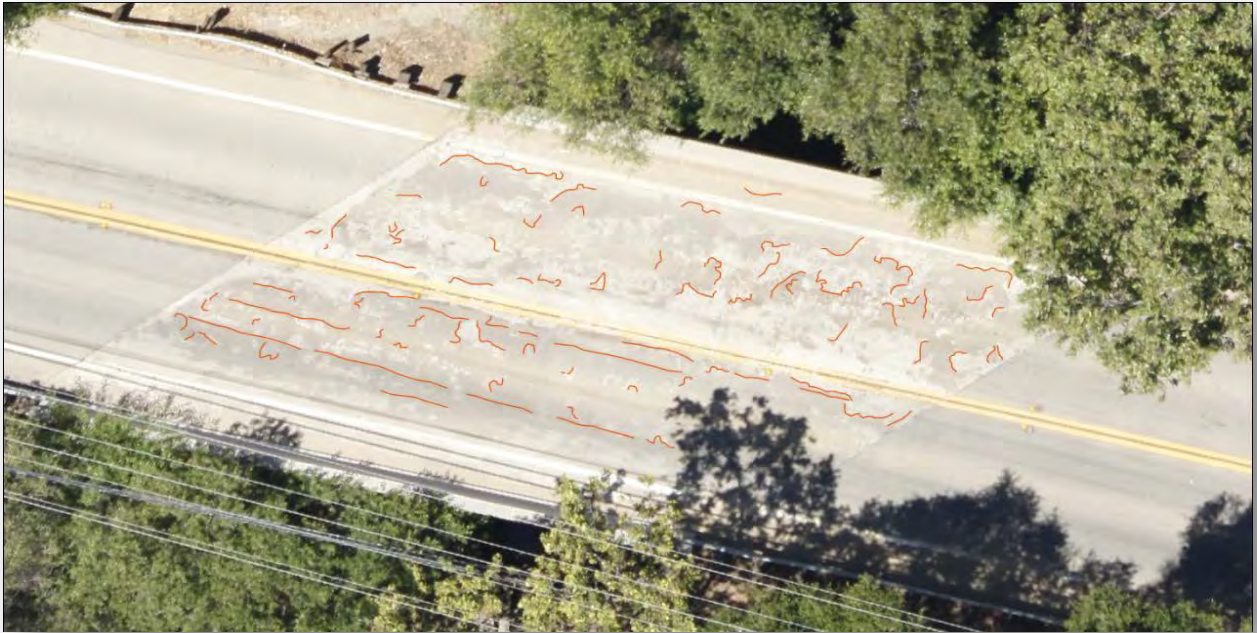
**Figure C.2.22: Bridge NO. 53C0981 Crack Image**

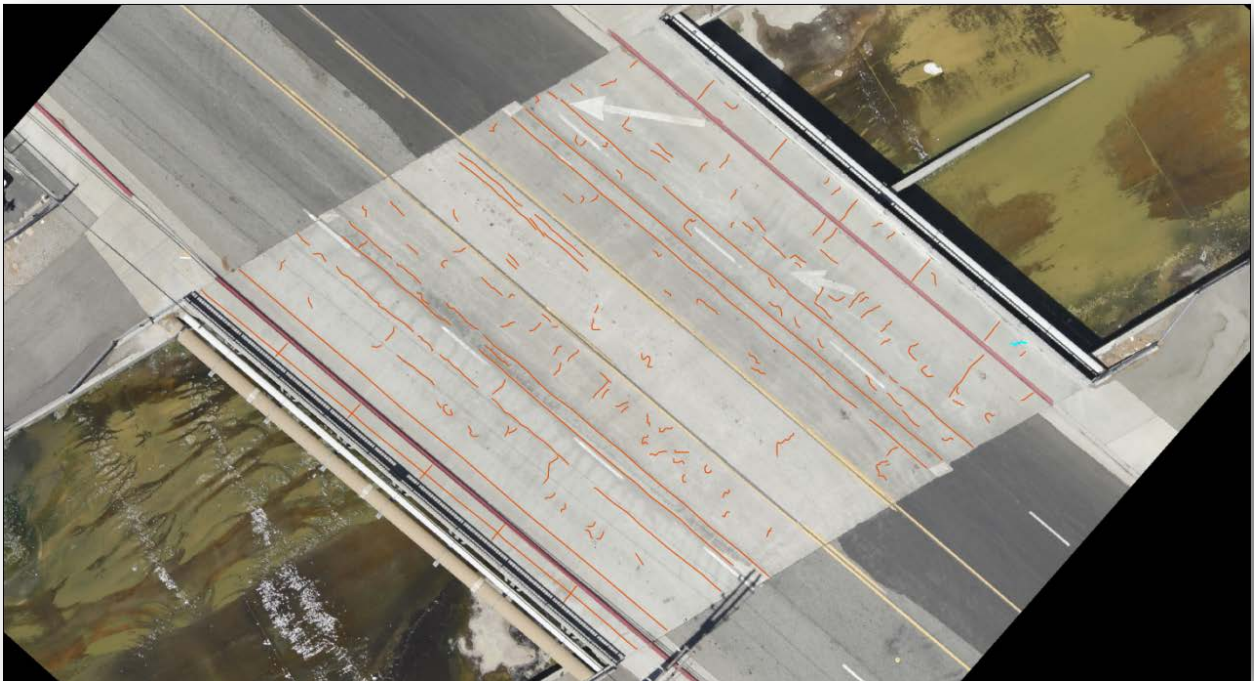
**Figure C.2.25: Bridge NO. 53C1008 Crack Image**

**Table C.2.3321: Bridge NO. 53C1008 Span Area**

Span Area						
FID	Span	Area	# Cracks	Obstruction Area	DV	Crack Density
0	A	7929.712	165	177.5308495	16.403	2.128433234

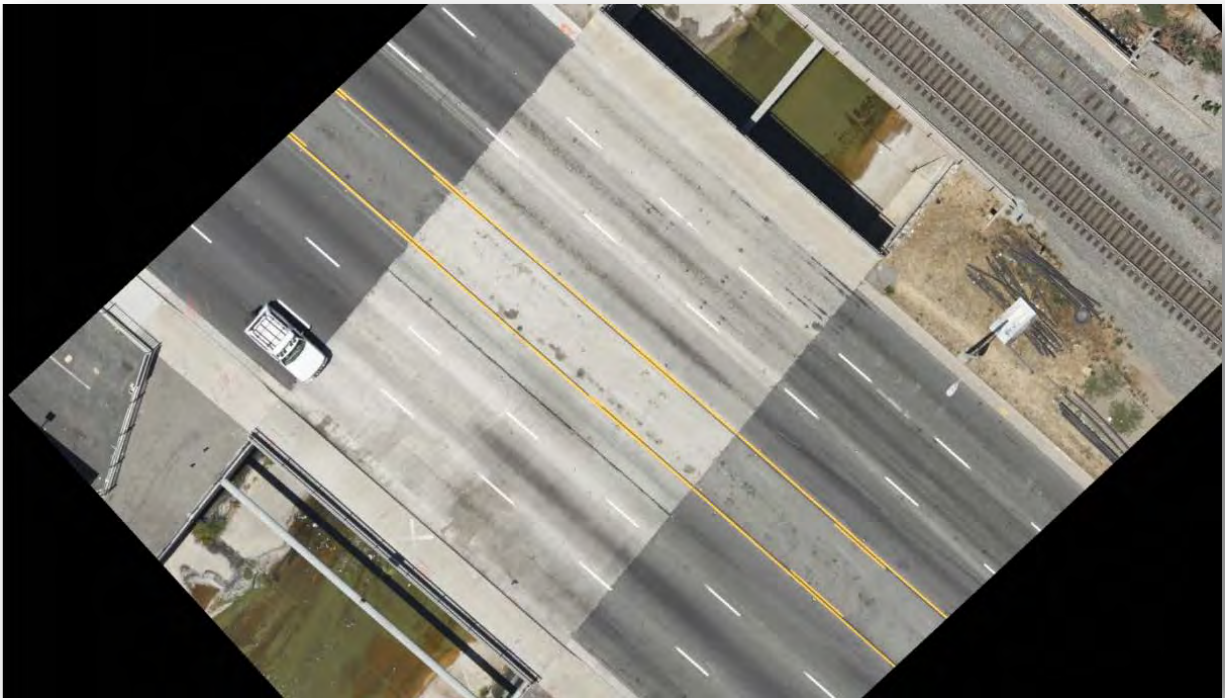
**Figure C.2.2613: Bridge NO. 53C0431 Blank Image**

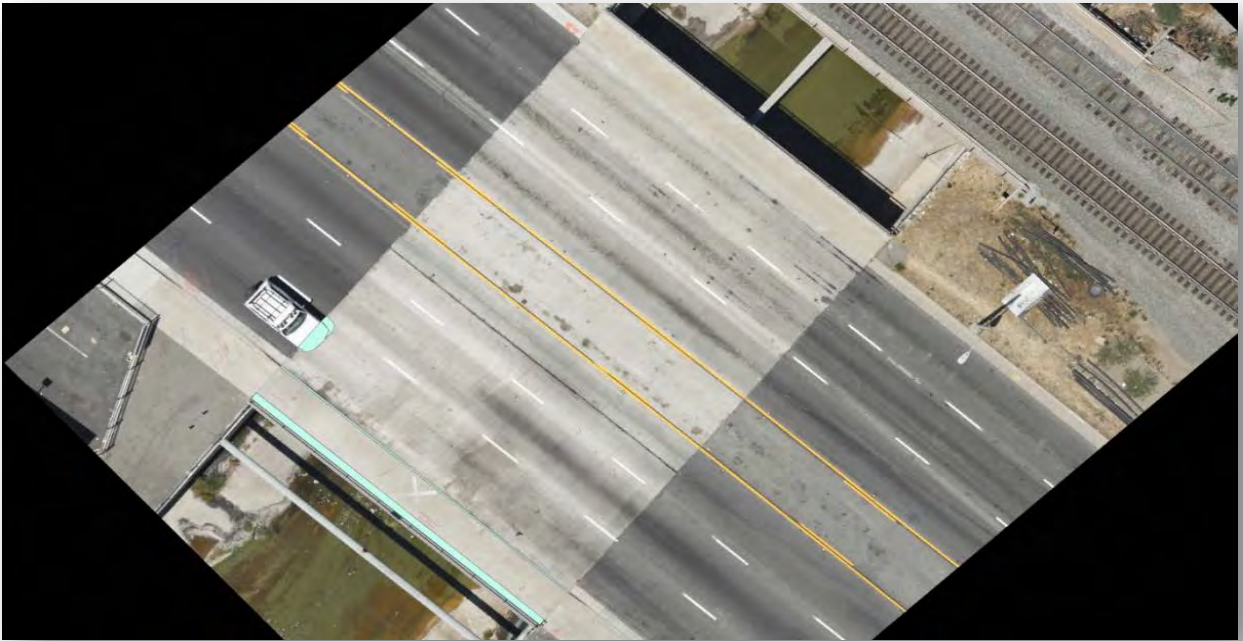
**Figure C.2.27: Bridge NO. 53C0431 Obstruction Image**

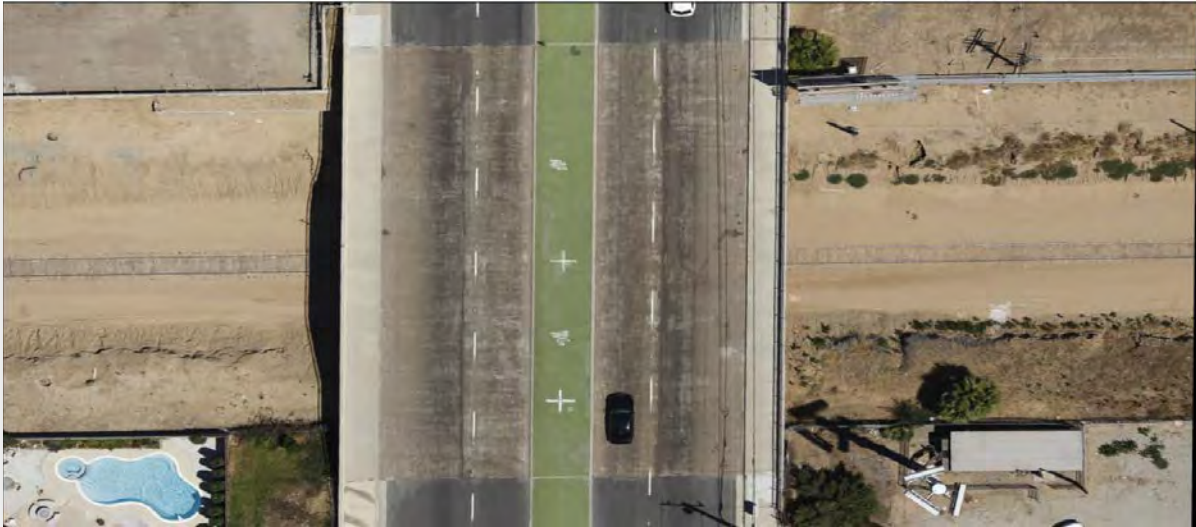
**Figure C.2.29: Bridge NO. 53C0825 Blank Image**

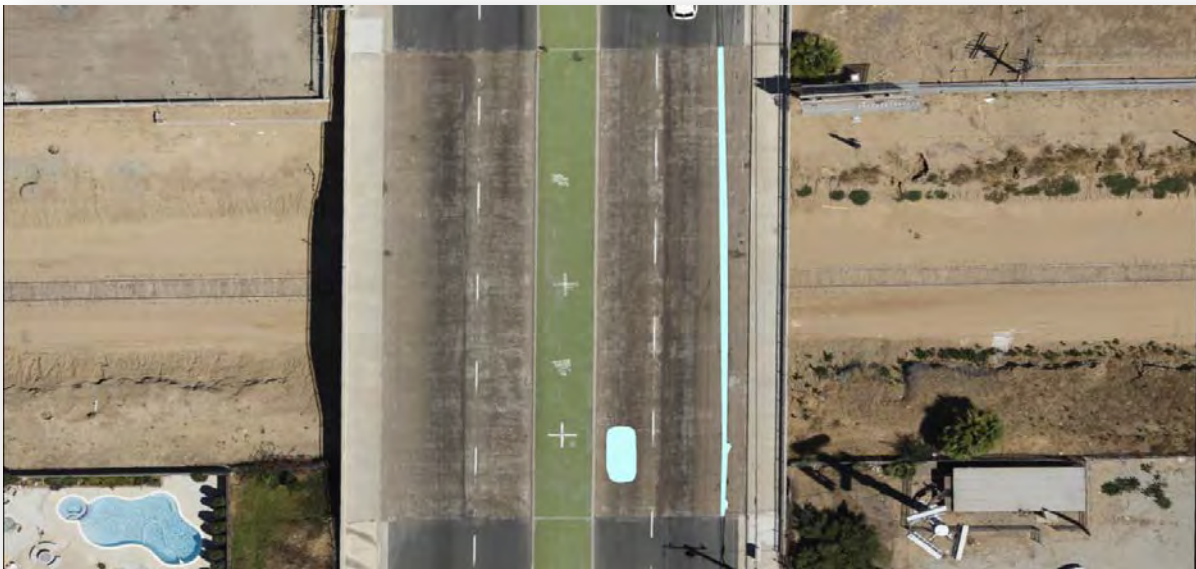
**Figure C.2.30: Bridge NO. 53C0825 Obstruction Image**

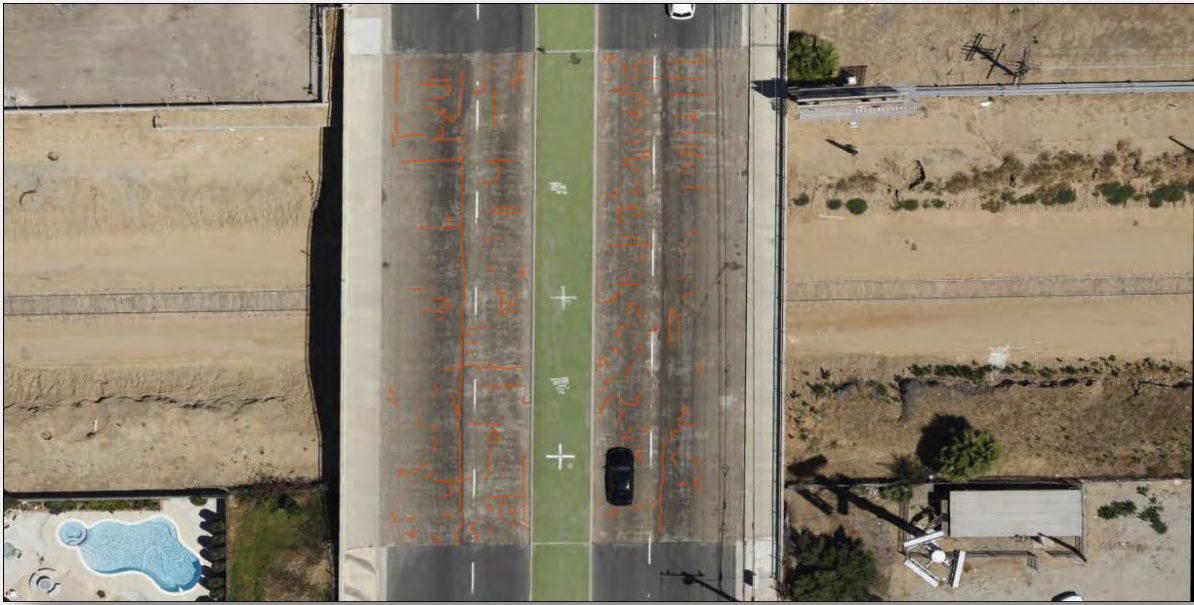
Figure C.2.31: Bridge NO. 53C0825 Crack Image

Table C.2.41: Bridge NO. 53C0825 Span Area

Span Area						
FID	Span	Area	# Cracks	Obstruction Area	DV	Crack Density
0	A	6406.11	85	447.669014	7.714314	1.42654765
1	B	6447.903	83	0	5.482979	1.287240166

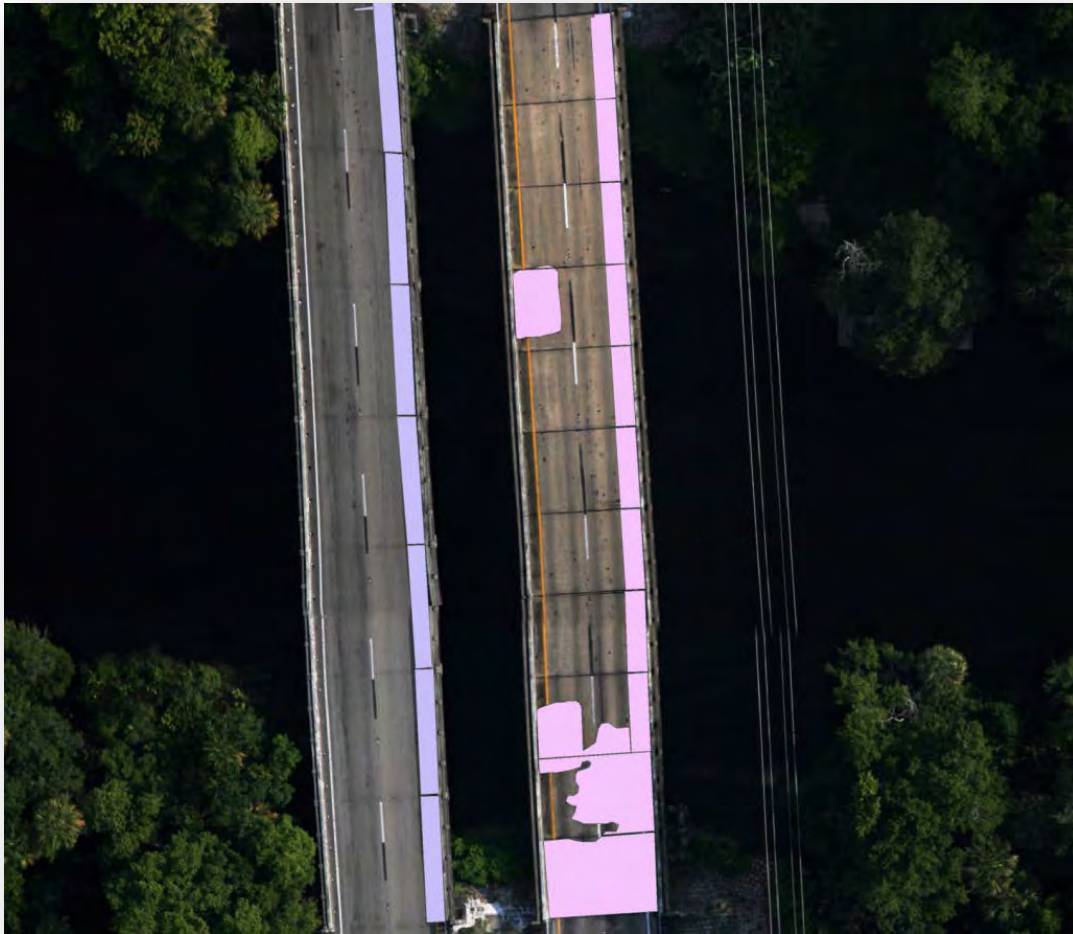
**Figure C.3.214: Bridge NO. 730008 Obstruction Image**
