**INTEGRATED REMOTE SENSING AND VISUALIZATION (IRSV)  
SYSTEM FOR TRANSPORTATION INFRASTRUCTURE  
OPERATIONS AND MANAGEMENT:  
PHASE TWO**

**VOLUME 5**

**AERIAL BRIDGE DECK IMAGING DATA COLLECTION AND  
SOFTWARE REVISION**

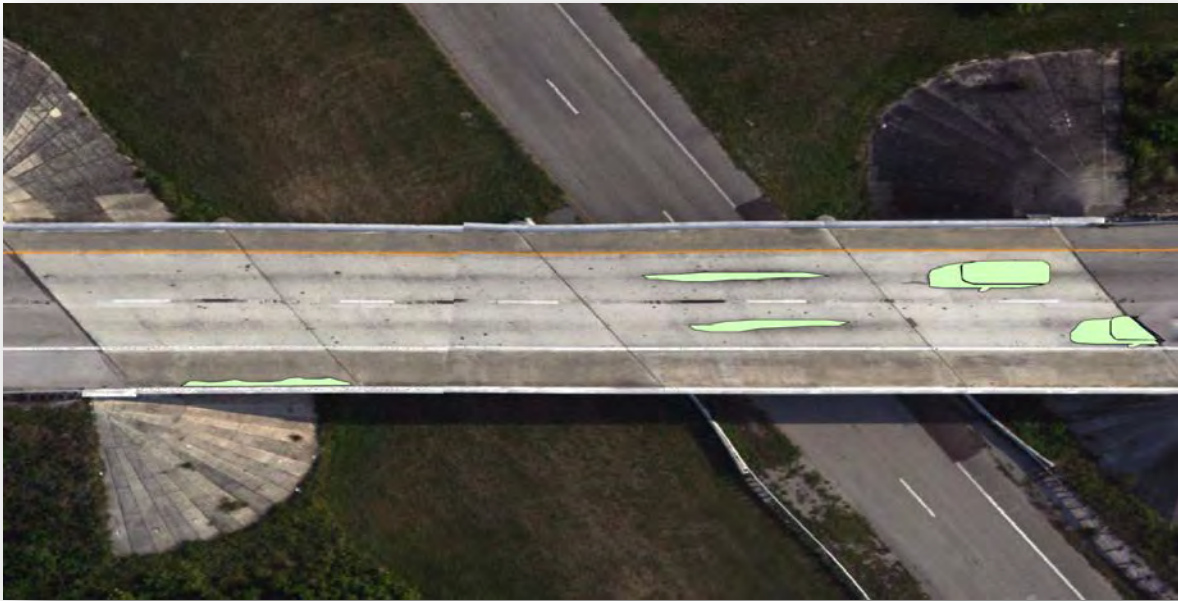
**Figure C.3.5: Bridge NO. 750143 Obstruction Image**

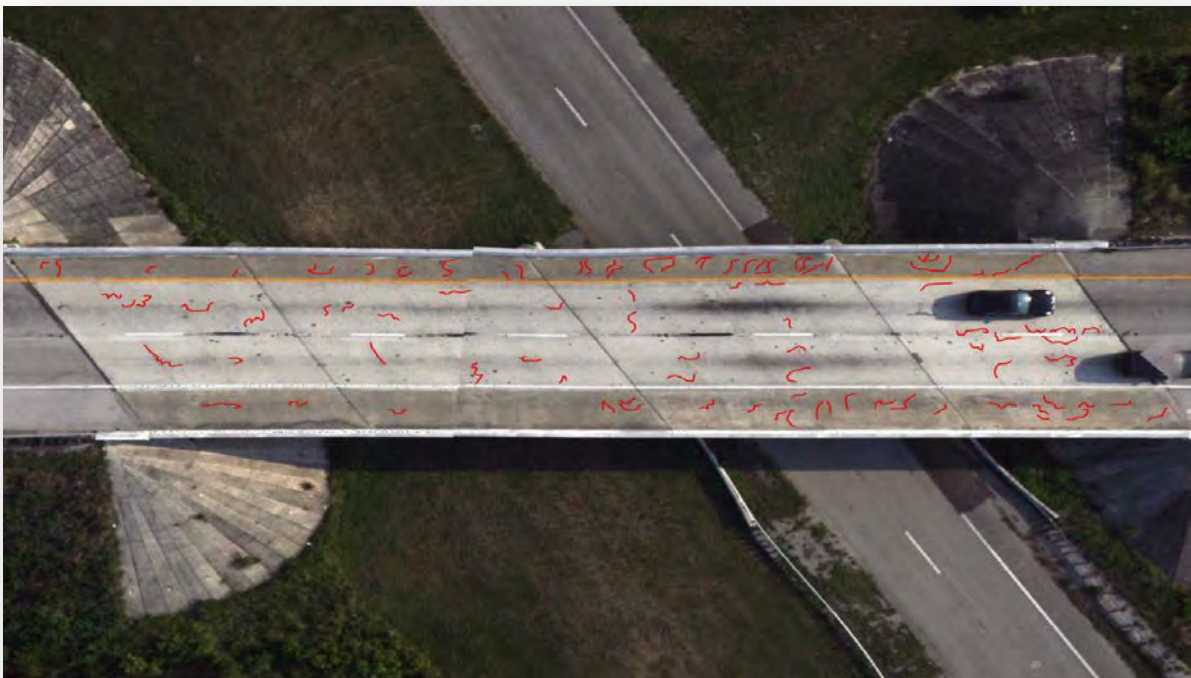
**Figure C.3.6: Bridge NO. 750143 Crack Image**

**Table C.3.6: Bridge NO. 750143 Span Area**

<b>Span Area</b>						
<b>FID</b>	<b>Span</b>	<b>Area</b>	<b># Cracks</b>	<b>Obstruction Area</b>	<b>DV</b>	<b>Crack Density</b>
<b>0</b>	<b>A</b>	<b>2591.26</b>	<b>19</b>	<b>0</b>	<b>1</b>	<b>0.733234025</b>
<b>1</b>	<b>B</b>	<b>2696.96</b>	<b>36</b>	<b>126.6315002</b>	<b>7.315693</b>	<b>1.400599184</b>
<b>2</b>	<b>C</b>	<b>2039.68</b>	<b>24</b>	<b>269.7761002</b>	<b>6.613078</b>	<b>1.356005826</b>
<b>3</b>	<b>D</b>	<b>2038.61</b>	<b>13</b>	<b>48.37900162</b>	<b>1</b>	<b>0.65319051</b>

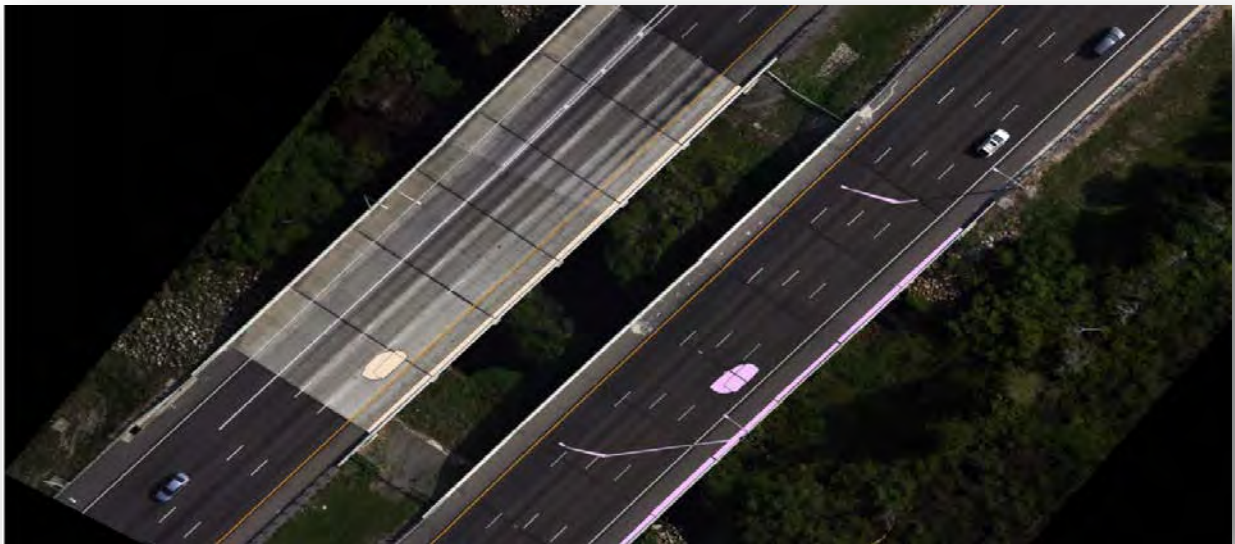
**Figure C.3.8: Bridge NO. 920098 Obstruction Image**

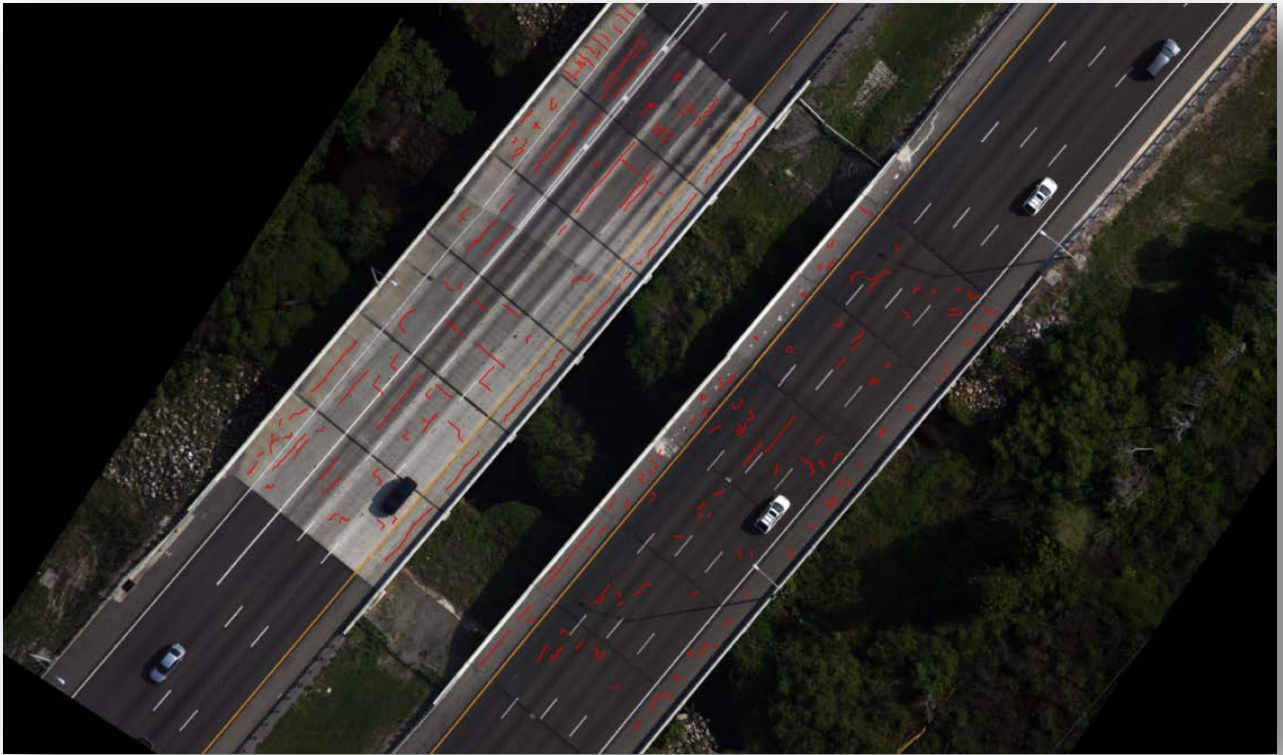
**Figure C.3.9: Bridge NO. 920098 Crack Image**

**Table C.3.10: Bridge NO. 920098 Span Area**

Span Area						
FID	Span	Area	# Cracks	Obstruction Area	DV	Crack Density
0	A	3517.408	12	103.3799286	1	0.351490959
1	B	3521.154	11	112.8386178	1	0.322740086
2	C	3493.143	9	104.6304092	1	0.265603263
3	D	3521.353	26	100.0149918	1	0.759936608
4	E	3582.966	19	112.6114502	1	0.547494492
5	F	3448.504	20	291.7434101	1	0.633560875

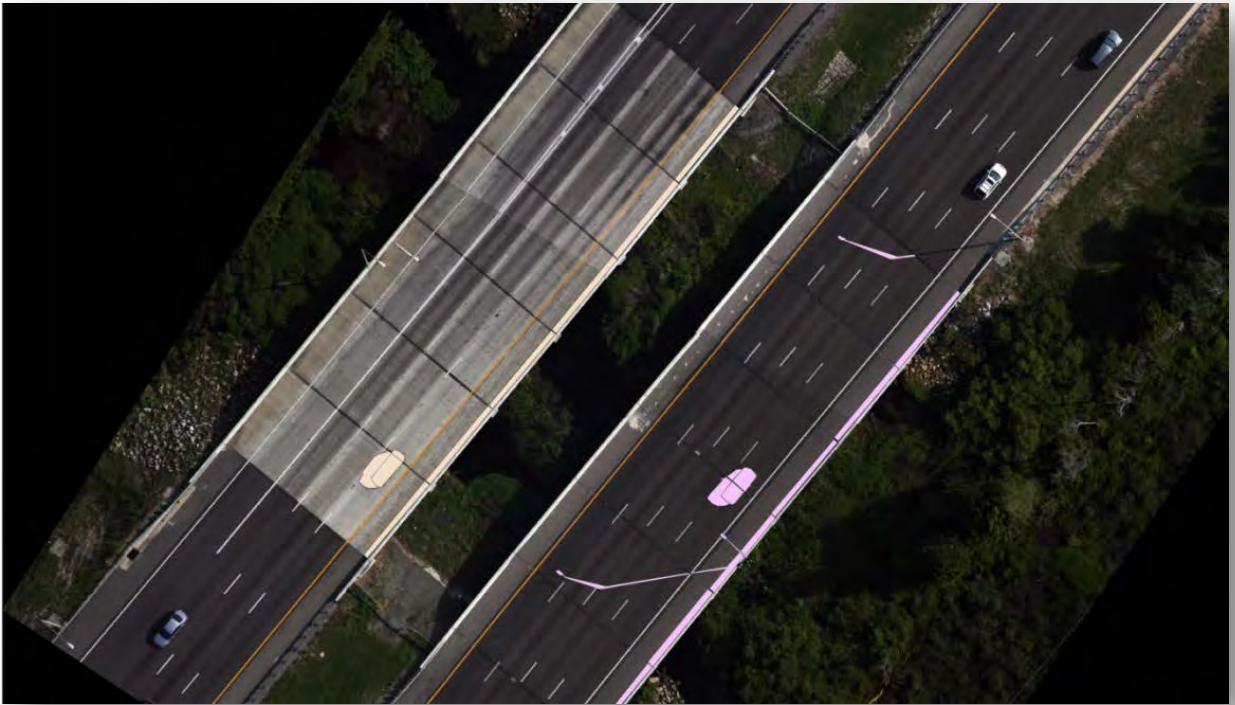
**Figure C.3.11: Bridge NO. 920099 Obstruction Image**

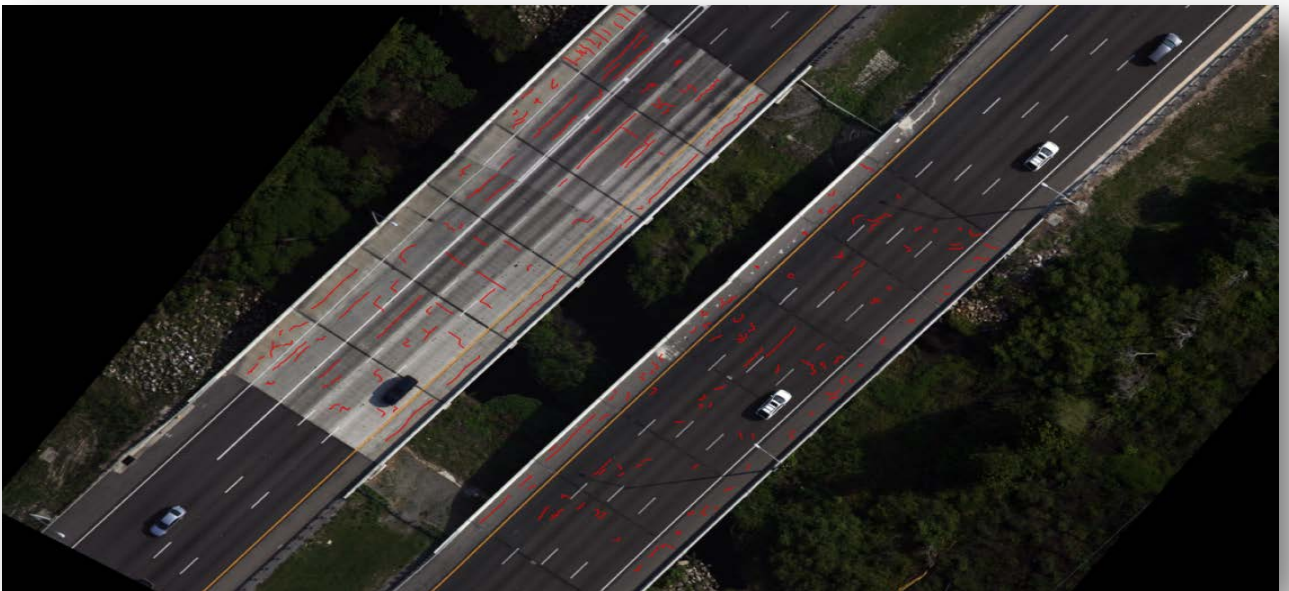
**Figure C.3.12: Bridge NO. 920099 Crack Image**

**Table C.3.14: Bridge NO. 920099 Span Area**

<b>Span Area</b>						
<b>FID</b>	<b>Span</b>	<b>Area</b>	<b># Cracks</b>	<b>Obstruction Area</b>	<b>DV</b>	<b>Crack Density</b>
0	A	3333.86	17	91.06322479	1	0.524238834
1	B	3271.418	17	173.3792419	1	0.548734258
2	C	3346.323	18	247.3802662	1	0.58084326
3	D	3329.202	24	169.2161407	1	0.75949707
4	E	3249.325	13	101.4396057	1	0.412975645
5	F	3309.469	23	142.3213005	1	0.726205475

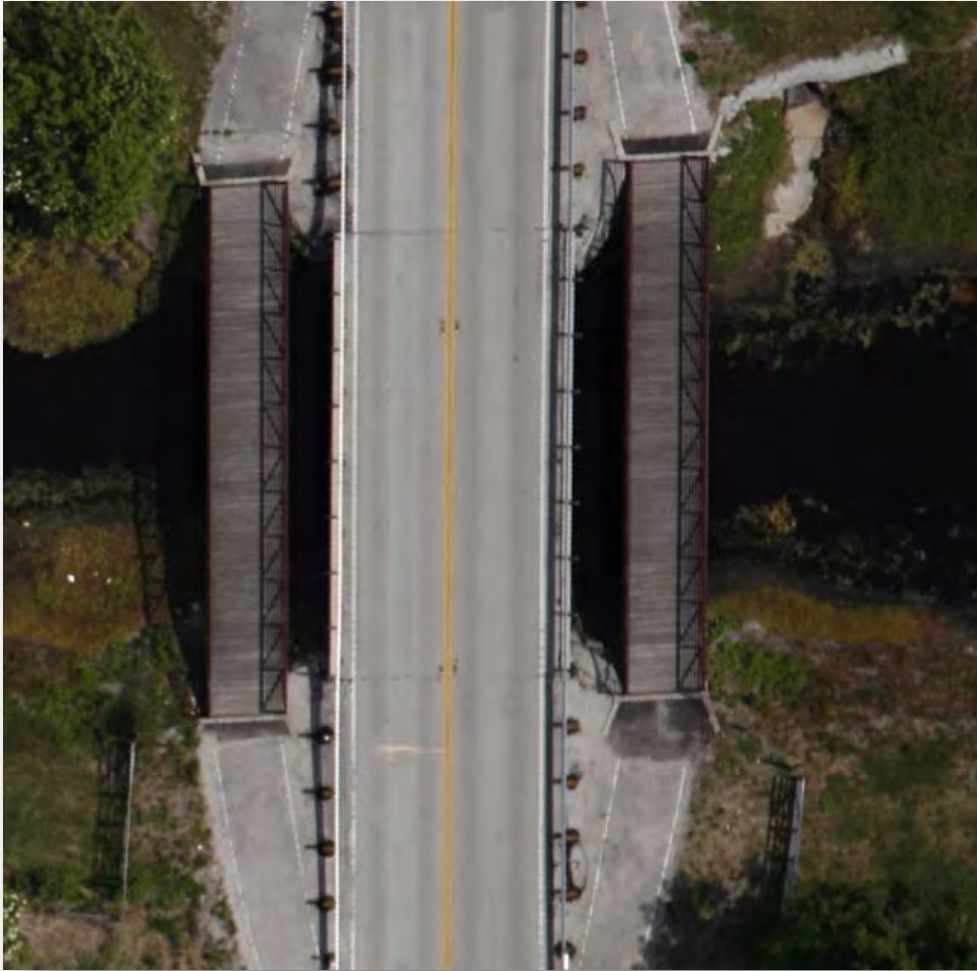
**Figure C.3.13: Bridge NO. 924038 Blank Image**

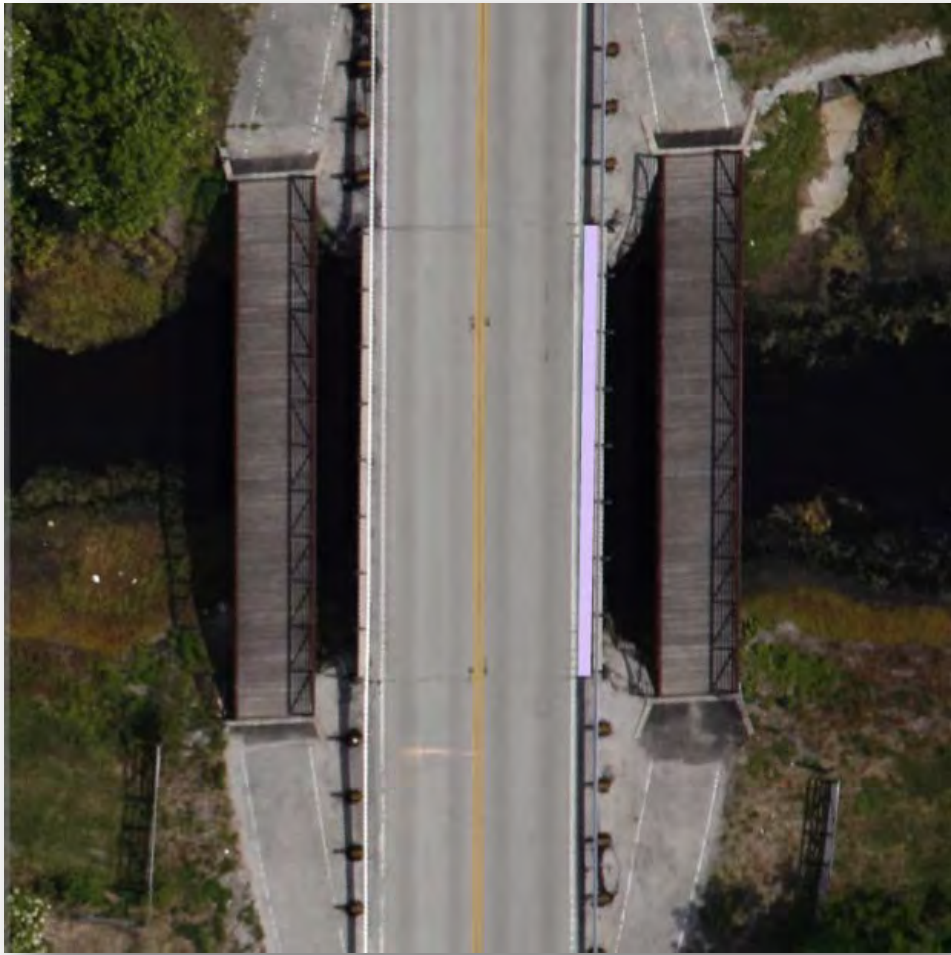
**Figure C.3.14: Bridge NO. 924038 Obstruction Image**

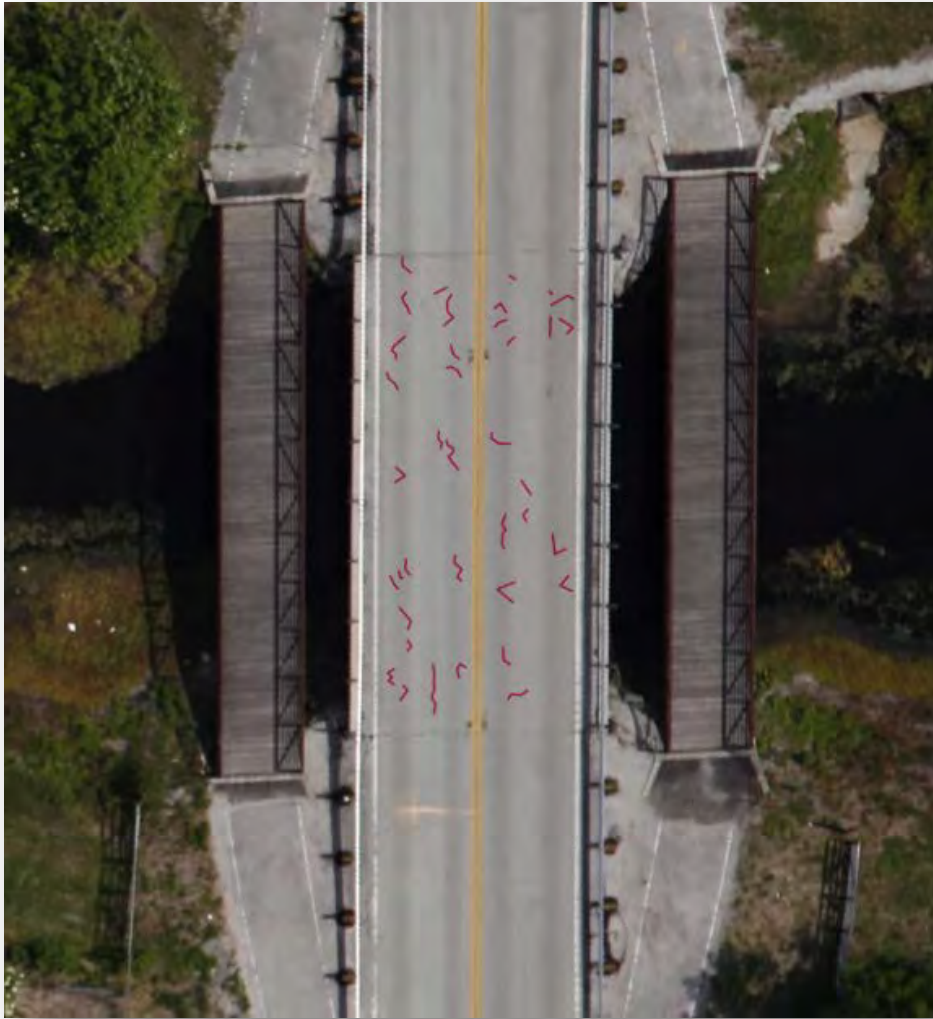
**Figure C.3.15: Bridge NO. 924038 Crack Image**

**Table C.3.18: Bridge NO. 924038 Span Area**

Span Area						
FID	Span	Area	# Cracks	Obstruction Area	DV	Crack Density
0	A	1572.75	38	97.04570007	20.53921	2.575041626

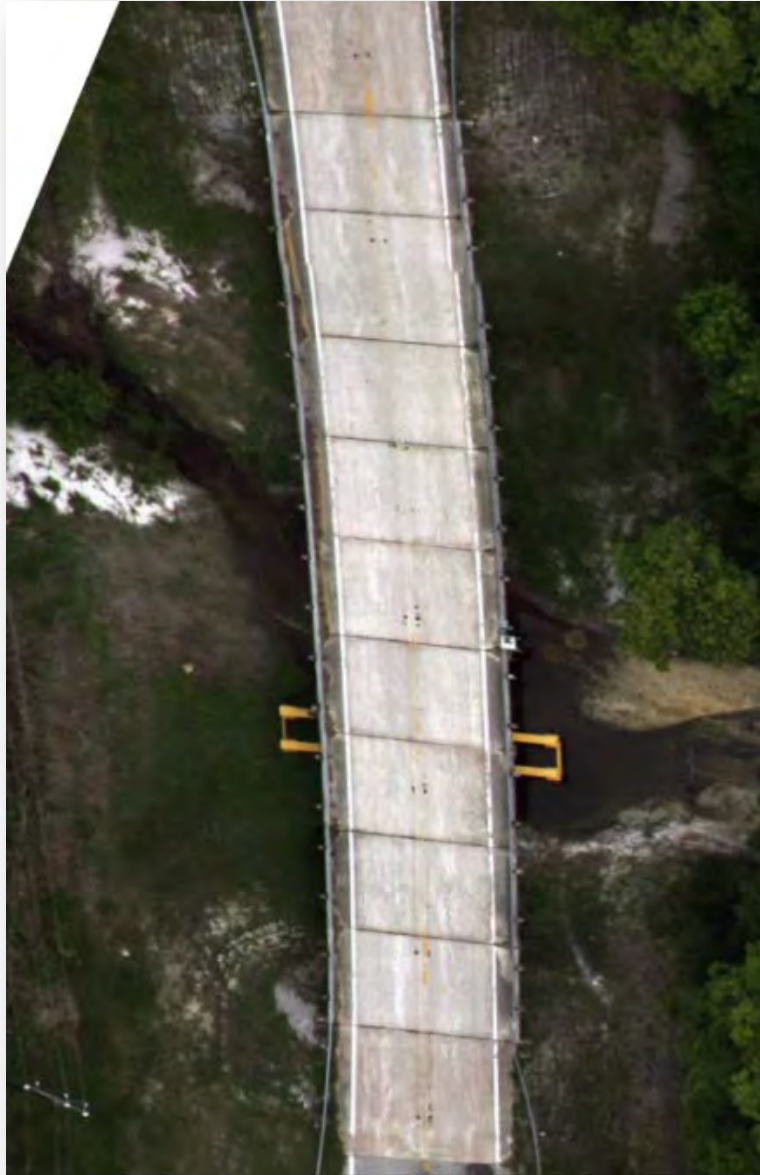
**Figure C.3.16: Bridge NO. 924046 Blank Image**

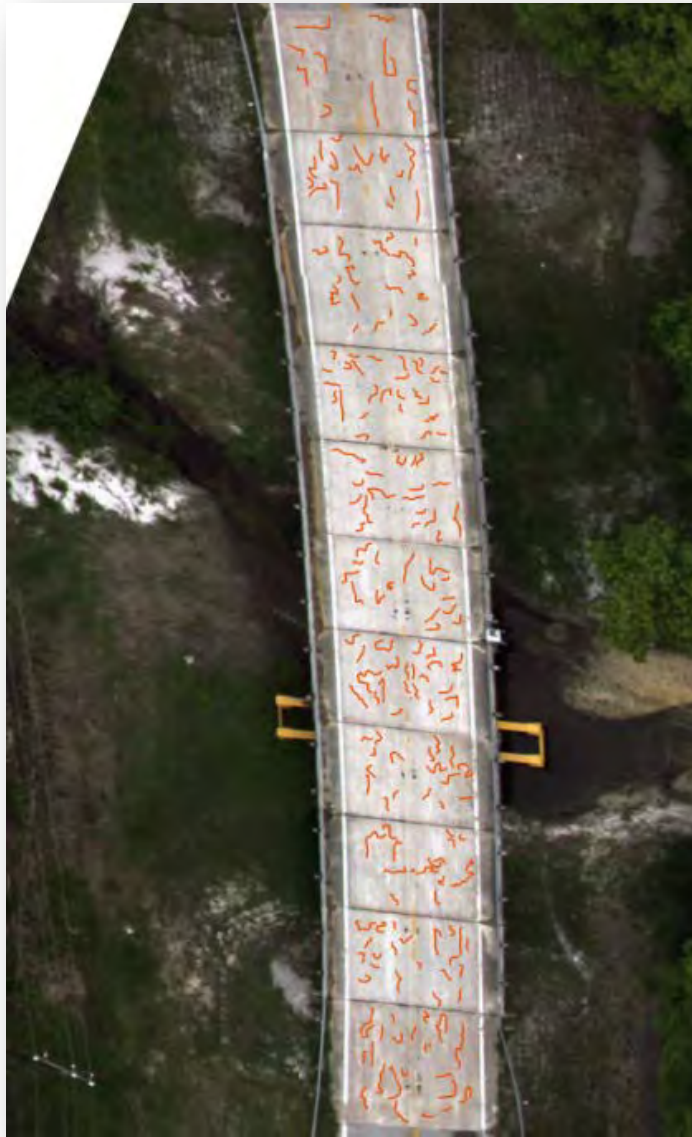
**Figure C.3.17: Bridge NO. 924046 Crack Image**

**Table C.3.22: Bridge NO. 924046 Span Area**

<b>Span Area</b>						
<b>FID</b>	<b>Span</b>	<b>Area</b>	<b># Cracks</b>	<b>Obstruction Area</b>	<b>DV</b>	<b>Crack Density</b>
0	A	507.0936	11	0.920557991	16.85468	2.173169788
1	B	370.3431	15	0.291976996	30.39148	4.053494203
2	C	474.425	21	0.852480598	32.34164	4.434378765
3	D	376.7293	27	0.150527	42.7754	7.169815256
4	E	369.9904	18	0.71405641	34.39605	4.874398162
5	F	362.9606	16	1.093272999	32.27853	4.421509854
6	G	359.3296	22	0.155990005	39.35591	6.125171221
7	H	351.9516	18	0.774569988	35.48732	5.125620515
8	I	355.6457	16	0.184229001	32.66637	4.501190611
9	J	356.8933	22	0.508311003	39.52516	6.173099655
10	K	475.7328	23	1.26809001	34.2762	4.847567929

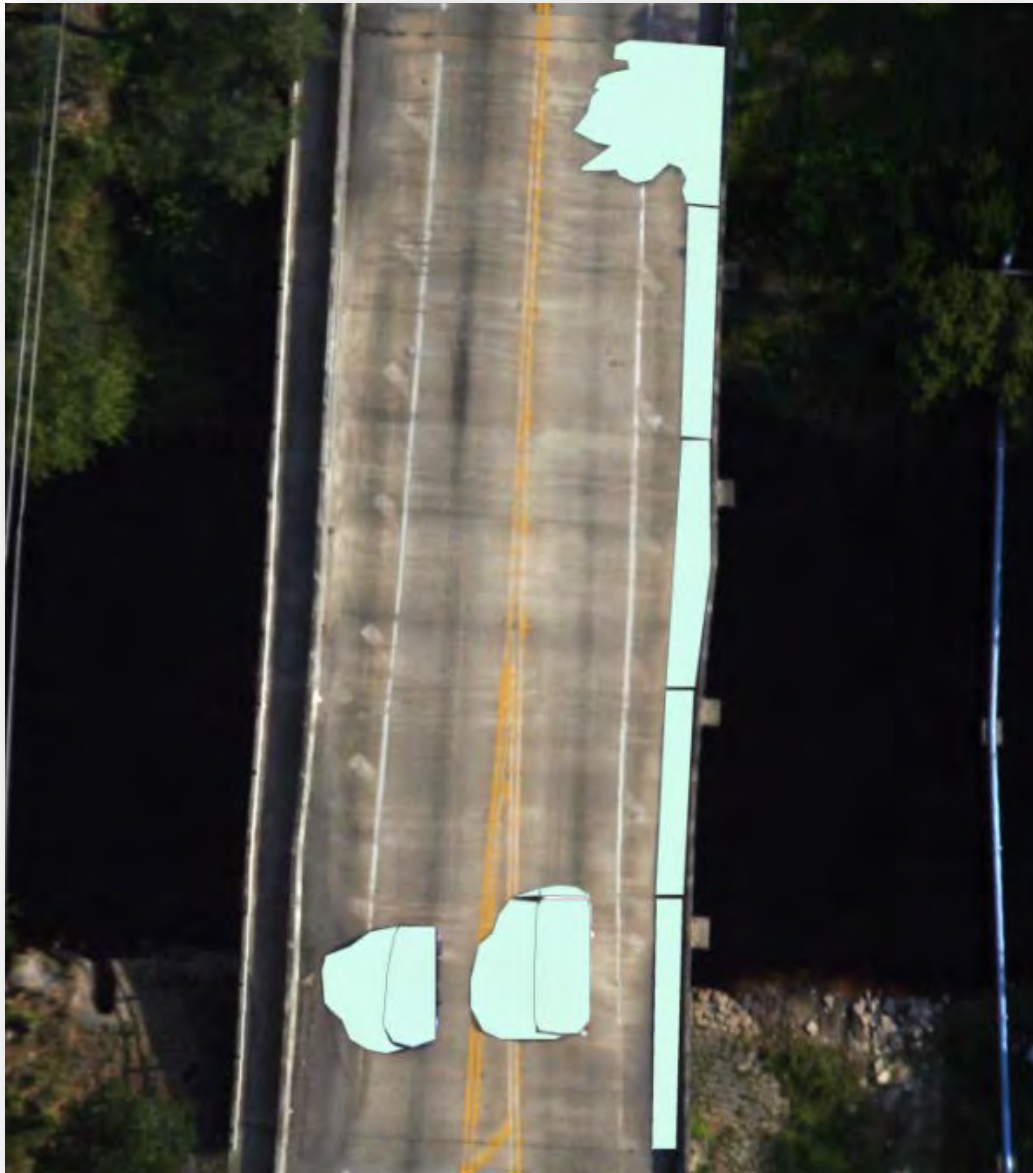
**Figure C.3.21: Bridge NO. 924153 Obstruction Image**

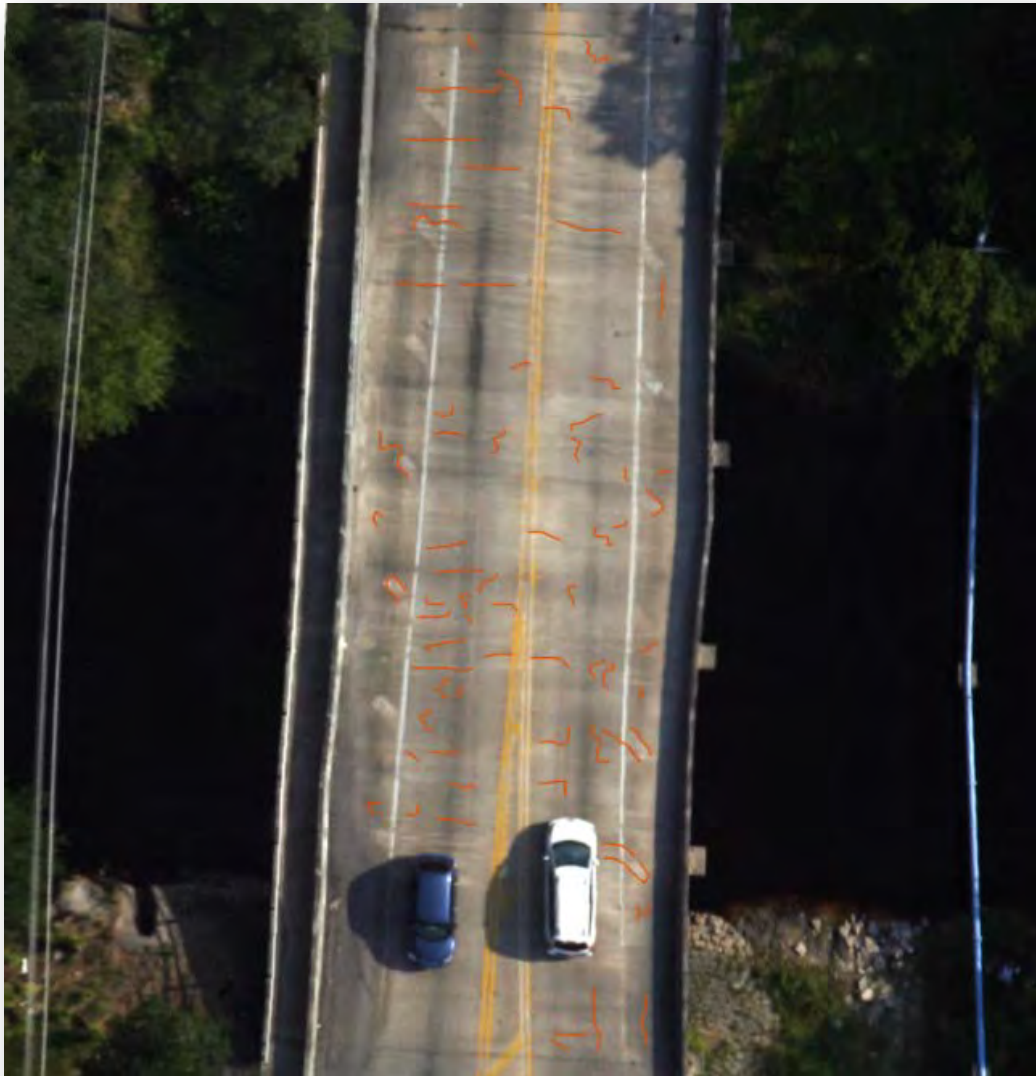
**Figure C.3.22: Bridge NO. 924153 Crack Image**

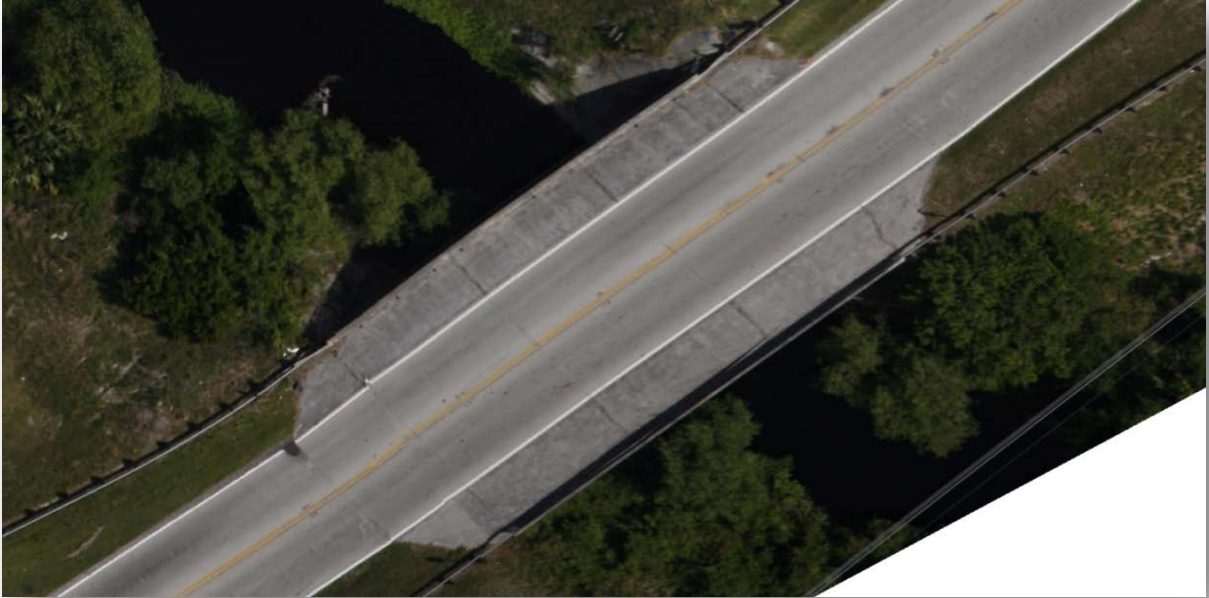
**Figure C.3.2317: Bridge NO. 924510 Blank Image**

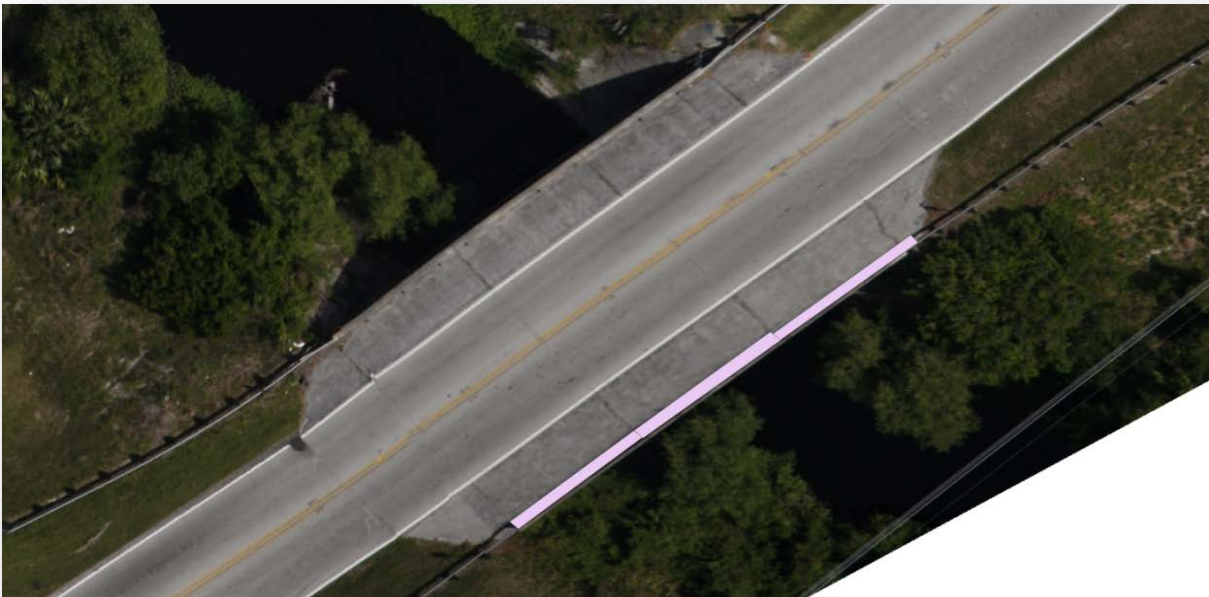
**Figure C.3.24: Bridge NO. 924510 Obstruction Image**

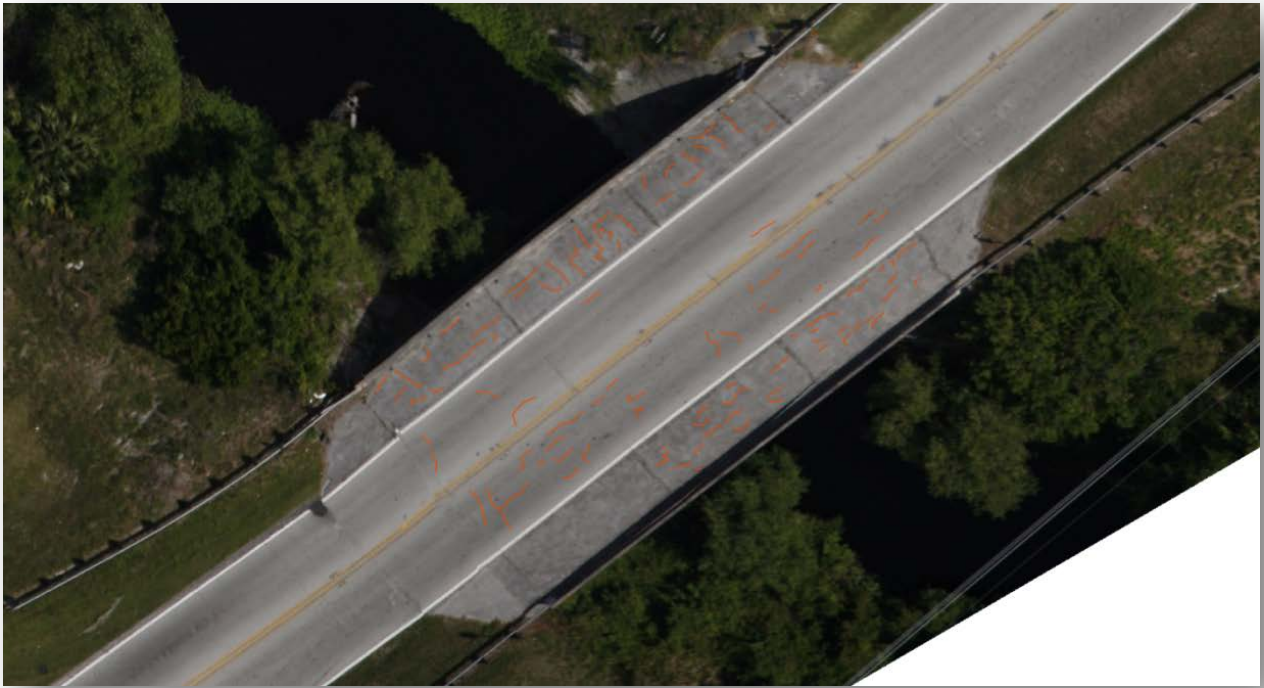
**Figure C.3.25: Bridge NO. 924510 Crack Image**

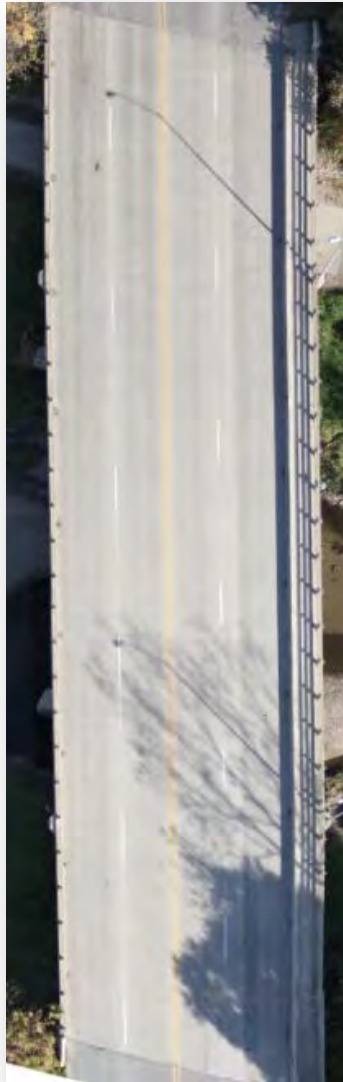
**Figure C.4.118: Bridge NO. 3826 Blank Image**

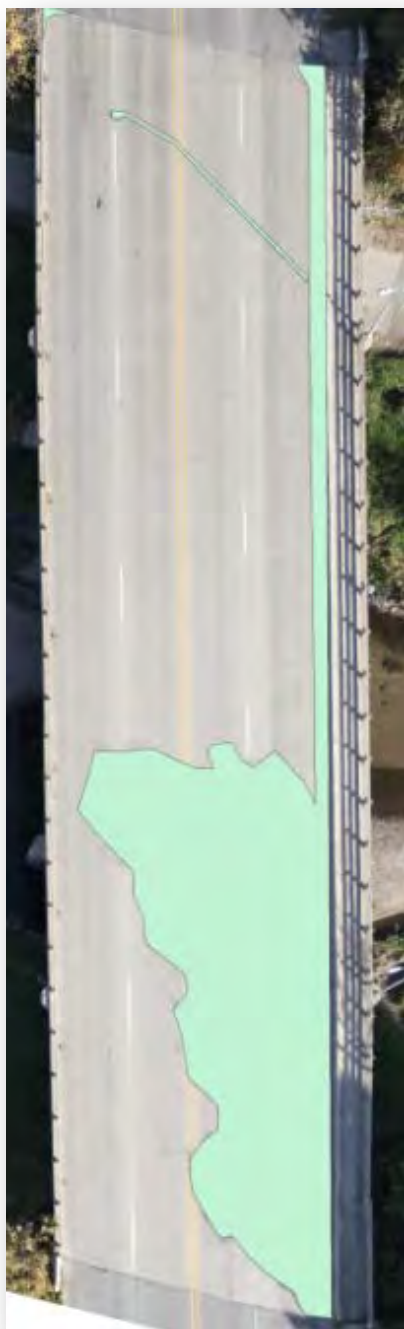
**Figure C.4.2: Bridge NO. 3826 Obstruction Image**

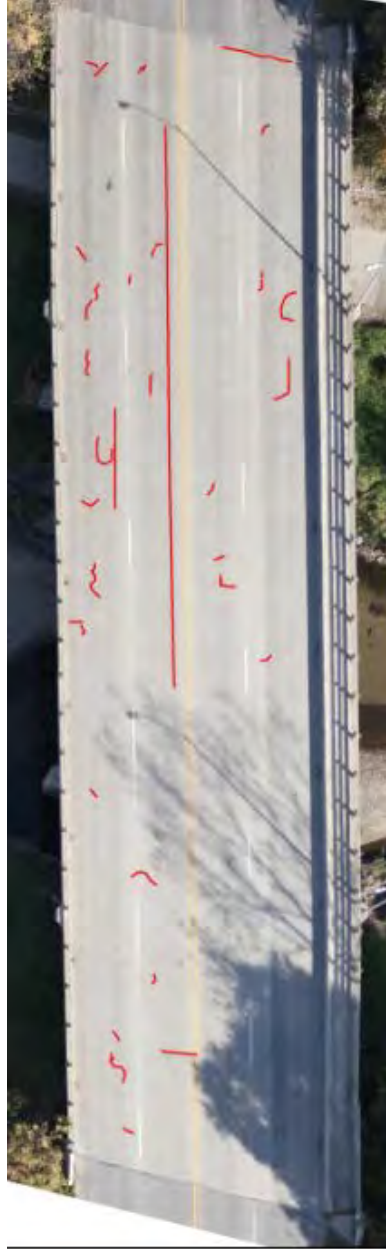
Figure C.4.3: Bridge NO. 3826 Crack Image

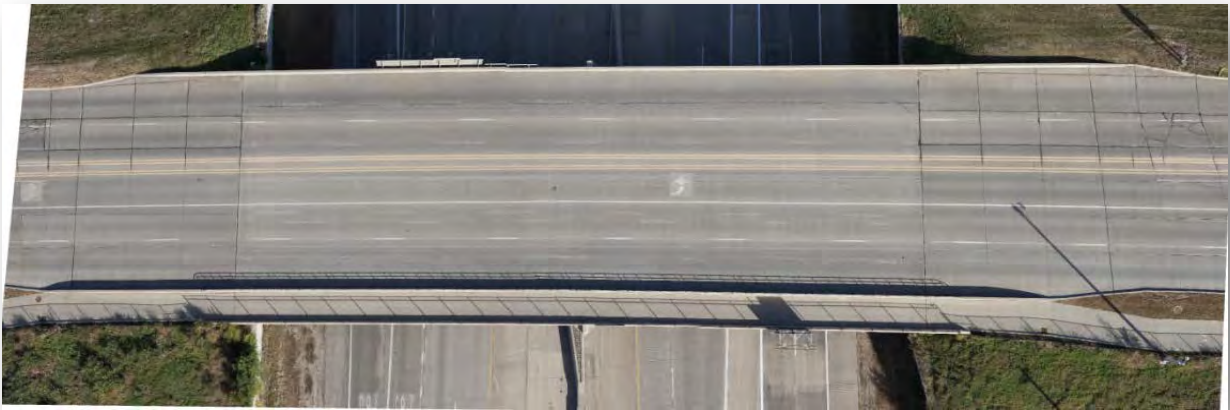
**Figure C.4.4: Bridge NO. 12491 Blank Image**

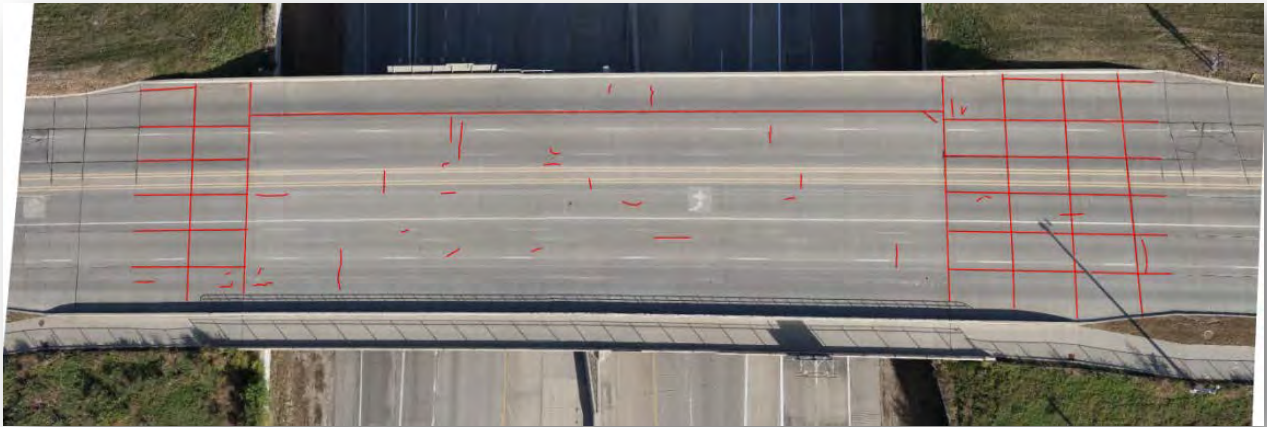
**Figure C.4.6: Bridge NO. 12491 Crack Image**

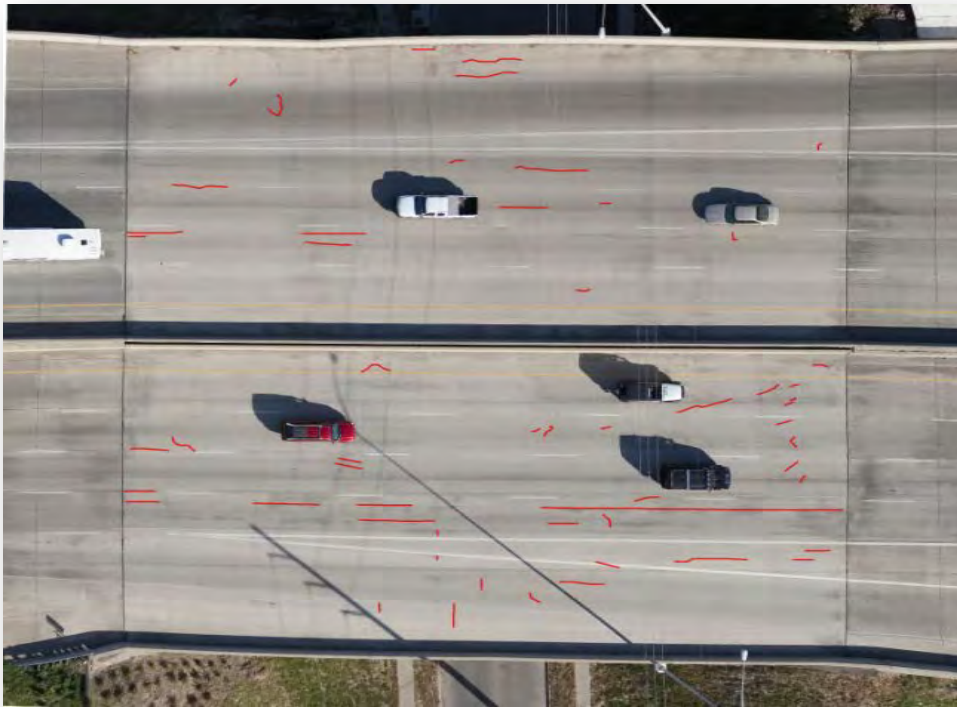
**Figure C.4.15: Bridge NO. 42381-91 Crack Image**

**Table C.4.18: Bridge NO. 42381-91 Span Area**

<b>Span Area</b>						
<b>FID</b>	<b>Span</b>	<b>Area</b>	<b># Cracks</b>	<b>Obstruction Area</b>	<b>DV</b>	<b>Crack Density</b>
<b>0</b>	<b>A</b>	<b>52830.95</b>	<b>55</b>	<b>5384.7957</b>	<b>1</b>	<b>0.115920889</b>

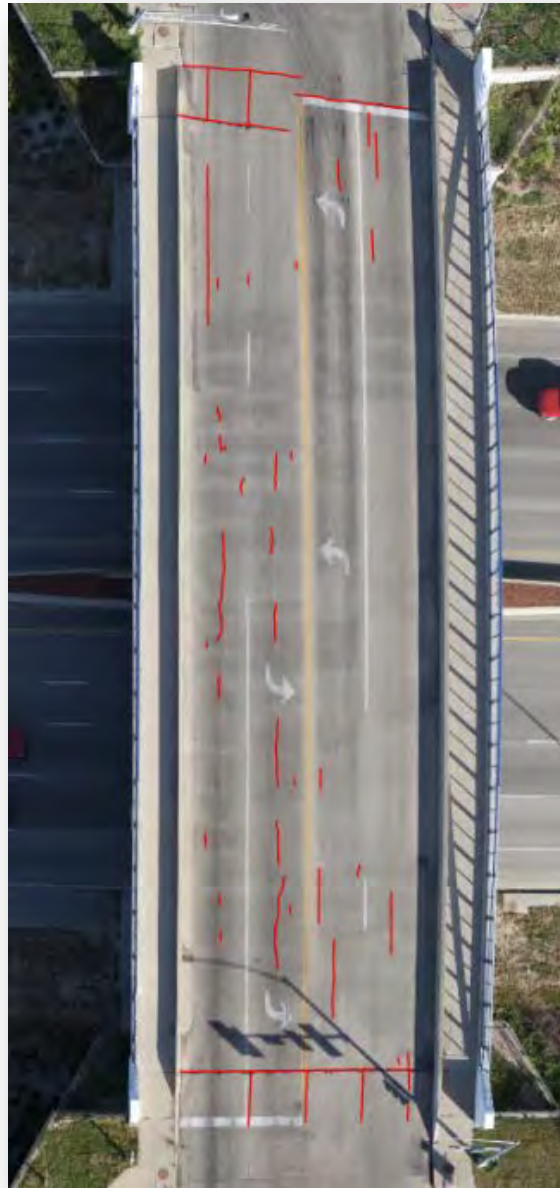
**Figure C.4.18: Bridge NO. 42401 Crack Image**

**Table C.4.22: Bridge NO. 42401 Span Area**

Span Area						
FID	Span	Area	# Cracks	Obstruction Area	DV	Crack Density
0	A	22248.04	46	2080.032695	1	0.228084016

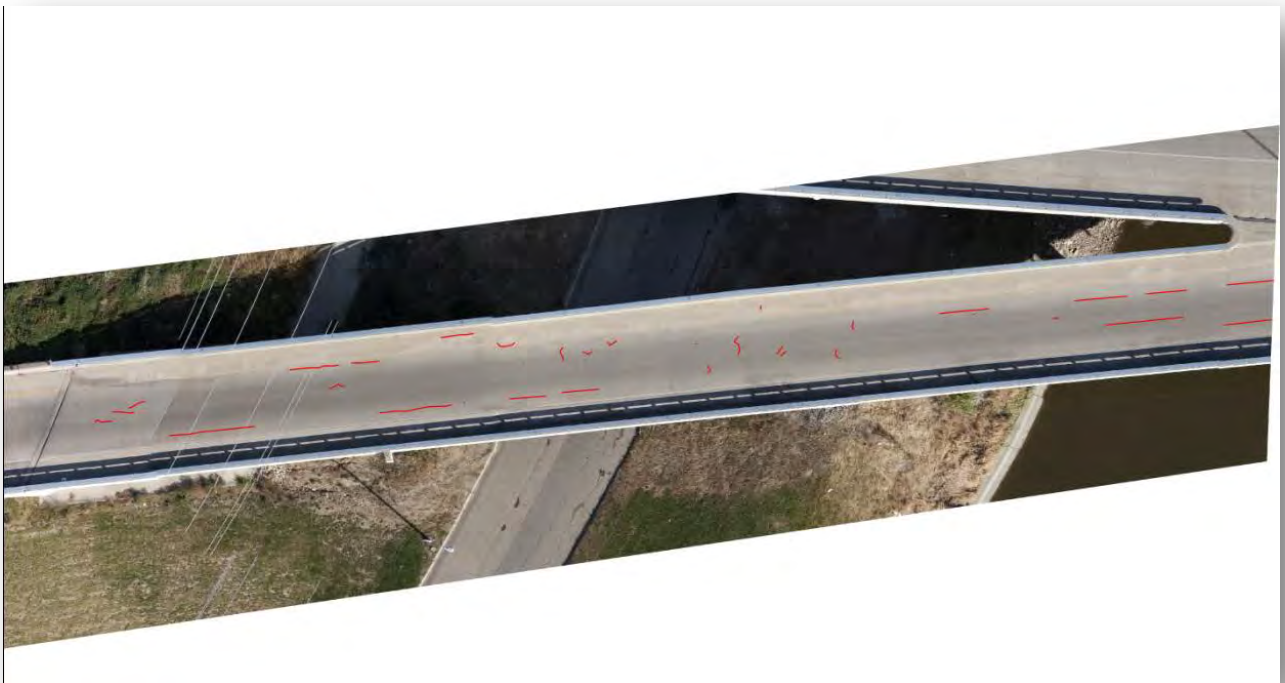
**Figure C.4.21: Bridge NO. 42761 Crack Image**

**Table C.4.26: Bridge NO. 42761 Span Area**

<b>Span Area</b>						
<b>FID</b>	<b>Span</b>	<b>Area</b>	<b># Cracks</b>	<b>Obstruction Area</b>	<b>DV</b>	<b>Crack Density</b>
0	A	12995.91	29	2162.202582	1	0.267683129

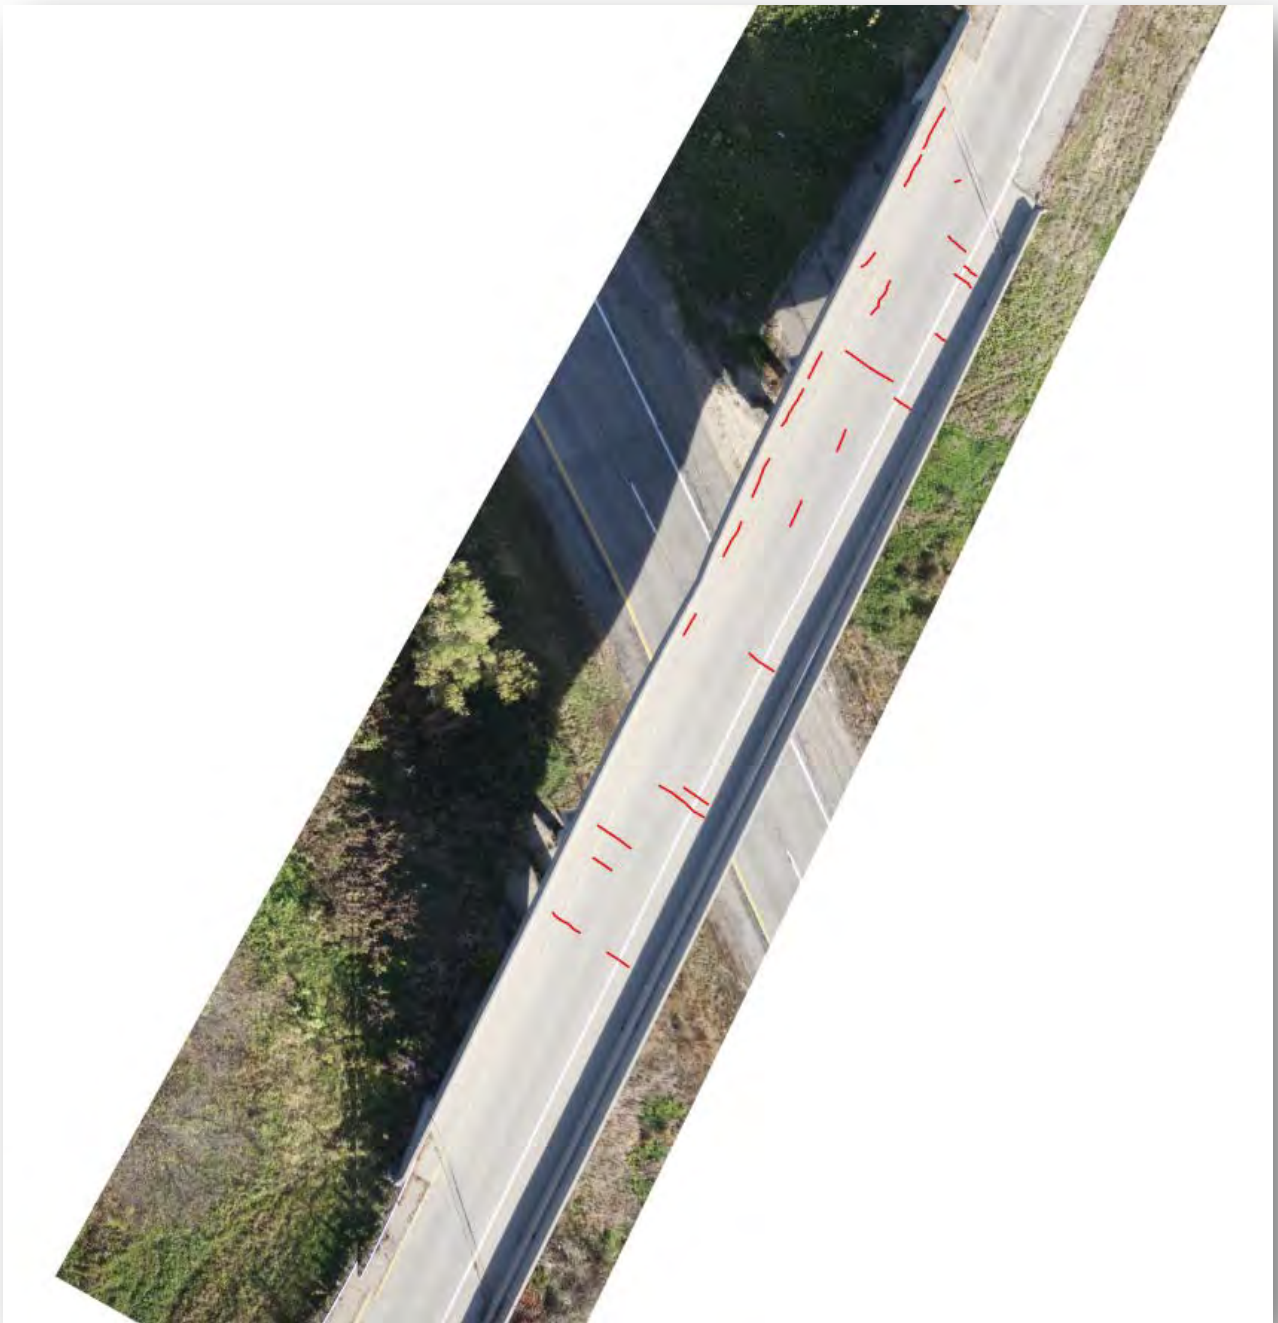
**Figure C.4.24: Bridge NO. 605405 Crack Image**

**Table C.4.30: Bridge NO. 605405 Span Area**

<b>Span Area</b>						
<b>FID</b>	<b>Span</b>	<b>Area</b>	<b># Cracks</b>	<b>Obstruction Area</b>	<b>DV</b>	<b>Crack Density</b>
<b>0</b>	<b>A</b>	<b>11598.48</b>	<b>26</b>	<b>1616.721512</b>	<b>1</b>	<b>0.260475271</b>

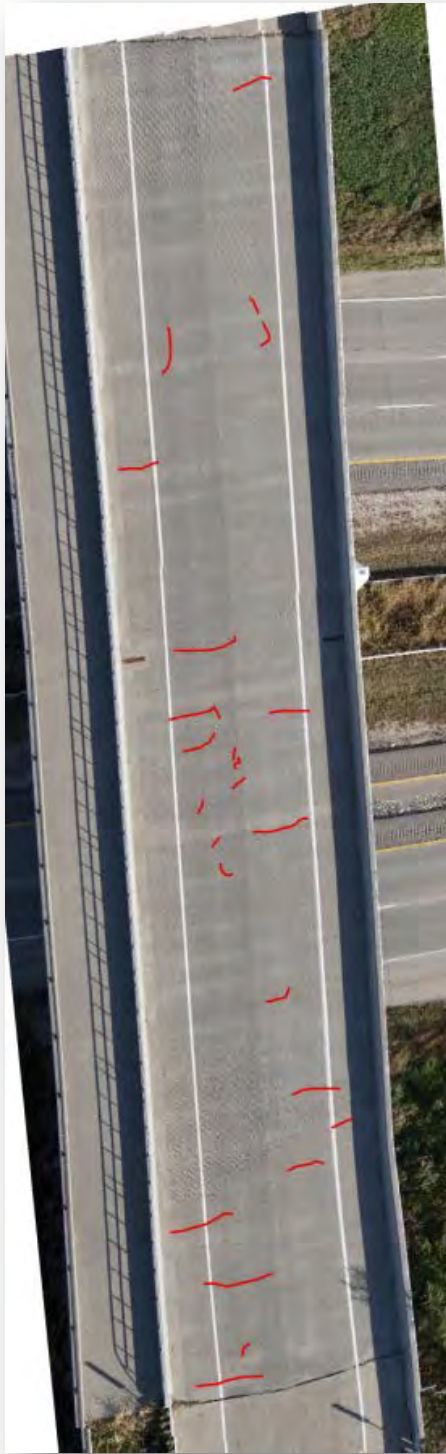
**Figure C.4.30: Bridge NO. 608575 Crack Image**

**Table C.4.3831: Bridge NO. 608575 Span Area**

<b>Span Area</b>						
<b>FID</b>	<b>Span</b>	<b>Area</b>	<b># Cracks</b>	<b>Obstruction Area</b>	<b>DV</b>	<b>Crack Density</b>
0	A	20597.97	24	2581.137421	1	0.133208787
