**INTEGRATED REMOTE SENSING AND VISUALIZATION (IRSV)  
SYSTEM FOR TRANSPORTATION INFRASTRUCTURE  
OPERATIONS AND MANAGEMENT:  
PHASE TWO**

**VOLUME 5**

**AERIAL BRIDGE DECK IMAGING DATA COLLECTION AND  
SOFTWARE REVISION**

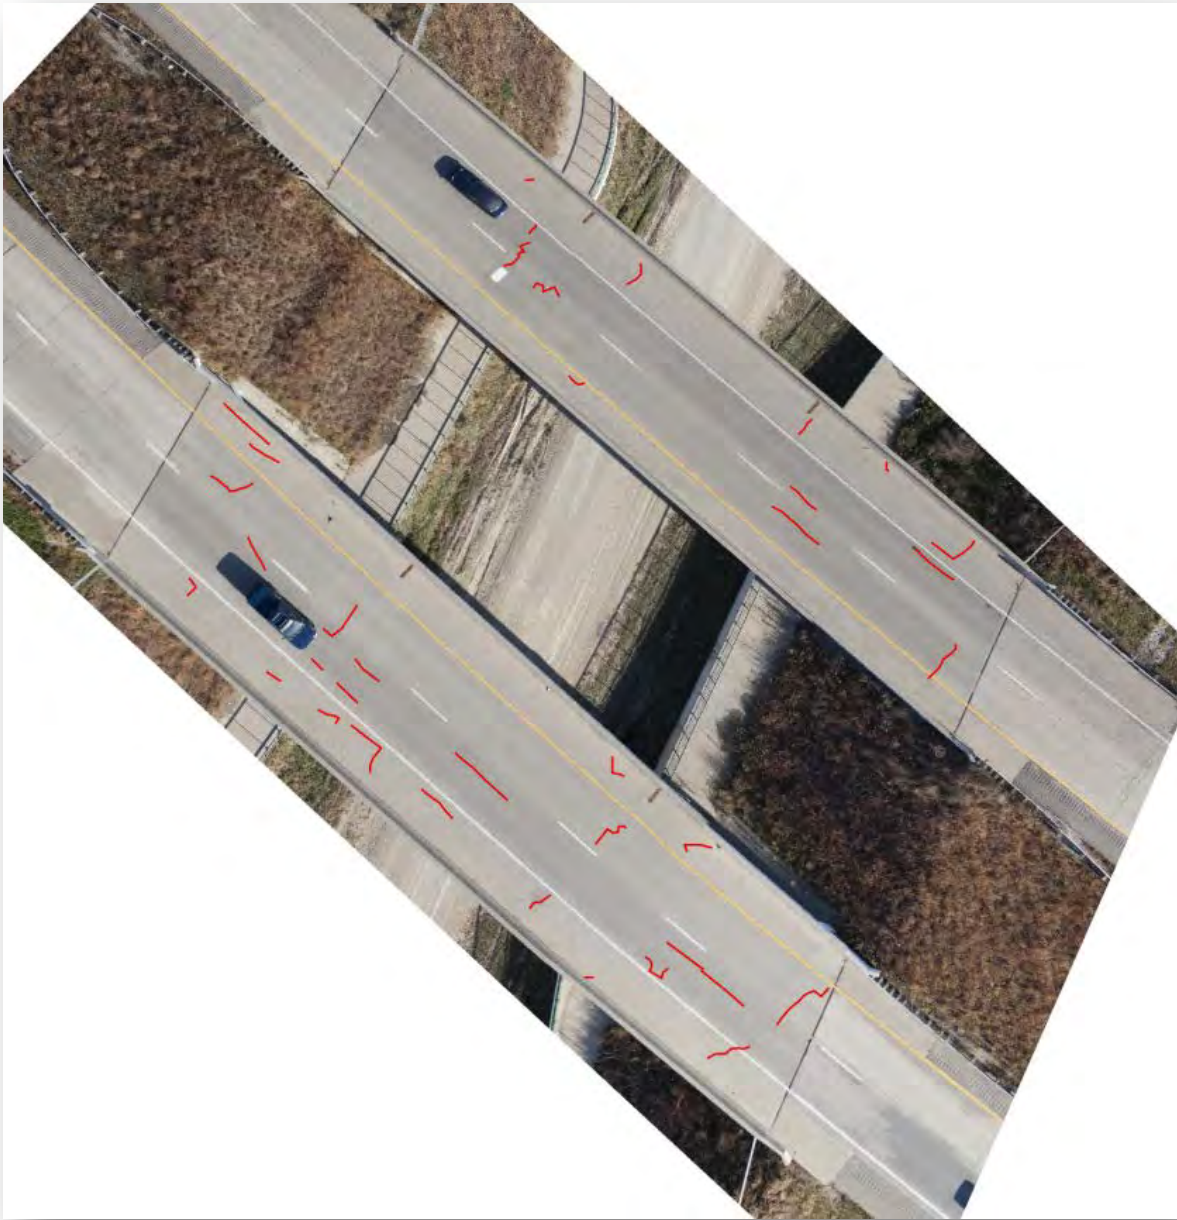
**Figure C.4.36: Bridge NO. 608660 Crack Image**

**Table C.4.46: Bridge NO. 608660 Span Area**

Span Area						
<b>FID</b>	<b>Span</b>	<b>Area</b>	<b># Cracks</b>	<b>Obstruction Area</b>	<b>DV</b>	<b>Crack Density</b>
<b>0</b>	<b>A</b>	<b>14124.49</b>	<b>13</b>	<b>200.2414143</b>	<b>1</b>	<b>0.09336232</b>
<b>1</b>	<b>B</b>	<b>17847.06</b>	<b>24</b>	<b>368.8653968</b>	<b>1</b>	<b>0.137313988</b>

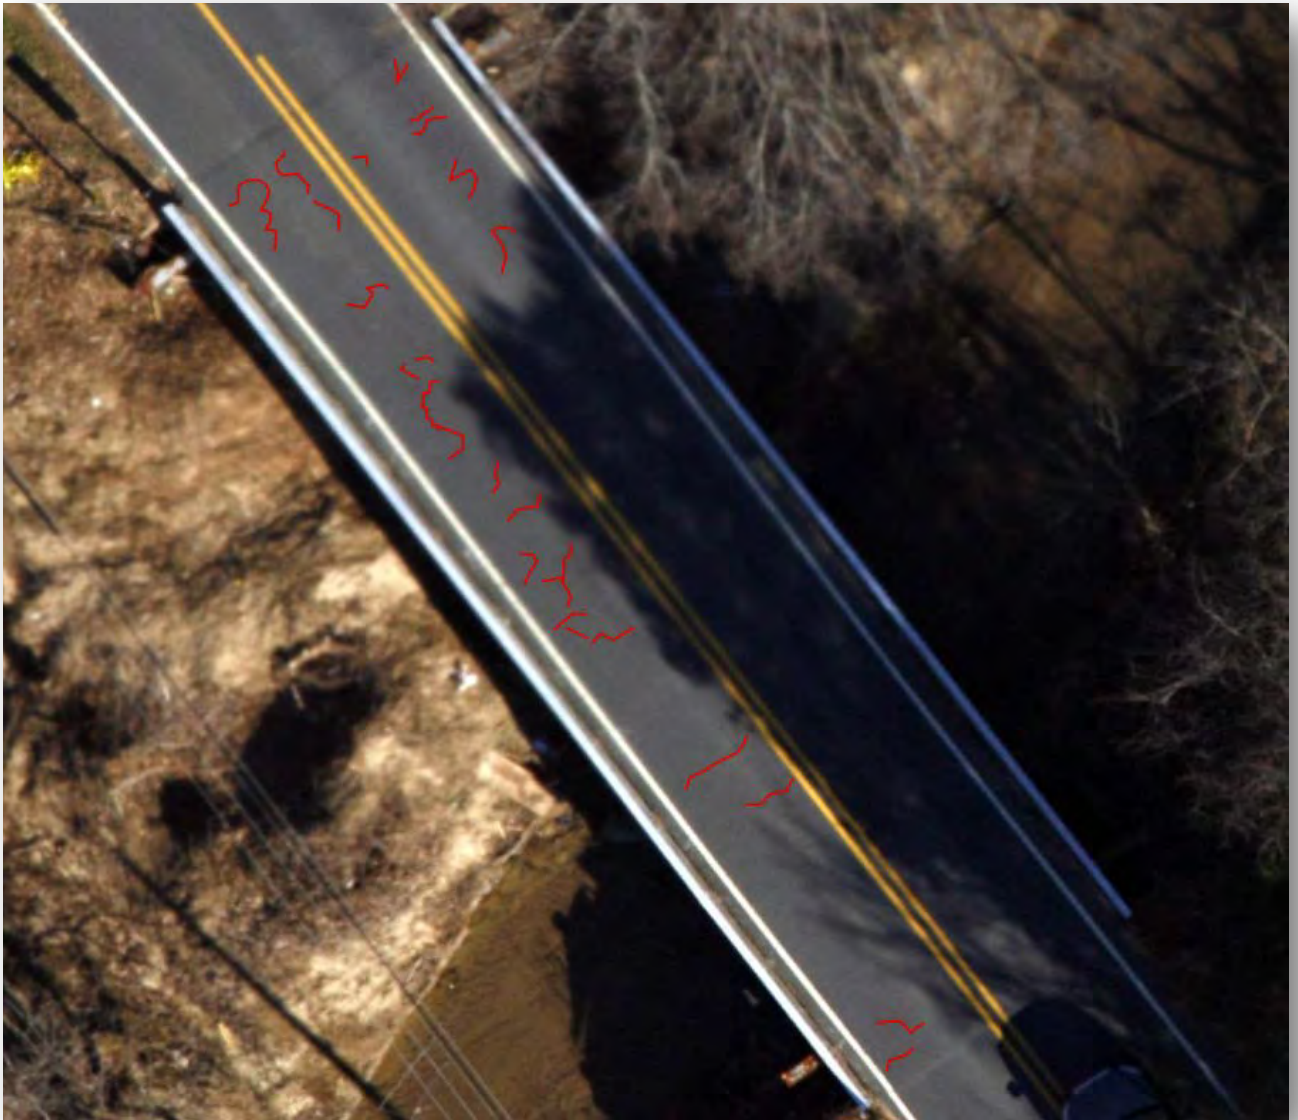
**Figure C.5.12: Bridge NO. 590059 Crack Image**

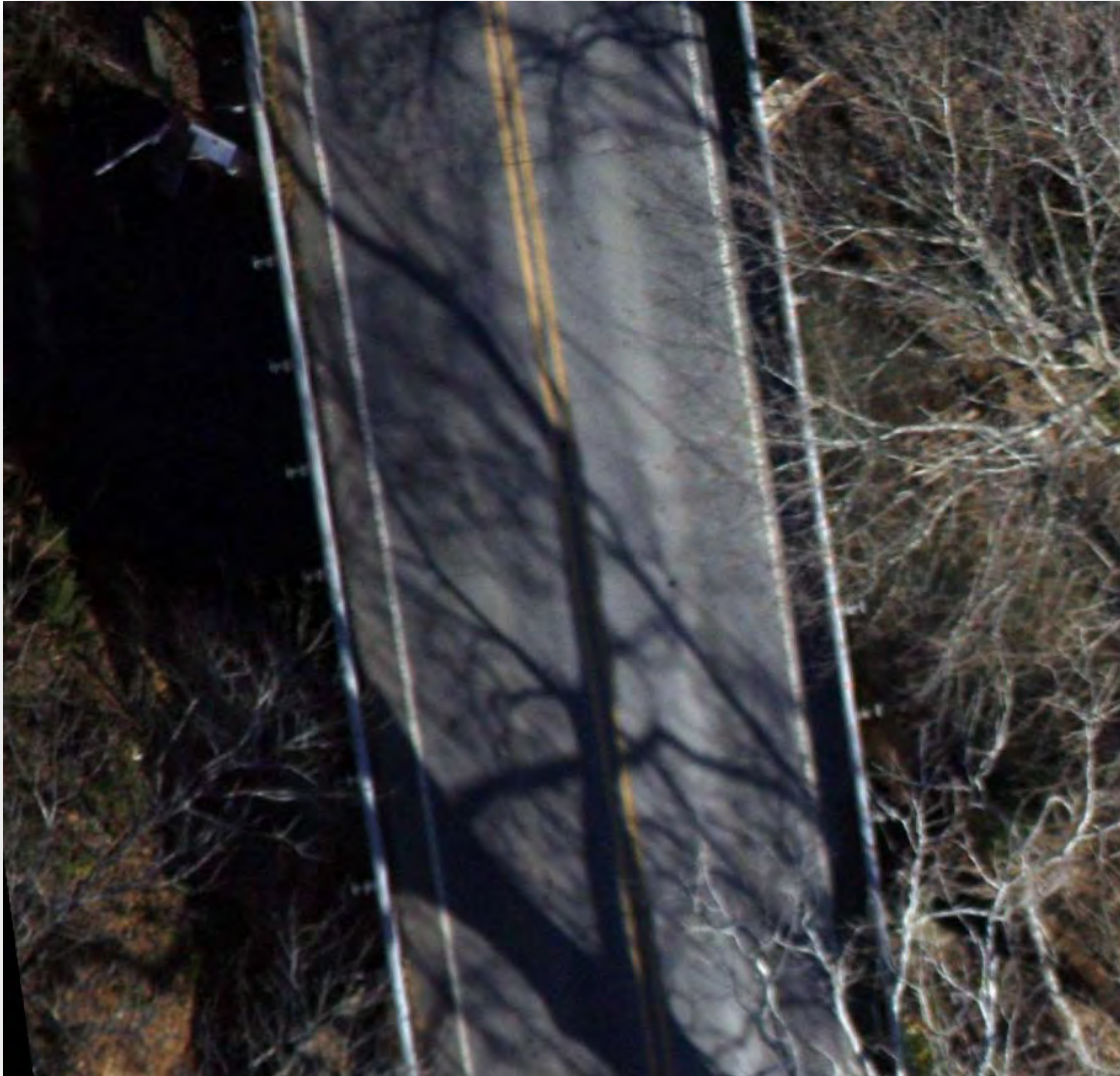
**Figure C.5.13: Bridge NO. 590038 Blank Image**

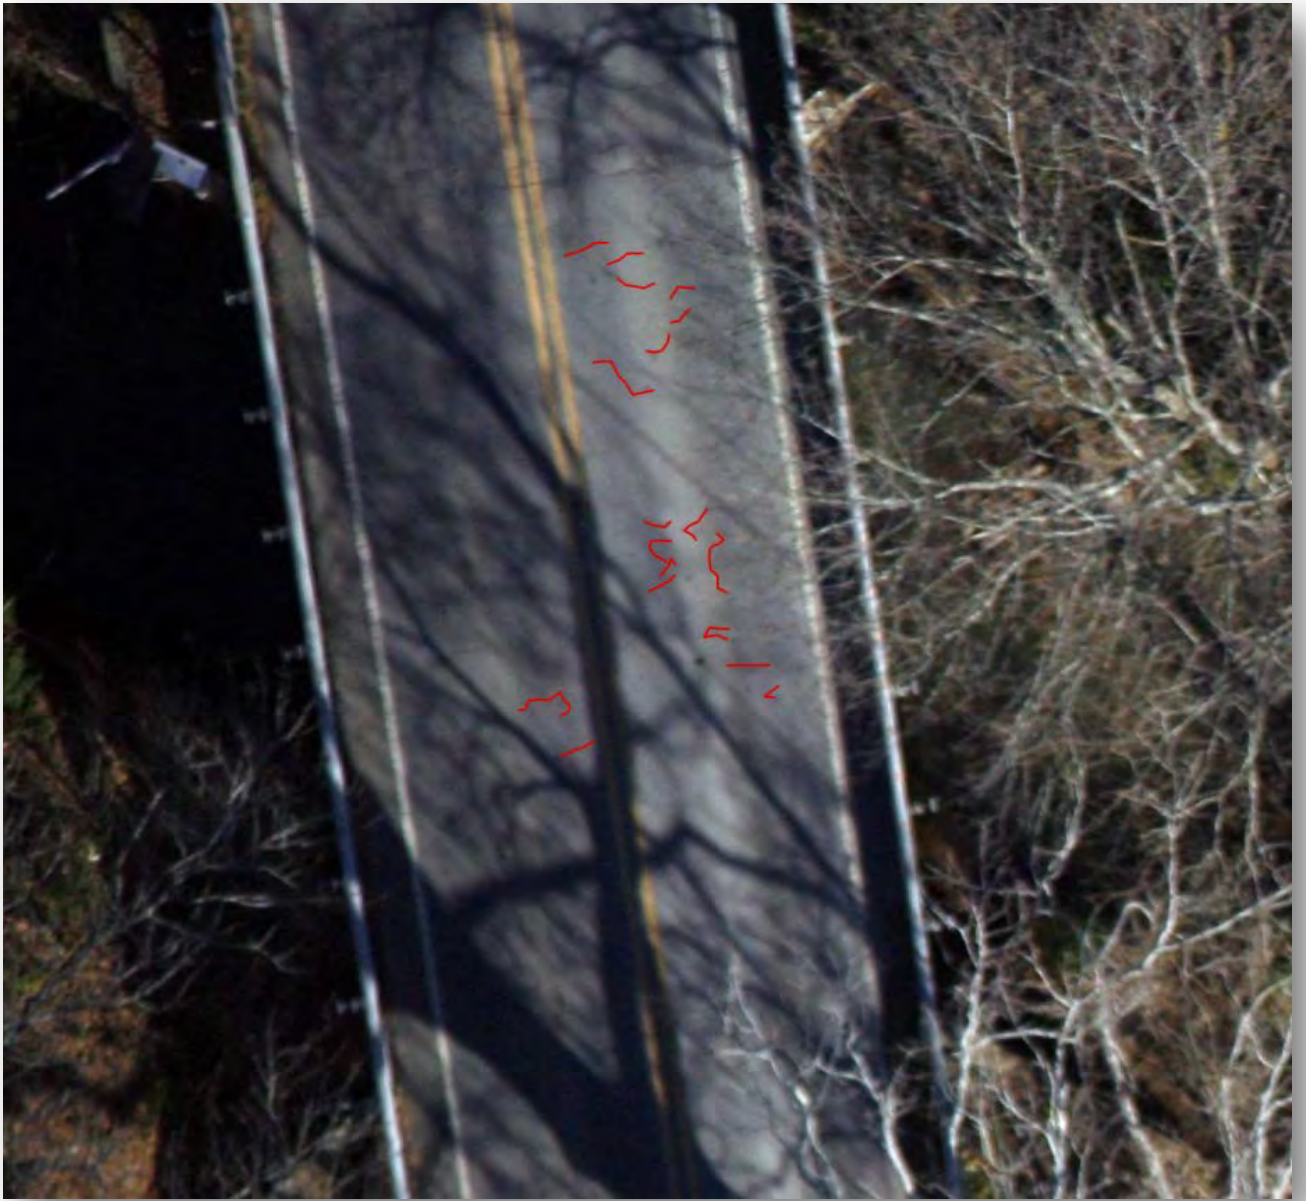
**Figure C.5.15: Bridge NO. 590038 Crack Image**

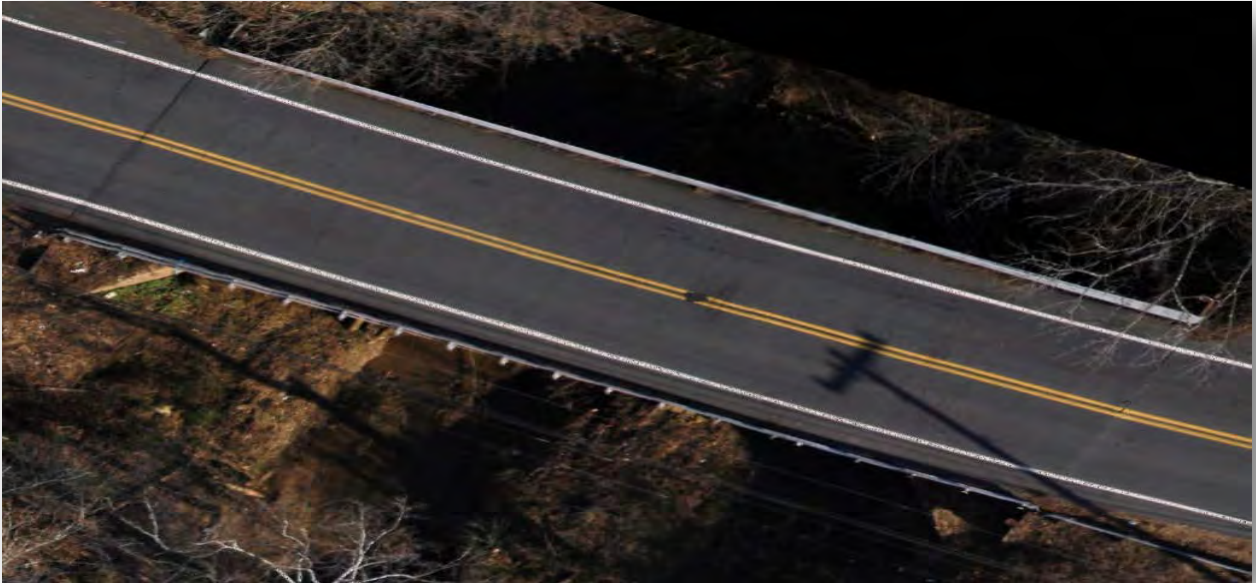
**Figure C.5.16: Bridge NO. 590165 Blank Image**

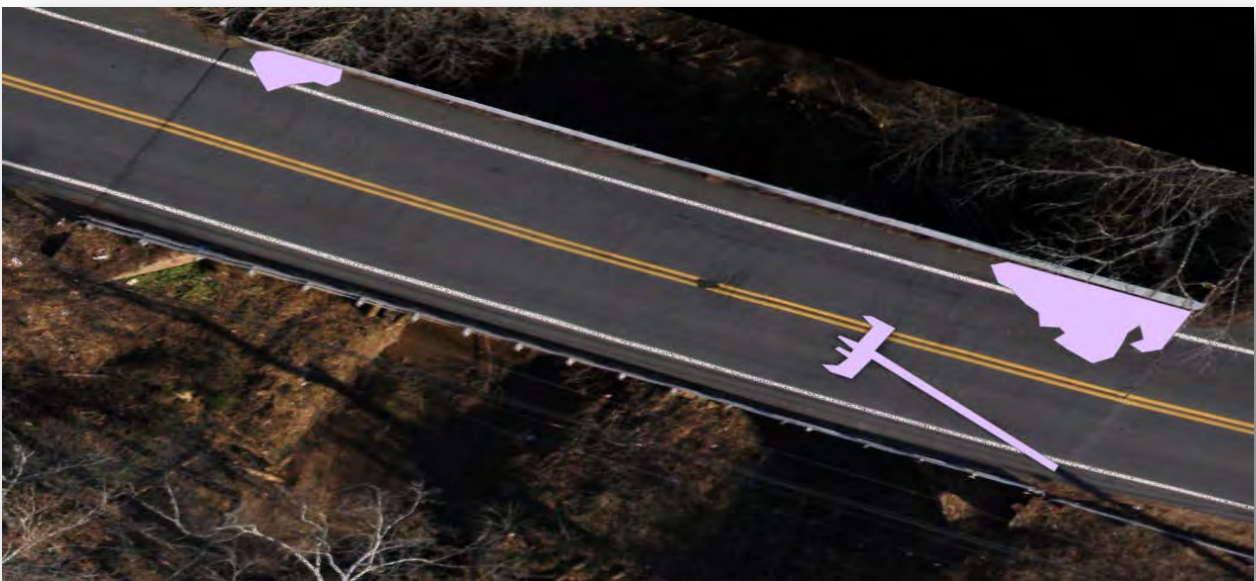
**Figure 24: Bridge NO. 590165 Obstruction Image**

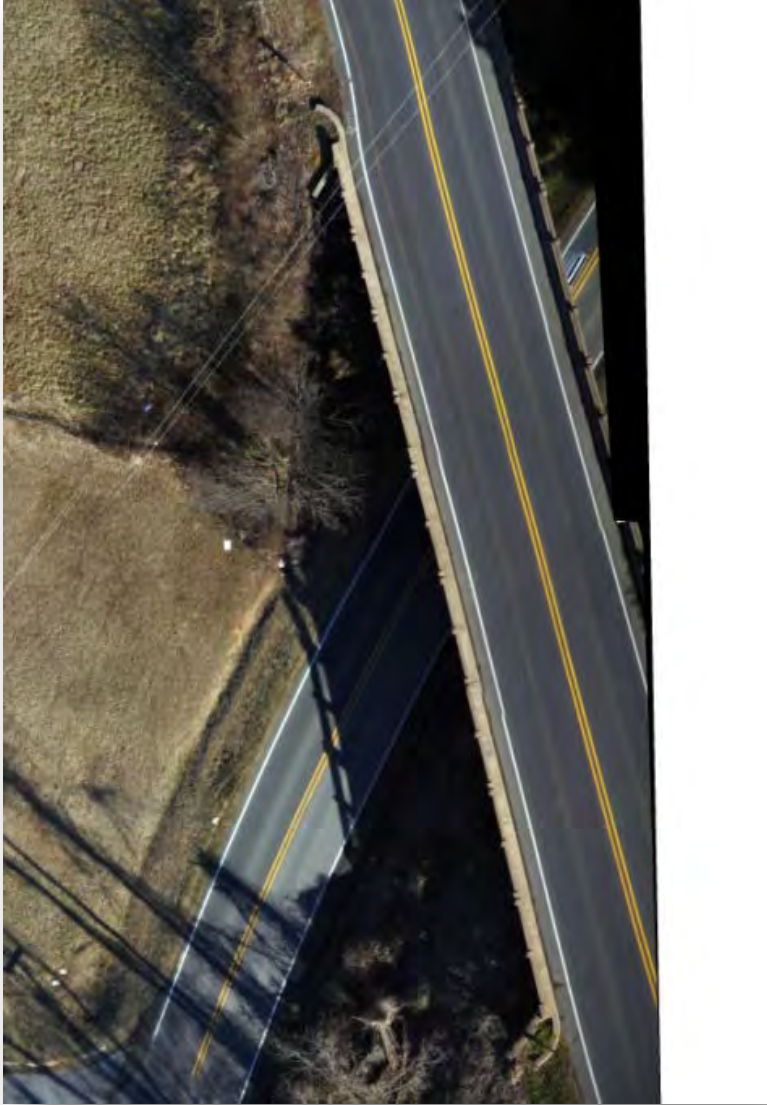
**Figure C.5.22: Bridge NO. US21 St. 2004 Blank Image**

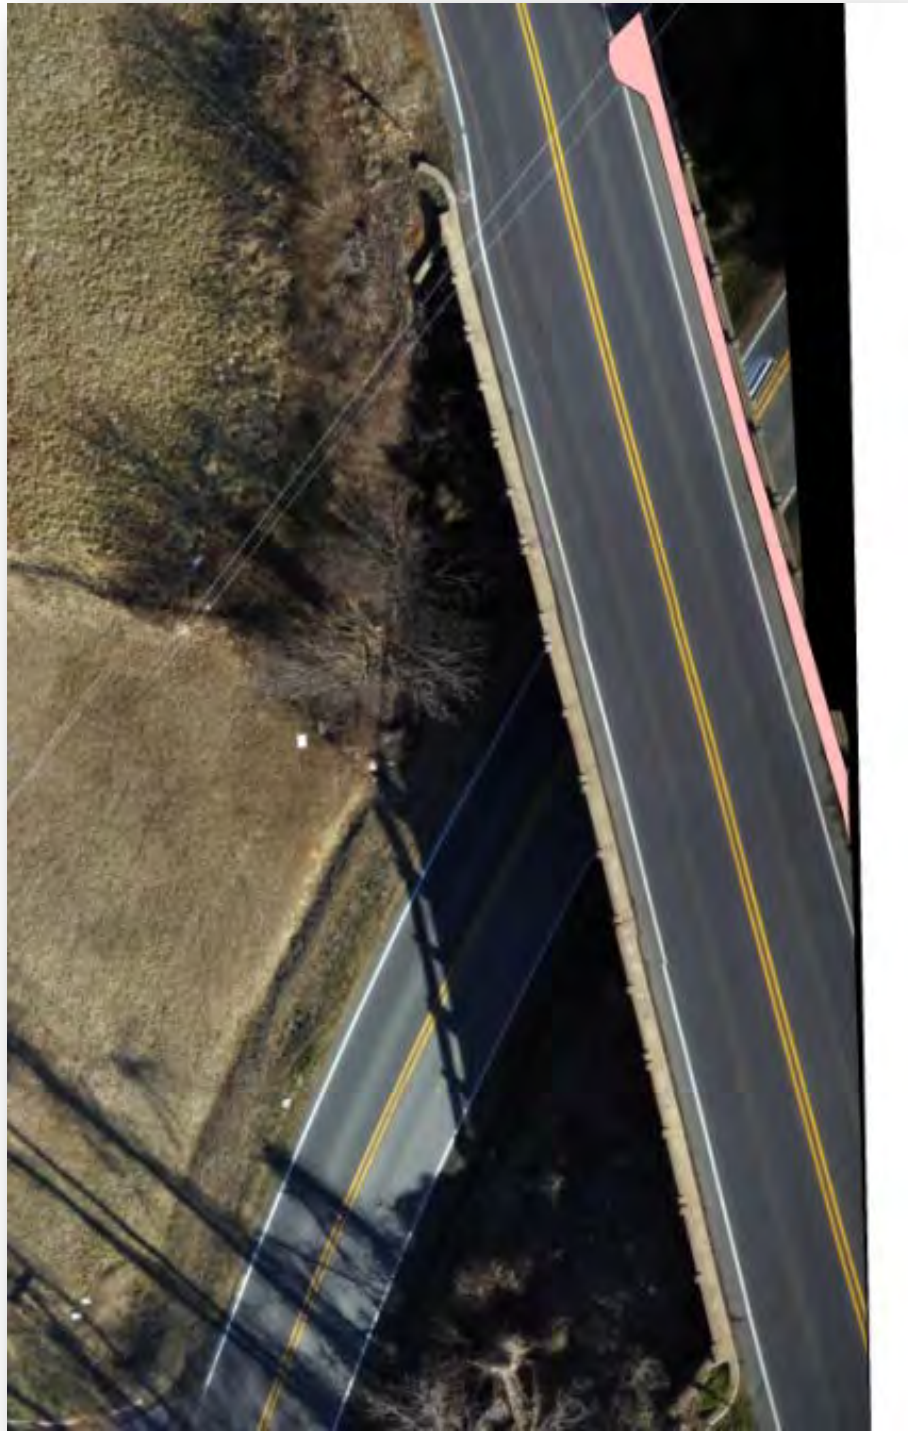
**Figure C.5.23: Bridge NO. US21 St. 2004 Obstruction Image**

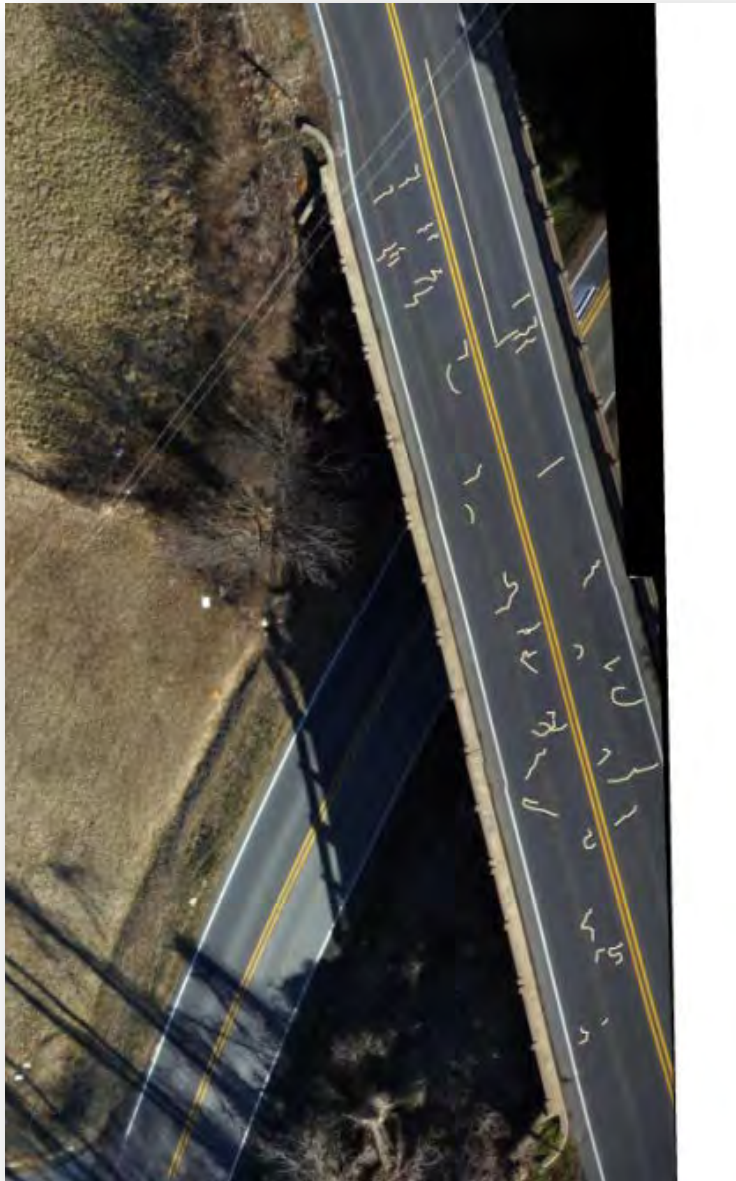
**Figure C.5.24: Bridge NO. US21 St. 2004 Crack Image**

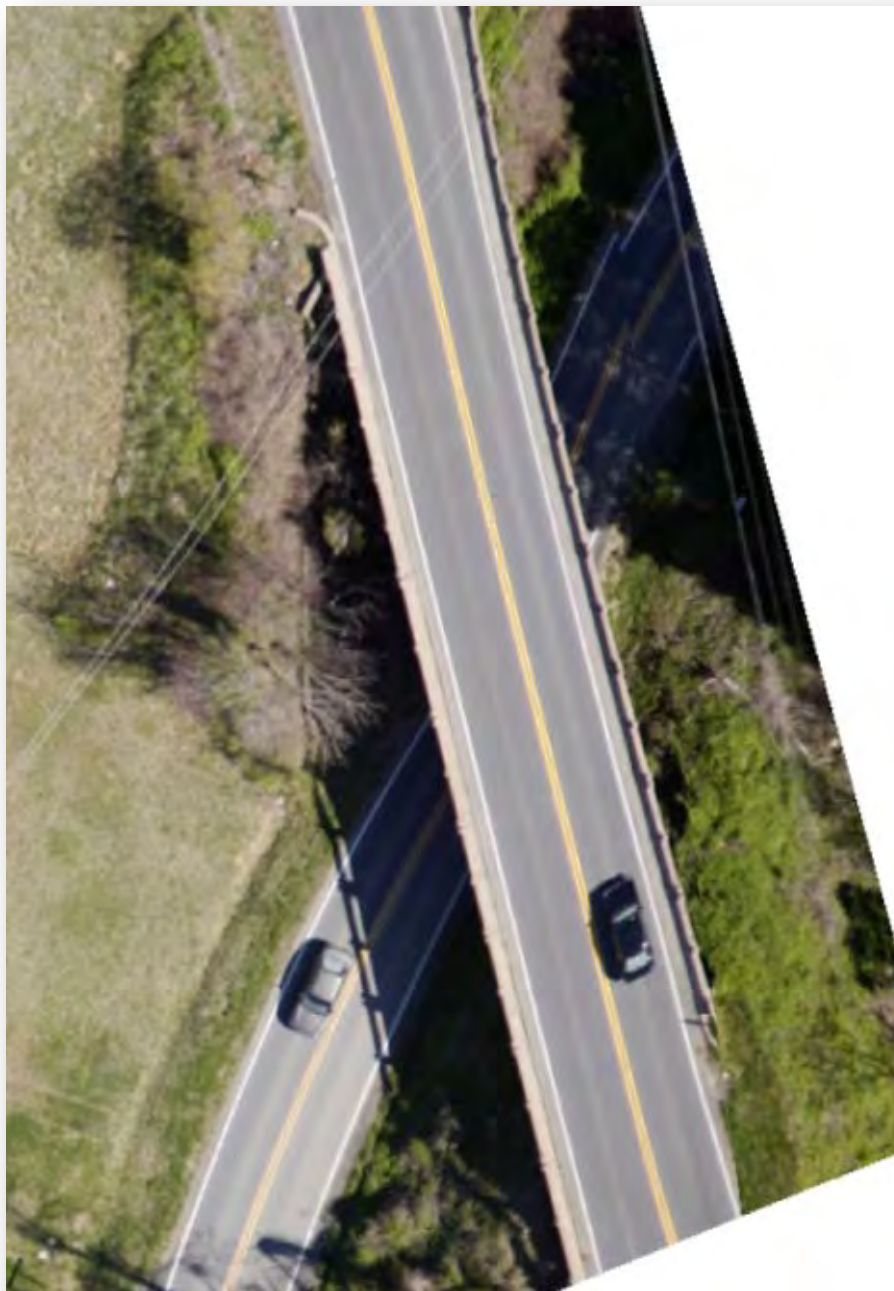
**Figure C.5.25: Bridge NO. US21 St. 21 Blank Image**

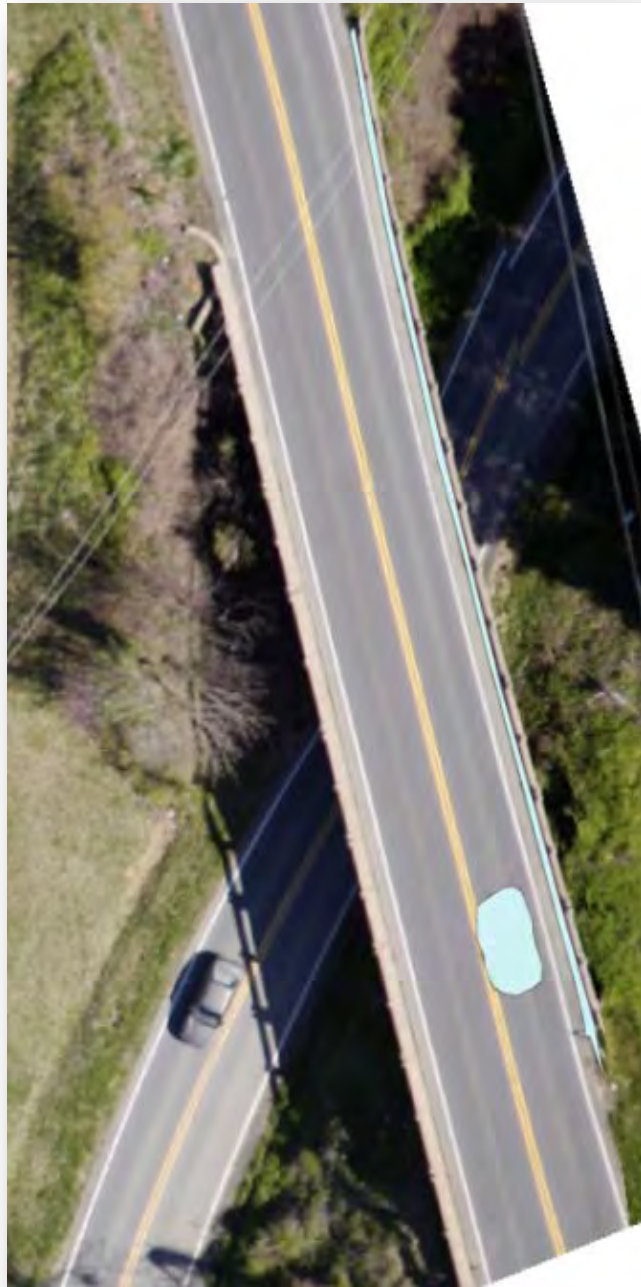
**Figure C.5.26: Bridge NO. US21 St. 21 Obstruction Image**

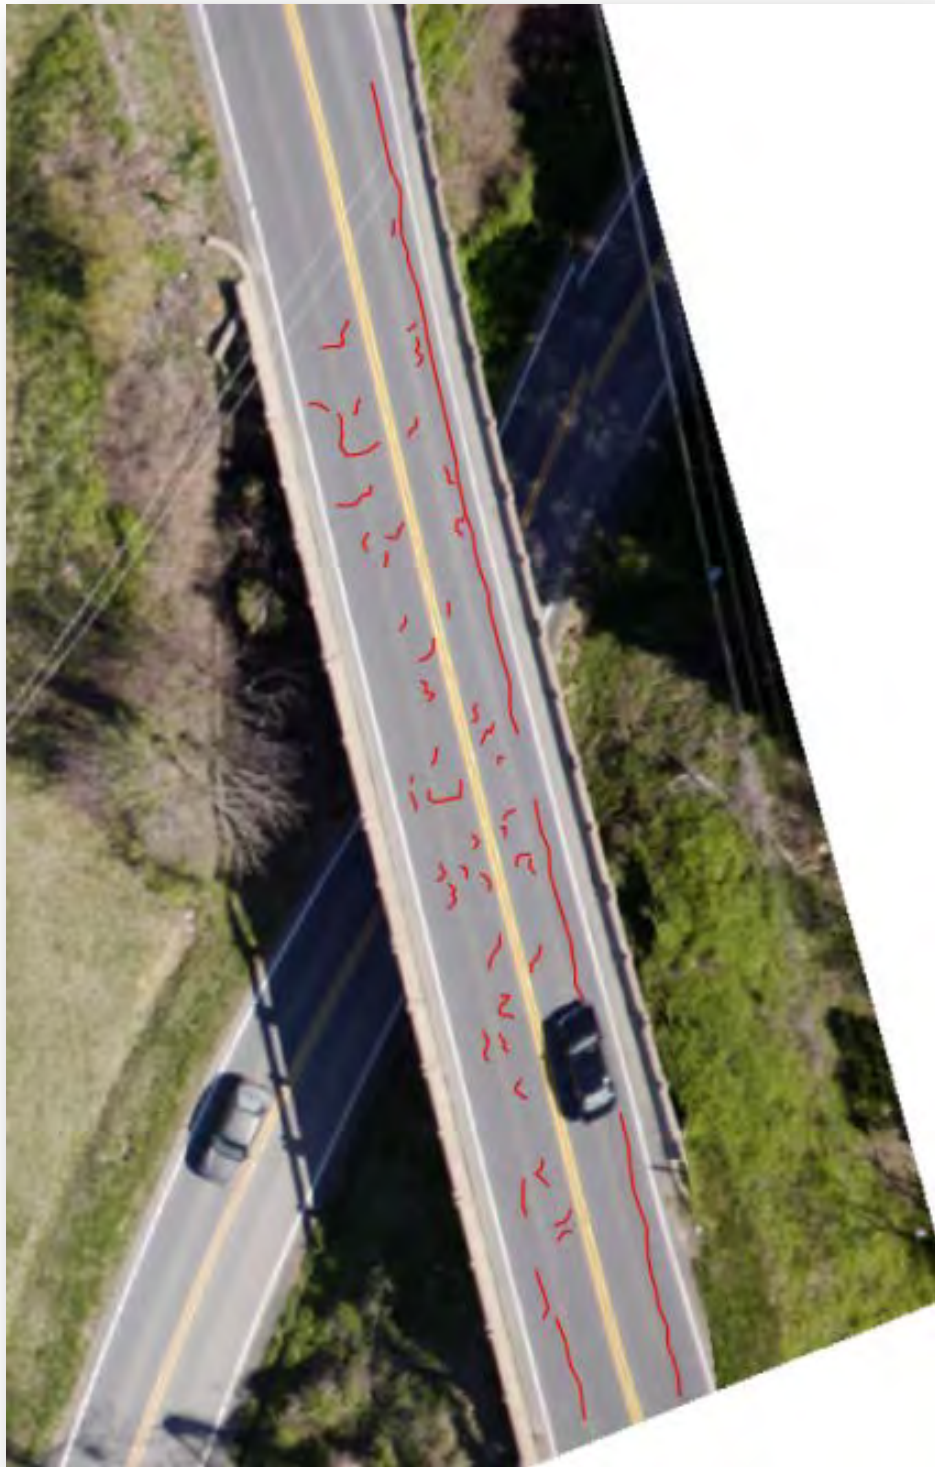
**Figure C.5.27: Bridge NO. US21 St. 21 Crack Image**

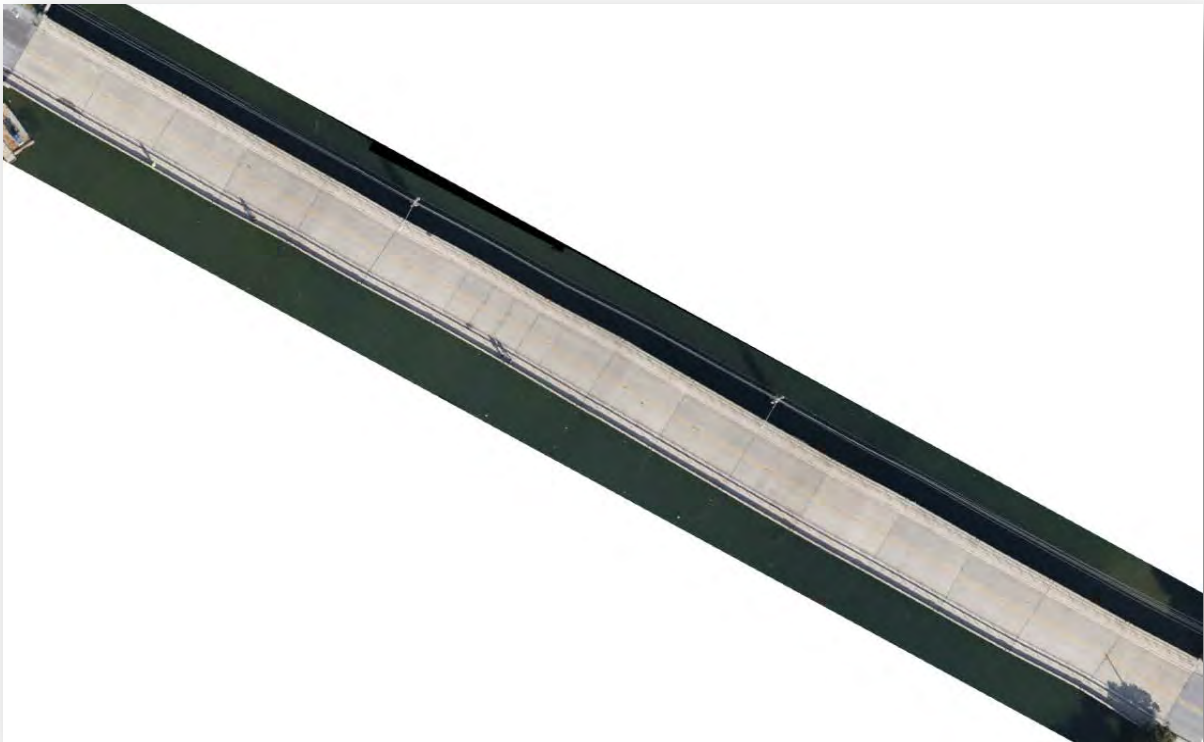
**Figure C.5.28: Bridge NO. Wilmington Blank Image**

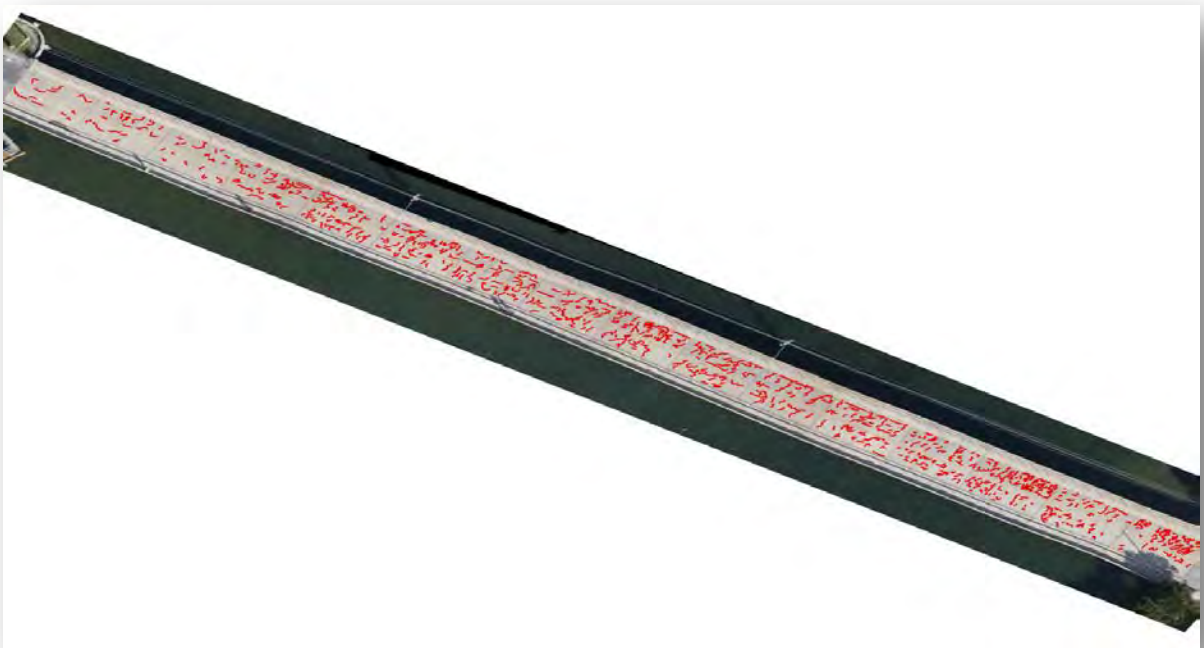
**Figure C.5.30: Bridge NO. Wilmington Crack Image**

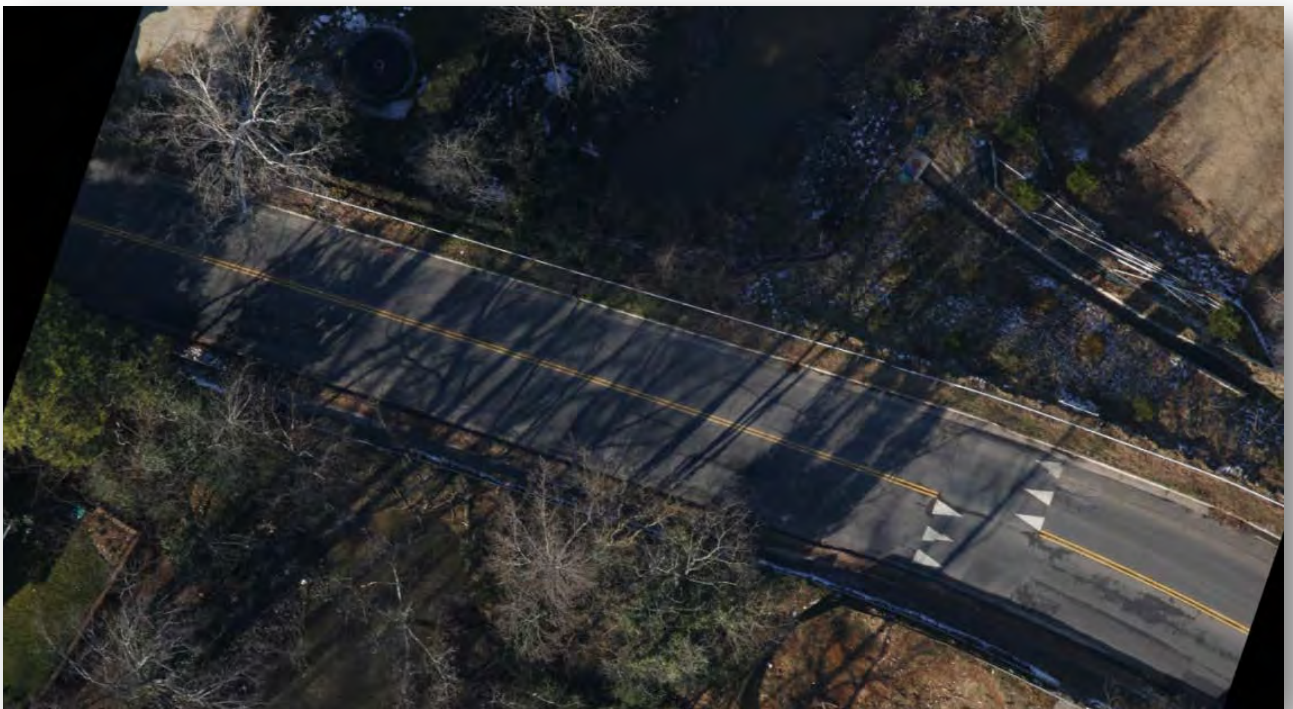
**Figure C.6.1: Bridge NO. 1190447 Blank Image**

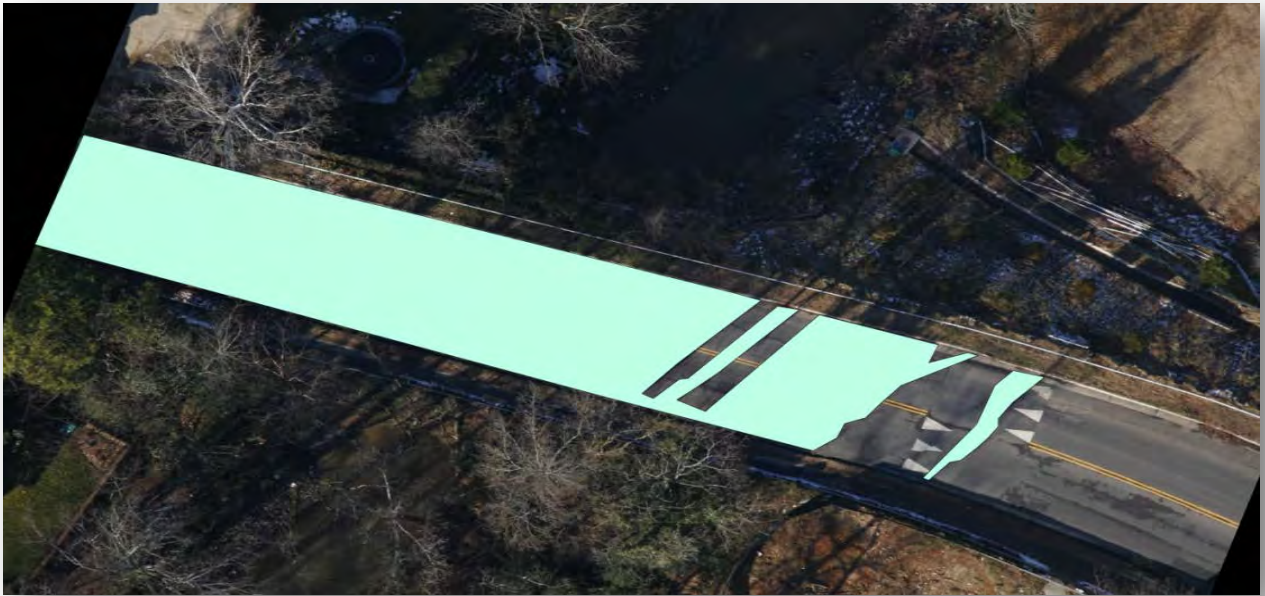
**Figure C.6.2: Bridge NO. 1190447 Obstruction Image**

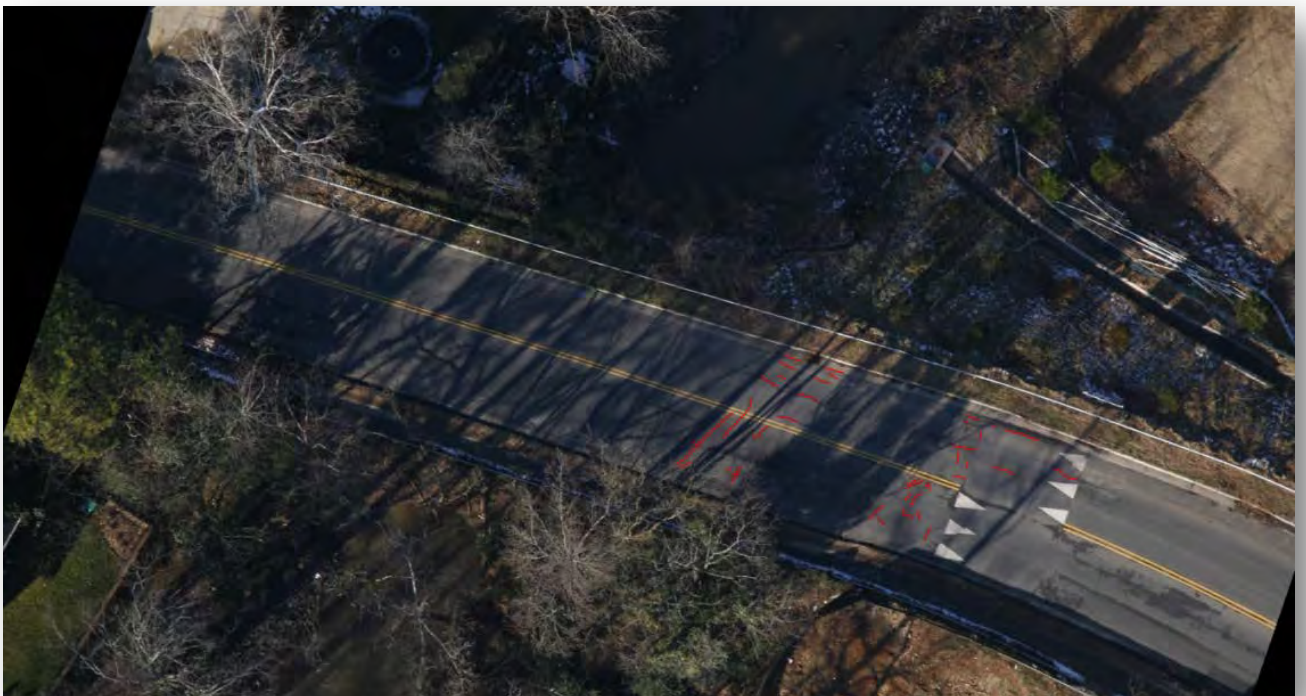
**Figure C.6.3: Bridge NO. 1190447 Crack Image**

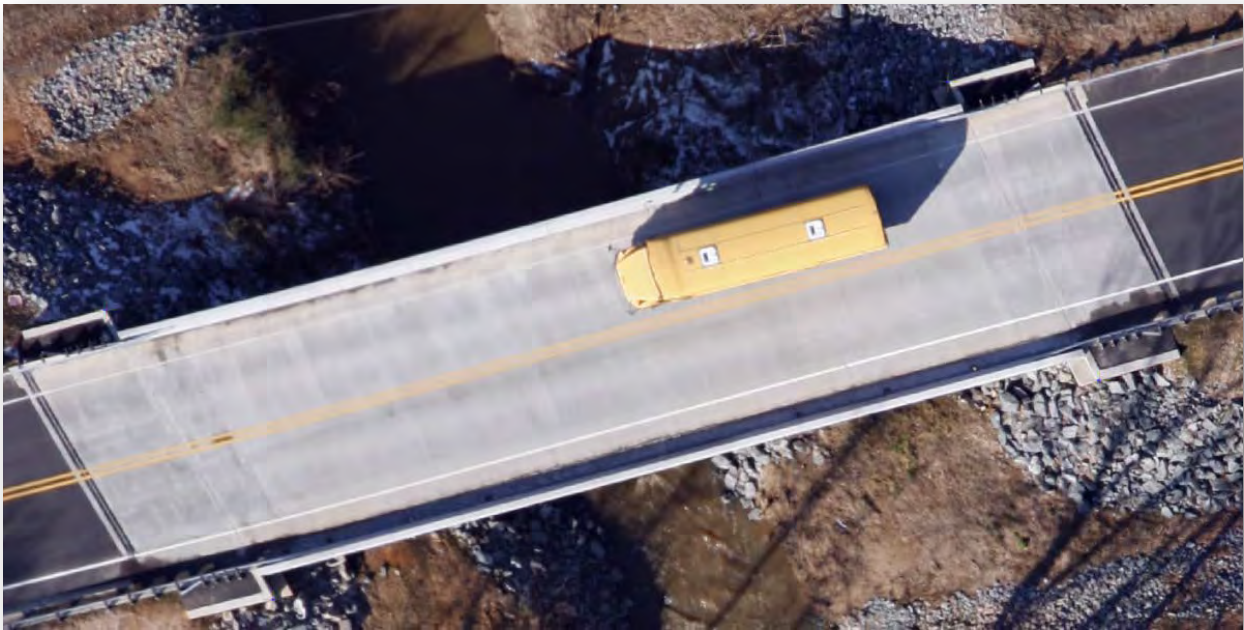
**Figure C.6.4: Bridge NO. 374000000001790223 Blank Image**

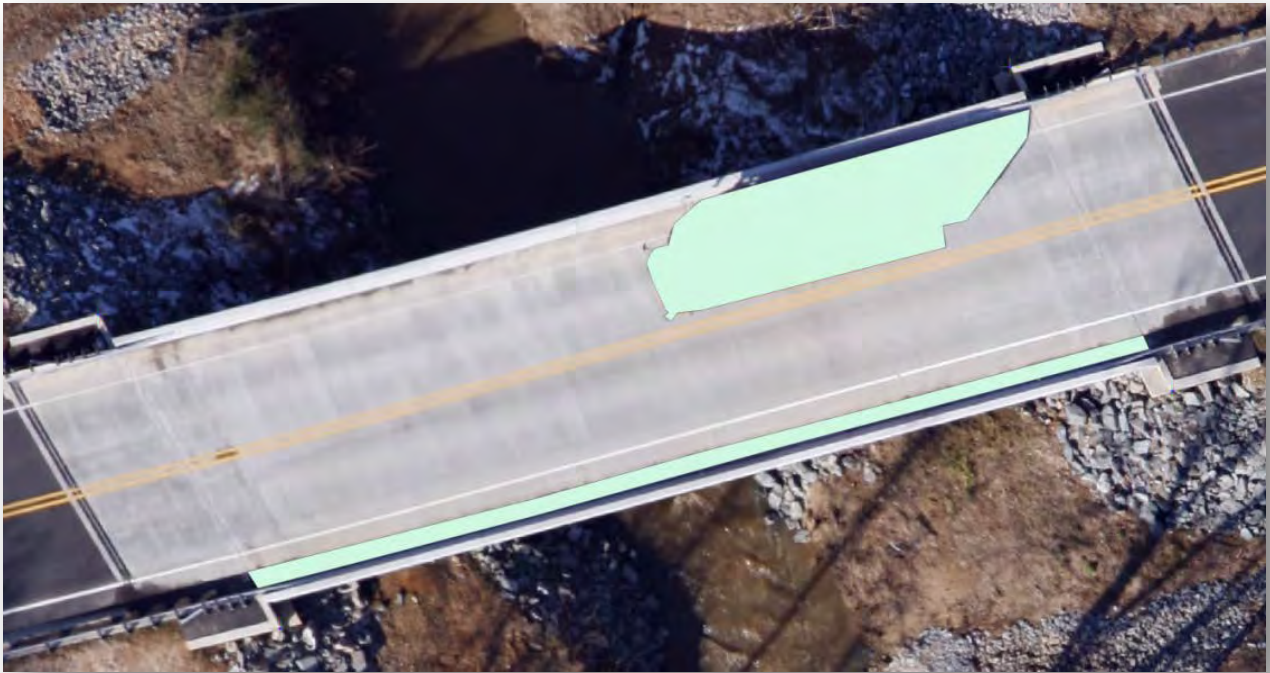
**Figure C.6.5: Bridge NO. 374000000001790223 Obstruction Image**

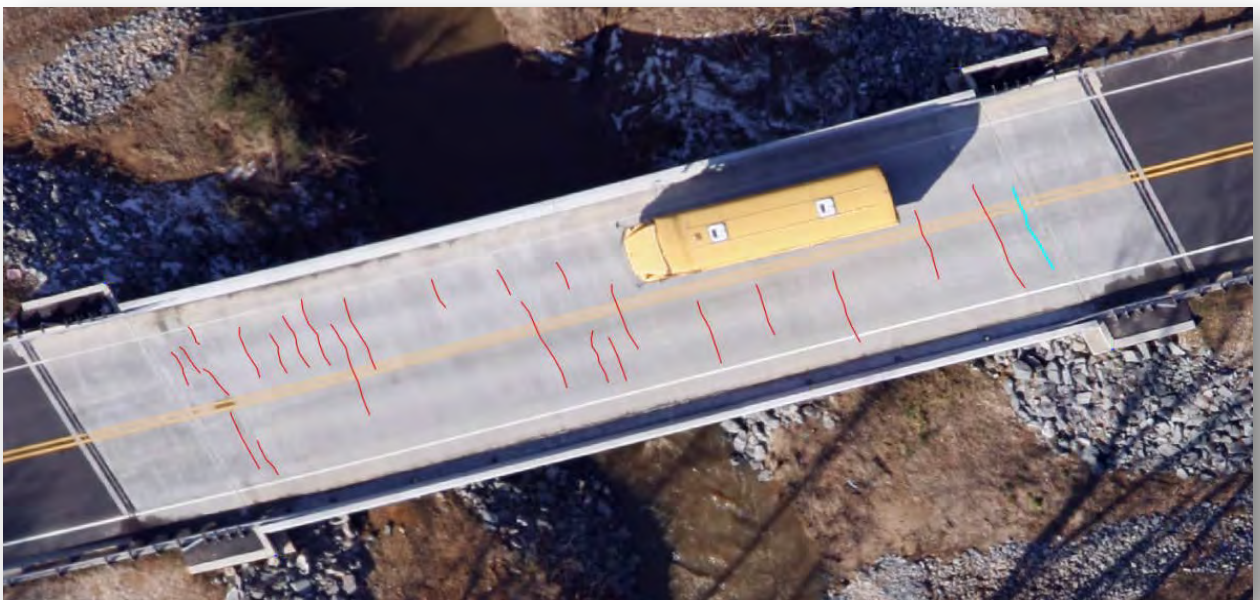
**Figure C.6.6: Bridge NO. 374000000001790223 Crack Image**

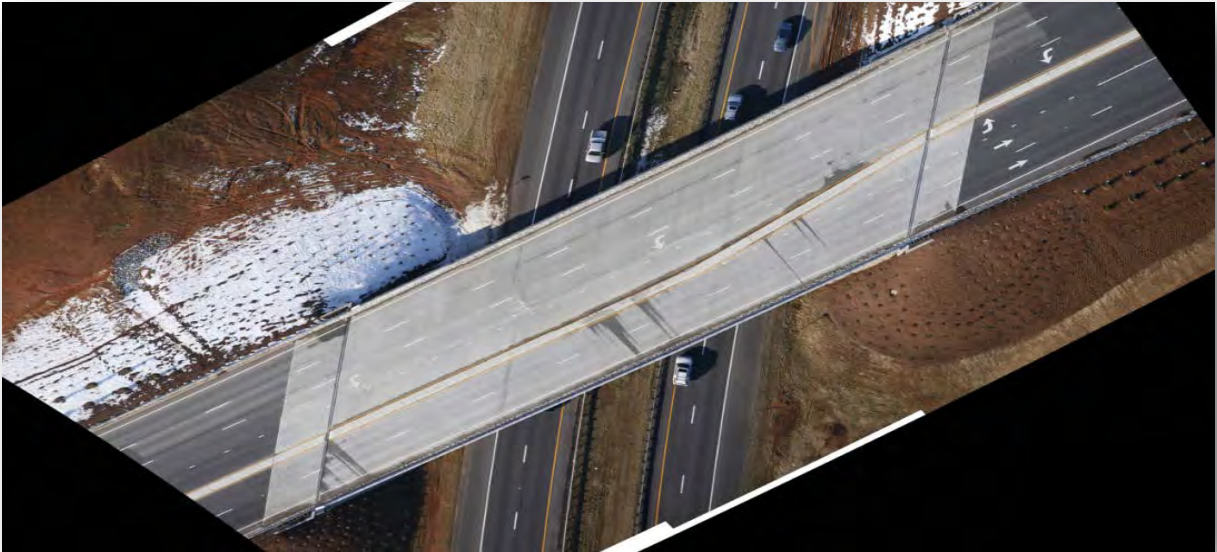
**Figure C.6.7: Bridge NO. 37400000000970028 Blank Image**

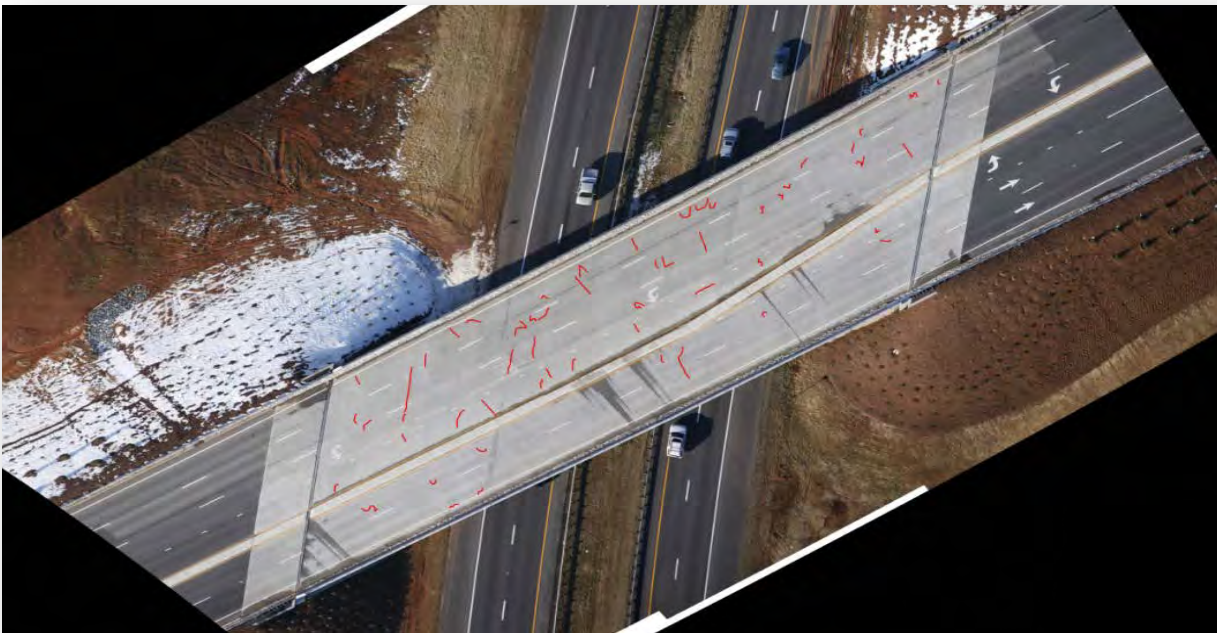
**Figure C.6.8: Bridge NO. 37400000000970028 Crack Image**

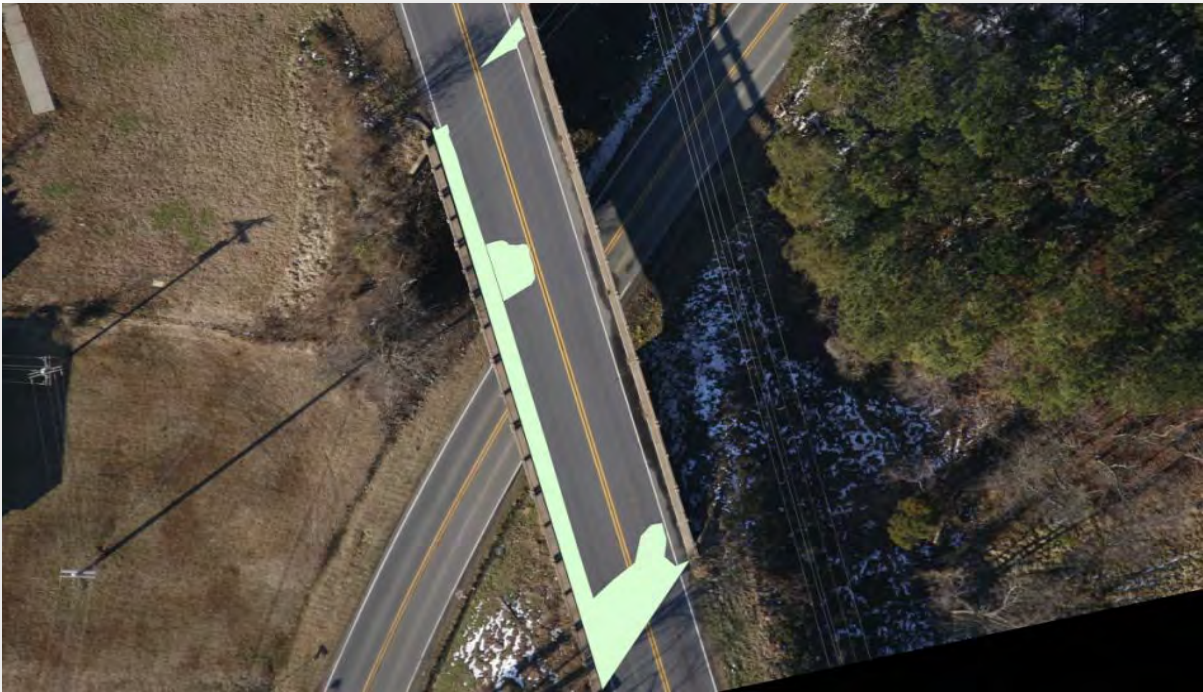
**Figure C.6.10: Bridge NO. US21 Obstruction Image**
