**INTEGRATED REMOTE SENSING AND VISUALIZATION (IRSV)  
SYSTEM FOR TRANSPORTATION INFRASTRUCTURE  
OPERATIONS AND MANAGEMENT:  
PHASE TWO**

**VOLUME 5**

**AERIAL BRIDGE DECK IMAGING DATA COLLECTION AND  
SOFTWARE REVISION**

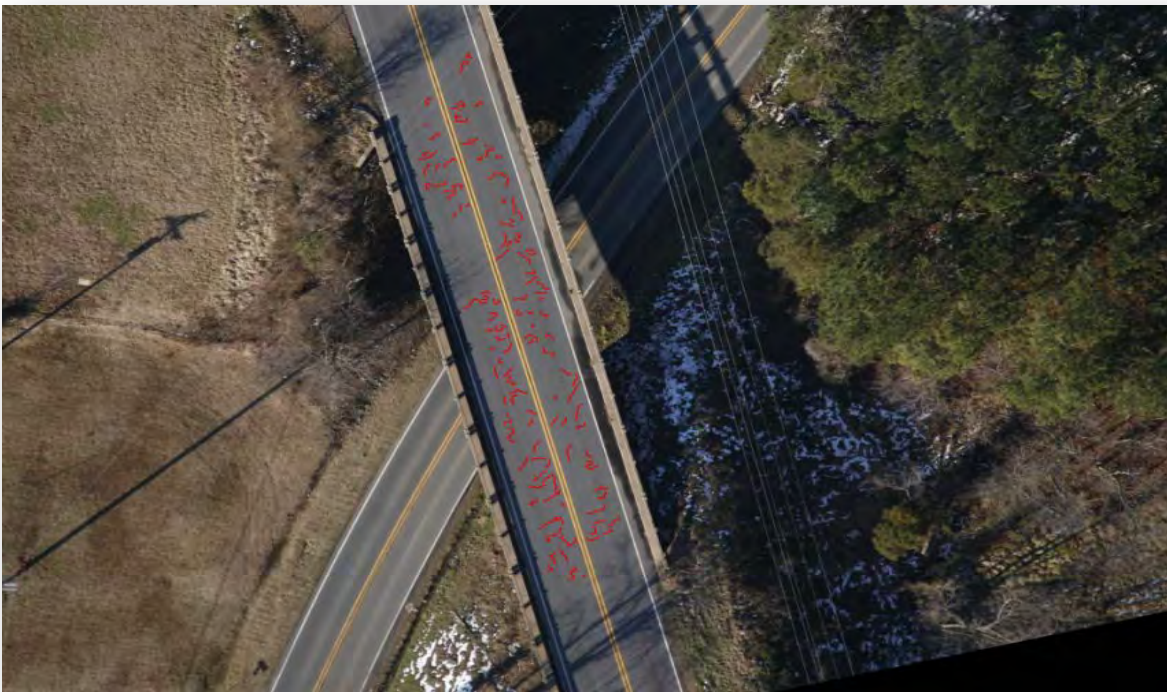
**Figure C.6.11: Bridge NO. US21 Crack Image**

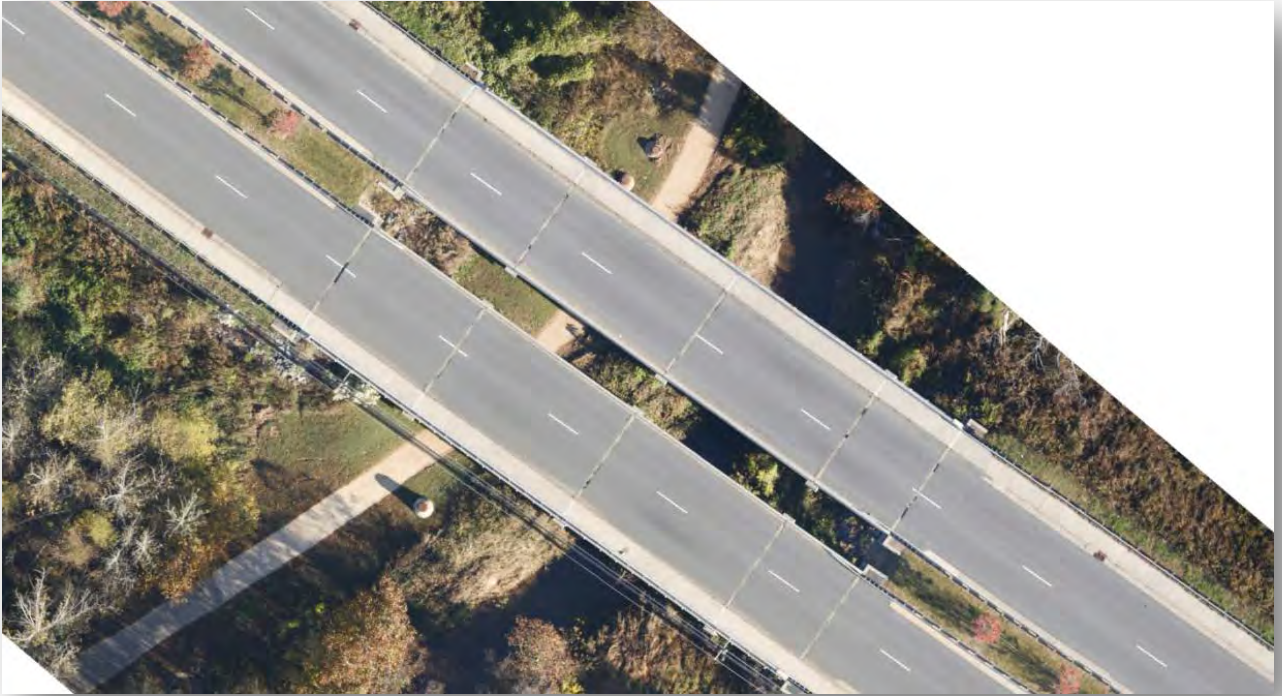
**Figure C.7.1: Bridge NO. 590084 Blank Image**

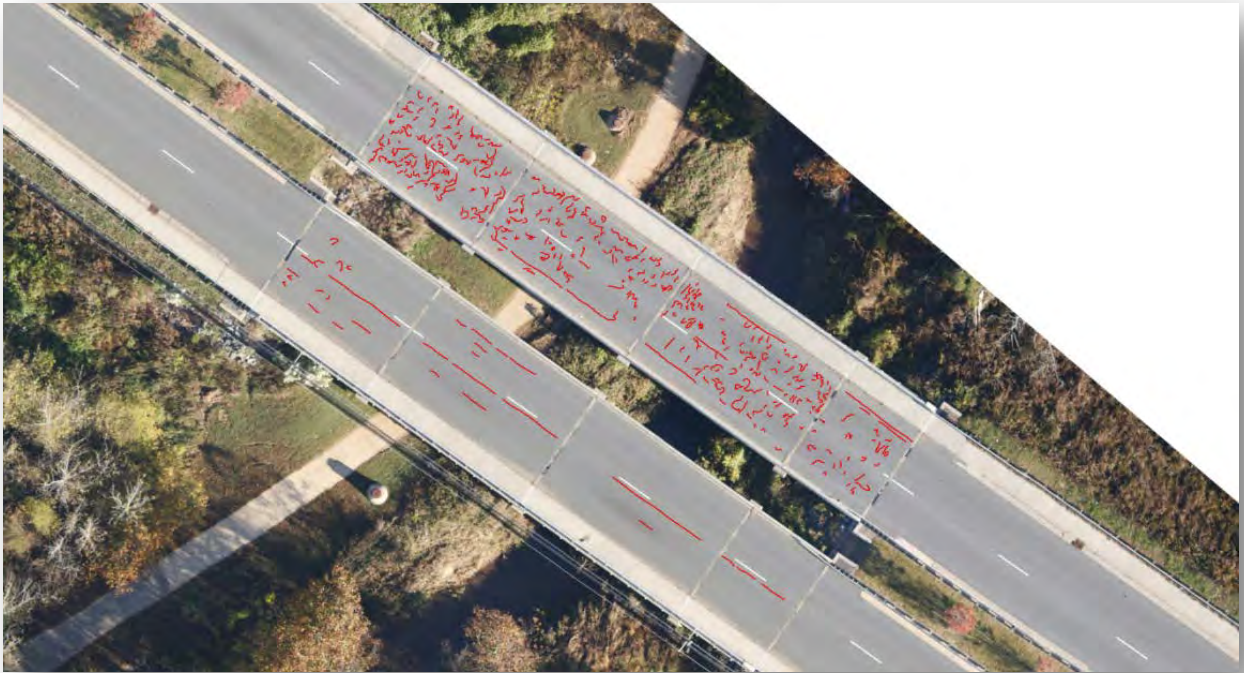
**Figure C.7.2: Bridge NO. 590084 Crack Image**

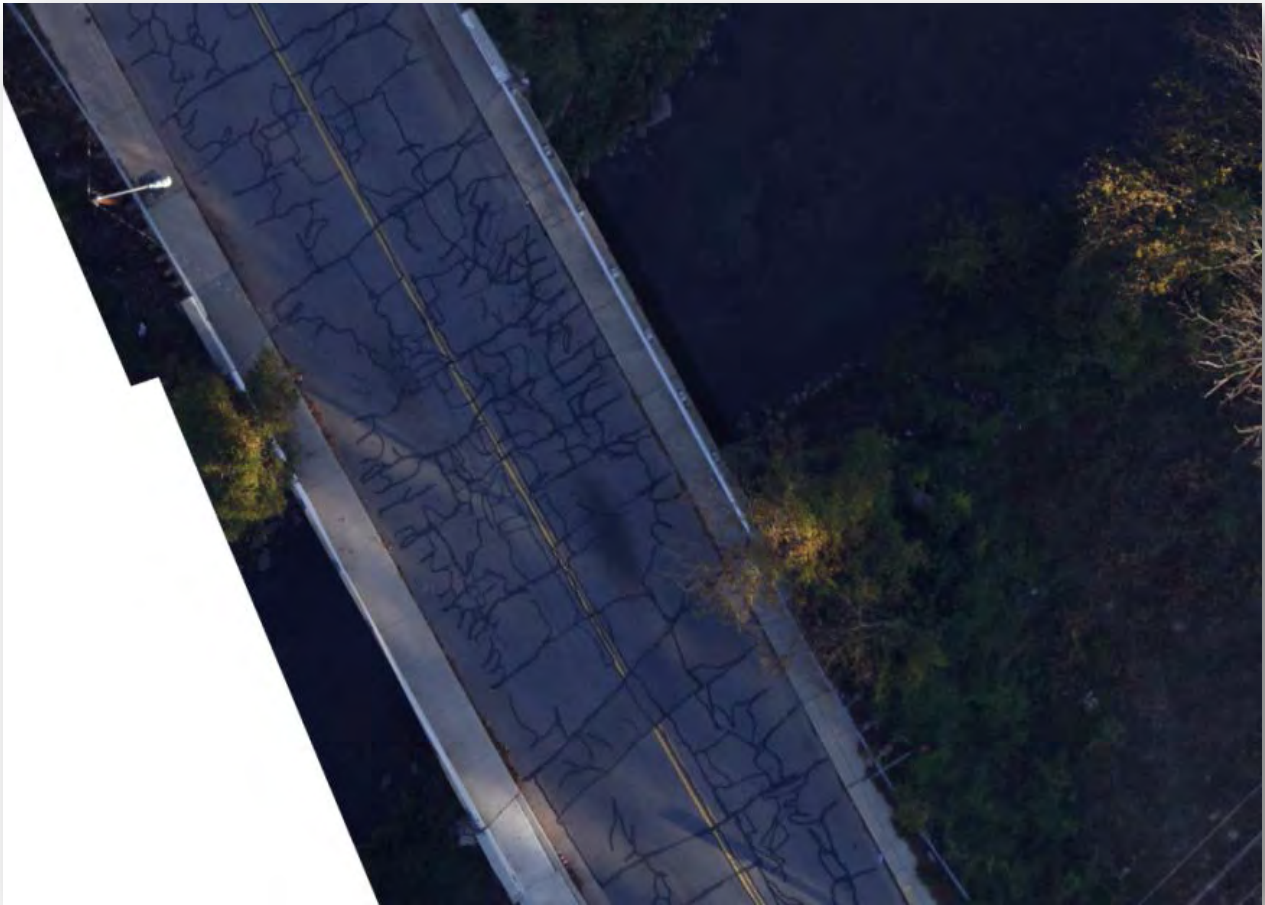
**Figure C.7.3: Bridge NO. 590376 Blank Image**

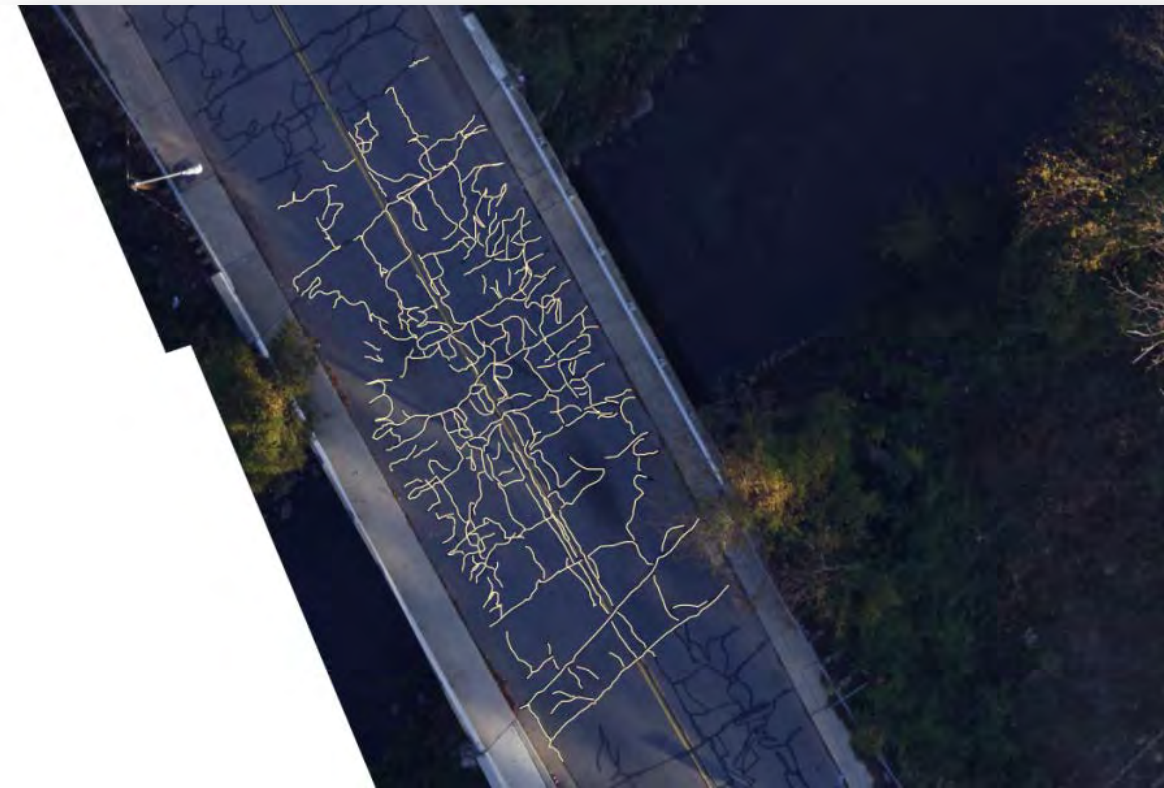
**Figure C.7.4: Bridge NO. 590376 Crack Image**

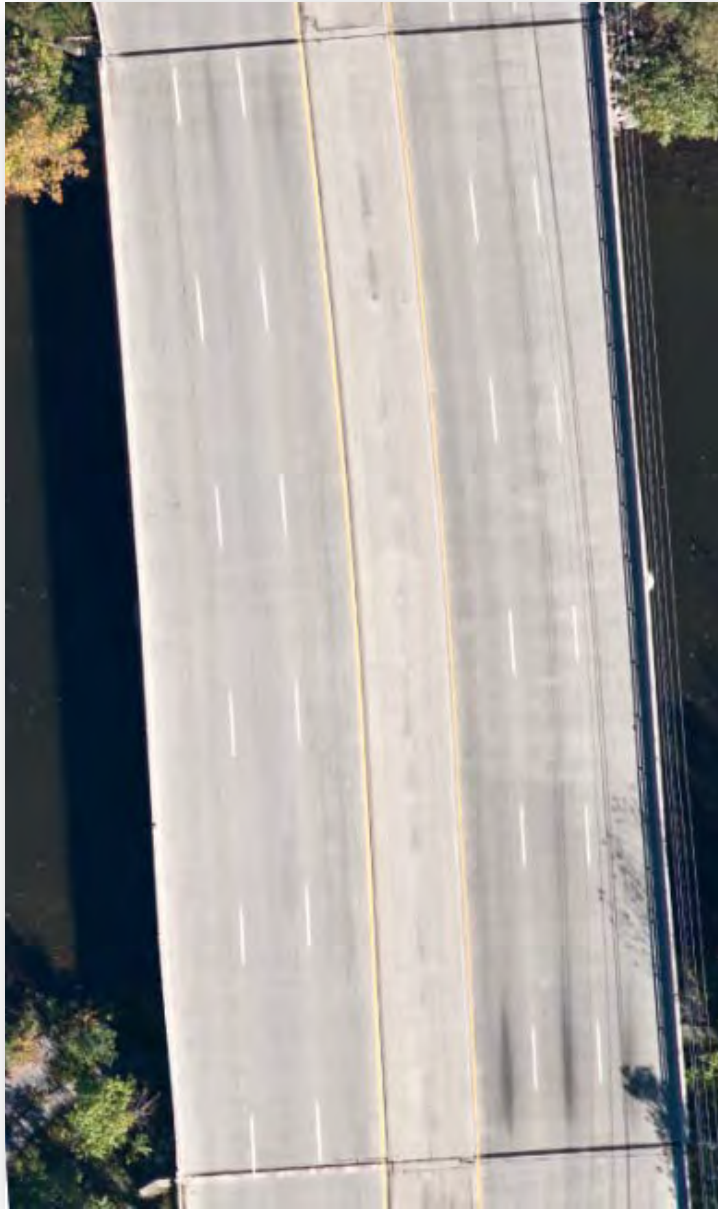
Figure C.8.1: Bridge NO. 1005220 Blank Image

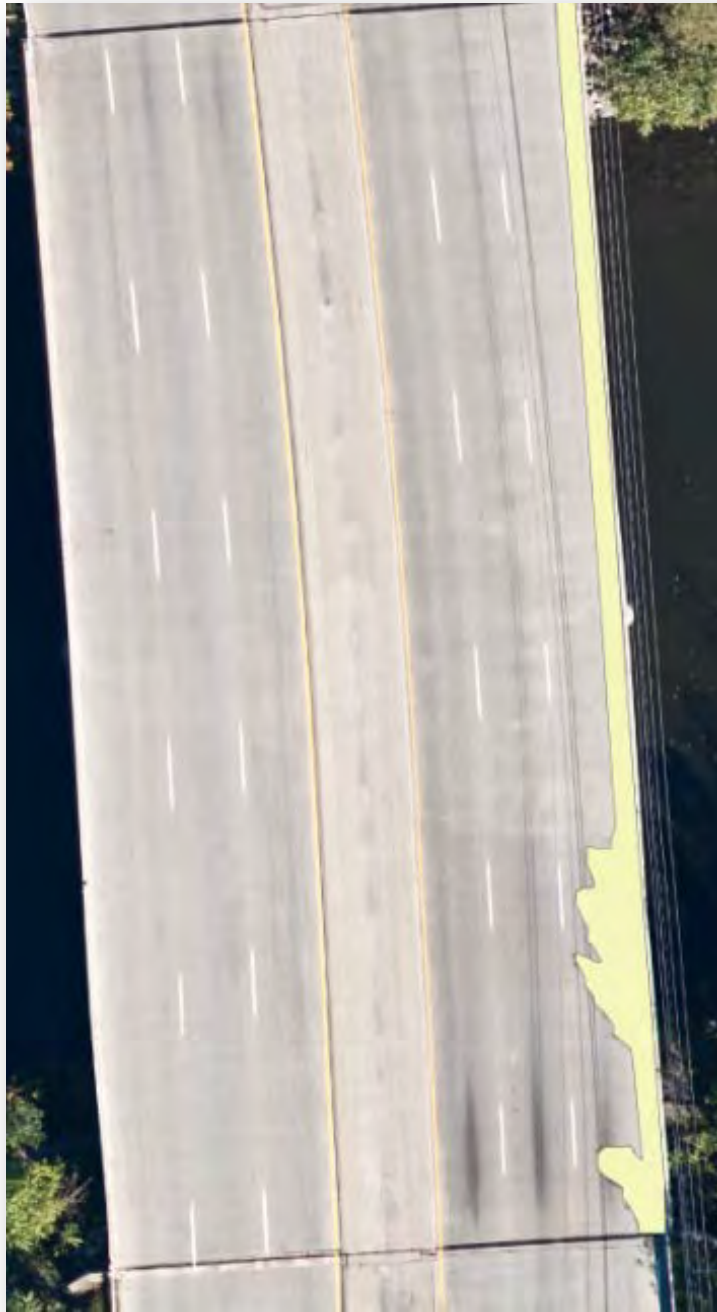
**Figure C.8.2: Bridge NO. 1005220 Obstruction Image**

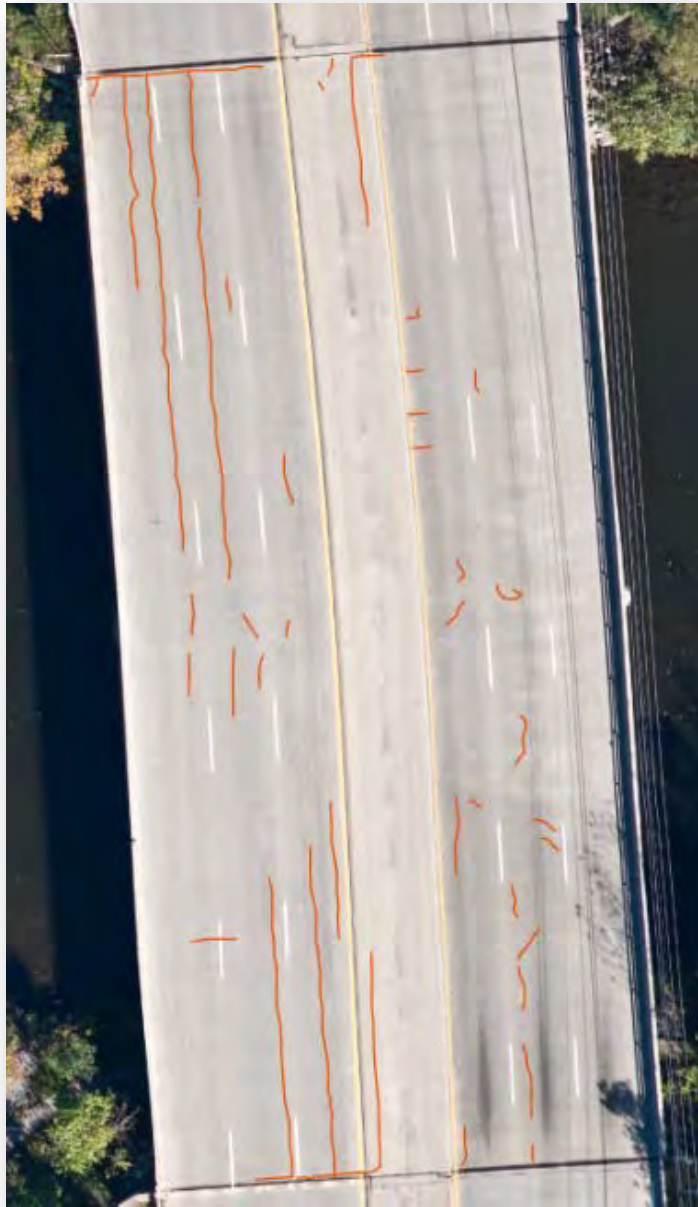
**Figure C.8.3: Bridge NO. 1005220 Crack Image**

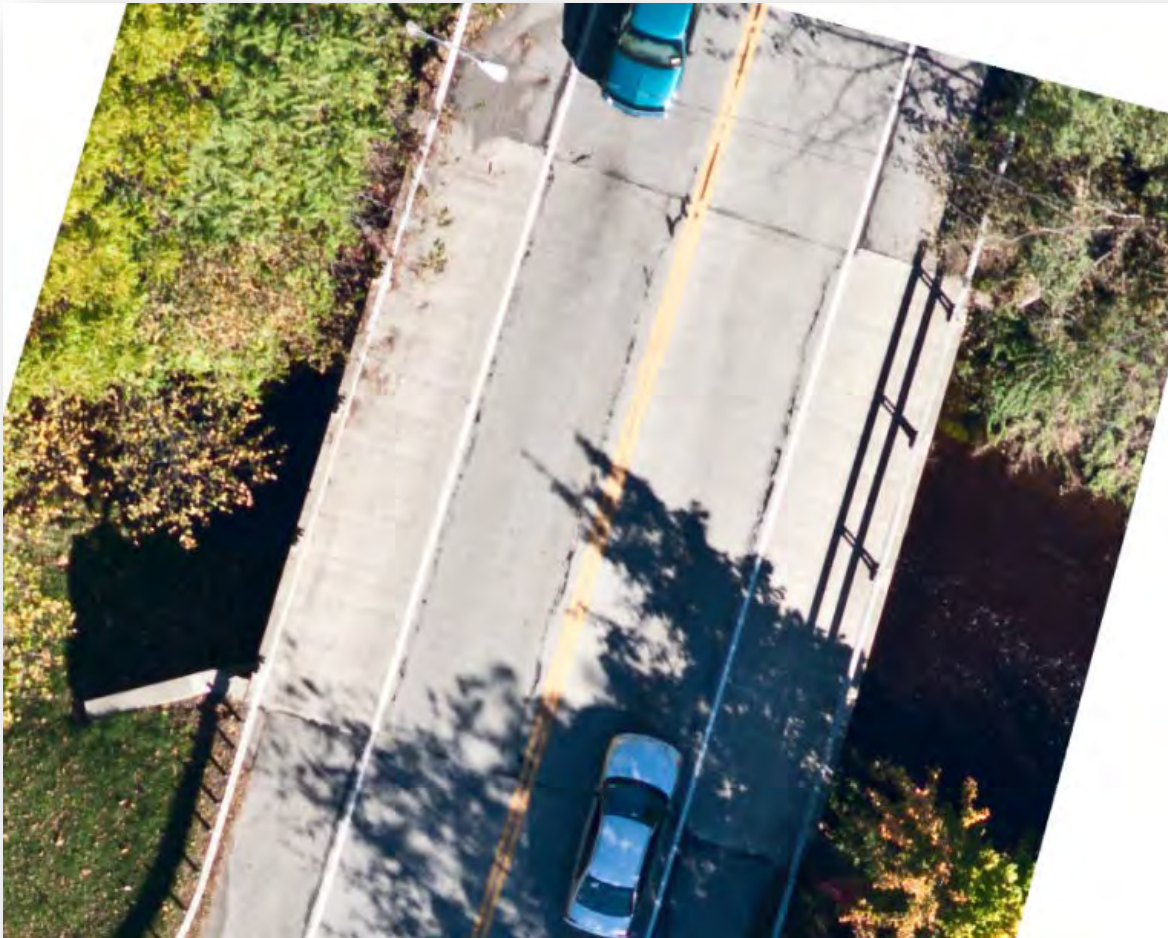
**Figure C.8.4: Bridge NO. 1006370 Blank Image**

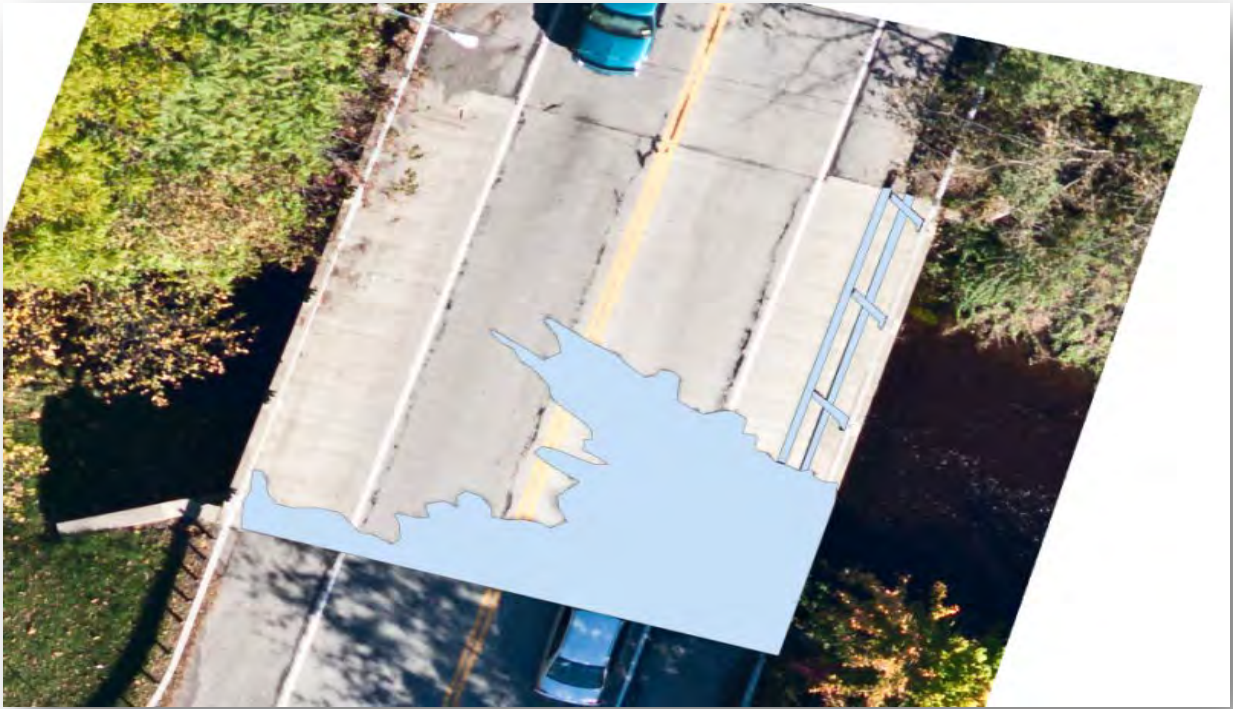
**Figure C.8.5: Bridge NO. 1006370 Obstruction Image**

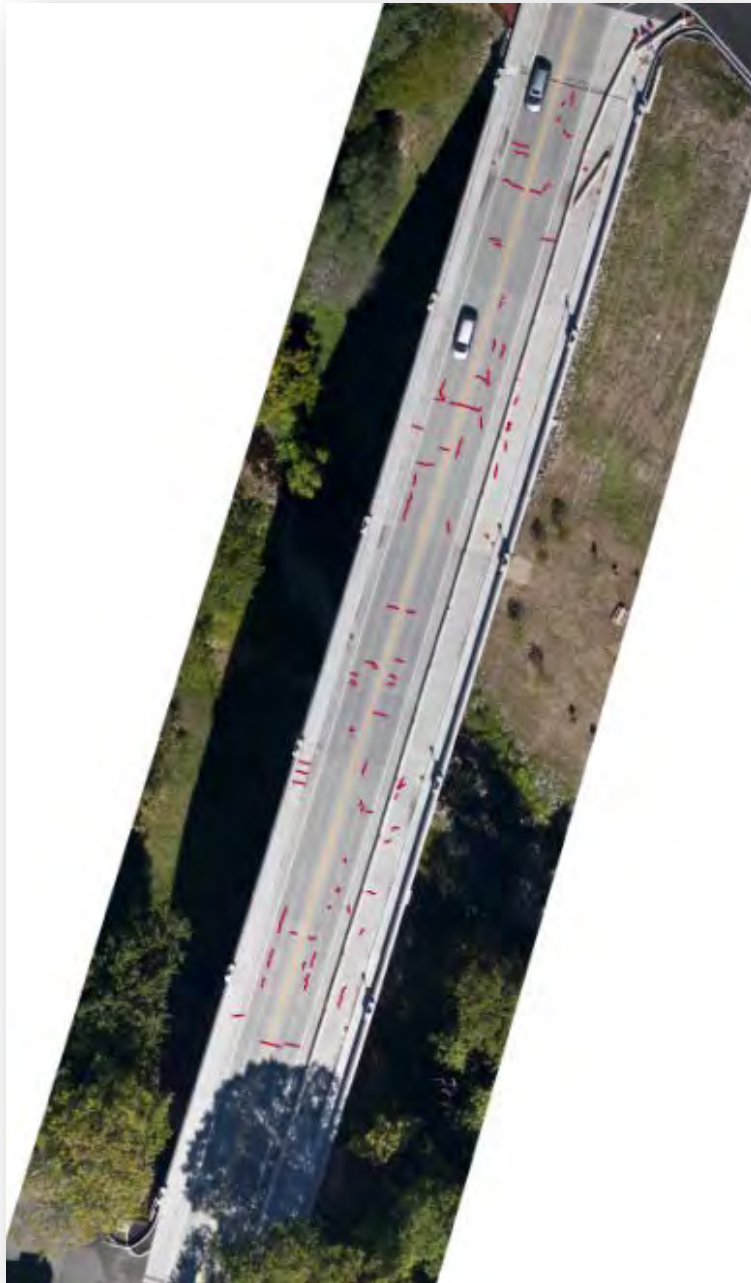
**Figure C.8.9: Bridge NO. 1007140 Crack Image**

<b>Span Area</b>						
<b>FID</b>	<b>Span</b>	<b>Area</b>	<b># Cracks</b>	<b>Obstruction Area</b>	<b>DV</b>	<b>Crack Density</b>
0	A	6693.009	3	4454.241234	1	0.134002316
1	B	7730.062	29	646.1852357	1	0.409380371
2	C	6927.103	12	637.803677	1	0.190800267
3	D	7541.329	23	212.568353	1	0.313832064
4	E	6557.109	14	1467.624723	1	0.275076961

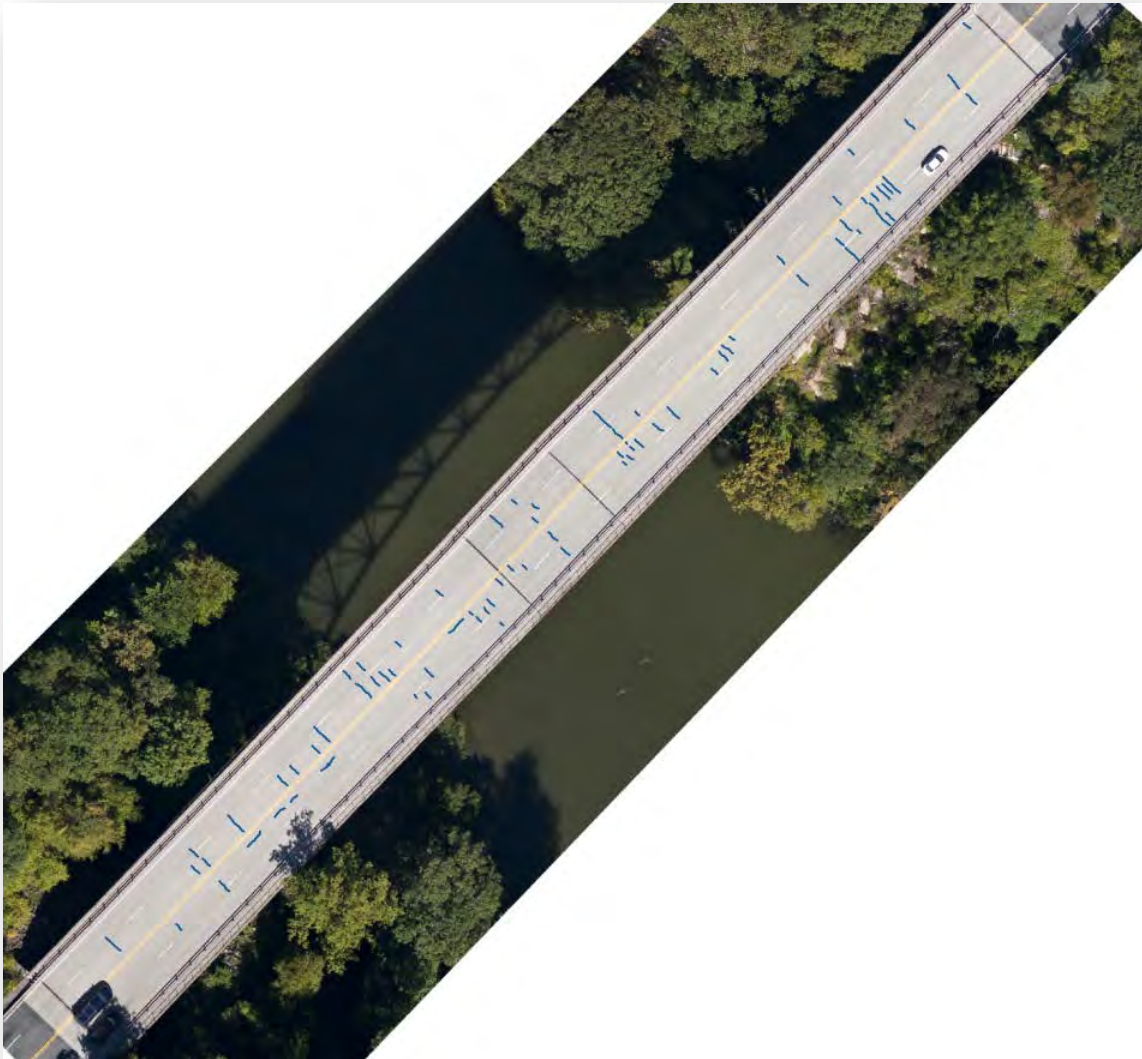
**Figure C.8.12: Bridge NO. 1007150 Crack Image**

Span Area						
FID	Span	Area	# Cracks	Obstruction Area	DV	Crack Density
0	A	22842.1	34	1171.318188	1	0.156893278
1	B	4545.08	8	1313.609985	1	0.247565348
2	C	22736	35	1818.200443	1	0.167321615

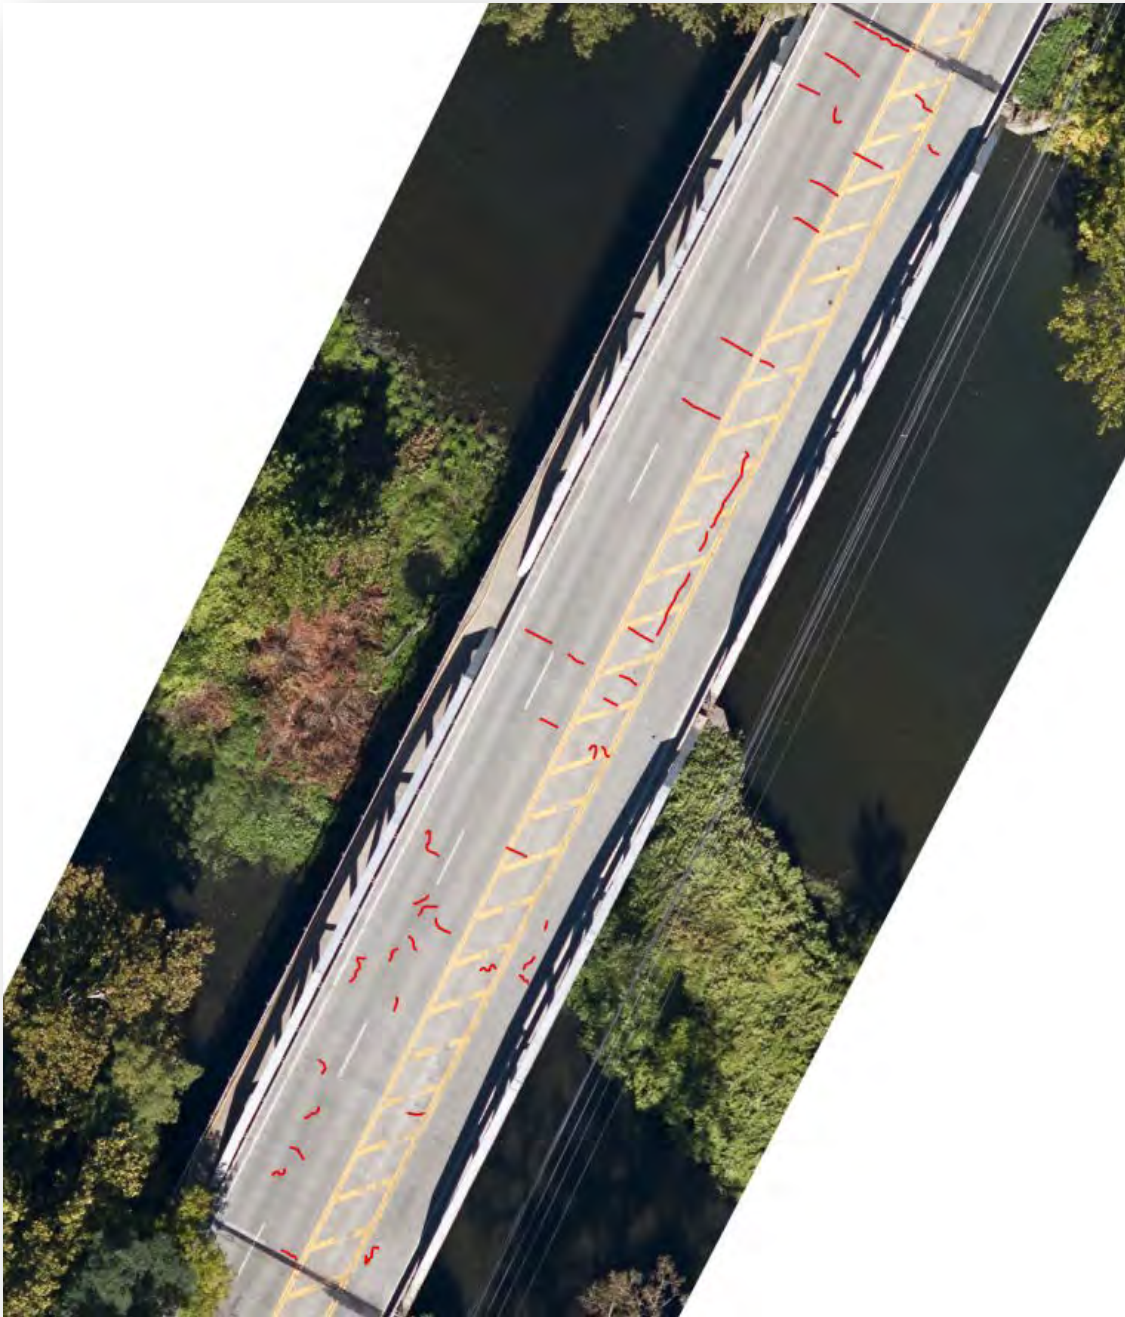
**Figure C.8.1525: Bridge NO. 1007260 Crack Image**

Span Area						
<b>FID</b>	<b>Span</b>	<b>Area</b>	<b># Cracks</b>	<b>Obstruction Area</b>	<b>DV</b>	<b>Crack Density</b>
<b>0</b>	<b>A</b>	<b>7575.64</b>	<b>27</b>	<b>682.443718</b>	<b>1</b>	<b>0.391690573</b>
<b>1</b>	<b>B</b>	<b>7490.08</b>	<b>16</b>	<b>666.1889267</b>	<b>1</b>	<b>0.234470331</b>

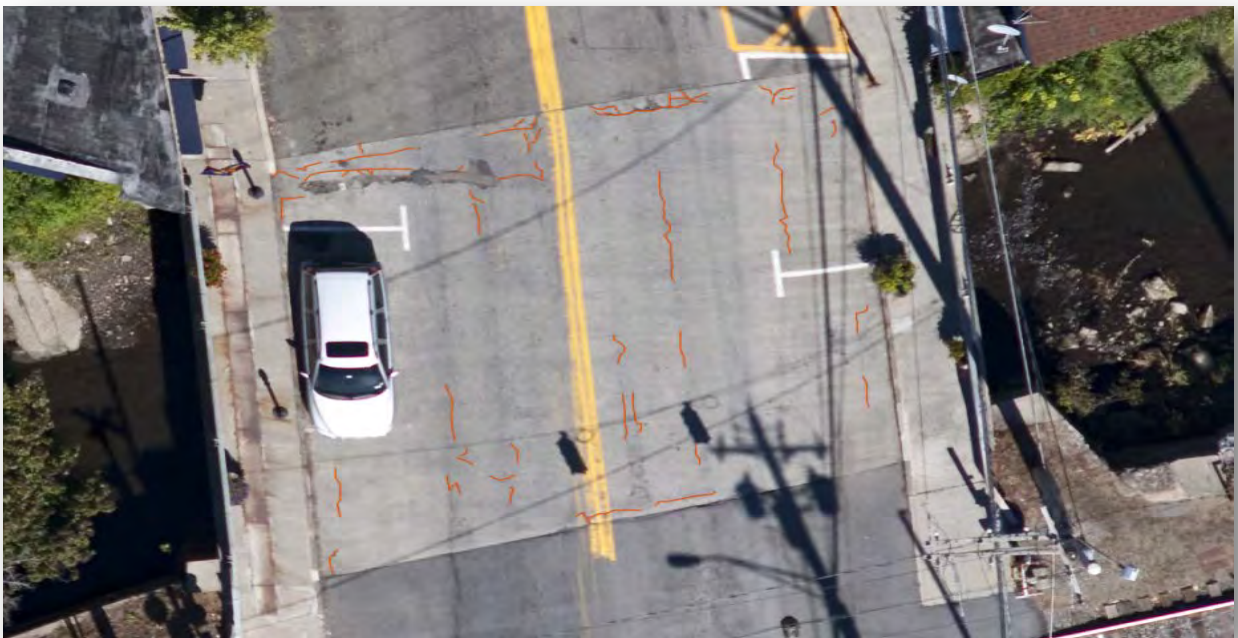
**Figure C.8.21: Bridge NO. 1014090 Crack Image**

<b>Span Area</b>						
<b>FID</b>	<b>Span</b>	<b>Area</b>	<b># Cracks</b>	<b>Obstruction Area</b>	<b>DV</b>	<b>Crack Density</b>
0	A	2622.59	51	445.668728	18.48637	2.342758126

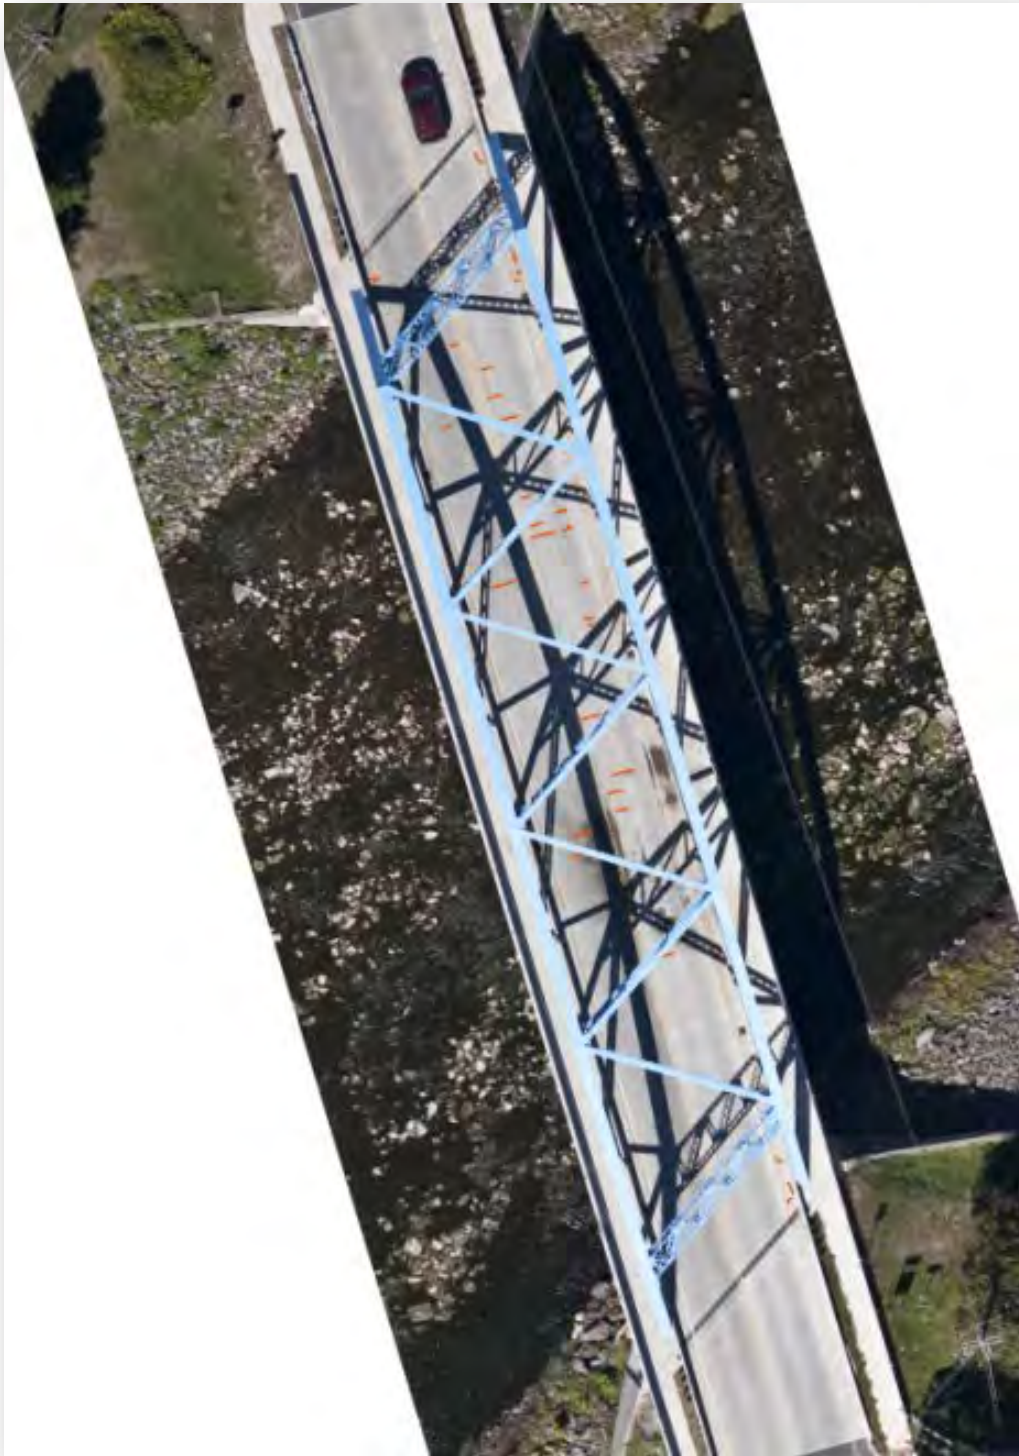
**Figure C.8.24: Bridge NO. 1022310 Crack Image**

<b>Span Area</b>						
<b>FID</b>	<b>Span</b>	<b>Area</b>	<b># Cracks</b>	<b>Obstruction Area</b>	<b>DV</b>	<b>Crack Density</b>
<b>0</b>	<b>A</b>	<b>12312.54</b>	<b>31</b>	<b>4814.955434</b>	<b>1</b>	<b>0.413466768</b>

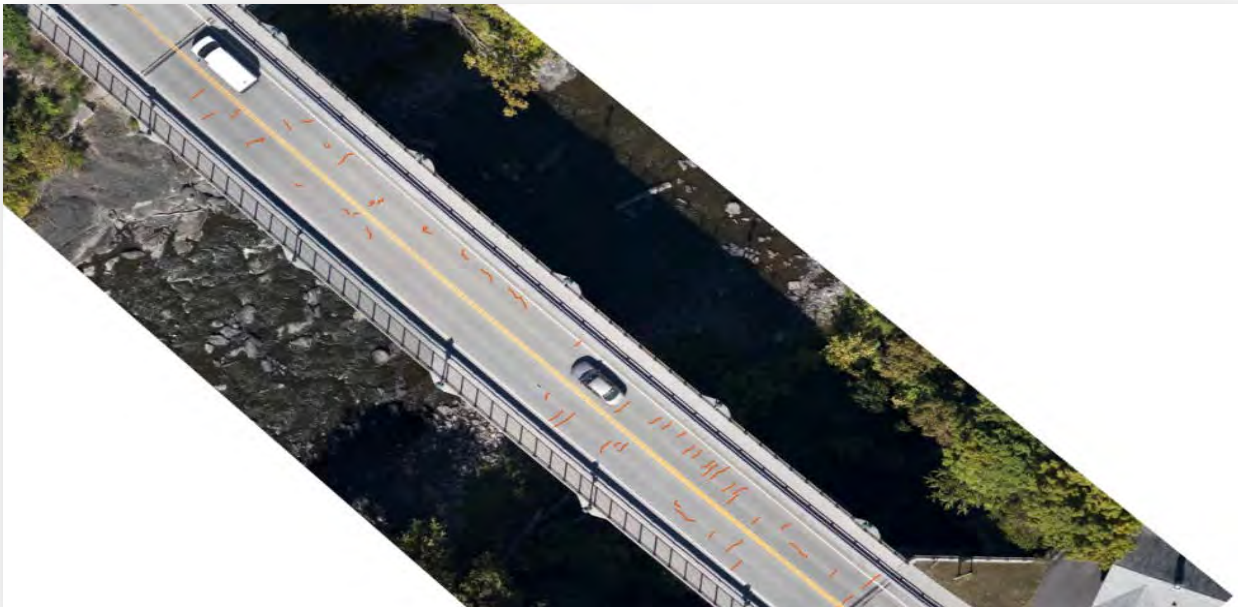
**Figure C.8.27: Bridge NO. 1026680 Crack Image**

<b>Span Area</b>						
<b>FID</b>	<b>Span</b>	<b>Area</b>	<b># Cracks</b>	<b>Obstruction Area</b>	<b>DV</b>	<b>Crack Density</b>
0	A	3346.186	20	221.5328379	1	0.640071113
1	B	2681.156	11	386.8493306	1	0.479447617
2	C	2566.777	8	168.4429988	1	0.333564815
3	D	3224.126	10	571.0751627	1	0.376924597

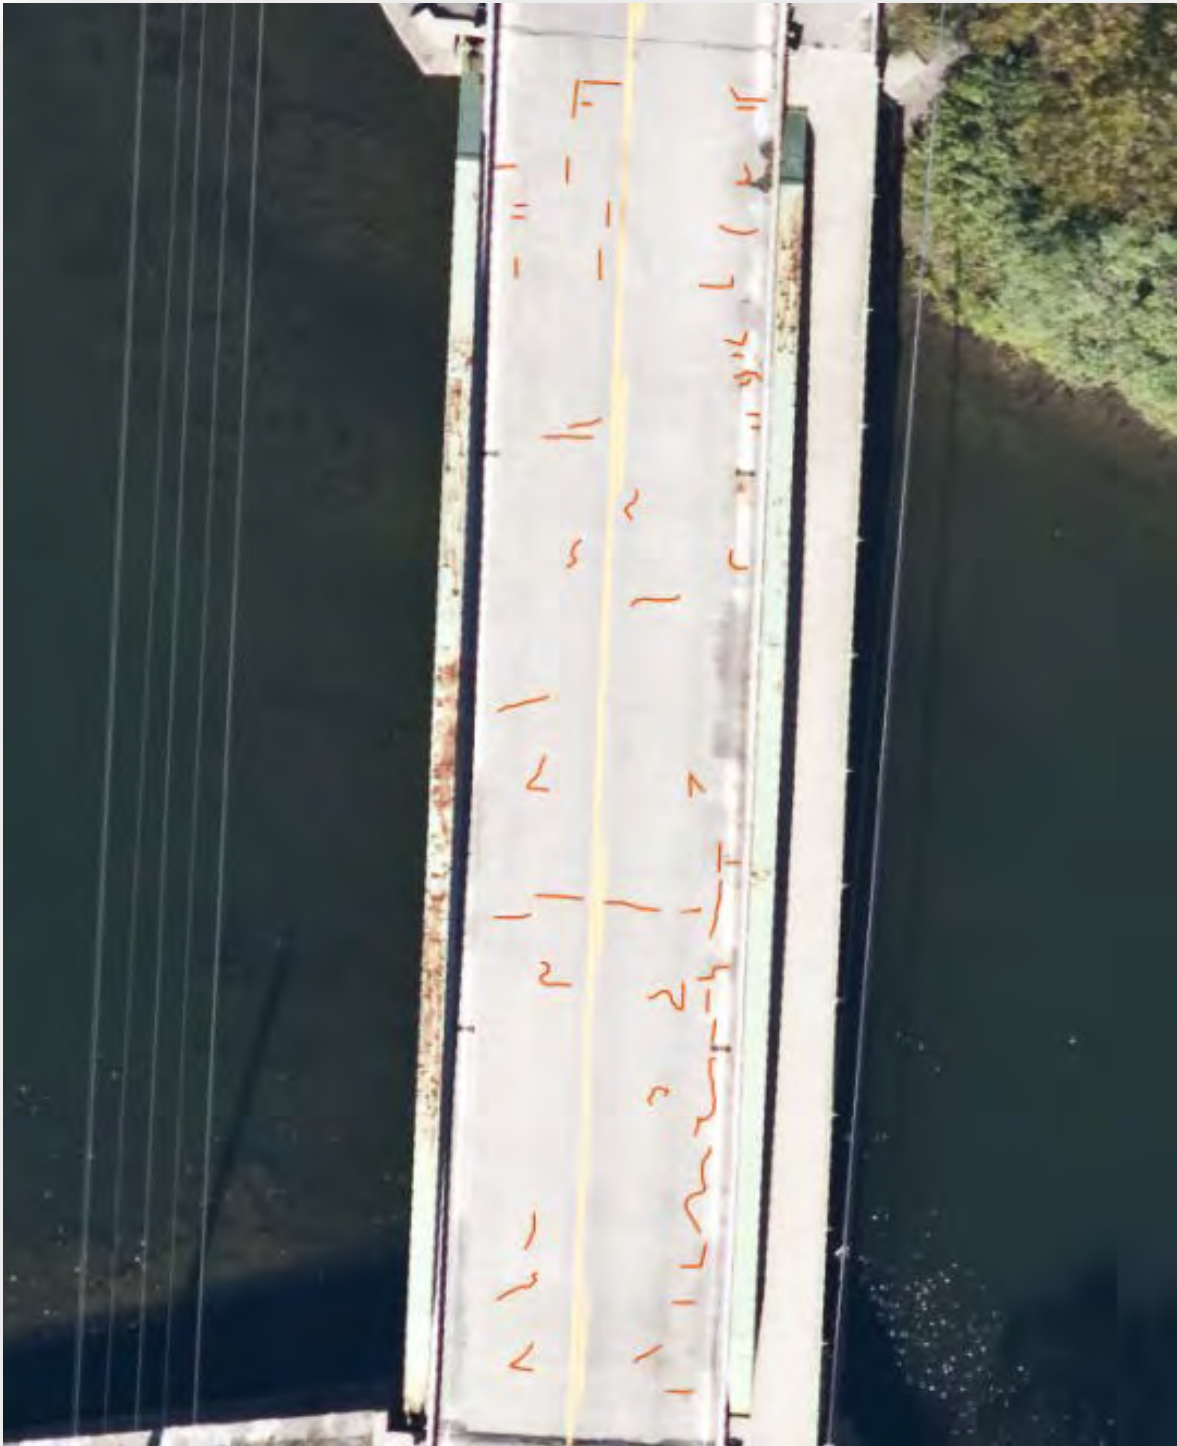
**Figure C.8.30: Bridge NO. 1027090 Crack Image**

<b>Span Area</b>						
<b>FID</b>	<b>Span</b>	<b>Area</b>	<b># Cracks</b>	<b>Obstruction Area</b>	<b>DV</b>	<b>Crack Density</b>
<b>0</b>	<b>A</b>	<b>5499.8</b>	<b>53</b>	<b>74.63389015</b>	<b>1</b>	<b>0.976928612</b>

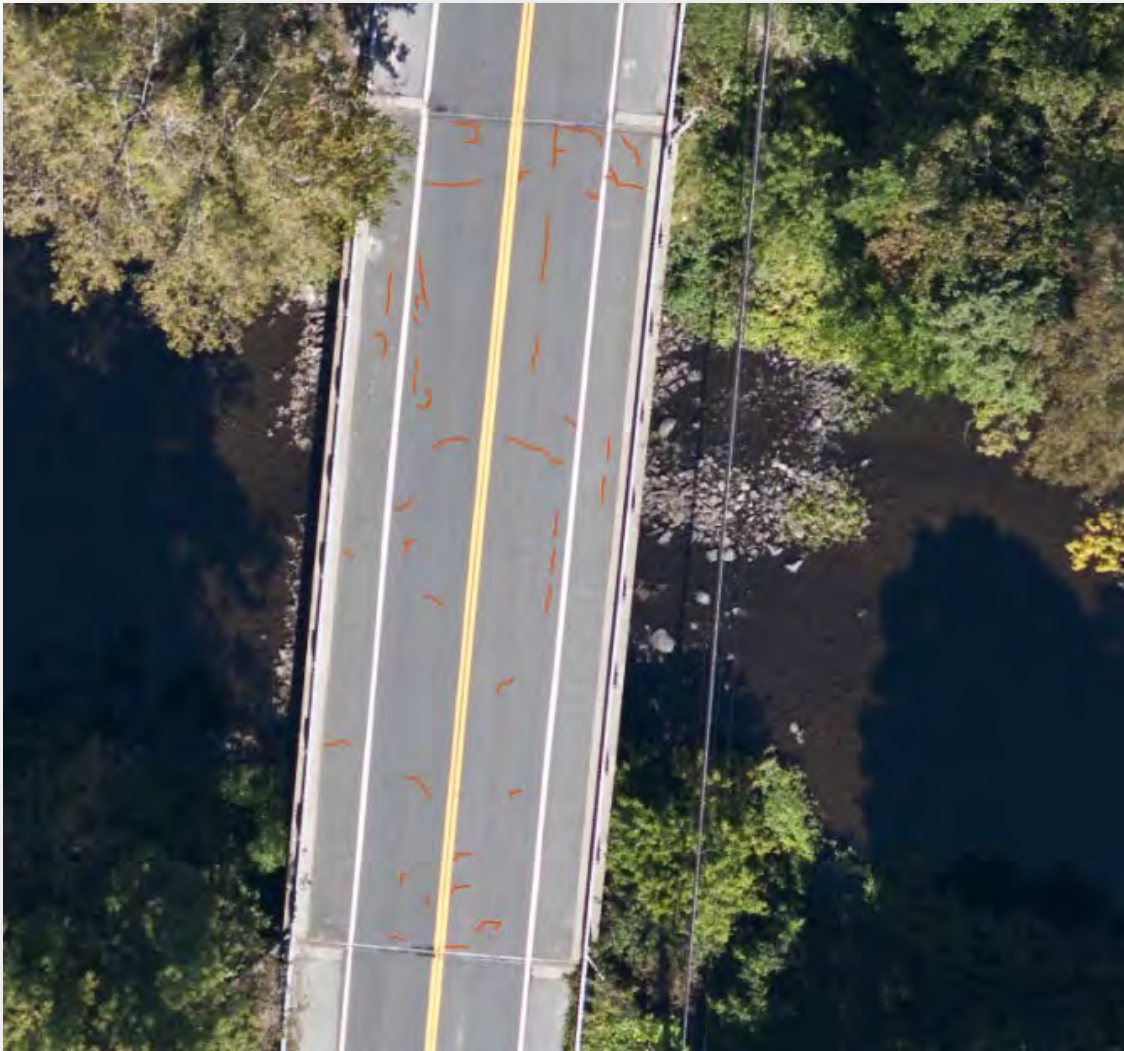
**Figure C.8.33: Bridge NO. 1034880 Crack Image**

<b>Span Area</b>						
<b>FID</b>	<b>Span</b>	<b>Area</b>	<b># Cracks</b>	<b>Obstruction Area</b>	<b>DV</b>	<b>Crack Density</b>
<b>0</b>	<b>A</b>	<b>6176.28</b>	<b>43</b>	<b>121.1884689</b>	<b>1</b>	<b>0.71014616</b>

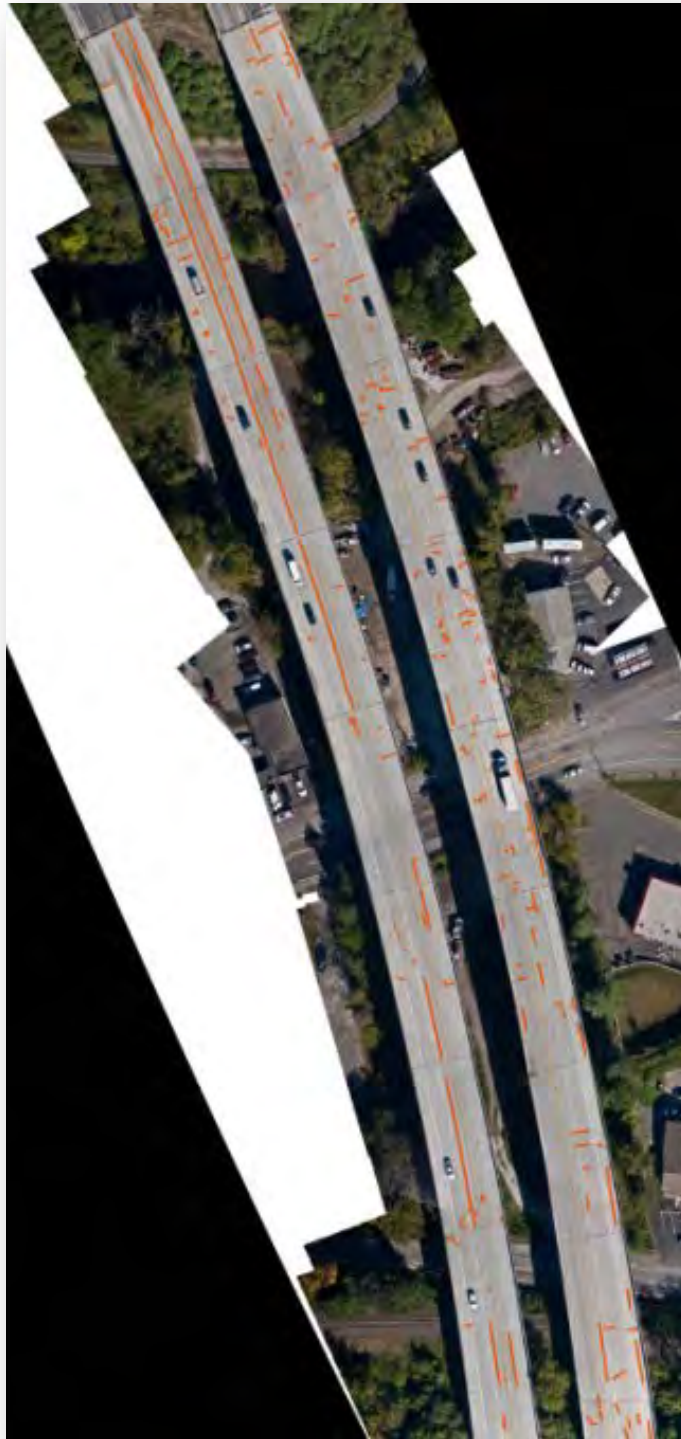
**Figure C.8.36: Bridge NO. 1052841 Crack Image**

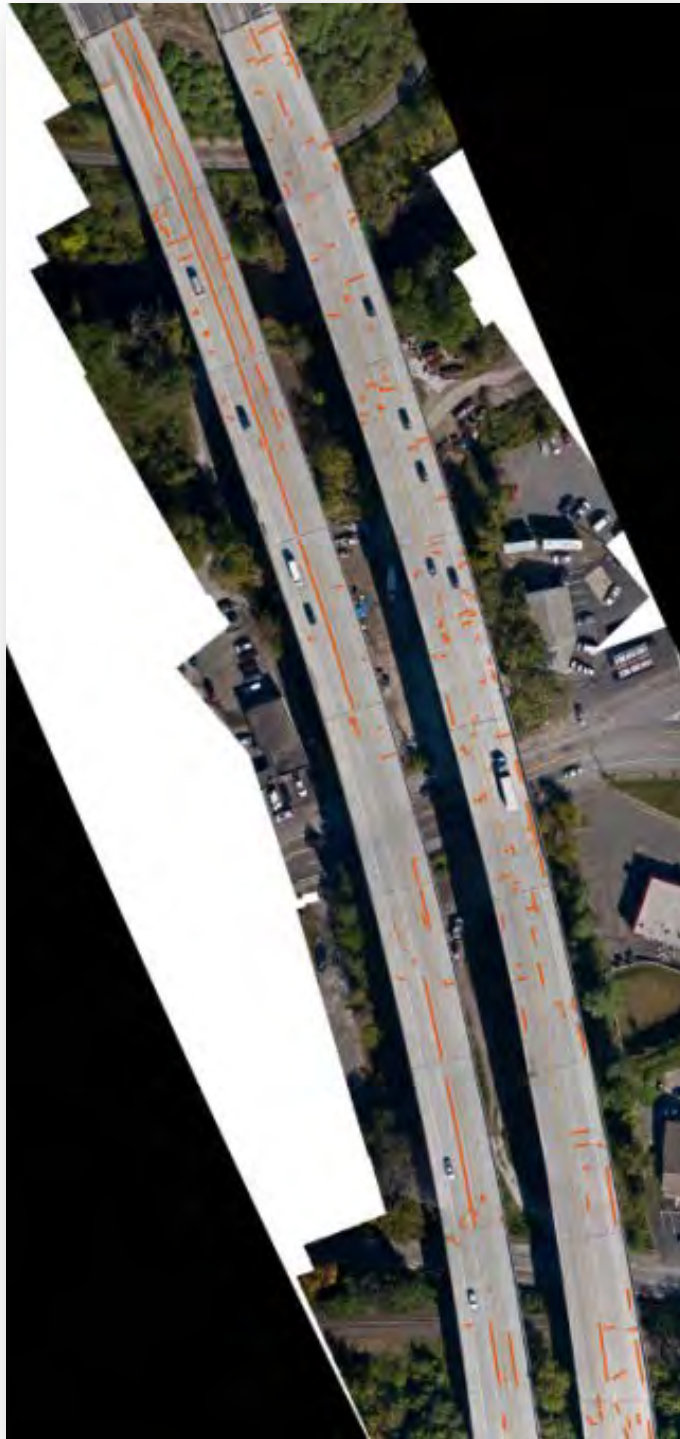
**Figure C.8.39: Bridge NO. 1052842 Crack Image**

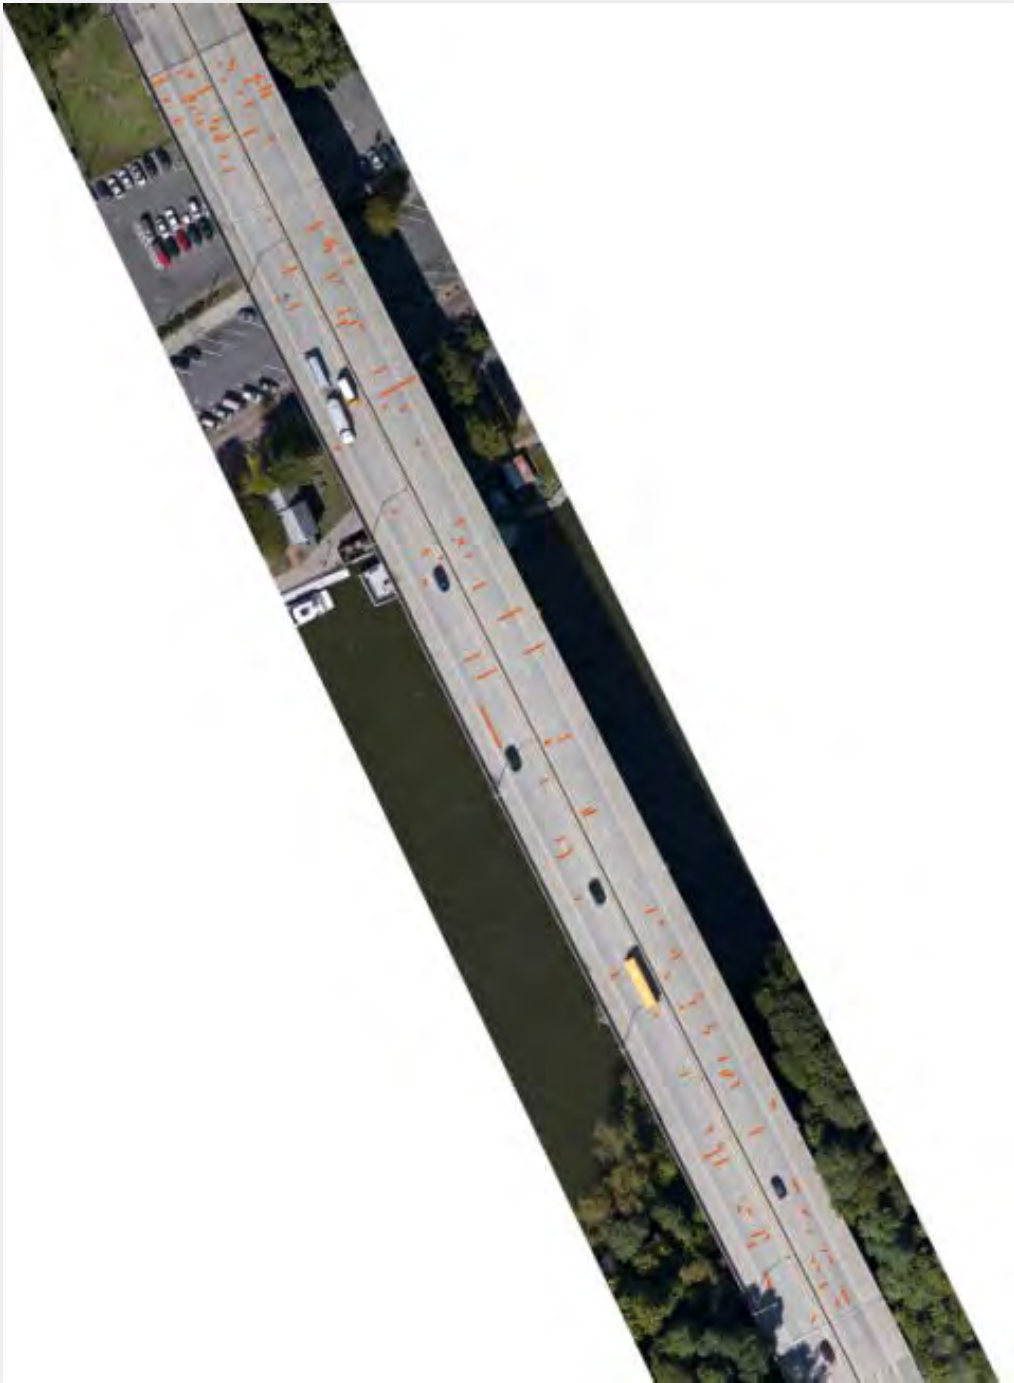
**Figure C.8.42: Bridge NO. 1069749 Crack Image**
